TALIESIN WEST PRESERVATION MASTER PLAN

Harboe Architects, PC

MAY 21, 2015

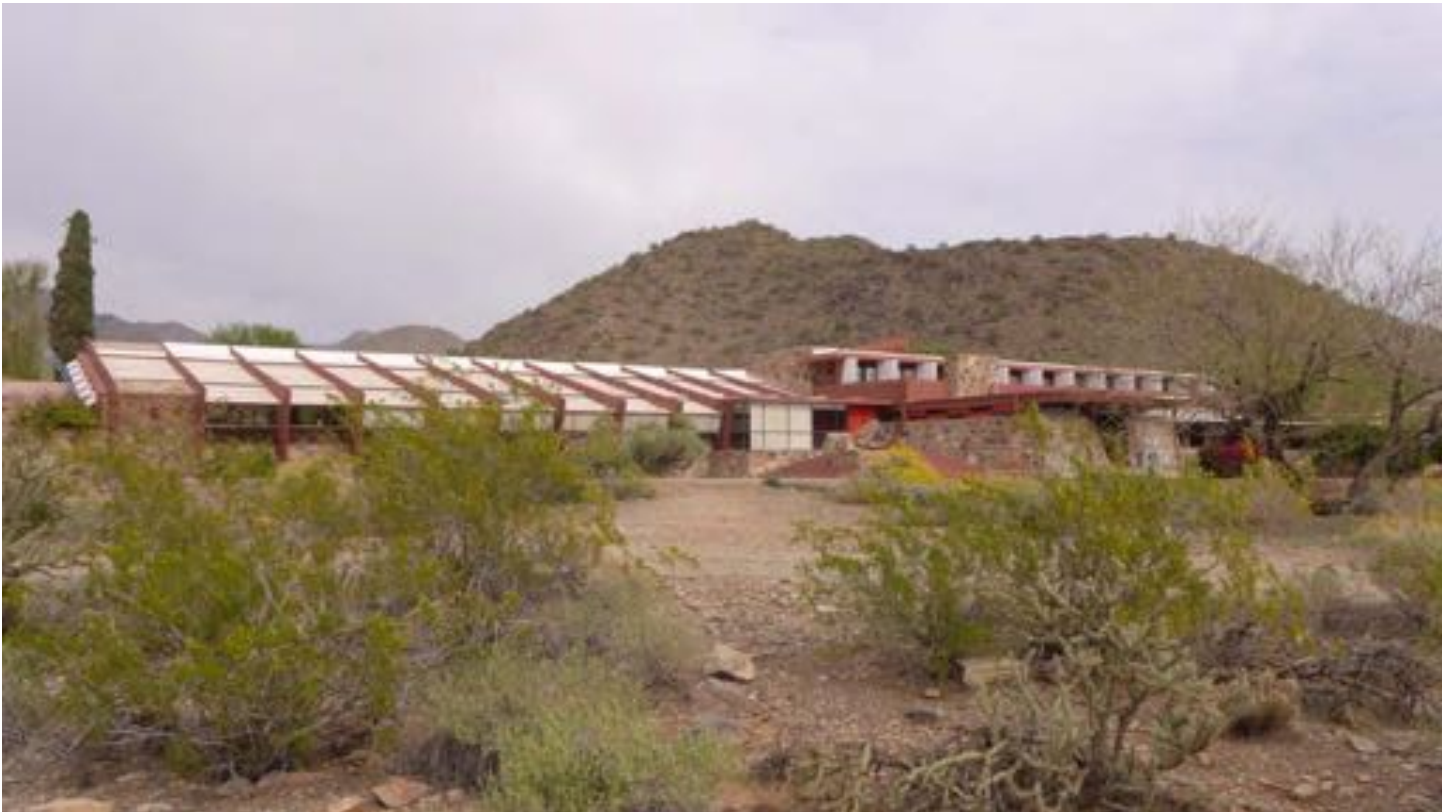
Figure 4-1 - View of Taliesin West looking northeast at Drafting Studio, Original Dining Room and Guest Deck, 2014 (Harboe Architects)

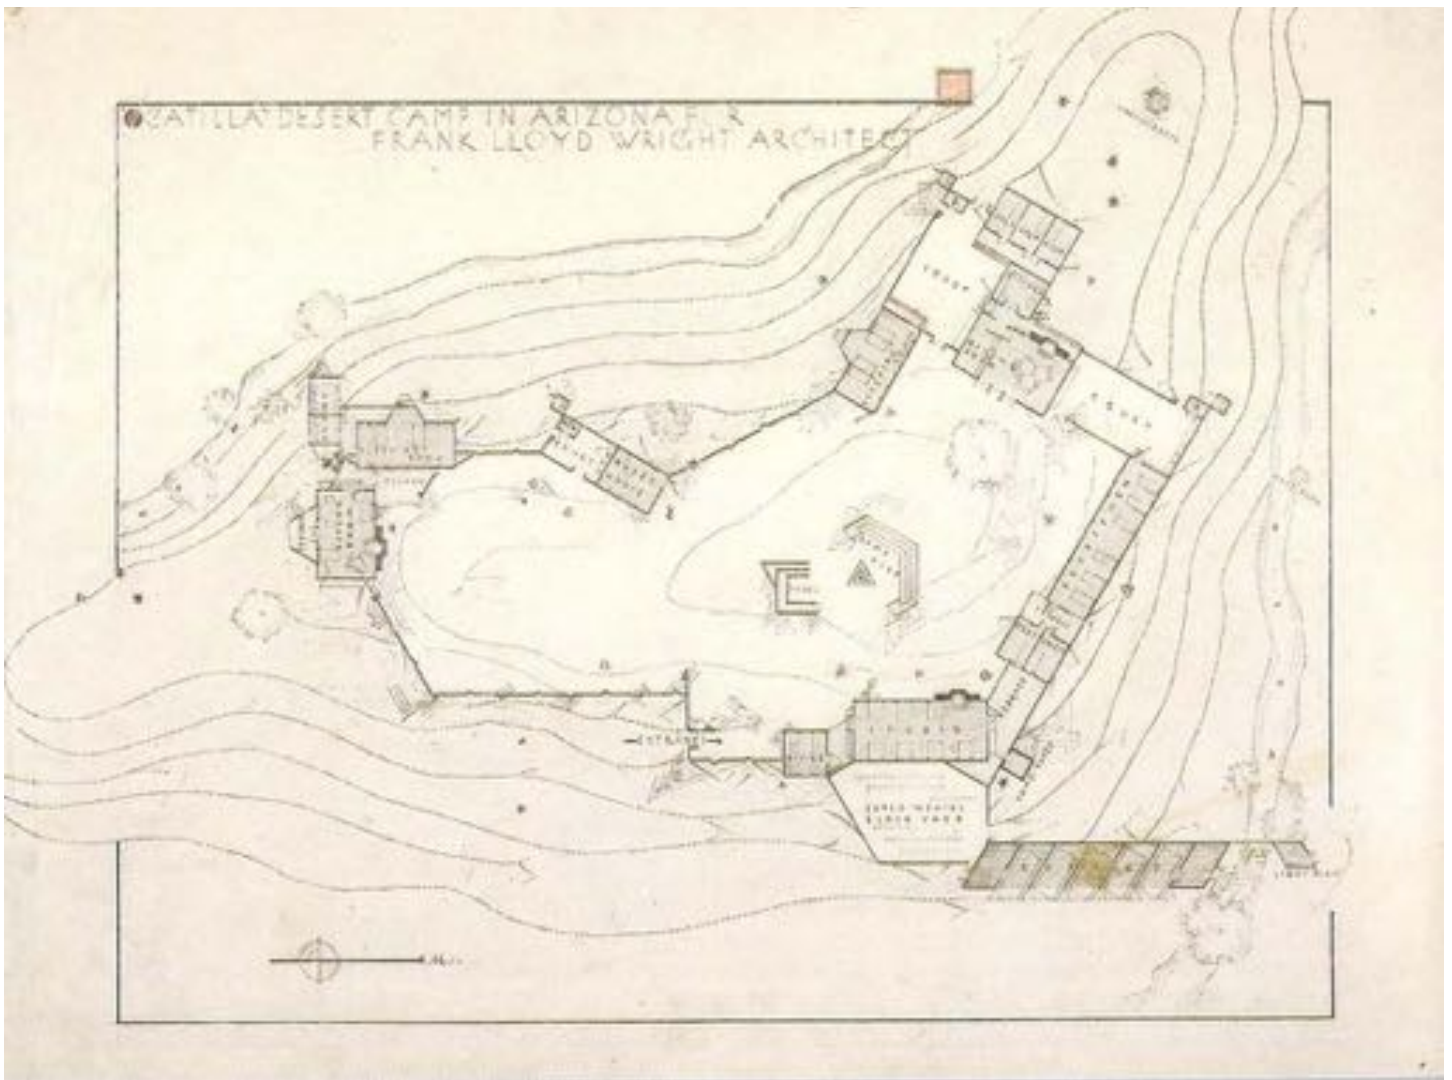
Figure 6-4 - Site plan for Ocatilla (The Frank Lloyd Wright Foundation Archives, The Museum of Modern Art | Avery Architectural & Fine Arts Library, Columbia University, New York).

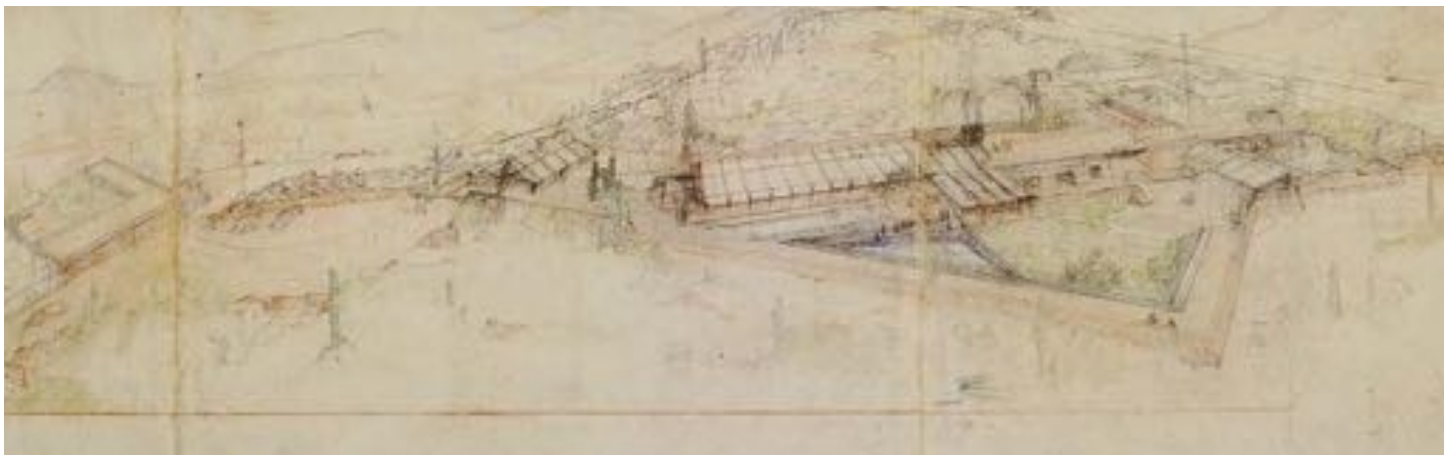
Figure 6-7 - Axial perspective drawing of Taliesin West (The Frank Lloyd Wright Foundation Archives, The Museum of Modern Art | Avery Architectural & Fine Arts Library, Columbia University, New York).

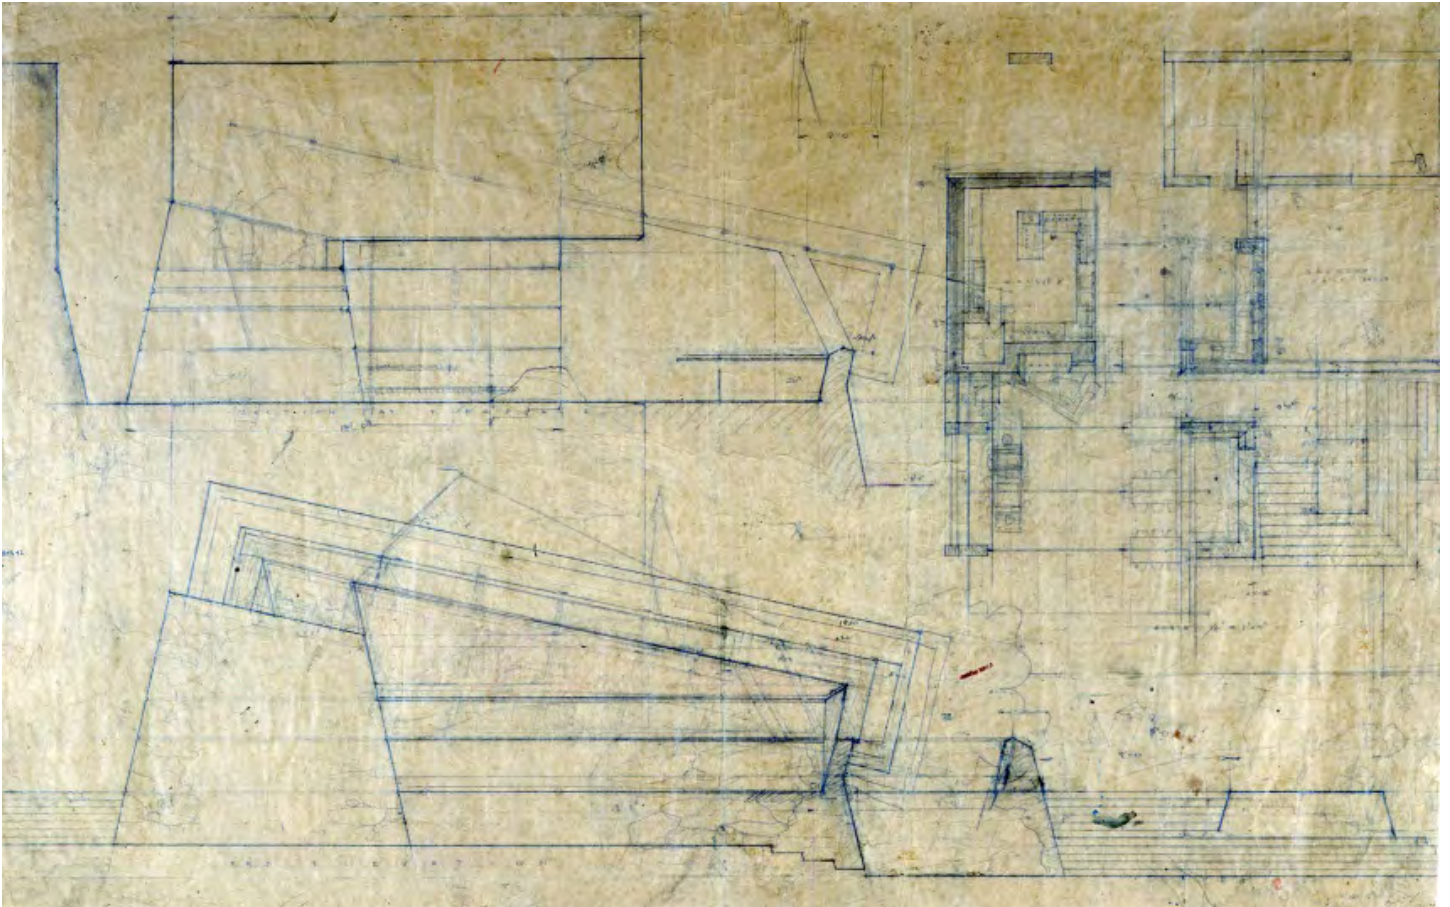
Figure 6-11 - Drawing of Drafting Studio (The Frank Lloyd Wright Foundation Archives, The Museum of Modern Art | Avery Architectural & Fine Arts Library, Columbia University, New York).

The individual buildings at Taliesin West were ingeniously designed by Wright as well. Drafted out in the open desert on brown butcher paper (to cut down on glare) Wright's plans, elevations, sections, and details appeared more like schematic sketches than working construction drawings. They had few, if any, dimensions and provided minimal information for construction; however, Wright personally oversaw the daily construction on site and made sure that each structure was built to fulfill the vision he had created in his mind. He regularly made design modifications as the buildings were being constructed. Seemingly never fully satisfied with the designs, or at least seeing room for improvement, Wright was continuously making alterations to the buildings and landscapes at Taliesin West up to the time of his death in 1959. It was an ever evolving experiment in the desert.

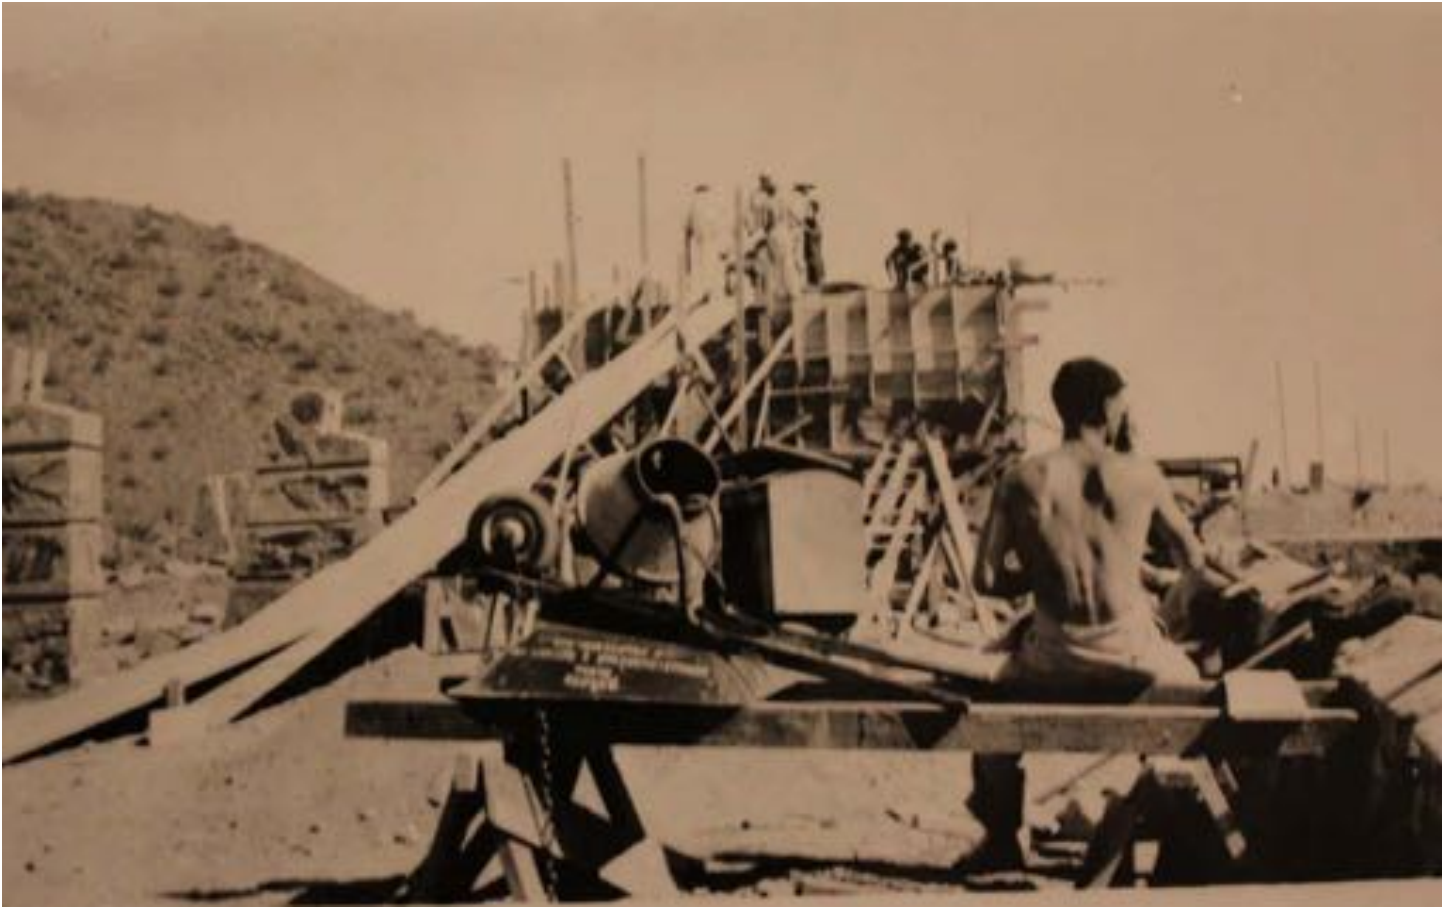
Figure 6-12 - Construction of Kitchen and Drafting Studio, ca 1938 (The Frank Lloyd Wright Foundation Archives, The Museum of Modern Art | Avery Architectural & Fine Arts Library, Columbia University, New York).

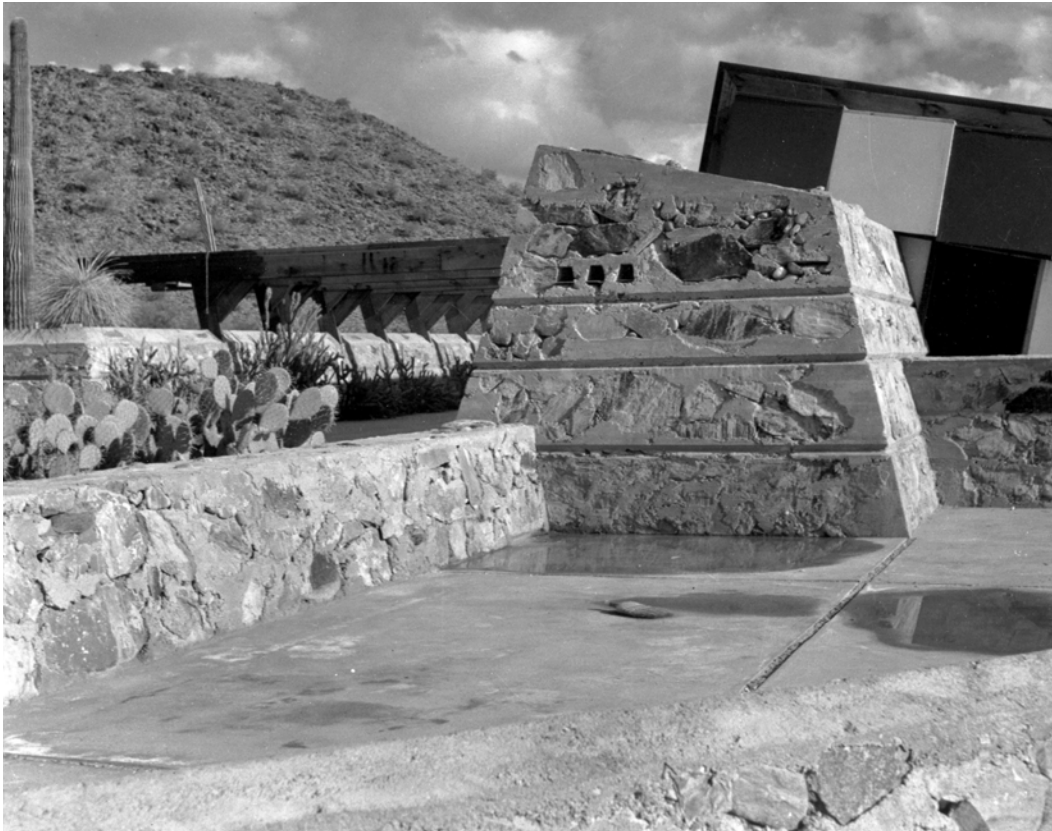
Figure 6-13 - Desert masonry vault at west end of Drafting Studio, ca. 1940 (The Frank Lloyd Wright Foundation Archives, The Museum of Modern Art | Avery Architectural & Fine Arts Library, Columbia University, New York).

Construction began in 1938 and continued into 1941 for these core buildings.¹⁸ The first structure to be built was the vault at the northwest end of the studio. The completion of the vault was crucial, as it was to hold the drawings being completed for all of Wright's architectural projects at the time. The walls of the vault were constructed of what Wright initially termed "desert rubble stone" but eventually came to be known as simply "desert masonry". Wright devised a way to use the abundant native stone around the site mixed with a dry cement mix to construct thick, solid walls to enclose the buildings he designed. What began in the vault quickly became the architectural vocabulary for the structures throughout the rest of the camp.¹⁹ The buildings were literally made of the desert.

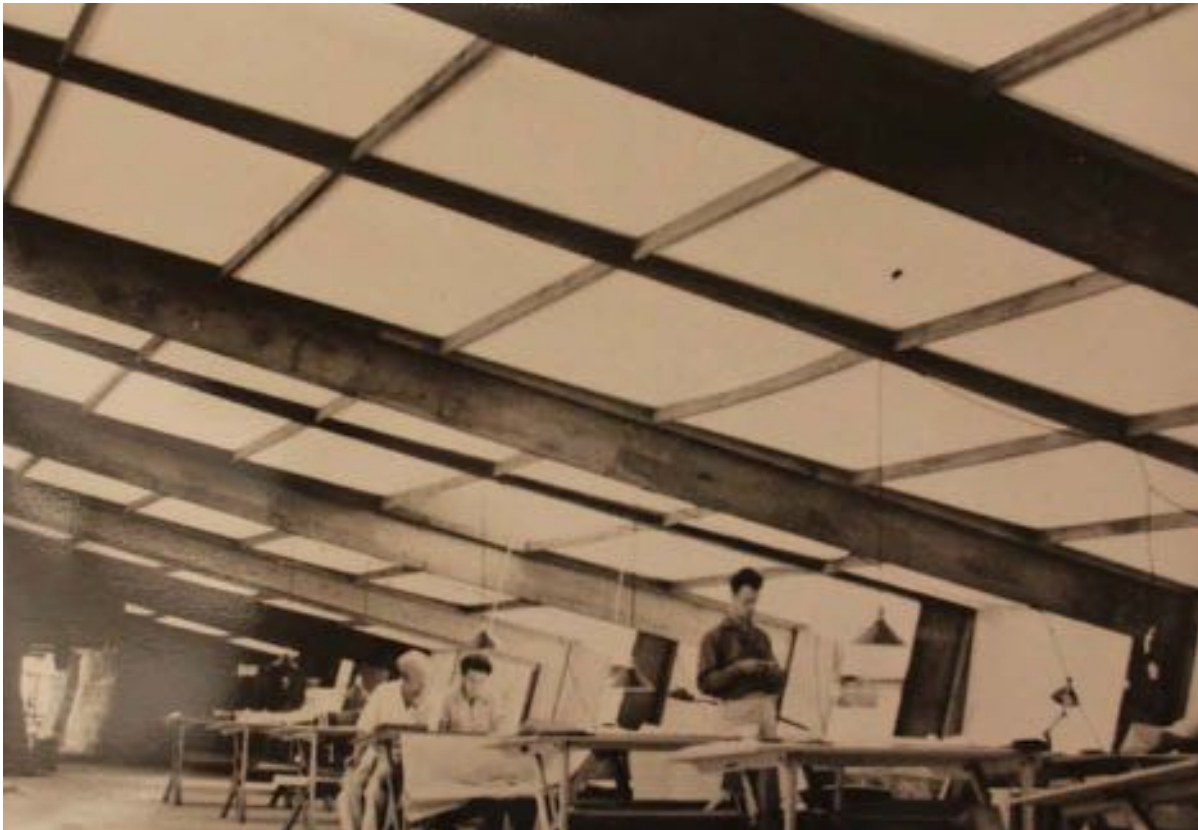
Figure 6-14 - Canvas roof overhead in Drafting Studio, ca. 1939 Drafting Studio (The Frank Lloyd Wright Foundation Archives, The Museum of Modern Art | Avery Architectural & Fine Arts Library, Columbia University, New York).

In the early days, some apprentices even slept in sleeping bags on the Drafting Studio floor every night before they had constructed their own tents. Although it was covered by a canvas roof, the Drafting Studio was largely exposed to the desert environment. Openings at the west end and between the masonry piers on the north side were left uncovered, leaving occupants exposed to the climate and creatures of the Arizona desert. On the north side of the Studio was a wood framed pergola.²⁵

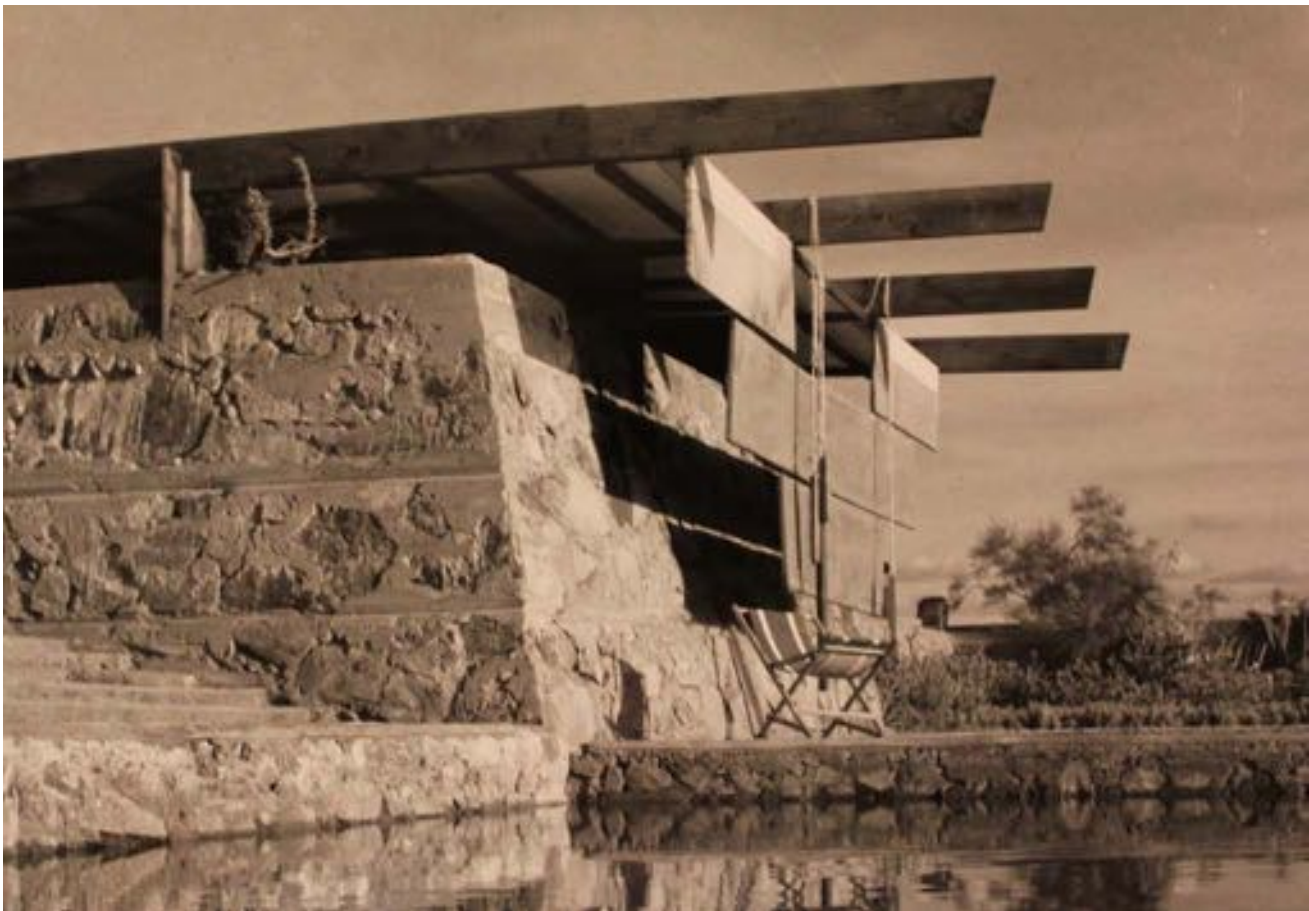
Figure 6-16 - Exterior of Original Dining Room, ca. 1939 (The Frank Lloyd Wright Foundation Archives, The Museum of Modern Art | Avery Architectural & Fine Arts Library, Columbia University, New York).

Adjacent to the Drafting Studio was the Kitchen which also had a concrete floor, walls of desert masonry, a serving counter, a large stove for cooking, a sink for washing dishes, and a storage room to keep the food. The Original Dining Room was accessed through the Kitchen. After it was completed, meals for the apprentices moved from the Drafting Studio to the Dining Room. The room was a rectangular mass that extended to the south of the Kitchen into the prow. It had thick, battered desert masonry walls and the north end of the room had a large masonry fireplace. The floor was smooth concrete separated into panels by wide mortar joints with exposed aggregate. The roof structure was raised up above the desert masonry walls to create a continuous slotted opening on three sides. The roof beams extended out past the wall on the south side with decorative wood "icicles" hanging from the ends. At the center of the roof was a large canvas skylight that let diffused natural light enter the space. Wood tables with small wooden stools provided the apprentices with places to eat their meals. Though not as enclosed as the Kiva, this was an inward looking contained space.

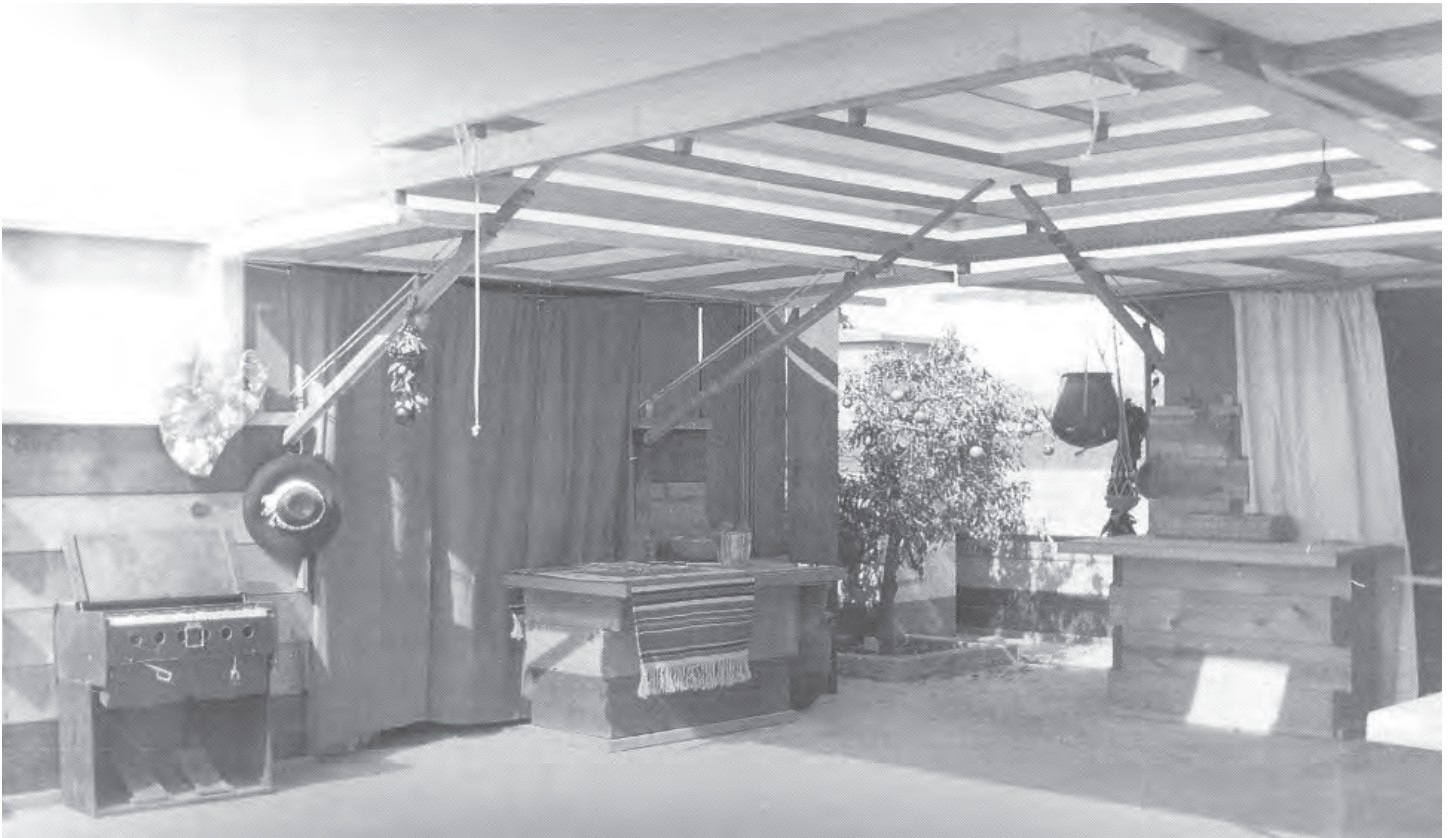
Figure 6-20 - Interior of Sun Trap, ca. 1939 (The Frank Lloyd Wright Foundation Archives, The Museum of Modern Art | Avery Architectural & Fine Arts Library, Columbia University, New York).

To the east and separated from the main core of the camp by a wash was a structure that Wright designed and built as temporary living quarters for himself, his wife, Olgivanna, and their daughter, Lovanna. It was located east of the main core of the campus and constructed of wood framing, with wood board and canvas used to enclose the spaces within. It contained three sleeping boxes (one for each of its three occupants) surrounding a central square courtyard that was paved in concrete. In his book, *Working With Mr. Wright*, Curtis Besinger described the conditions inside the Sun Trap as follows:

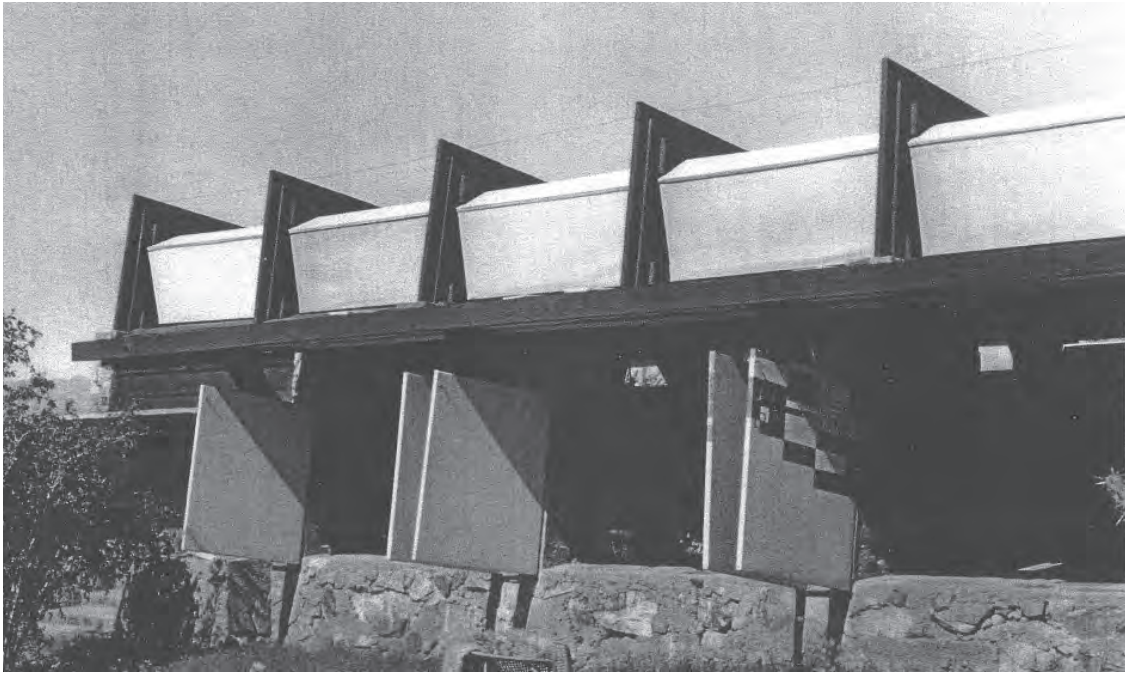
Figure 6-22 - East side of Garden Room, ca. 1940 (The Frank Lloyd Wright Foundation Archives, The Museum of Modern Art | Avery Architectural & Fine Arts Library, Columbia University, New York).

Construction of the main core of the camp continued each Winter/Spring season at Taliesin West up through 1941. By this time additional buildings had been completed including the Garden Room, Wrights' Living Quarters, Apprentice Court, and Guest Deck. The Garden Room was completed in 1940 as a living room for the Wrights, but it became a shared space for all of the Fellowship, often hosting parties and formal evenings of lively music and stimulating conversation. To the north was a dining cove with a large desert masonry fireplace, an intimate dining space for the Wrights and their dinner guests. The walls of the Garden Room, like the other buildings on campus, were constructed of desert masonry, and the floors were concrete covered with a rose colored shag carpet. Overhead was a slanted roof constructed of redwood framing and operable canvas panels similar to the Drafting Studio and Office. The east side of the room opened up onto a terrace and the Wright's private garden. The west wall of the room was lined with built in benches covered with upholstered seat cushions and pillows. The south end of the room had an opening that looked out to the valley and Camelback Mountain beyond. The grand piano that was originally in the Drafting Studio was moved to the south end of the Garden Room and next to it stood lovanna's harp. Throughout the room there were also small wooden hassocks with cushions for additional seating.²⁹

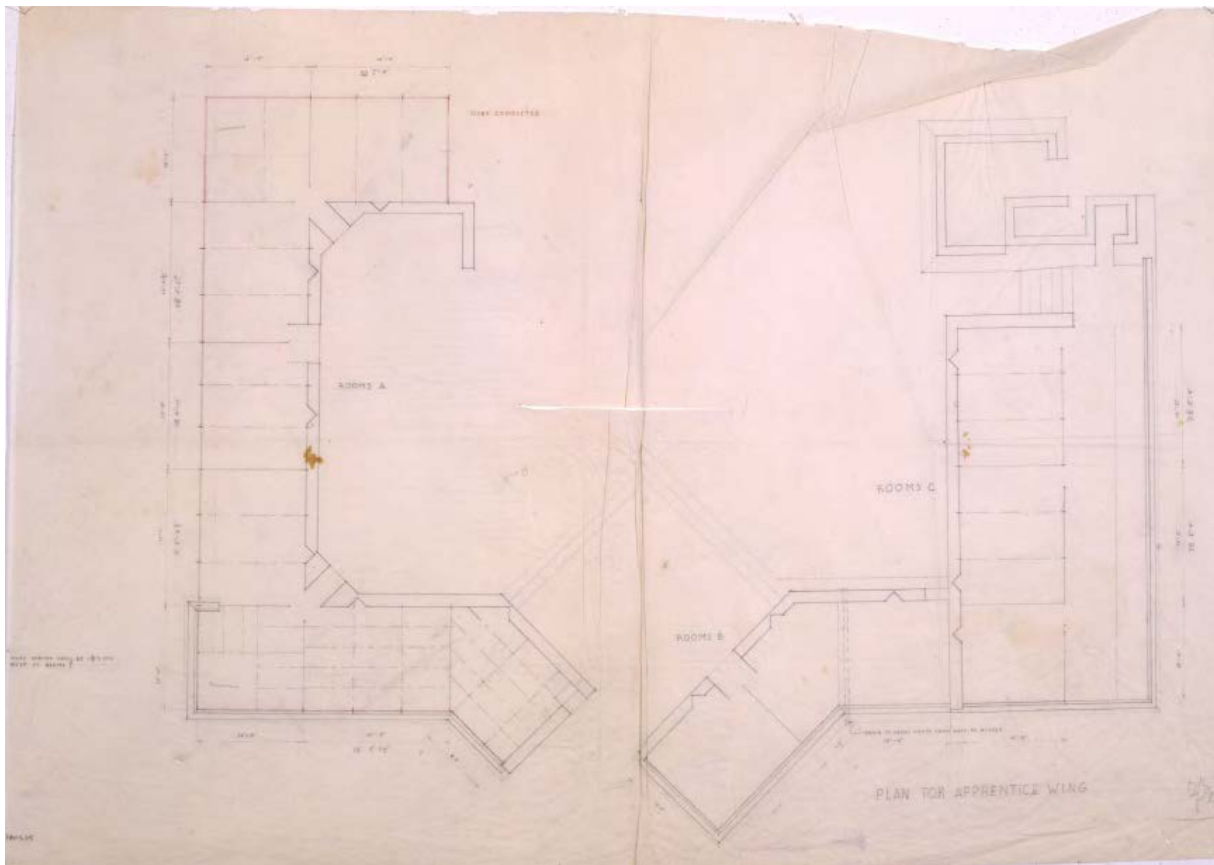
Figure 6-24 - Plan of Apprentice Court (The Frank Lloyd Wright Foundation Archives, The Museum of Modern Art | Avery Architectural & Fine Arts Library, Columbia University, New York).

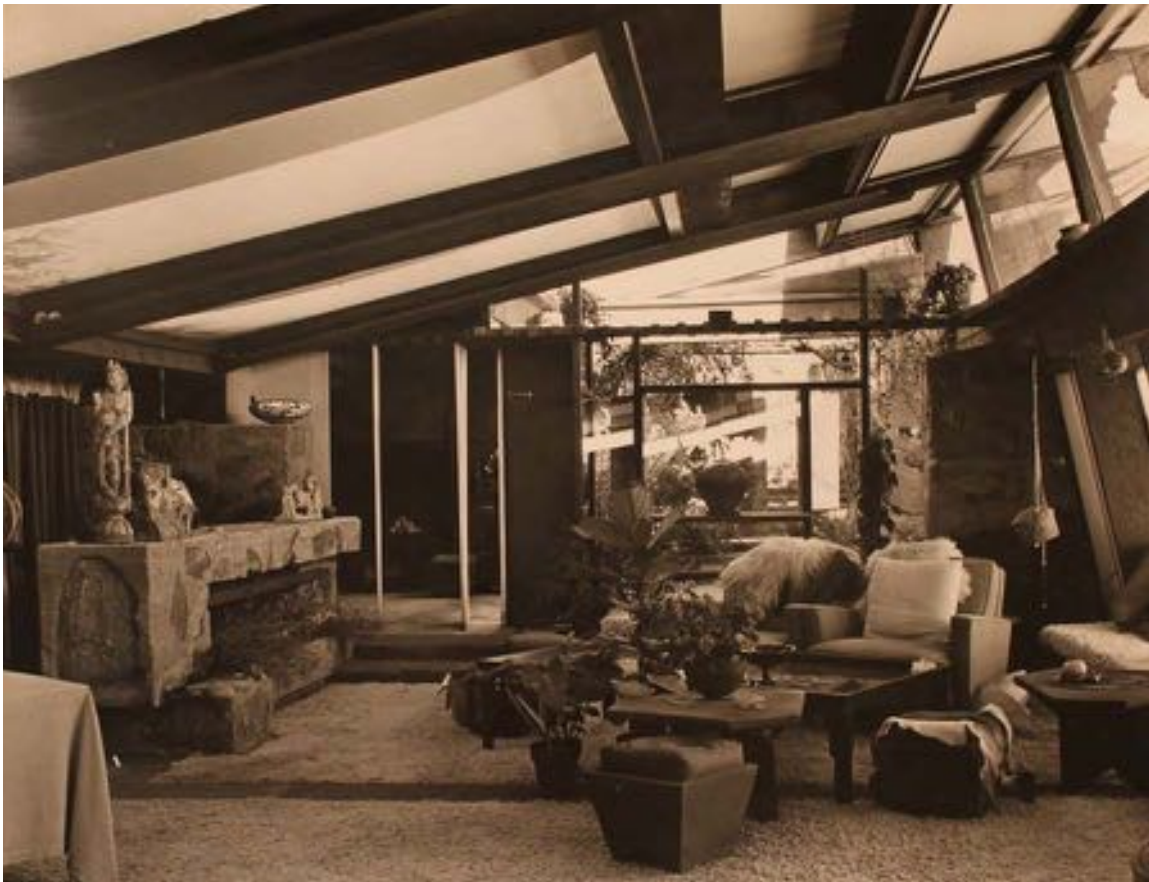
Figure 6-26 - Garden Room looking north after glass installed at clerestory and north wall, ca. 1948 (The Frank Lloyd Wright Foundation Archives, The Museum of Modern Art | Avery Architectural & Fine Arts Library, Columbia University, New York).

According to Bruce Brooks Pfeiffer, it was Olgivanna Lloyd Wright that convinced her husband to install glass when she told him of a dream she had of the two of them looking out on a storm over the desert through large walls of glass.³⁶ In 1946, Wright had glass added to the clerestories on the north side of the Drafting Studio and east side of the Garden Room. Continuing throughout the late 1940s and early 1950s, glass was added to many of the buildings at Taliesin West, creating a transparency that had previously not existed and enclosing the buildings from the exterior climate. Whether it was due to his wife's convincing or by his own conviction, the introduction of glass had a profound effect on the character and architecture of Taliesin West and began the transition from desert camp to permanent settlement. In addition to the introduction of glass, the Garden Room was redecorated with new rugs and furnishings and many of the desert plants, such as the staghorn and prickly pear cacti, were removed and replaced with non-native plantings. Former apprentice, Curtis Besinger, described the changes as follows, "It had lost much of its large and bold, archaic quality. It was no longer a camp. Its scale had been changed by the introduction of smaller-scale elements. It had become domesticated and civilized."³⁷

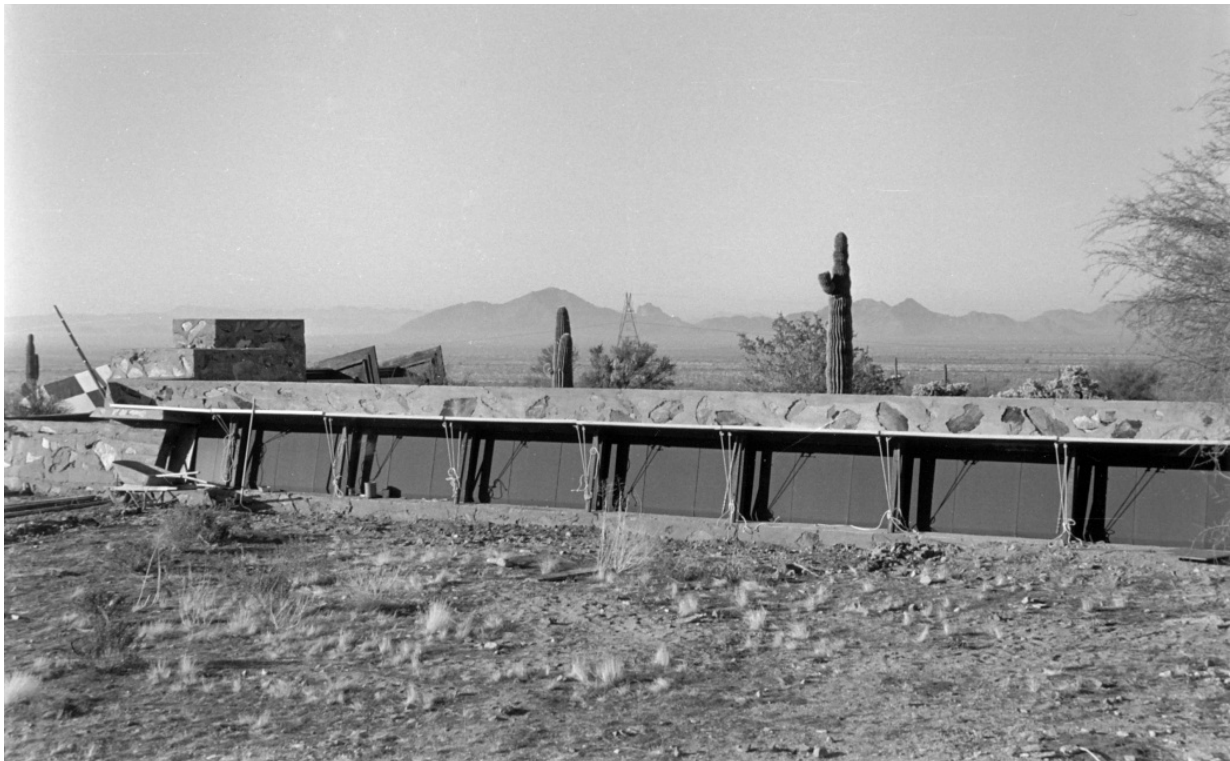
Figure 6-28 - Exterior of Cabaret, ca. 1950 (The Frank Lloyd Wright Foundation Archives, The Museum of Modern Art | Avery Architectural & Fine Arts Library, Columbia University, New York).

With the influx of all the new apprentices, the Kiva could no longer hold all the members of the Fellowship comfortably. So, the same year the Sun Cottage was built, the apprentices began work on the construction of the Cabaret, which proved to be quite challenging. To complete the theater, the apprentices had to dig a large hole in the ground. This was extremely difficult to do by hand as much of the ground was solid caliche, which is a hard layer of sand and clay cemented together with calcium carbonate and other minerals. After a number of failed attempts by the apprentices, Wright hired a bulldozer to come out from Phoenix to excavate the site. Once this was complete, the apprentices began forming the desert masonry walls. The greatest challenge on the Cabaret was the construction of the roof slab. It was designed with conventional sizes and spacing for steel reinforcing bar; however, Wright insisted that the roof slab have large stones in it to be consistent with the appearance of the walls. Because of this, he “replaced conventional reinforcing with only 2 large bars, about one inch square in each bay. They were placed to make an X in each bay.”³⁸ The formwork was left in place during the summer of 1949 so that the concrete could achieve ultimate strength before removing it. The following winter, when the apprentices arrived back at camp the formwork was removed and large cracks appeared in the slab. Worried that the roof would not hold, Wright's solution was to add a series of inverted concrete beams above the slab.³⁹

The Cabaret was completed in December of 1950, just in time for Christmas Eve dinner. The finished building included a large theater space with tiered seating. Each row of seating faced the movie screen at the front of the room and had a built in counter so that meals could be served during film screenings. Wright loved to watch movies and it was almost a ritualistic social activity. Through his granddaughter, actress Anne Baxter, Wright was able to access many new films of the time. He was fascinated by the relationship of the soundtrack to the visual images and had the projectors modified so that the visual display of the soundtrack could be viewed along side the image. Some might have found it distracting, Wright found it fascinating. Gene Masselink kept detailed records of what films were shown when.

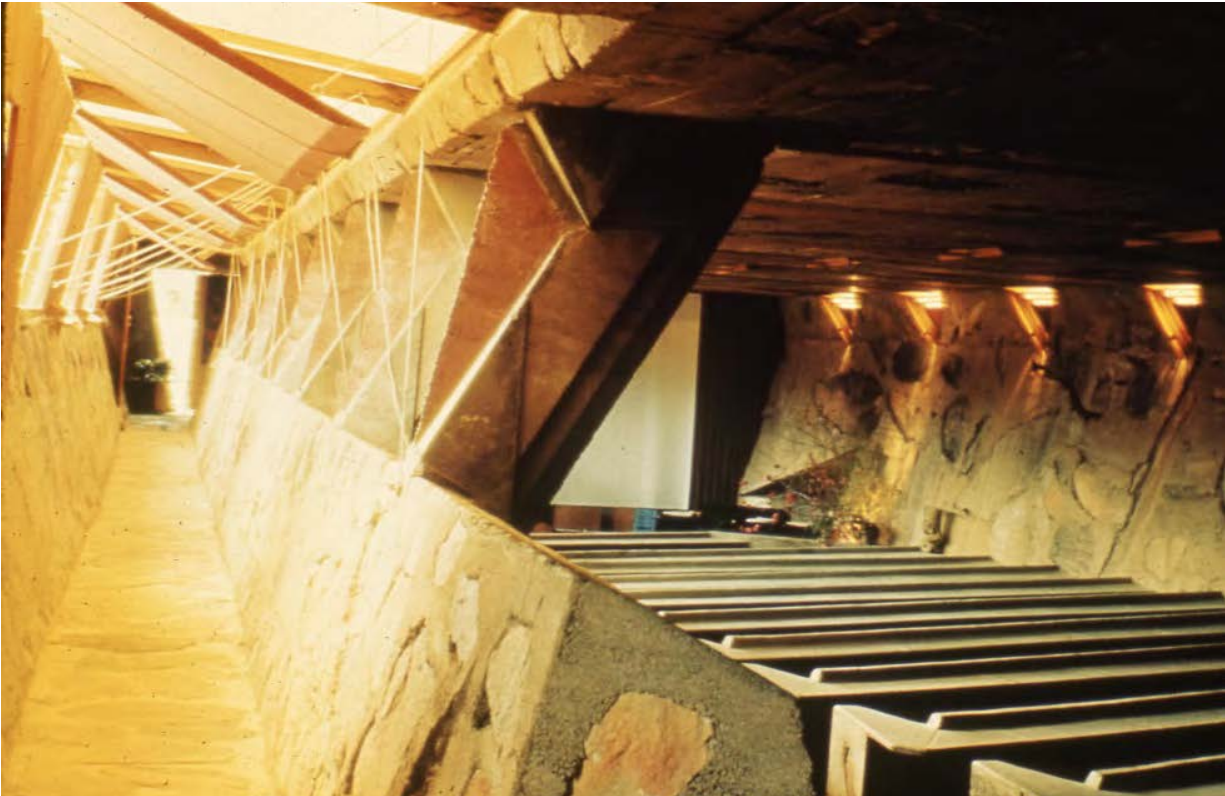
Figure 6-29 - Inside Cabaret showing corridor with operable canvas panels and theater space, ca. 1952 (The Frank Lloyd Wright Foundation Archives, The Museum of Modern Art | Avery Architectural & Fine Arts Library, Columbia University, New York).

A sunken orchestra pit below the screen featured a large grand piano. The long narrow corridor that led to the back of the theater had a series of openings on the east side that were fitted with operable red canvas flaps.⁴⁰ With a new theater constructed, the Kiva was renovated into a library for the Fellowship. The stepped seating and tables were removed; however, the benches around the perimeter were left intact. New wood pendant lights were added at the ceiling as well. Also, around this same time, the west half of the loggia was enclosed with glass windows and wood base wall between the masonry piers to create a new, larger dining room for the Fellowship, which had outgrown the Original Dining Room. The Original Dining Room, in turn, became a private dining space for the Wrights to entertain clients and guests.

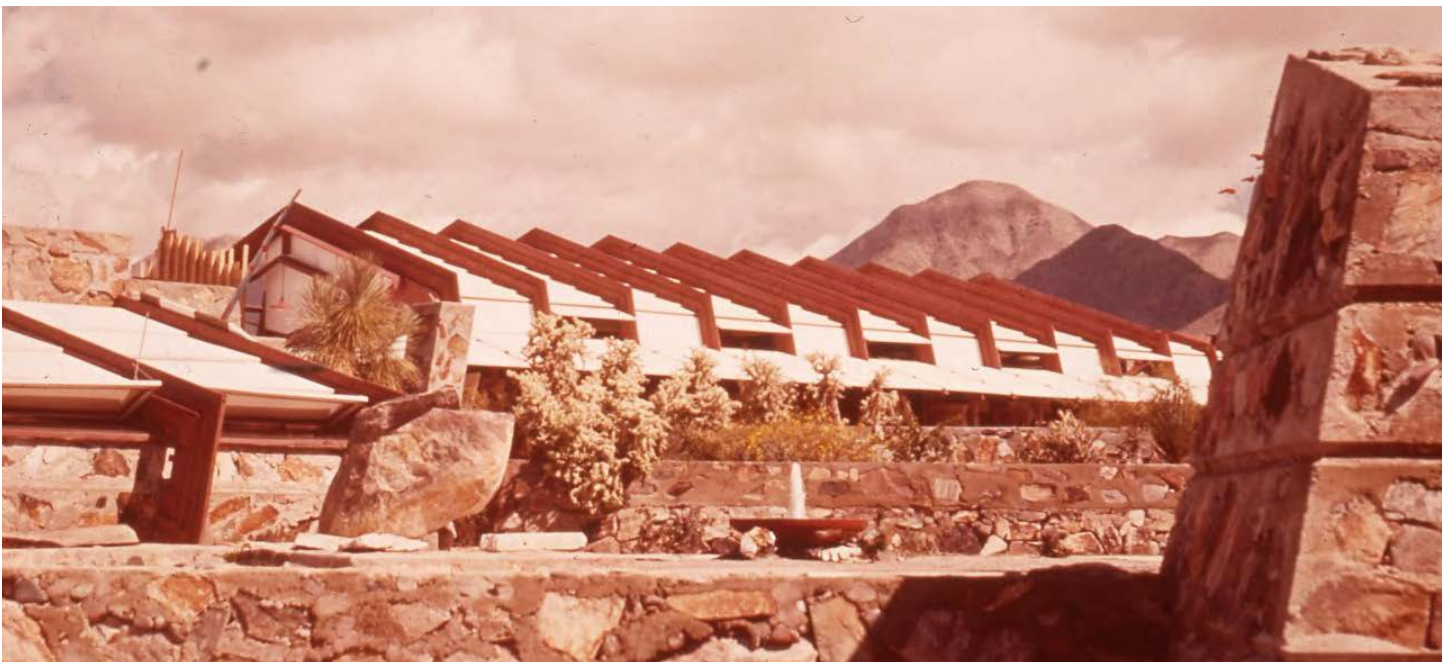
Figure 6-30 - Exterior of Pavilion, ca. 1958 (The Frank Lloyd Wright Foundation Archives, The Museum of Modern Art | Avery Architectural & Fine Arts Library, Columbia University, New York).

The late 1950s brought major changes at Taliesin West beginning with the design and construction of the Movements Pavilion. Even before meeting Frank Lloyd Wright, Olgivanna Wright had a long time relationship with the spiritual leader Georges Ivanovich Gurdjieff who espoused a school of self-awareness based on what he called the “Fourth Way” or “The Work”. A key component of his teachings involved the “Movements” which could be seen as a form of dance or dance therapy. It was something in which Olgivanna excelled. Although she eventually drifted from Gurdjieff, who died in 1949, she continued her love of movement and dance. She and Iovanna had been asking Wright to build them a performance space for a number of years, and in 1954 he set to work designing and later constructing the new Pavilion on the east side of the Cabaret. The Pavilion was completed in 1957 and constructed with desert masonry piers that supported a roof structure of built-up redwood framing with fabric panels, similar to the construction of the roof on the Drafting Studio. It featured rows of tiered seating with a large stage in front.

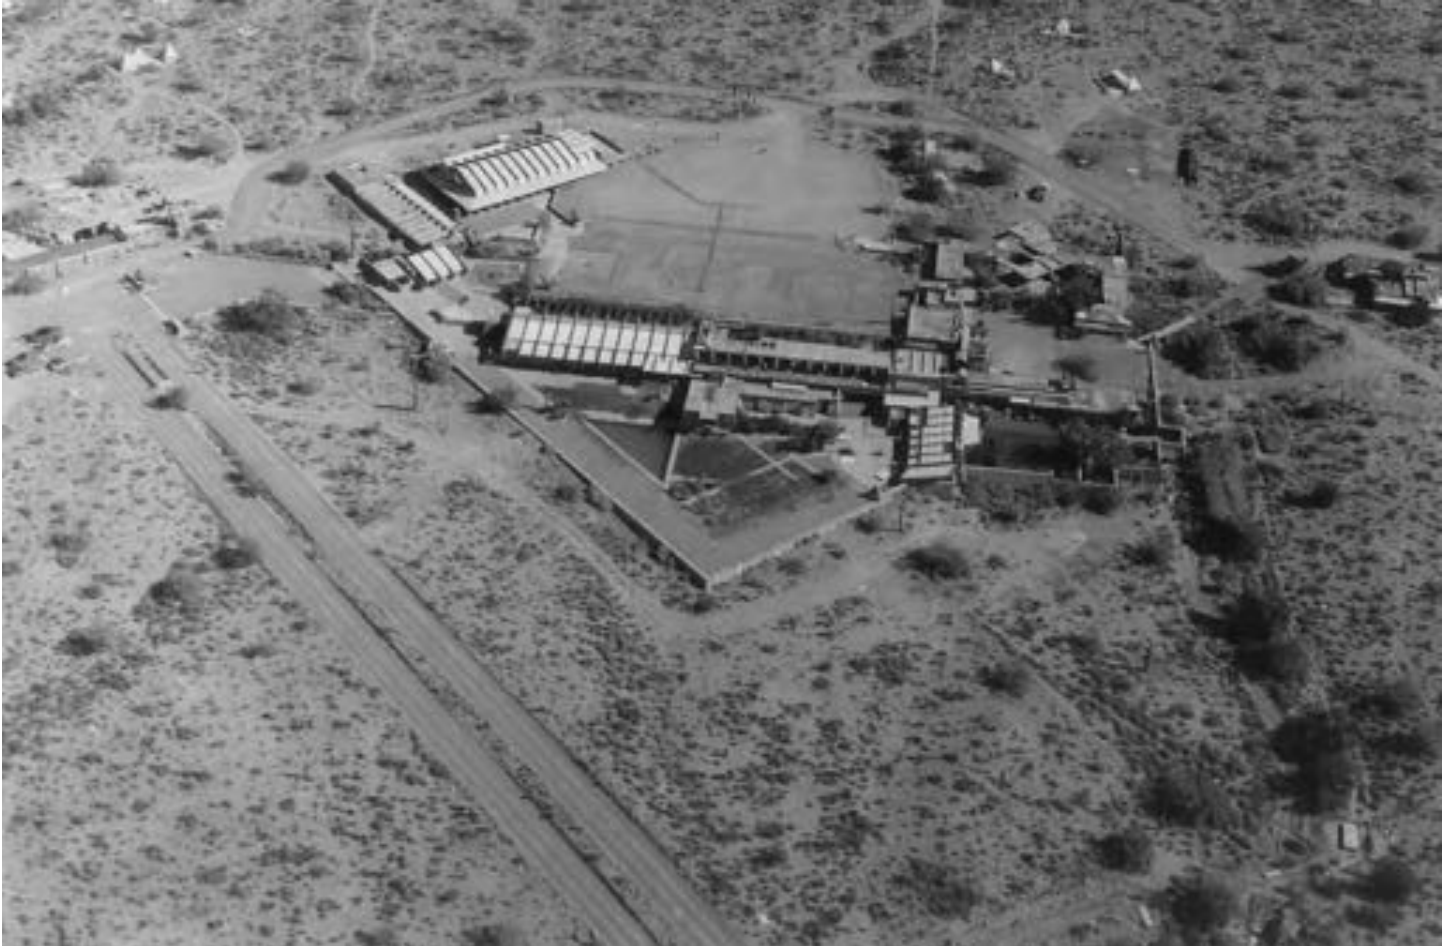
Figure 6-31 - Aerial view of Taliesin West showing new entry drive and area cleared for orchard, 1959 (Pedro Guerrero)

In 1959, nearing the end of his life, Wright continued to make significant changes, especially to the landscape of Taliesin West. He drew up a new design to reroute the entry drive so that visitors would have a more direct view of the prow and buildings as they approached. He also laid out a plan for a new orchard to be planted north of the Drafting Studio.⁴⁴ Frank Lloyd Wright died on April 9, 1959 at the age of 91; however, his legacy lived on through Olgivanna Lloyd Wright and the loyal apprentices that continued his work long after his death.

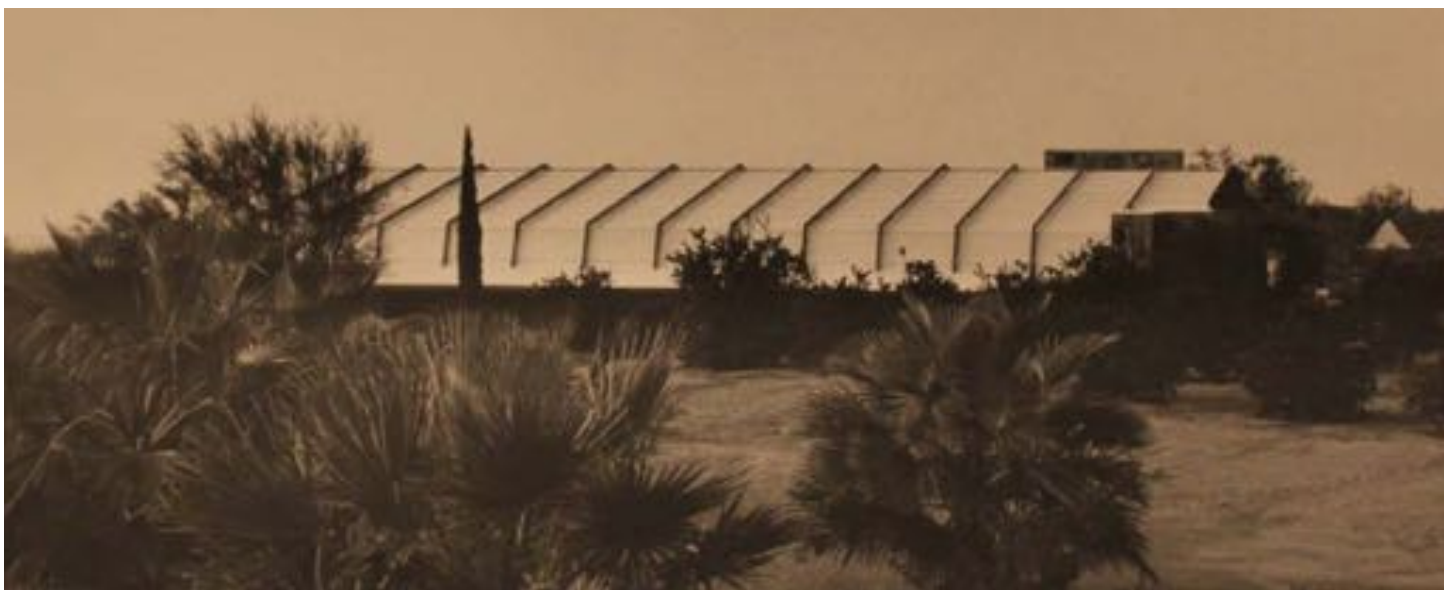
Figure 6-32 - Reconstructed Pavilion ca. 1965 (The Frank Lloyd Wright Foundation Archives, The Museum of Modern Art | Avery Architectural & Fine Arts Library, Columbia University, New York).
