TALIESIN WEST PRESERVATION MASTER PLAN

Harboe Architects, PC

MAY 21, 2015

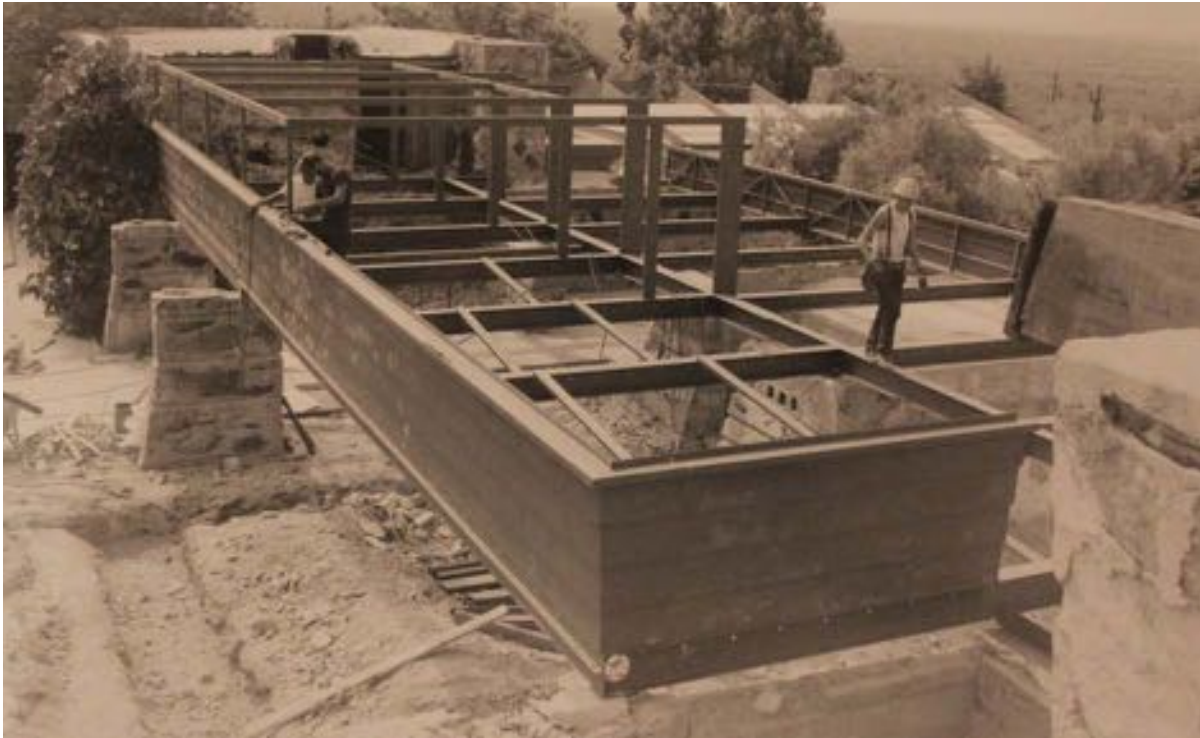
Figure 6-33 - Reconstruction of the Guest Deck in 1970 (The Frank Lloyd Wright Foundation Archives, The Museum of Modern Art | Avery Architectural & Fine Arts Library, Columbia University, New York).

The 1970s brought about additional renovations at Taliesin West. The most significant update came in 1970. The wood structure of the Guest Deck had been sagging and causing concern about its structural integrity. Because of this, the senior apprentices decided to demolish the entire Guest Deck over the Kitchen and Dining Room and reconstruct it in steel. This was a complex project and required a professional construction crew as well as a crane to mount the steel structure in place. The entire Guest Deck was demolished down to the desert masonry and the original wood framing was replaced with steel. The Kitchen and Dining Room were also renovated at this time and the pergola on the north side of the Drafting Studio was rebuilt in steel ten inches higher than it was originally constructed. Everything was removed and rebuilt except the desert masonry walls and piers. The completed Guest Deck, although painted metal instead of wood, had generally the same appearance as the original; however, a number of key dimensions such as ceiling heights were changed.

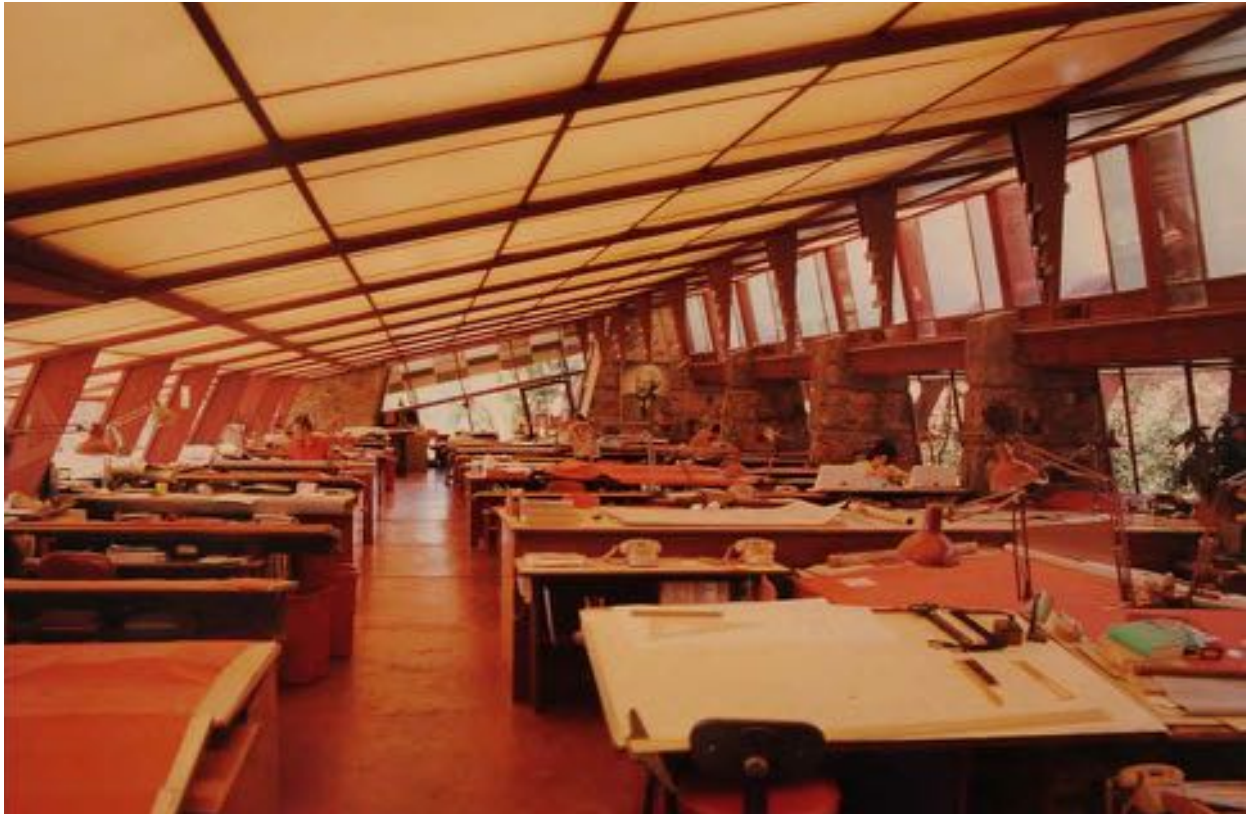
Figure 6-35 - Drafting Studio with fiberglass roof panels, ca. 1980 (The Frank Lloyd Wright Foundation Archives, The Museum of Modern Art | Avery Architectural & Fine Arts Library, Columbia University, New York).

- Fabric roof panels were replaced with fiberglass panels.

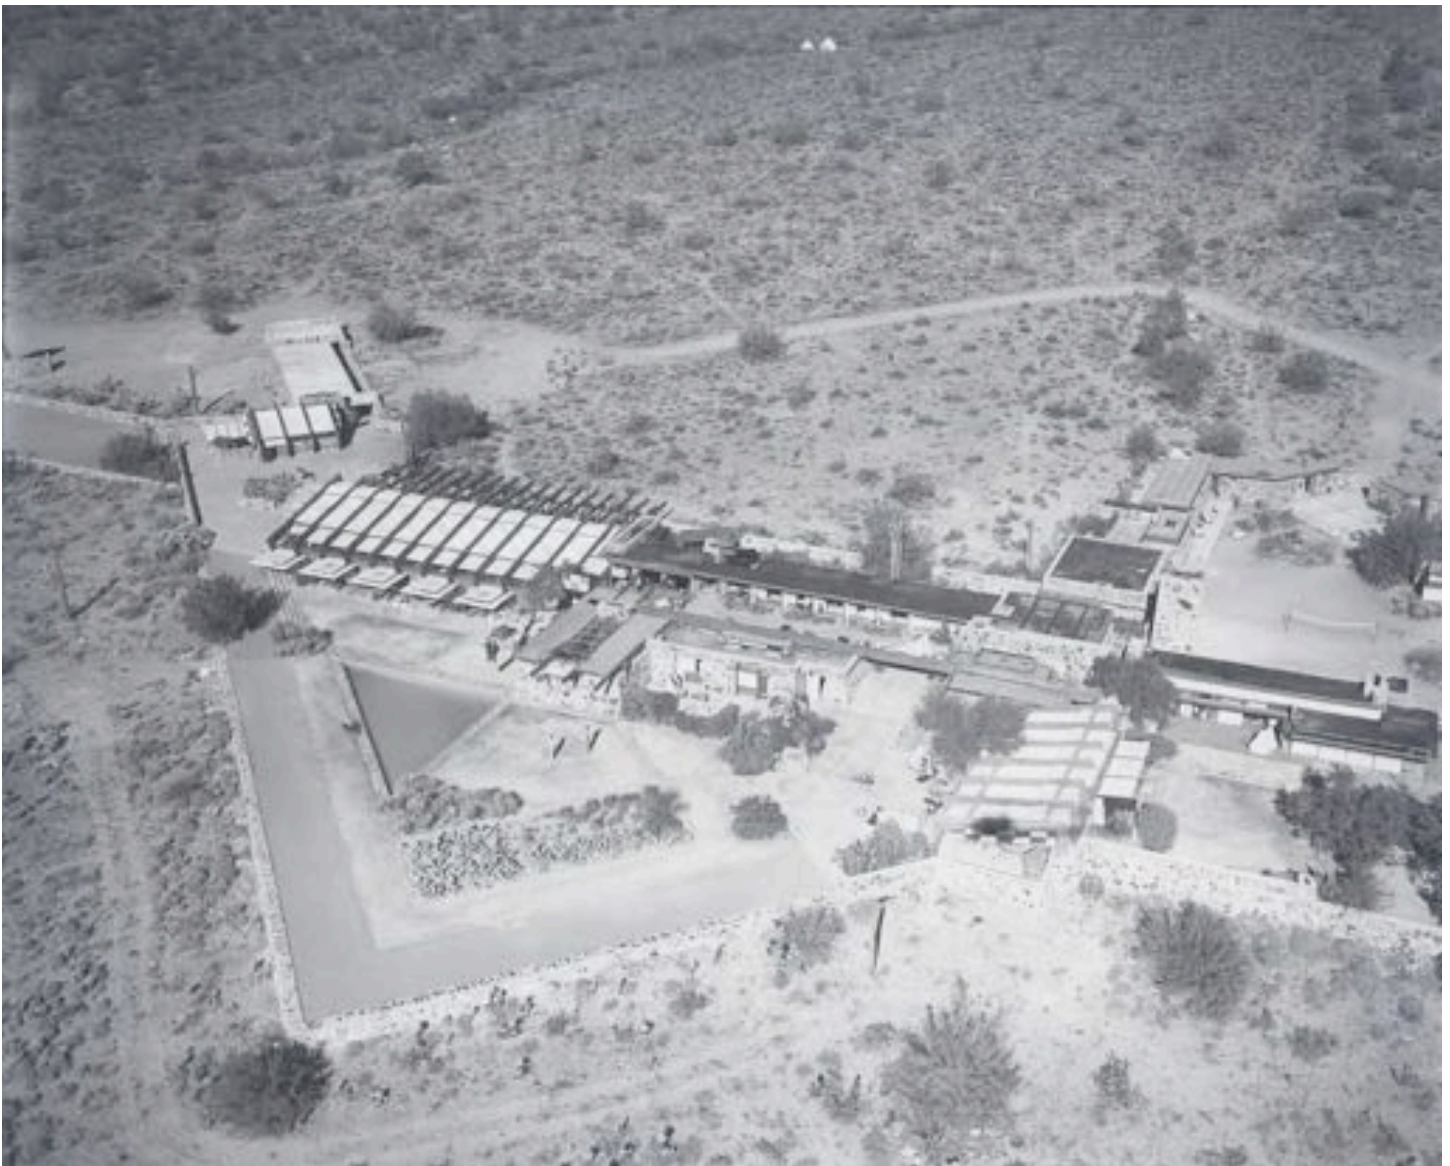
Figure 7-1 - Aerial view of Taliesin West, ca. 1949 (Dorothy & Herb McLaughlin Collection, Arizona State University Archives)

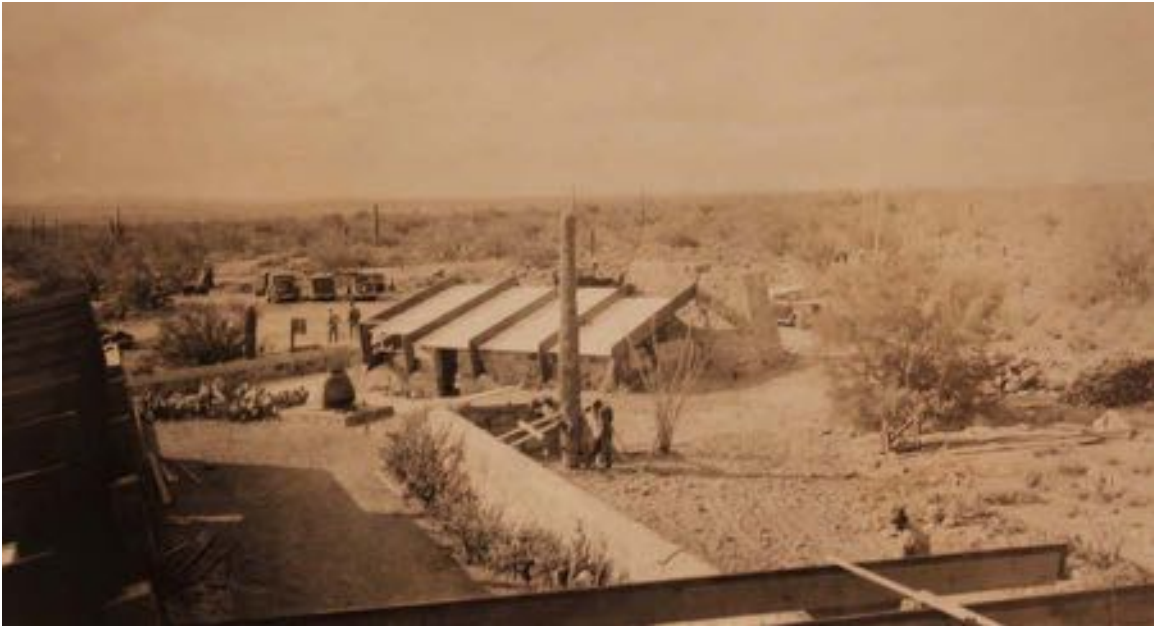
Figure 7-2 - Frank Lloyd Wright's office ca. 1939 (The Frank Lloyd Wright Foundation Archives, The Museum of Modern Art | Avery Architectural & Fine Arts Library, Columbia University, New York).

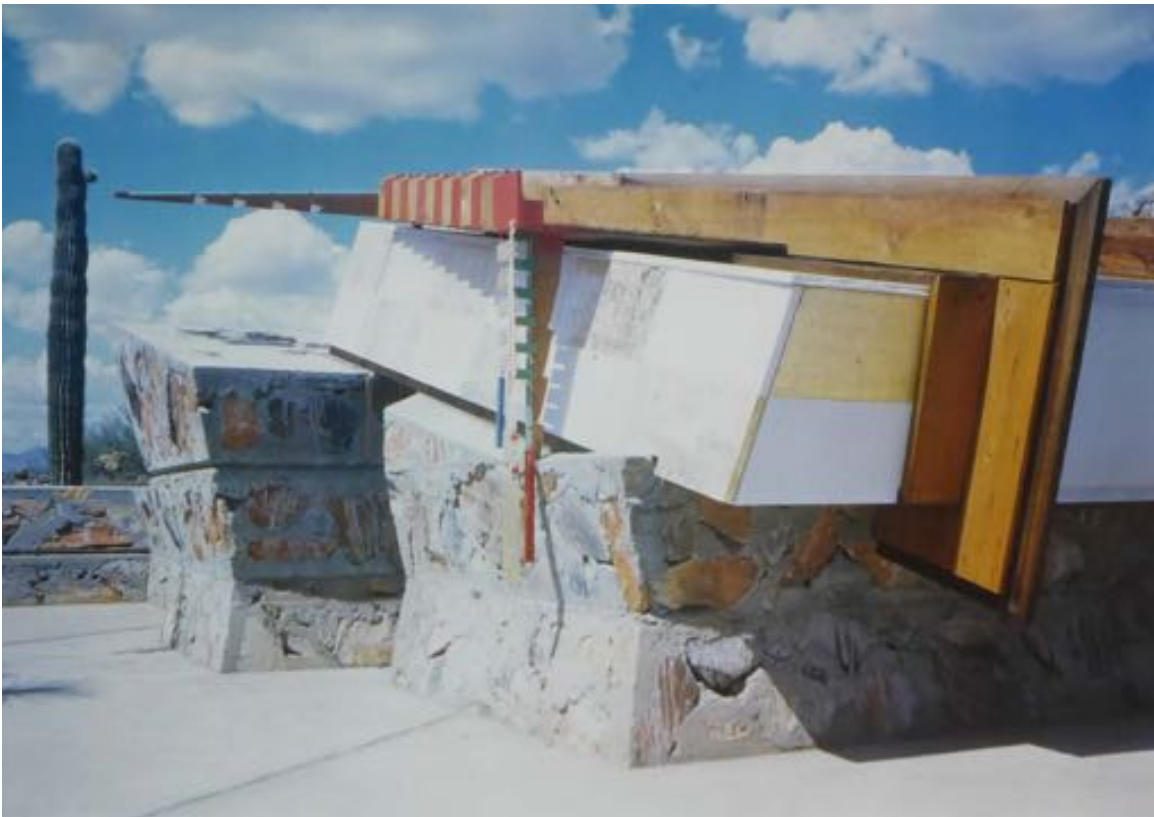
Figure 7-3 - West end of Frank Lloyd Wright's office ca. 1941 (The Frank Lloyd Wright Foundation Archives, The Museum of Modern Art | Avery Architectural & Fine Arts Library, Columbia University, New York).

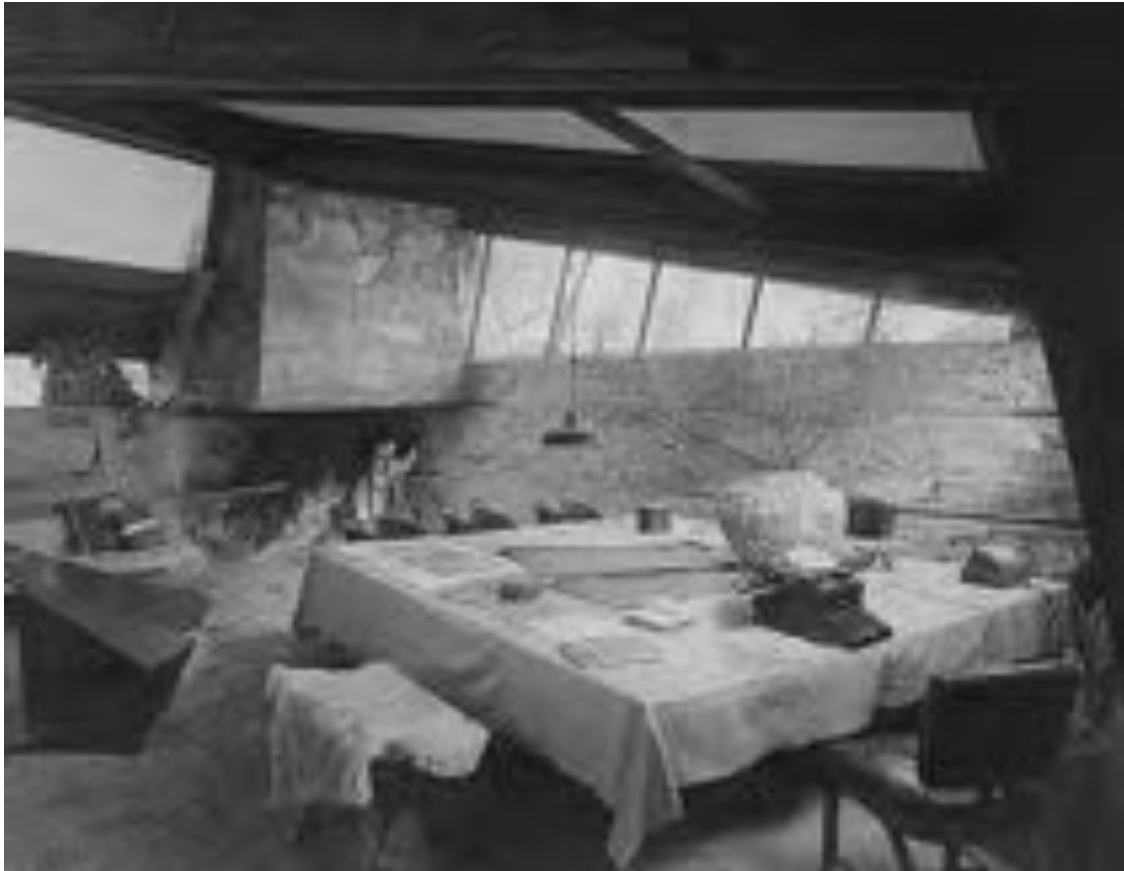
Figure 7-4 - Interior of Frank Lloyd Wright's office looking northeast, 1950 (Ezra Stoller)

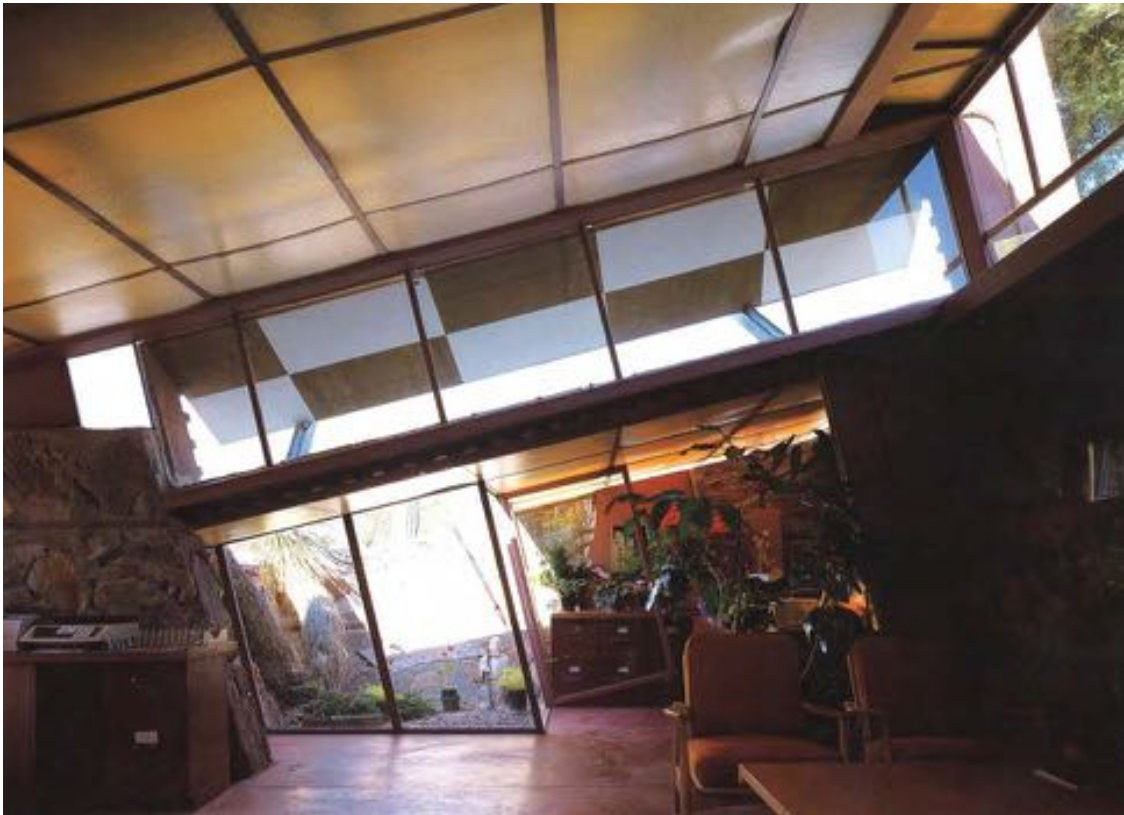
Figure 7-5 - Interior of Frank Lloyd Wright's office, looking west, ca. 1980 (The Frank Lloyd Wright Foundation Archives, The Museum of Modern Art | Avery Architectural & Fine Arts Library, Columbia University, New York).

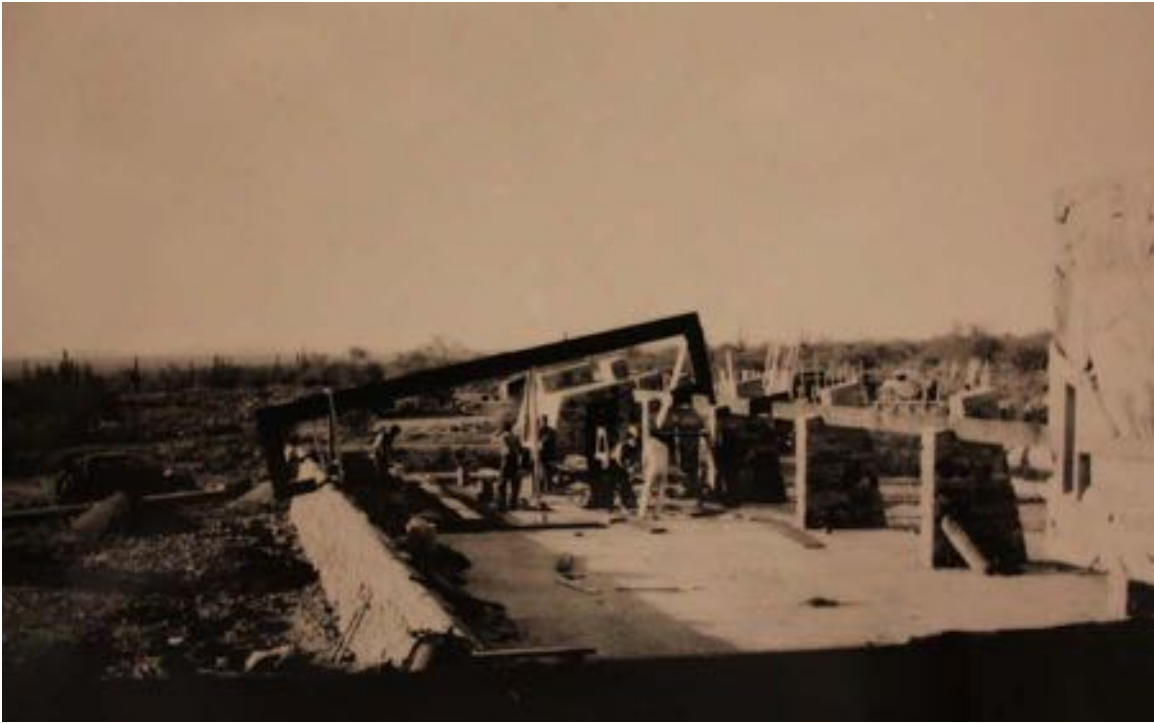
Figure 7-6 - Construction of the Drafting Studio, ca. 1938 (The Frank Lloyd Wright Foundation Archives, The Museum of Modern Art | Avery Architectural & Fine Arts Library, Columbia University, New York).

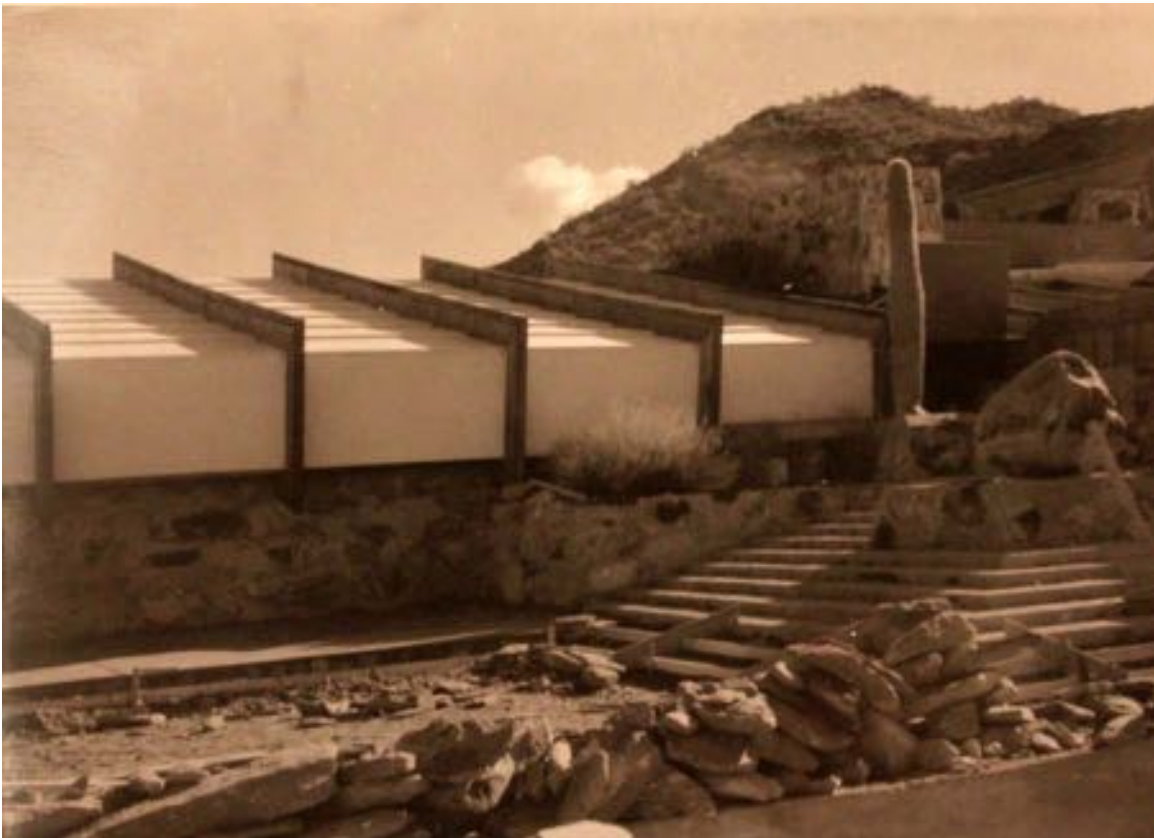
Figure 7-7 - South side of Drafting Studio, ca. 1939 (The Frank Lloyd Wright Foundation Archives, The Museum of Modern Art | Avery Architectural & Fine Arts Library, Columbia University, New York).

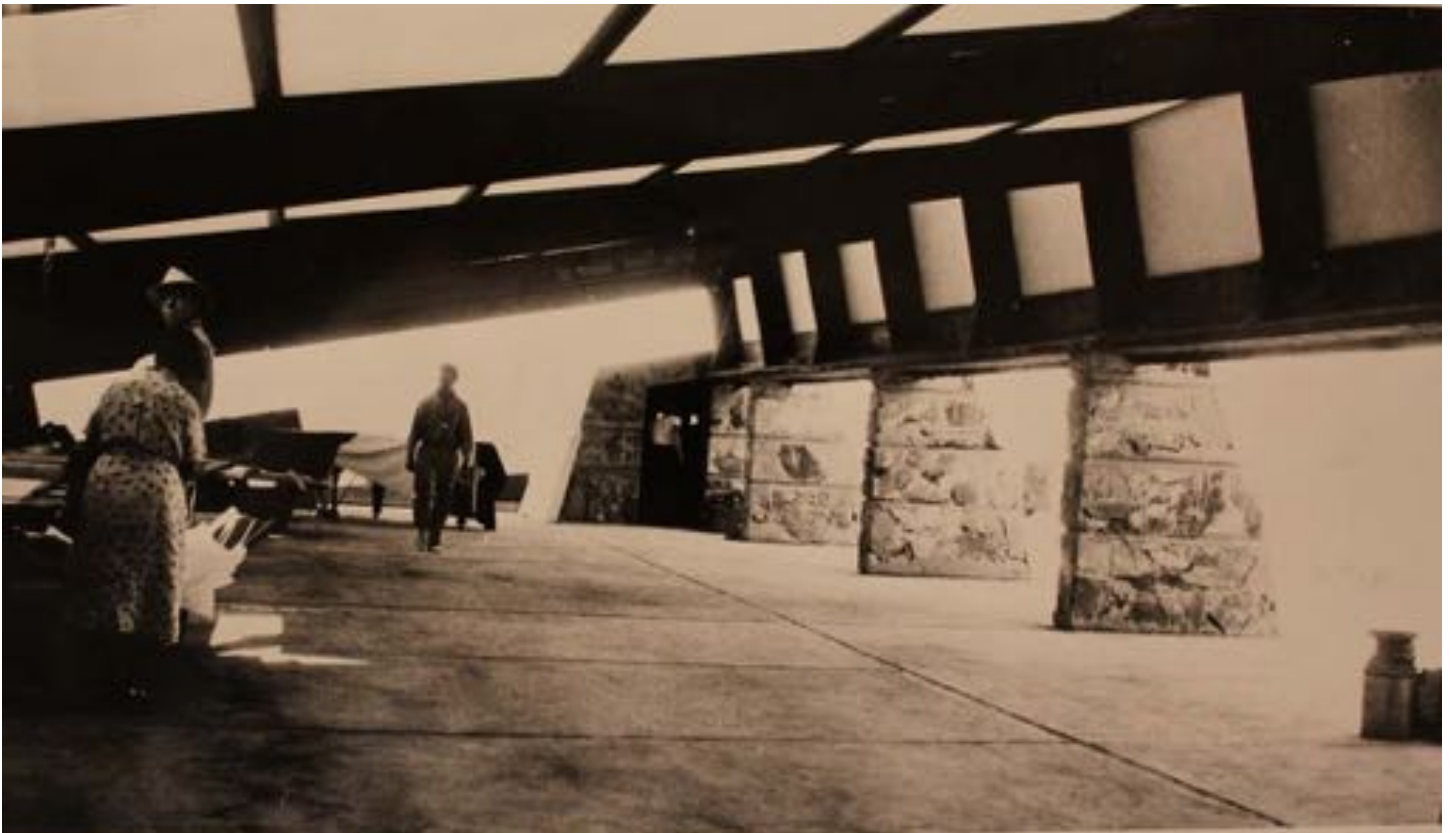
Figure 7-8 - Inside Drafting Studio looking northwest, ca. 1939 (The Frank Lloyd Wright Foundation Archives, The Museum of Modern Art | Avery Architectural & Fine Arts Library, Columbia University, New York).

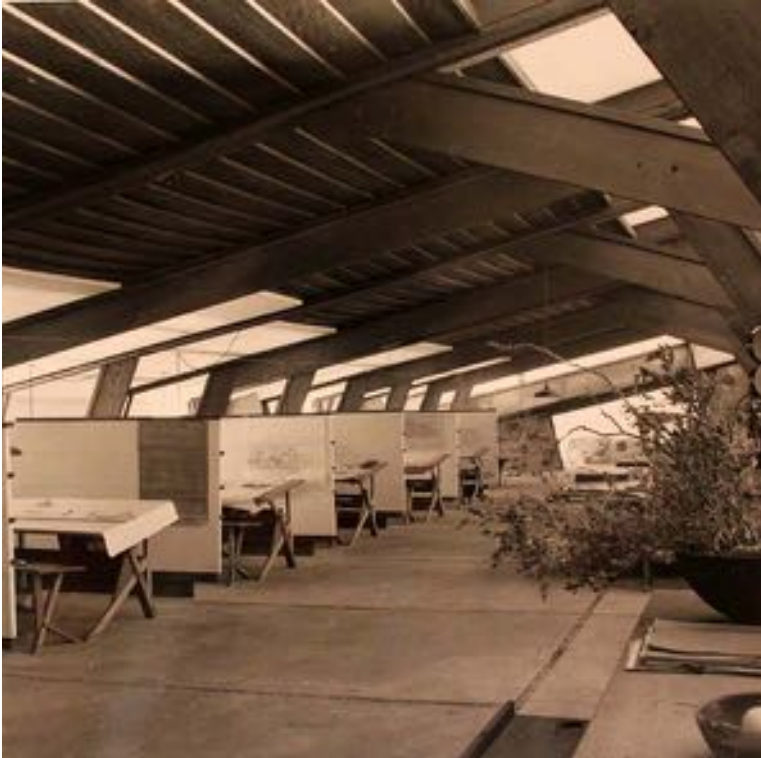
Figure 7-9 - Inside Drafting Studio with wood boards at the center of the ceiling, ca. 1941 (The Frank Lloyd Wright Foundation Archives, The Museum of Modern Art | Avery Architectural & Fine Arts Library, Columbia University, New York).

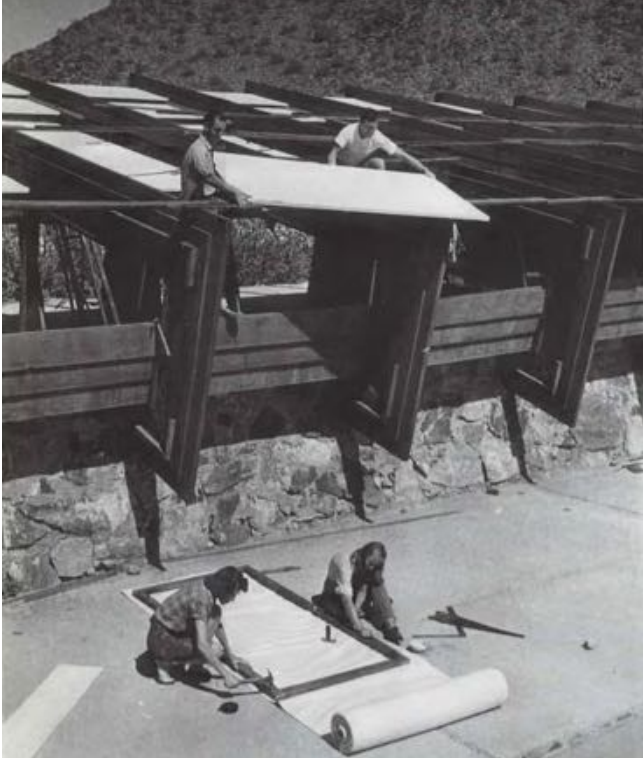
Figure 7-10 - Apprentices replacing canvas panels on the Drafting Studio, ca. 1945 (The Frank Lloyd Wright Foundation Archives, The Museum of Modern Art | Avery Architectural & Fine Arts Library, Columbia University, New York).

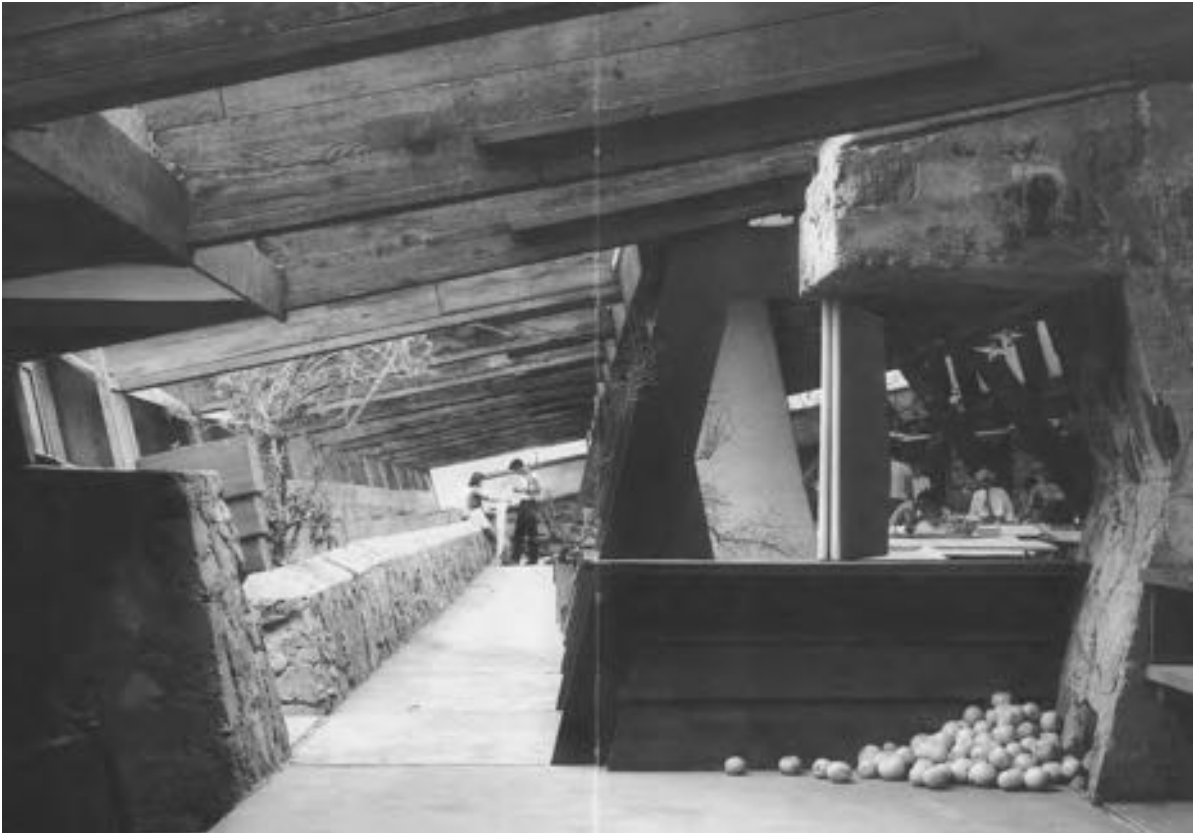
Figure 7-11 - Walkway on south side of the Drafting Studio, 1946 (Ezra Stoller)

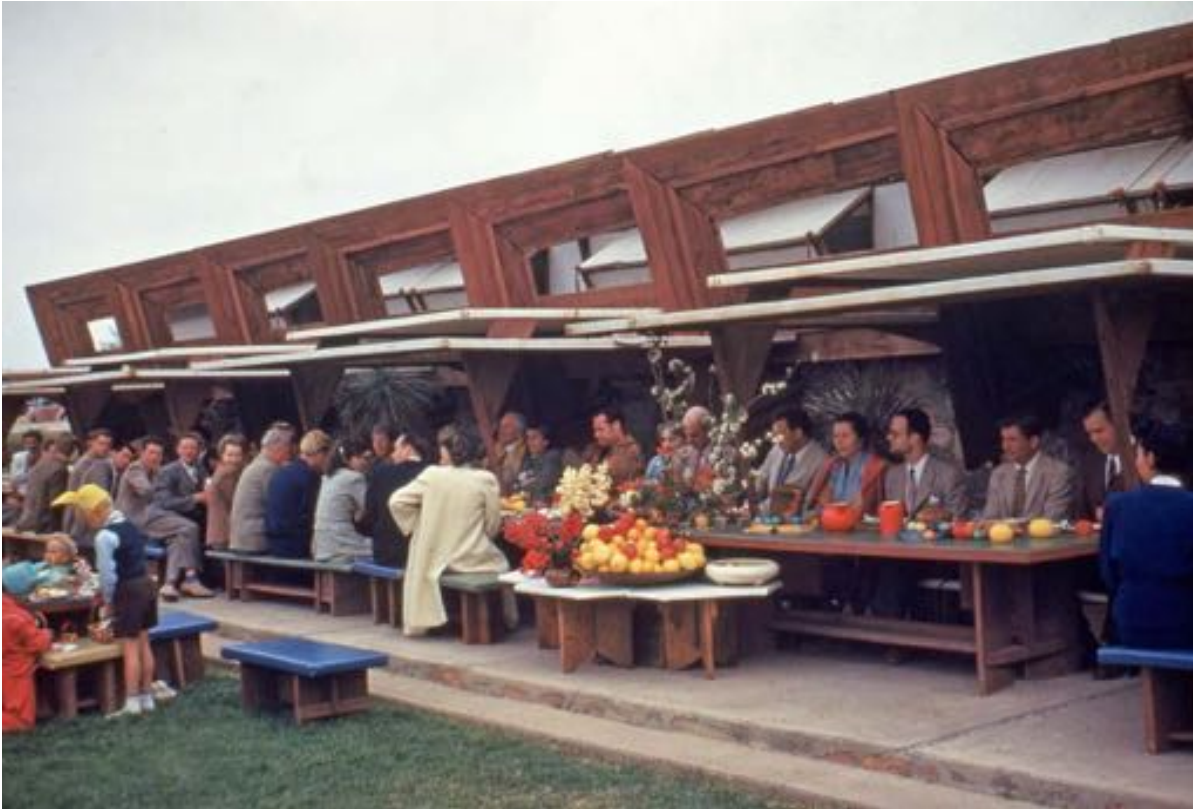
Figure 7-12 - Easter dinner 1949 showing awnings over terrace on the south side of the Drafting Studio (The Frank Lloyd Wright Foundation Archives, The Museum of Modern Art | Avery Architectural & Fine Arts Library, Columbia University, New York).

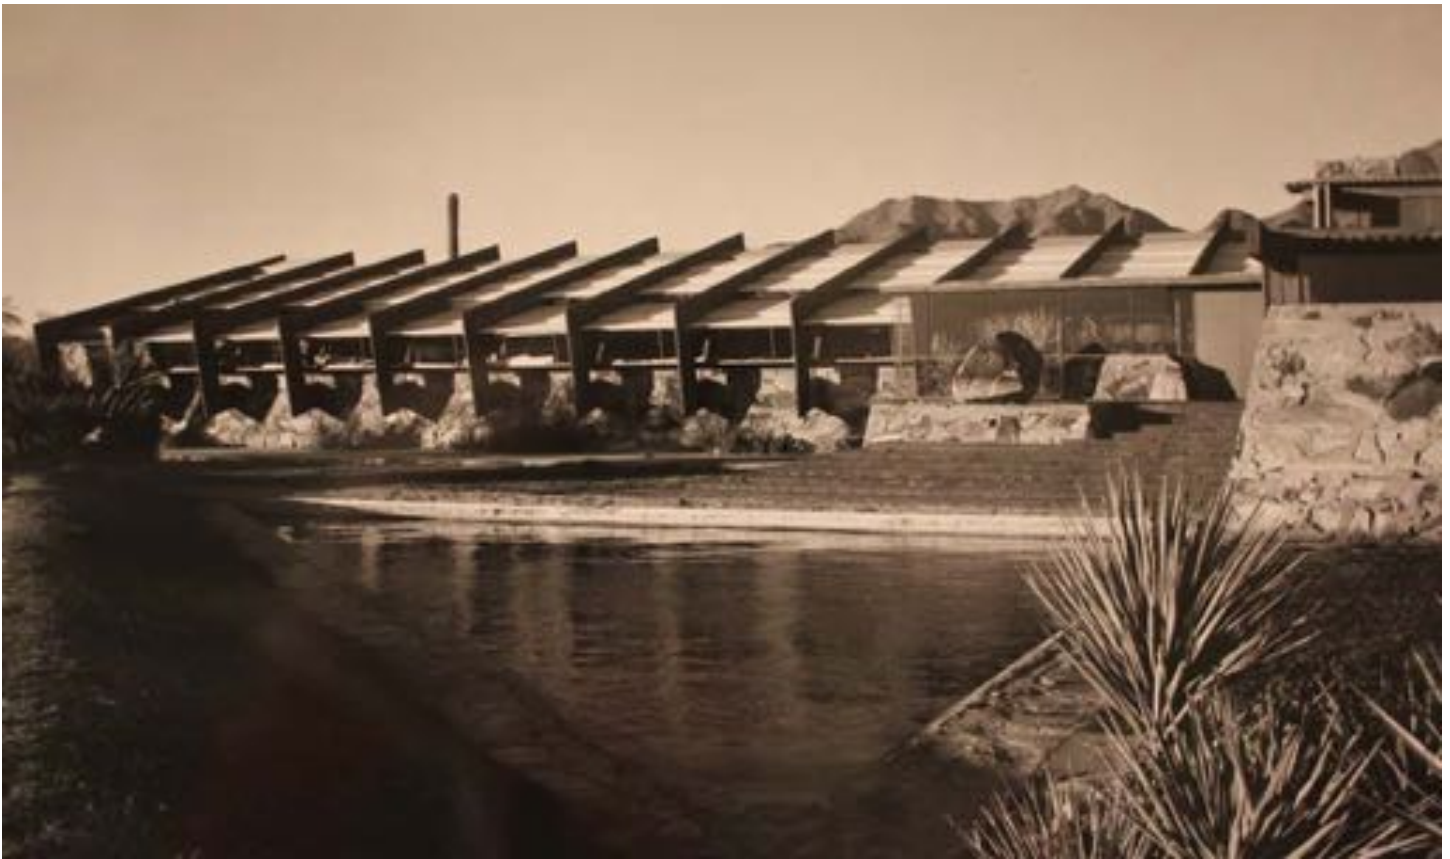
Figure 7-13 - South side of the Drafting Studio ca. 1958 (The Frank Lloyd Wright Foundation Archives, The Museum of Modern Art | Avery Architectural & Fine Arts Library, Columbia University, New York).

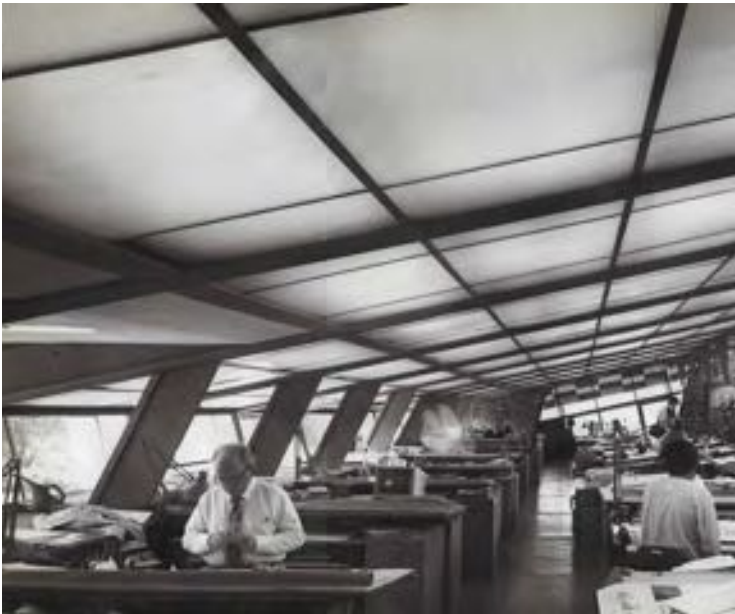
Figure 7-14 - Interior of the Drafting Studio, ca 1980 (The Frank Lloyd Wright Foundation Archives, The Museum of Modern Art | Avery Architectural & Fine Arts Library, Columbia University, New York).

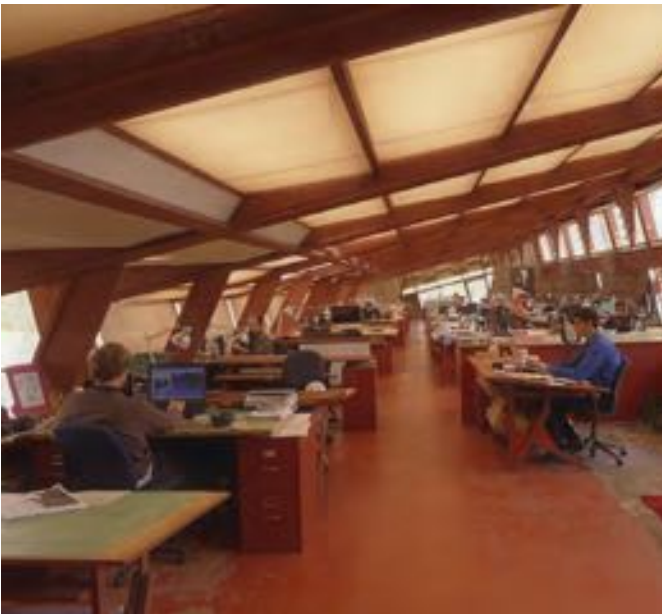
Figure 7-15 - Interior of the Drafting Studio, 2014 (Harboe Architects)

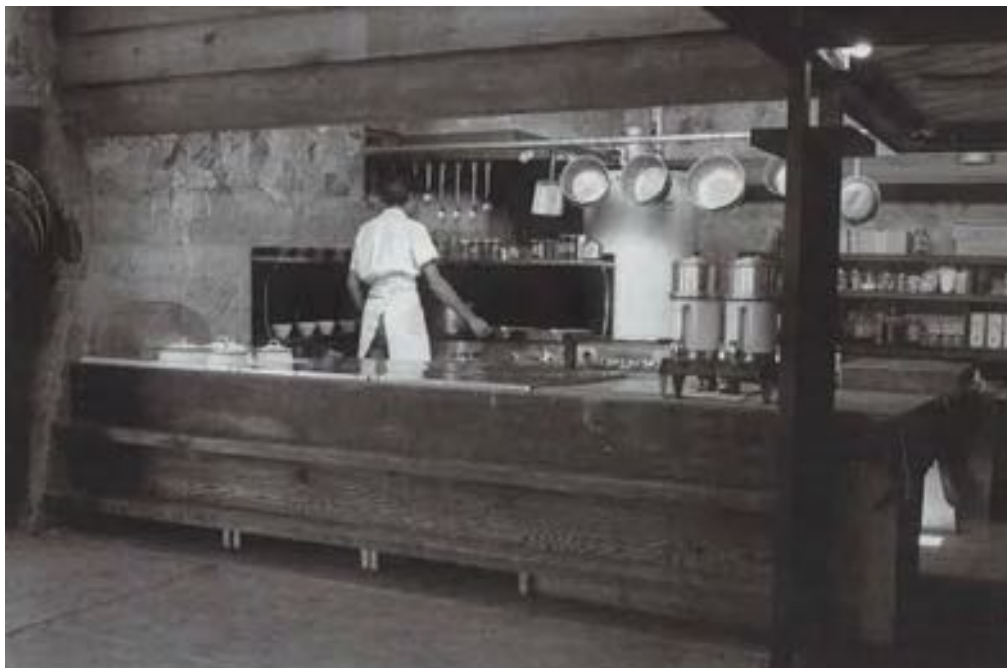
Figure 7-16 - Inside Taliesin West Kitchen, ca. 1941 (The Frank Lloyd Wright Foundation Archives, The Museum of Modern Art | Avery Architectural & Fine Arts Library, Columbia University, New York).

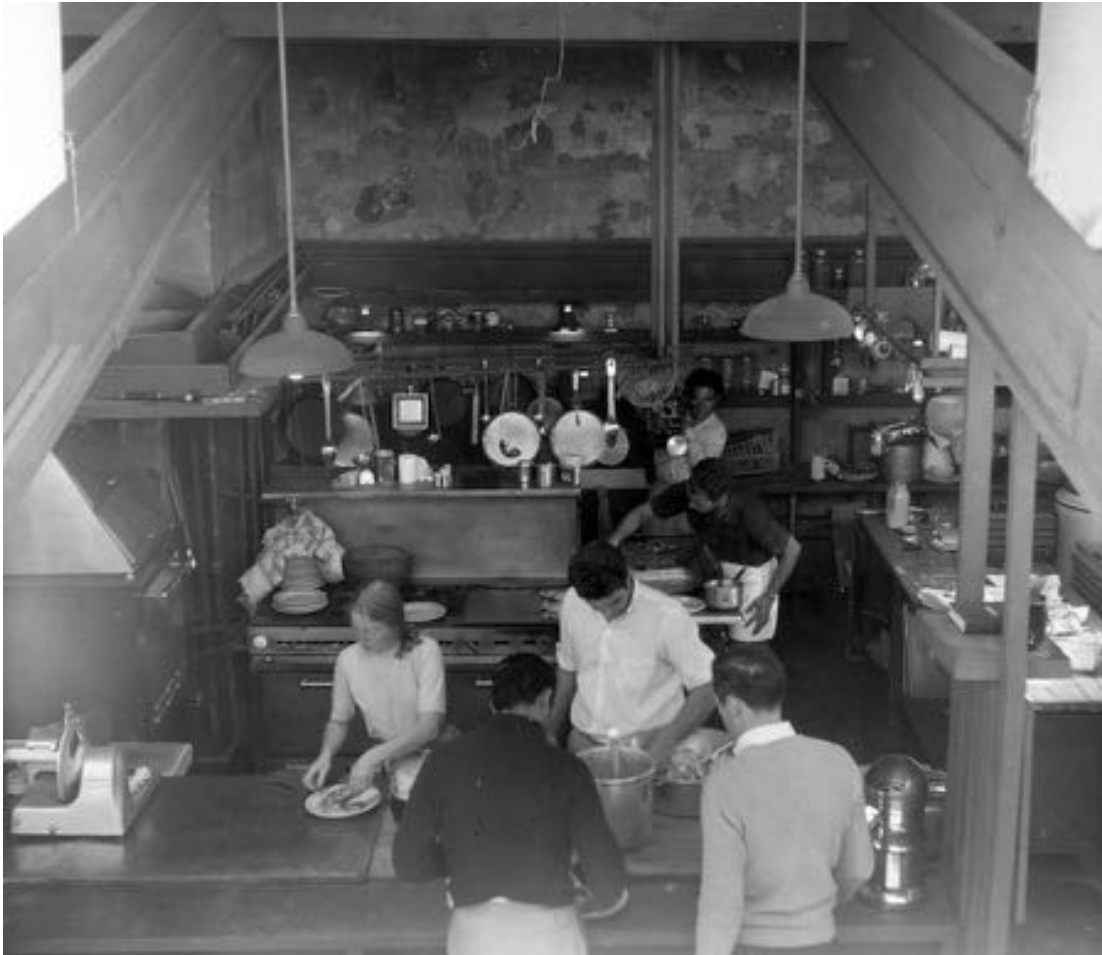
Figure 7-17 - Inside Taliesin West Kitchen, ca. 1950 (The Frank Lloyd Wright Foundation Archives, The Museum of Modern Art | Avery Architectural & Fine Arts Library, Columbia University, New York).

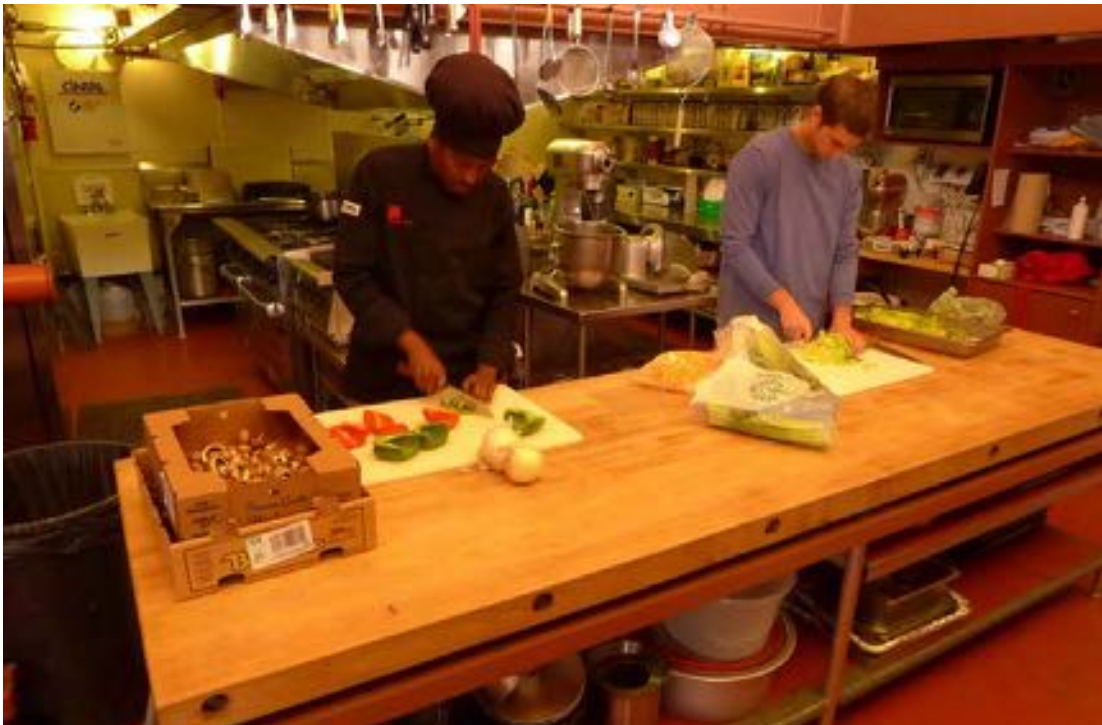
Figure 7-18 - Inside Taliesin West Kitchen, 2014 (Harboe Architects).

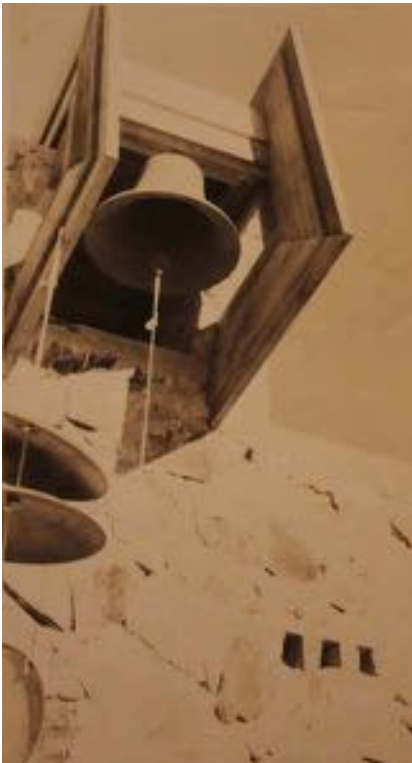
Figure 7-19 - Bell Tower, ca. 1939 (The Frank Lloyd Wright Foundation Archives, The Museum of Modern Art | Avery Architectural & Fine Arts Library, Columbia University, New York).

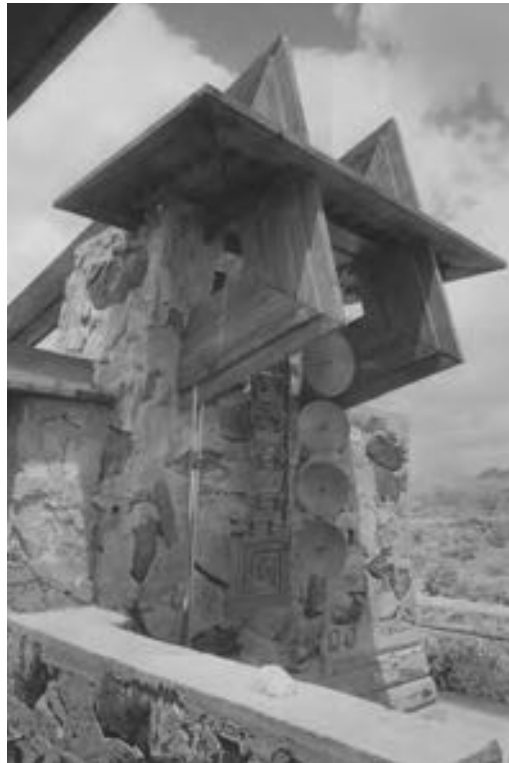
Figure 7-20 - Bell Tower, ca. 1952 (The Frank Lloyd Wright Foundation Archives, The Museum of Modern Art | Avery Architectural & Fine Arts Library, Columbia University, New York).

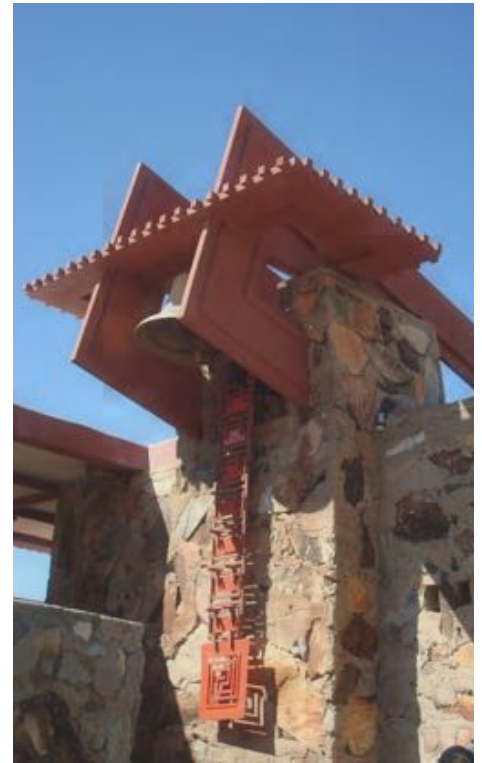
Figure 7-21 - Bell Tower, 2014 (Harboe Architects).

- The Bell Tower was reconstructed with a steel structure.

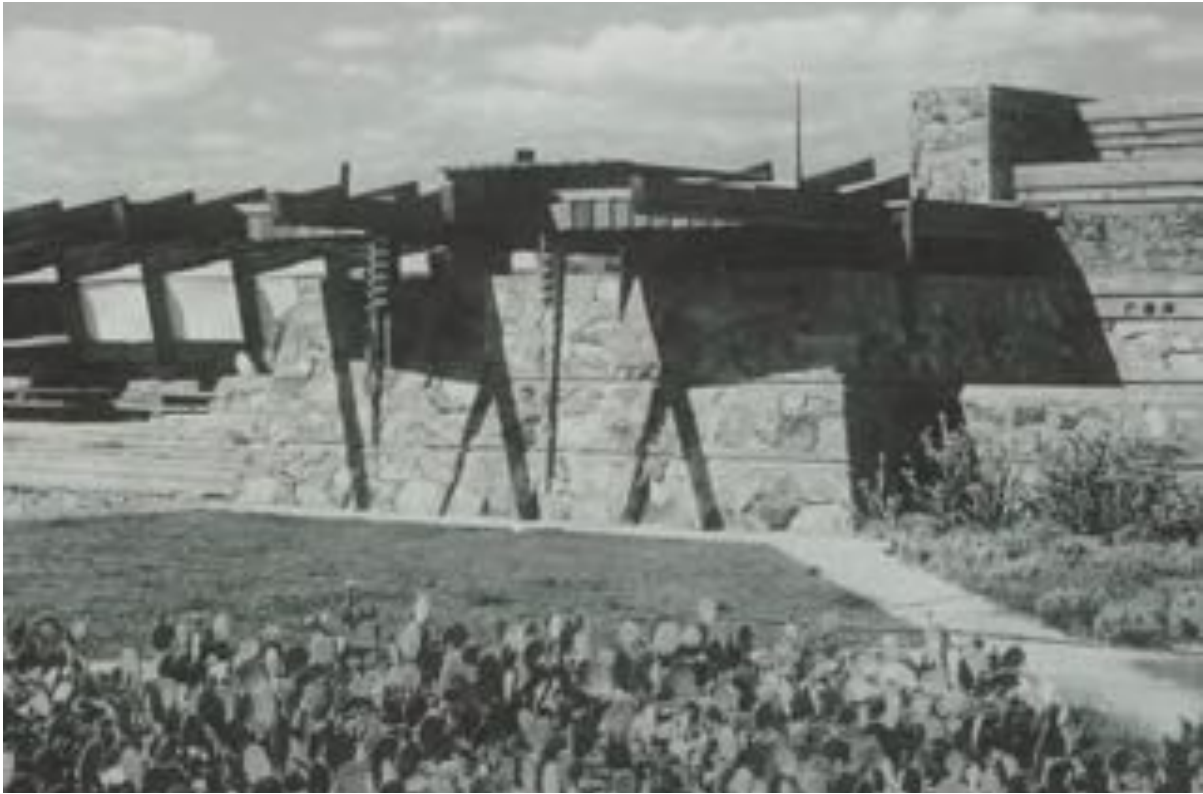
Figure 7-22 - Original Dining Room, ca. 1941 (The Frank Lloyd Wright Foundation Archives, The Museum of Modern Art | Avery Architectural & Fine Arts Library, Columbia University, New York).

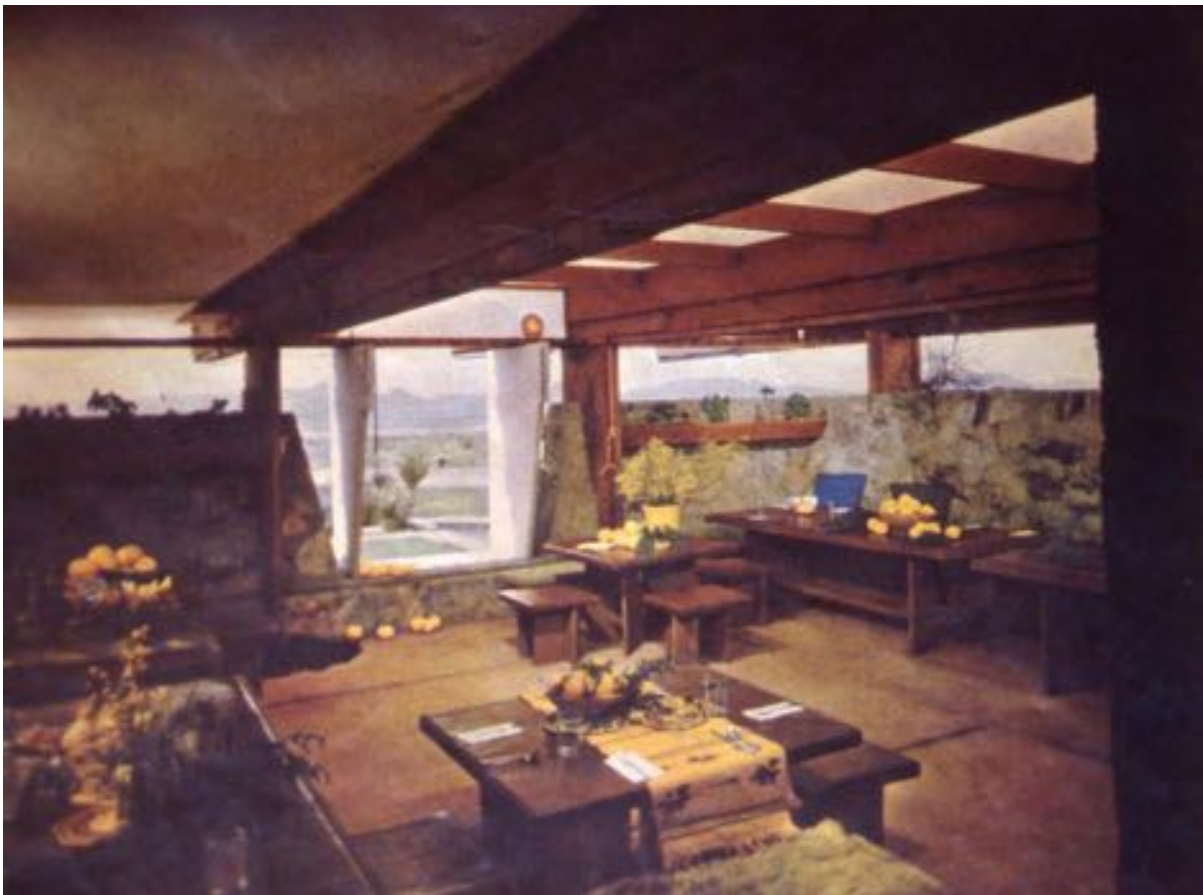
Figure 7-23 - Interior of Original Dining Room, ca. 1946 (The Frank Lloyd Wright Foundation Archives, The Museum of Modern Art | Avery Architectural & Fine Arts Library, Columbia University, New York).
