TALIESIN WEST PRESERVATION MASTER PLAN

Harboe Architects, PC

MAY 21, 2015

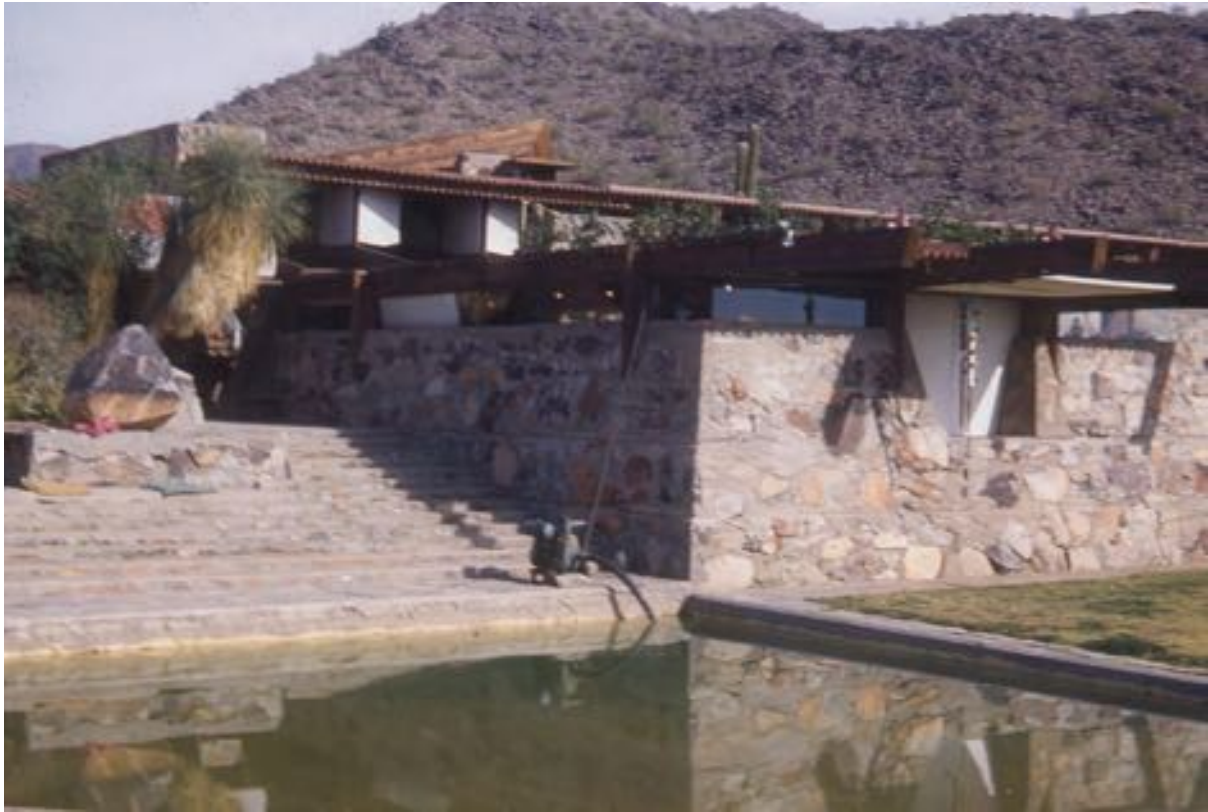
Figure 7-24 - Exterior of Original Dining Room, ca. 1947 (The Frank Lloyd Wright Foundation Archives, The Museum of Modern Art | Avery Architectural & Fine Arts Library, Columbia University, New York).

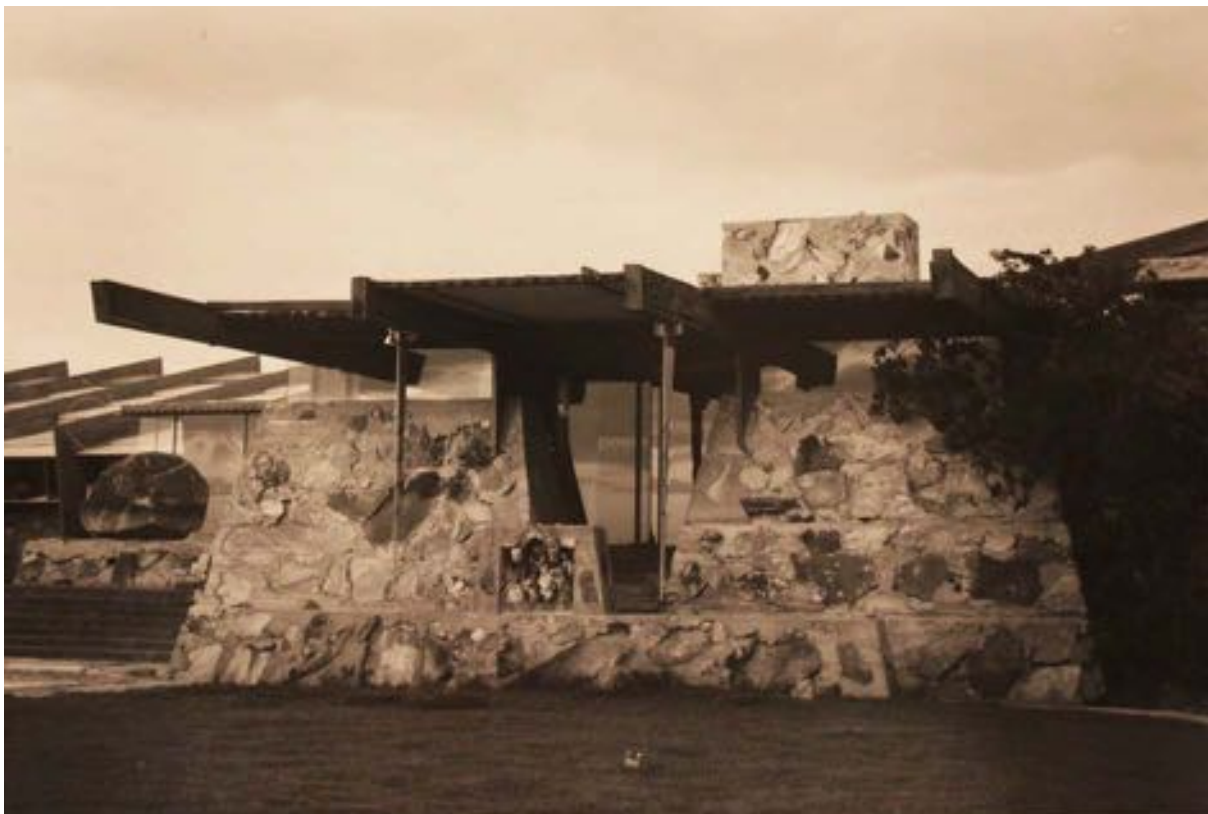
Figure 7-25 - Exterior of Original Dining Room, ca. 1958 (The Frank Lloyd Wright Foundation Archives, The Museum of Modern Art | Avery Architectural & Fine Arts Library, Columbia University, New York).

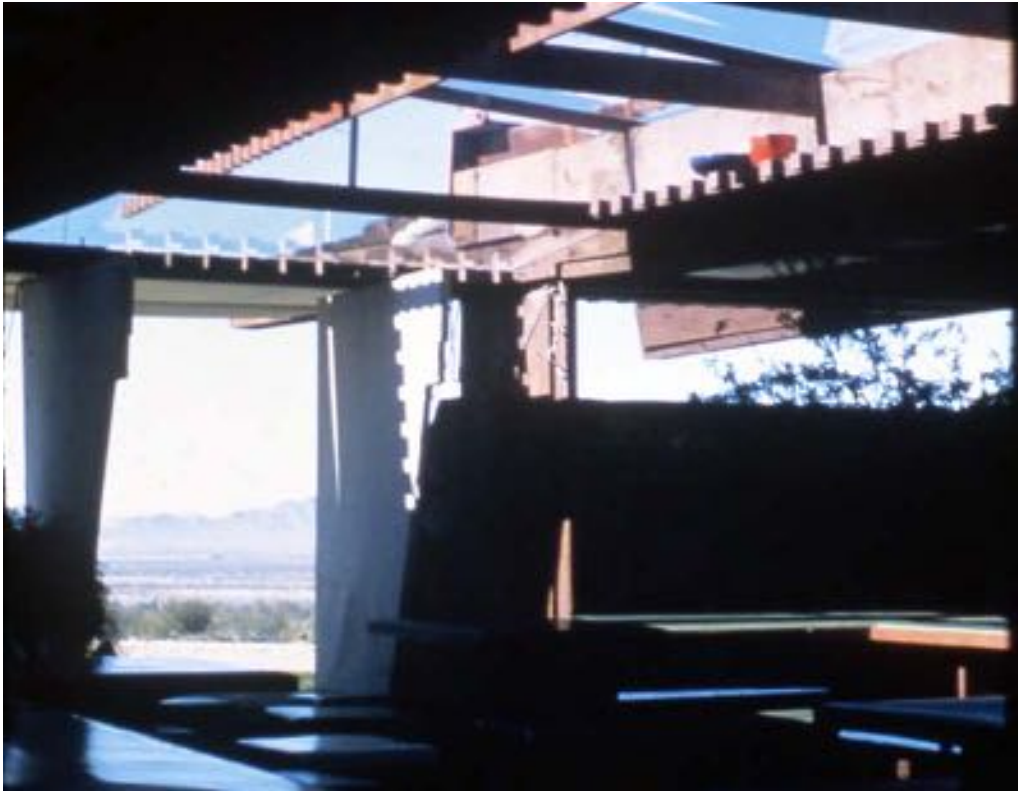
Figure 7-26 - Interior of the Original Dining Room ca. 1950 (The Frank Lloyd Wright Foundation Archives, The Museum of Modern Art | Avery Architectural & Fine Arts Library, Columbia University, New York).

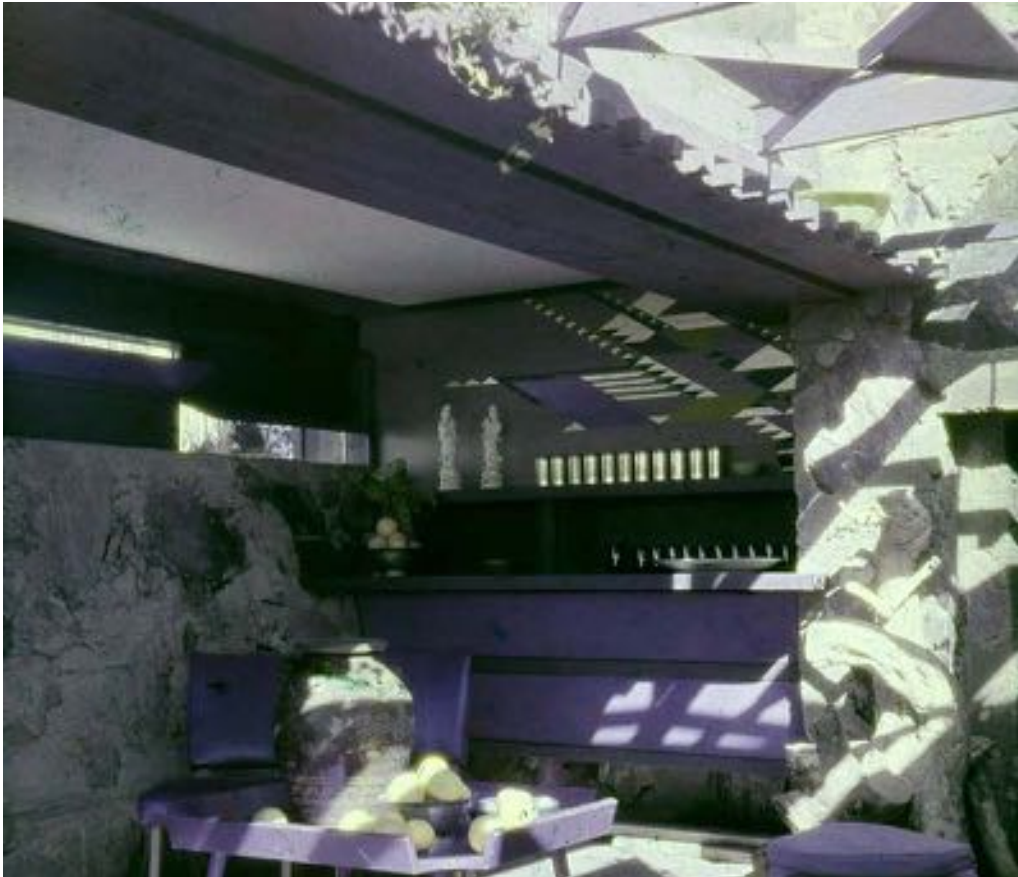
Figure 7-27 - Interior of the Original Dining Room ca. 1958 (The Frank Lloyd Wright Foundation Archives, The Museum of Modern Art | Avery Architectural & Fine Arts Library, Columbia University, New York).

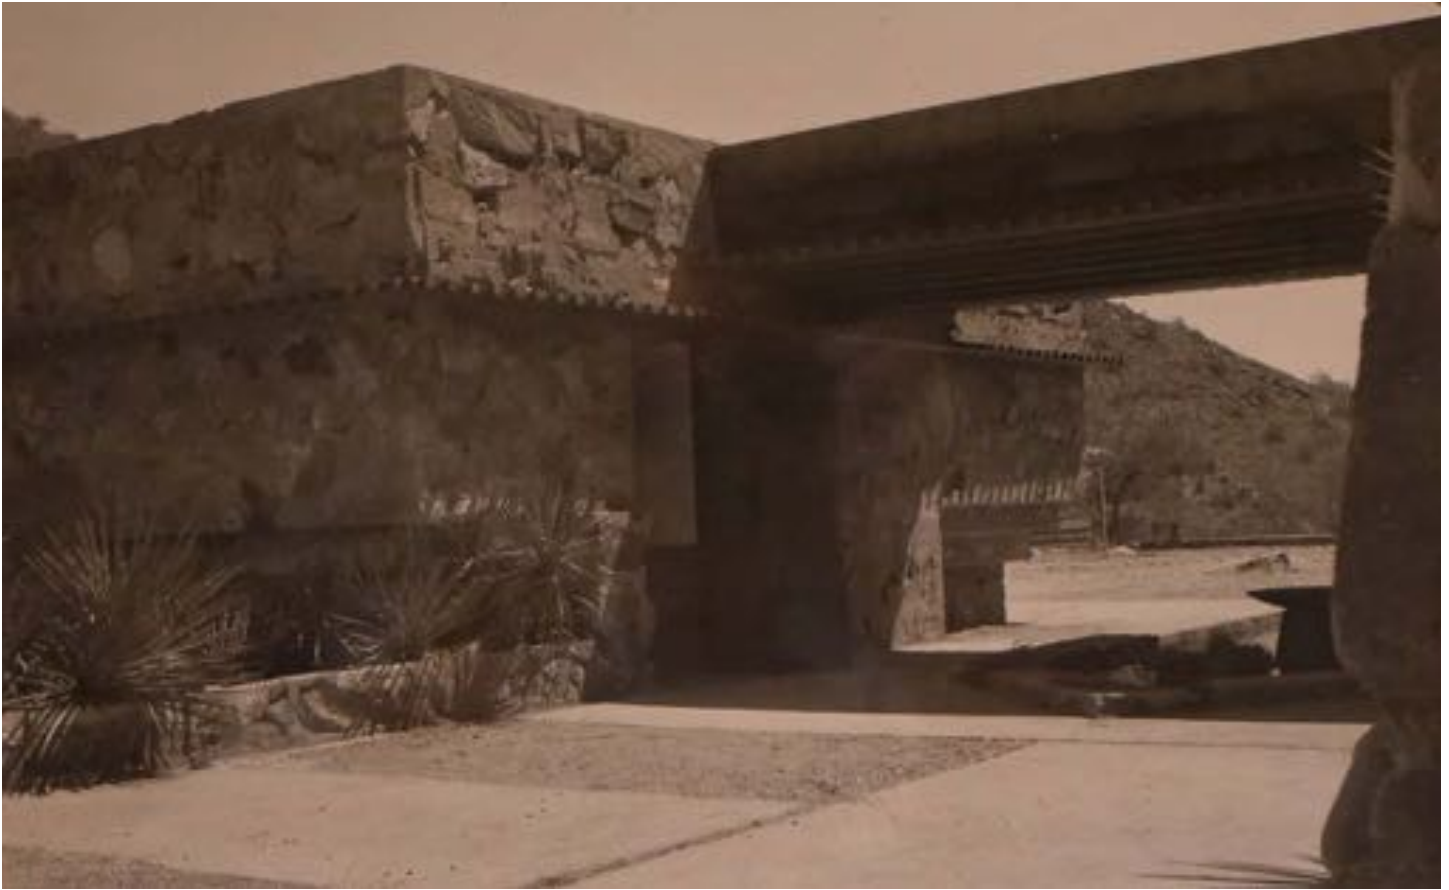
Figure 7-28 - Outside Kiva showing original wood bridge, ca. 1941 (The Frank Lloyd Wright Foundation Archives, The Museum of Modern Art | Avery Architectural & Fine Arts Library, Columbia University, New York).

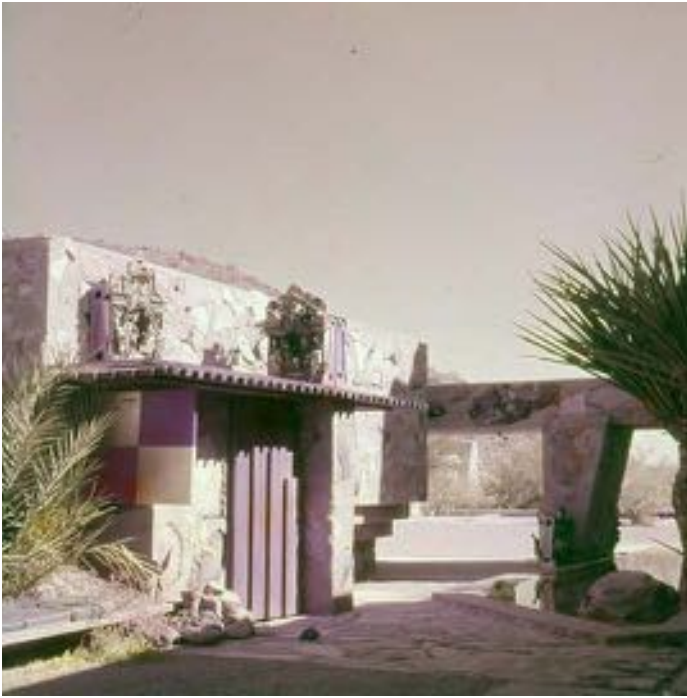
Figure 7-31 - Outside the Kiva, ca. 1950 (The Frank Lloyd Wright Foundation Archives, The Museum of Modern Art | Avery Architectural & Fine Arts Library, Columbia University, New York).

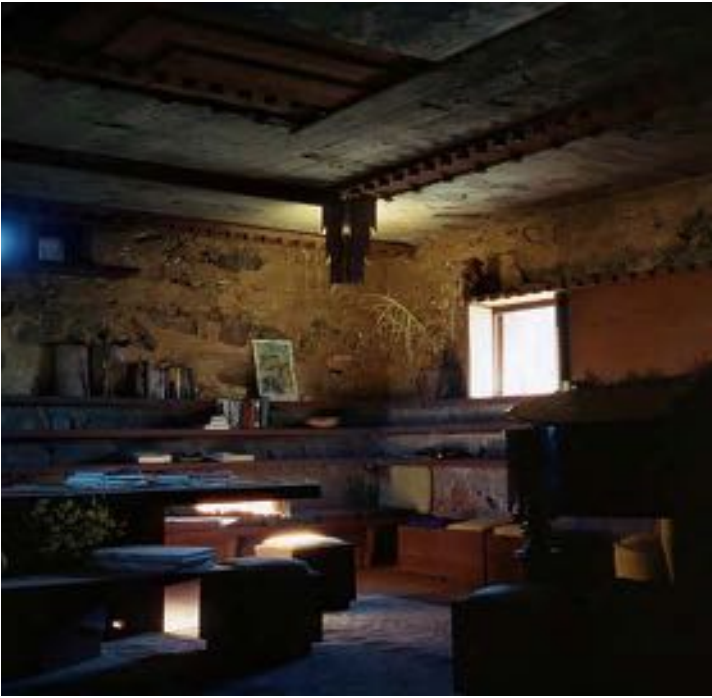
Figure 7-32 - Interior of Kiva, ca. 1952 (The Frank Lloyd Wright Foundation Archives, The Museum of Modern Art | Avery Architectural & Fine Arts Library, Columbia University, New York).

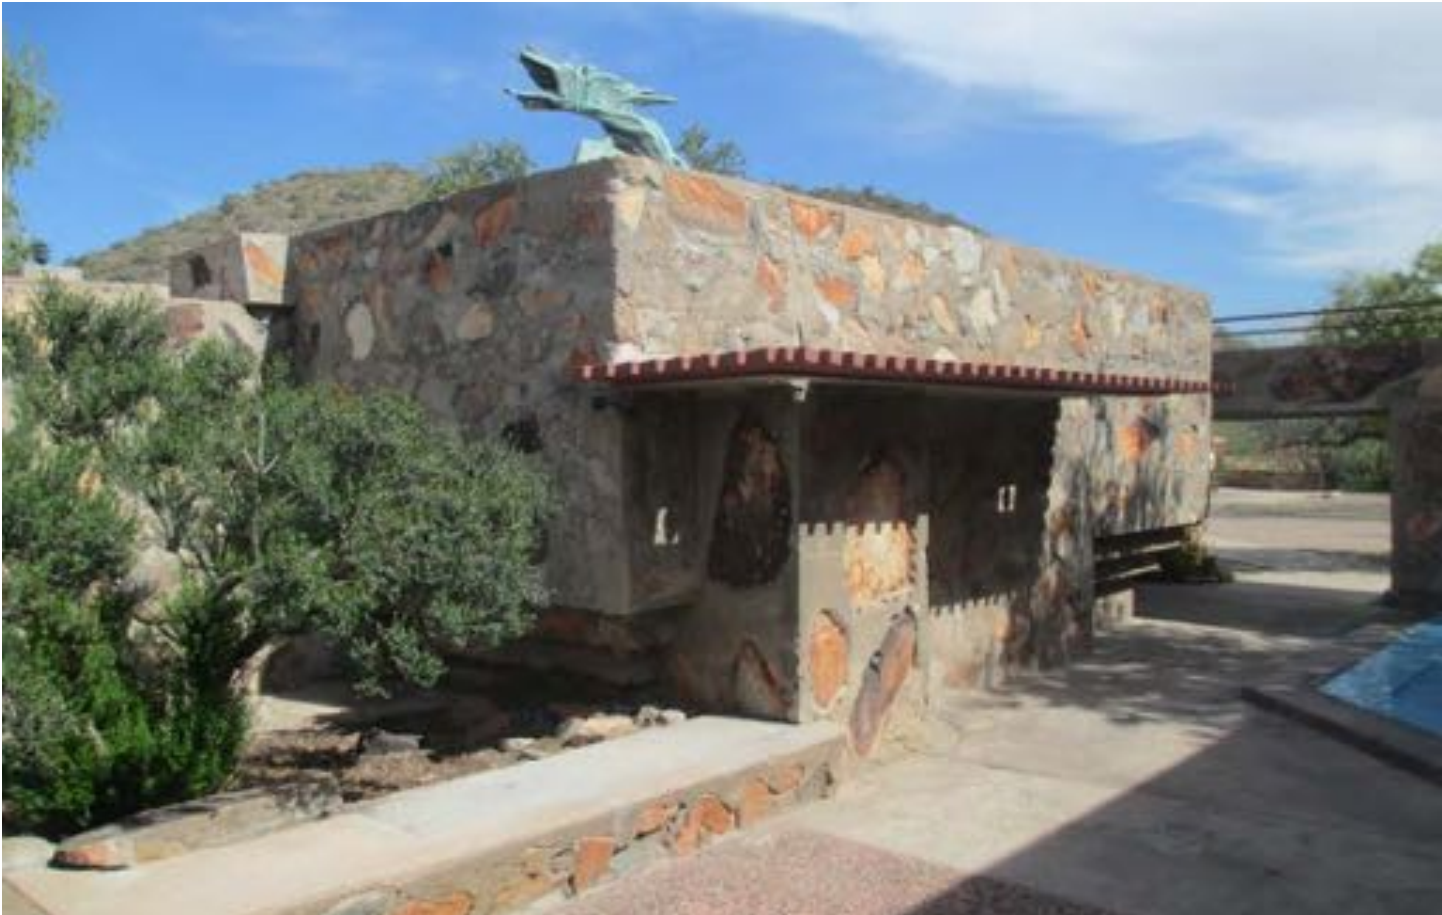
Figure 7-33 - Outside the Kiva, 2014 (Harboe Architects).

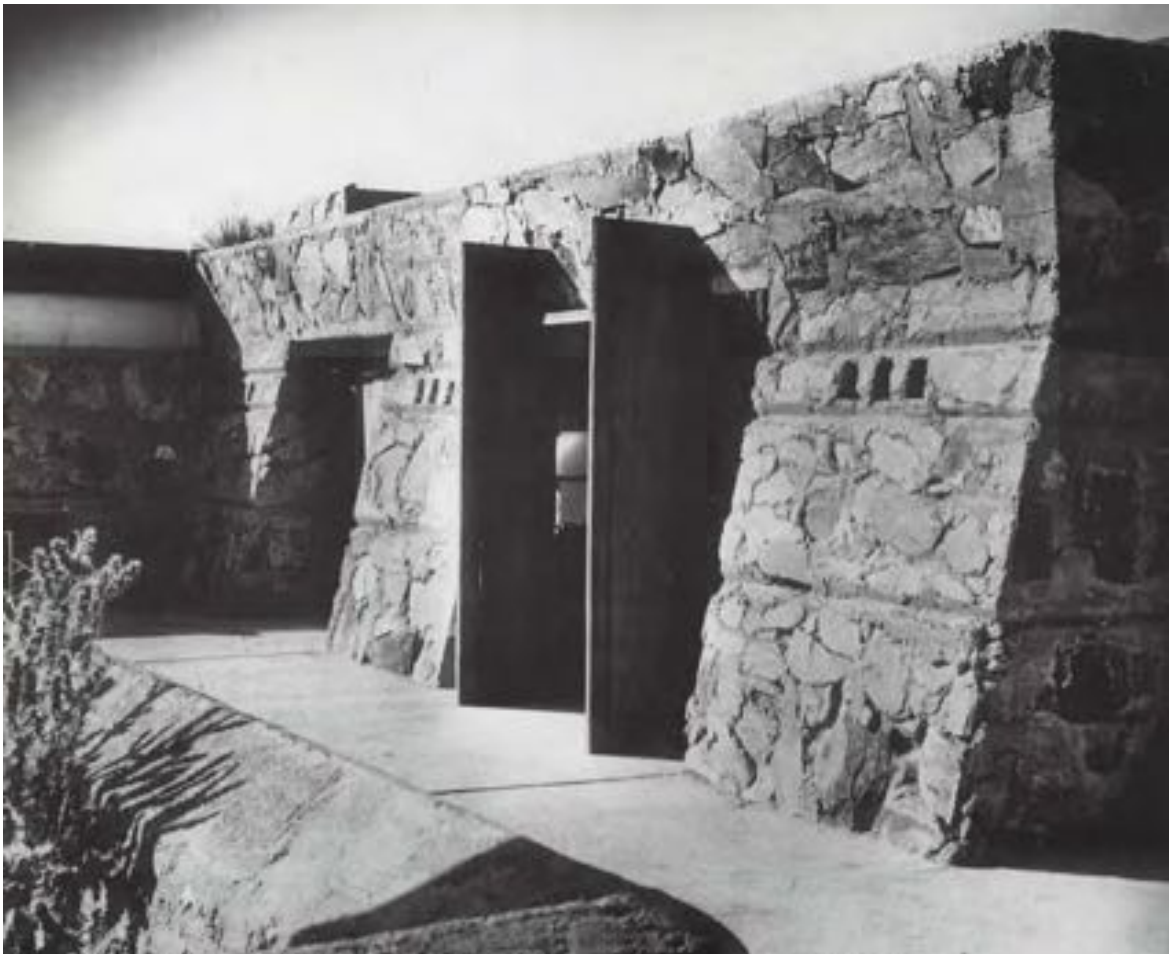
Figure 7-34 - Peters rooms, ca. 1940 (The Frank Lloyd Wright Foundation Archives, The Museum of Modern Art | Avery Architectural & Fine Arts Library, Columbia University, New York).

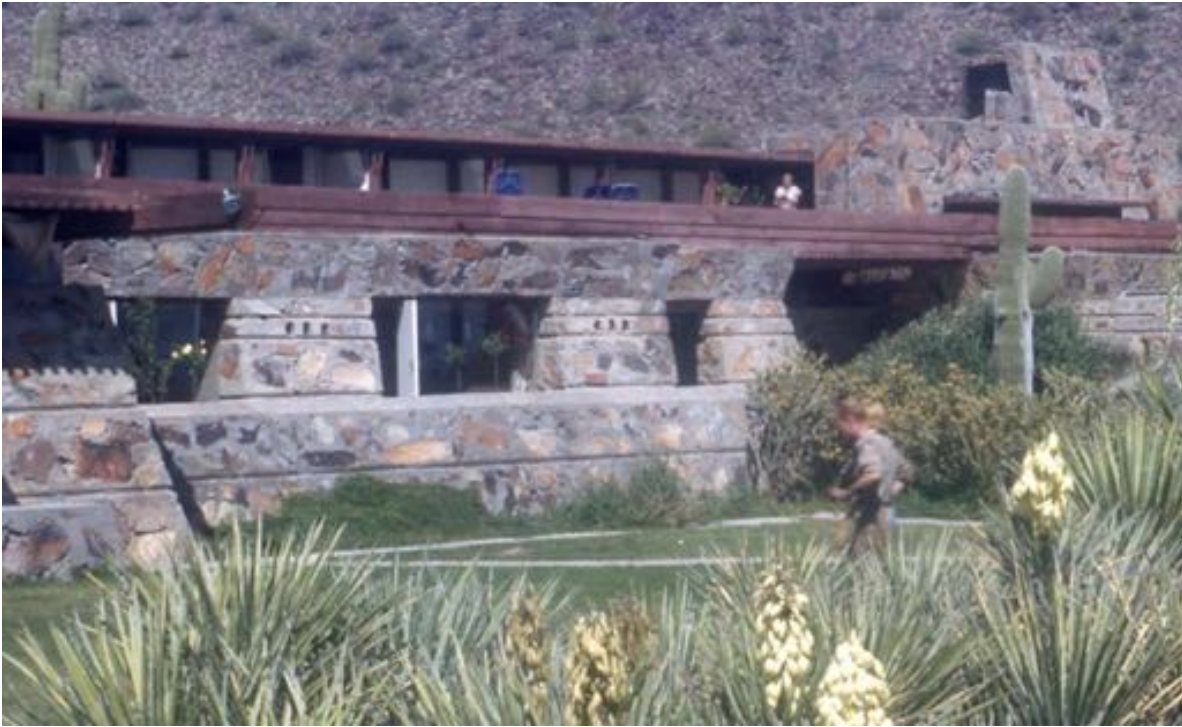
Figure 7-35 - Peters & Masselink rooms, ca. 1955 (The Frank Lloyd Wright Foundation Archives, The Museum of Modern Art | Avery Architectural & Fine Arts Library, Columbia University, New York).

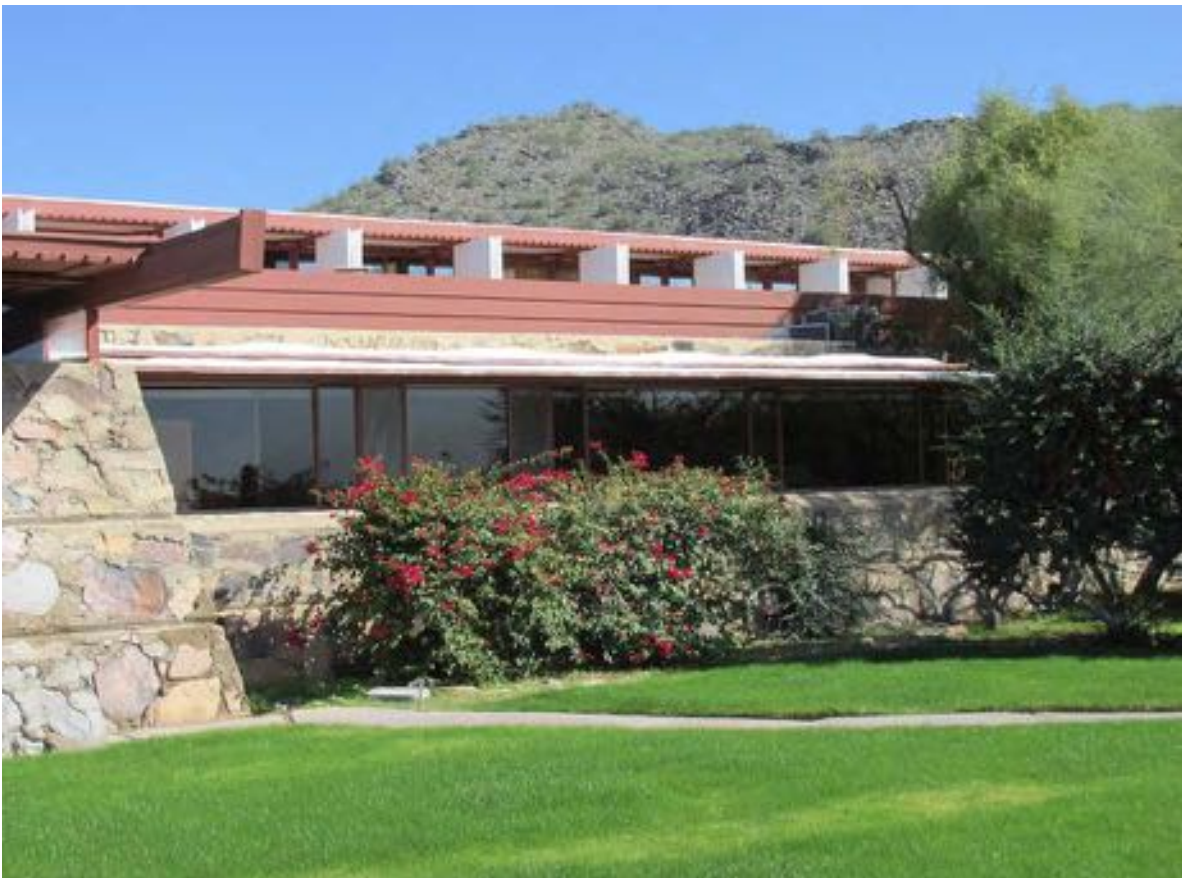
Figure 7-36 - William Wesley Peters Conference Room, 2014 (Harboe Architects).

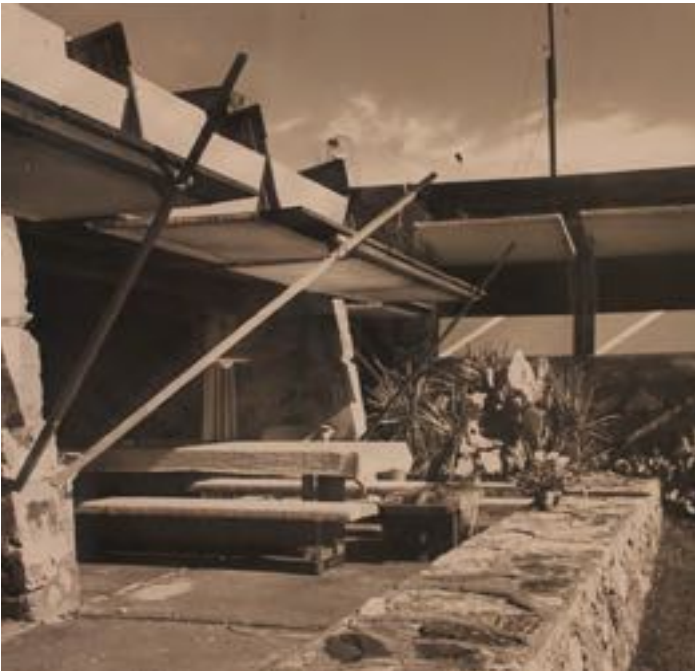
Figure 7-37 - Terrace outside the Garden Room ca. 1941 (The Frank Lloyd Wright Foundation Archives, The Museum of Modern Art | Avery Architectural & Fine Arts Library, Columbia University, New York).

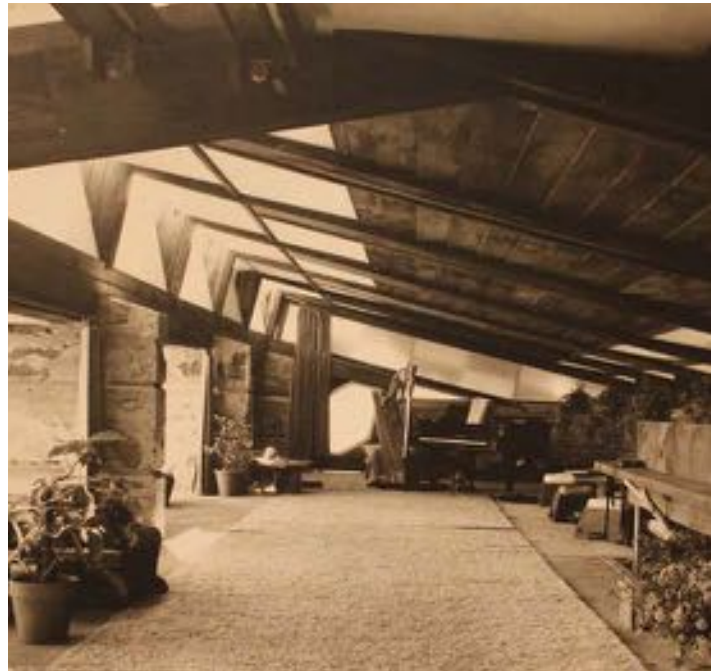
Figure 7-38 - Interior of the Garden Room ca. 1941 (The Frank Lloyd Wright Foundation Archives, The Museum of Modern Art | Avery Architectural & Fine Arts Library, Columbia University, New York).

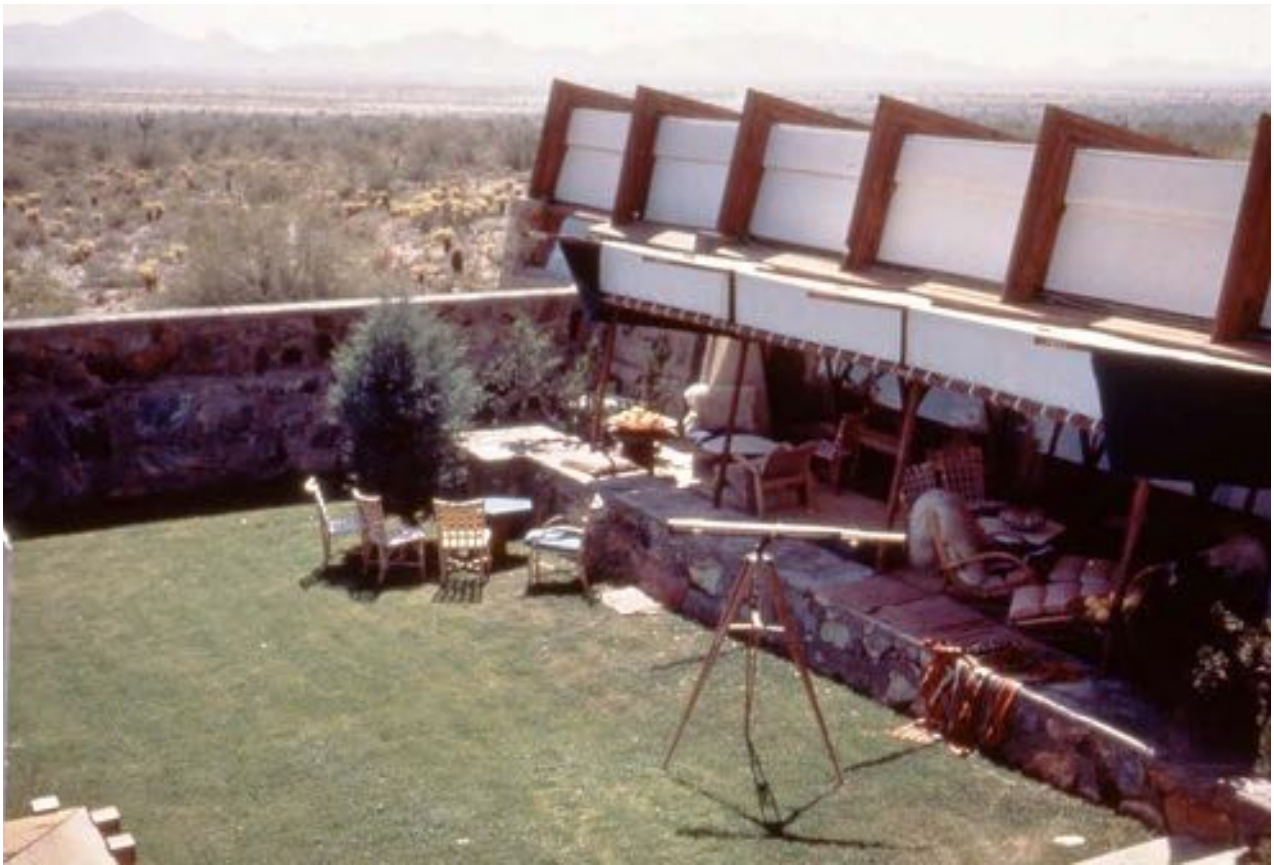
Figure 7-39 - View of Garden Room from roof of Wright Living Quarters, ca. 1947 (The Frank Lloyd Wright Foundation Archives, The Museum of Modern Art | Avery Architectural & Fine Arts Library, Columbia University, New York).

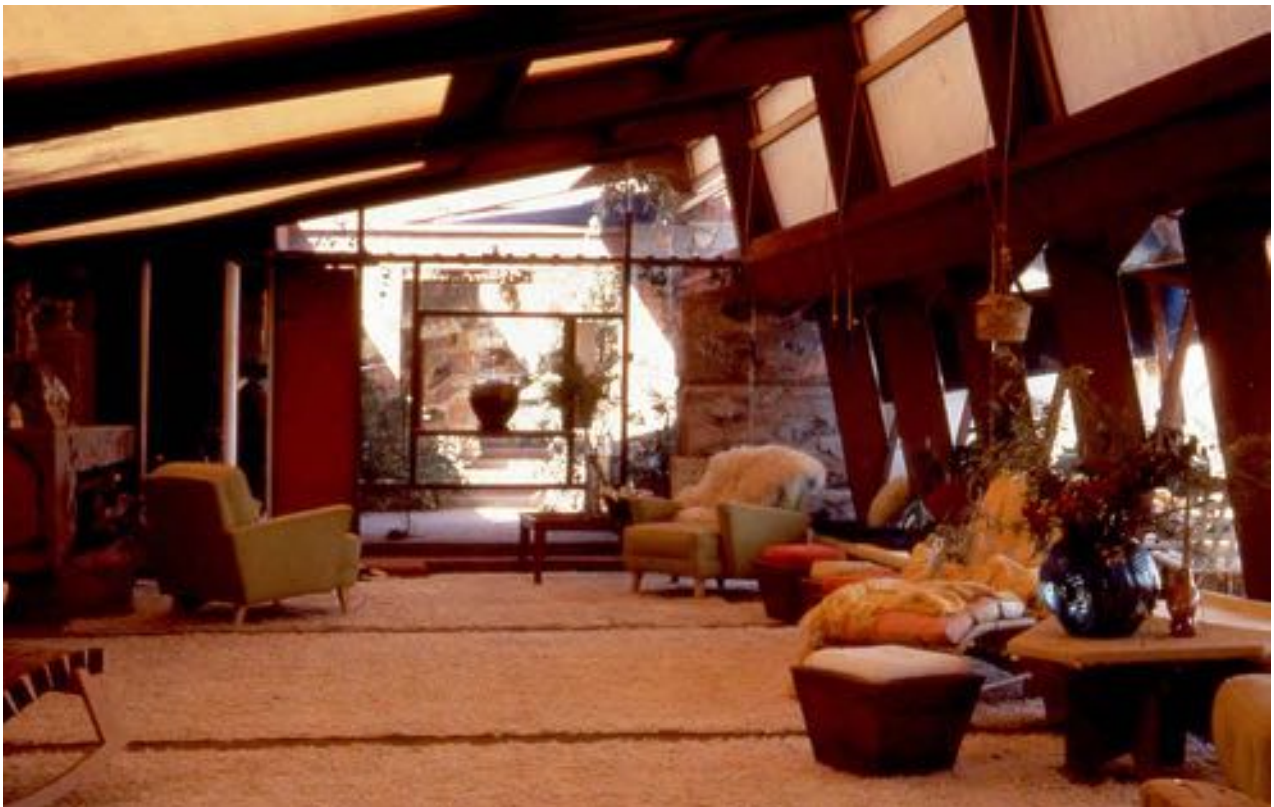
Figure 7-40 - Interior of Garden Room looking north, ca. 1949 (The Frank Lloyd Wright Foundation Archives, The Museum of Modern Art | Avery Architectural & Fine Arts Library, Columbia University, New York).

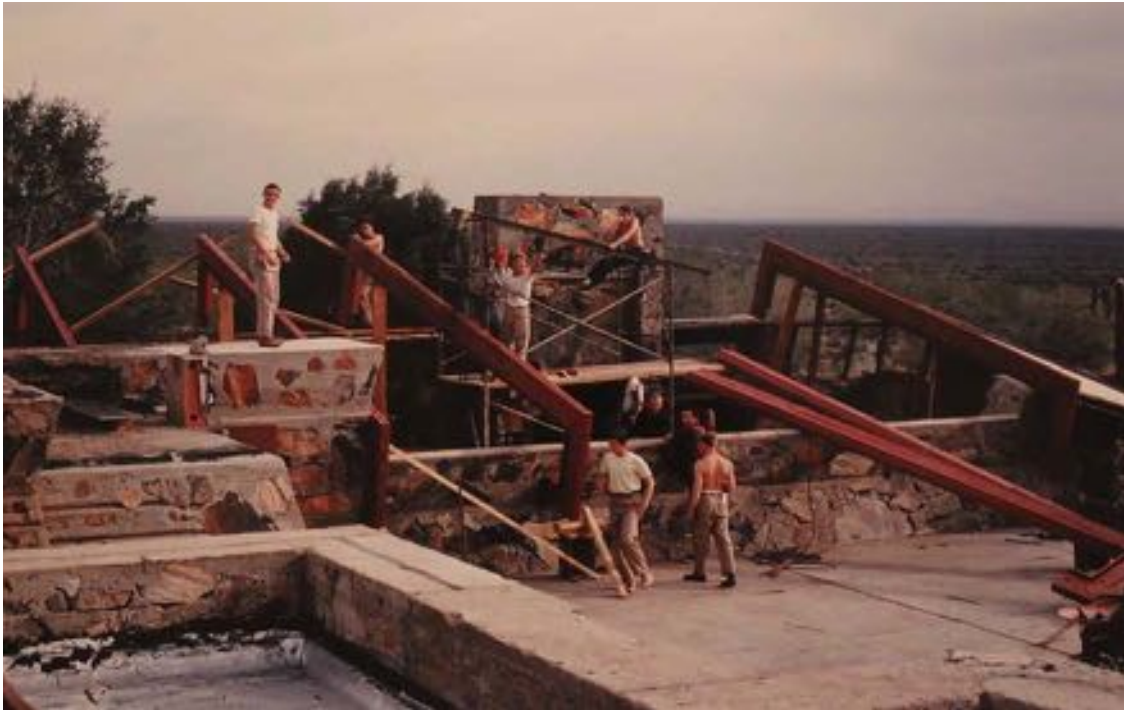
Figure 7-41 - Reconstruction of the Garden Room roof, 1958 (The Frank Lloyd Wright Foundation Archives, The Museum of Modern Art | Avery Architectural & Fine Arts Library, Columbia University, New York).

- The roof on the Garden Room was completely reconstructed. New wood beams with steel fitch plates were constructed and canvas panels were replaced.
- Skylights are added.

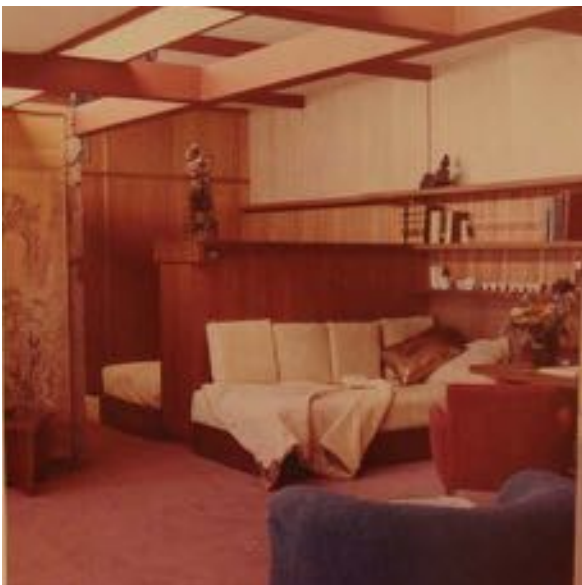
Figure 7-46 - Interior of Wright's Room pre-restoration, ca 1985 (The Frank Lloyd Wright Foundation Archives, The Museum of Modern Art | Avery Architectural & Fine Arts Library, Columbia University, New York).

- Restoration of Wright's Living Quarters. Changes made by Olgivanna Lloyd Wright after Frank Lloyd Wright's death were reversed and the living quarters were restored to their appearance during Frank Lloyd Wright's lifetime.

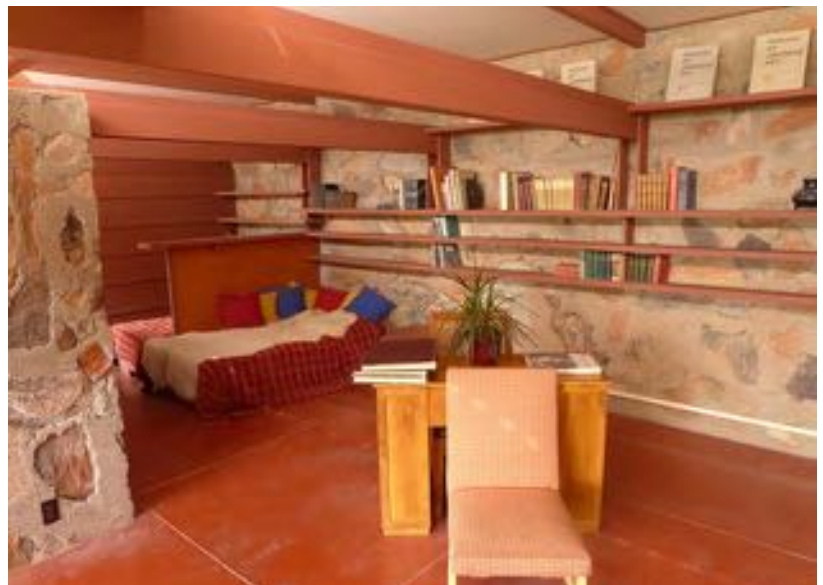
Figure 7-47 - Interior of Wright's Room post-restoration, ca 2014 (Harboe Architects).

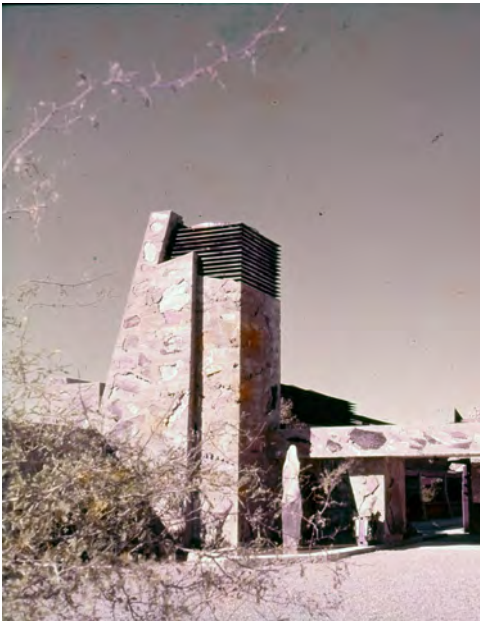
Figure 7-48 - Water Tower ca. 1950 (The Frank Lloyd Wright Foundation Archives, The Museum of Modern Art | Avery Architectural & Fine Arts Library, Columbia University, New York).

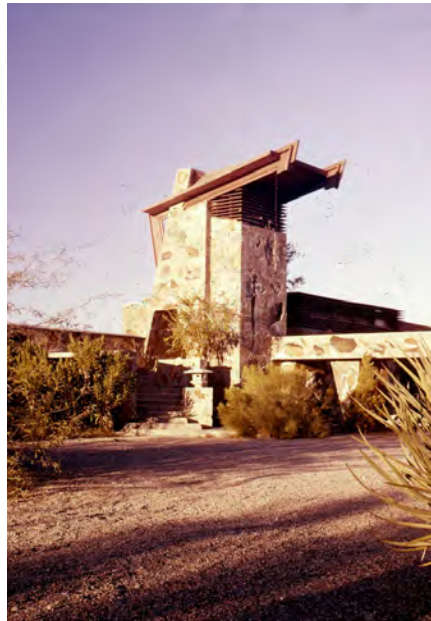
Figure 7-49 - Water Tower ca. 1958 (The Frank Lloyd Wright Foundation Archives, The Museum of Modern Art | Avery Architectural & Fine Arts Library, Columbia University, New York).

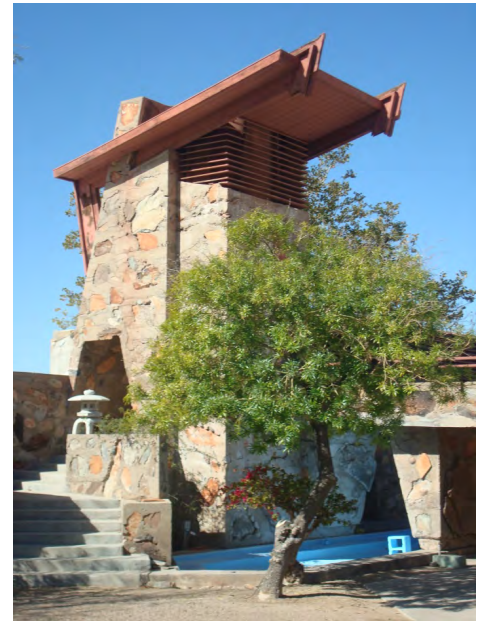
Figure 7-50 - Water Tower 2014 (Harboe Architects).

- Water Tower roof was renovated.

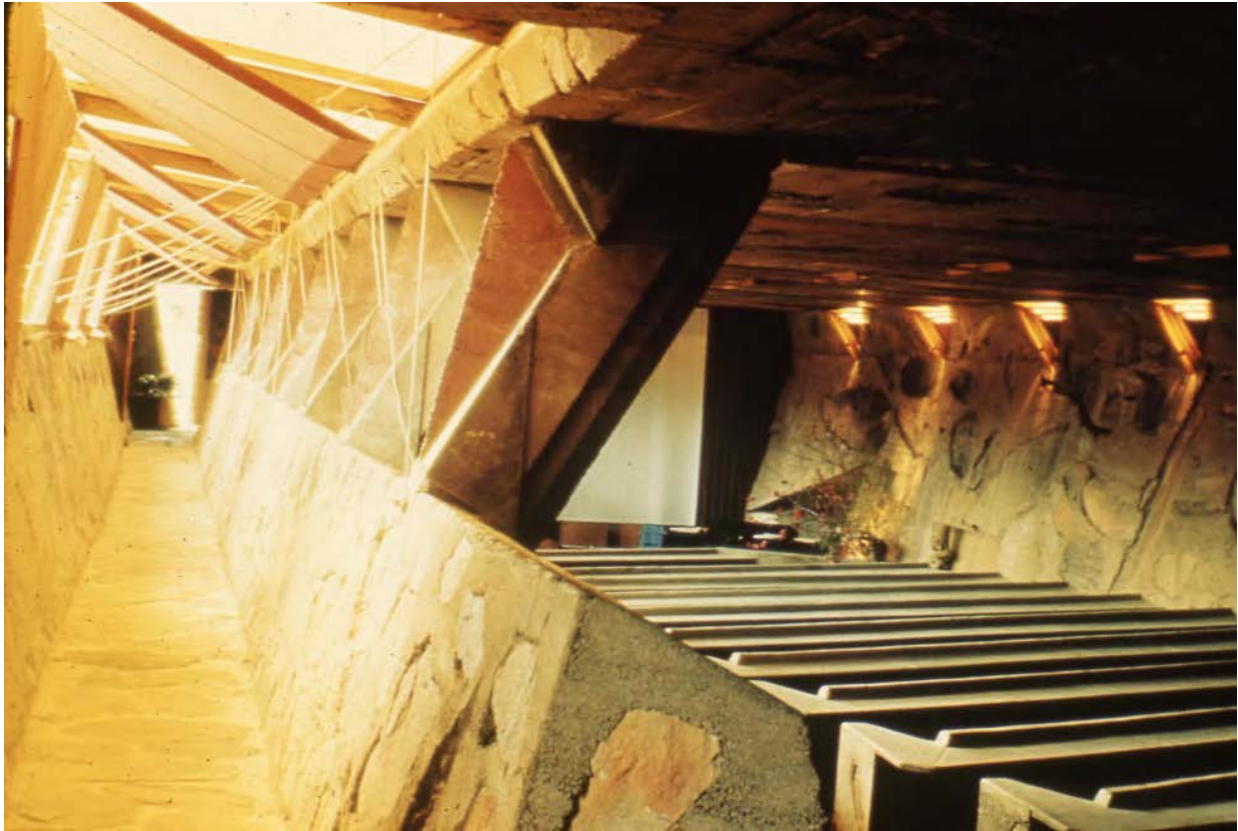
Figure 7-52 - Inside the Cabaret corridor with operable canvas panels, ca. 1952 (The Frank Lloyd Wright Foundation Archives, The Museum of Modern Art | Avery Architectural & Fine Arts Library, Columbia University, New York).

- Fabric panels at the openings along the Cabaret entry corridor were replaced with plywood panels.
- The string lights were added at the ceiling.

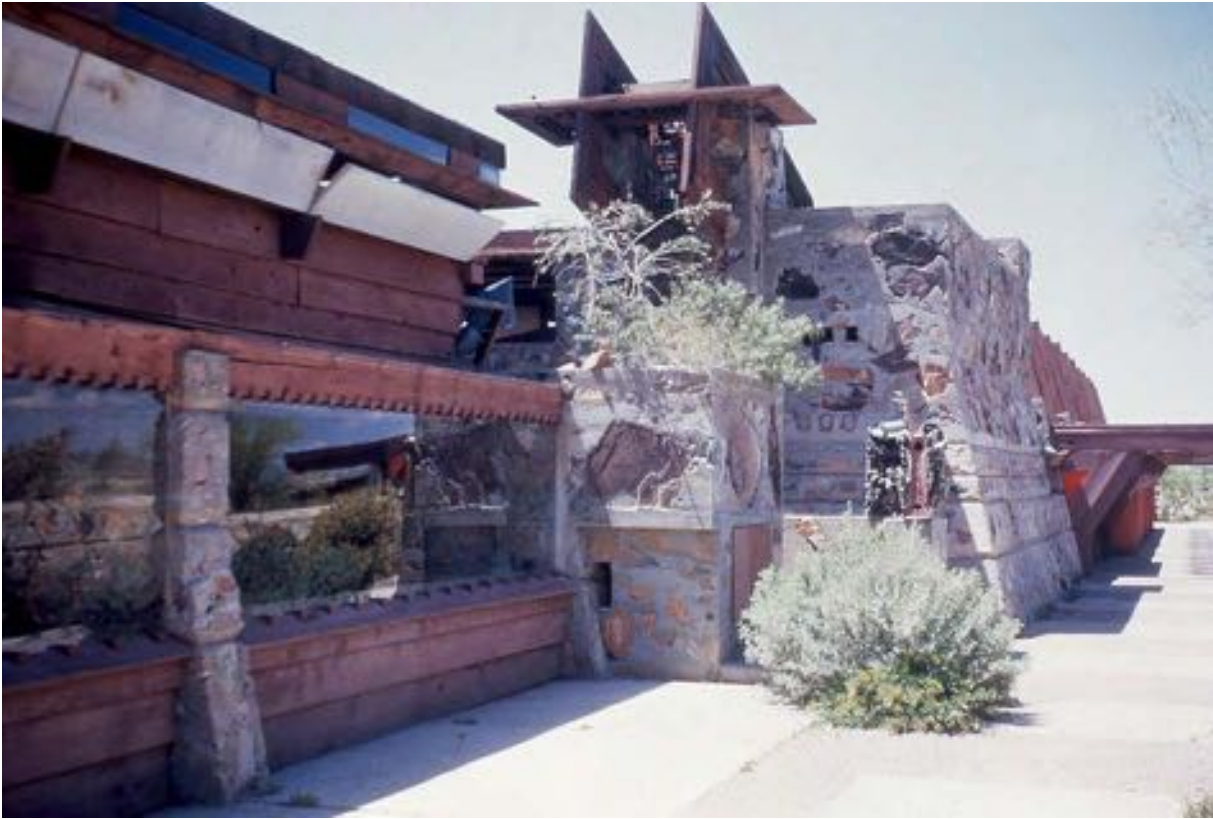
Figure 7-57 - Dining Room following its enclosure in 1950 (The Frank Lloyd Wright Foundation Archives, The Museum of Modern Art | Avery Architectural & Fine Arts Library, Columbia University, New York).

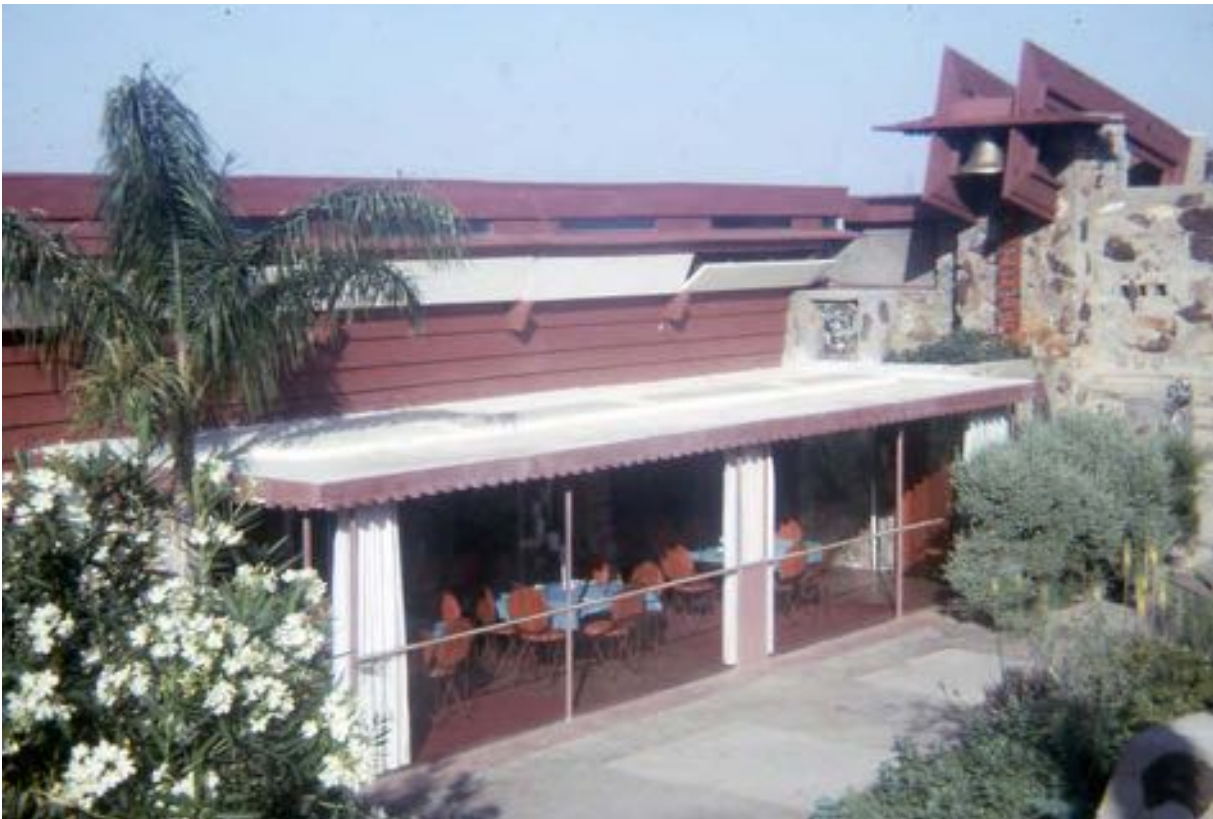
Figure 7-58 - Dining Room following the addition in 1958 (The Frank Lloyd Wright Foundation Archives, The Museum of Modern Art | Avery Architectural & Fine Arts Library, Columbia University, New York).

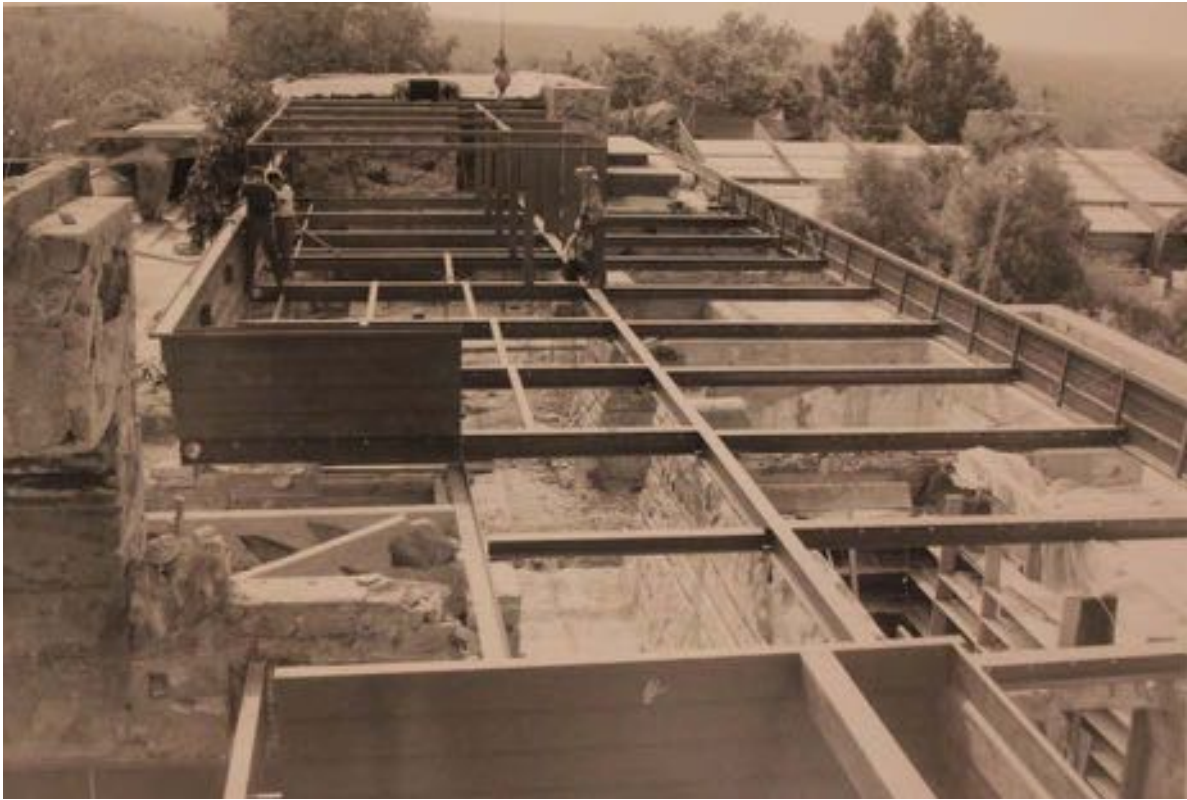
Figure 7-63 - Reconstruction of the Guest Deck ca. 1970 (The Frank Lloyd Wright Foundation Archives, The Museum of Modern Art | Avery Architectural & Fine Arts Library, Columbia University, New York).

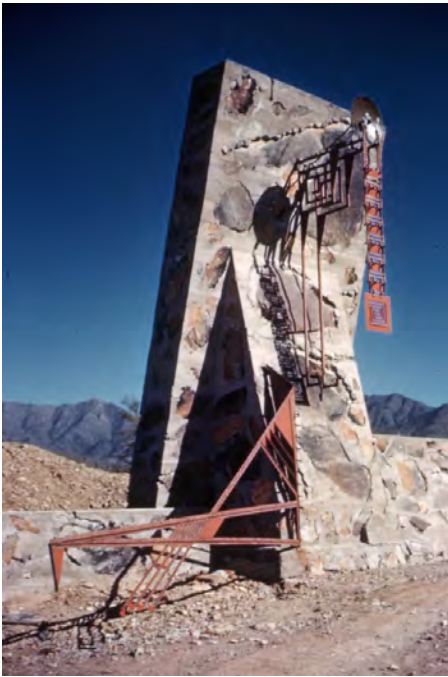
Figure 7-71 - Light Tower, ca. 1945 (The Frank Lloyd Wright Foundation Archives, The Museum of Modern Art | Avery Architectural & Fine Arts Library, Columbia University, New York).

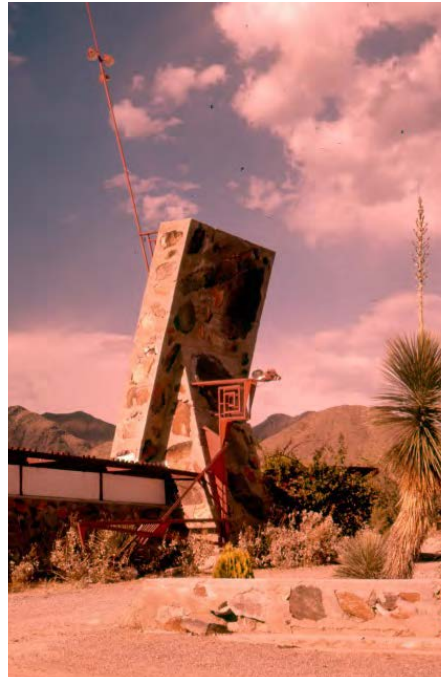
Figure 7-72 - Light Tower, ca. 1955 (The Frank Lloyd Wright Foundation Archives, The Museum of Modern Art | Avery Architectural & Fine Arts Library, Columbia University, New York).

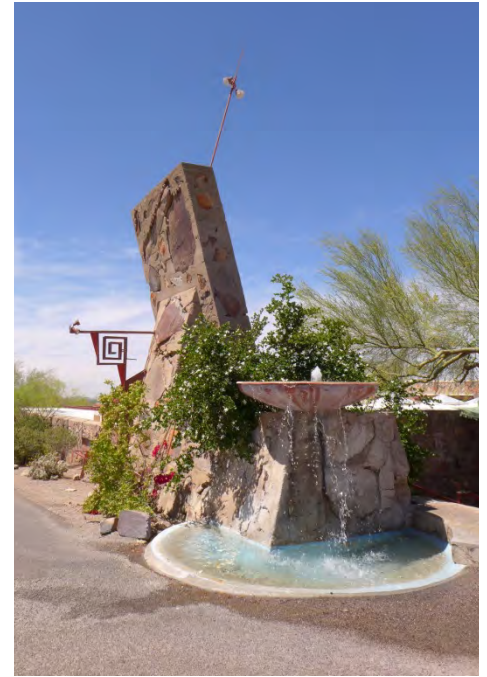
Figure 7-73 - Light Tower, 2014 (Harboe Architects).

- Workings of the lights were replaced with LED fixtures. The original metal reflectors were retained.

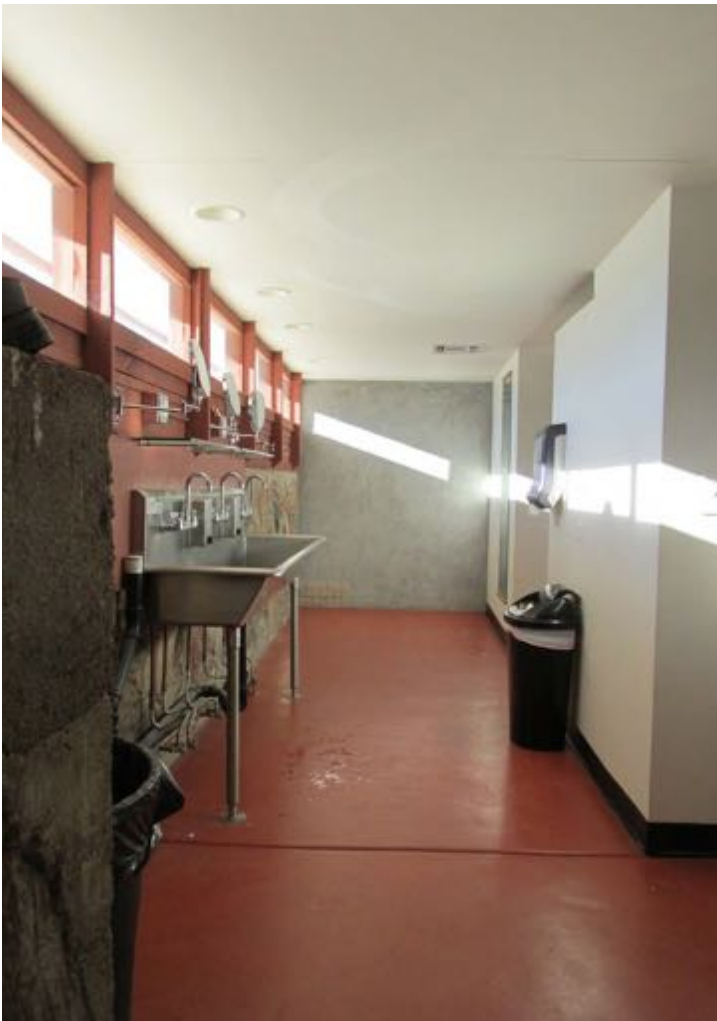
Figure 7-74 - Men's Locker Room bathroom, 2014 (Harboe Architects).

- Men's Locker Room was remodeled with new toilet and shower facilities. The roof structure and deck was rebuilt.
