TALIESIN WEST PRESERVATION MASTER PLAN

Harboe Architects, PC

MAY 21, 2015

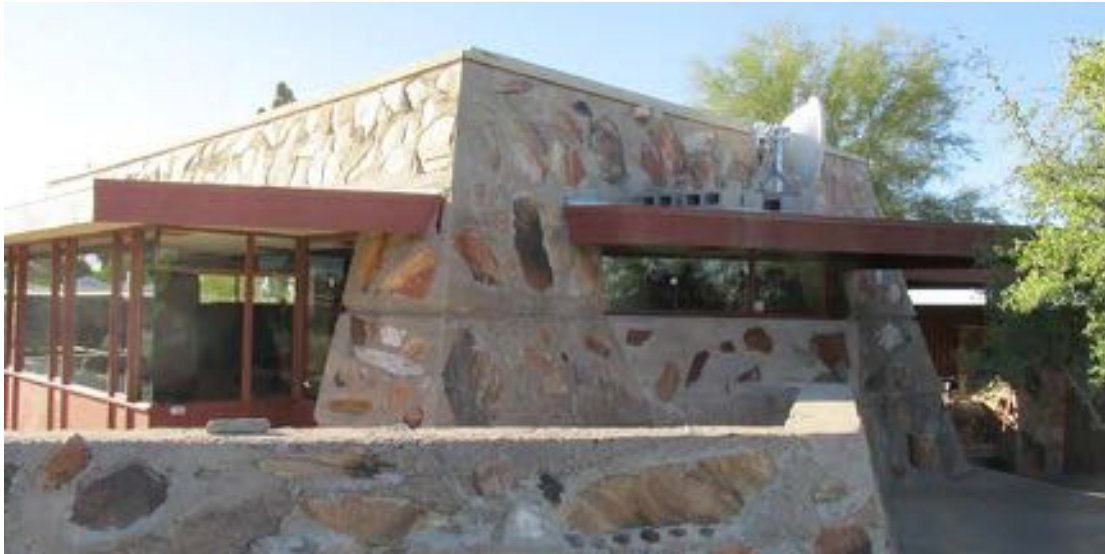
Figure 7-76 - Reading Room, 2014 (Harboe Architects).

- Damaged plaster at the soffits on the northwest side of the Reading Room was removed.

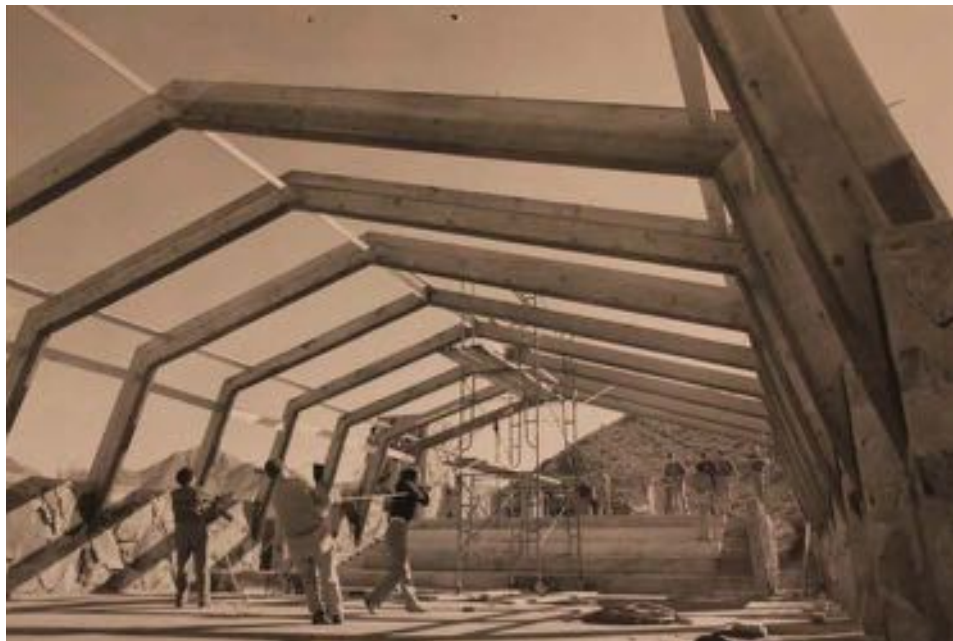
Figure 7-83 - Construction of the Pavilion ca. 1955 (The Frank Lloyd Wright Foundation Archives, The Museum of Modern Art | Avery Architectural & Fine Arts Library, Columbia University, New York).

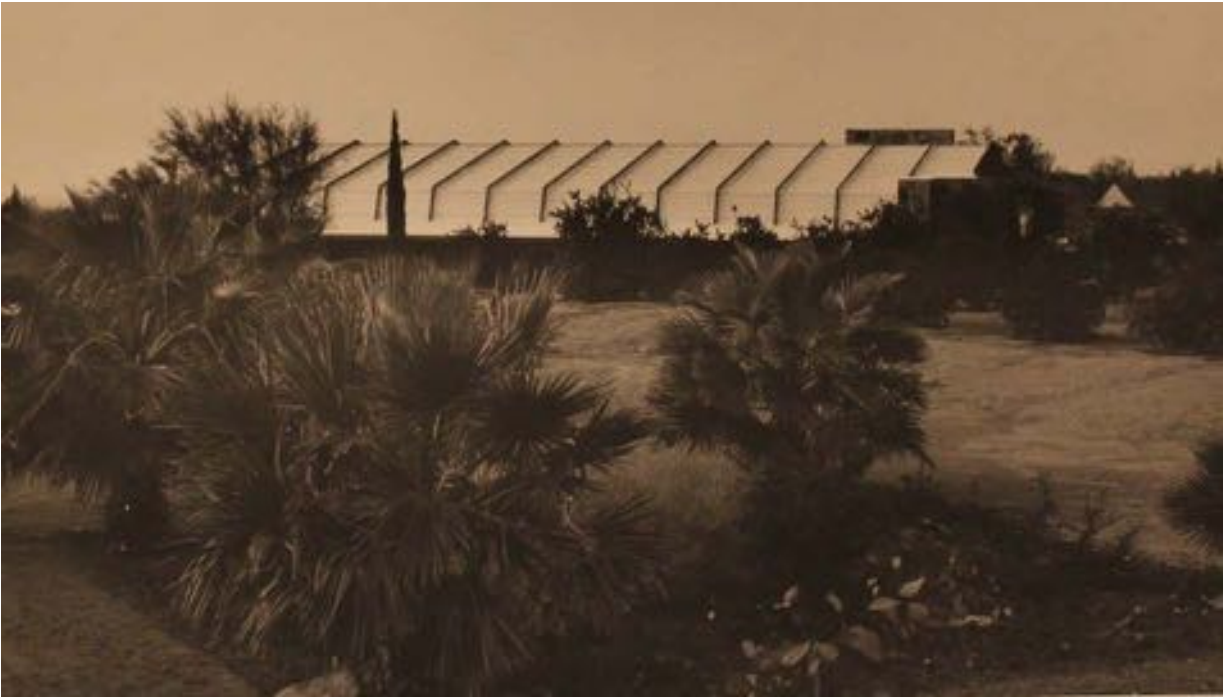
Figure 7-86 - Reconstructed Pavilion ca. 1965 (The Frank Lloyd Wright Foundation Archives, The Museum of Modern Art | Avery Architectural & Fine Arts Library, Columbia University, New York).

- The fabric panels on the roof of the Pavilion were replaced with rigid plastic panels (Alsynite).

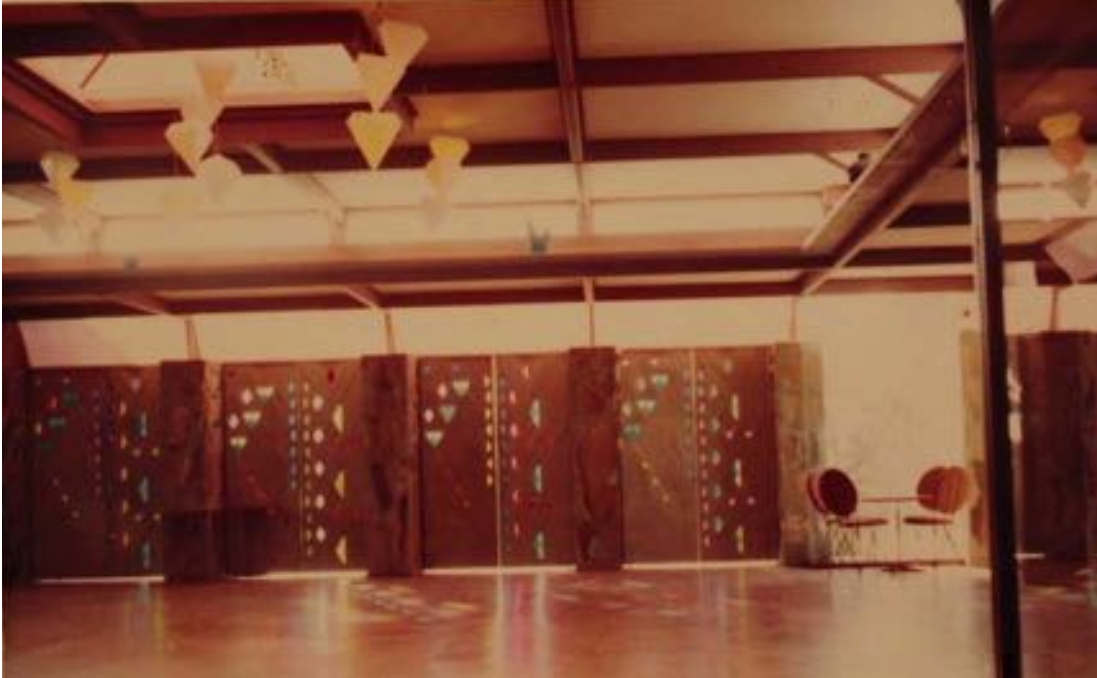
Figure 7-91 - Interior of the Atrium ca. 1961 (The Frank Lloyd Wright Foundation Archives, The Museum of Modern Art | Avery Architectural & Fine Arts Library, Columbia University, New York).

- The Atrium was constructed on the concrete slab on the east side of the Sun Cottage. The structure was original open with no glazing and enclosed on the south and east sides by concrete panels with inset stained glass.

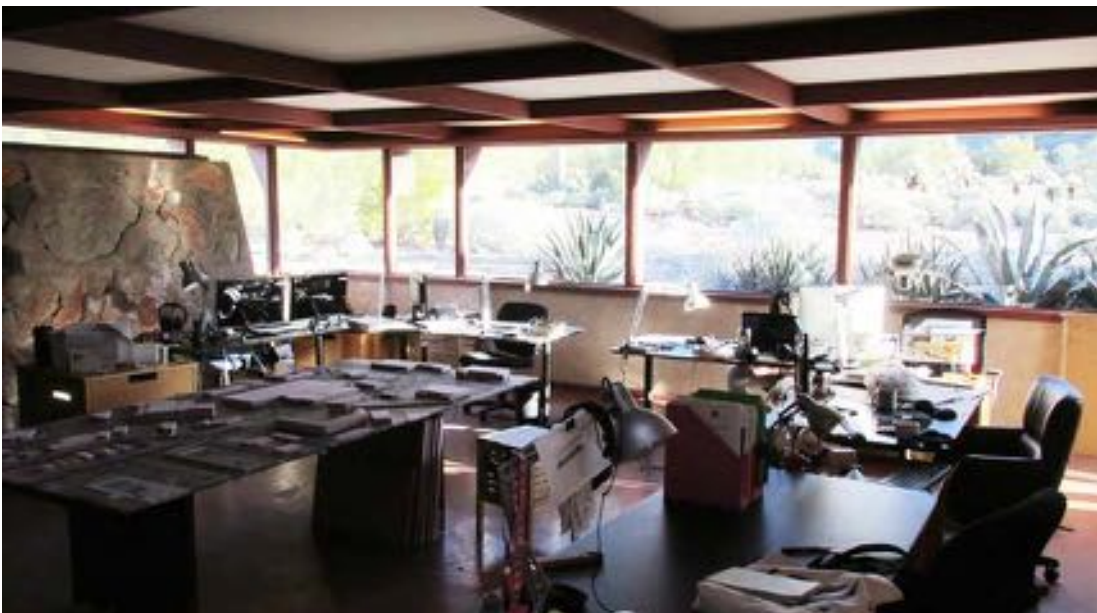
Figure 7-92 - Interior of the Atrium addition, 2014 (Harboe Architects).

- The Atrium was renovated and an addition was constructed on the north side of the building.

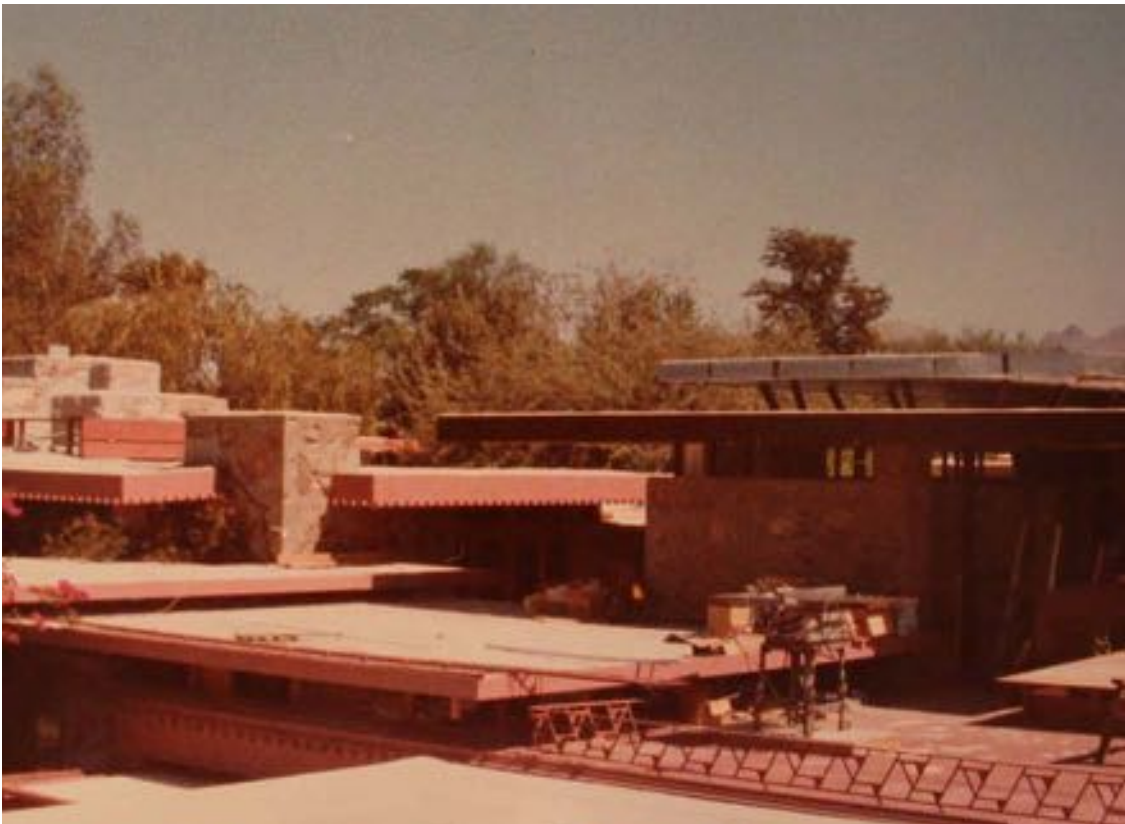
Figure 7-98 - Construction of Tower Room in 1977 (The Frank Lloyd Wright Foundation Archives, The Museum of Modern Art | Avery Architectural & Fine Arts Library, Columbia University, New York).

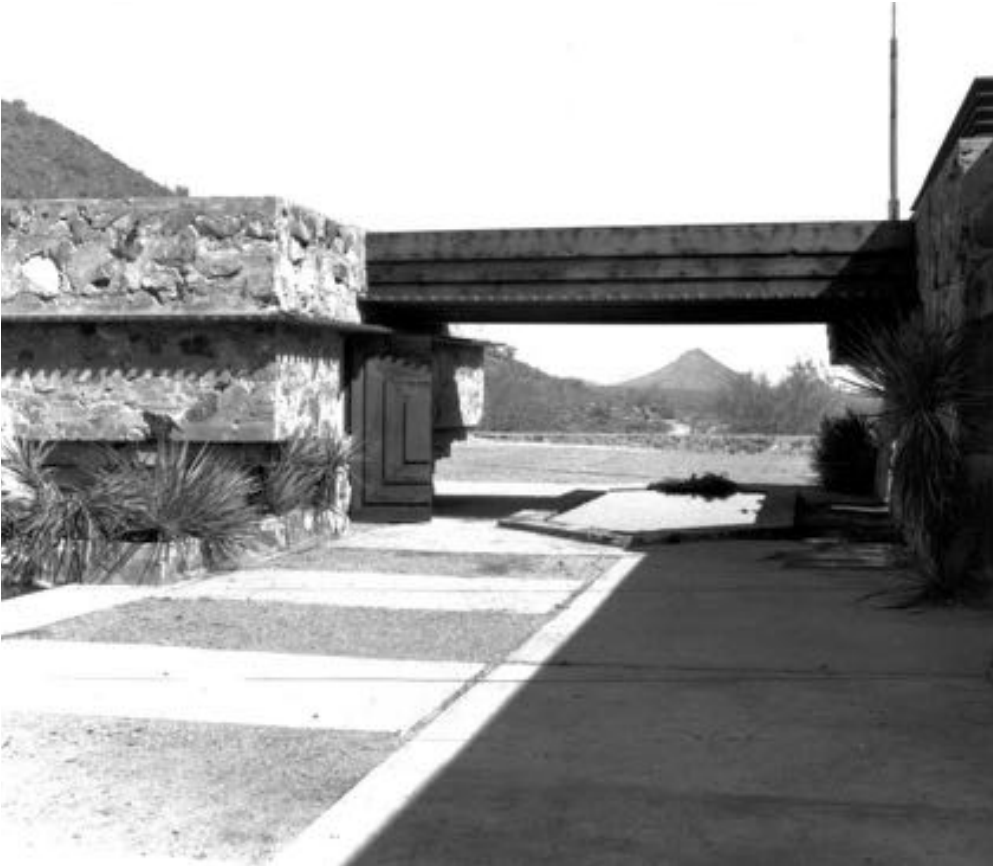
Figure 7-102 - Original Kiva Bridge, ca. 1942 (The Frank Lloyd Wright Foundation Archives, The Museum of Modern Art | Avery Architectural & Fine Arts Library, Columbia University, New York).

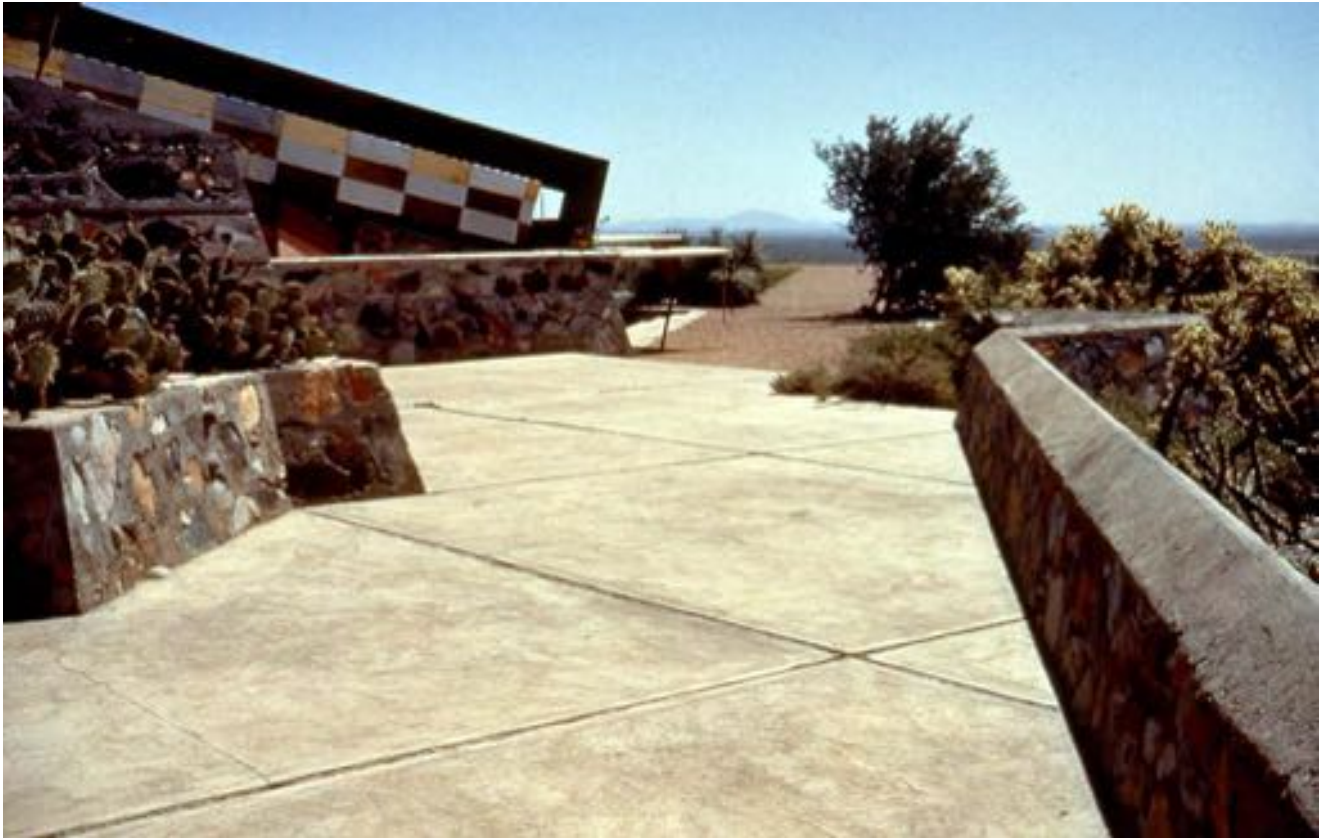
Figure 7-103 - Concrete paving on the west side of the Drafting Studio, ca. 1949 (The Frank Lloyd Wright Foundation Archives, The Museum of Modern Art | Avery Architectural & Fine Arts Library, Columbia University, New York).

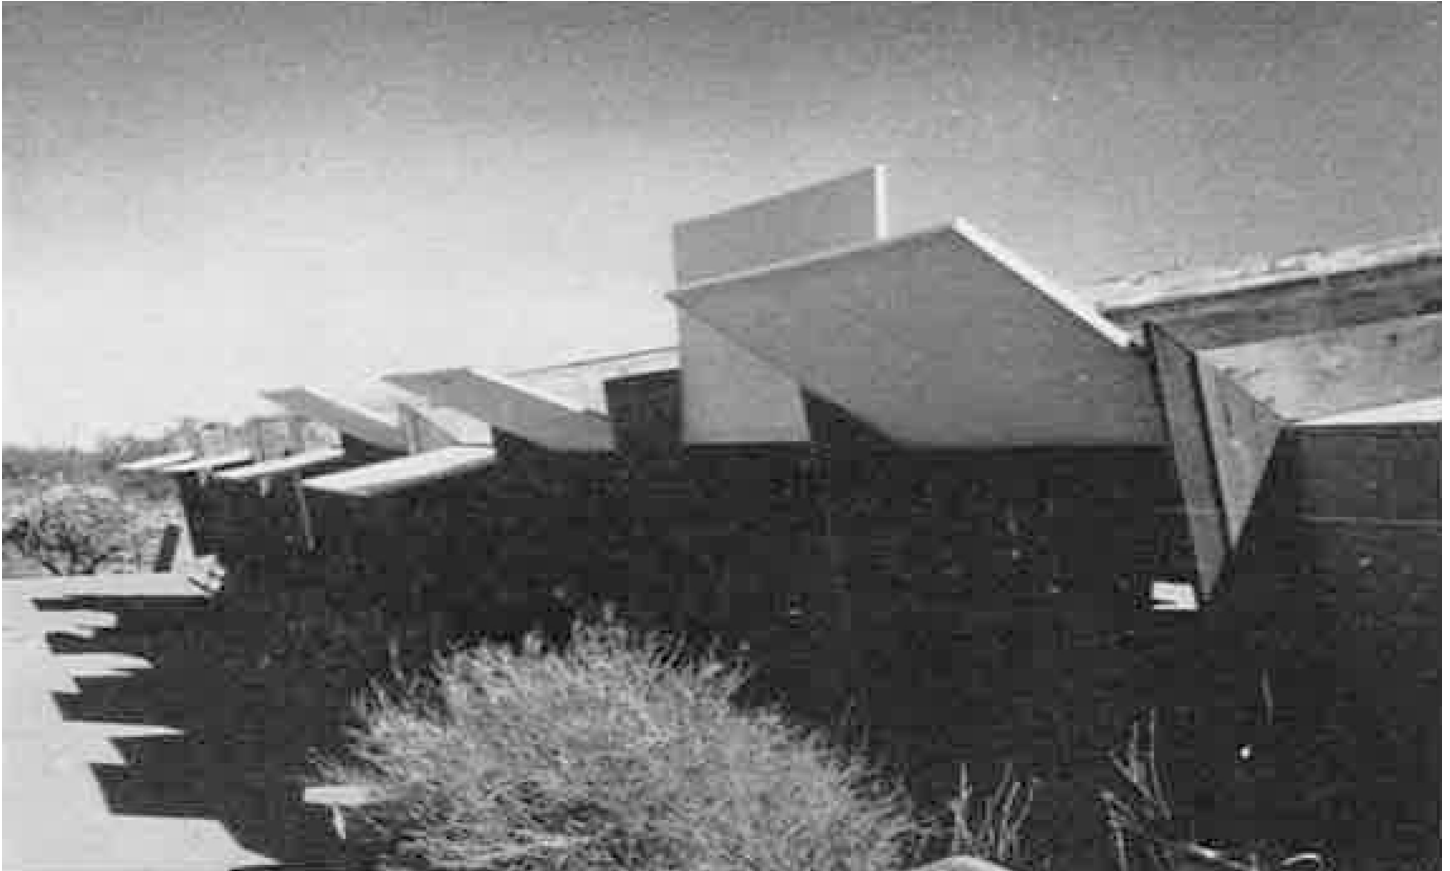
Figure 8-3 - Operable canvas panels on the Drafting Studio, ca. 1939 (The Frank Lloyd Wright Foundation Archives, The Museum of Modern Art | Avery Architectural & Fine Arts Library, Columbia University, New York).

The canvas roof systems were constantly altered as Wright continued to experiment with different configurations throughout the 1940s and 1950s, ever striving to improve upon the previous design. He was trying to keep out the rain while maintaining the soft, even light he so valued. Versions of the roof system in the early 1940s included a section of lapped wood boards running down the center of the roof. It is believed this was done in an attempt to decrease the amount of water leaking in when it rained and to reduce solar heat gain in the spaces. By the late 1940s the system had changed again to large expanses of inoperable canvas. By the late 1950s, Wright experimented with a new rubberized fabric material called Fiberthin for the roofs. However, the expanding and contracting qualities of this material made it a poor choice for the roofs. Despite multiple changes over the course of twenty years, the canvas enclosures undoubtedly promoted the camp atmosphere Wright was trying to achieve for Taliesin West.

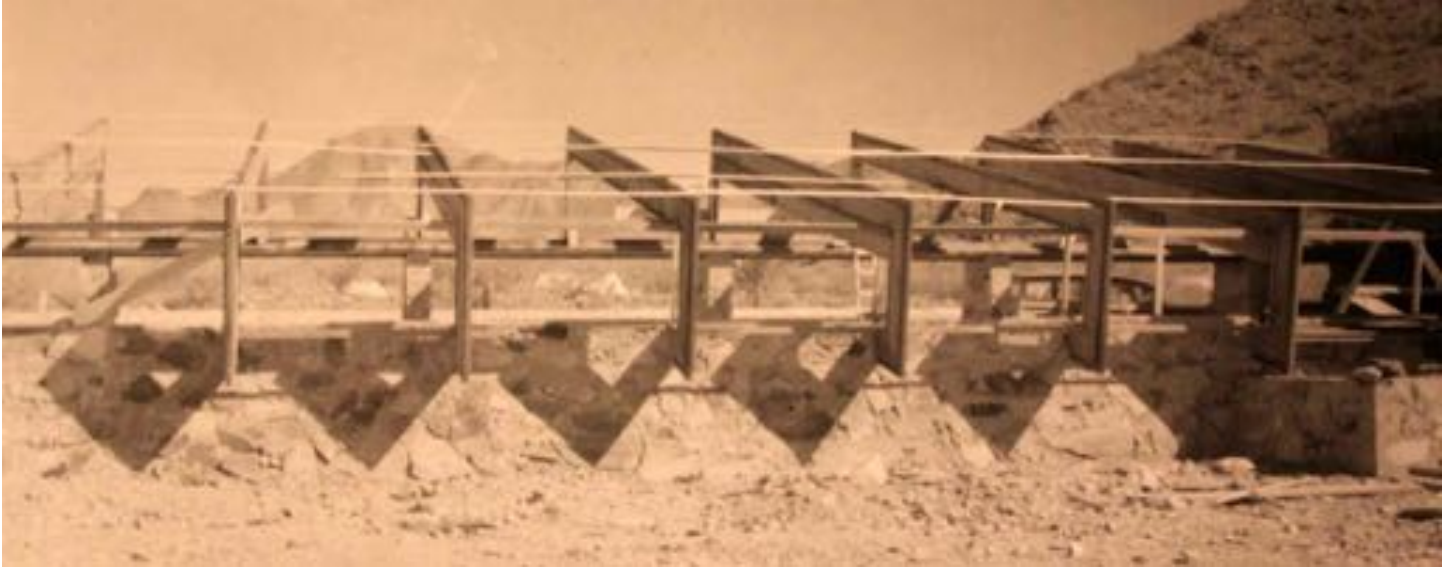
Figure 8-10 - Construction of the Drafting Studio, ca. 1939 (The Frank Lloyd Wright Foundation Archives, The Museum of Modern Art | Avery Architectural & Fine Arts Library, Columbia University, New York).

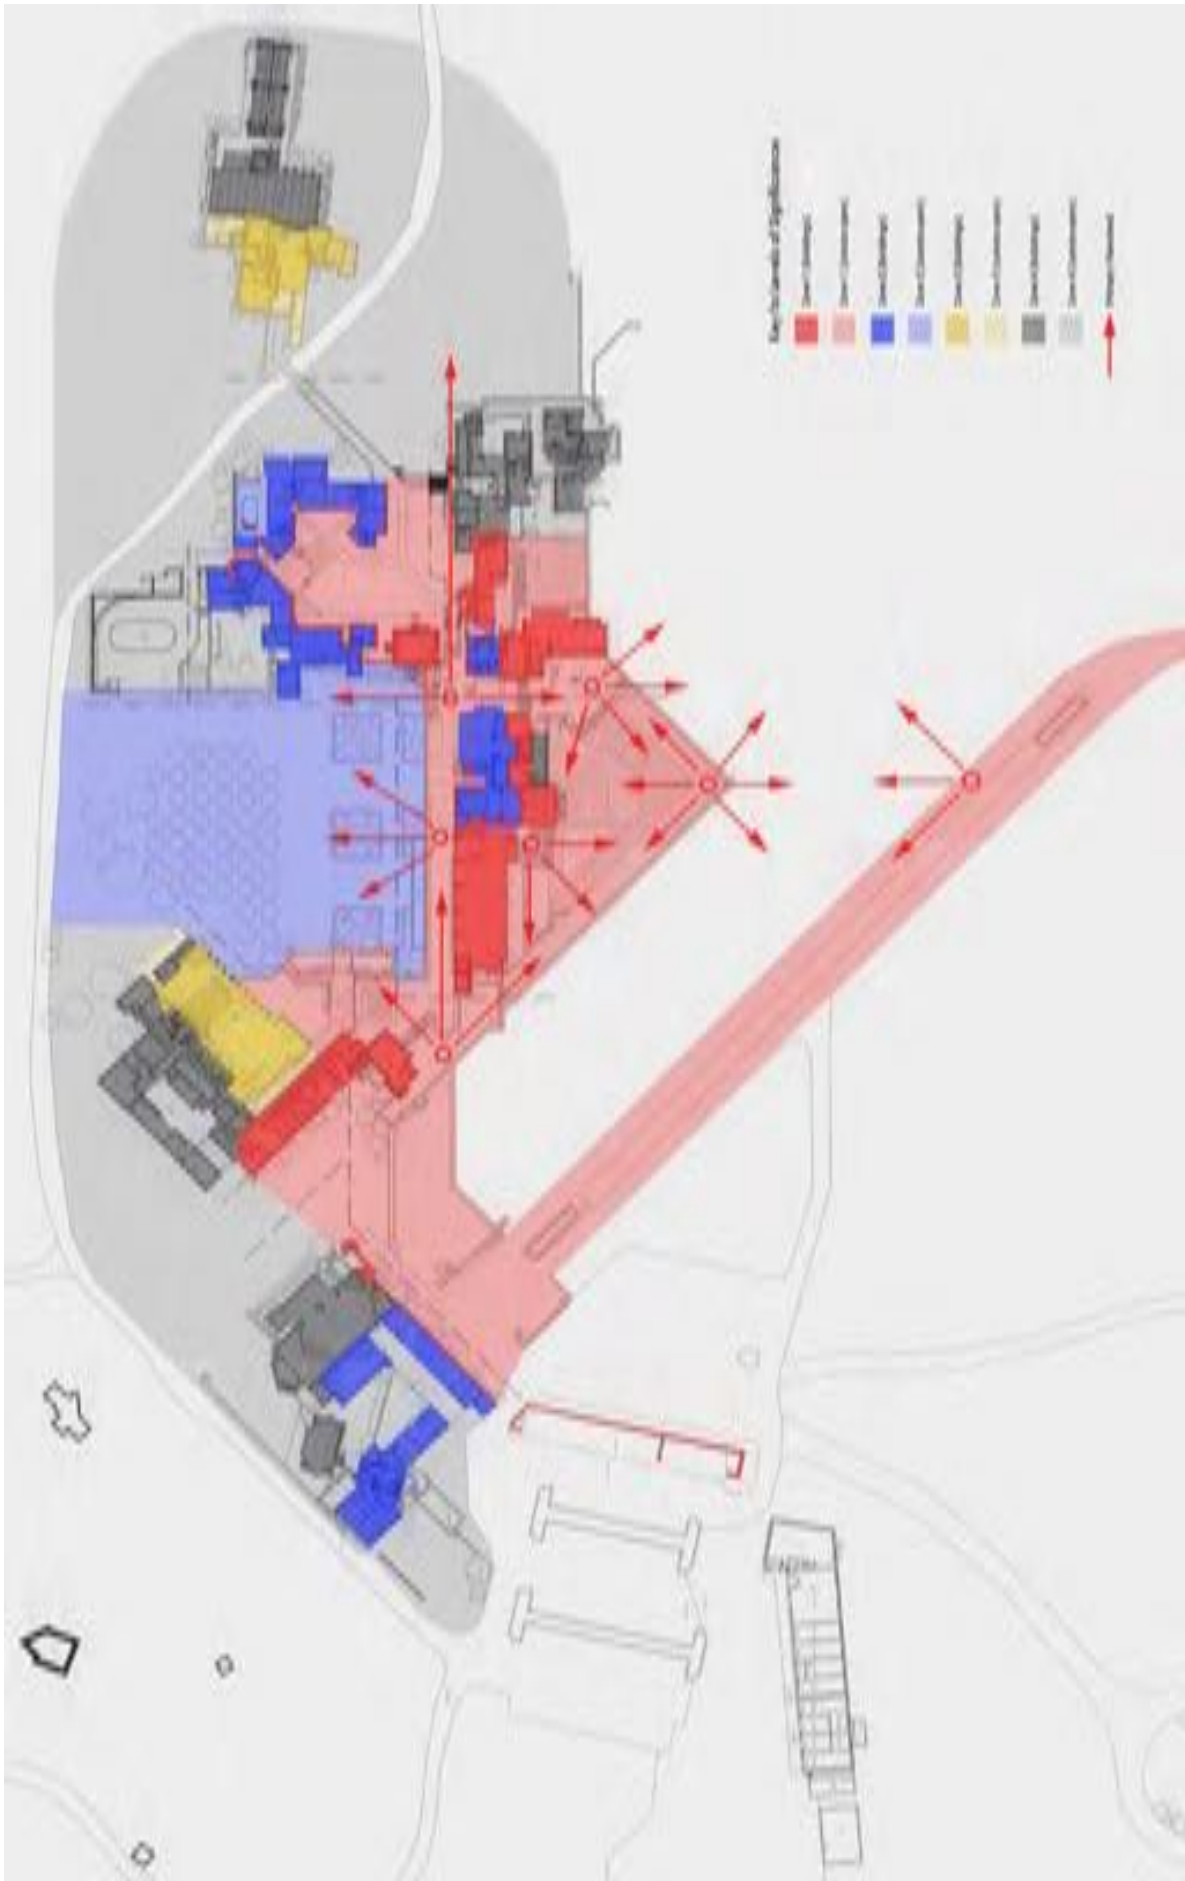
Figure 8-21 - Preservation Zoning Plan of Taliesin West.

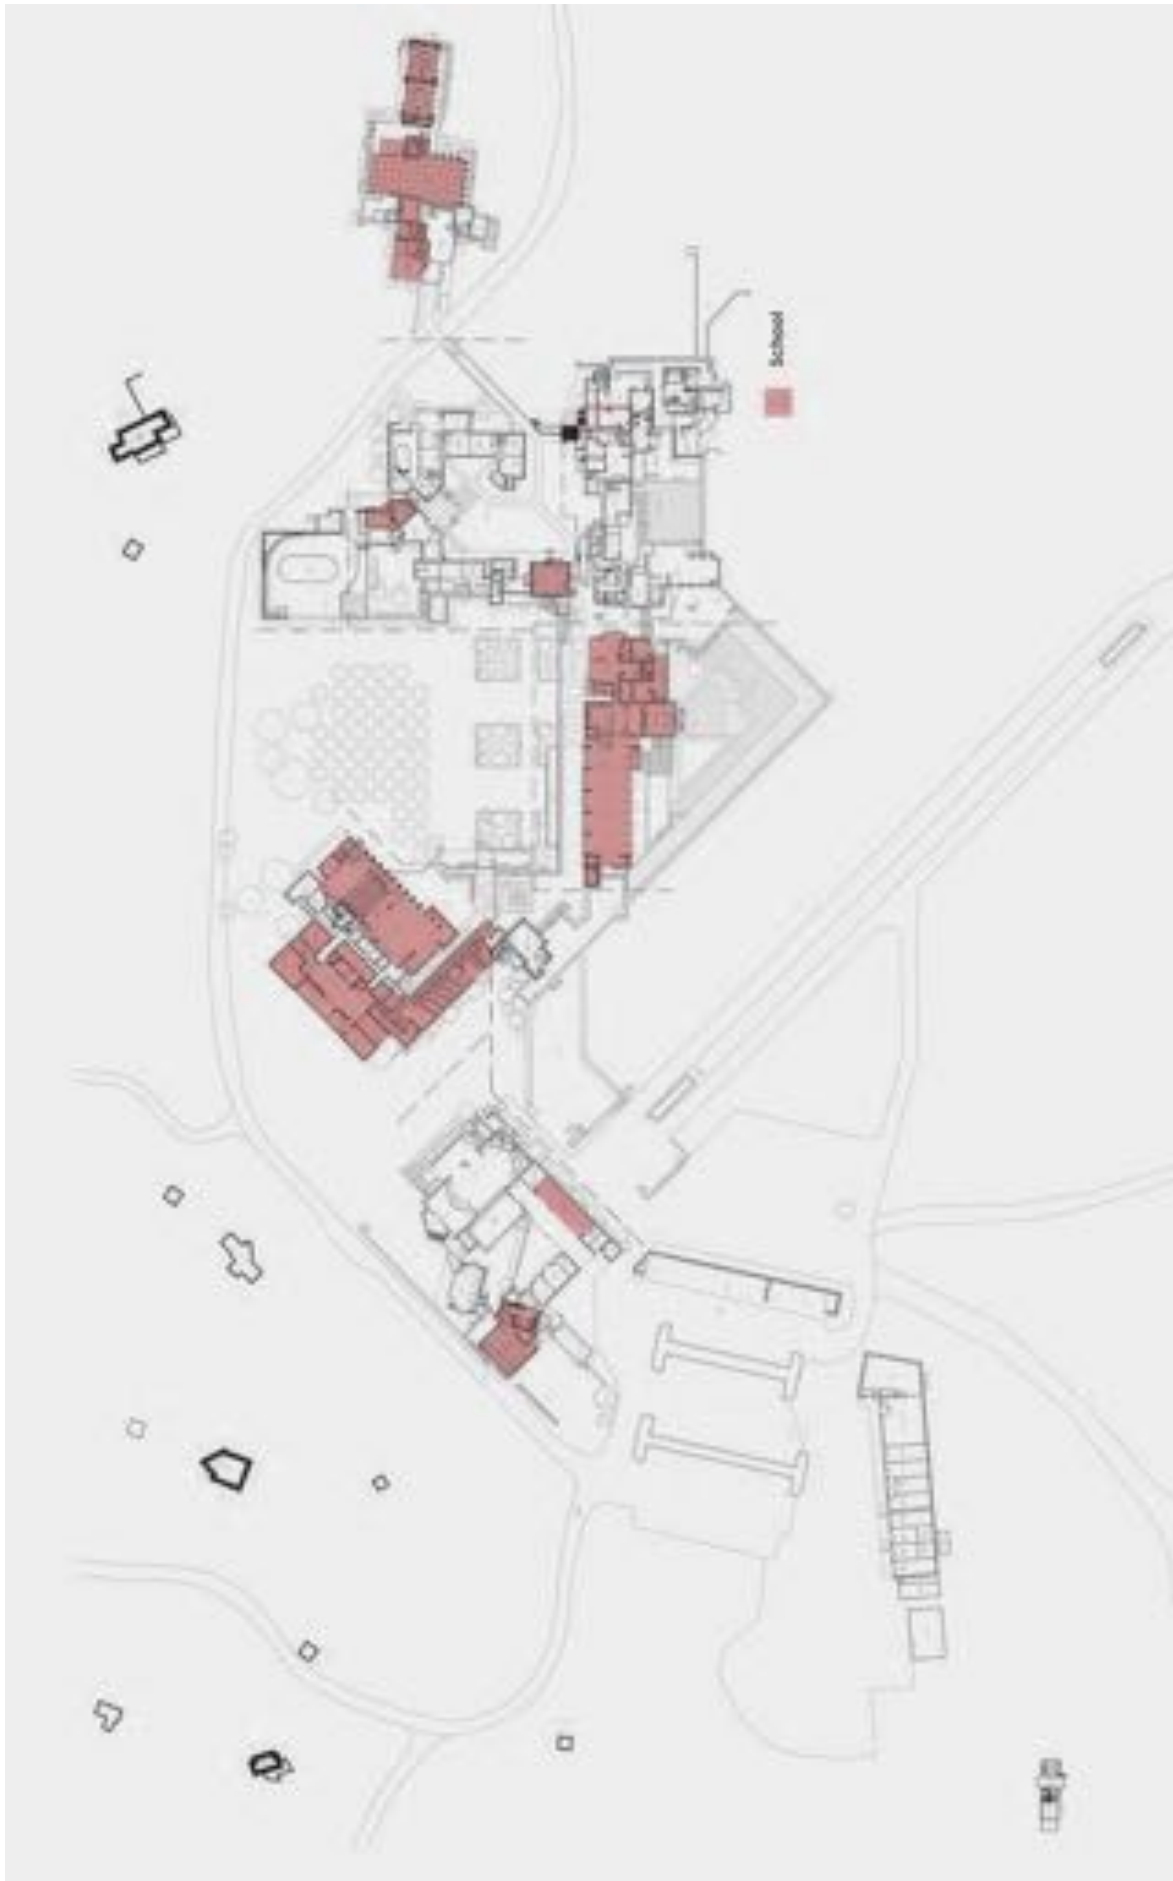
Figure 9-1 - Site plan of Taliesin West showing the locations of spaces used by the Frank Lloyd Wright School of Architecture.

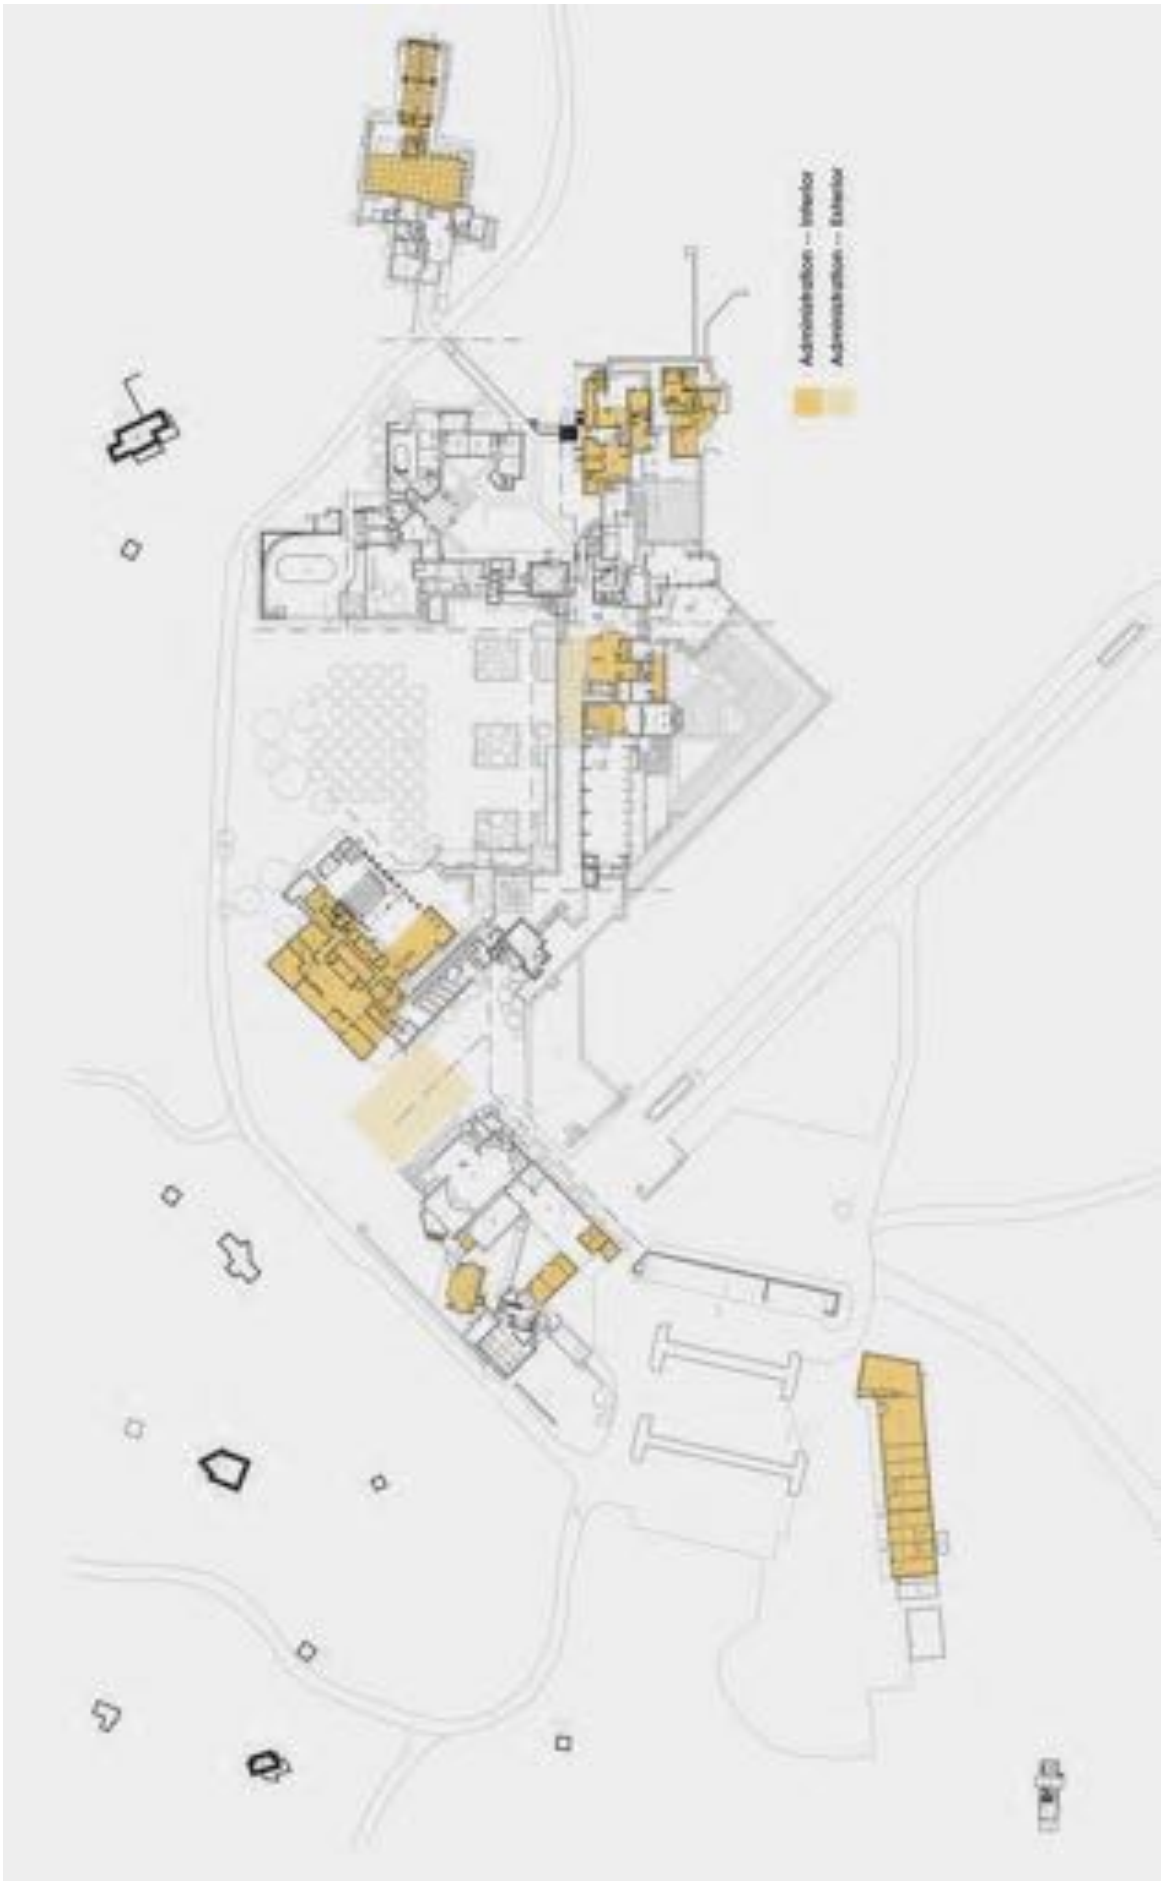
Figure 9-2 - Site plan of Taliesin West showing the locations of spaces used by the Frank Lloyd Wright Foundation administration.

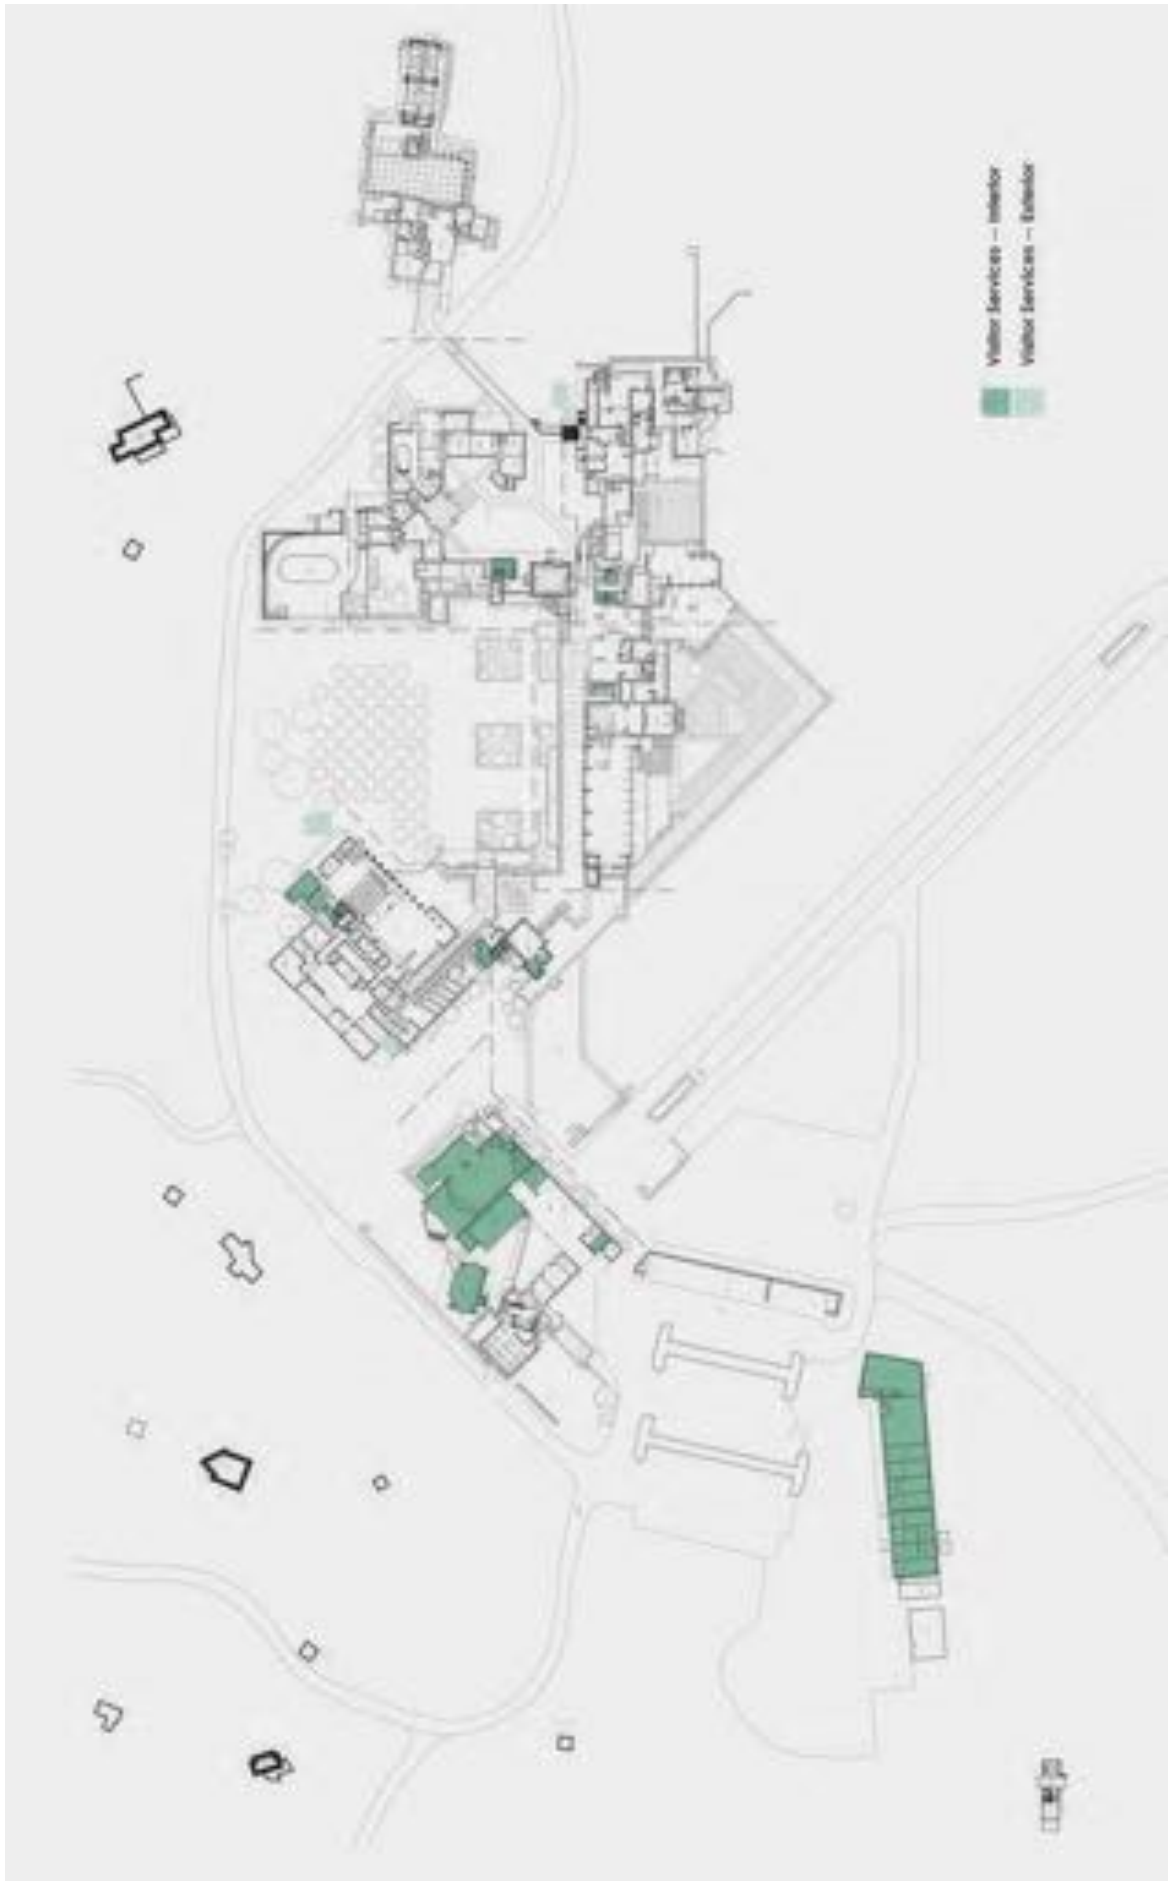
Figure 9-3 - Site plan of Taliesin West showing the locations of spaces used by the visitors' services staff.

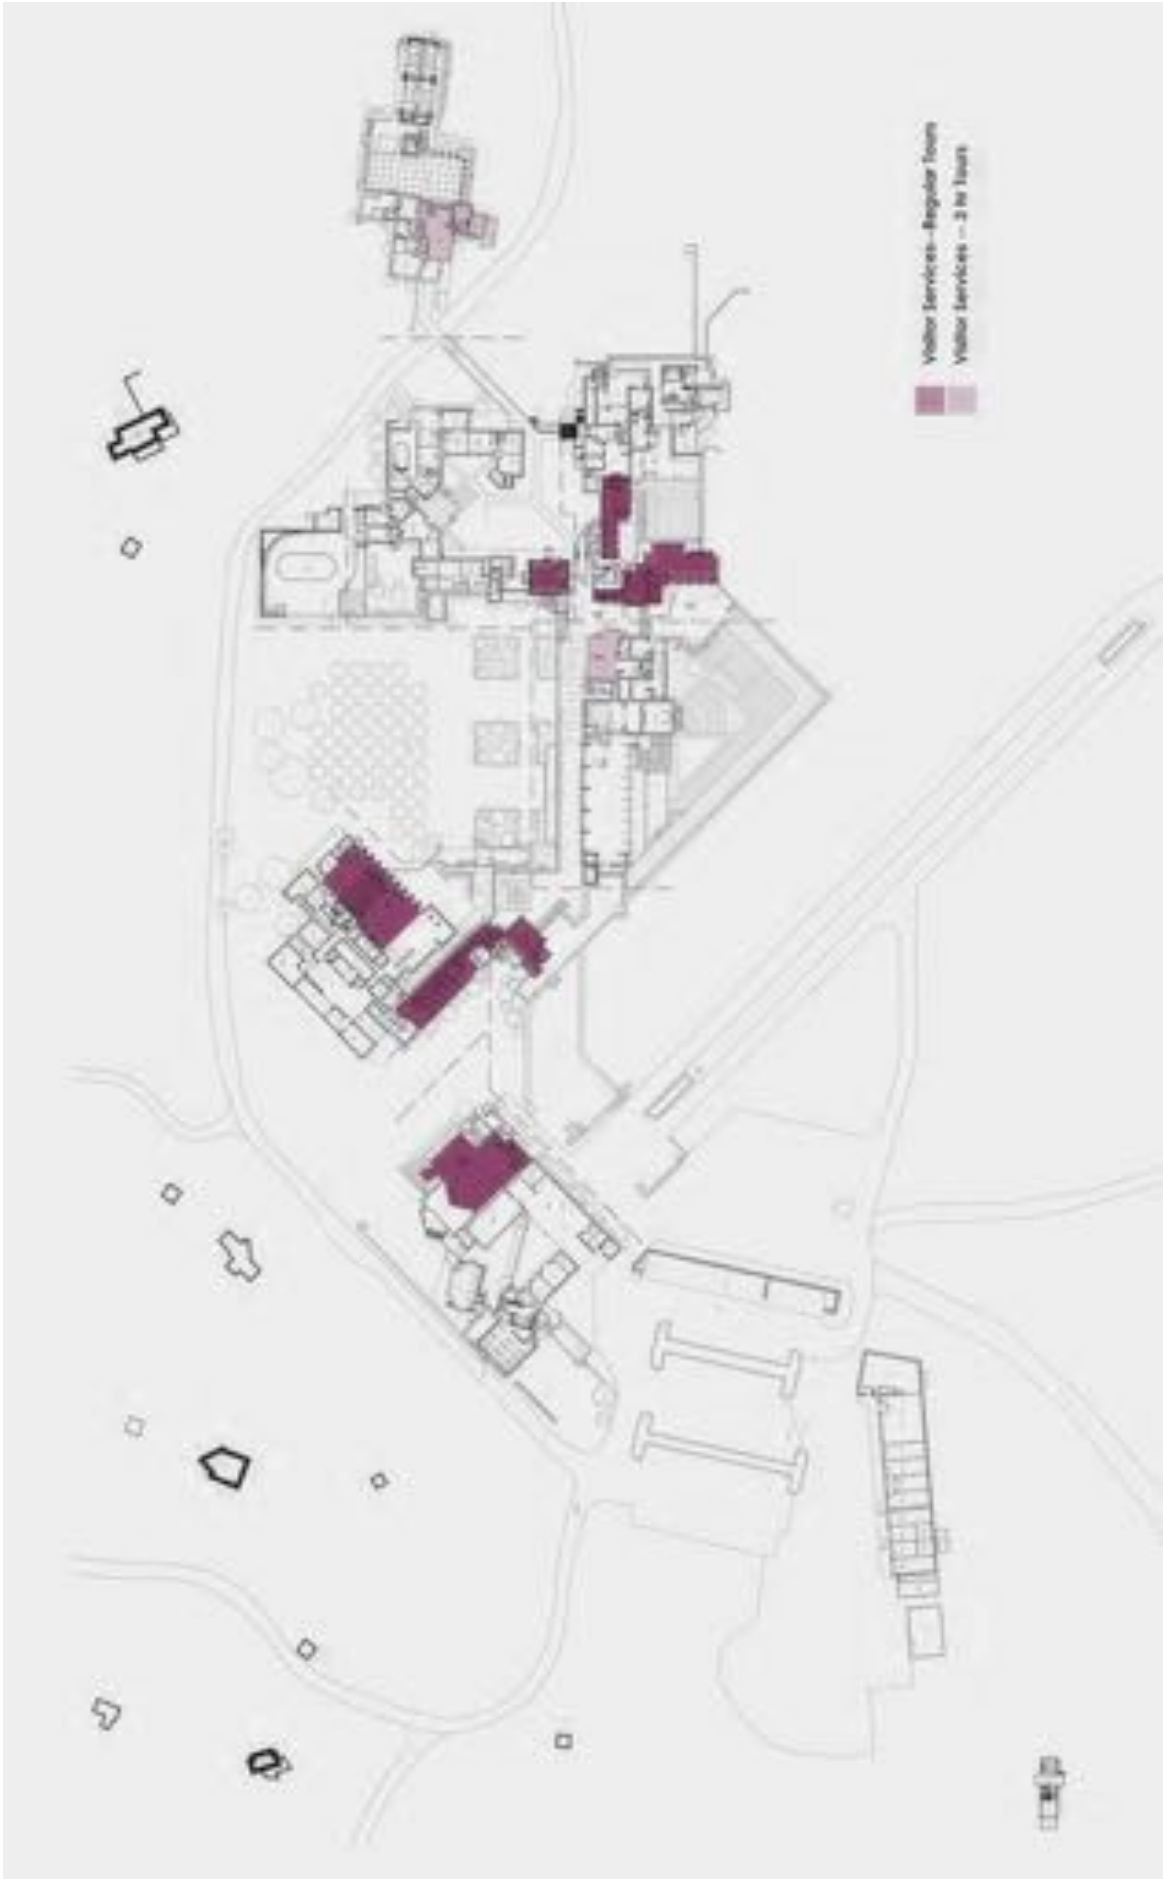
Figure 9-4 - Site plan of Taliesin West showing the locations of spaces used for tours.

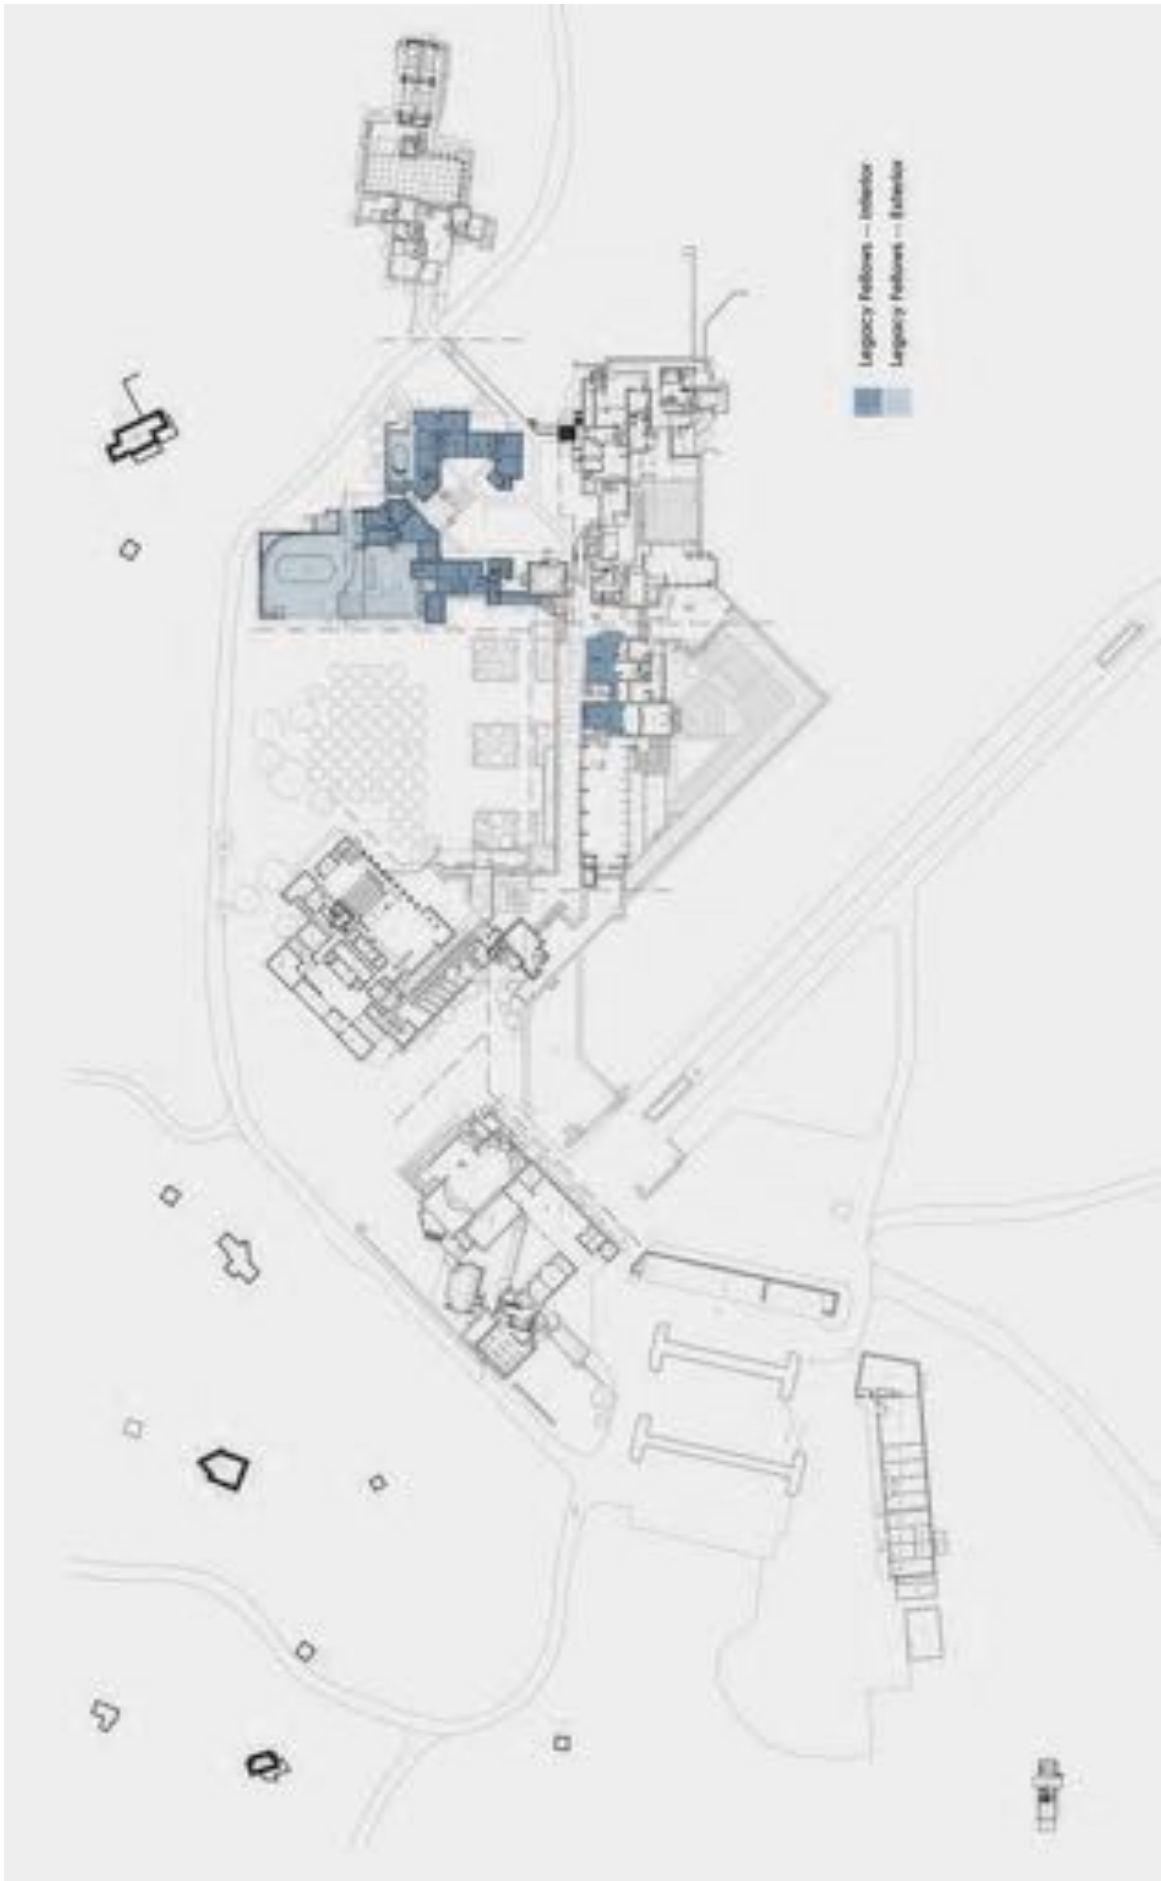
Figure 9-5 - Site plan of Taliesin West showing the locations of spaces used by the Legacy Fellows.
