TALIESIN WEST PRESERVATION MASTER PLAN

Harboe Architects, PC

MAY 21, 2015

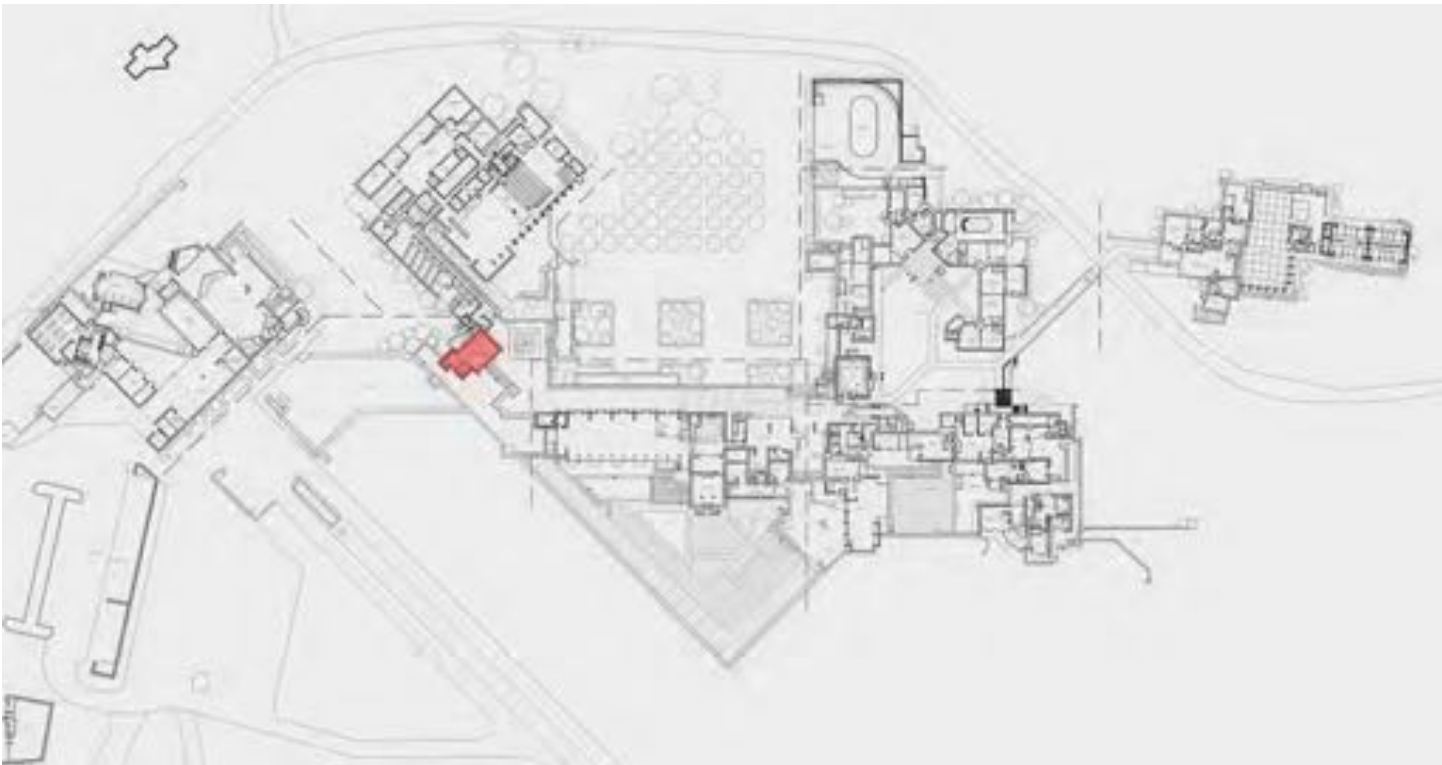
Figure 10-1 - Office Location Plan

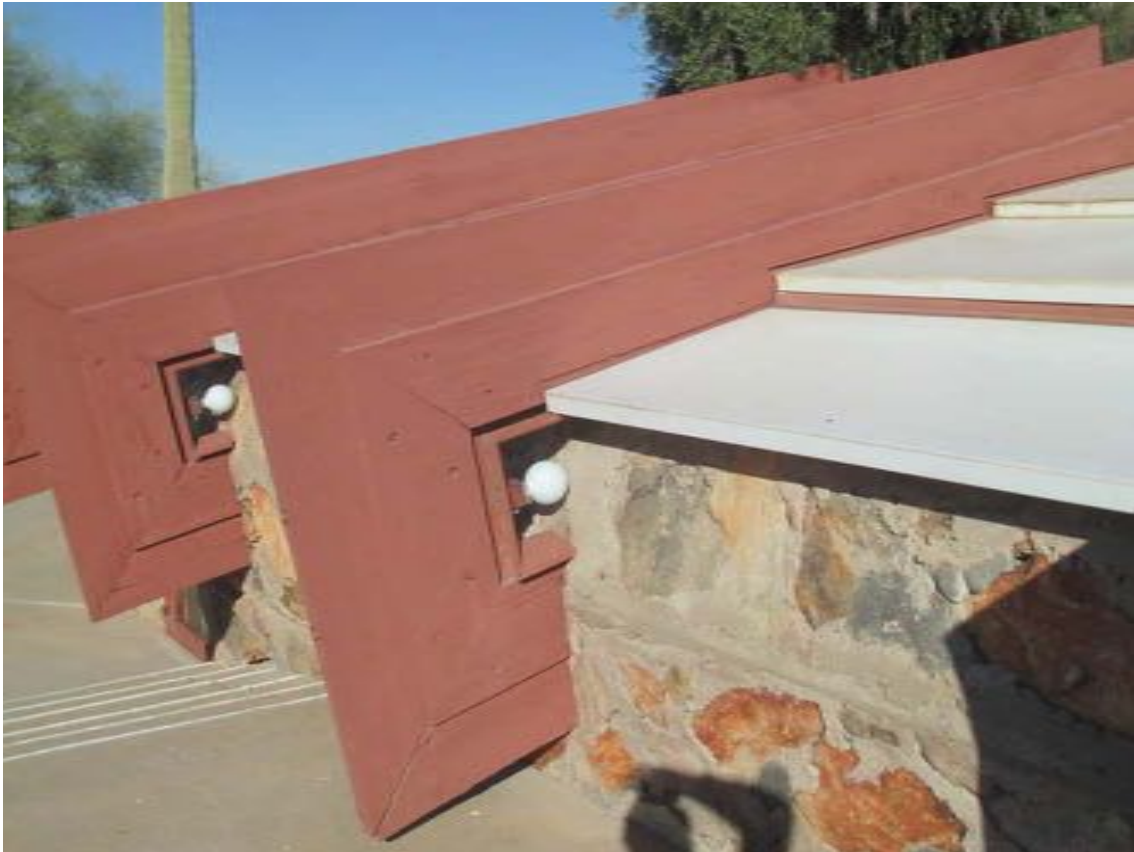
Figure 10-5 - Roof trusses on the office in 2014 (Harboe Architects).

The existing built up beams are in fair condition. There are localized areas of UV and rot damage. This is typically limited to the jointed corners and at the bottom of the built up beams where they rest on the desert masonry. Additionally, the design of the beams and roof system does not appear to provide significant lateral bracing between trusses allowing for significant lateral deflection in heavy wind conditions.

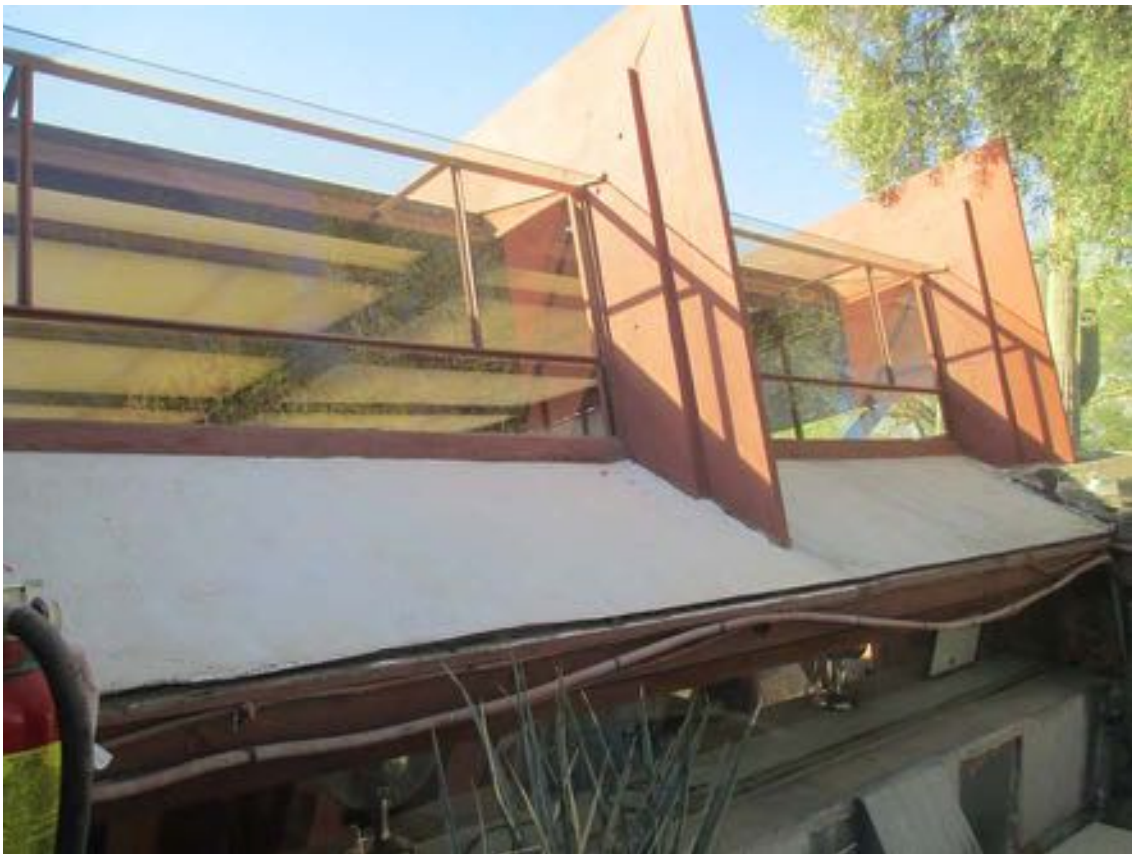
Figure 10-6 - North clerestory windows and roof on the office in 2014 (Harboe Architects).

The glazing is typically in good condition. The glass is typically set with minimal metal framing to minimize its visual modification to the original open air design. The addition of glazing has significantly decreased the option of cooling the Office with natural ventilation.

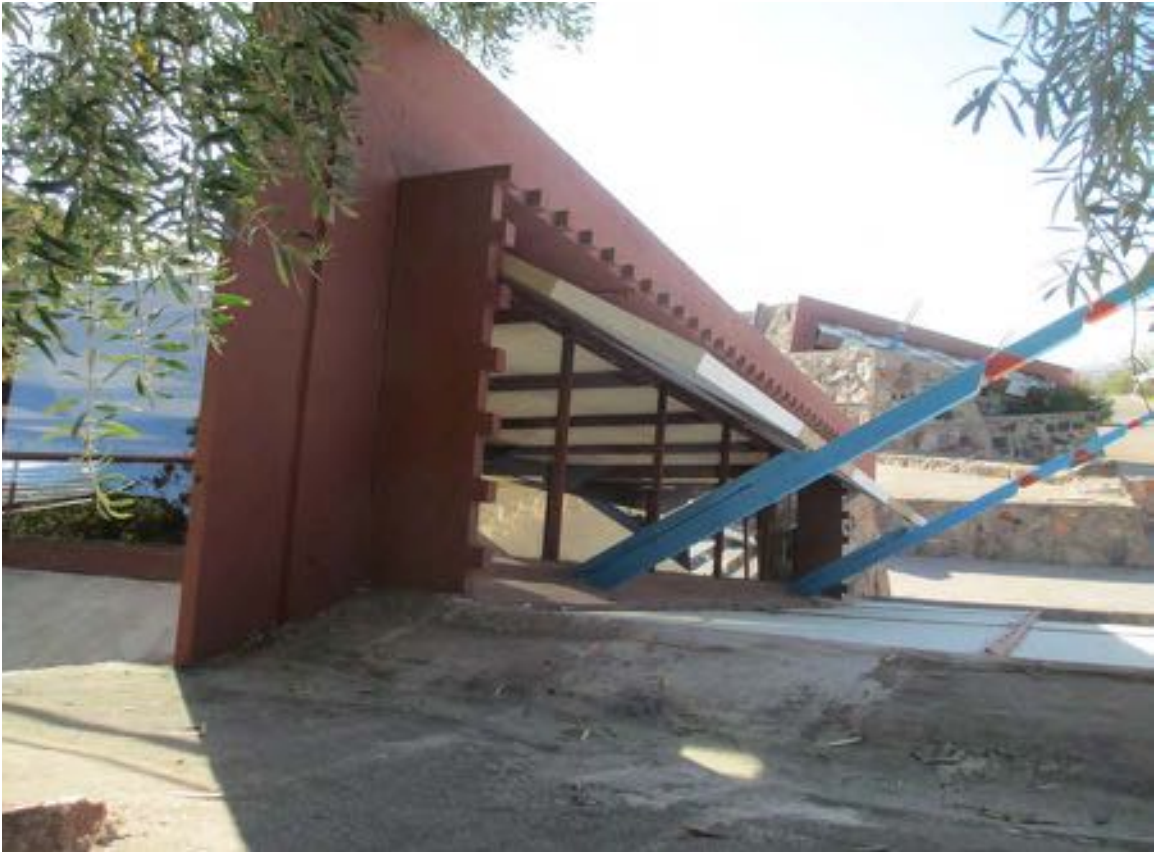
Figure 10-7 - Sunshade and supports on the office in 2014 (Harboe Architects).

The sunshades are in fair condition.

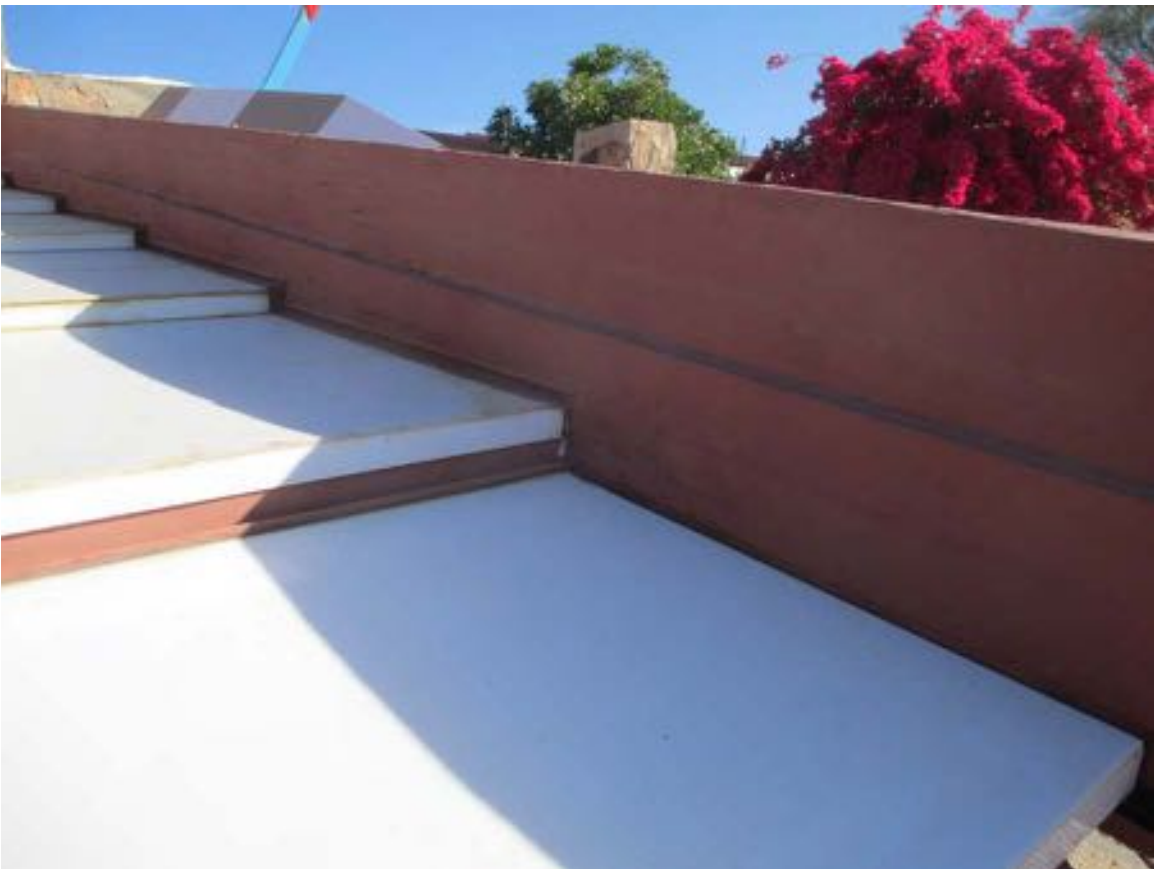
Figure 10-8 - Roof on the office in 2014 (Harboe Architects).

The existing acrylic roof panels leak. This typically occurs at the intersection of the acrylic panels and the built up wood beams. This joint is simply a sealant joint between the two materials. The wood and acrylic move differently with thermal expansion and the lateral deflection of the wood beams likely contribute to the failure of the sealant joint. The texture and appearance of the acrylic panels also differs from the canvas used during the period of significance.

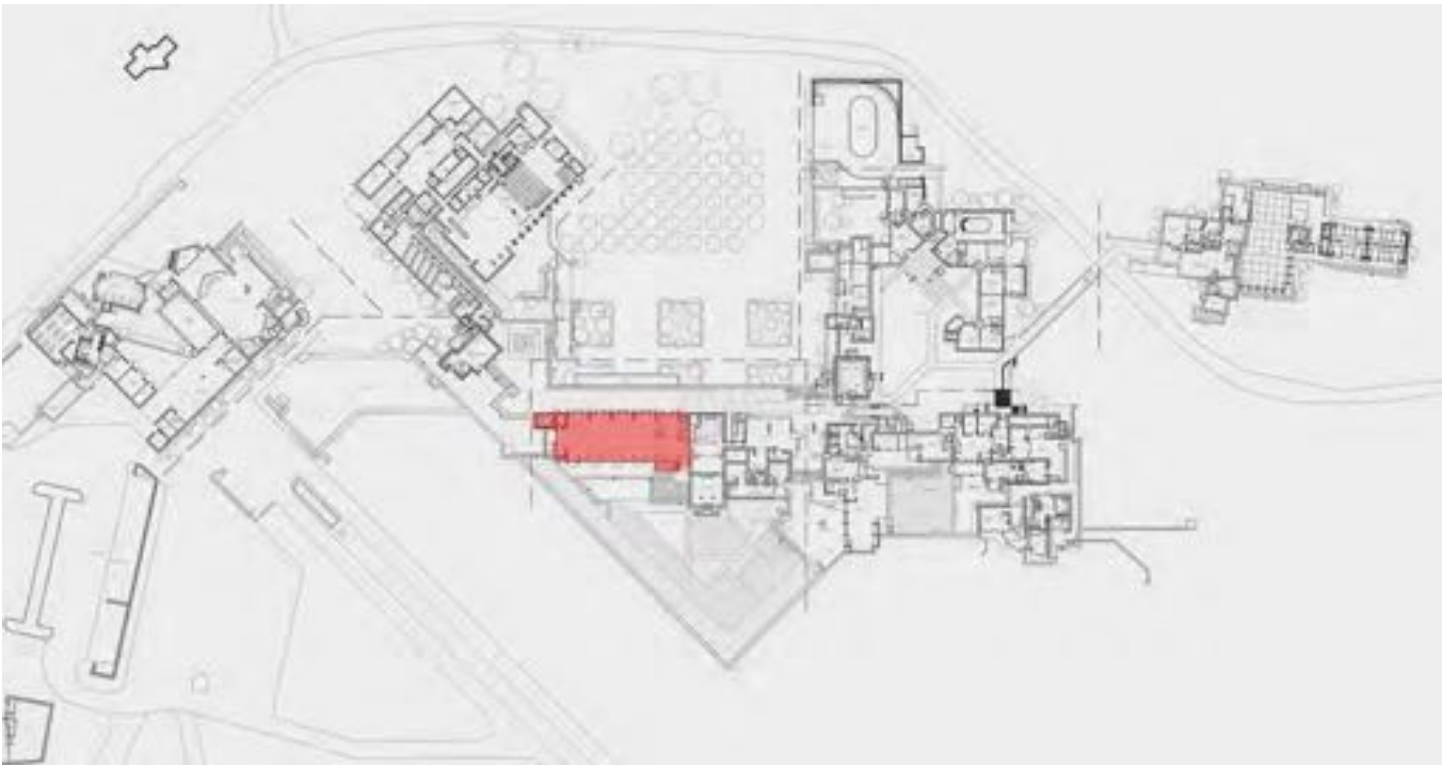
Figure 10-11 - Drafting Studio Location Plan

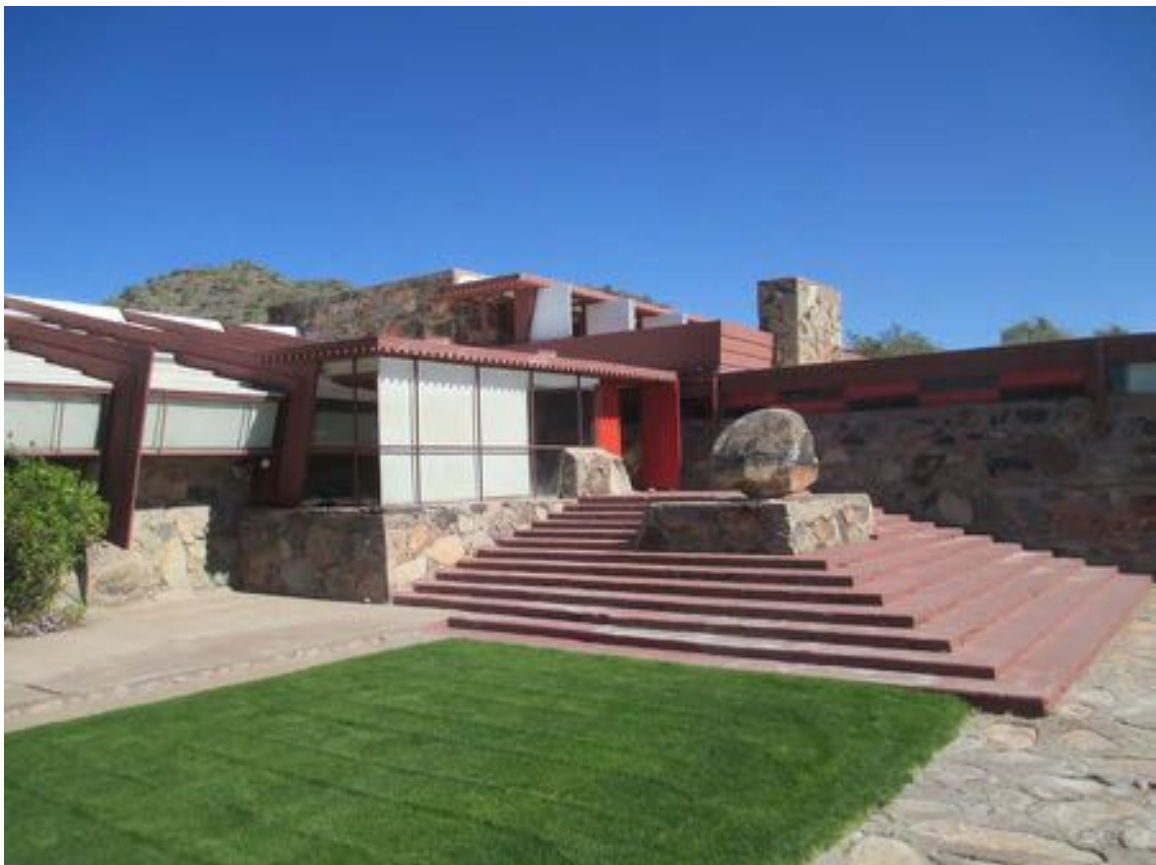
Figure 10-14 - Solarium and terrace on southeast side of Drafting Studio, 2014 (Harboe Architects).

The solarium is in fair/good condition. The painted concrete floor is worn and faded. The steel mullions and glass are generally in good condition. The roof is in fair condition.

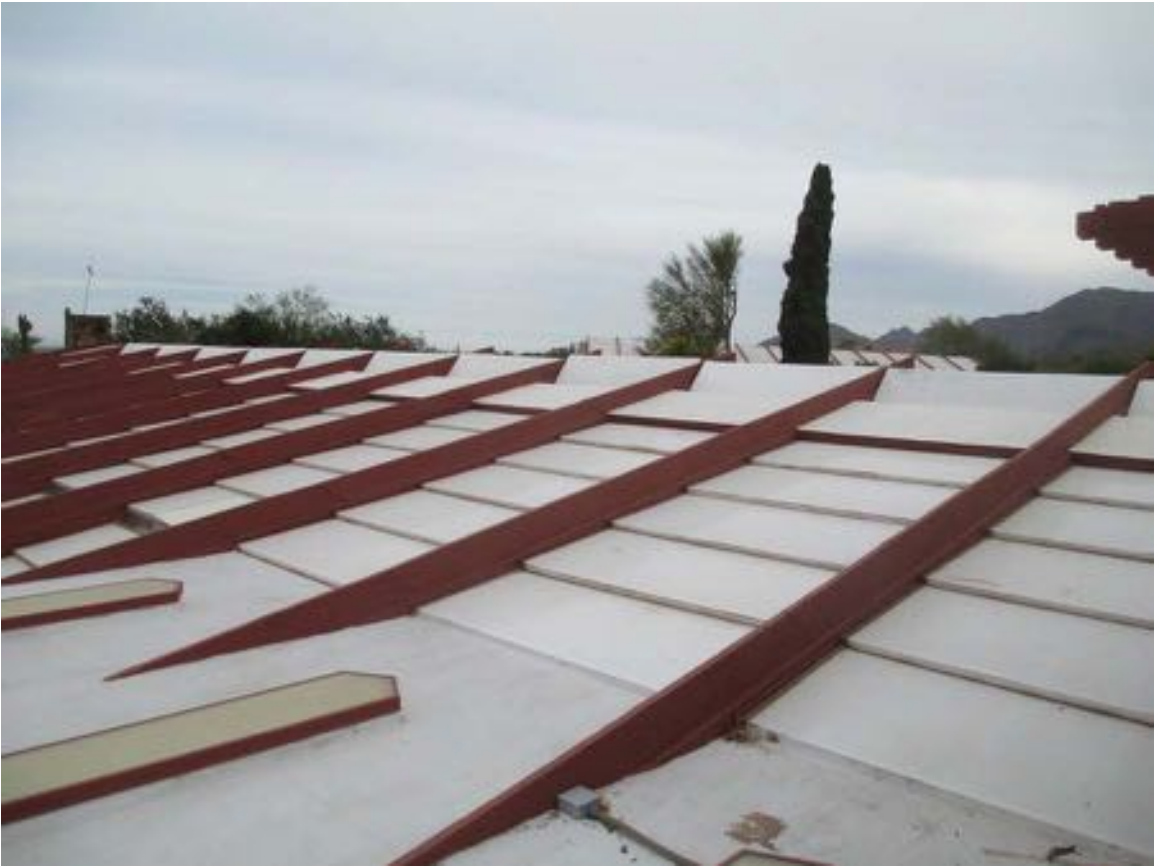
Figure 10-15 - Roof on Drafting Studio, 2014 (Harboe Architects).

The existing wood roof framing is in fair condition. There are localized areas of ultraviolet and rot damage. This is typically limited to the jointed corners of the built up beams and at the bottom of the beams where they rest on the desert masonry. Additionally, the design of the built up beams and roof system does not appear to provide significant lateral bracing between beams allowing for significant lateral deflection in heavy wind conditions.

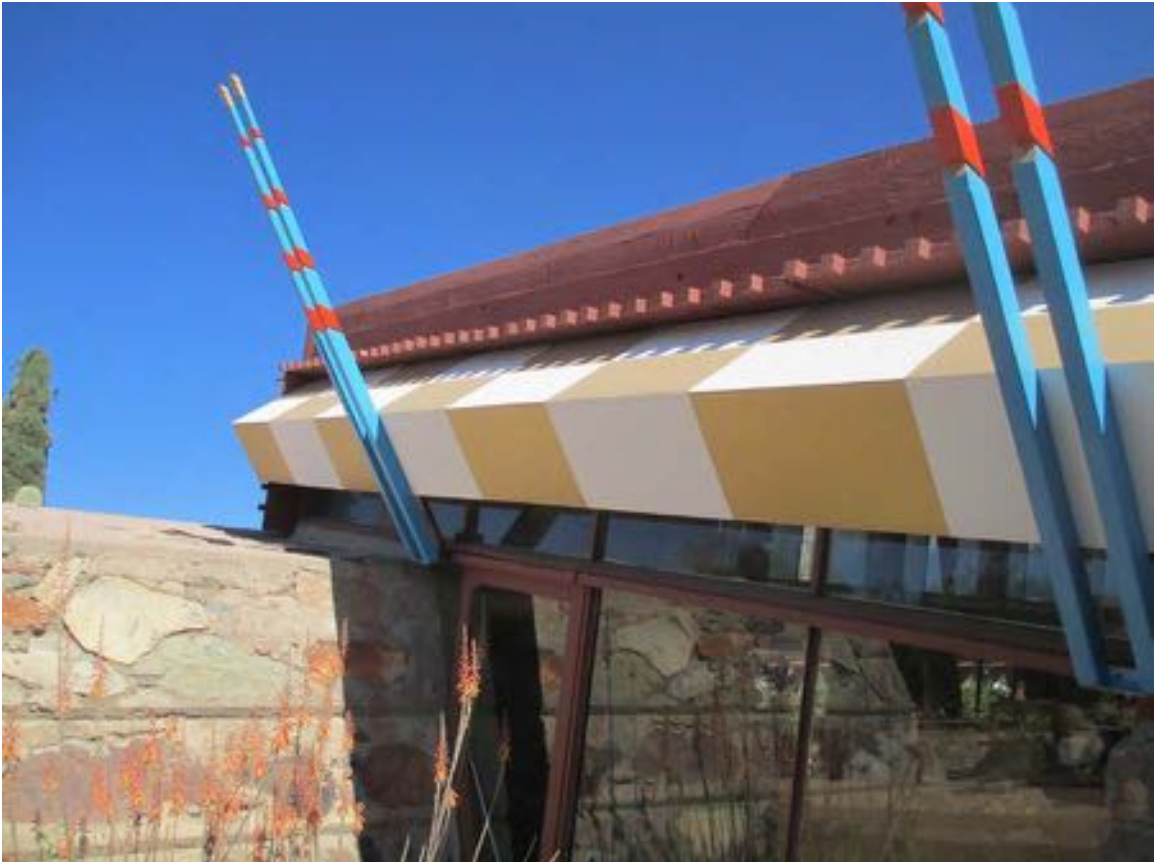
Figure 10-17- Sunshade and decorative wood pinnacles, 2014 (Harboe Architects).

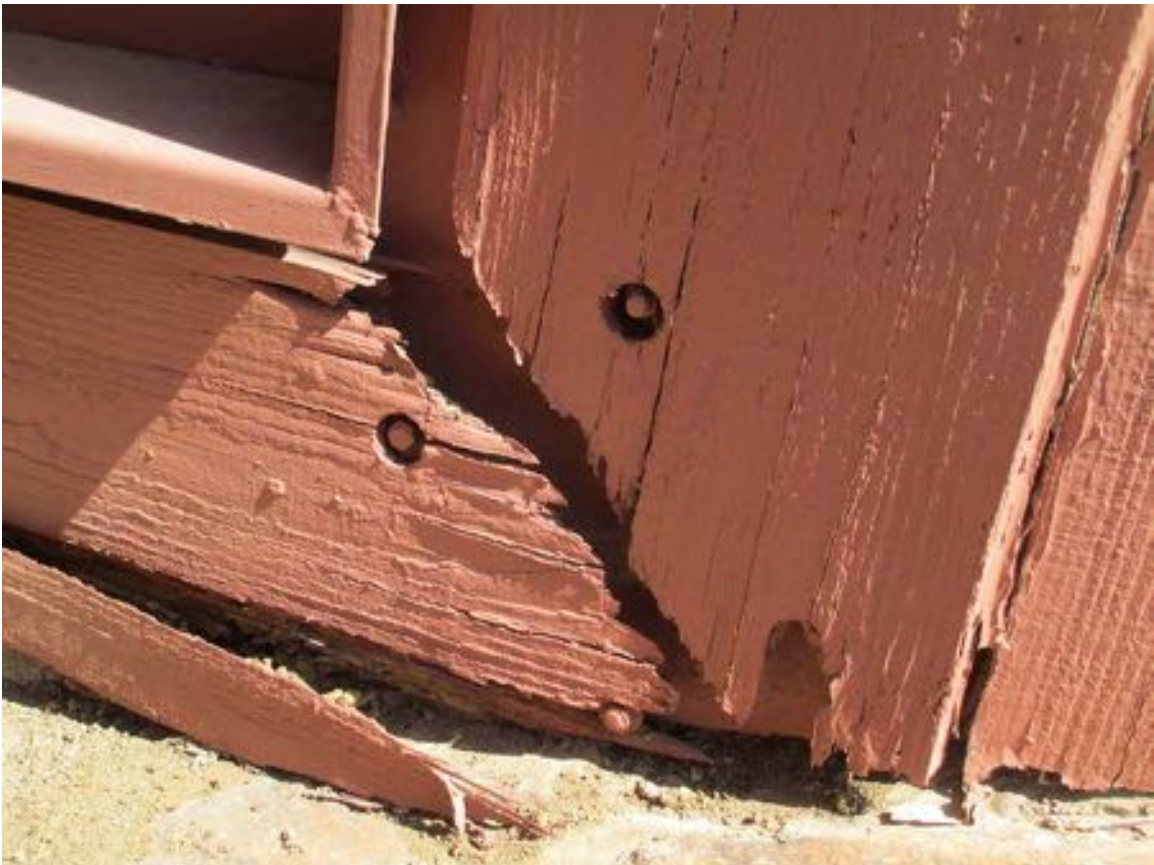
Figure 10-18 - Damaged wood on south side of Drafting Studio, 2014 (Harboe Architects).

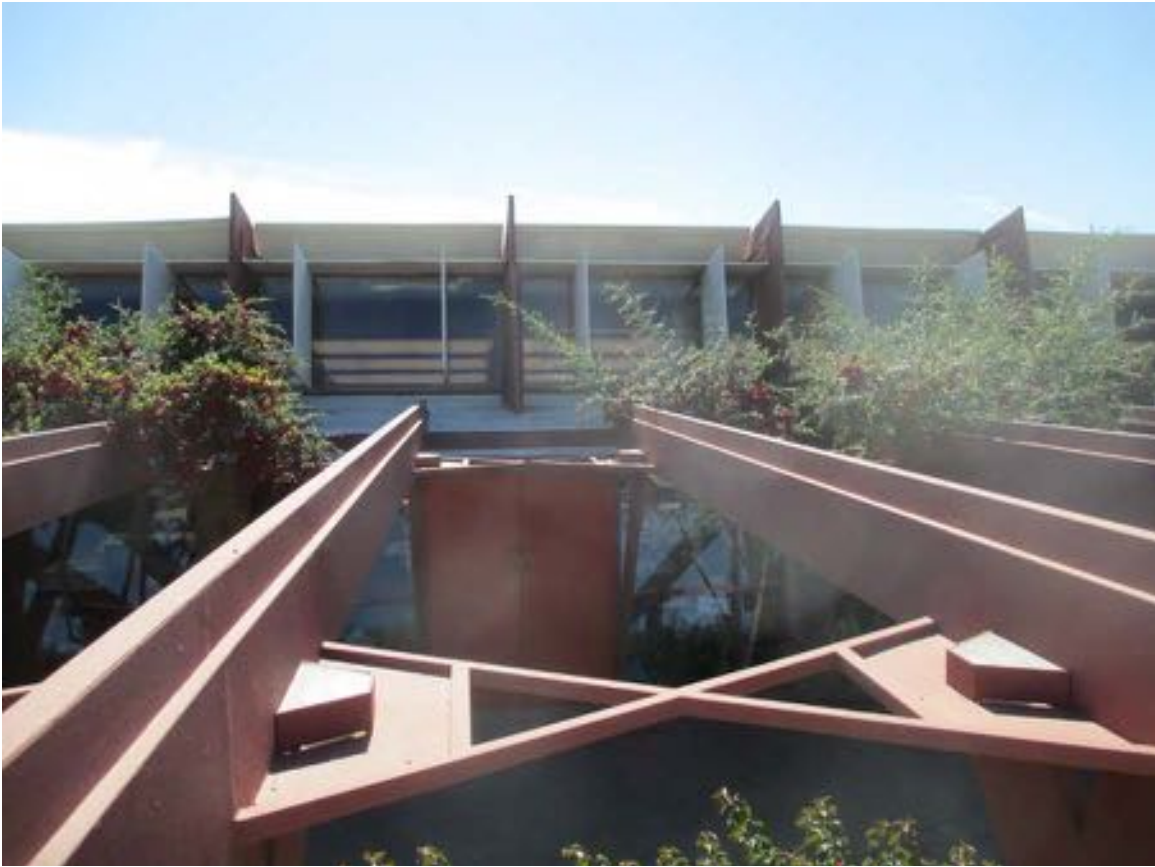
Figure 10-19- Pergola on north side of Drafting Studio, 2014 (Harboe Architects).

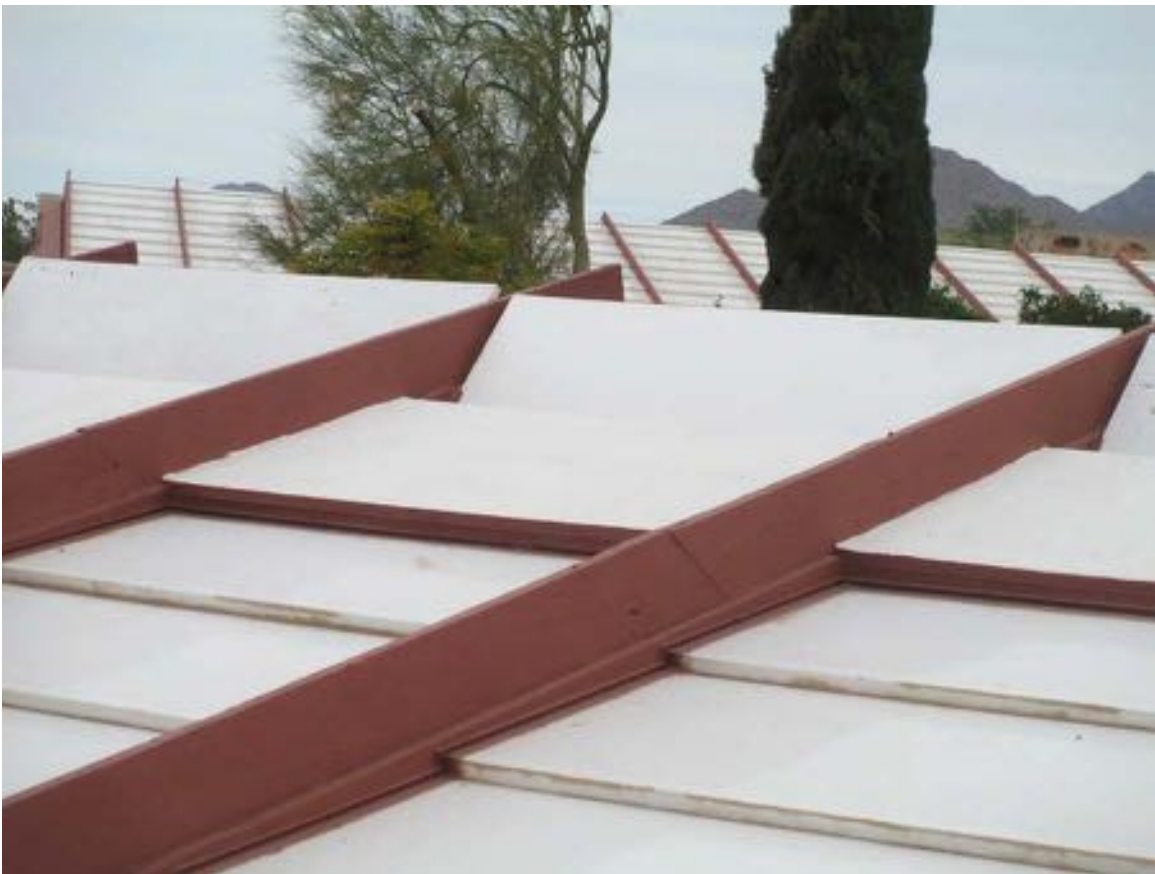
Figure 10-20 - Drafting studio roof, 2014 (Harboe Architects).

The studio was originally constructed with operable canvas roof panels consisting of canvas wrapped on a wood frame. These panels were operable to control sun shading and natural ventilation. The canvas roof panels were replaced and reconfigured frequently (every 1 to 3 years from 1938 to 1959). Following Wright's death, the Fellowship replaced the fabric roof panels with fiberglass panels. These panels were replaced in the 1990s with acrylic panels. The current roof panels are constructed of fixed translucent acrylic panels with a supplemental canvas interior panel suspended below the acrylic panels to diffuse the day light and replicate the appearance of the original canvas panels. This system dates from 1998.

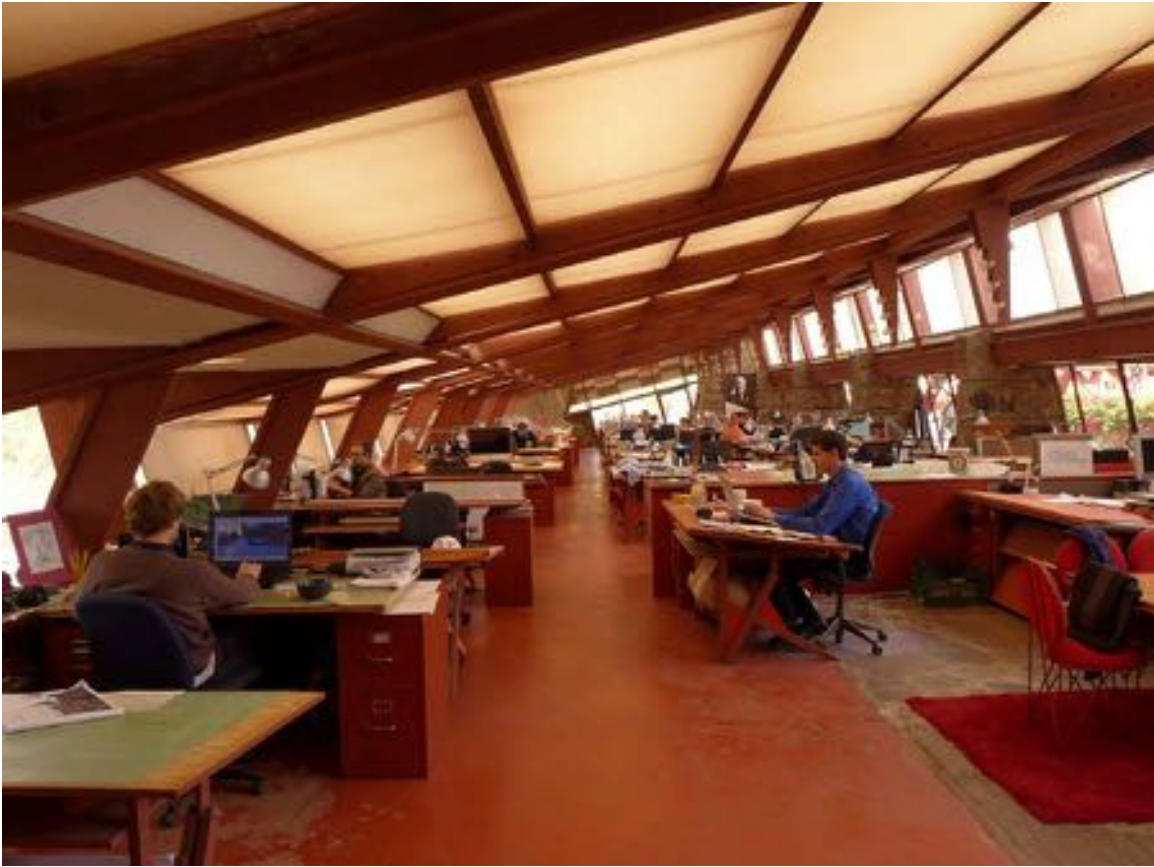
Figure 10-21 - Interior of Drafting Studio looking northwest, 2014 (Harboe Architects).

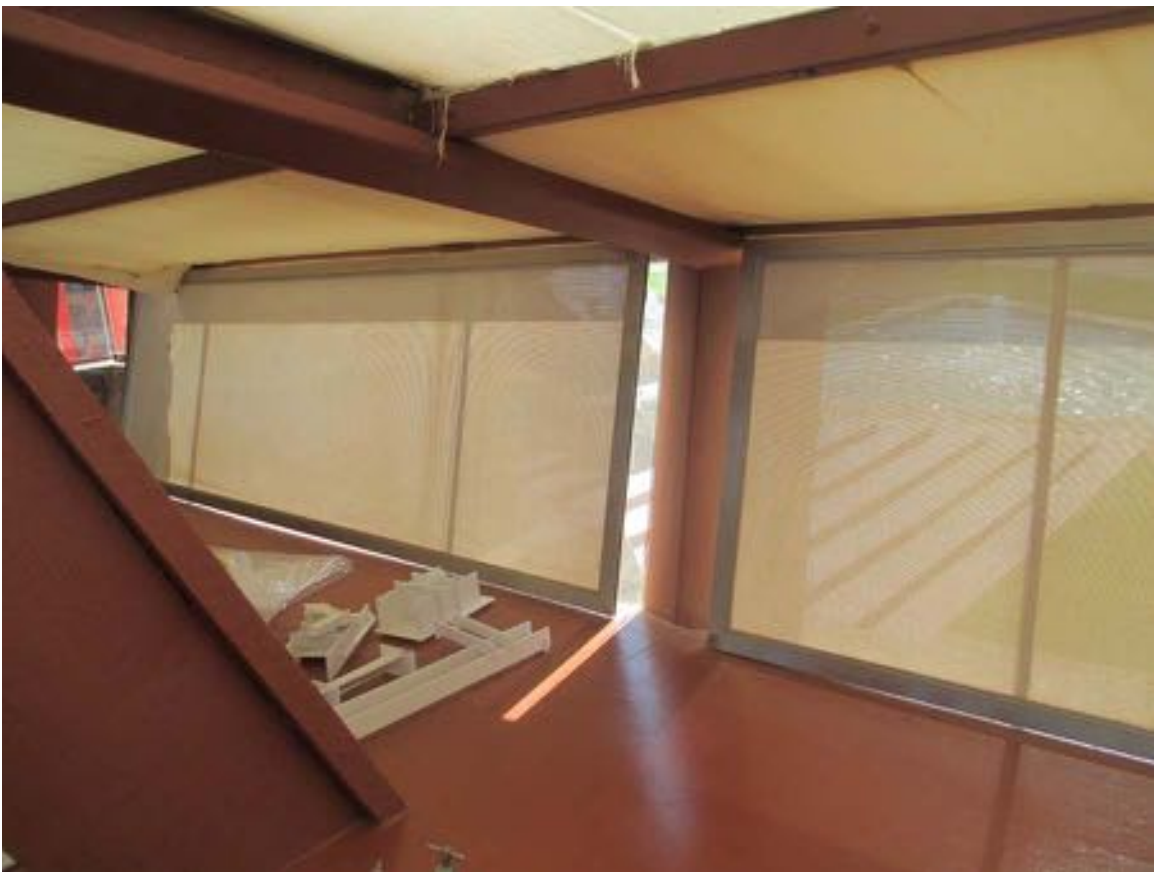
Figure 10-24 - South windows with damaged canvas above, 2014 (Harboe Architects).

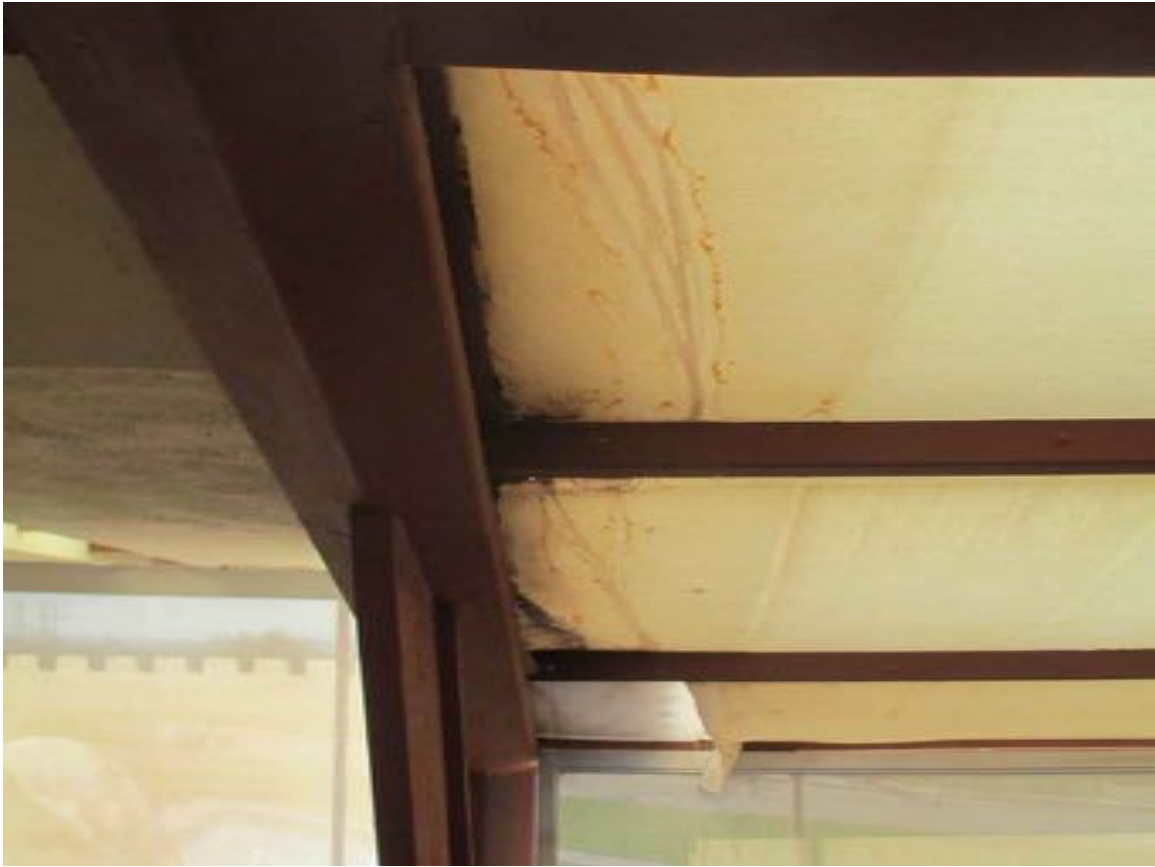
Figure 10-25 - Damaged canvas roof, 2014 (Harboe Architects).

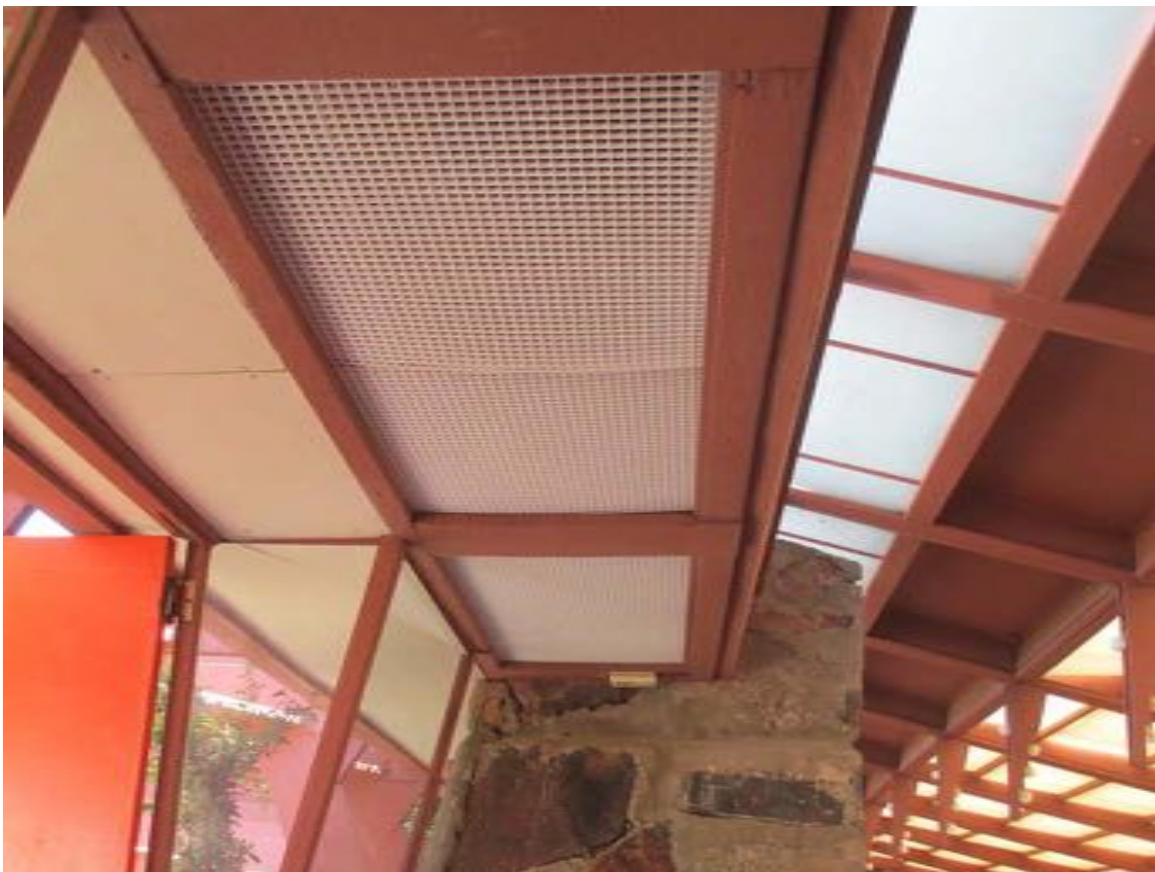
Figure 10-26 - Soffit under north clerestory, 2014 (Harboe Architects).

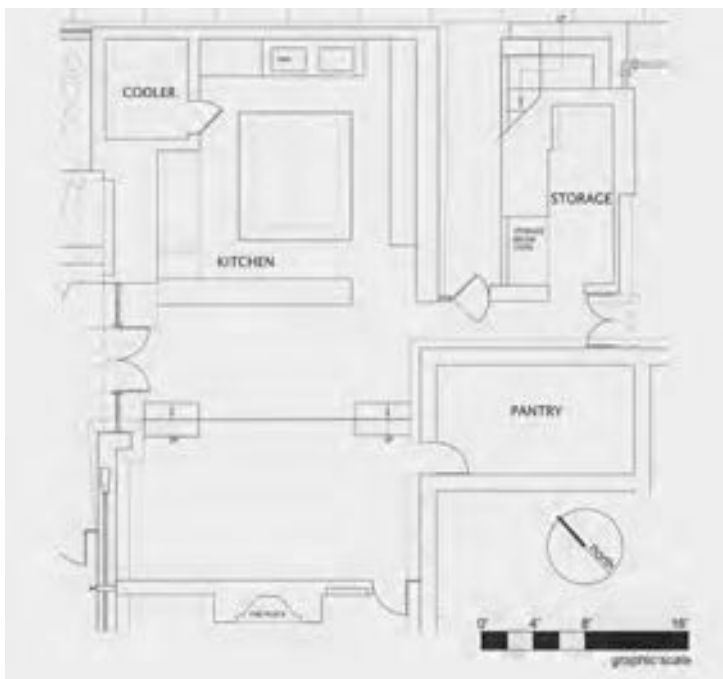
Figure 10-28 - Kitchen Floor Plan

The dishwash area in the Kitchen has a painted concrete floor, painted plaster walls, a ceramic tile counter with sinks, wood shelves, a stainless steel industrial grade dishwasher, and gypsum coated foam ceiling with surface mounted light fixtures.

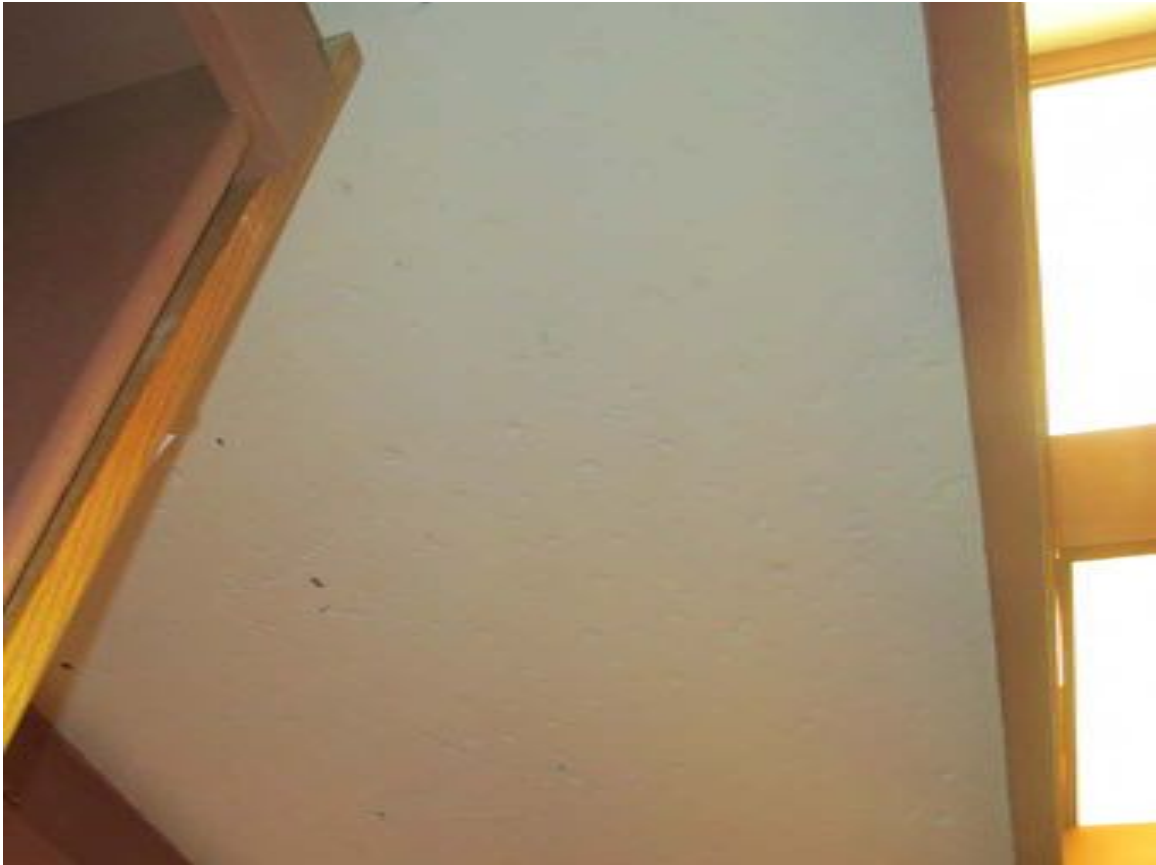
Figure 10-31 - Damaged kitchen ceiling, 2014 (Harboe Architects).

The gypsum coated foam ceiling is problematic because it is easily damaged and there are multiple areas of damage. There are also some areas of water damage.

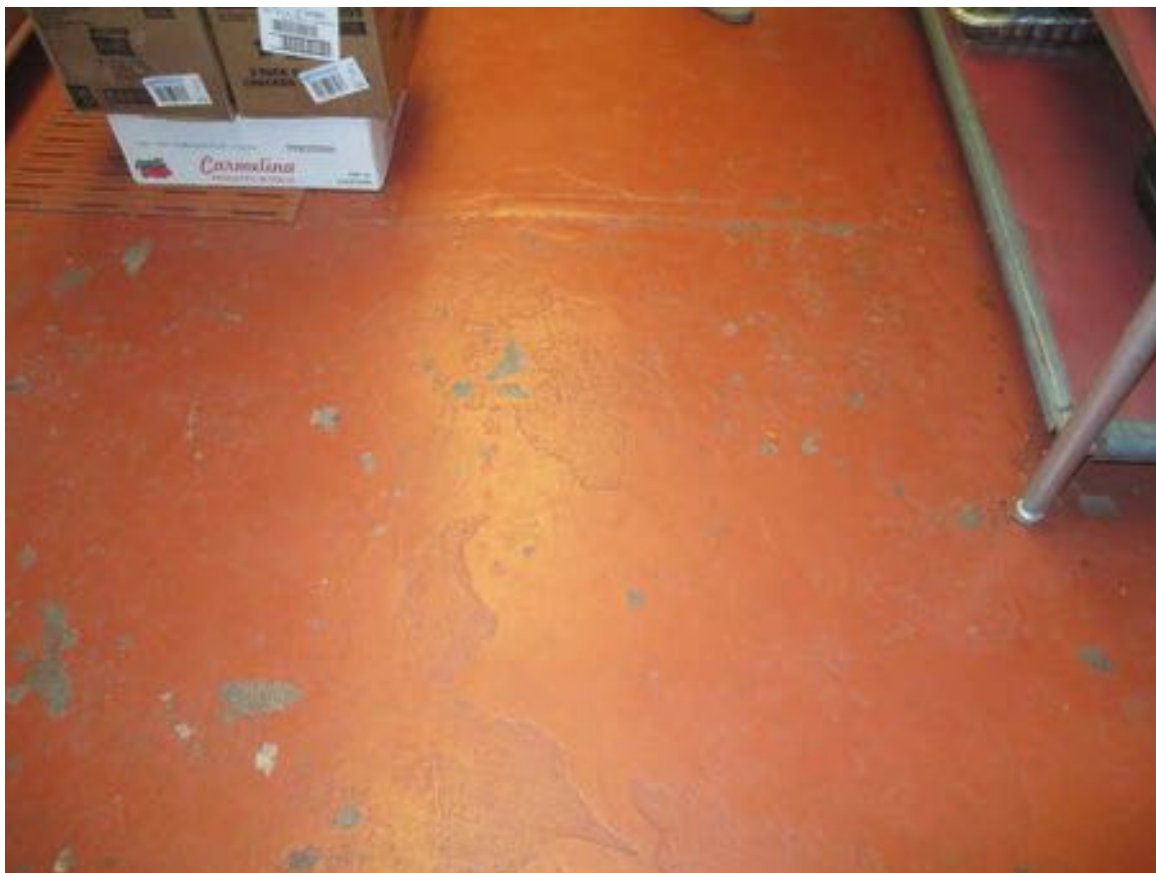
Figure 10-32 - Kitchen floor, 2014 (Harboe Architects).

The kitchen floor is in poor to fair condition. The concrete has many areas of heavy wear and loss of the original smooth face texture. The red paint is also worn and has chipped away in some locations.

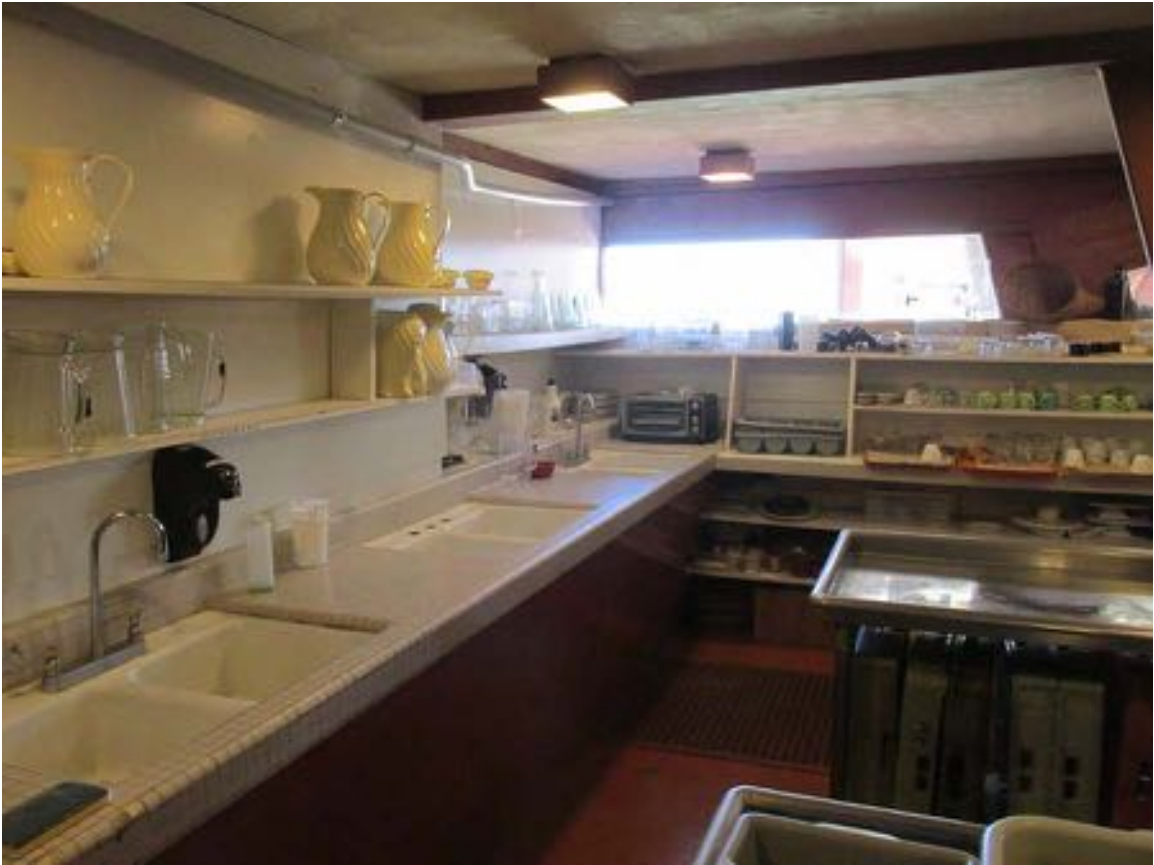
Figure 10-33 - Kitchen dishwash area looking northwest, 2015 (Harboe Architects).

The dishwash area is in fair condition. The painted concrete floor is worn. Some of the ceramic tile on

the counter is cracked or broken. The ceiling is damaged with several holes and scratches. The ceiling mounted light fixtures as well as the dishwasher appear to be in good condition.

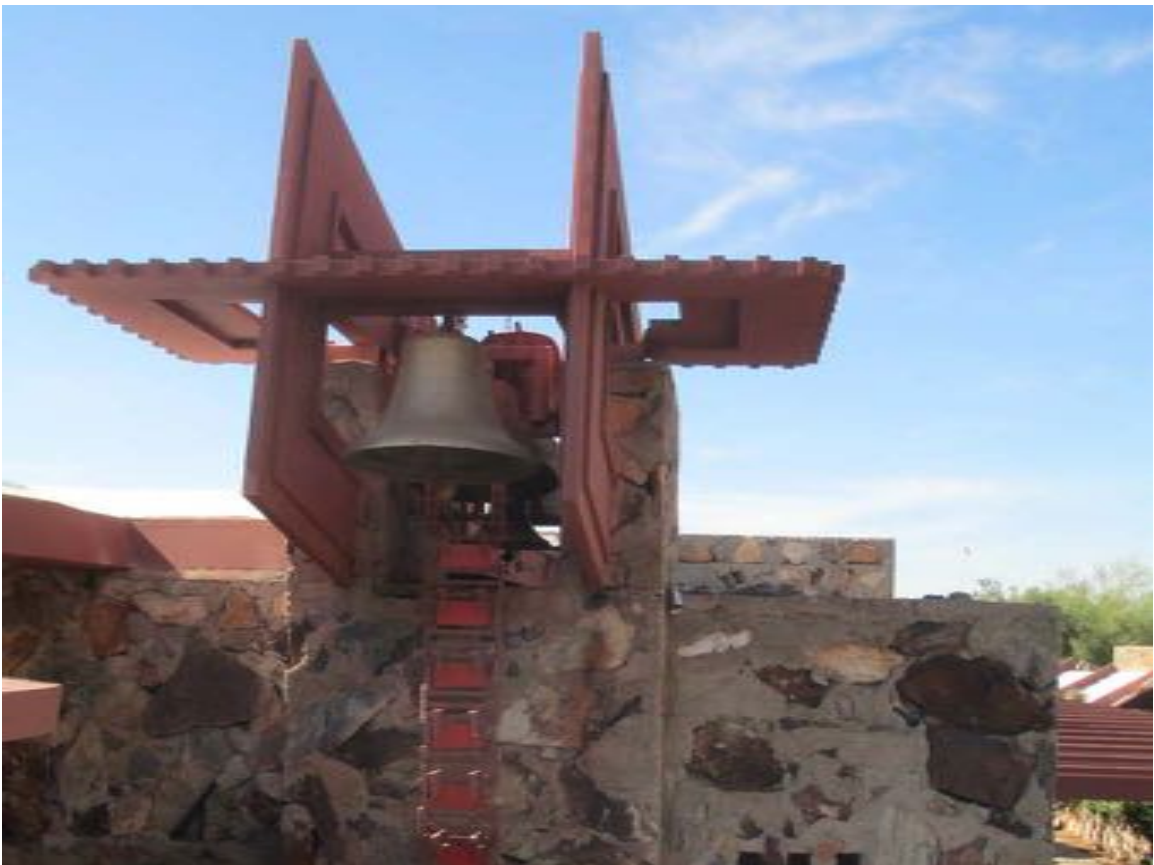
Figure 10-34 - Bell Tower, 2014 (Harboe Architects).

The bell tower appears to be in good condition.

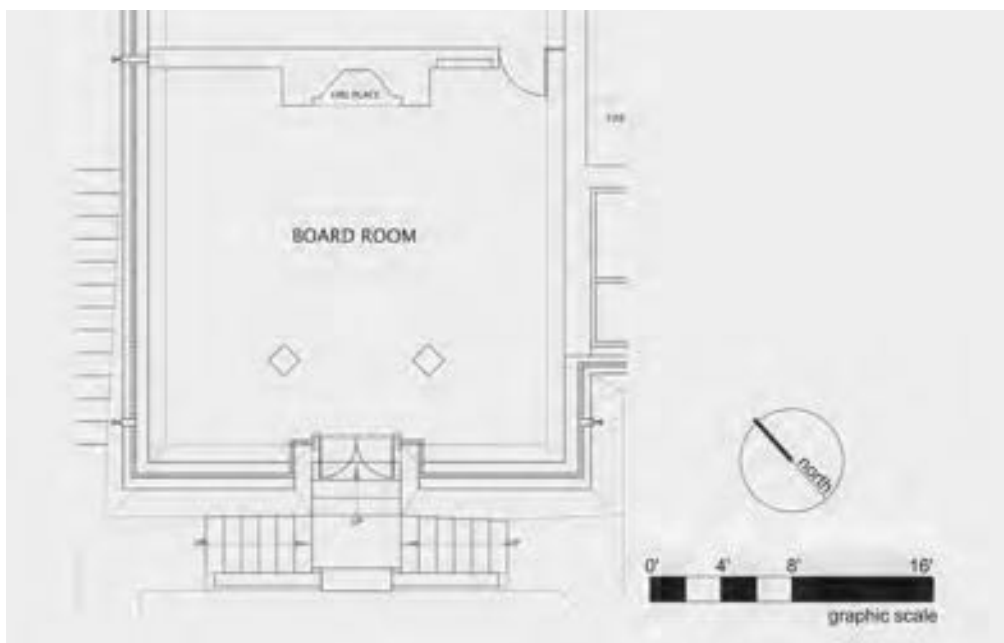
Figure 10-36 - Original Dining Room (Board Room) Floor Plan
