TALIESIN WEST PRESERVATION MASTER PLAN

Harboe Architects, PC

MAY 21, 2015

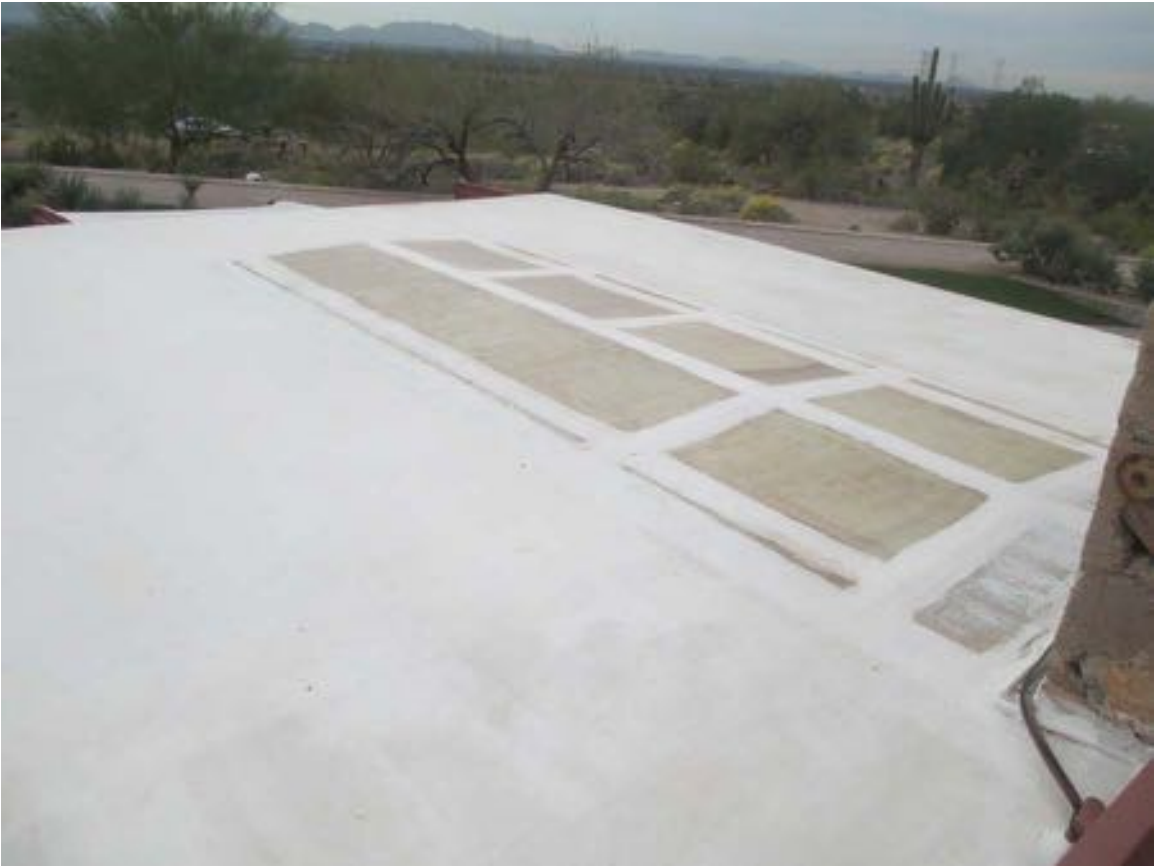
Figure 10-39 - Roof of Original Dining Room (Board Room) showing skylight, 2014 (Harboe Architects).

When the Original Dining Room was constructed in 1939 the skylights were covered with canvas panels. The canvas panels were replaced with glass in the 1950s and later with fiberglass panels in the 1960s. The current skylight is made up of fiberglass panels set on wood framing with sealant at all joints.

The fiberglass panels are in poor condition. The panels leak at failed sealant joints and are heavily soiled, which diminishes the quality of natural light in the room.

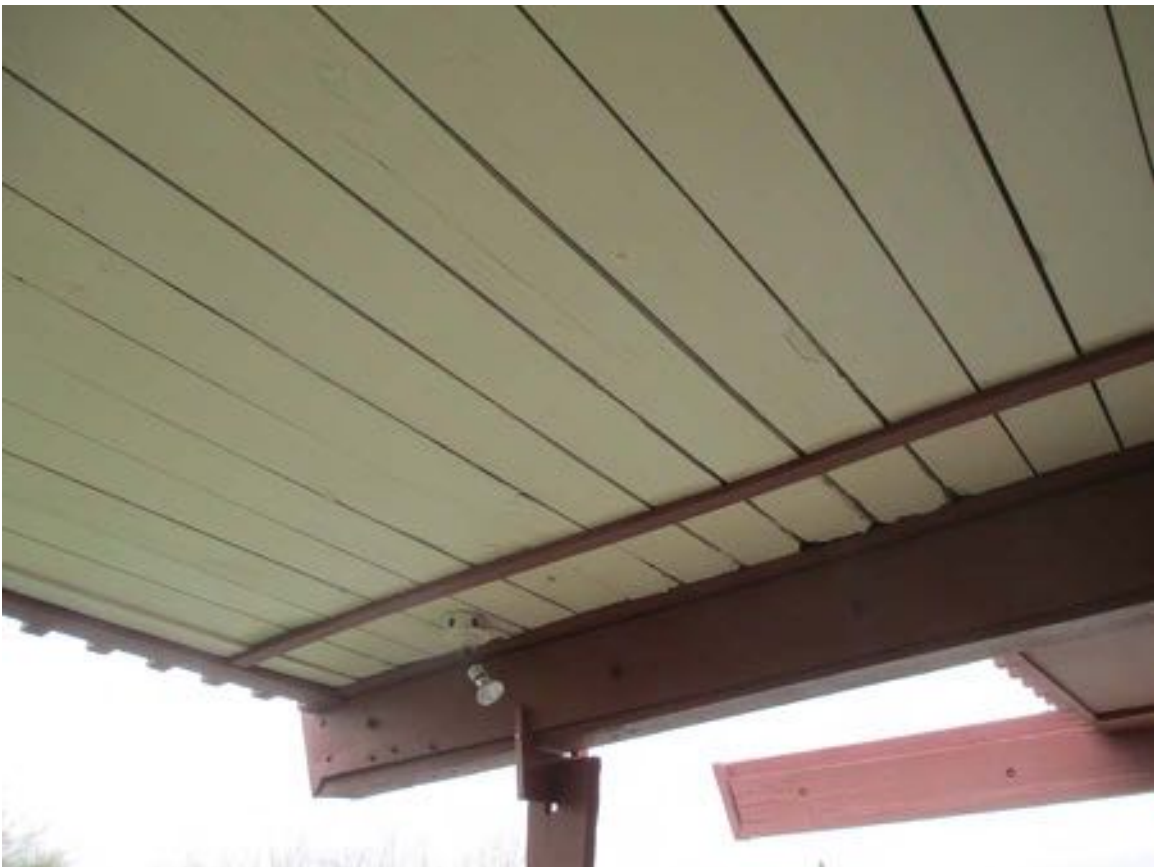
Figure 10-40 - Underside of wood deck, 2014 (Harboe Architects).

There is a significant amount of UV damage and rot at the exterior wood beams and trim as well as the underside of the wood decking outside the south entry. There is also some damage and rot at the ends of the interior framing at the skylight.

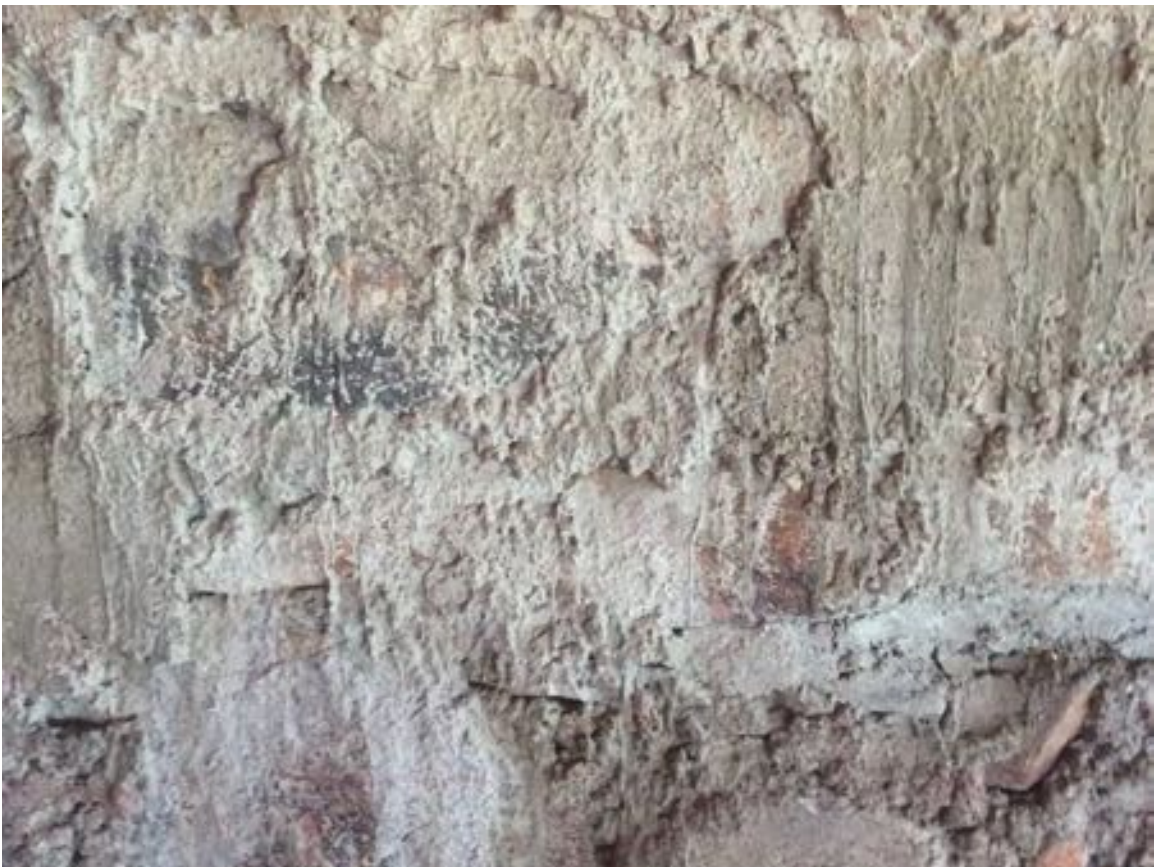
Figure 10-42 - Water damage on desert masonry wall, 2014 (Harboe Architects).

Desert masonry is in good condition. There is generally a light soiling on the surface of the desert masonry with heavier soot and soiling at fireplace. There is also evidence of previous roof leaks on the desert masonry on the east wall and paint splatter on the desert masonry on the west wall. The desert masonry piers have sections of non-matching patches.

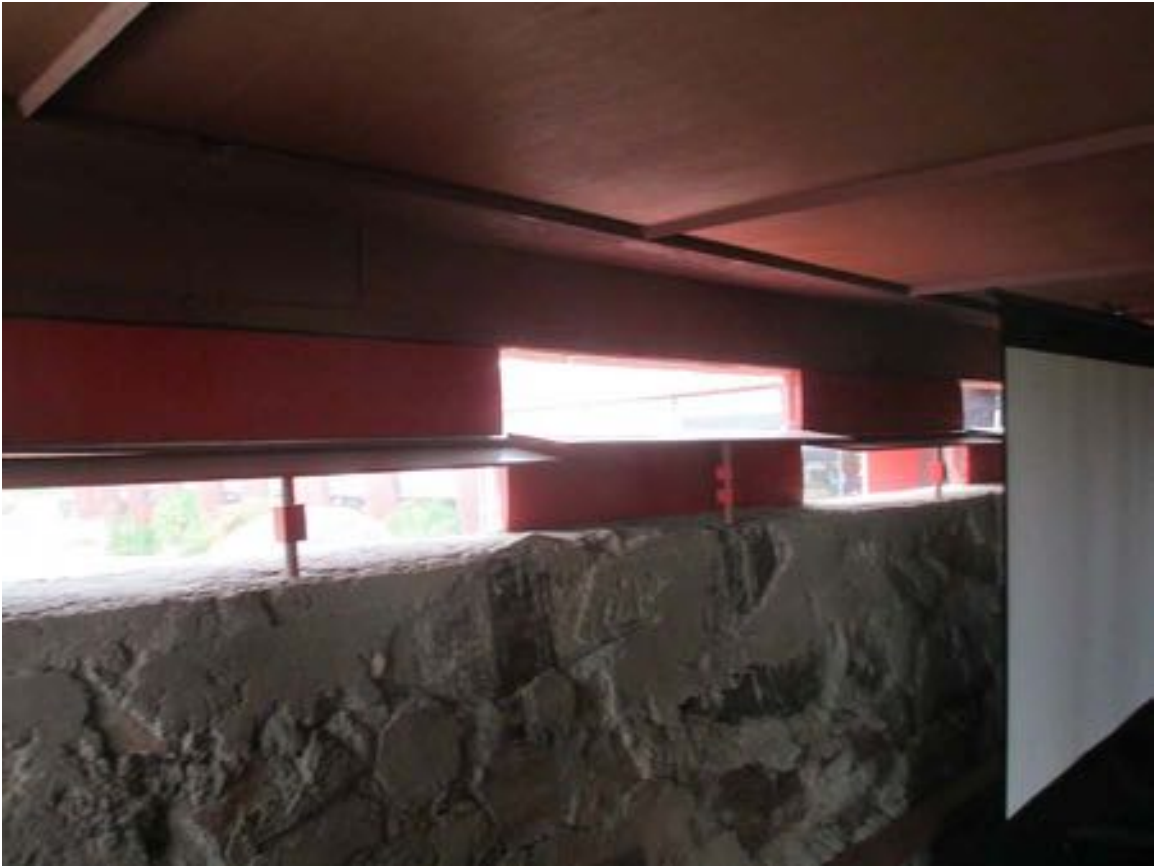
Figure 10-43 - Windows on northwest wall of Original Dining Room, 2014 (Harboe Architects).

When it was constructed in 1939, the Original Dining Room had no glazing. The opening in the southwest wall did not exist originally. The opening was added around 1946 and covered with operable canvas panels. In the 1950s the opening was expanded and made into a doorway with glass doors. Glazing was first added in the late 1940s at the clerestory. Originally, the clerestory openings were open to the outside with no glazing or wood shutters. The current glazing is a mix of glass dating from the 1940s and later replacement panels.

The glazing is in fair/poor condition. Many panels of glass are cracked or chipped and the glass at the southeast corner was replaced with a plastic panel. Additionally, when the addition to the Wes Peter's Apartment was constructed the clear glazing at the east clerestory was removed and replaced with mirrored glass.

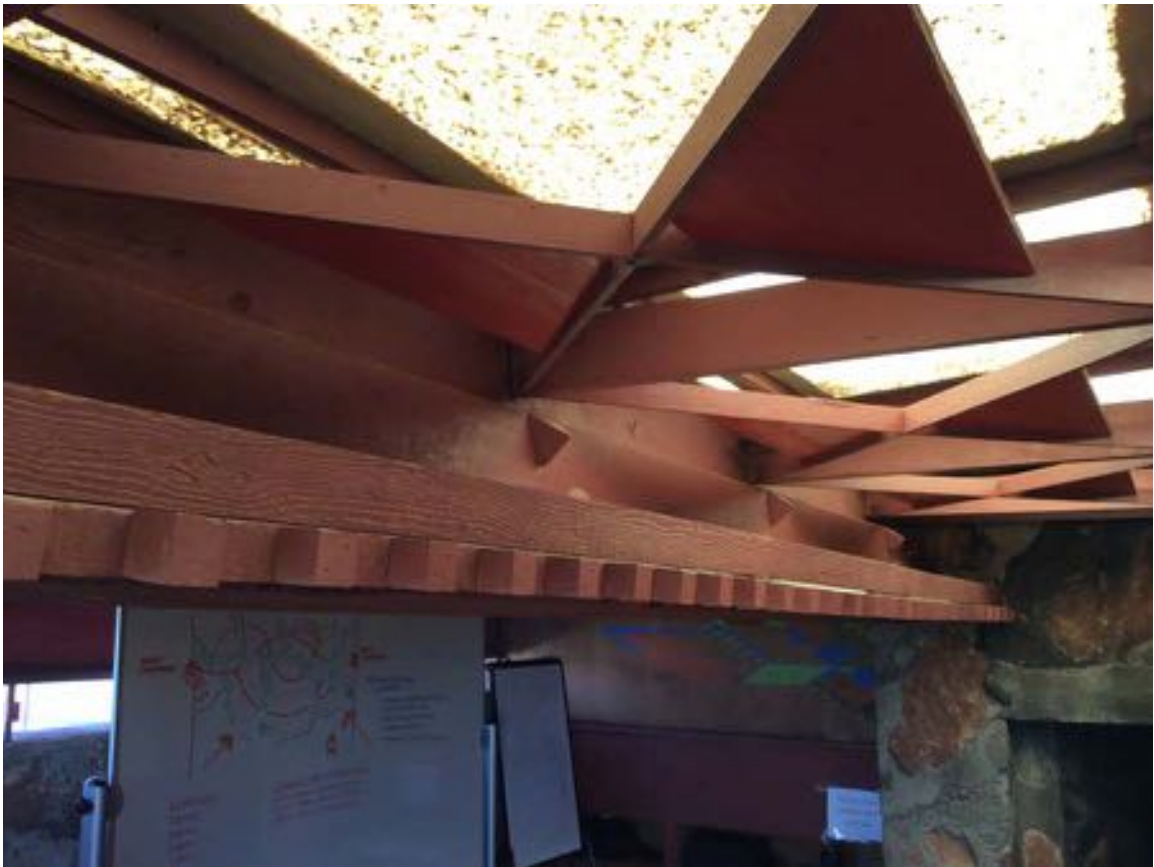
Figure 10-45 - Wood trellis work under the skylight, 2014 (Harboe Architects).

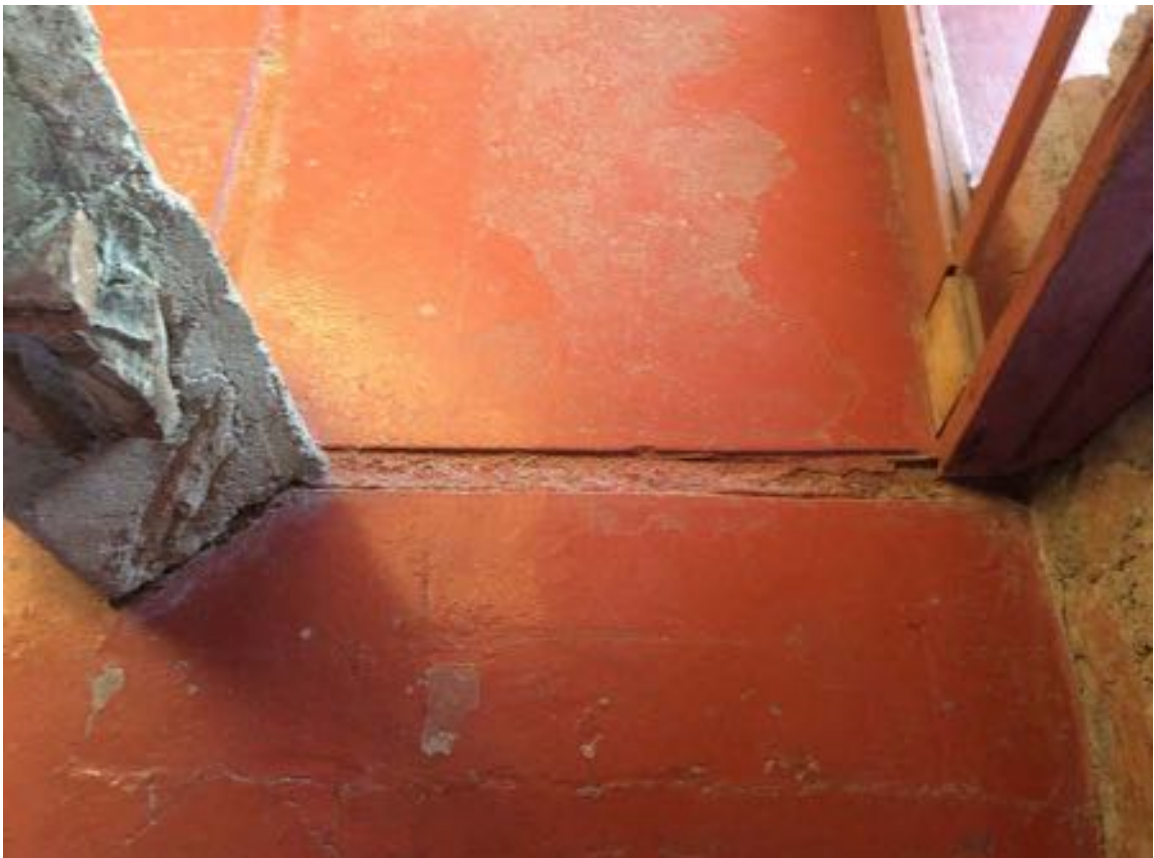
Figure 10-46 - Board room floor, 2014 (Harboe Architects).

The concrete flooring is in fair/poor condition. The concrete has many areas of heavy wear and loss of original smooth face texture. It is suspected that there maybe select areas of previous patches, but this would not be known unless the existing paint coating is removed. There are shrinkage cracks in most of the panels. These cracks are typically fairly tight with only slight or no displacement in the concrete. There are also a select number of holes in the floor at the northwest side of the room.

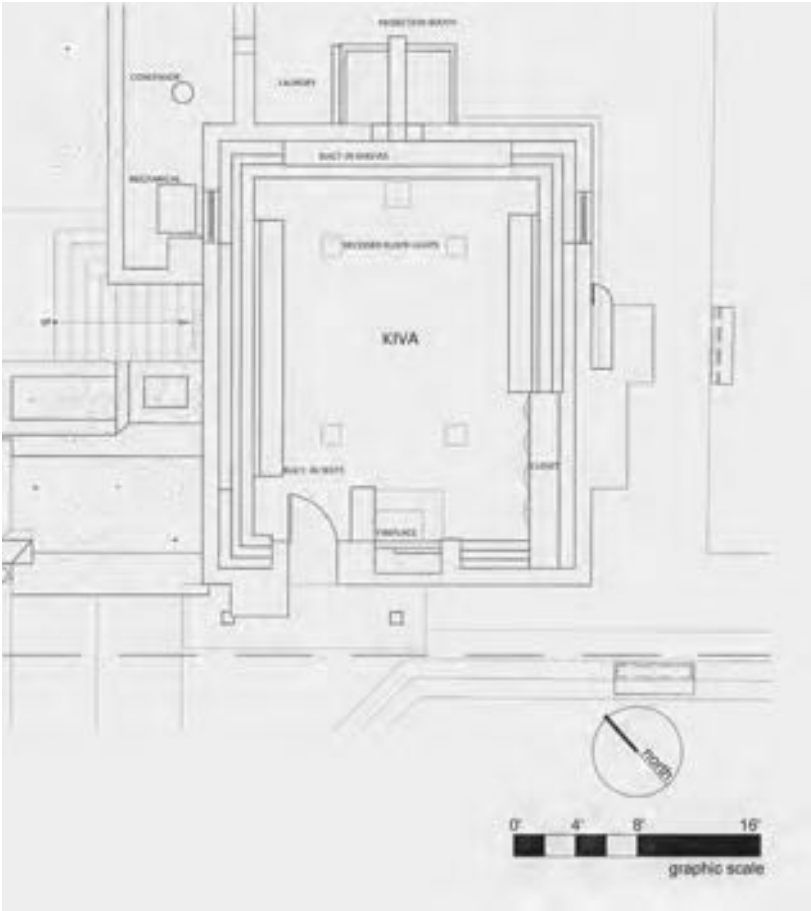
Figure 10-48 - Kiva Floor Plan

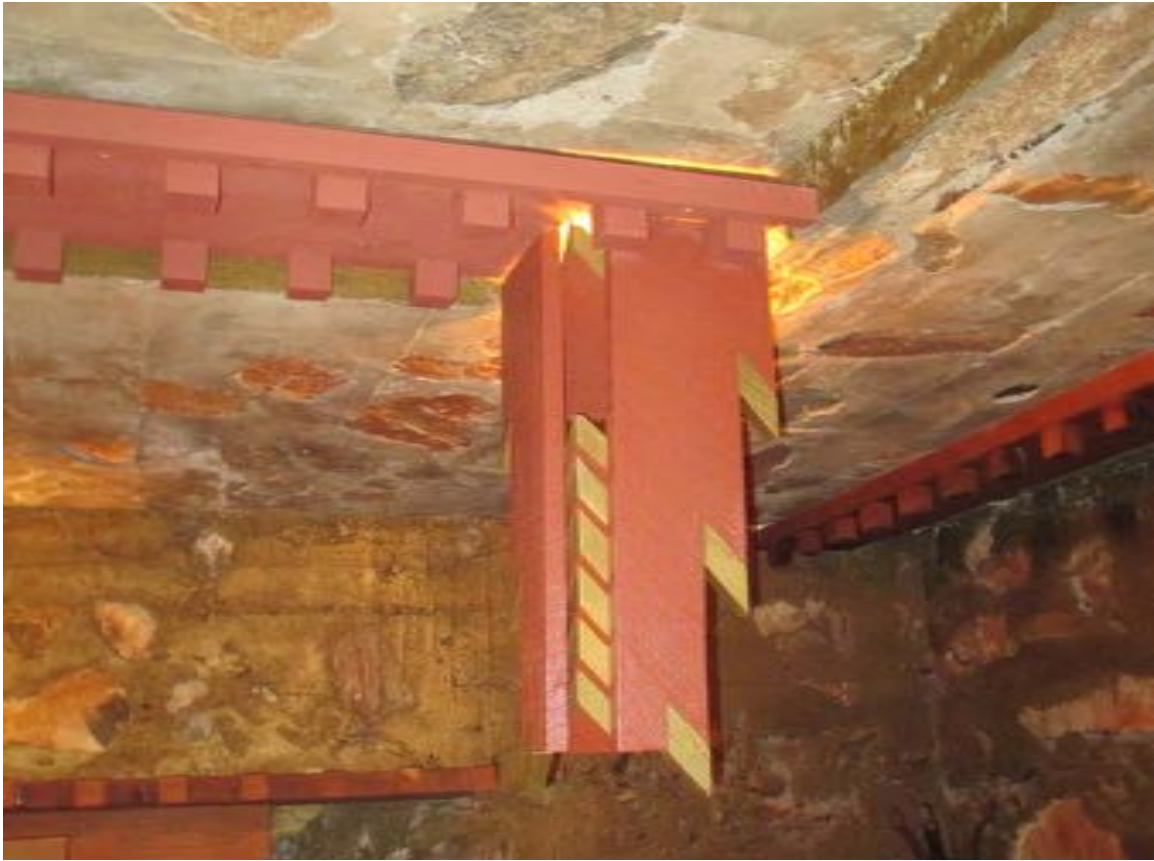
Figure 10-53 - Wood pendant light fixture in Kiva, 2014 (Harboe Architects).

The lighting appears to be in good condition.

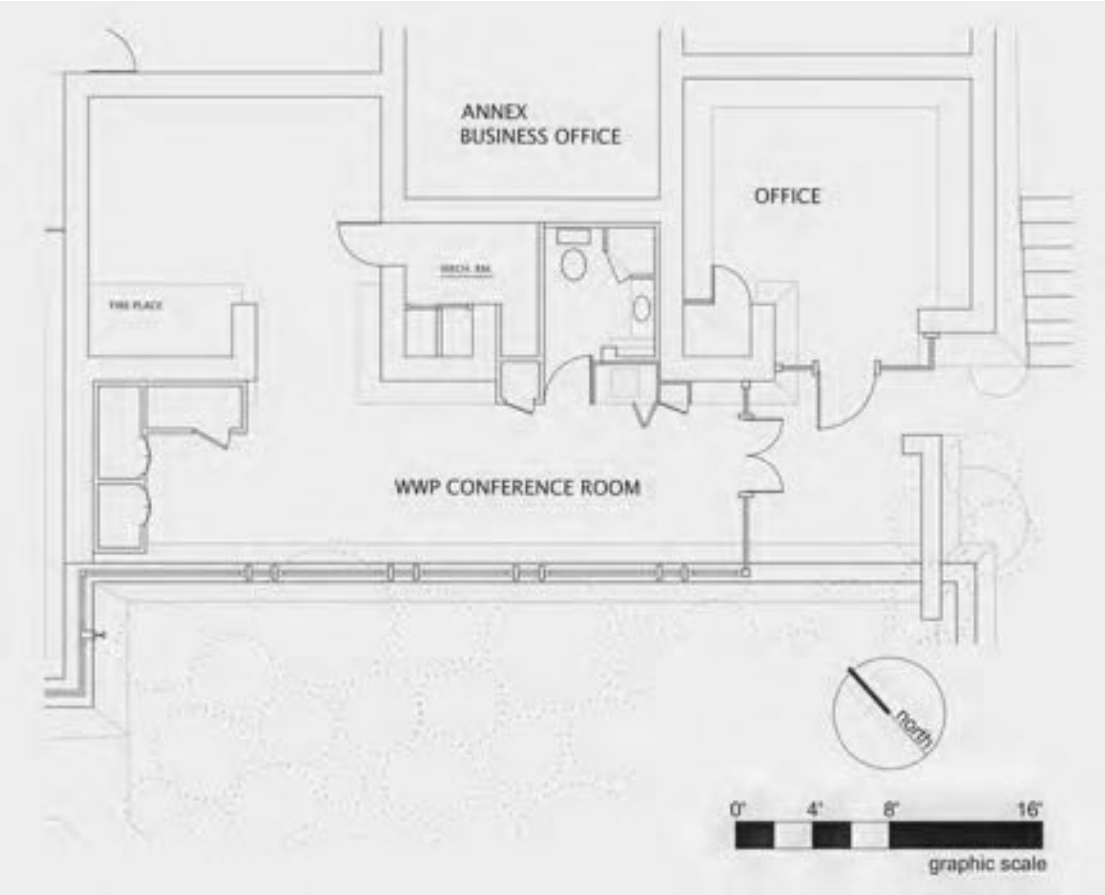
Figure 10-56 - Peters/Masselink Rooms (WWP Conference Room) Floor Plan

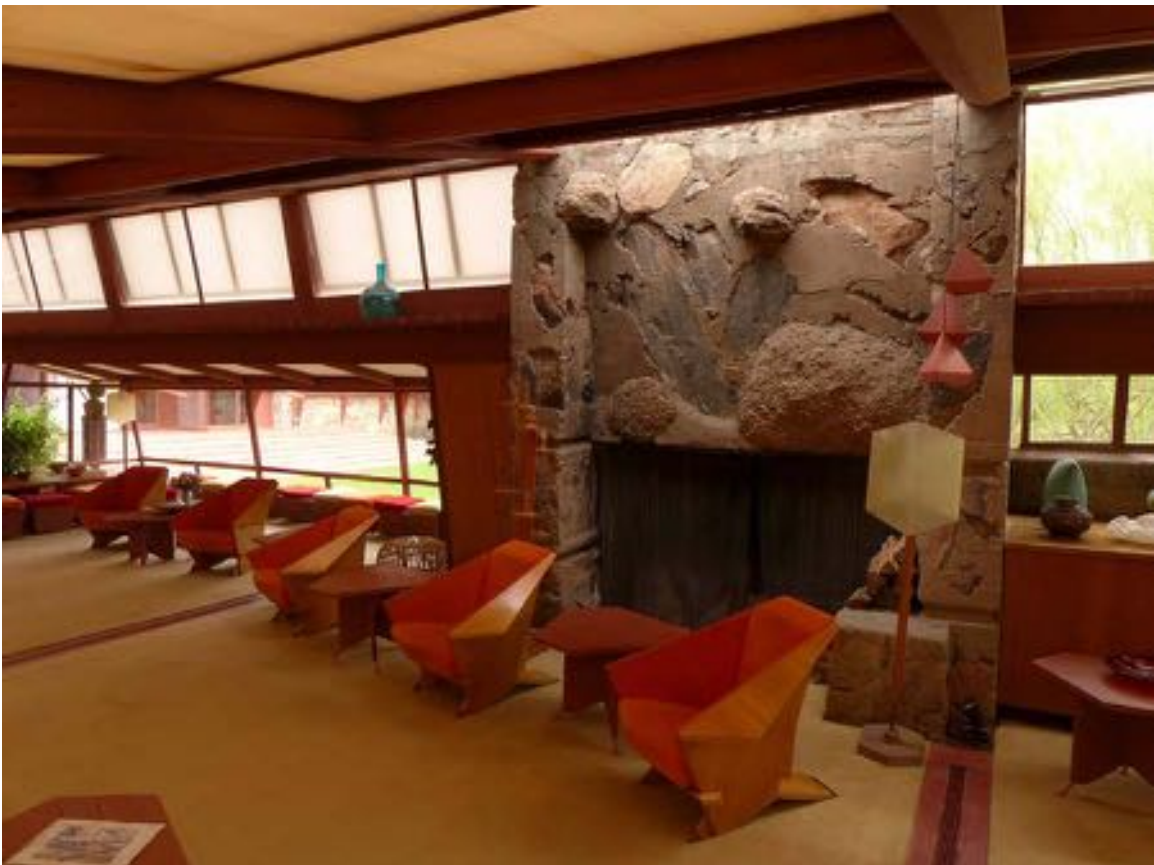
Figure 10-70 - Interior of Garden Room looking east at fireplace, 2014 (Harboe Architects).

The desert masonry walls and piers as well as the fireplace are in good condition. There is generally a light soiling on all desert masonry with heavier soiling at the fireplace. There are also select areas of non-matching patches.

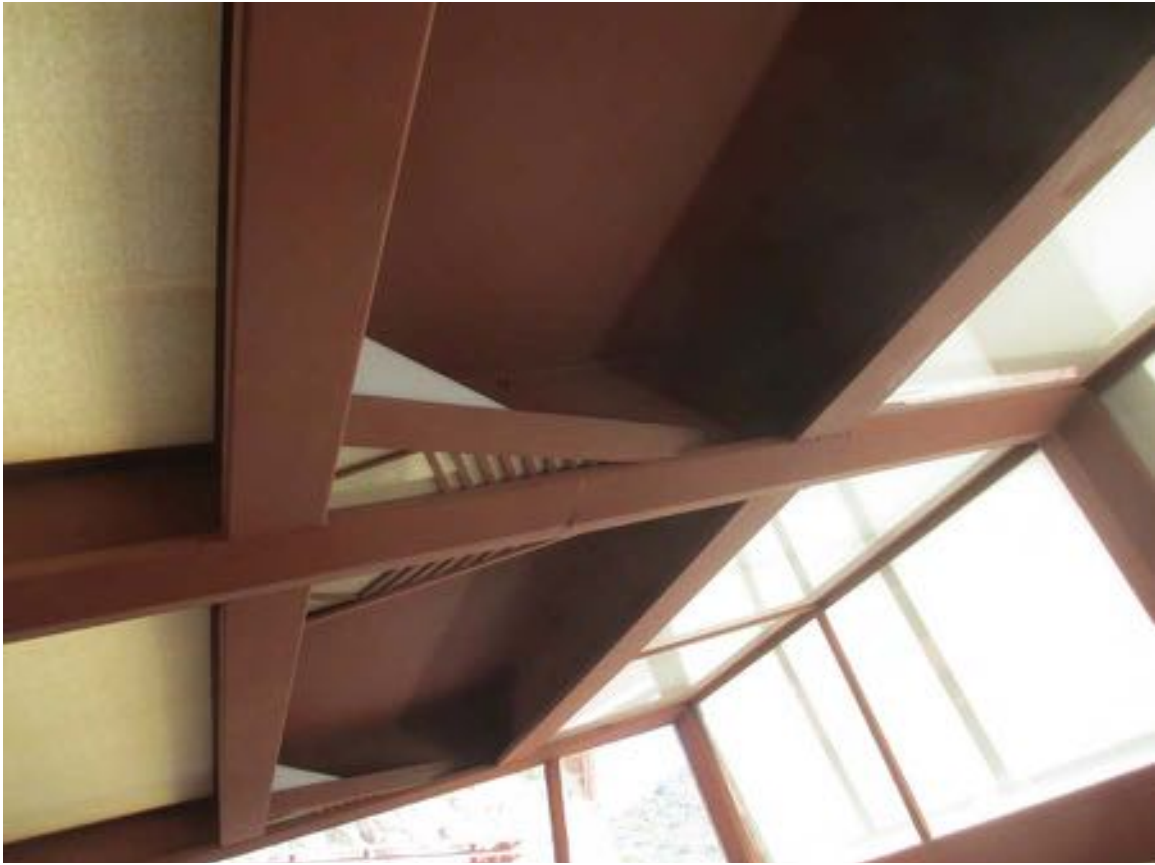
Figure 10-71 - Garden Room light fixtures, 2014 (Harboe Architects).

Lighting in the Garden Room is provided with decorative wood and frosted glass fixtures that are integrated into the roof system. These lights were added in the late 1950s during Frank Lloyd Wright's lifetime and reconstructed in 1998. Additional lighting is provided at the skylights near the east entry, as well as a few surface mounted and recessed fixtures, and floor lamps.

The lighting in the Garden Room appears to be in good condition.

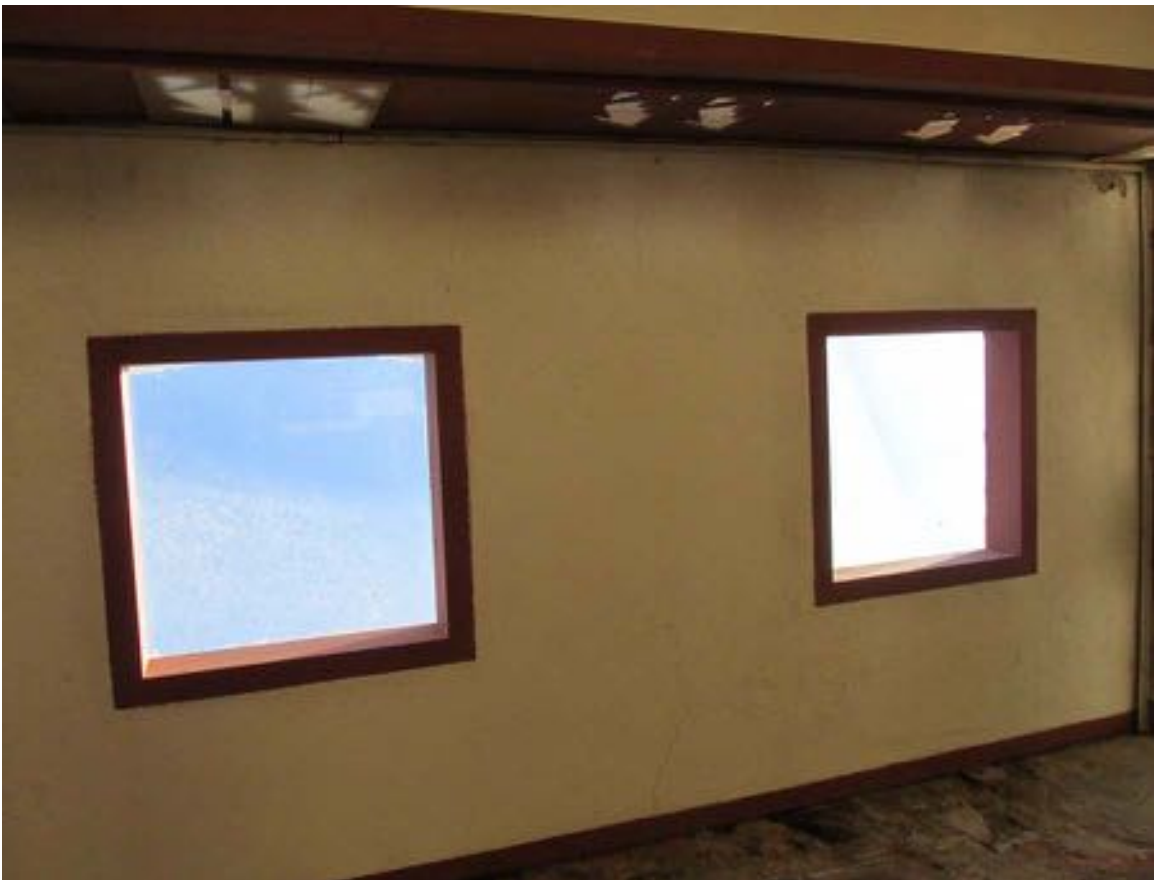
Figure 10-74 - Dining Cove skylights and ceiling, 2015 (Harboe Architects).

The skylights appear to be in good condition. There is no visible evidence of current or past leaks.

The ceiling is in fair condition. There are areas of staining due to water infiltration. In addition, the plaster ceiling around the skylights in the Dining Cove is cracked in several locations.

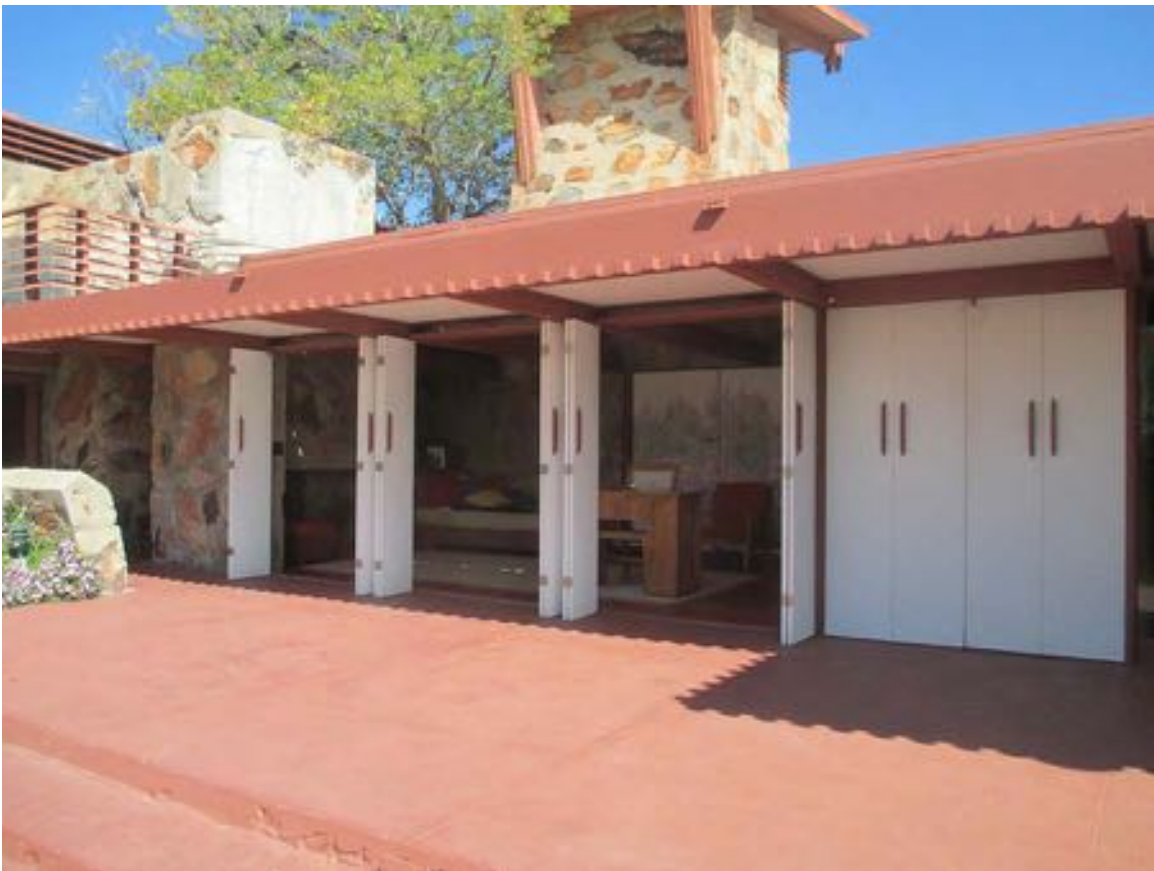
Figure 10-78 - Wright's Living Quarters looking north at wood bi-fold doors, 2014 (Harboe Architects).

The painted masonite bi-fold doors on the south (garden) side of the living quarters were added during the 2003 restoration. Originally the openings were covered with canvas panels. Masonite covered doors replaced the canvas panels in the late 1950s.

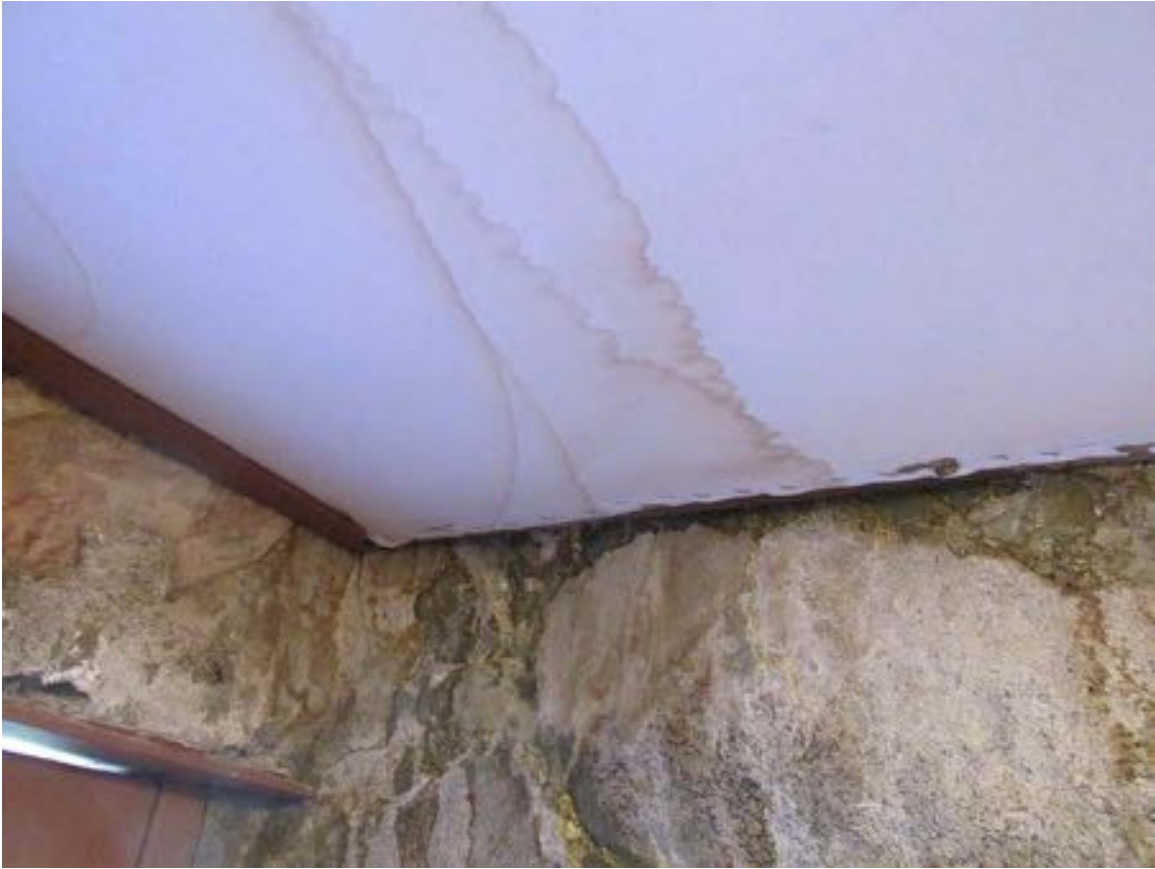
Figure 10-85 - Water stained canvas ceiling in hallway outside the kitchen, 2015 (Harboe Architects).

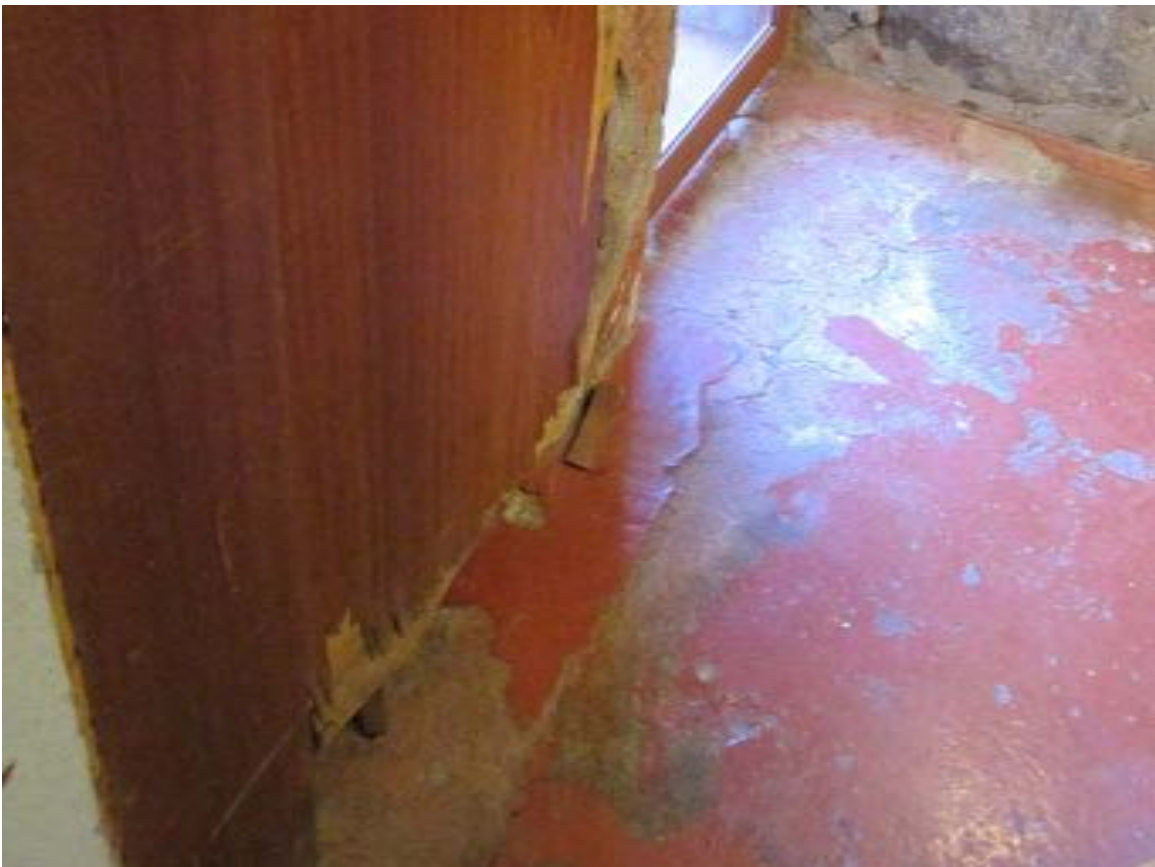
Figure 10-86 - Damaged wood veneer door and painted floor in the hallway outside the kitchen, 2015 (Harboe Architects).

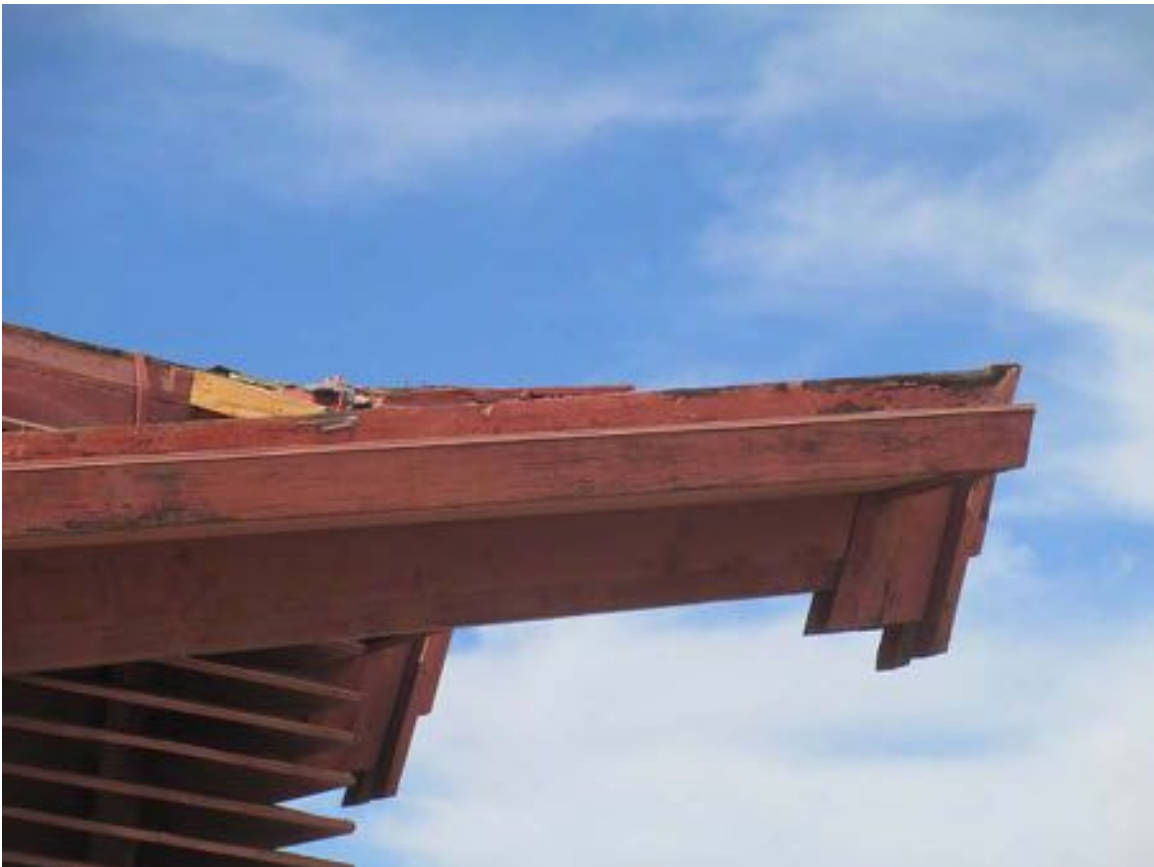
Figure 10-88 - Detail of Water Tower roof showing damaged wood, 2014 (Harboe Architects).

The Water Tower roof is in poor condition. The OSB decking is severely deteriorated as well as the 1x boards that support the decking. The wood beams are in fair condition with select areas of damage.

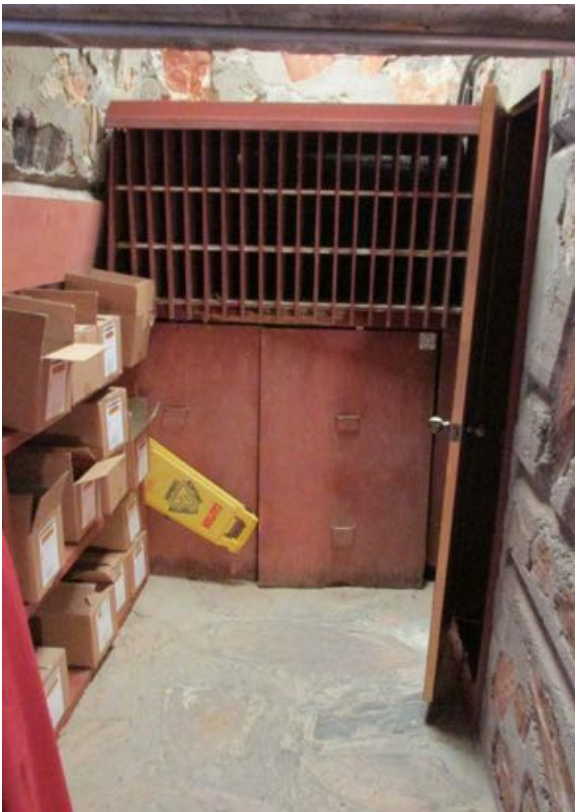
Figure 10-100 - Mailbox area outside of the men's restroom, 2015 (Harboe Architects).

The restrooms appear to be in good condition. Lighting levels in the women's restroom are low. The mailboxes and cabinets in the space outside the men's restroom are damaged. The cabinet doors are detached and in need of repair.

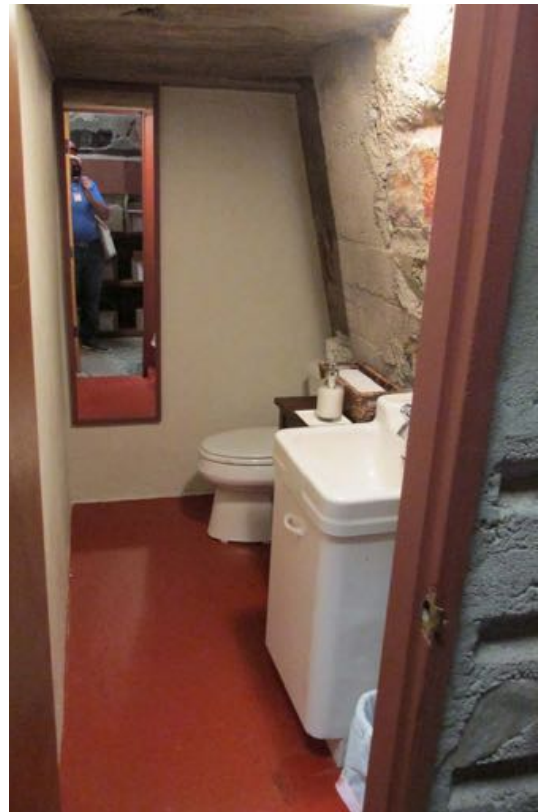
Figure 10-101 - Men's restroom, 2015 (Harboe Architects).

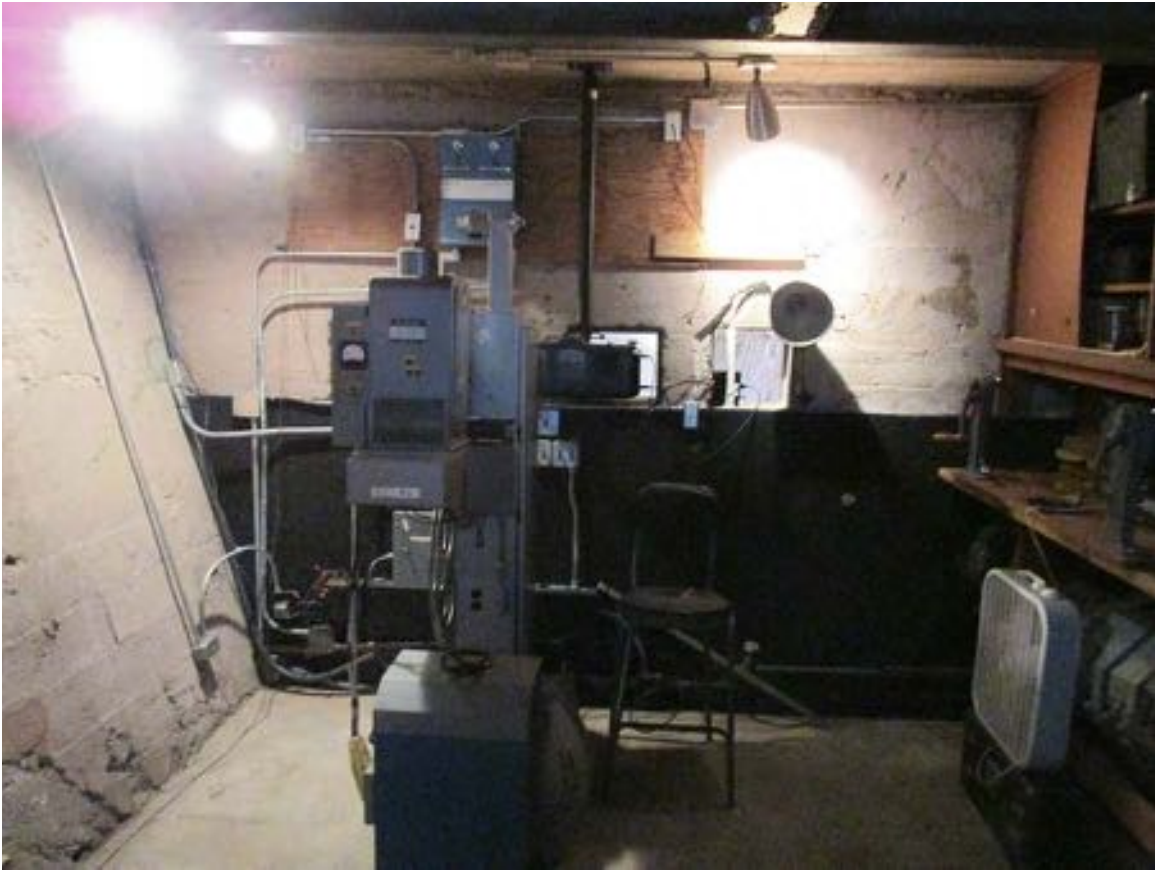
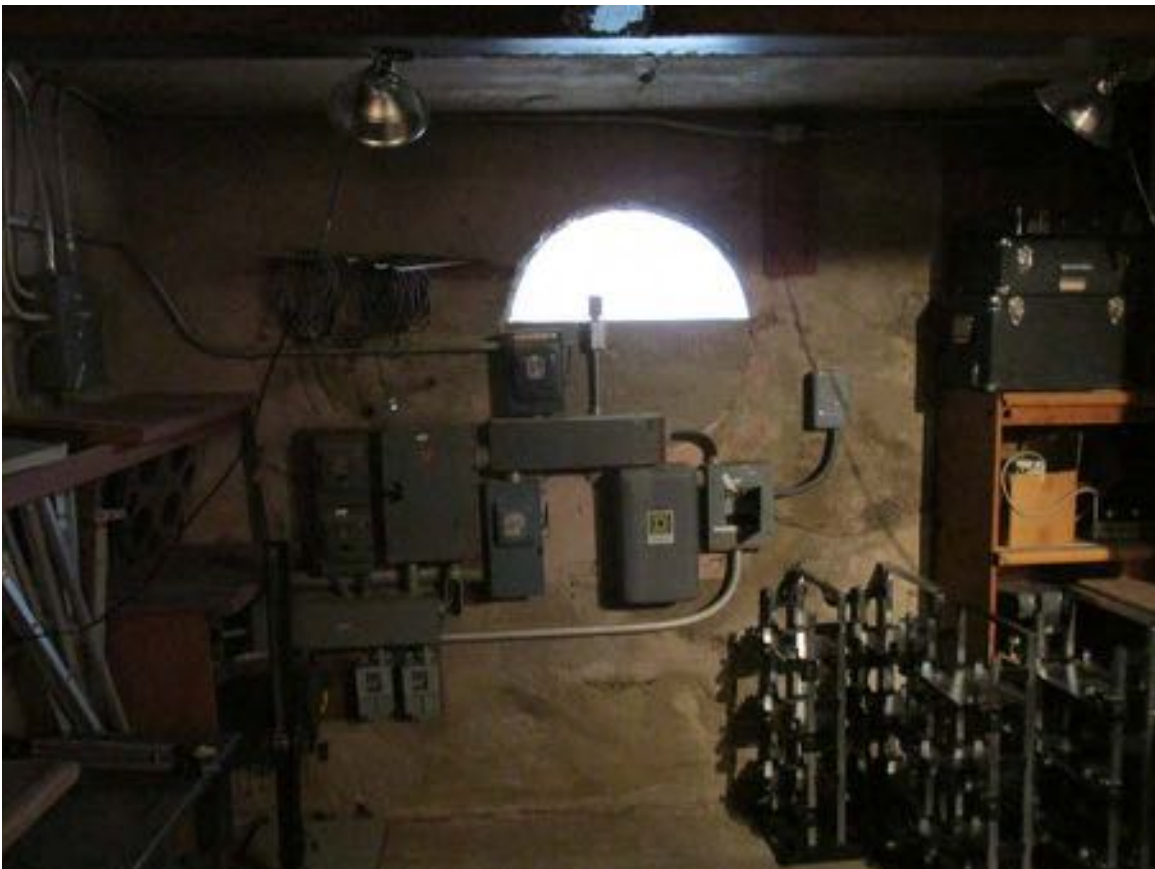
Figure 10-102 - Cabaret projection room, 2015 (Harboe Architects).

Figure 10-103 - Cabaret projection room, 2015 (Harboe Architects).

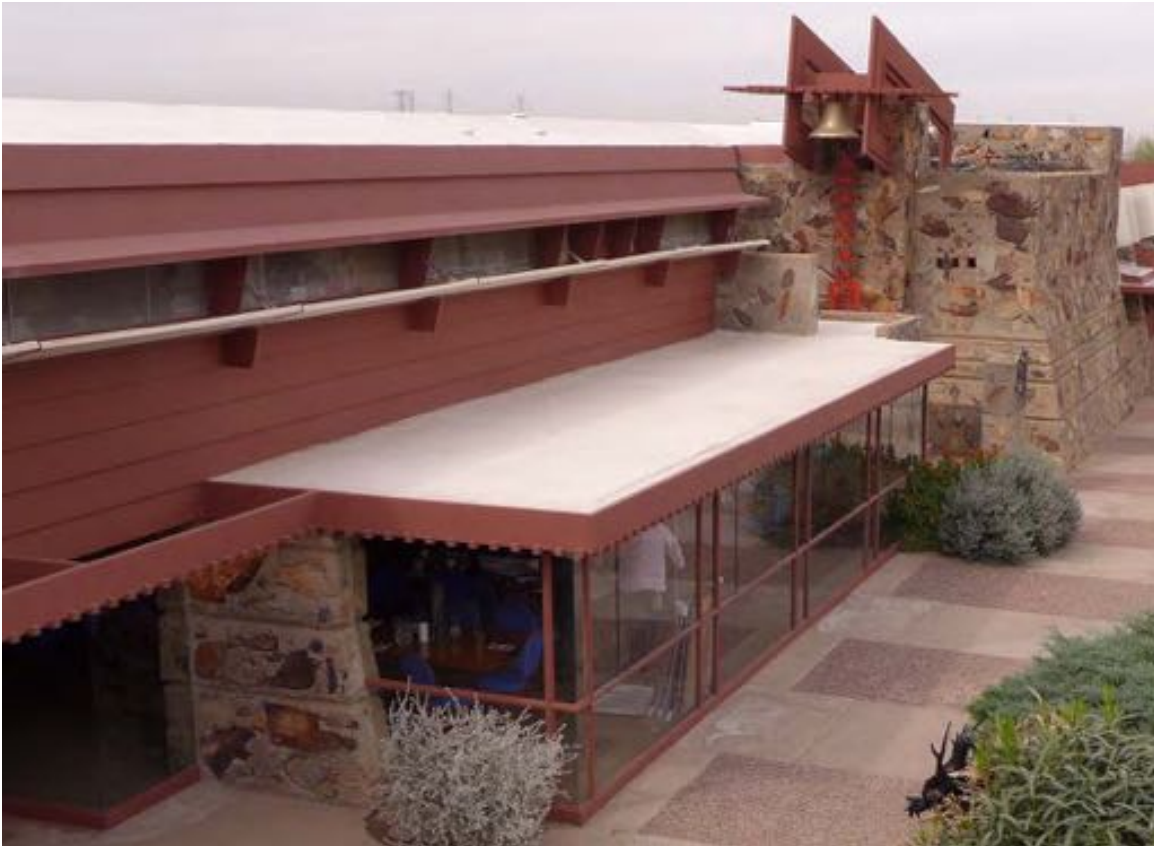
Figure 10-106 - View of Dining Room from Kiva roof, 2014 (Harboe Architects).

This roof is in good/fair condition. The membrane is in good condition; however, the area around the ceramic Chinese frieze leaks causing water staining on the fabric ceiling panels below. The roof drains are only 1" in diameter, which is inadequate during a rain storm in the Arizona desert and results in ponding on the roof.

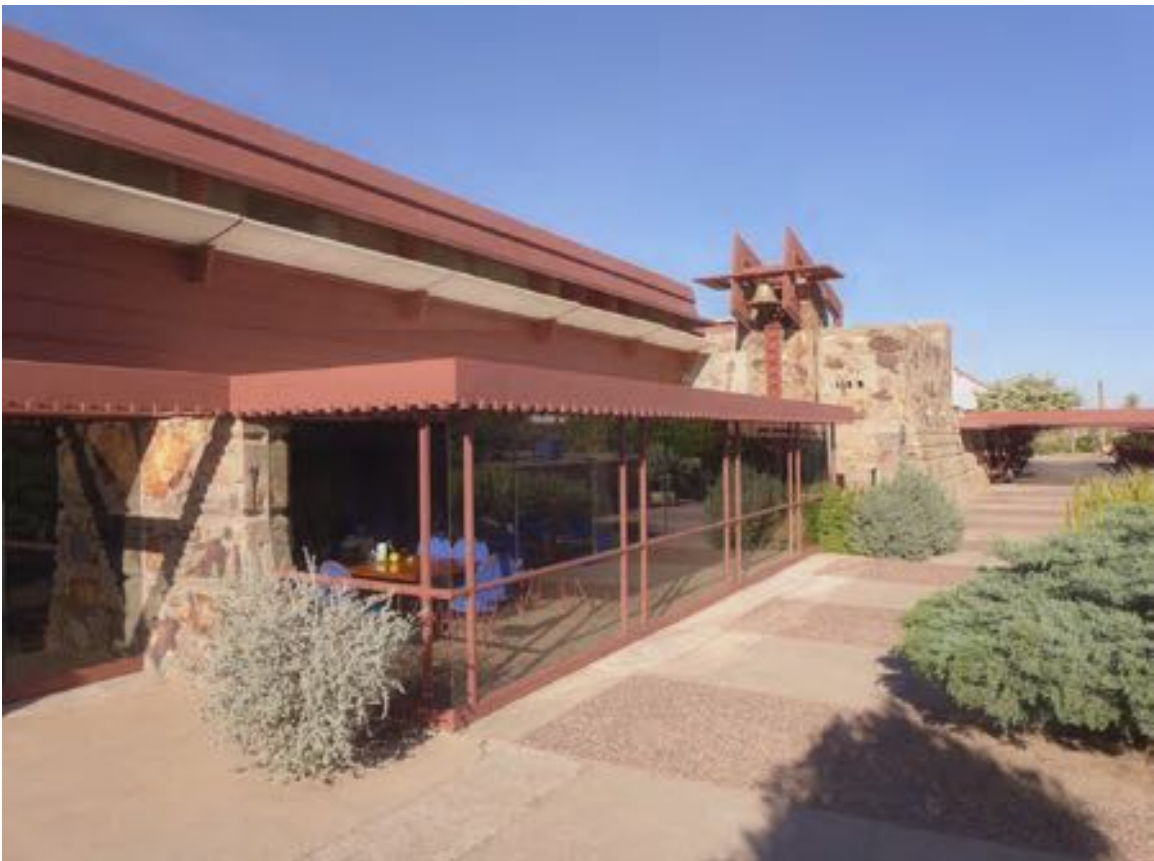
Figure 10-107 - Exterior of Dining Room looking west, 2014 (Harboe Architects).

The steel frame and glazing is in fair condition. There is some corrosion at the steel base and at the bottom stops. Also, some of the edges of the sliding glass panels are chipped.
