TALIESIN WEST PRESERVATION MASTER PLAN

Harboe Architects, PC

MAY 21, 2015

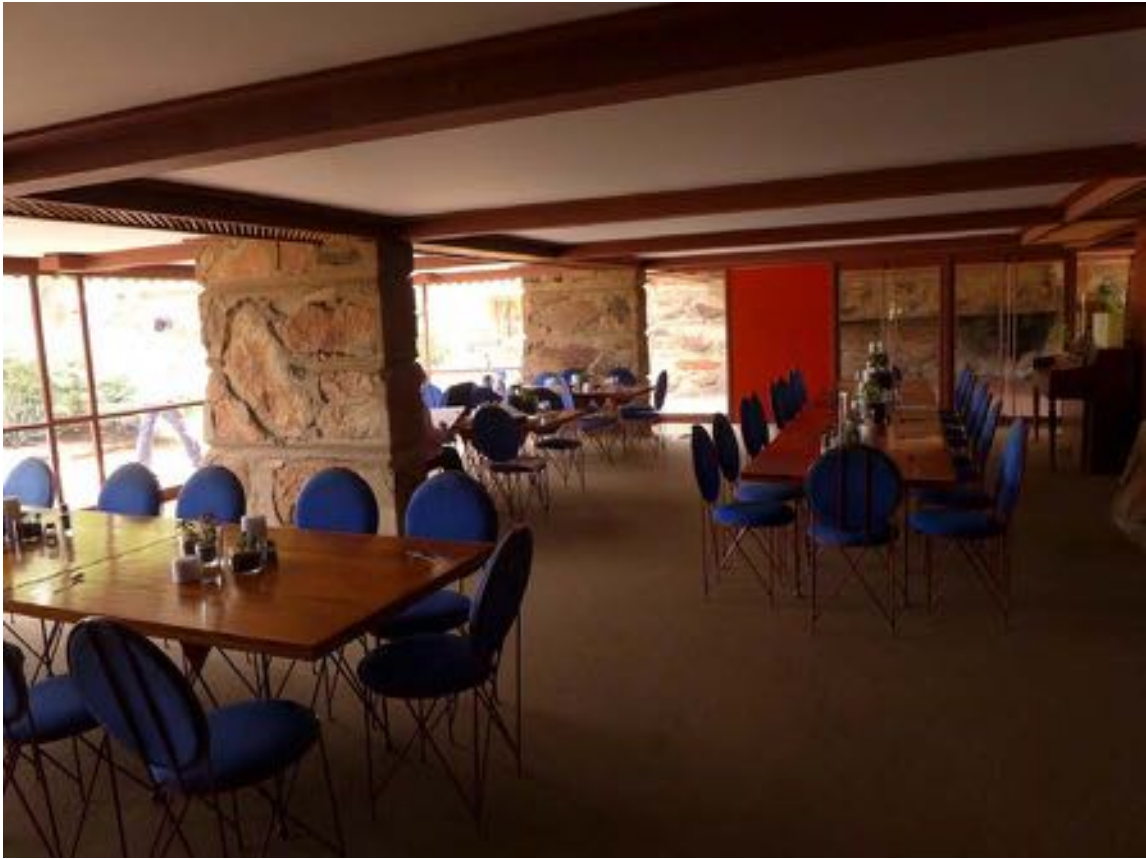
Figure 10-108 - Interior of Dining Room looking southeast, 2014 (Harboe Architects).

The steel framing is painted red and is in good condition. The fabric panels appear to be in good condition. There is one section on the west side of the dining room that has some water staining. The ceiling in the annex is in fair condition.

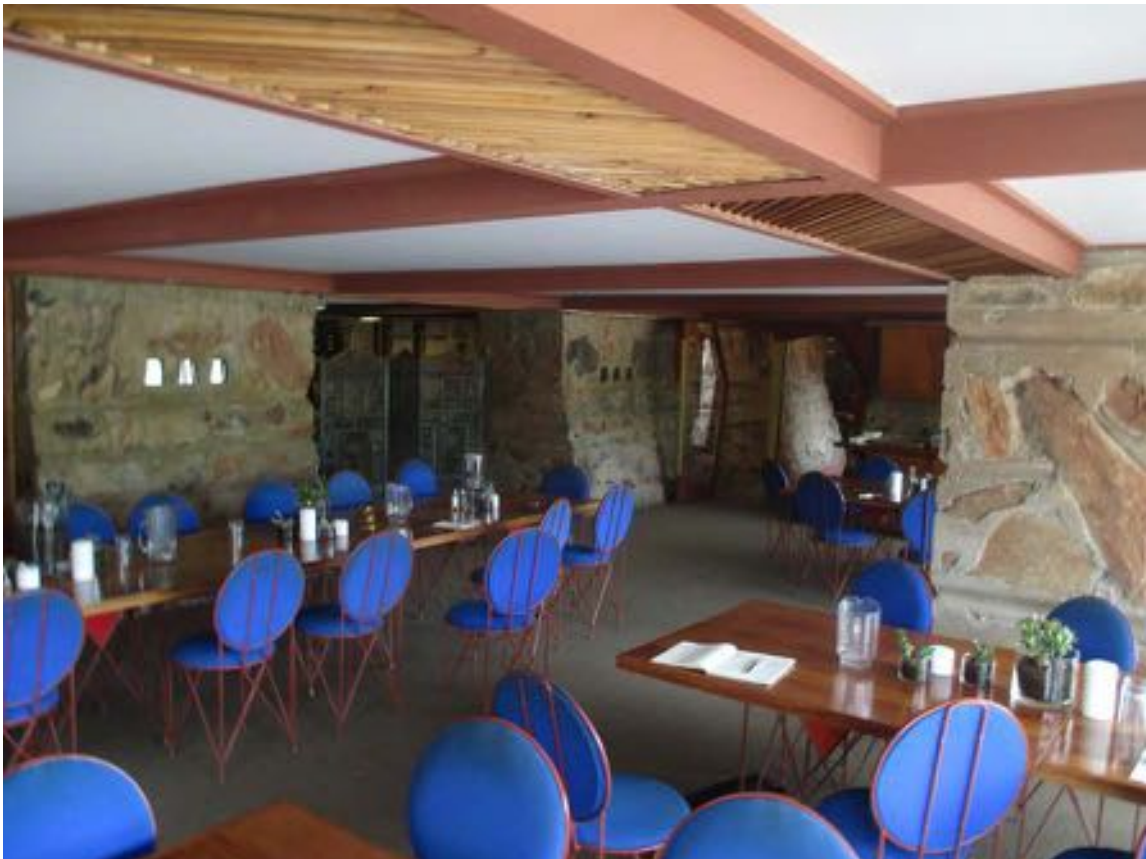
Figure 10-109 - Interior of Dining Room looking west, 2014 (Harboe Architects).

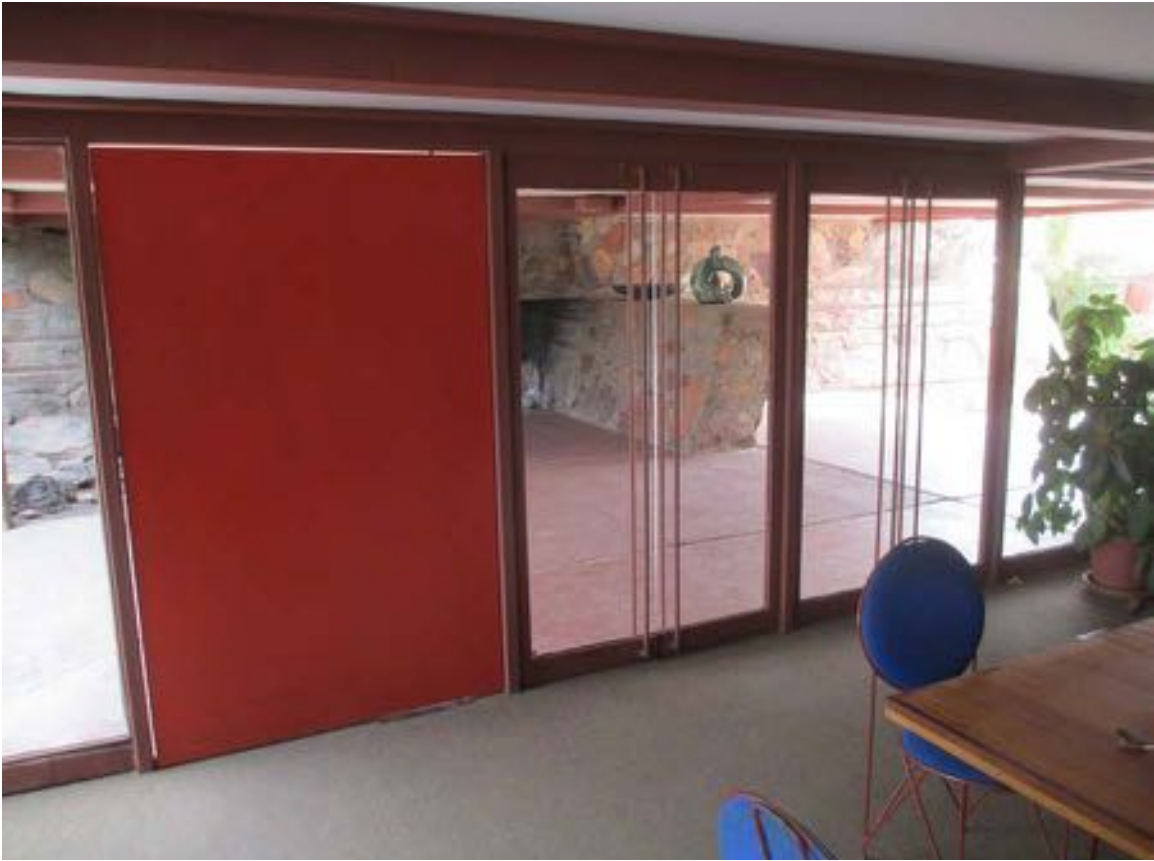
Figure 10-110 - Interior of Dining Room looking south at door, 2014 (Harboe Architects).

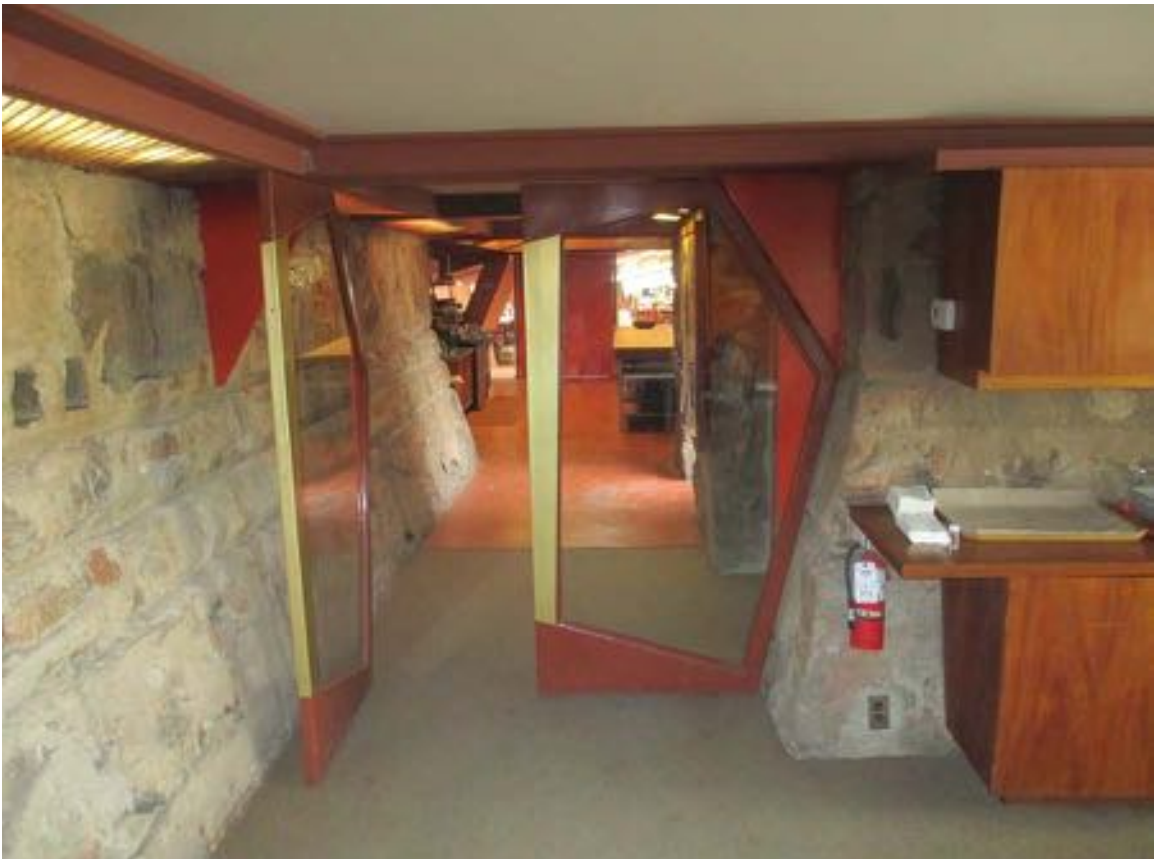
Figure 10-111 - Dining Room looking northwest at doors to kitchen, 2014 (Harboe Architects).

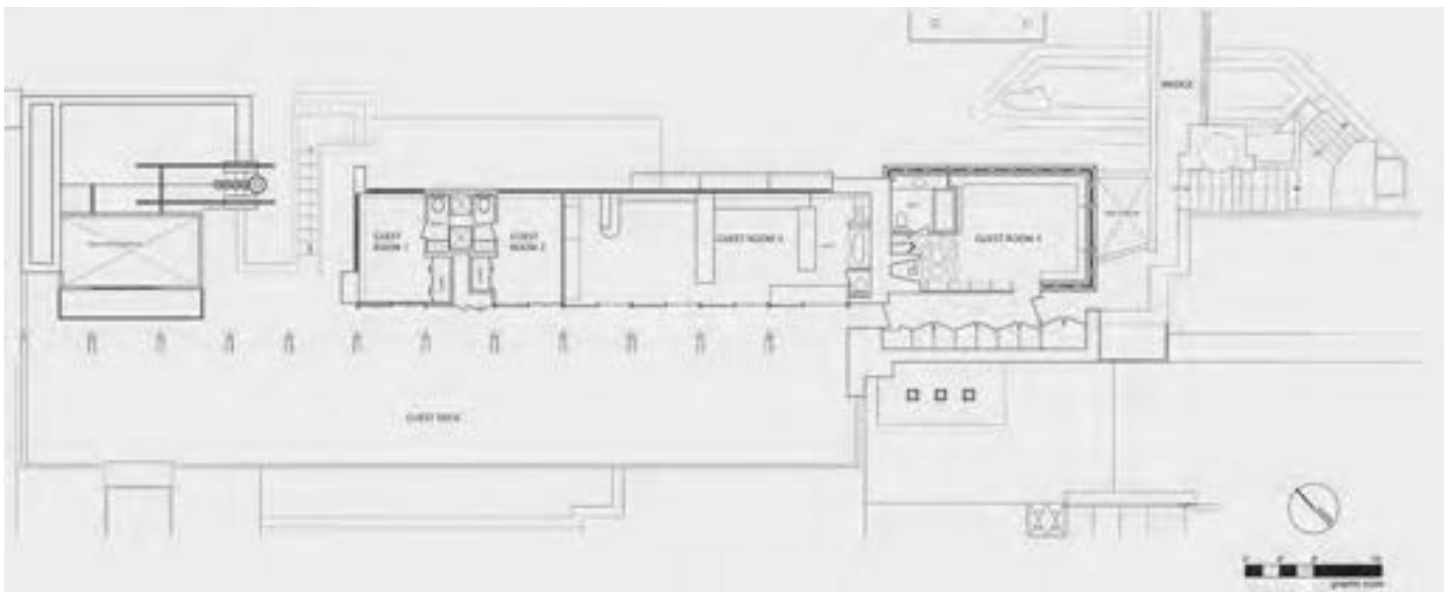
Figure 10-113 - Guest Deck Floor Plan

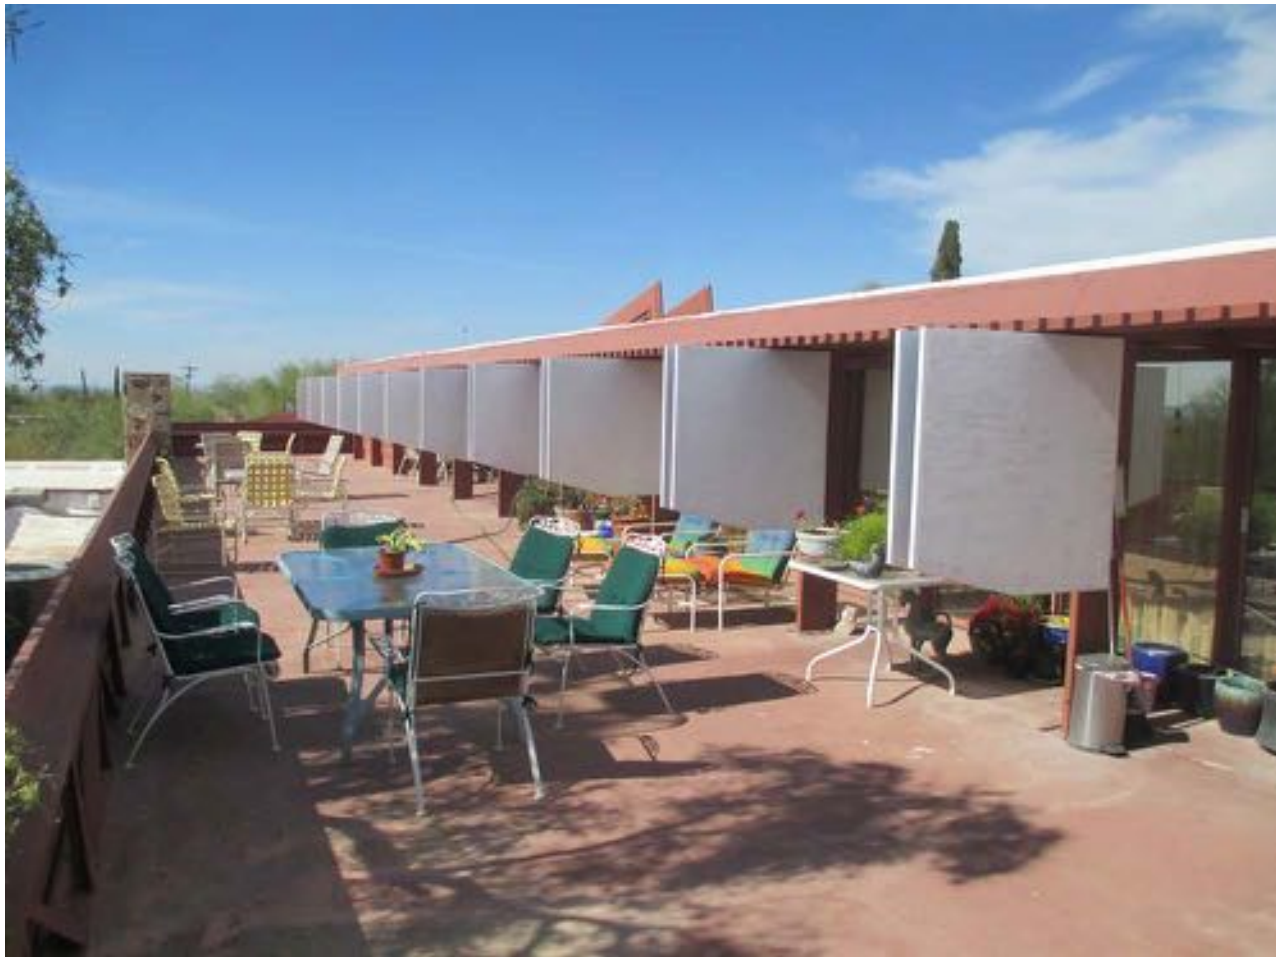
Figure 10-114 - Guest Deck looking west, 2014 (Harboe Architects).

The roof deck and membrane is damaged and leaking and in need of replacement. The soffit under the roof is also damaged and needs repairs.

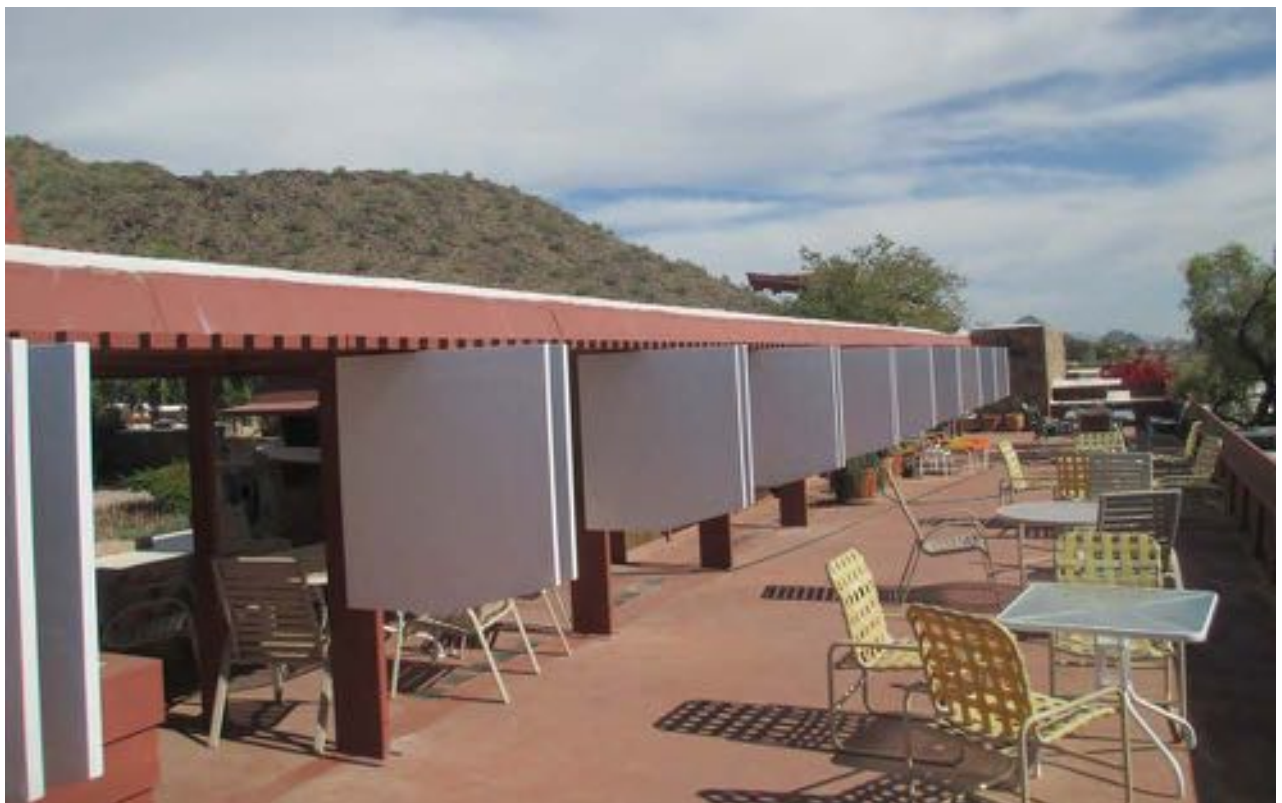
Figure 10-115 - Guest Deck looking east, 2014 (Harboe Architects).

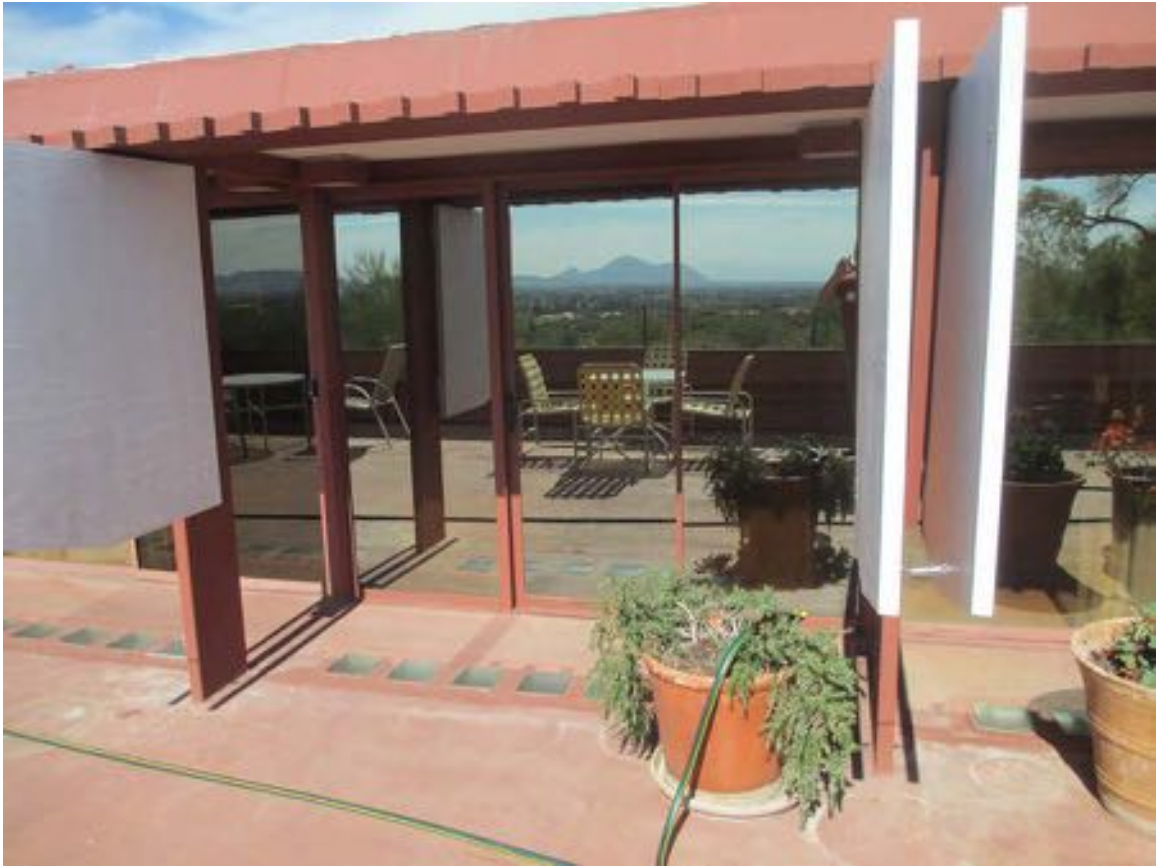
Figure 10-116 - Looking north at guest room with open wood flaps, 2014 (Harboe Architects).

The painted plywood shutters appear to be in relatively good condition. Some of the shutters do not close properly and are out of alignment.

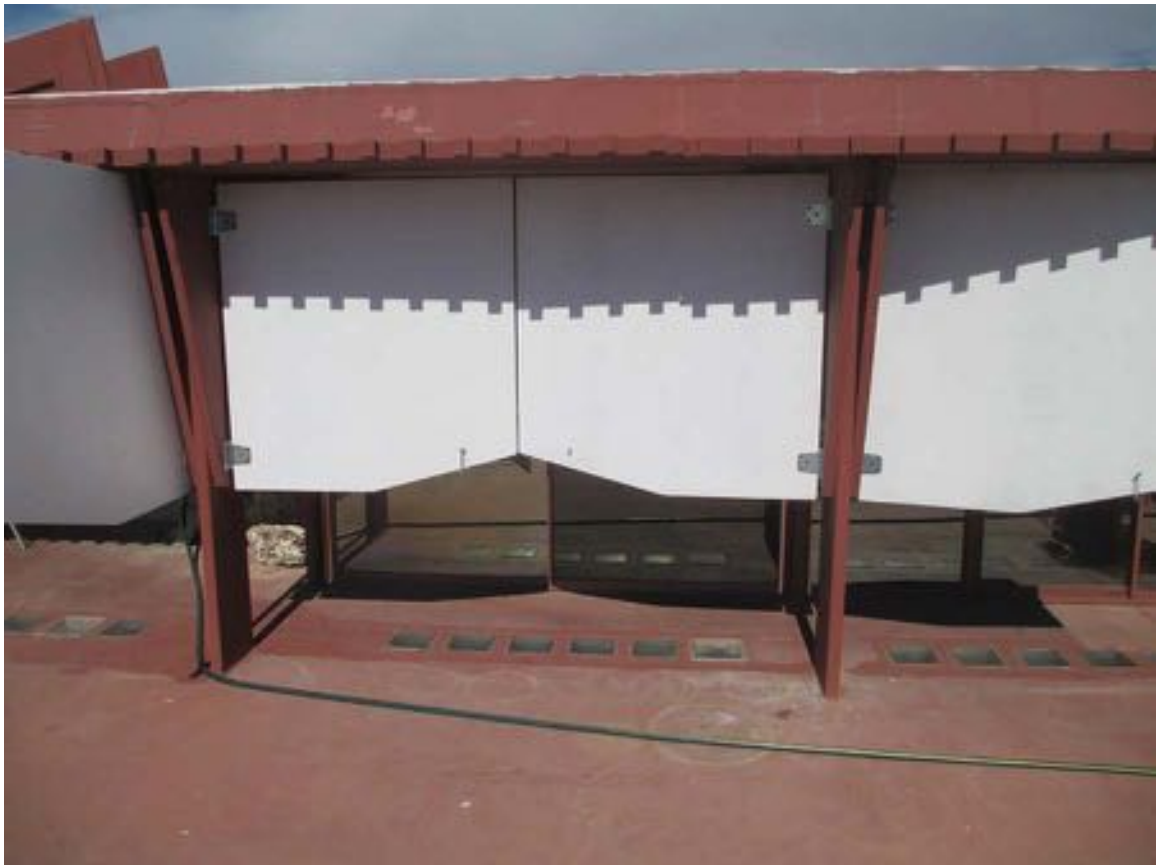
Figure 10-117 - Looking north at guest room with closed wood flaps, 2014 (Harboe Architects).

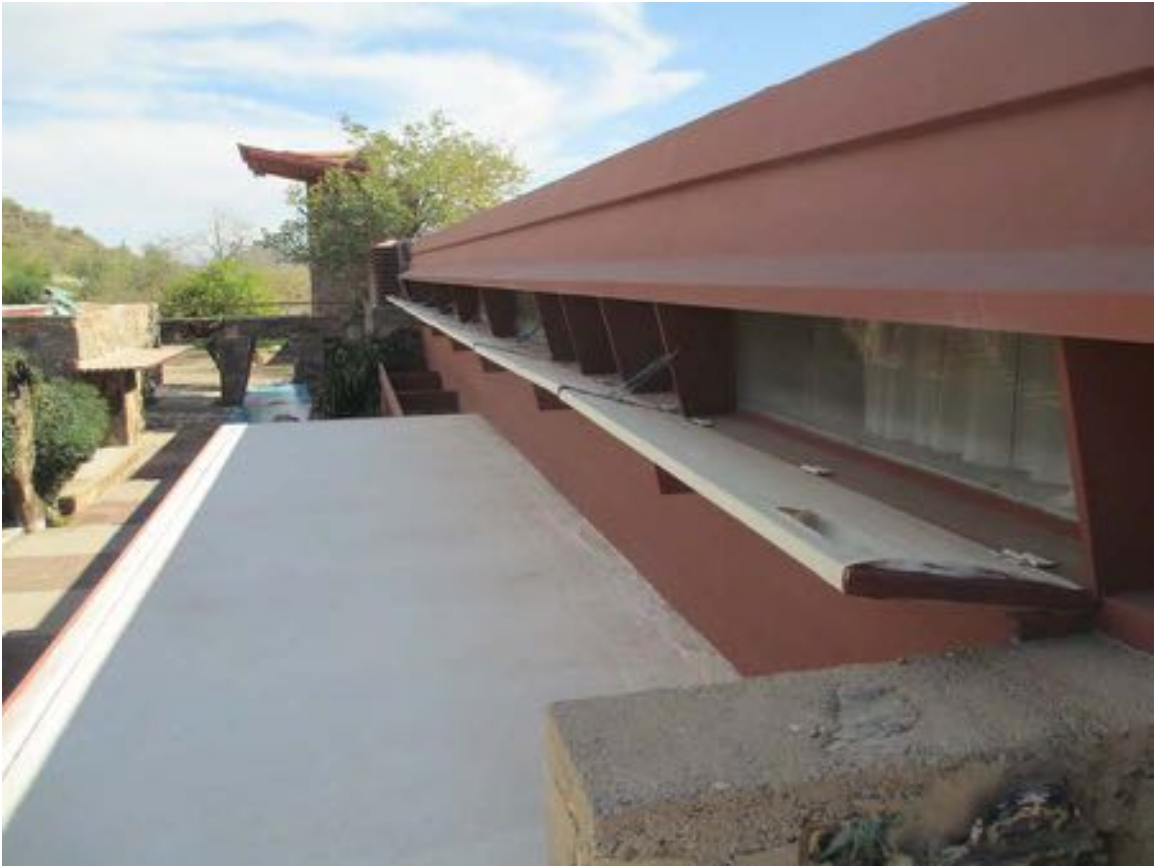
Figure 10-118 - North side of guest rooms looking east, 2014 (Harboe Architects).

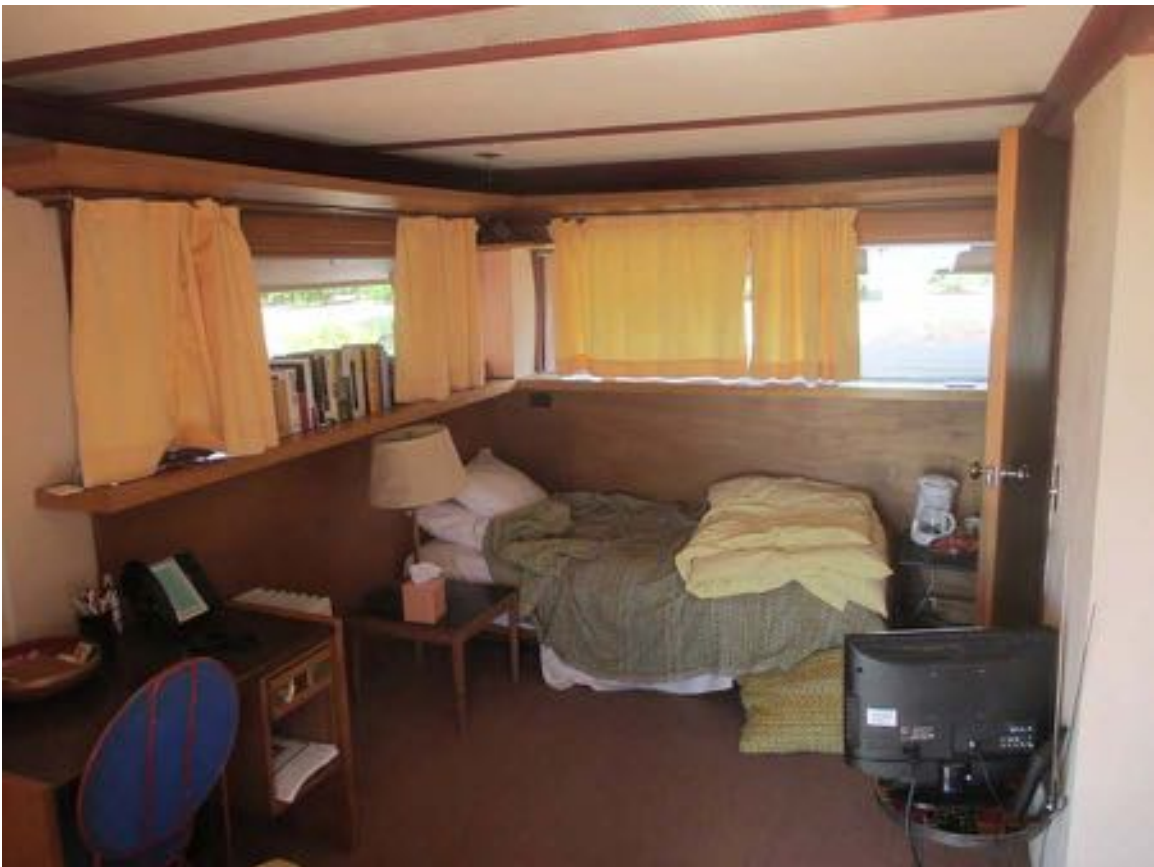
Figure 10-119 - Interior of typical guest room, 2014 (Harboe Architects).

The walls are in fair condition and require some repair at damaged areas of drywall.

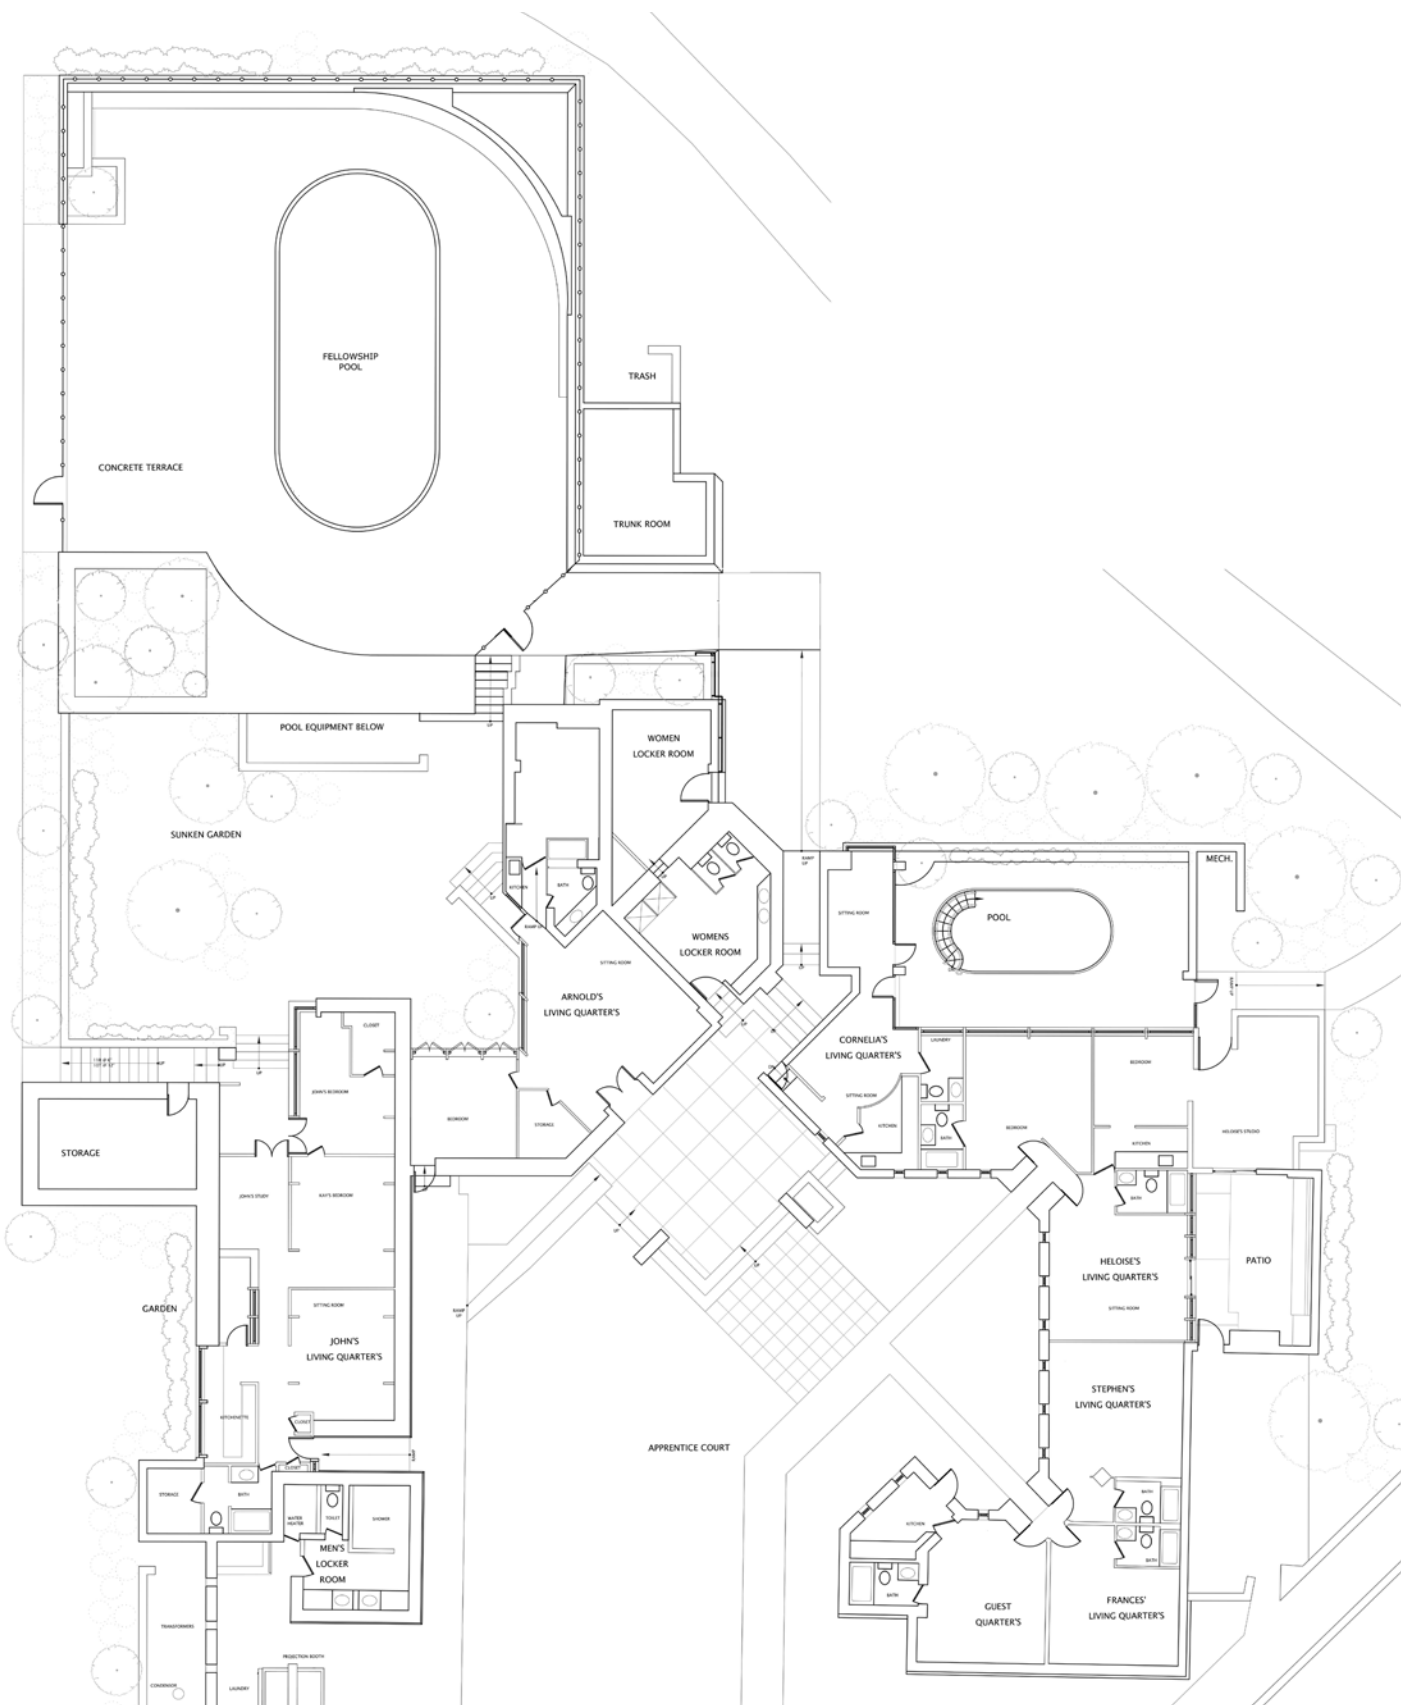
Figure 10-121 - Apprentice Court Floor Plan

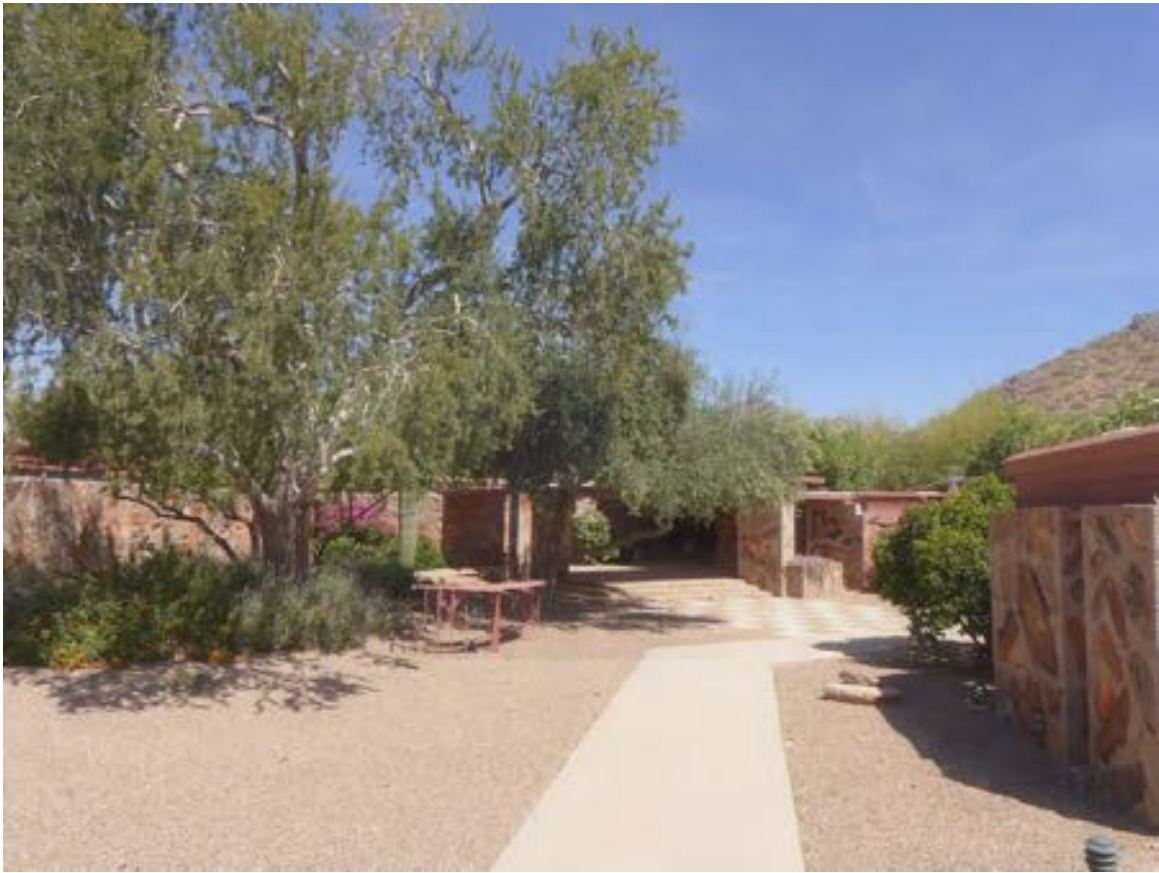
Figure 10-122 - Apprentice Court looking northeast, 2014 (Harboe Architects).

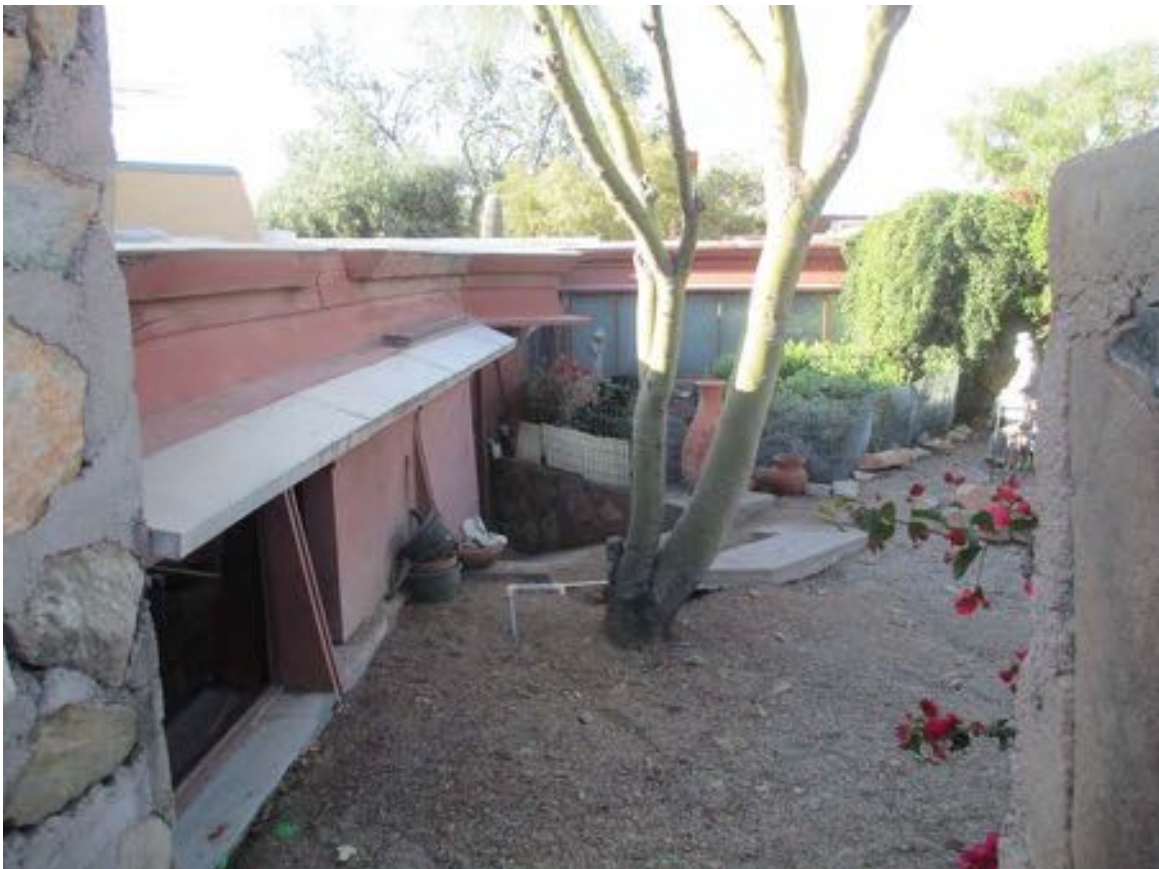
Figure 10-123 - North side of the Apprentice Court, 2014 (Harboe Architects).

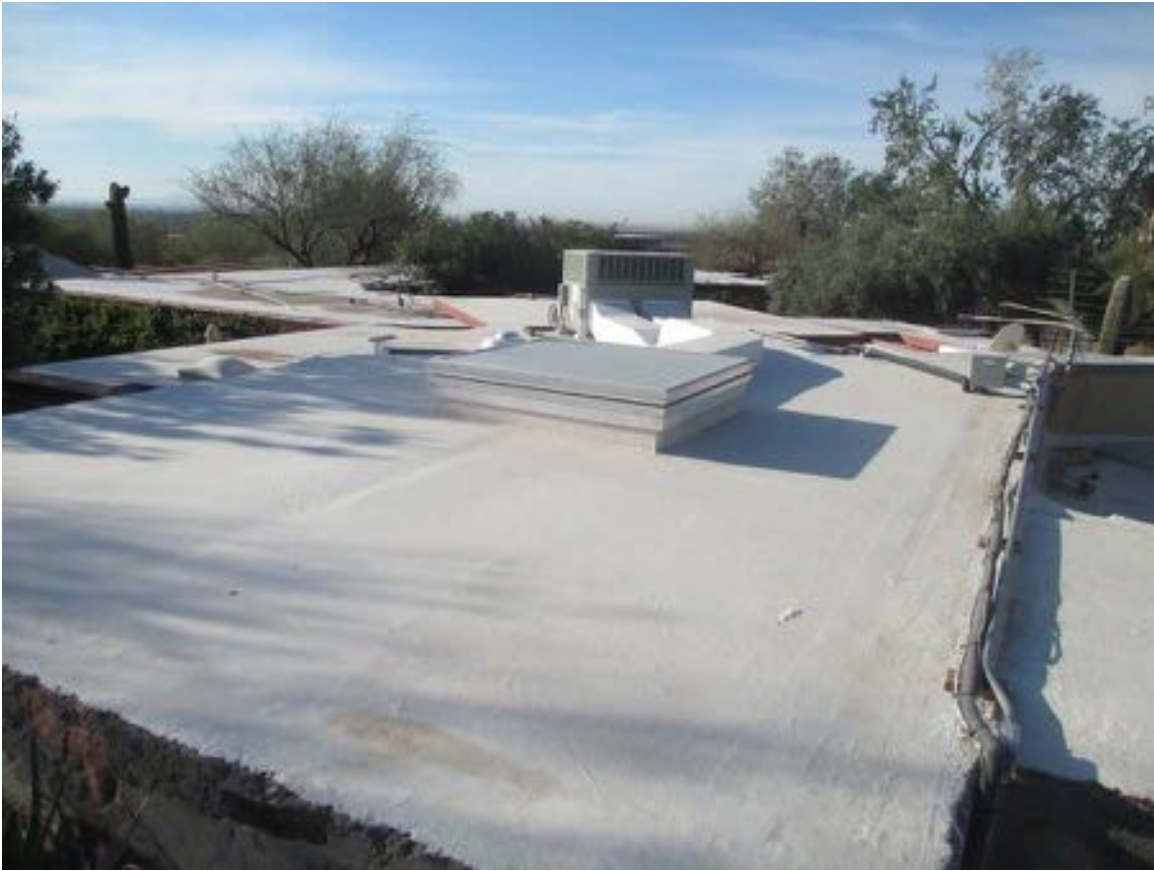
Figure 10-124 - Apprentice Court apartments roof, 2014 (Harboe Architects).

The membrane roof is at the end of its usable life and needs to be replaced. The fascia at the eaves is in relatively good condition. There are a few select areas of damage to the wood fascia on the west side of the Apprentice Court. The entire fascia needs to be painted.

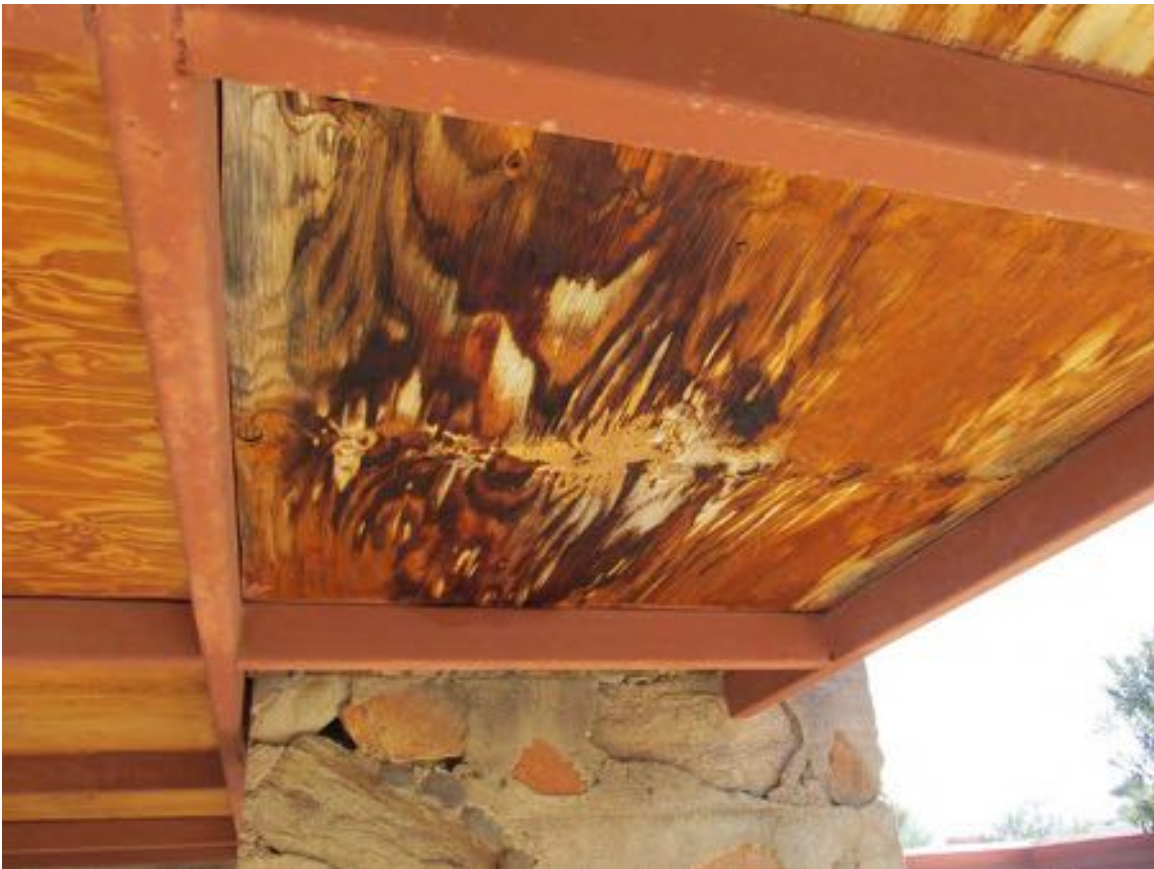
Figure 10-125 - Damaged underside of roof decking at Apprentice Court, 2015 (Harboe Architects).

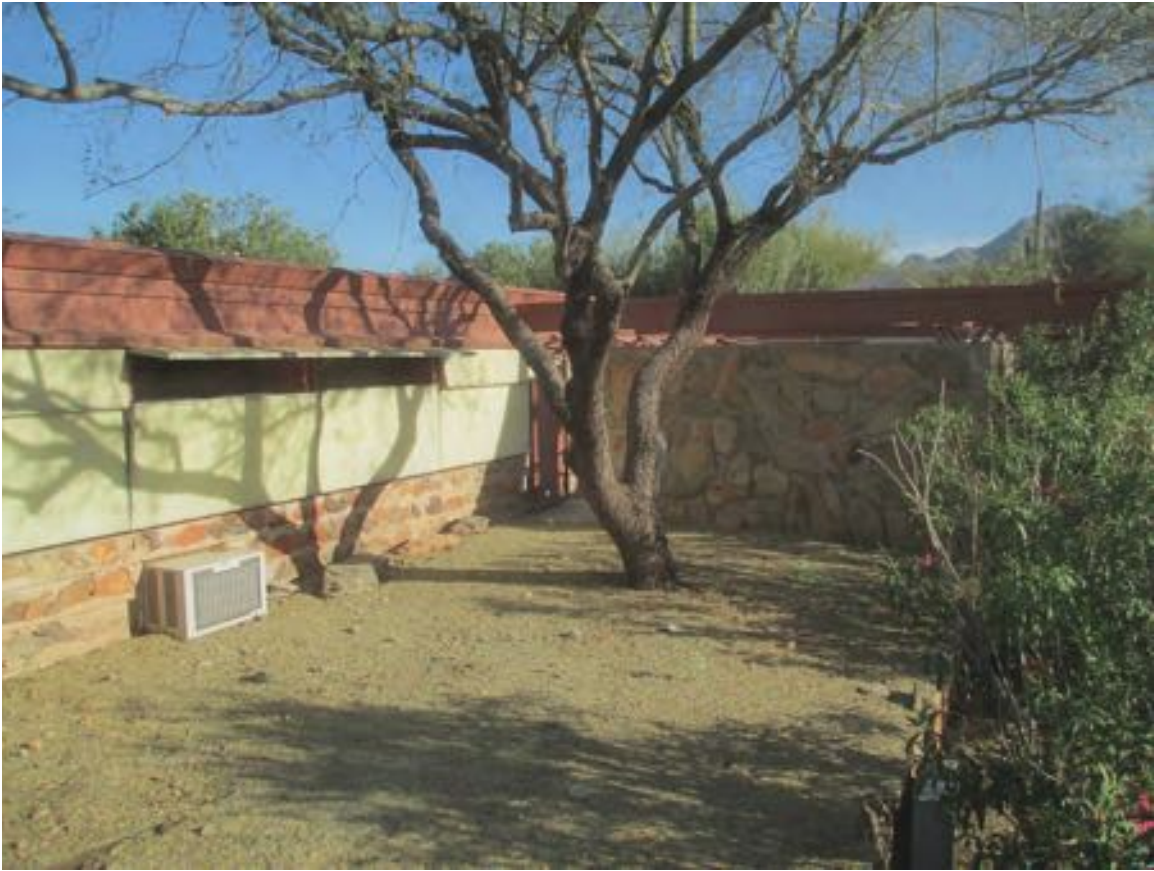
Figure 10-126 - South side of Apprentice Court apartments, 2014 (Harboe Architects).

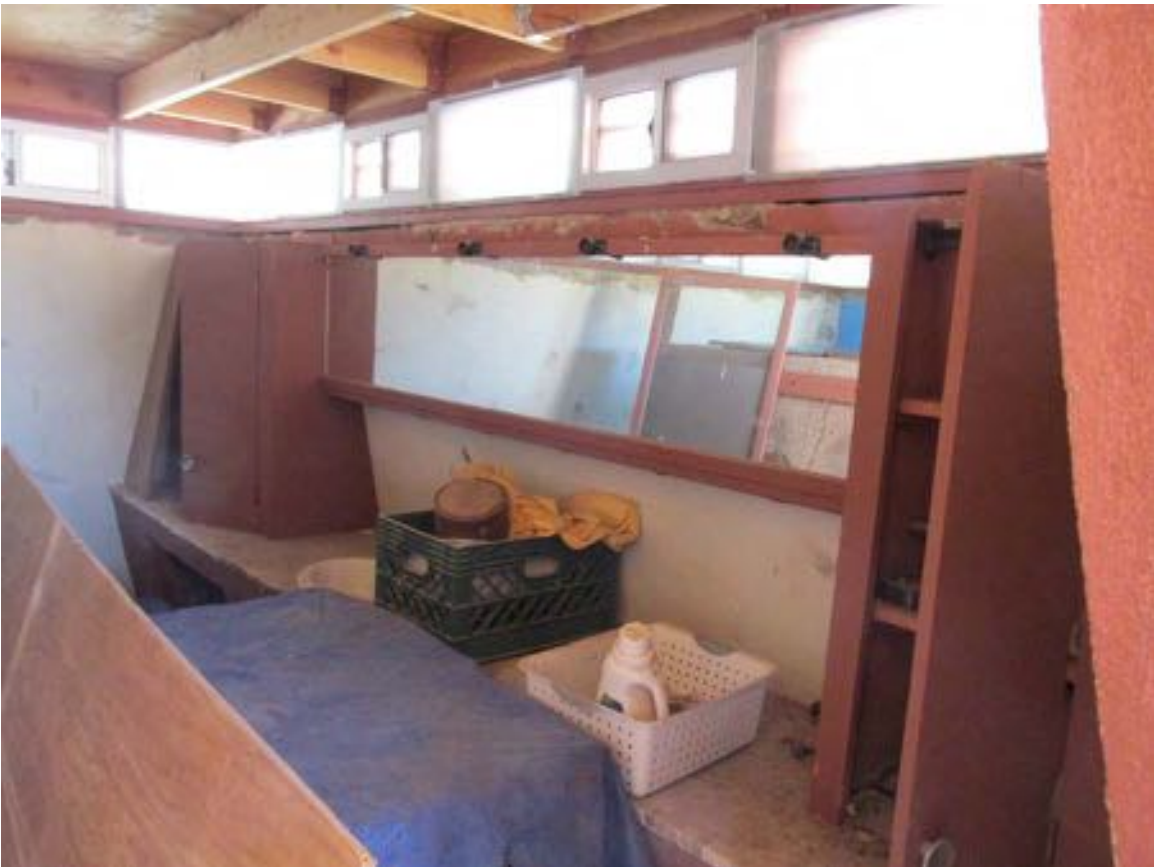
Figure 10-127 - Sink area in Old Men's Locker Room, 2015 (Harboe Architects).

In many of the apartments the carpet is old and worn and in need of replacement. The tile flooring in the women's locker room is in good condition. This tile floor was installed during the most recent remodel of the locker room in the mid-2000s. The concrete floor in the old men's locker room is in poor condition.

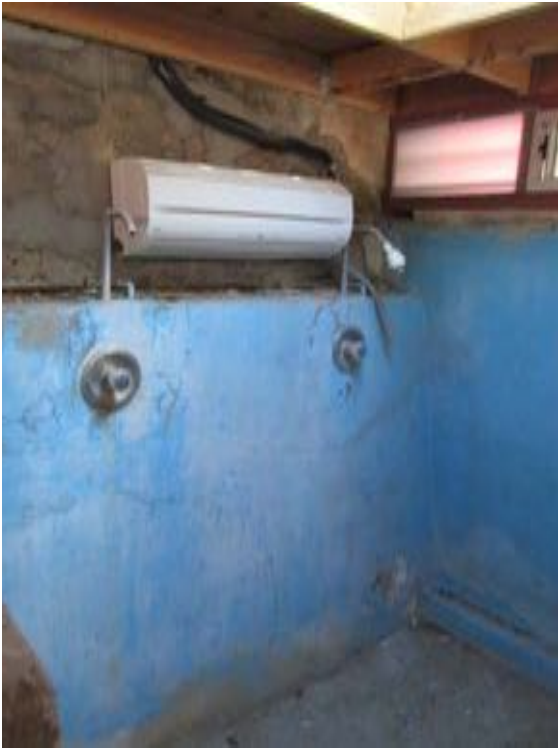
Figure 10-128 - Shower area in Old Men's Locker Room, 2015 (Harboe Architects).

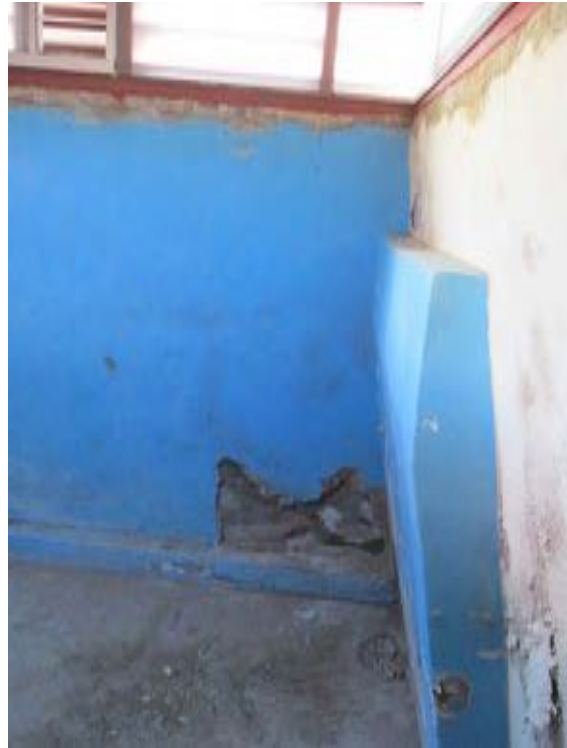
Figure 10-129 - Damaged wall in shower area in Old Men's Locker Room, 2015 (Harboe Architects).

The desert masonry walls are in good condition. There is generally a light soiling on all desert masonry. Painted plaster walls in the old men's locker room are damaged with multiple cracks and portions of failing and crumbling plaster. The old men's locker room is currently not used.

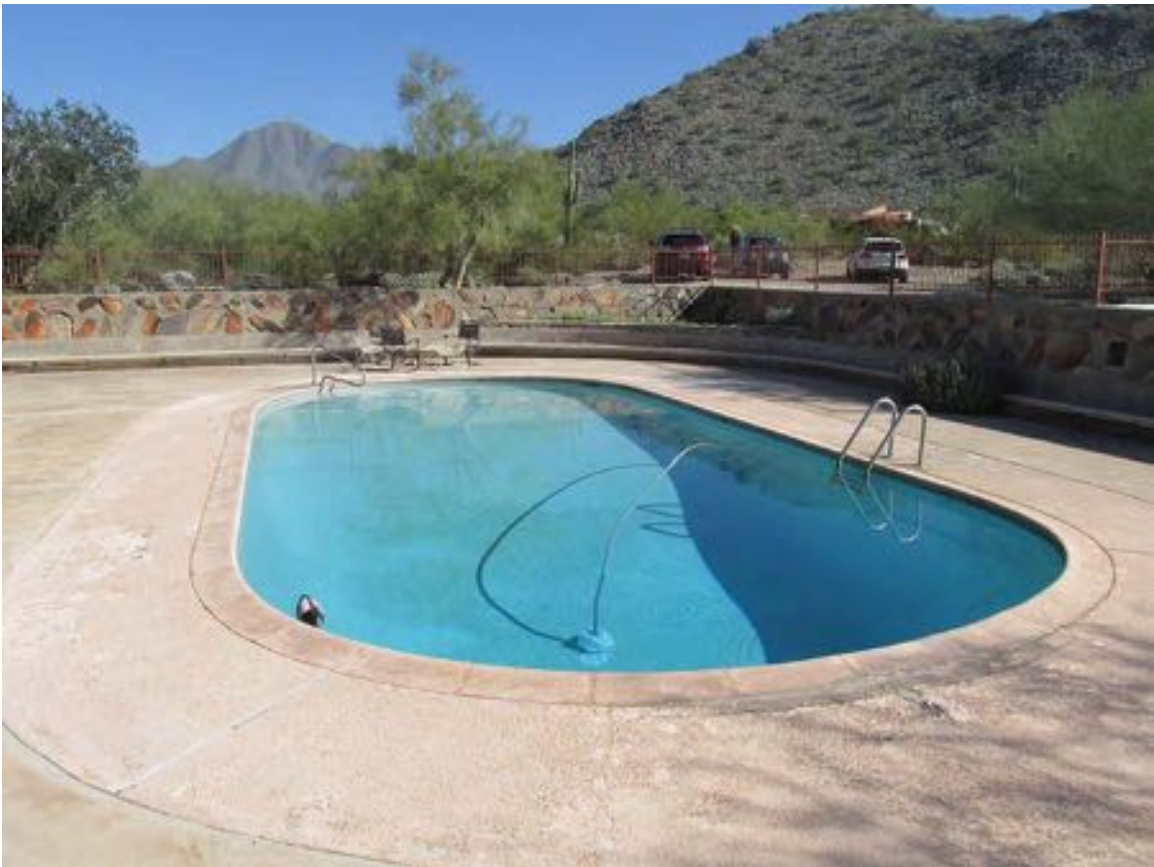
Figure 10-130 - Fellowship Pool, 2015 (Harboe Architects).

The painted concrete on the inside face of the pool is in good condition. The textured mortar topping on the inner pool deck is in poor condition. The topping is delaminating and cracking in multiple locations. There are also many open mortar joints and some areas of previous non-matching patches and repairs. The outer pool deck is in fair condition. There are some cracks and non-matching repairs. The cast concrete bench is in fair condition with areas of spalling, erosion, and cracking. The steel picket fence is in good condition. Lighting is in fair condition. Many of the lights are missing lenses.
