TALIESIN WEST PRESERVATION MASTER PLAN

Harboe Architects, PC

MAY 21, 2015

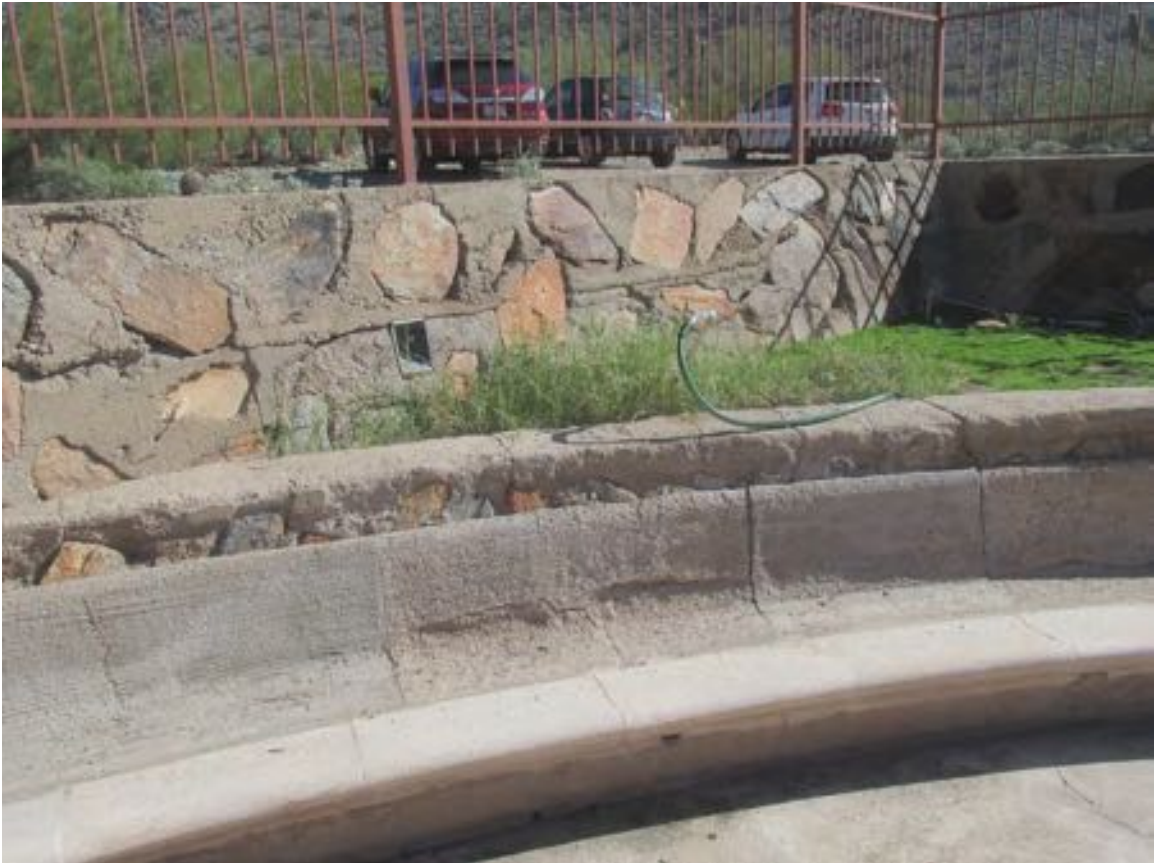
Figure 10-131 - Concrete bench around perimeter of Fellowship Pool, 2015 (Harboe Architects).

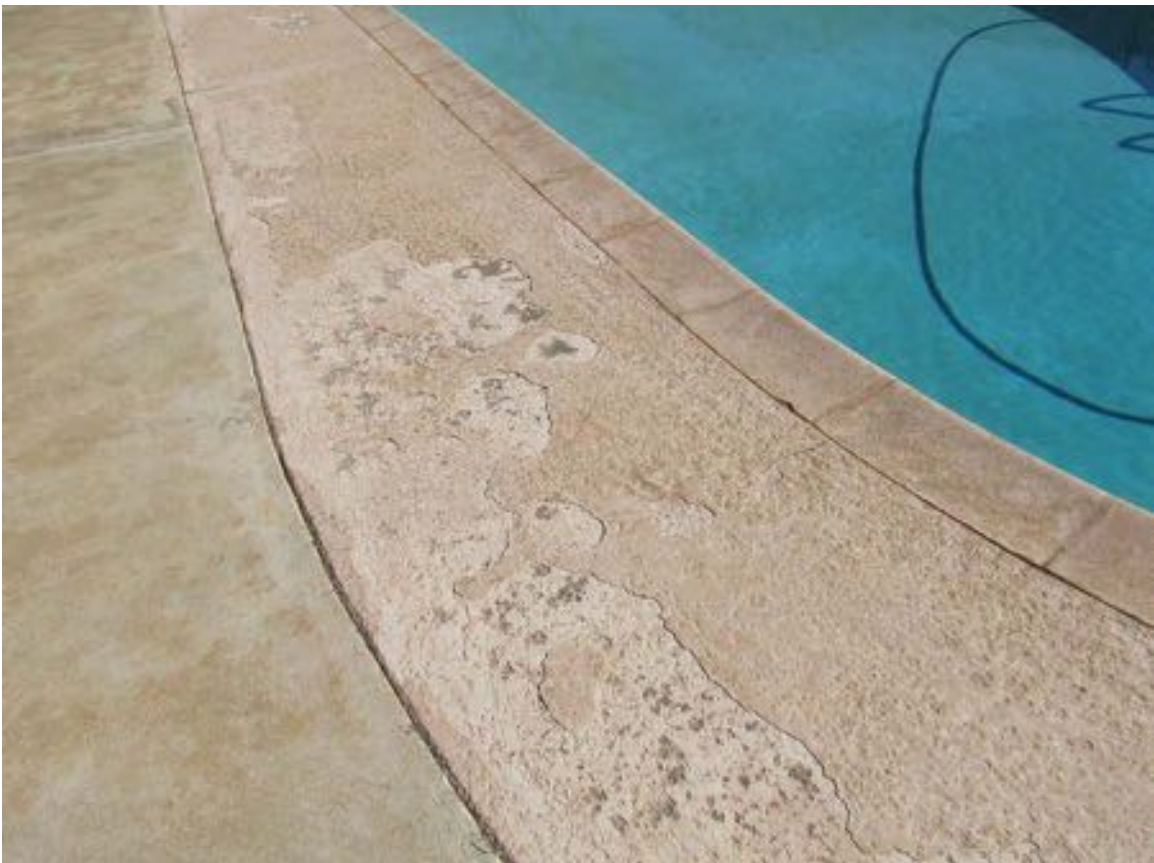
Figure 10-132 - Delaminated mortar topping of inner pool deck, 2015 (Harboe Architects).

The painted concrete on the inside face of the pool is in good condition. The textured mortar topping on the inner pool deck is in poor condition. The topping is delaminating and cracking in multiple locations. There are also many open mortar joints and some areas of previous non-matching patches and repairs. The outer pool deck is in fair condition. There are some cracks and non-matching repairs. The cast concrete bench is in fair condition with areas of spalling, erosion, and cracking. The steel picket fence is in good condition. Lighting is in fair condition. Many of the lights are missing lenses.

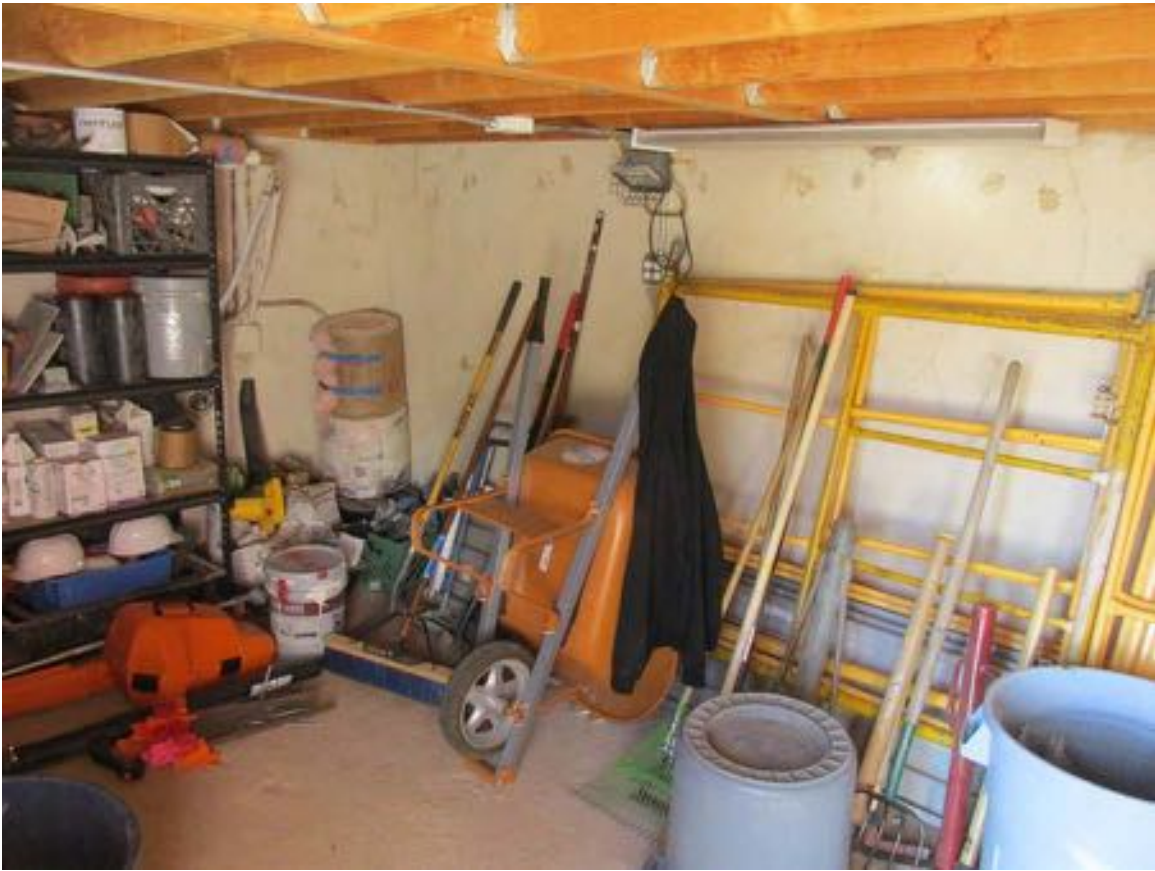
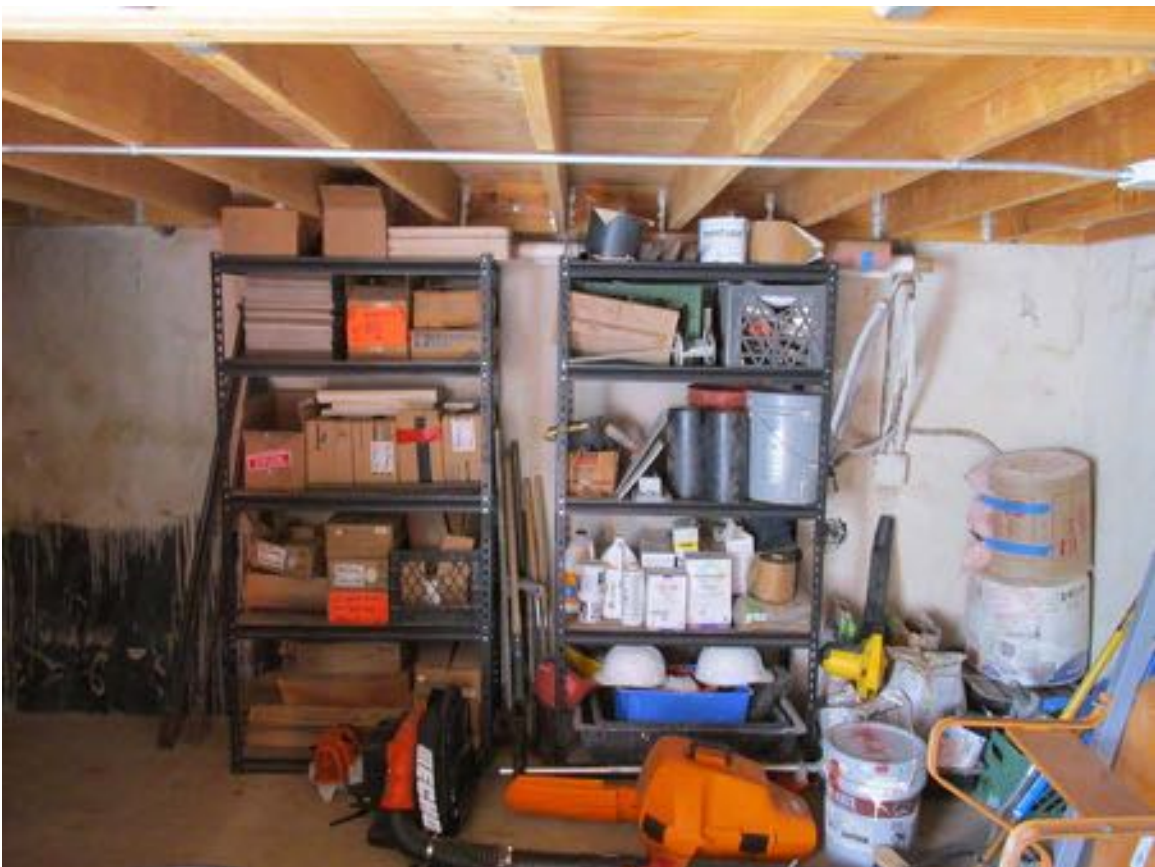
Figure 10-133 - Interior of Trunk Room, 2015 (Harboe Architects).

Figure 10-134 - Interior of Trunk Room, 2015 (Harboe Architects).

The trunk room is in good condition.

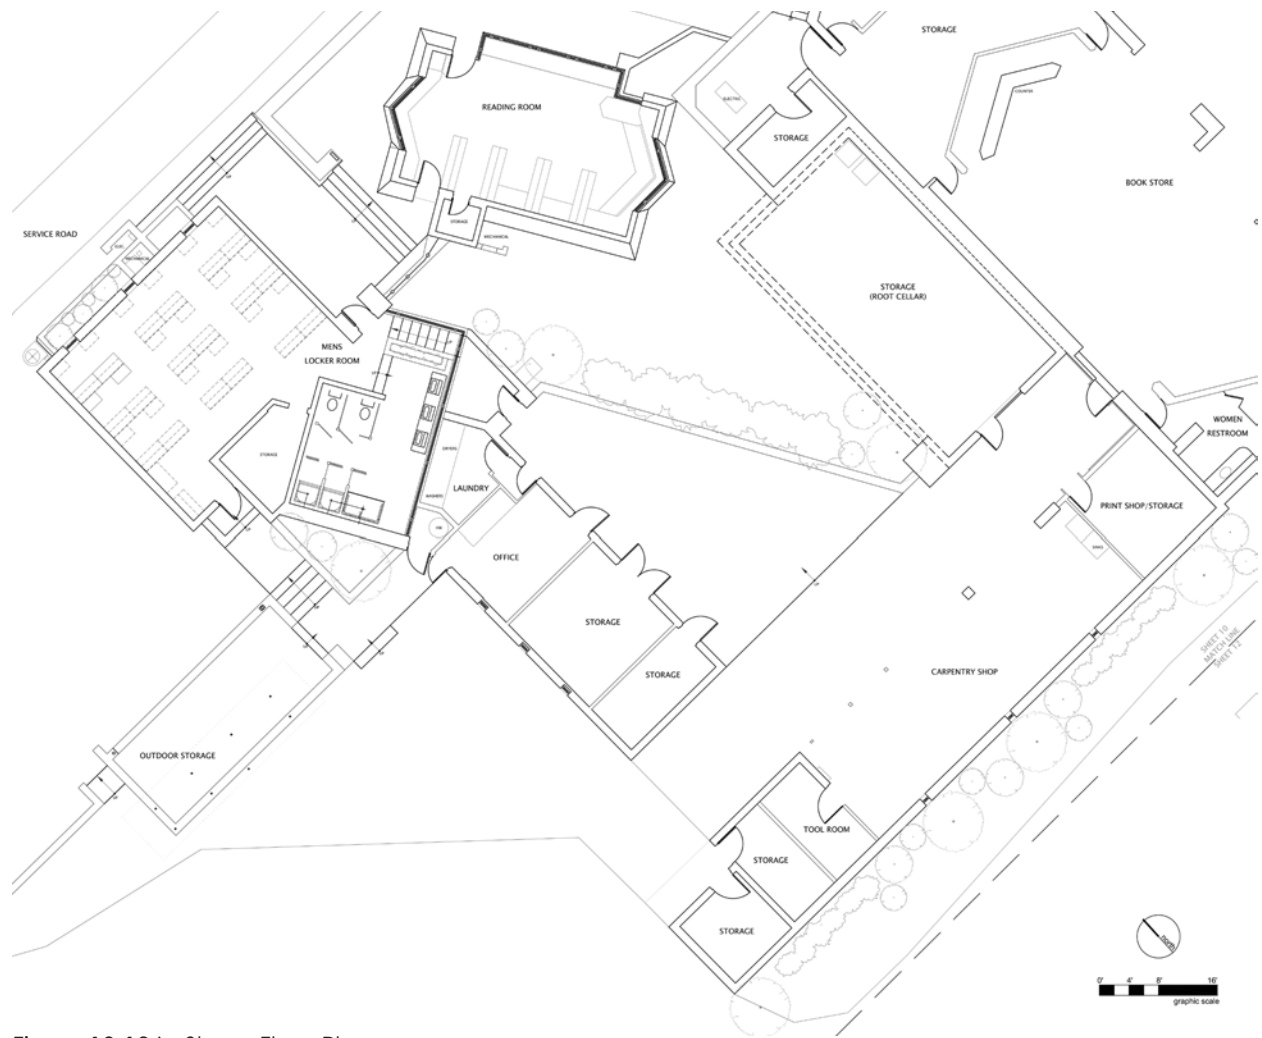
Figure 10-136 - Shops Floor Plan

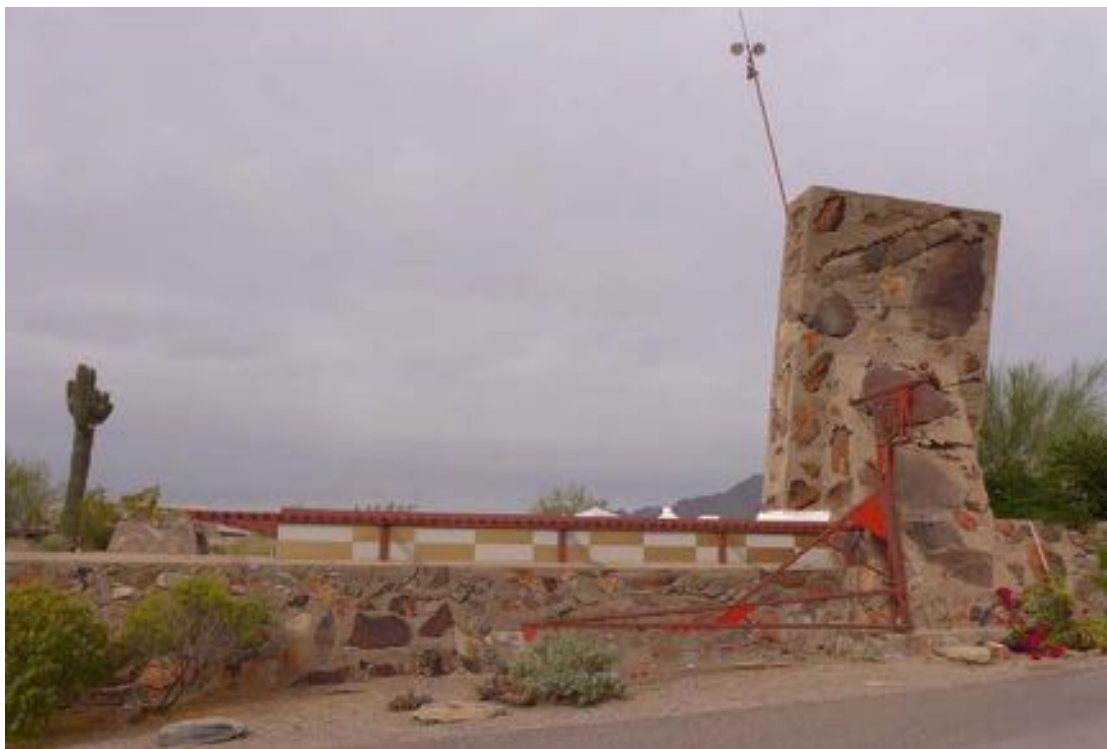
Figure 10-137 - View of Shops and Light Tower looking north, 2014 (Harboe Architects).

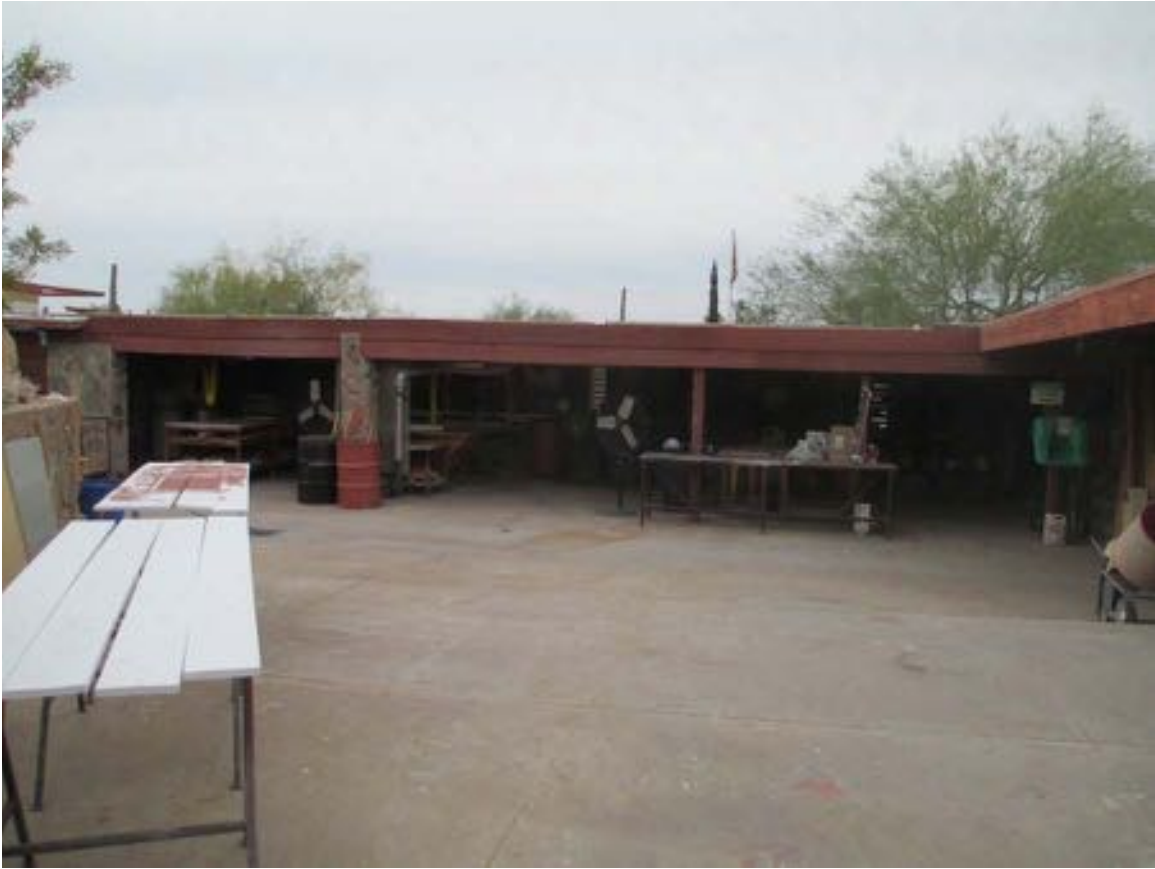
Figure 10-138 - View of Shops looking south, 2014 (Harboe Architects).

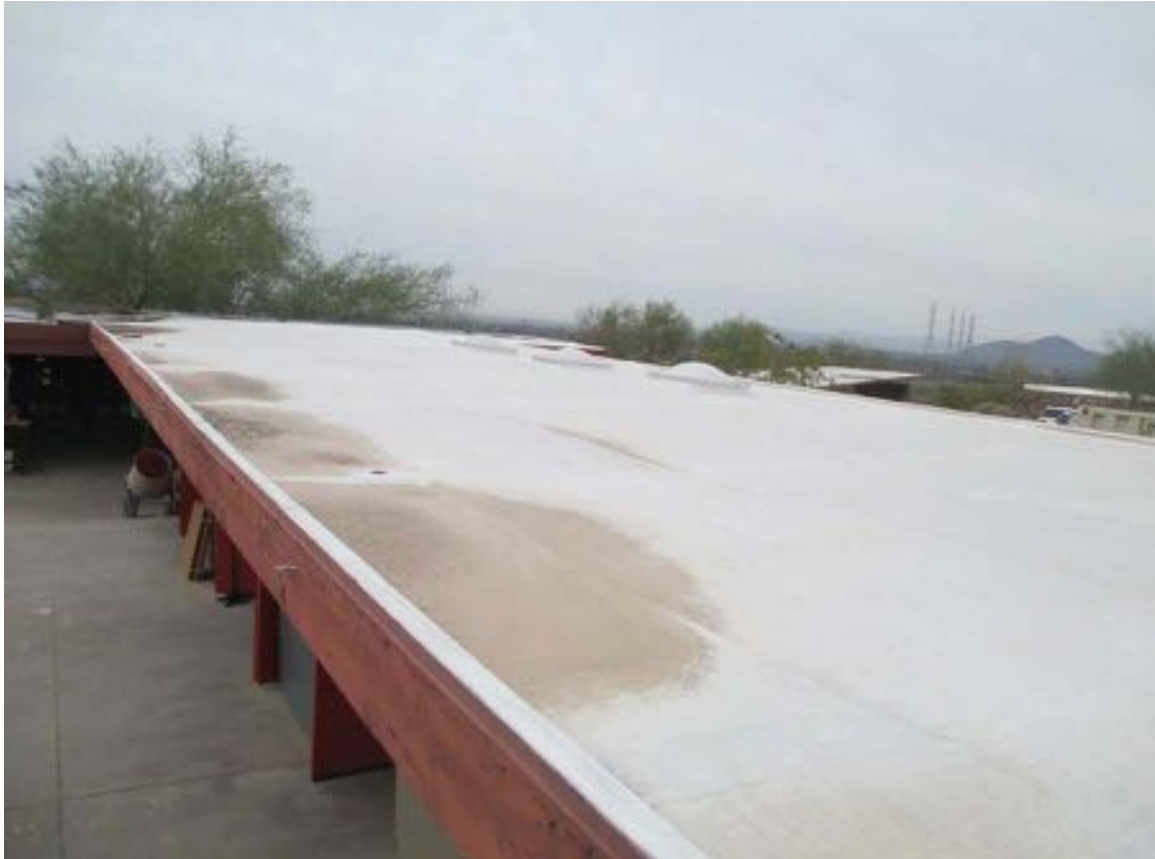
Figure 10-139 - View of Shops roof, 2014 (Harboe Architects).

There is some cracking in the concrete roof slab that requires further analysis.

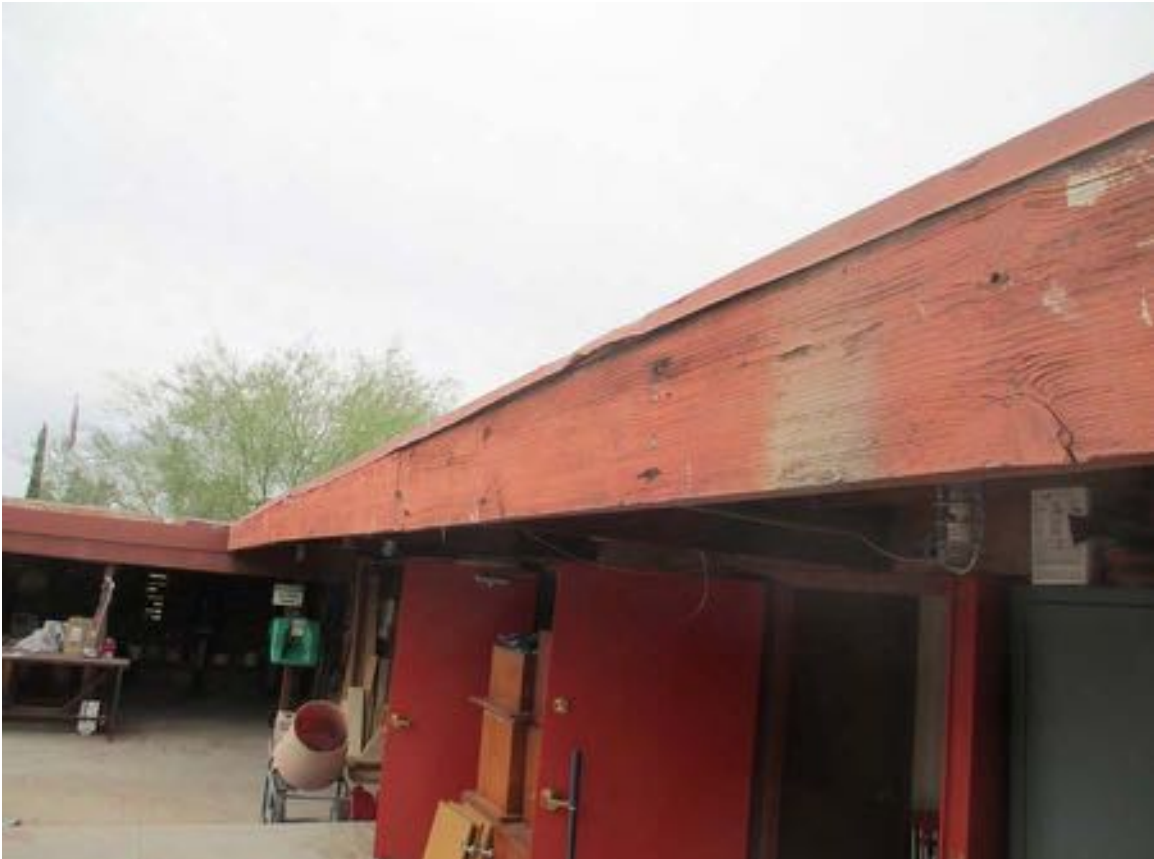
Figure 10-140 - View of Shops showing wood fascia at eaves, 2014 (Harboe Architects).

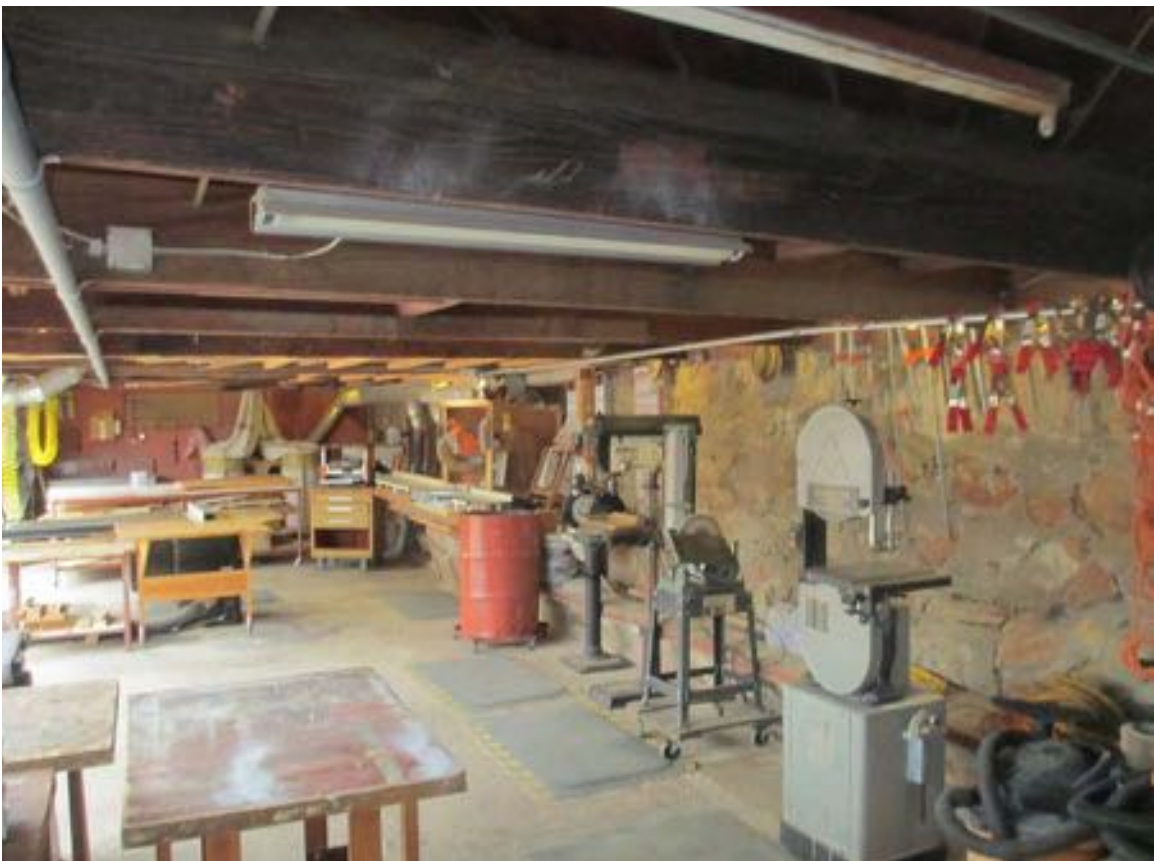
Figure 10-141 - Interior of shops, 2014 (Harboe Architects).

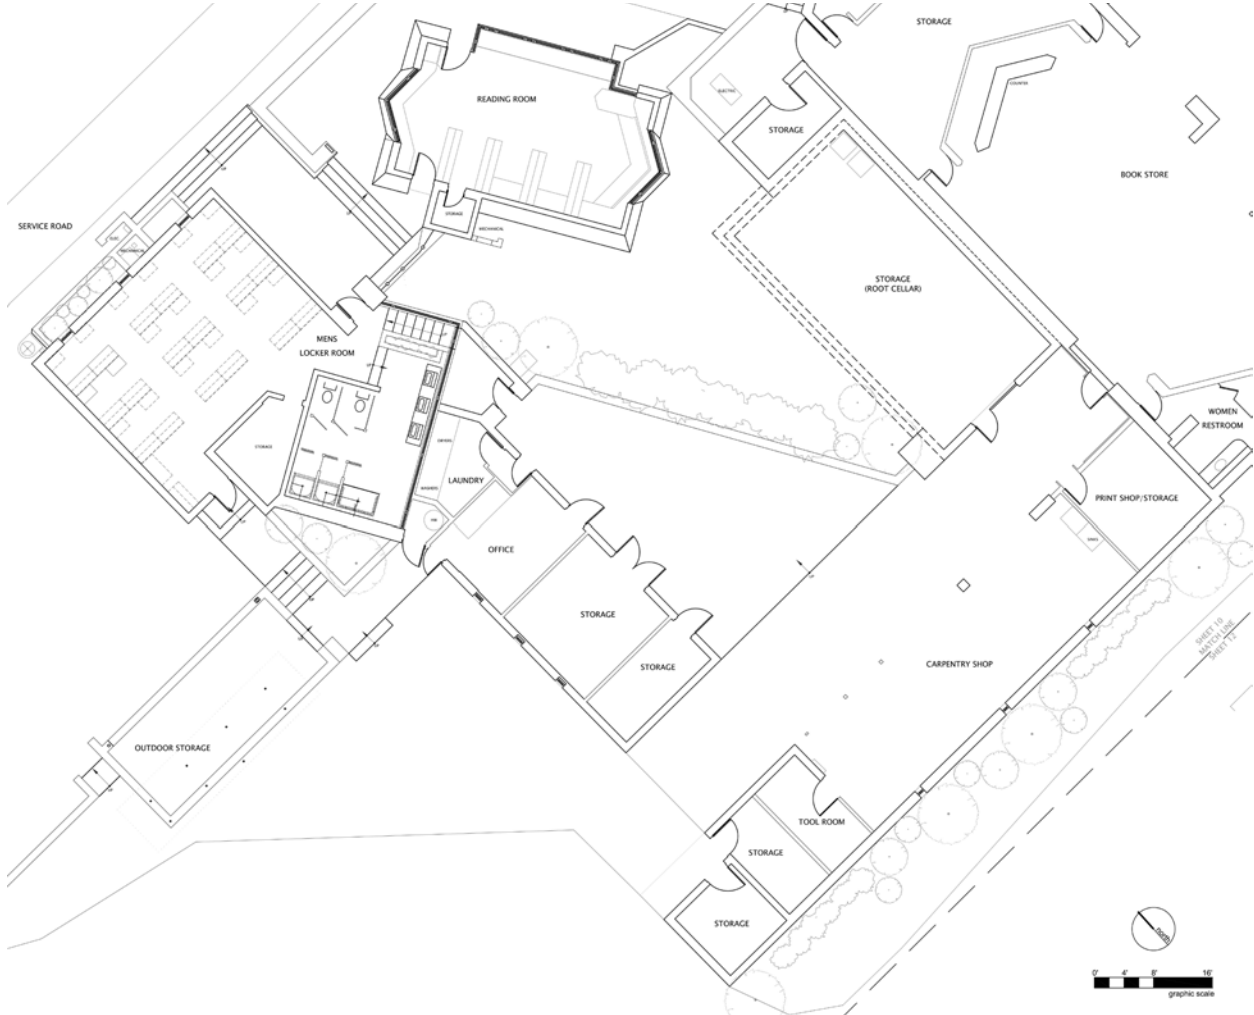
Figure 10-145 - Men's Locker Room Floor Plan

The Men's Locker Room was constructed in 1952 near the shops to replace the much smaller old men's locker room in the Apprentice Court. The locker room was renovated and added onto in 1957. Since that time the locker room has been renovated multiple times. While the exterior walls remain intact, the interior has been significantly altered over the years. The Men's Locker Room has secondary significance.

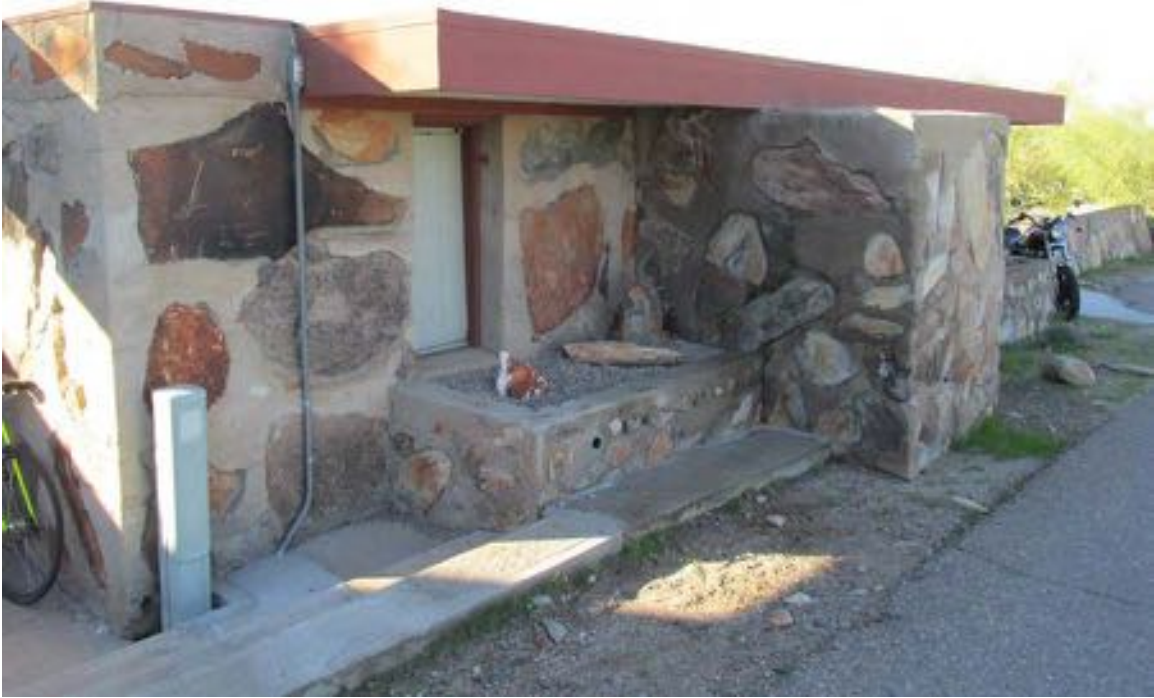
Figure 10-146 - North side of Men's Locker Room, 2015 (Harboe Architects).

The soffit on the north side of the Men's Locker Room was unfinished at the time of the survey. The gypsum board was installed but was missing the skim coat of plaster.

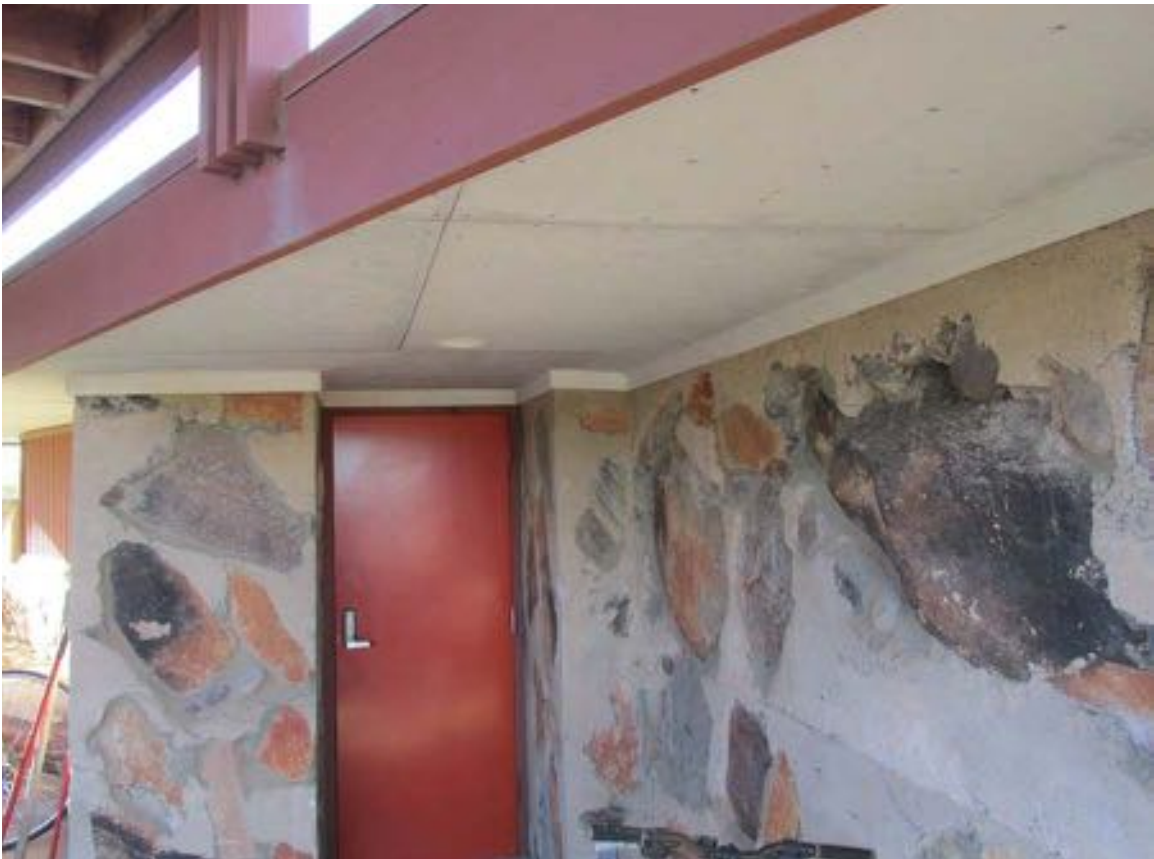
Figure 10-147 - Soffit on northeast side of Men's Locker Room, 2015 (Harboe Architects).

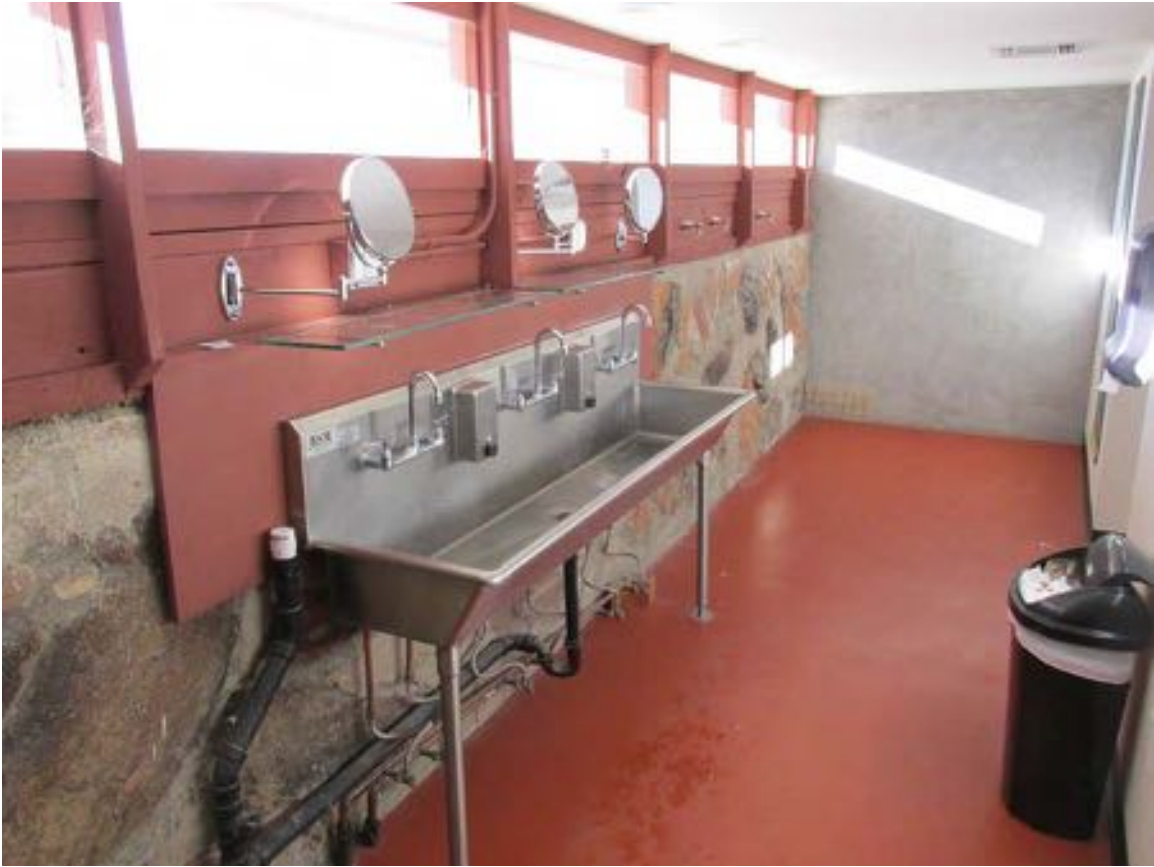
Figure 10-148 - Sink area inside Men's Locker Room, 2015 (Harboe Architects).

The bathroom facilities were remodeled in 2011. The shower stalls are white fiberglass; sinks are stainless steel with three small circular mirrors mounted above sinks. The toilets and urinal are white porcelain.

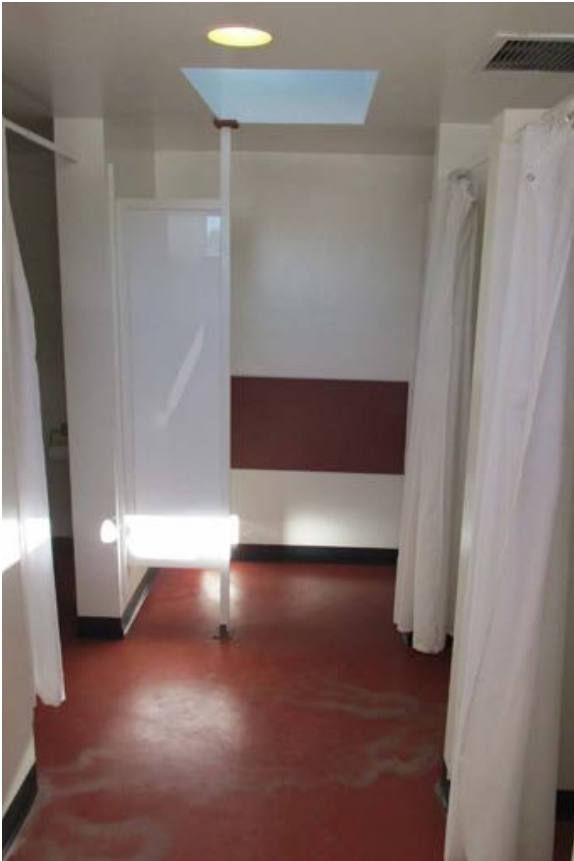
Figure 10-150 - Shower and toilet stalls inside Men's Locker Room, 2015 (Harboe Architects).

The floors are generally in good condition. There is some water staining and worn paint finish in the bathroom area, especially near the showers.

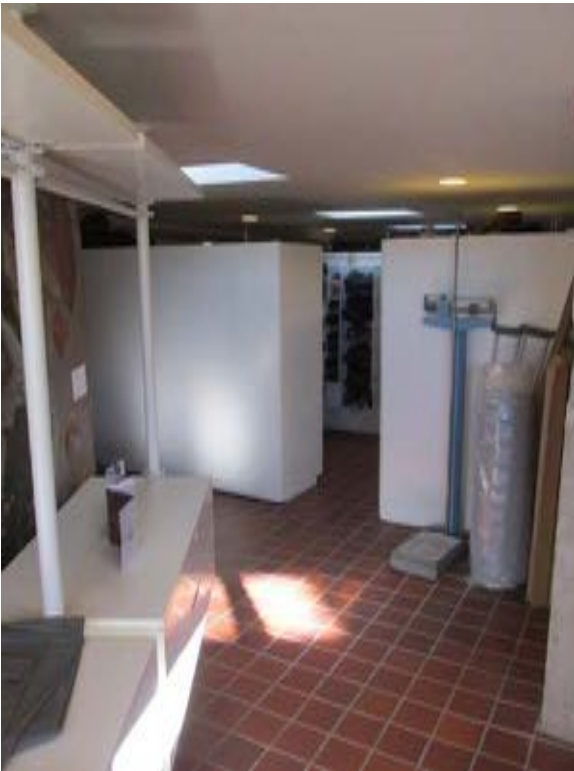
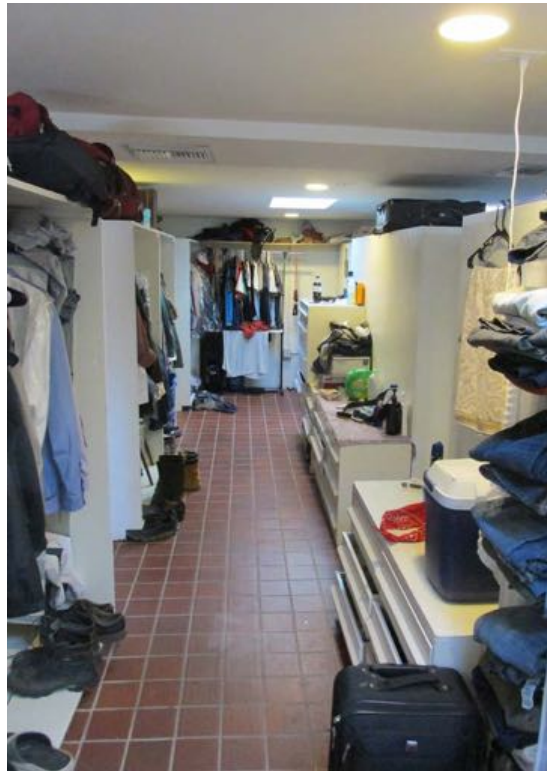
Figure 10-152 - Locker area inside Men's Locker Room, 2015 (Harboe Architects).

Figure 10-153 - Locker area inside Men's Locker Room, 2015 (Harboe Architects).

The lockers are in fair condition. Some lockers have broken shelves and there is some delamination of the plywood at the base of the lockers.

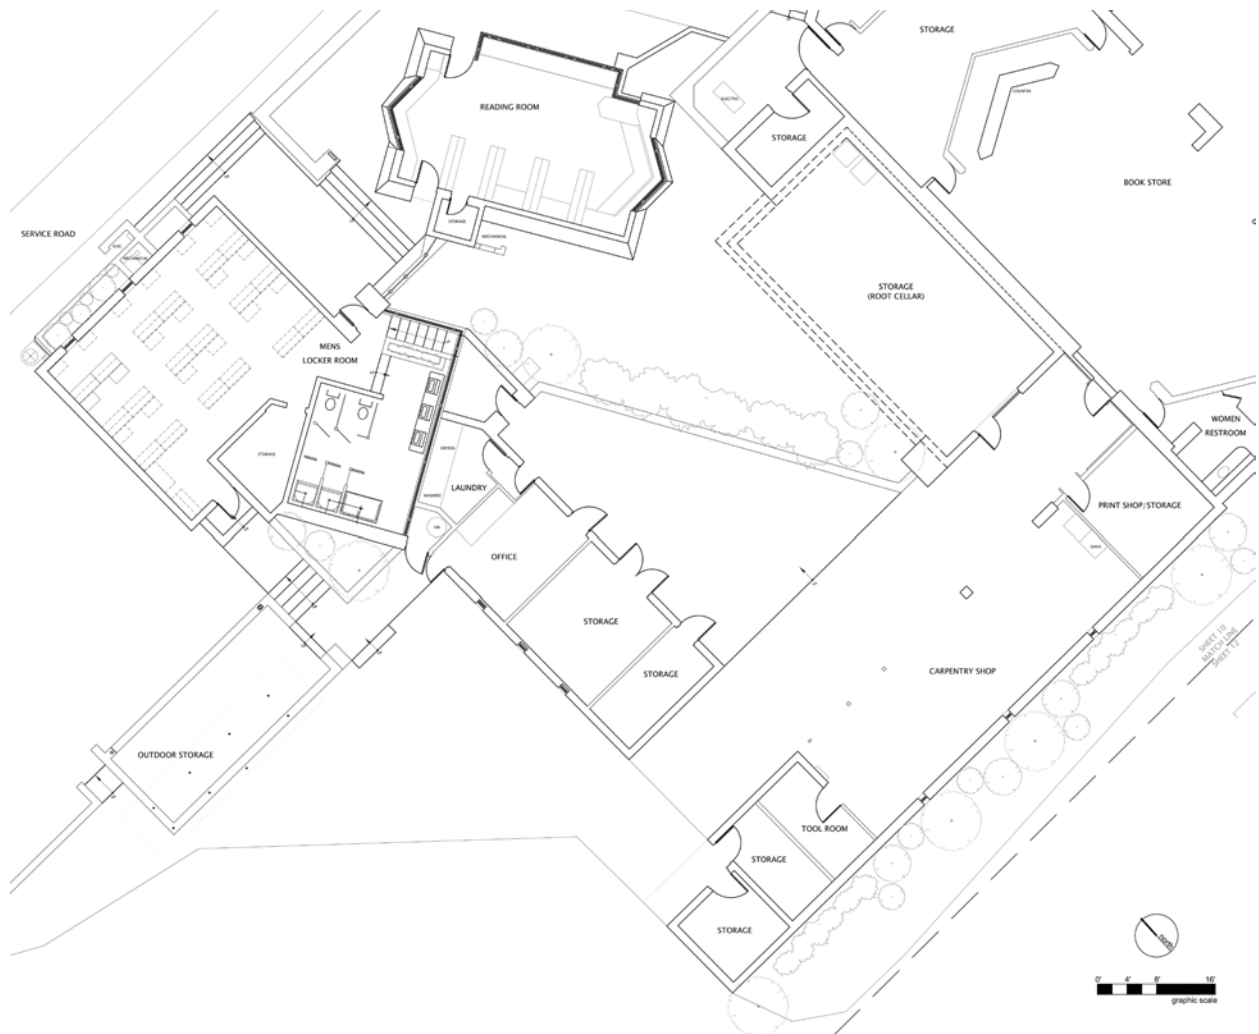
Figure 10-155 - Reading Room Floor Plan

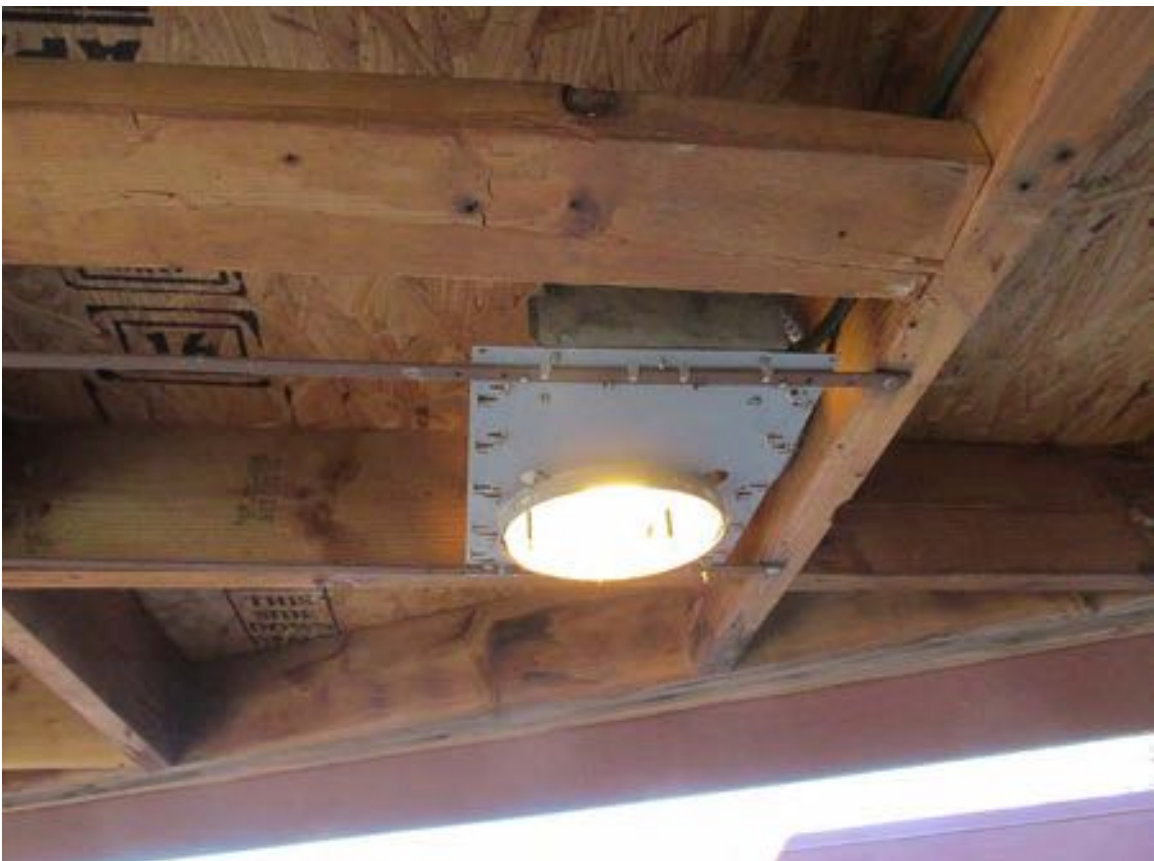
Figure 10-159 - Soffit on north side with exposed wood structure and deck, 2015 (Harboe Architects).

The soffit on the north side of the Reading Room was unfinished at the time of the survey, exposing the wood framing and underside of the plywood deck. The soffit on the south and east sides of the building are in good condition.

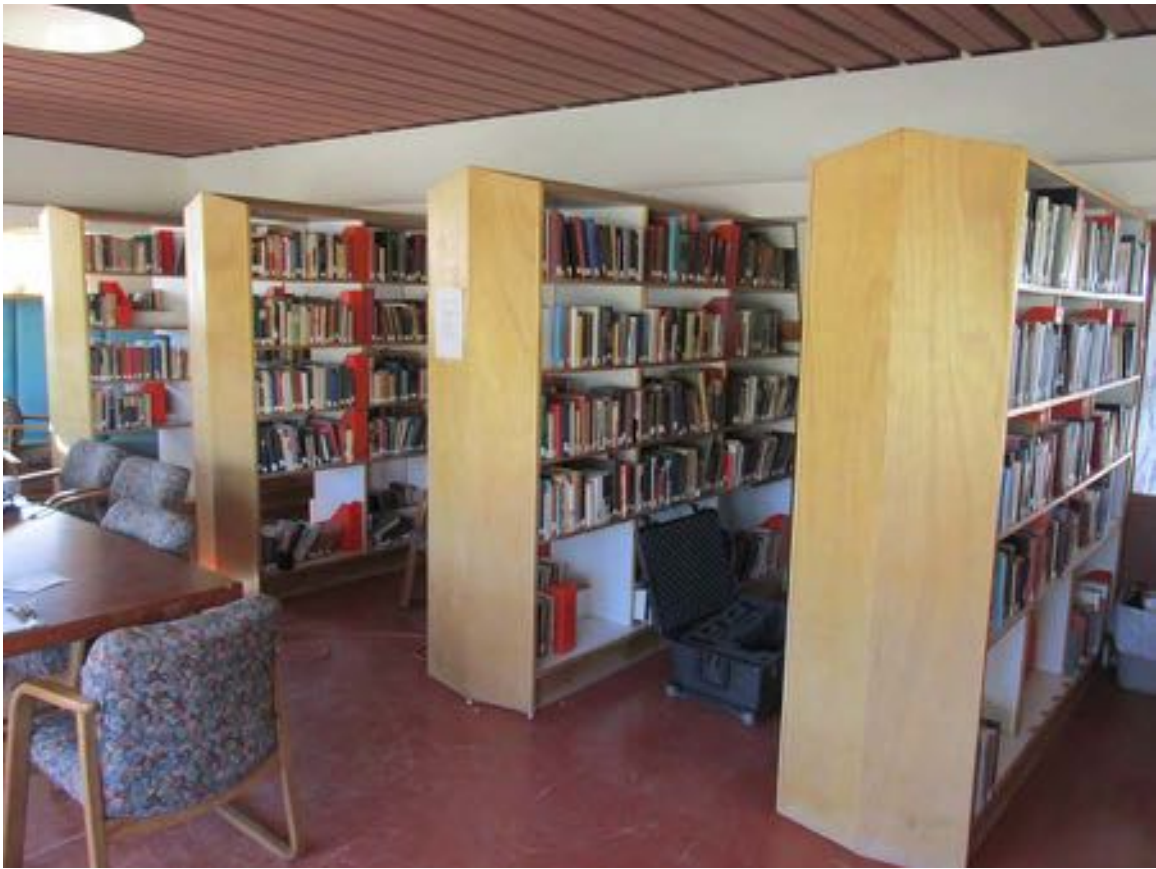
Figure 10-162 - Reading Room bookshelves, 2015 (Harboe Architects).

The millwork is in relatively good condition. There are some areas - especially near the floor - where the finish on the wood shelves and benches is worn. The vinyl seats are in good condition except for one small tear.

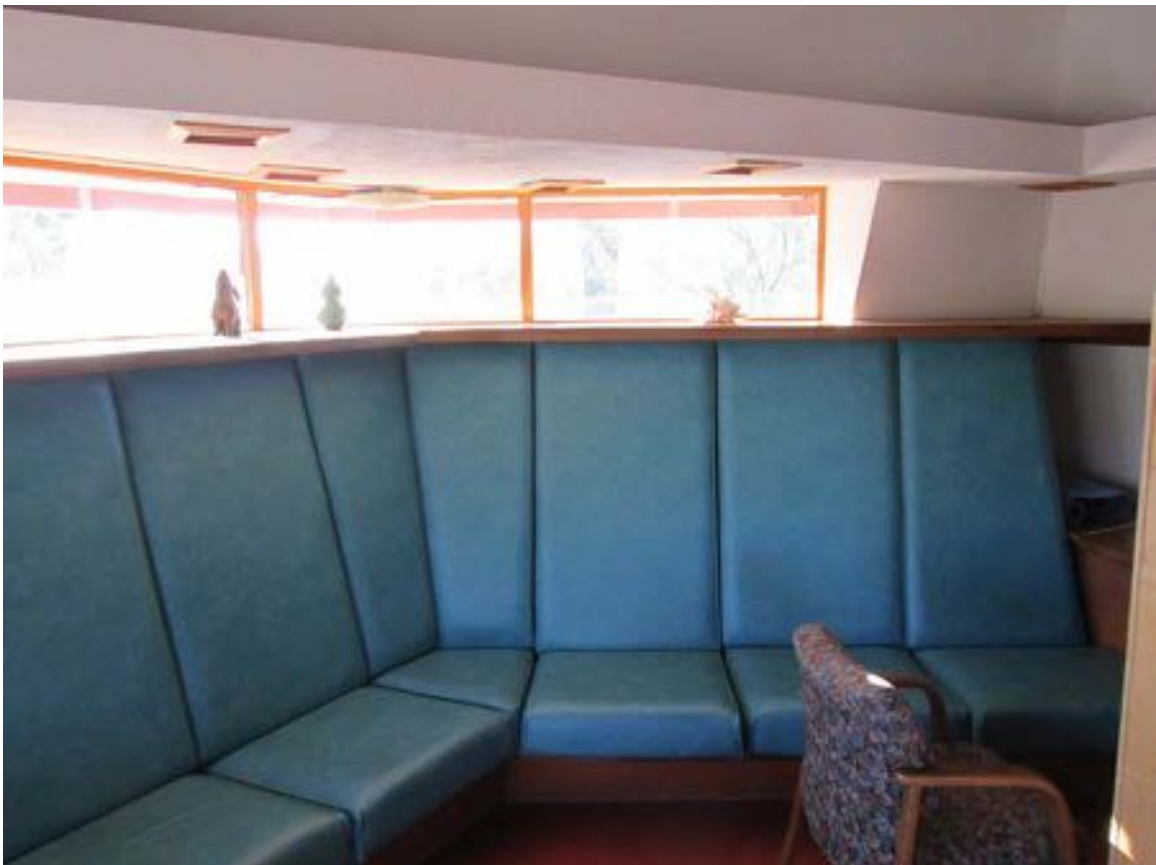
Figure 10-163 - Built-in bench inside Reading Room, 2015 (Harboe Architects).

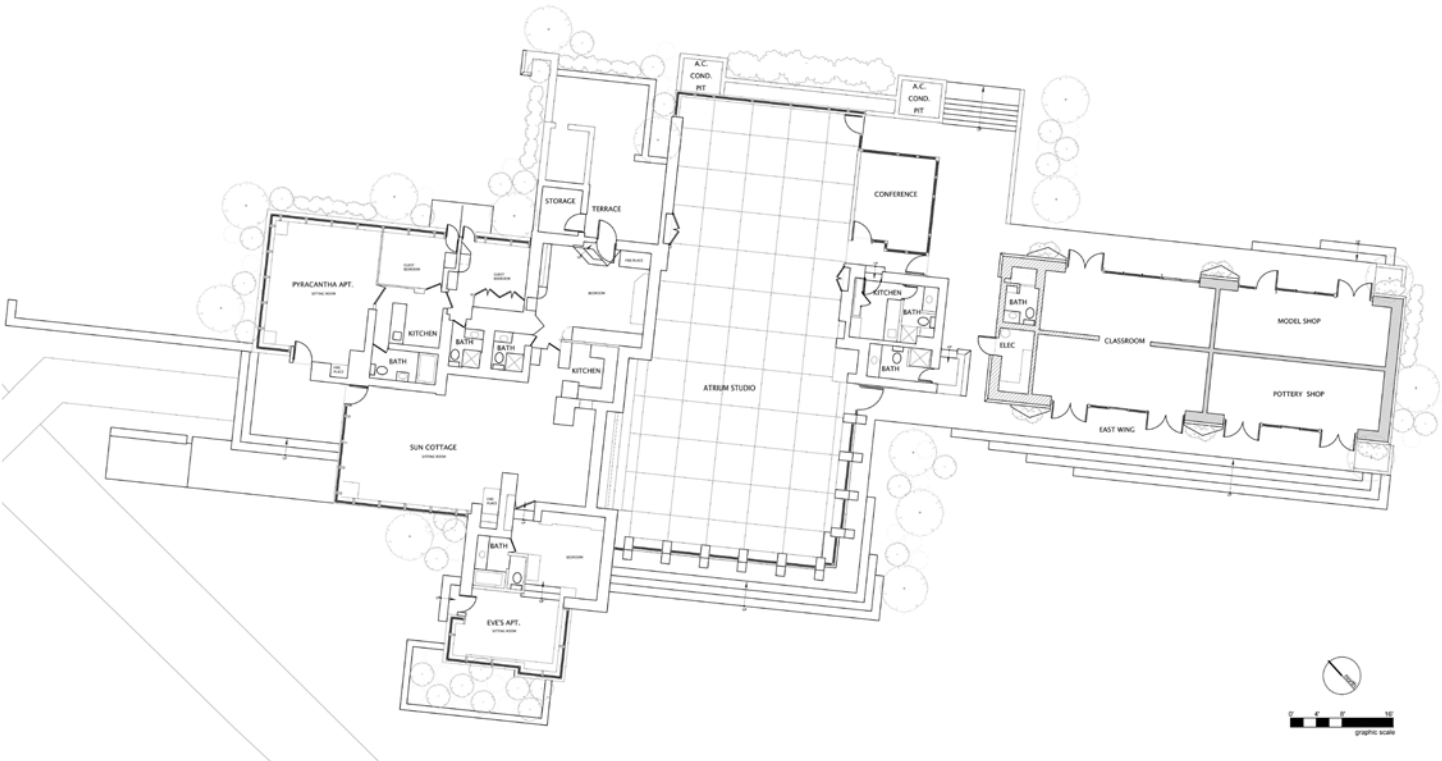
Figure 10-165 - Sun Cottage Floor Plan

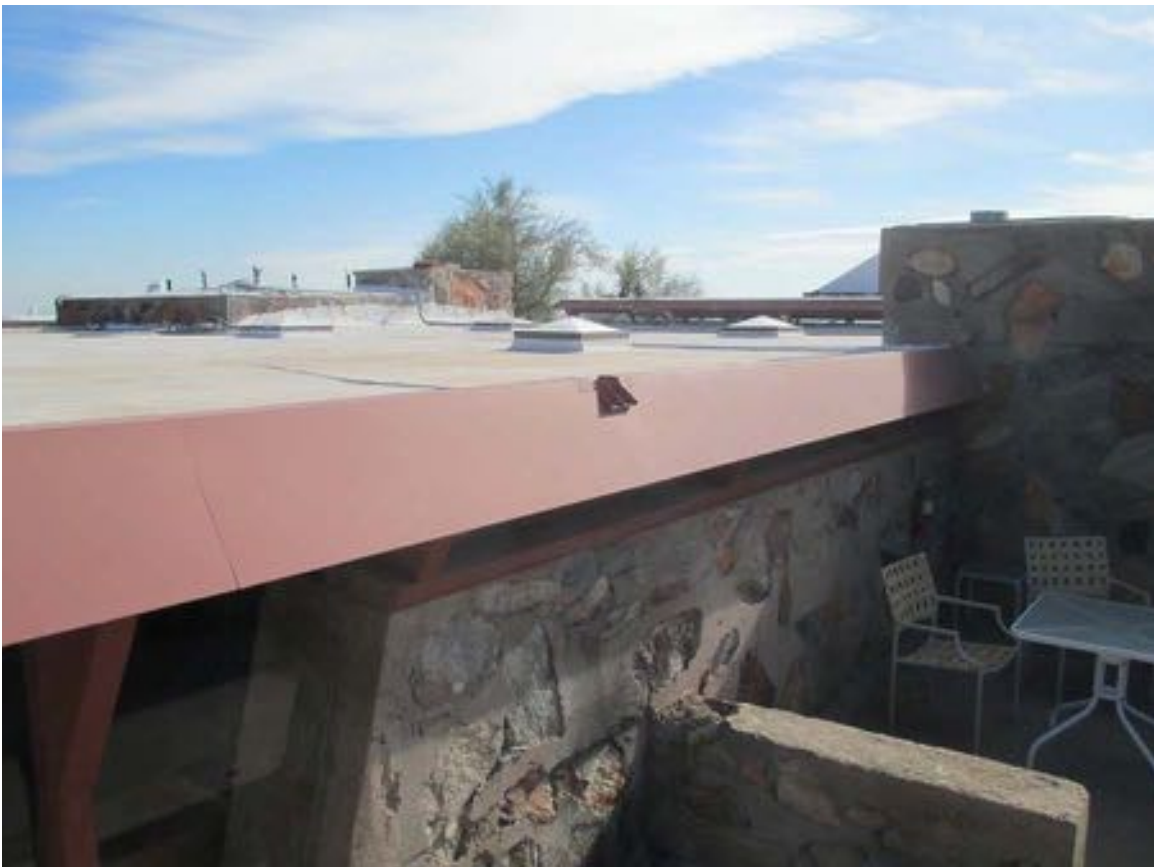
Figure 10-169 - Metal fascia and roof of Sun Cottage, 2014 (Harboe Architects).

The roof of the Sun Cottage varies. Some sections of the roof are comprised of a built-up liquid applied membrane roof system while others are foam roofing. This roof surface is not original. The roof decking is lightweight concrete on tongue and groove wood deck. It is supported on a steel frame structure. Originally, all of the roof framing on the Sun Cottage was wood. During the 1960 renovation, the wood structure was replaced with steel framing. There is painted metal fascia around the roof eaves.

The built-up membrane and foam roof are past their useful lives and should be replaced. There are also areas of the roof deck that are damaged and/or leaking and need to be replaced. There is some water staining on the ceiling in the Guest Apartment.
