TALIESIN WEST PRESERVATION MASTER PLAN

Harboe Architects, PC

MAY 21, 2015

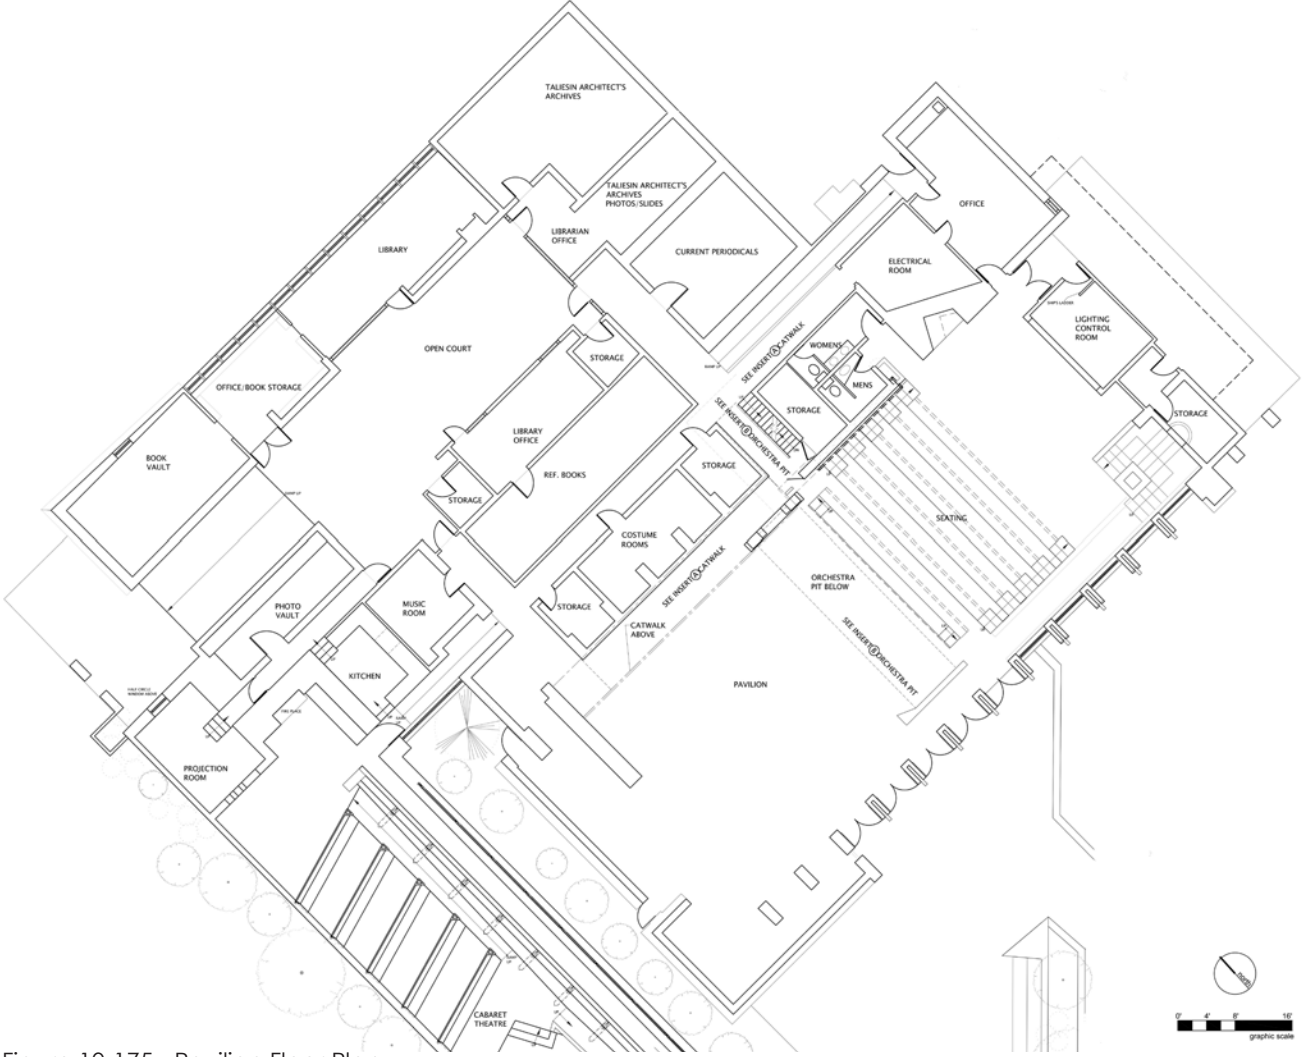
Figure 10-175 - Pavilion Floor Plan

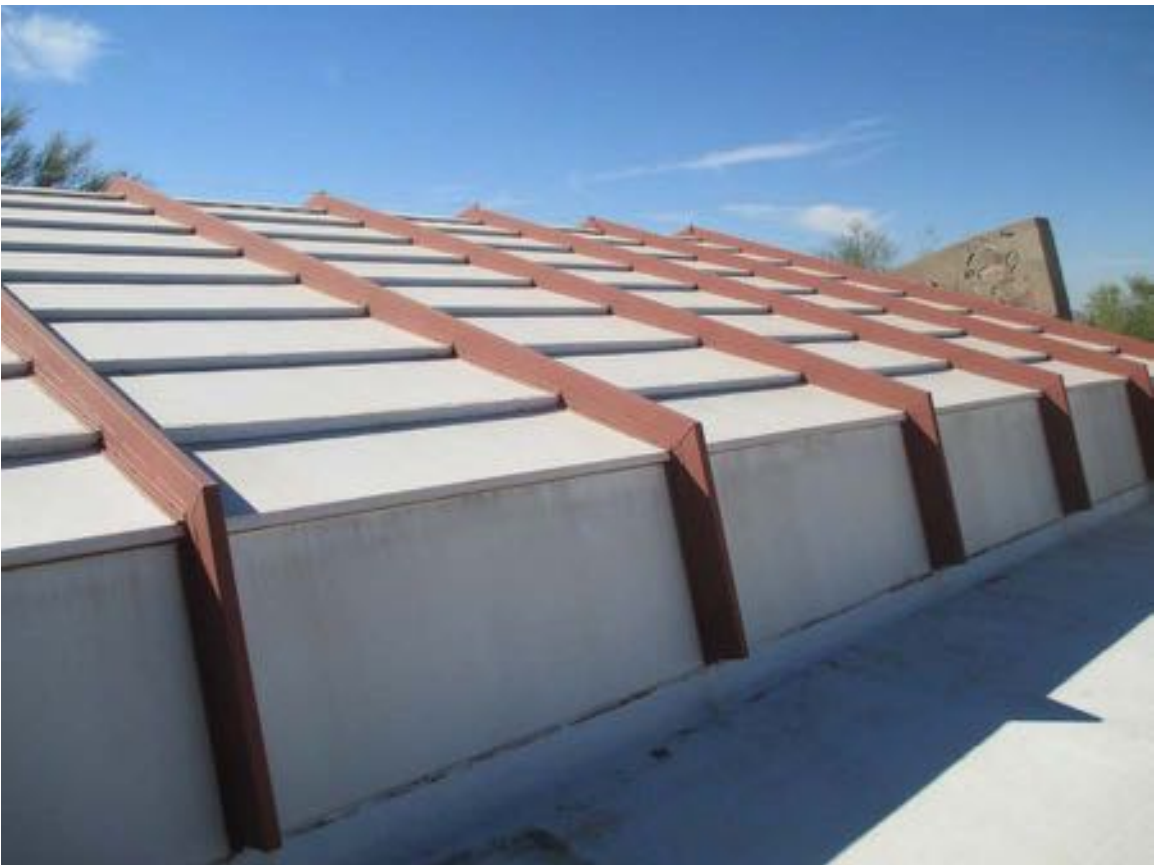
Figure 10-177 - Pavilion roof, 2014 (Harboe Architects).

The Pavilion was originally constructed with operable canvas roof panels consisting of canvas wrapped on a wood frame. These panels were operable to control sun shading and natural ventilation. Following the fire in 1963, the Fellowship replaced the fabric roof panels with fiberglass panels. These panels were replaced in the 1990s with acrylic panels. The current roof panels are constructed of fixed translucent acrylic panels with a supplemental canvas interior panel suspended below the acrylic panels to diffuse the day light and replicate the appearance of the original canvas panels. This system dates from 1998.

The current canvas is worn and needs to be replaced.

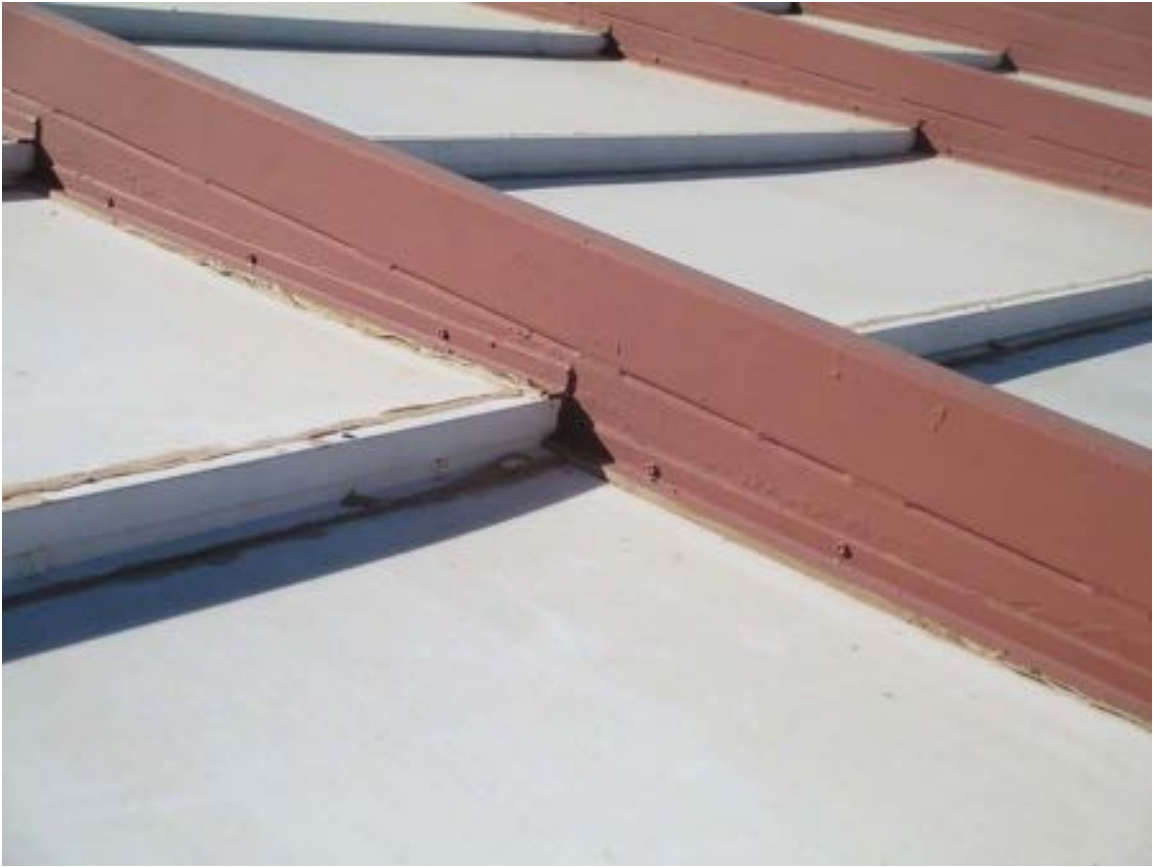
Figure 10-178 - Detail of Pavilion roof, 2014 (Harboe Architects).

The existing steel roof framing is in good condition.

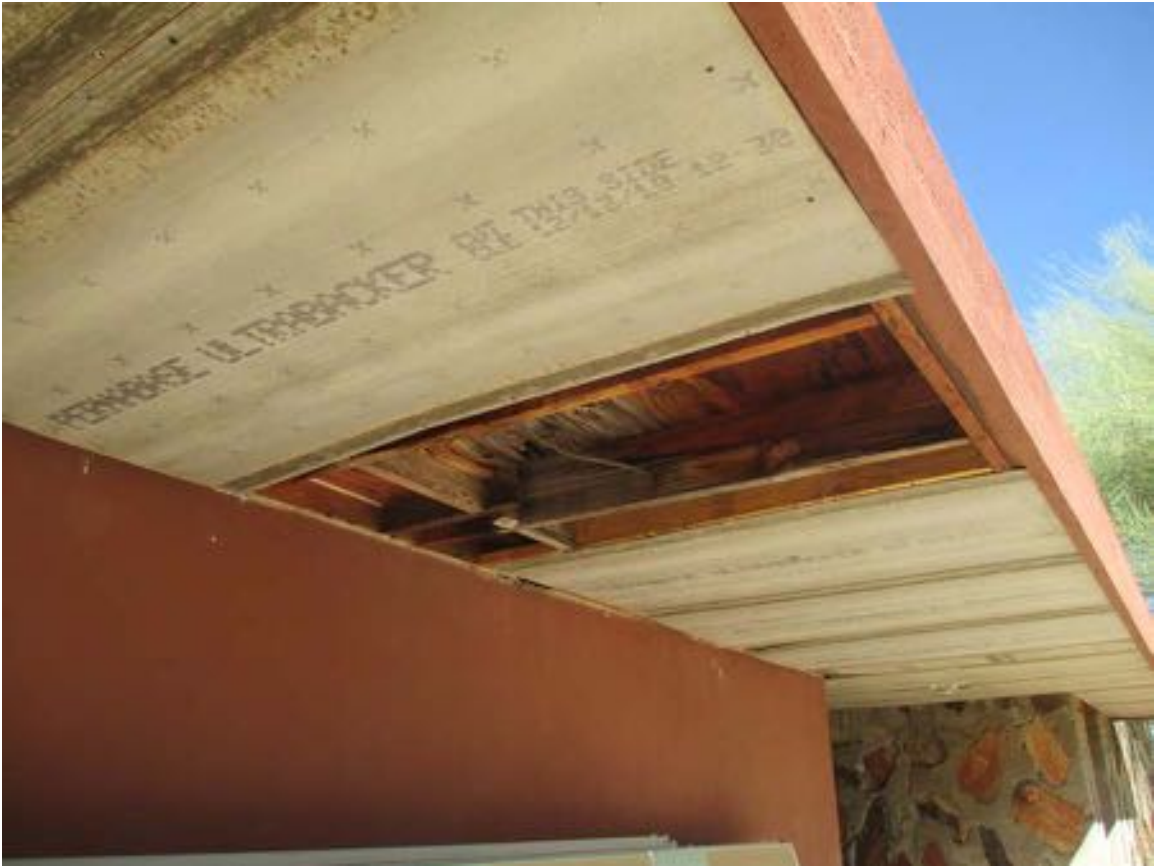
Figure 10-180 - Damaged soffit under flat roof on east side of the Pavilion, 2014 (Harboe Architects).

The plywood deck appears to be in good condition. The masonite panels on ceiling are sagging.

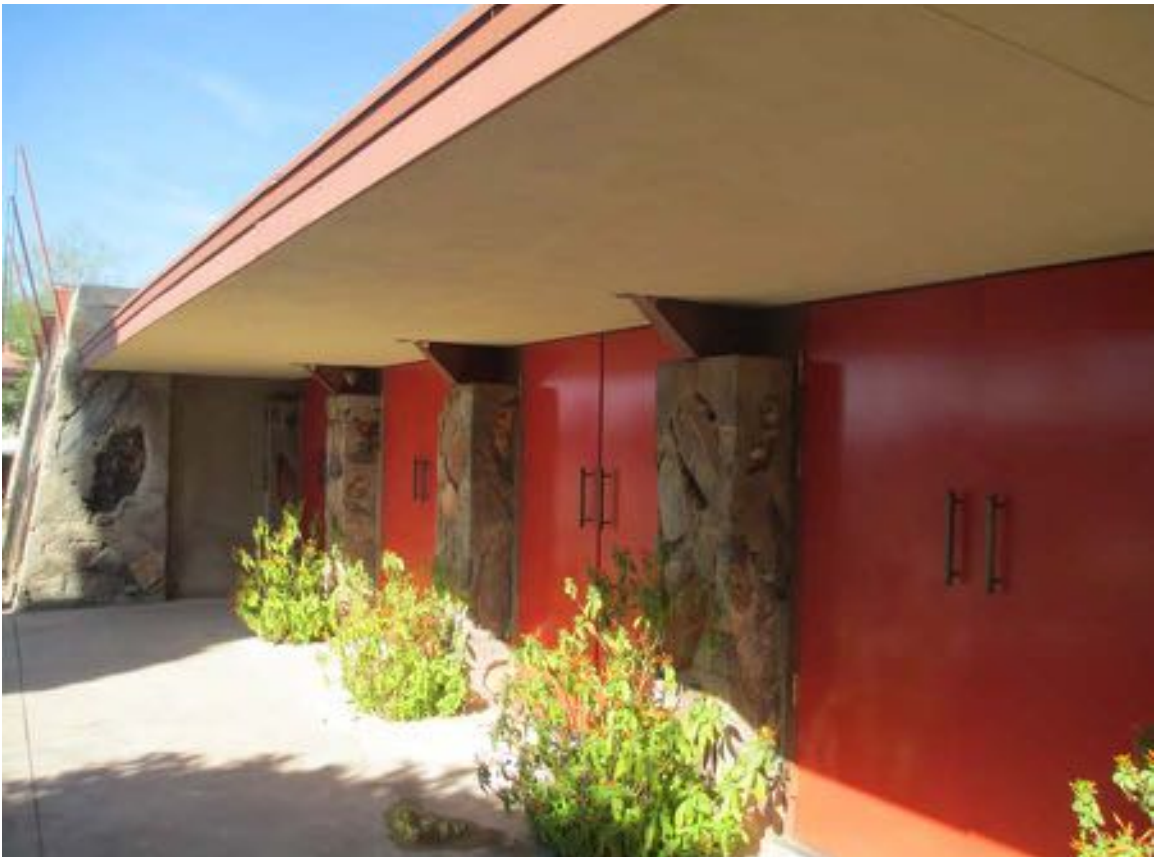
Figure 10-181 - South entry doors on the Pavilion, 2014 (Harboe Architects).

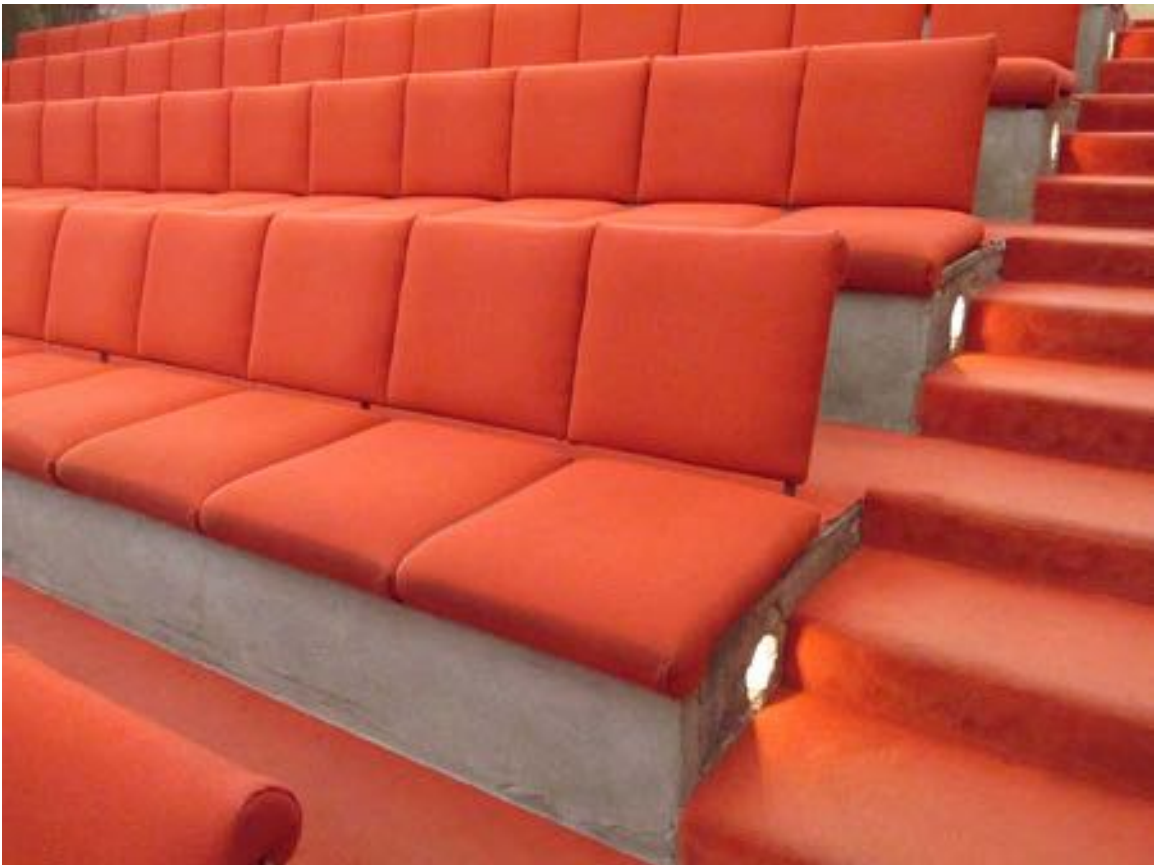
Figure 10-187 - Seating in the Pavilion, 2015 (Harboe Architects).

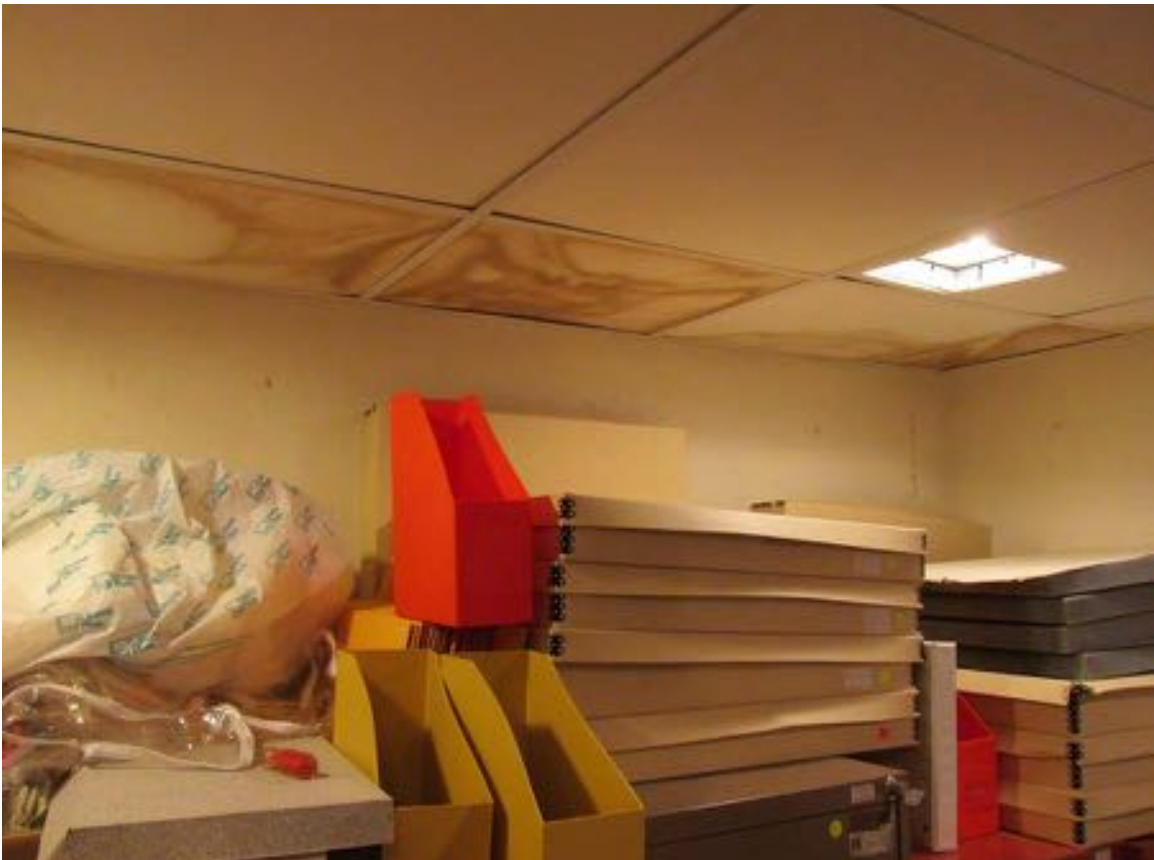
Figure 10-205 - Water damaged ceiling tiles in the reference book room, 2015 (Harboe Architects).

The ceilings appear to be in good condition. There are some water stains on the ceiling tiles along the east wall of the reference book storage room.

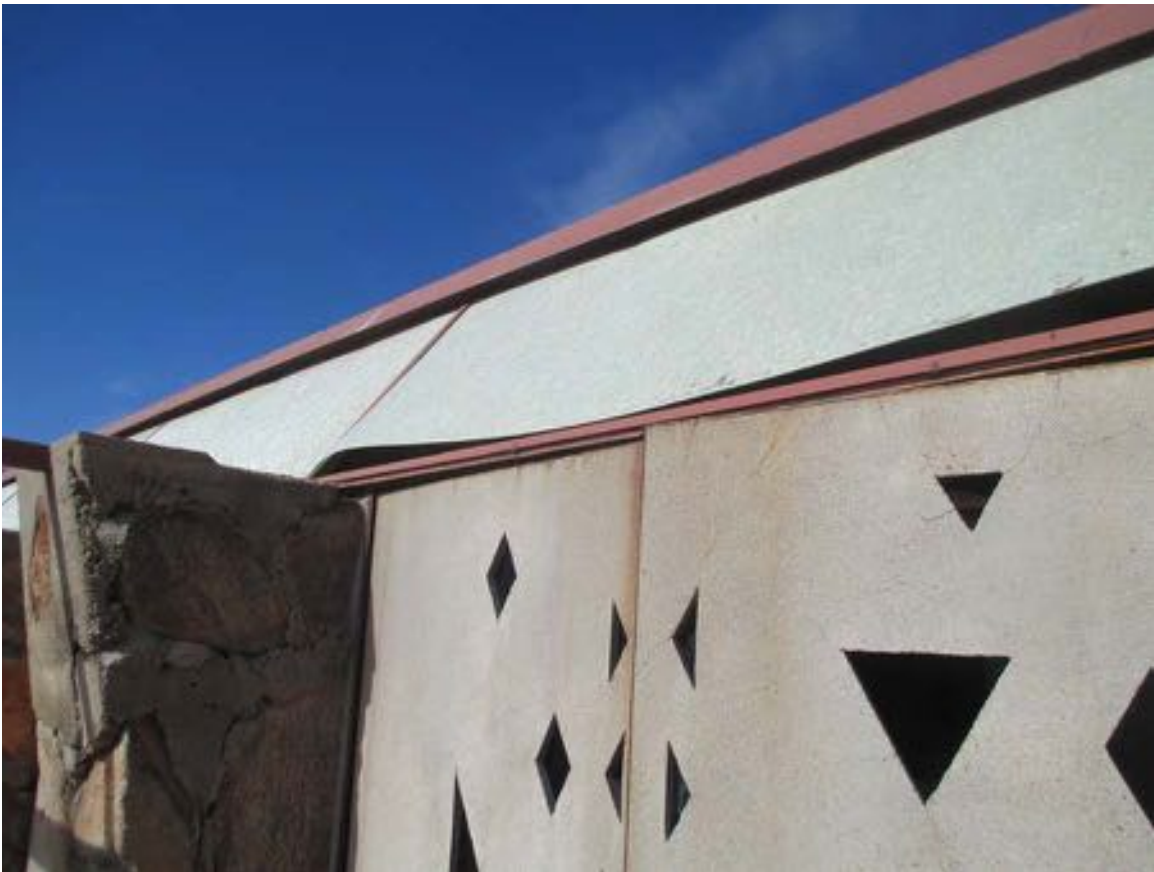
Figure 10-209 - Concrete panels and fiberglass panels above, 2014 (Harboe Architects).

There are decorative concrete panels that enclose the building glazing on the southeast and southwest sides. The panels are on pivots and can be opened and closed. The panels are constructed of concrete with inset triangular and diamond shaped stained glass. The panels are original to the 1961 construction.

The decorative concrete panels are in fair condition. Many of the concrete panels are cracked in several locations.

The clear glass windows in metal frames appears to be in good condition with minor corrosion and worn paint. There is one crack in the glass on the south side of the conference room. The fiberglass panels are in poor condition. They are stained, warped, and have a few small holes in them. The fiberglass panels are set with foam tape which is coming off, displacing the panels. The clerestory windows are in fair condition and have some minor surface corrosion on the frames.

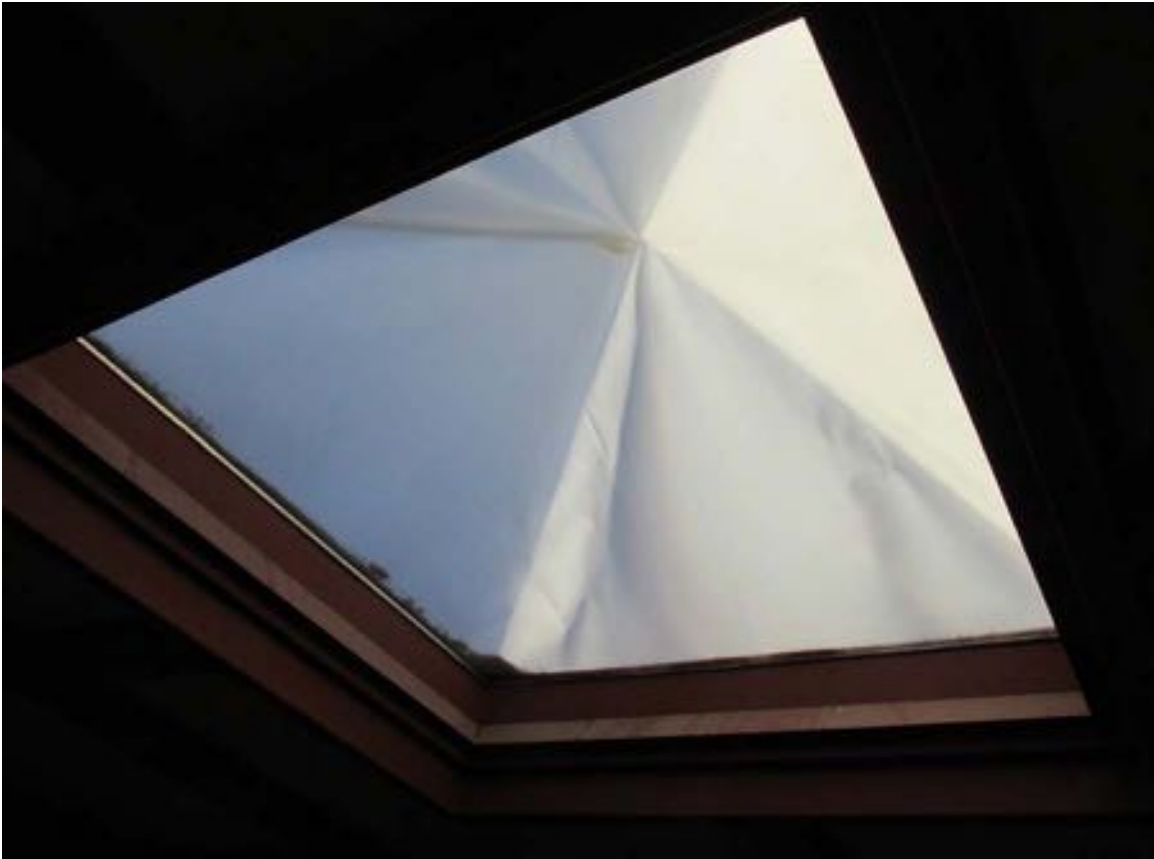
Figure 10-212 - Atrium skylight, 2014 (Harboe Architects).

The pyramidal skylight is cracked and leaking and needs to be replaced. At the time of the survey, the pyramidal skylight was covered with a plastic tarp. The other skylights appear to be in good condition.

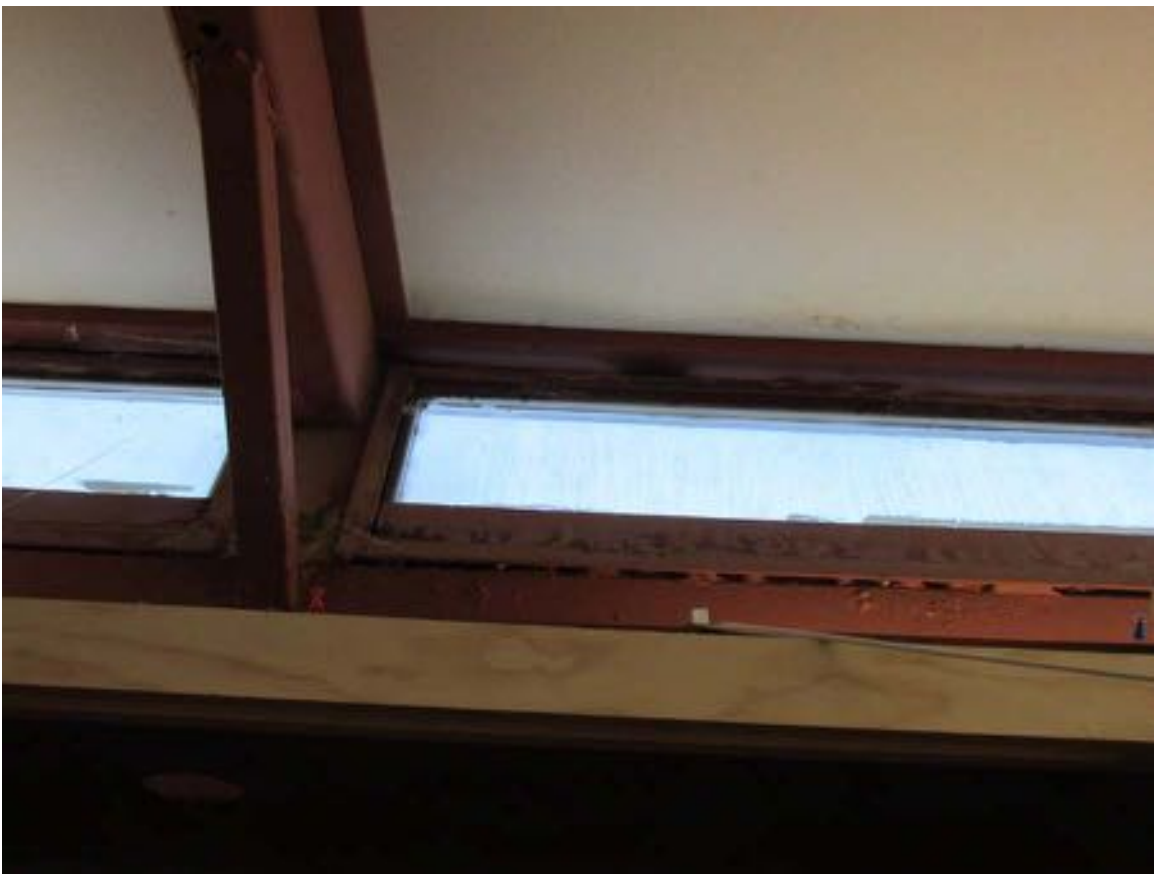
Figure 10-213 - Clerestory windows showing corrosion on metal frame, 2014 (Harboe Architects).

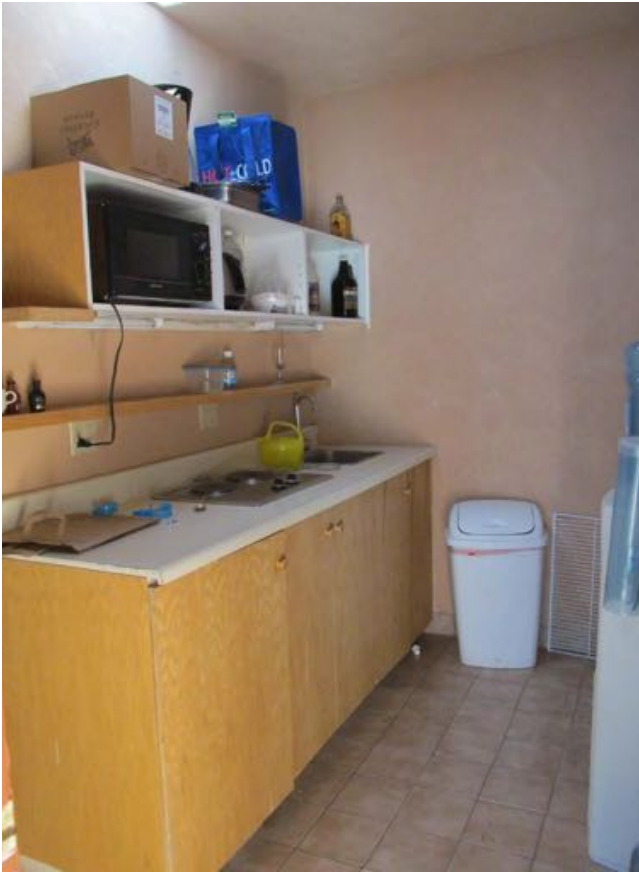
Figure 10-216 - Atrium kitchen, 2015 (Harboe Architects).

The kitchen has a ceramic tile floor, gypsum board ceiling and walls with painted textured plaster coating, plywood base cabinets and shelves, laminate countertop, and a stainless steel sink.

The kitchen is in fair condition. There is a light soiling on the tile floor, water damage at the ceiling near the roof drain, and some delamination and damage on the plywood cabinets.

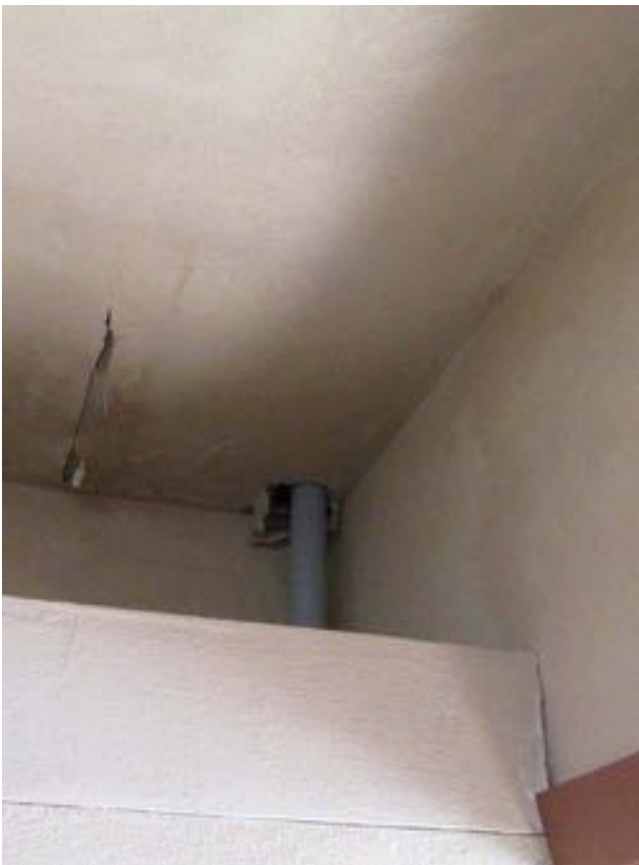
Figure 10-218 - Water damage at kitchen ceiling, 2015 (Harboe Architects).

The ceiling is generally in good condition. There are select areas of water staining on the canvas in the back hallway near the kitchen and bathroom. The ceiling in the kitchen is water damaged near the roof drain pipe.

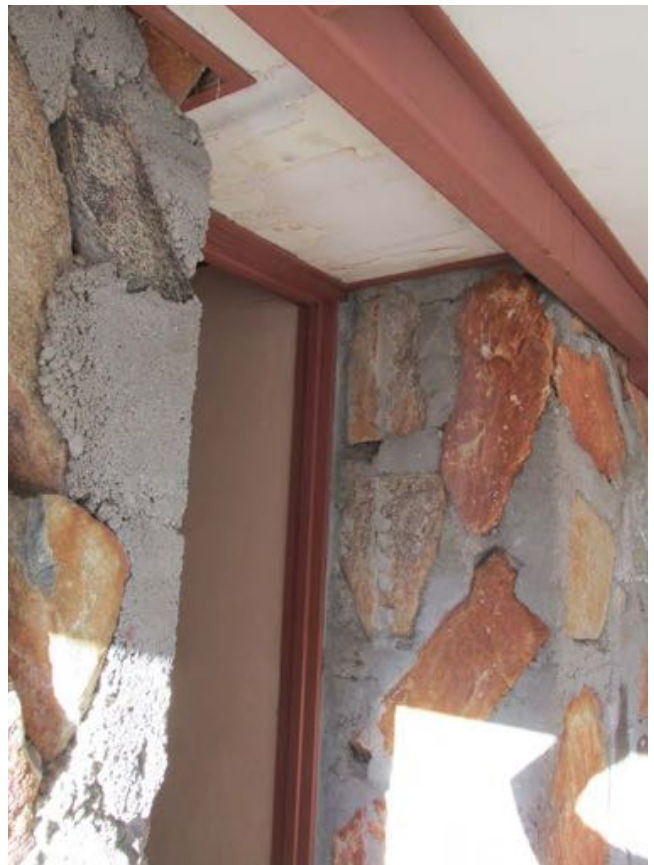
Figure 10-219 - Water staining on canvas ceiling next to kitchen entrance, 2015 (Harboe Architects).

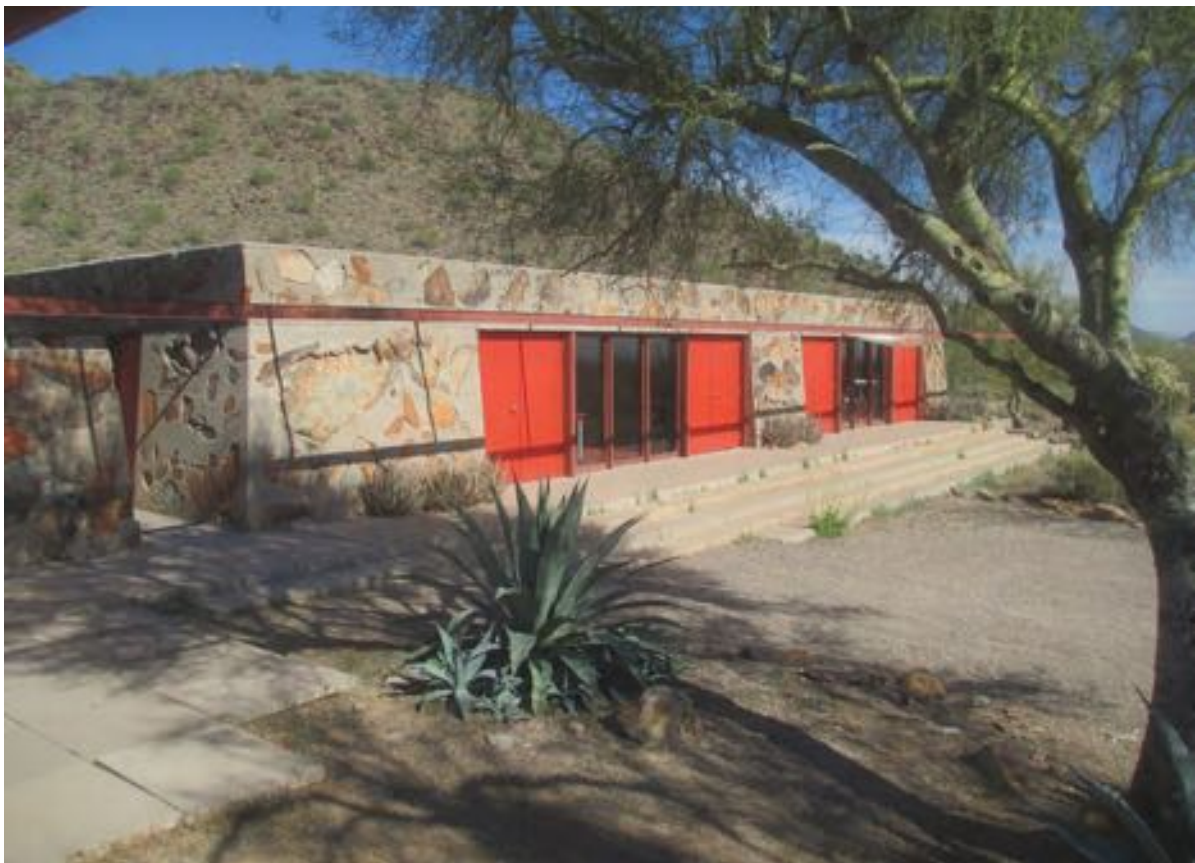
Figure 10-222 - Looking east at the East Wing, 2014 (Harboe Architects).

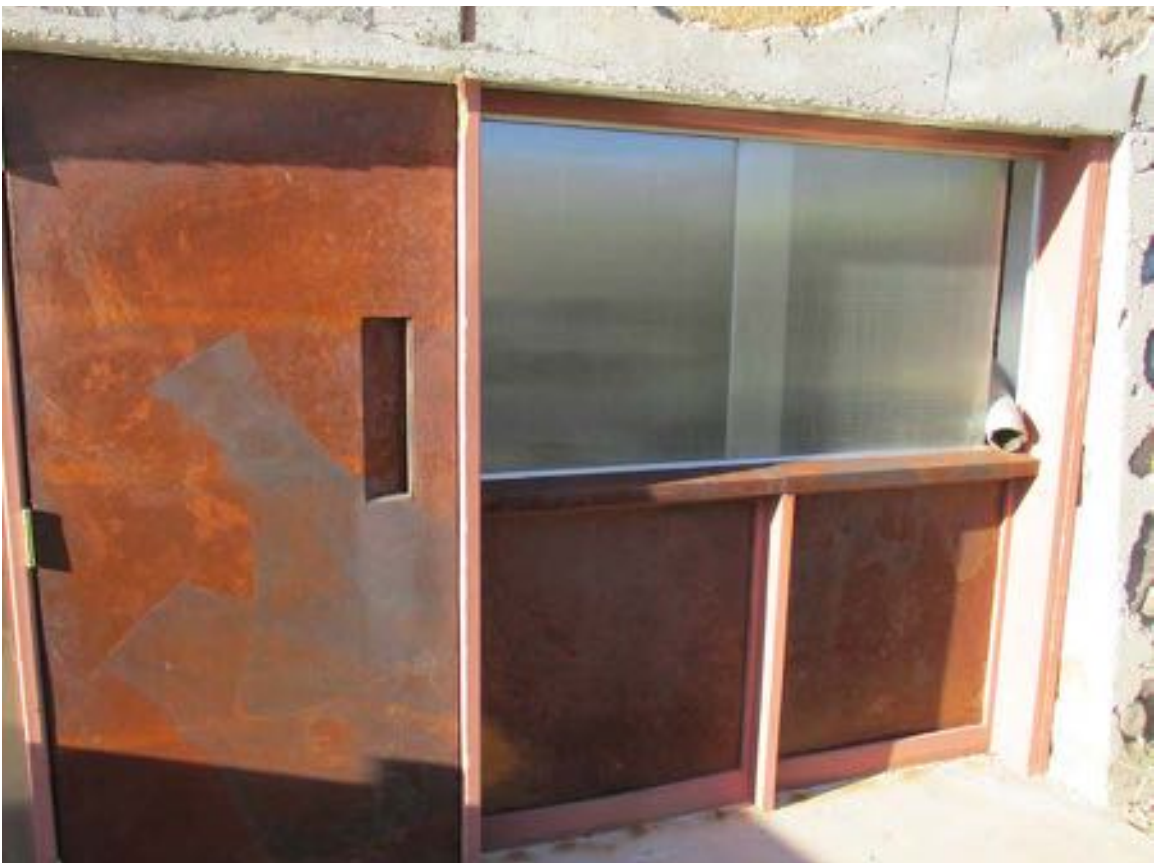
Figure 10-228 - Metal door and glazing on north side of East Wing, 2015 (Harboe Architects).

The painted wood doors are in good condition. The metal doors and surrounding metal panels are corroded.

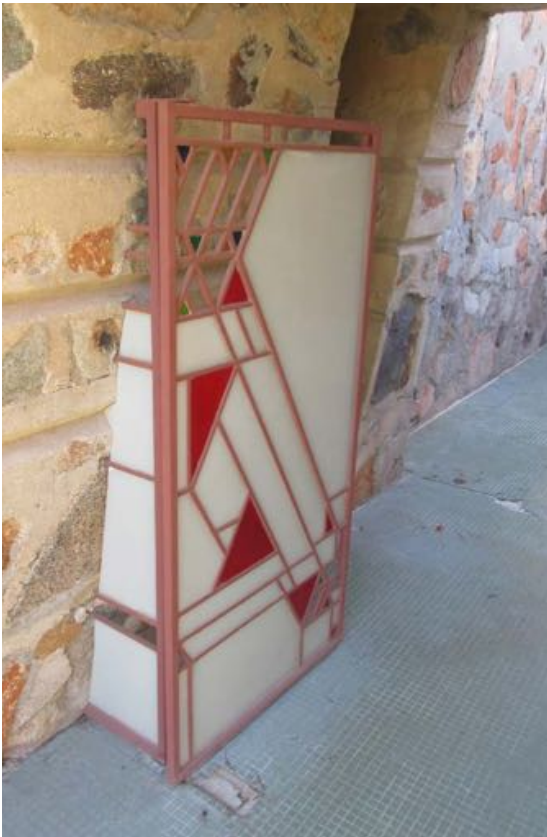
Figure 10-234 - Metal and glass gate at opening to courtyard outside of Finance Office, 2015 (Harboe Architects).

The gates appear to be in good condition.

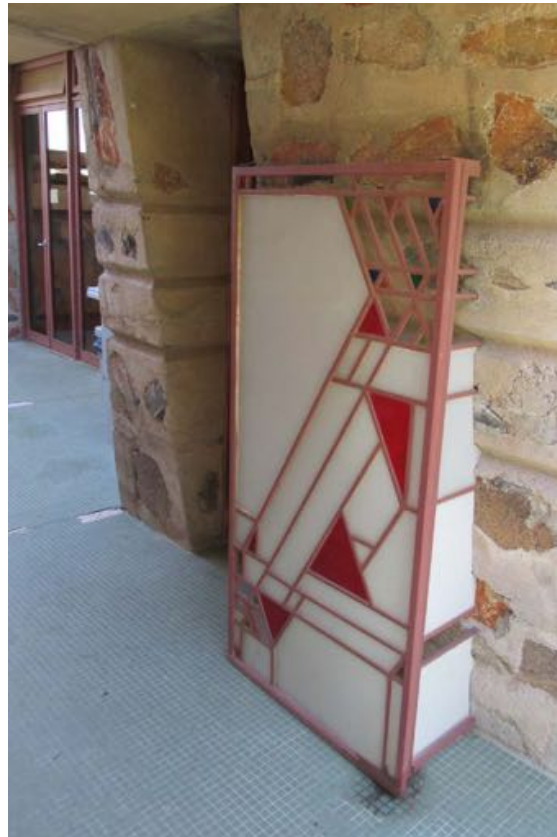
Figure 10-235 - Metal and glass gate at opening to courtyard outside of Finance Office, 2015 (Harboe Architects).

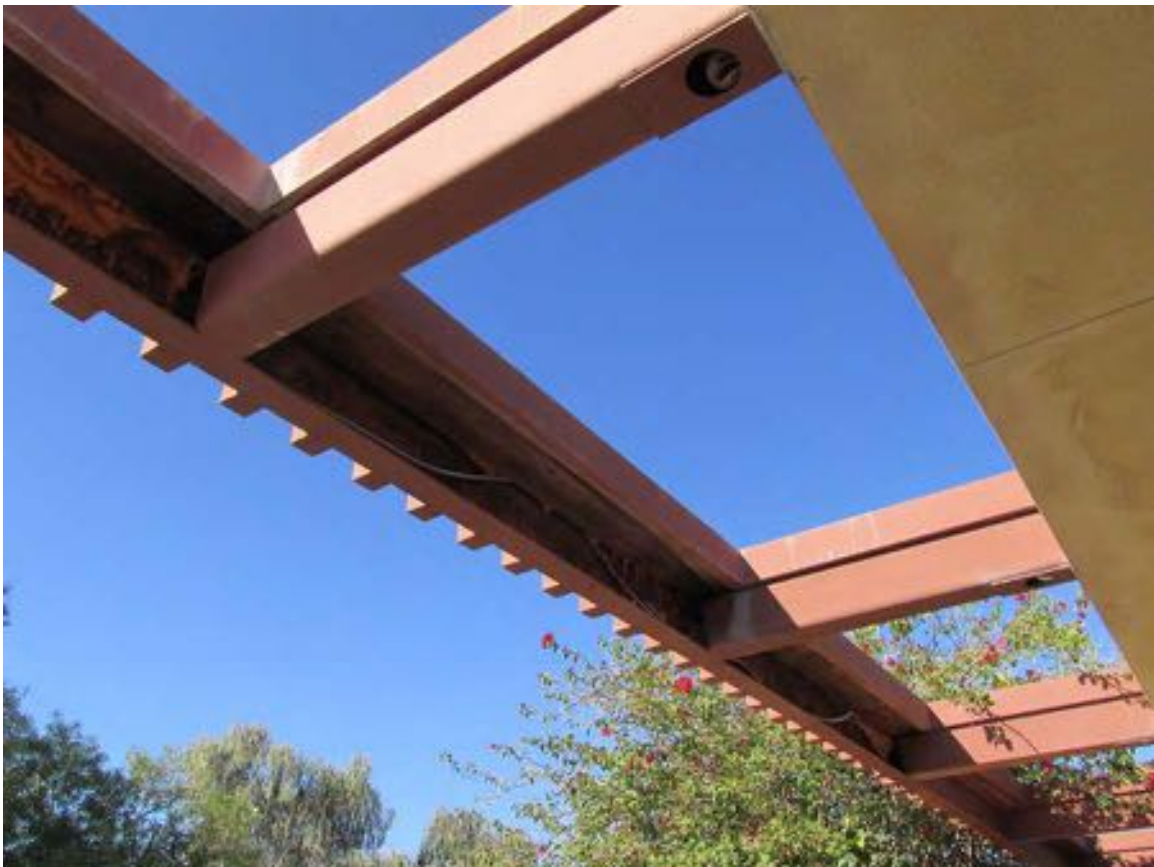
Figure 10-237 - Missing fascia on back of trellis on south side of Finance Office (Harboe Architects).

The membrane roof system is in poor condition. The membrane is past its useful life and needs to be replaced along with the foam insulation. The plywood deck appears to be in good condition. The paint on the steel fascia is worn and there is some minor corrosion.

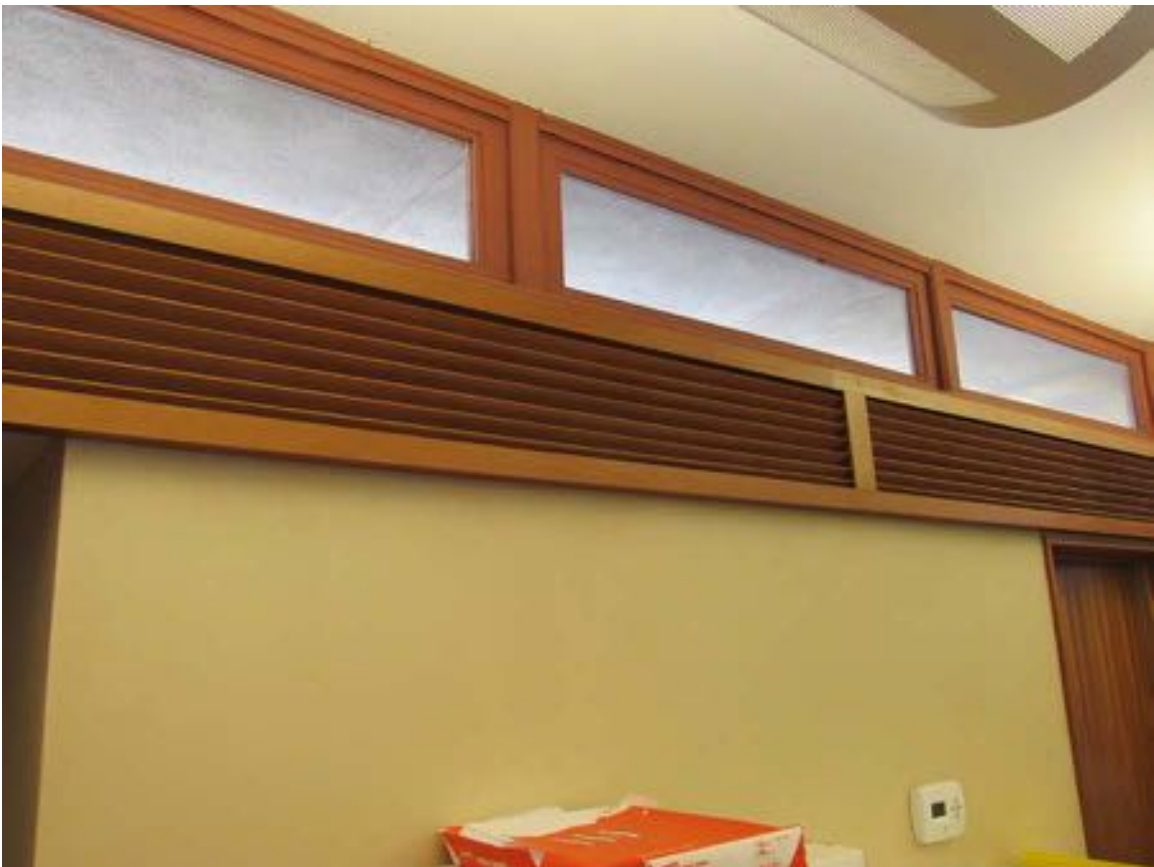
Figure 10-239 - Clerestory windows in Finance Office, 2015 (Harboe Architects).

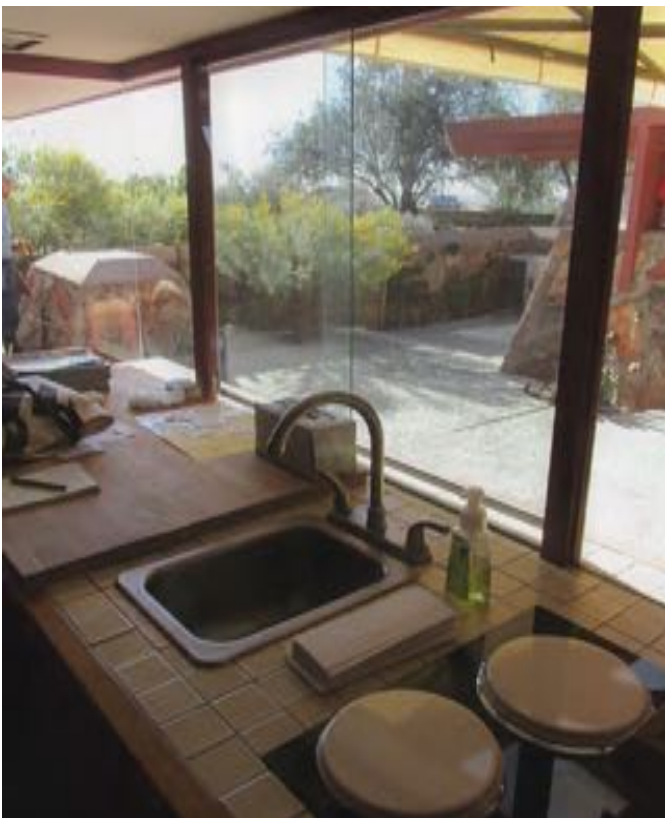
Figure 10-250 - Kitchen countertop, 2015 (Harboe Architects).

The ceramic tile is in fair condition. There are broken and missing tiles and grout. The cabinets are in good condition.

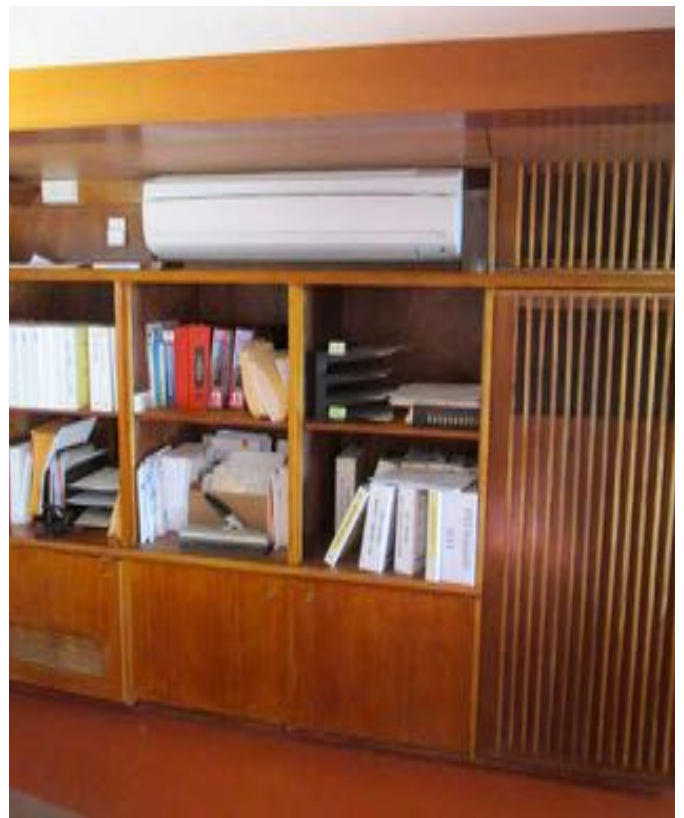
Figure 10-251 - Built-in wood shelves in Dekoven Hill office, 2015 (Harboe Architects).

The wood trim and shelving is in good condition.

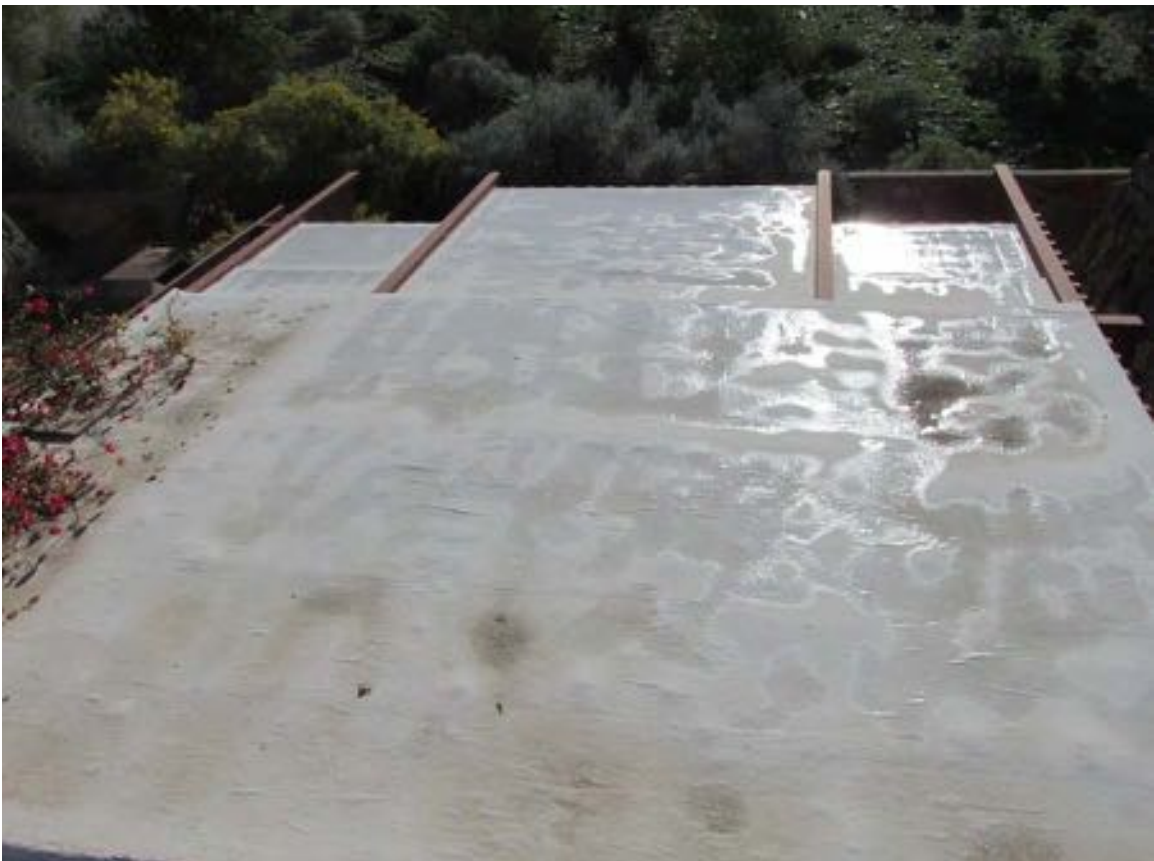
Figure 10-257 - Roof of Dr. Joe Office, 2015 (Harboe Architects).

The membrane roof system is in poor condition. The membrane is past its useful life and needs to be replaced along with the foam insulation. The deck appears to be in good condition. The painted wood beams appear to be in good condition, as does the fascia and dentils around the cantilevered roof and the fascia at the main roof edge.

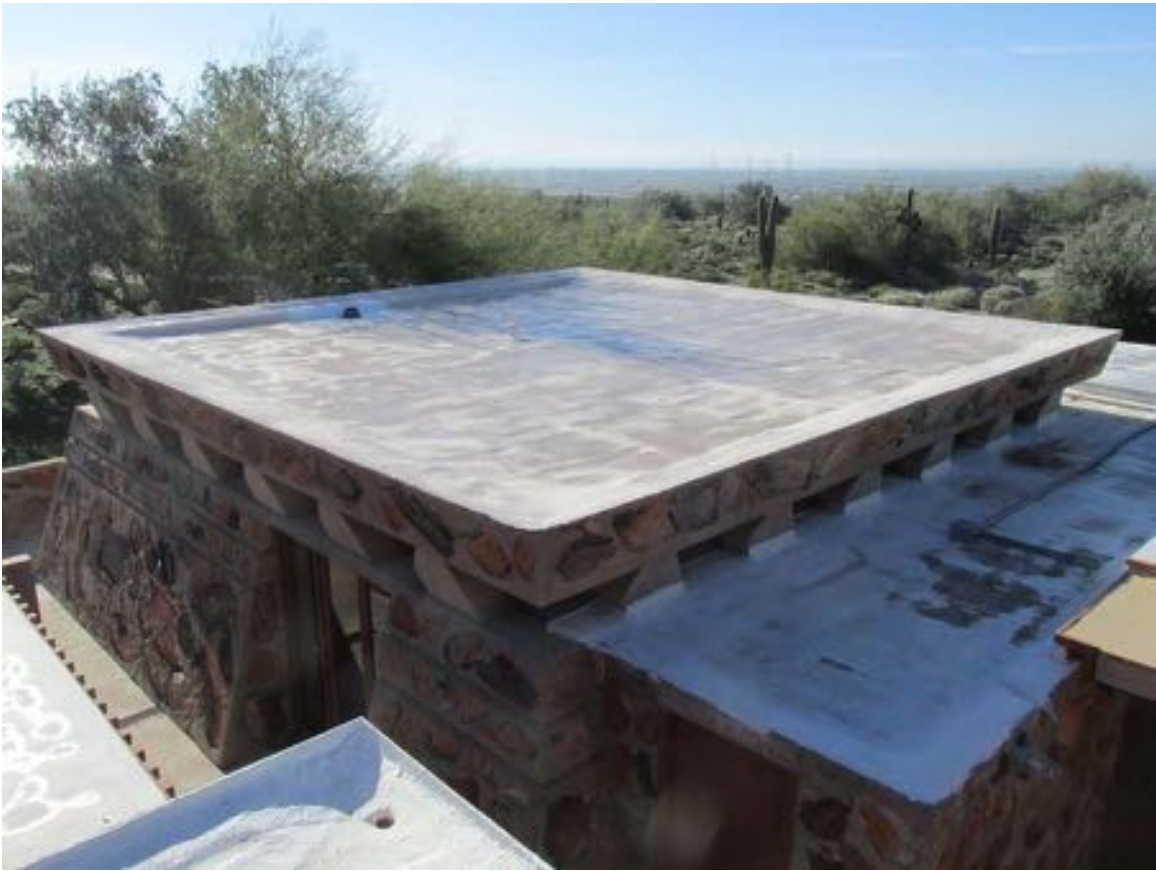
Figure 10-267 - Roof of Clinic Office, 2015 (Harboe Architects).

The membrane roof system is in poor condition. The membrane is past its useful life and needs to be replaced along with the foam insulation. The deck appears to be in good condition. There is a temporary wood support at the corner of the roof overhang on the south side.

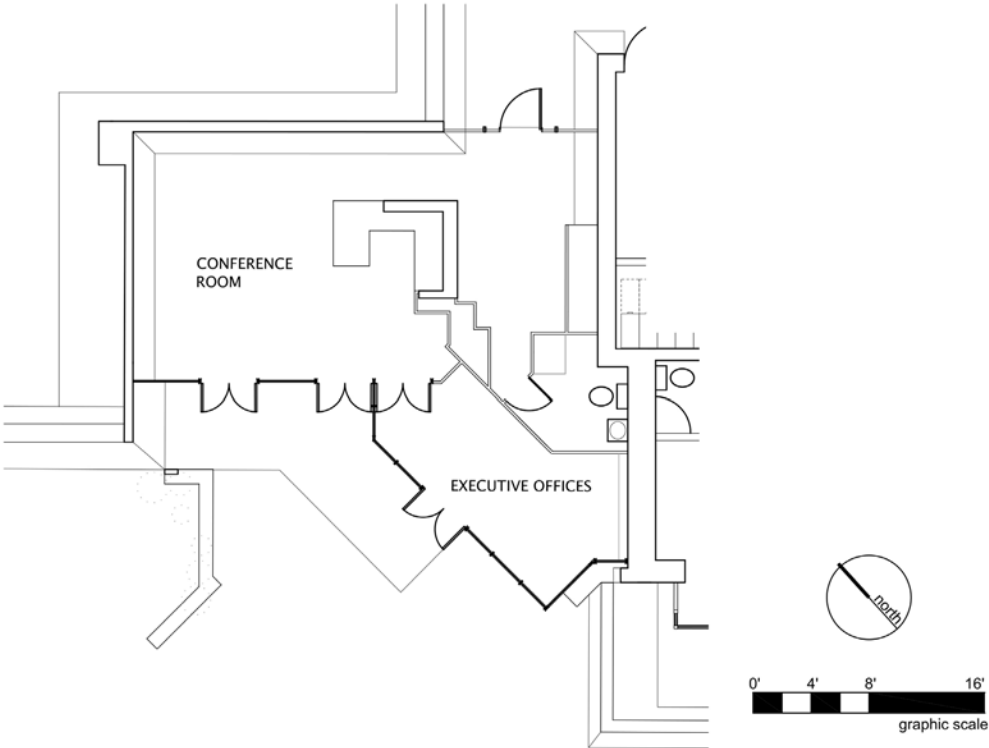
Figure 10-275 - Carney Office Floor Plan
