TALIESIN WEST PRESERVATION MASTER PLAN

Harboe Architects, PC

MAY 21, 2015

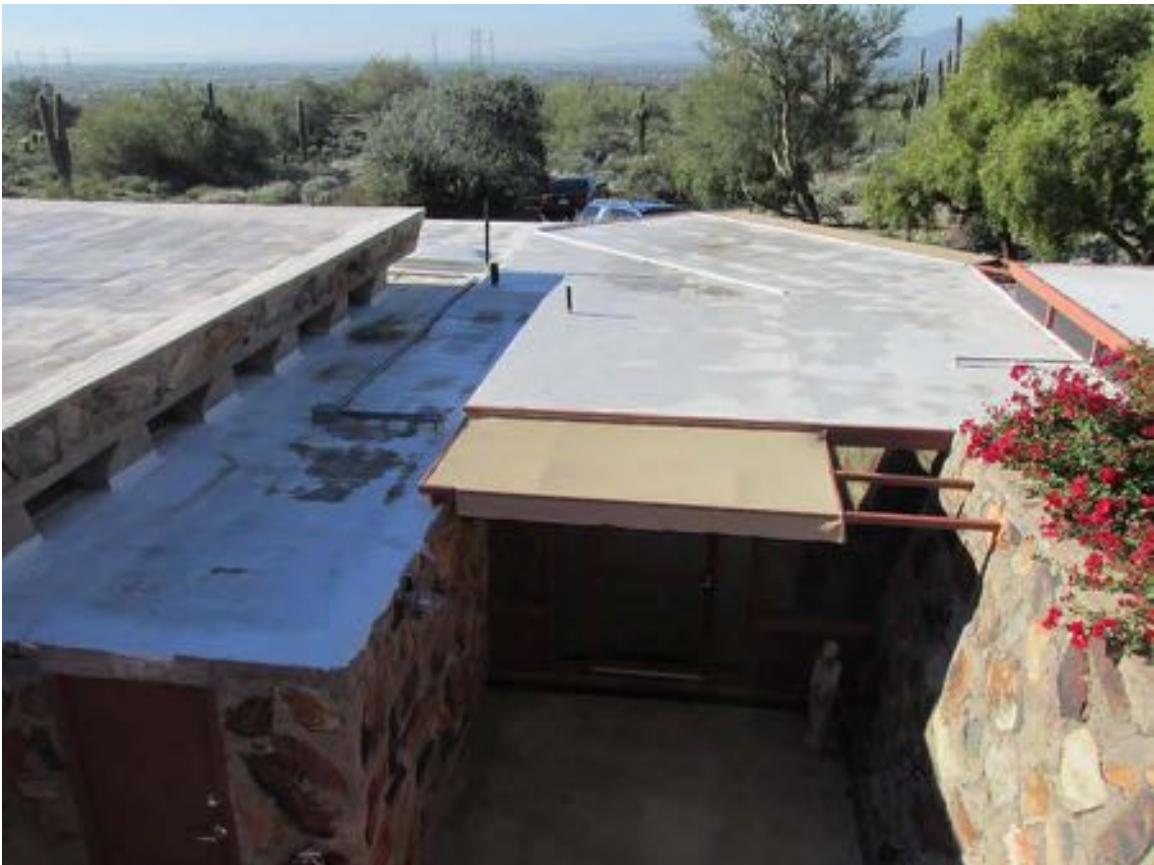
Materials

The membrane roof system is in poor condition. The membrane is past its useful life and needs to be replaced along with the foam insulation. The wood deck appears to be in good condition.

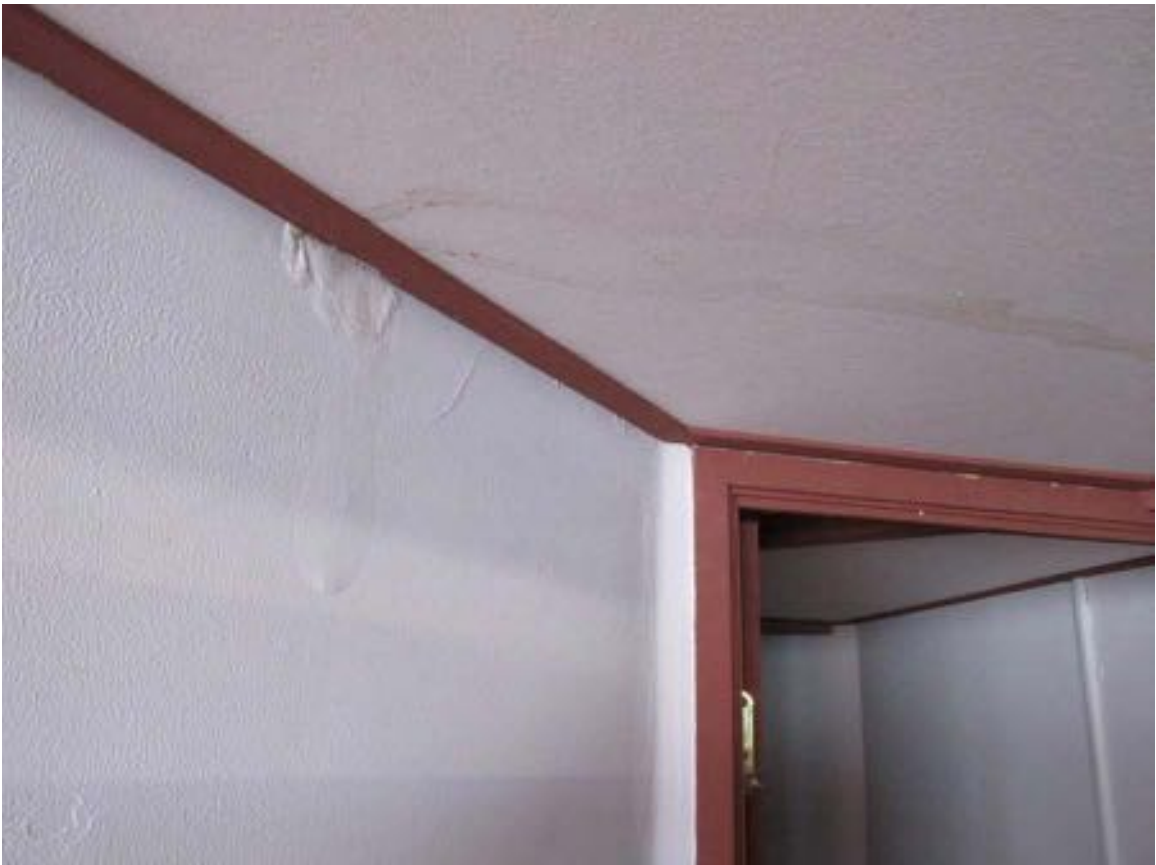
Figure 10-282 - Carney Office showing water damage to wall and ceiling, 2015 (Harboe Architects).

The desert masonry walls are in good condition. The gypsum board walls are generally in good condition except for a small area next to the bathroom that has water damage.

The ceilings are generally in good condition. There is a small area of water staining on the ceiling next to the bathroom.

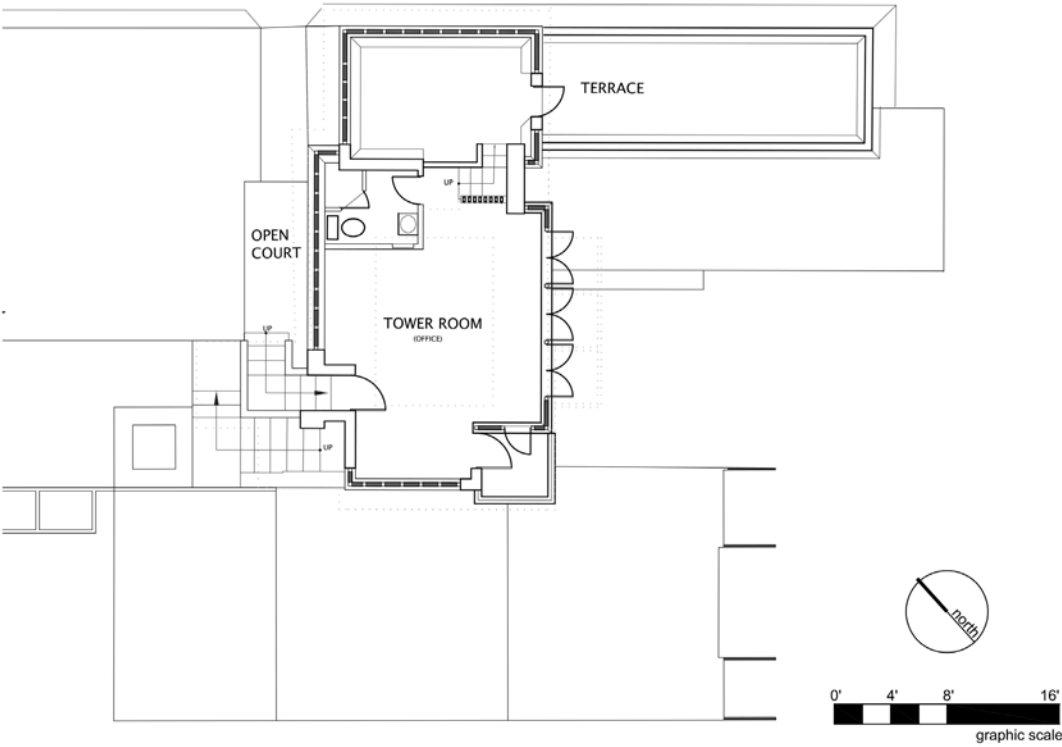
Figure 10-284 - Tower Office Floor Plan

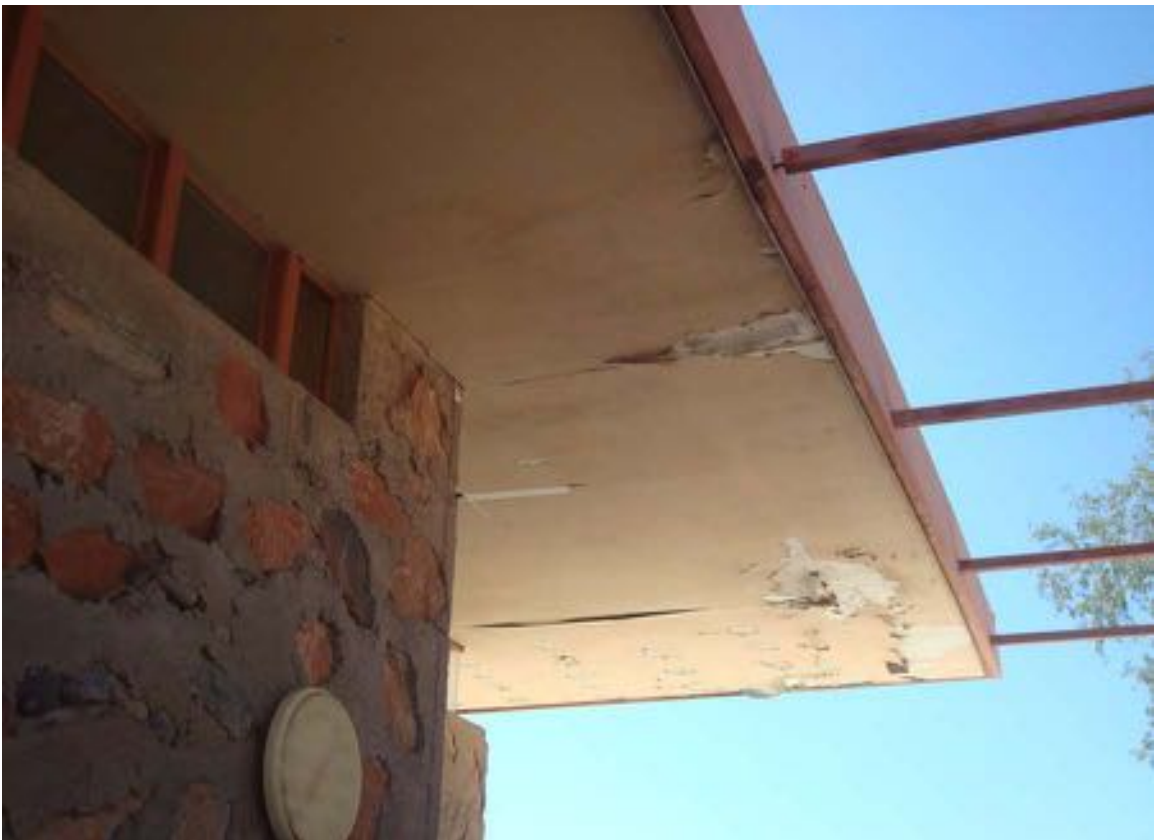
Figure 10-288 - Damage to soffit on Tower Office, 2015 (Harboe Architects).

The soffits are in poor condition. They have significant damage and need to be replaced.

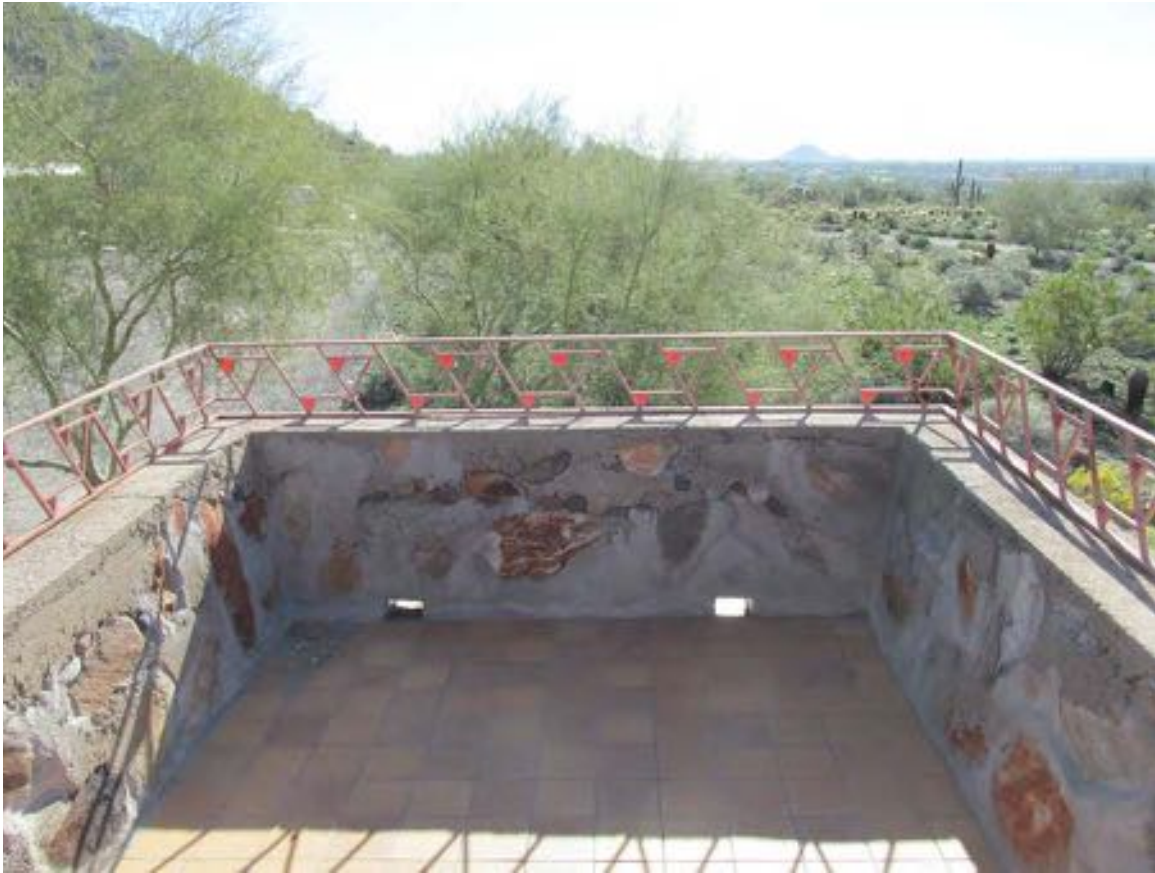
Figure 10-289 - Tower Office terrace, 2015 (Harboe Architects).

The tile is in fair/poor condition. Many of the tiles are cracked and damaged. The desert masonry is in good condition. The metal railings are in fair condition. The paint finish is worn and there is some minor surface corrosion.

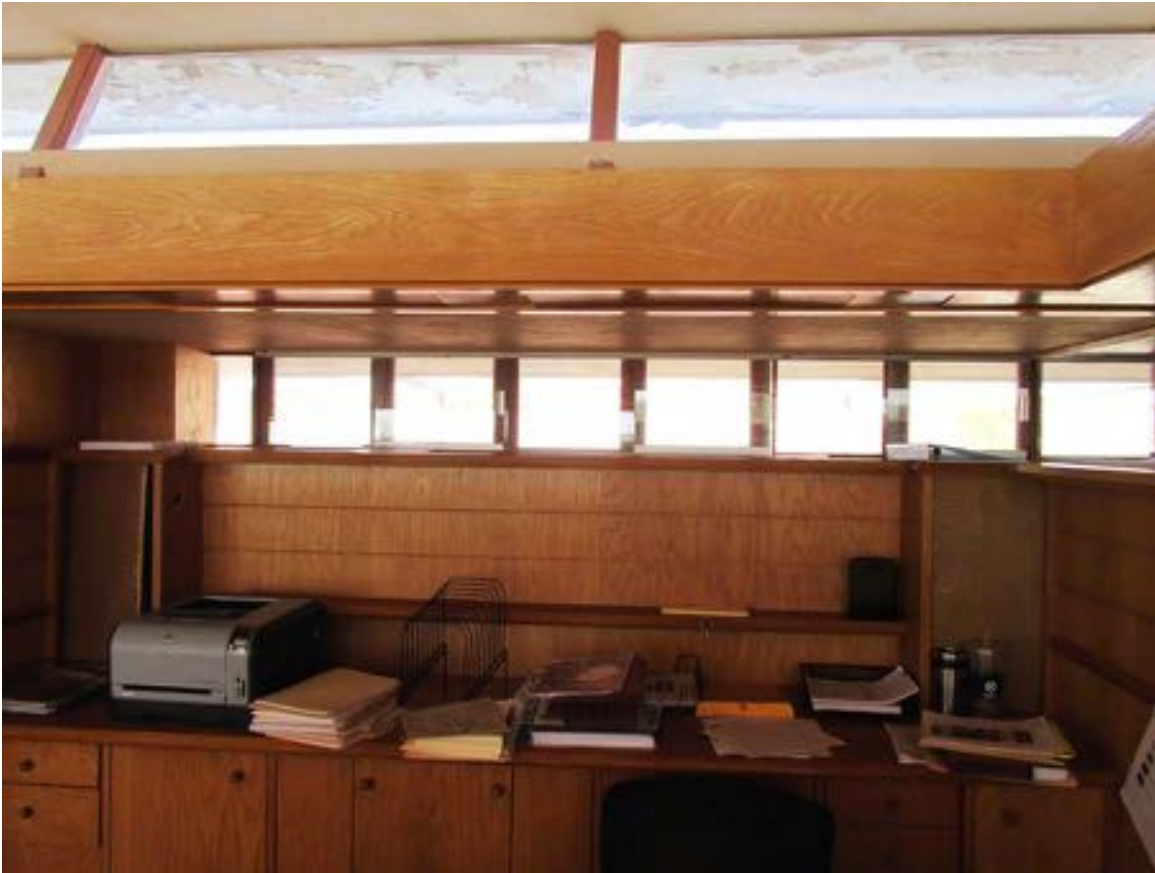
Figure 10-294 - Built-in cabinets with windows above in Tower Office, 2015 (Harboe Architects).

The millwork is in good condition with a few minor scratches and nicks.

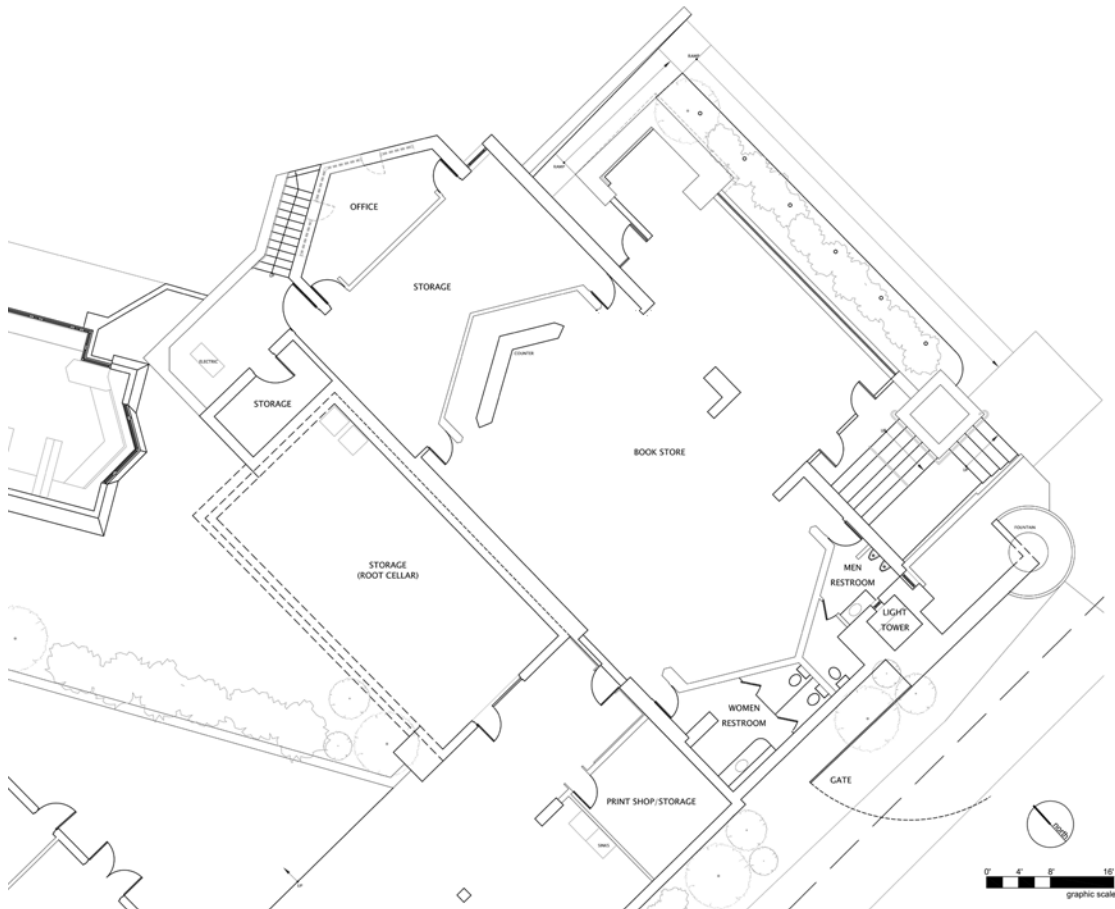
Figure 10-297 - Bookstore Floor Plan

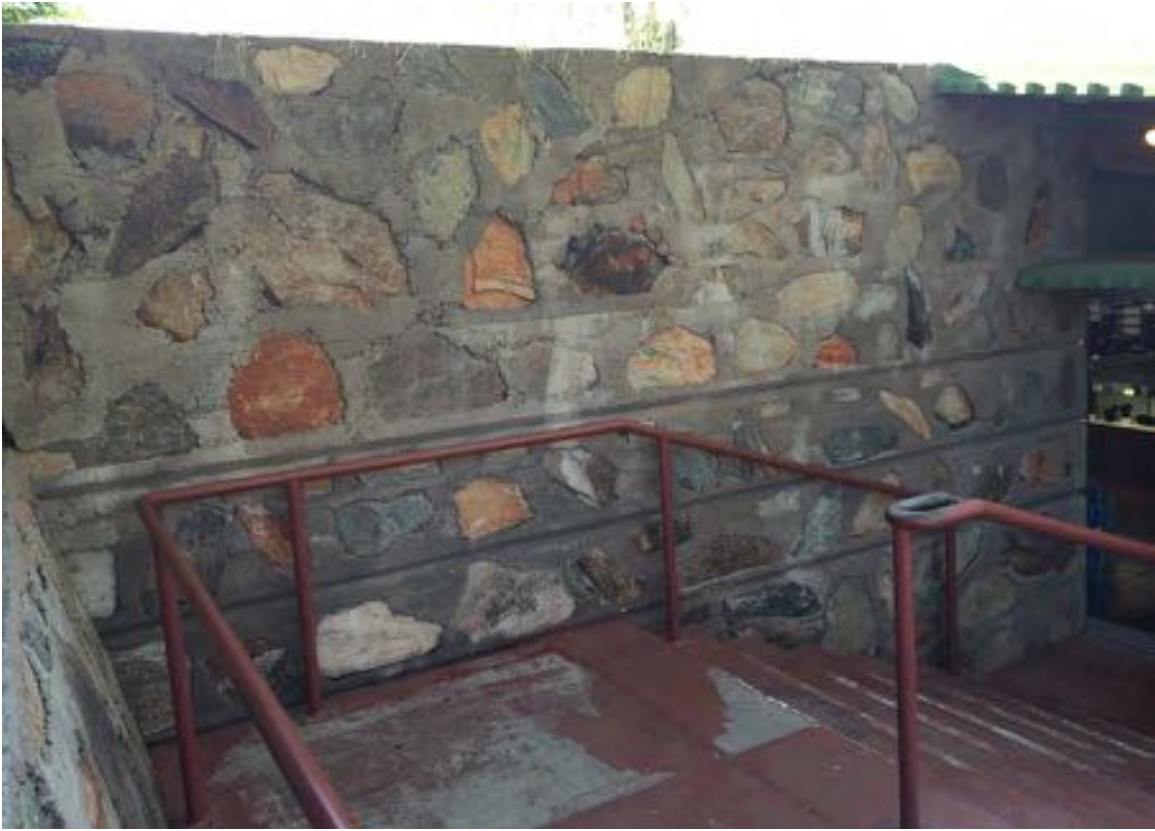
Figure 10-298 - Desert masonry wall outside of the Bookstore (Fred Prozzillo).

The desert masonry is in good condition. The painted wood siding is in fair condition. The paint is faded and some of the boards are cracked.

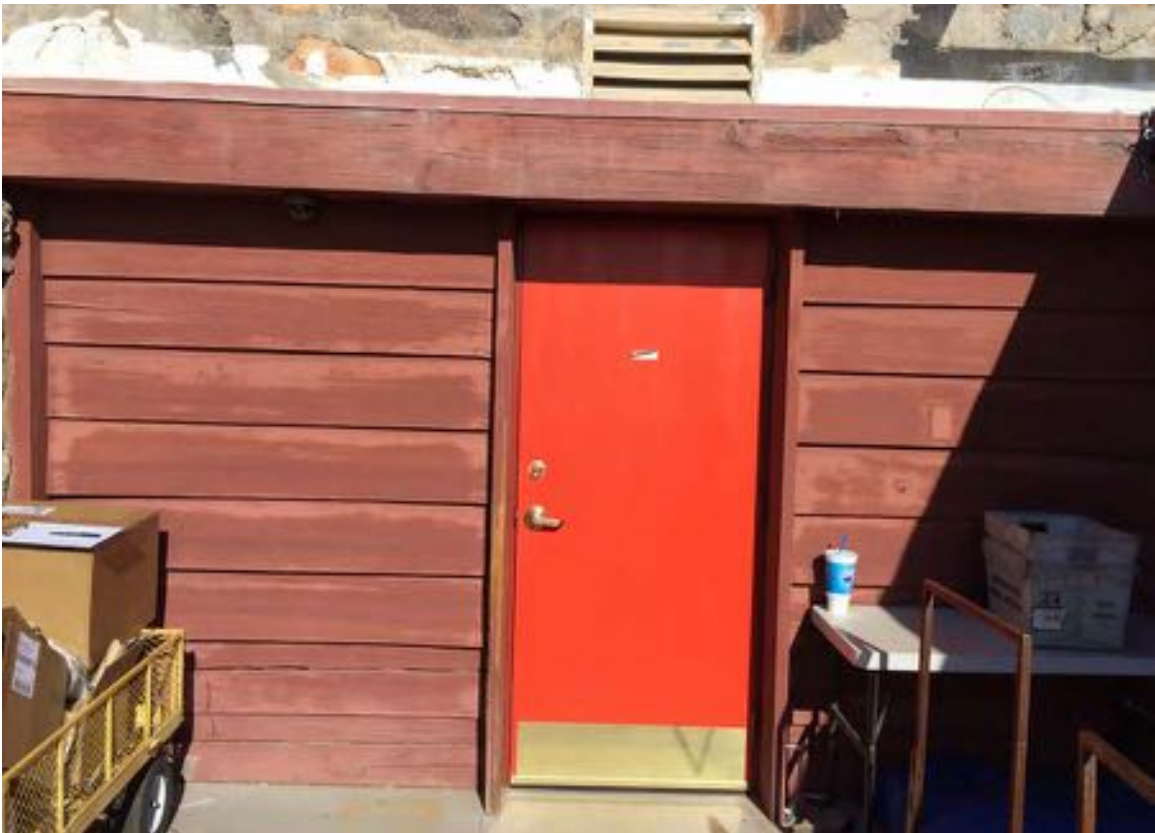
Figure 10-299 - Lap board siding and wood door on west side of Bookstore (Fred Prozzillo).

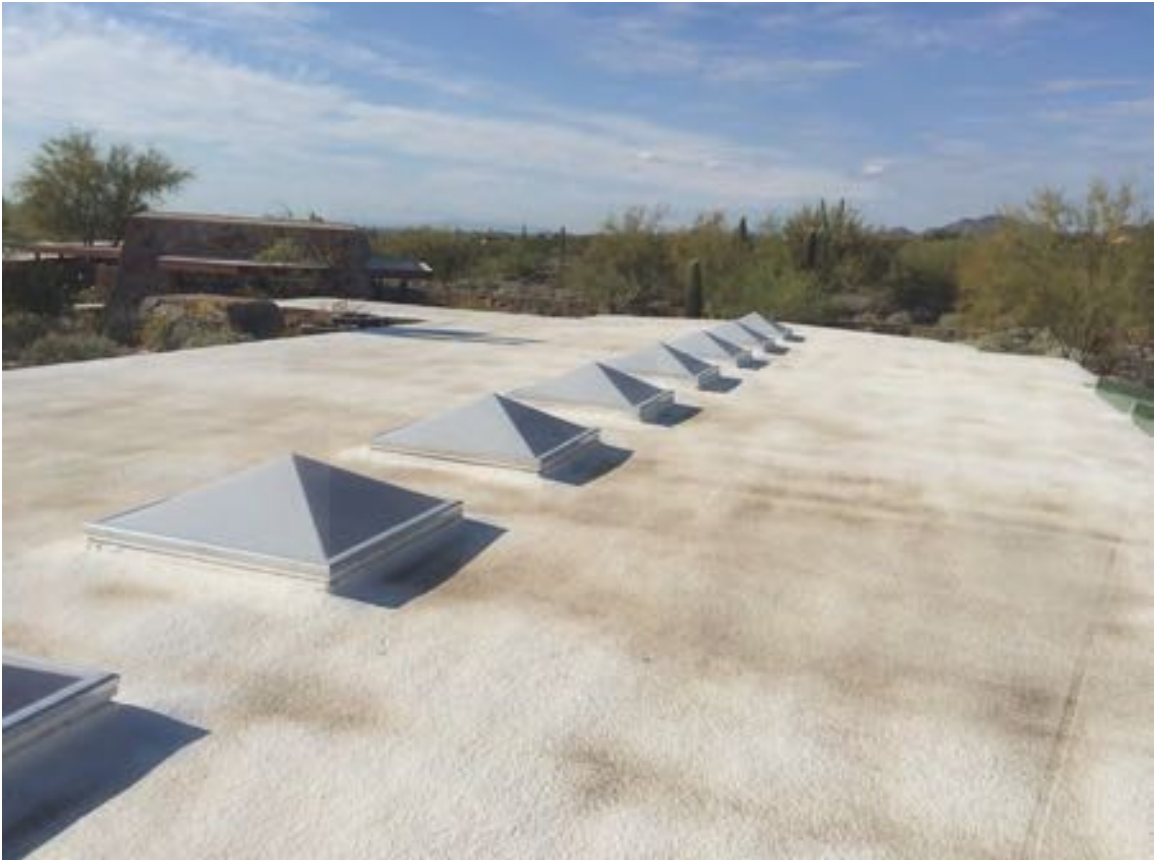
Figure 10-300 - Bookstore roof (Fred Prozzillo).

The roof is in good condition. There are some locations where it is delaminating from the glulam beams.

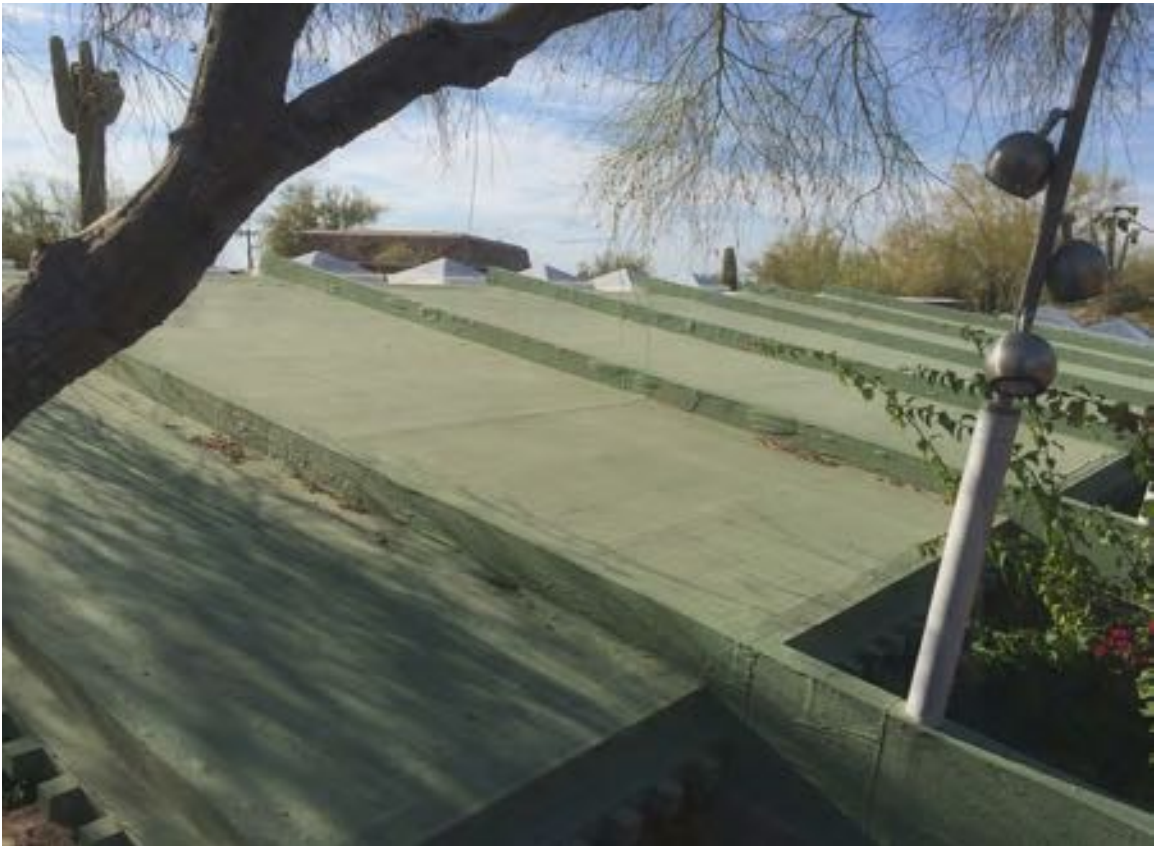
Figure 10-301 - Shed roof addition on Bookstore (Fred Prozzillo).

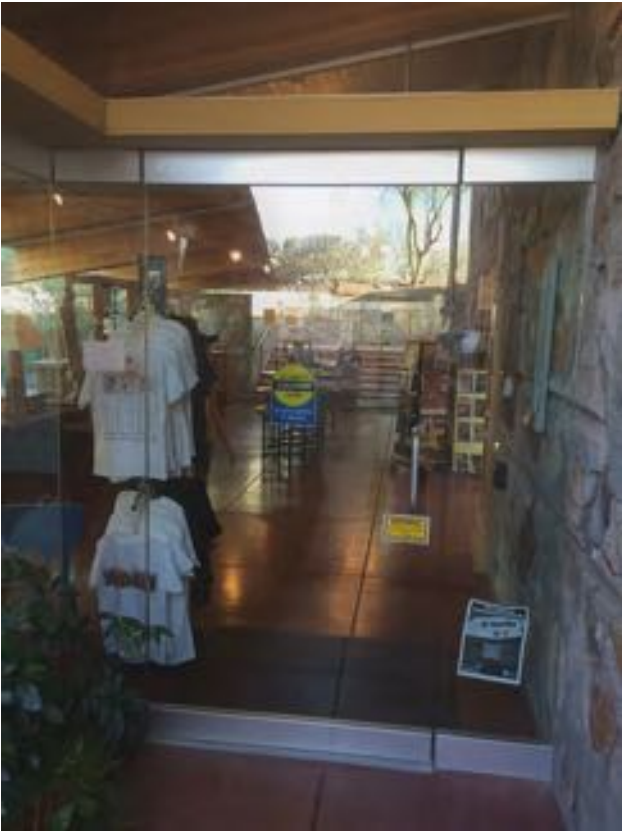
Figure 10-302 - Glass doors at entry to Bookstore (Fred Prozzillo).

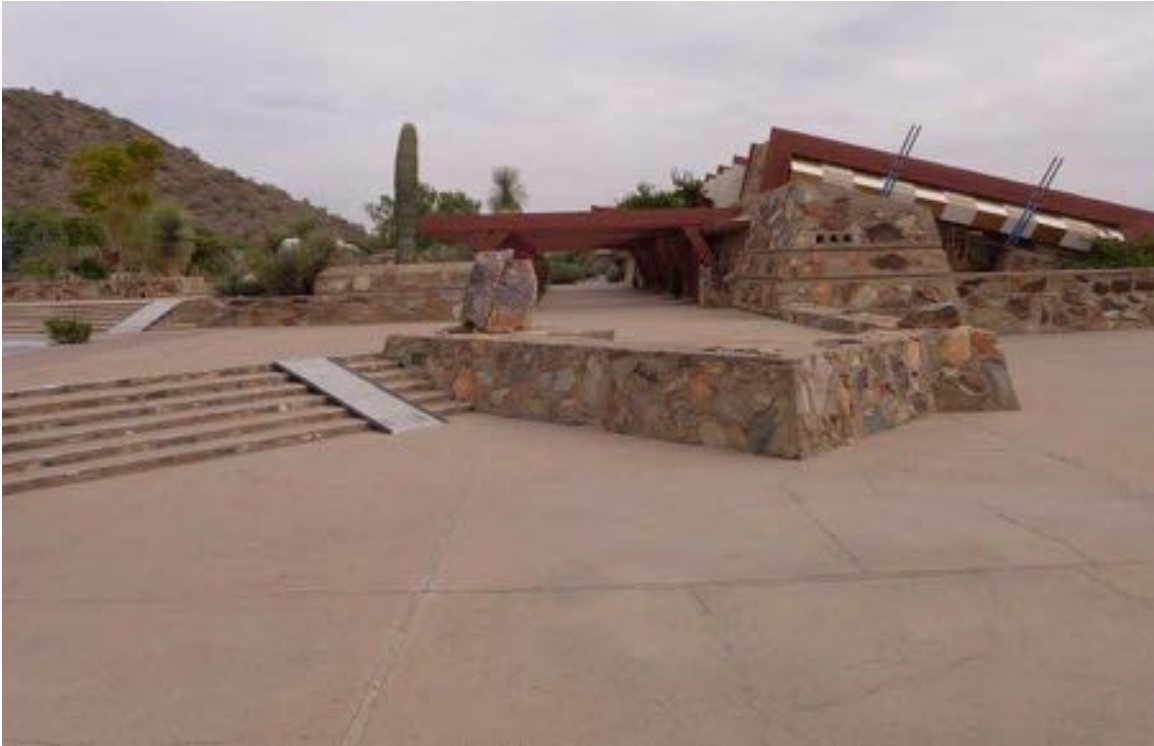
Figure 10-309 - Paved area between the office and Drafting Studio, 2014 (Harboe Architects).

The paving is comprised of floated concrete configured in panels that are separated by 2-1/2" mortar joints. The mortar joints originally had exposed small stone aggregate. Some original joints are still present while others have been replaced.

The paving is in poor to fair condition. There are cracks in many of the concrete panels and many of the mortar joints do not contain their original mortar. Some of the concrete panels have heaved causing tripping hazards. The finish on the painted concrete is significantly worn and faded.

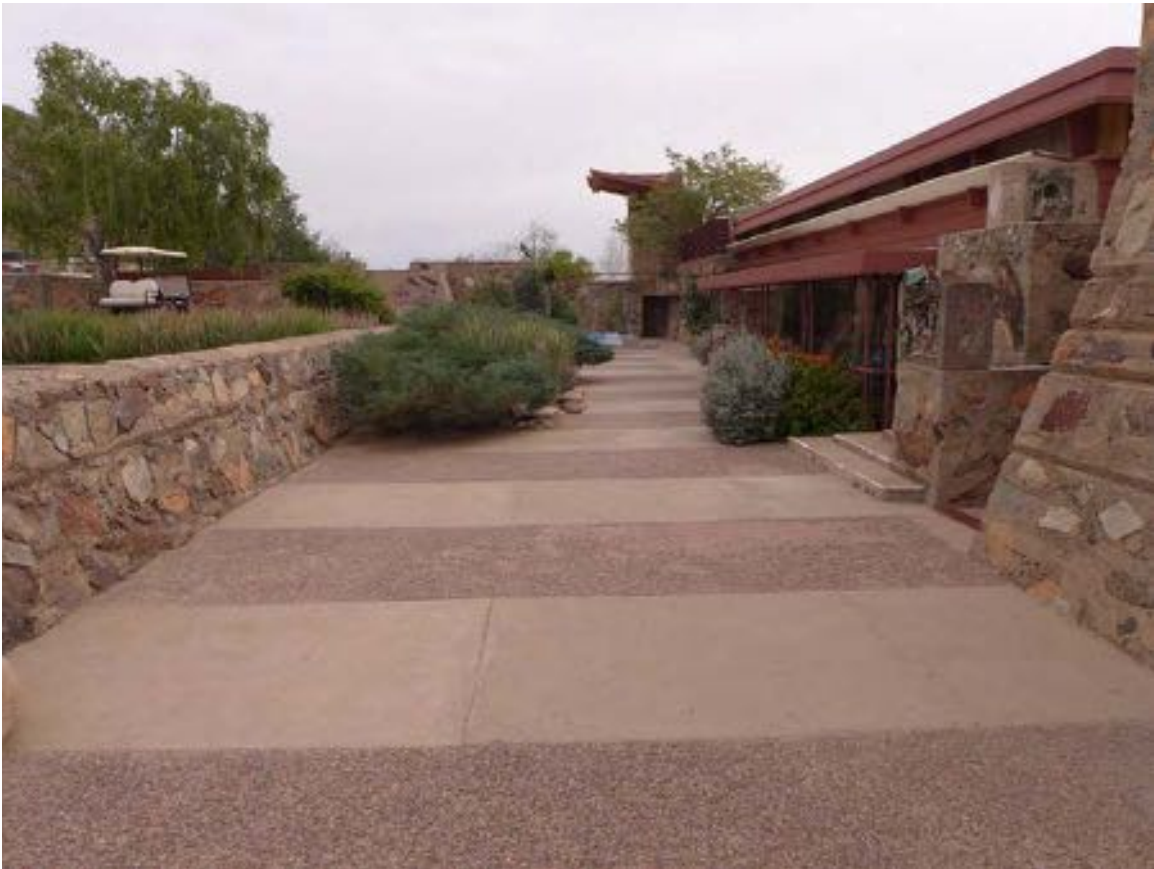
Figure 10-310 - Paved walkway on northwest side of Drafting Studio, 2014 (Harboe Architects).

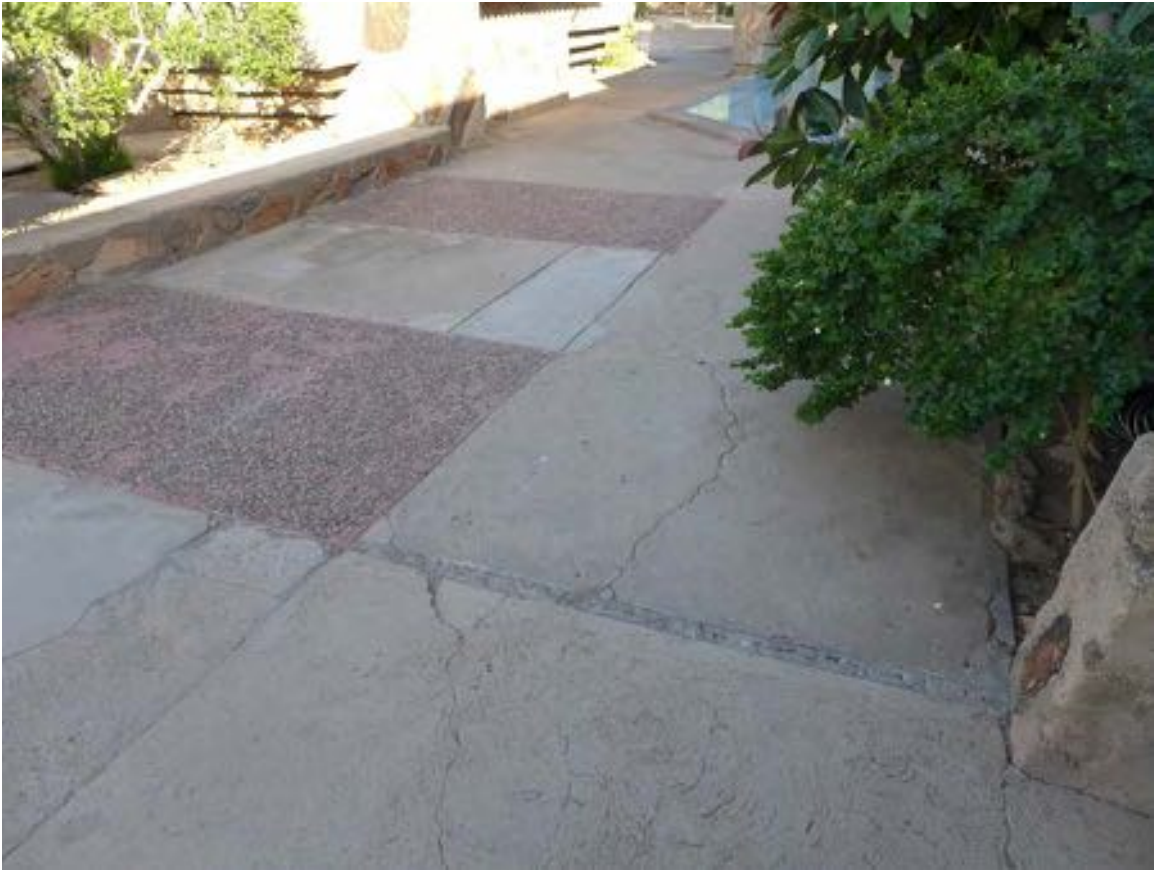
Figure 10-313 - Damaged concrete paving on north side of living quarters, 2014 (Harboe Architects).

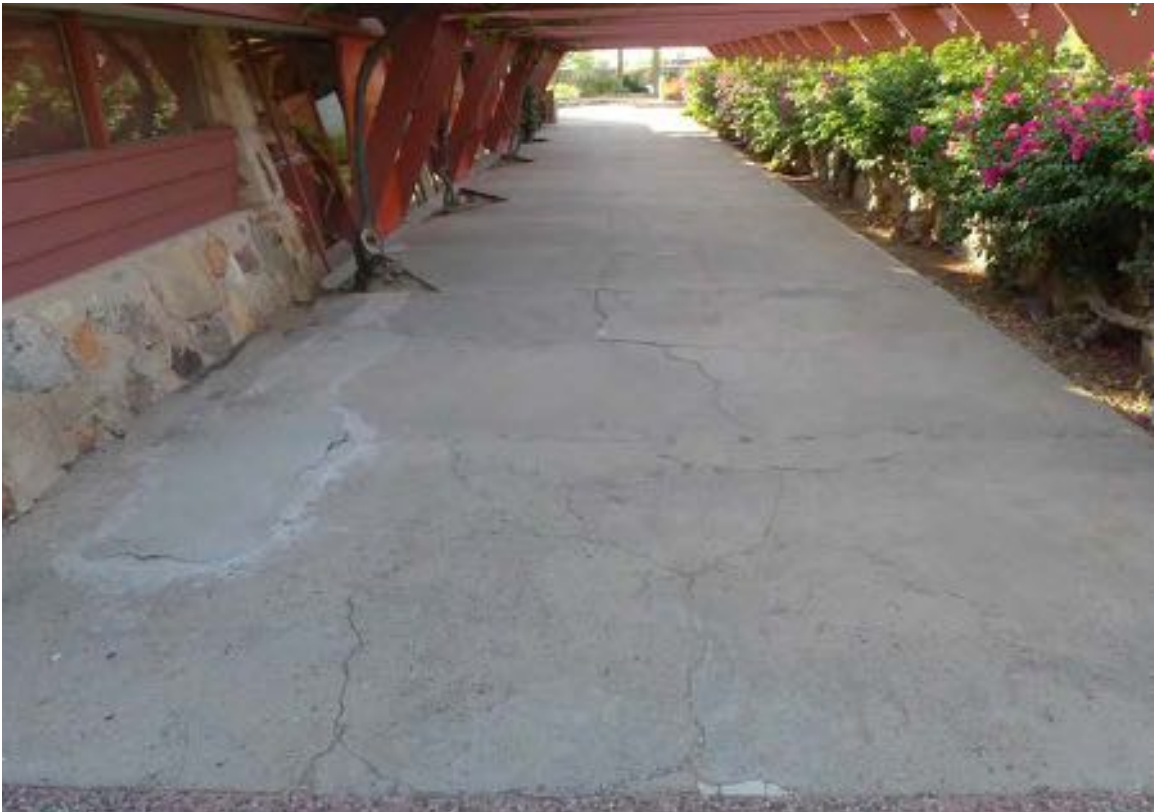
Figure 10-314 - Damaged concrete paving on north side of Studio, 2014 (Harboe Architects).

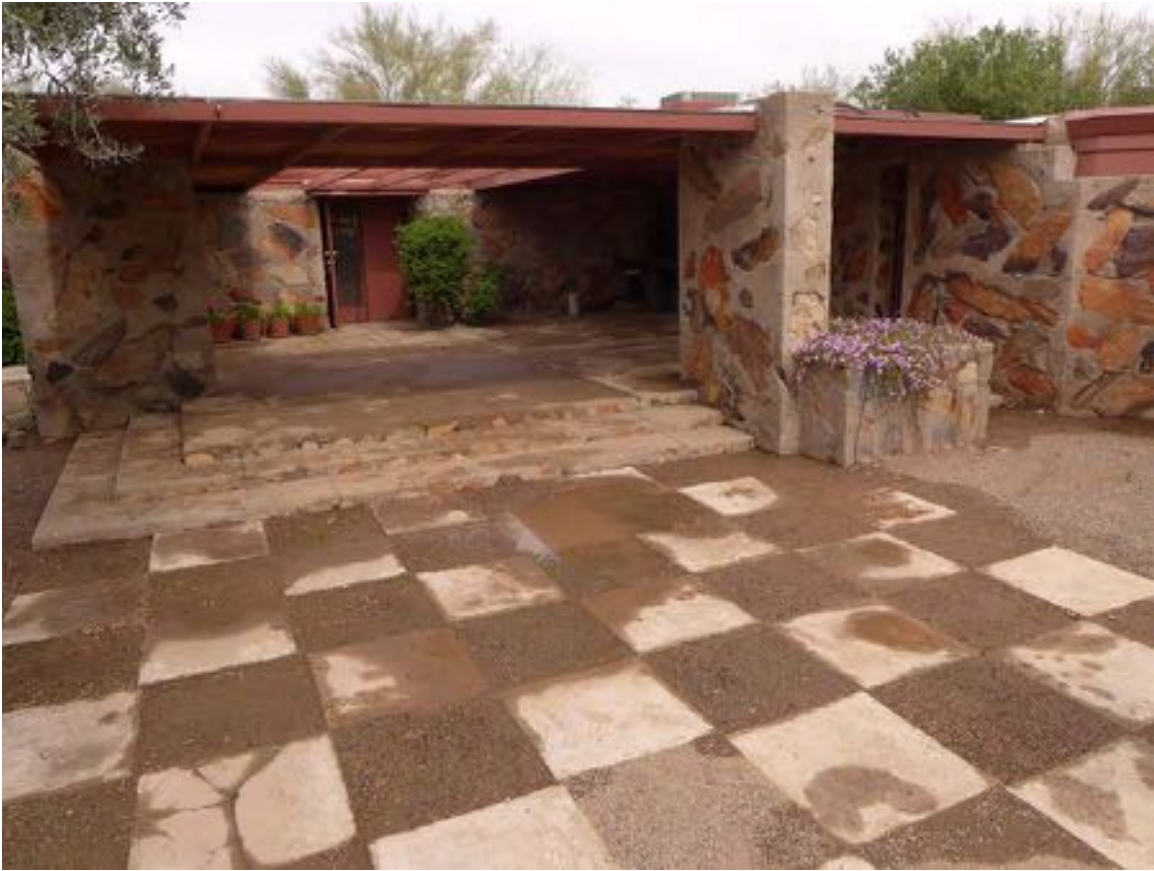
Figure 10-315 - Apprentice Court showing damaged pavers, 2014 (Harboe Architects).

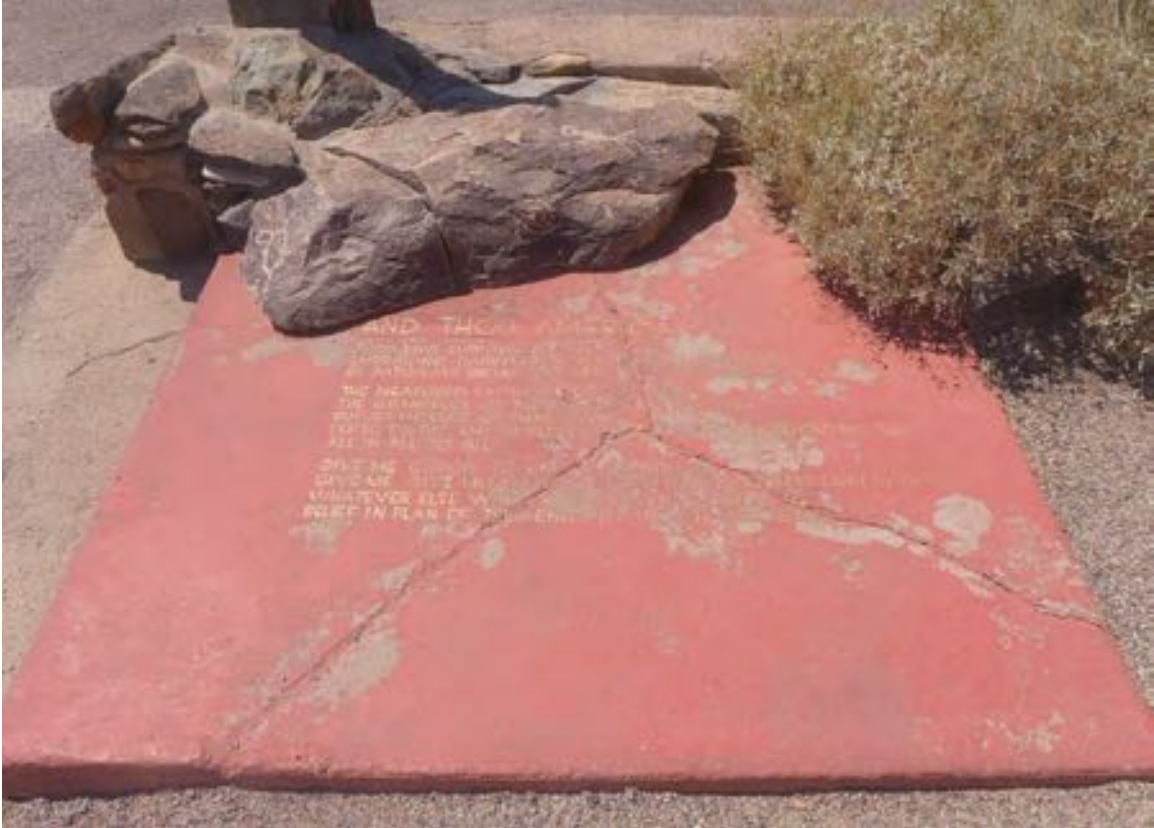
Figure 10-326 - Whitman Square, 2014 (Harboe Architects).

The Whitman Square is significantly deteriorated and has major cracks in the concrete. The red paint finish is worn and gold lettering is faded.

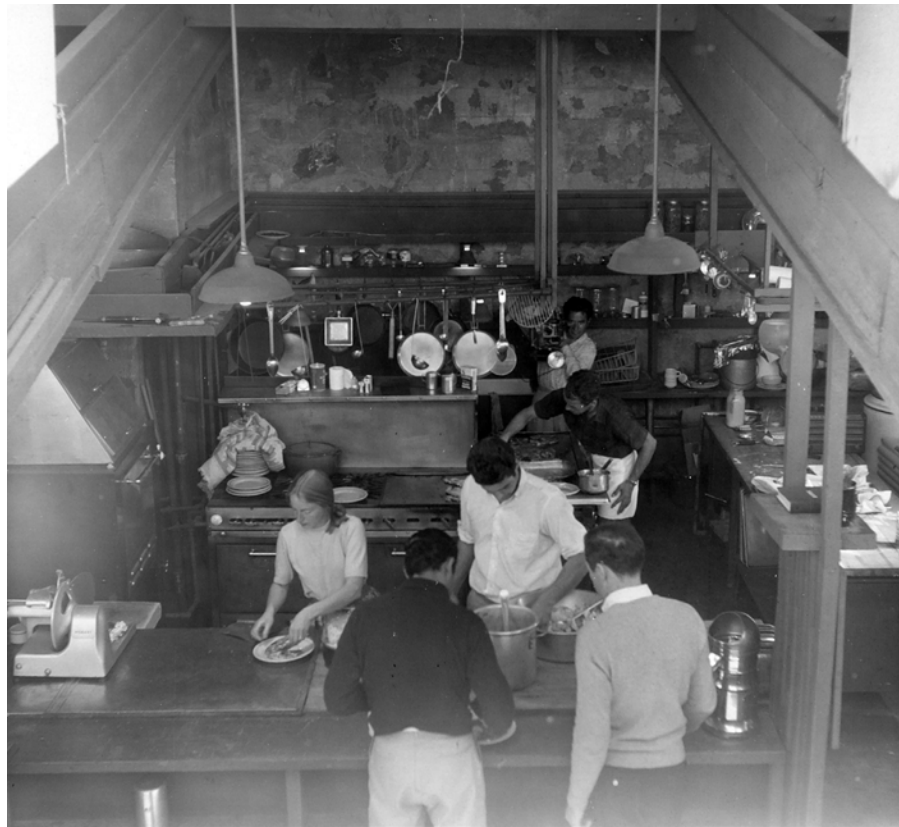
Figure 11-30 - Looking down into Kitchen from clerestory windows , ca. 1959 (The Frank Lloyd Wright Foundation Archives, The Museum of Modern Art | Avery Architectural & Fine Arts Library, Columbia University, New York).

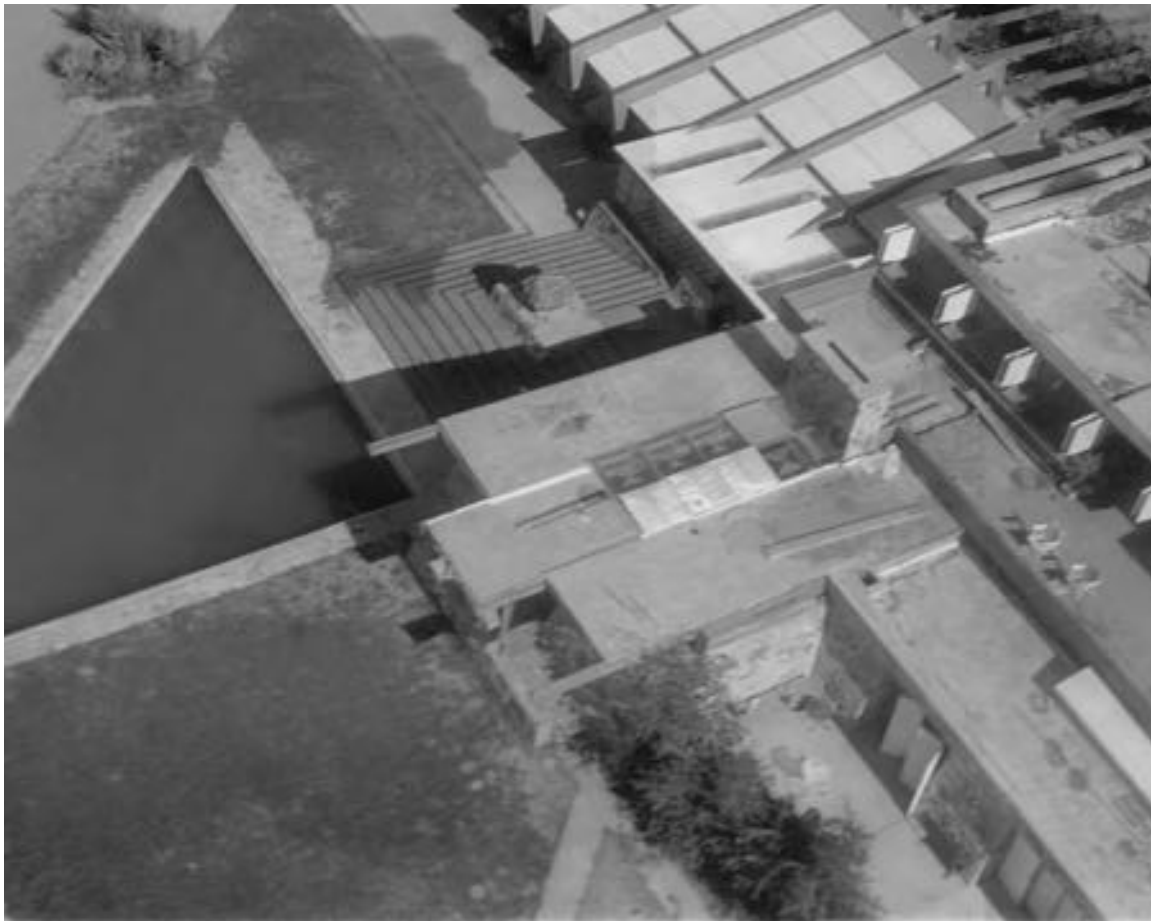
Figure 11-38 - Aerial view of Original Dining Room (Board Room) ca. 1959 (The Frank Lloyd Wright Foundation Archives, The Museum of Modern Art | Avery Architectural & Fine Arts Library, Columbia University, New York).

- Roof Surface
Replace the existing roofing membrane with a new liquid applied membrane.
- Skylight
Remove the non-historic existing fiberglass panels at the skylight. Install a new skylight with clear glass panels and painted wood frame to match the skylight that existed in this location in 1959. The skylight design will be based on historic photographs.

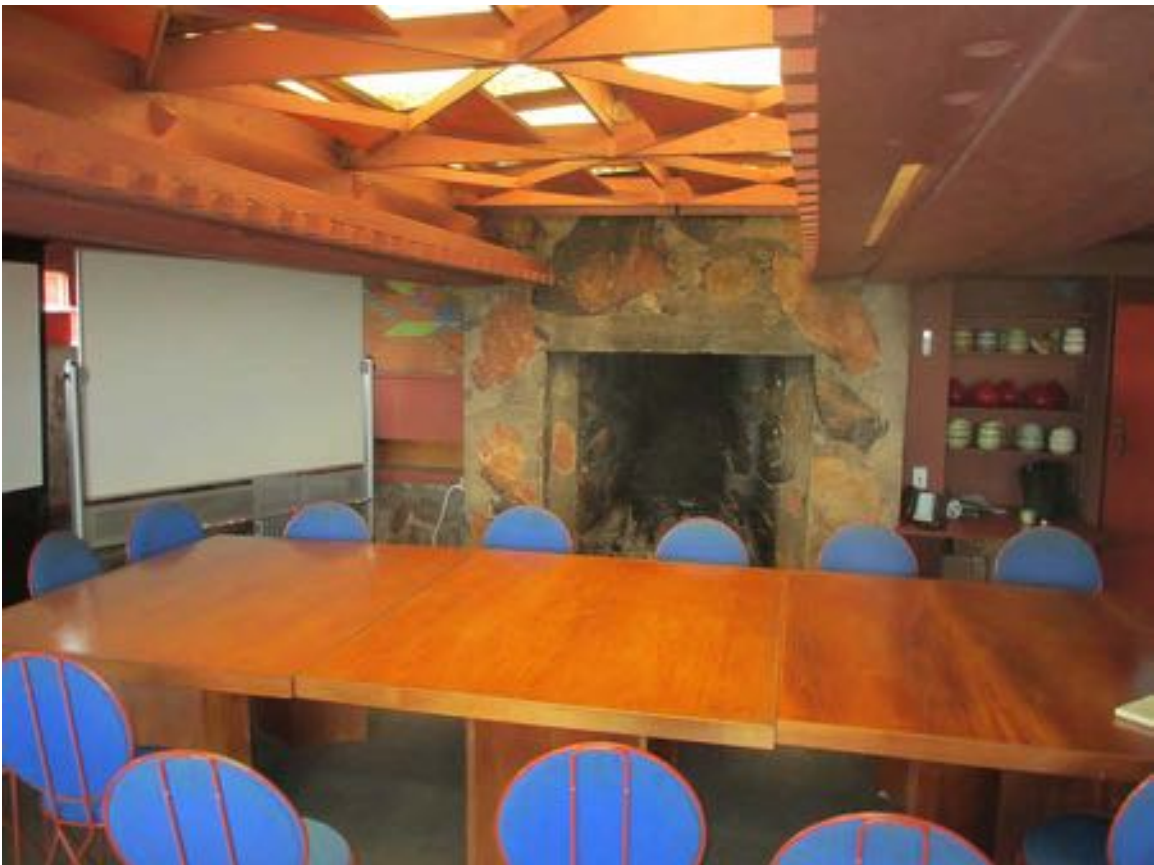
Figure 11-46 - Interior of Original Dining Room looking northeast, 2014 (Harboe Architects).

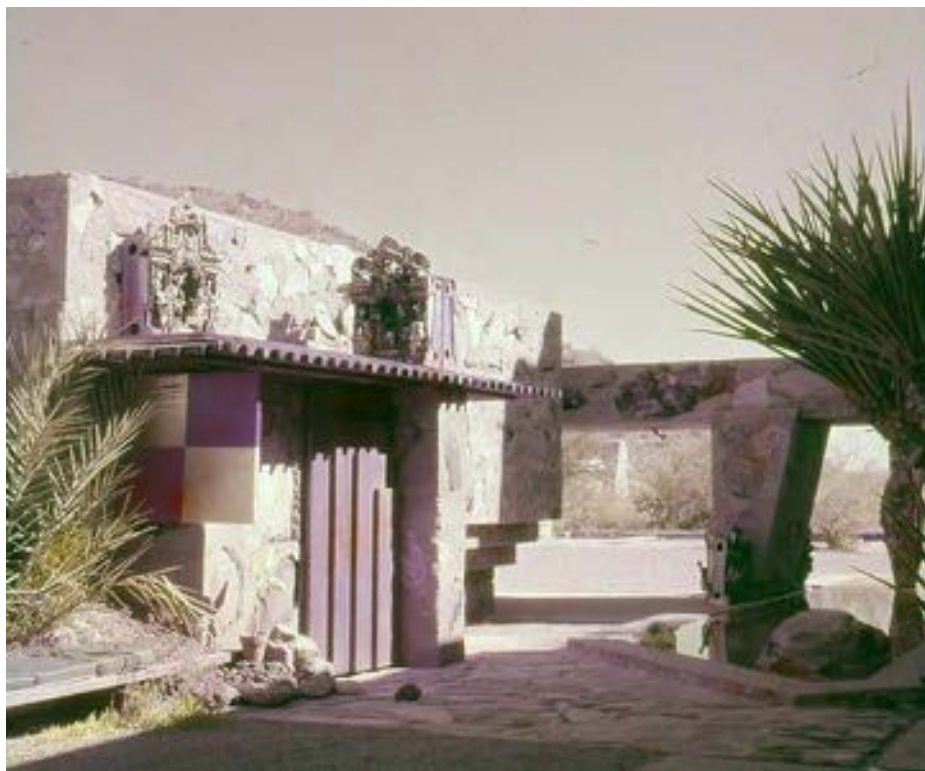
Figure 11-51 - Exterior of Kiva ca. 1952 (The Frank Lloyd Wright Foundation Archives, The Museum of Modern Art | Avery Architectural & Fine Arts Library, Columbia University, New York).

- Paving
Remove the concrete paving surrounding the entry and fountain and replace it with new stone paving to match what was there in the 1950s based on photographic evidence.

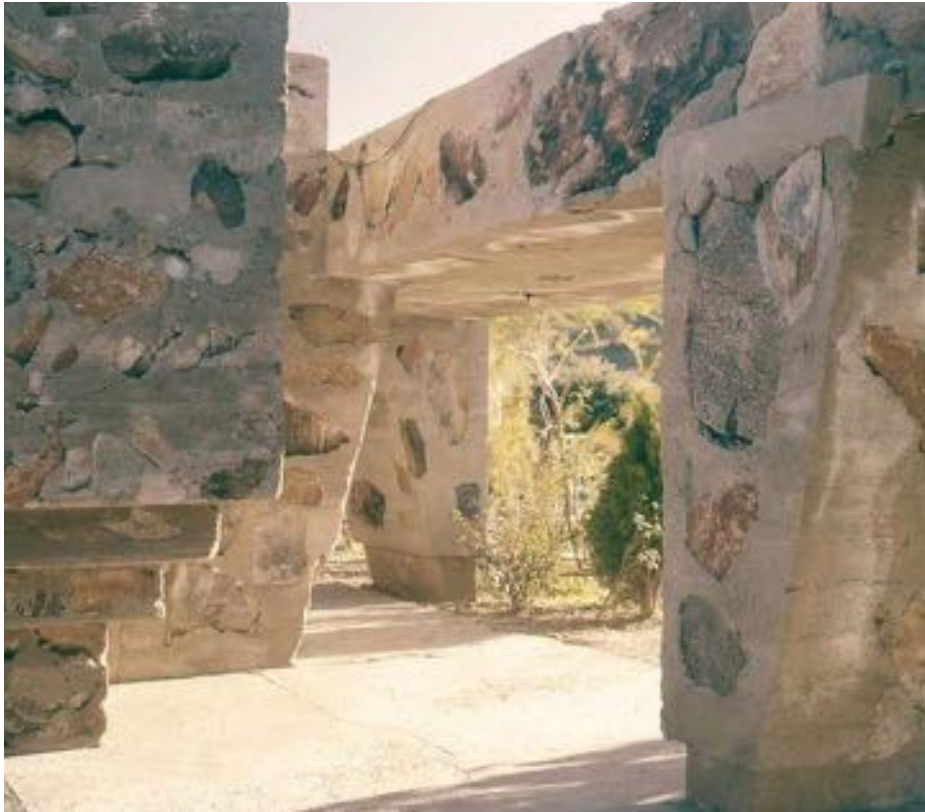
Figure 11-52 - Kiva bridge ca. 1952 (The Frank Lloyd Wright Foundation Archives, The Museum of Modern Art | Avery Architectural & Fine Arts Library, Columbia University, New York).
