TALIESIN WEST PRESERVATION MASTER PLAN

Harboe Architects, PC

MAY 21, 2015

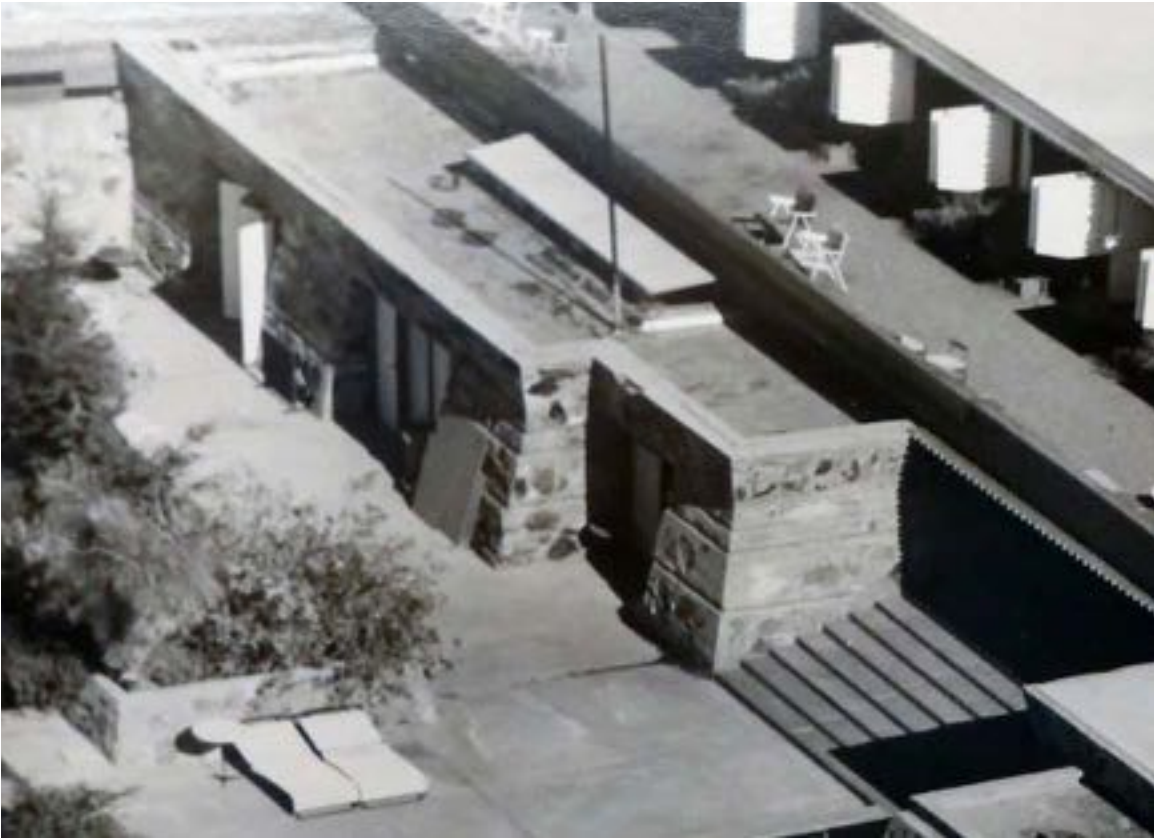
Figure 11-62 - Aerial view of Peters/Masselink Apartments ca. 1959 (The Frank Lloyd Wright Foundation Archives, The Museum of Modern Art | Avery Architectural & Fine Arts Library, Columbia University, New York).

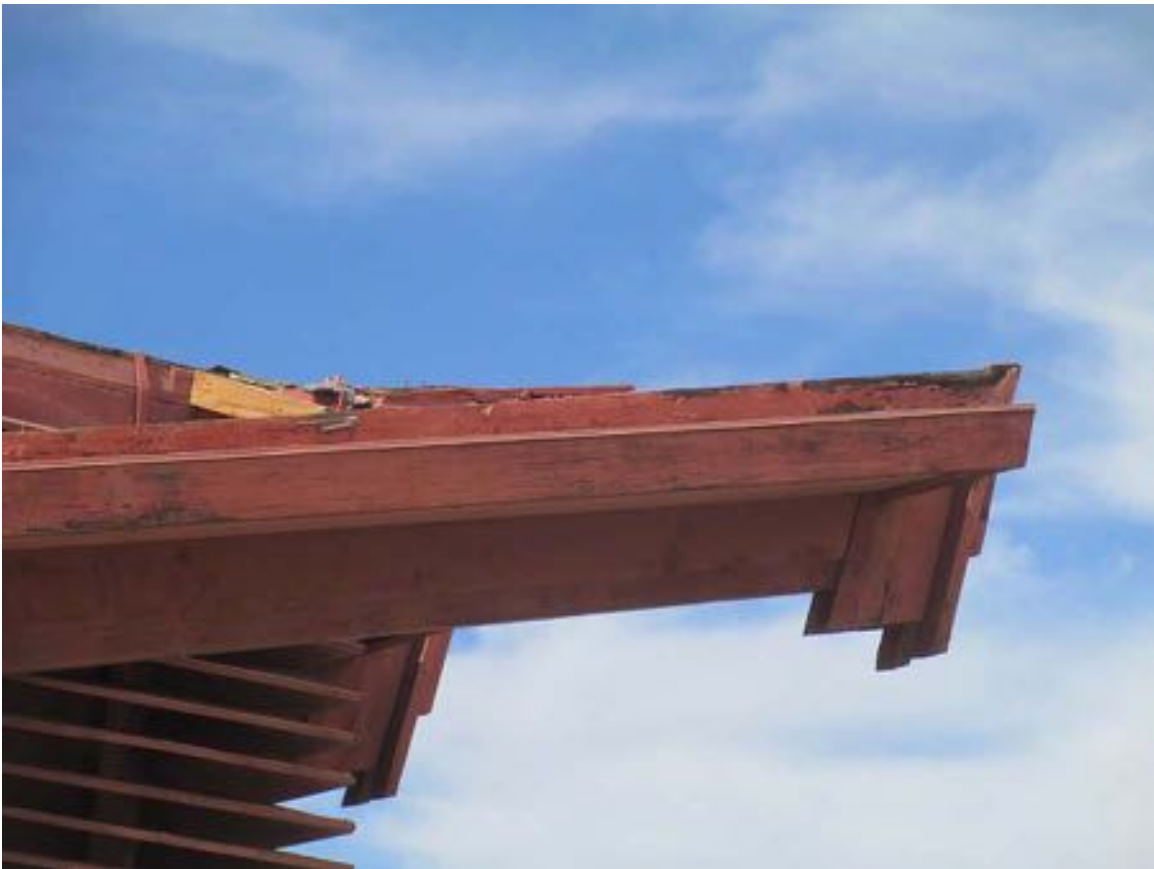
Figure 11-91 - Detail of Water Tower roof showing damaged wood, 2014 (Harboe Architects).

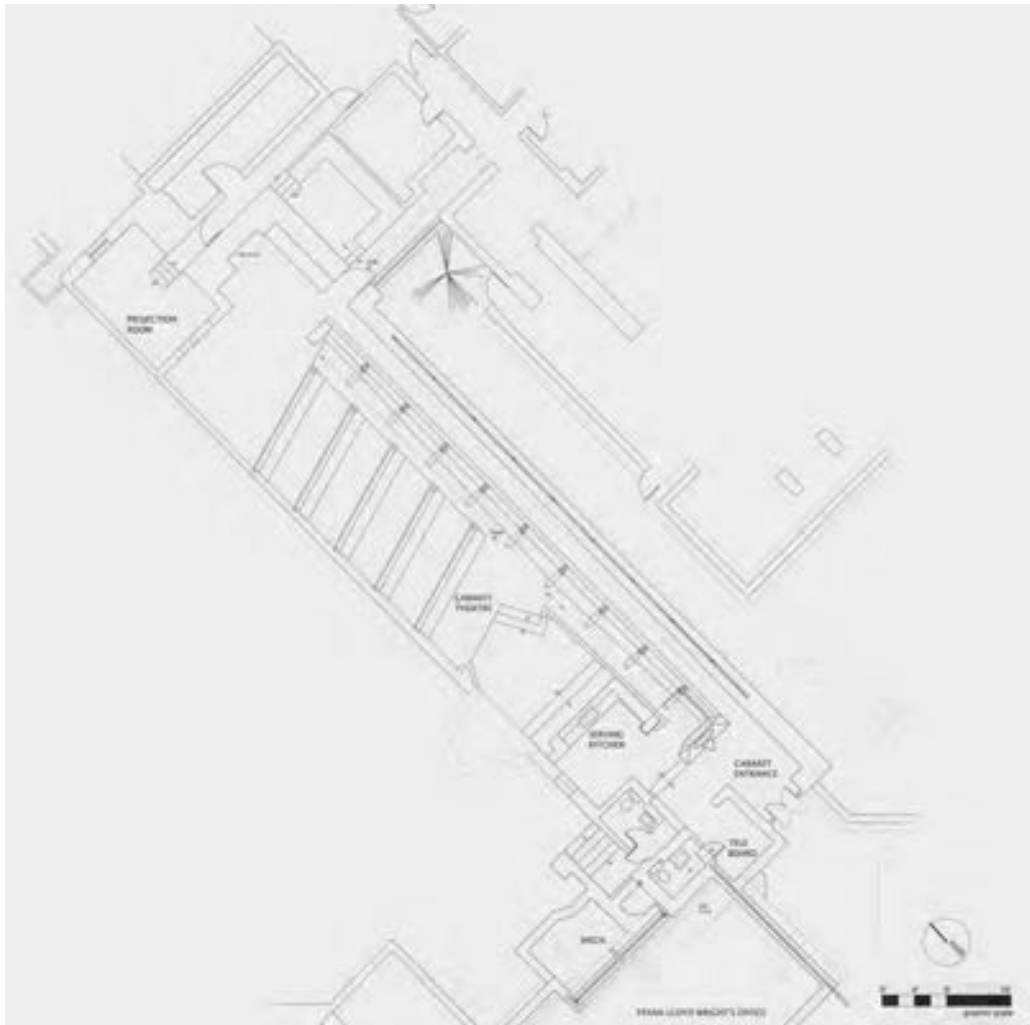
Figure 11-93 - Cabaret Floor Plan

- Desert Masonry
All areas of non-matching patches and replacement concrete in the desert masonry walls should be replaced. Prior to replacement, analysis of the desert masonry walls should be conducted to identify physical properties and mix designs for all repairs. Mock-ups should be prepared and materials and processes well documented.
Clean desert masonry walls and ceiling to remove all efflorescence.

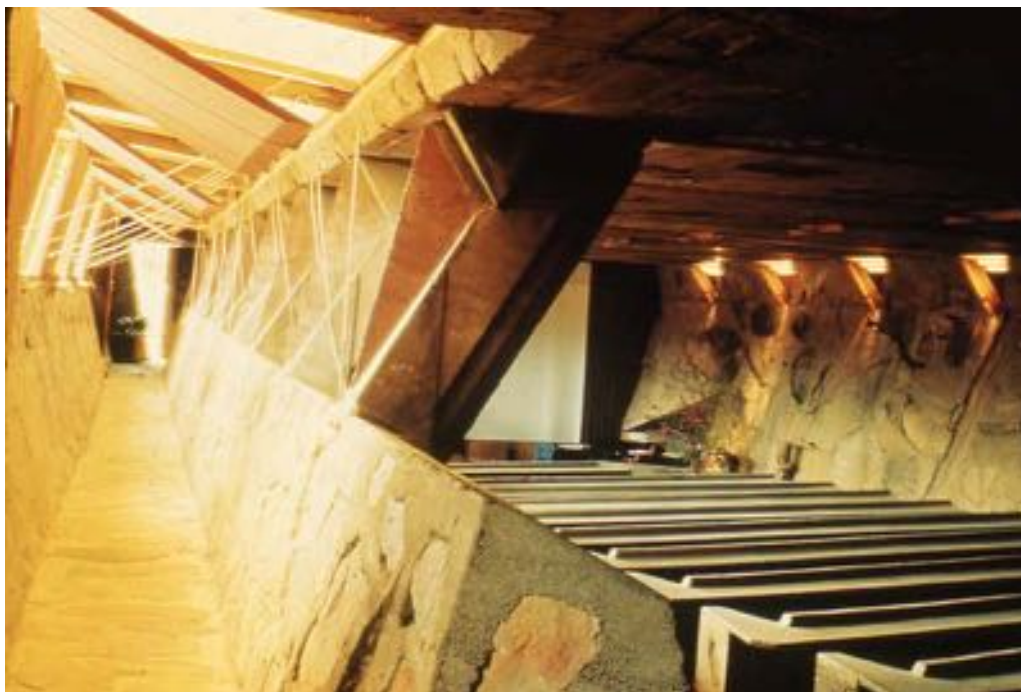
Figure 11-94 - Interior of Cabaret looking south at operable canvas flaps, ca. 1955 (The Frank Lloyd Wright Foundation Archives, The Museum of Modern Art | Avery Architectural & Fine Arts Library, Columbia University, New York).

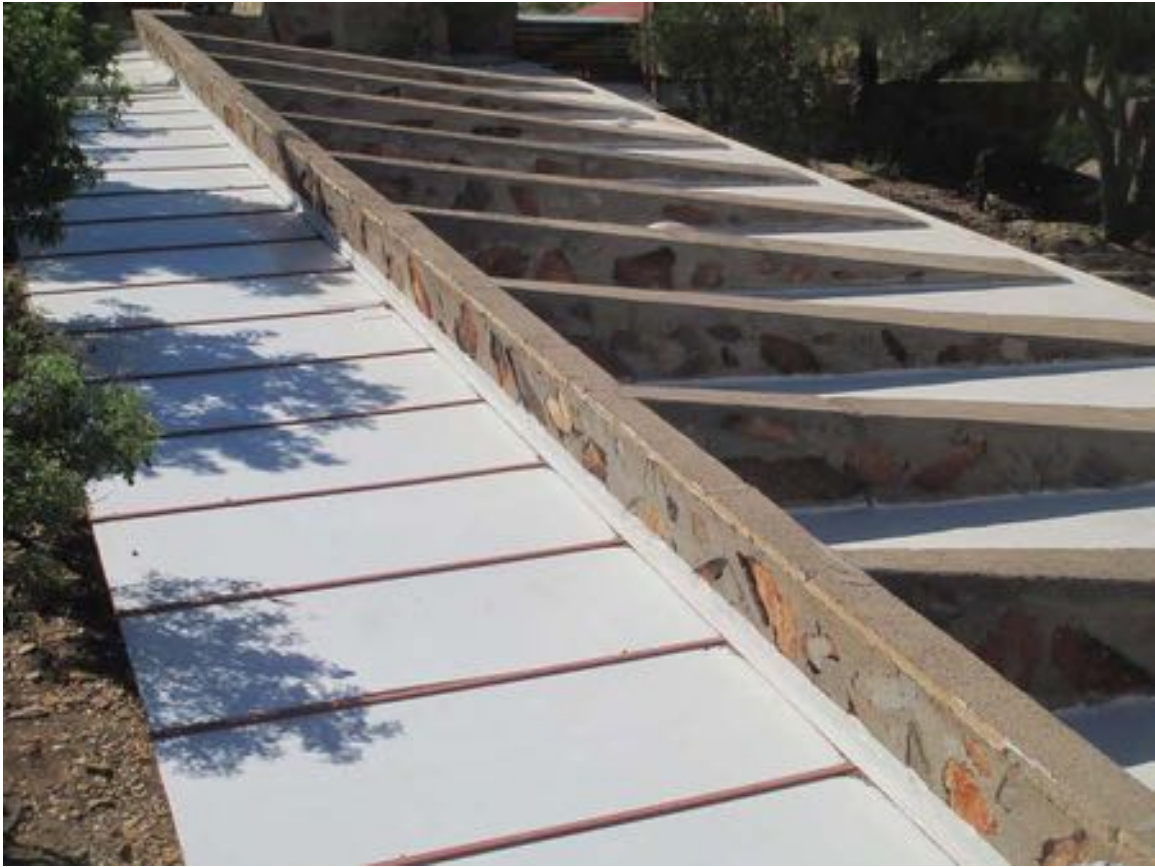
Figure 11-99 - Roof of Cabaret, 2014 (Harboe Architects).

- Roof Structure
Recommendations made in the report prepared by MCC 1200 Architectural Engineers in 2013, including structural monitoring of the roof slab and materials testing, should be executed prior to any restoration project on the Cabaret.

- Roof Surface
The non-historic roof membrane is to be replaced with a new liquid applied membrane.
- Doors
The wood entry doors on the Cabaret are to be painted to match the color of doors prior to Wright's death in 1959. More research is needed to determine the historic color of the doors. The decorative carved wood panels on the interior of the doors are to be carefully documented, dismantled, and stored in the archives. New replica carved wood panels are to be created and installed on the doors.

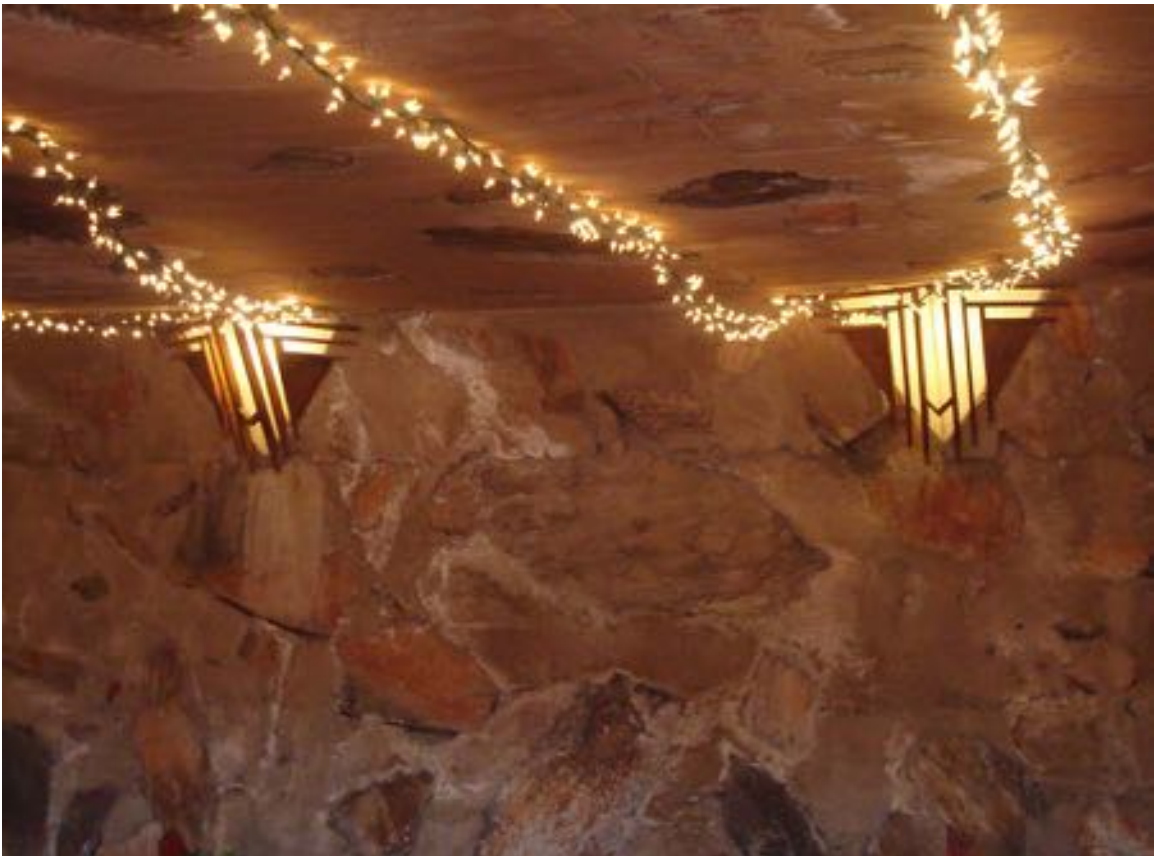
Figure 11-104 - Cabaret theater lights, 2014 (Harboe Architects).

- Wood Trim
Recreate the decorative wood trim at the ceiling of the Cabaret using historic drawings and photographs.
- Lighting
Remove the string lights at the ceiling. The existing wall sconces are to remain. Missing and damaged lenses on the lights at the base of the wall in the corridor and along the aisle in the theater are to be replaced with new lenses that match the color and translucency of the existing lenses. Restore the ceiling light above the stage.

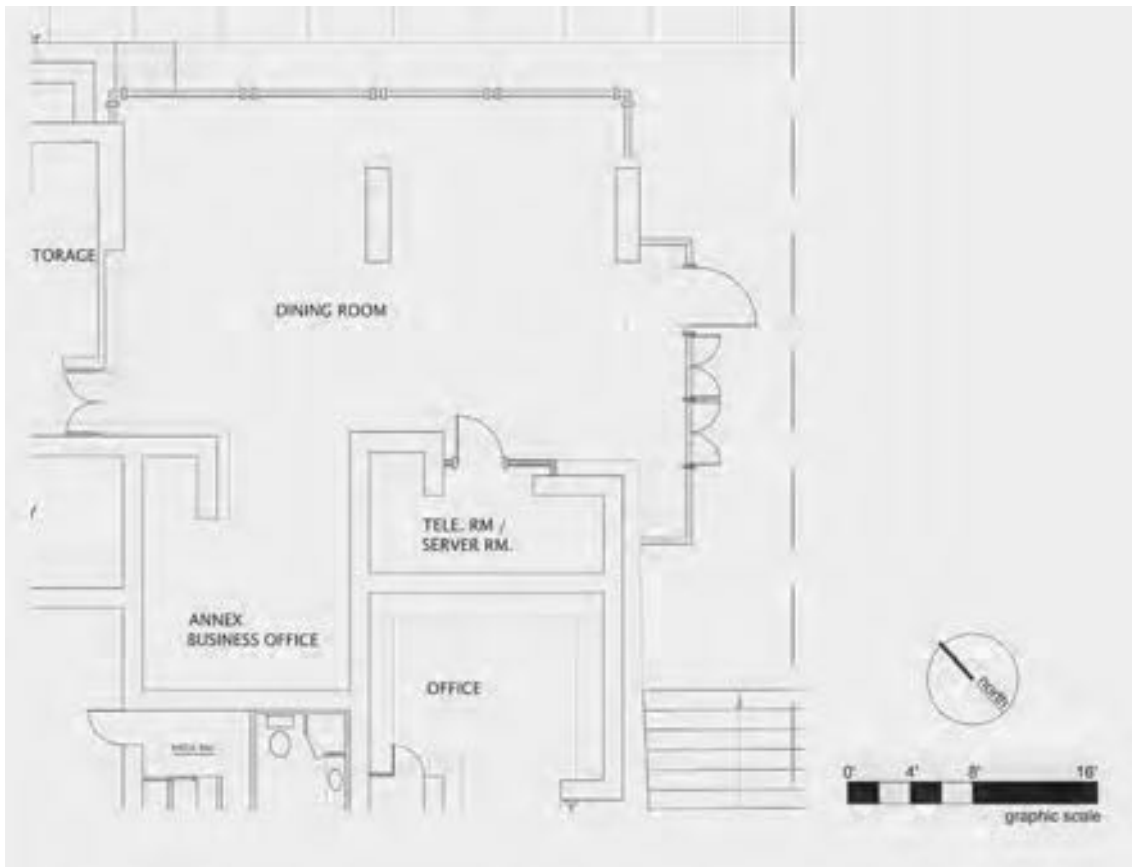
Figure 11-106 - Dining Room Floor Plan

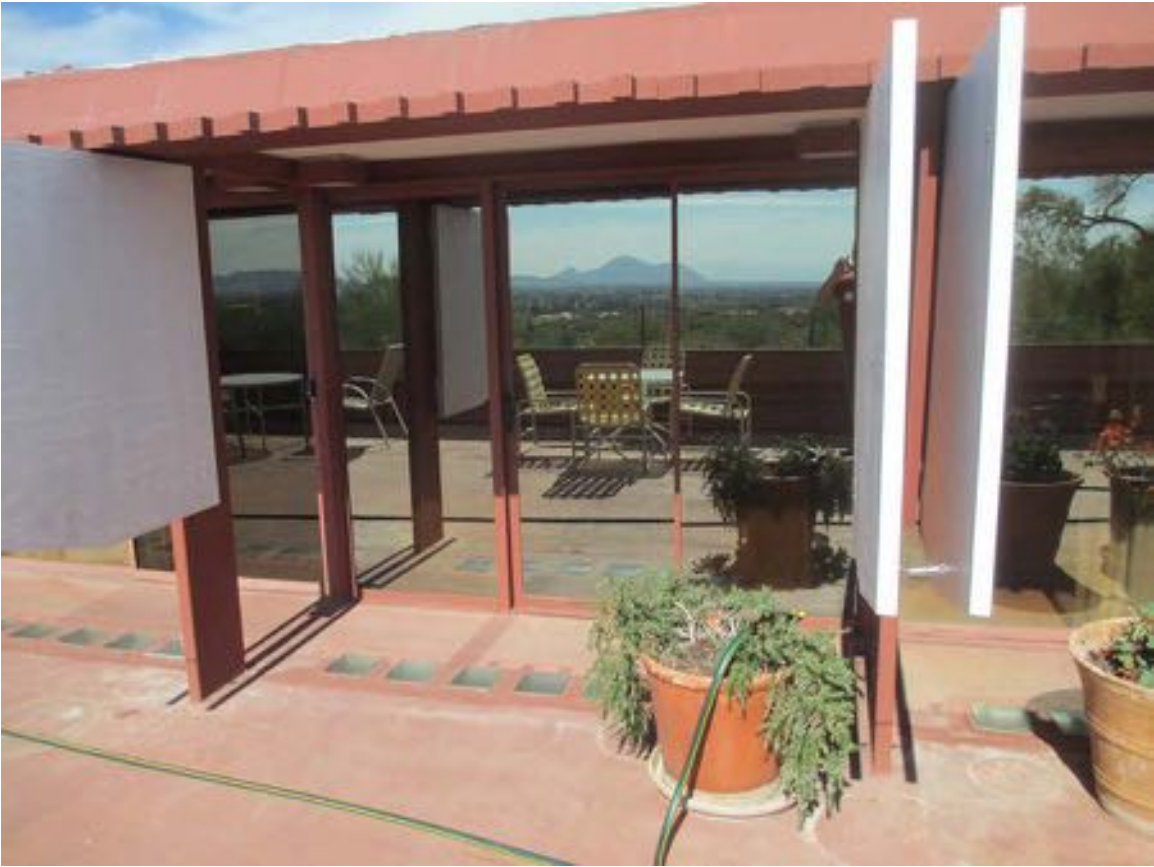
Figure 11-117 - Guest Deck looking north at guest room with open wood flaps, 2014 (Harboe Architects).

- Doors
The mirrored glass doors at the entrances to each guest room are to be replaced with clear glass doors.
- Plywood Shutters
The painted plywood shutters are to be prepared and painted.

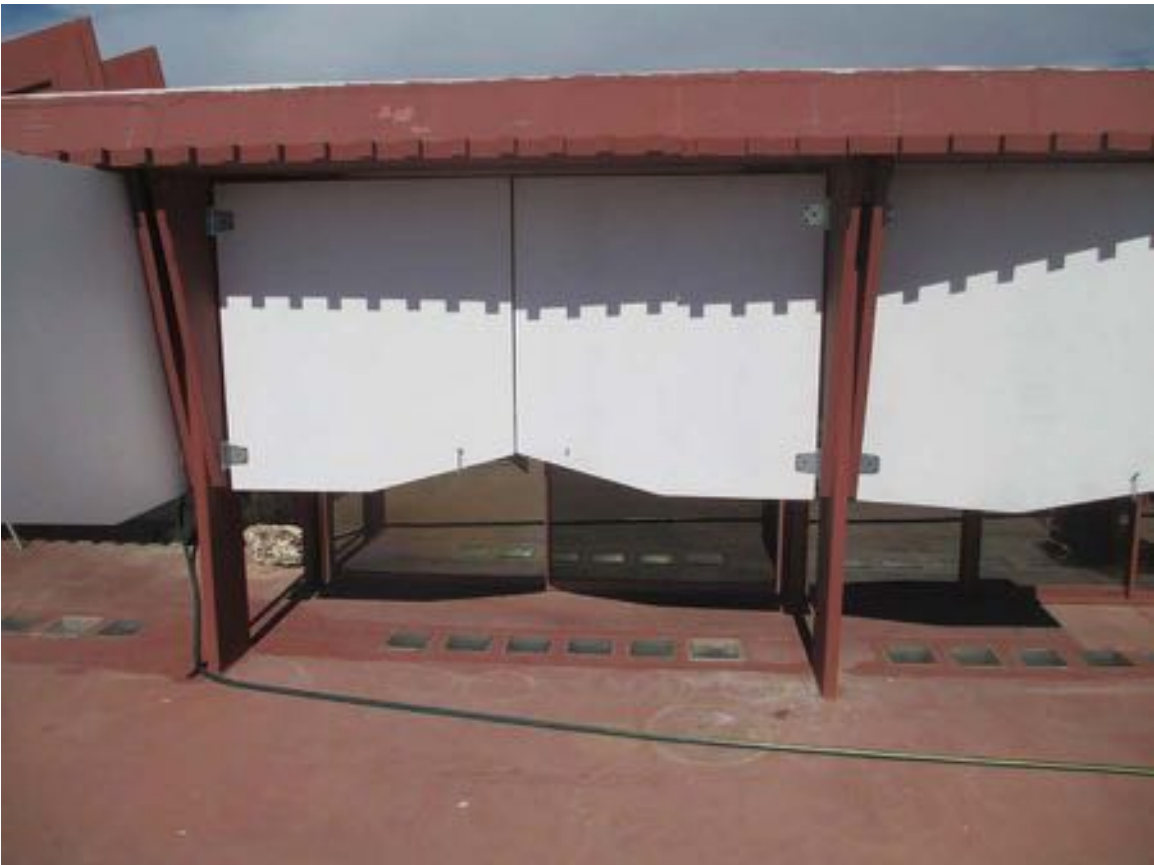
Figure 11-118 - Guest Deck looking north at guest room with closed wood flaps, 2014 (Harboe Architects).

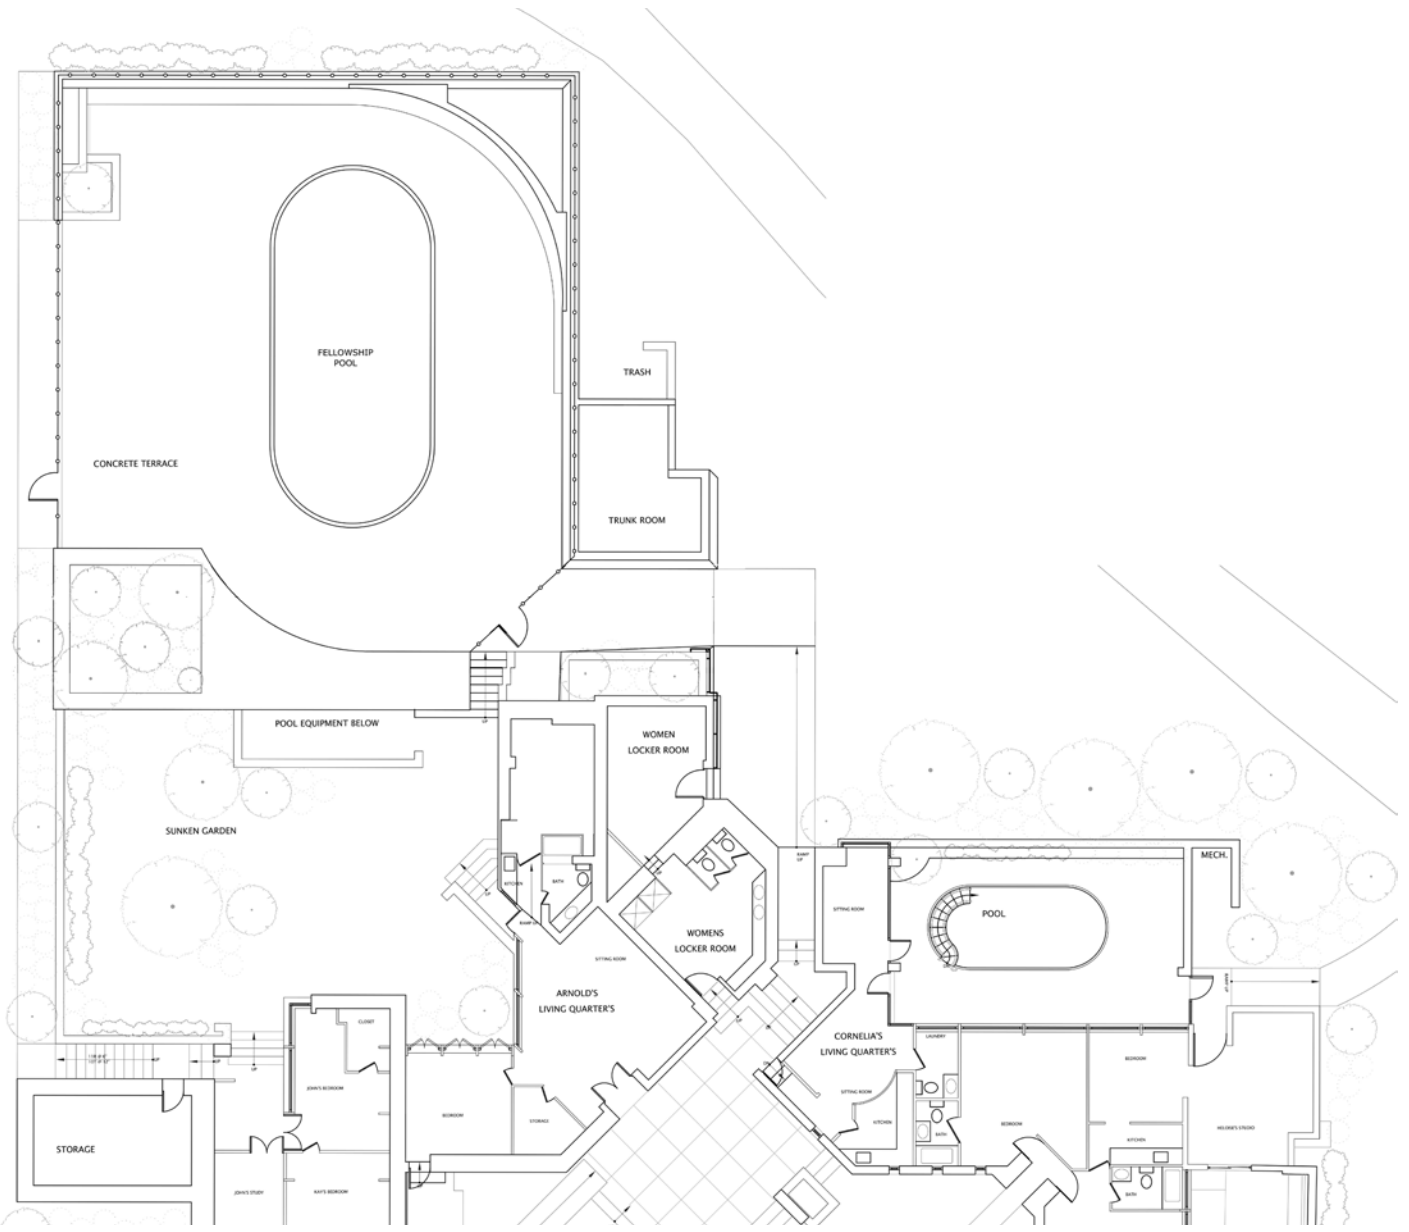
Figure 11-123 - Apprentice Court Floor Plan

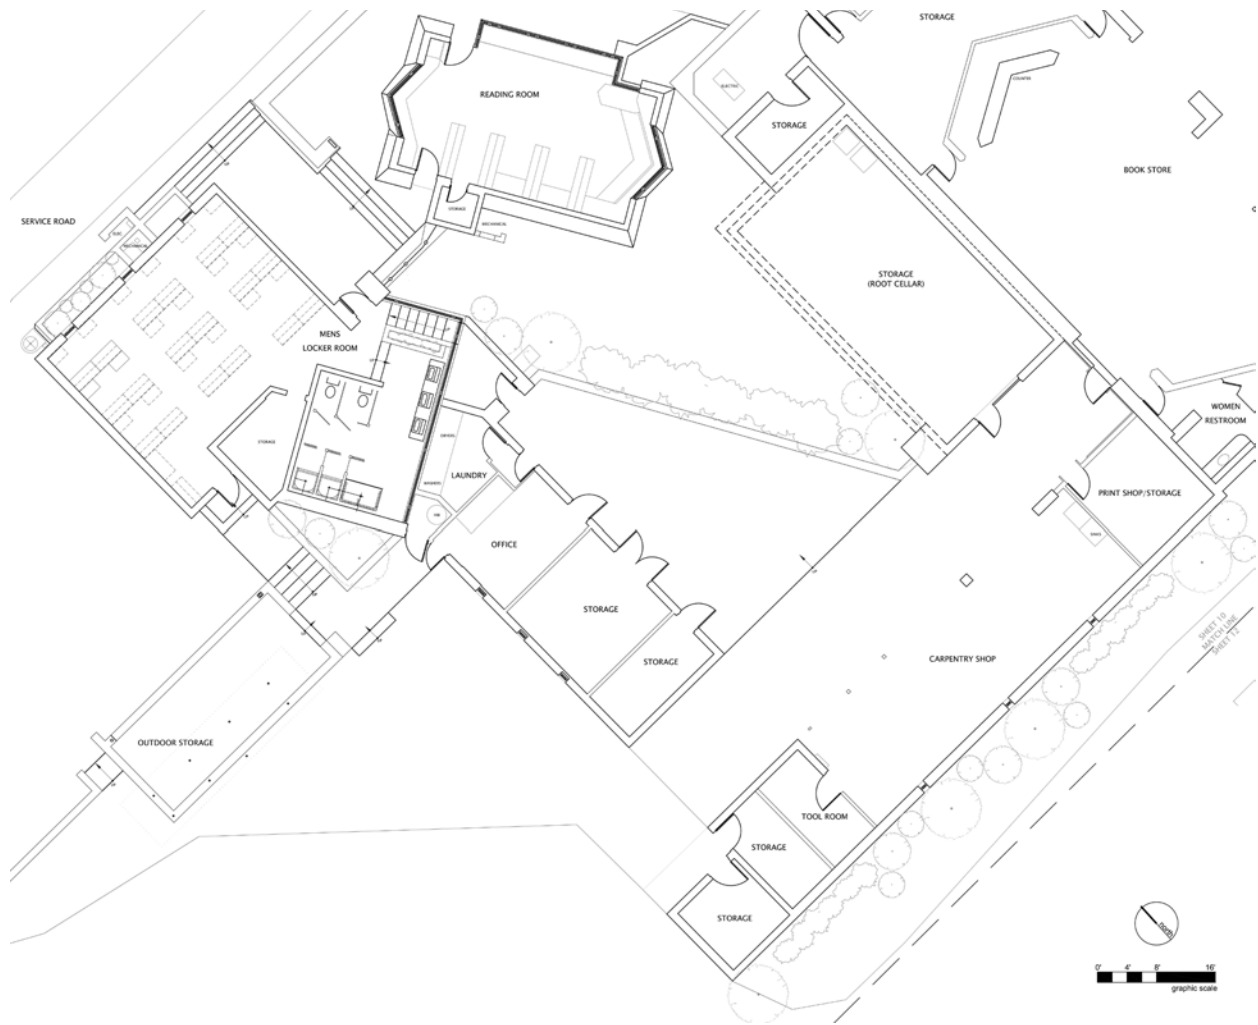
Figure 11-129 - Shops Floor Plan

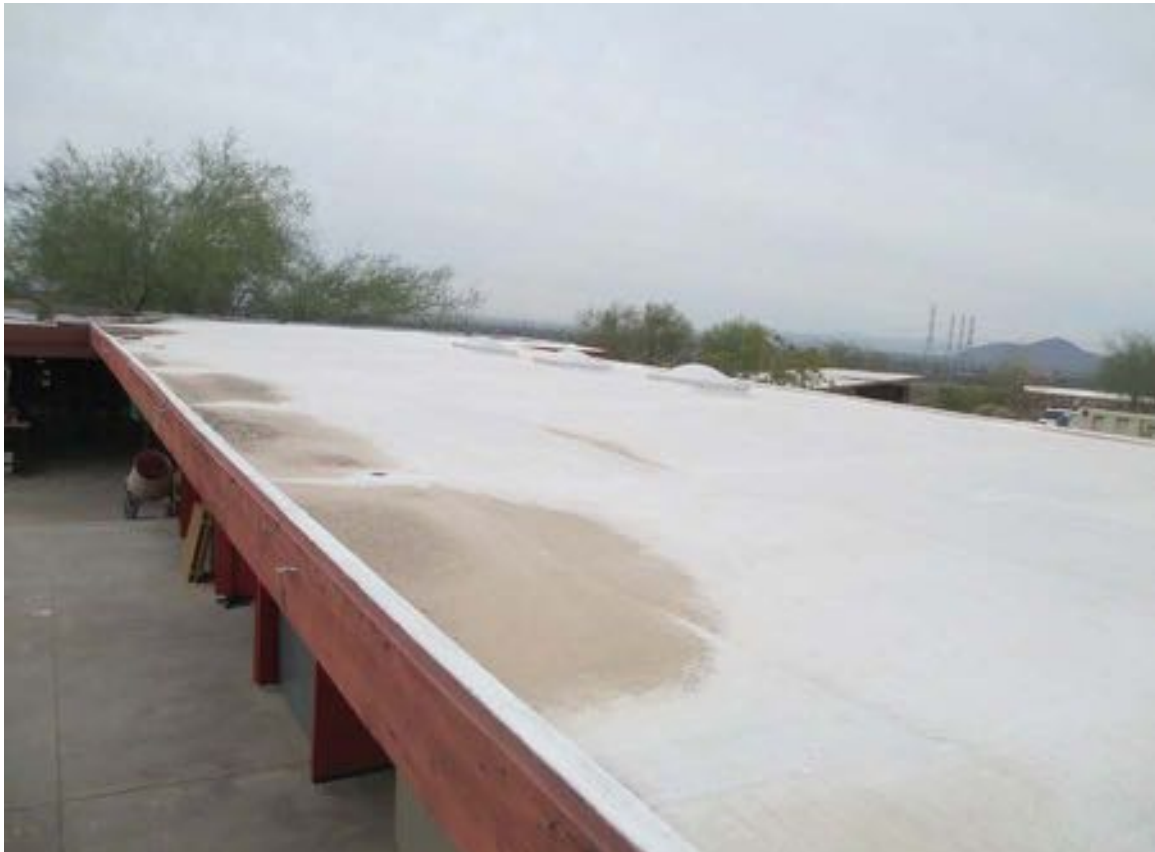
Figure 11-134 - View of Shops roof, 2014 (Harboe Architects).

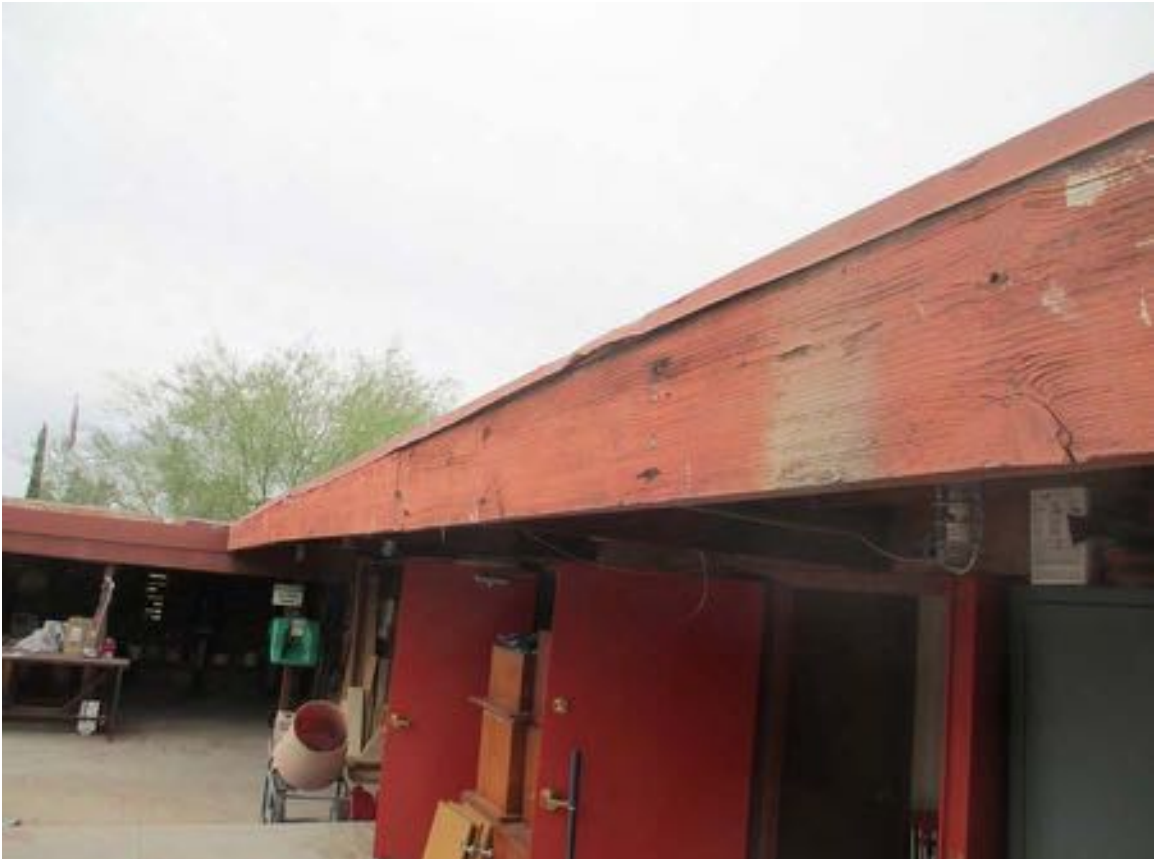
Figure 11-135 - View of Shops showing wood fascia at eaves, 2014 (Harboe Architects).

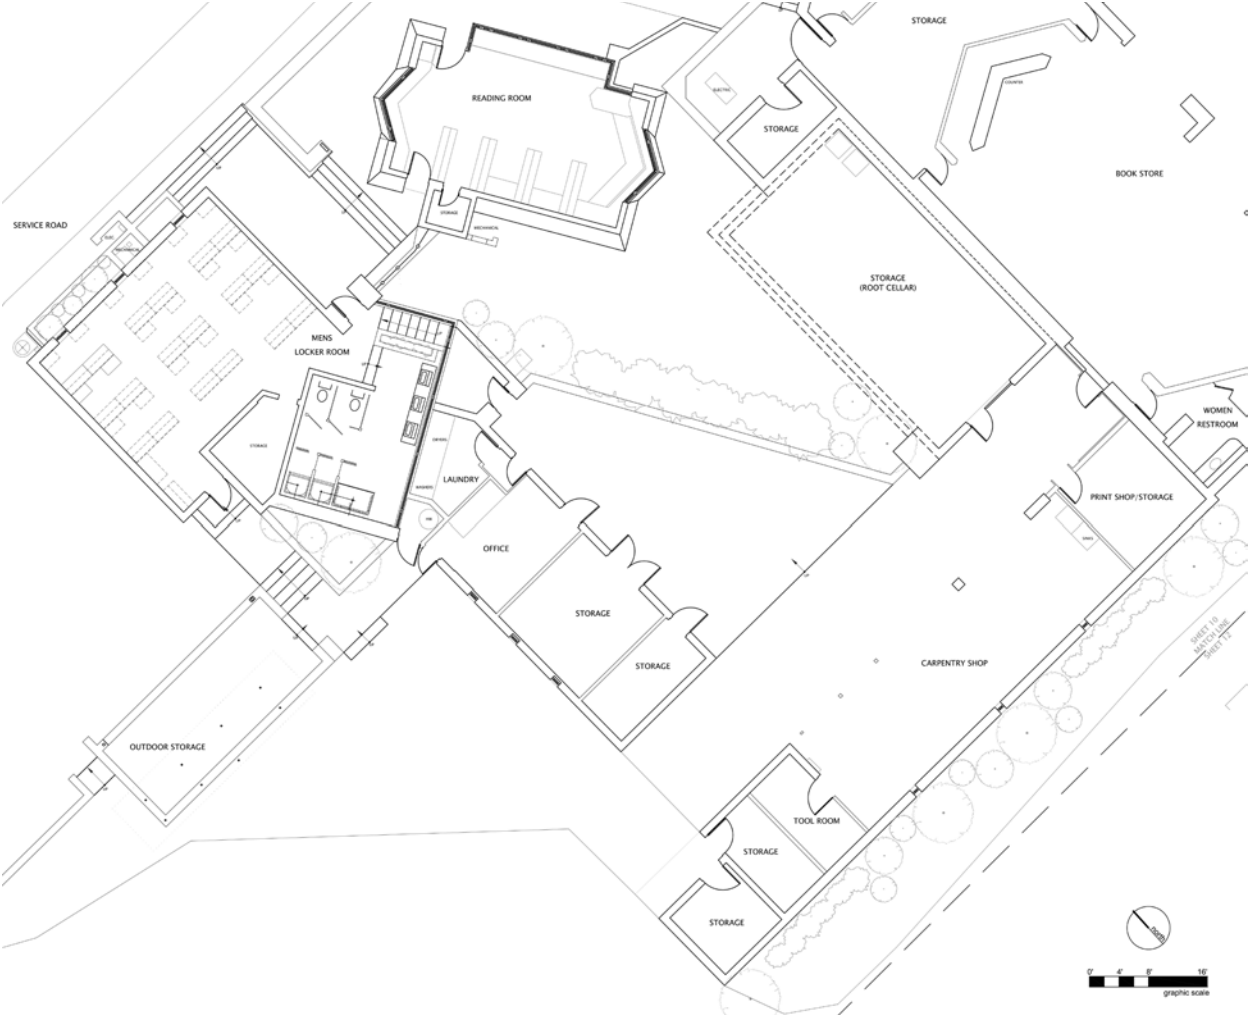
Figure 11-138 - Men's Locker Room Floor Plan

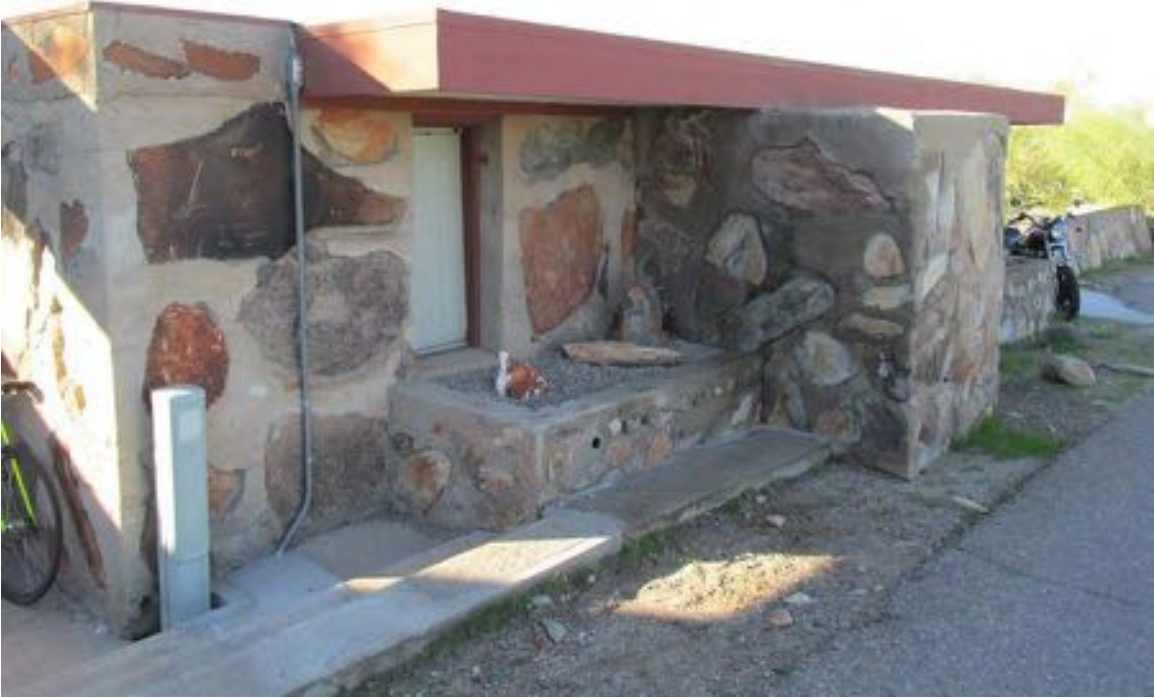
Figure 11-139 - North side of Men's Locker Room, 2015 (Harboe Architects).

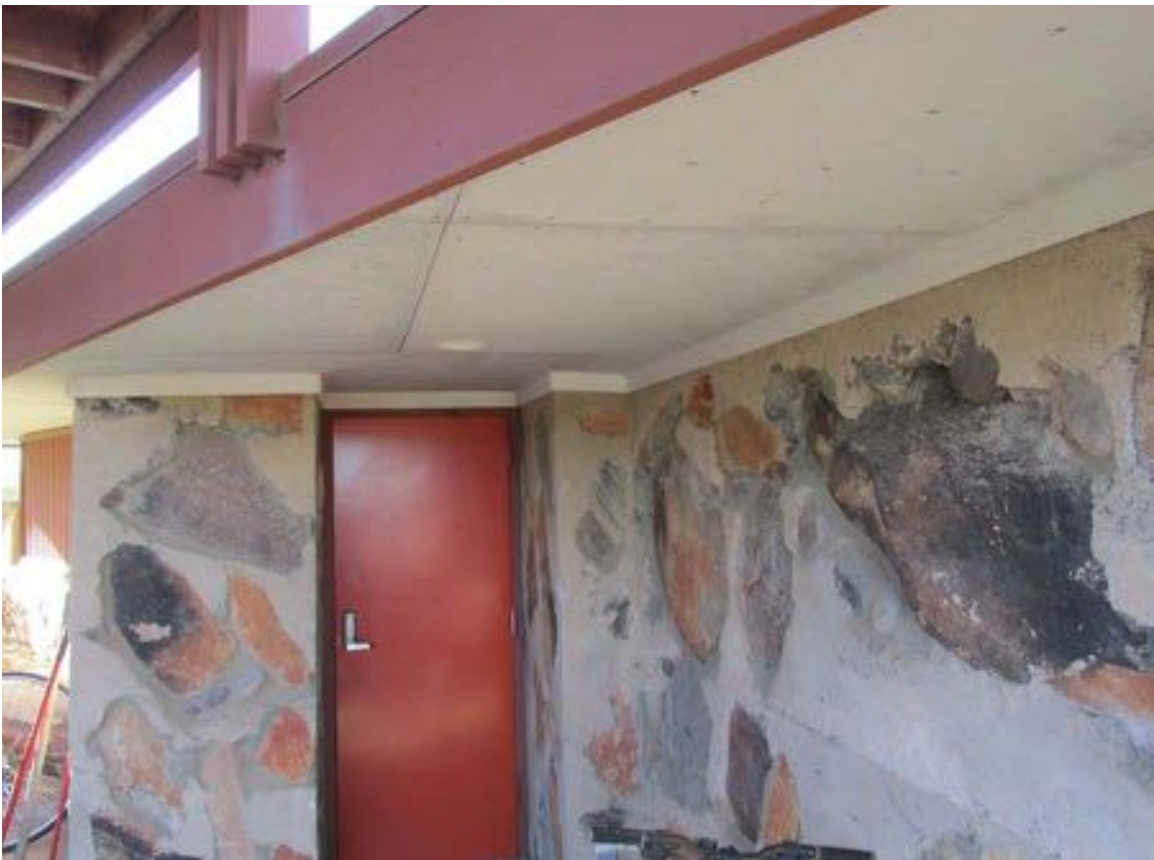
Figure 11-140 - Soffit on northeast side of Men's Locker Room, 2015 (Harboe Architects).

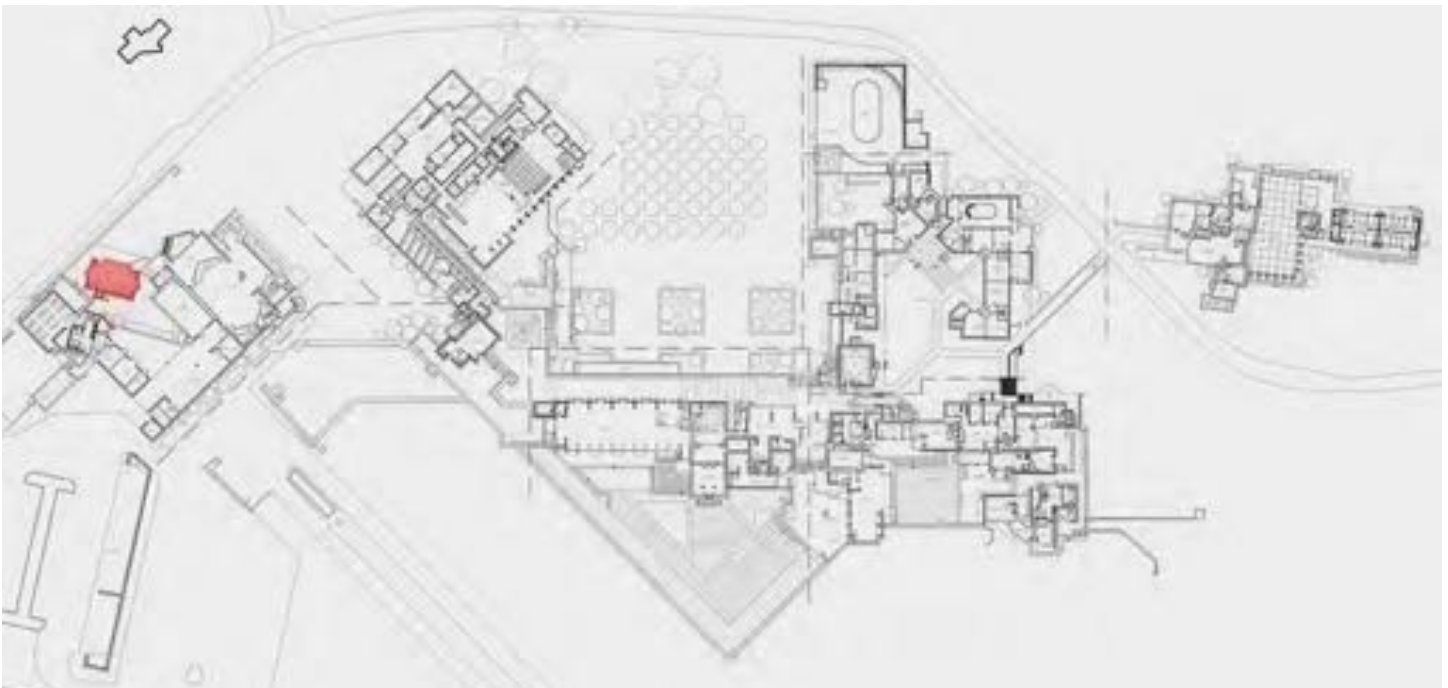
Figure 11-143 - Reading Room Location Plan

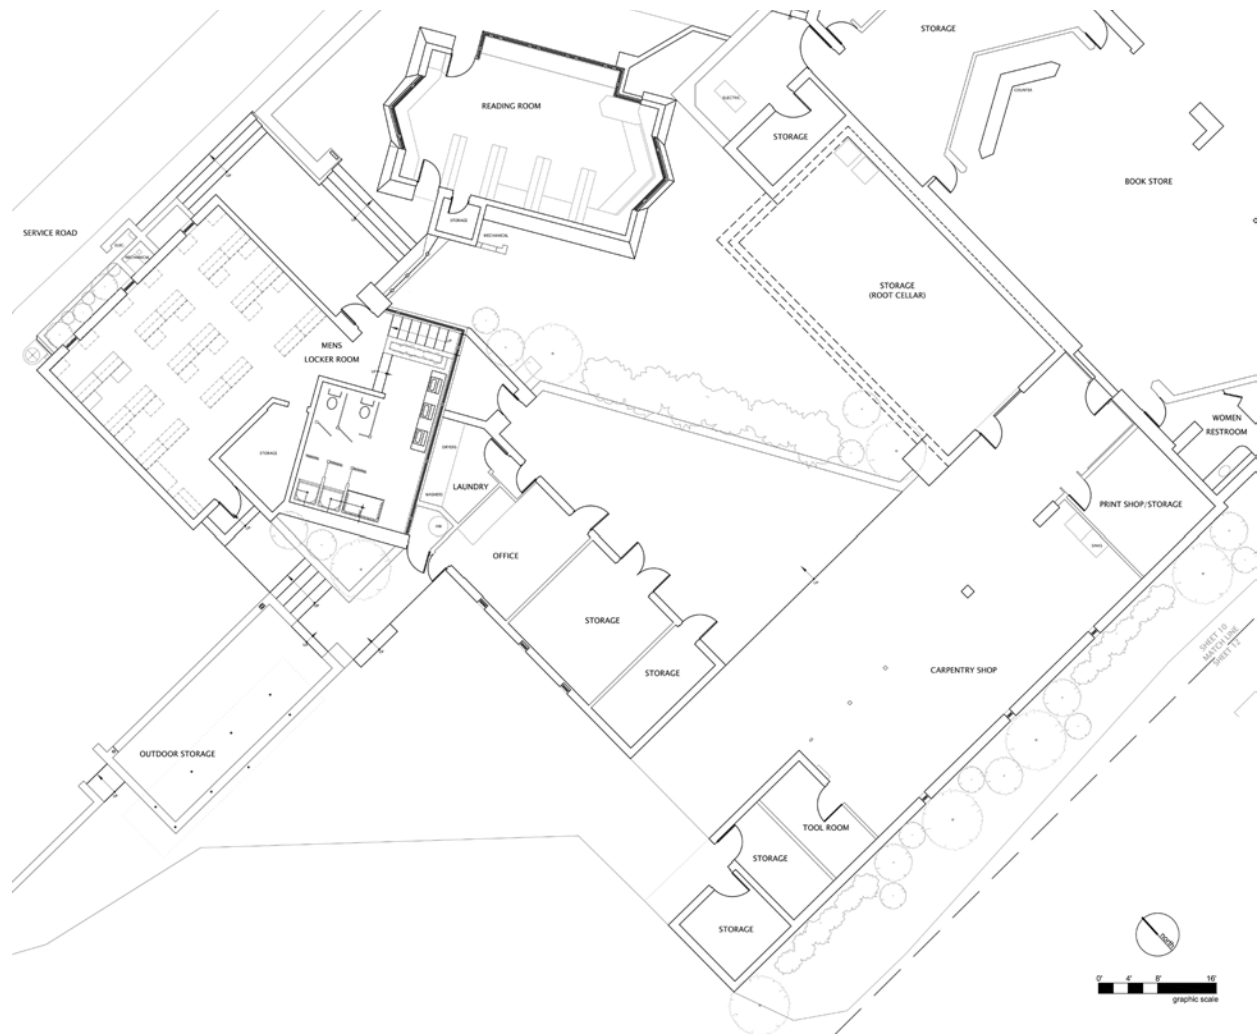
Figure 11-144 - Reading Room Floor Plan

- Interior Renovations
The interior of the Reading Room can be renovated as necessary to meet the programmatic needs of the Frank Lloyd Wright Foundation. A square footage allowance is to be included for general remodeling.
- Fire Protection
It may be necessary to provide a new fire suppression system per Scottsdale code requirements. For the purpose of pricing the scope of work, it should be assumed that a new concealed sprinkler system will be installed.

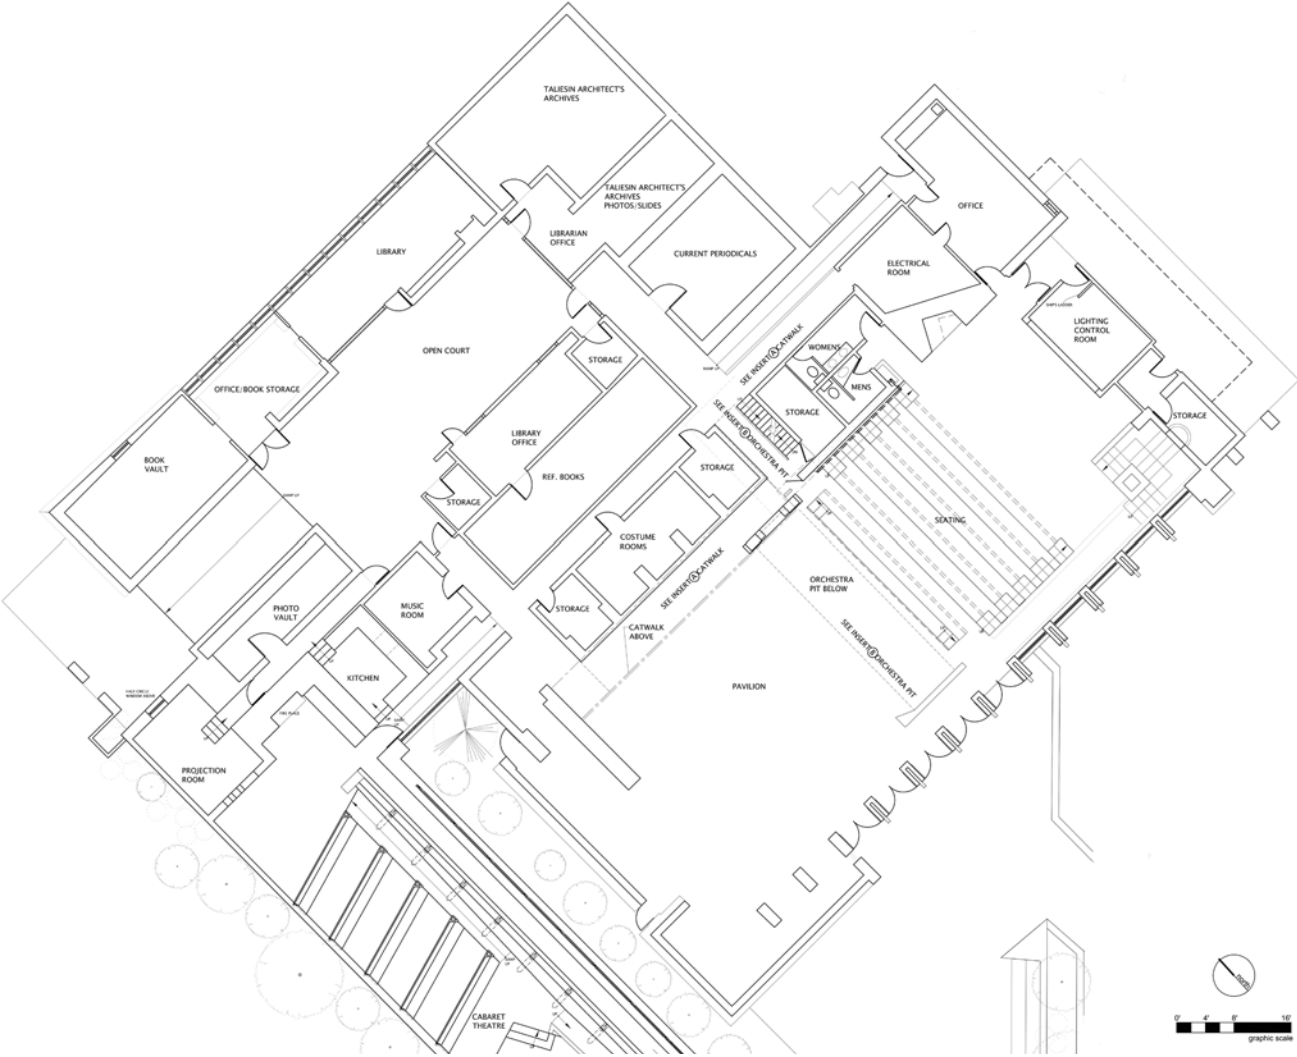
Figure 11-159 - Pavilion Floor Plan

- Flat Roofs
The existing flat roofs are to be replaced with a new liquid applied membrane. Exposed metal at the roof eaves is to be prepared and painted. There is extensive damage to the decking on the flat roofs on all sides of the Pavilion. All existing plywood decking is to be replaced with new plywood decking.

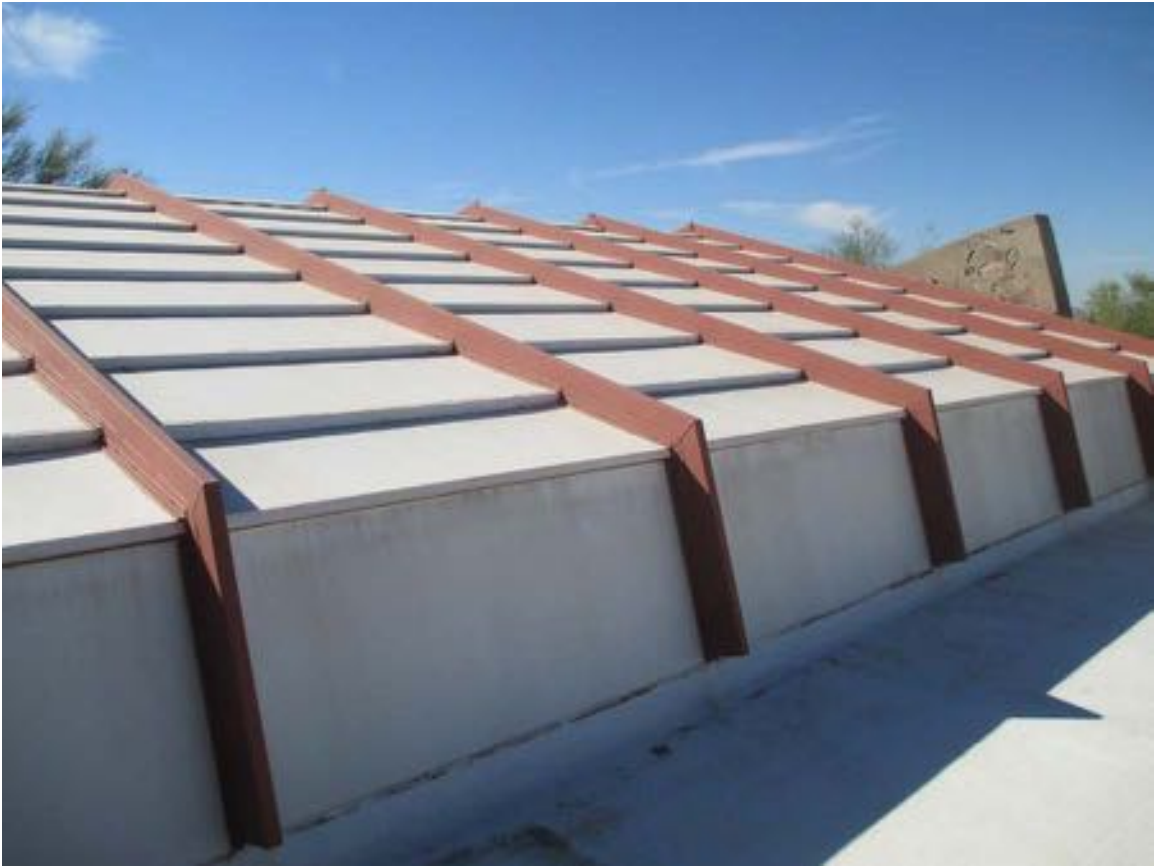
Figure 11-160 - Pavilion roof, 2014 (Harboe Architects).

- Roof Structure
The steel roof structure is to remain and be painted as necessary for continued maintenance.
- Roof Surface
The existing non-historic acrylic roof system with interior canvas panels is to be maintained. As materials deteriorate or become damaged they should be replaced with new materials to match the existing. If at some point in the near future it is determined that the roof should be replaced, a new roof with rigid, translucent panels should be installed. The new roof should retain the same character and appearance as the current roof.
