TALIESIN WEST PRESERVATION MASTER PLAN

Harboe Architects, PC

MAY 21, 2015

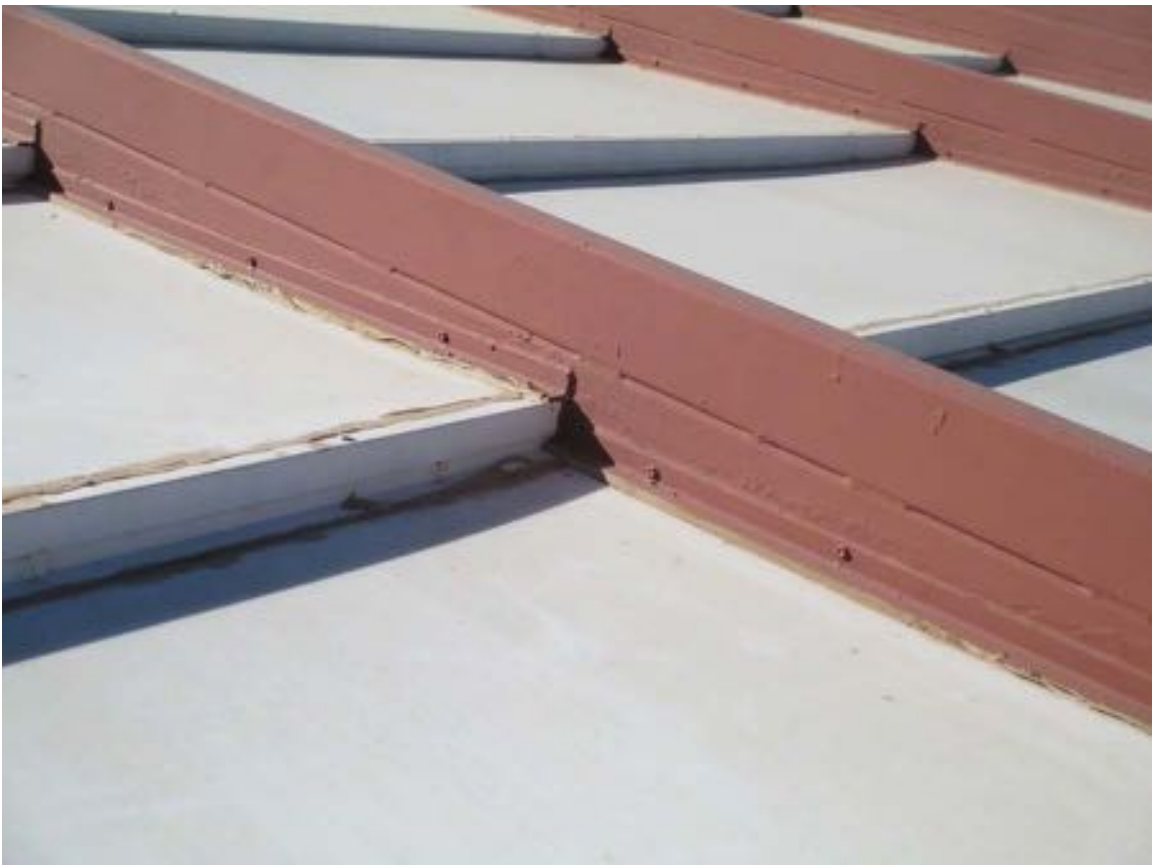
Figure 11-161 - Detail of Pavilion roof, 2014 (Harboe Architects).

- Roof Structure
The steel roof structure is to remain and be painted as necessary for continued maintenance.
- Roof Surface
The existing non-historic acrylic roof system with interior canvas panels is to be maintained. As materials deteriorate or become damaged they should be replaced with new materials to match the existing. If at some point in the near future it is determined that the roof should be replaced, a new roof with rigid, translucent panels should be installed. The new roof should retain the same character and appearance as the current roof.

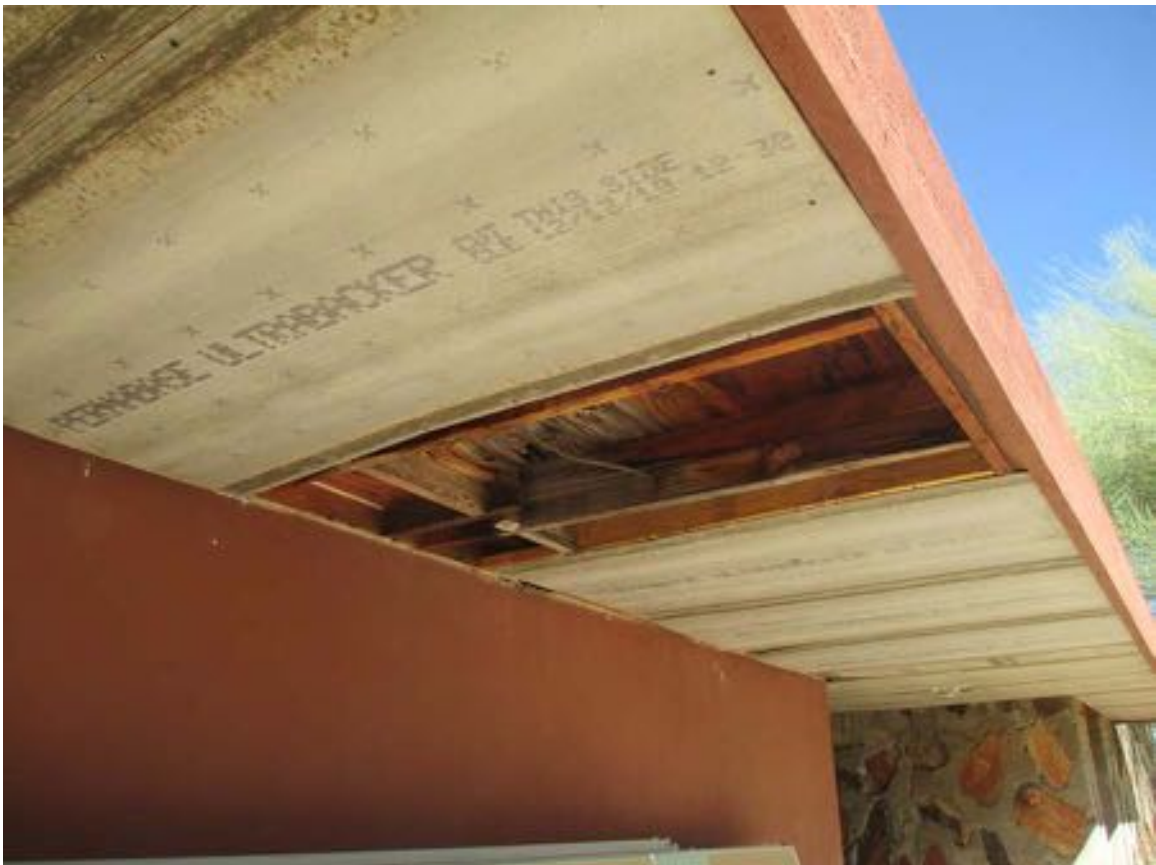
Figure 11-163 - Damaged soffit under flat roof on east side of the Pavilion, 2014 (Harboe Architects).

- Flat Roofs
The existing flat roofs are to be replaced with a new liquid applied membrane. Exposed metal at the roof eaves is to be prepared and painted. There is extensive damage to the decking on the flat roofs on all sides of the Pavilion. All existing plywood decking is to be replaced with new plywood decking.

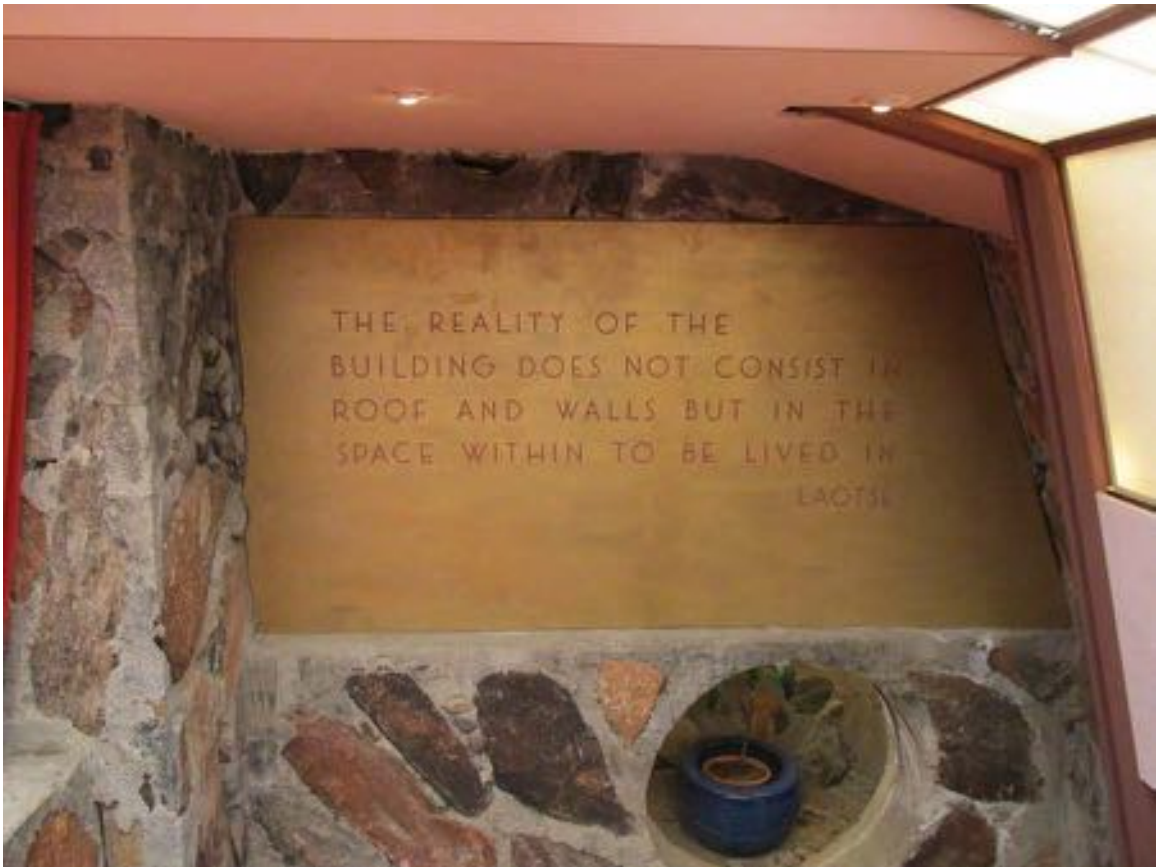
Figure 11-168 - Laotse quote, 2015 (Harboe Architects).

- Laotse Quote
The gold panel with the Laotse quote on it is to be carefully cleaned and conserved.
- Finishes, Fixtures & Furnishings
The curtains are stained and worn and are to be replaced. All other interior finishes, fixtures, and furnishings in the Pavilion requires continued cleaning and maintenance.

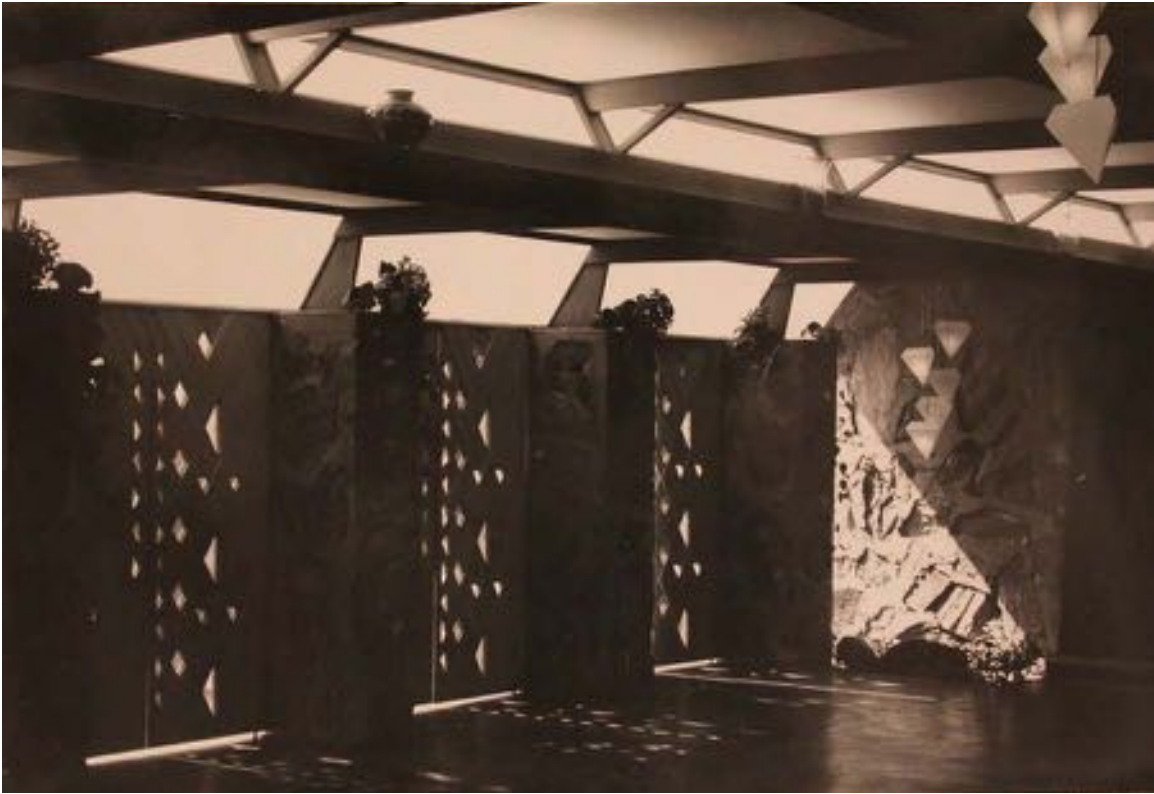
Figure 11-179 - Interior of Atrium looking at decorative concrete and glass panels, ca. 1962 (The Frank Lloyd Wright Foundation Archives, The Museum of Modern Art | Avery Architectural & Fine Arts Library, Columbia University, New York).

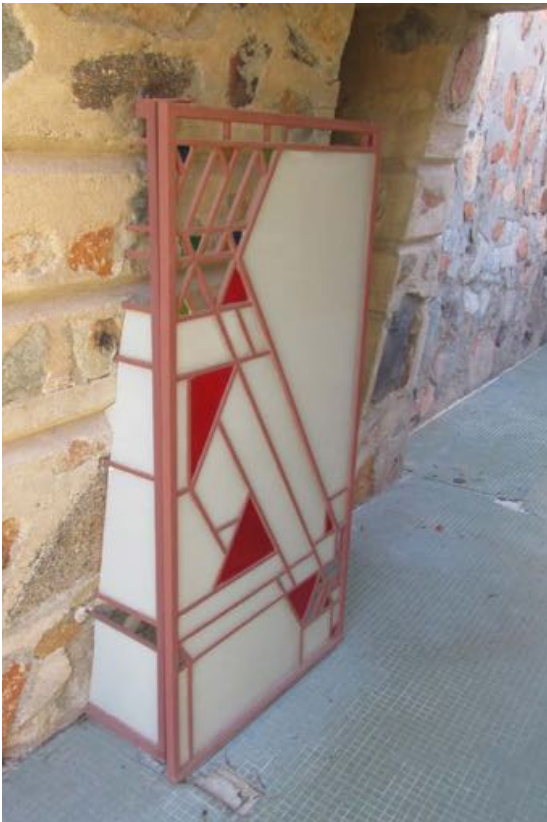
Figure 11-193 - Metal and glass gate at opening to courtyard outside of Finance Office, 2015 (Harboe Architects).

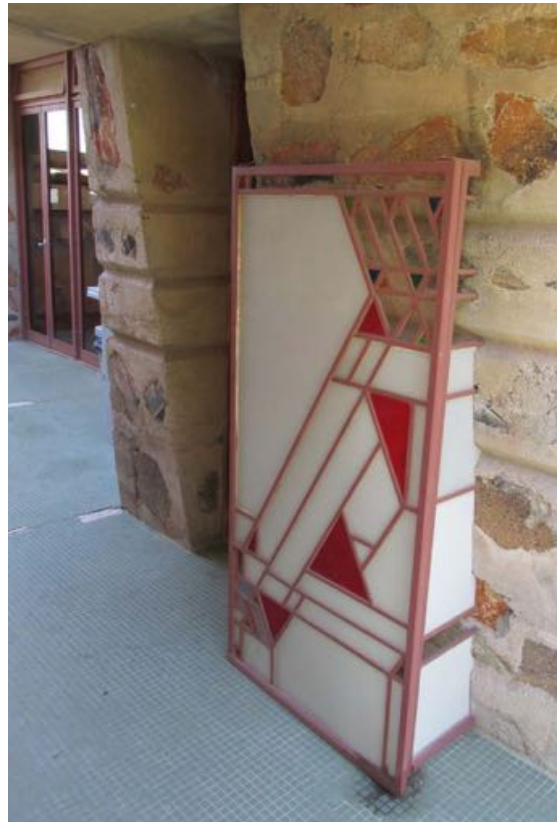
Figure 11-194 - Metal and glass gate at opening to courtyard outside of Finance Office, 2015 (Harboe Architects).

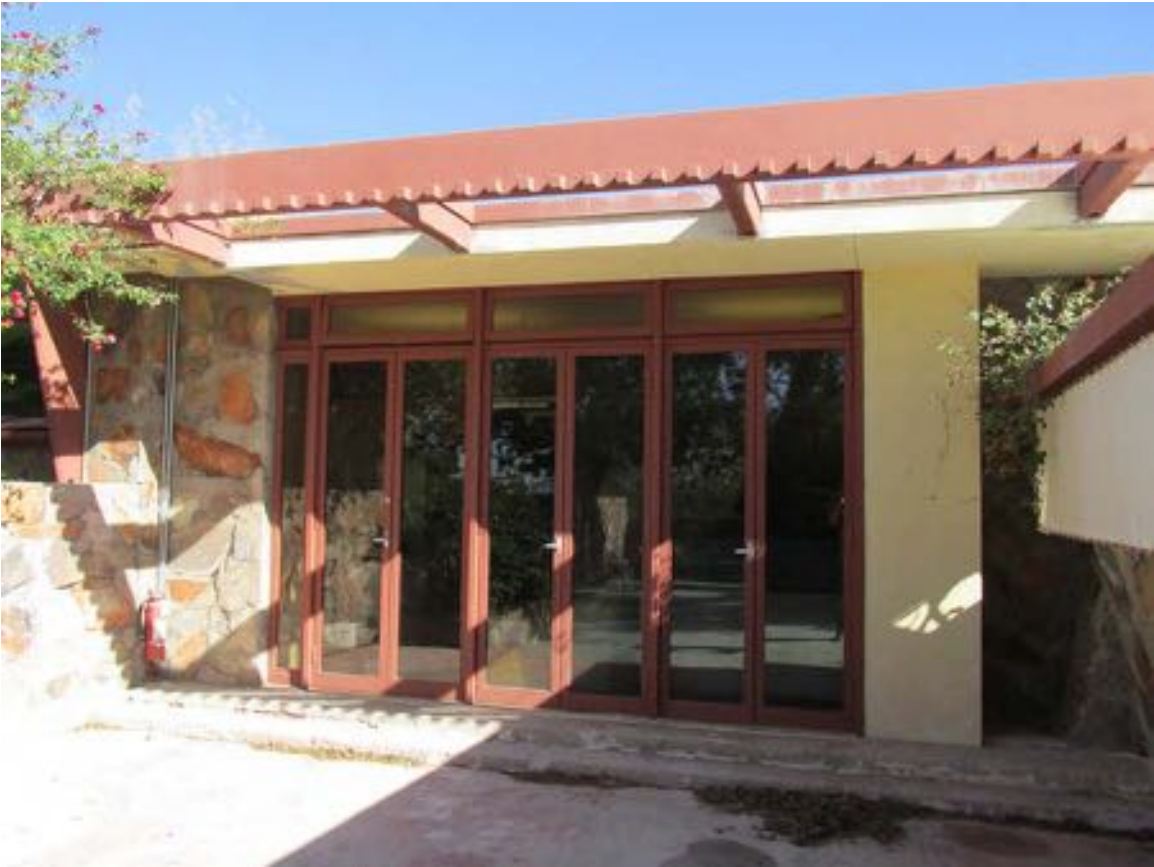
Figure 11-195 - View from lower garden to south side of the Finance Office, 2015 (Harboe Architects).

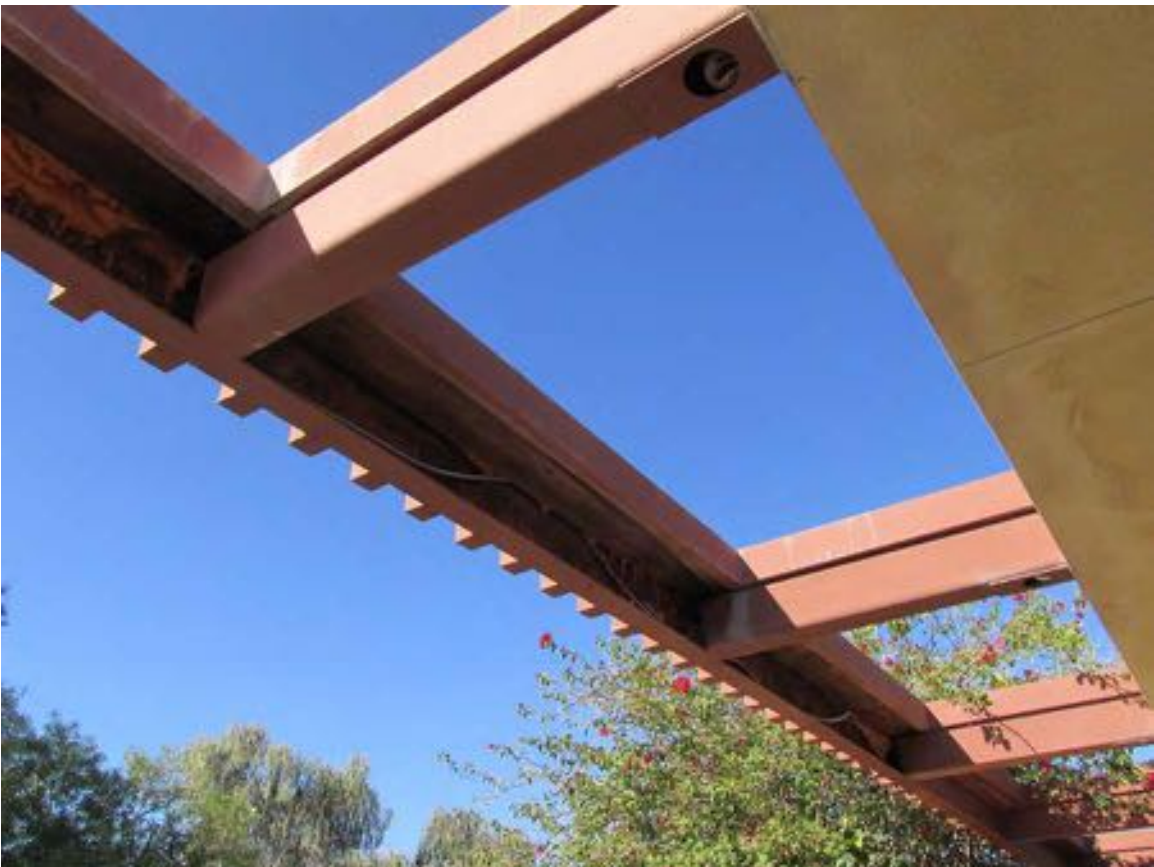
Figure 11-196 - Missing fascia on backside of trellis on south side of the Finance Office, 2015 (Harboe Architects).

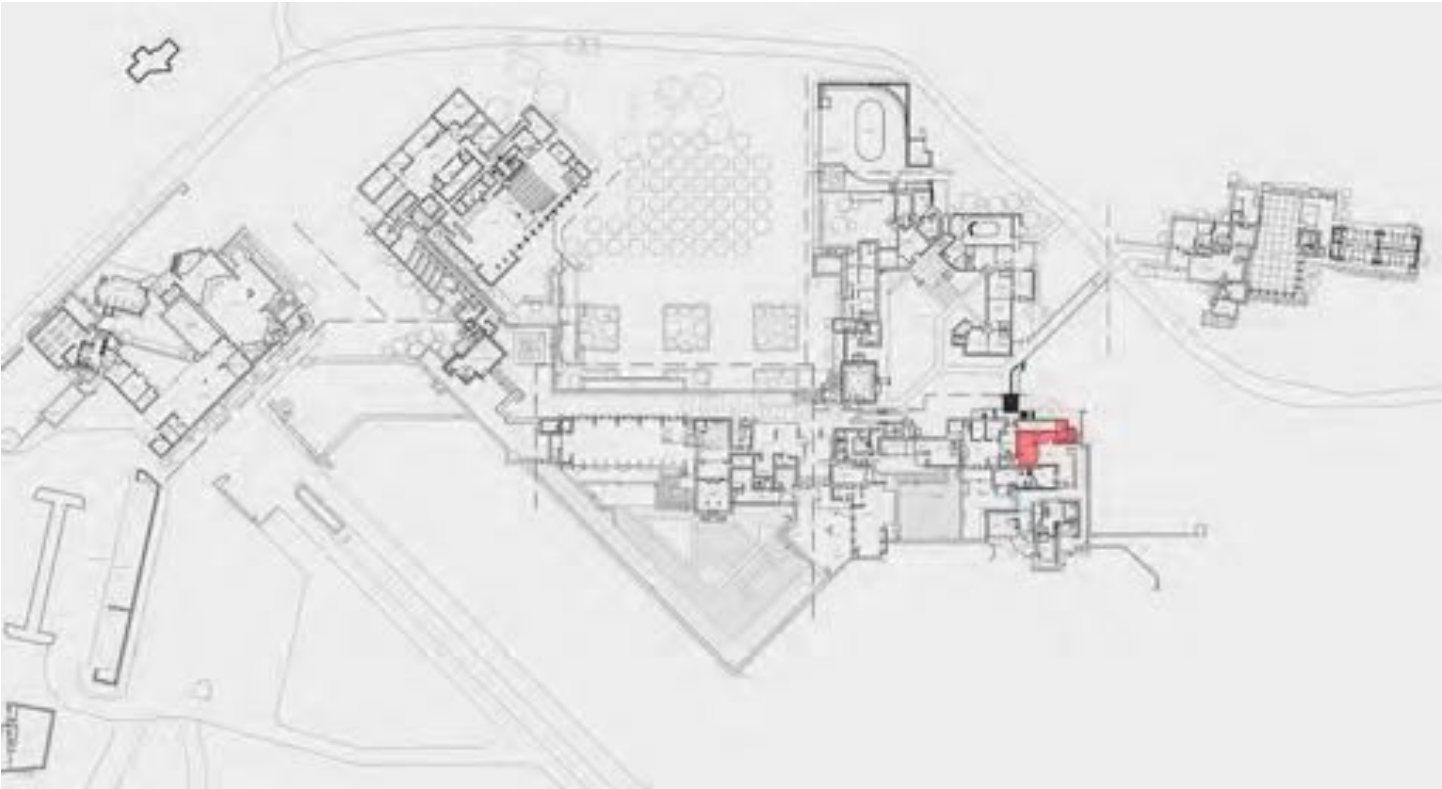
Figure 11-199 - Dekoven Hill Office Location Plan

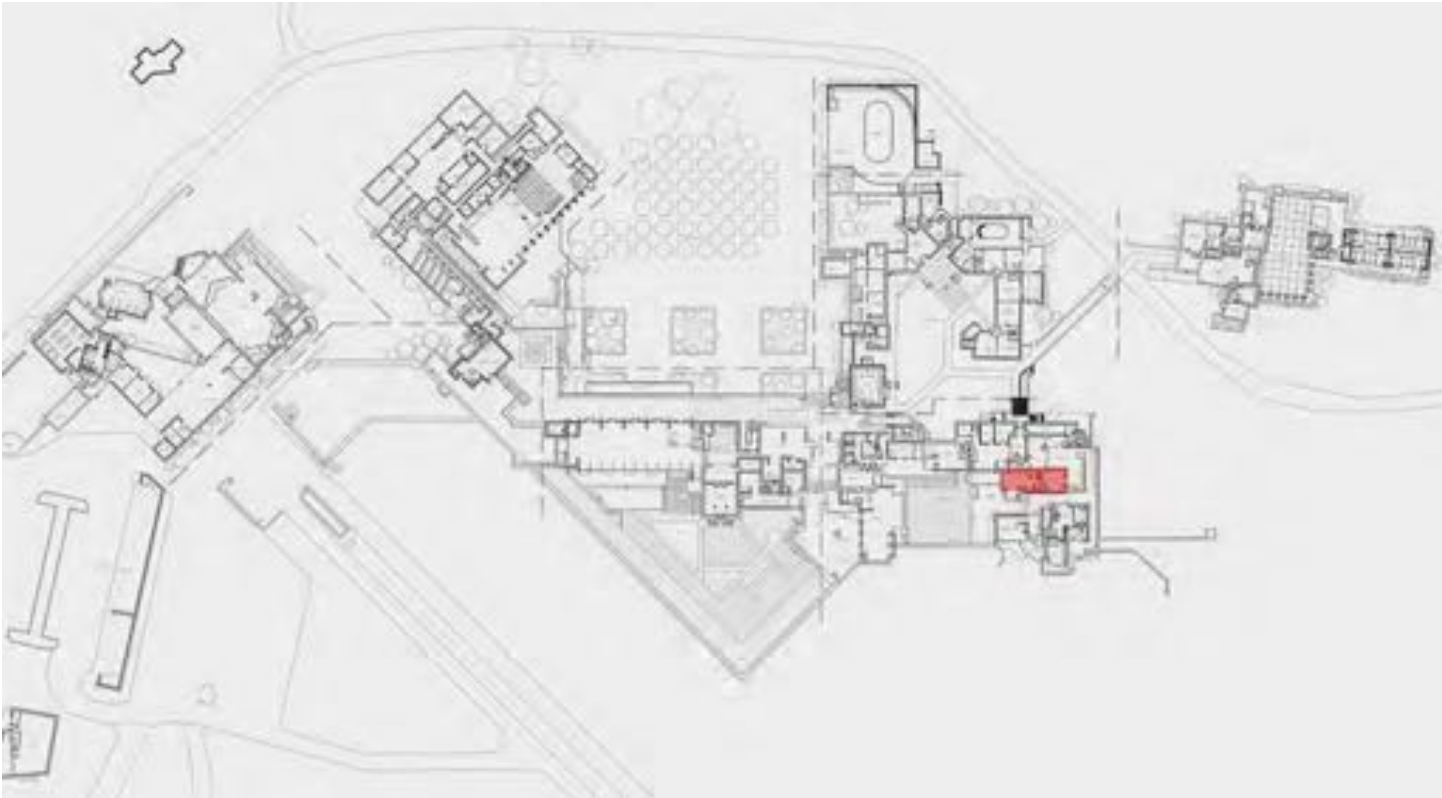
Figure 11-205 - Dr. Joe Office Location Plan

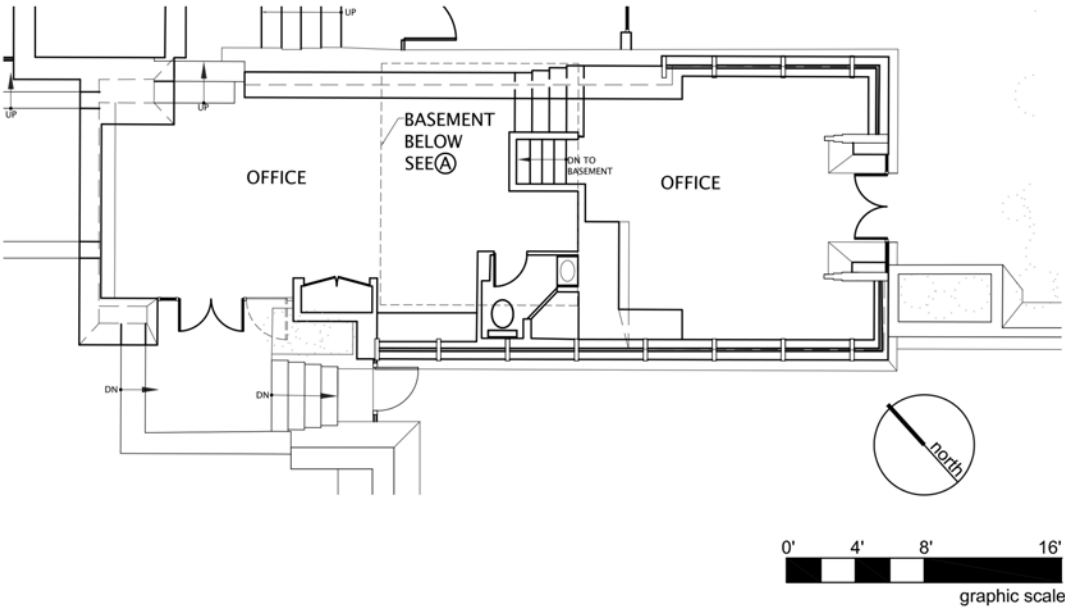
Figure 11-206 - Dr. Joe Office Floor Plan

- Roof
The roof surface is to be replaced with a new liquid applied membrane. Any damaged plywood roof deck discovered after the current roof membrane and foam are removed is to be replaced. Painted wood beams and fascia at the roof eaves is to be prepared and painted.

- Soffits
The soffits are to be prepared and painted.
- Concrete Paving
The exterior concrete paving is in good condition and is to remain.
- Glazing
The existing glazing in the Dr. Joe Office is in good condition and is to remain. Remove the film on the north clerestory windows.

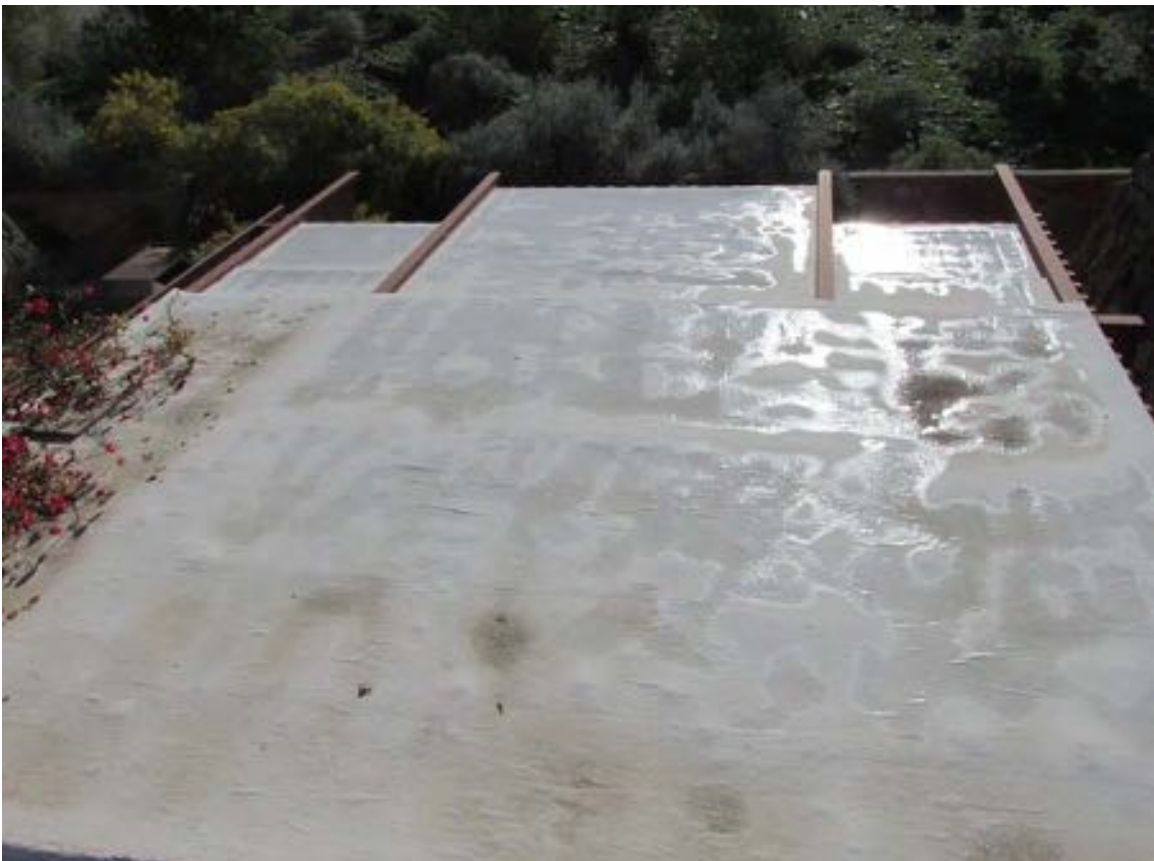
Figure 11-210 - Roof of Dr. Joe Office, 2015 (Harboe Architects).

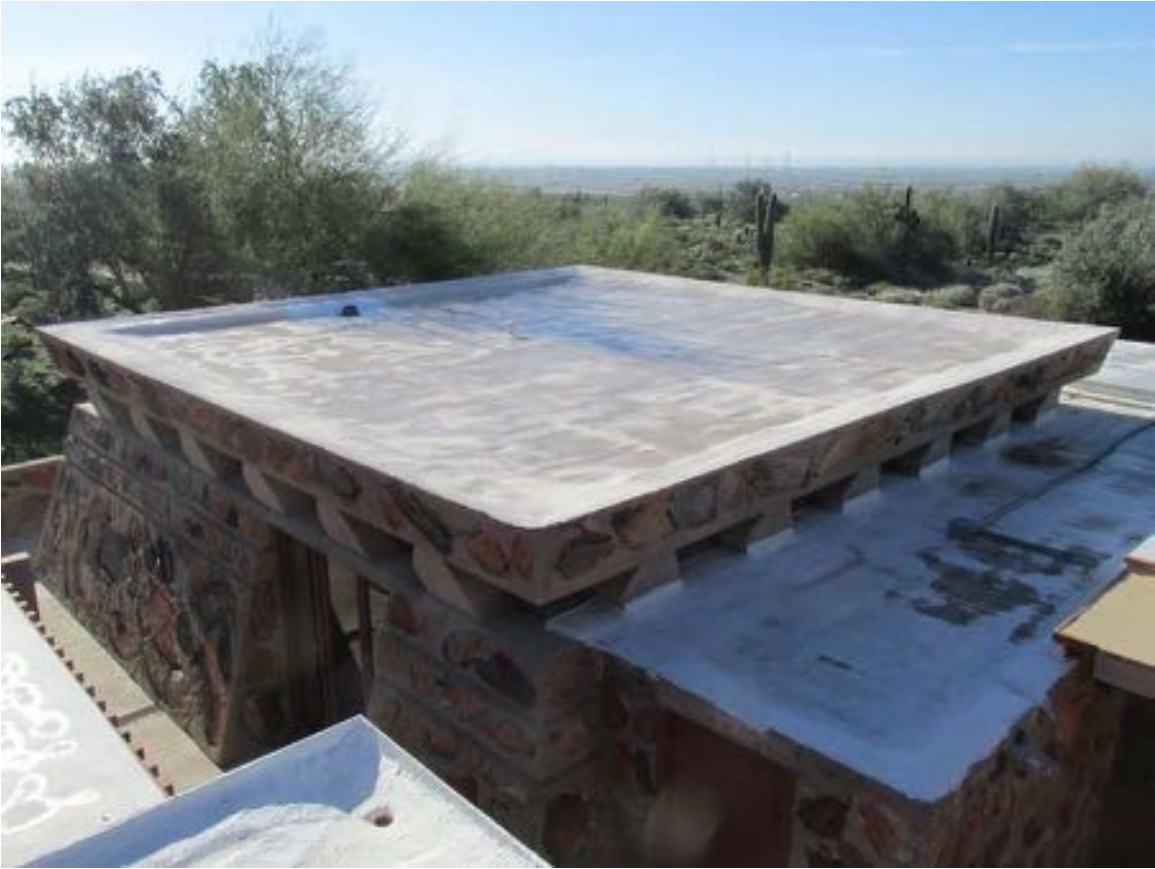
Figure 11-217 - Roof of Clinic Office, 2015 (Harboe Architects).

- Roof
The roof surface is to be replaced with a new liquid applied membrane. Any damaged plywood roof deck discovered after the current roof membrane and foam are removed is to be replaced. Painted wood fascia at the roof overhang over the south porch is to be prepared and painted.

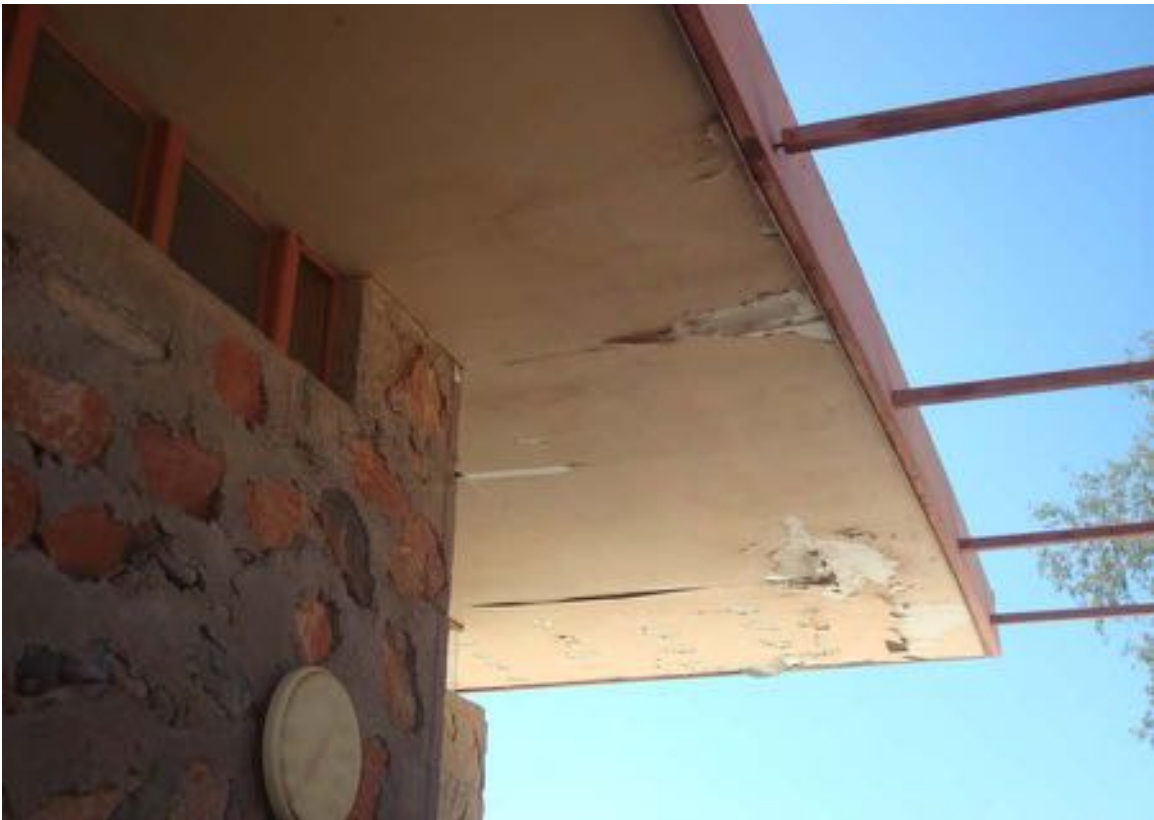
Figure 11-232 - Damage to soffit on Tower Office, 2015 (Harboe Architects).

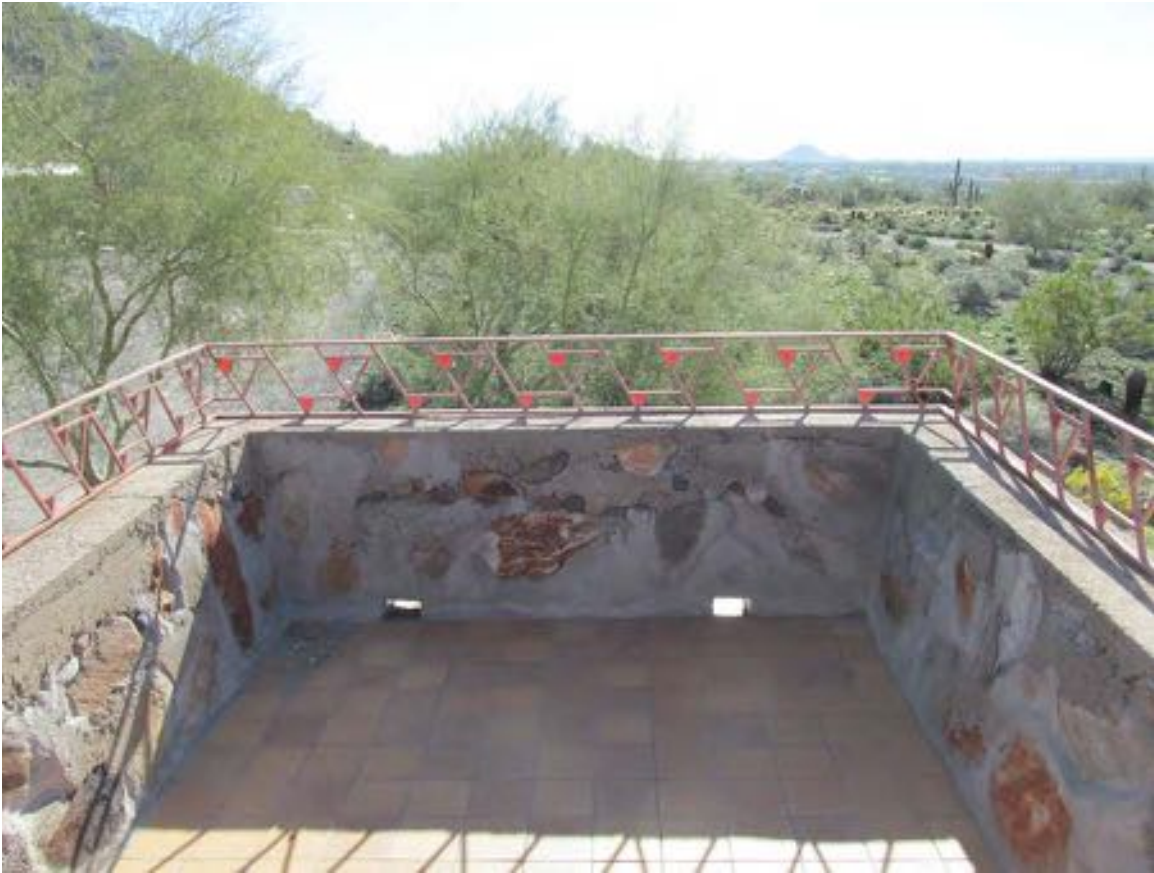
Figure 11-233 - Tower Office terrace, 2015 (Harboe Architects).

- Terrace
Replace damaged ceramic tile with new tile that matches the size, color, and finish of the existing adjacent tile. Prepare and paint the metal railing.

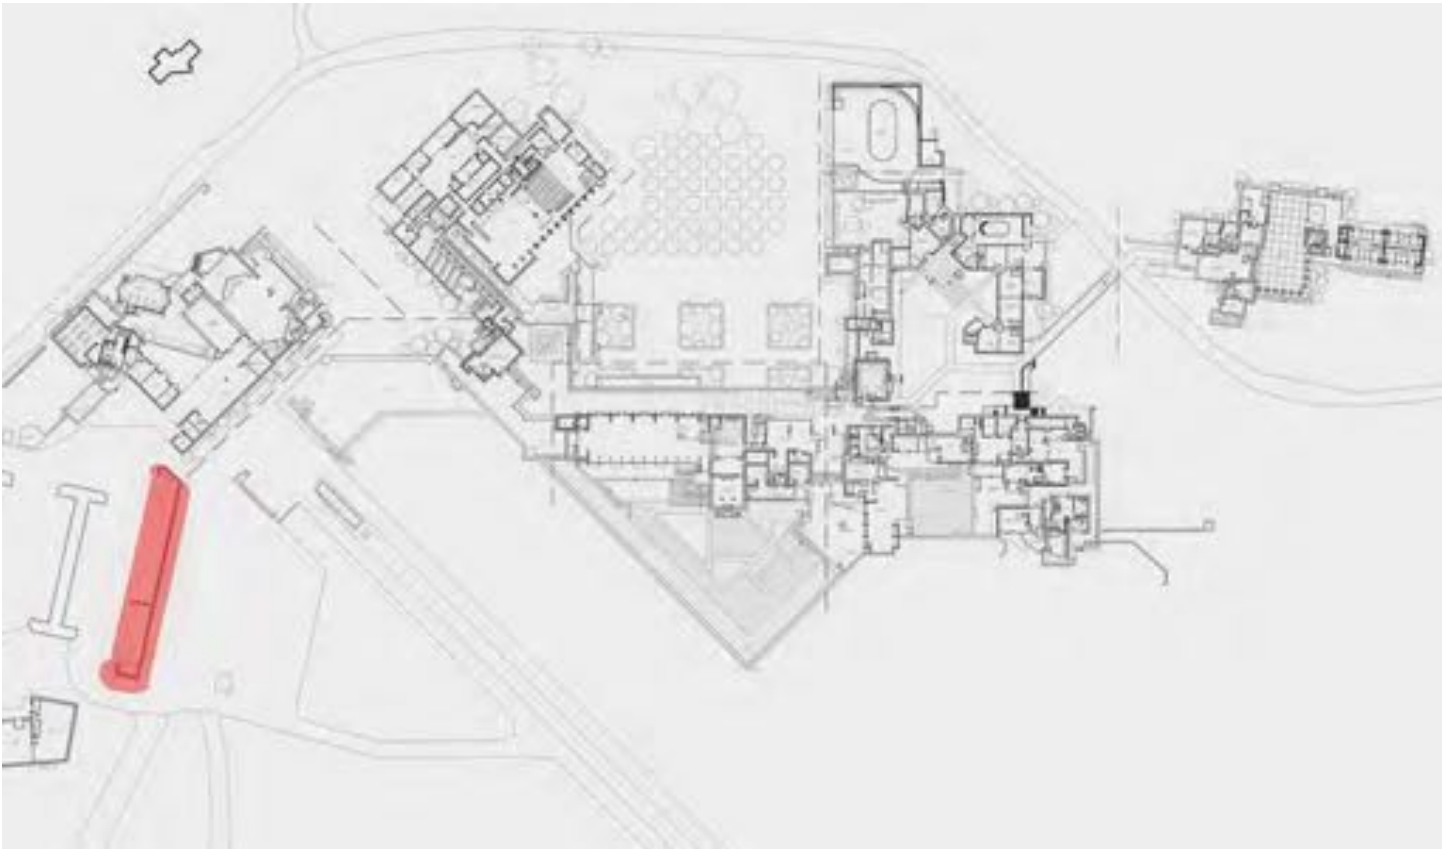
Figure 11-235 - Parking Canopy Location Plan

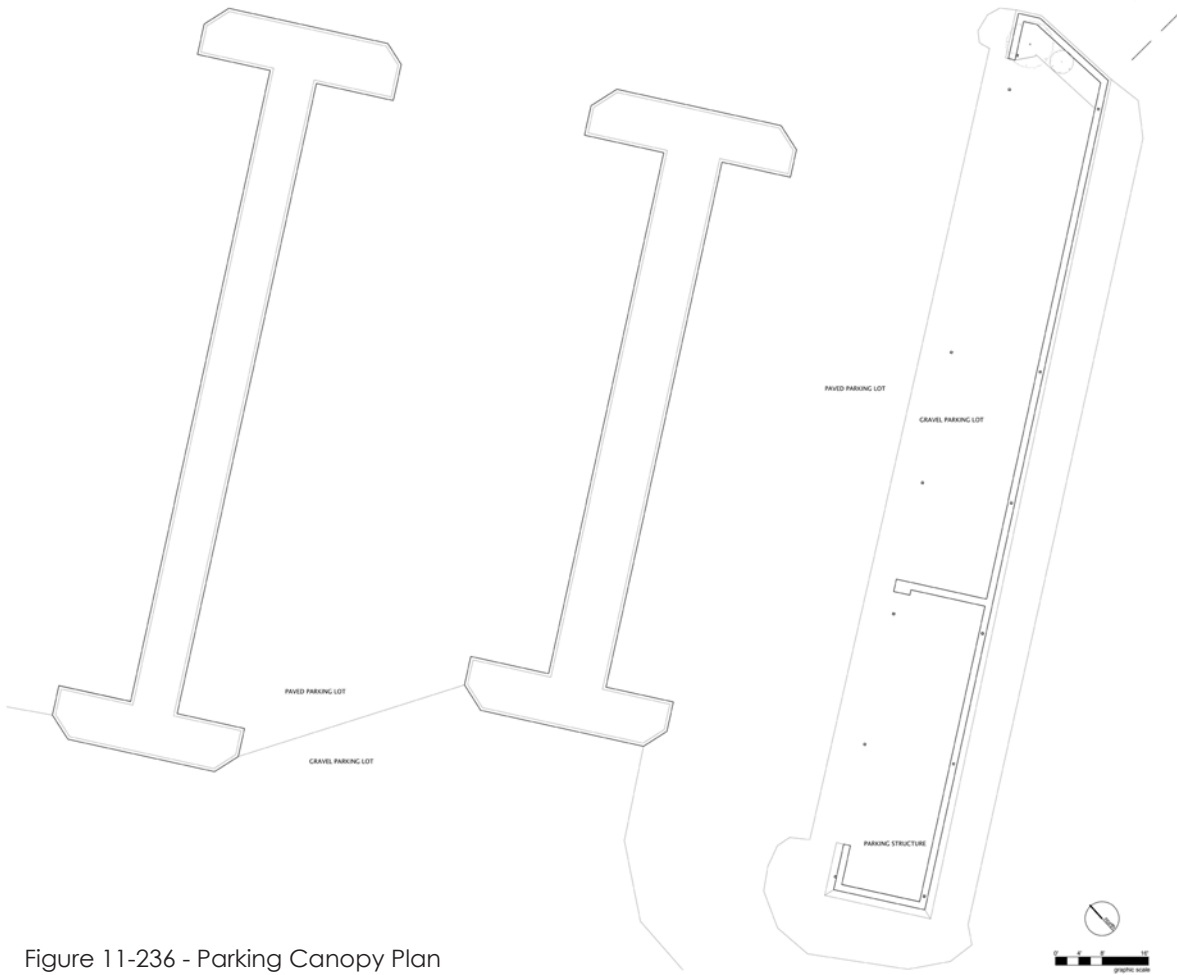
Figure 11-236 - Parking Canopy Plan

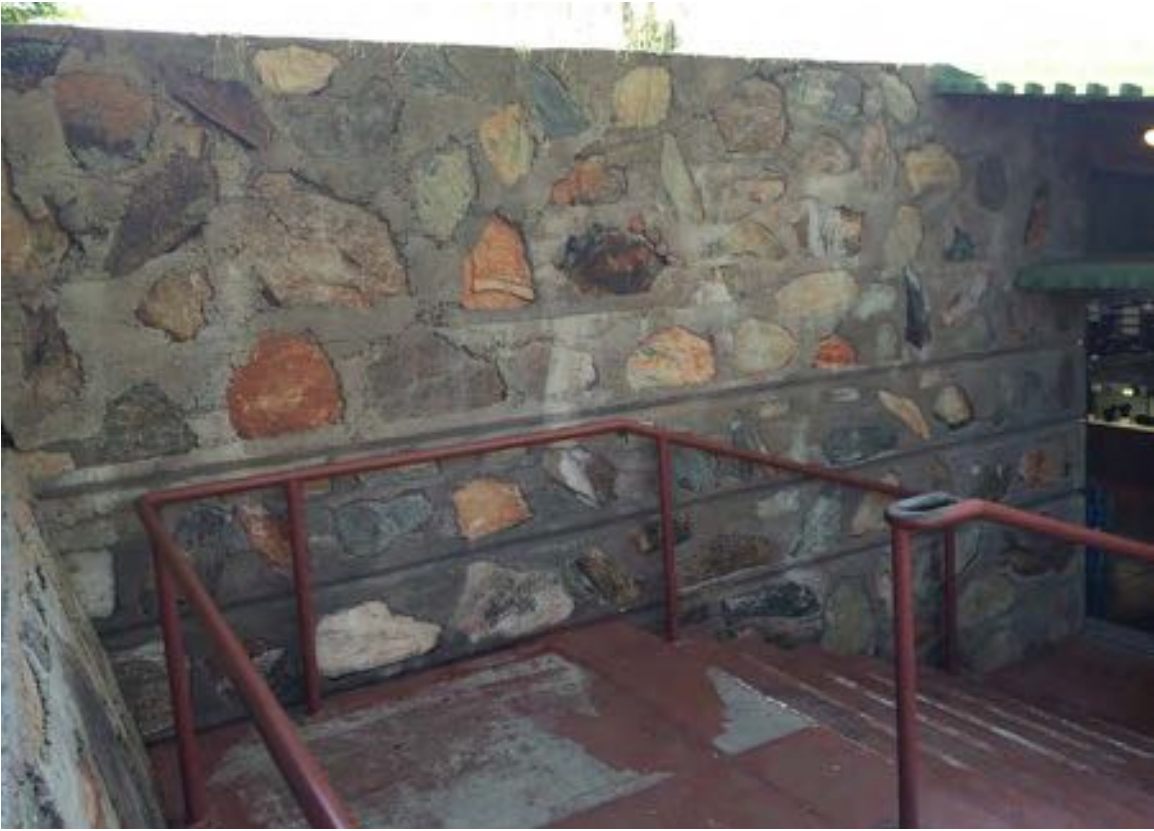
Figure 11-244 - Desert masonry wall outside of the Bookstore (Fred Prozzillo).

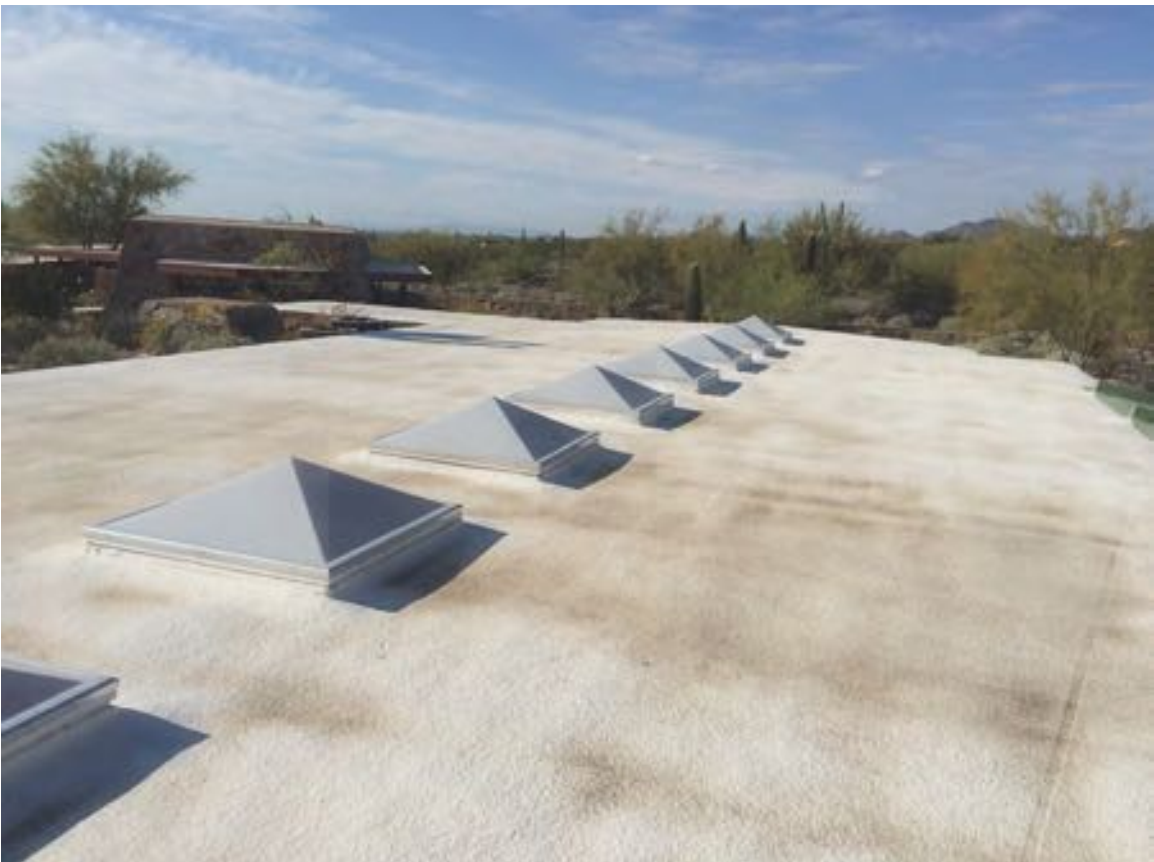
Figure 11-245 - Bookstore roof (Fred Prozzillo).

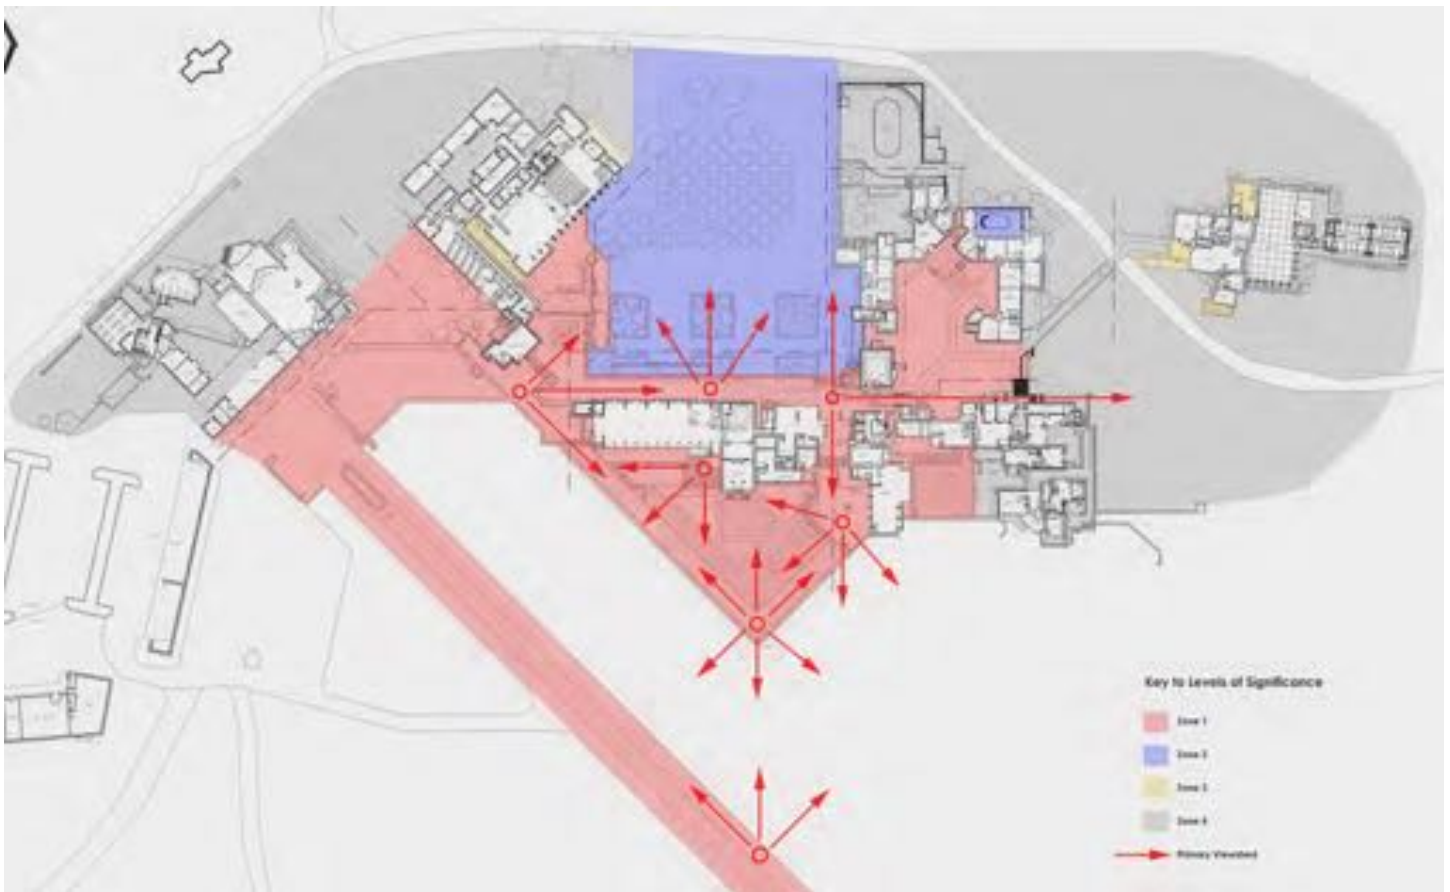
Figure 11-248 - Landscape Plan

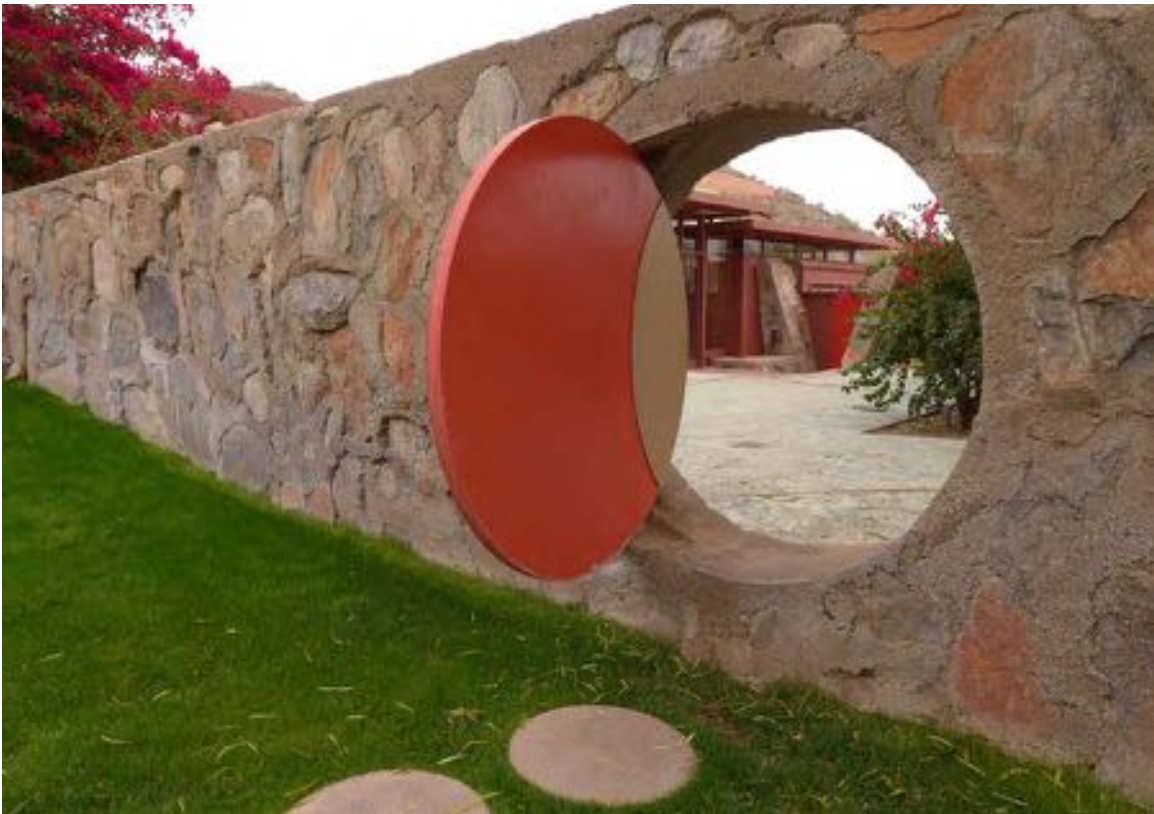
Figure 11-256 - Garden wall with moon gate, 2014 (Harboe Architects).
