TALIESIN WEST PRESERVATION MASTER PLAN

Harboe Architects, PC

MAY 21, 2015

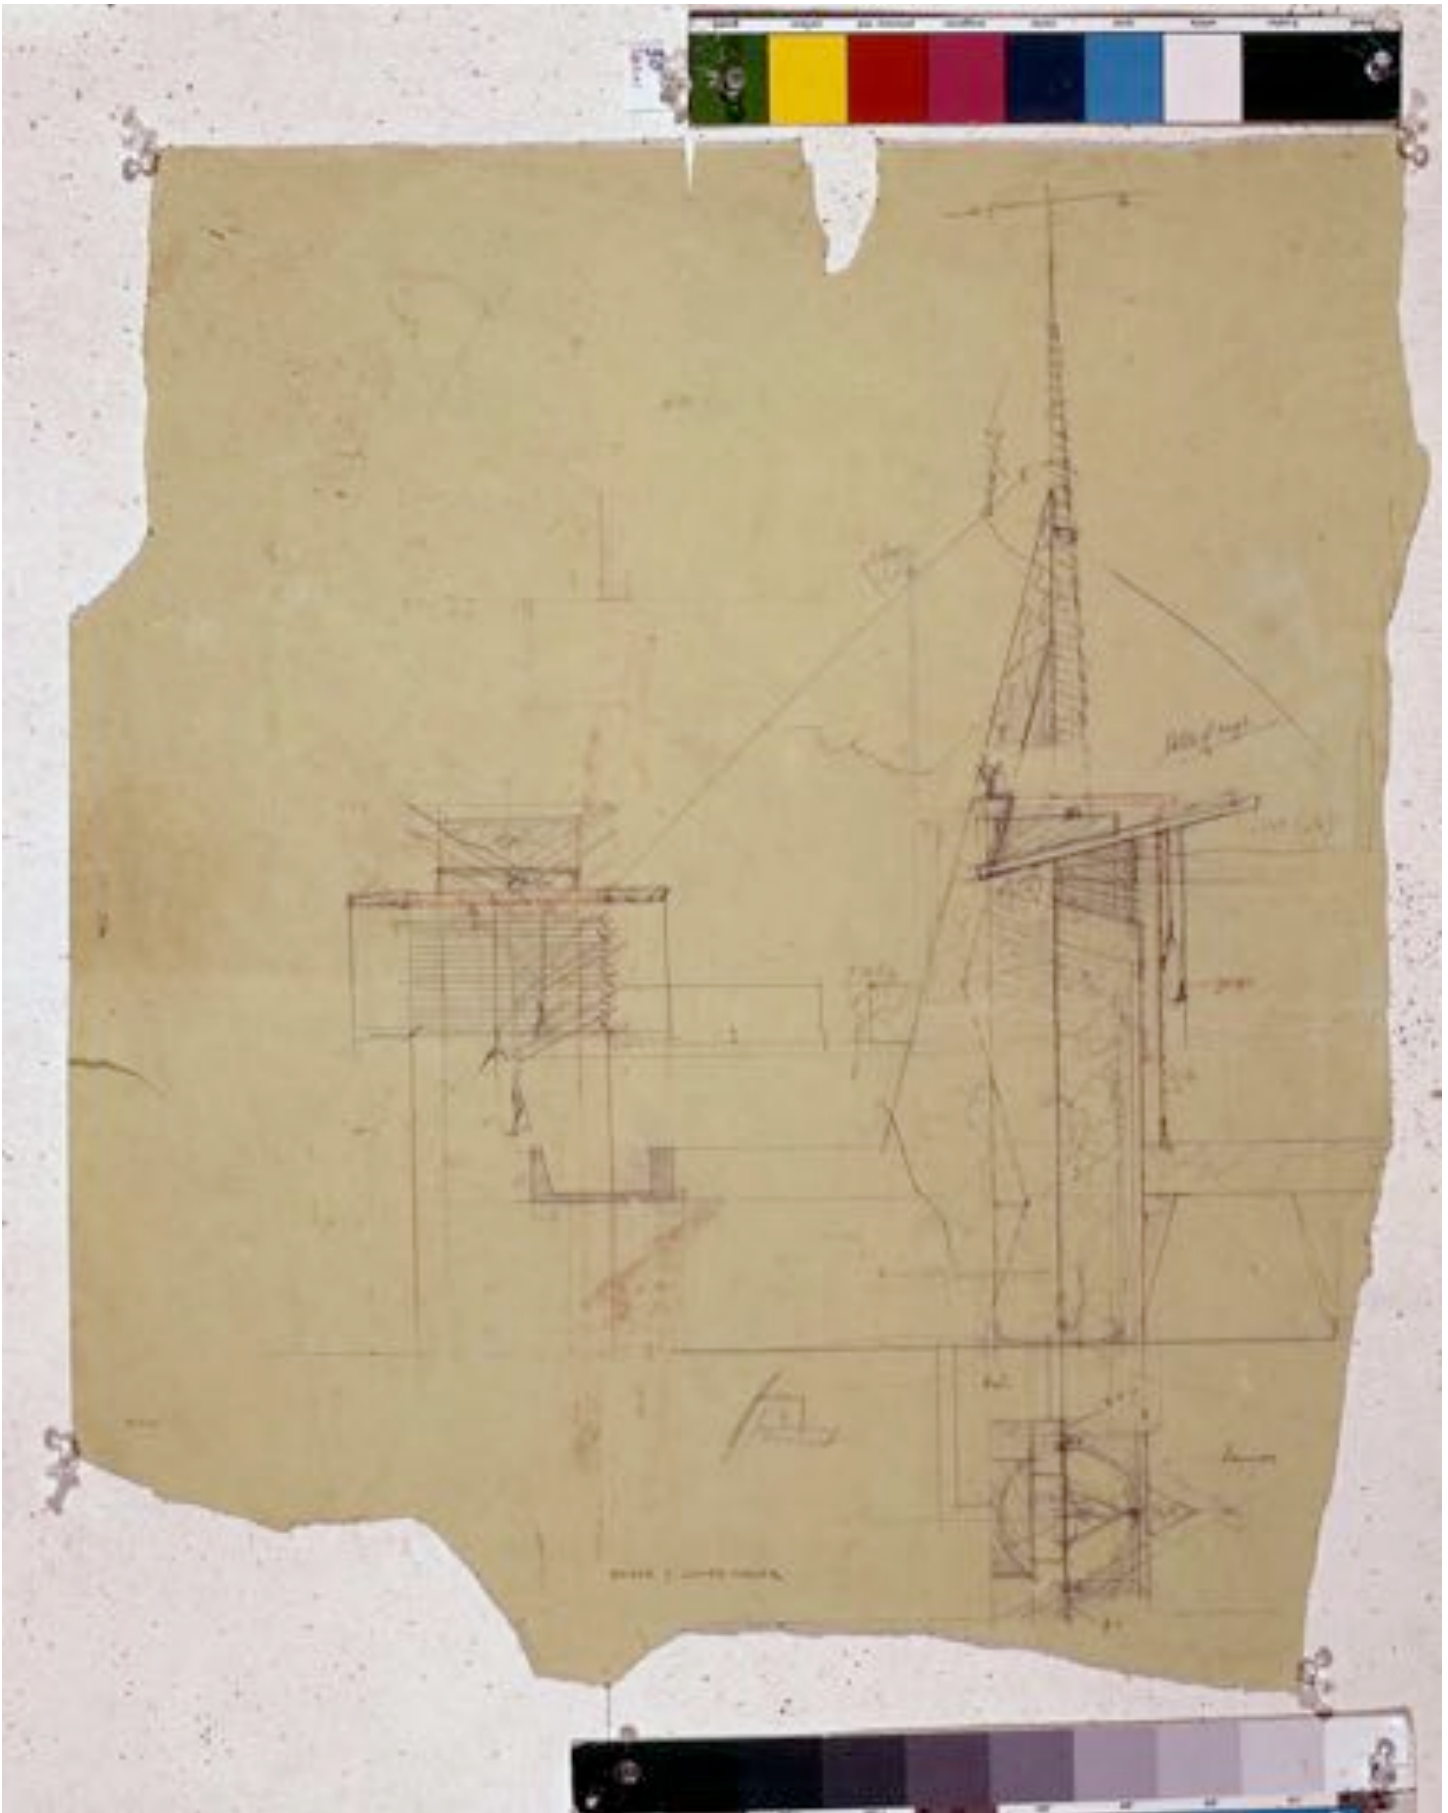
Figure B-1 - Bridge/Water Tower (The Frank Lloyd Wright Foundation Archives, The Museum of Modern Art | Avery Architectural & Fine Arts Library, Columbia University, New York).

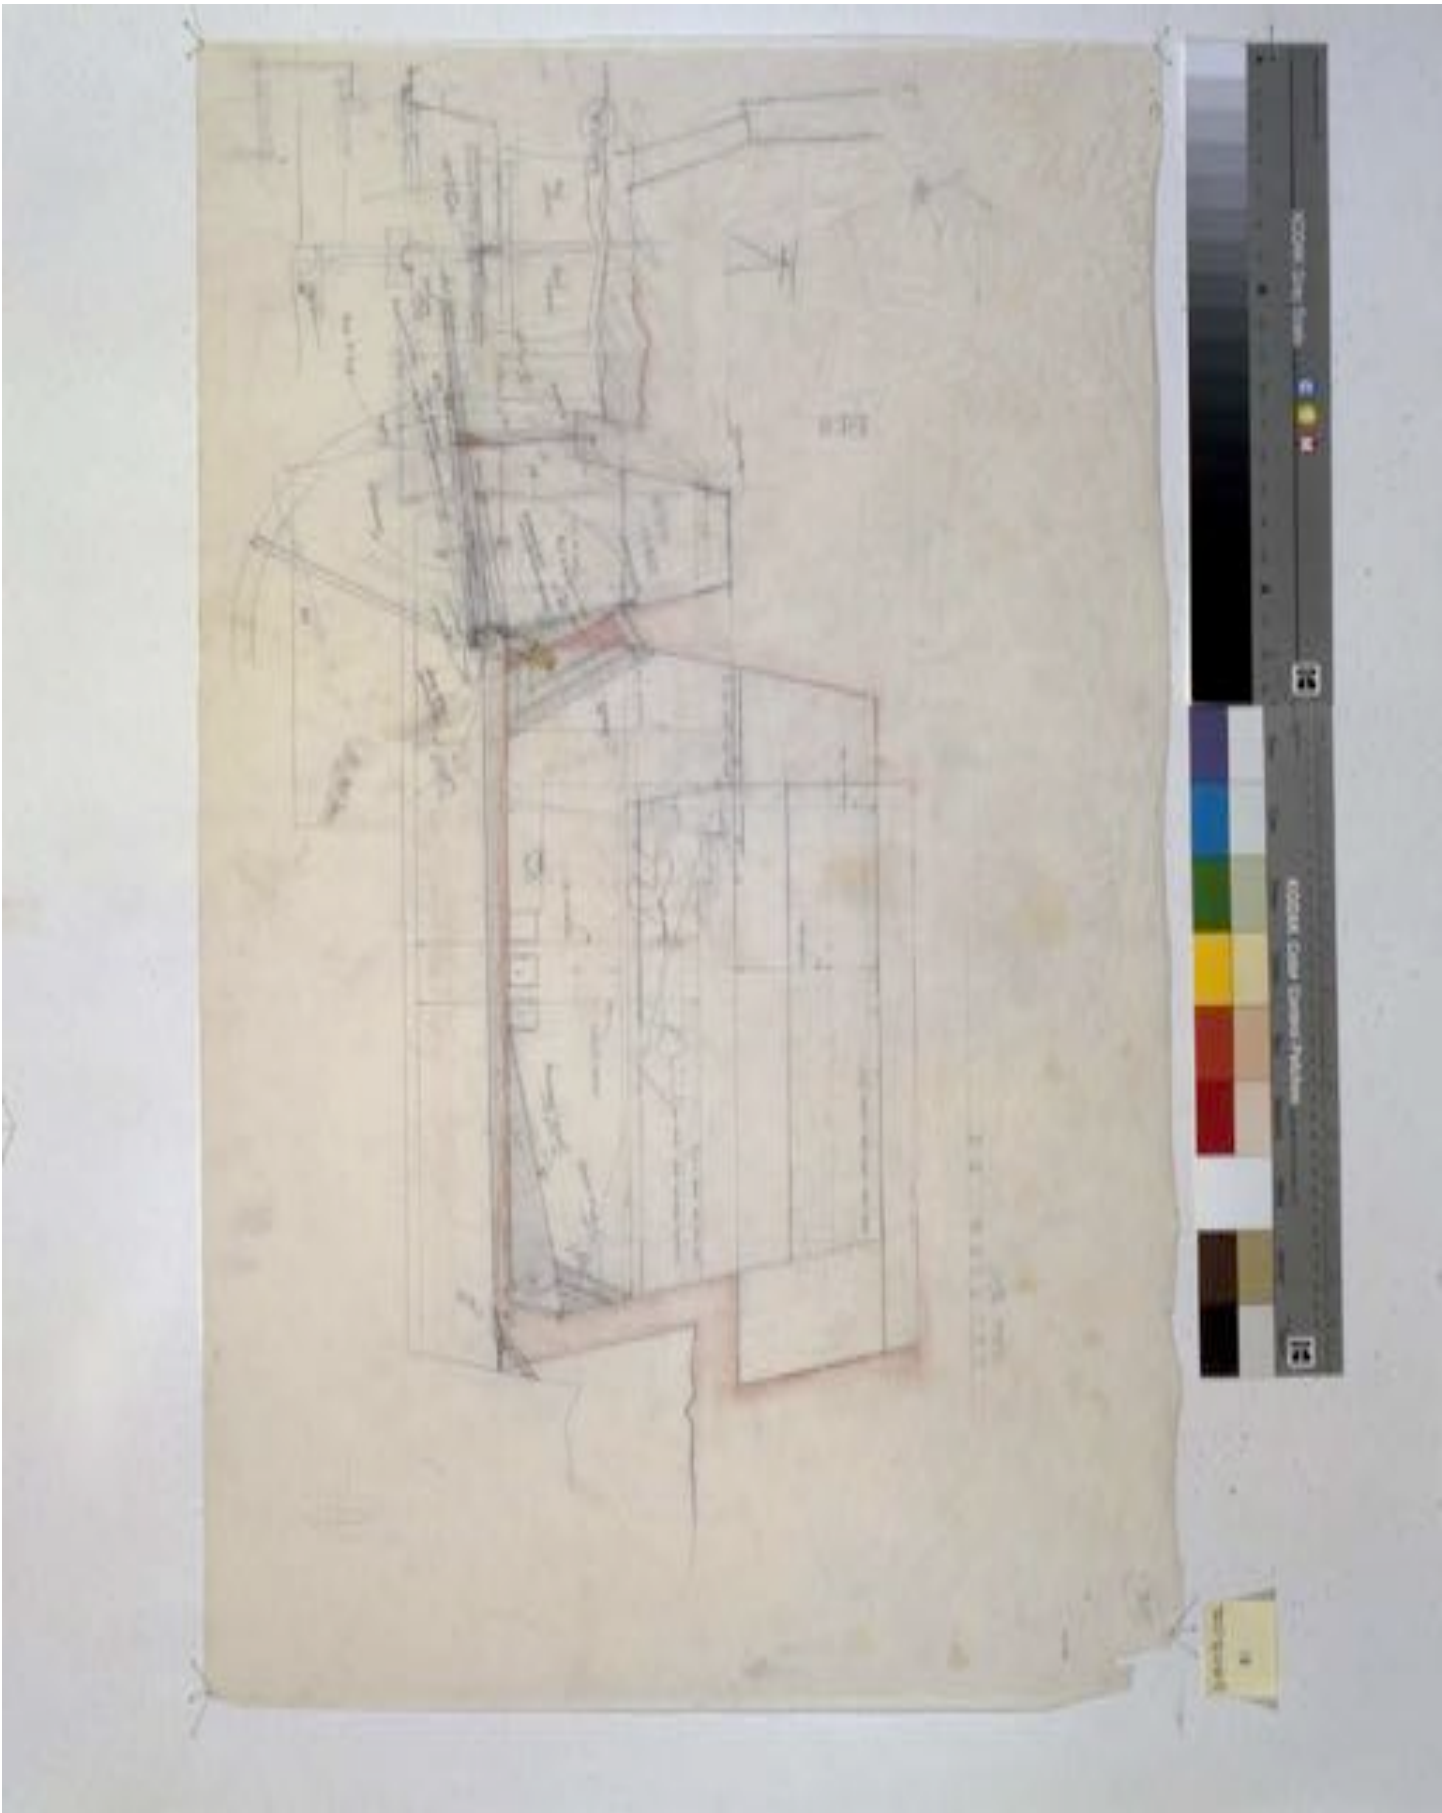
Figure B-2 - [Cabaret] Theater Section (The Frank Lloyd Wright Foundation Archives, The Museum of Modern Art | Avery Architectural & Fine Arts Library, Columbia University, New York).

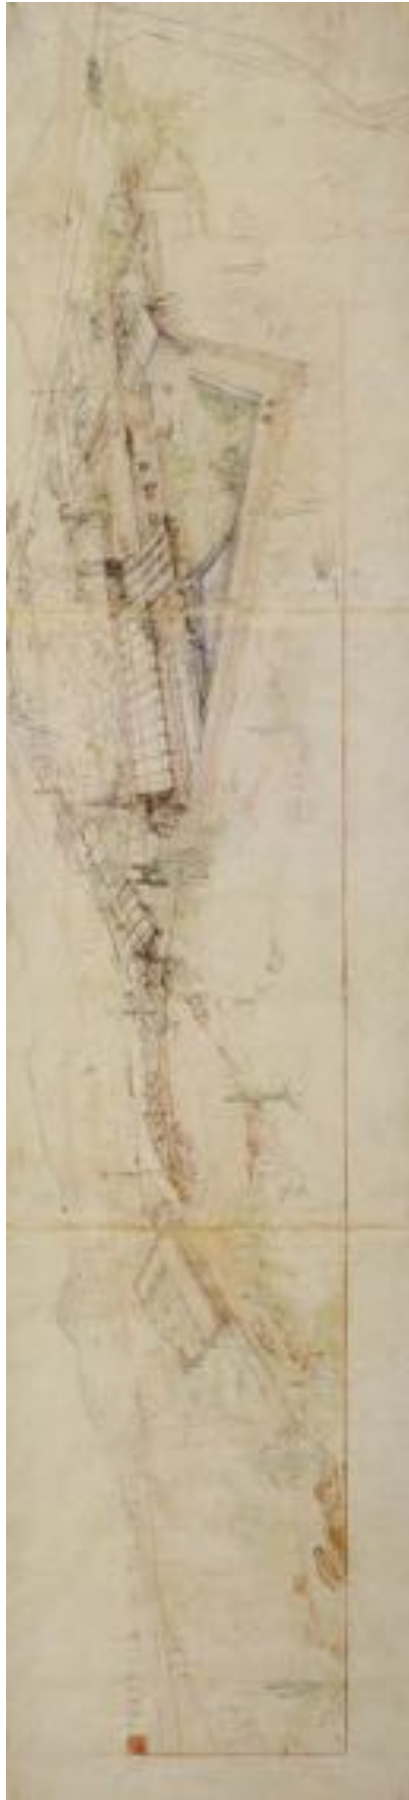
Figure B-3 - Air View, MOMA 1949 (The Frank Lloyd Wright Foundation Archives, The Museum of Modern Art | Avery Architectural & Fine Arts Library, Columbia University, New York).

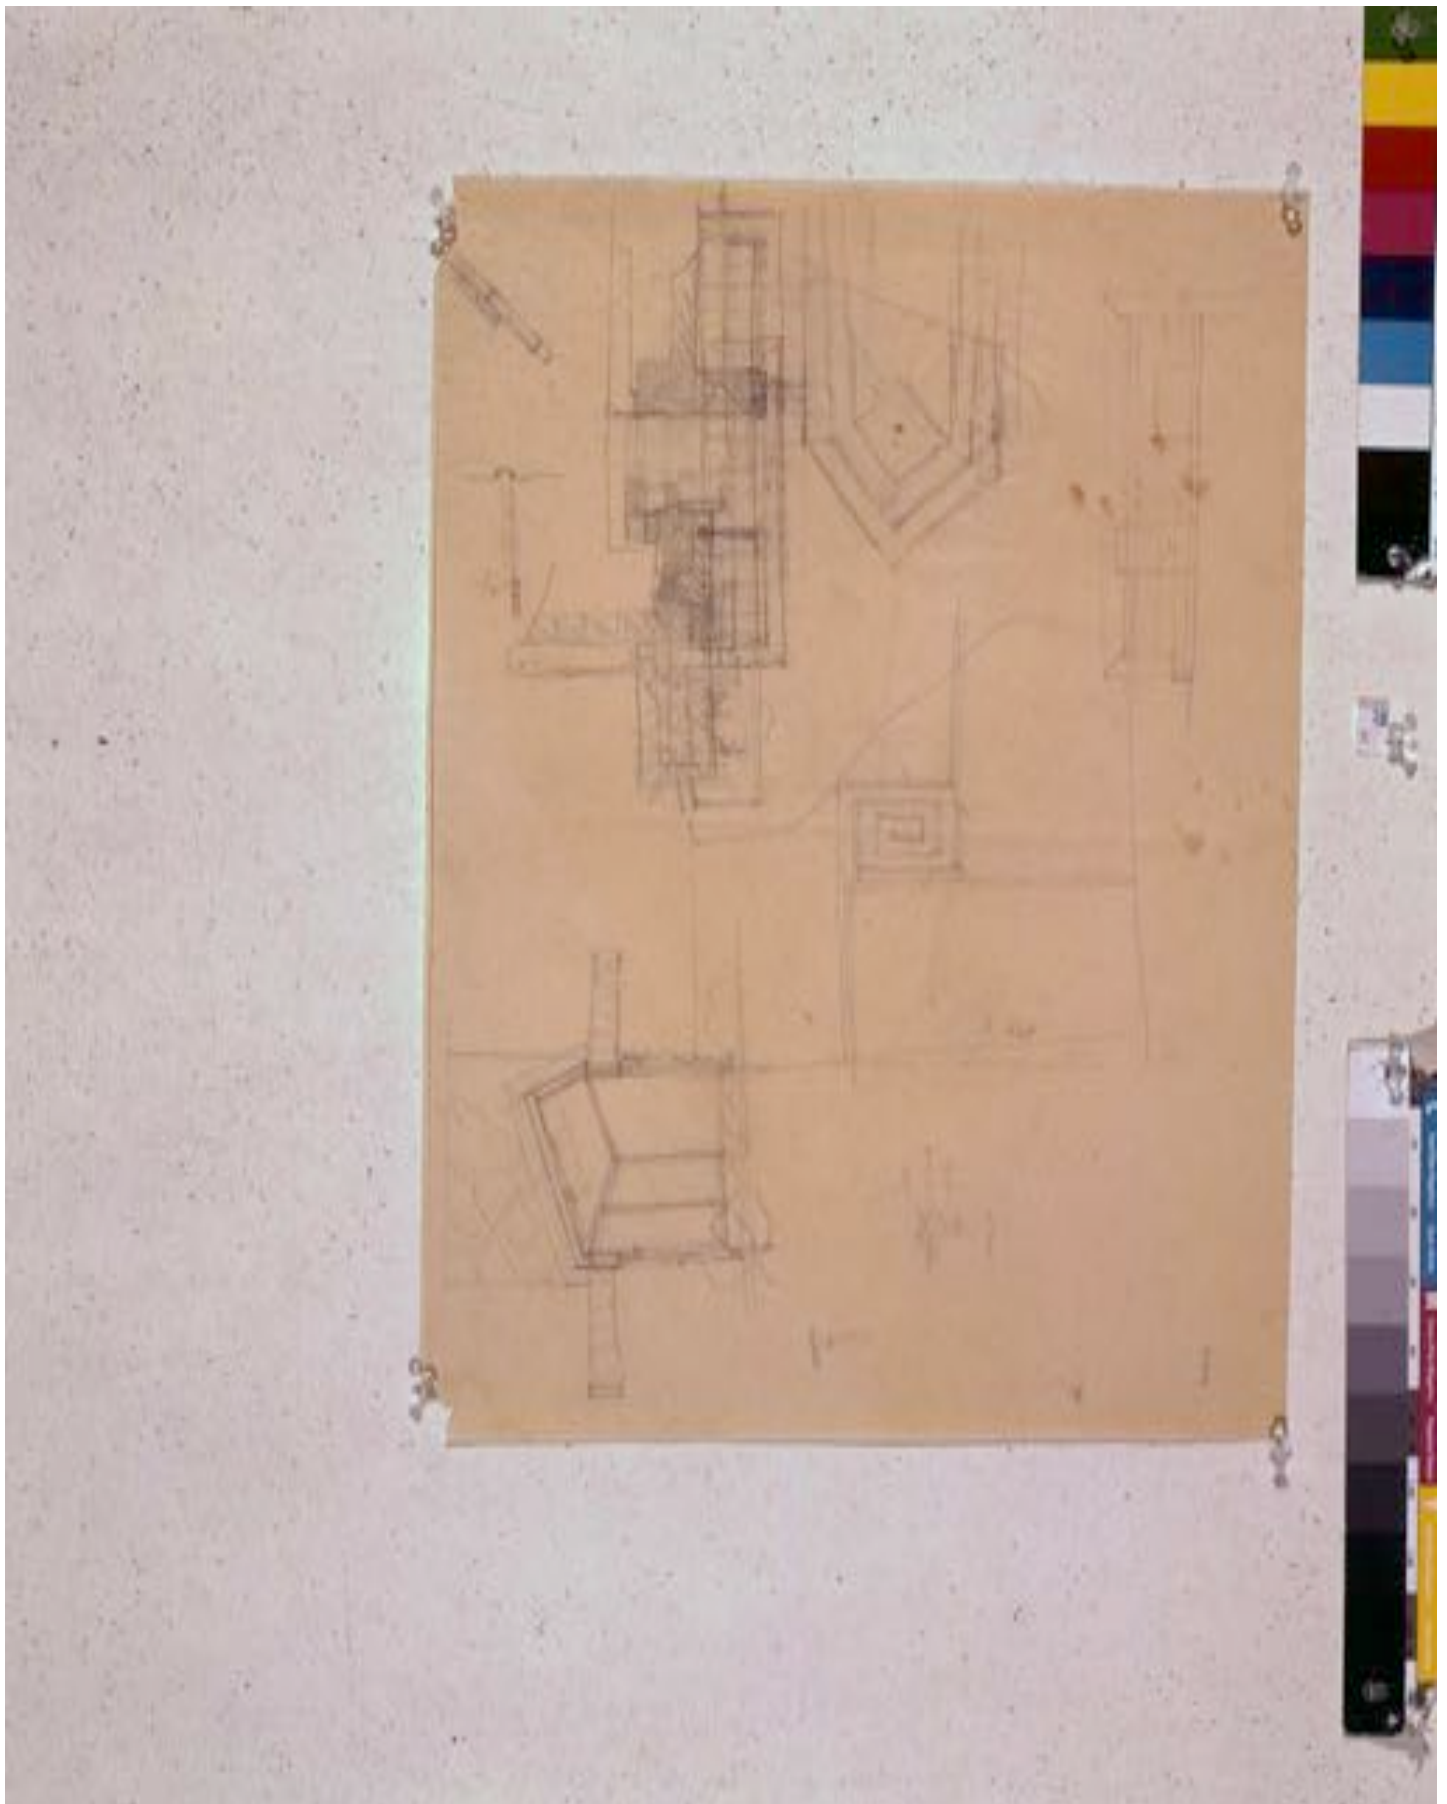
Figure B-5 - Theatre, Entry Pool (The Frank Lloyd Wright Foundation Archives, The Museum of Modern Art | Avery Architectural & Fine Arts Library, Columbia University, New York).

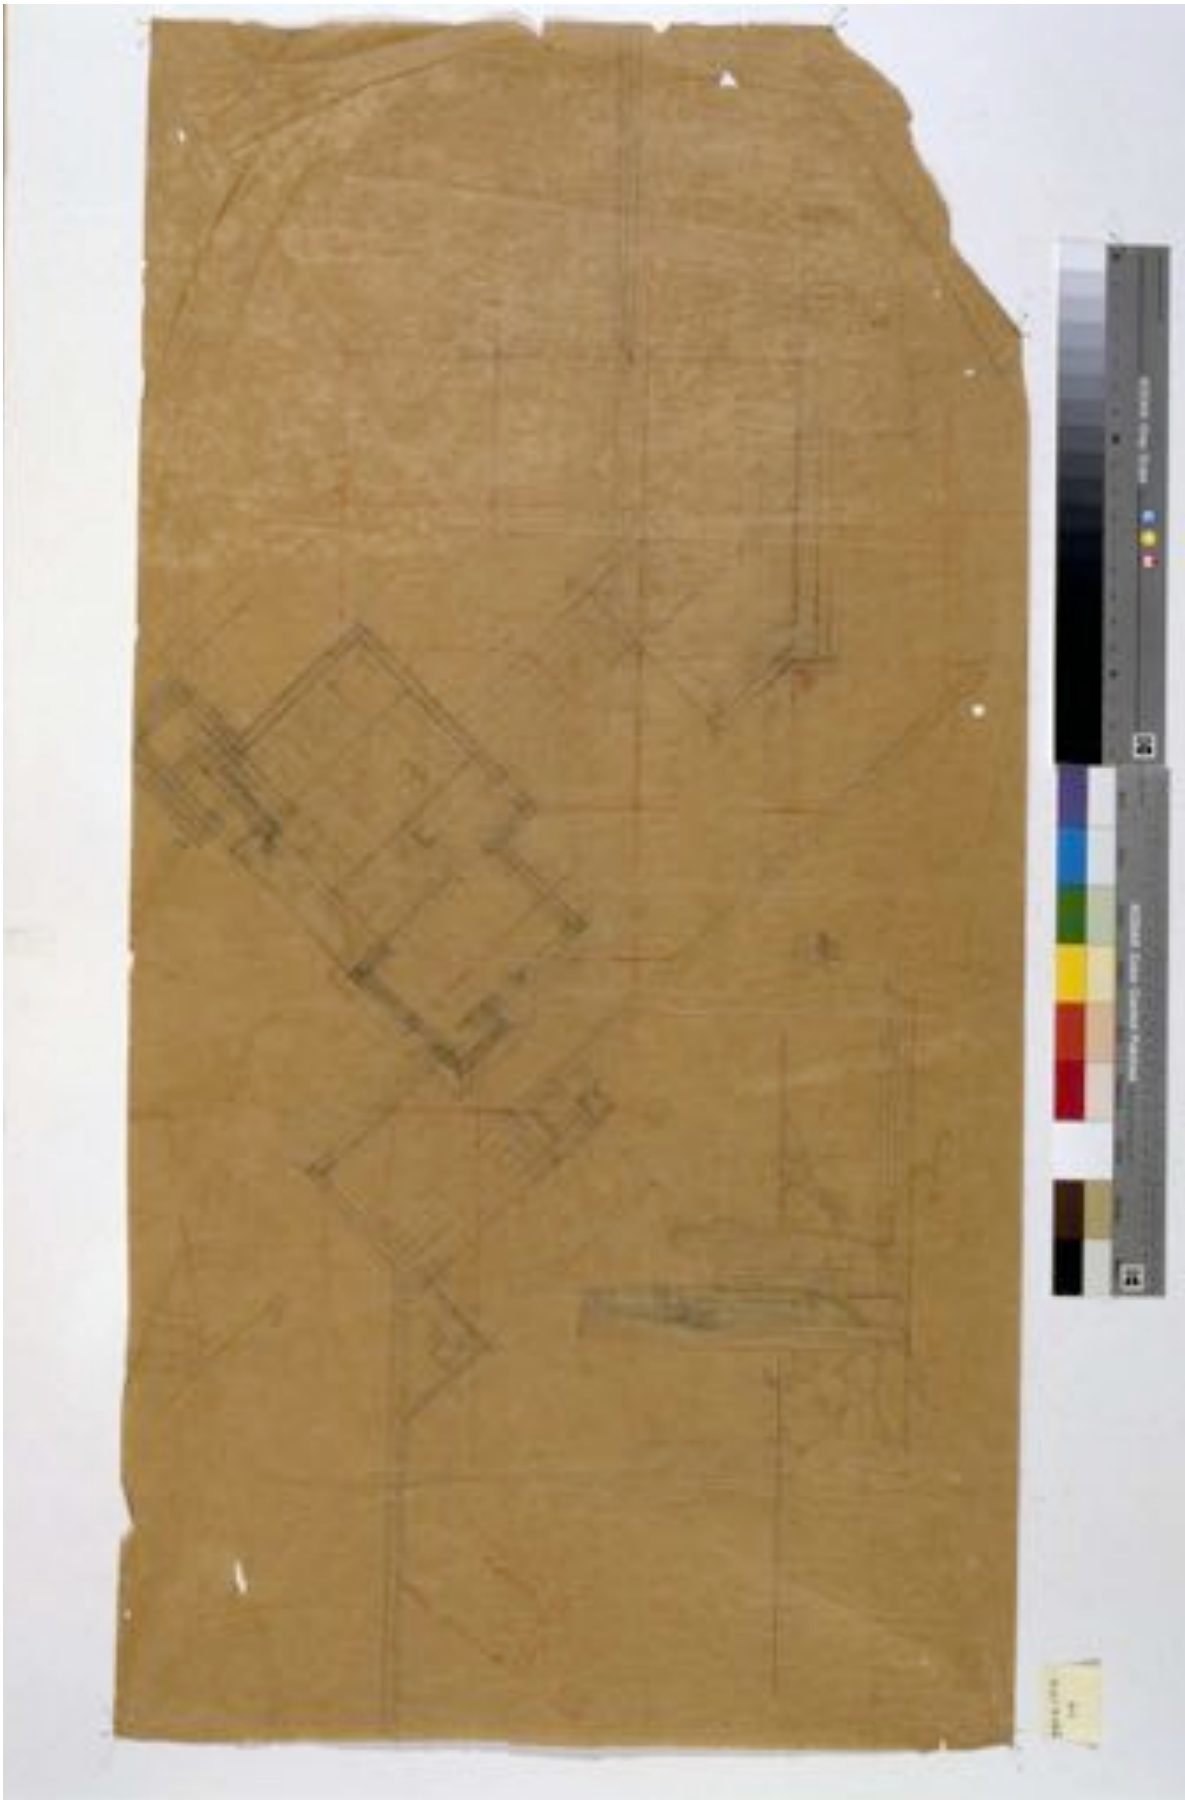
Figure B-6 - Office Plan, Saguaro (The Frank Lloyd Wright Foundation Archives, The Museum of Modern Art | Avery Architectural & Fine Arts Library, Columbia University, New York).

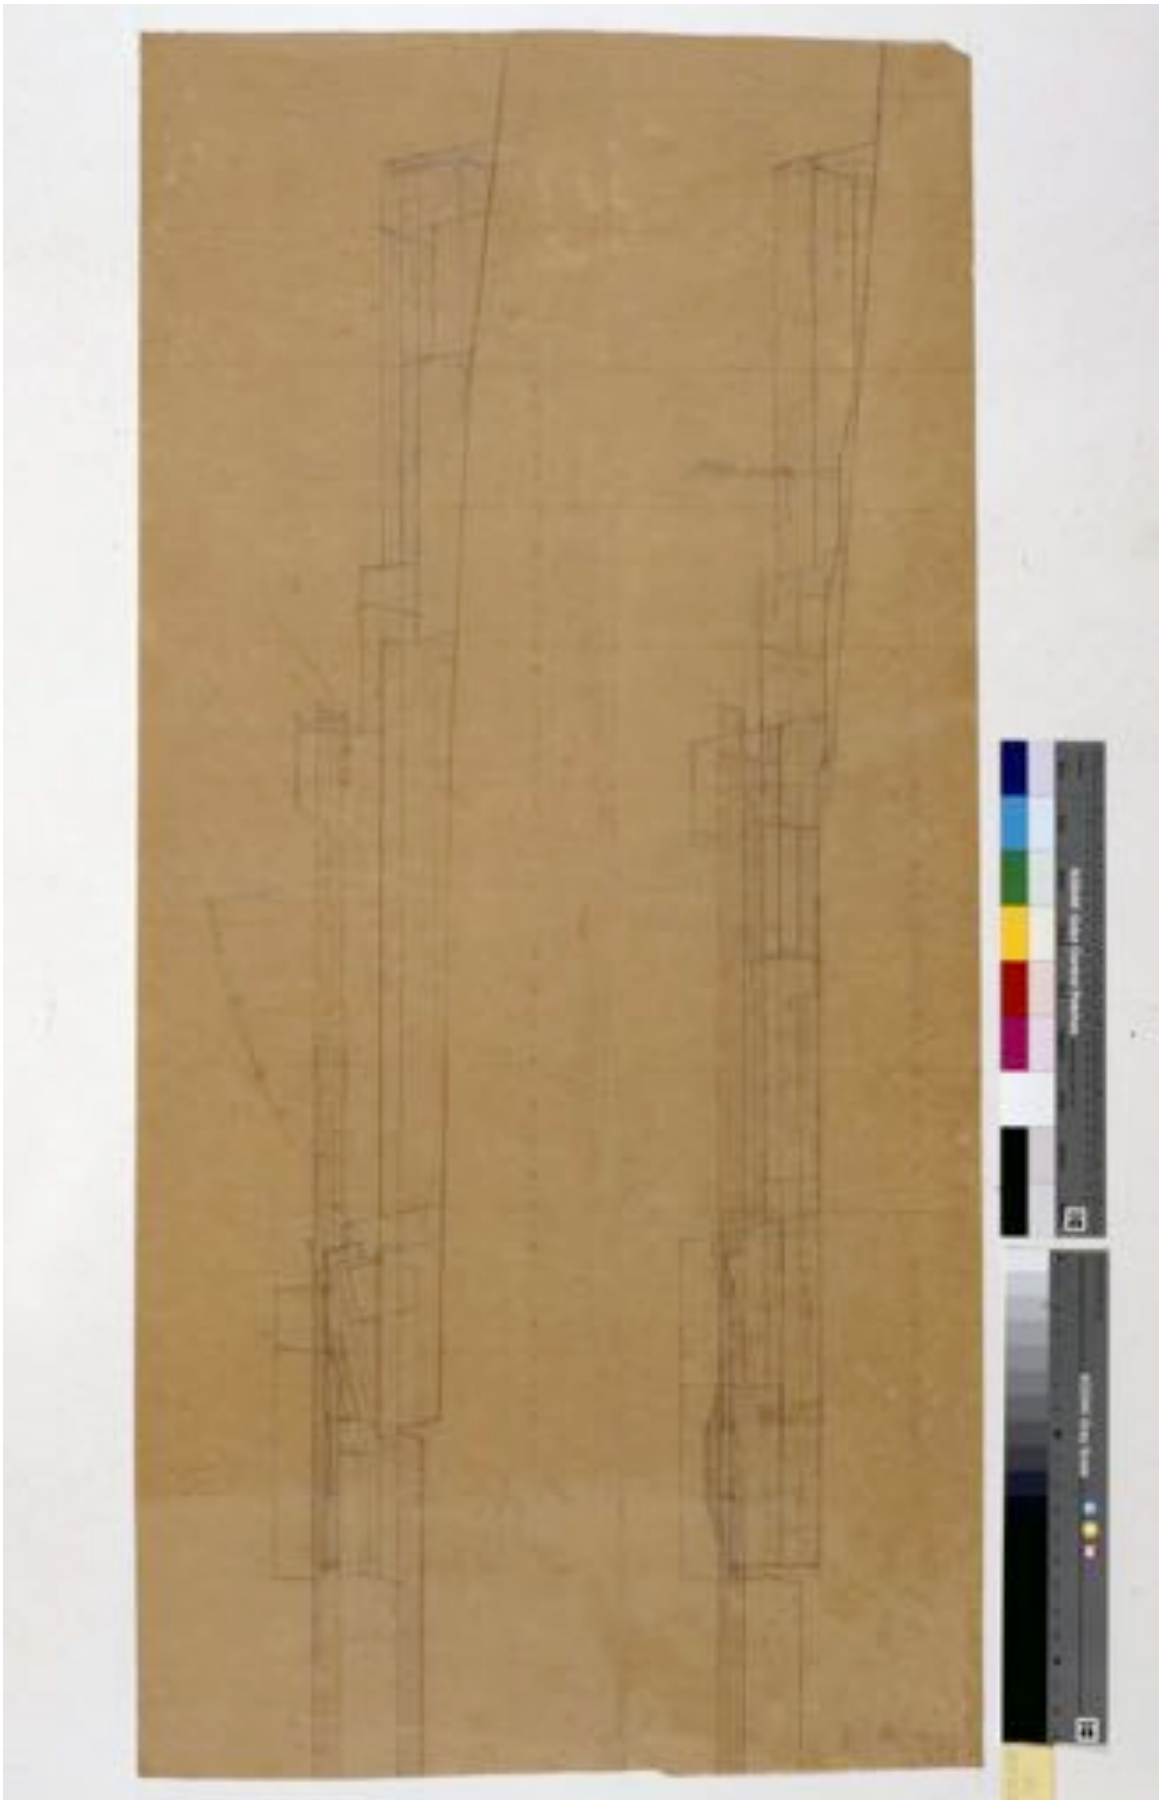
Figure B-8 - Garden Room Section (The Frank Lloyd Wright Foundation Archives, The Museum of Modern Art | Avery Architectural & Fine Arts Library, Columbia University, New York).

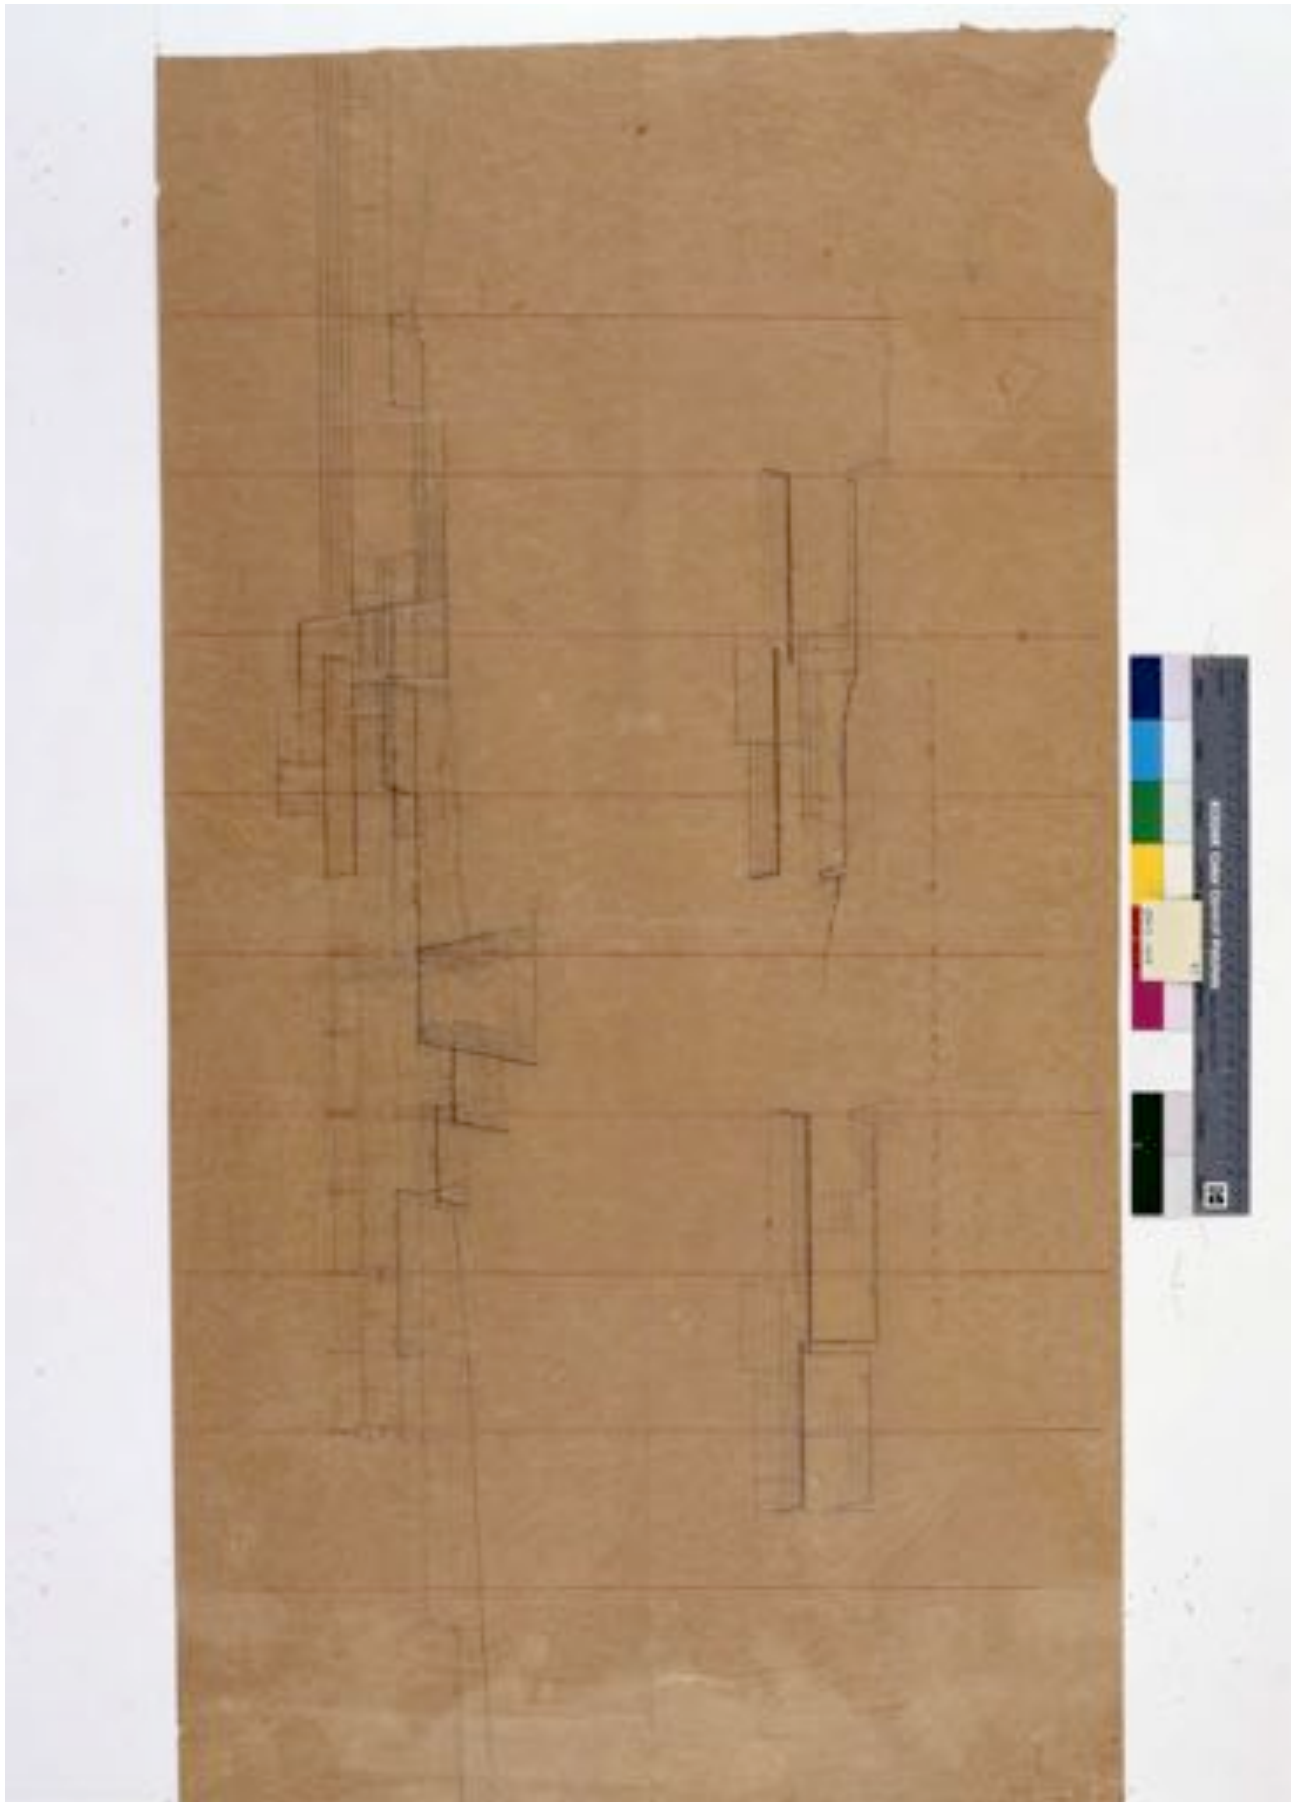
Figure B-9 - House [Wright Living Quarters] Section (The Frank Lloyd Wright Foundation Archives, The Museum of Modern Art | Avery Architectural & Fine Arts Library, Columbia University, New York).

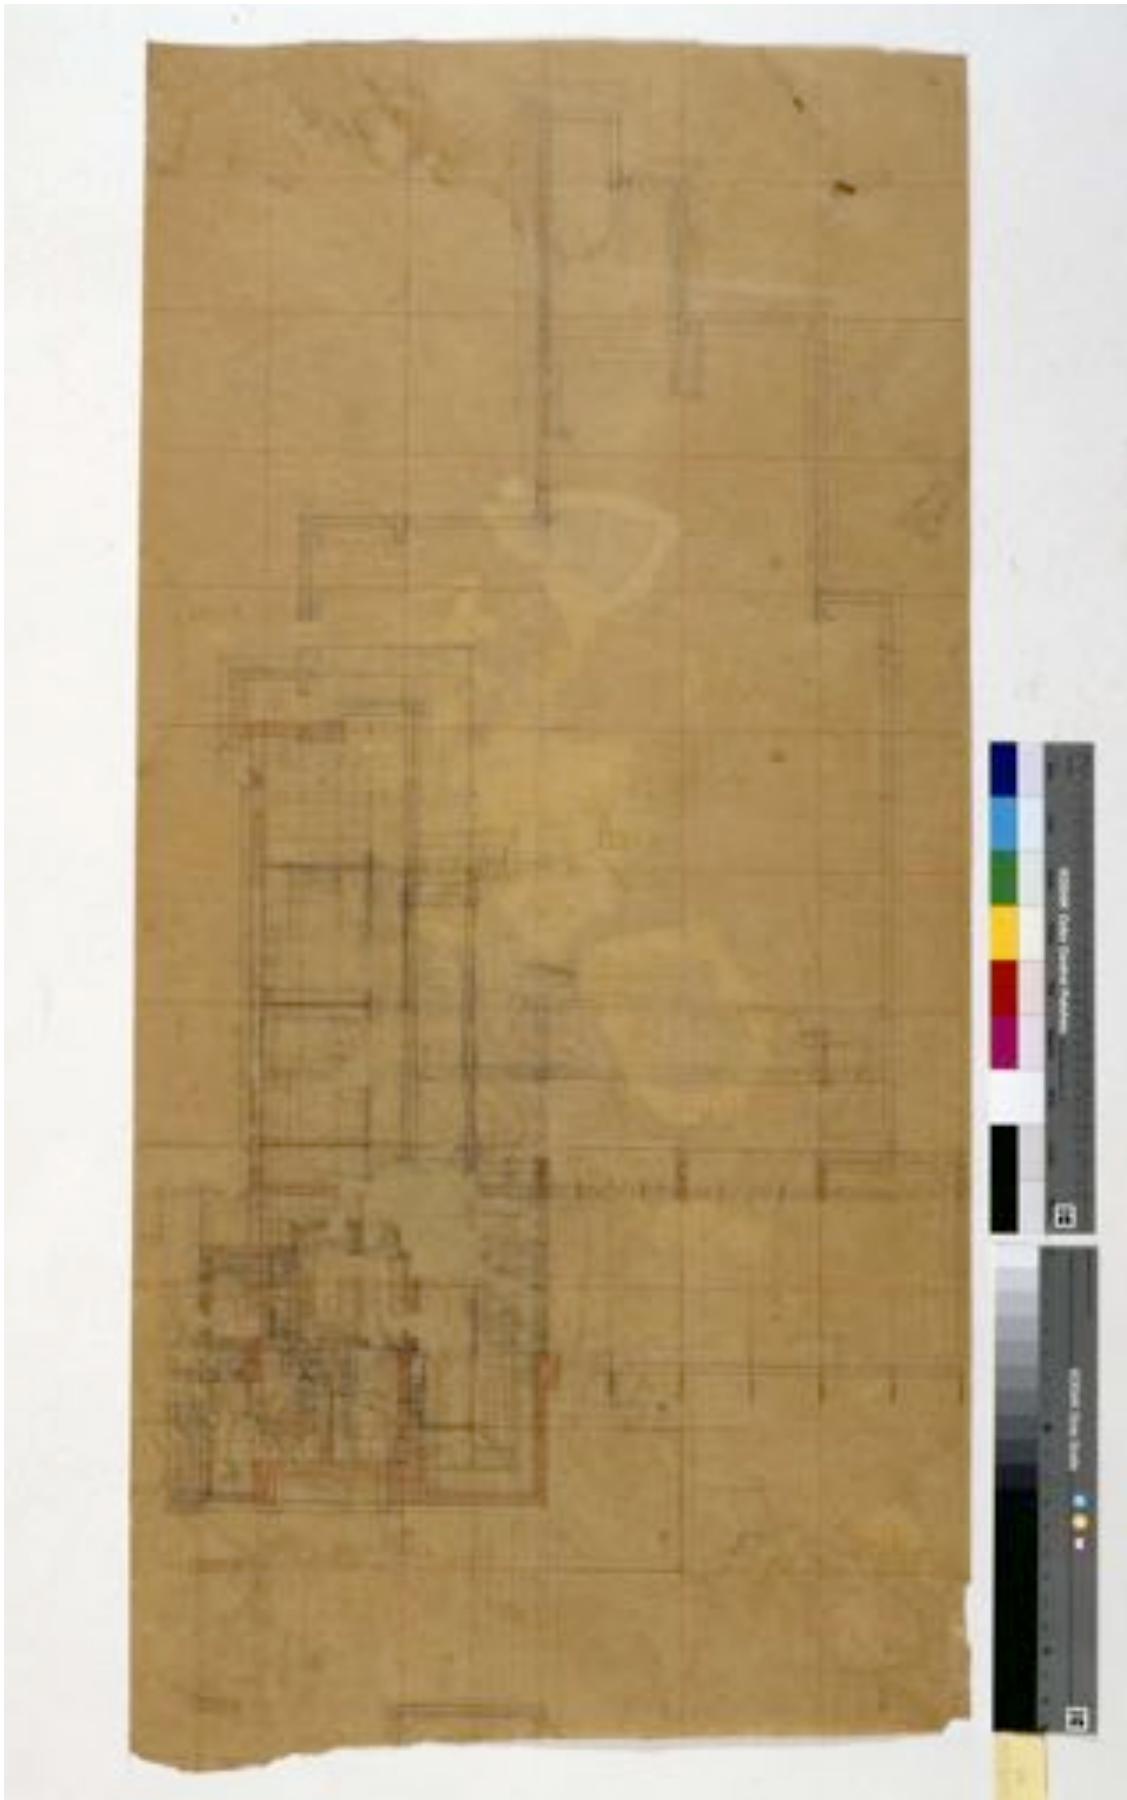
Figure B-10 - Plan of House [Wright Living Quarters] Area (The Frank Lloyd Wright Foundation Archives, The Museum of Modern Art | Avery Architectural & Fine Arts Library, Columbia University, New York).

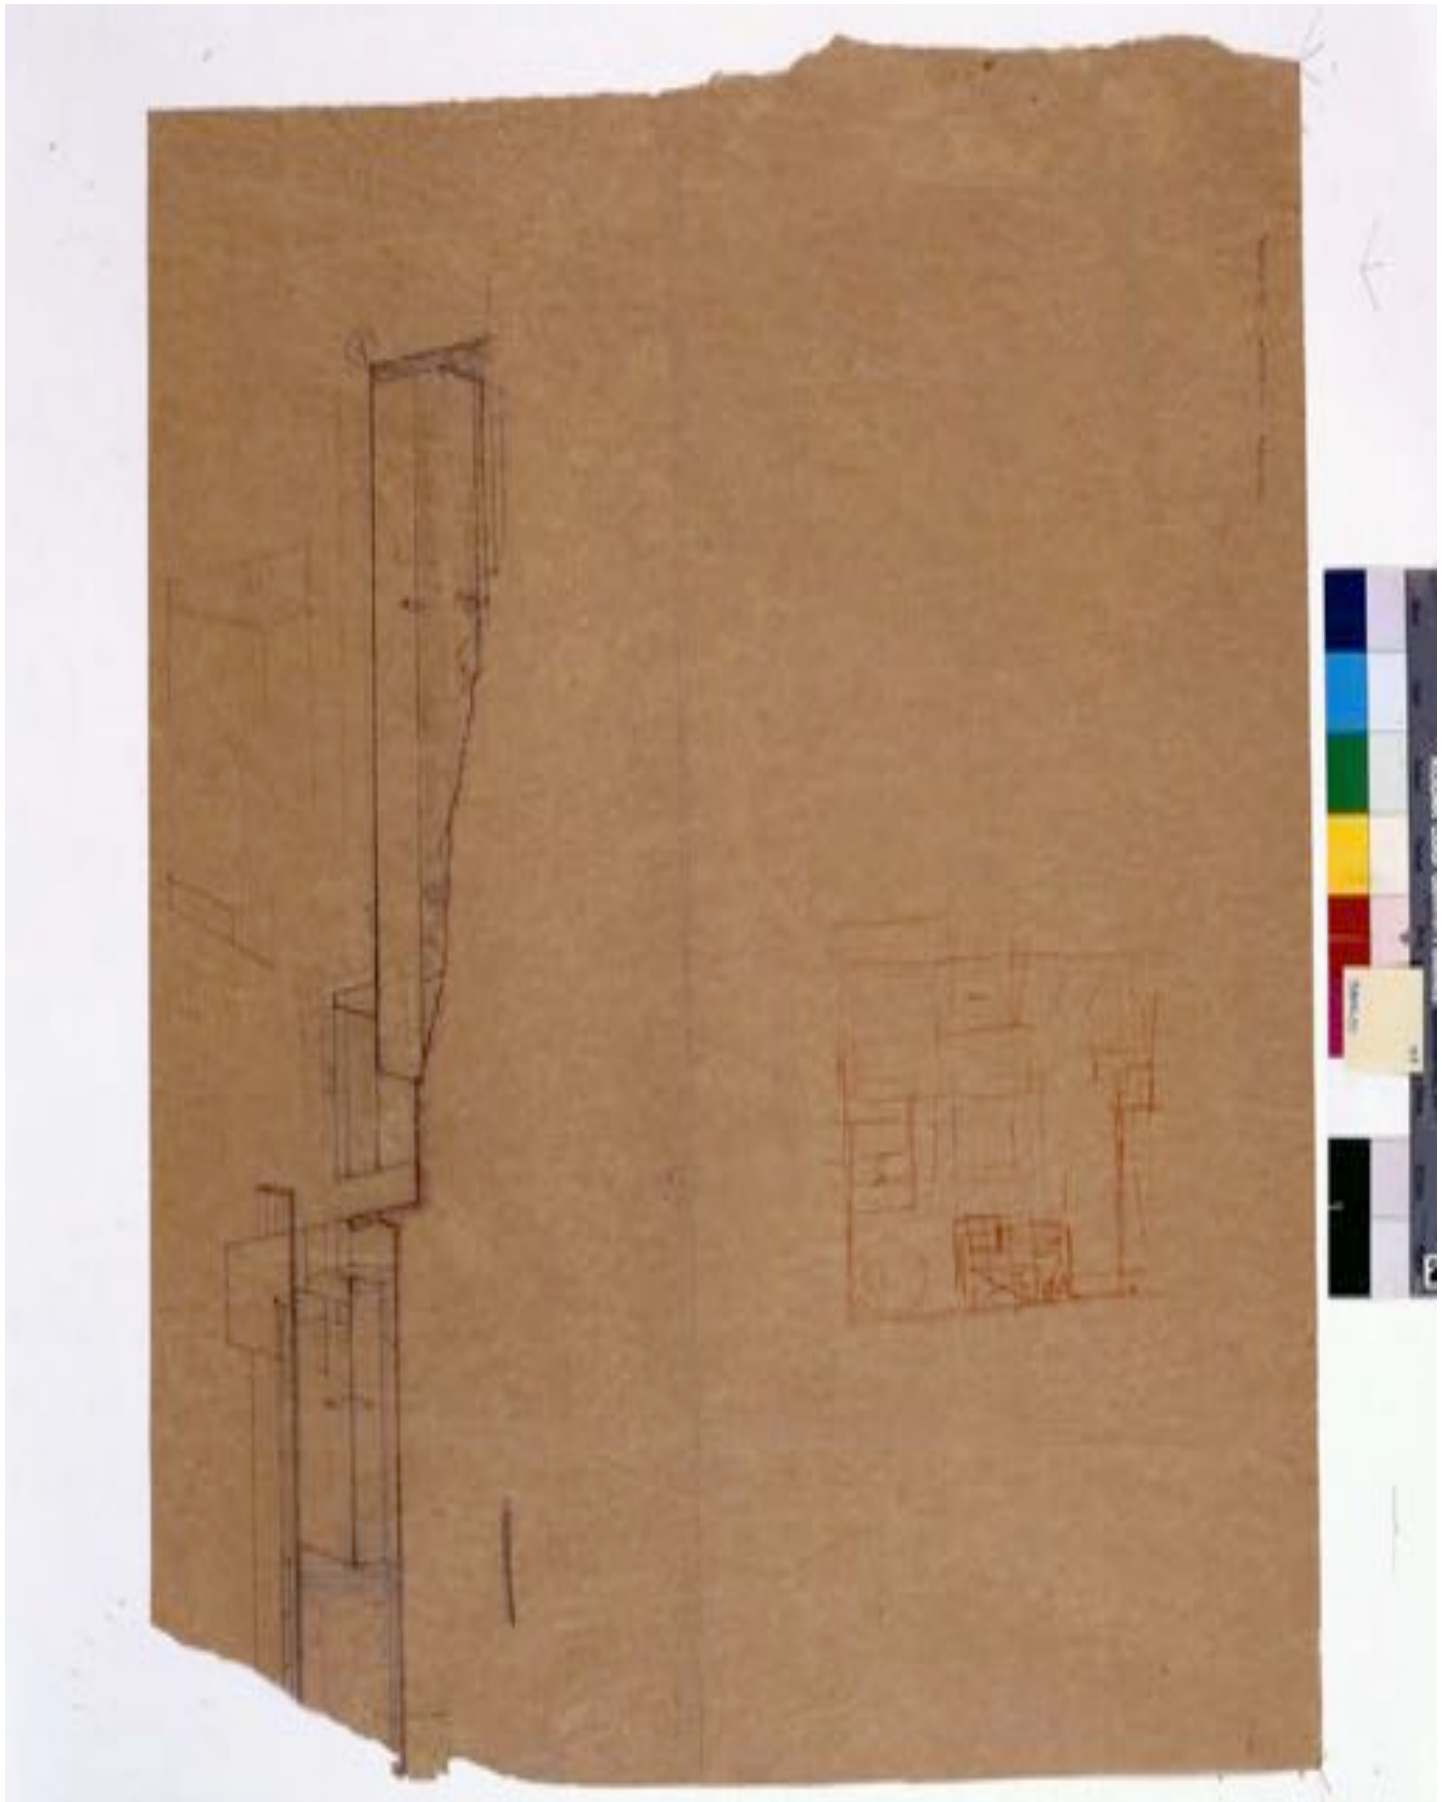
Figure B-11 - Section of House [Wright Living Quarters], fragment/plunge pool (The Frank Lloyd Wright Foundation Archives, The Museum of Modern Art | Avery Architectural & Fine Arts Library, Columbia University, New York).

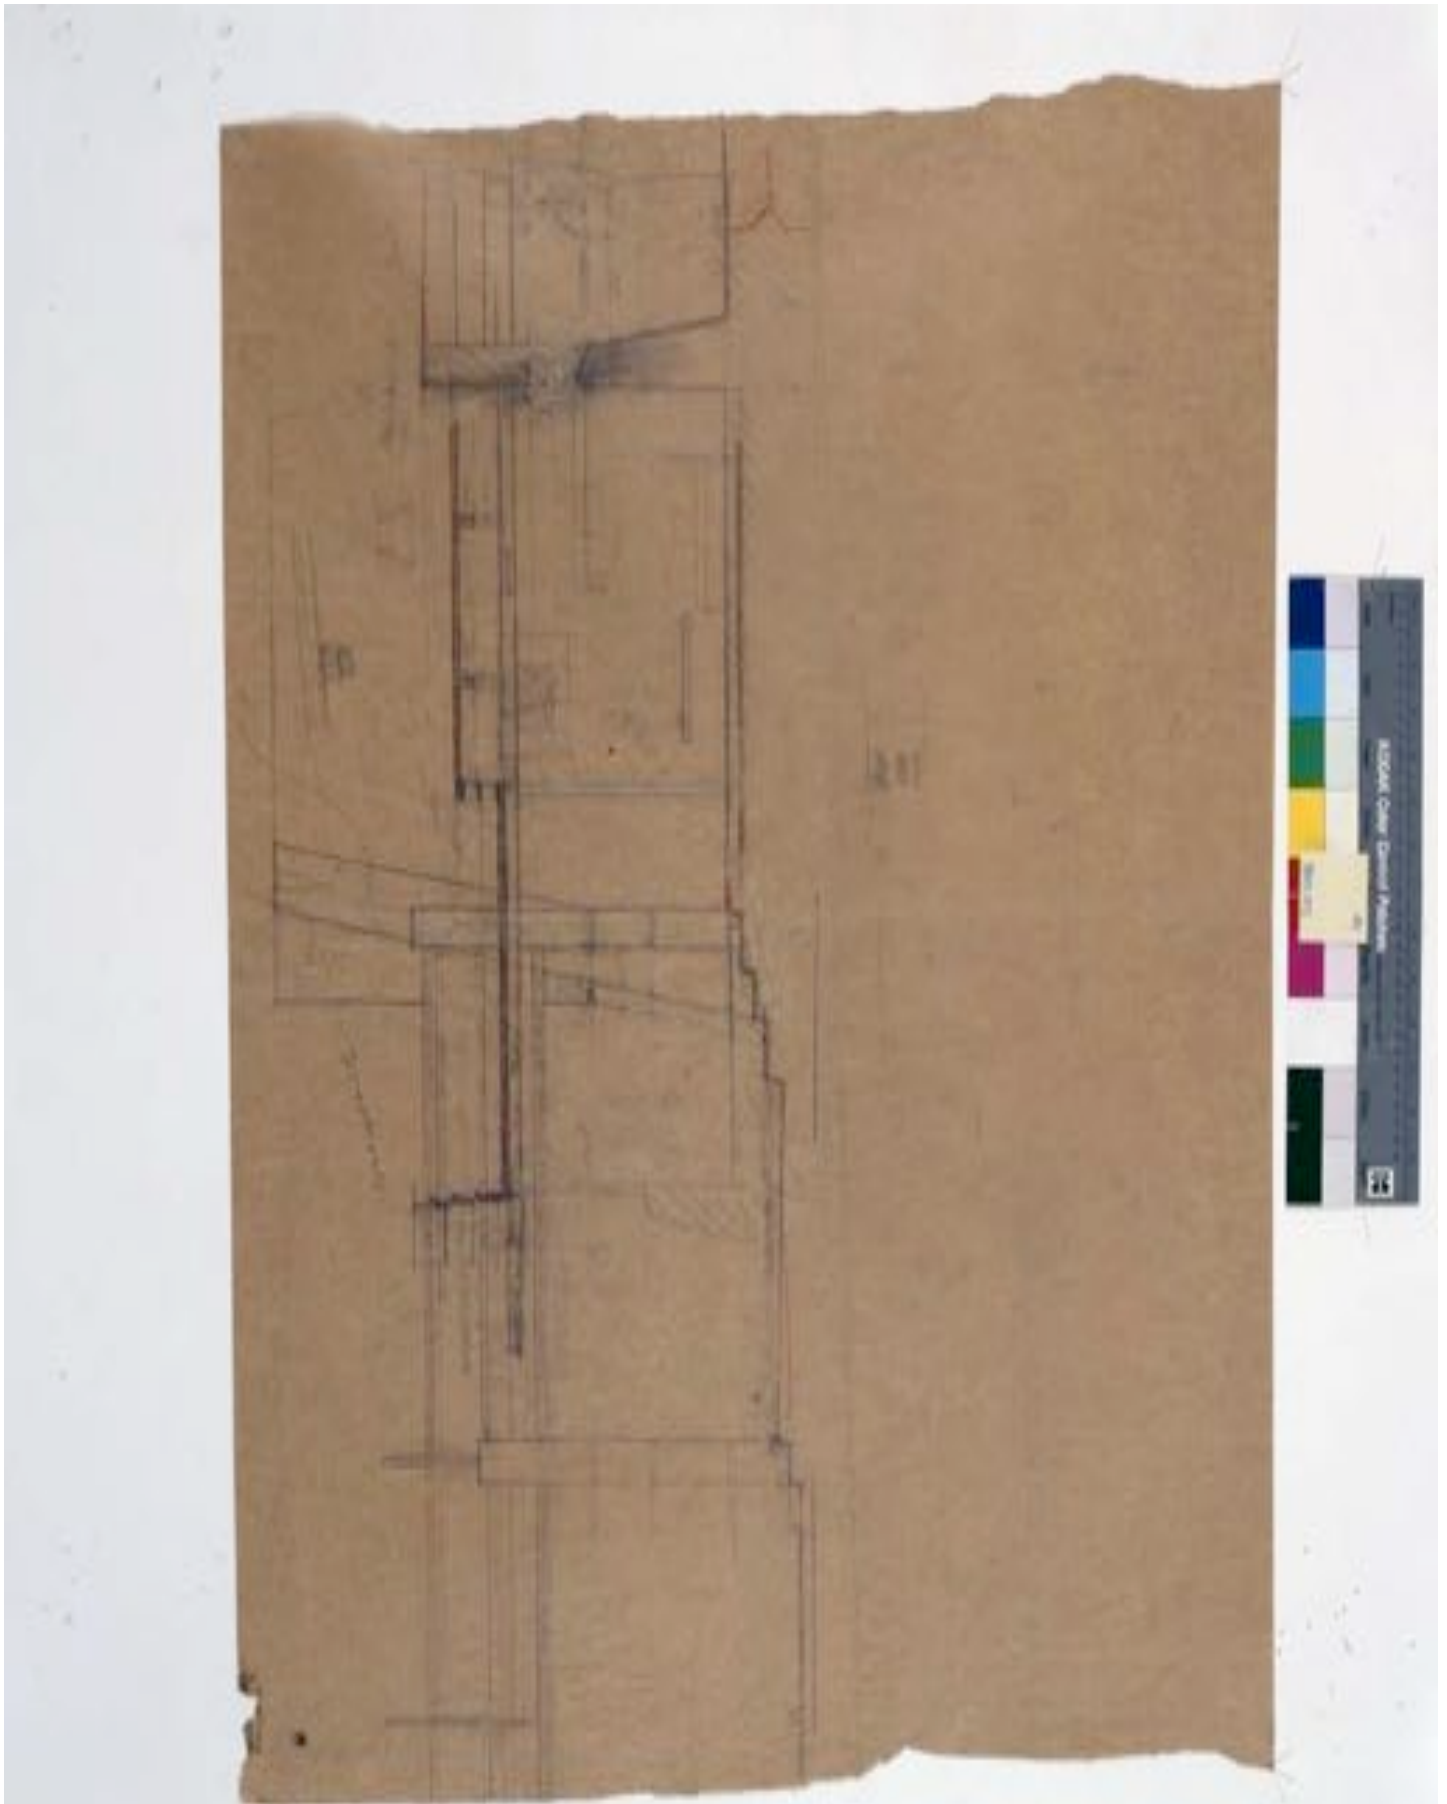
Figure B-12 - House [Wright Living Quarters] Section (The Frank Lloyd Wright Foundation Archives, The Museum of Modern Art | Avery Architectural & Fine Arts Library, Columbia University, New York).
