TALIESIN WEST PRESERVATION MASTER PLAN

Harboe Architects, PC

MAY 21, 2015

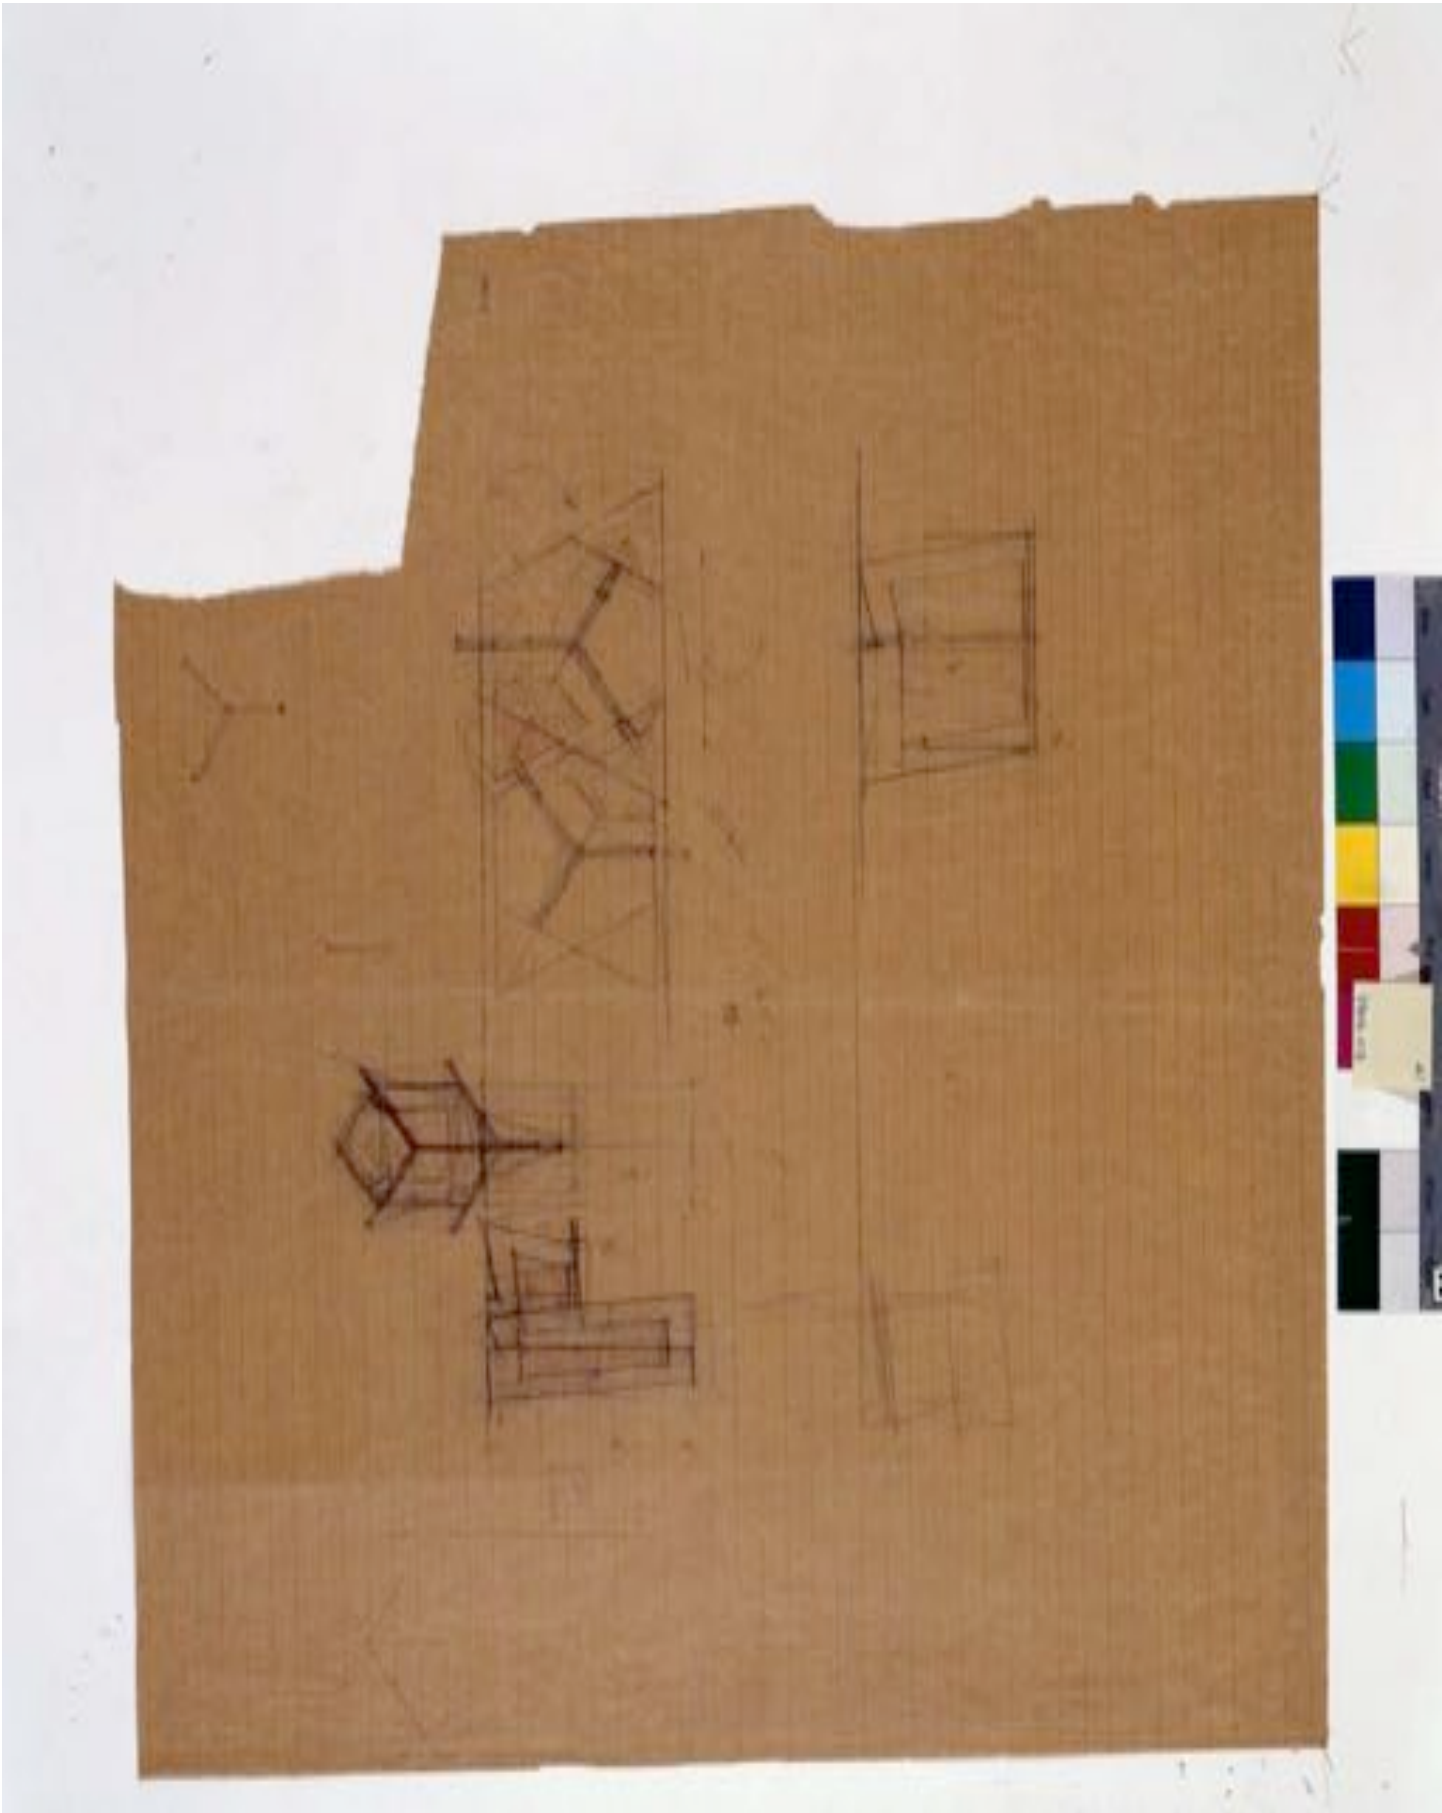
Figure B-13 - Table and Chair (The Frank Lloyd Wright Foundation Archives, The Museum of Modern Art | Avery Architectural & Fine Arts Library, Columbia University, New York).

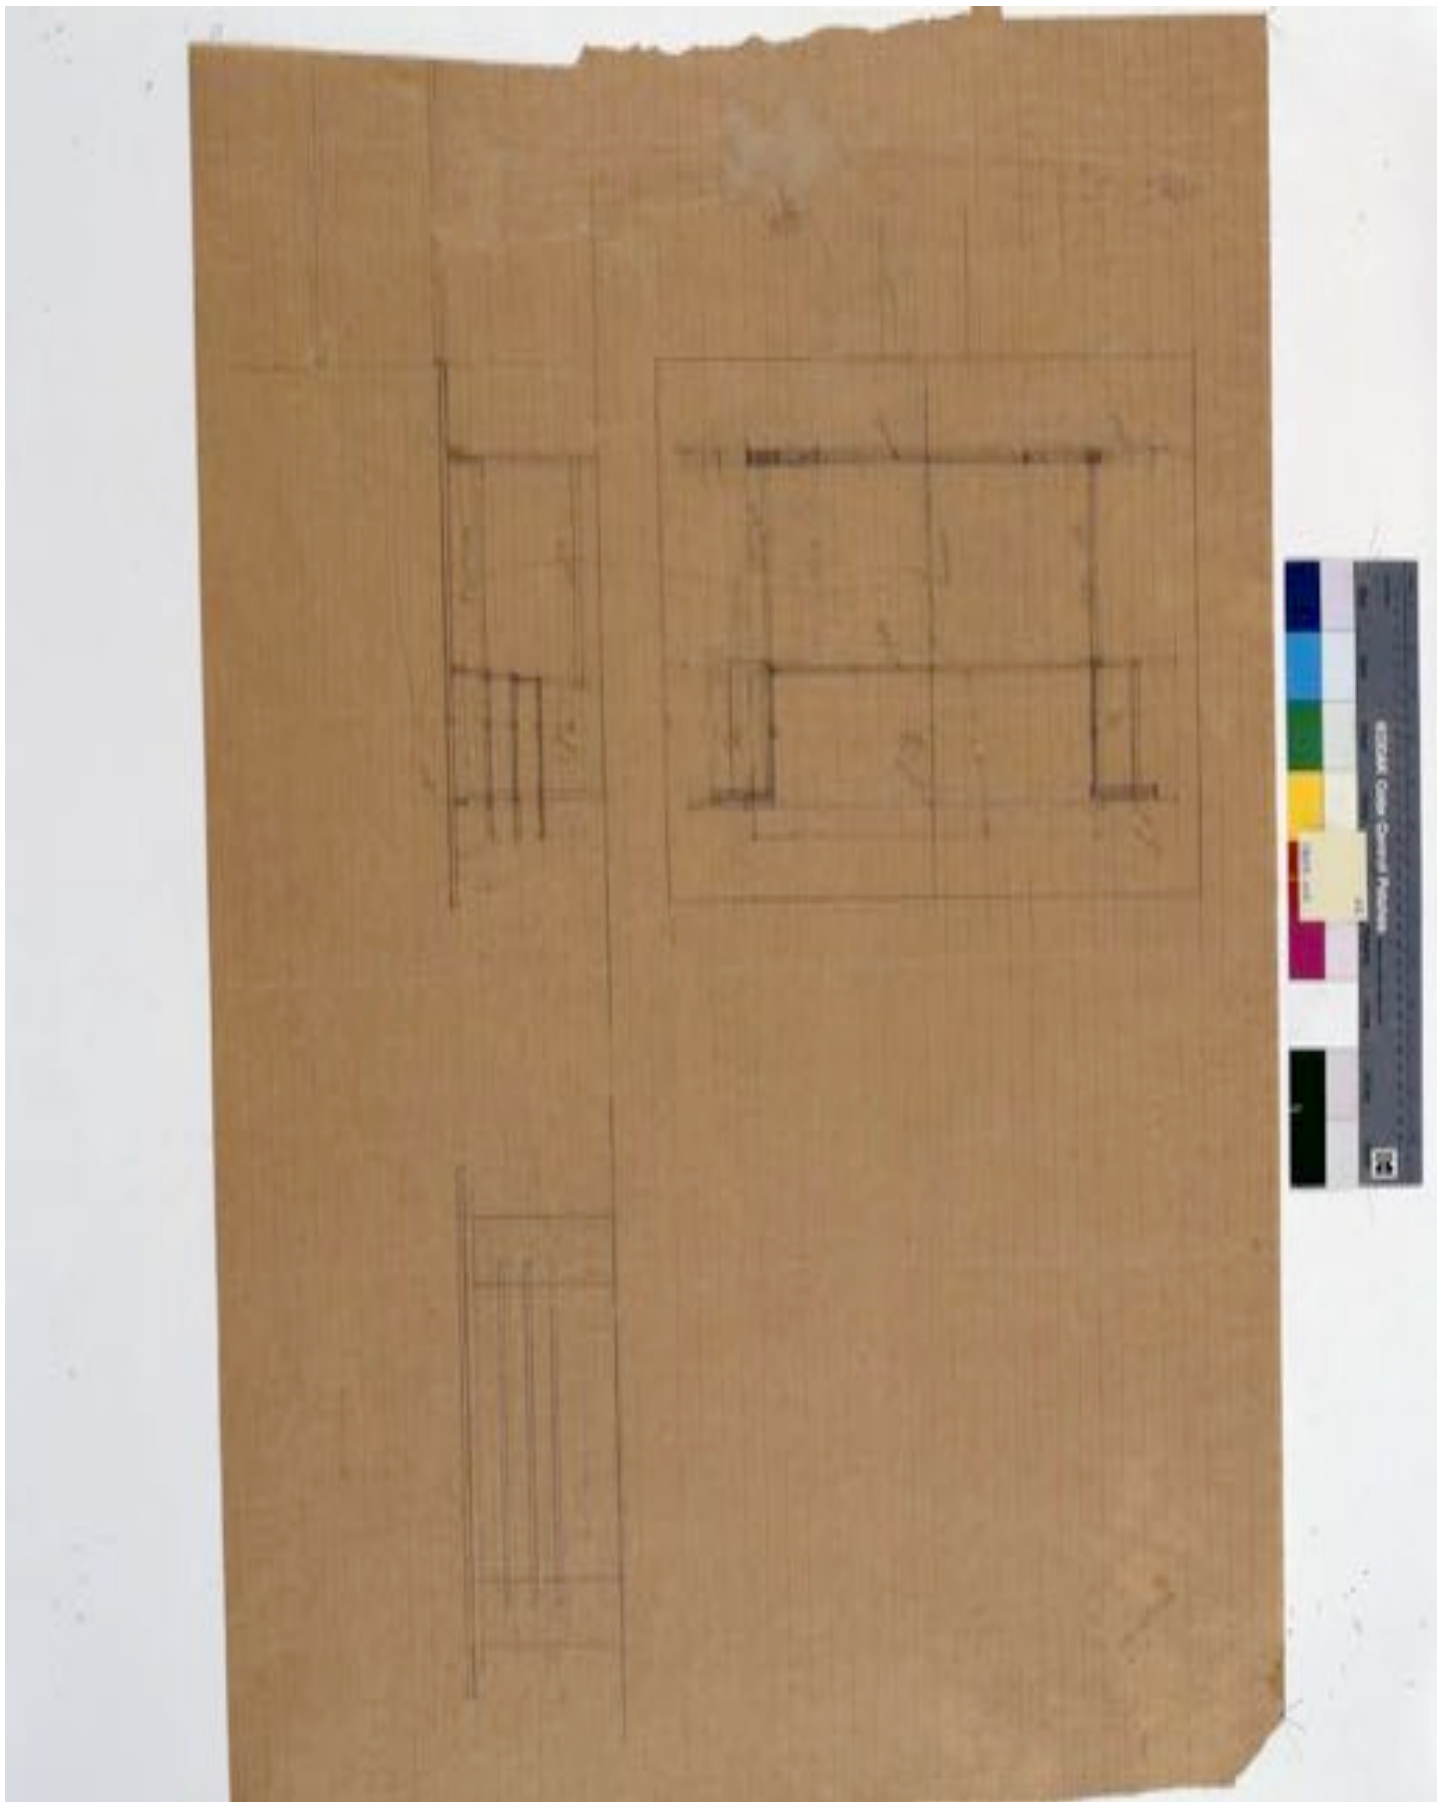
Figure B-14 - Drawing table (The Frank Lloyd Wright Foundation Archives, The Museum of Modern Art | Avery Architectural & Fine Arts Library, Columbia University, New York).

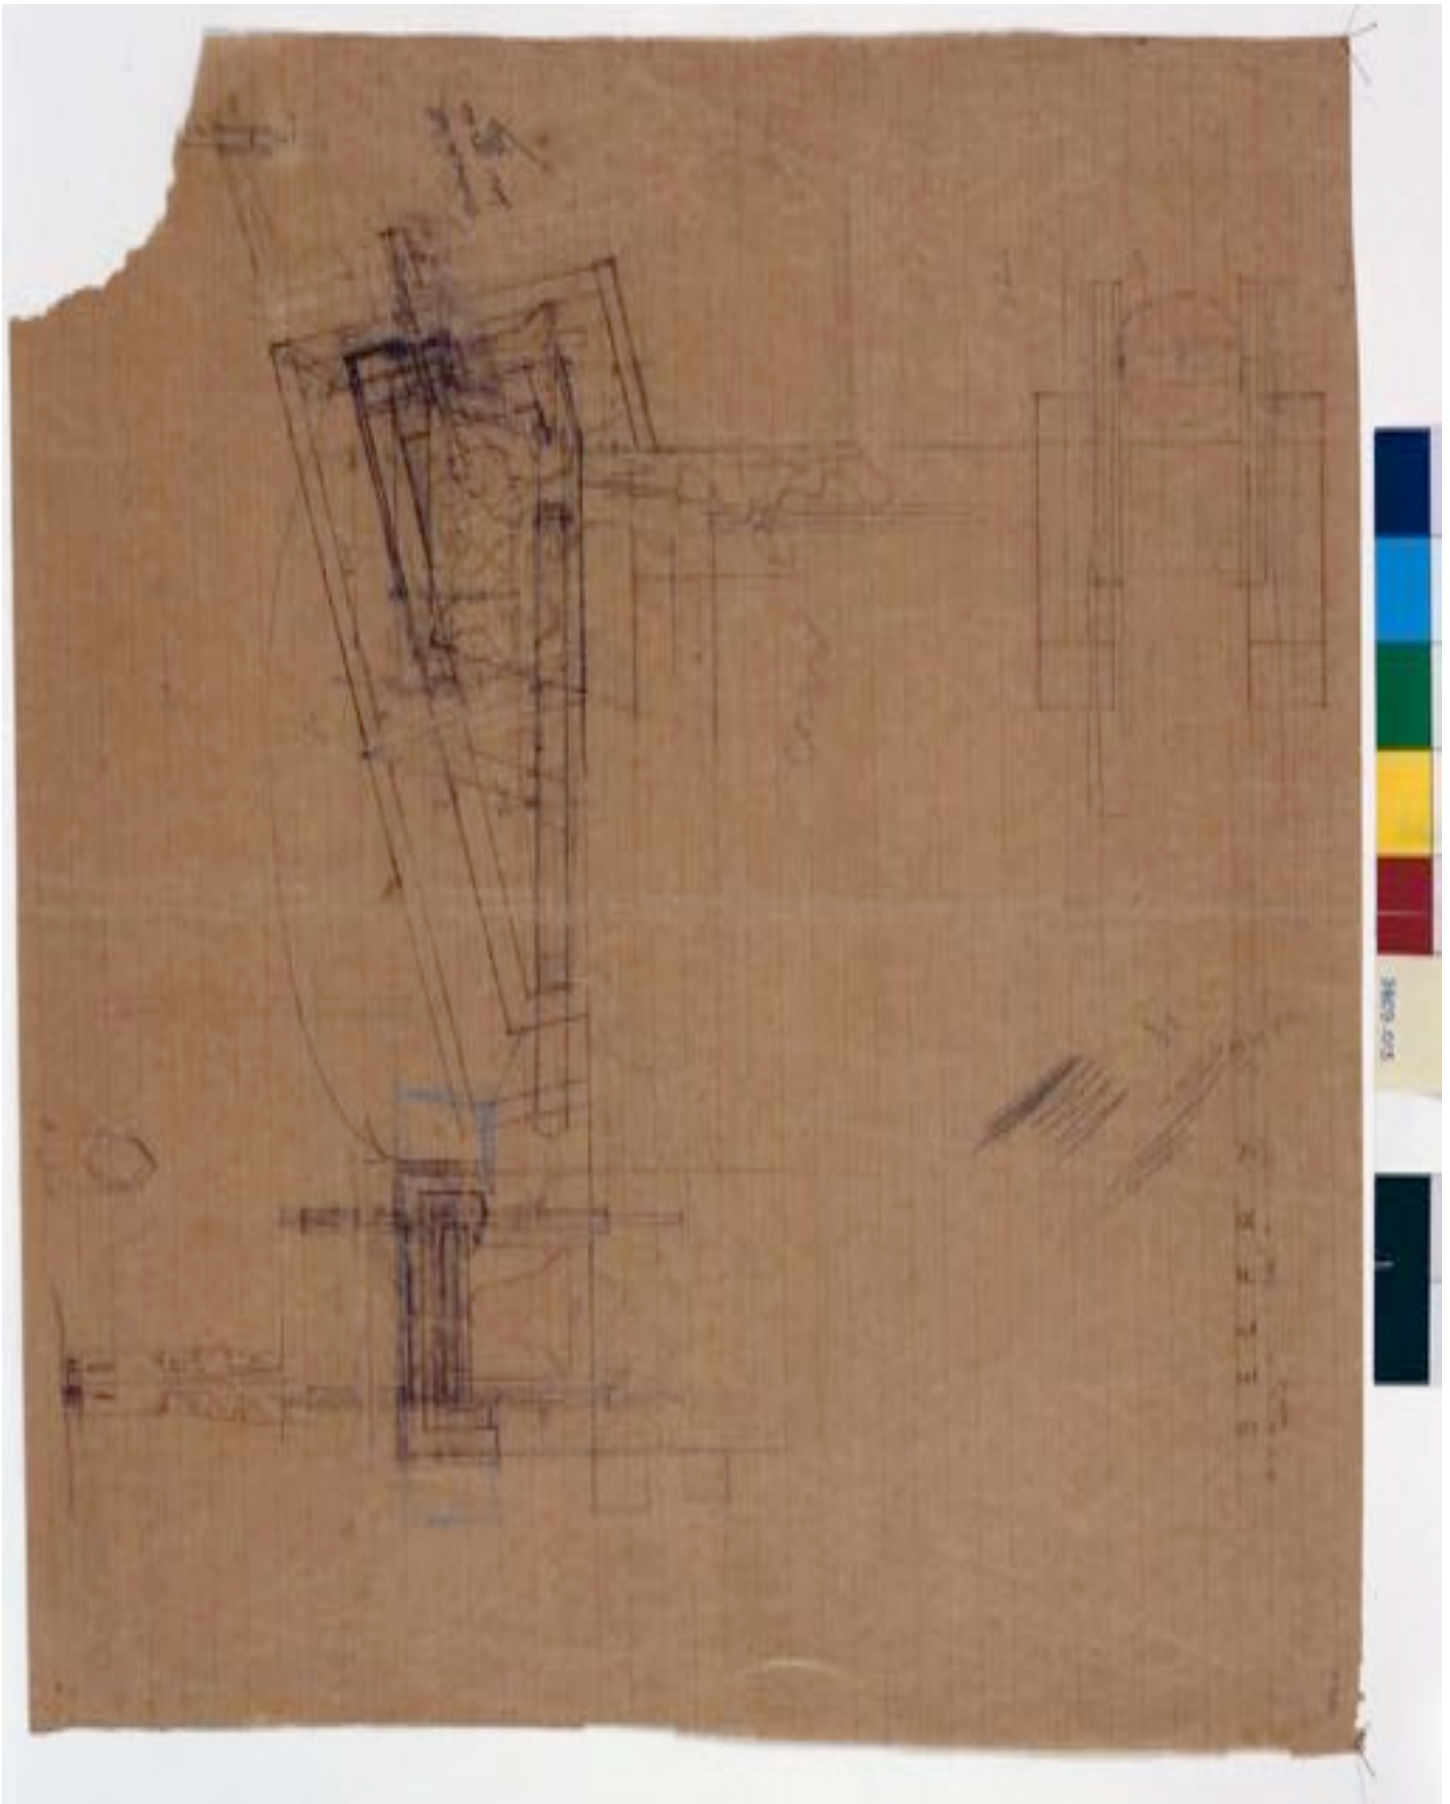
Figure B-15 - Bell Tower/Kitchen Plan (The Frank Lloyd Wright Foundation Archives, The Museum of Modern Art | Avery Architectural & Fine Arts Library, Columbia University, New York).

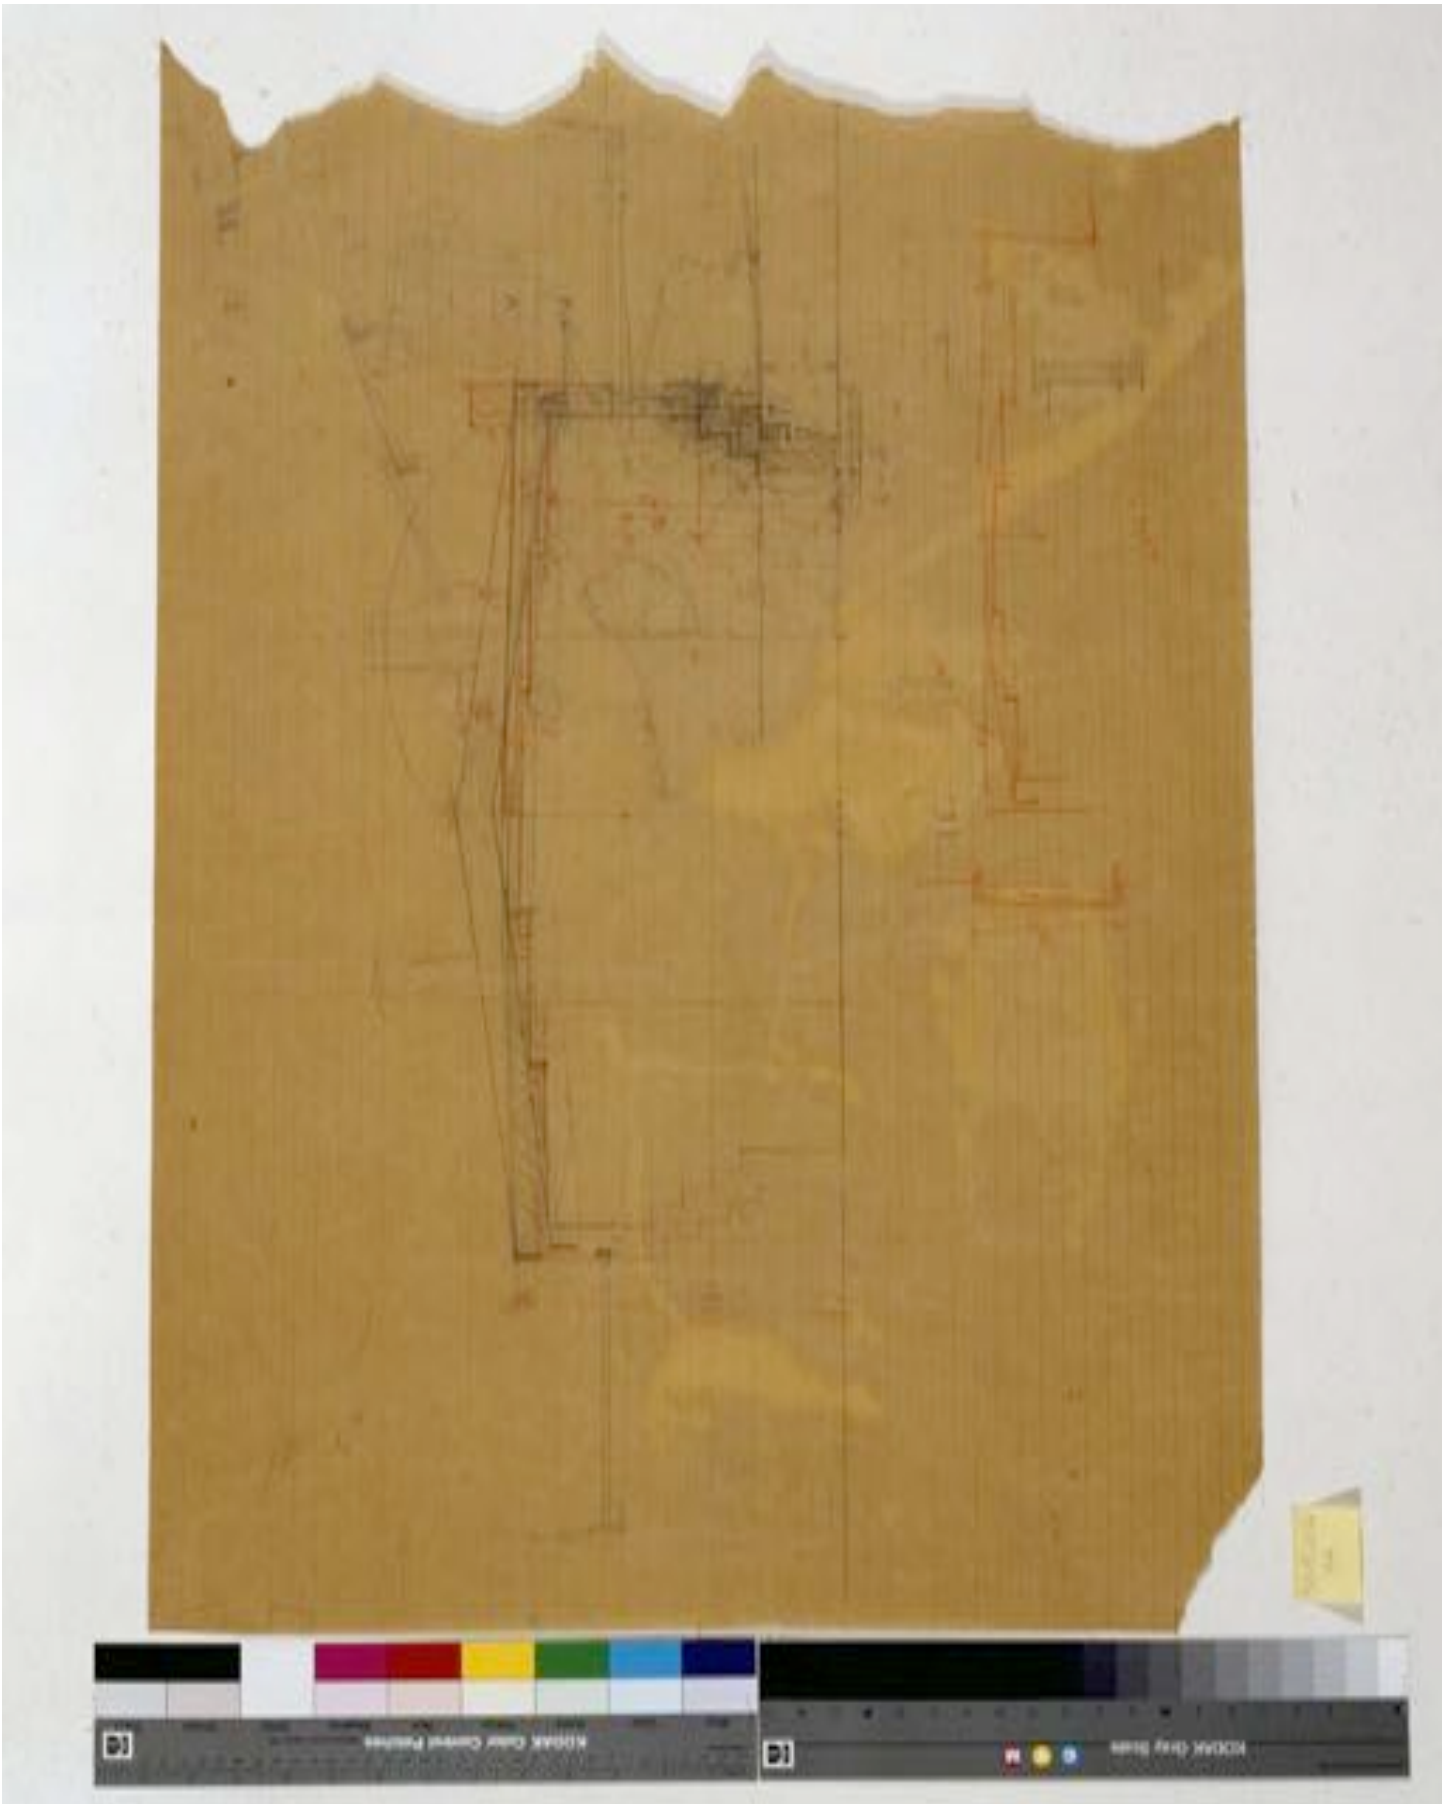
Figure B-16 - Theatre Section (The Frank Lloyd Wright Foundation Archives, The Museum of Modern Art | Avery Architectural & Fine Arts Library, Columbia University, New York).

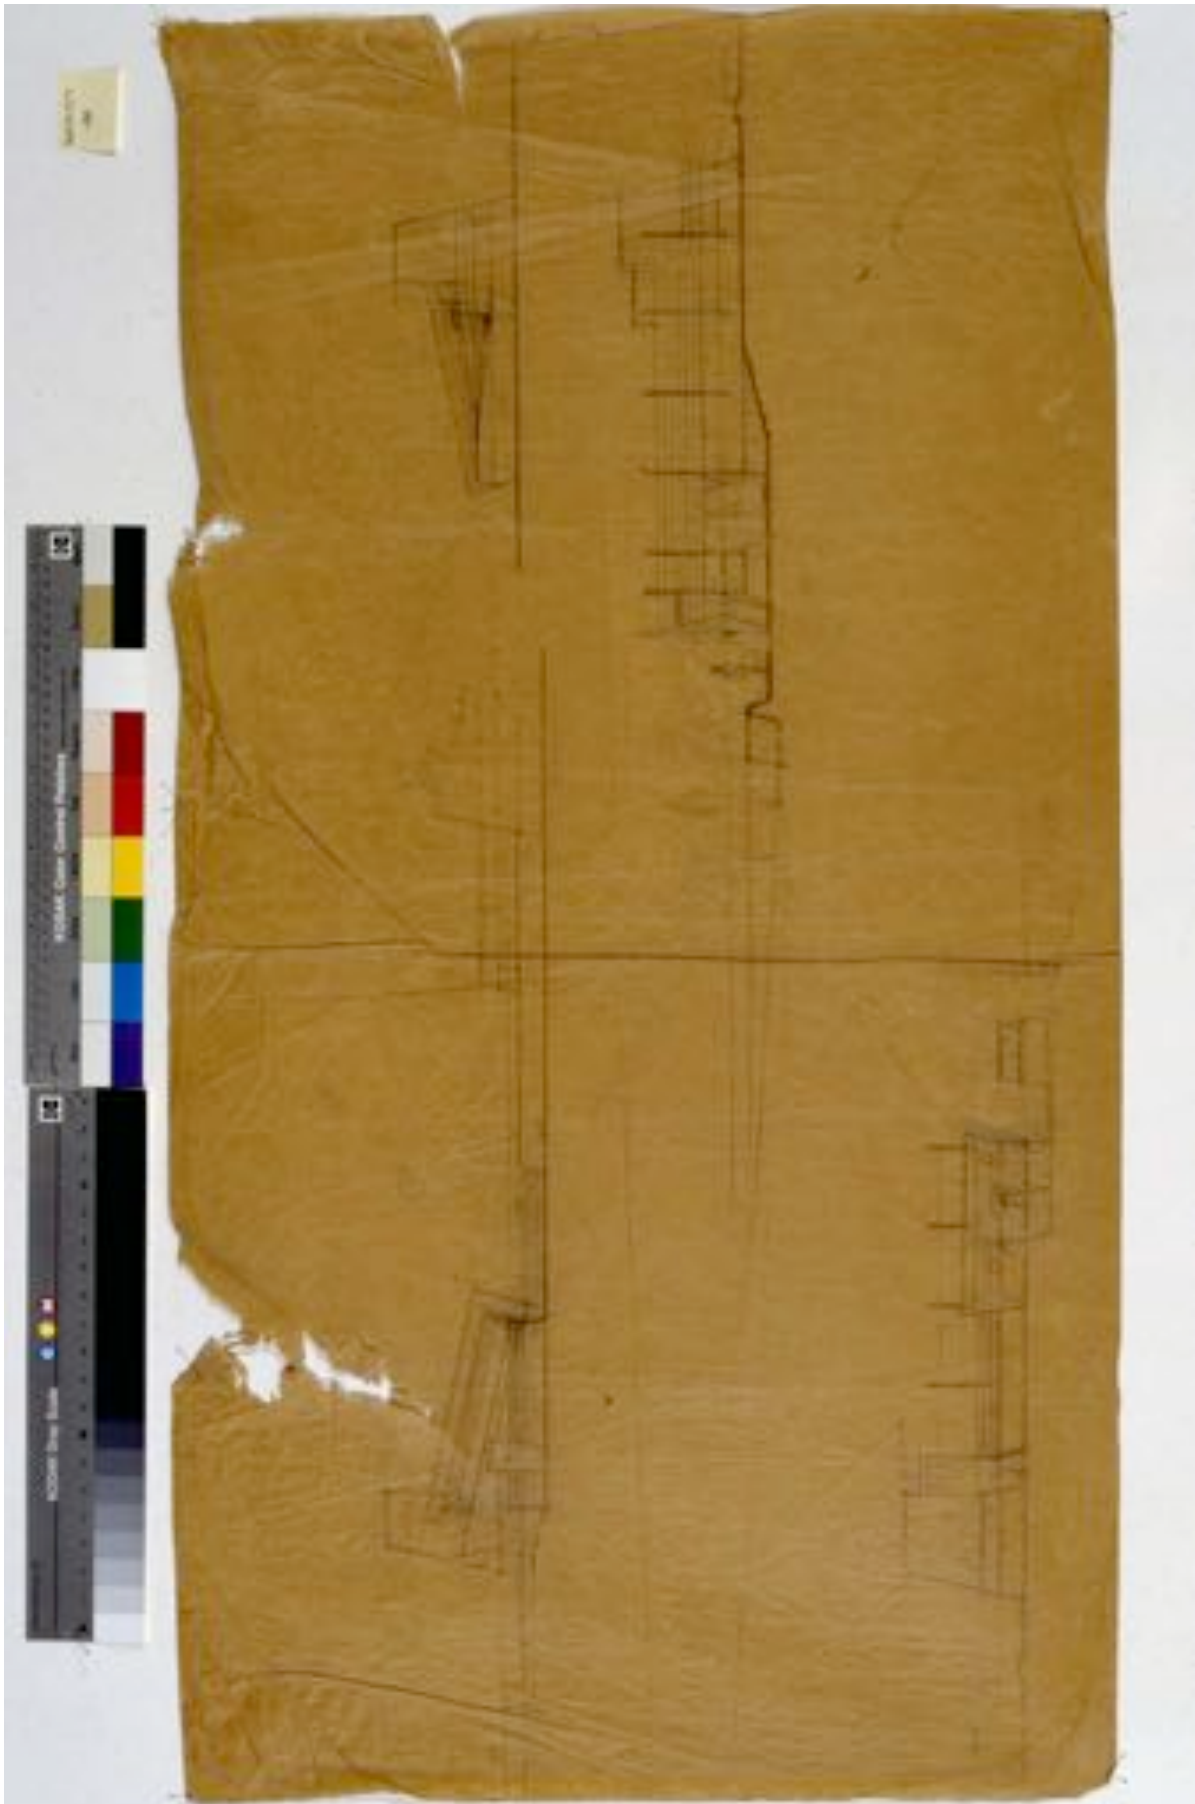
Figure B-17 - Office Elevations (The Frank Lloyd Wright Foundation Archives, The Museum of Modern Art | Avery Architectural & Fine Arts Library, Columbia University, New York).

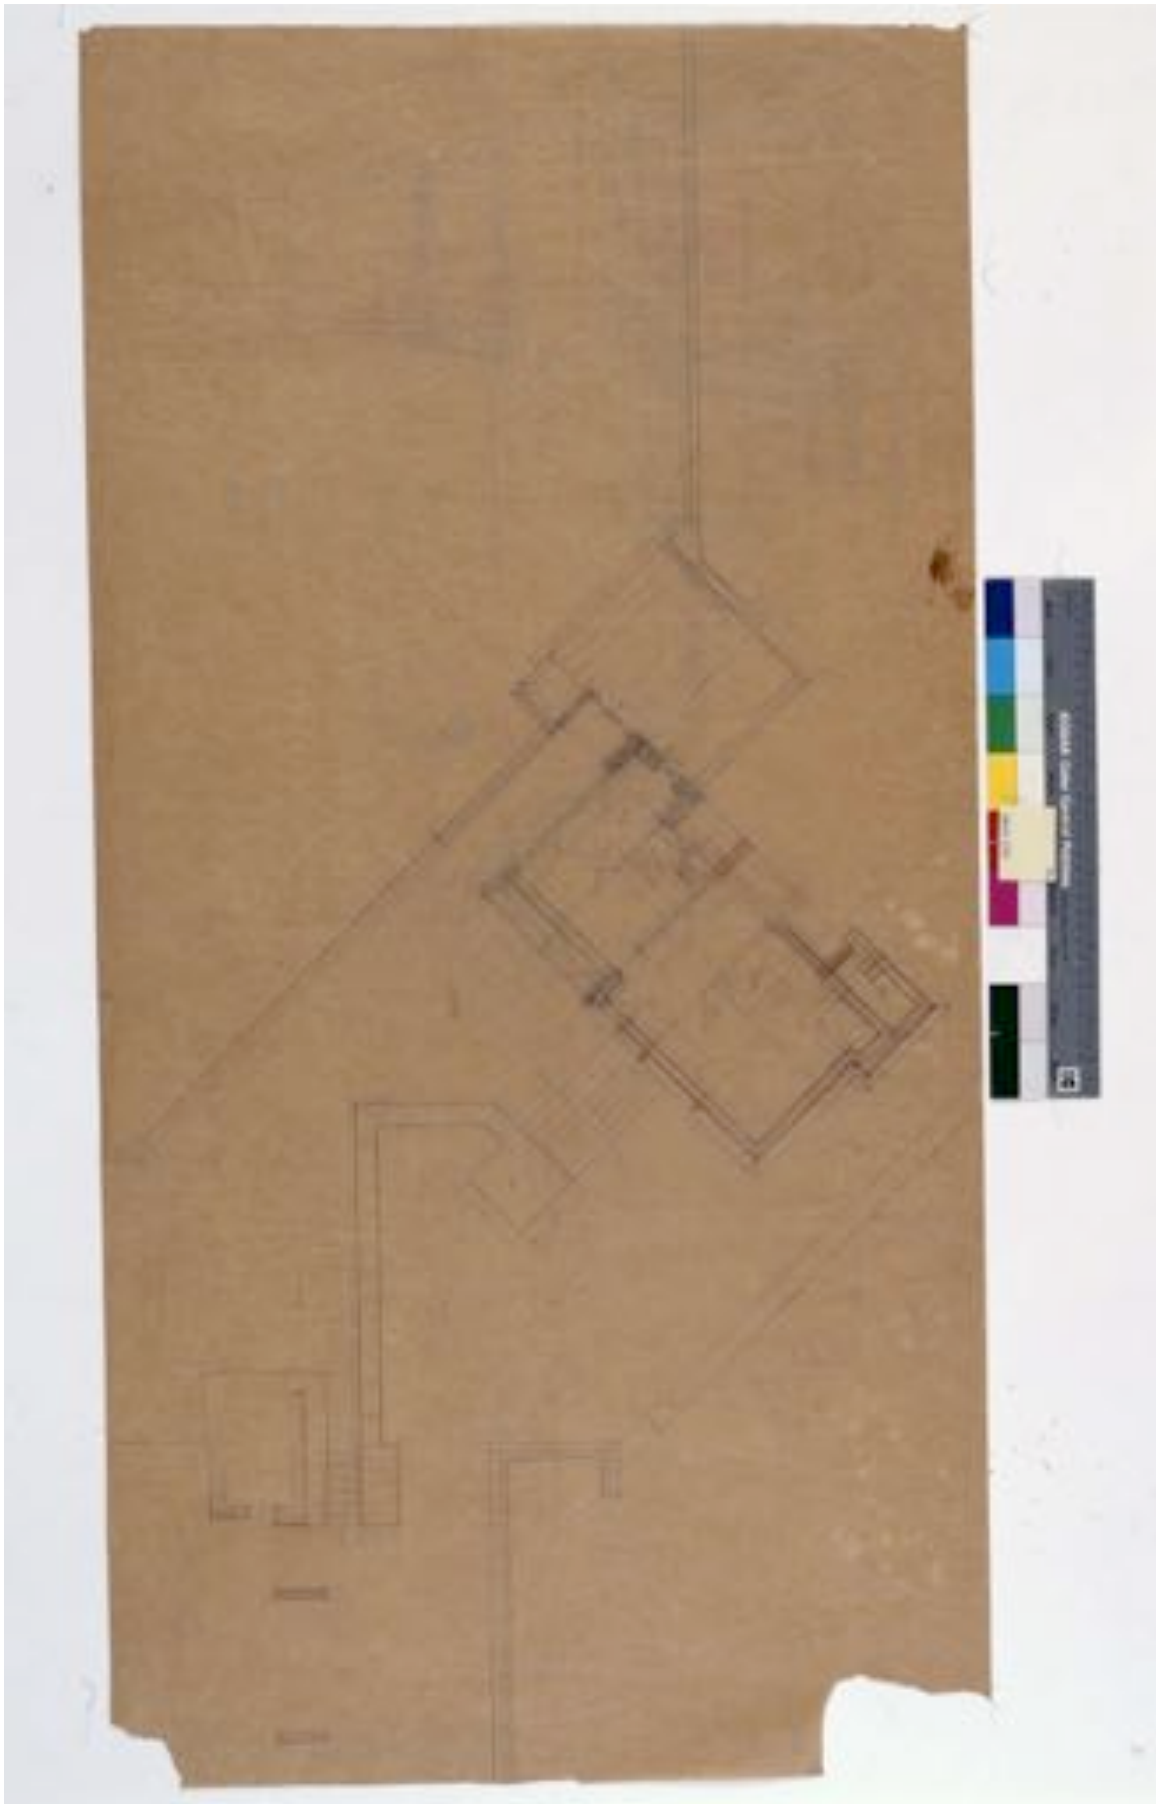
Figure B-18 - Office Plan (The Frank Lloyd Wright Foundation Archives, The Museum of Modern Art | Avery Architectural & Fine Arts Library, Columbia University, New York).

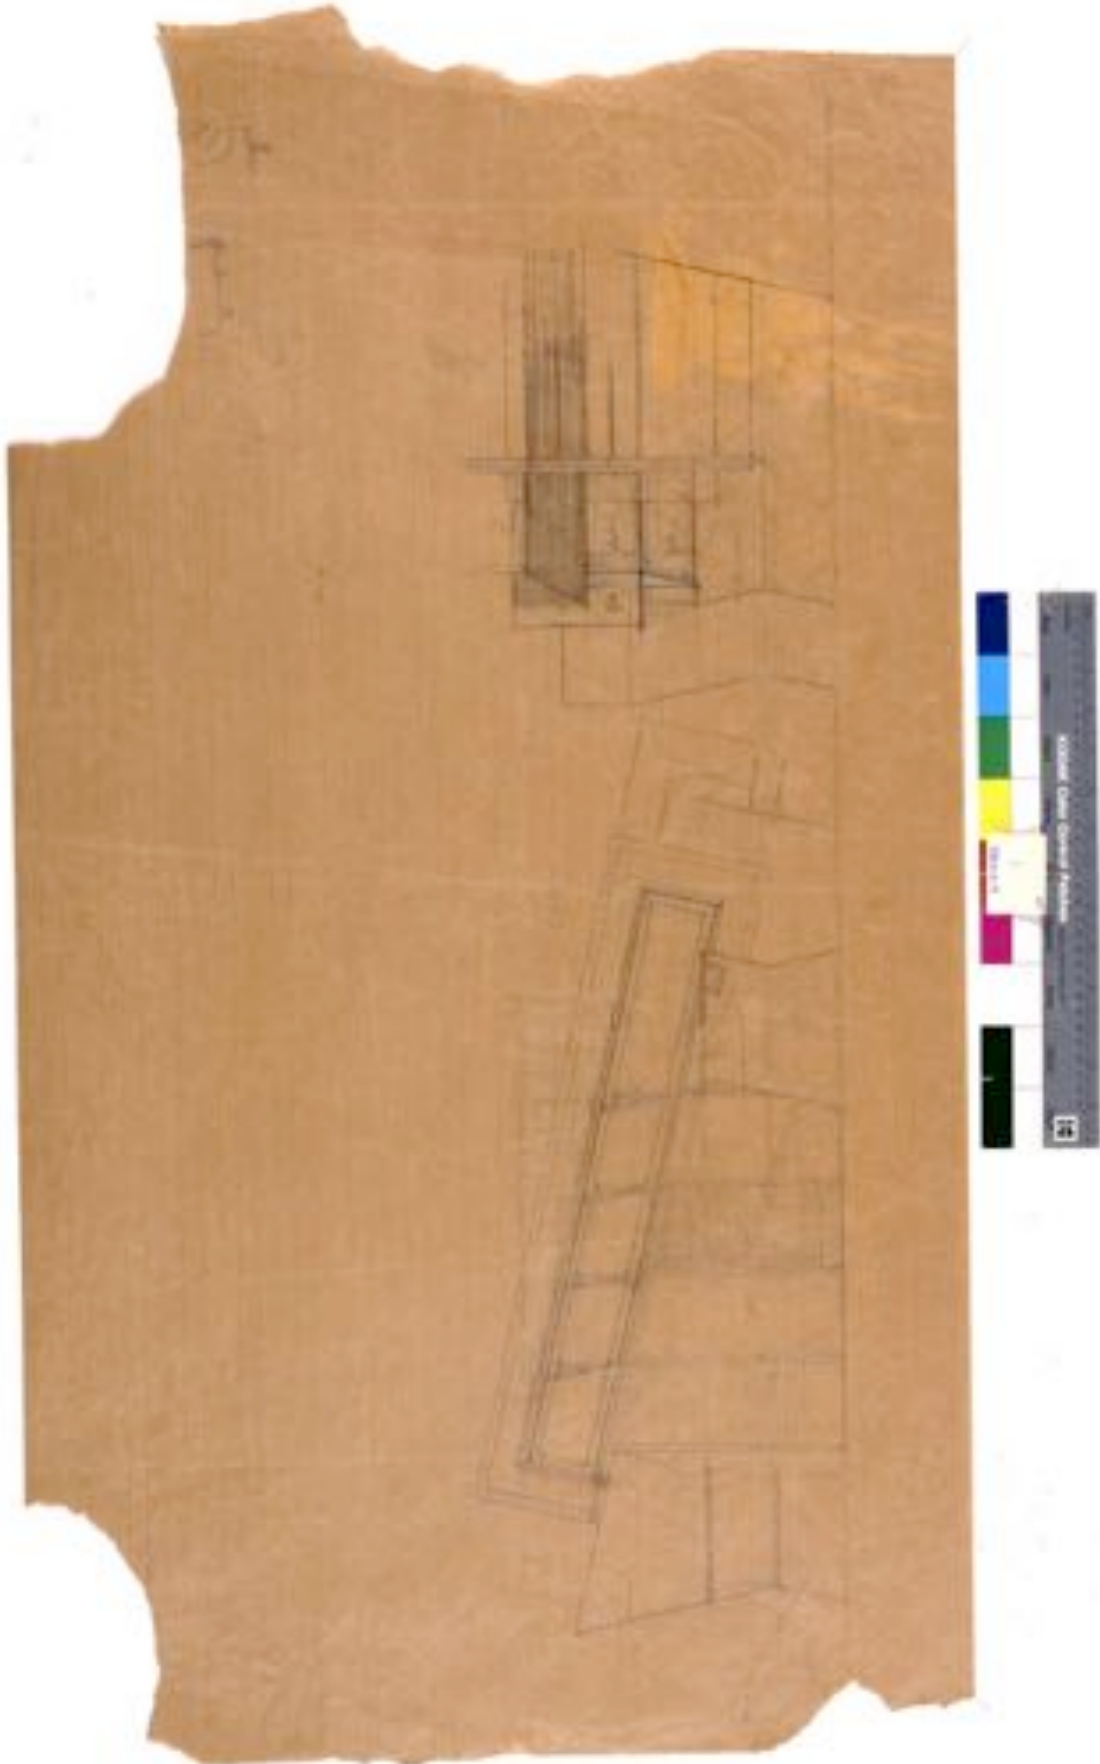
Figure B-19 - Office Elevations (The Frank Lloyd Wright Foundation Archives, The Museum of Modern Art | Avery Architectural & Fine Arts Library, Columbia University, New York).

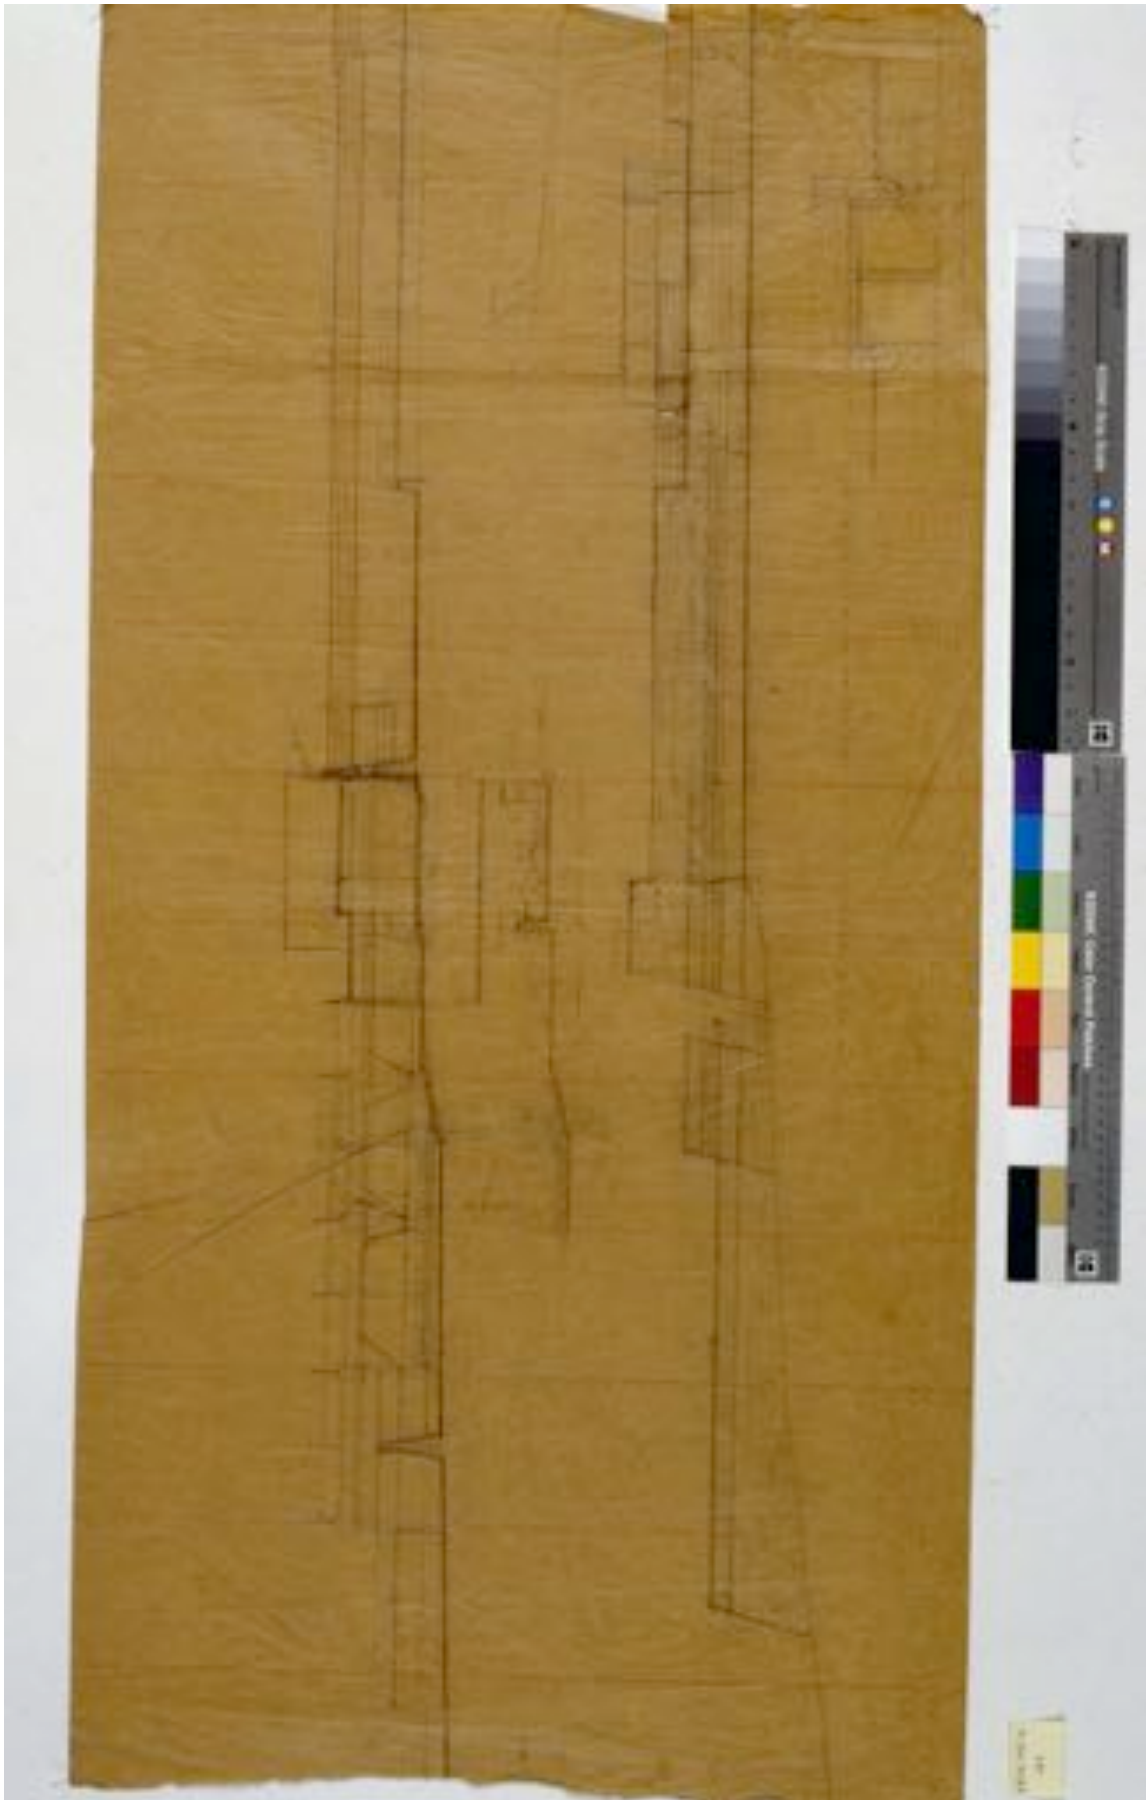
Figure B-21A - Full South Elevation A (The Frank Lloyd Wright Foundation Archives, The Museum of Modern Art | Avery Architectural & Fine Arts Library, Columbia University, New York).

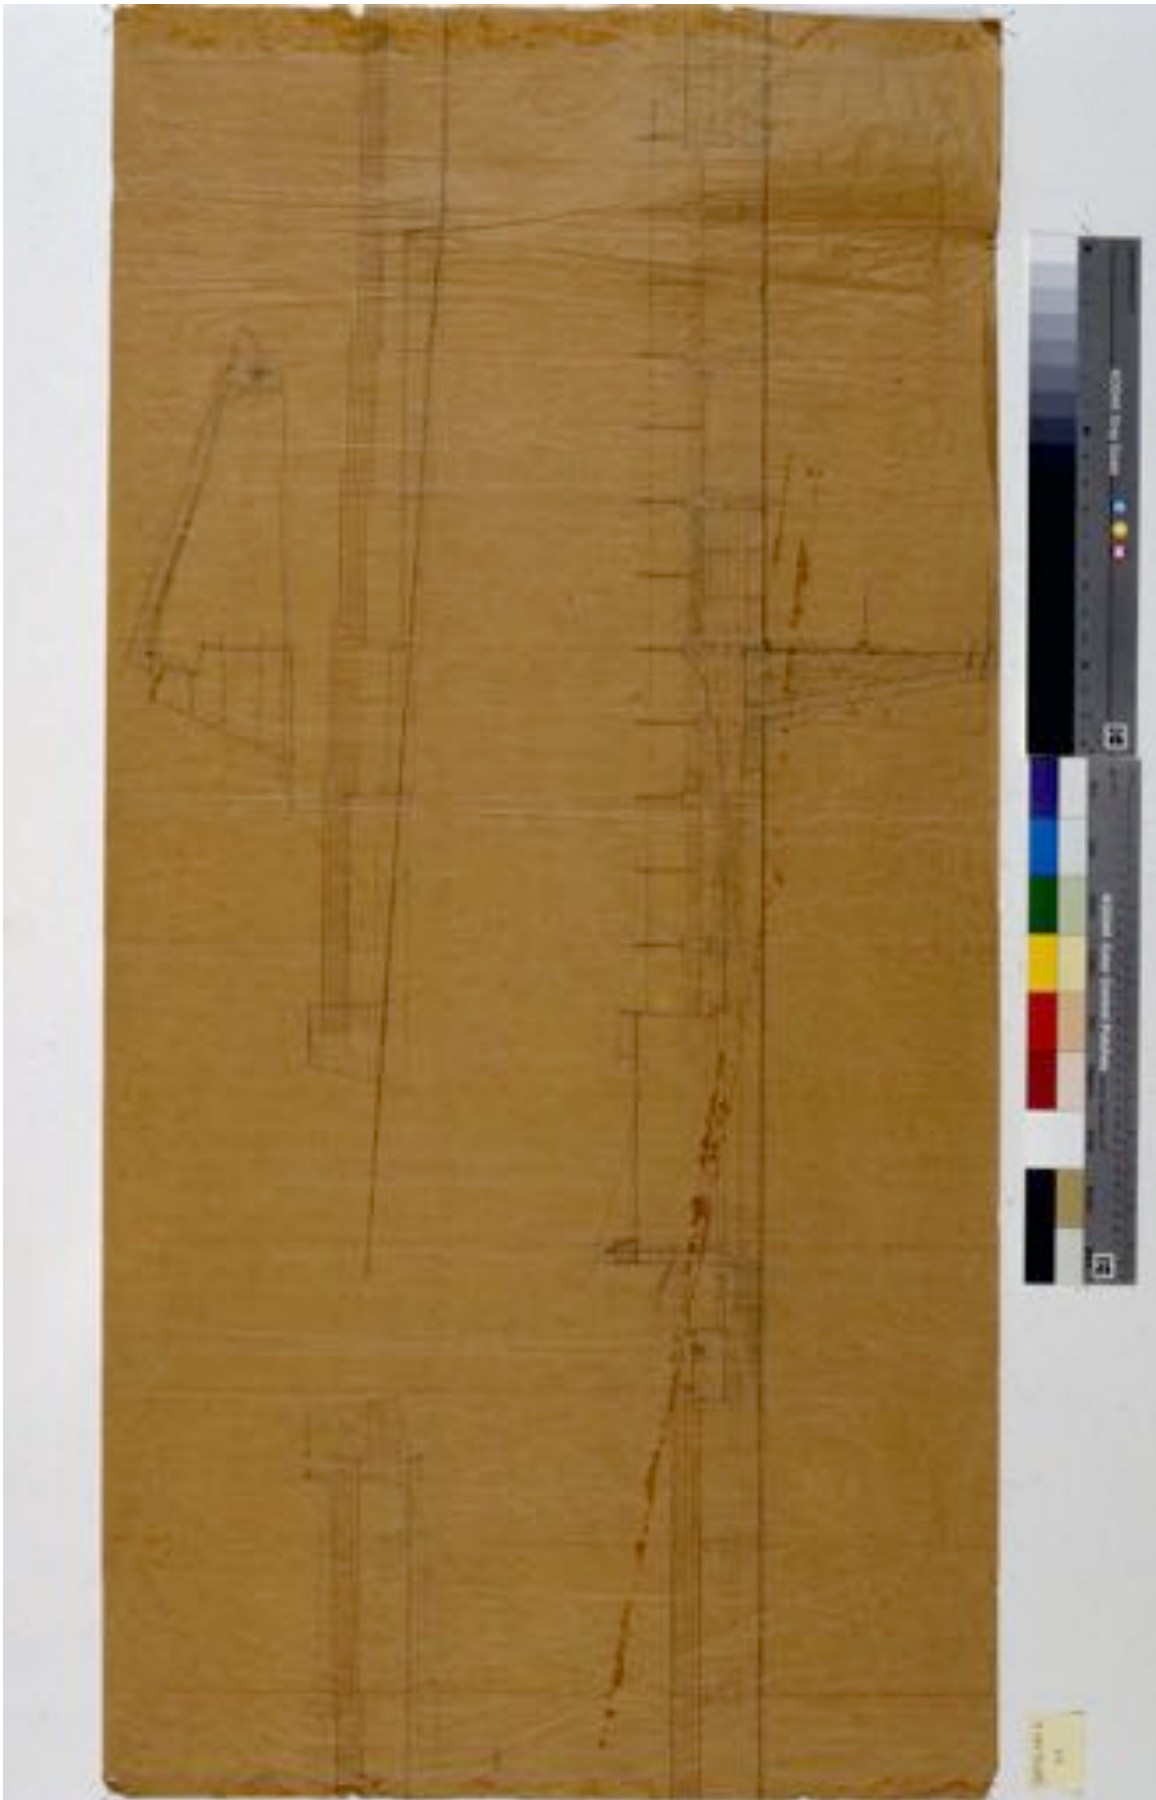
Figure B-21B - Full South Elevation B (The Frank Lloyd Wright Foundation Archives, The Museum of Modern Art | Avery Architectural & Fine Arts Library, Columbia University, New York).
