TALIESIN WEST PRESERVATION MASTER PLAN

Harboe Architects, PC

MAY 21, 2015

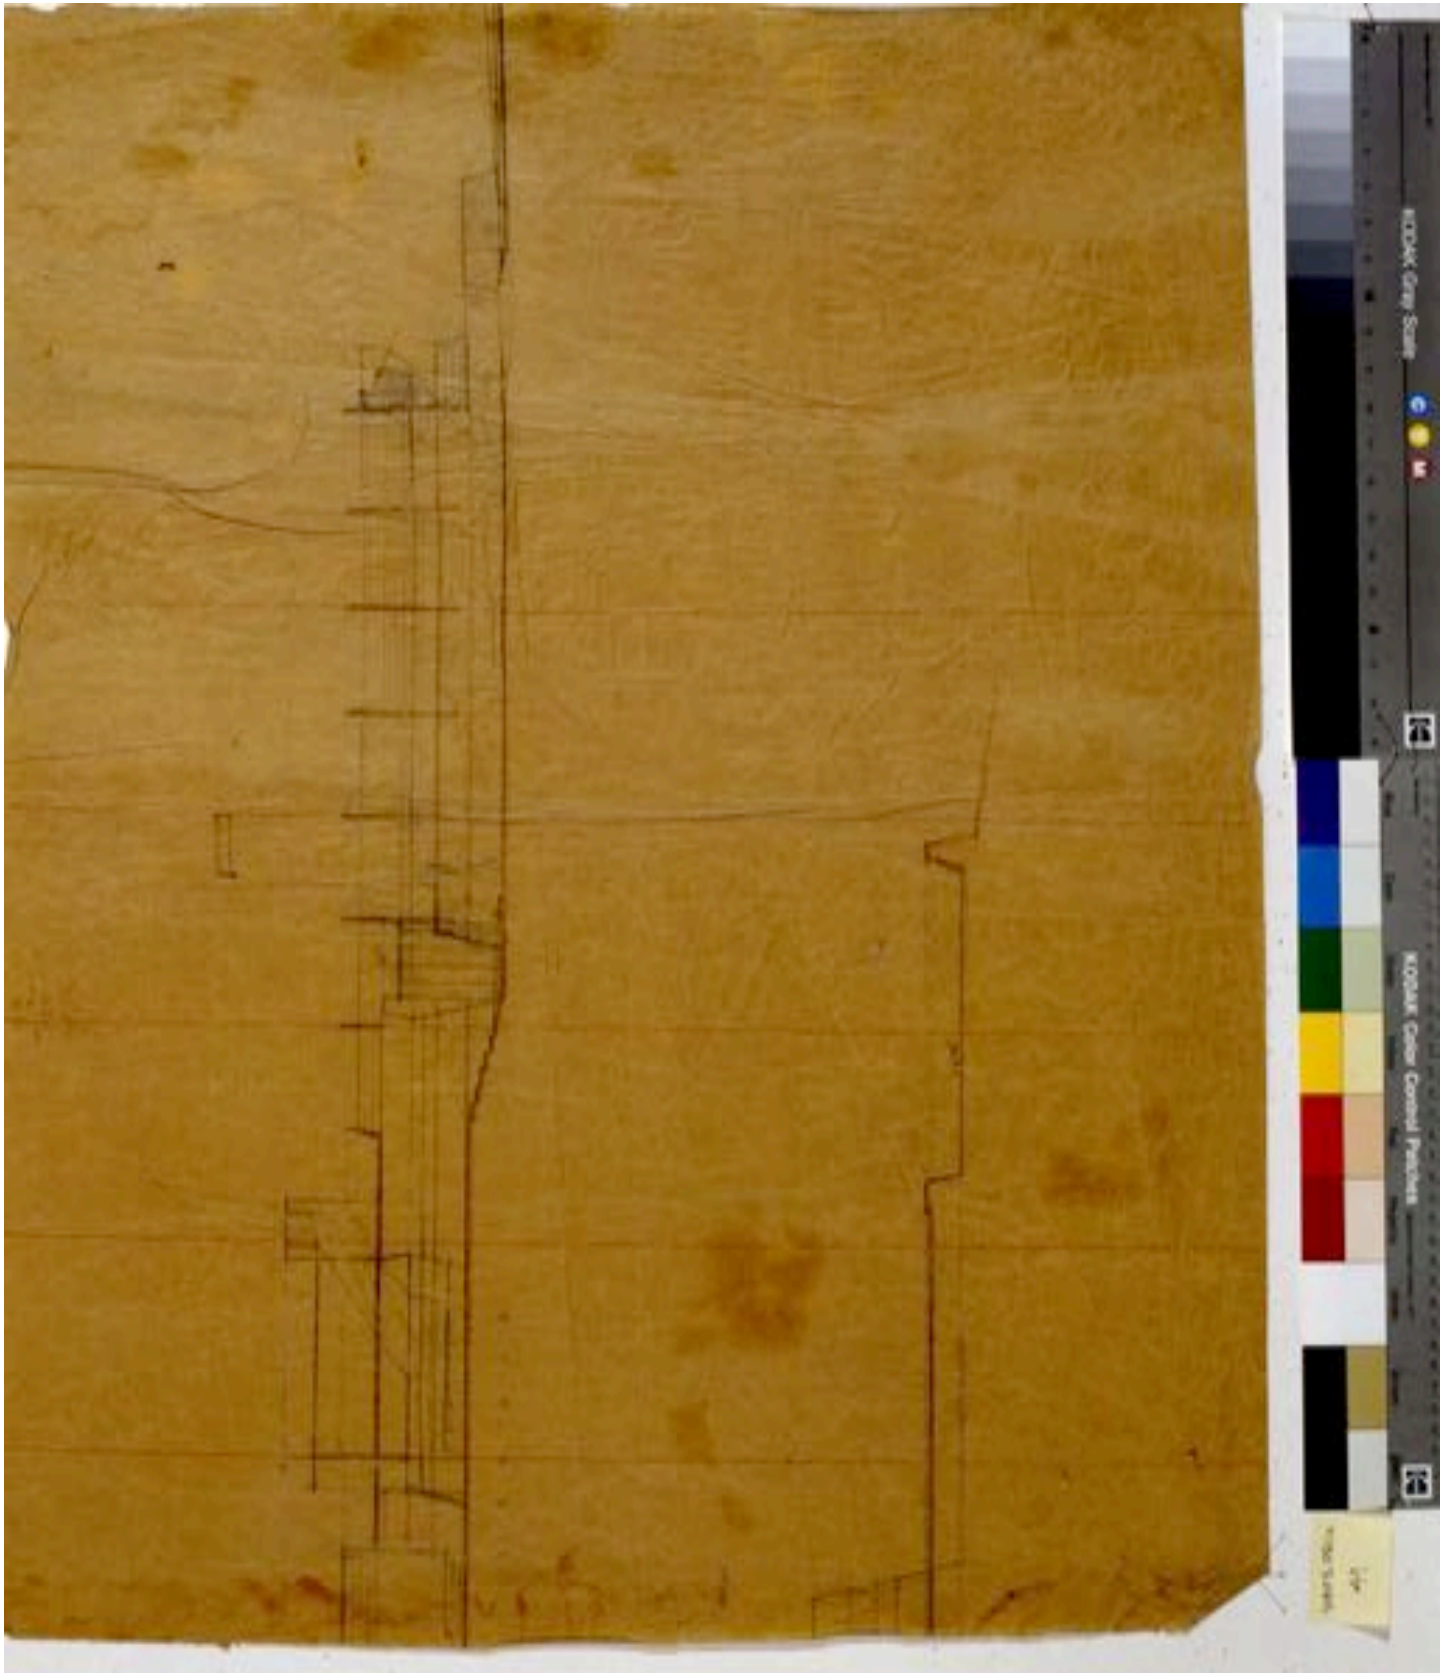
Figure B-21C - Full South Elevation C (The Frank Lloyd Wright Foundation Archives, The Museum of Modern Art | Avery Architectural & Fine Arts Library, Columbia University, New York).

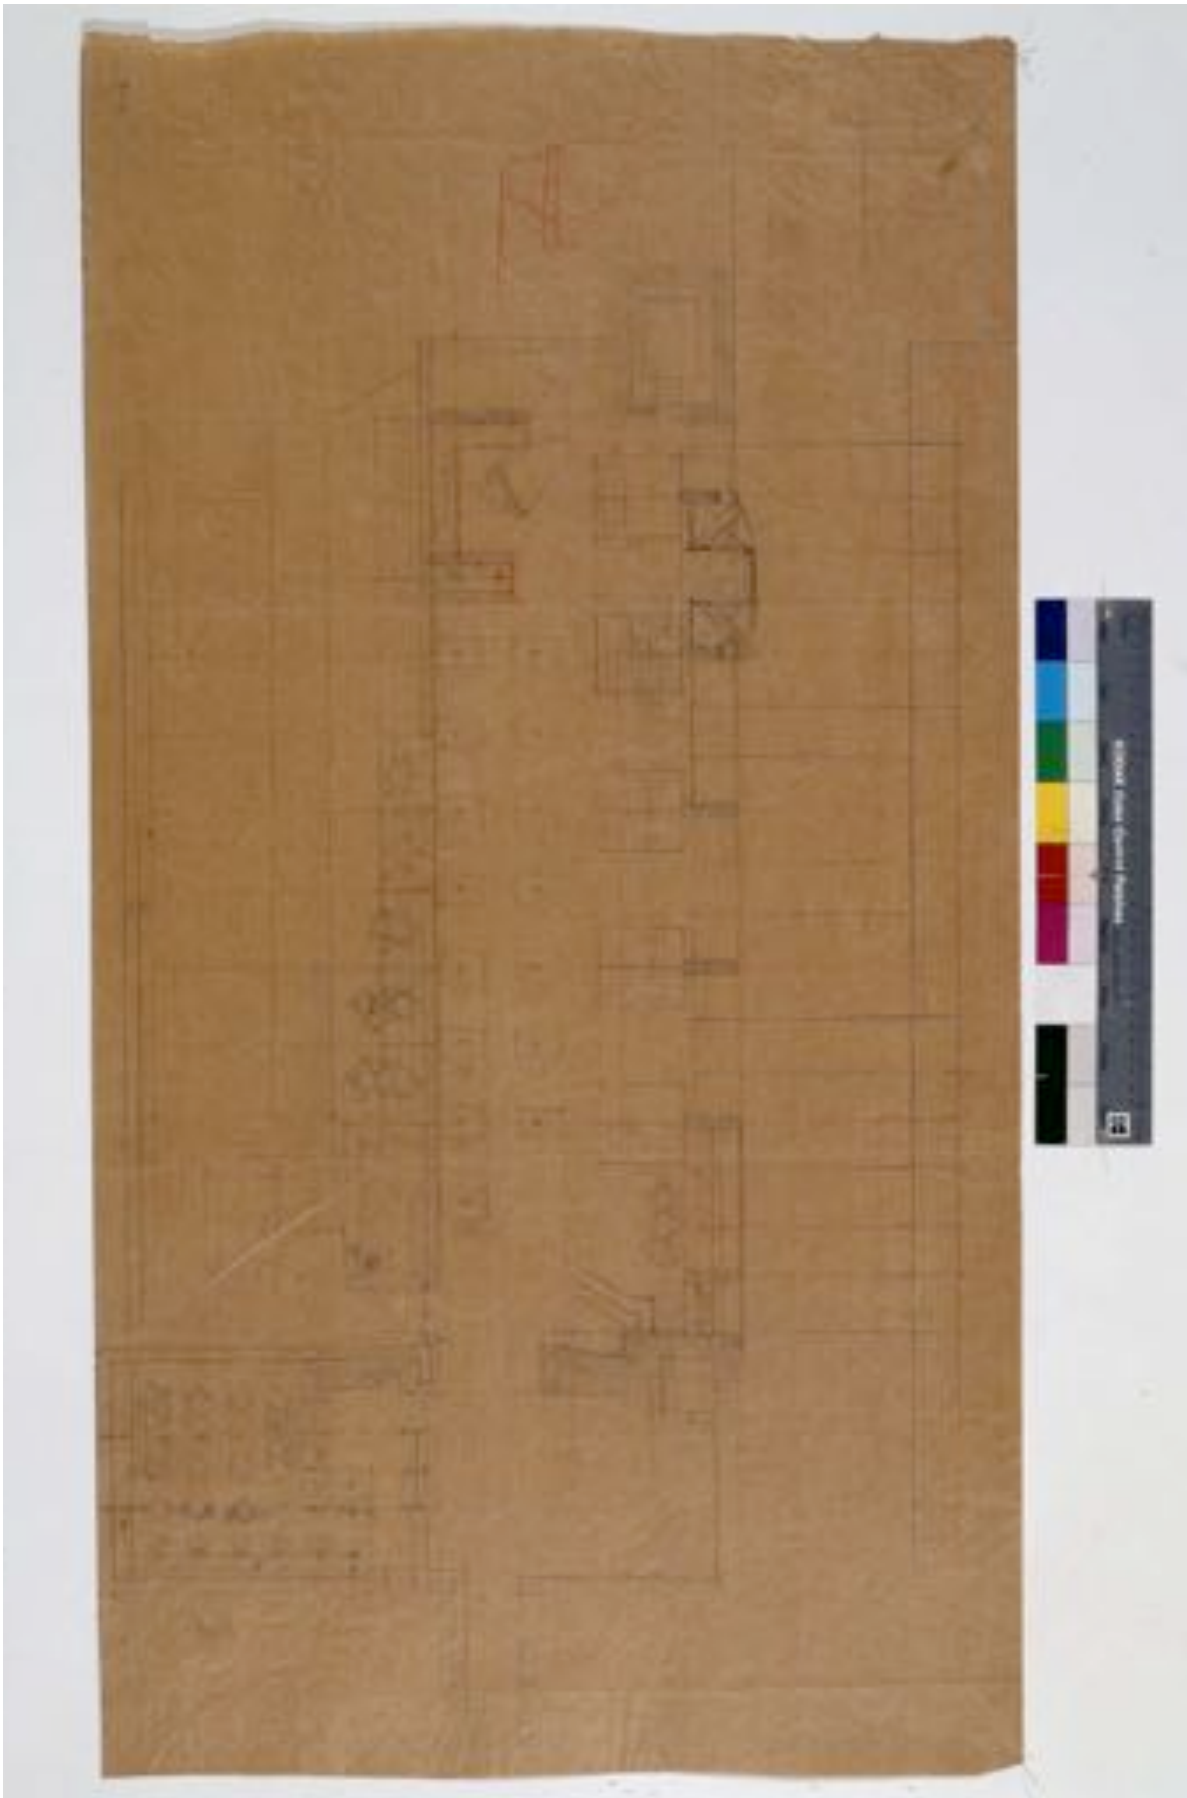
Figure B-22 - Drafting Room Plan (The Frank Lloyd Wright Foundation Archives, The Museum of Modern Art | Avery Architectural & Fine Arts Library, Columbia University, New York).

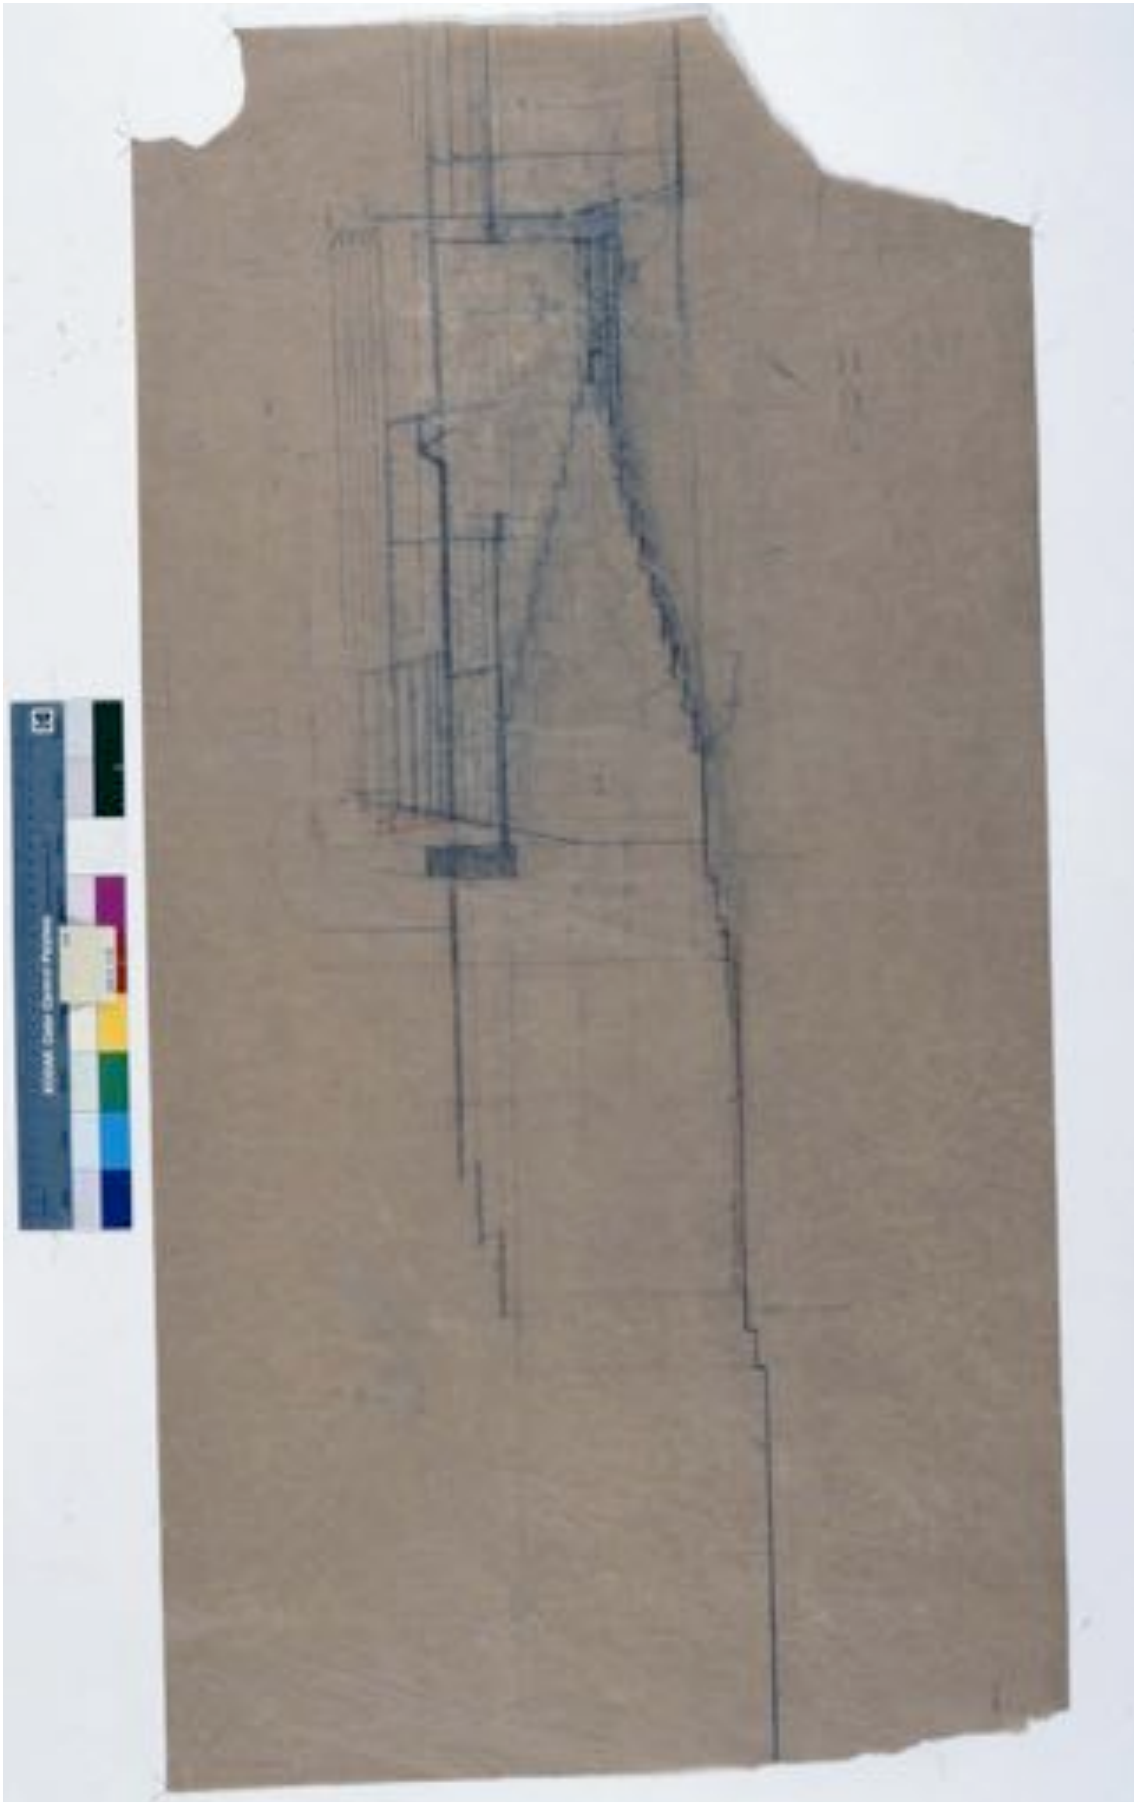
Figure B-24 - Little Kitchen Elevation (The Frank Lloyd Wright Foundation Archives, The Museum of Modern Art | Avery Architectural & Fine Arts Library, Columbia University, New York).

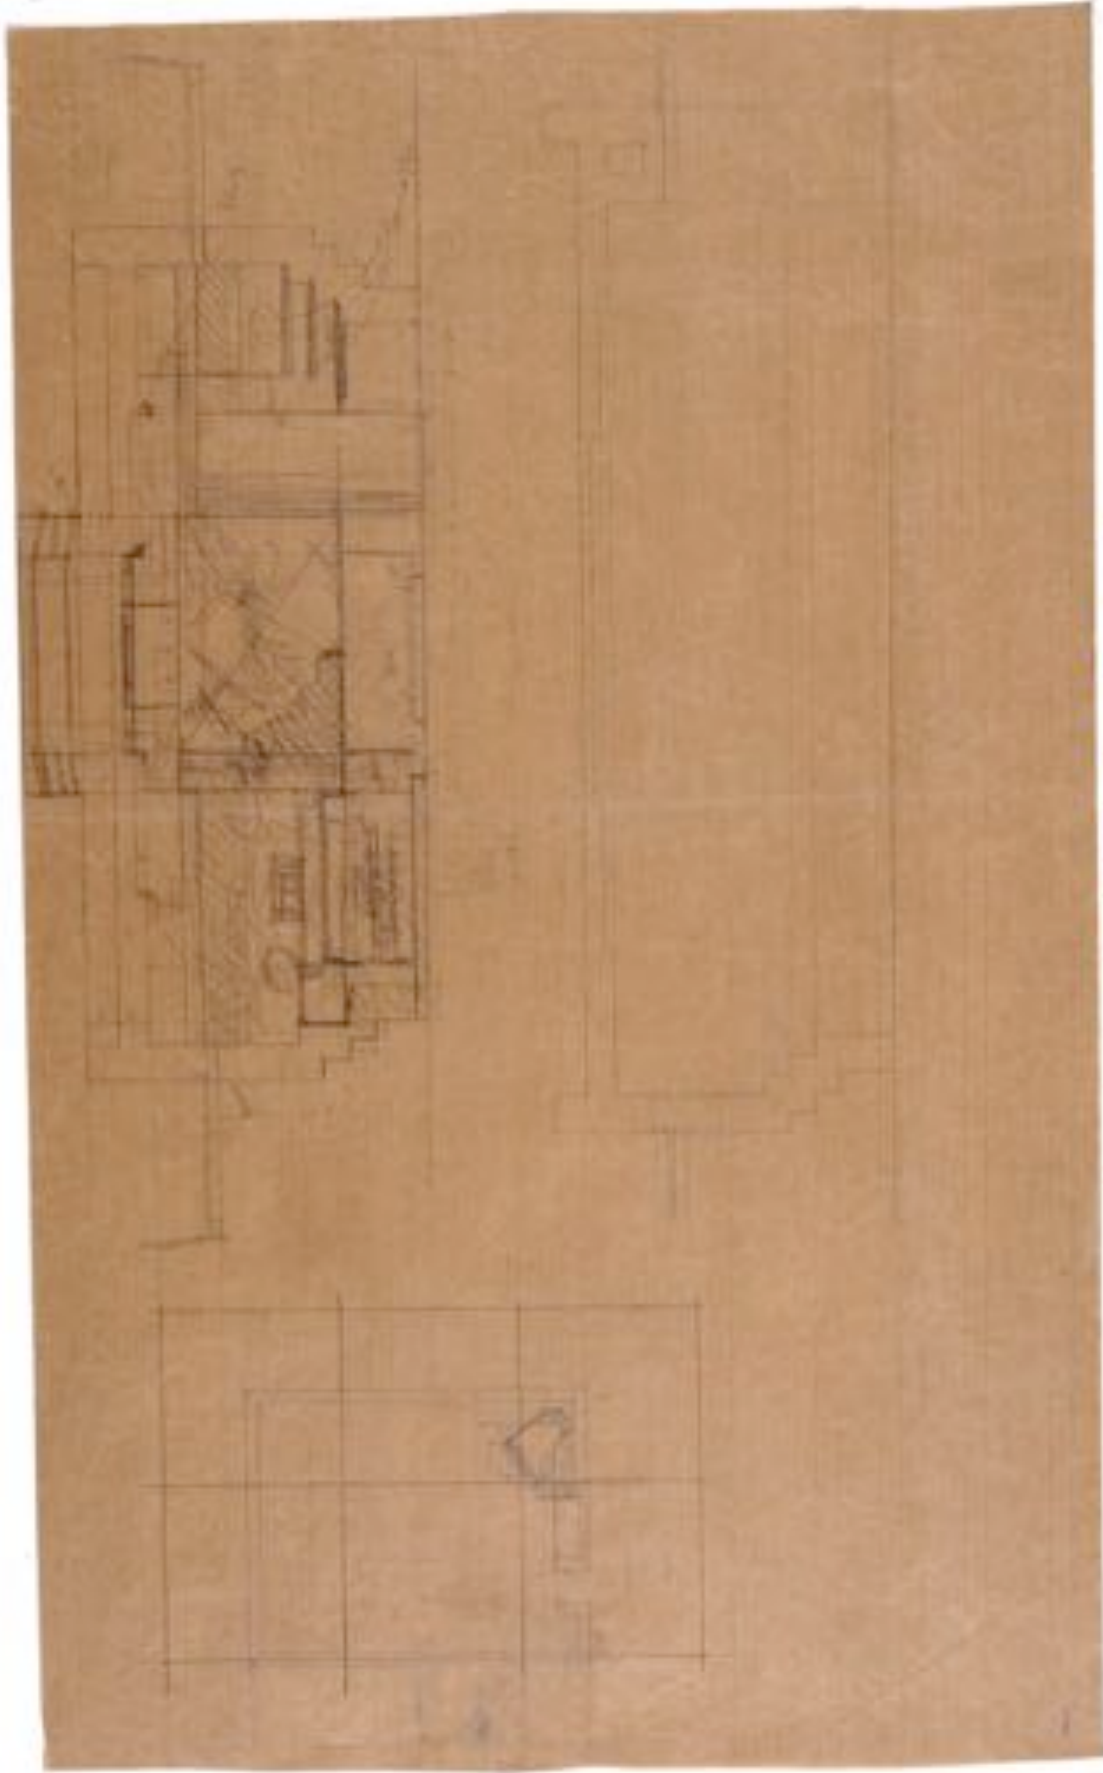
Figure B-25 - Theatre [Kiva] Section (The Frank Lloyd Wright Foundation Archives, The Museum of Modern Art | Avery Architectural & Fine Arts Library, Columbia University, New York).

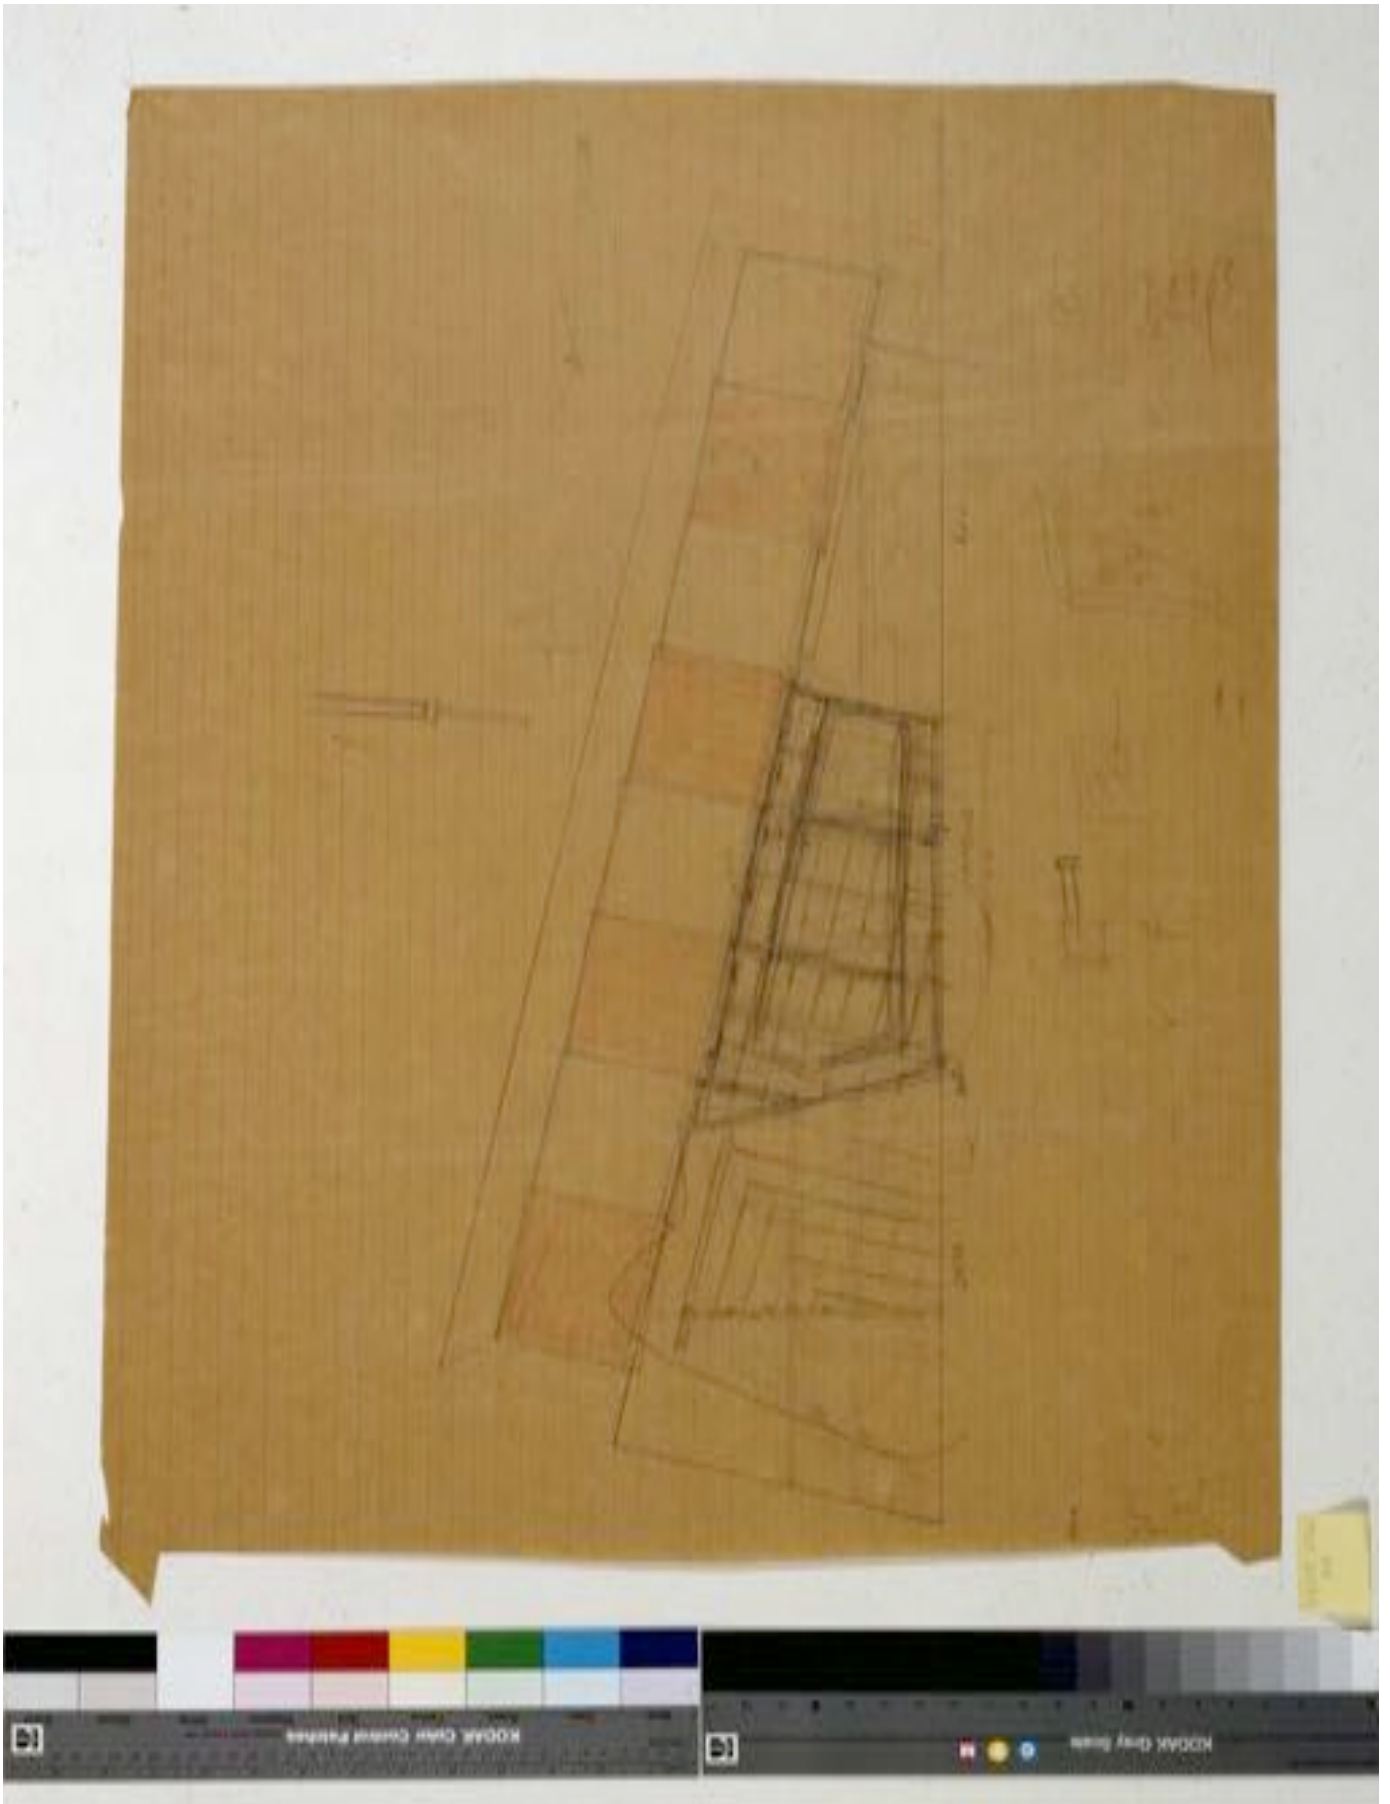
Figure B-26 - Drafting Room West Elevation (The Frank Lloyd Wright Foundation Archives, The Museum of Modern Art | Avery Architectural & Fine Arts Library, Columbia University, New York).

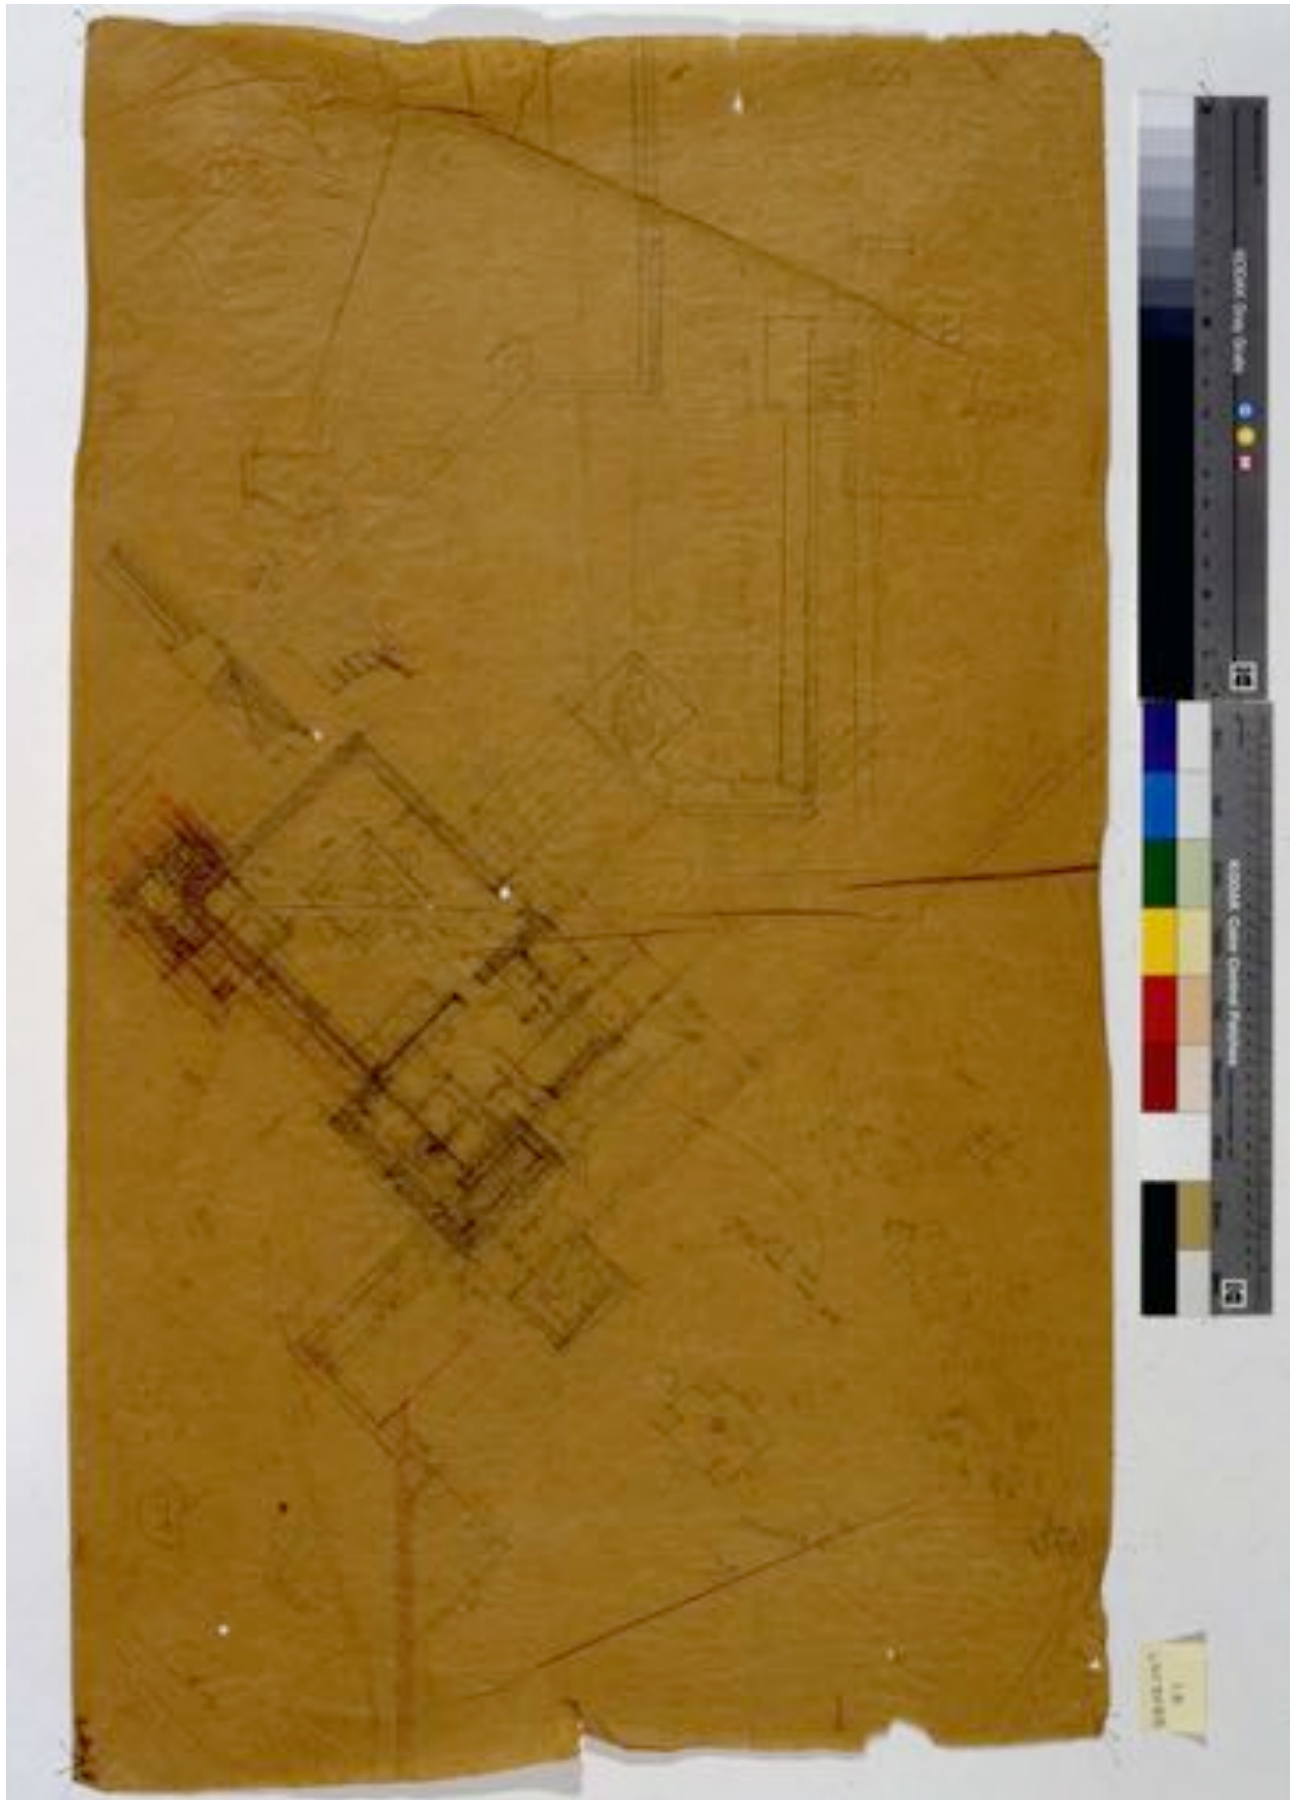
Figure B-27 - Office Plan (The Frank Lloyd Wright Foundation Archives, The Museum of Modern Art | Avery Architectural & Fine Arts Library, Columbia University, New York).

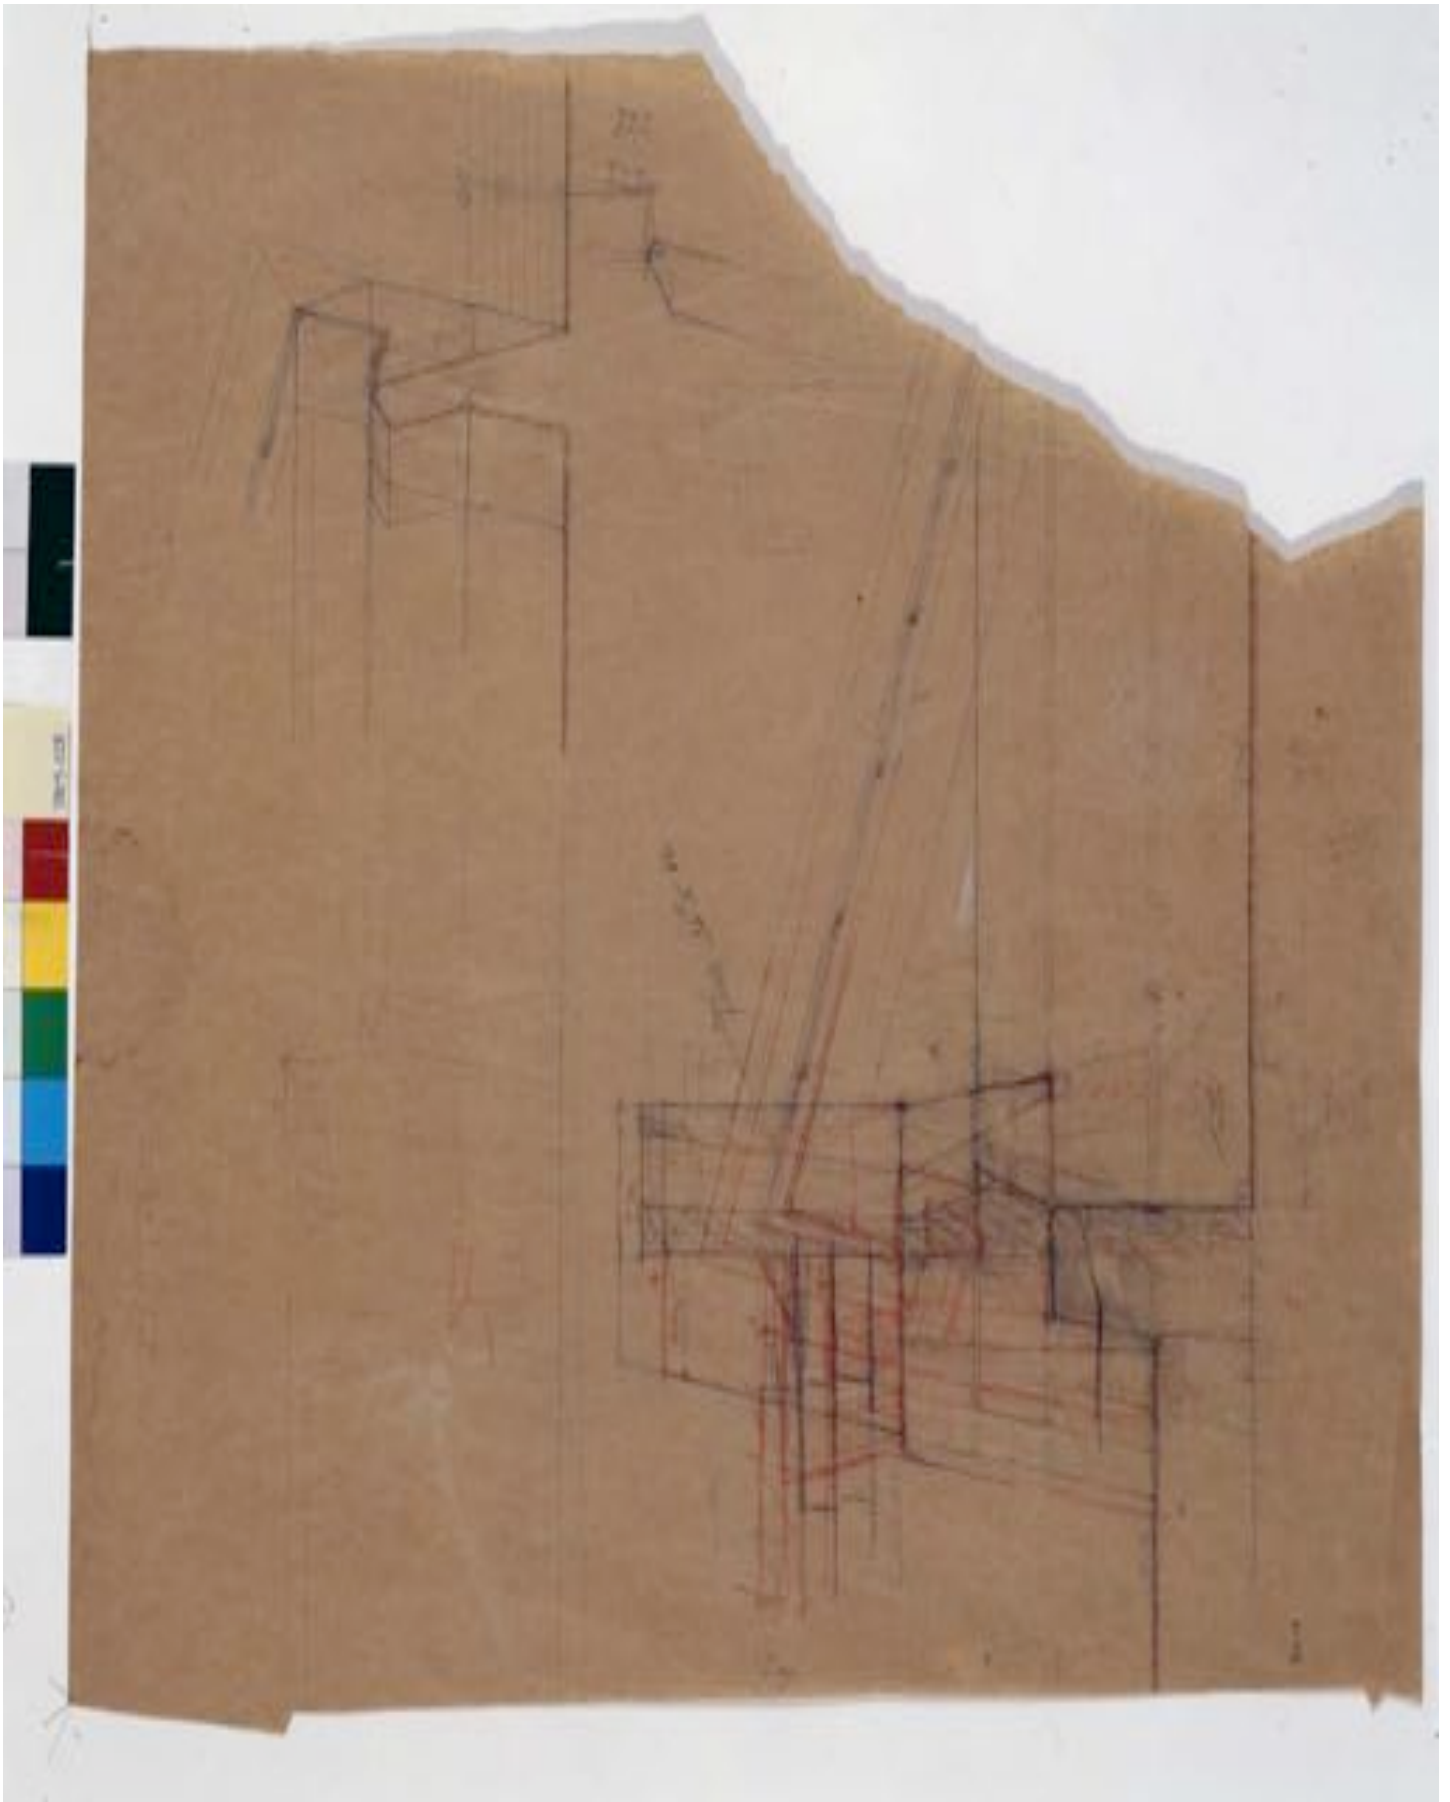
Figure B-28 - Office Fireplace/Section (The Frank Lloyd Wright Foundation Archives, The Museum of Modern Art | Avery Architectural & Fine Arts Library, Columbia University, New York).

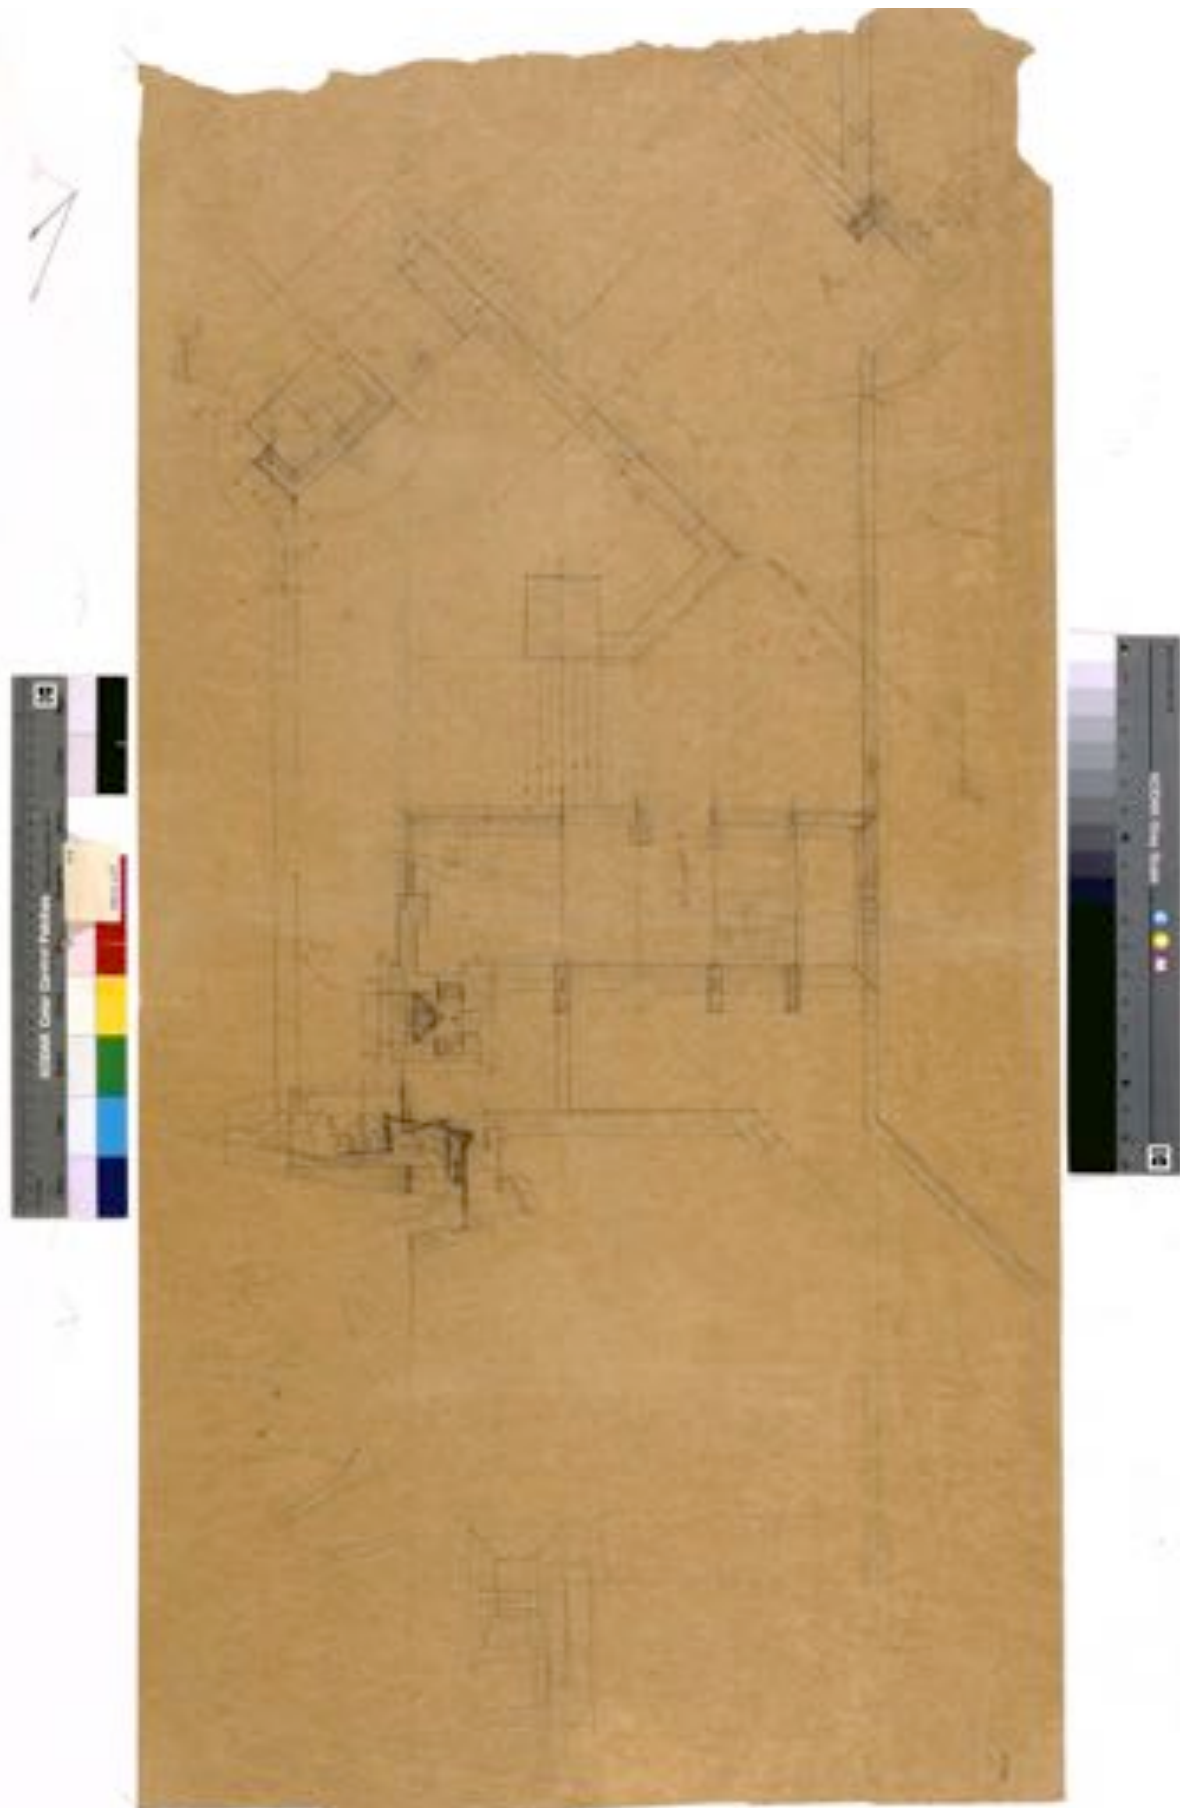
Figure B-29 - Office Toilet Plan (The Frank Lloyd Wright Foundation Archives, The Museum of Modern Art | Avery Architectural & Fine Arts Library, Columbia University, New York).

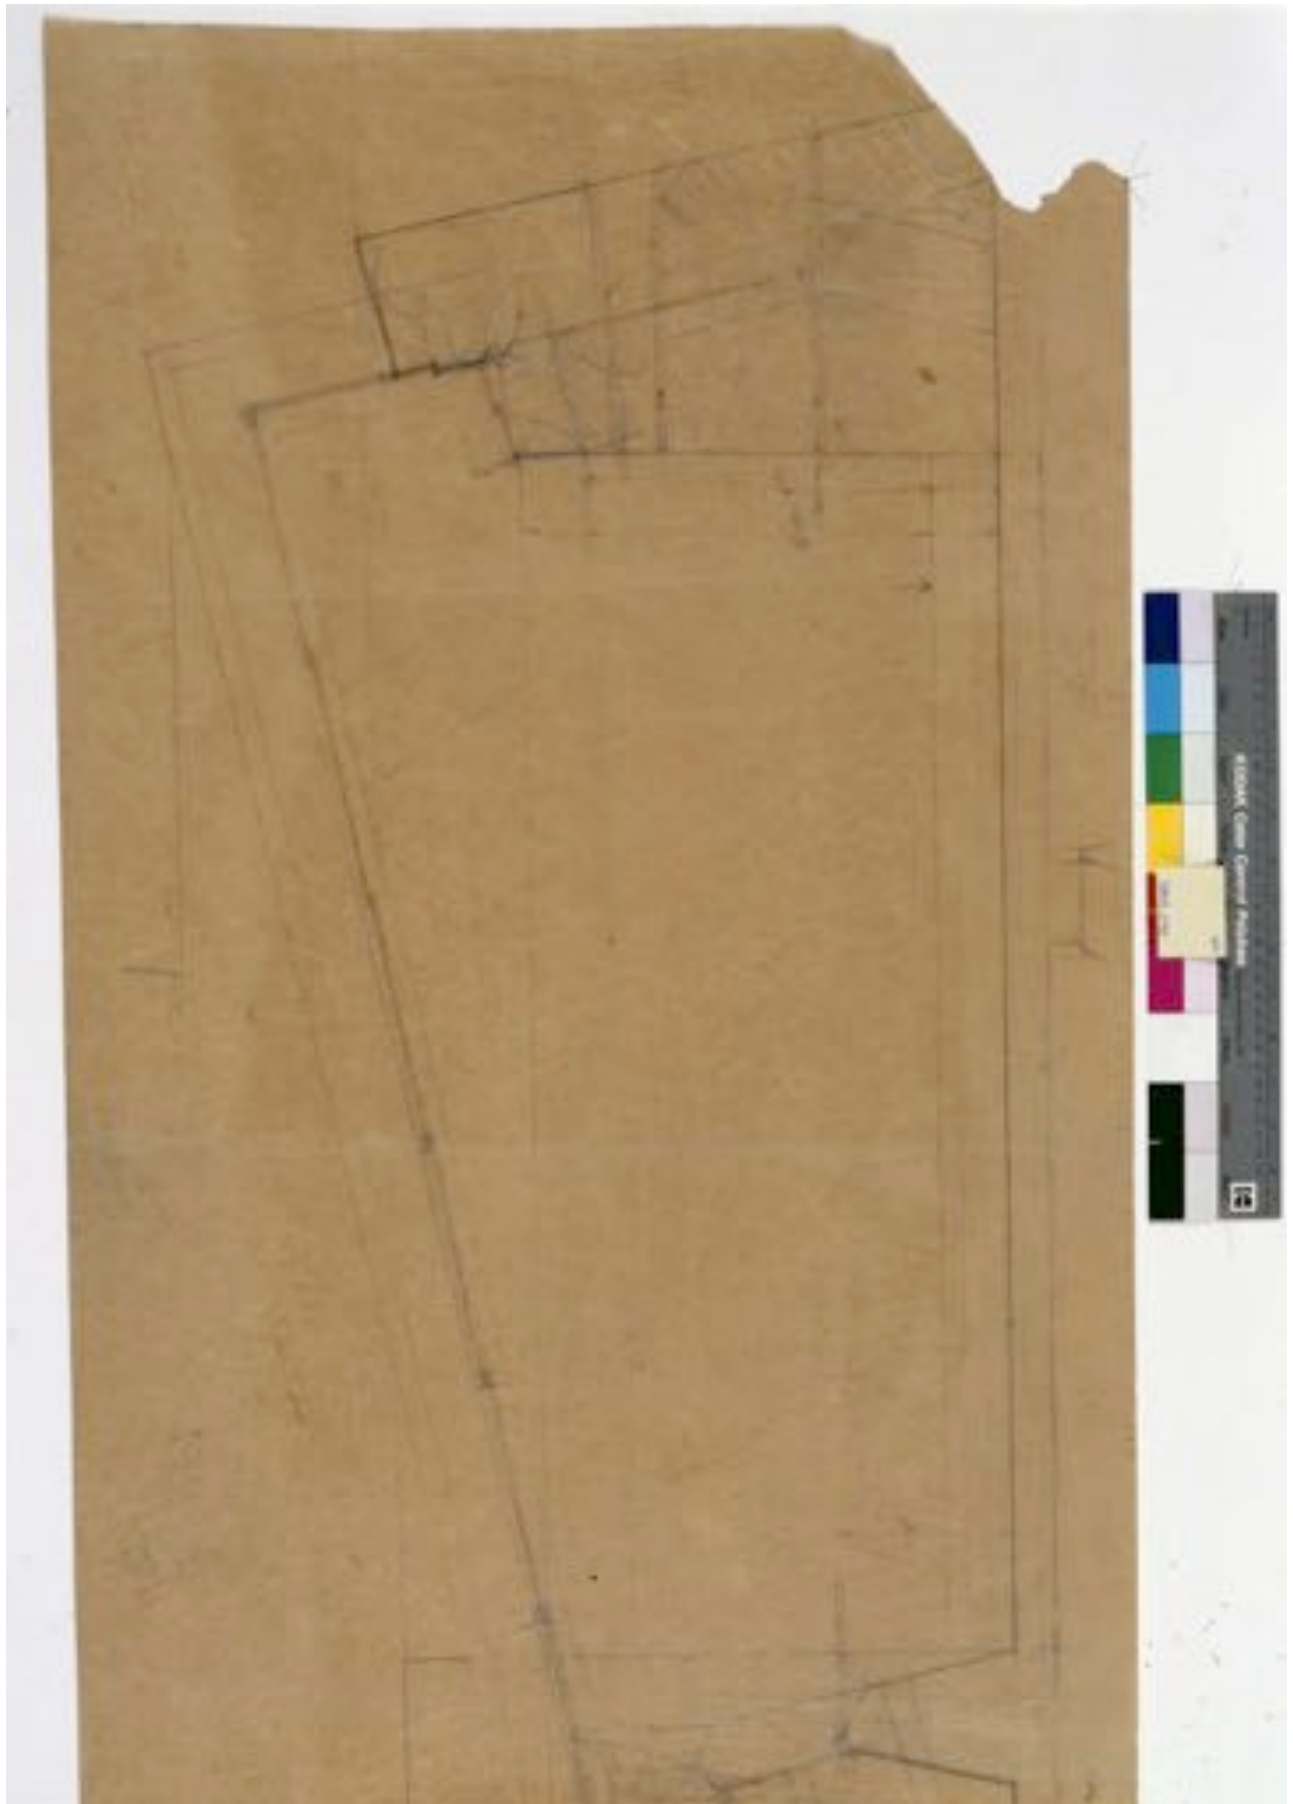
Figure B-30 - Music Room Section [Garden Room] (The Frank Lloyd Wright Foundation Archives, The Museum of Modern Art | Avery Architectural & Fine Arts Library, Columbia University, New York).

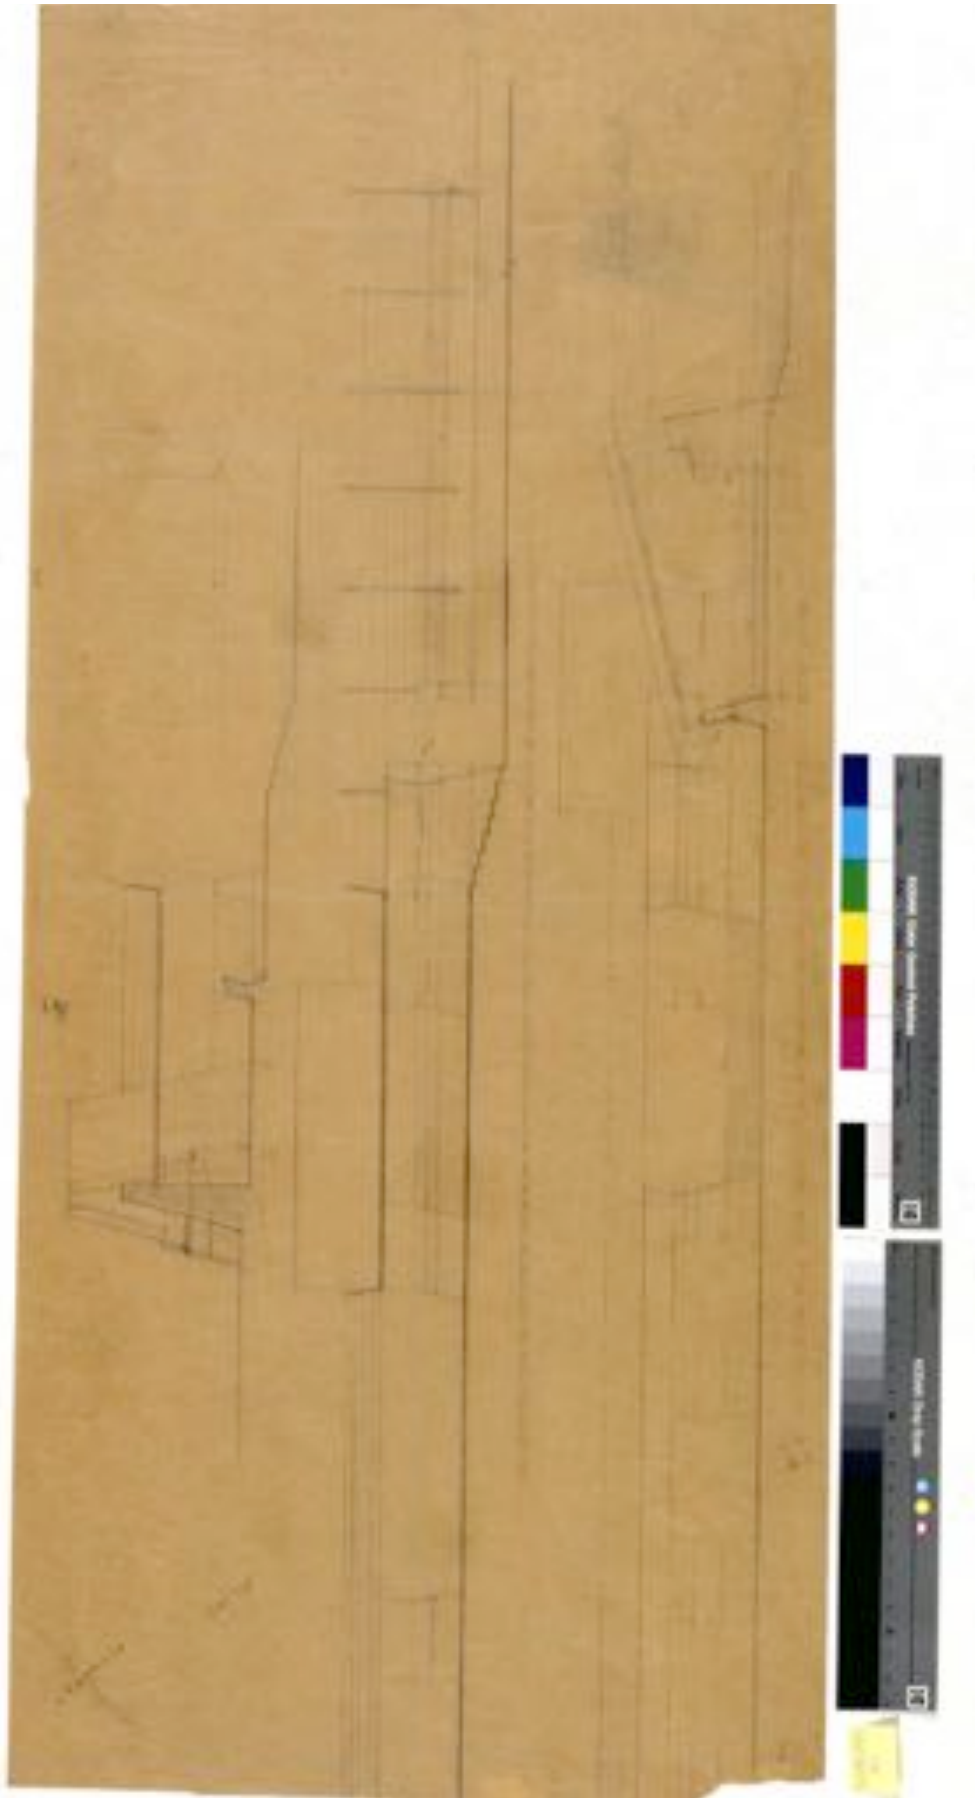
Figure B-31 - Garden Room "Alladin" (The Frank Lloyd Wright Foundation Archives, The Museum of Modern Art | Avery Architectural & Fine Arts Library, Columbia University, New York).
