TALIESIN WEST PRESERVATION MASTER PLAN

Harboe Architects, PC

MAY 21, 2015

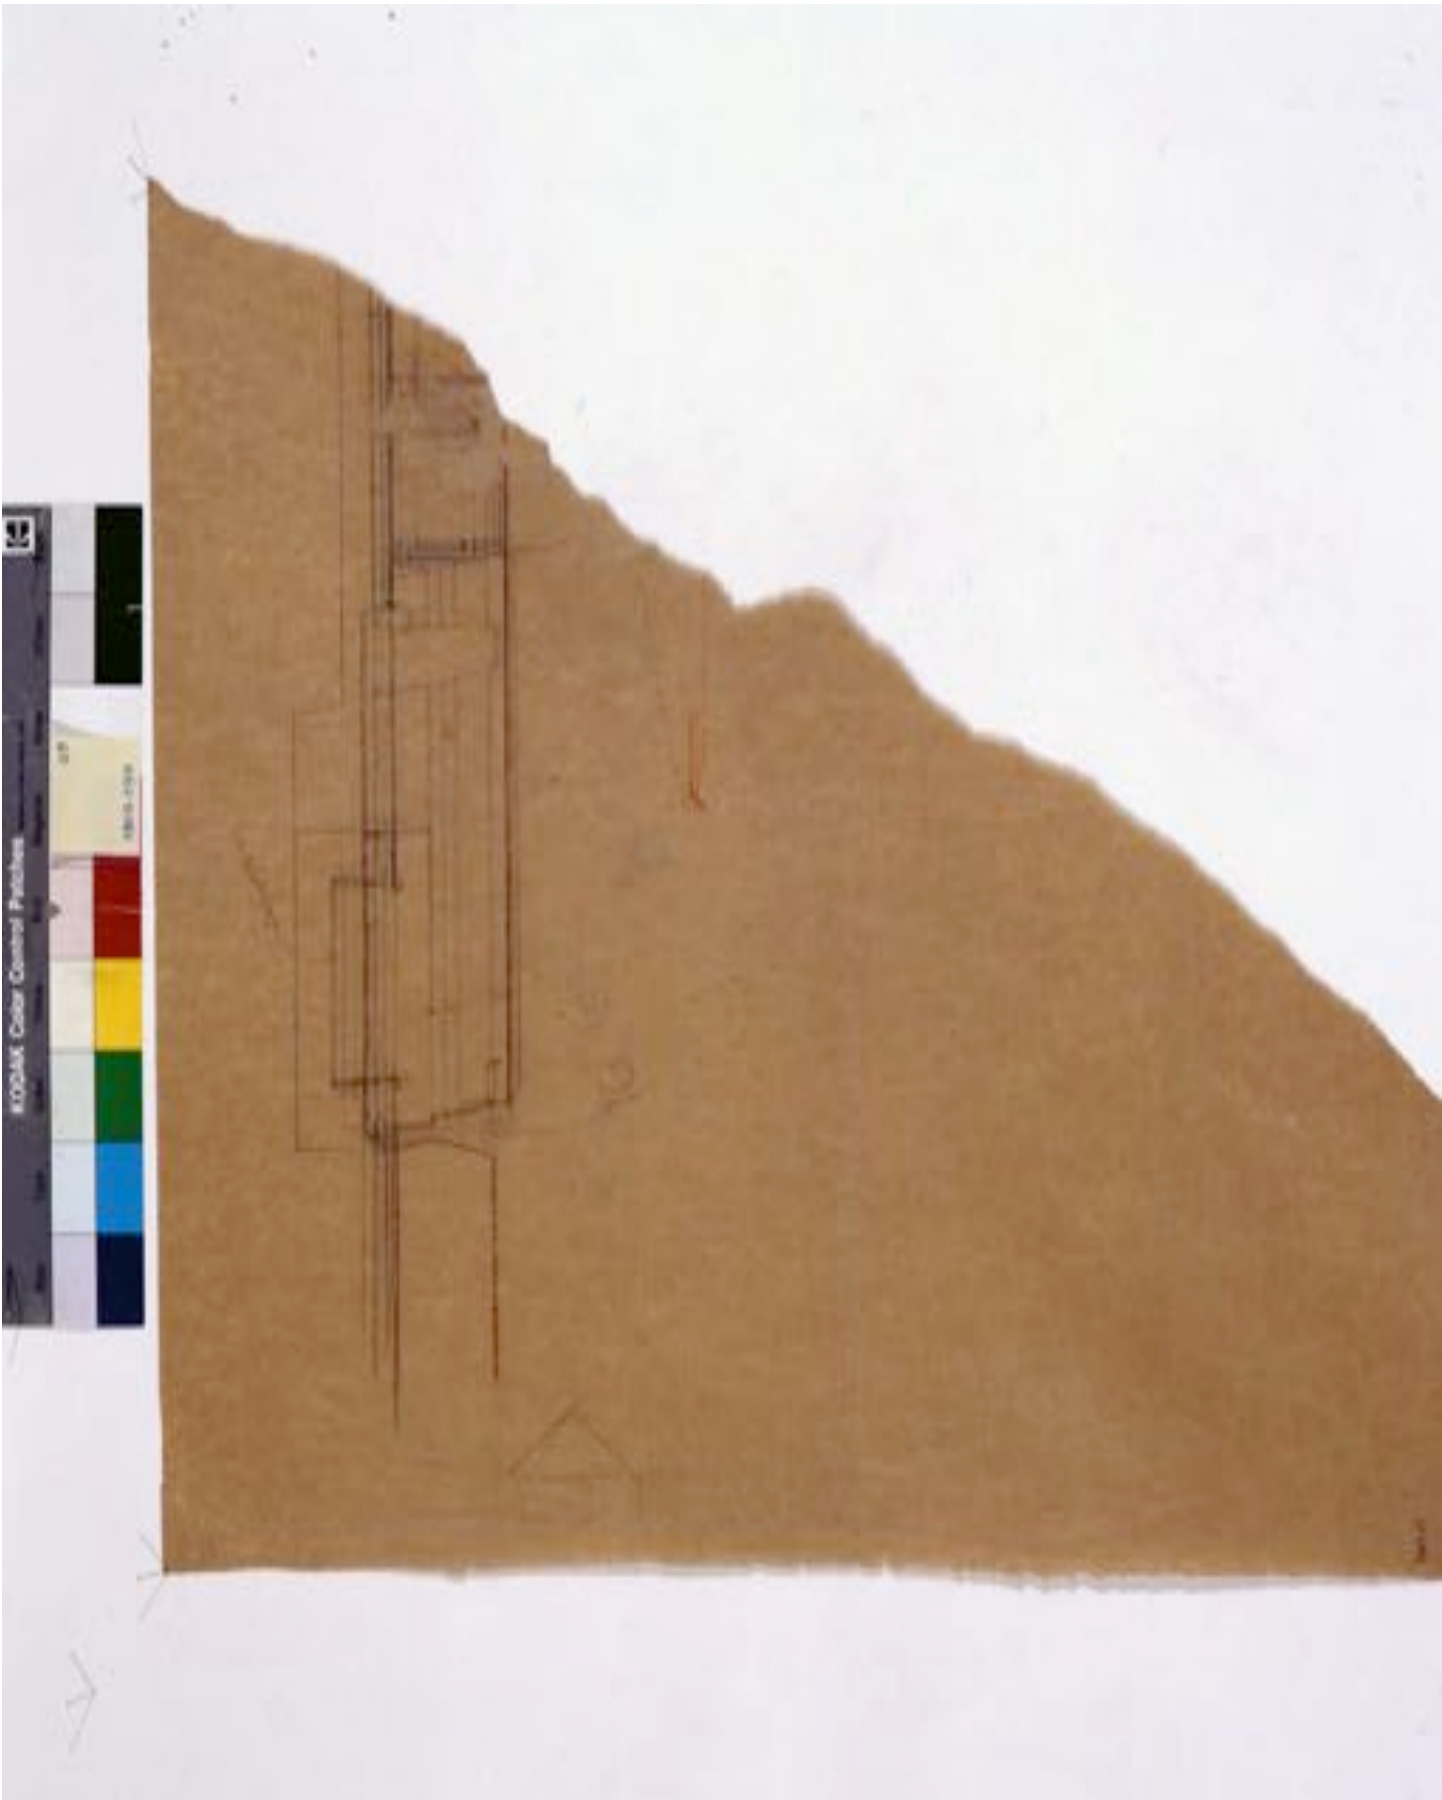
Figure B-33 - Cove Section/Fragment (The Frank Lloyd Wright Foundation Archives, The Museum of Modern Art | Avery Architectural & Fine Arts Library, Columbia University, New York).

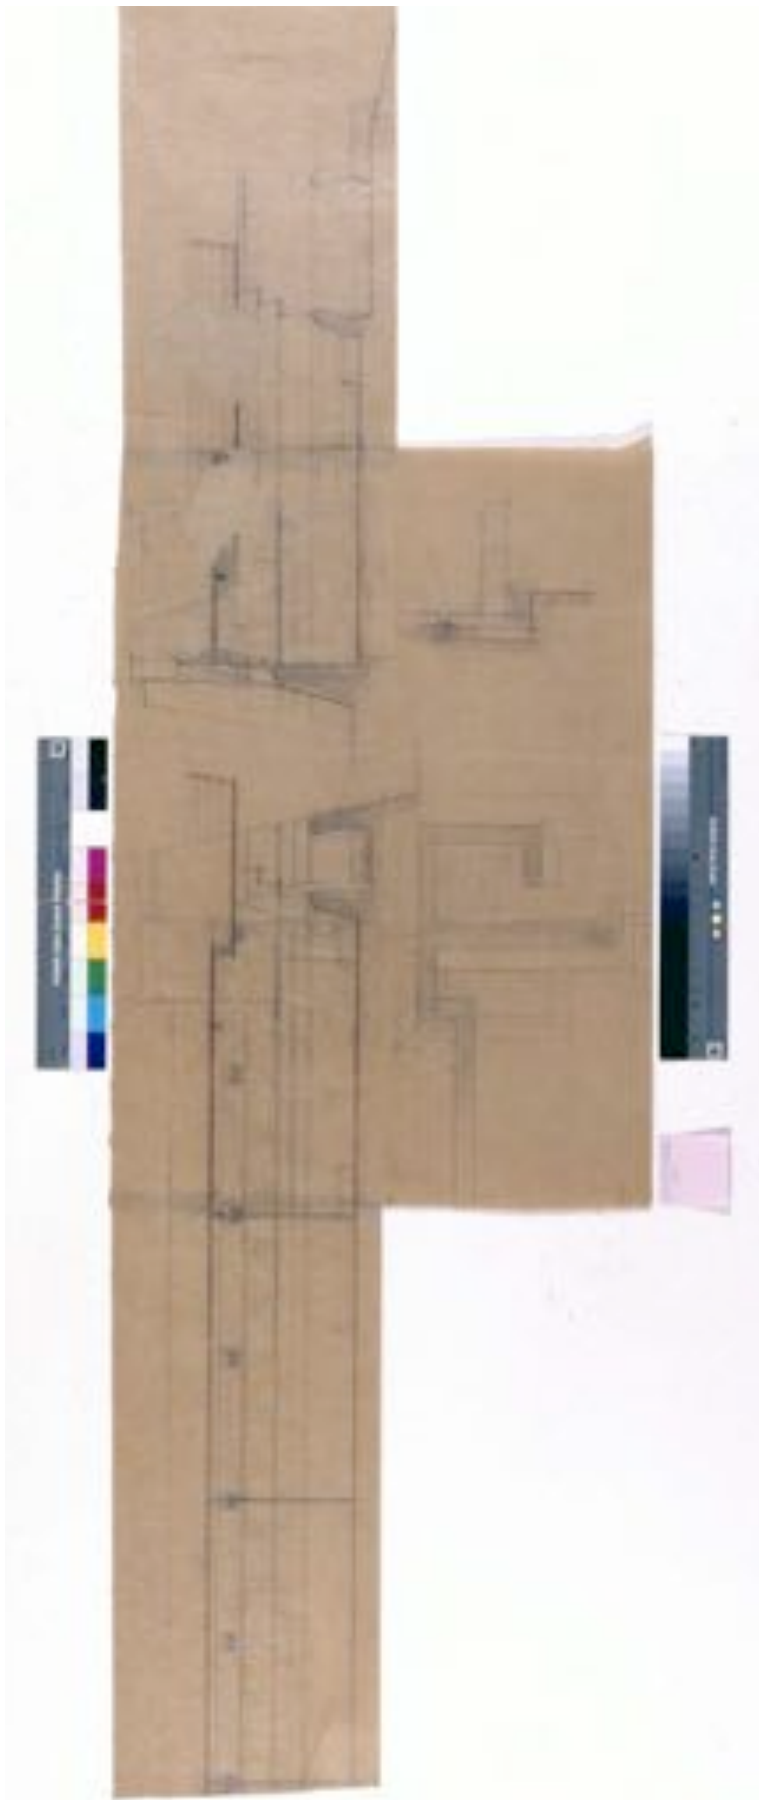
Figure B-34 - House [Wright Living Quarters] Section (The Frank Lloyd Wright Foundation Archives, The Museum of Modern Art | Avery Architectural & Fine Arts Library, Columbia University, New York).

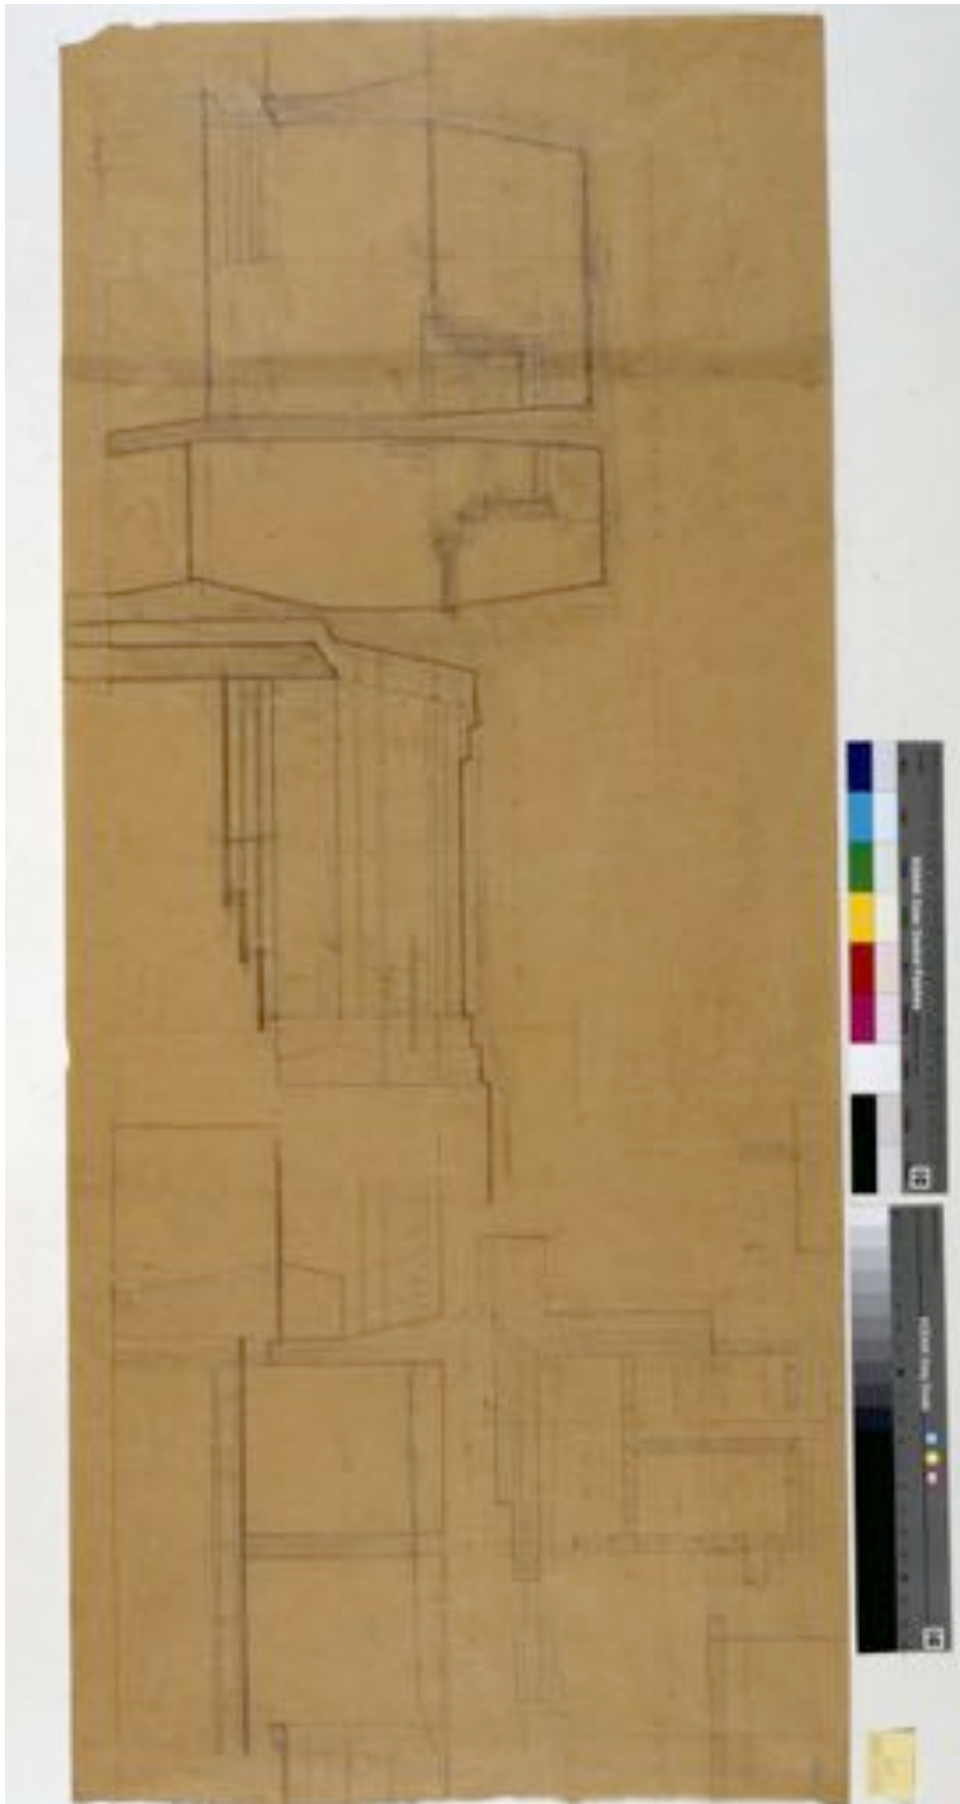
Figure B-35 - House [Wright Living Quarters] Bath Section (The Frank Lloyd Wright Foundation Archives, The Museum of Modern Art | Avery Architectural & Fine Arts Library, Columbia University, New York).

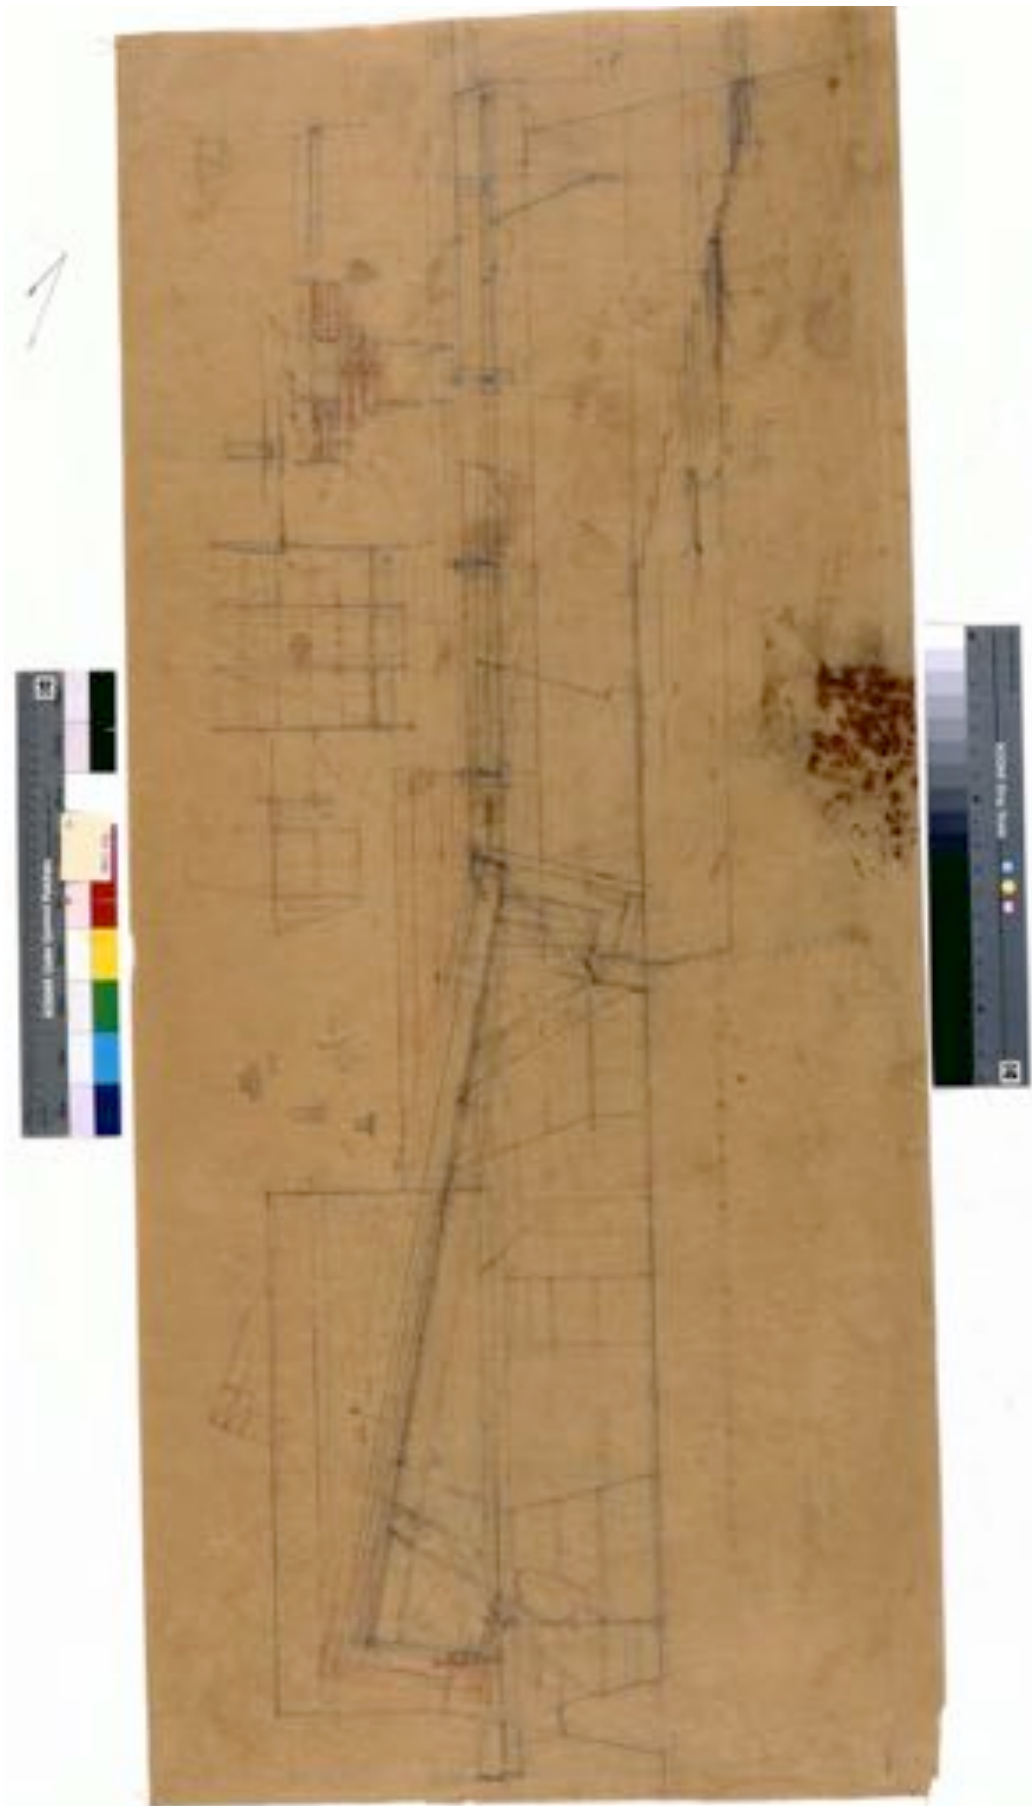
Figure B-36 - Drafting Room Section (The Frank Lloyd Wright Foundation Archives, The Museum of Modern Art | Avery Architectural & Fine Arts Library, Columbia University, New York).

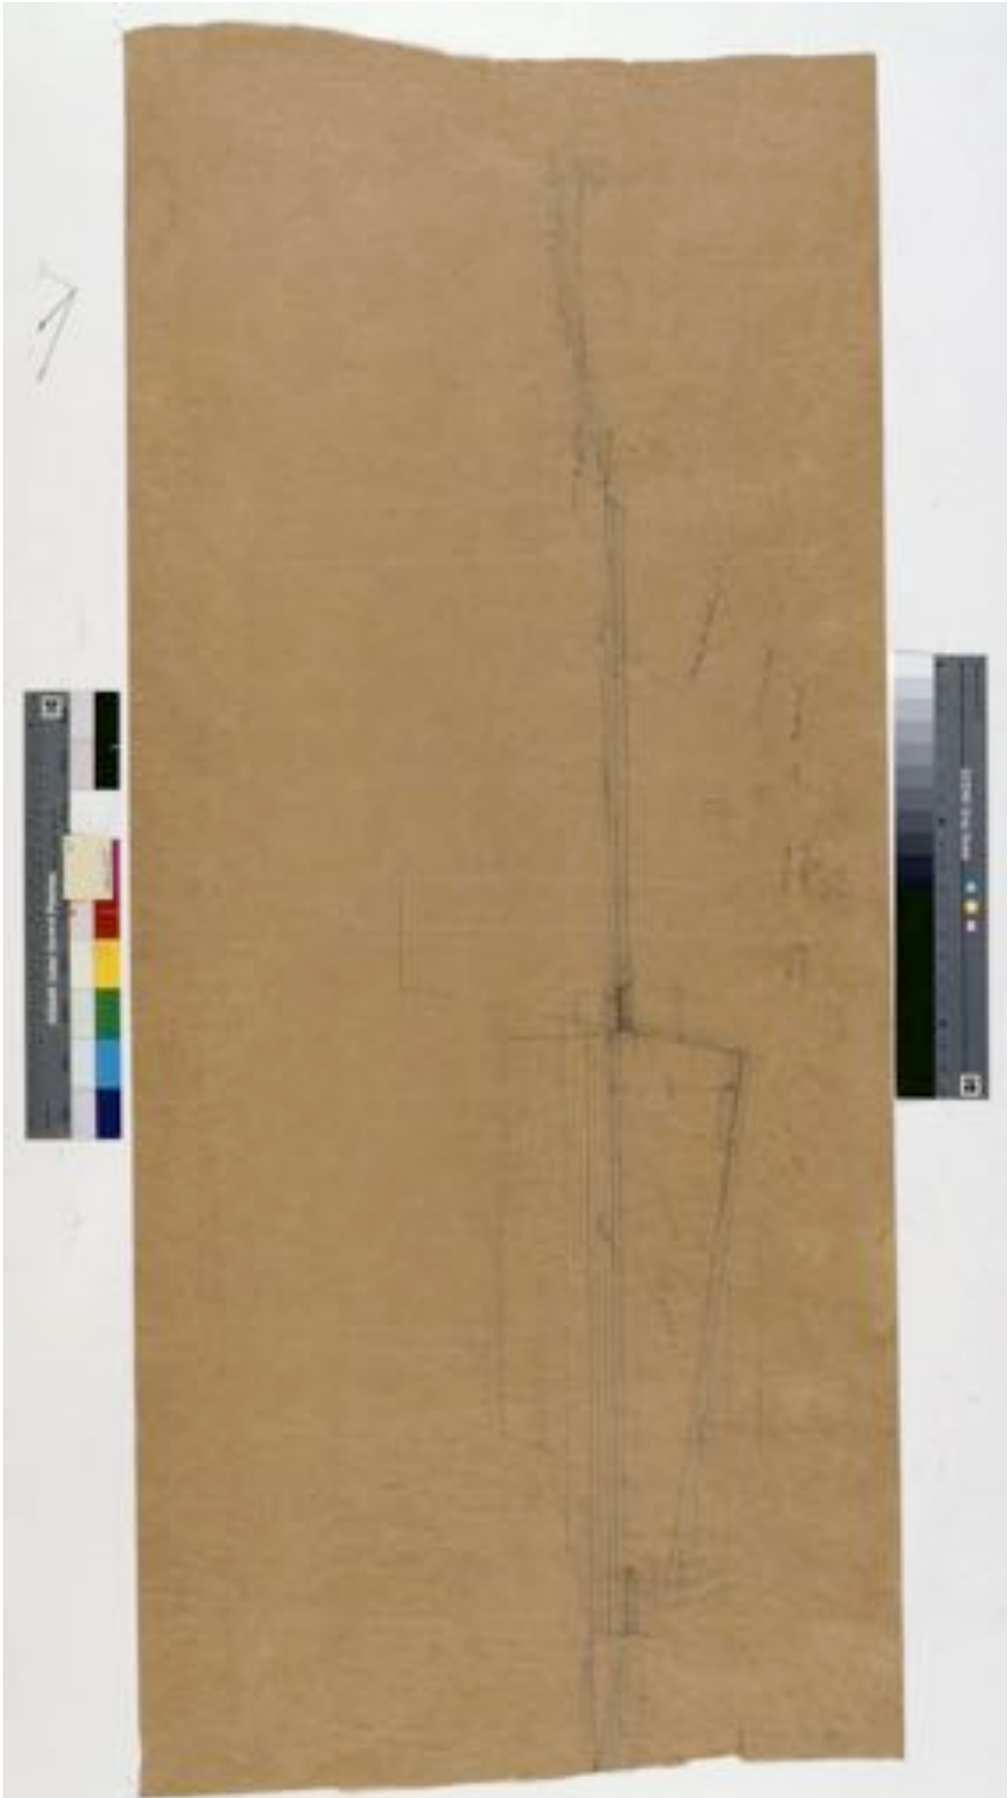
Figure B-37 - Drafting Room Pool Section (The Frank Lloyd Wright Foundation Archives, The Museum of Modern Art | Avery Architectural & Fine Arts Library, Columbia University, New York).

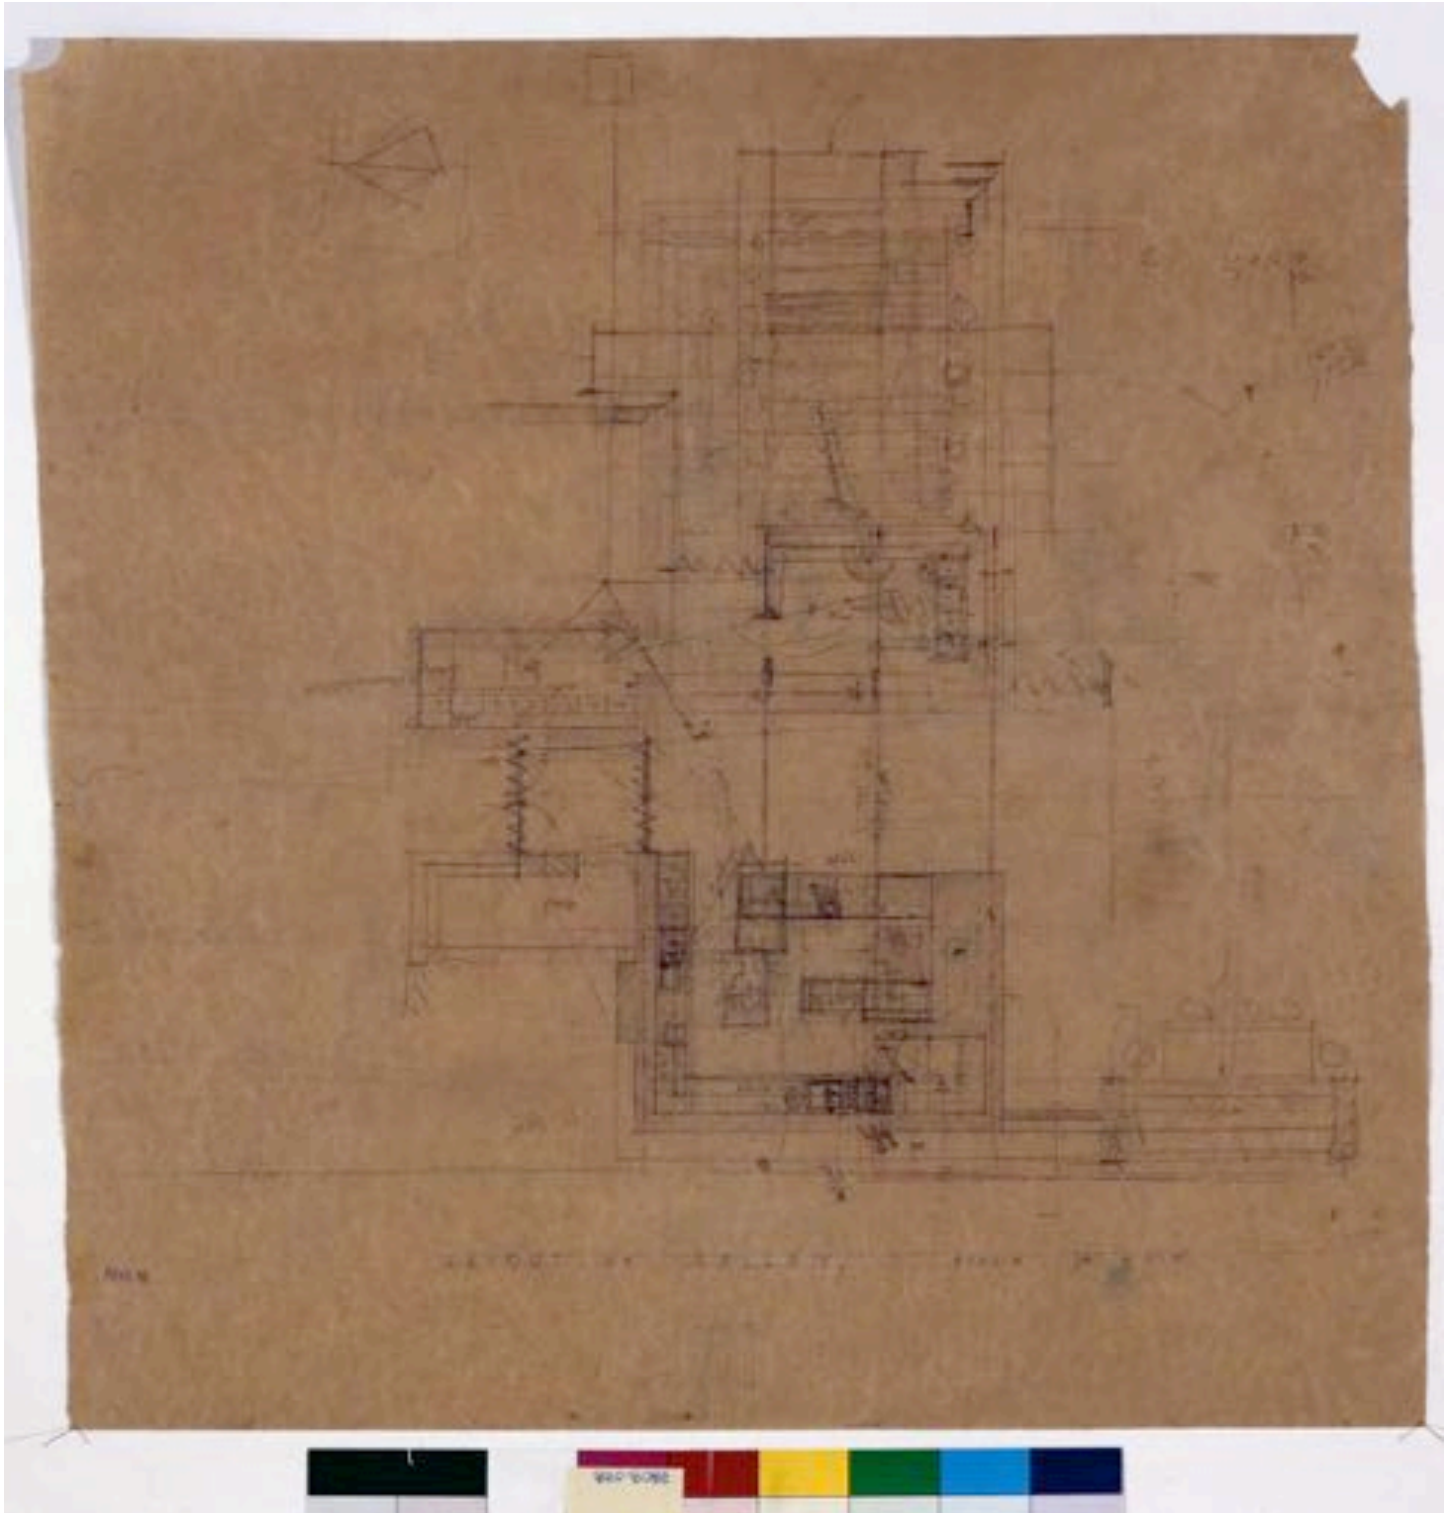
Figure B-38 - Kitchen [Galley] Plan (The Frank Lloyd Wright Foundation Archives, The Museum of Modern Art | Avery Architectural & Fine Arts Library, Columbia University, New York).

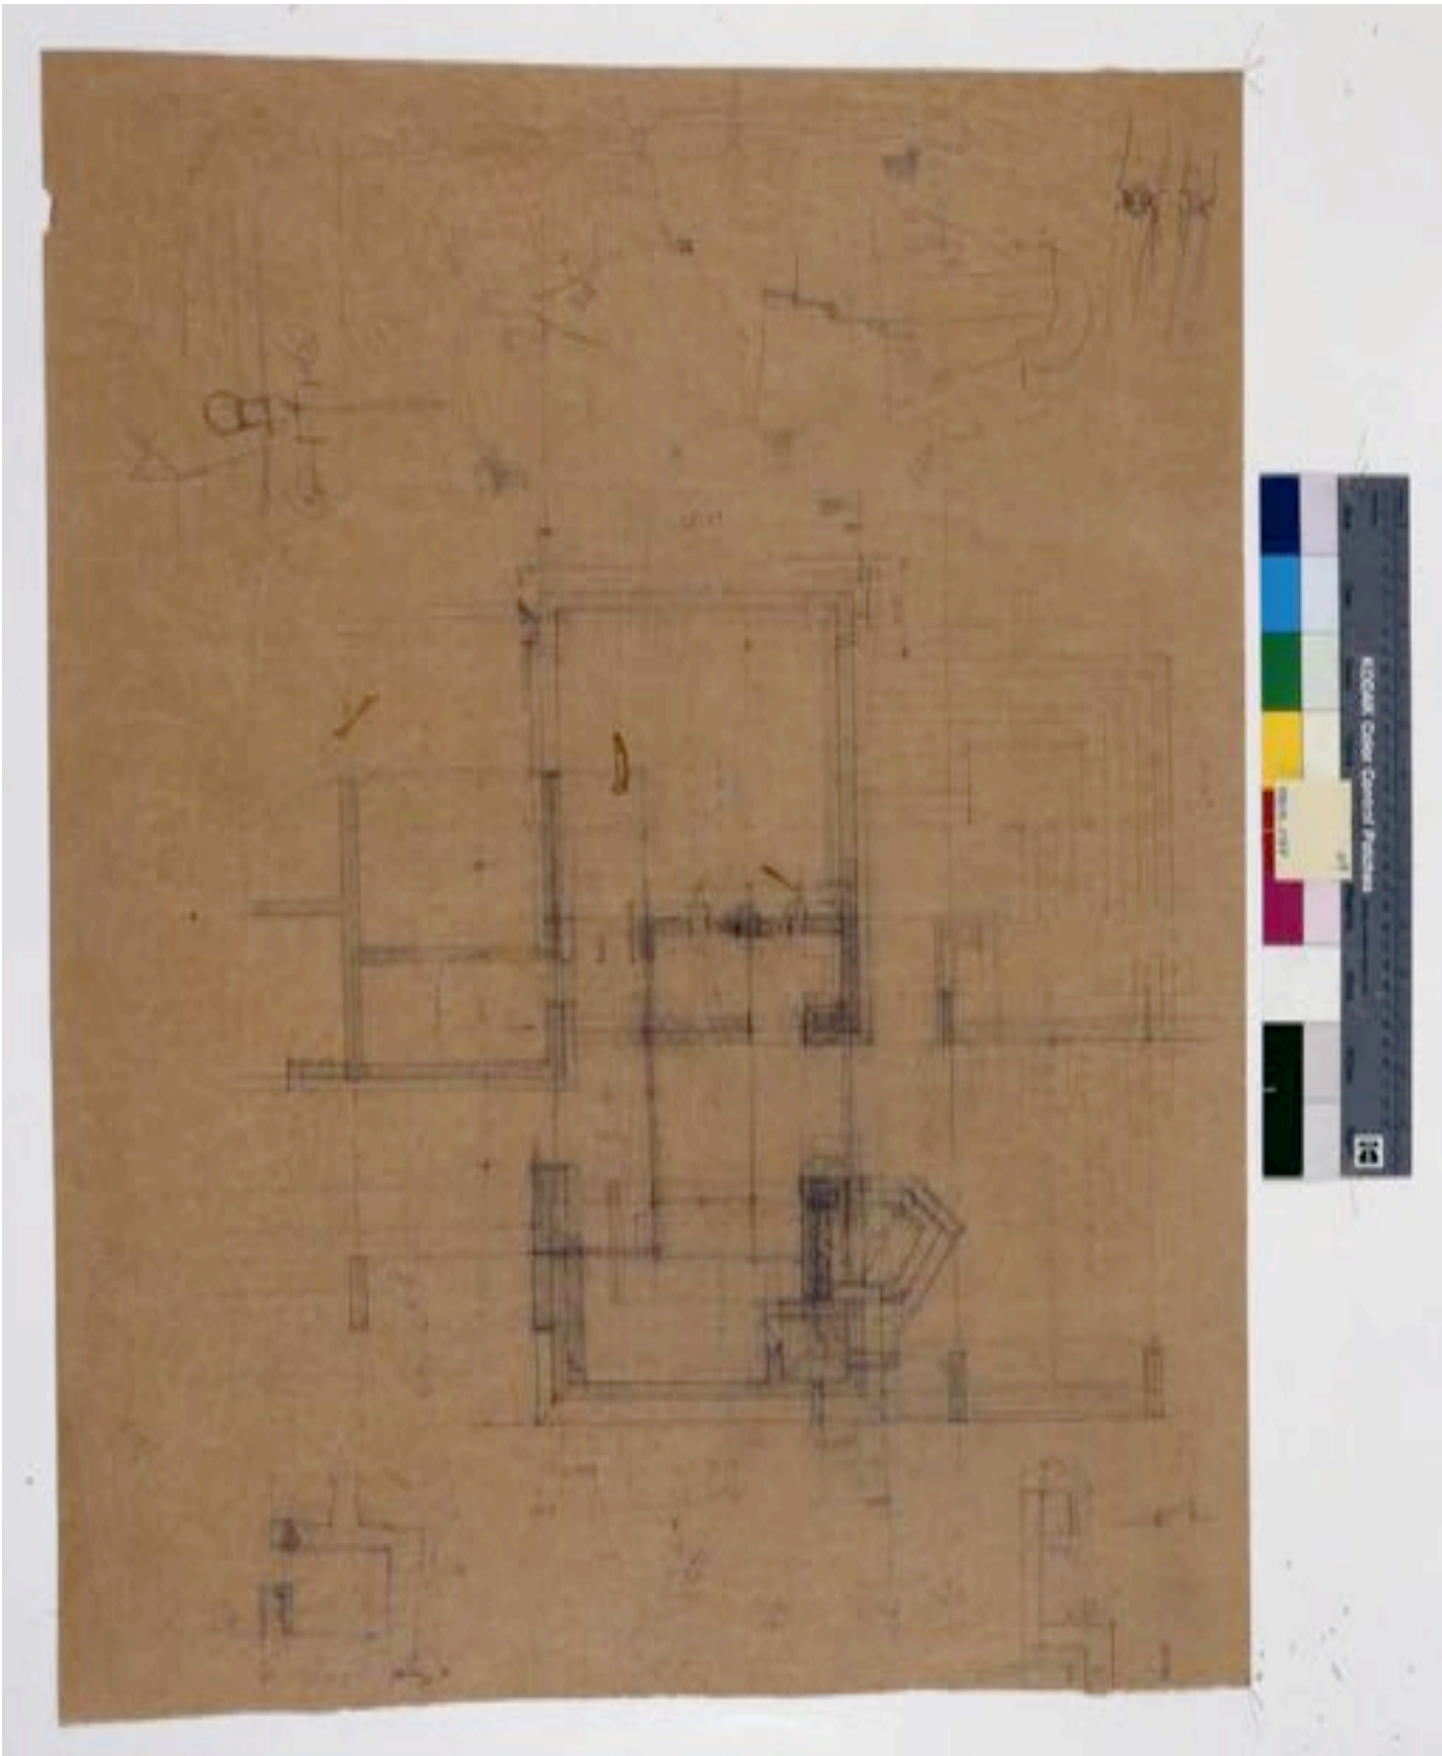
Figure B-39 - Drying Yard Plan (The Frank Lloyd Wright Foundation Archives, The Museum of Modern Art | Avery Architectural & Fine Arts Library, Columbia University, New York).

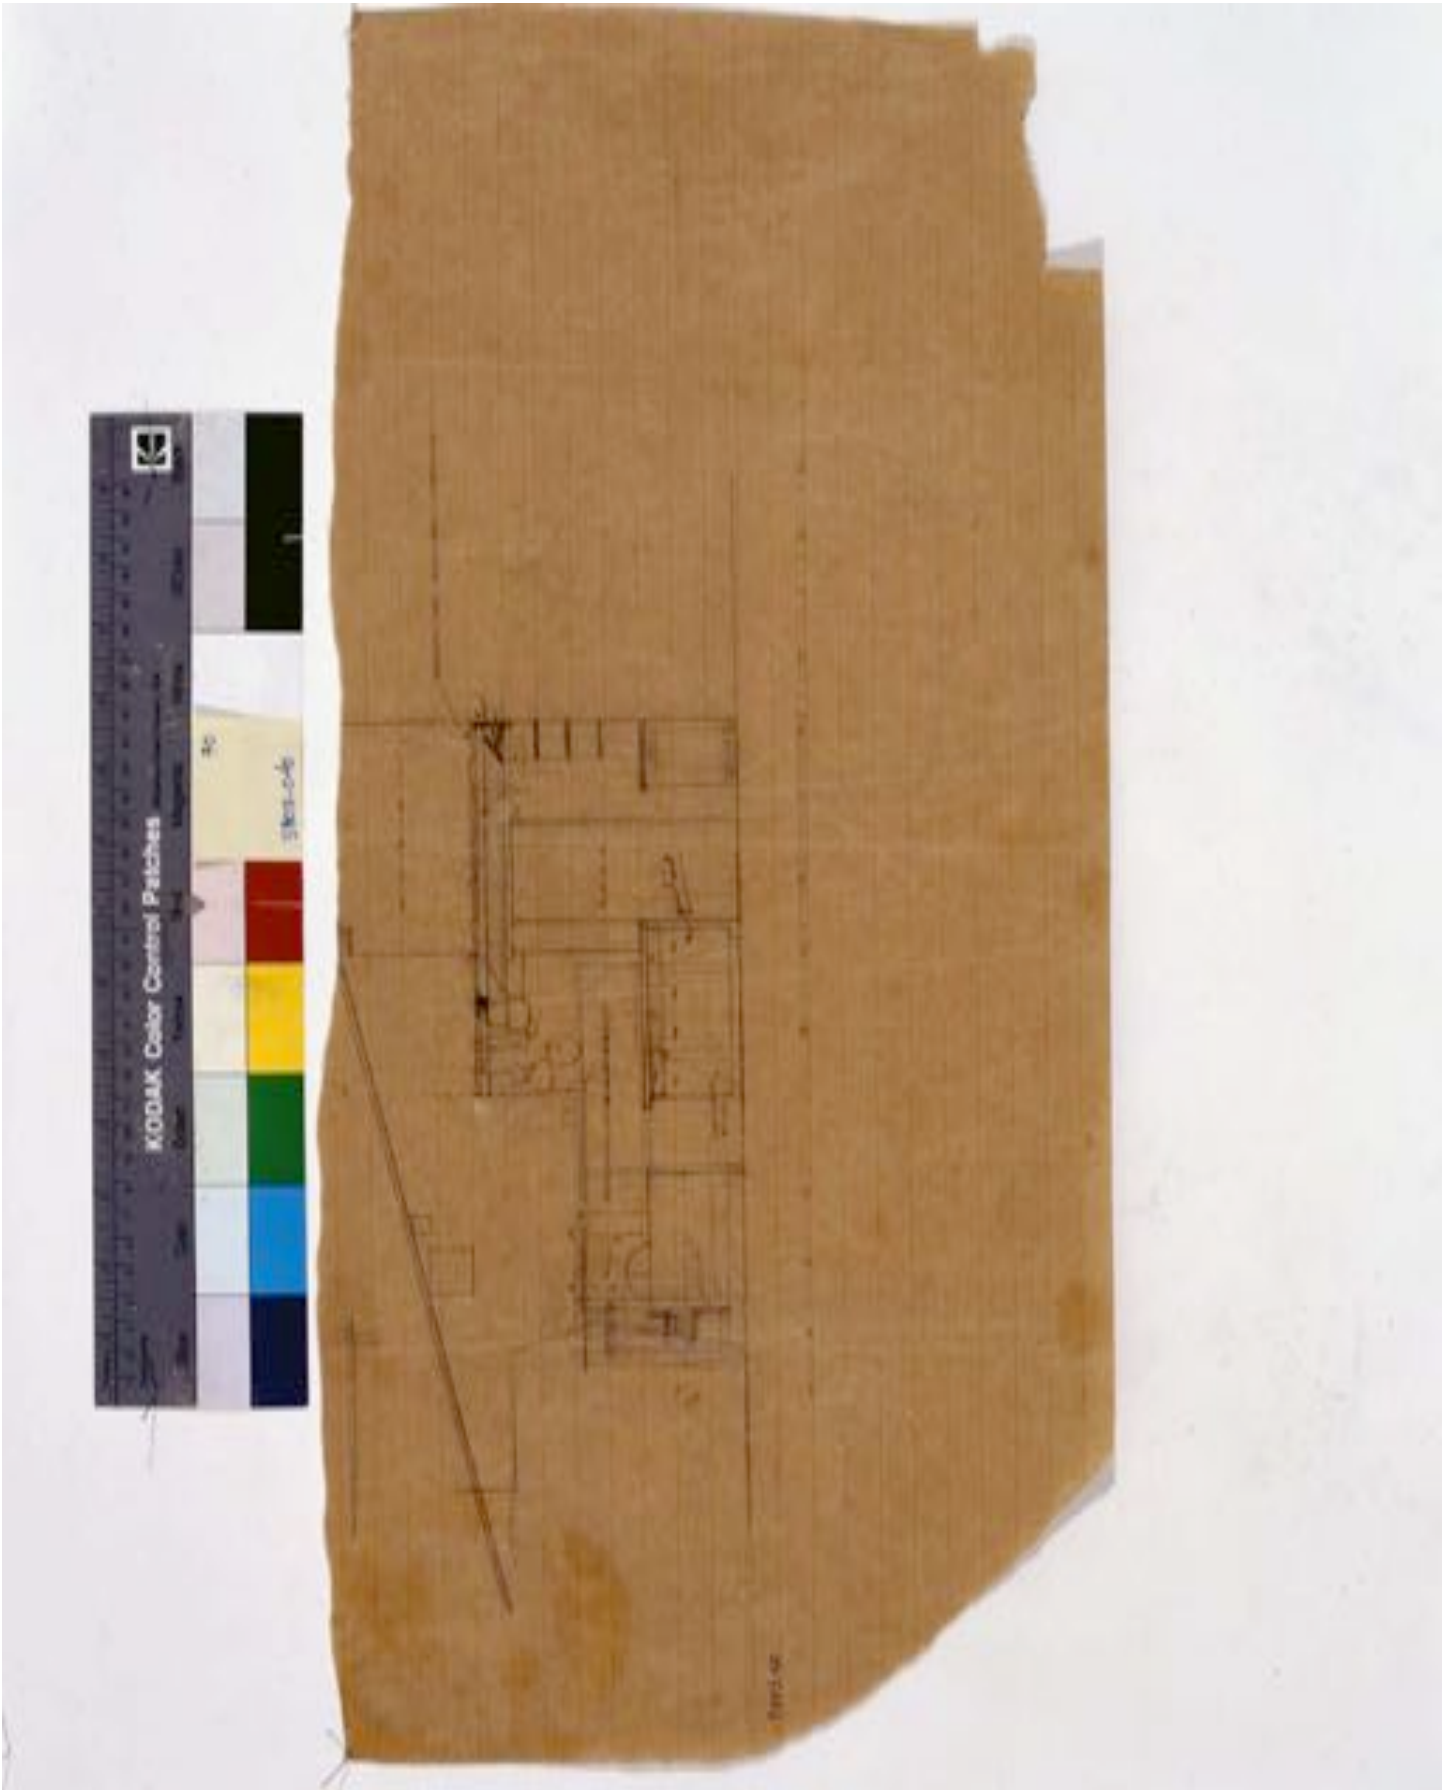
Figure B-40 - Kitchen Elevation (The Frank Lloyd Wright Foundation Archives, The Museum of Modern Art | Avery Architectural & Fine Arts Library, Columbia University, New York).

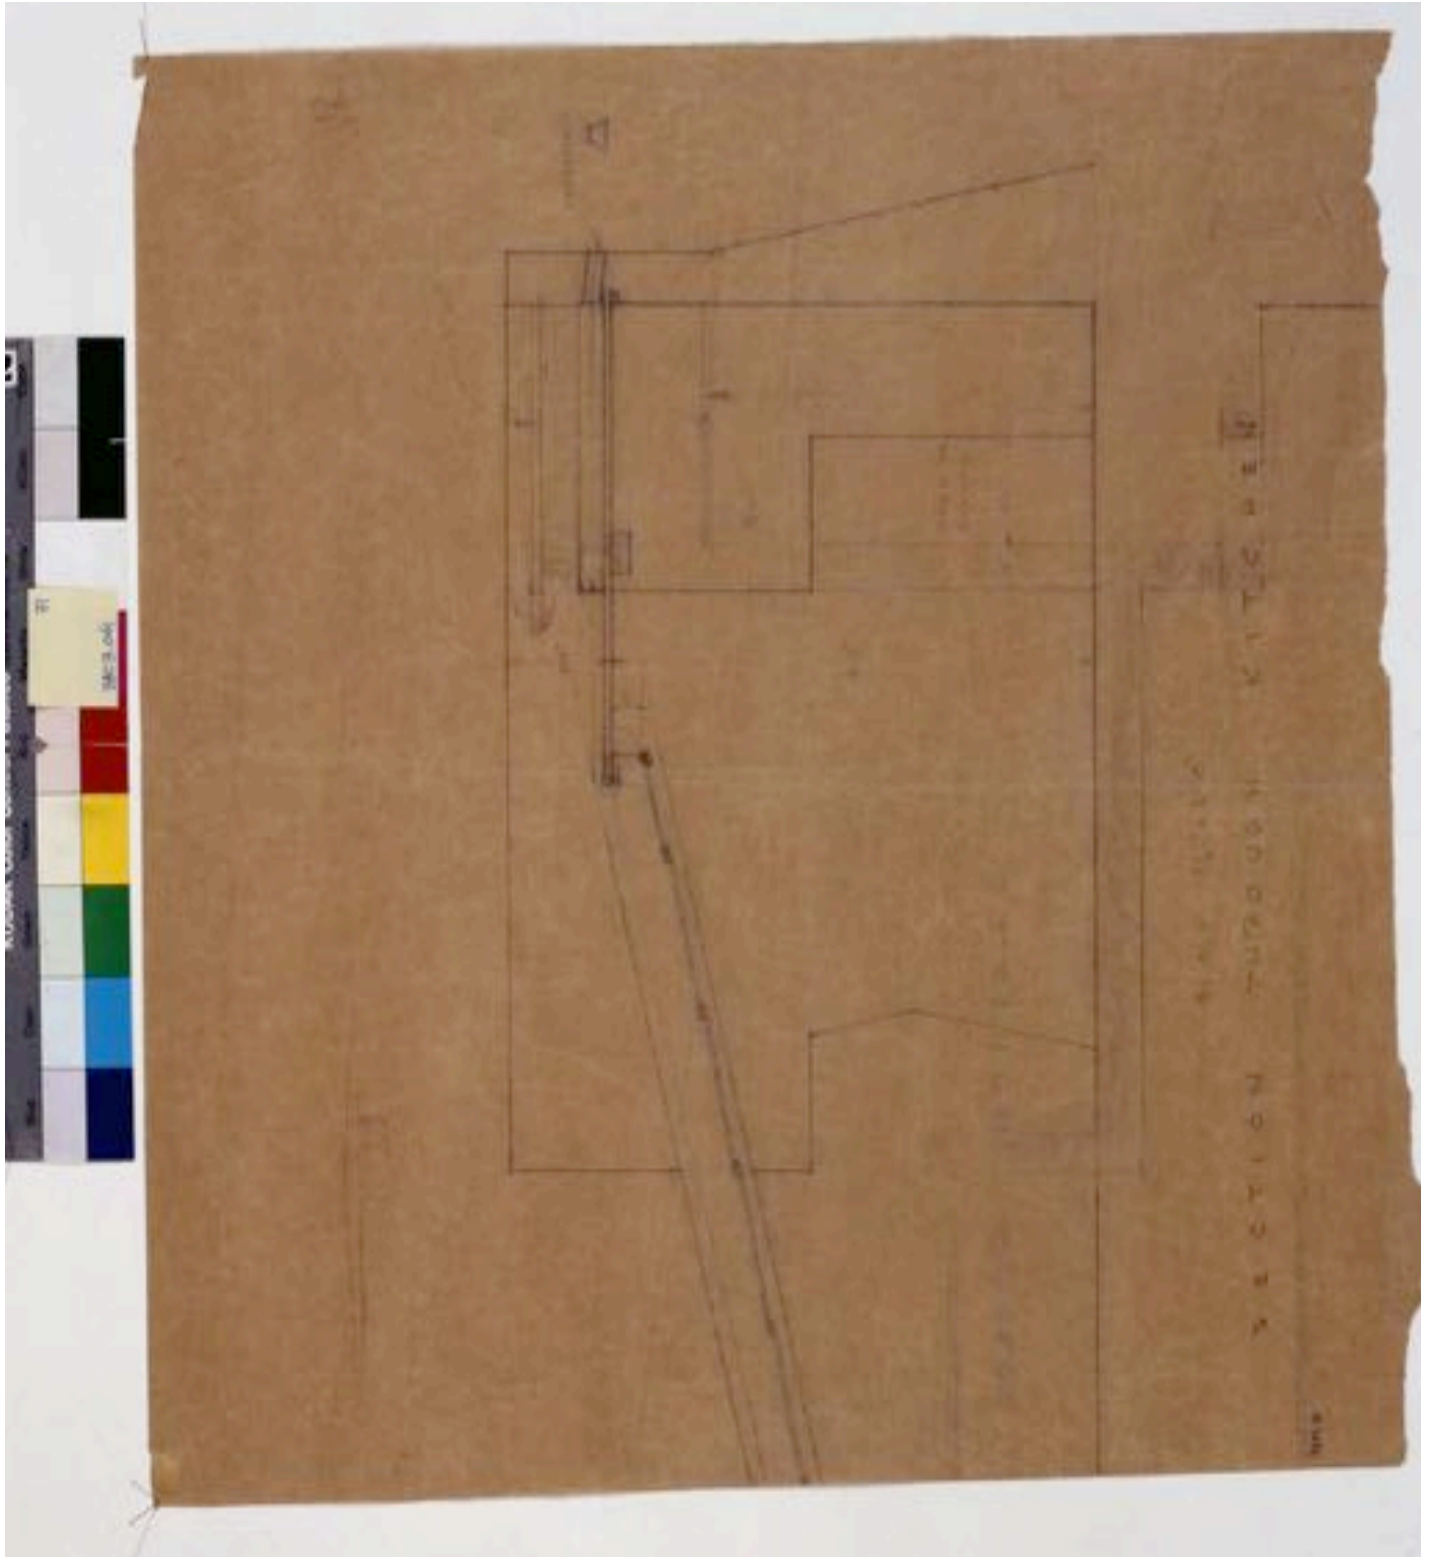
Figure B-41 - Section Through Kitchen, Cooler Door (The Frank Lloyd Wright Foundation Archives, The Museum of Modern Art | Avery Architectural & Fine Arts Library, Columbia University, New York).

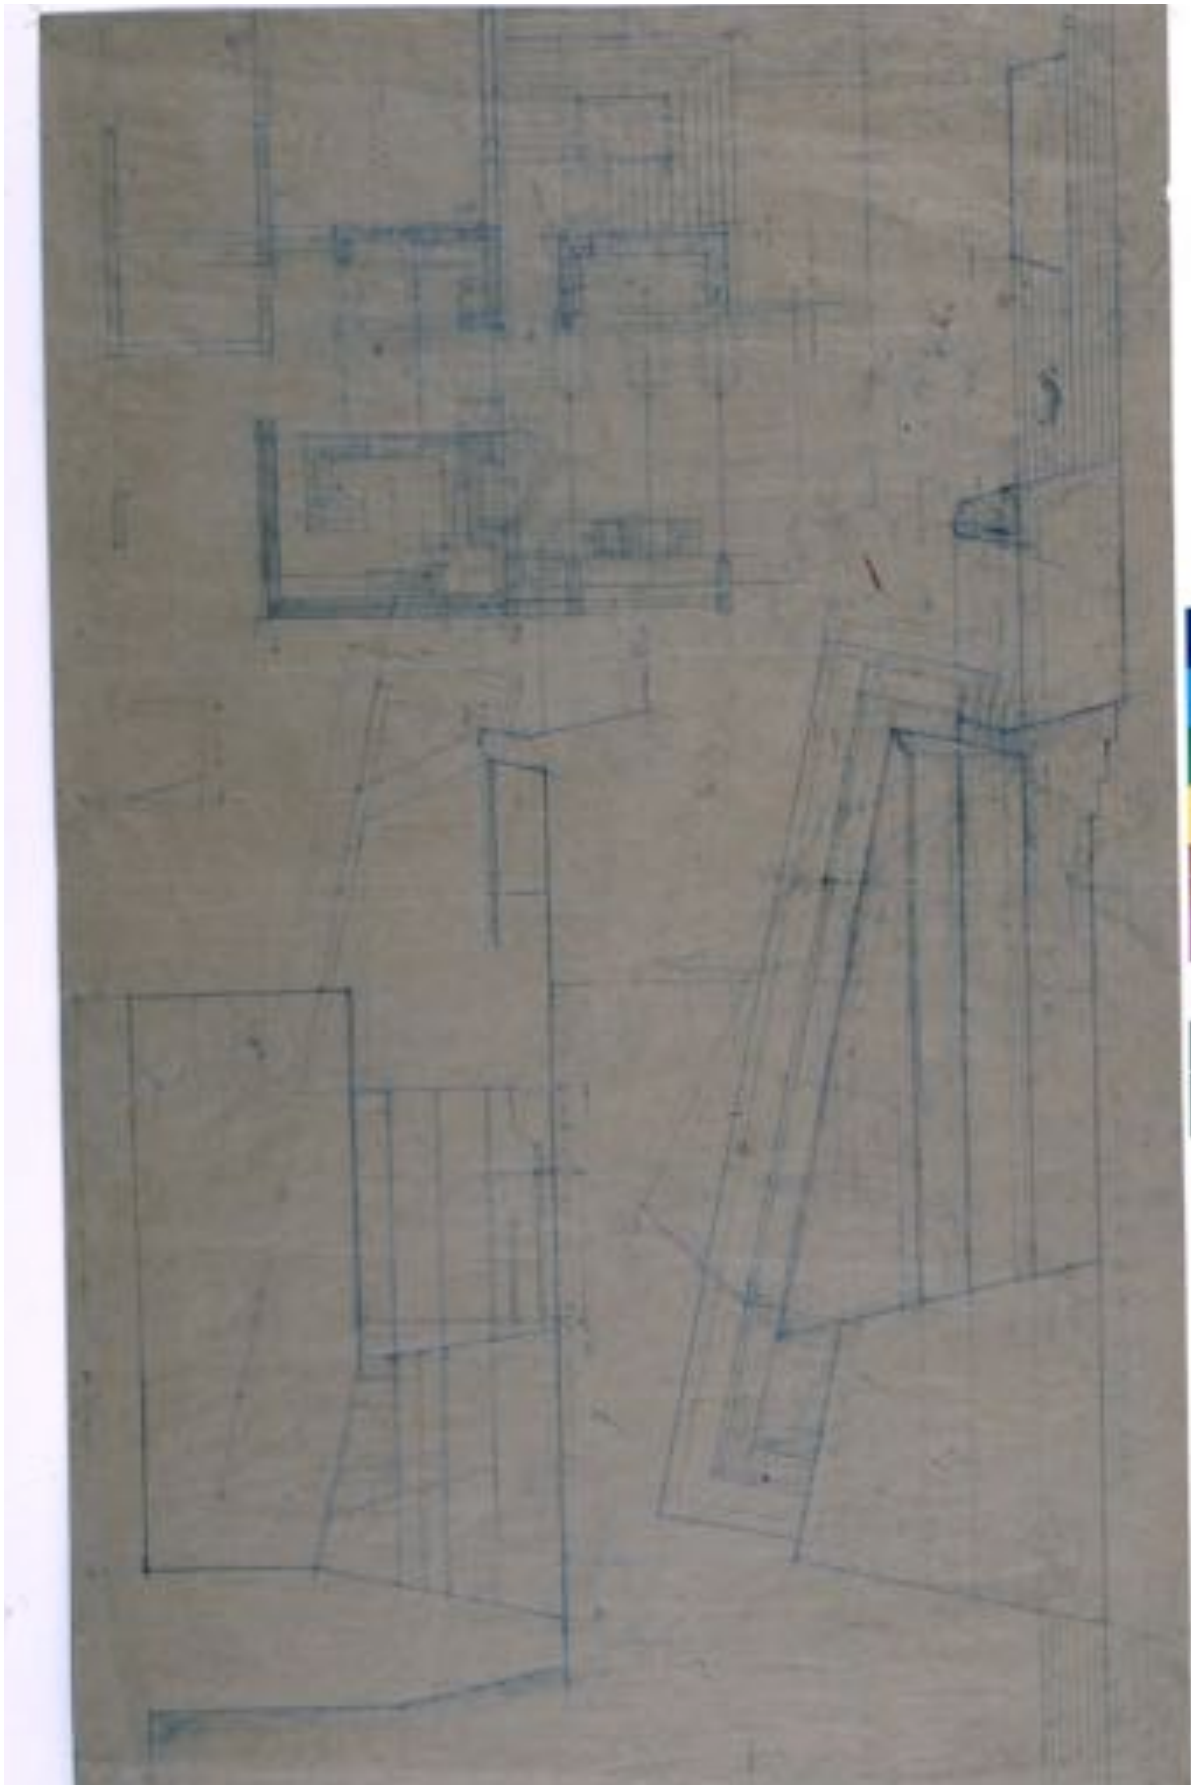
Figure B-42 - Drafting Room/Kitchen Elevation (The Frank Lloyd Wright Foundation Archives, The Museum of Modern Art | Avery Architectural & Fine Arts Library, Columbia University, New York).
