TALIESIN WEST PRESERVATION MASTER PLAN

Harboe Architects, PC

MAY 21, 2015

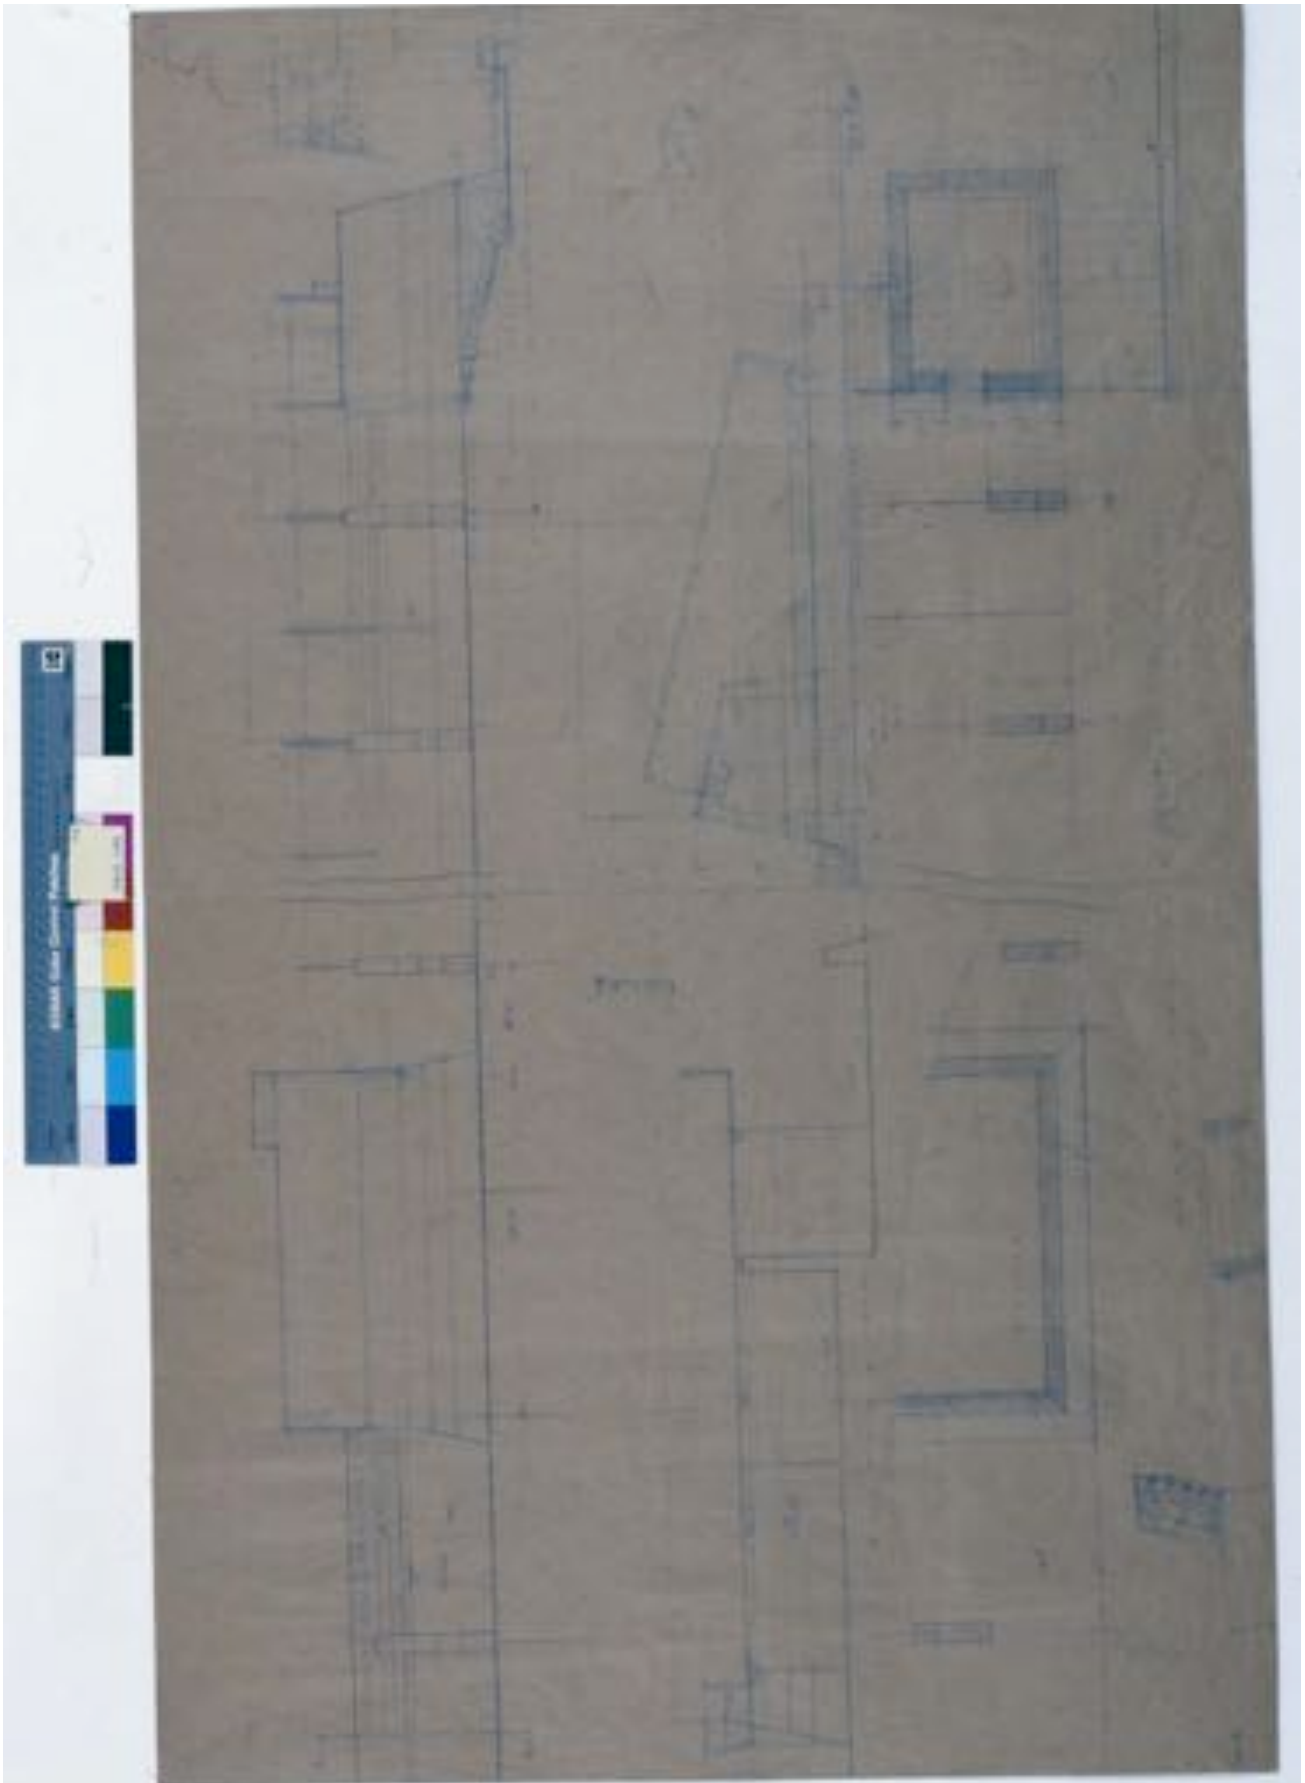
Figure B-43 - Drafting Room Section/Elevation (The Frank Lloyd Wright Foundation Archives, The Museum of Modern Art | Avery Architectural & Fine Arts Library, Columbia University, New York).

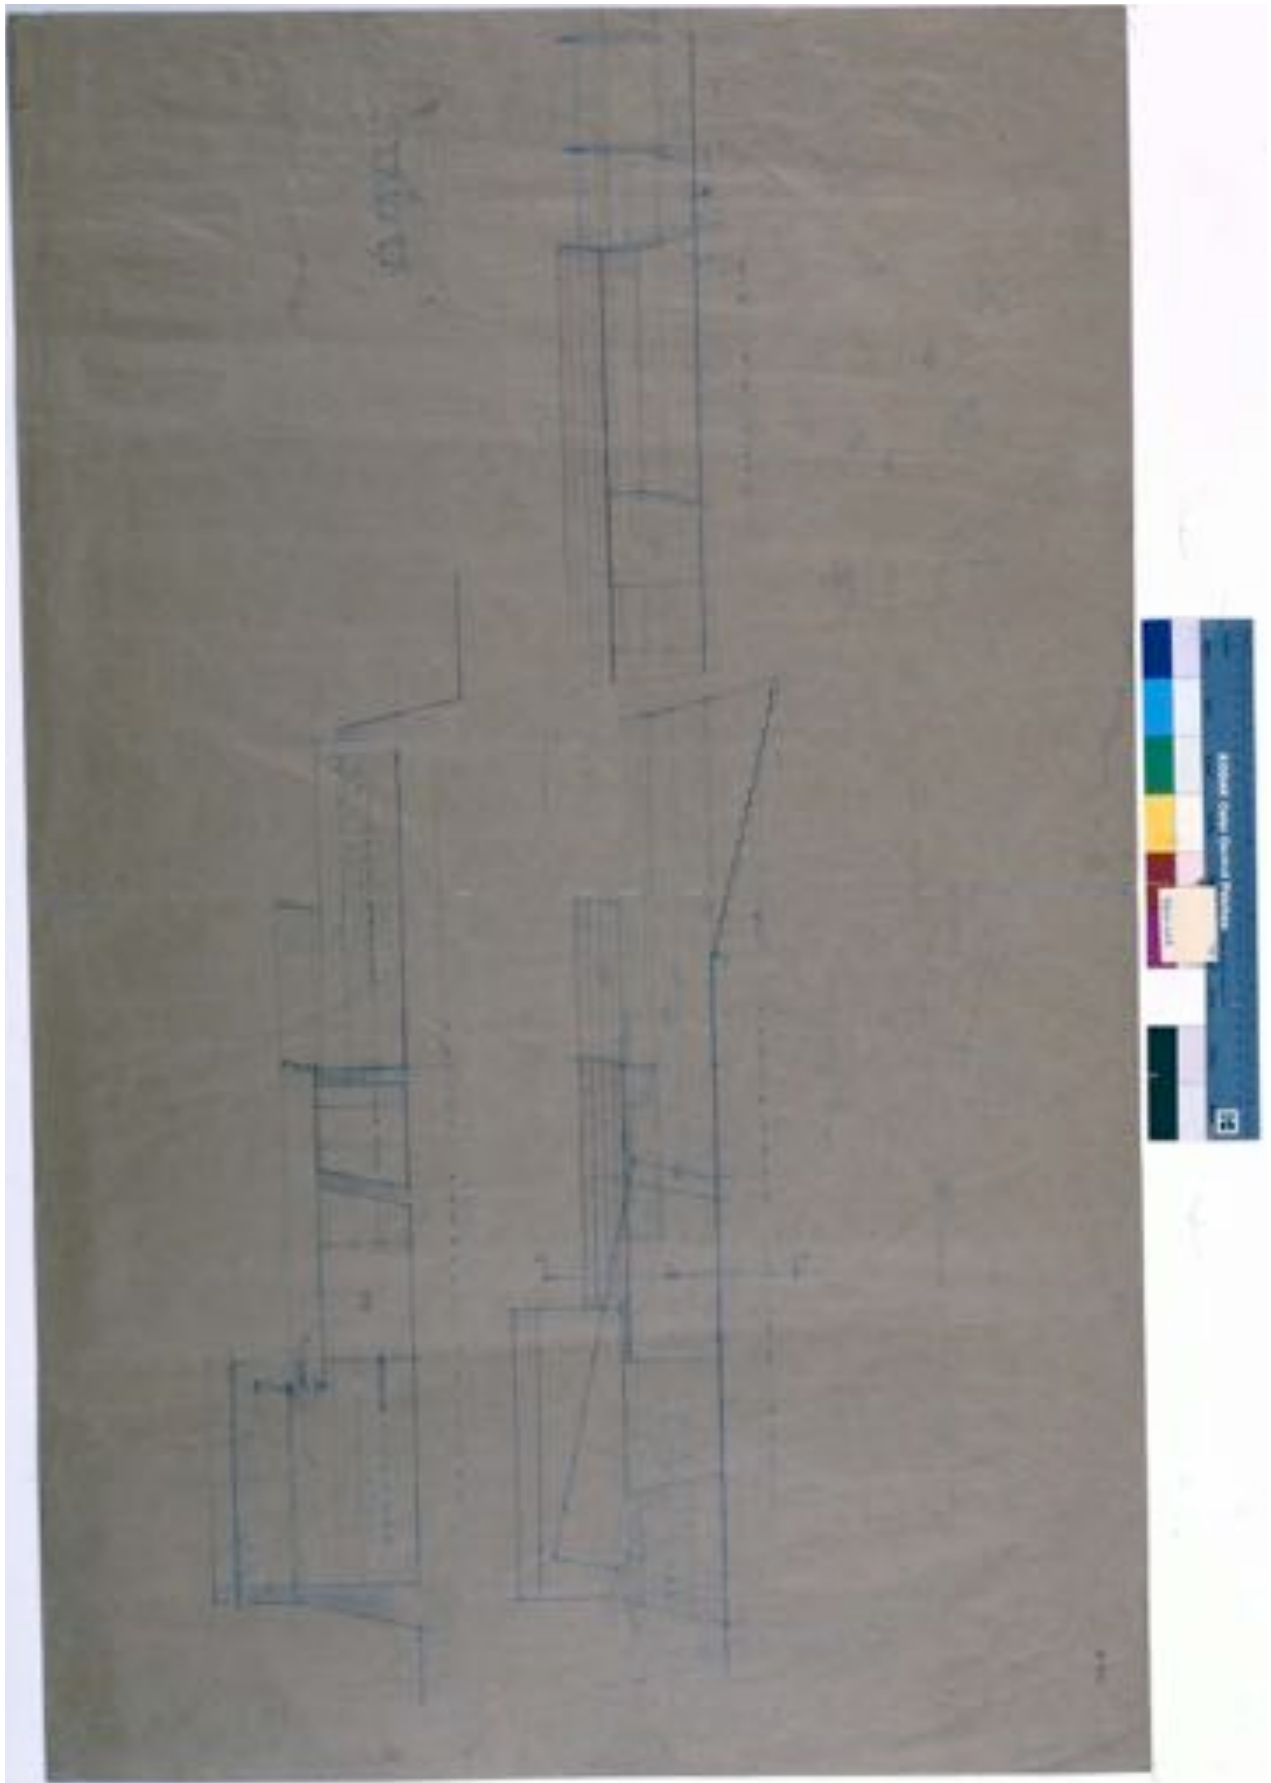
Figure B-44 - Drafting Room Section/Elevation (The Frank Lloyd Wright Foundation Archives, The Museum of Modern Art | Avery Architectural & Fine Arts Library, Columbia University, New York).

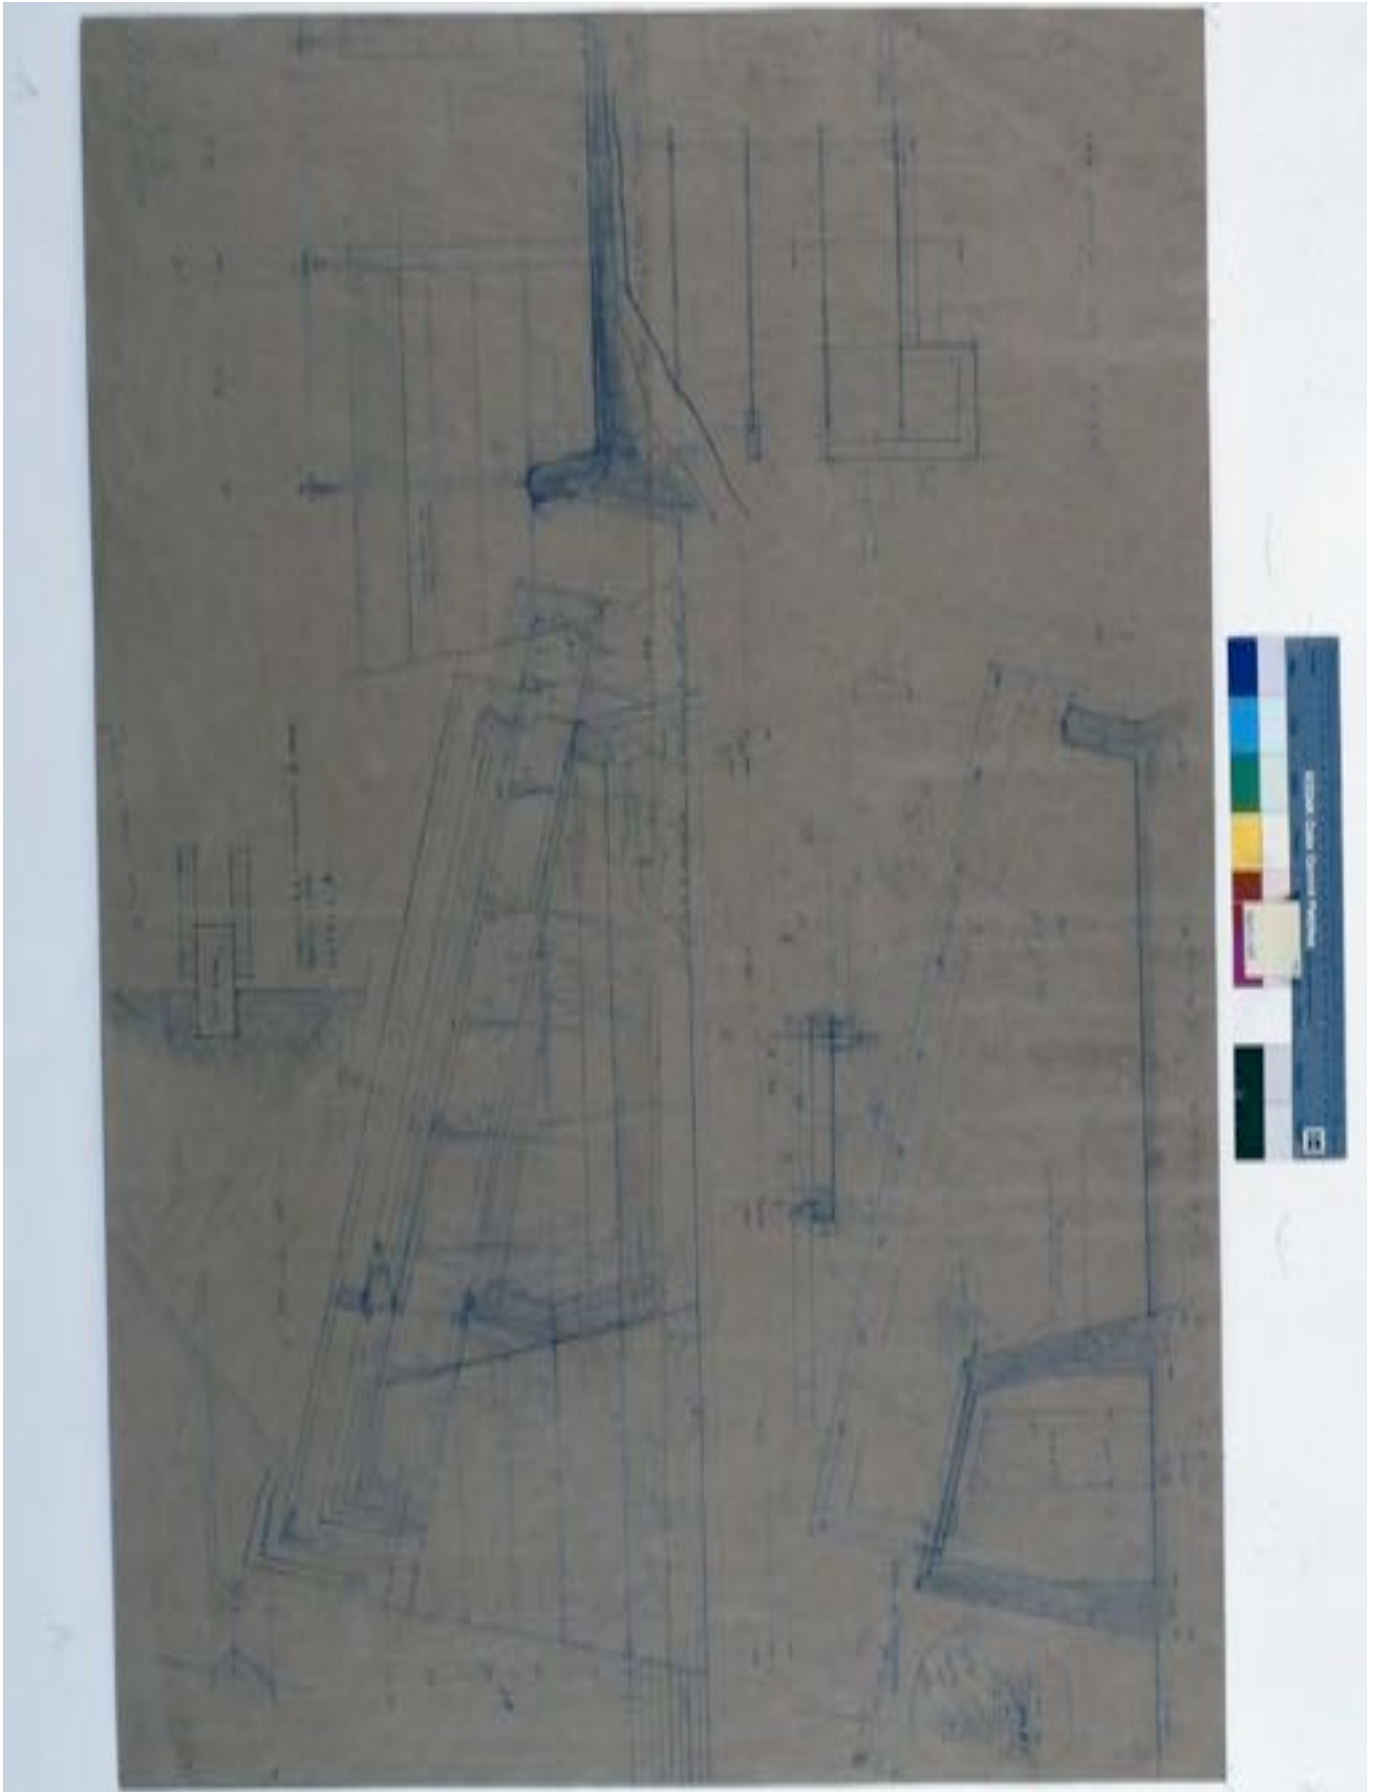
Figure B-45 - Drafting Room Section/Elevation (The Frank Lloyd Wright Foundation Archives, The Museum of Modern Art | Avery Architectural & Fine Arts Library, Columbia University, New York).

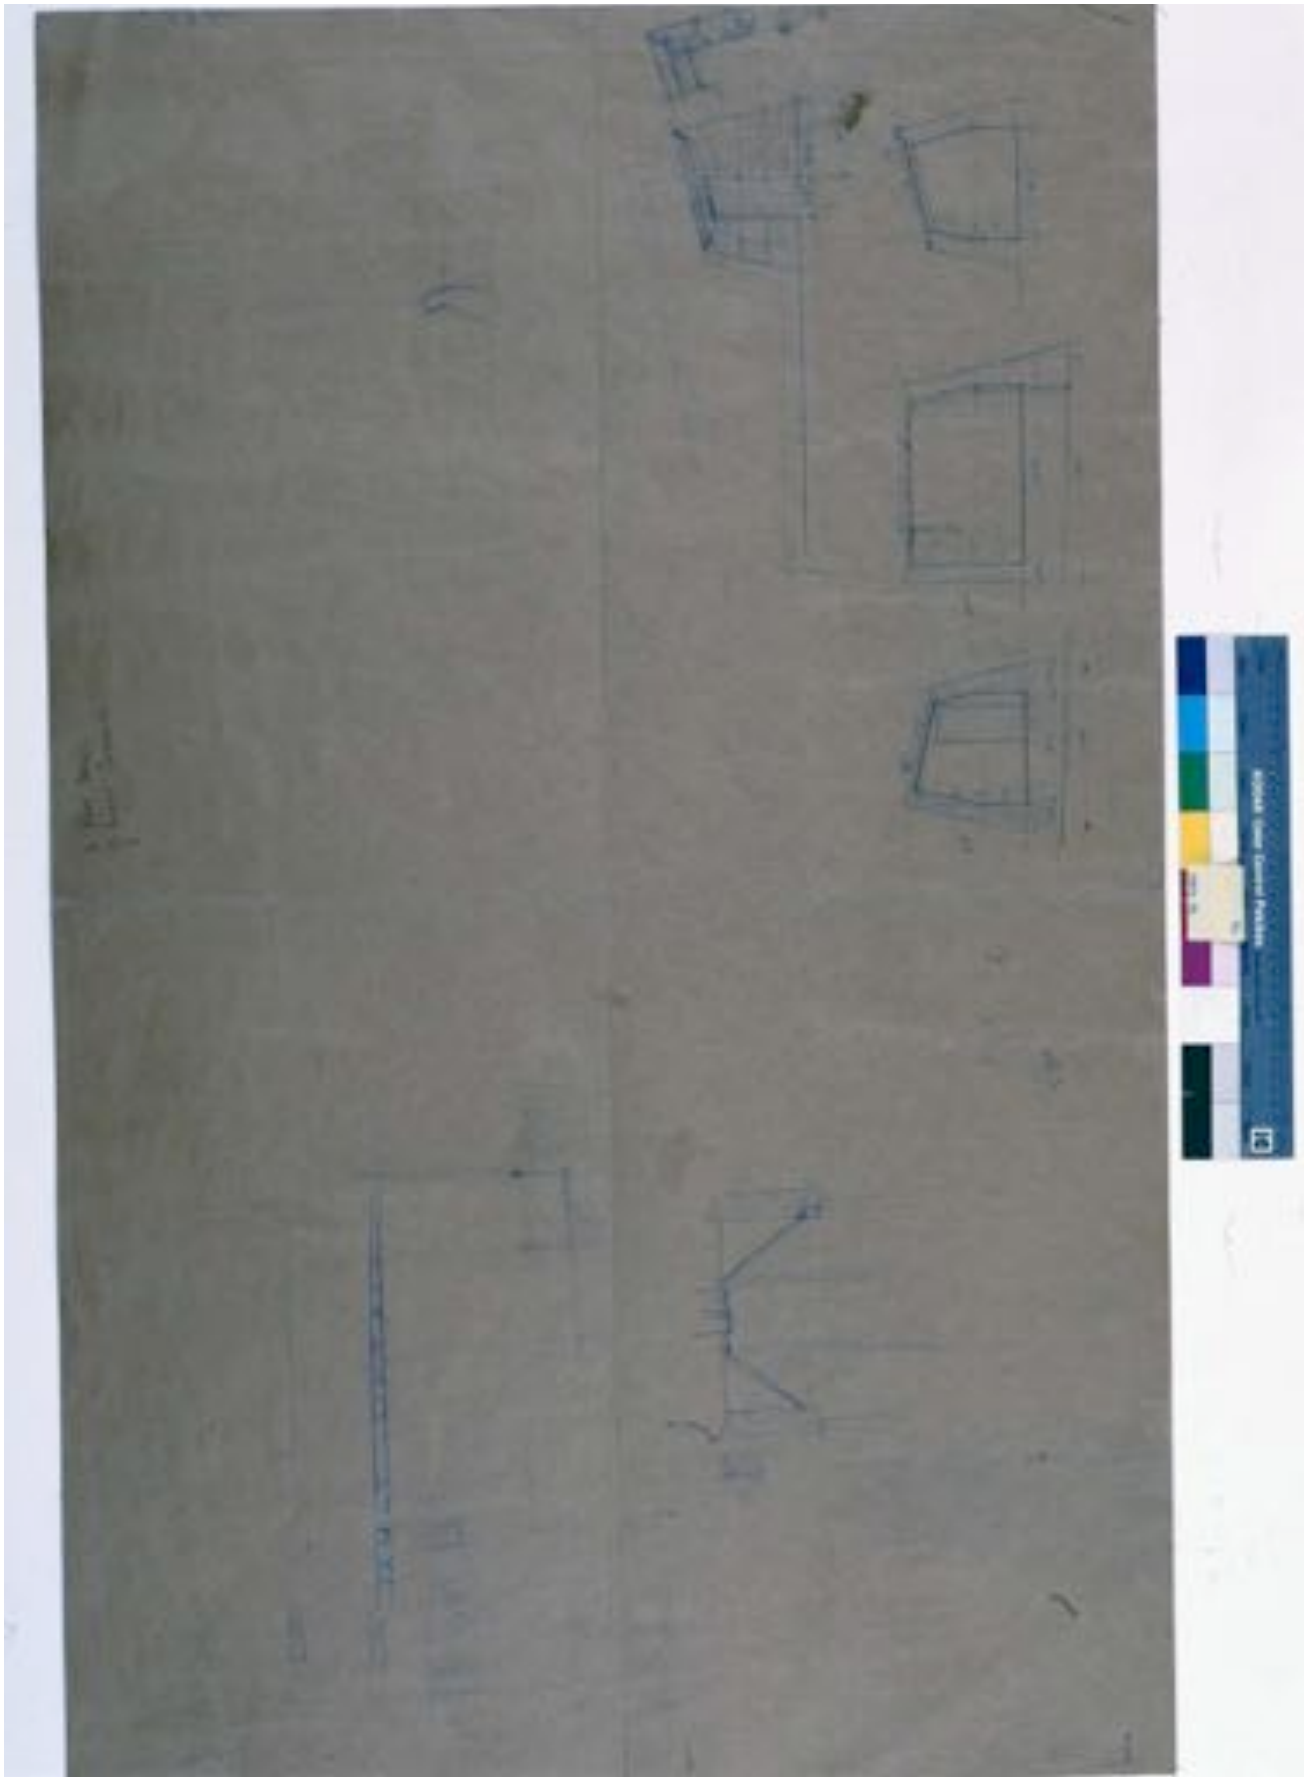
Figure B-46 - Drafting Room Section/Elevation (The Frank Lloyd Wright Foundation Archives, The Museum of Modern Art | Avery Architectural & Fine Arts Library, Columbia University, New York).

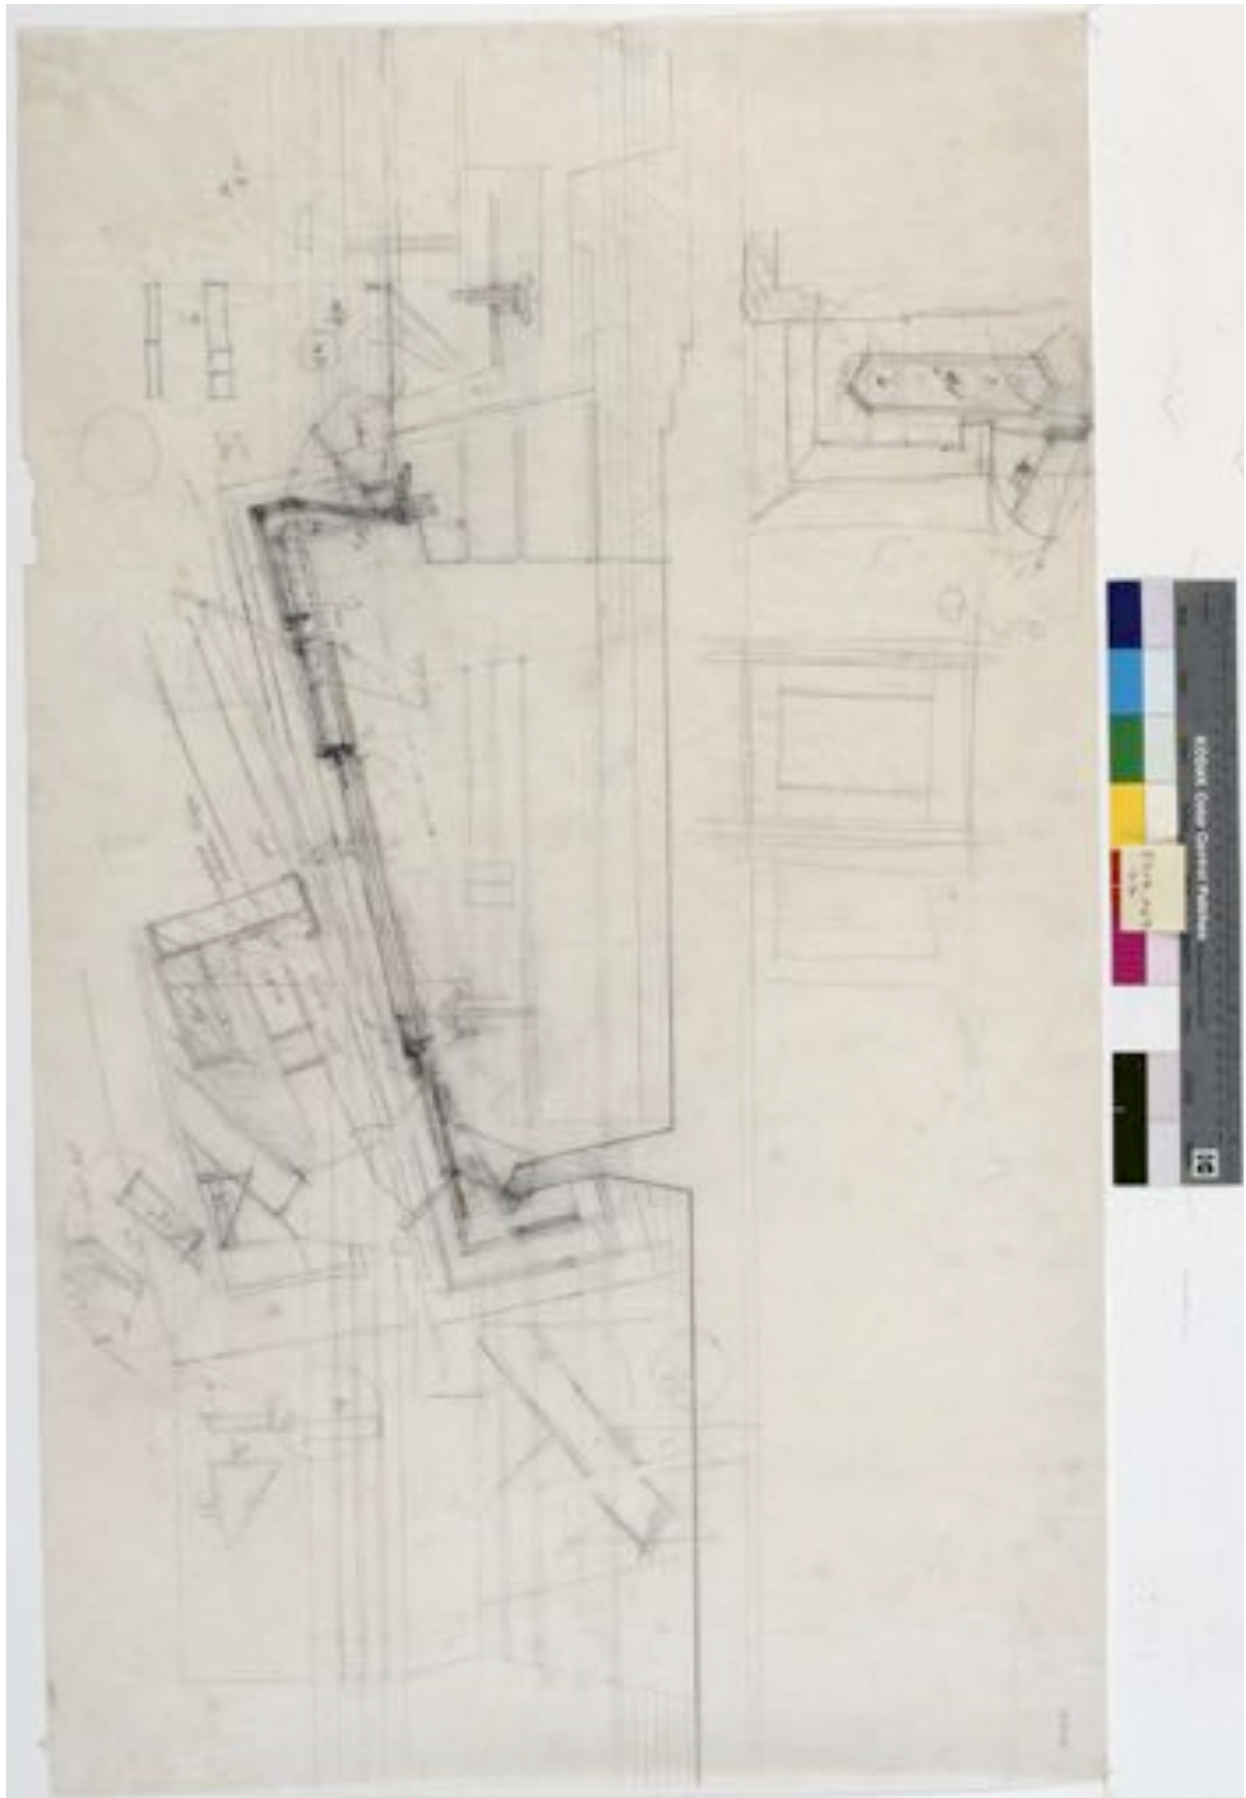
Figure B-47 - Garden Room Section (The Frank Lloyd Wright Foundation Archives, The Museum of Modern Art | Avery Architectural & Fine Arts Library, Columbia University, New York).

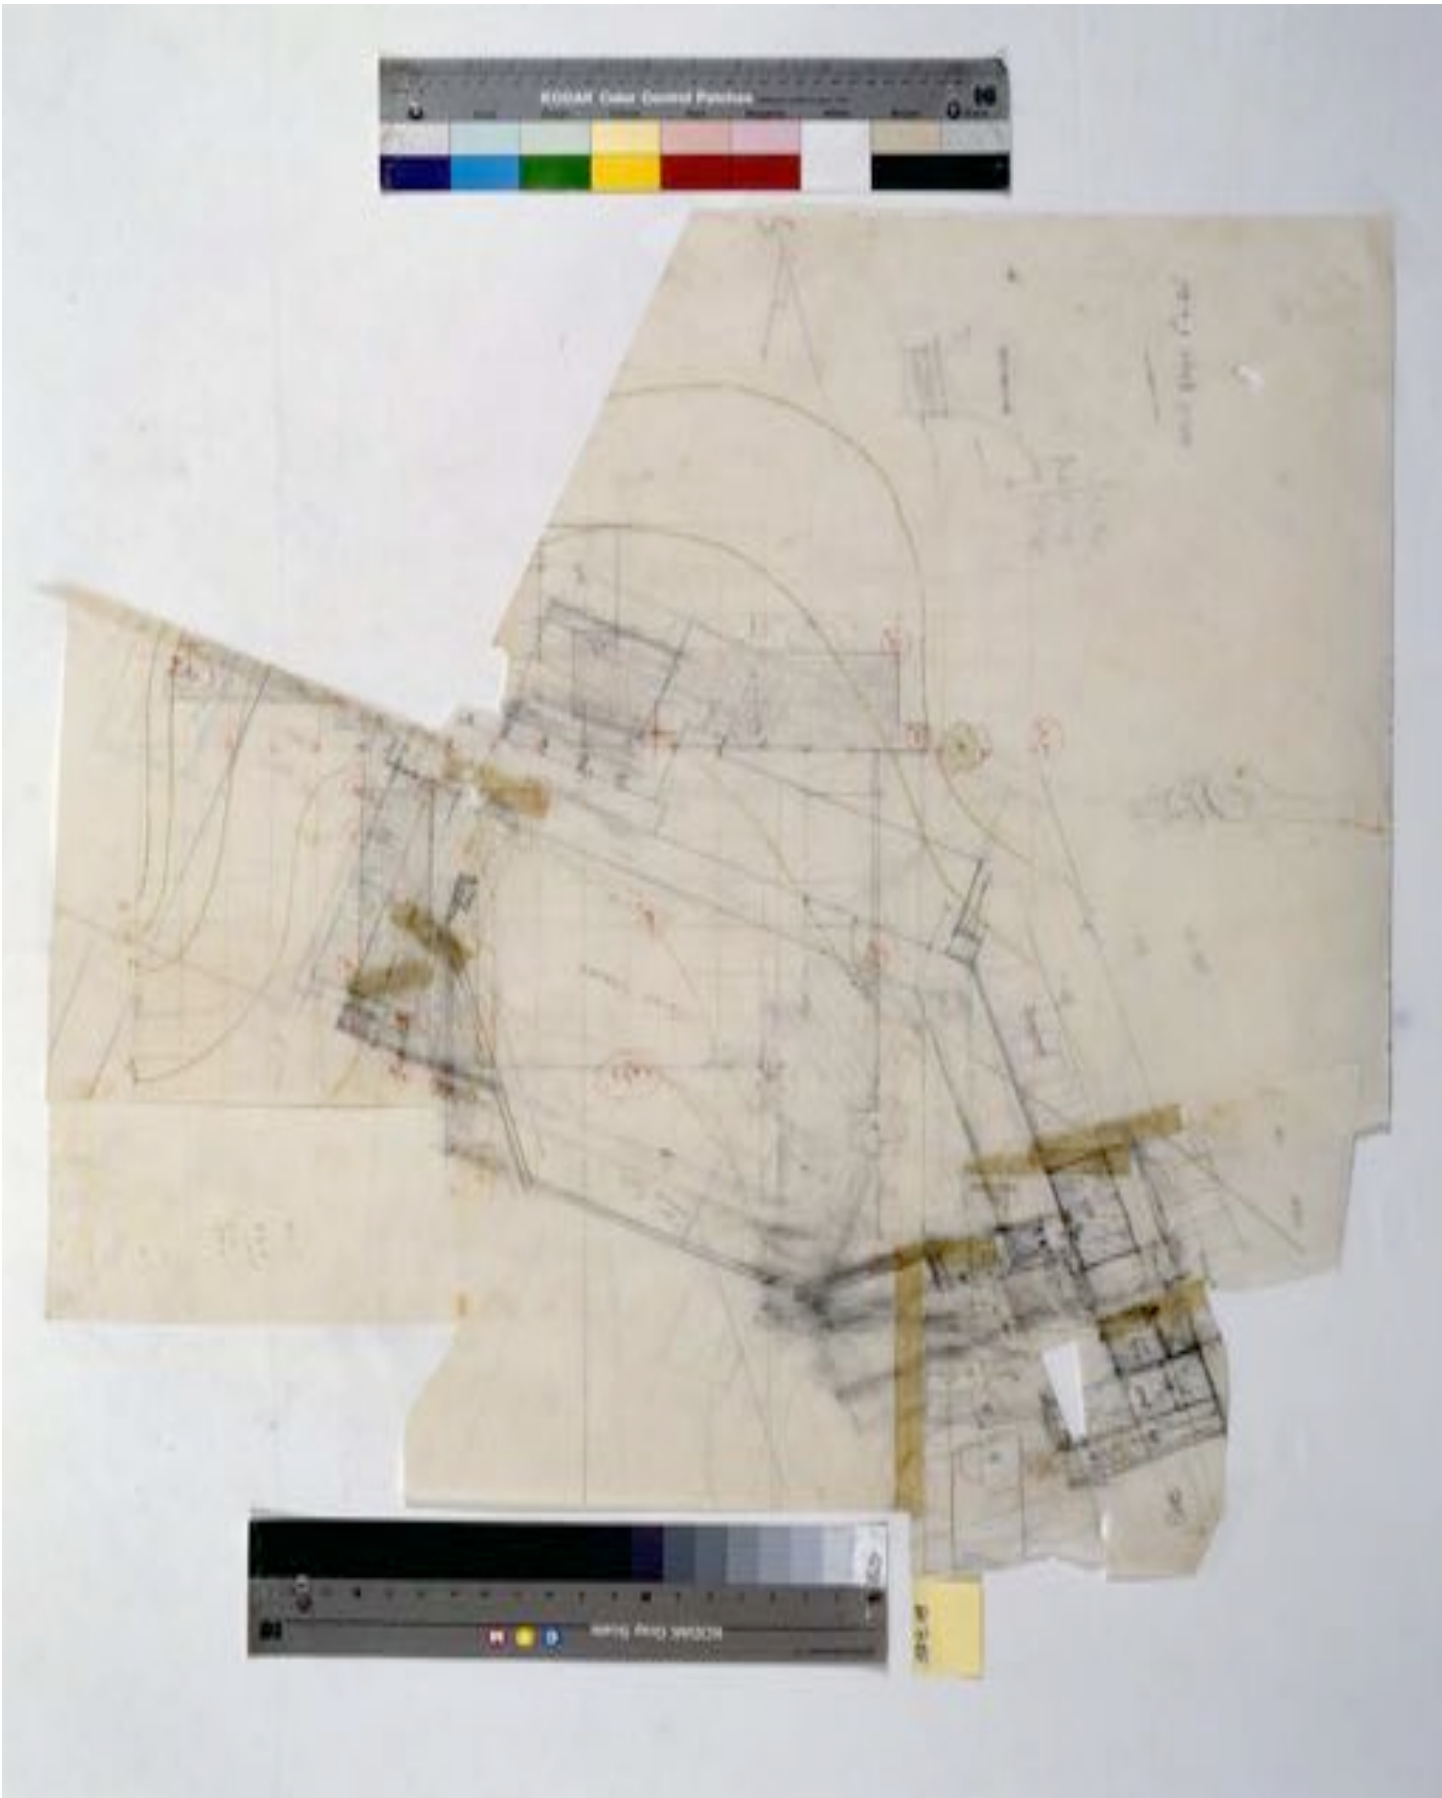
Figure B-48 - Shop Entry Plan (The Frank Lloyd Wright Foundation Archives, The Museum of Modern Art | Avery Architectural & Fine Arts Library, Columbia University, New York).

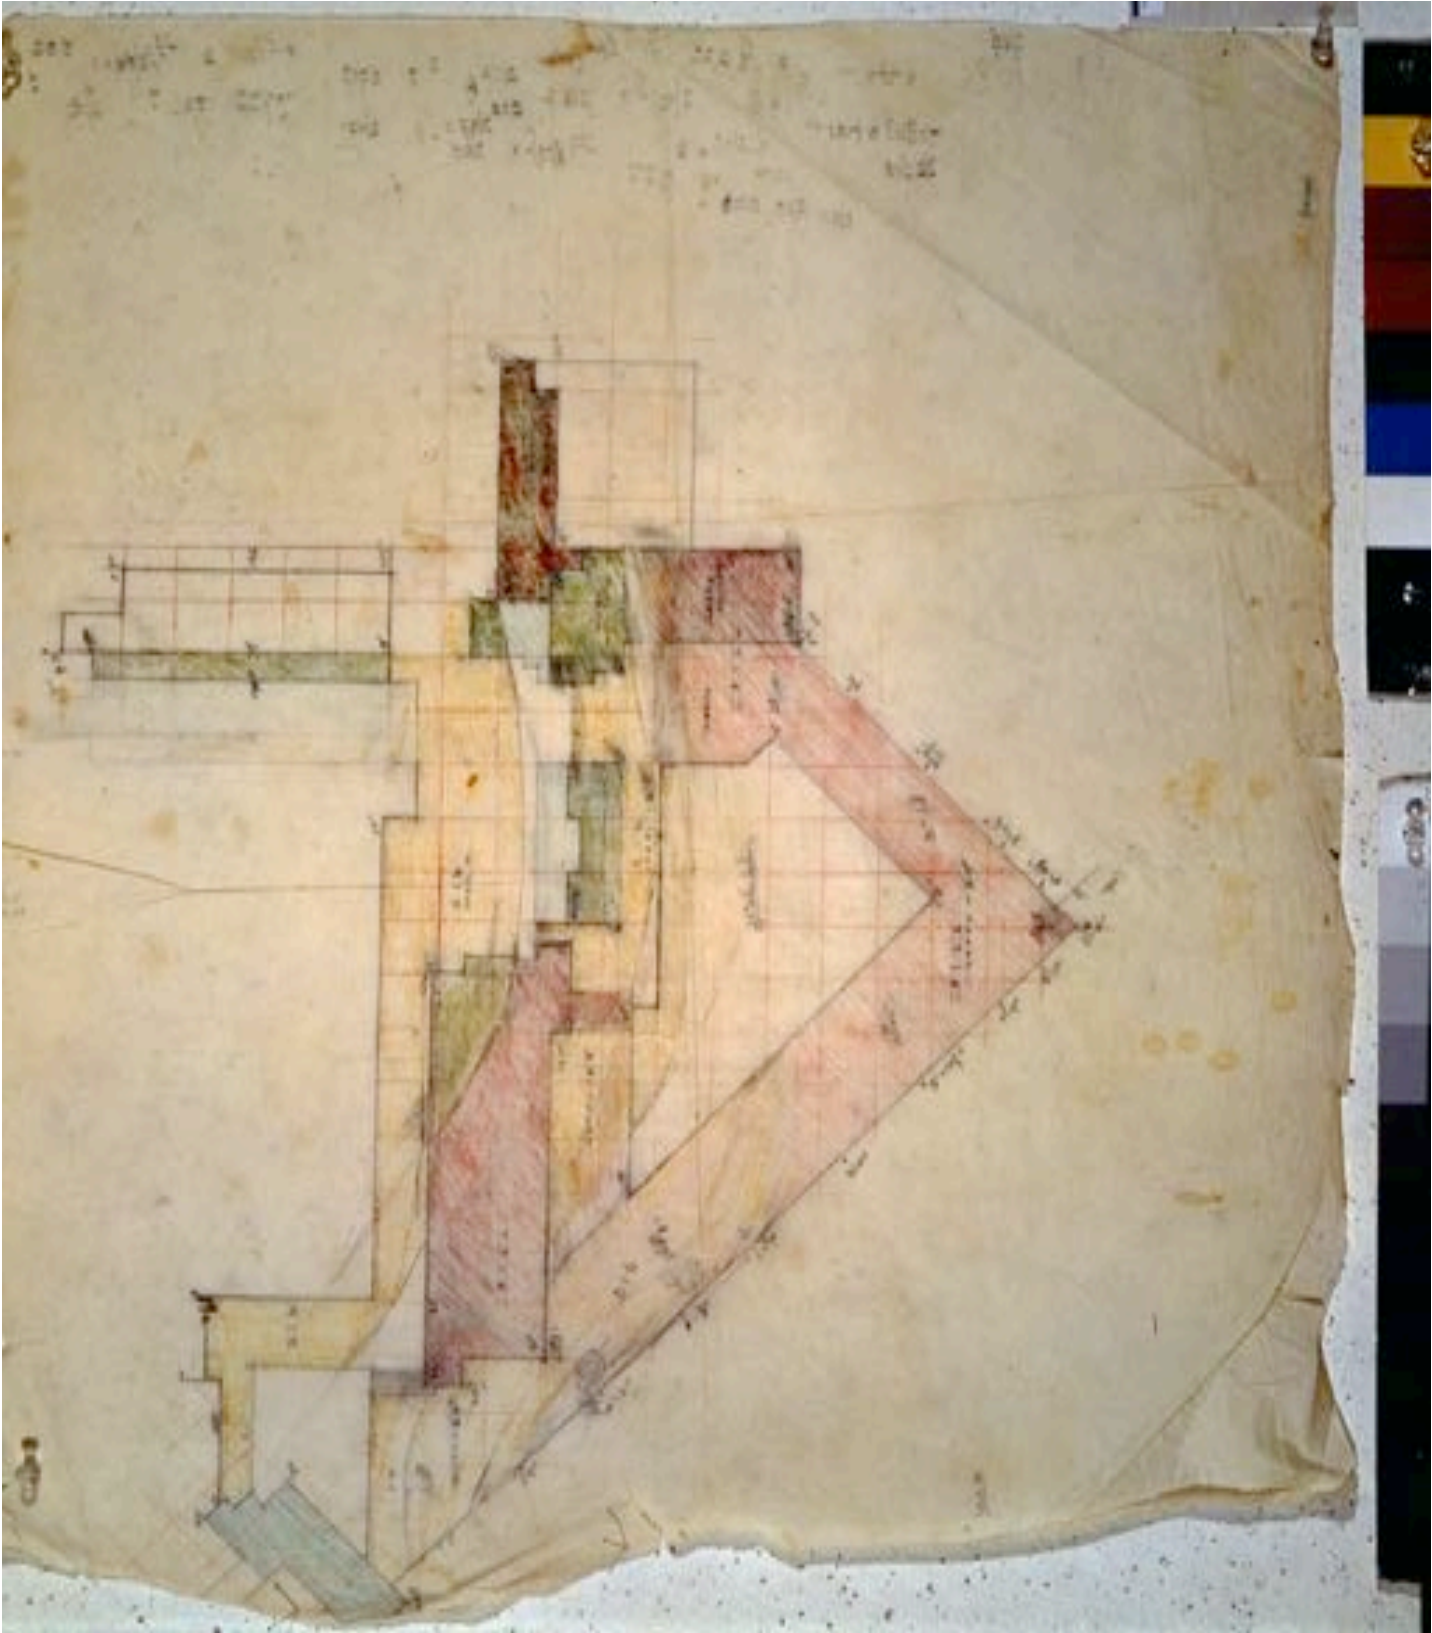
Figure B-49 - Excavation/Fill Plan (The Frank Lloyd Wright Foundation Archives, The Museum of Modern Art | Avery Architectural & Fine Arts Library, Columbia University, New York).

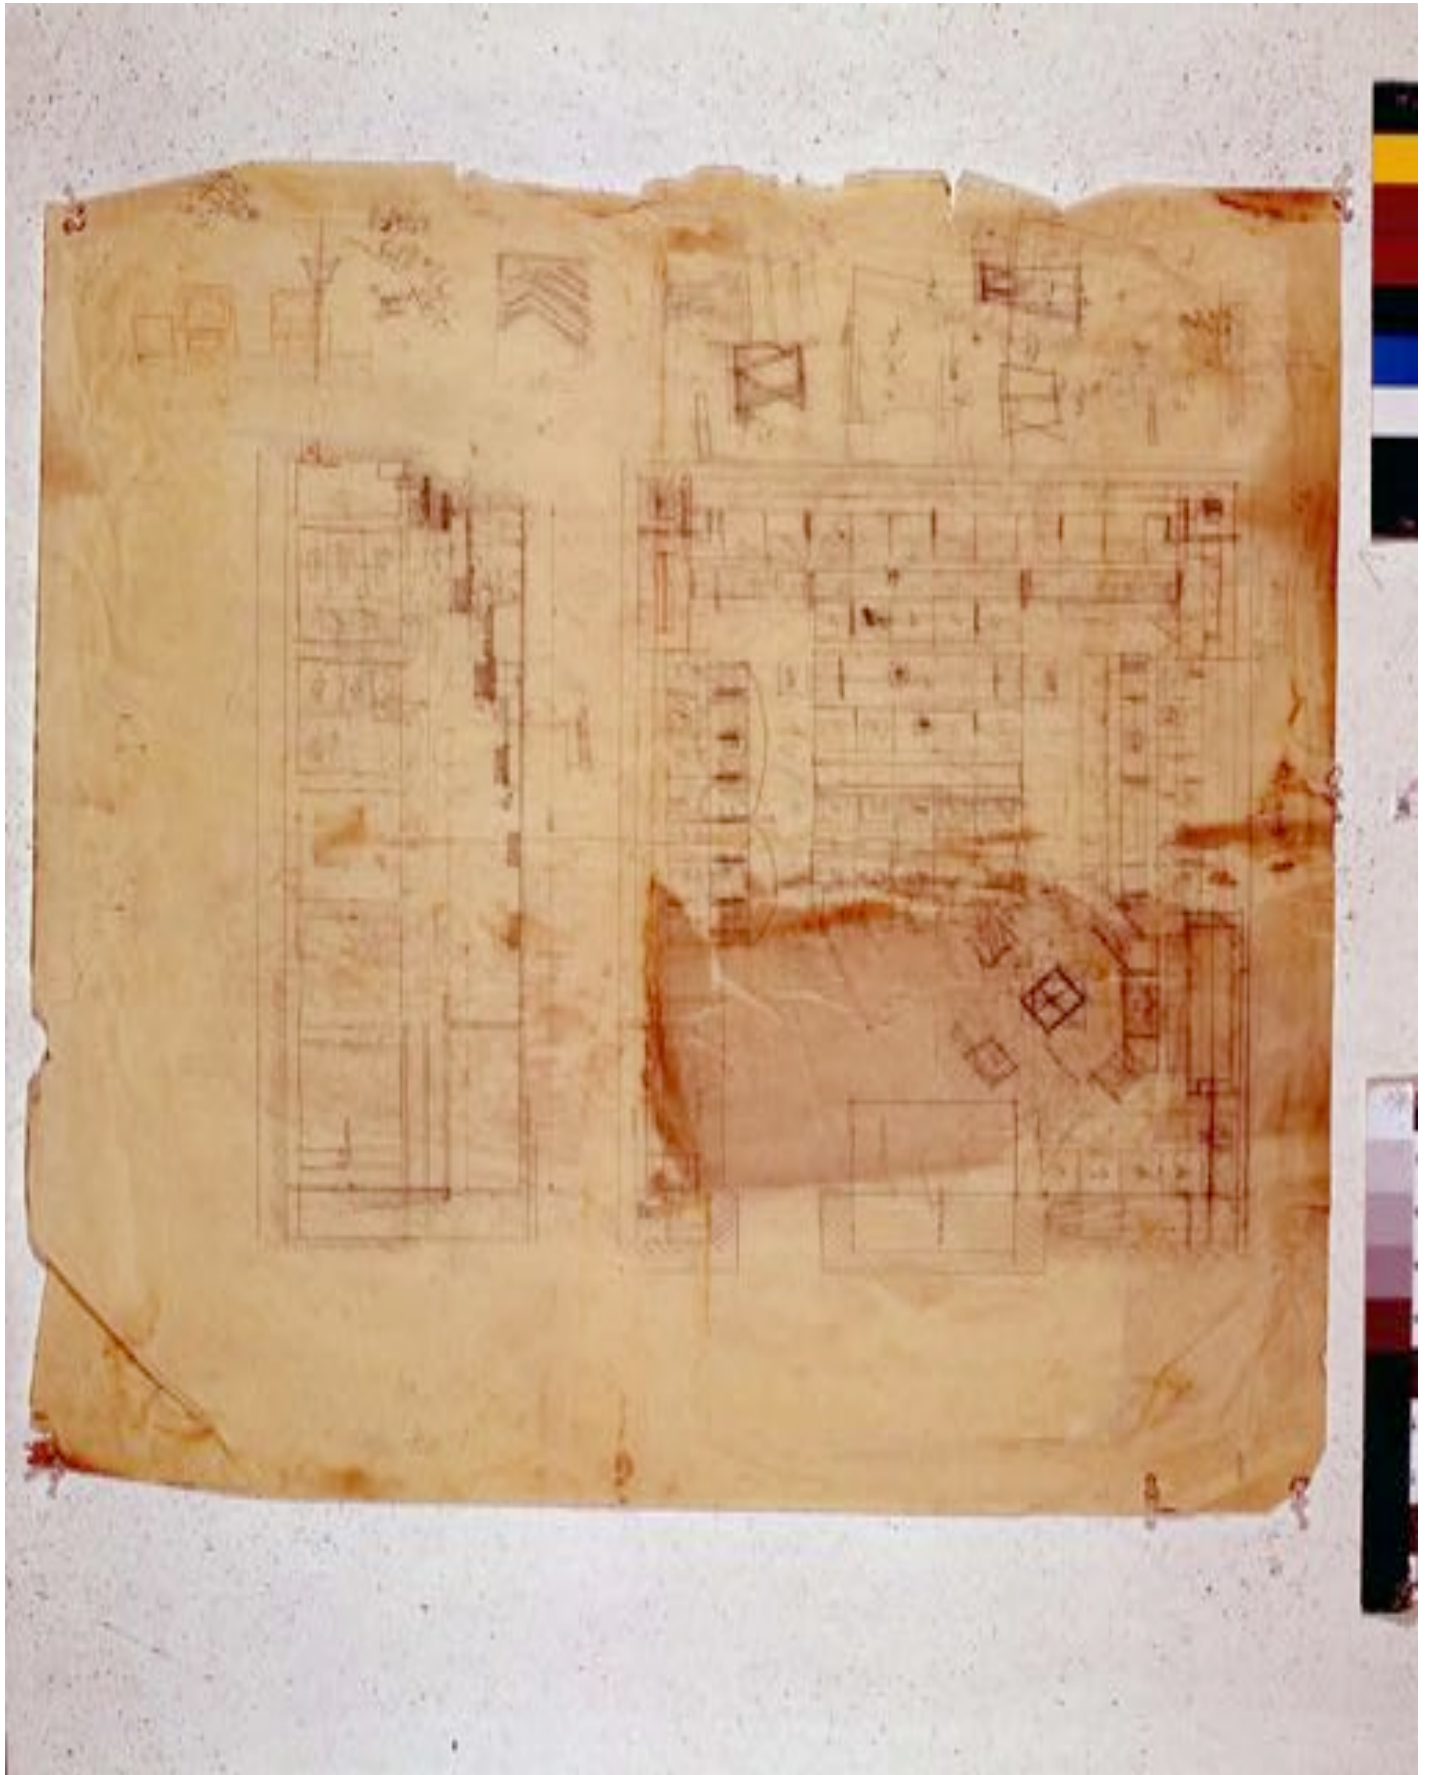
Figure B-50 - Theatre [Kiva] Plan/Section (The Frank Lloyd Wright Foundation Archives, The Museum of Modern Art | Avery Architectural & Fine Arts Library, Columbia University, New York).

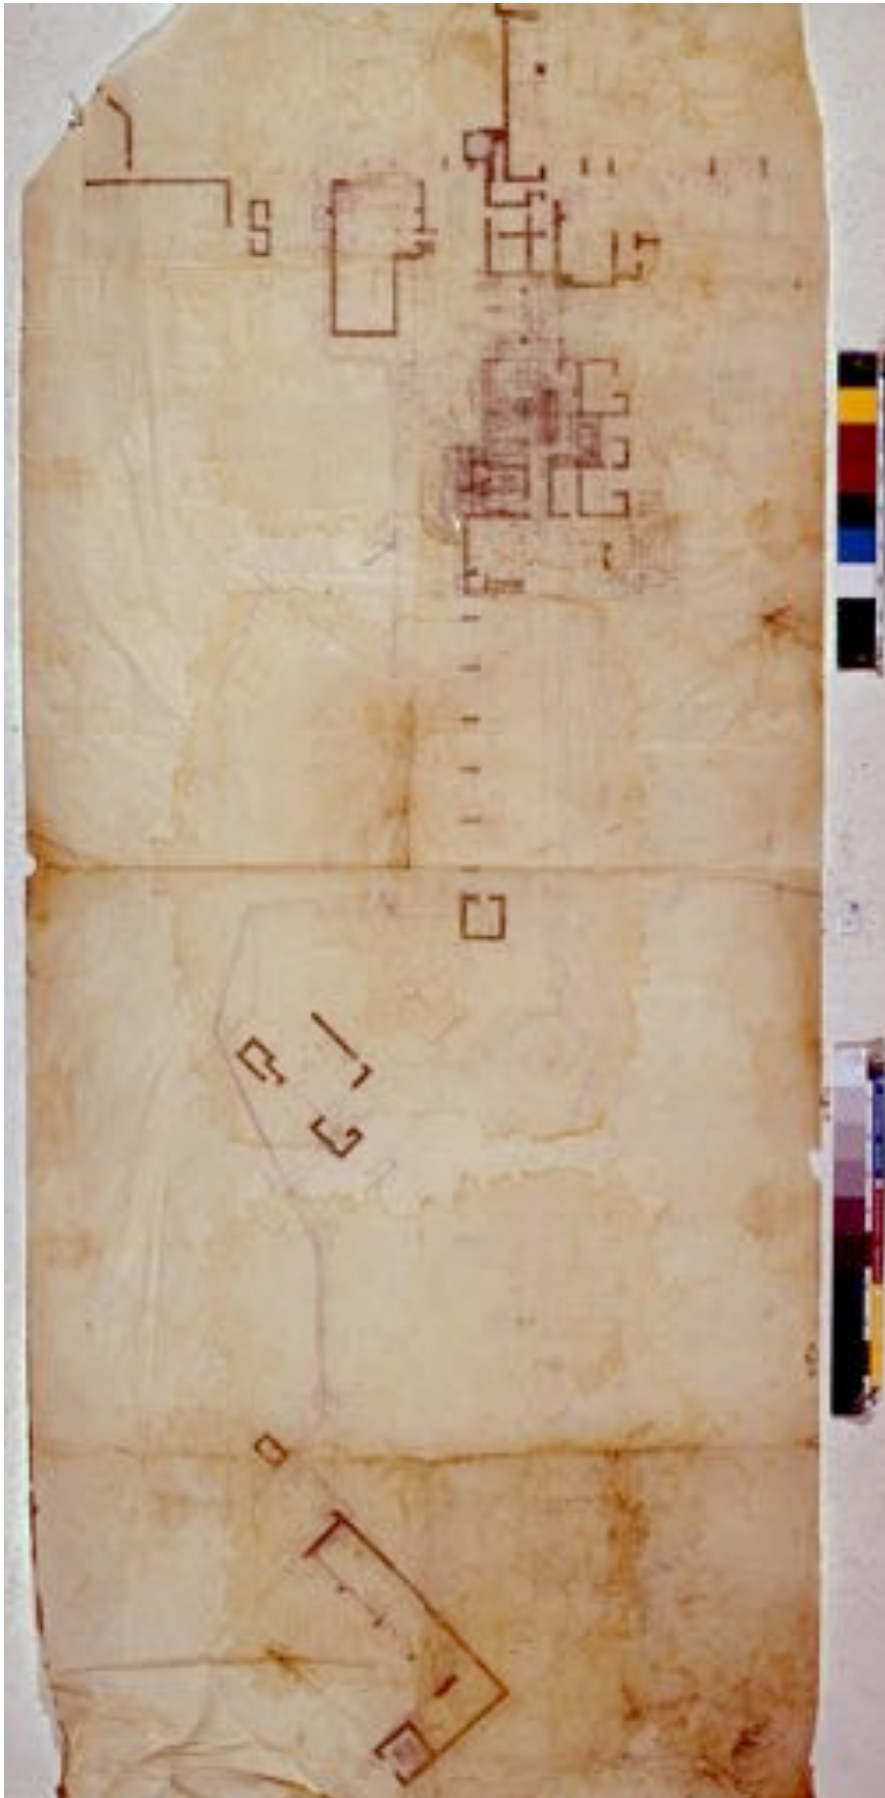
Figure B-51 - New Dining Room Plan (The Frank Lloyd Wright Foundation Archives, The Museum of Modern Art | Avery Architectural & Fine Arts Library, Columbia University, New York).
