TALIESIN WEST PRESERVATION MASTER PLAN

Harboe Architects, PC

MAY 21, 2015

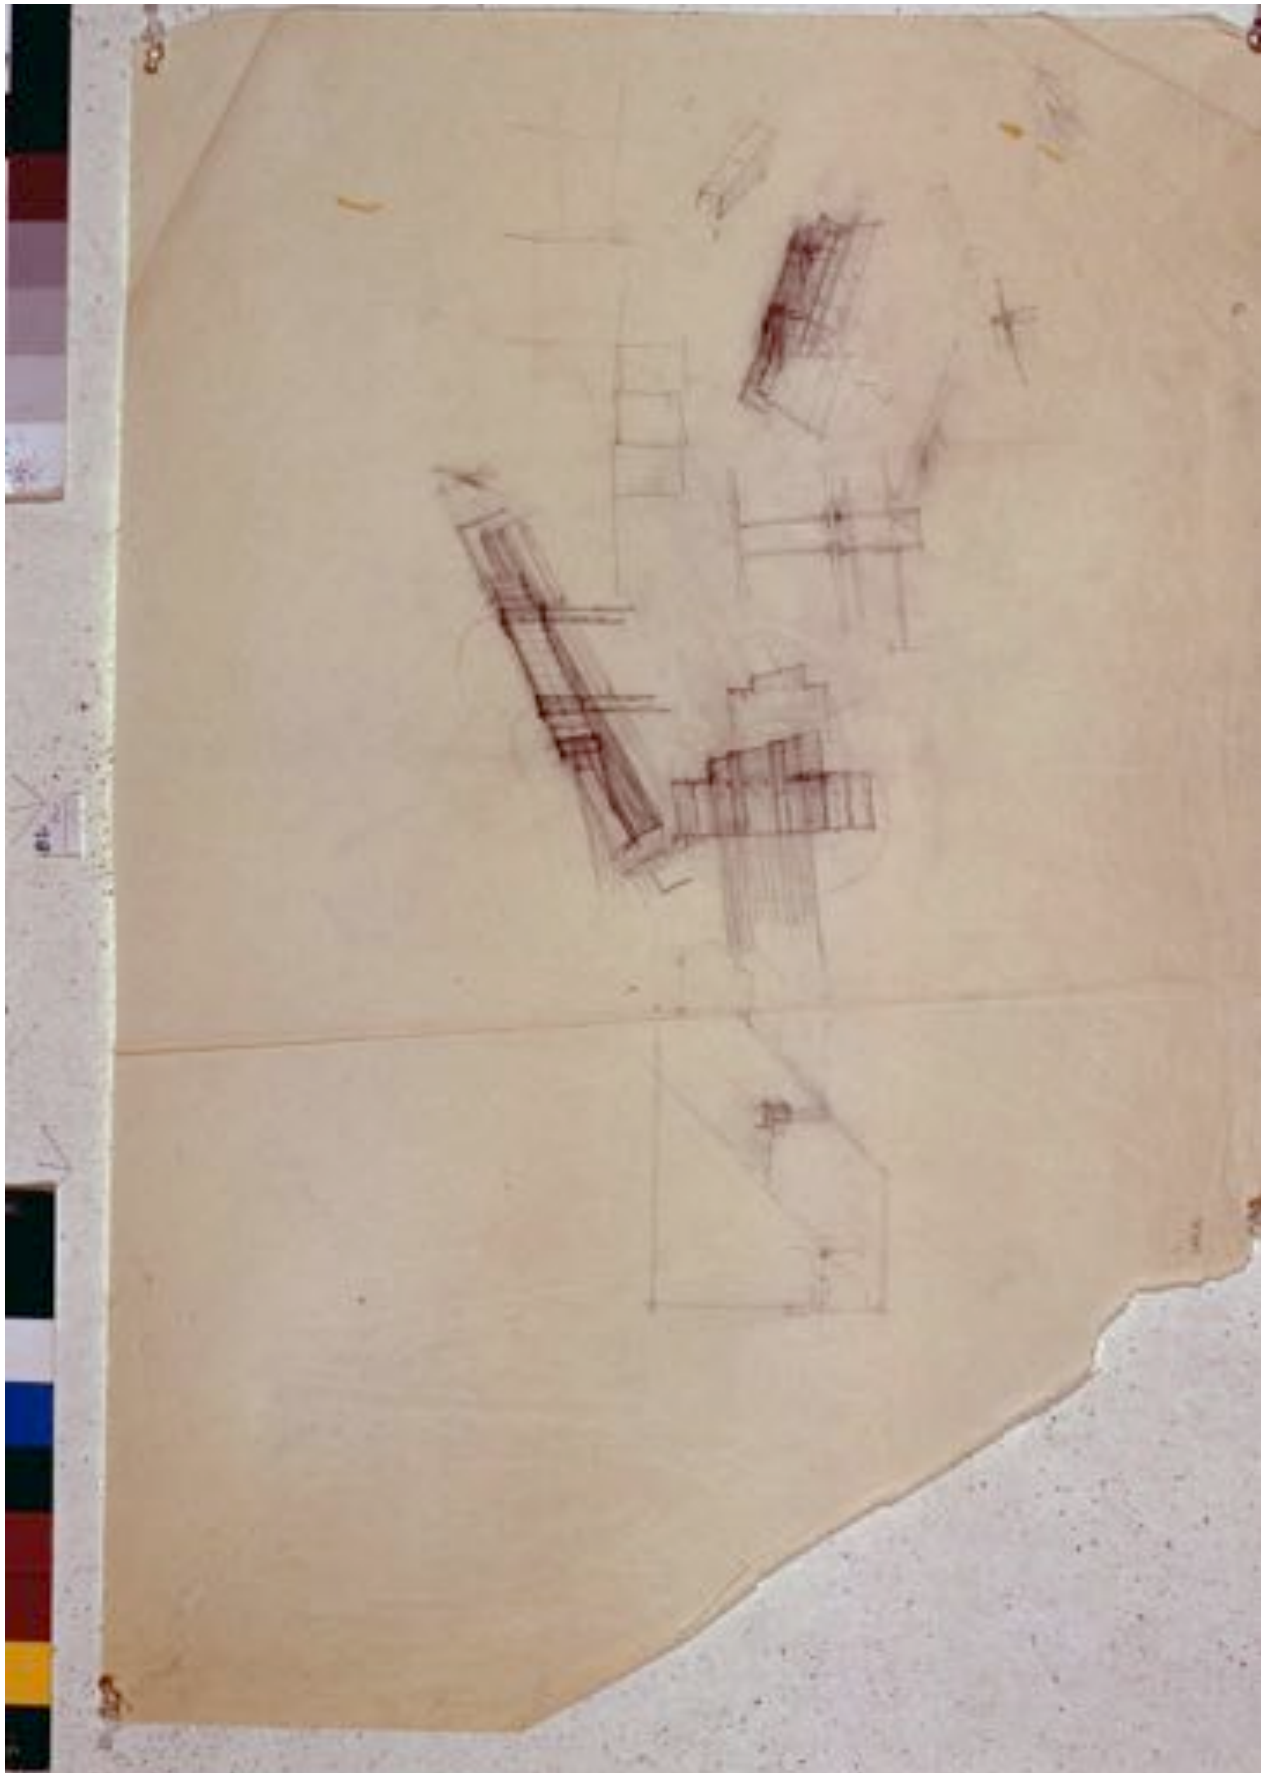
Figure B-52 - Ornamental Beam, Drafting Studio (The Frank Lloyd Wright Foundation Archives, The Museum of Modern Art | Avery Architectural & Fine Arts Library, Columbia University, New York).

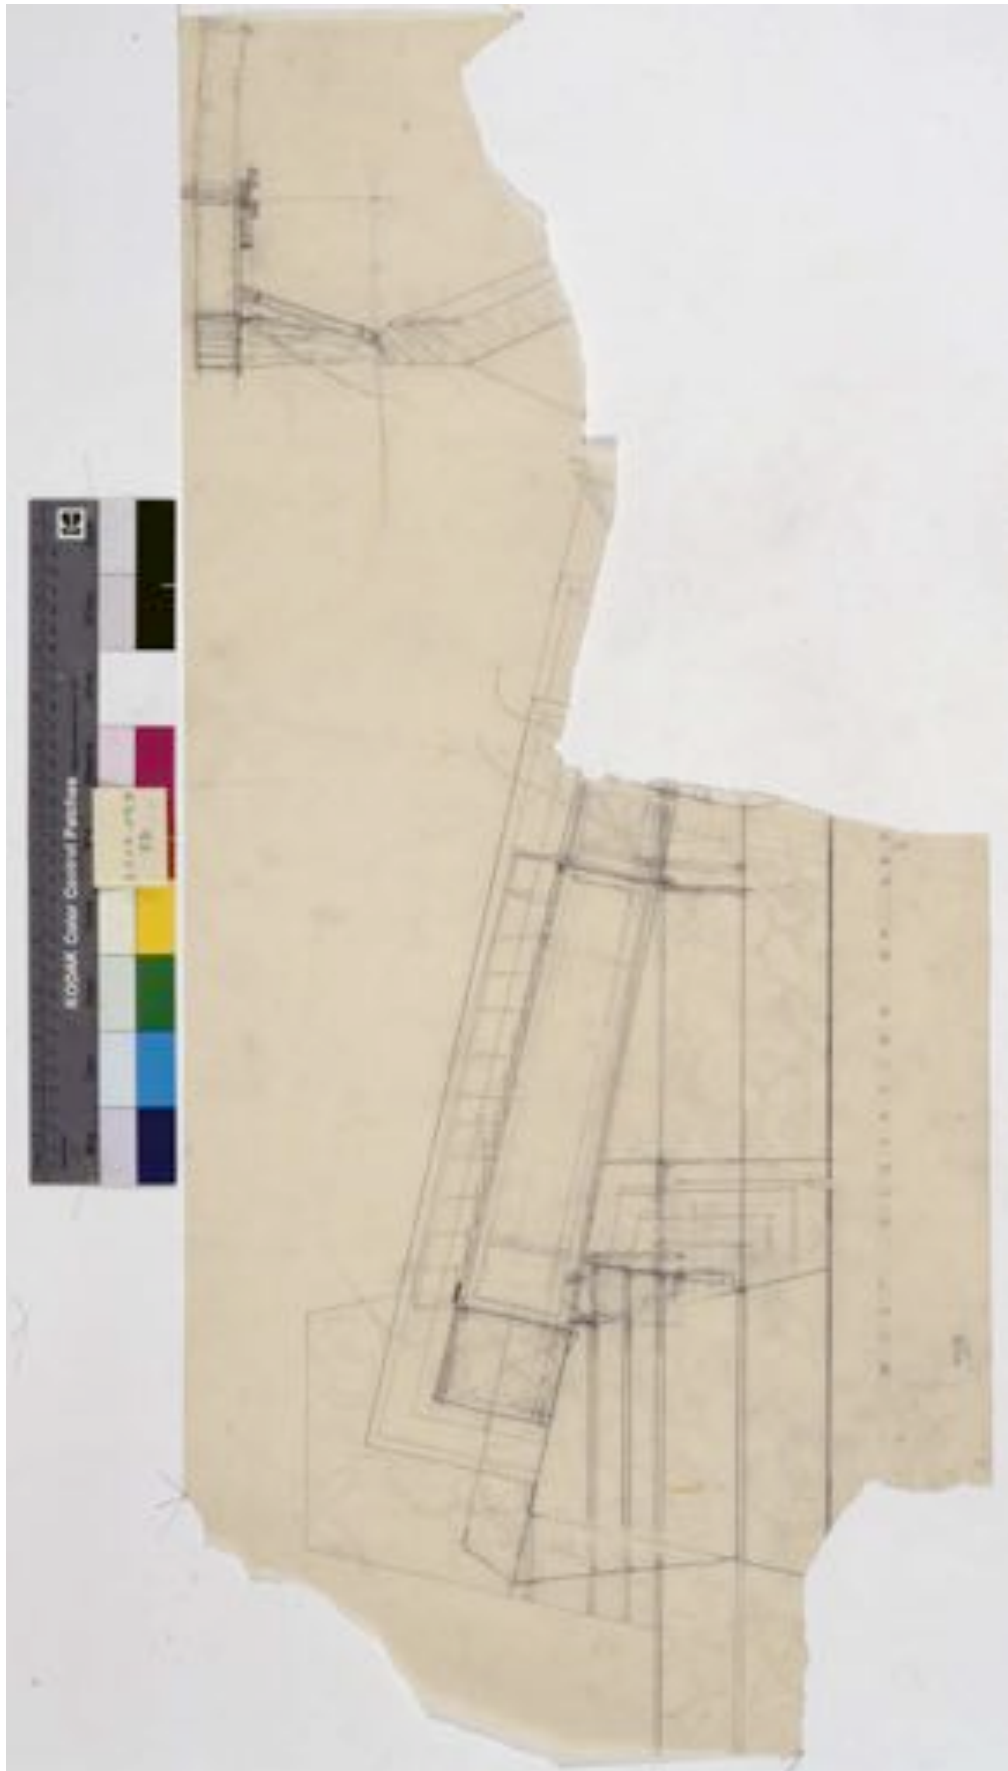
Figure B-53 - Office Elevation (The Frank Lloyd Wright Foundation Archives, The Museum of Modern Art | Avery Architectural & Fine Arts Library, Columbia University, New York).

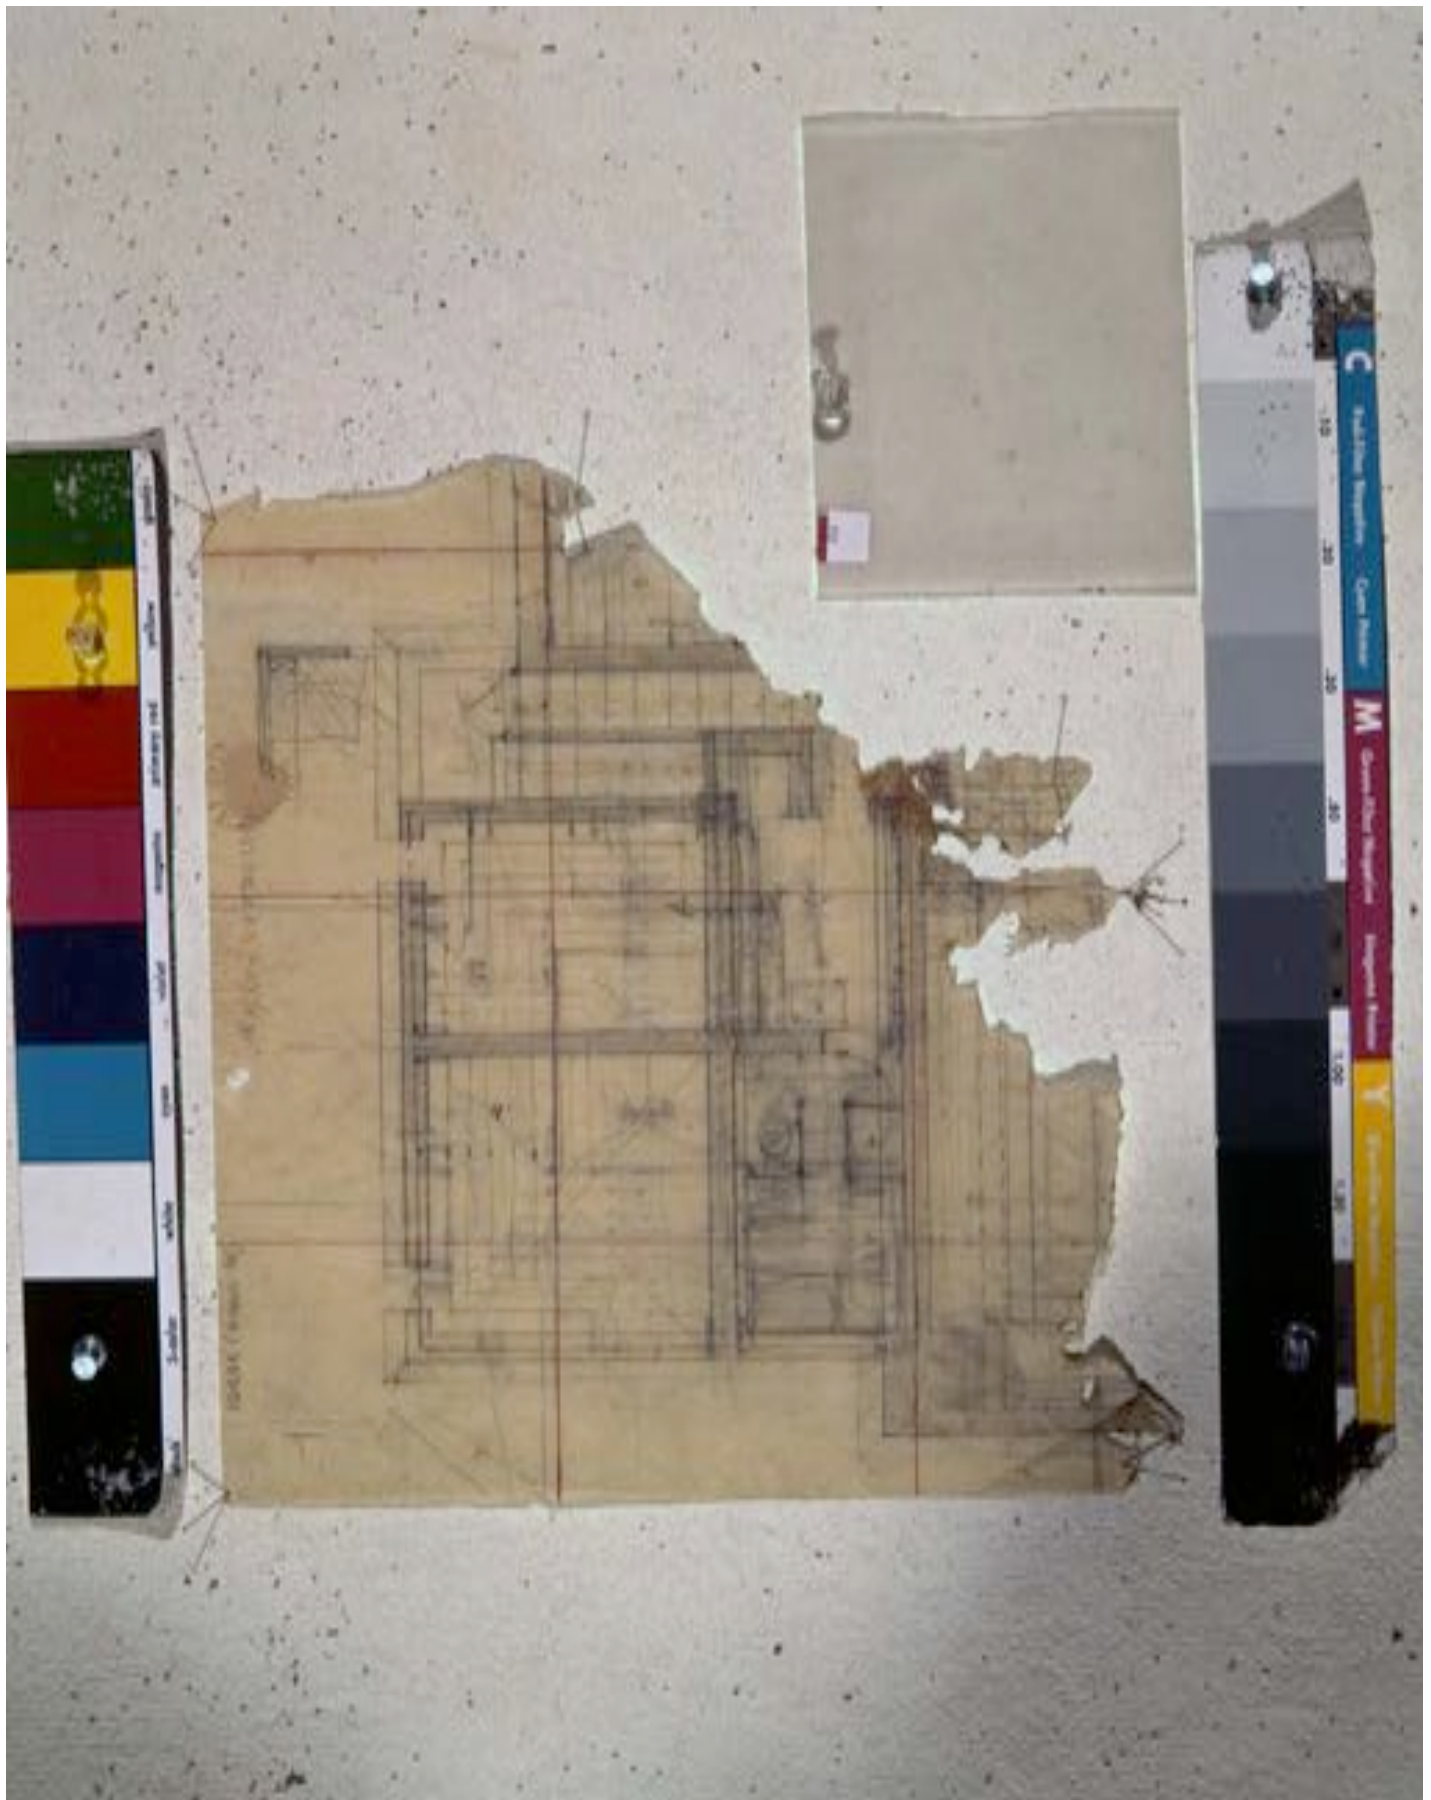
Figure B-54 - House [Wright Living Quarters] Bath/Kitchen Plan (The Frank Lloyd Wright Foundation Archives, The Museum of Modern Art | Avery Architectural & Fine Arts Library, Columbia University, New York).

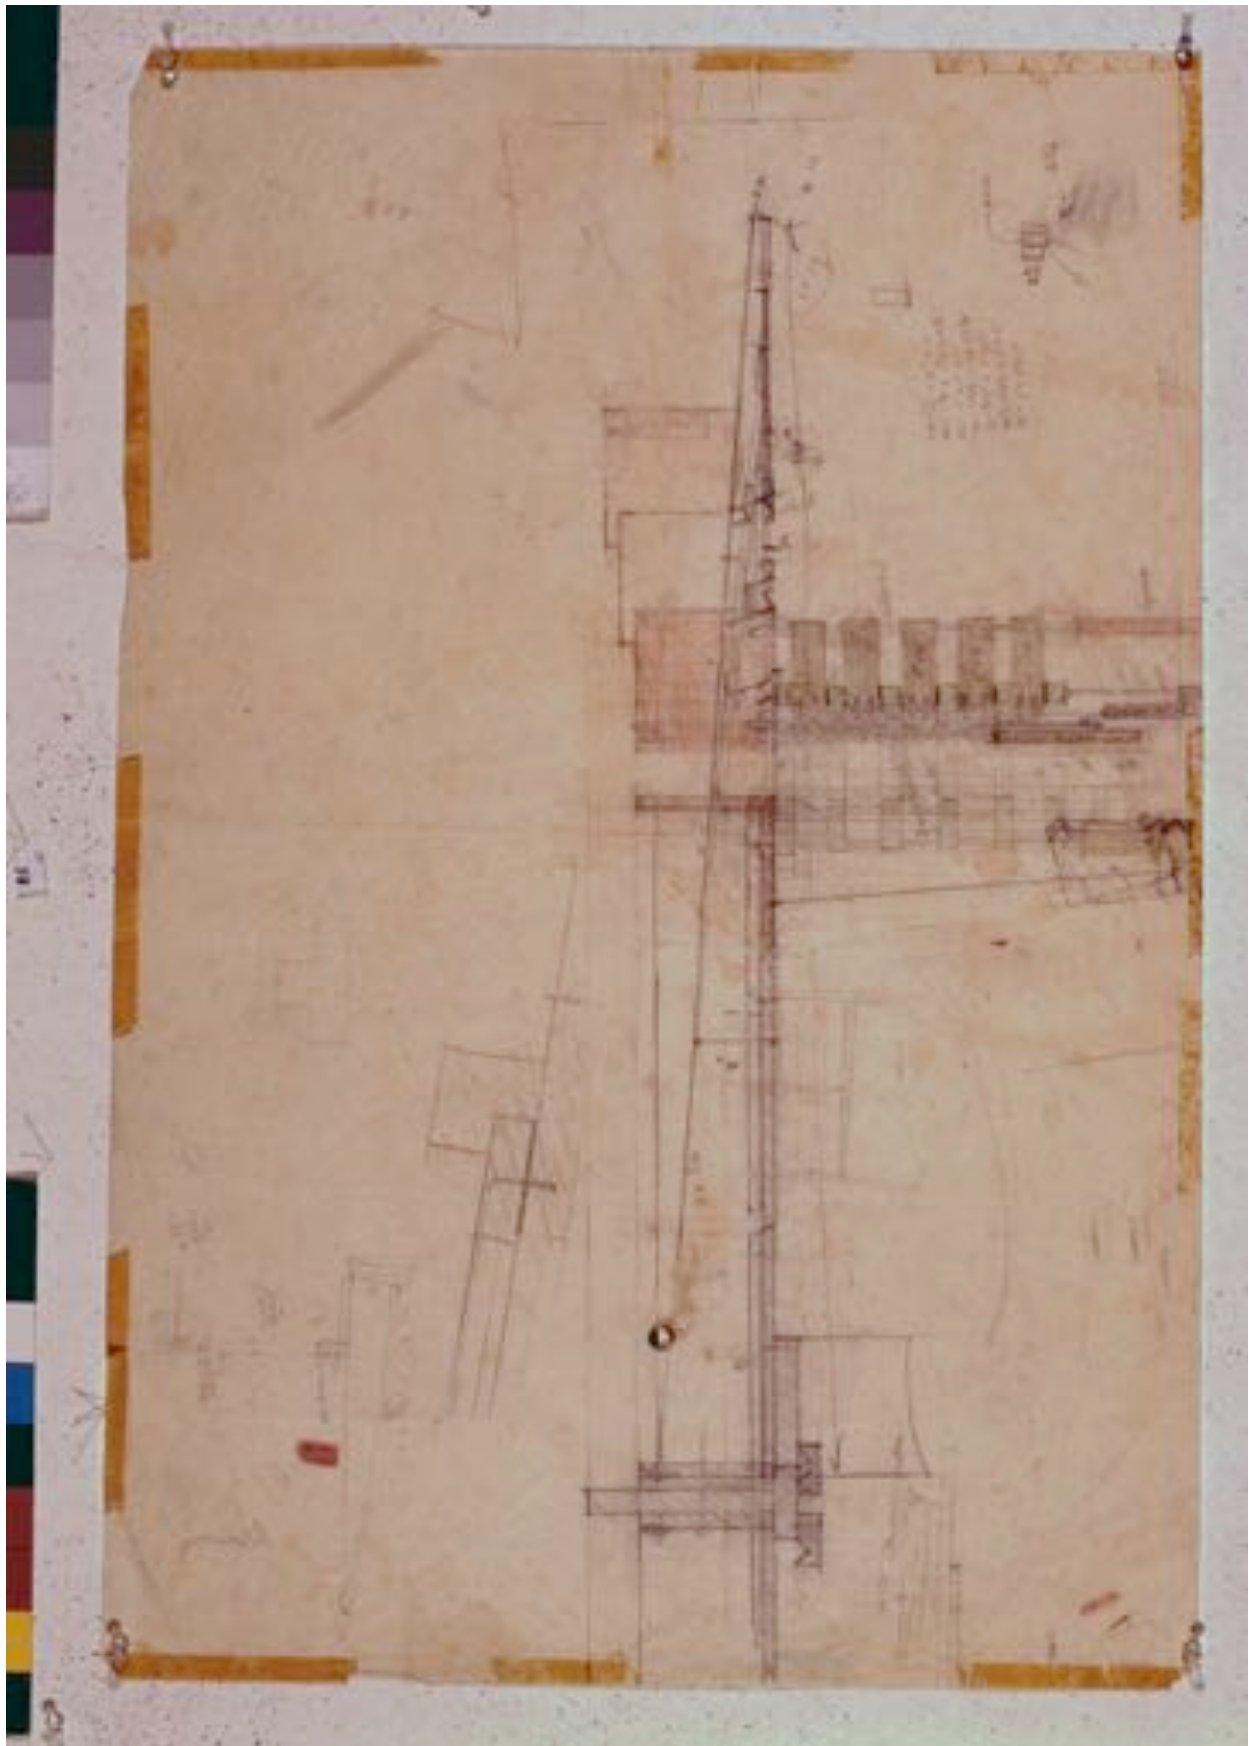
Figure B-55 - Hanging Pendant Design (The Frank Lloyd Wright Foundation Archives, The Museum of Modern Art | Avery Architectural & Fine Arts Library, Columbia University, New York).

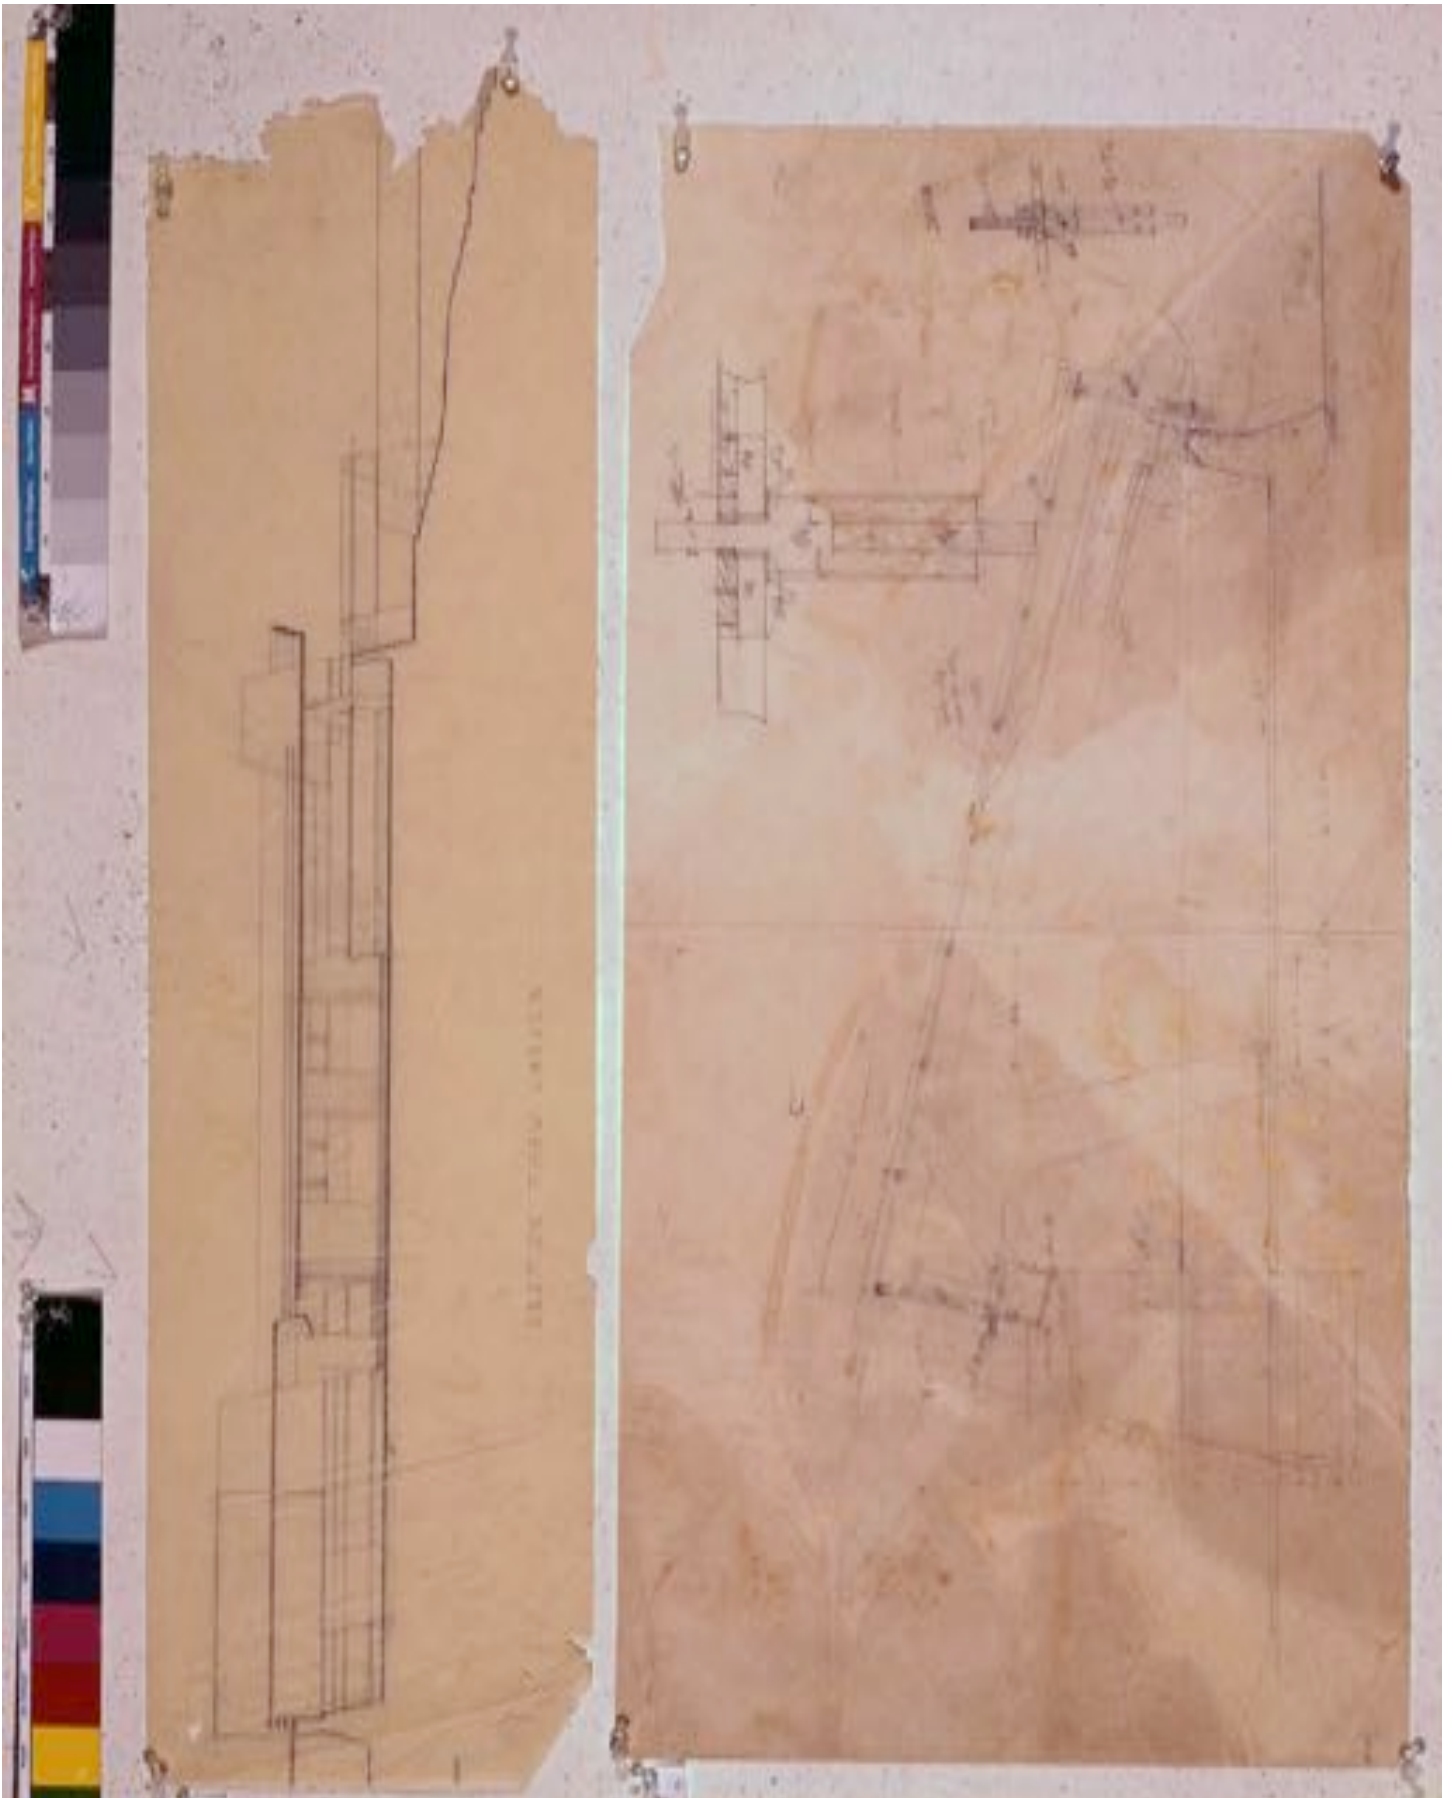
Figure B-56 - Garden Room Section (The Frank Lloyd Wright Foundation Archives, The Museum of Modern Art | Avery Architectural & Fine Arts Library, Columbia University, New York).

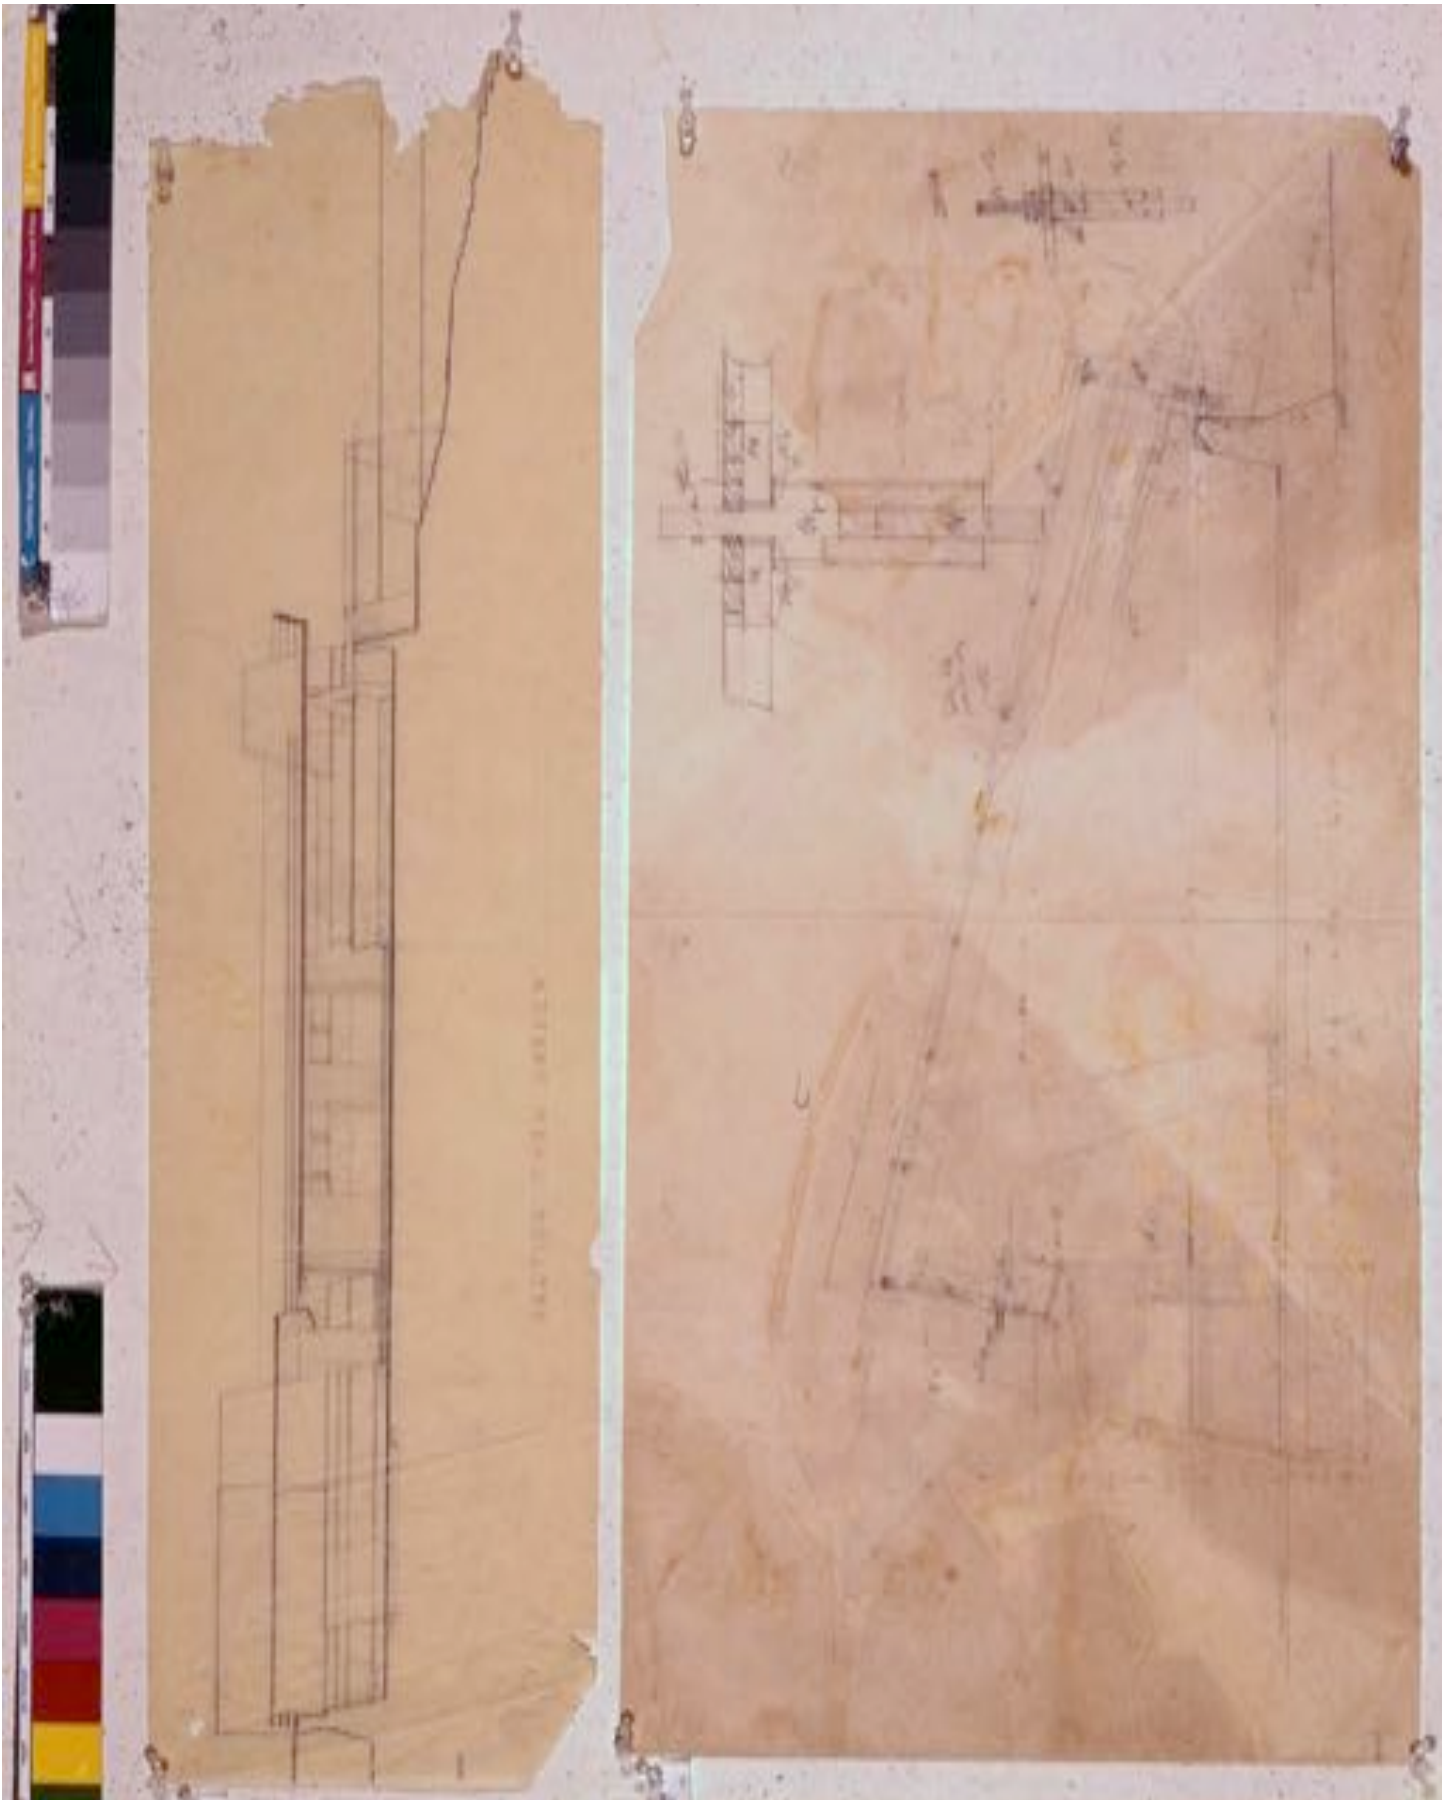
Figure B-57 - Drafting Room Section (The Frank Lloyd Wright Foundation Archives, The Museum of Modern Art | Avery Architectural & Fine Arts Library, Columbia University, New York).

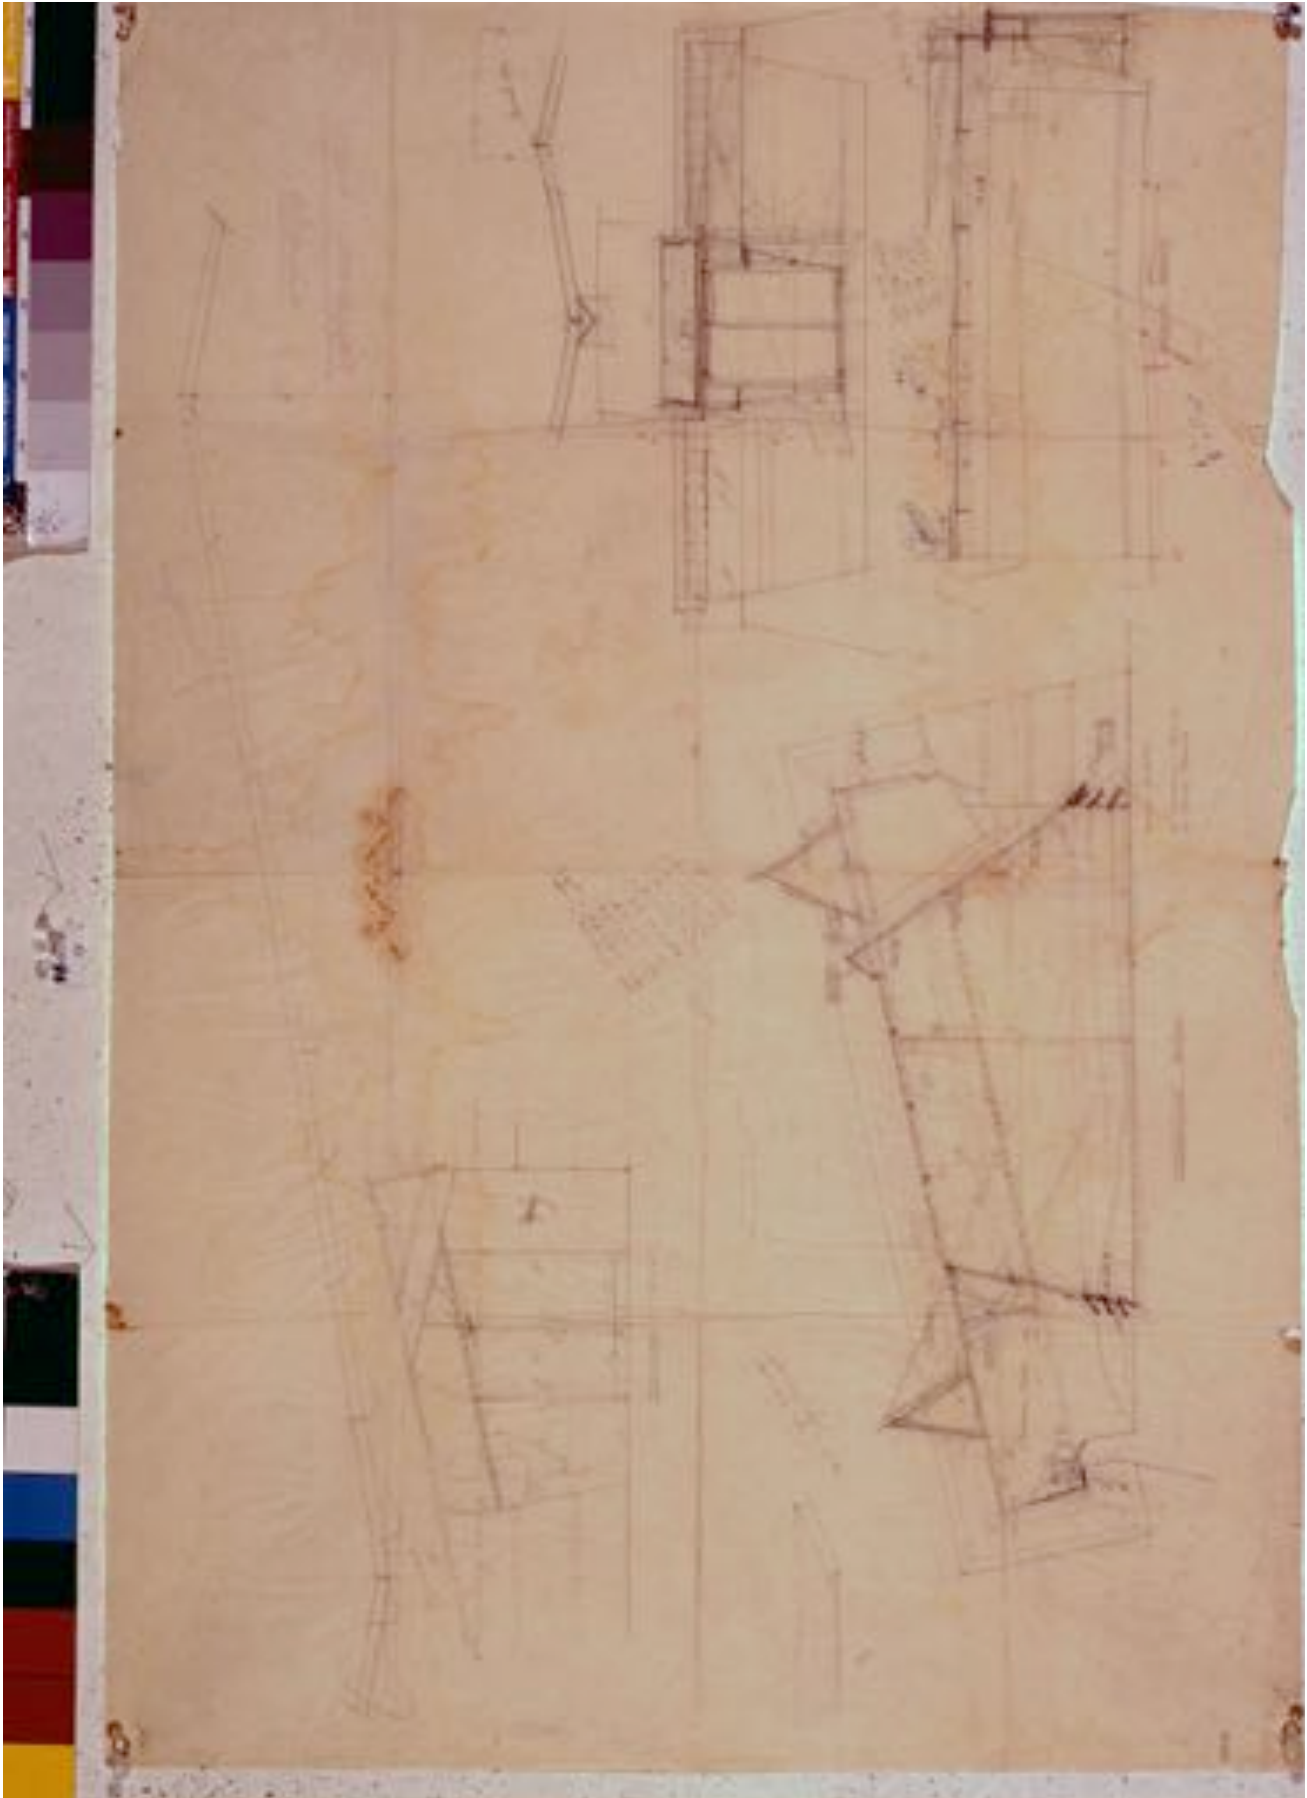
Figure B-58 - Drafting Room/ [Original] Dining Room Section (The Frank Lloyd Wright Foundation Archives, The Museum of Modern Art | Avery Architectural & Fine Arts Library, Columbia University, New York).

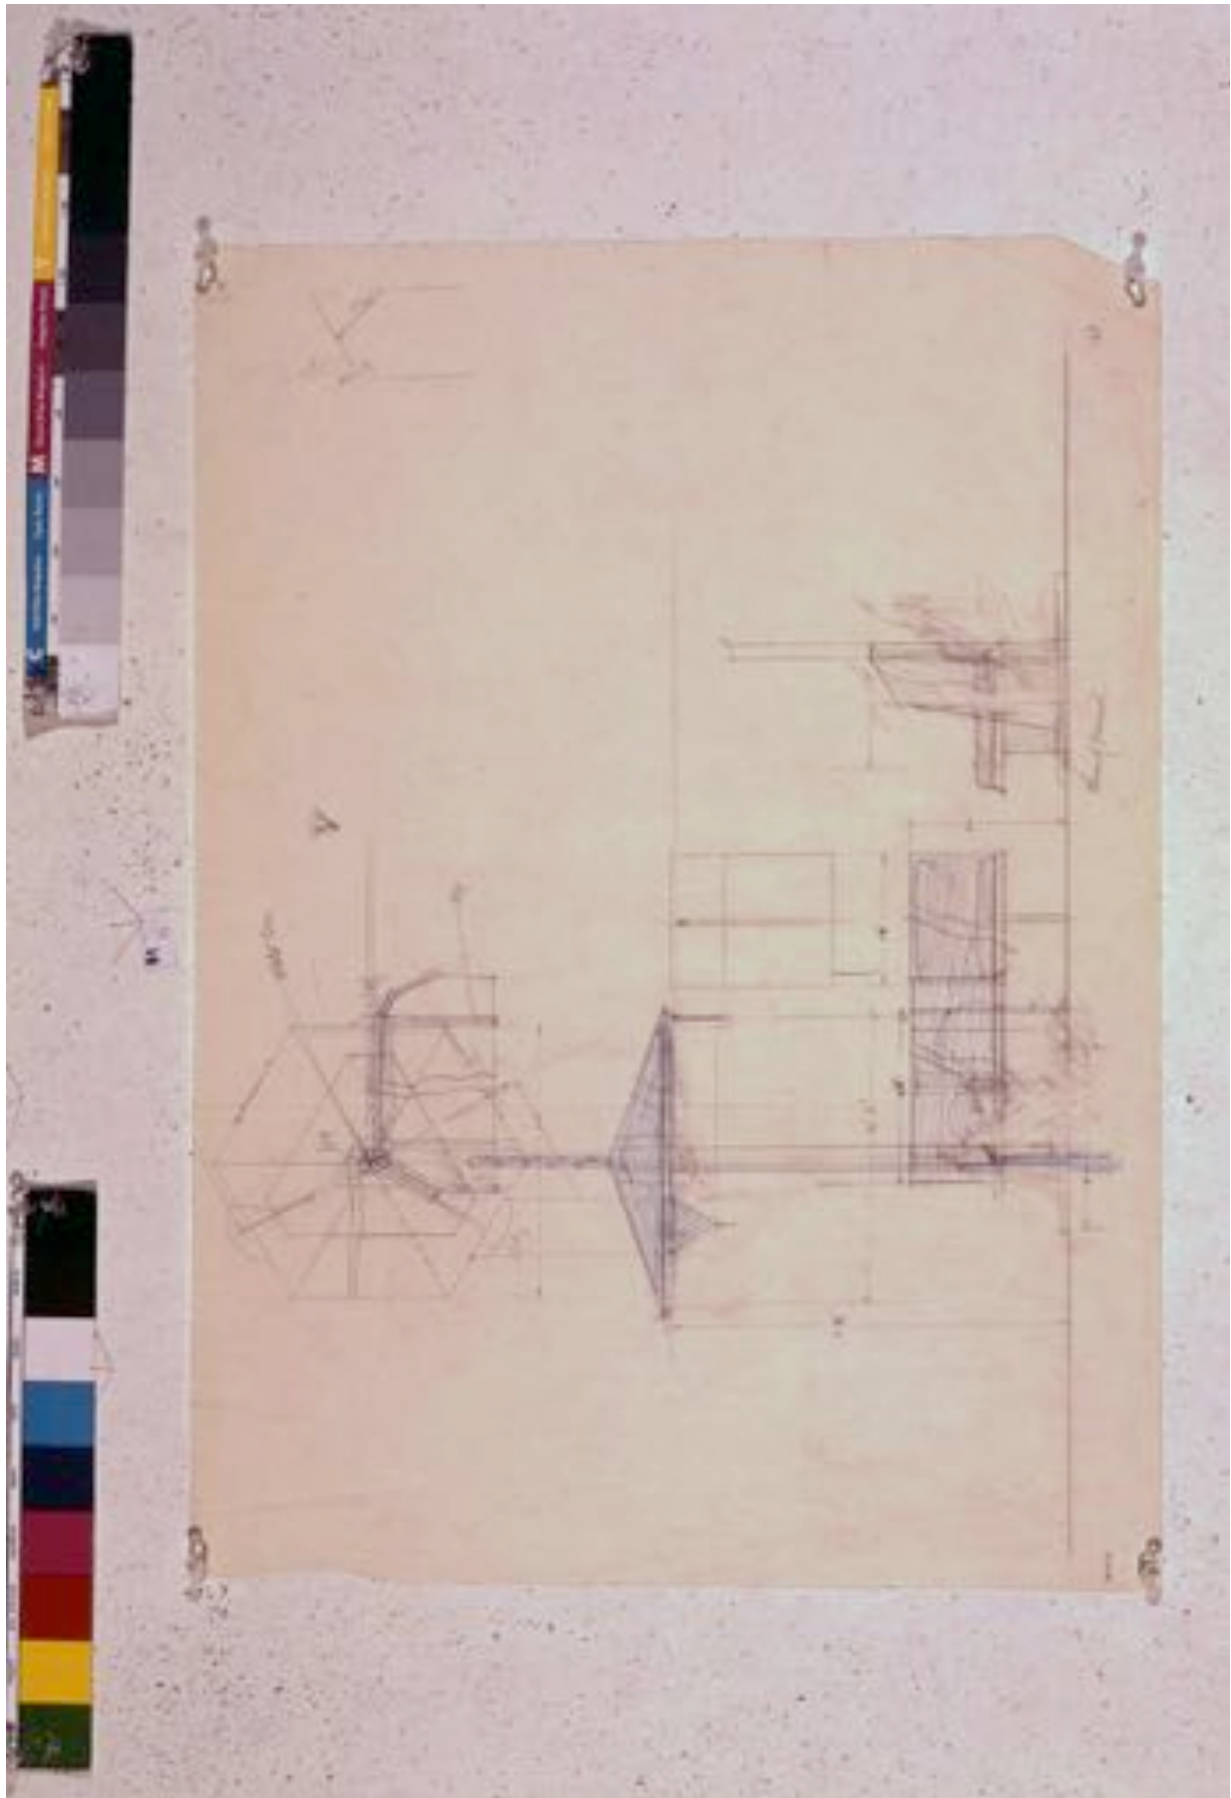
Figure B-59 - Parasol and Chair (The Frank Lloyd Wright Foundation Archives, The Museum of Modern Art | Avery Architectural & Fine Arts Library, Columbia University, New York).

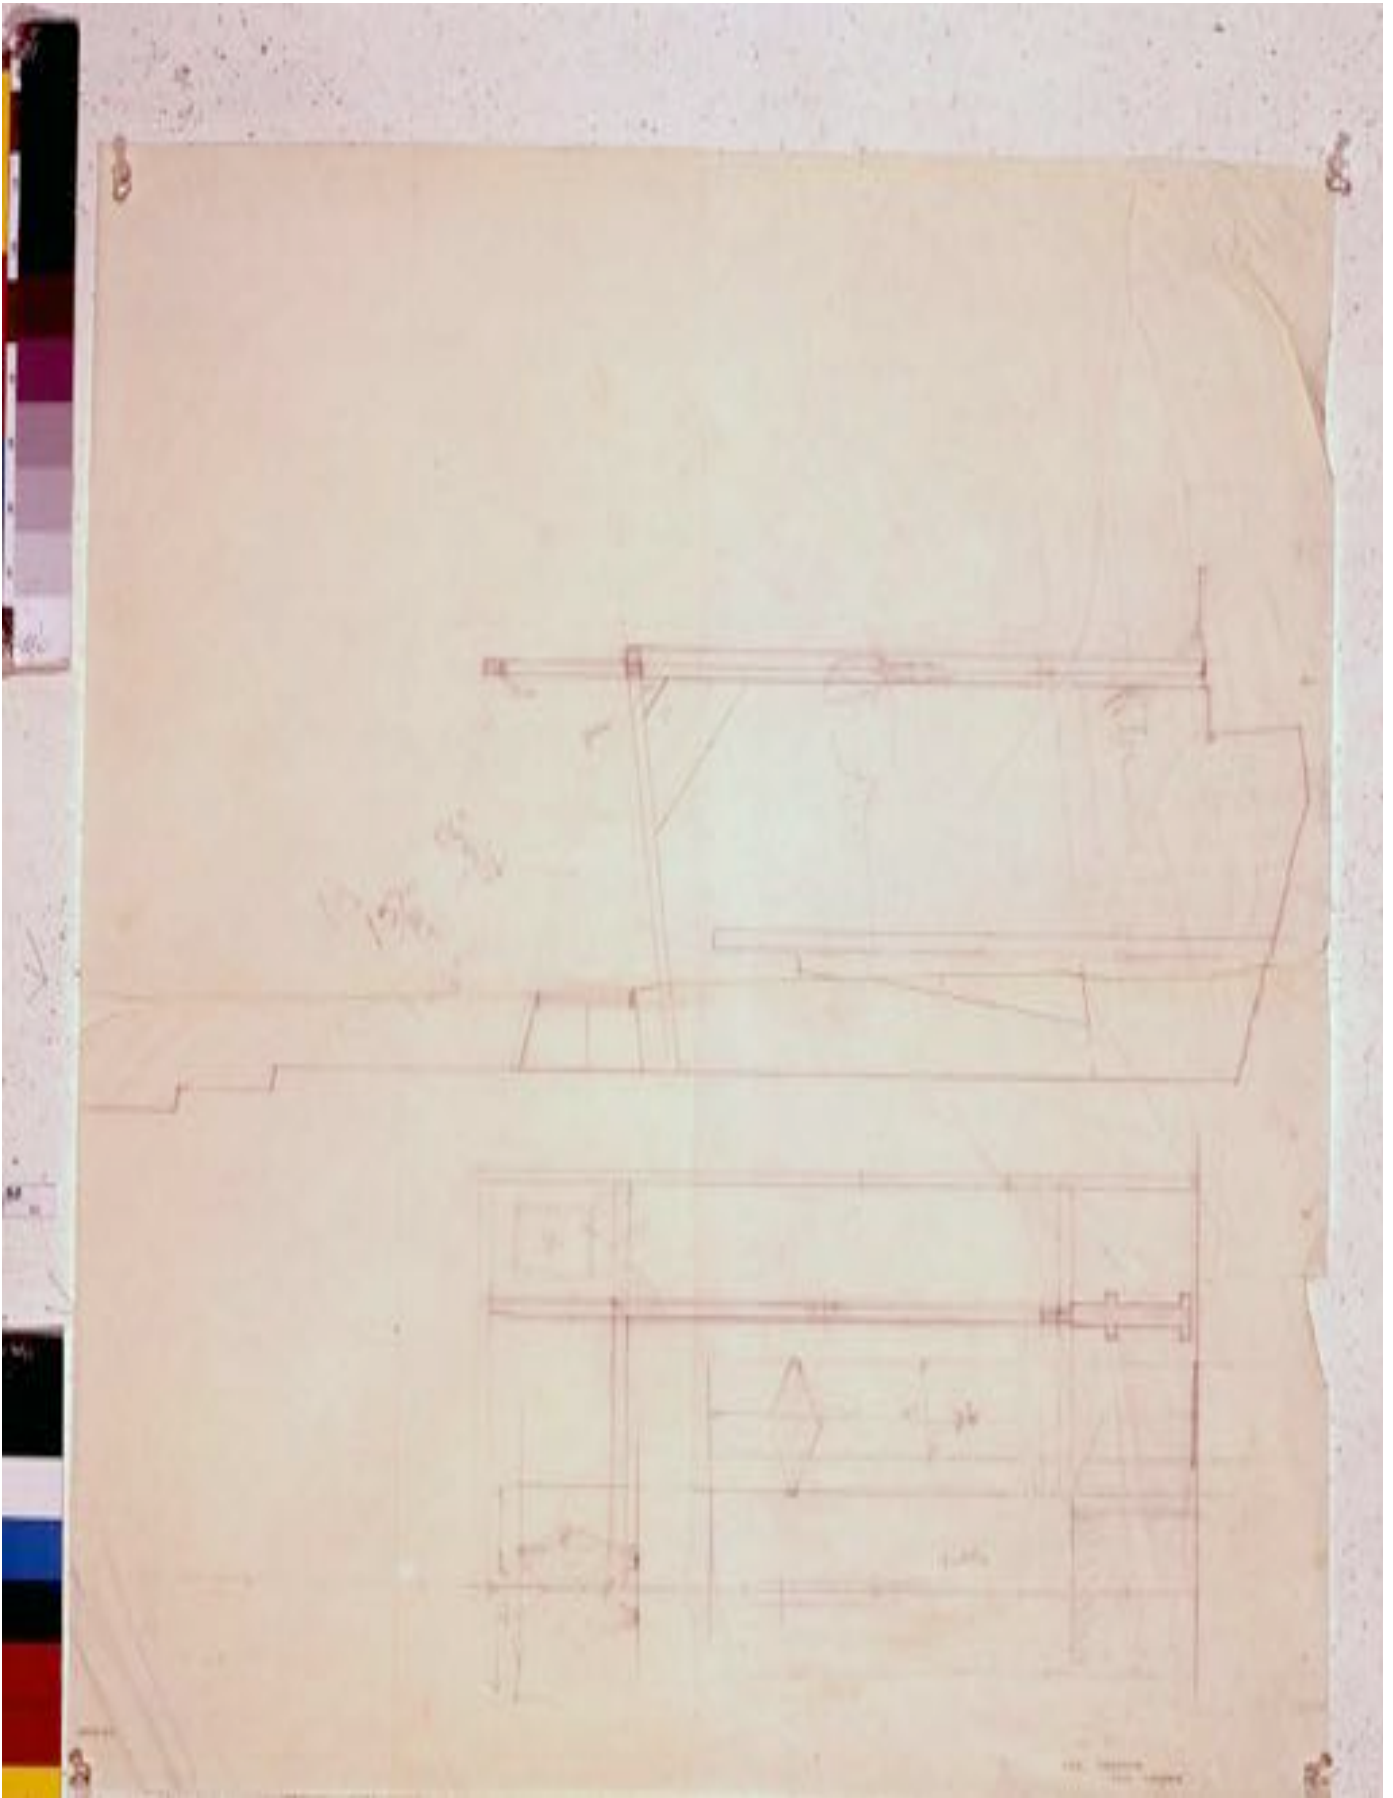
Figure B-60 - Drafting Room Sun Shades (The Frank Lloyd Wright Foundation Archives, The Museum of Modern Art | Avery Architectural & Fine Arts Library, Columbia University, New York).
