TALIESIN WEST PRESERVATION MASTER PLAN

Harboe Architects, PC

MAY 21, 2015

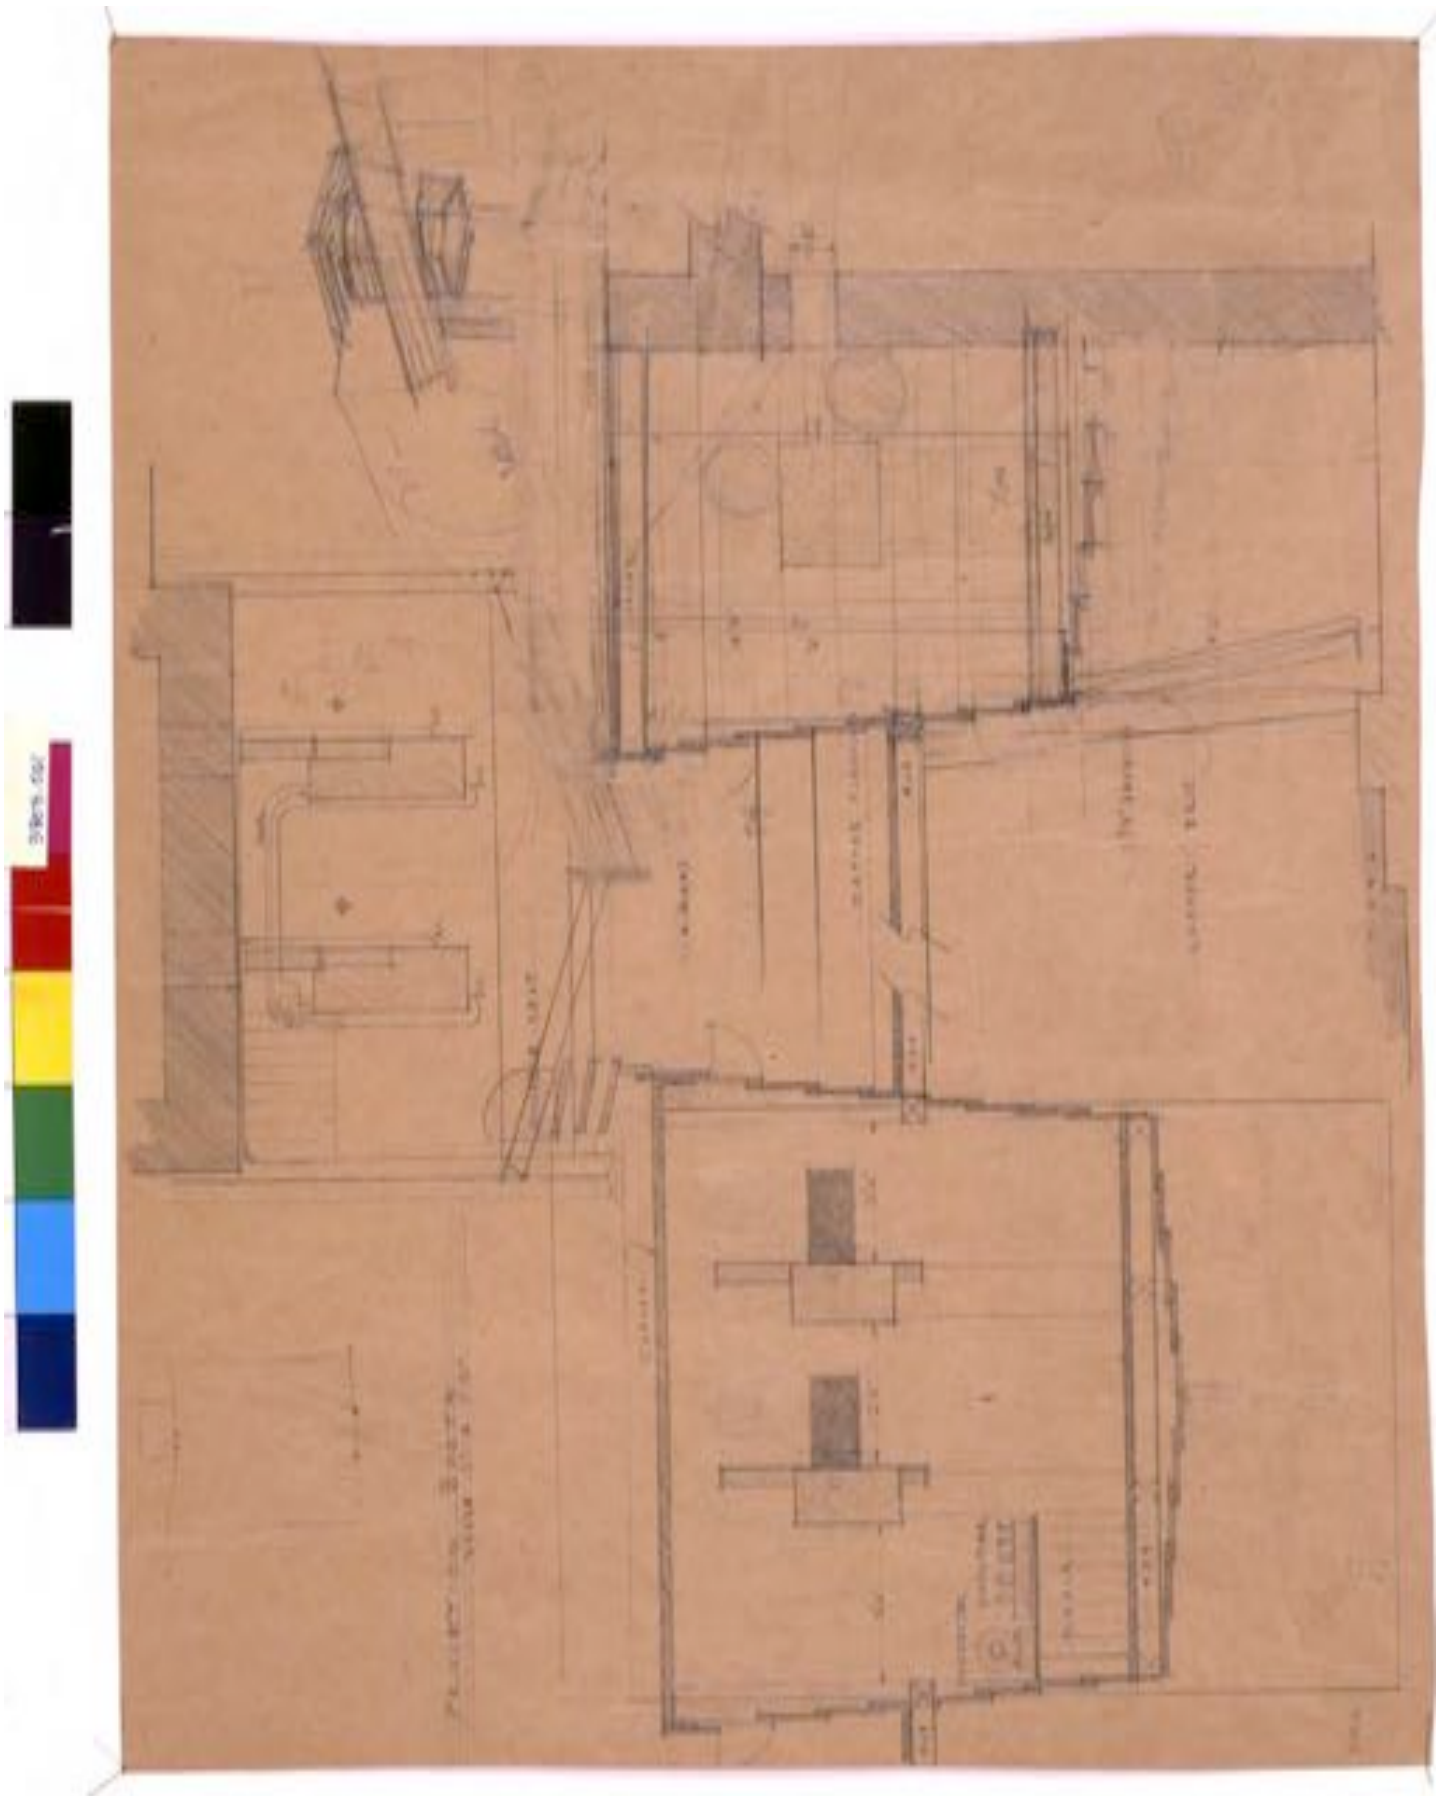
Figure B-61 - Projection Booth Plan (The Frank Lloyd Wright Foundation Archives, The Museum of Modern Art | Avery Architectural & Fine Arts Library, Columbia University, New York).

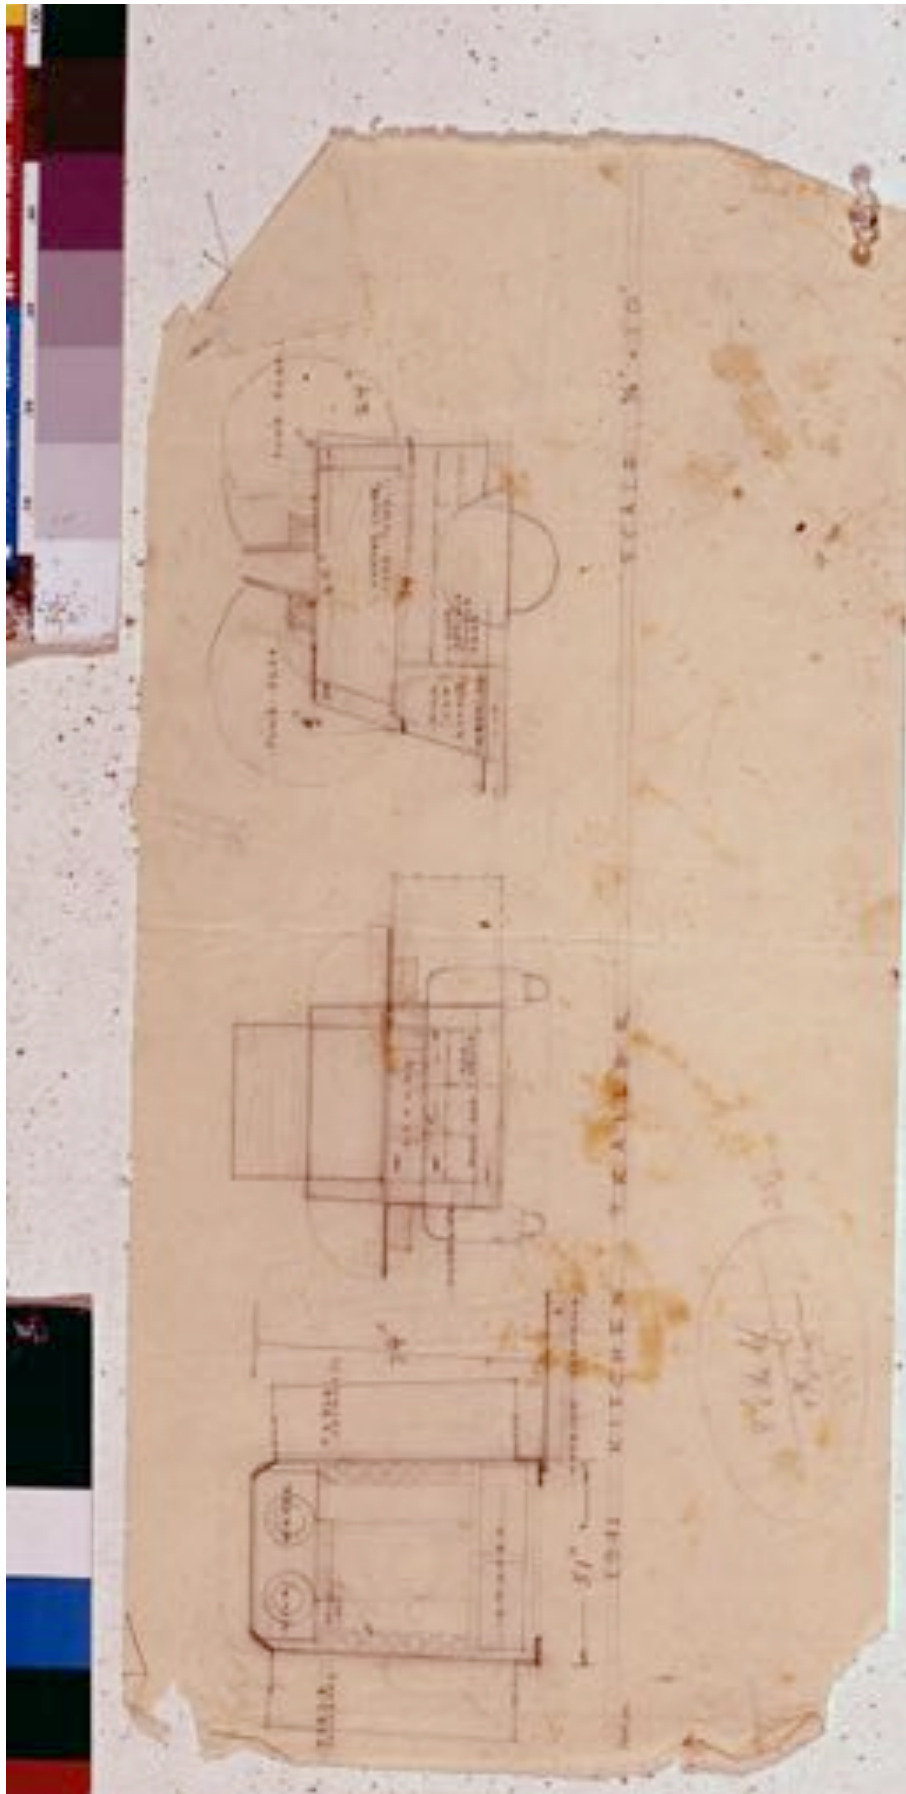
Figure B-62 - Kitchen Trailer (The Frank Lloyd Wright Foundation Archives, The Museum of Modern Art | Avery Architectural & Fine Arts Library, Columbia University, New York).

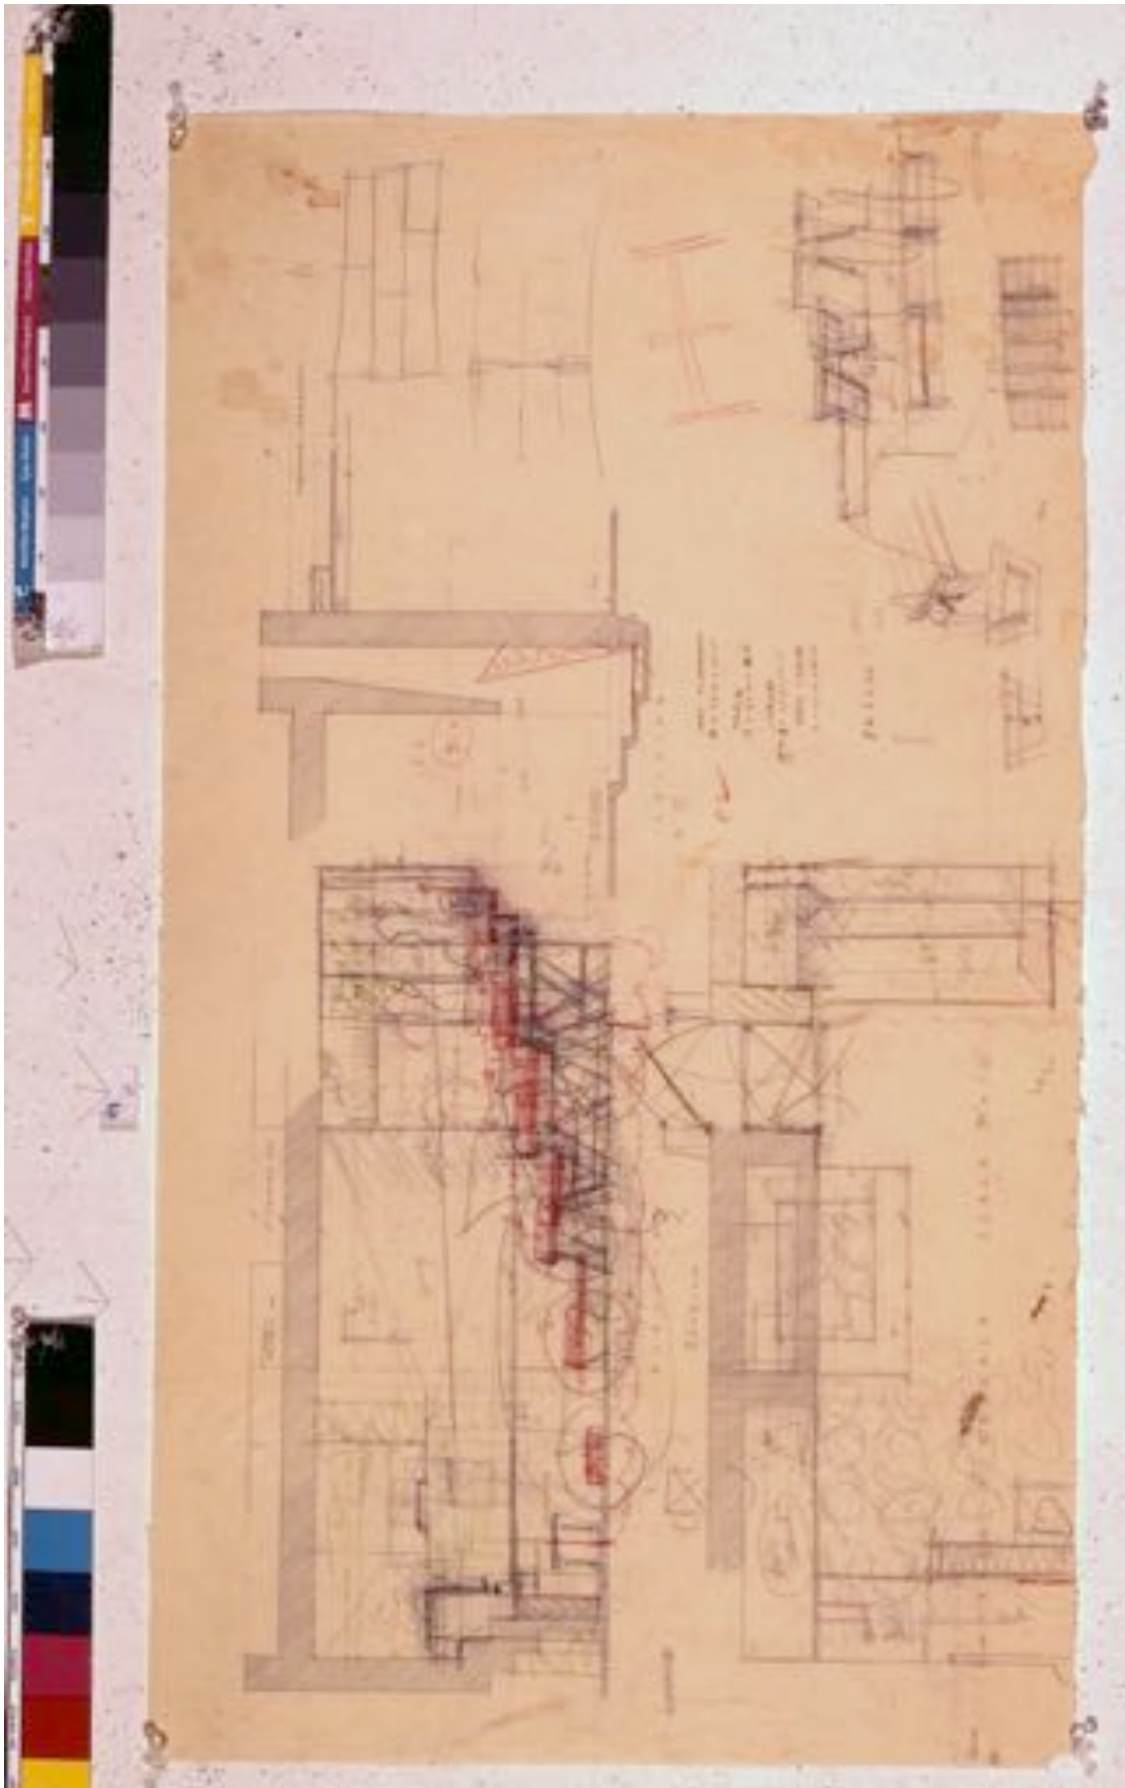
Figure B-63 - Theatre [Kiva] Section (The Frank Lloyd Wright Foundation Archives, The Museum of Modern Art | Avery Architectural & Fine Arts Library, Columbia University, New York).

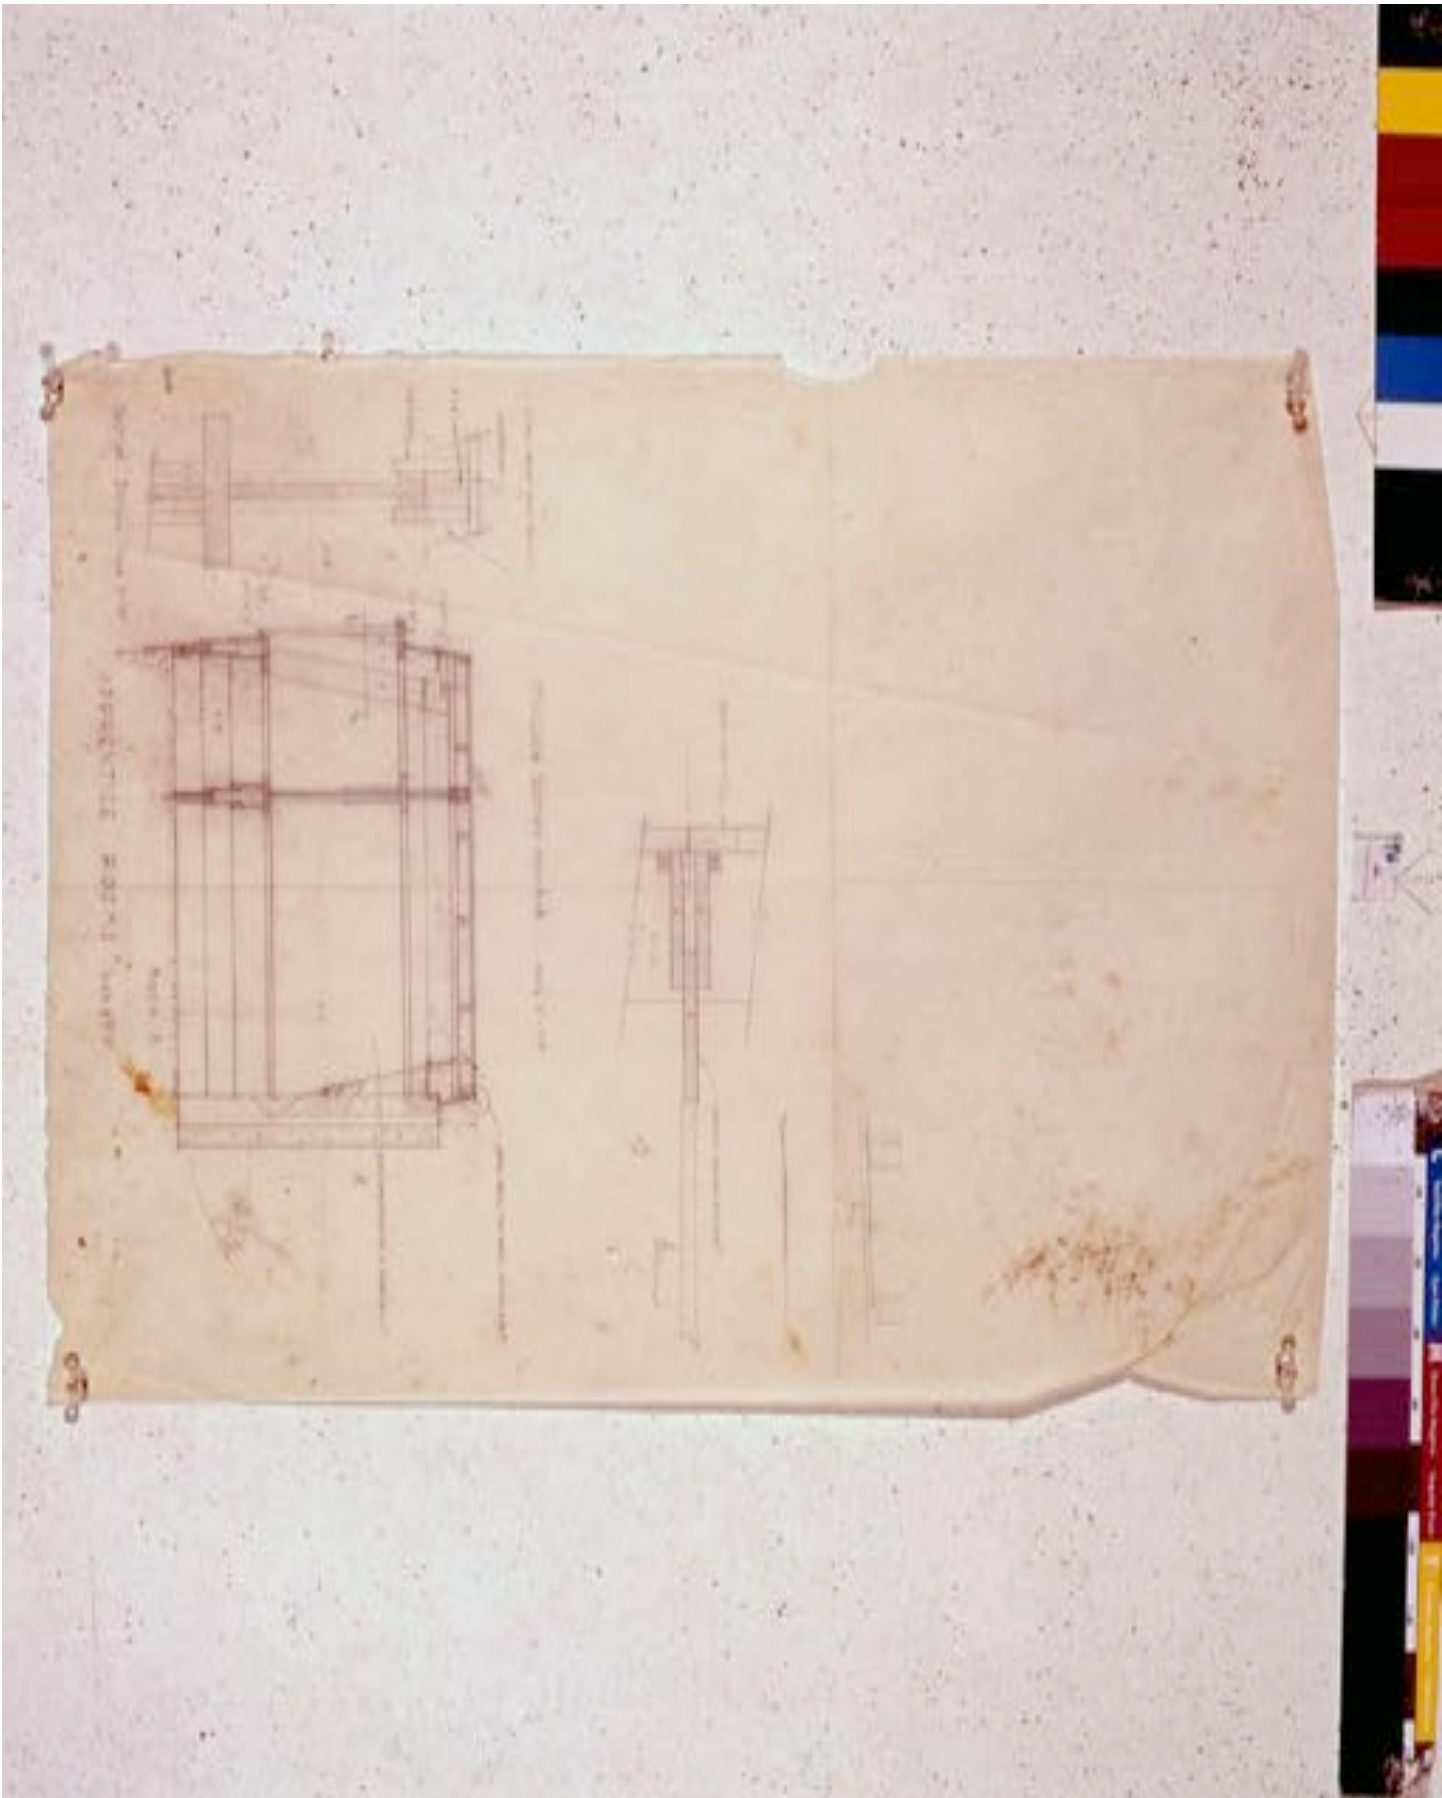
Figure B-66 - Apprentice Room Section (The Frank Lloyd Wright Foundation Archives, The Museum of Modern Art | Avery Architectural & Fine Arts Library, Columbia University, New York).

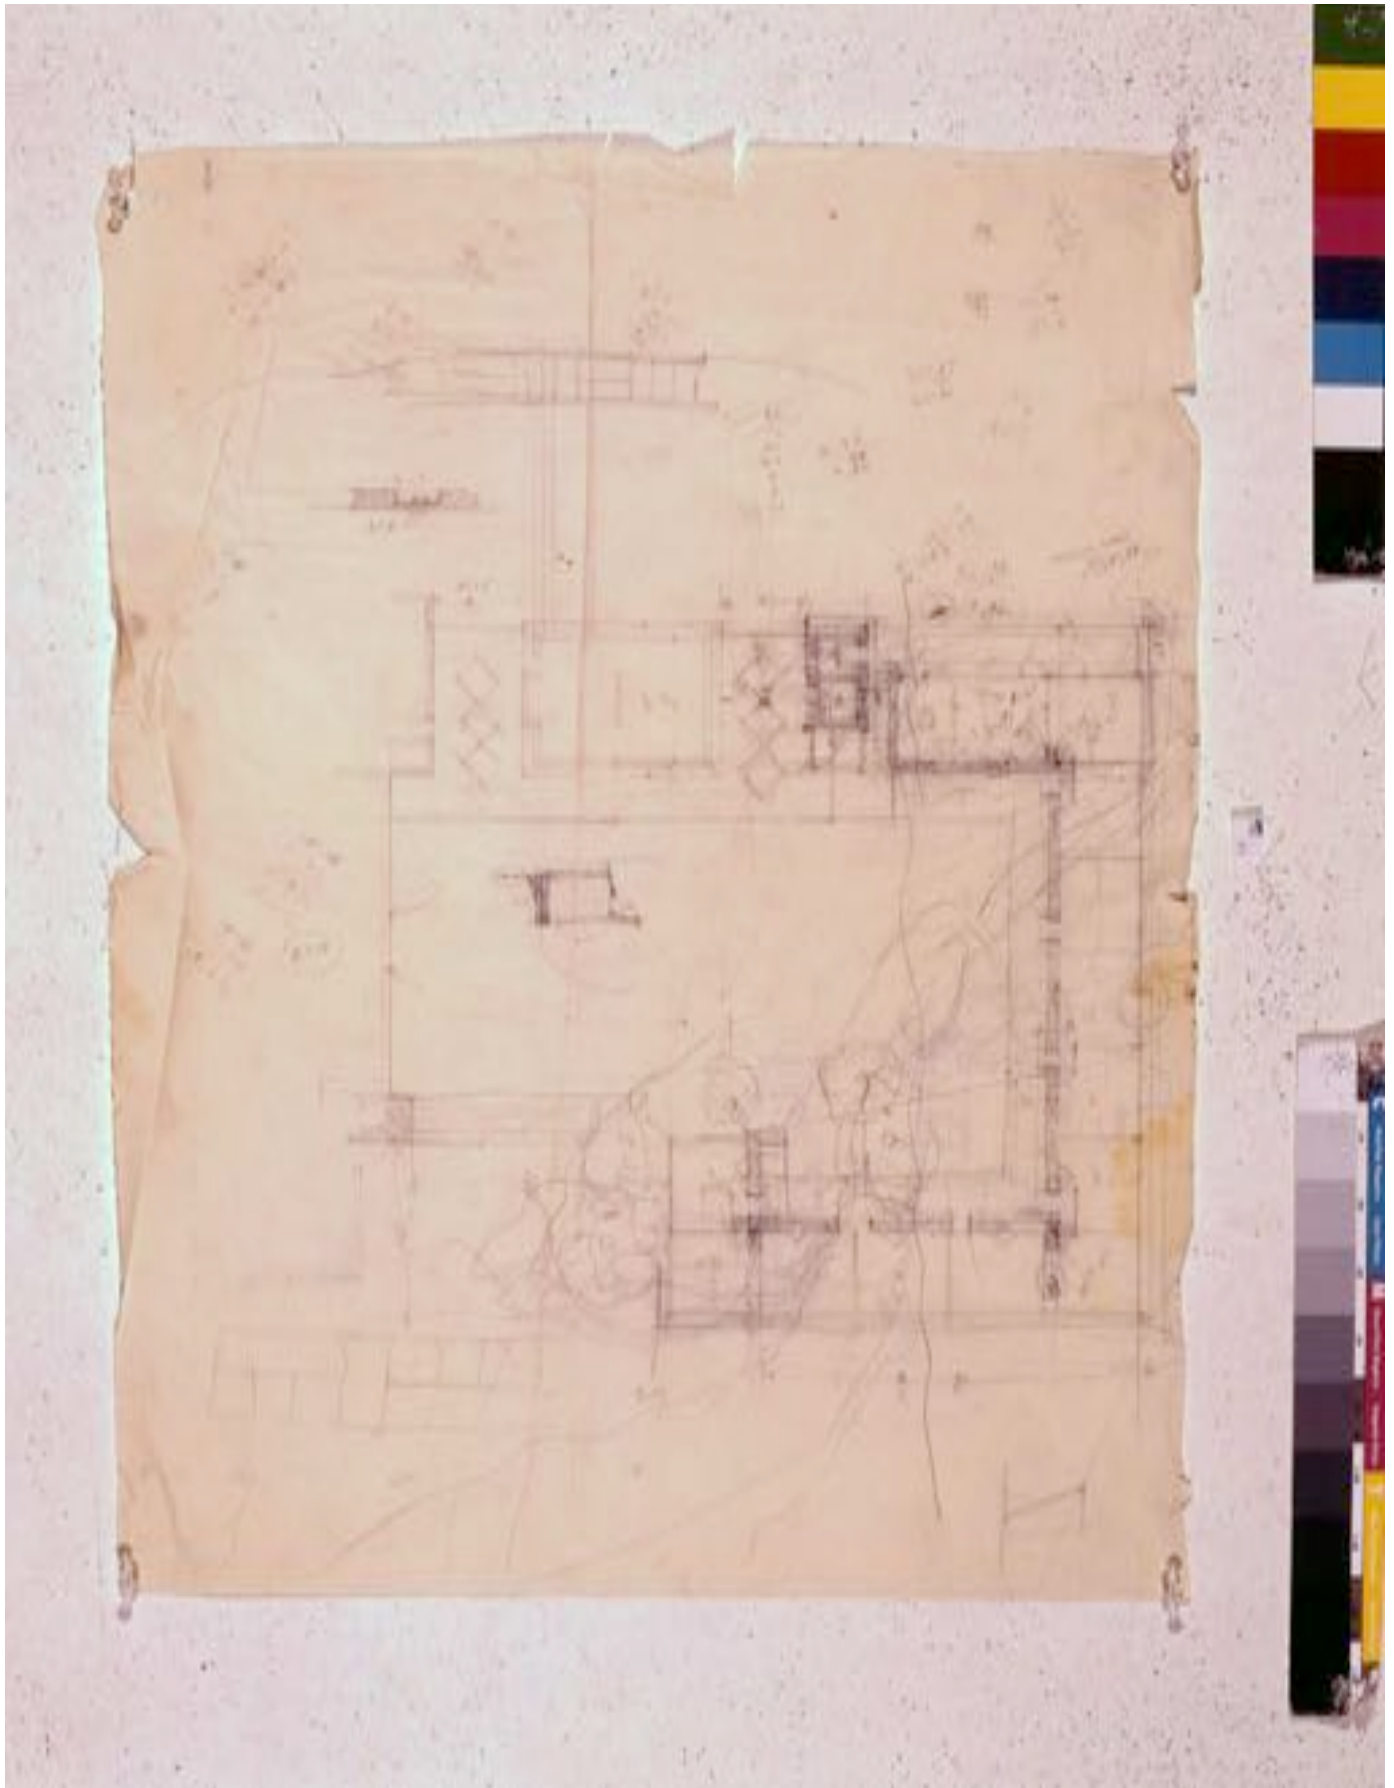
Figure B-67 - Apprentice Room Plan (The Frank Lloyd Wright Foundation Archives, The Museum of Modern Art | Avery Architectural & Fine Arts Library, Columbia University, New York).

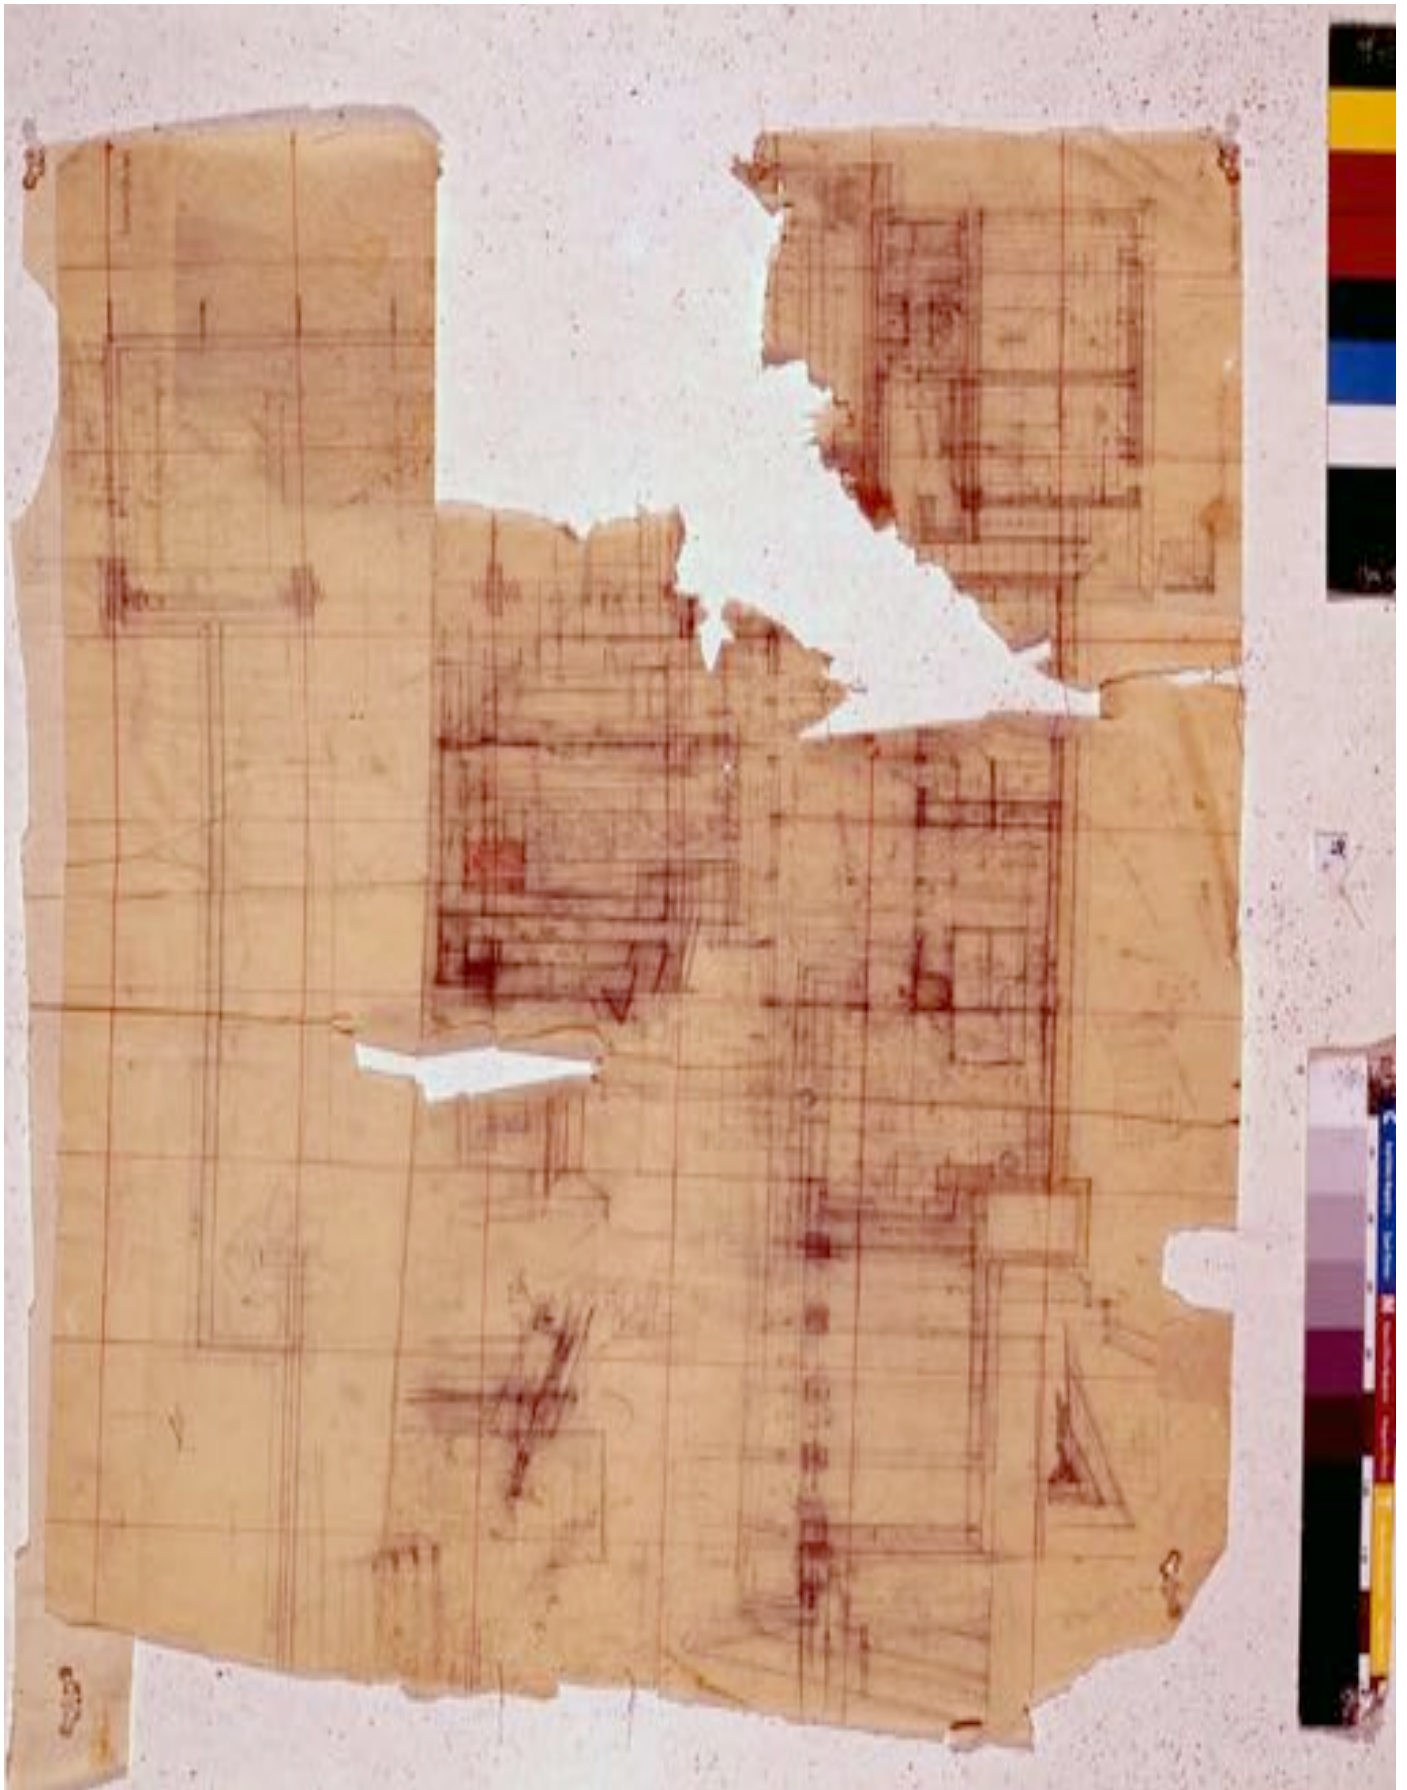
Figure B-68 - Lanai Plan (The Frank Lloyd Wright Foundation Archives, The Museum of Modern Art | Avery Architectural & Fine Arts Library, Columbia University, New York).

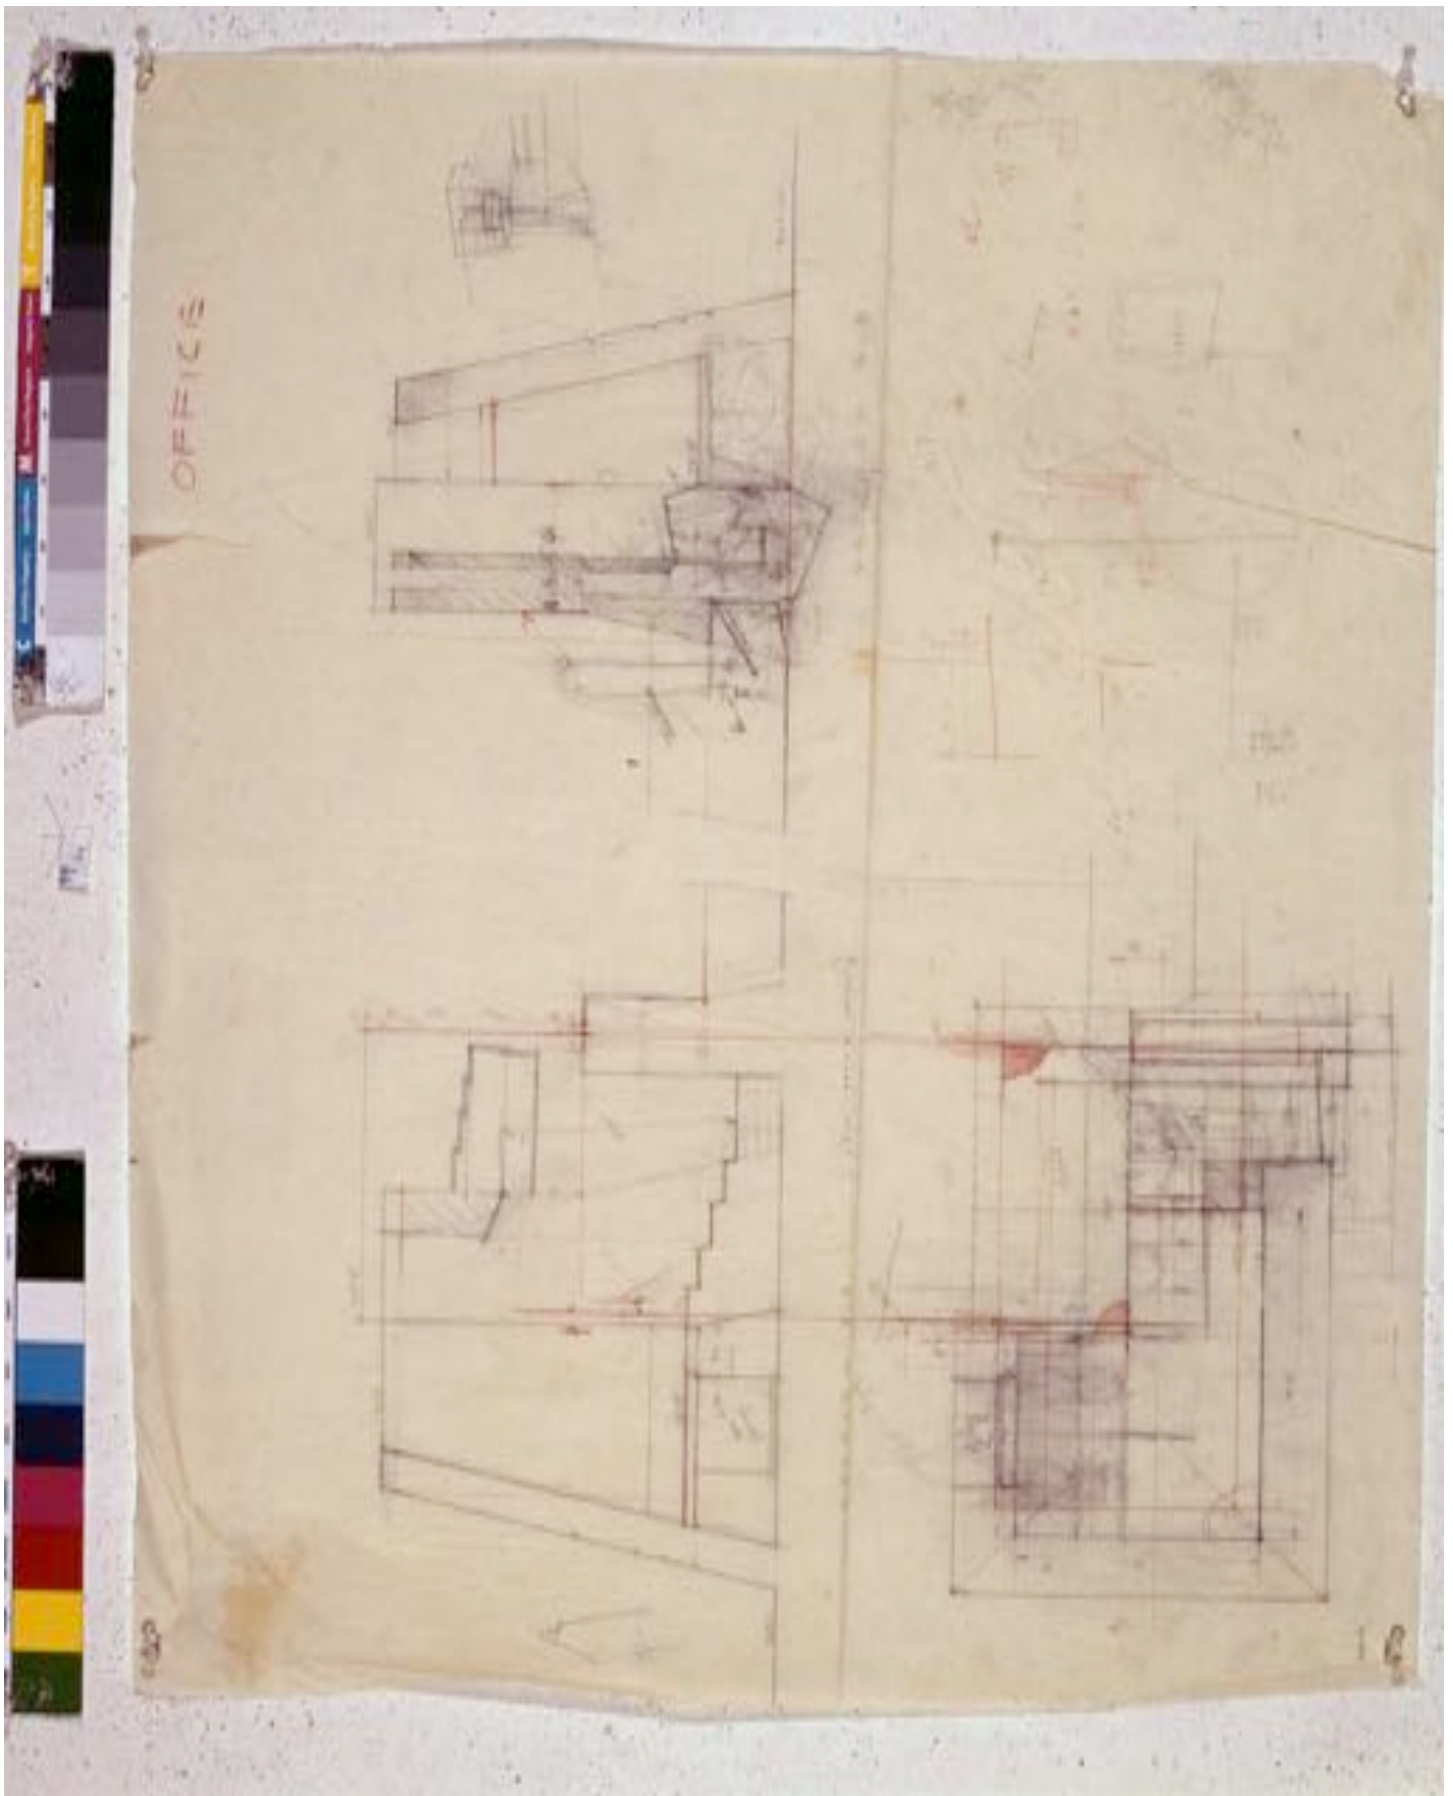
Figure B-69 - Plan of Fire Toilet (The Frank Lloyd Wright Foundation Archives, The Museum of Modern Art | Avery Architectural & Fine Arts Library, Columbia University, New York).

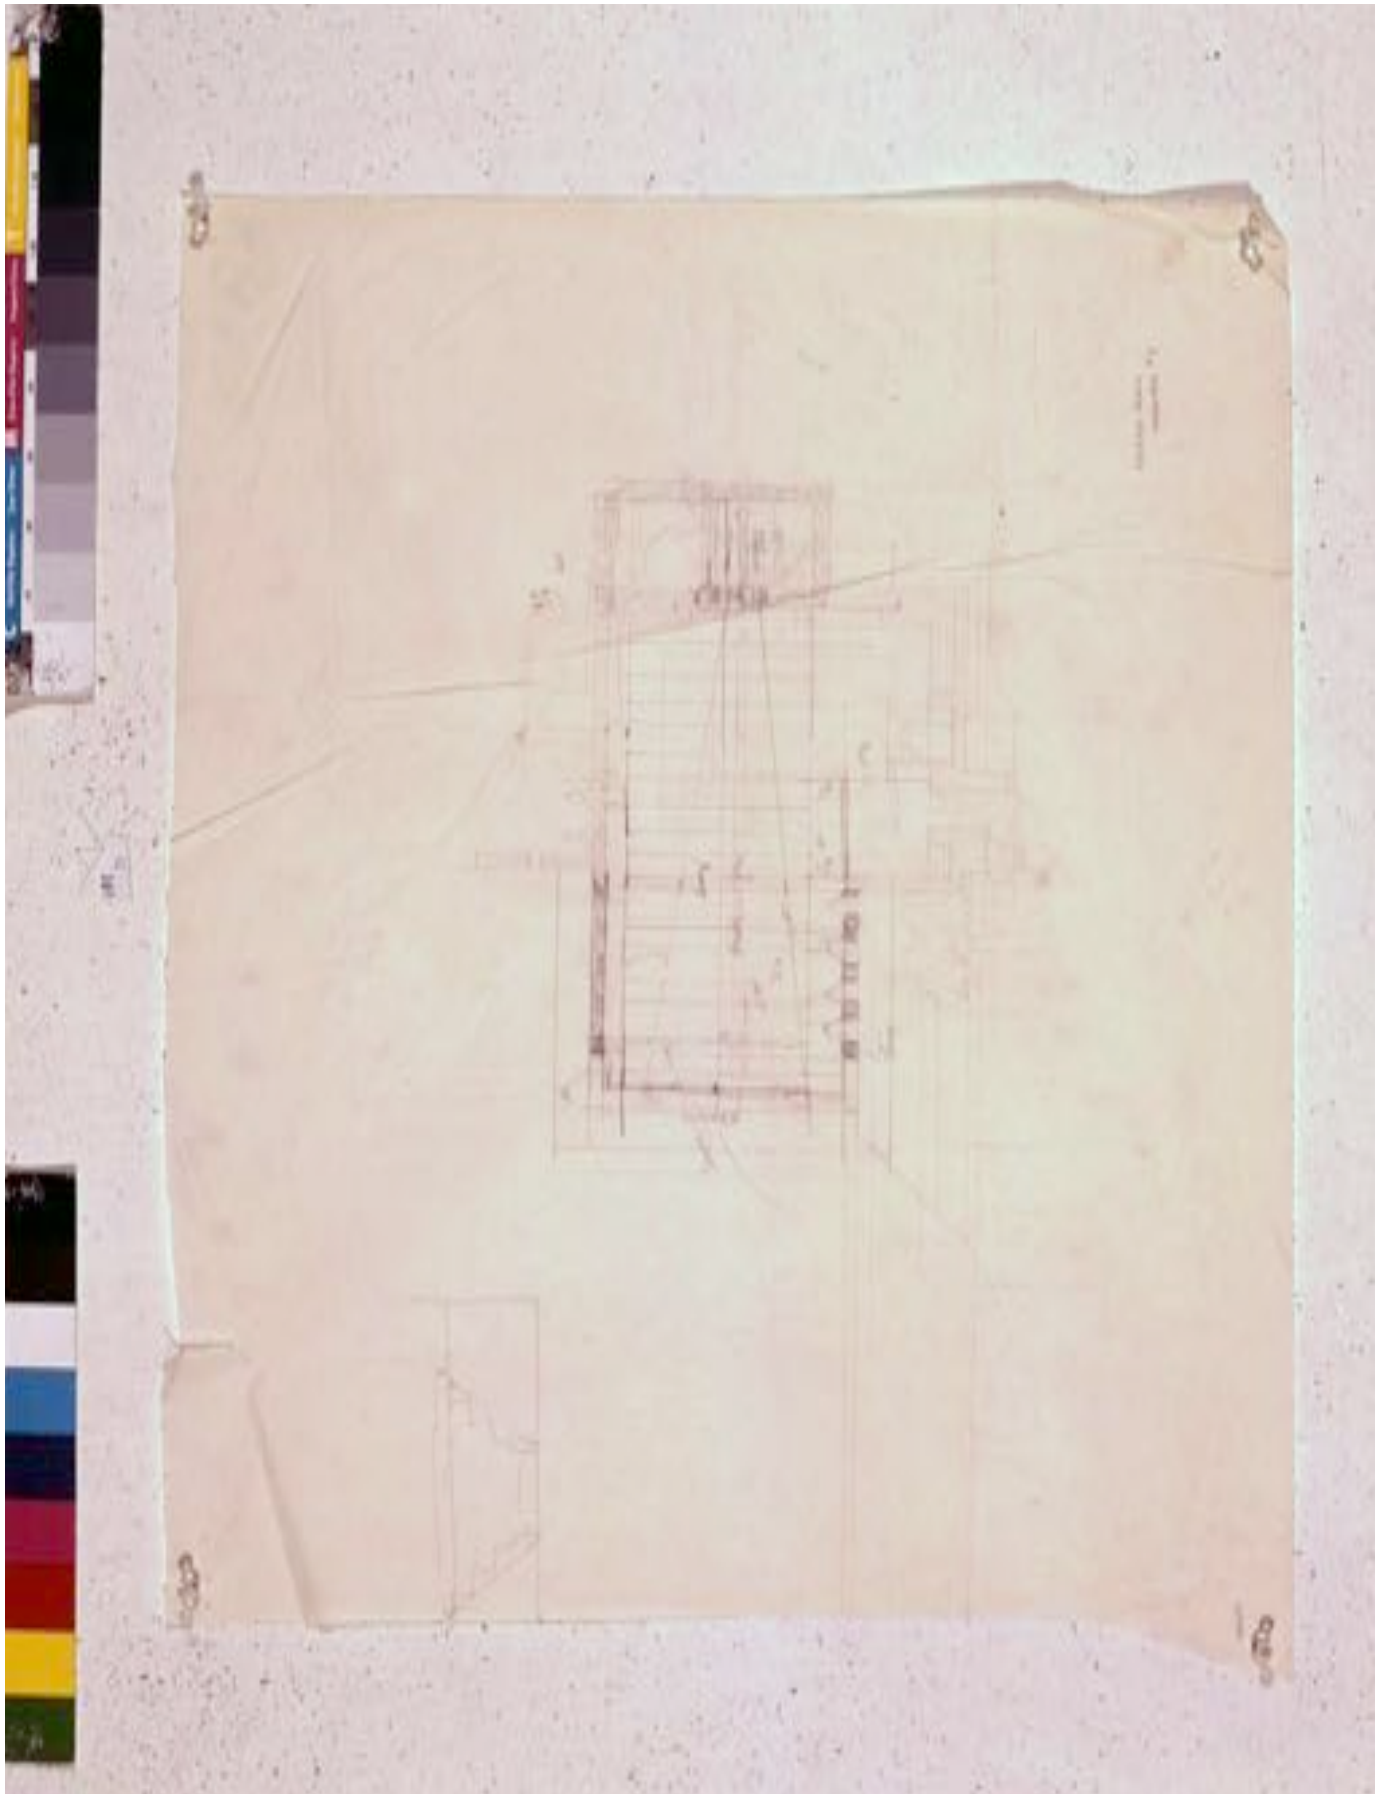
Figure B-71 - Theatre Expansion (The Frank Lloyd Wright Foundation Archives, The Museum of Modern Art | Avery Architectural & Fine Arts Library, Columbia University, New York).

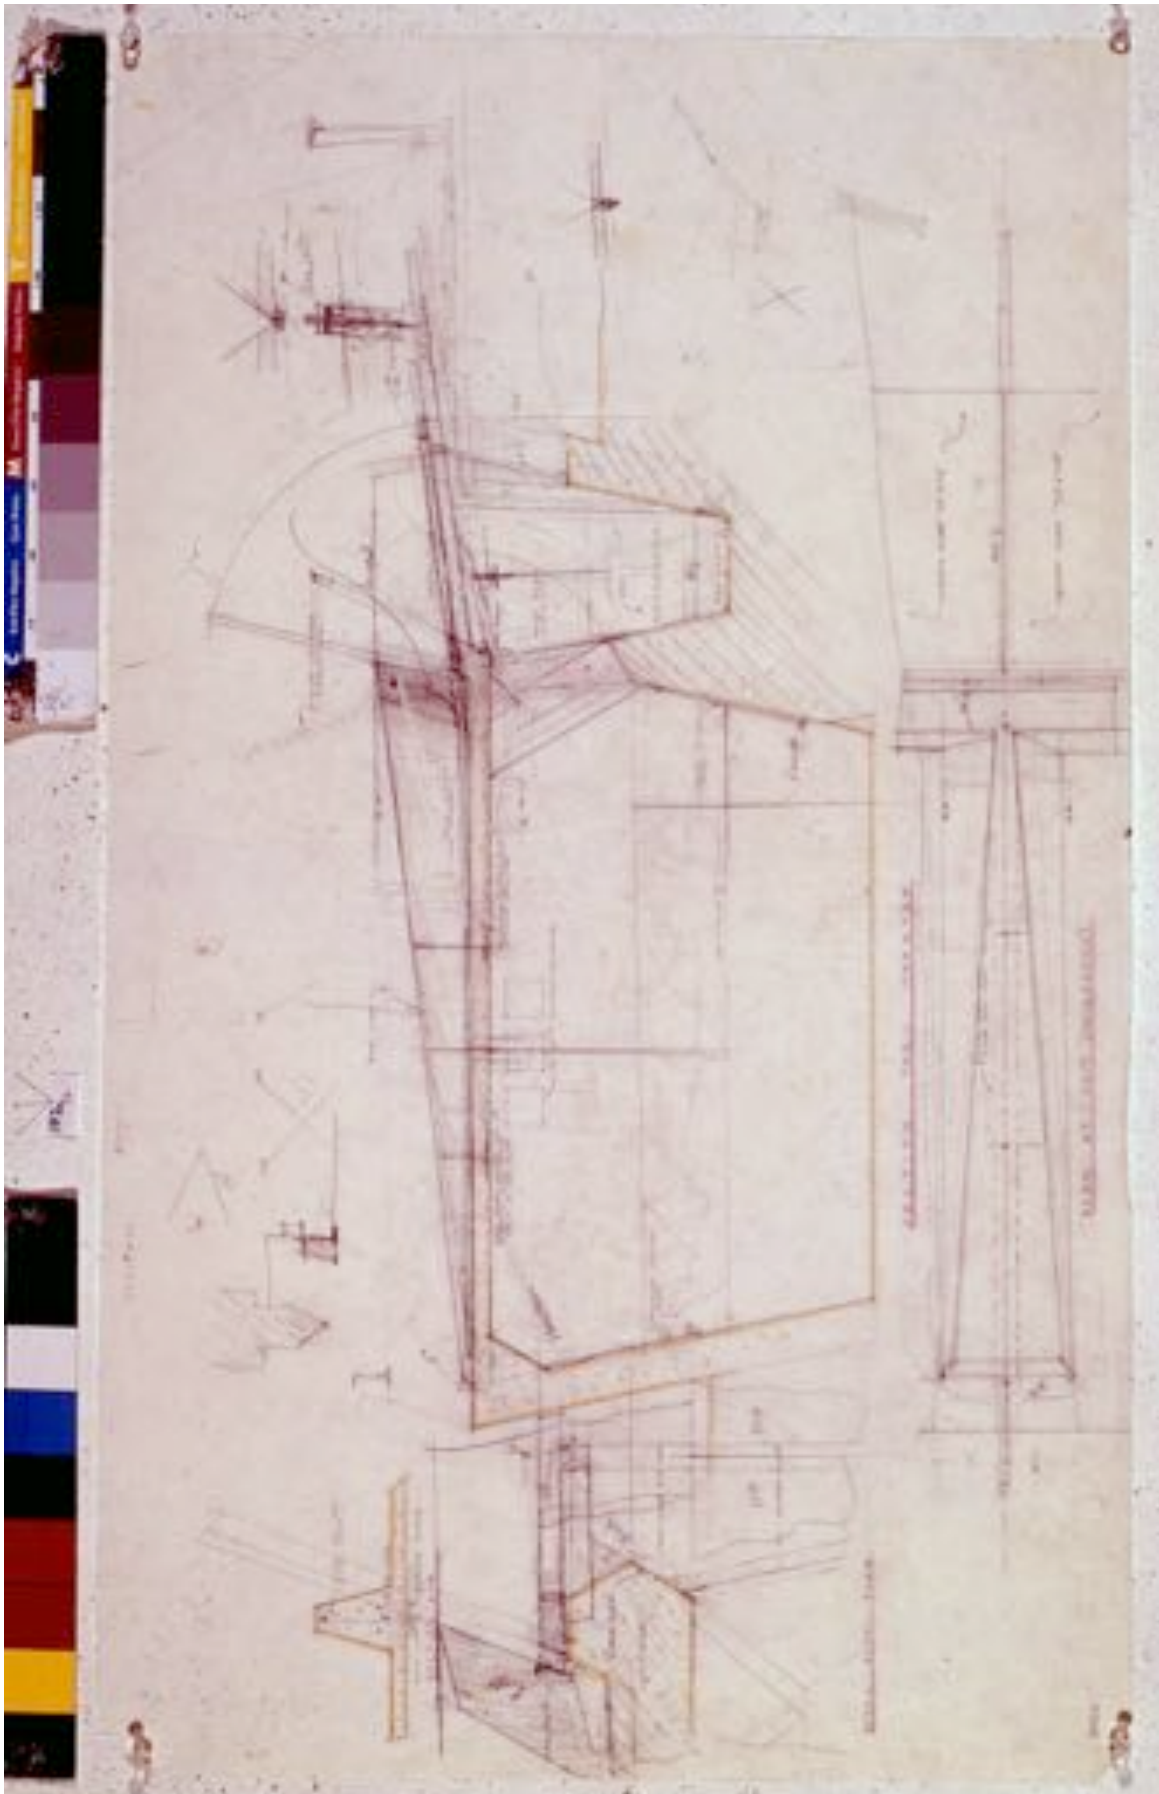
Figure B-72 - Cabaret Section (The Frank Lloyd Wright Foundation Archives, The Museum of Modern Art | Avery Architectural & Fine Arts Library, Columbia University, New York).
