TALIESIN WEST PRESERVATION MASTER PLAN

Harboe Architects, PC

MAY 21, 2015

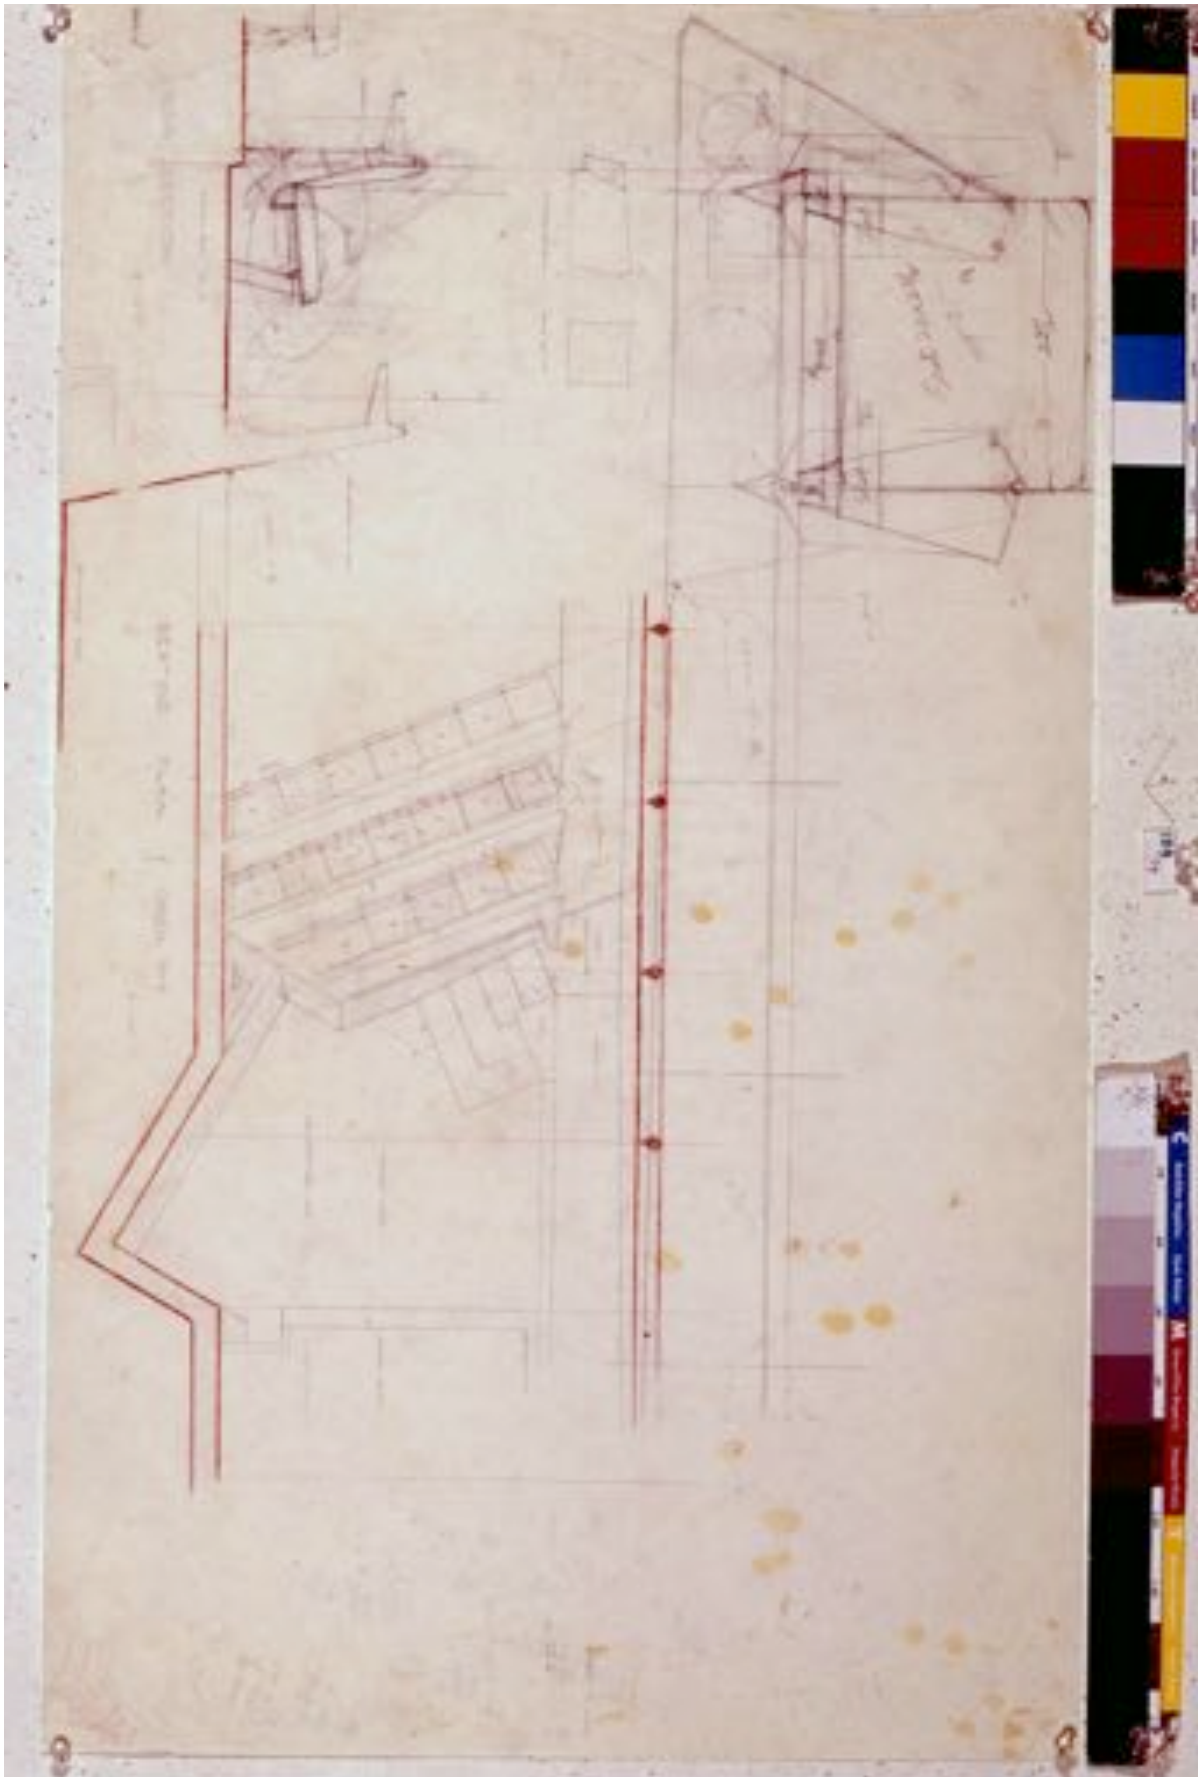
Figure B-74 - Cabaret Seats/Piers (The Frank Lloyd Wright Foundation Archives, The Museum of Modern Art | Avery Architectural & Fine Arts Library, Columbia University, New York).

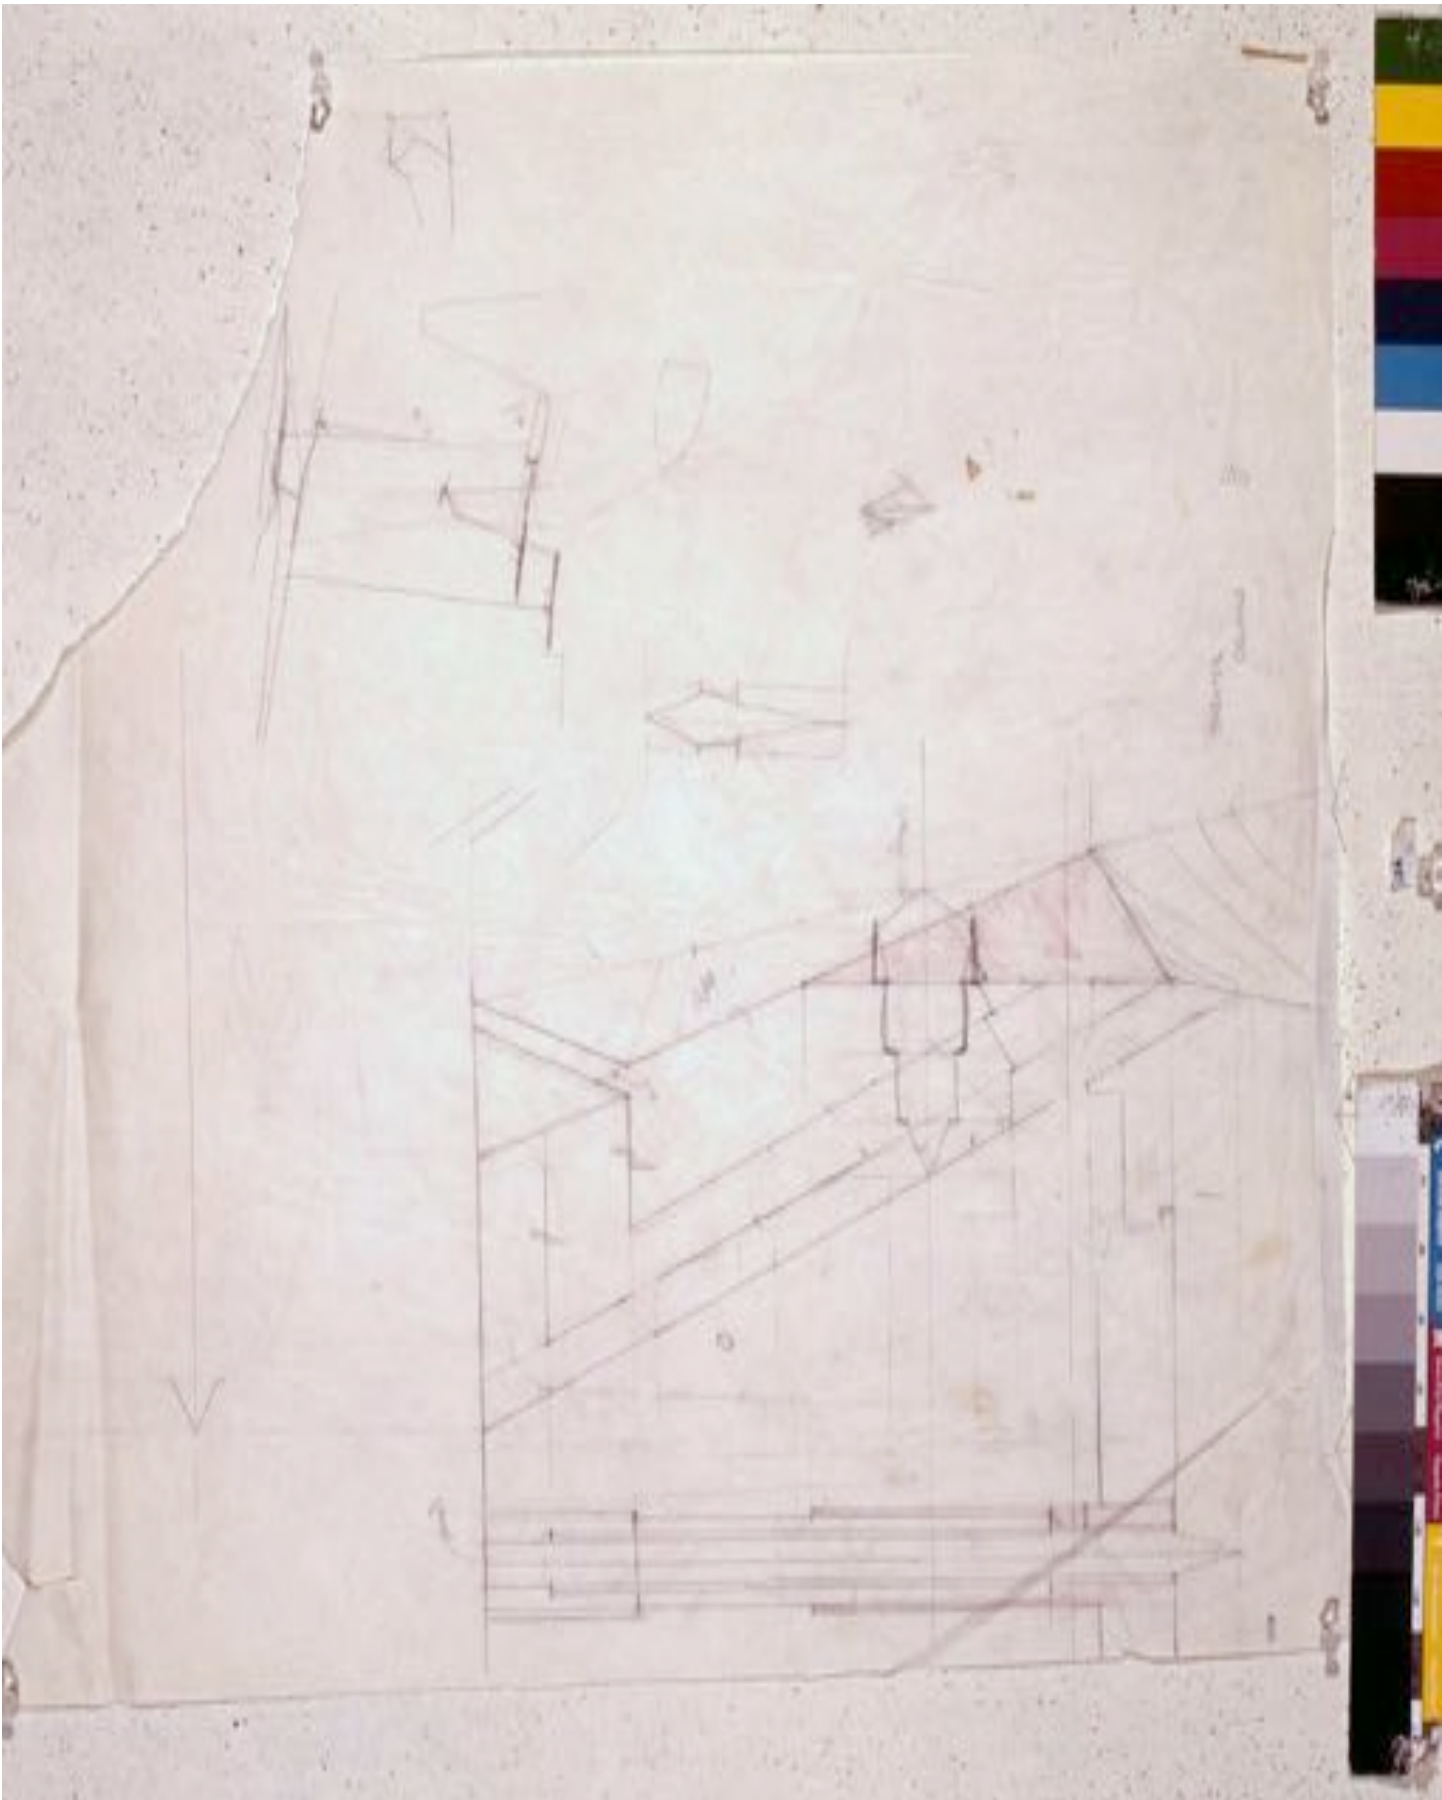
Figure B-76 - Cabaret Pier Detail (The Frank Lloyd Wright Foundation Archives, The Museum of Modern Art | Avery Architectural & Fine Arts Library, Columbia University, New York).

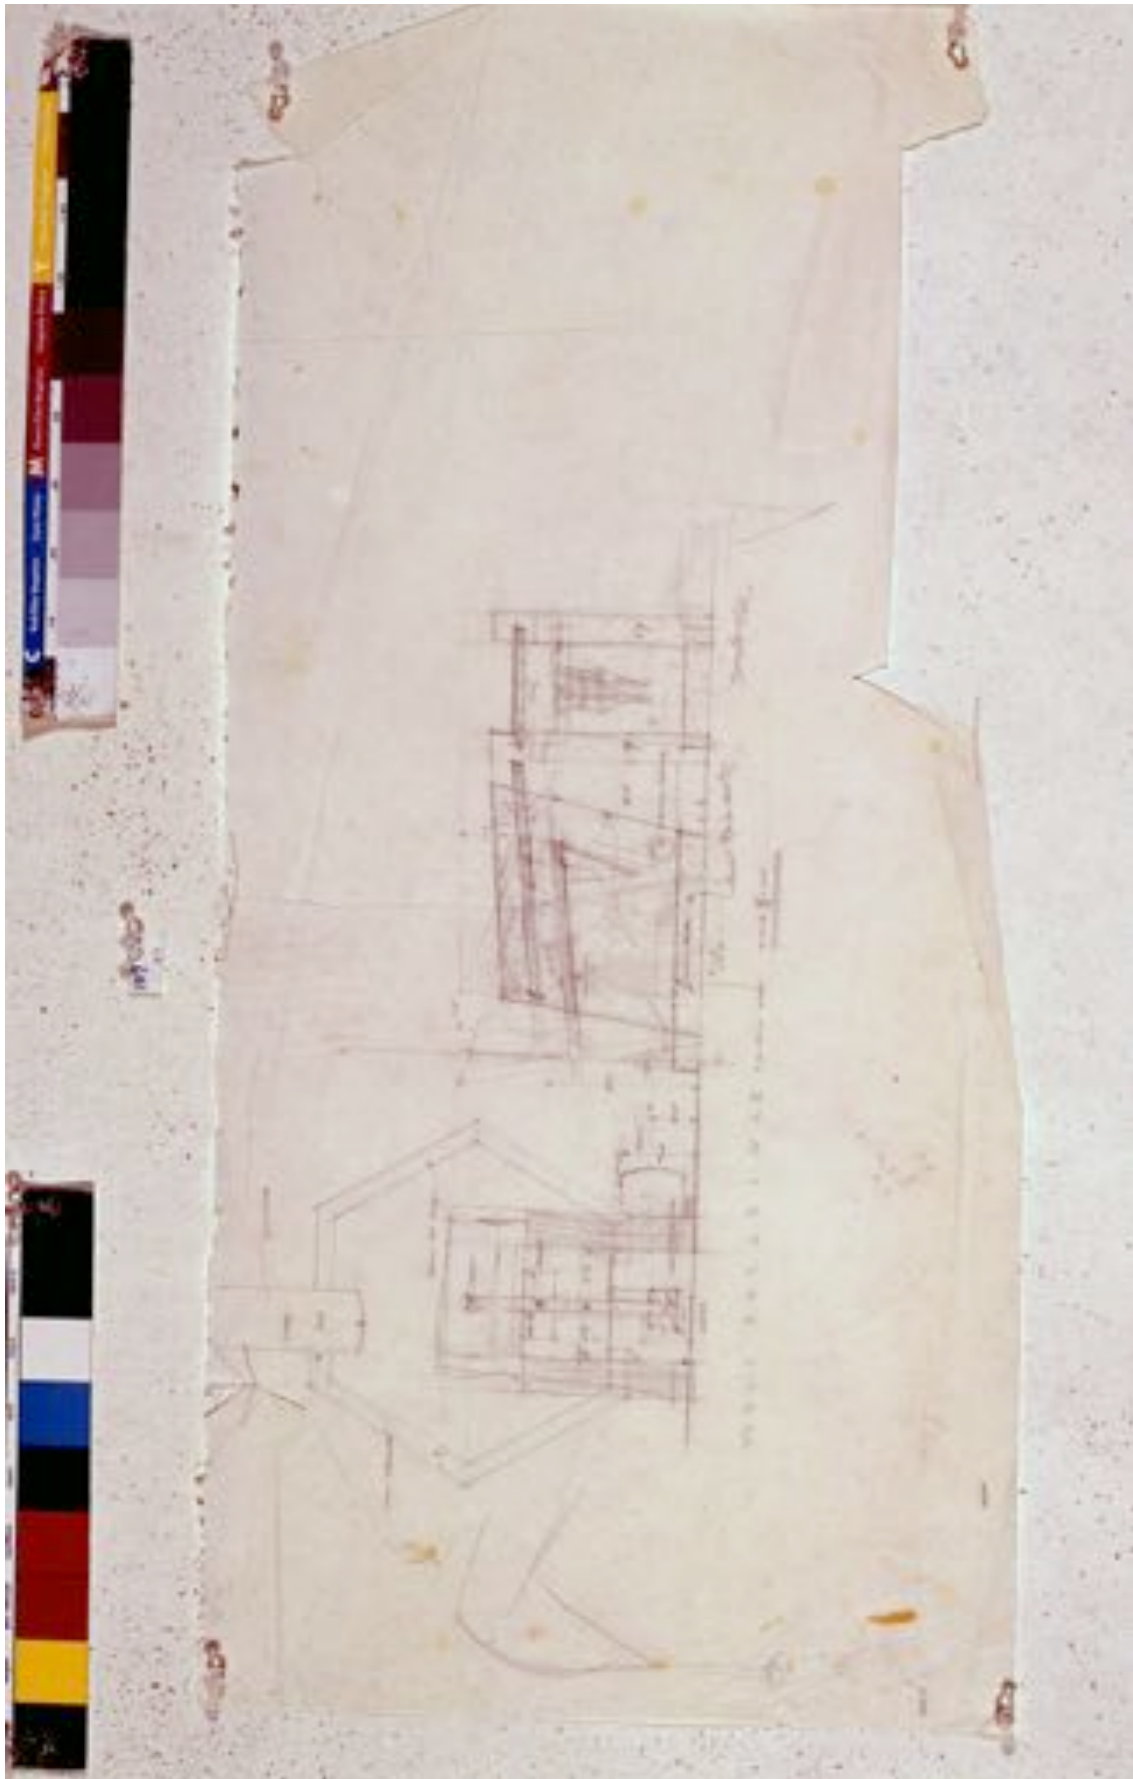
Figure B-77 - Pump House Elevation/Section (The Frank Lloyd Wright Foundation Archives, The Museum of Modern Art | Avery Architectural & Fine Arts Library, Columbia University, New York).

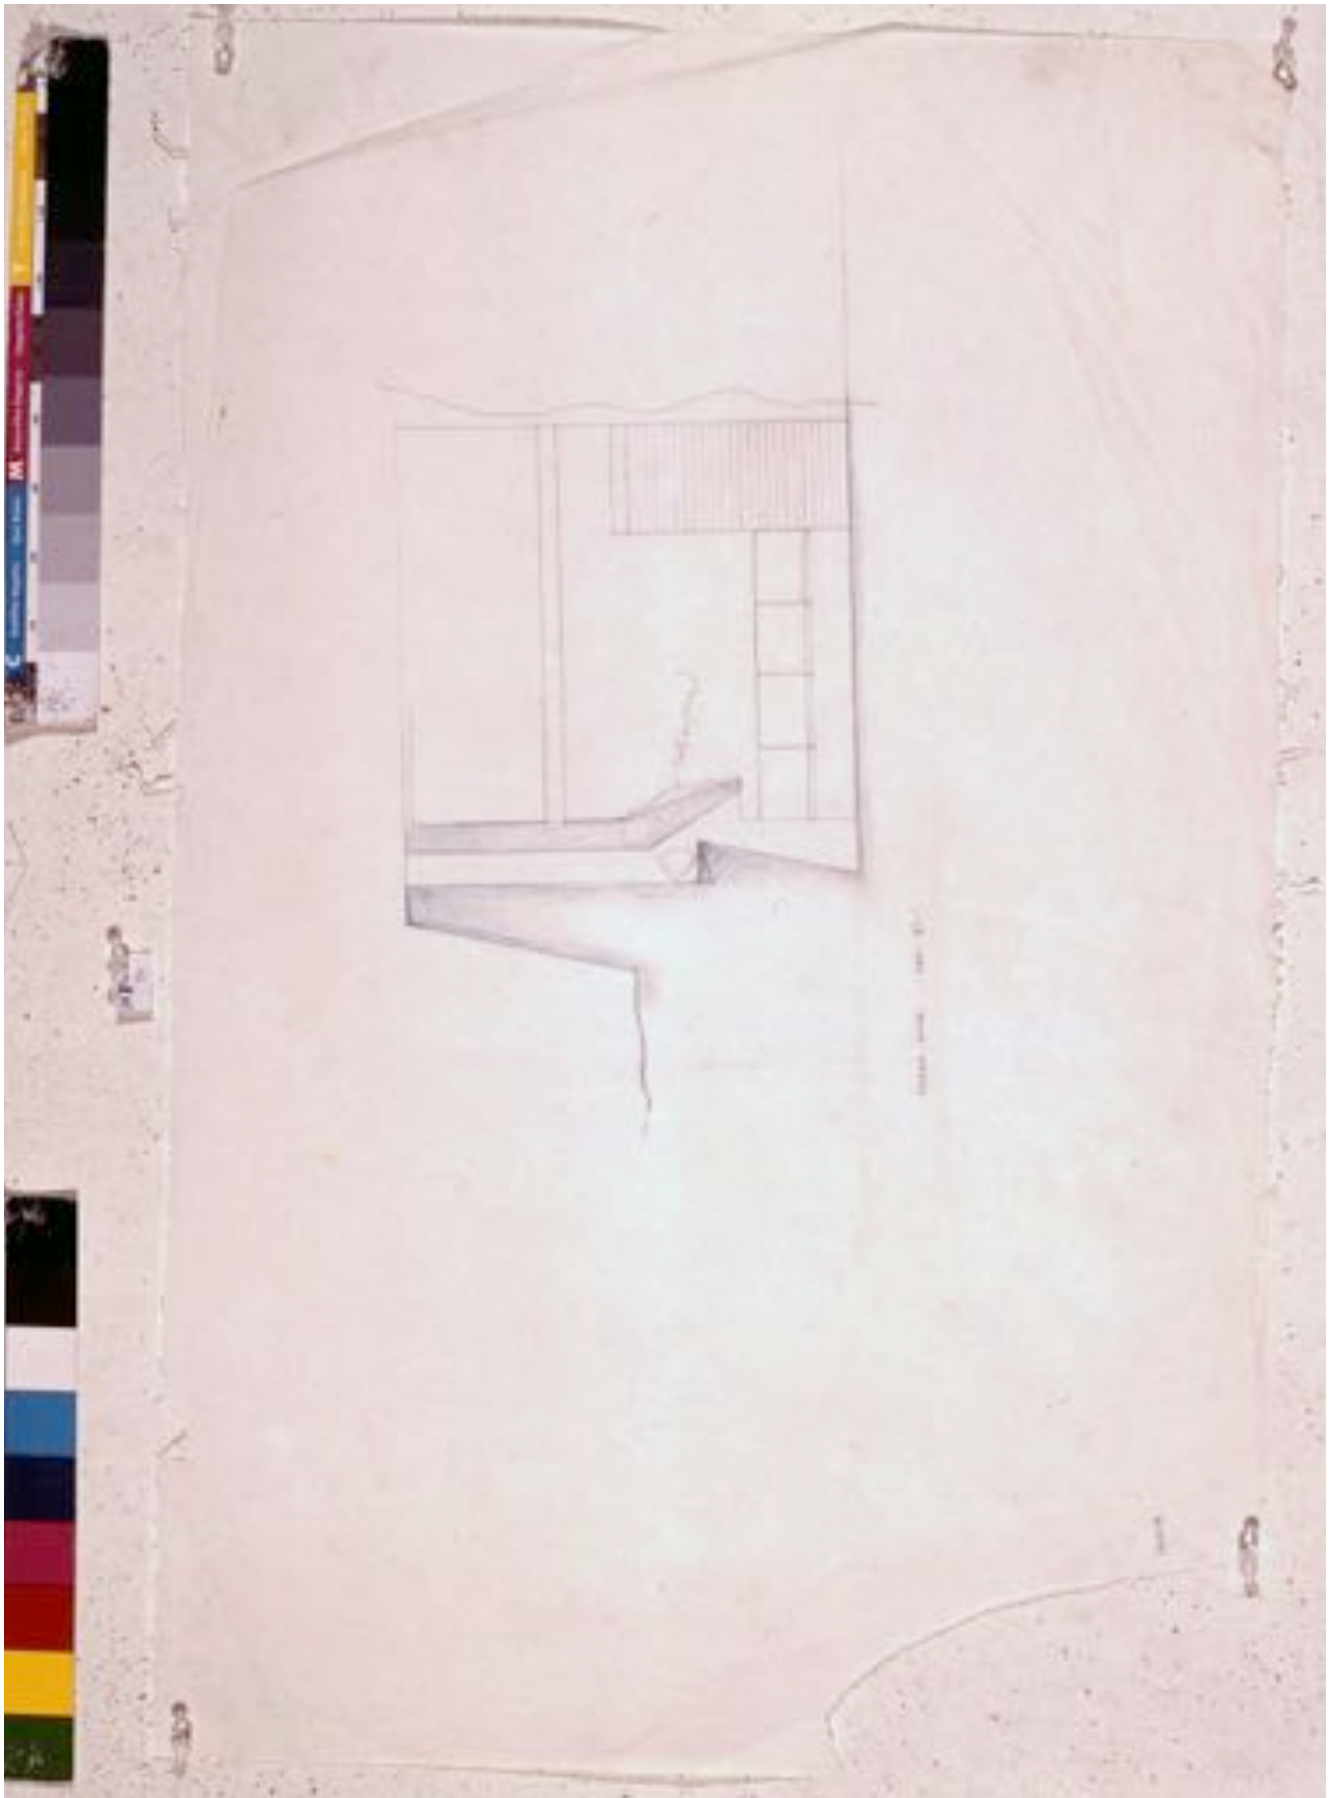
Figure B-78 - Cabaret Fireplace Section (The Frank Lloyd Wright Foundation Archives, The Museum of Modern Art | Avery Architectural & Fine Arts Library, Columbia University, New York).

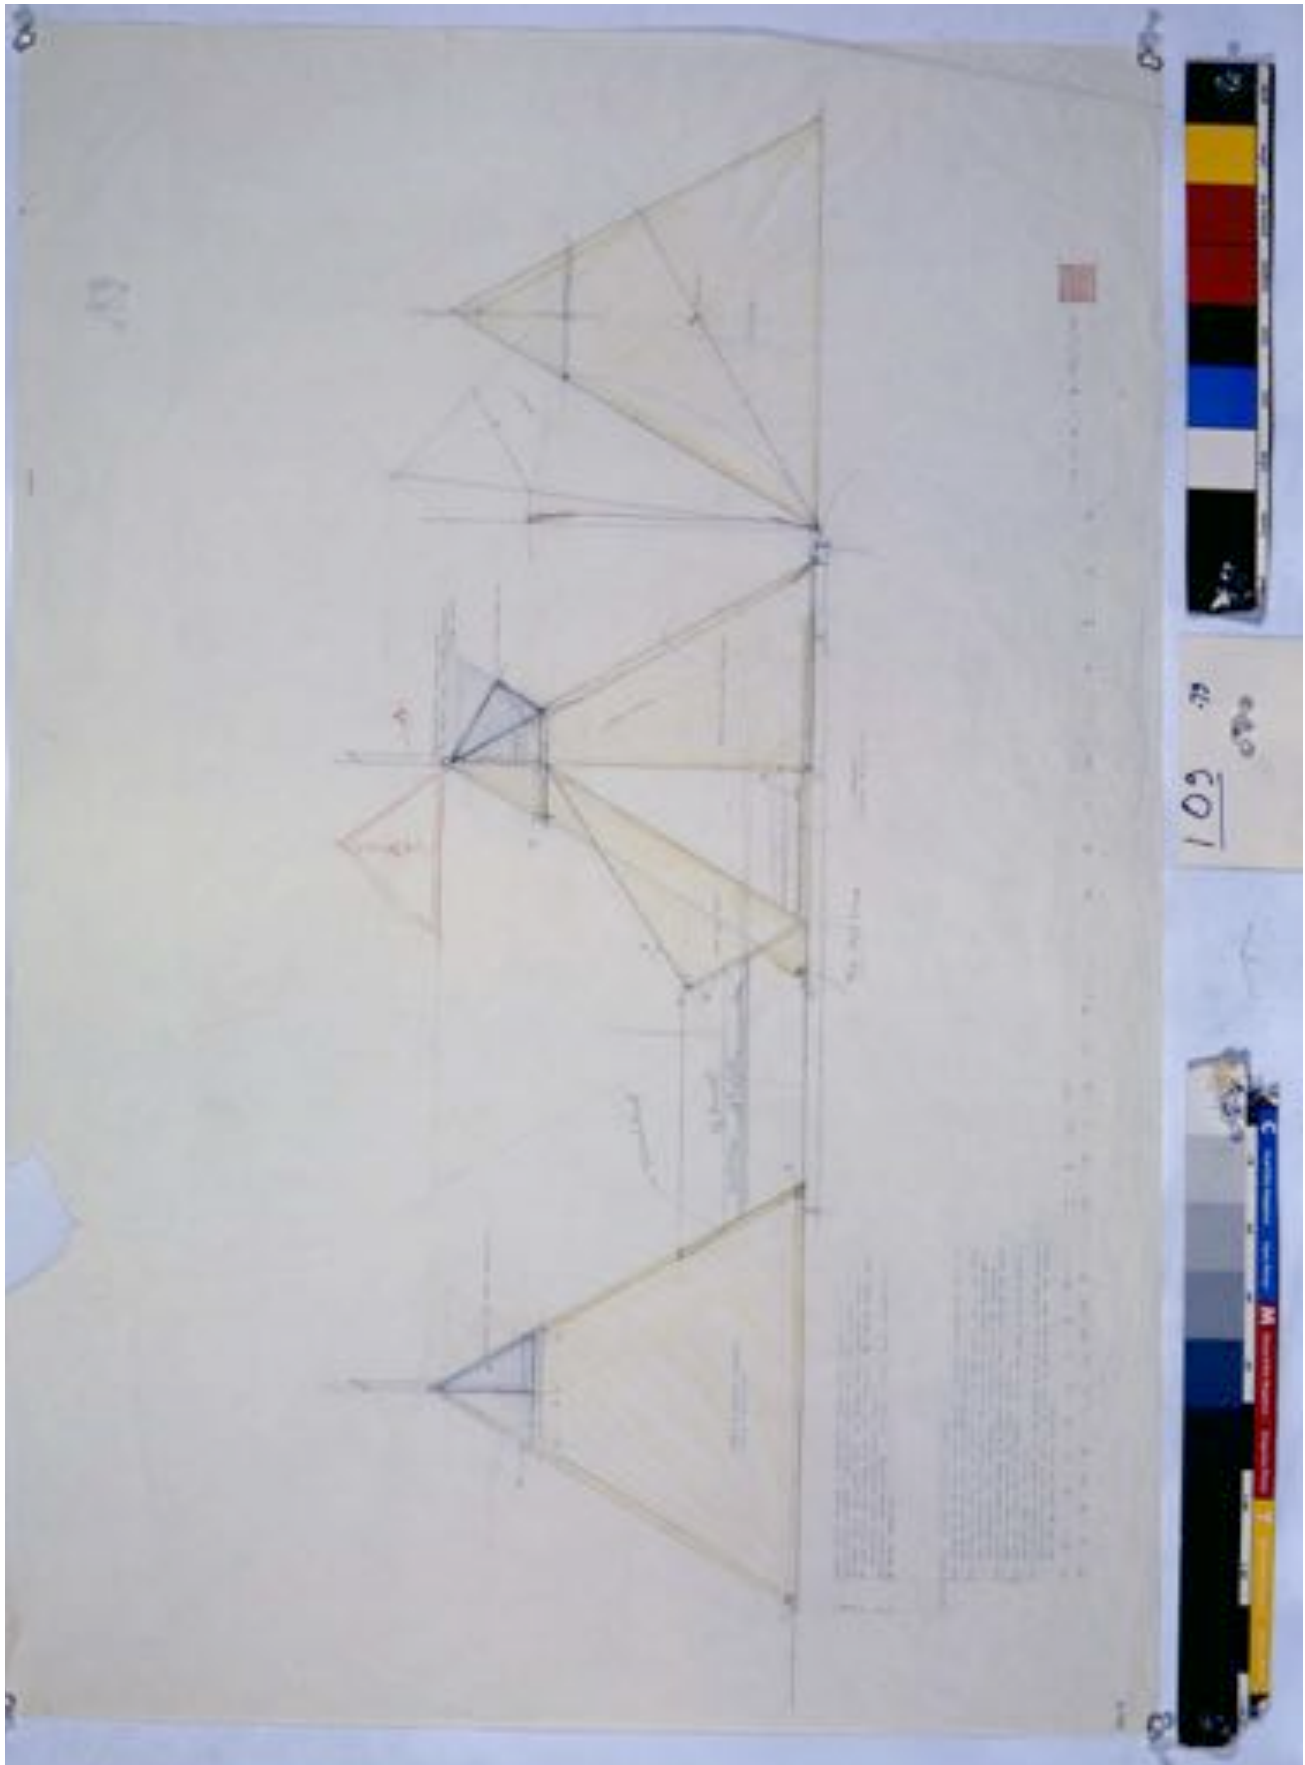
Figure B-79 - Triangular Tent Design (The Frank Lloyd Wright Foundation Archives, The Museum of Modern Art | Avery Architectural & Fine Arts Library, Columbia University, New York).

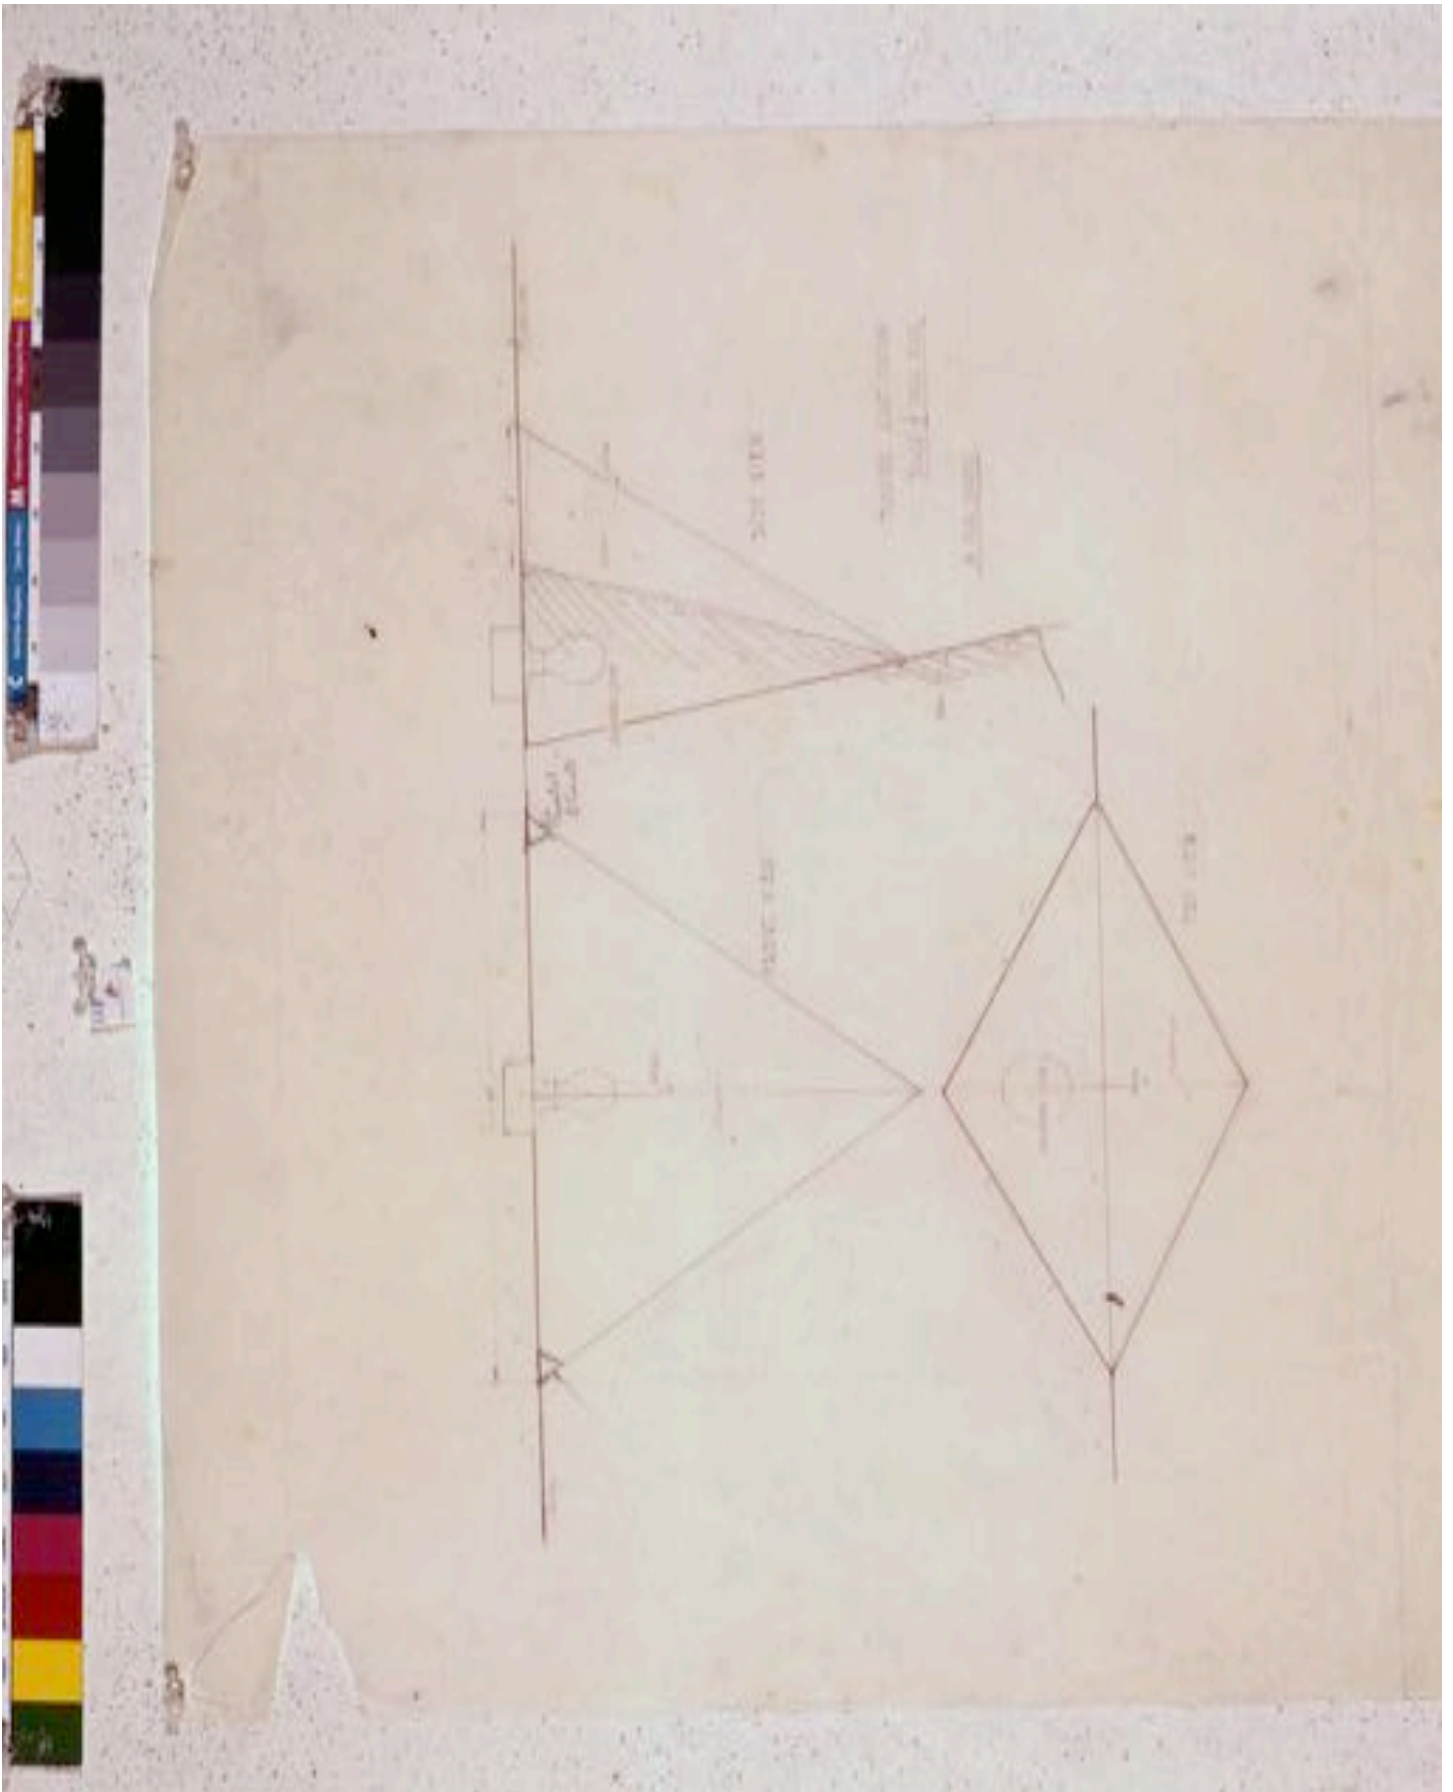
Figure B-80 - Cabaret Wall Light (The Frank Lloyd Wright Foundation Archives, The Museum of Modern Art | Avery Architectural & Fine Arts Library, Columbia University, New York).

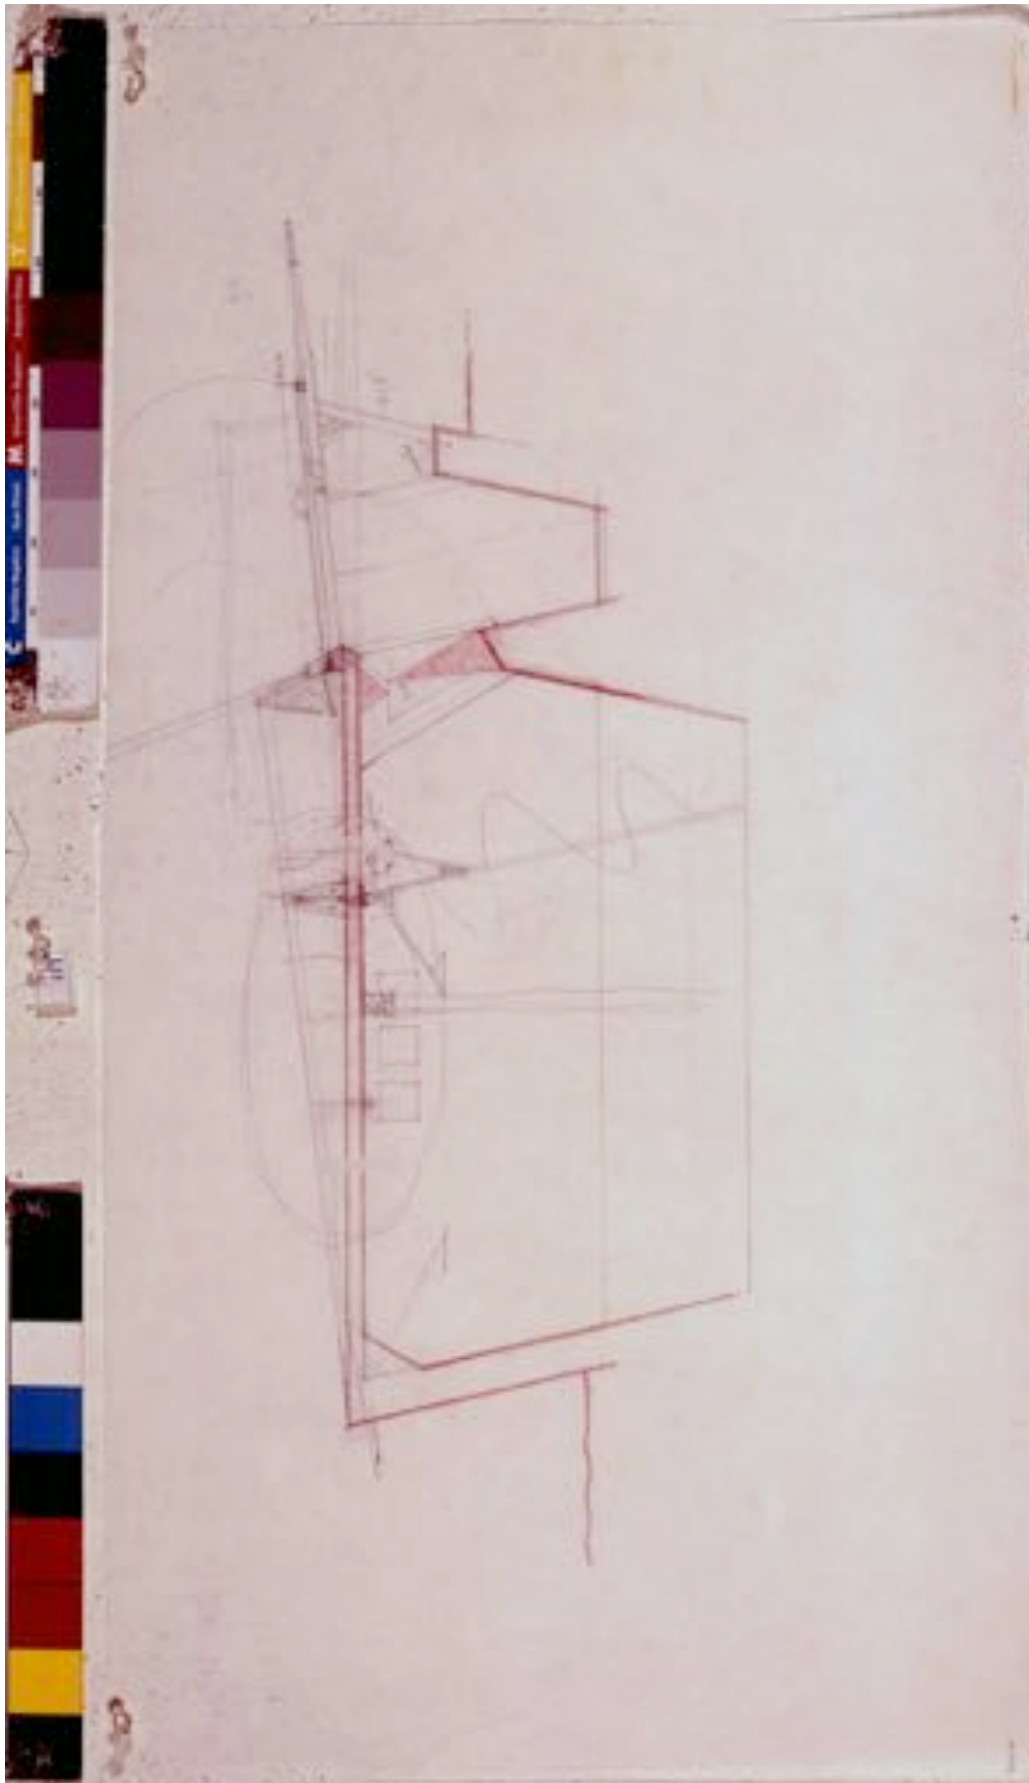
Figure B-81 - Cabaret Section (The Frank Lloyd Wright Foundation Archives, The Museum of Modern Art | Avery Architectural & Fine Arts Library, Columbia University, New York).

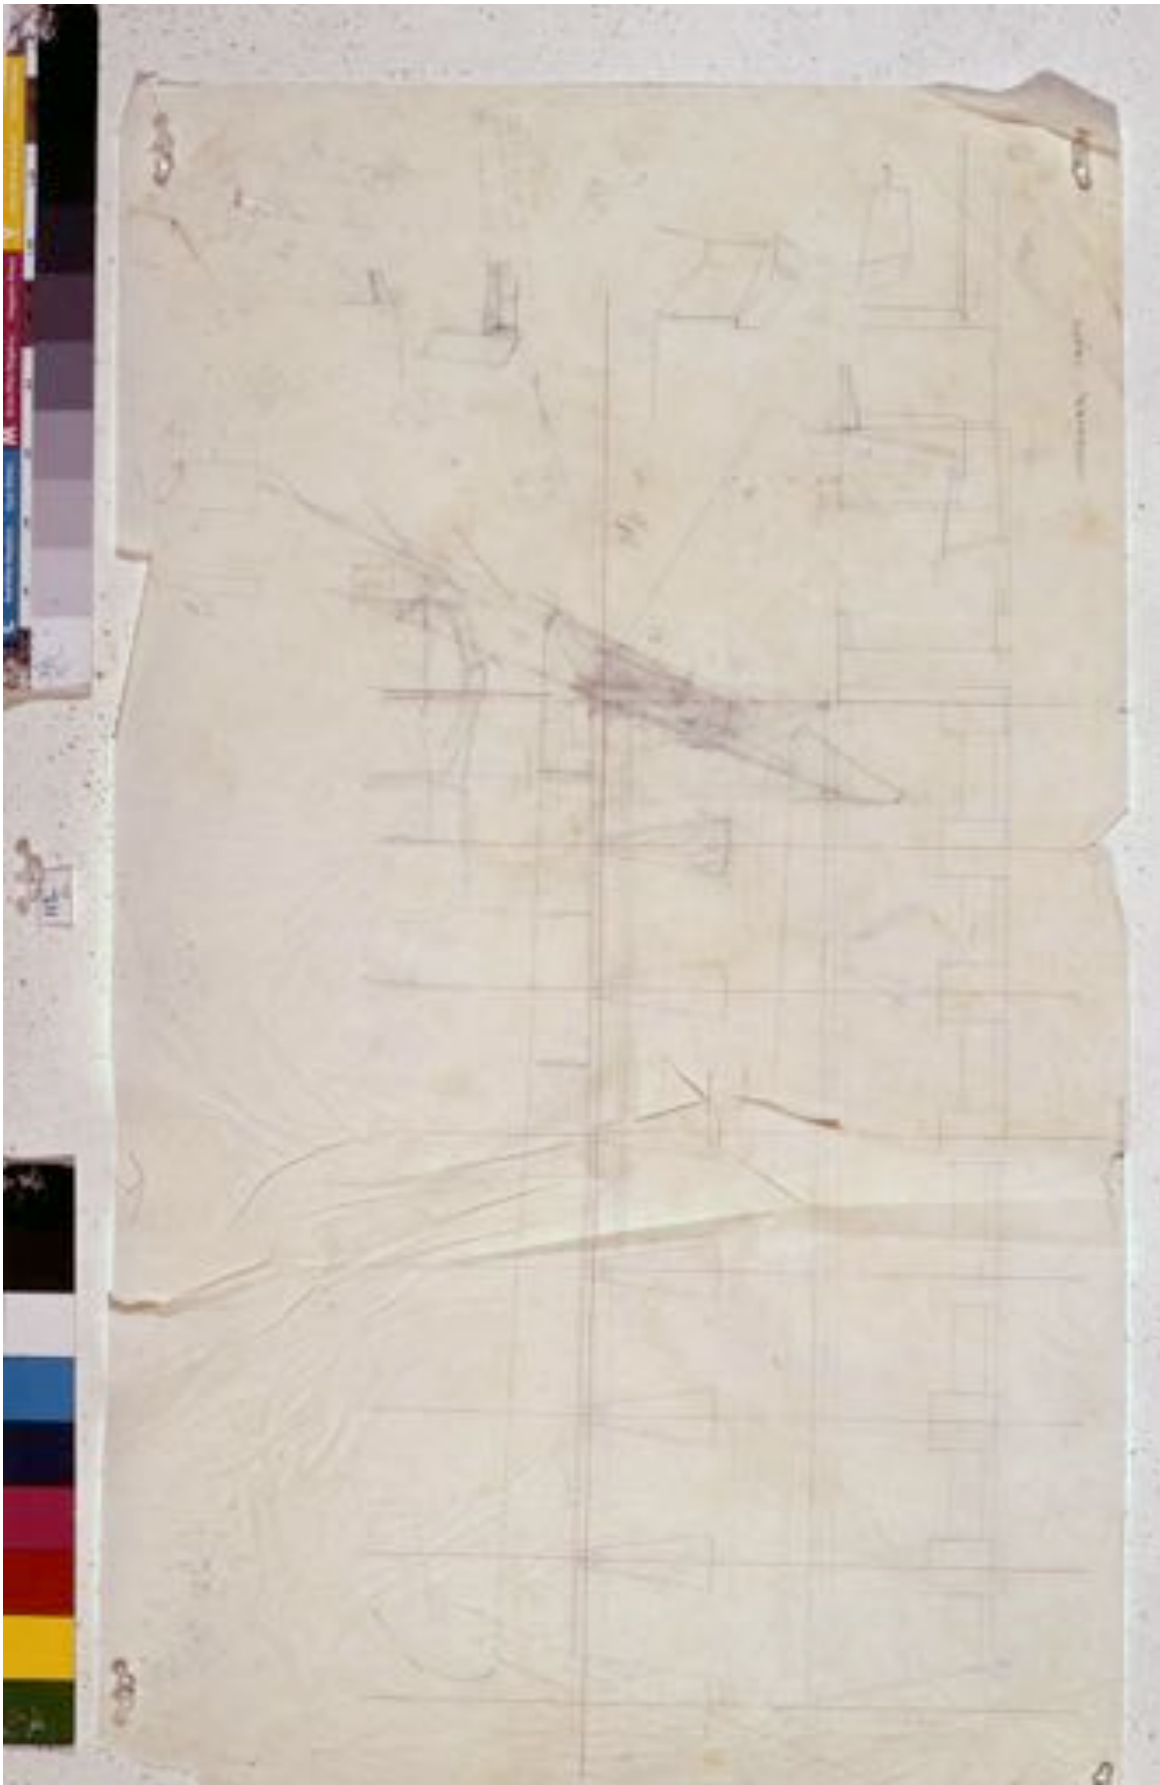
Figure B-82 - Cabaret Longitudinal Section (The Frank Lloyd Wright Foundation Archives, The Museum of Modern Art | Avery Architectural & Fine Arts Library, Columbia University, New York).

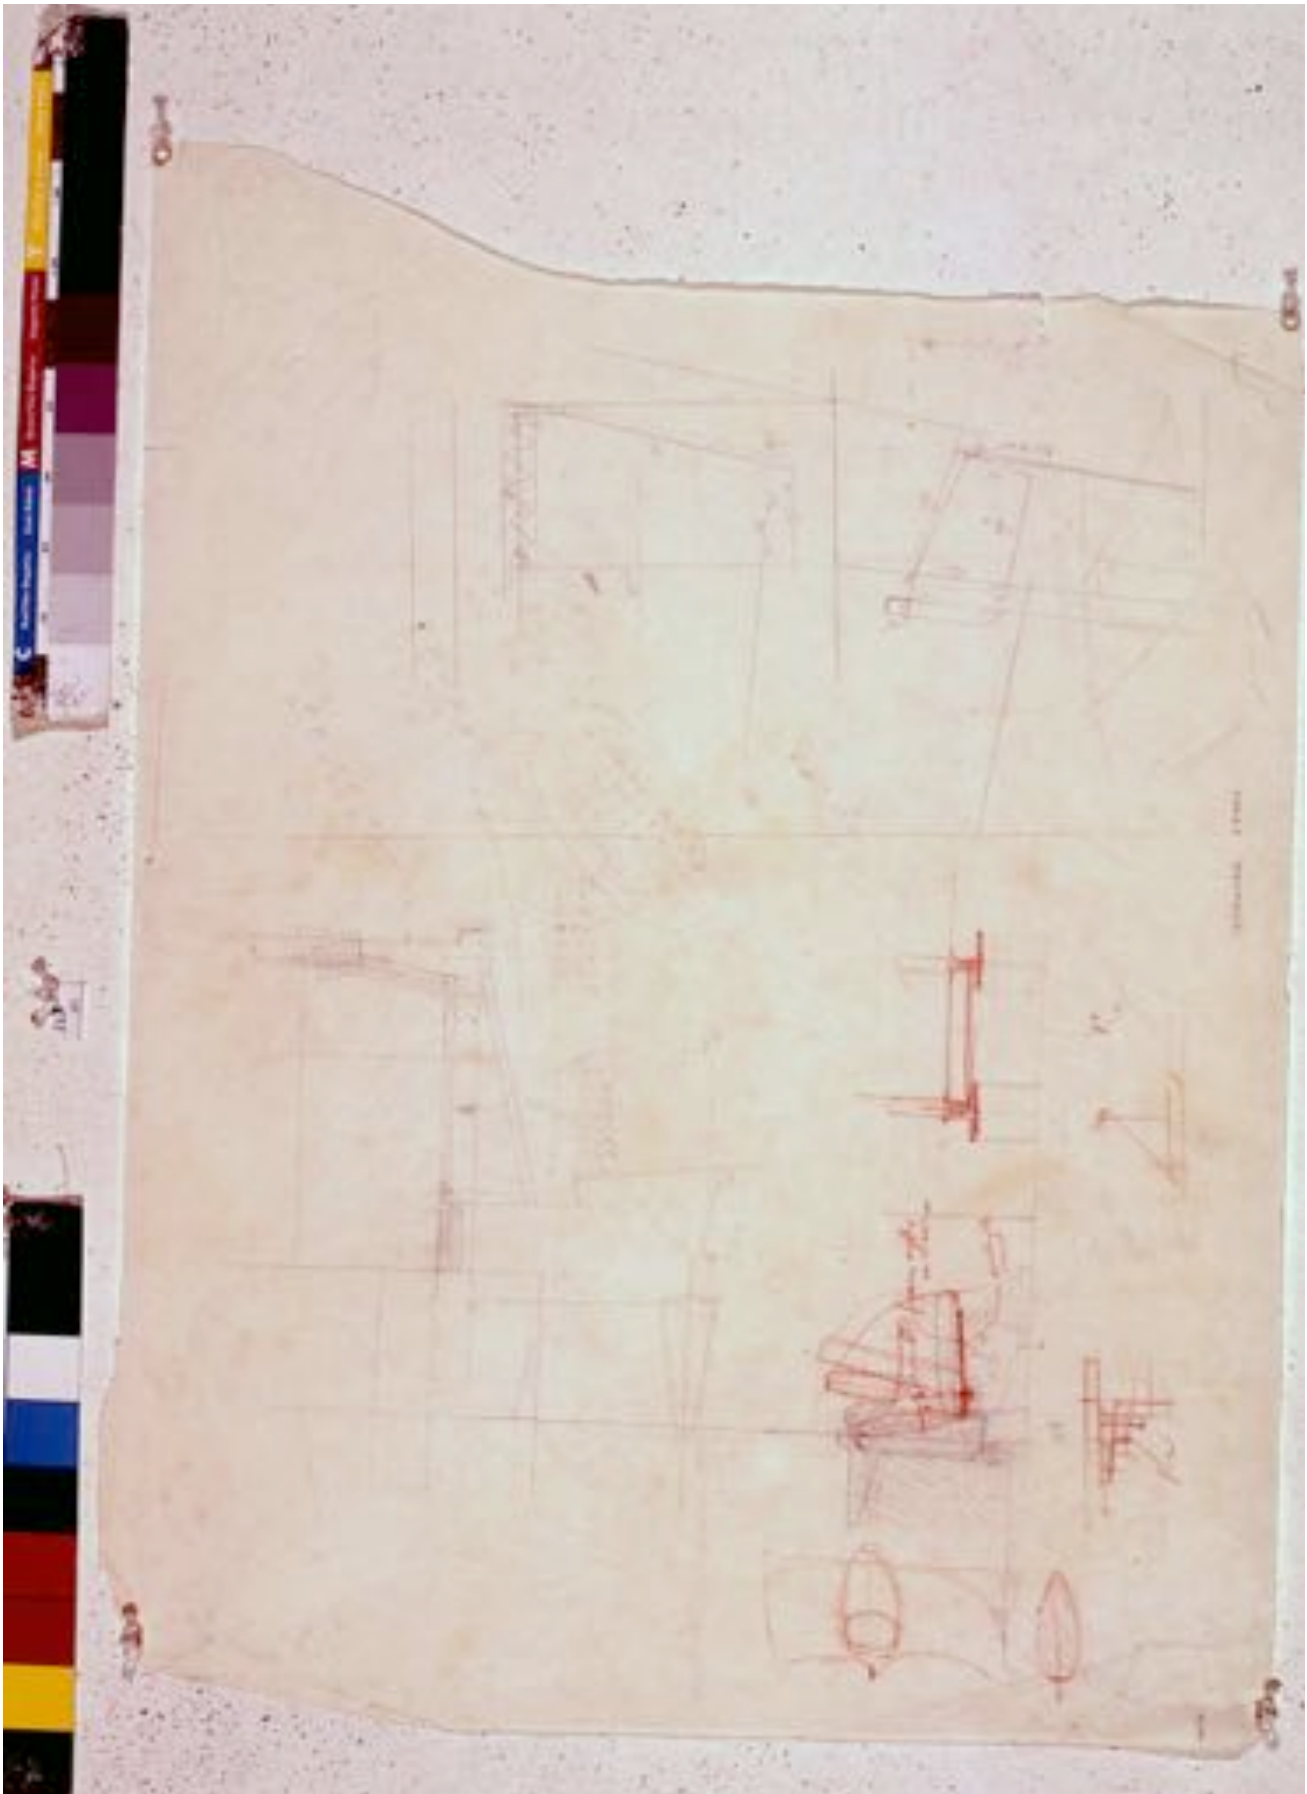
Figure B-83 - Cabaret Seating Detail (The Frank Lloyd Wright Foundation Archives, The Museum of Modern Art | Avery Architectural & Fine Arts Library, Columbia University, New York).

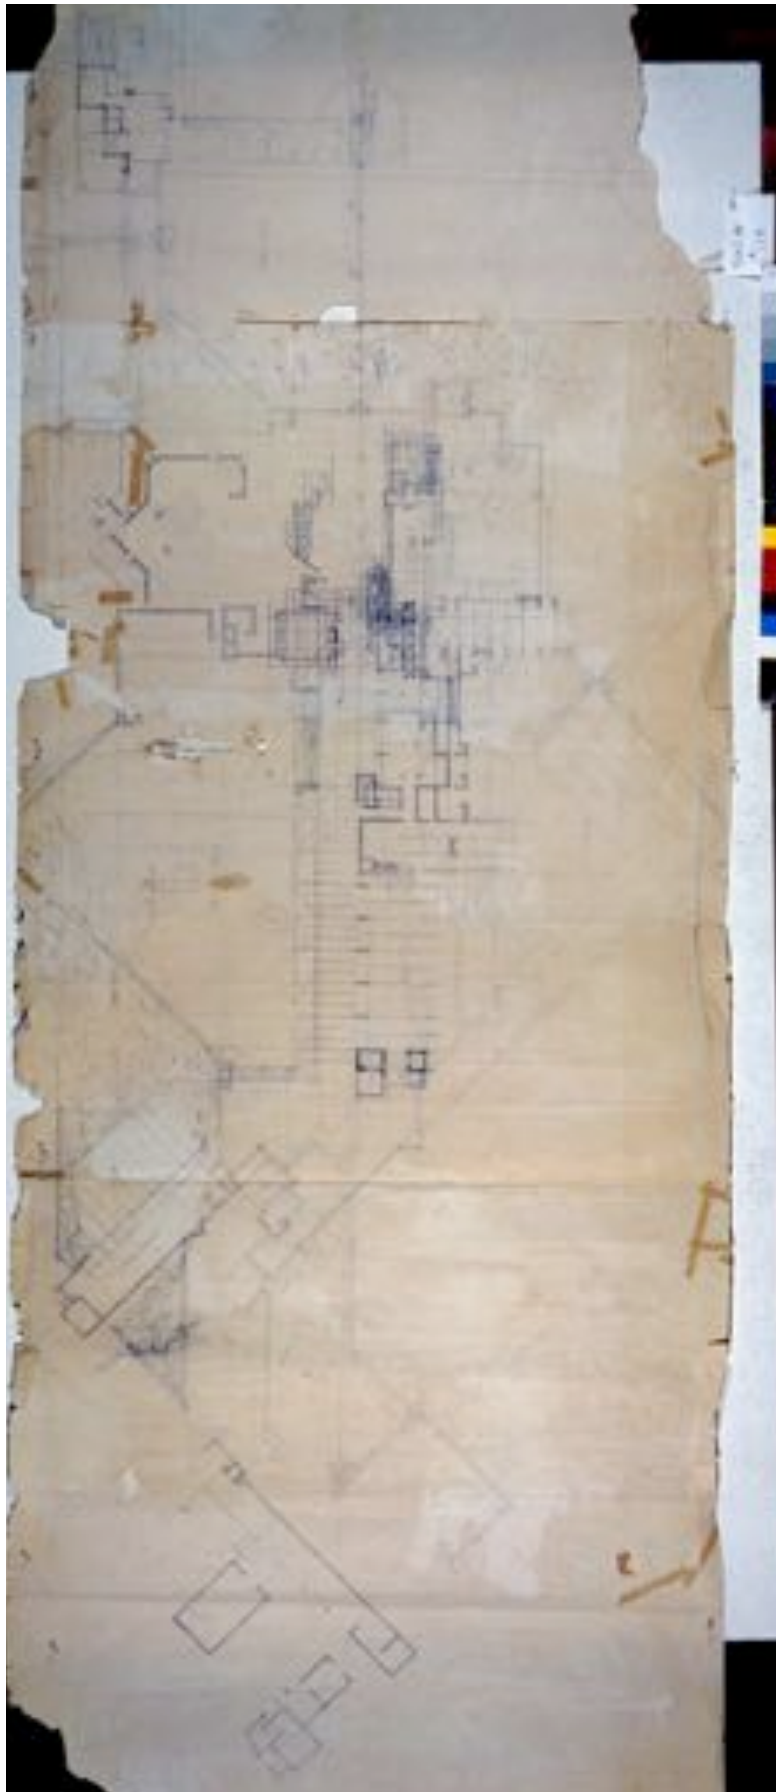
Figure B-84 - Master Plan Print (The Frank Lloyd Wright Foundation Archives, The Museum of Modern Art | Avery Architectural & Fine Arts Library, Columbia University, New York).
