TALIESIN WEST PRESERVATION MASTER PLAN

Harboe Architects, PC

MAY 21, 2015

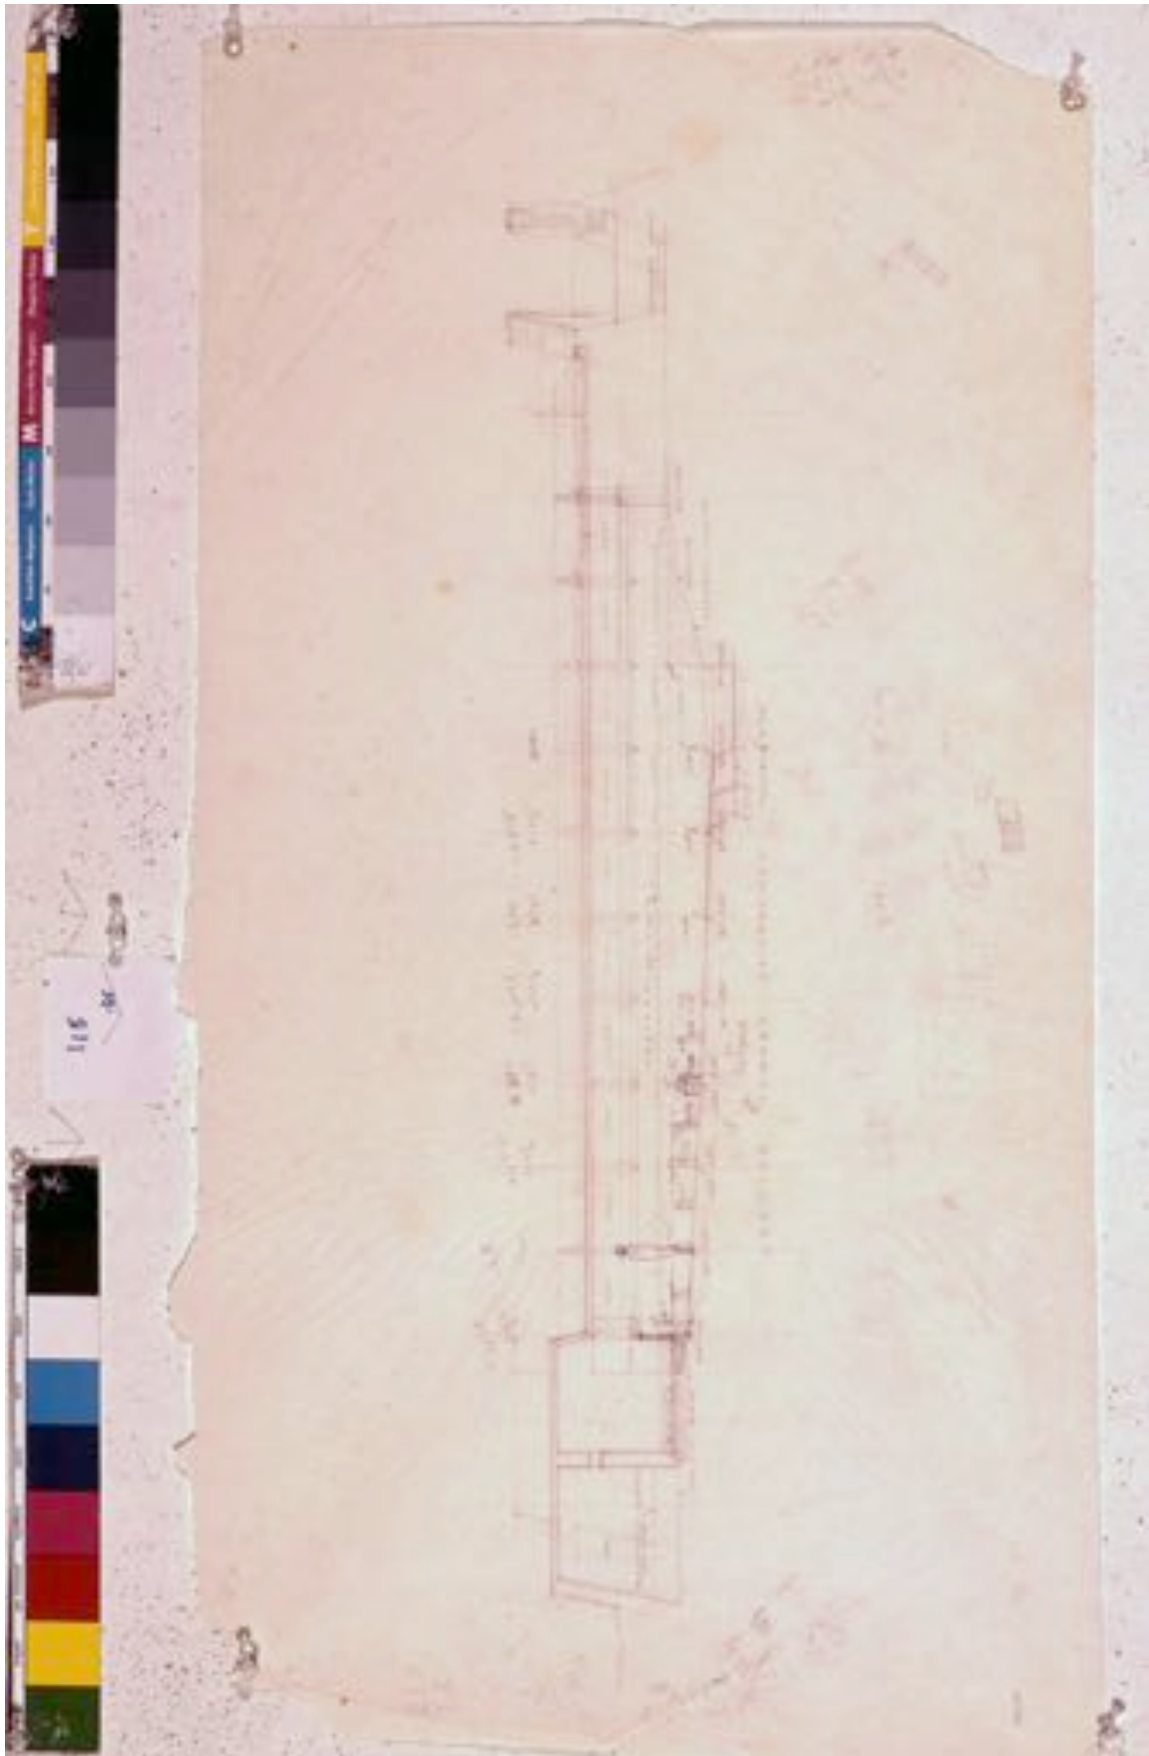
Figure B-85 - Cabaret Longitudinal Section (The Frank Lloyd Wright Foundation Archives, The Museum of Modern Art | Avery Architectural & Fine Arts Library, Columbia University, New York).

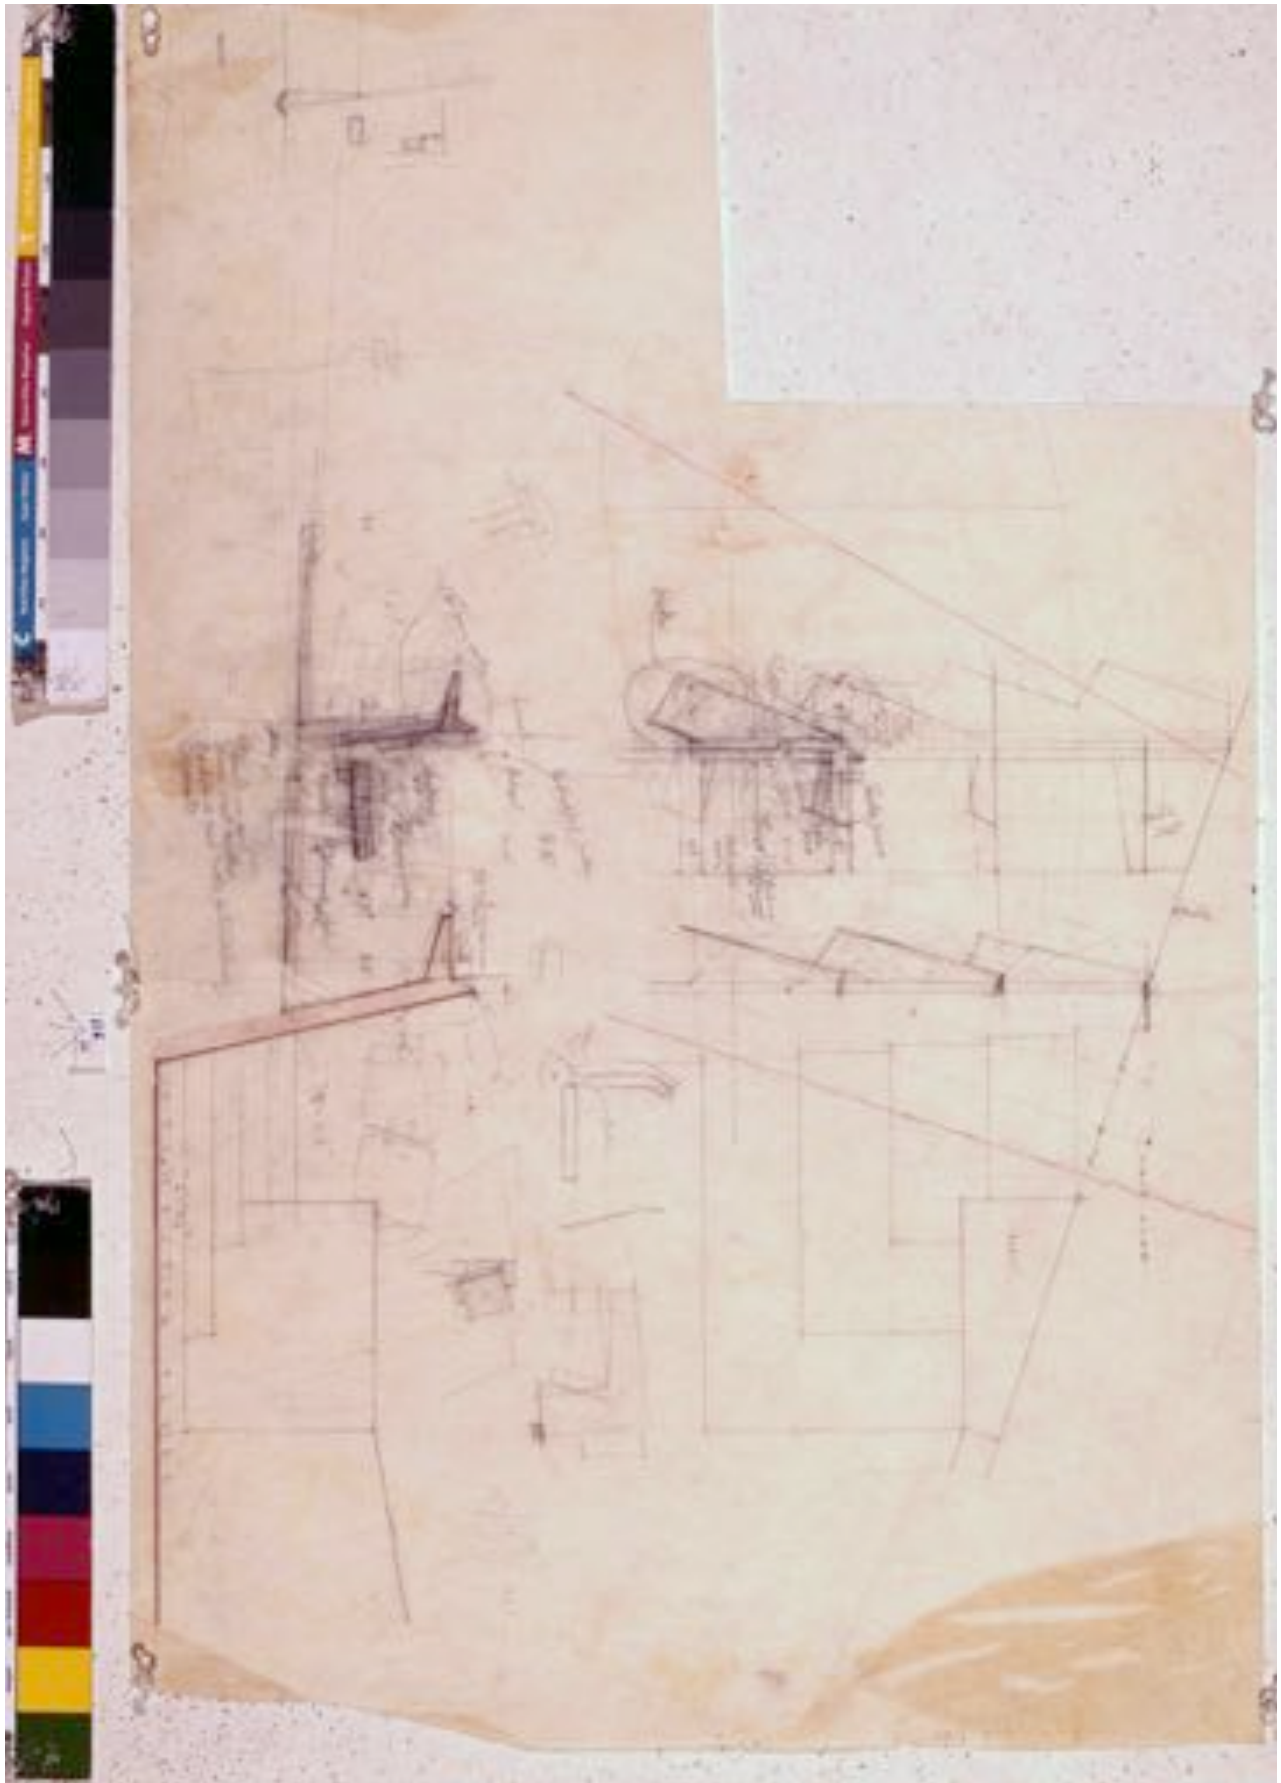
Figure B-86 - Cabaret Seating Detail (The Frank Lloyd Wright Foundation Archives, The Museum of Modern Art | Avery Architectural & Fine Arts Library, Columbia University, New York).

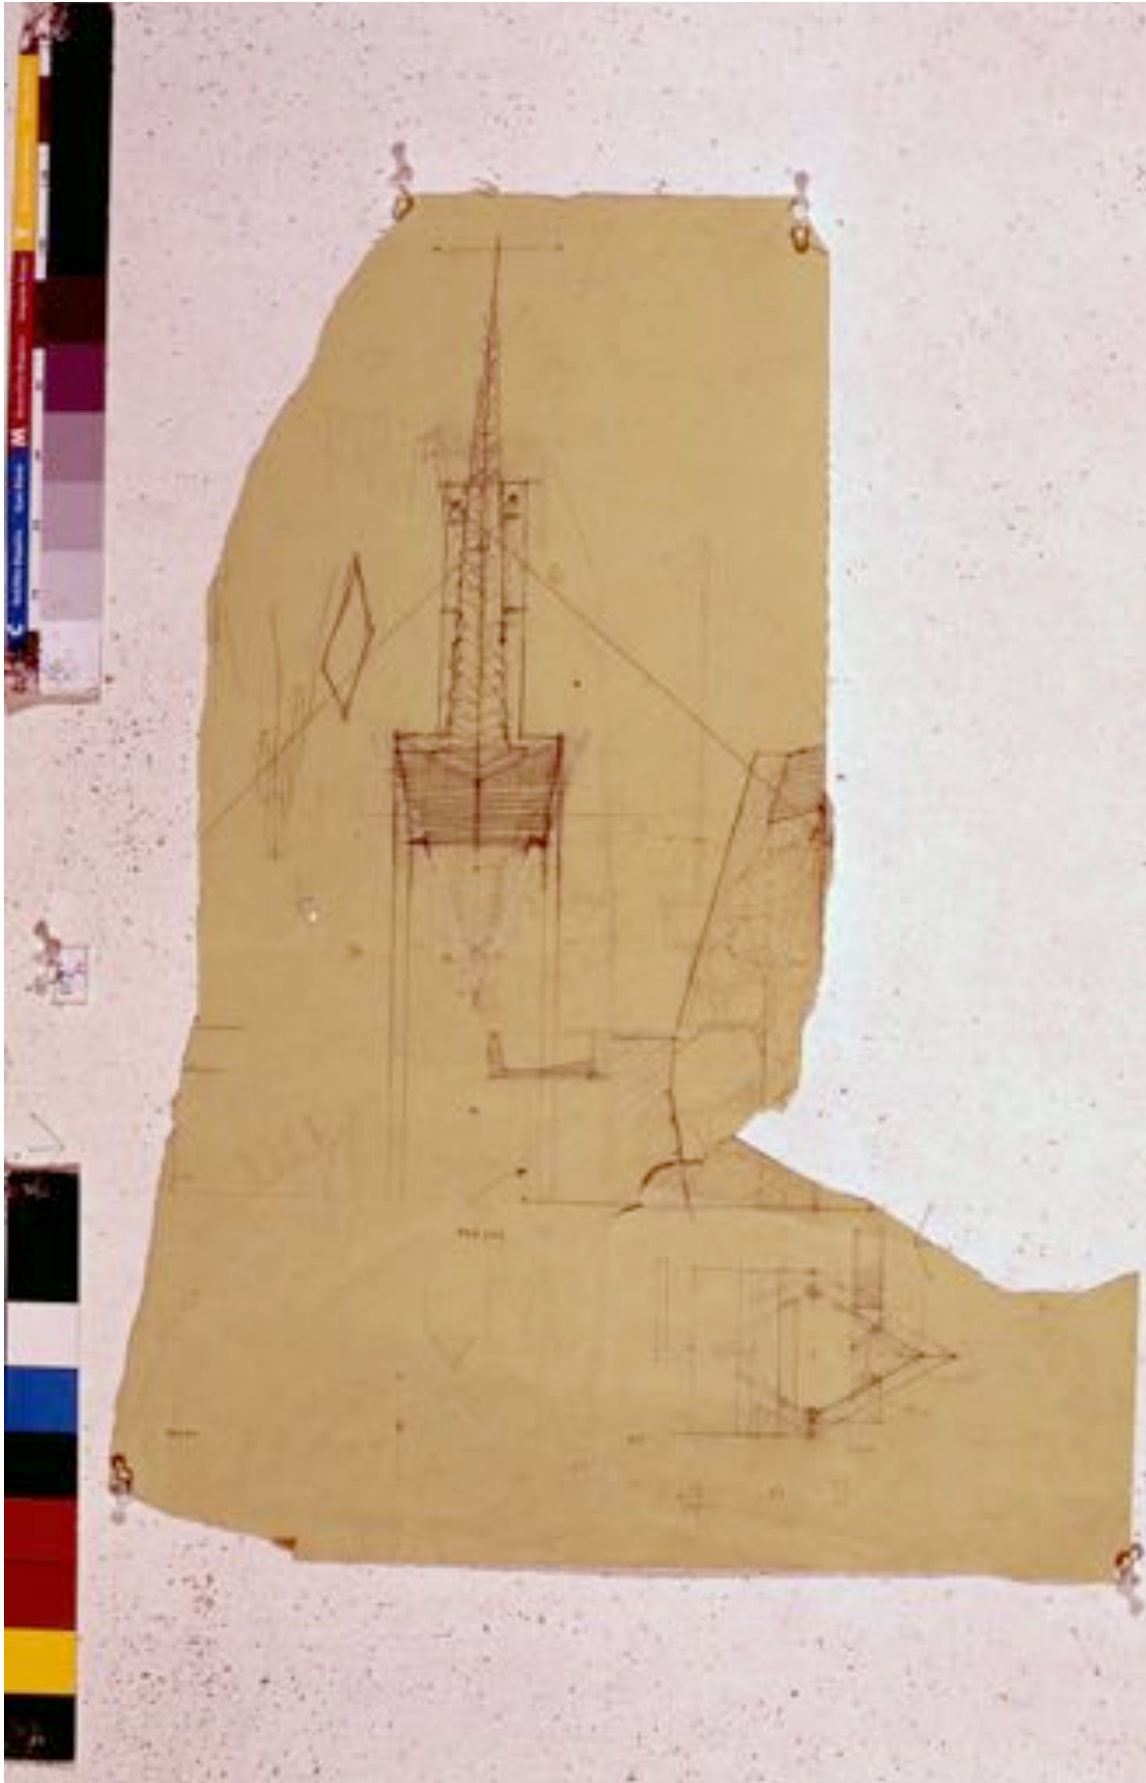
Figure B-87 - Water Tower Plan/Elevation (The Frank Lloyd Wright Foundation Archives, The Museum of Modern Art | Avery Architectural & Fine Arts Library, Columbia University, New York).

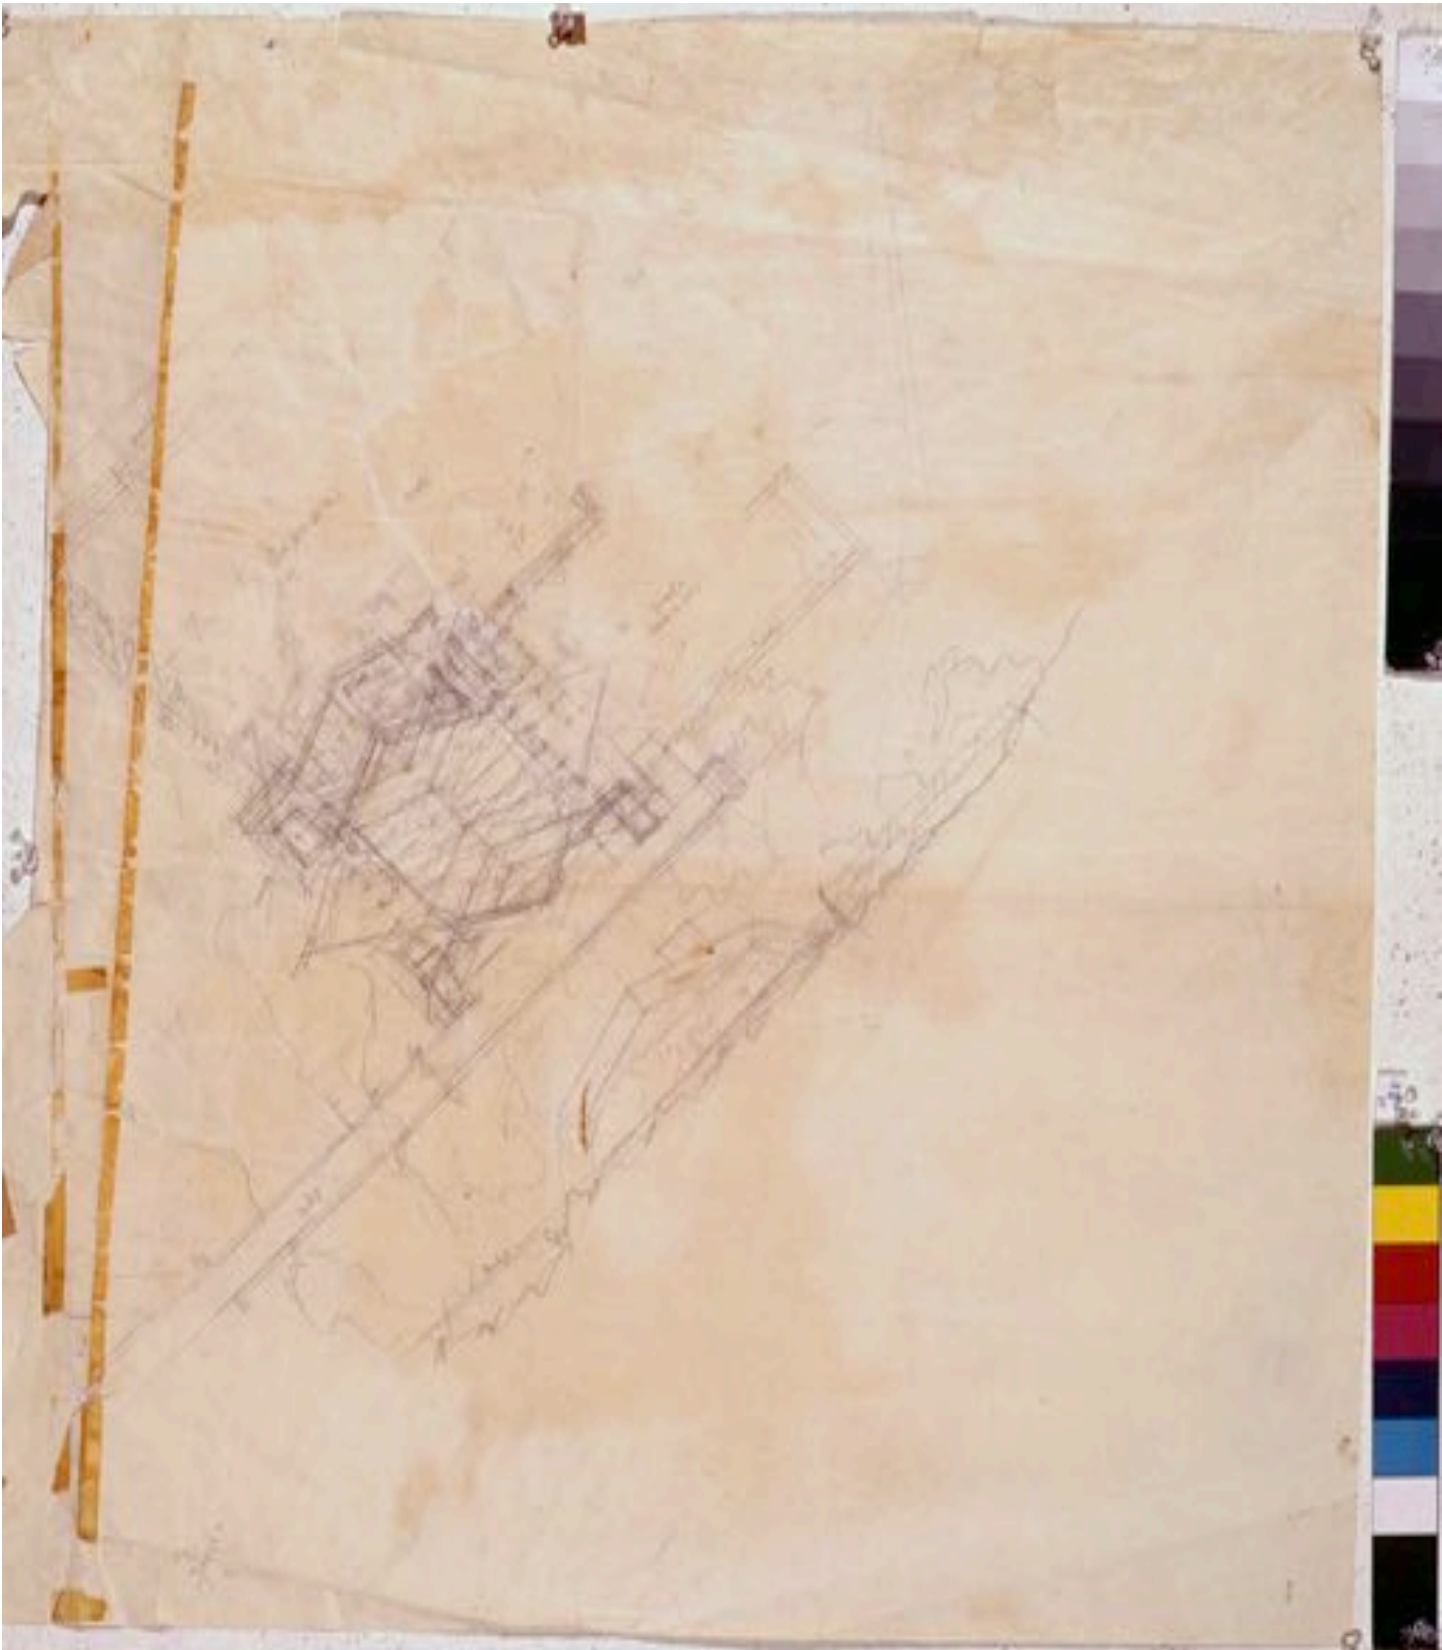
Figure B-88 - Dance Temple (Pavilion) Plan/Elevation (The Frank Lloyd Wright Foundation Archives, The Museum of Modern Art | Avery Architectural & Fine Arts Library, Columbia University, New York).

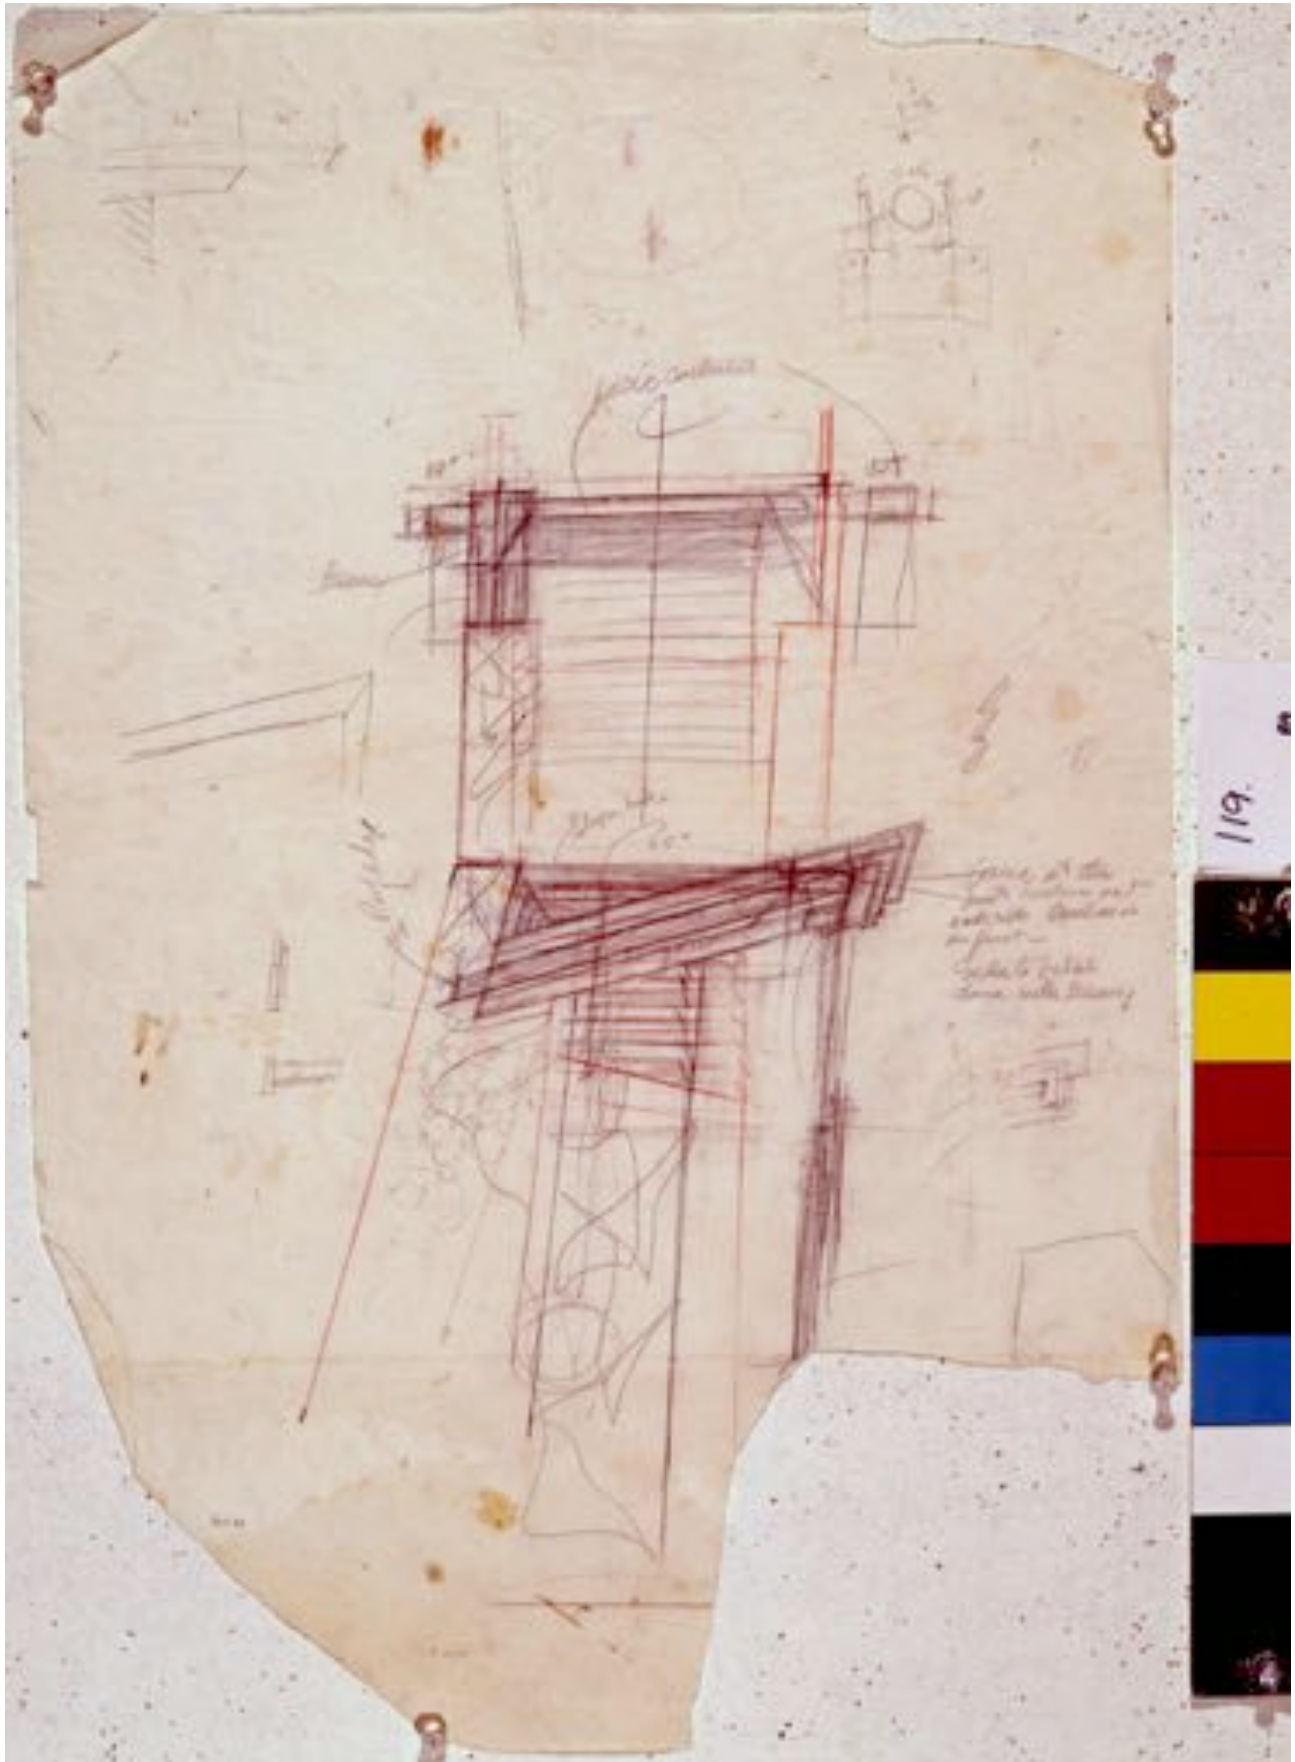
Figure B-89 - Water Tower Elevation (The Frank Lloyd Wright Foundation Archives, The Museum of Modern Art | Avery Architectural & Fine Arts Library, Columbia University, New York).

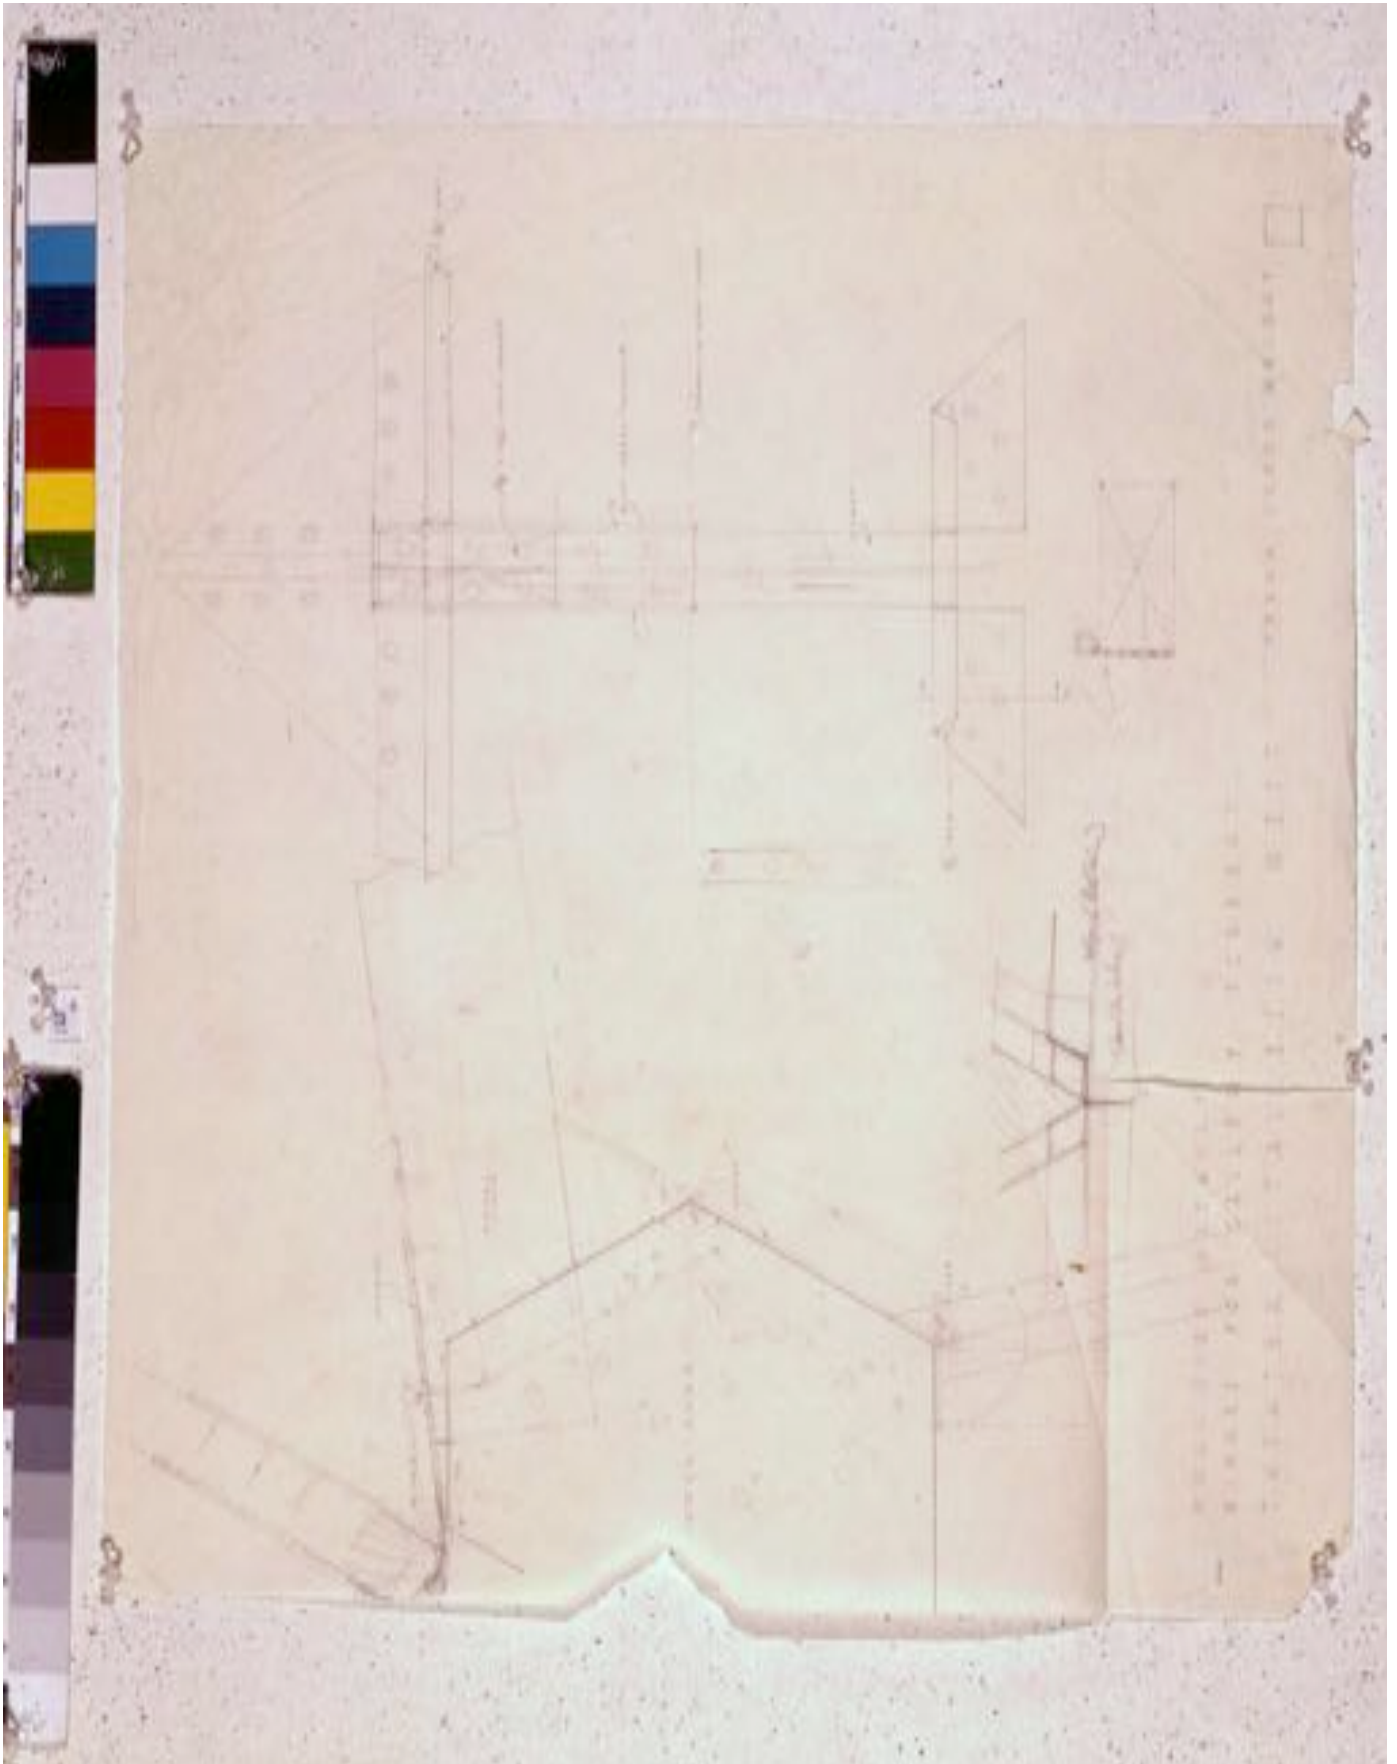
Figure B-90 - Cabaret Hinges/Screen (The Frank Lloyd Wright Foundation Archives, The Museum of Modern Art | Avery Architectural & Fine Arts Library, Columbia University, New York).

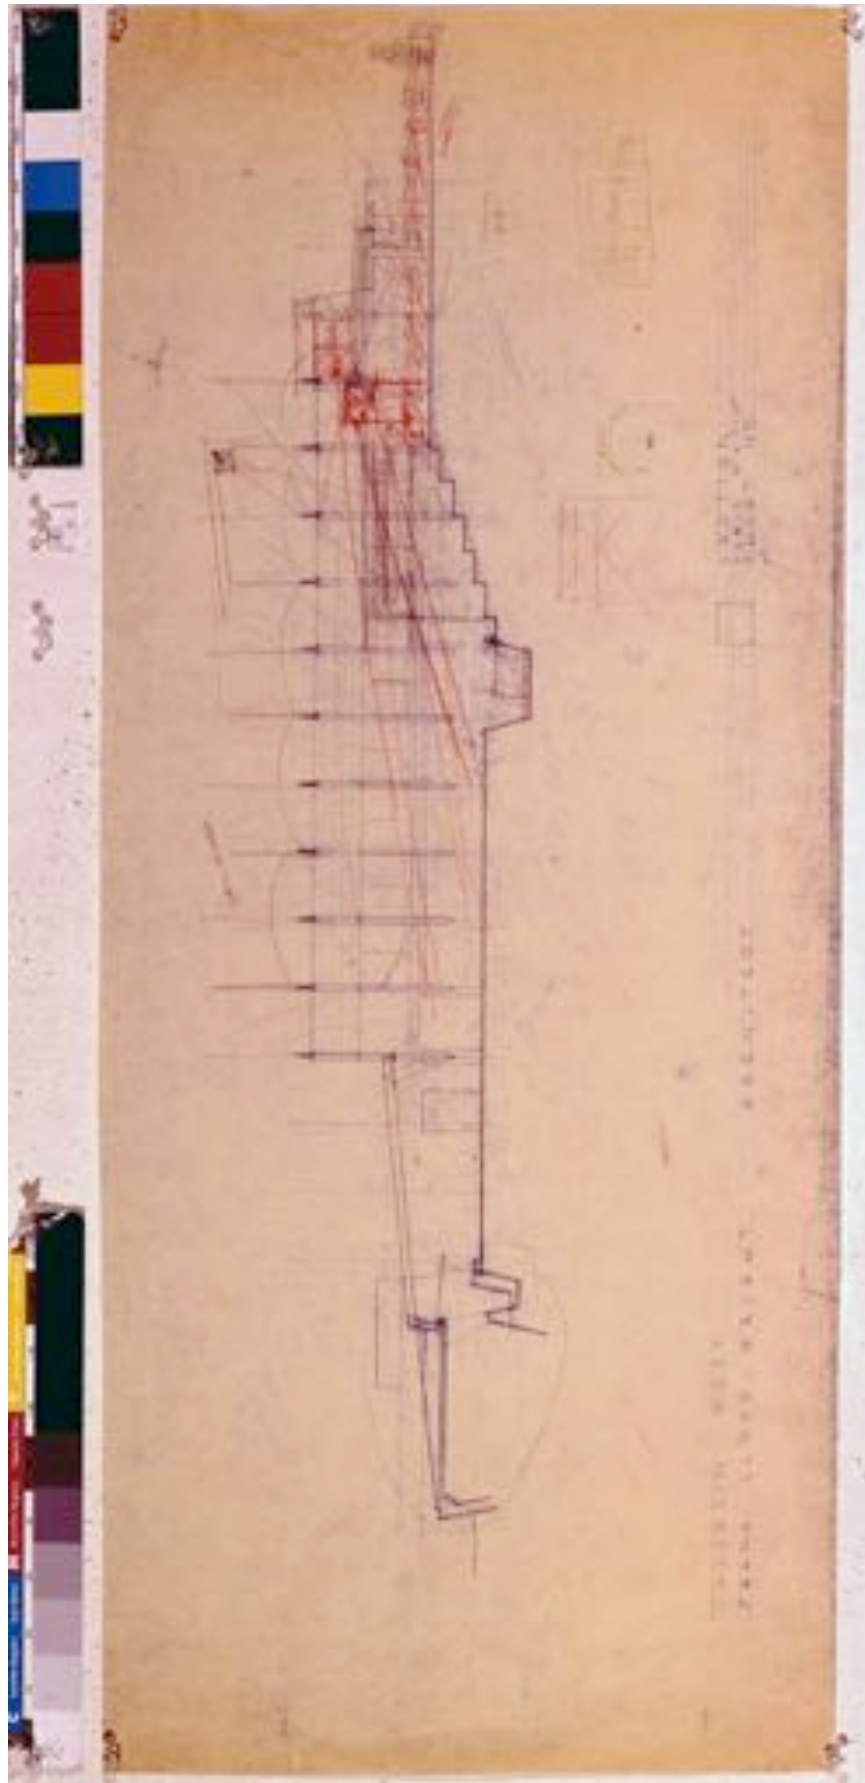
Figure B-91 - Pavilion Longitudinal Section (The Frank Lloyd Wright Foundation Archives, The Museum of Modern Art | Avery Architectural & Fine Arts Library, Columbia University, New York).

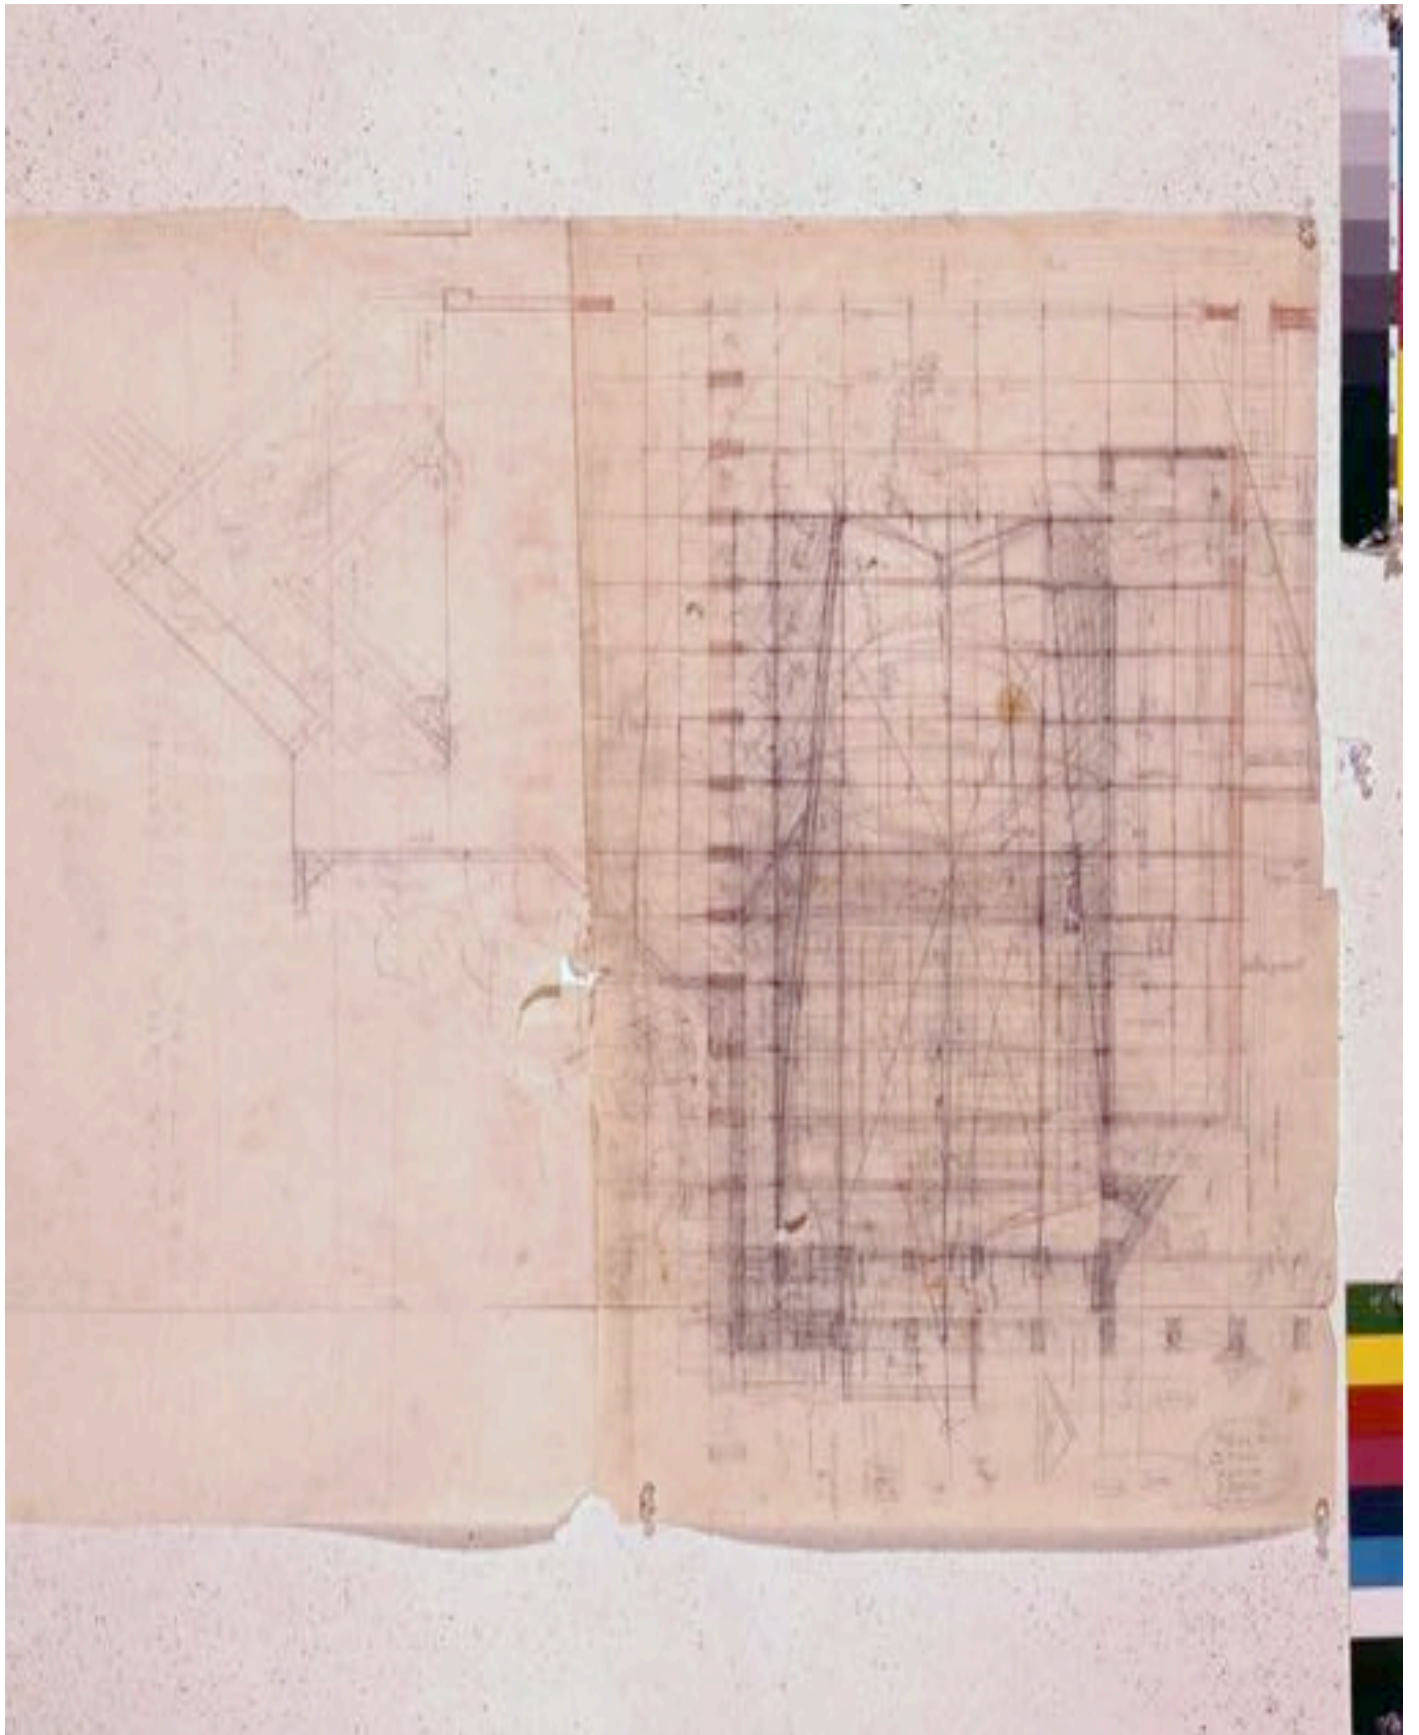
Figure B-92 - Pavilion Plan (The Frank Lloyd Wright Foundation Archives, The Museum of Modern Art | Avery Architectural & Fine Arts Library, Columbia University, New York).

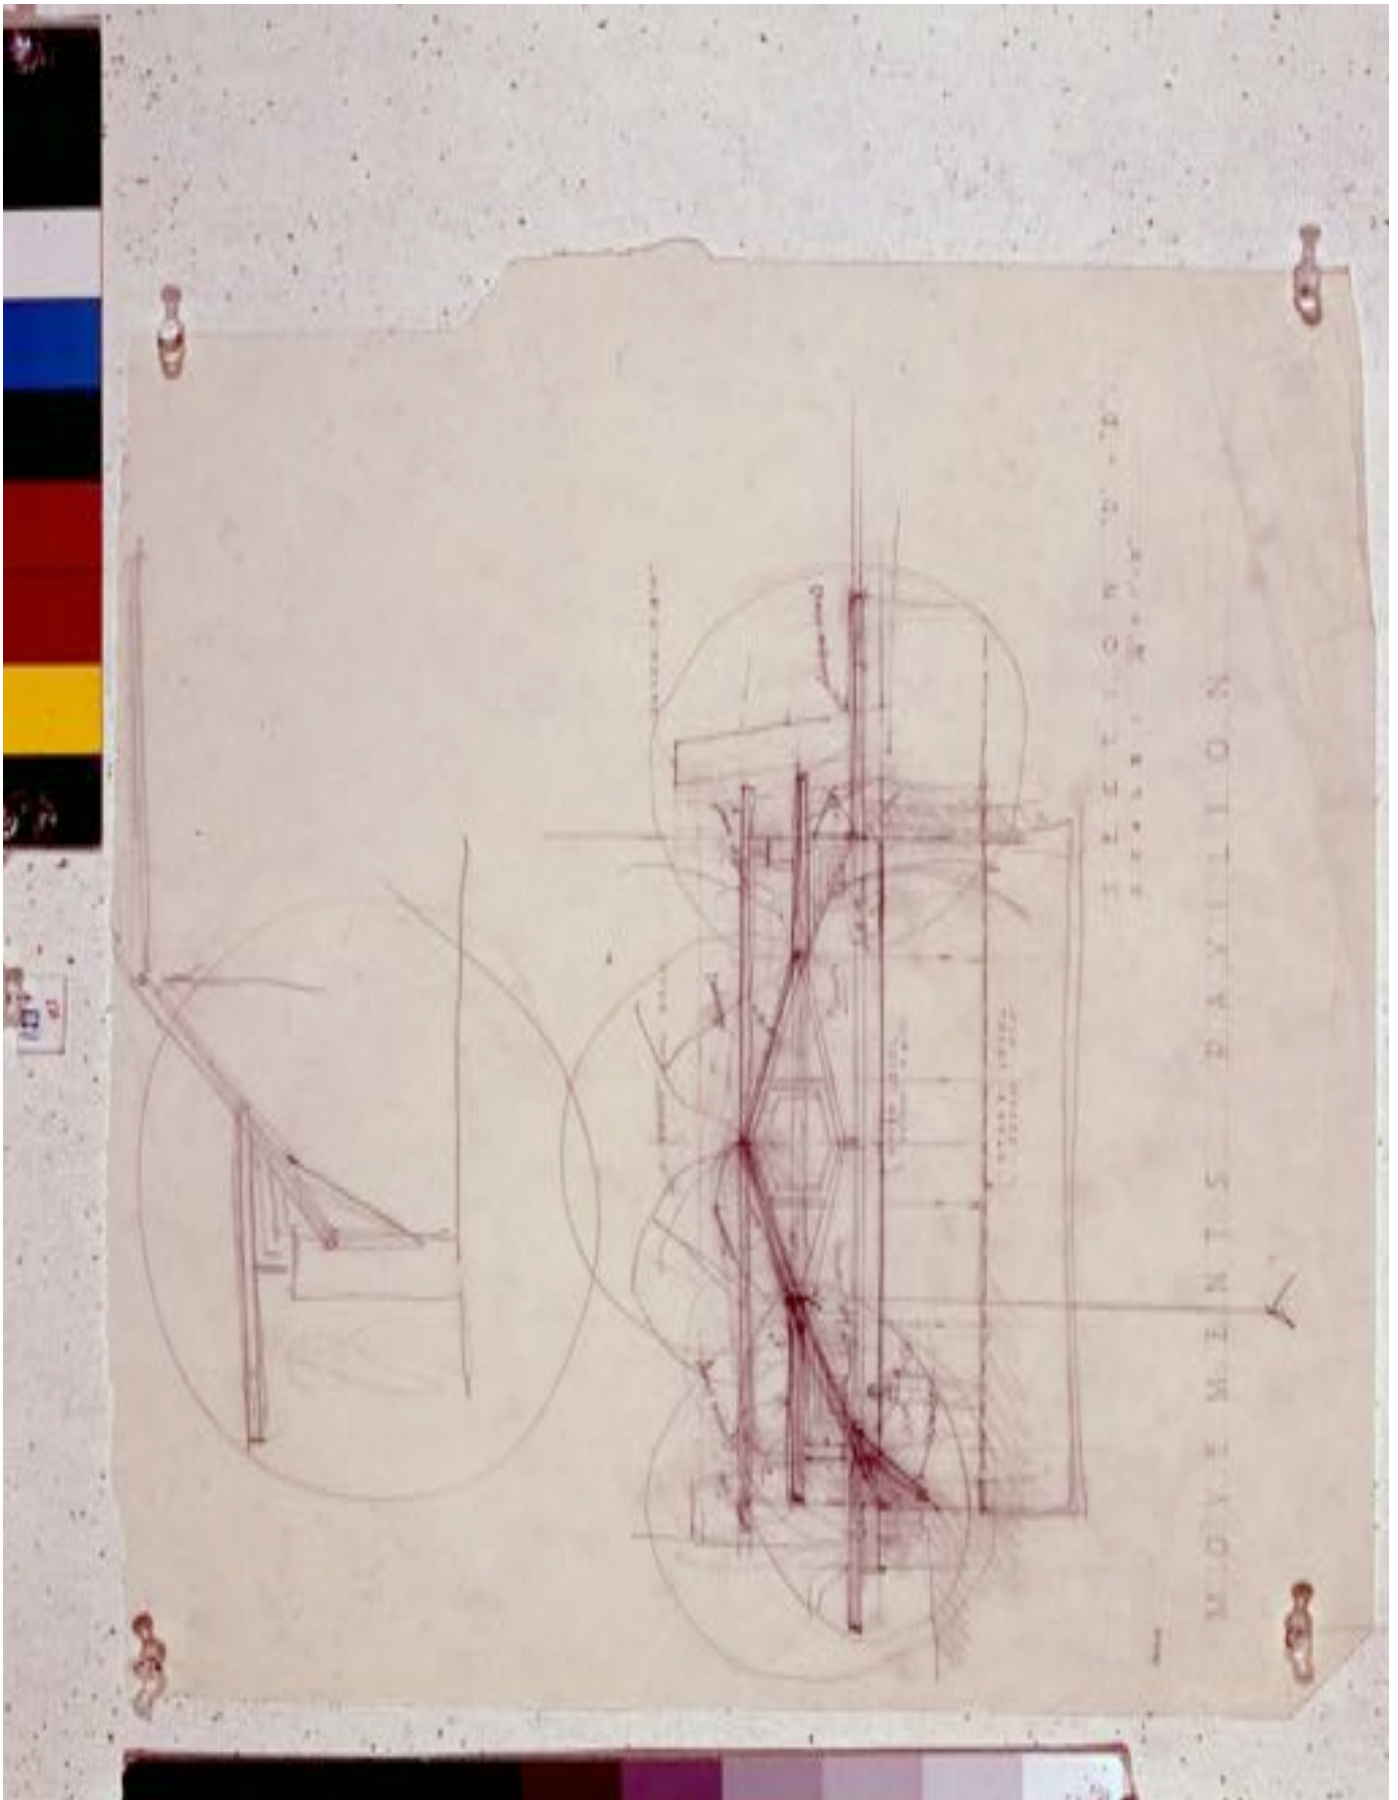
Figure B-93 - Pavilion Section (The Frank Lloyd Wright Foundation Archives, The Museum of Modern Art | Avery Architectural & Fine Arts Library, Columbia University, New York).

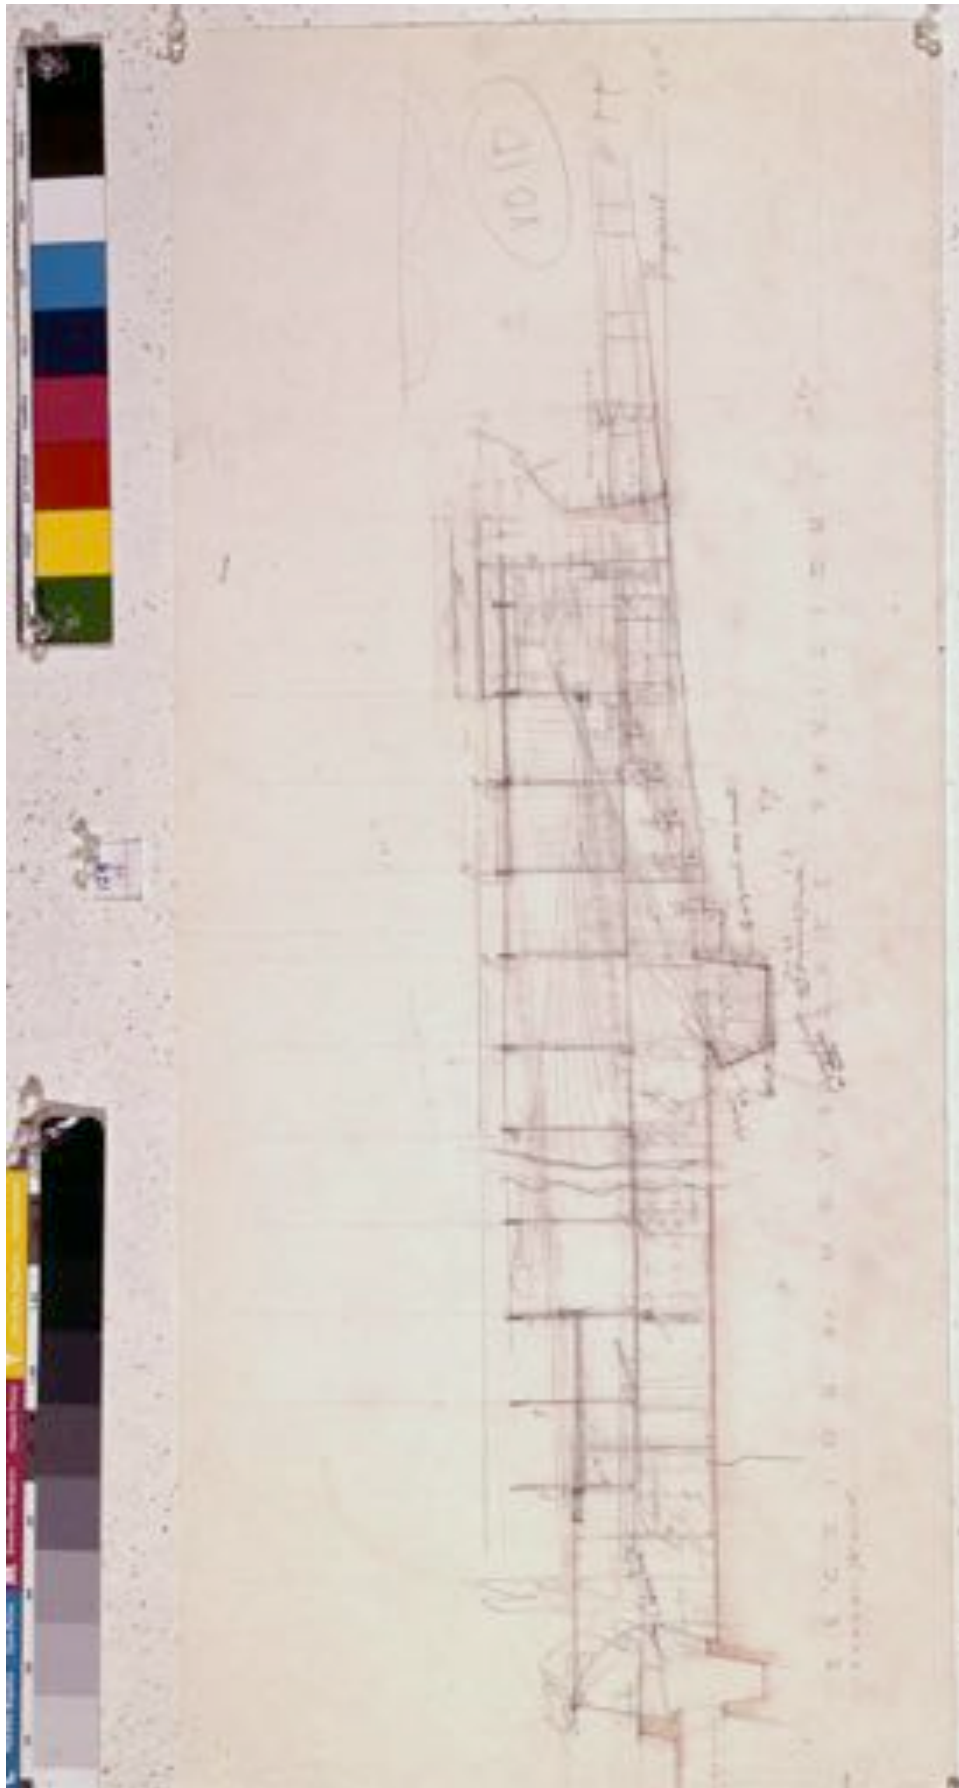
Figure B-94 - Pavilion Section (The Frank Lloyd Wright Foundation Archives, The Museum of Modern Art | Avery Architectural & Fine Arts Library, Columbia University, New York).
