TALIESIN WEST PRESERVATION MASTER PLAN

Harboe Architects, PC

MAY 21, 2015

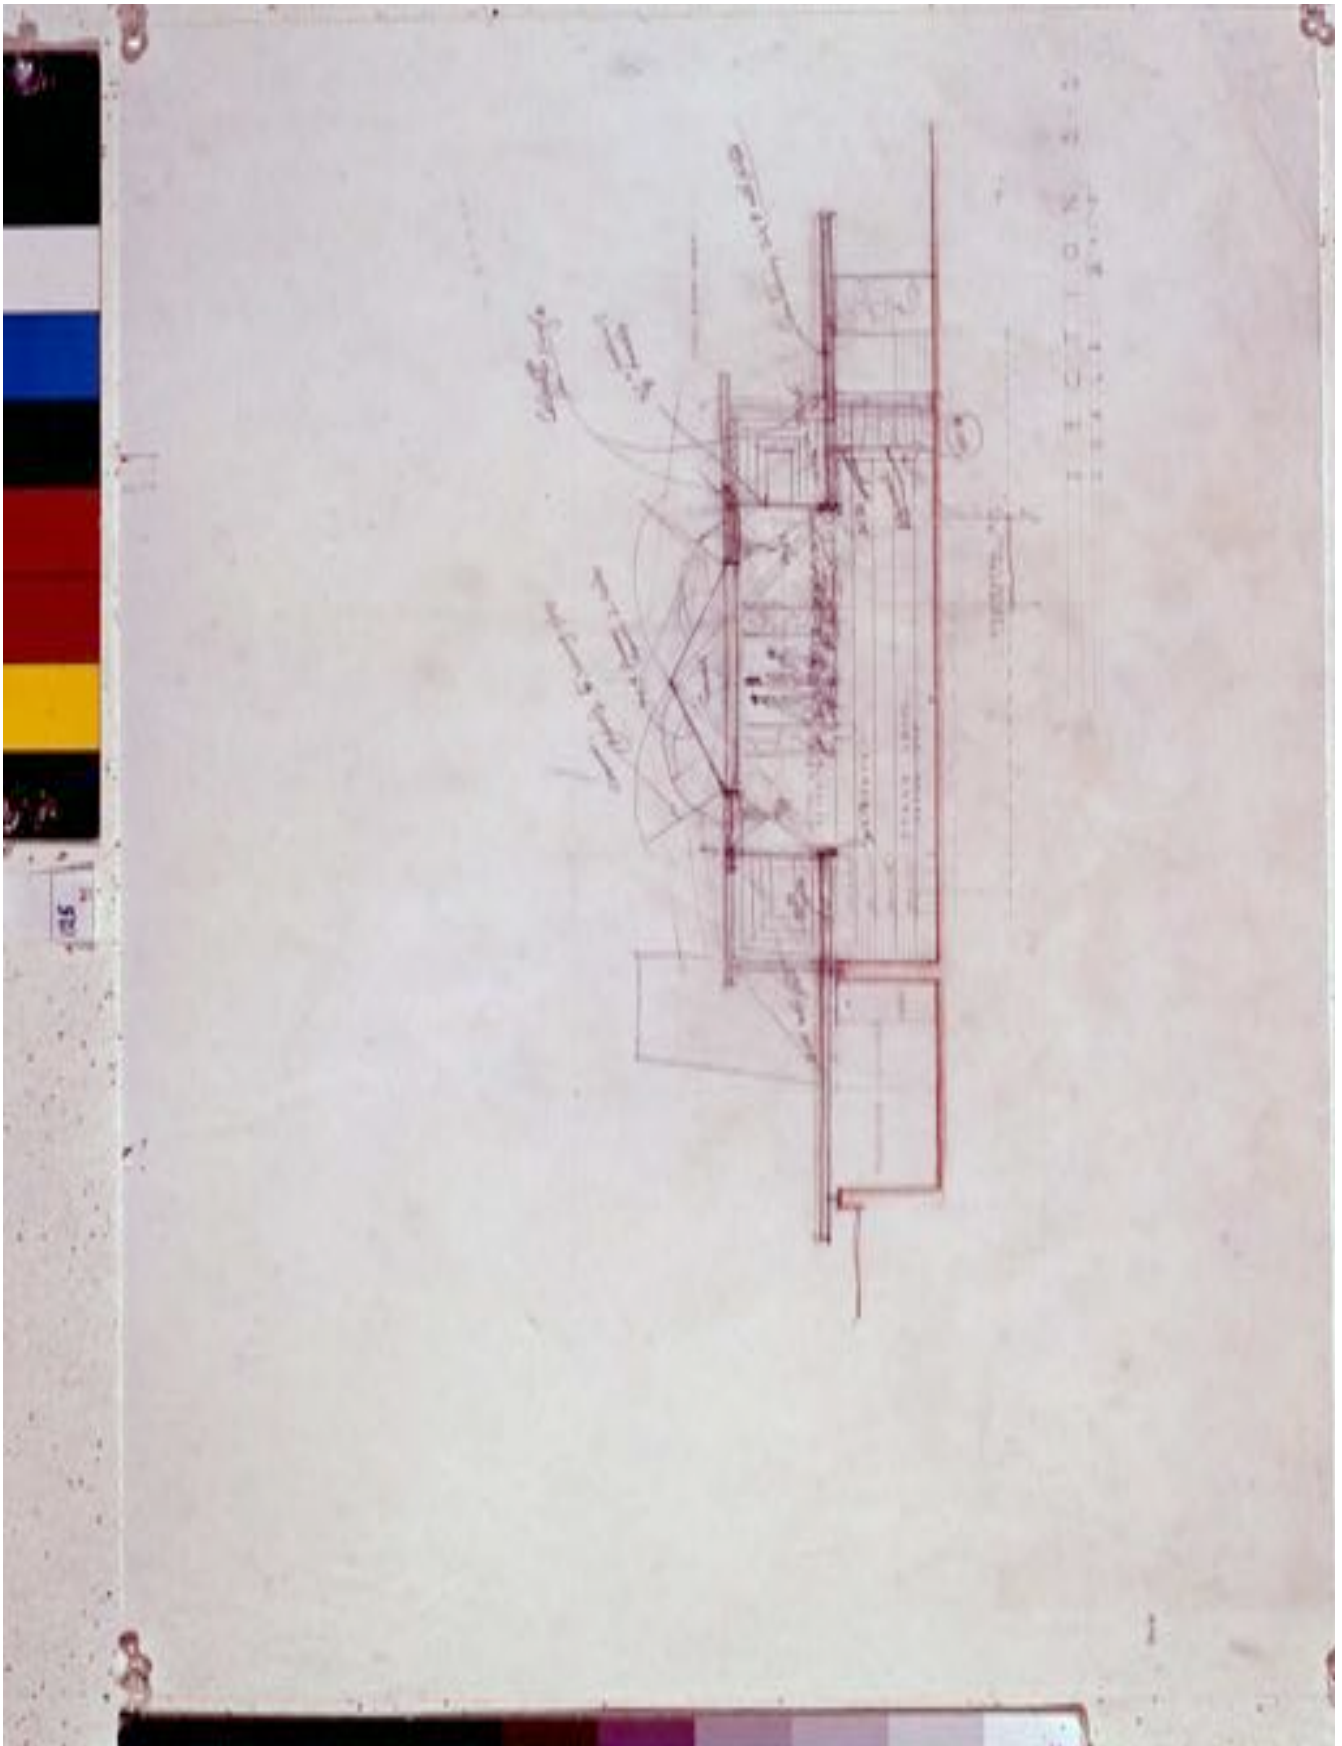
Figure B-95 - Pavilion Cross Section (The Frank Lloyd Wright Foundation Archives, The Museum of Modern Art | Avery Architectural & Fine Arts Library, Columbia University, New York).

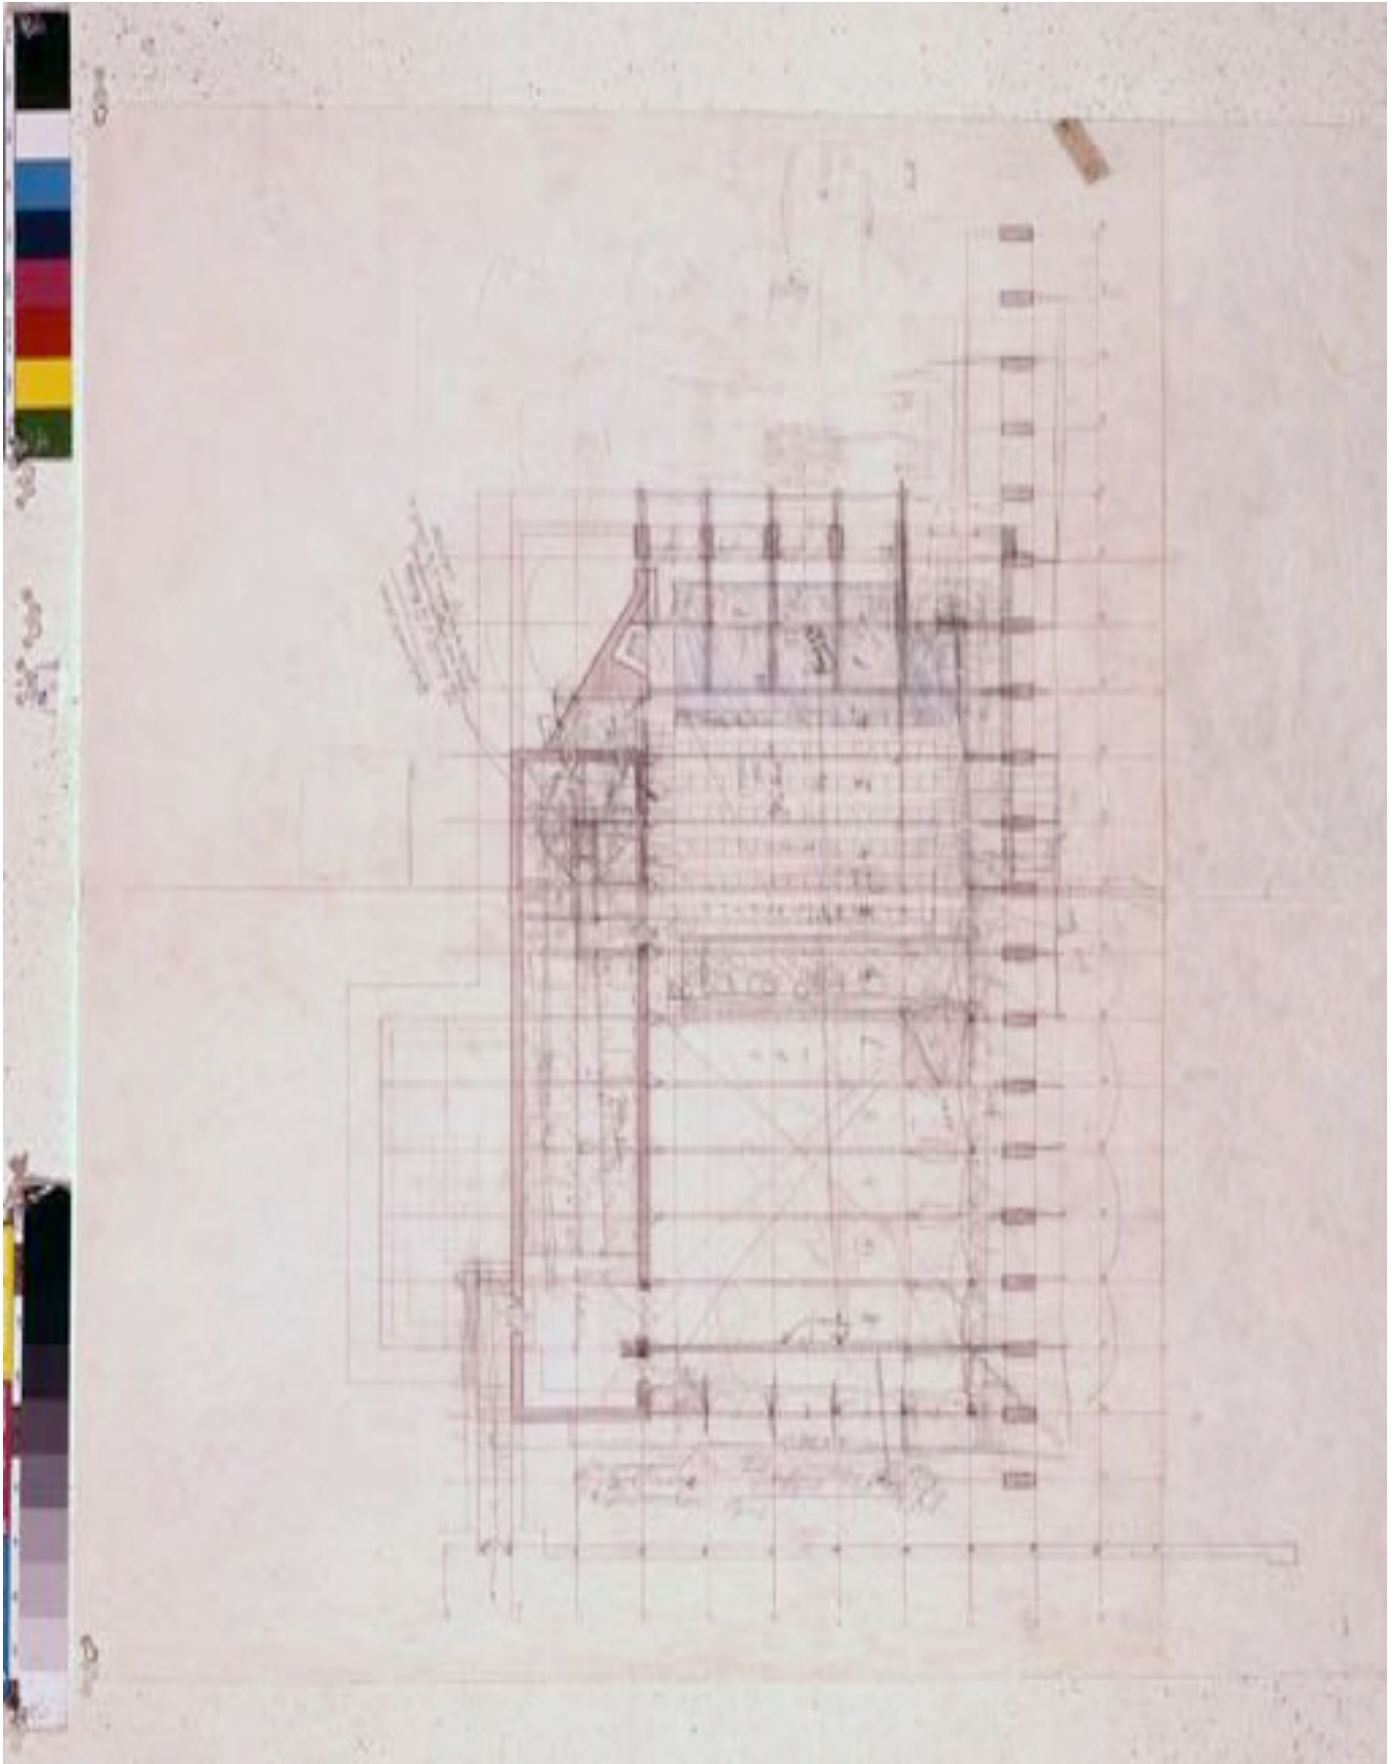
Figure B-96 - Pavilion Plan (The Frank Lloyd Wright Foundation Archives, The Museum of Modern Art | Avery Architectural & Fine Arts Library, Columbia University, New York).

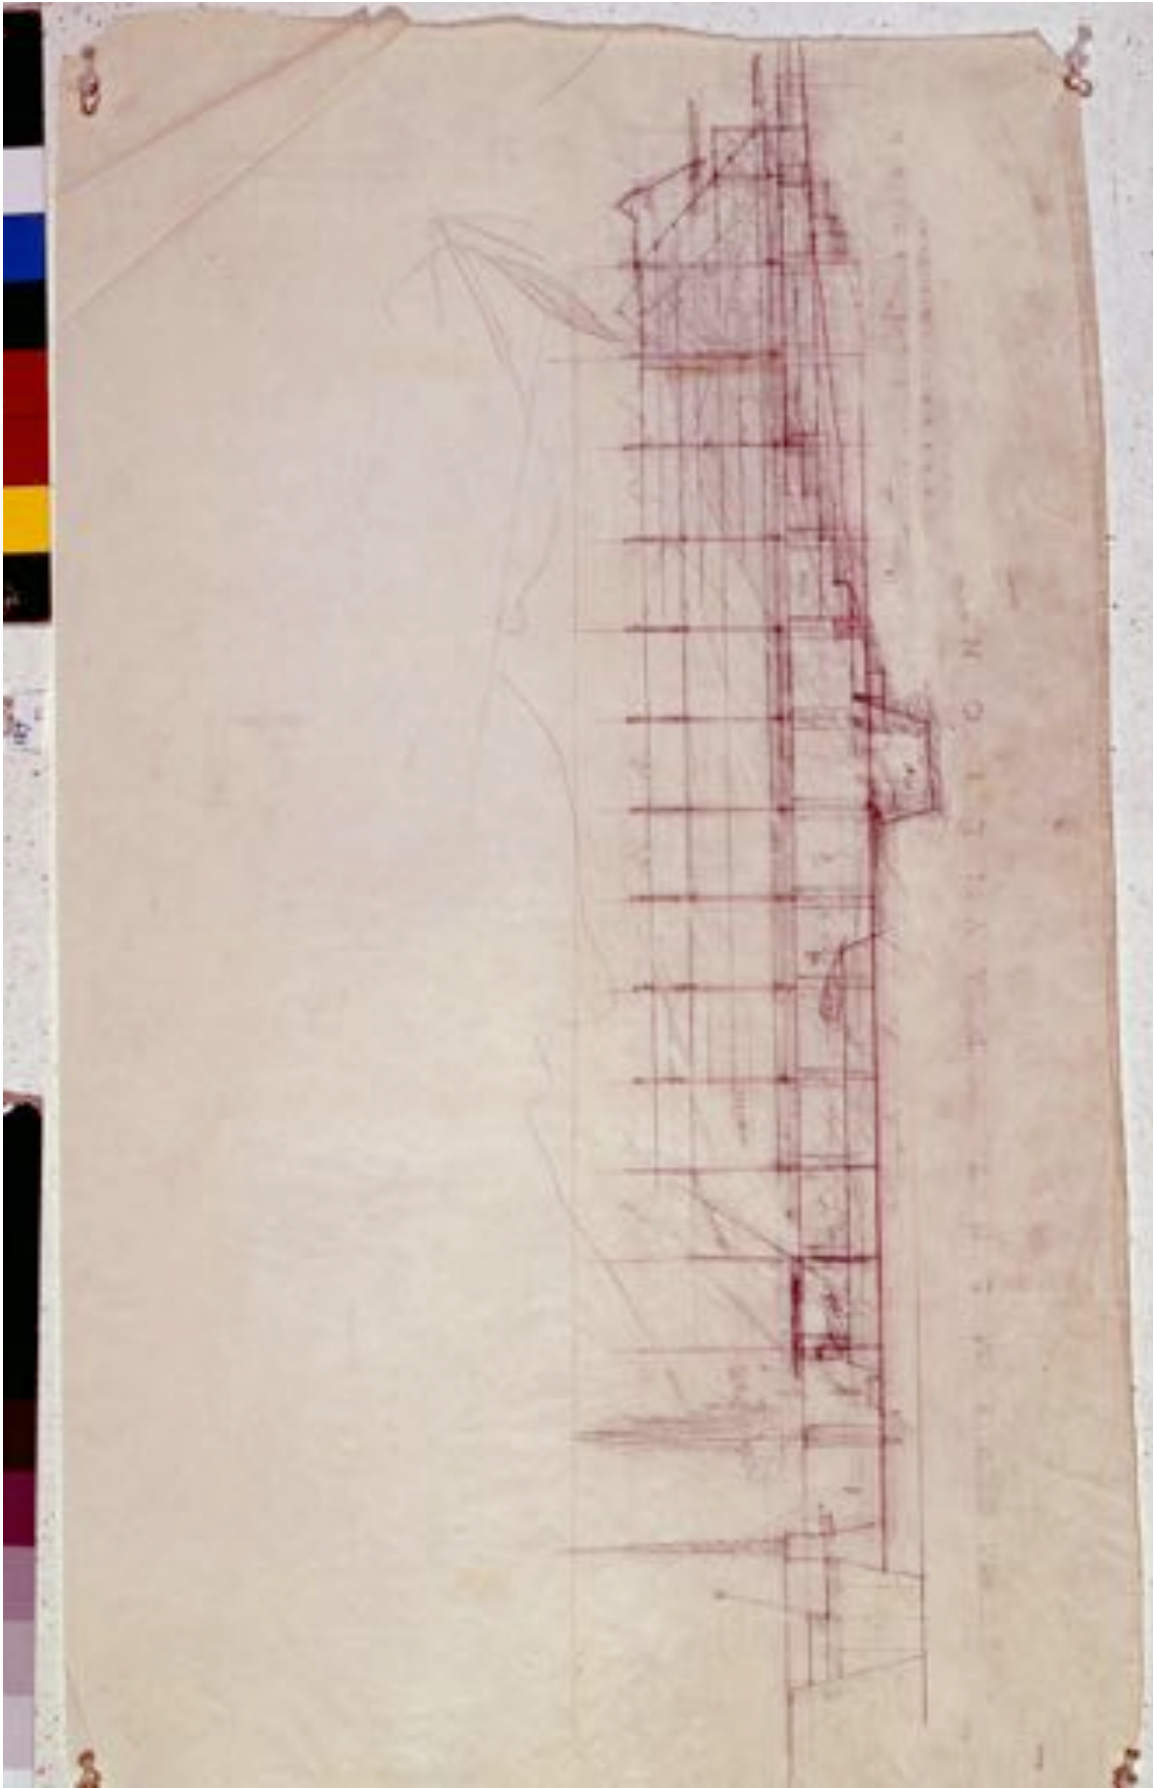
Figure B-97 - Pavilion Longitudinal Section (The Frank Lloyd Wright Foundation Archives, The Museum of Modern Art | Avery Architectural & Fine Arts Library, Columbia University, New York).

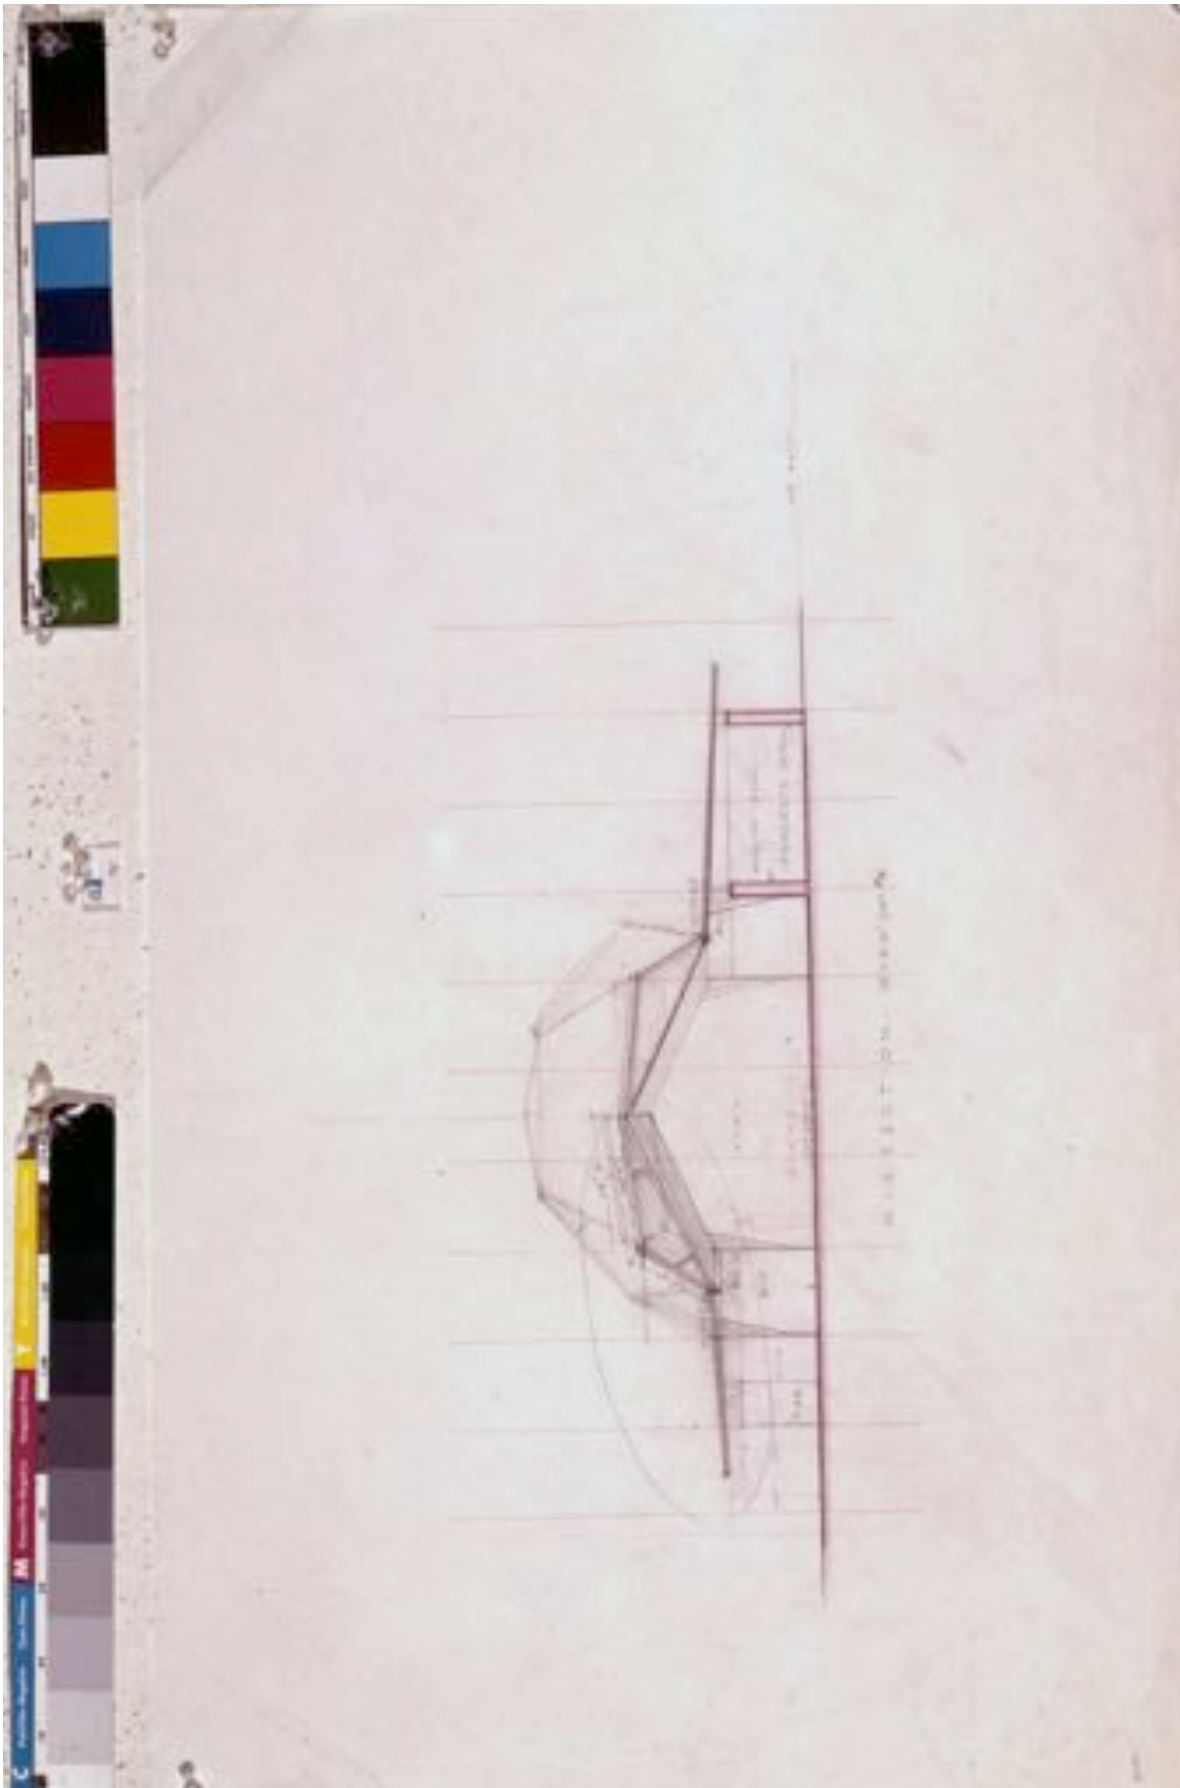
Figure B-98 - Pavilion Cross Section (The Frank Lloyd Wright Foundation Archives, The Museum of Modern Art | Avery Architectural & Fine Arts Library, Columbia University, New York).

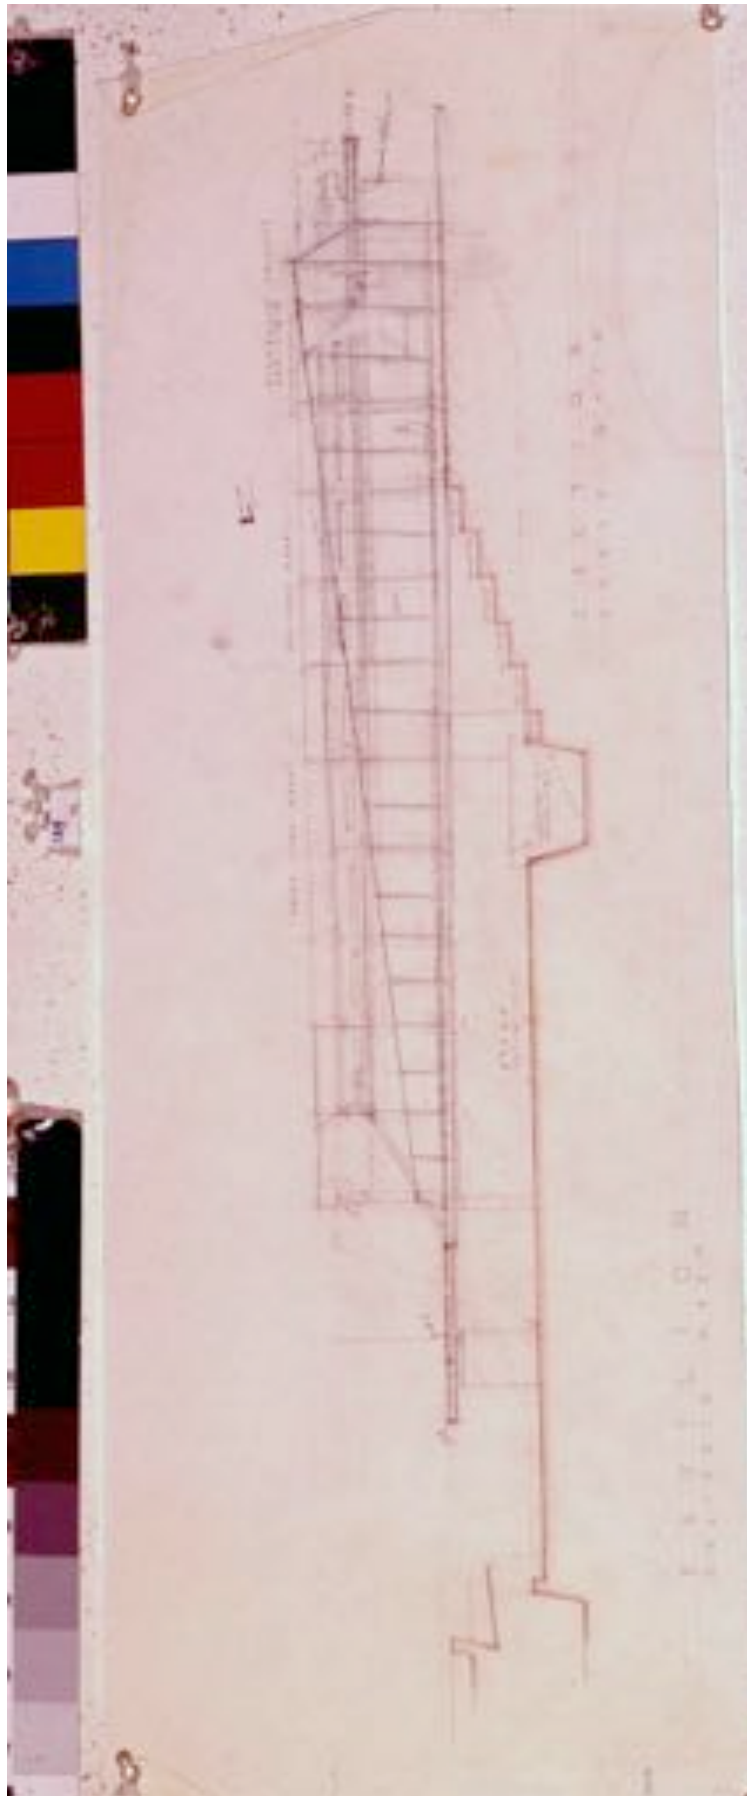
Figure B-99 - Pavilion Longitudinal Section (The Frank Lloyd Wright Foundation Archives, The Museum of Modern Art | Avery Architectural & Fine Arts Library, Columbia University, New York).

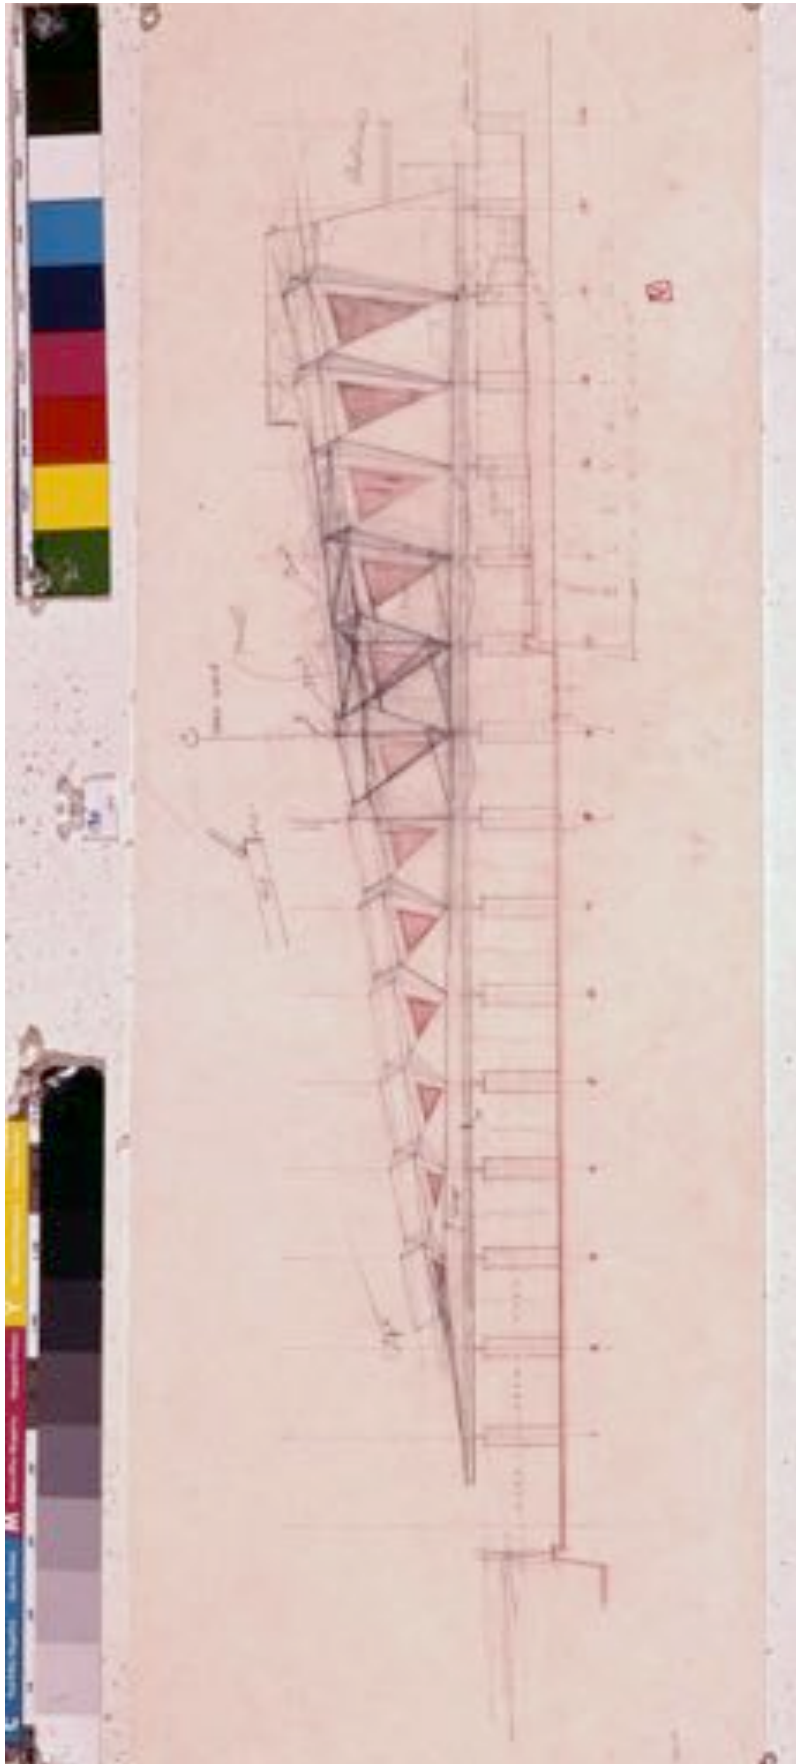
Figure B-100 - Pavilion Roof Elevation (The Frank Lloyd Wright Foundation Archives, The Museum of Modern Art | Avery Architectural & Fine Arts Library, Columbia University, New York).

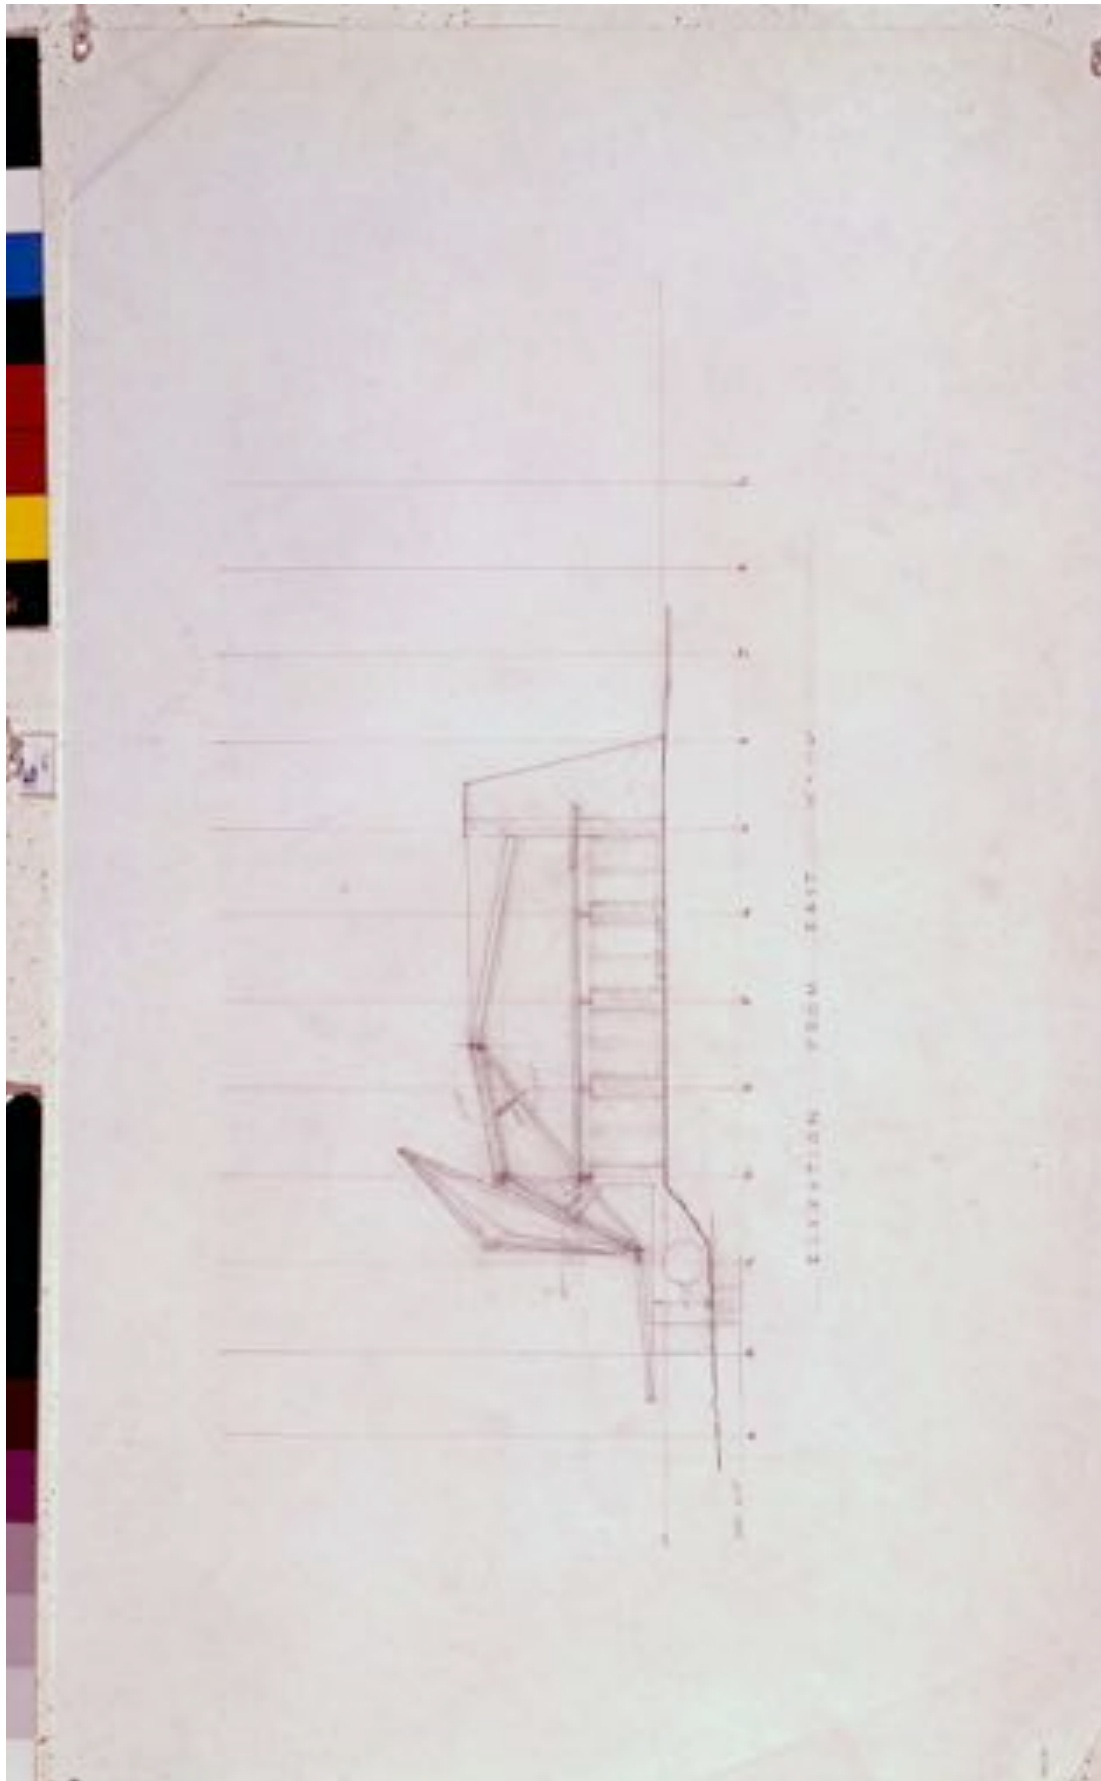
Figure B-102 - Pavilion Roof Open (The Frank Lloyd Wright Foundation Archives, The Museum of Modern Art | Avery Architectural & Fine Arts Library, Columbia University, New York).

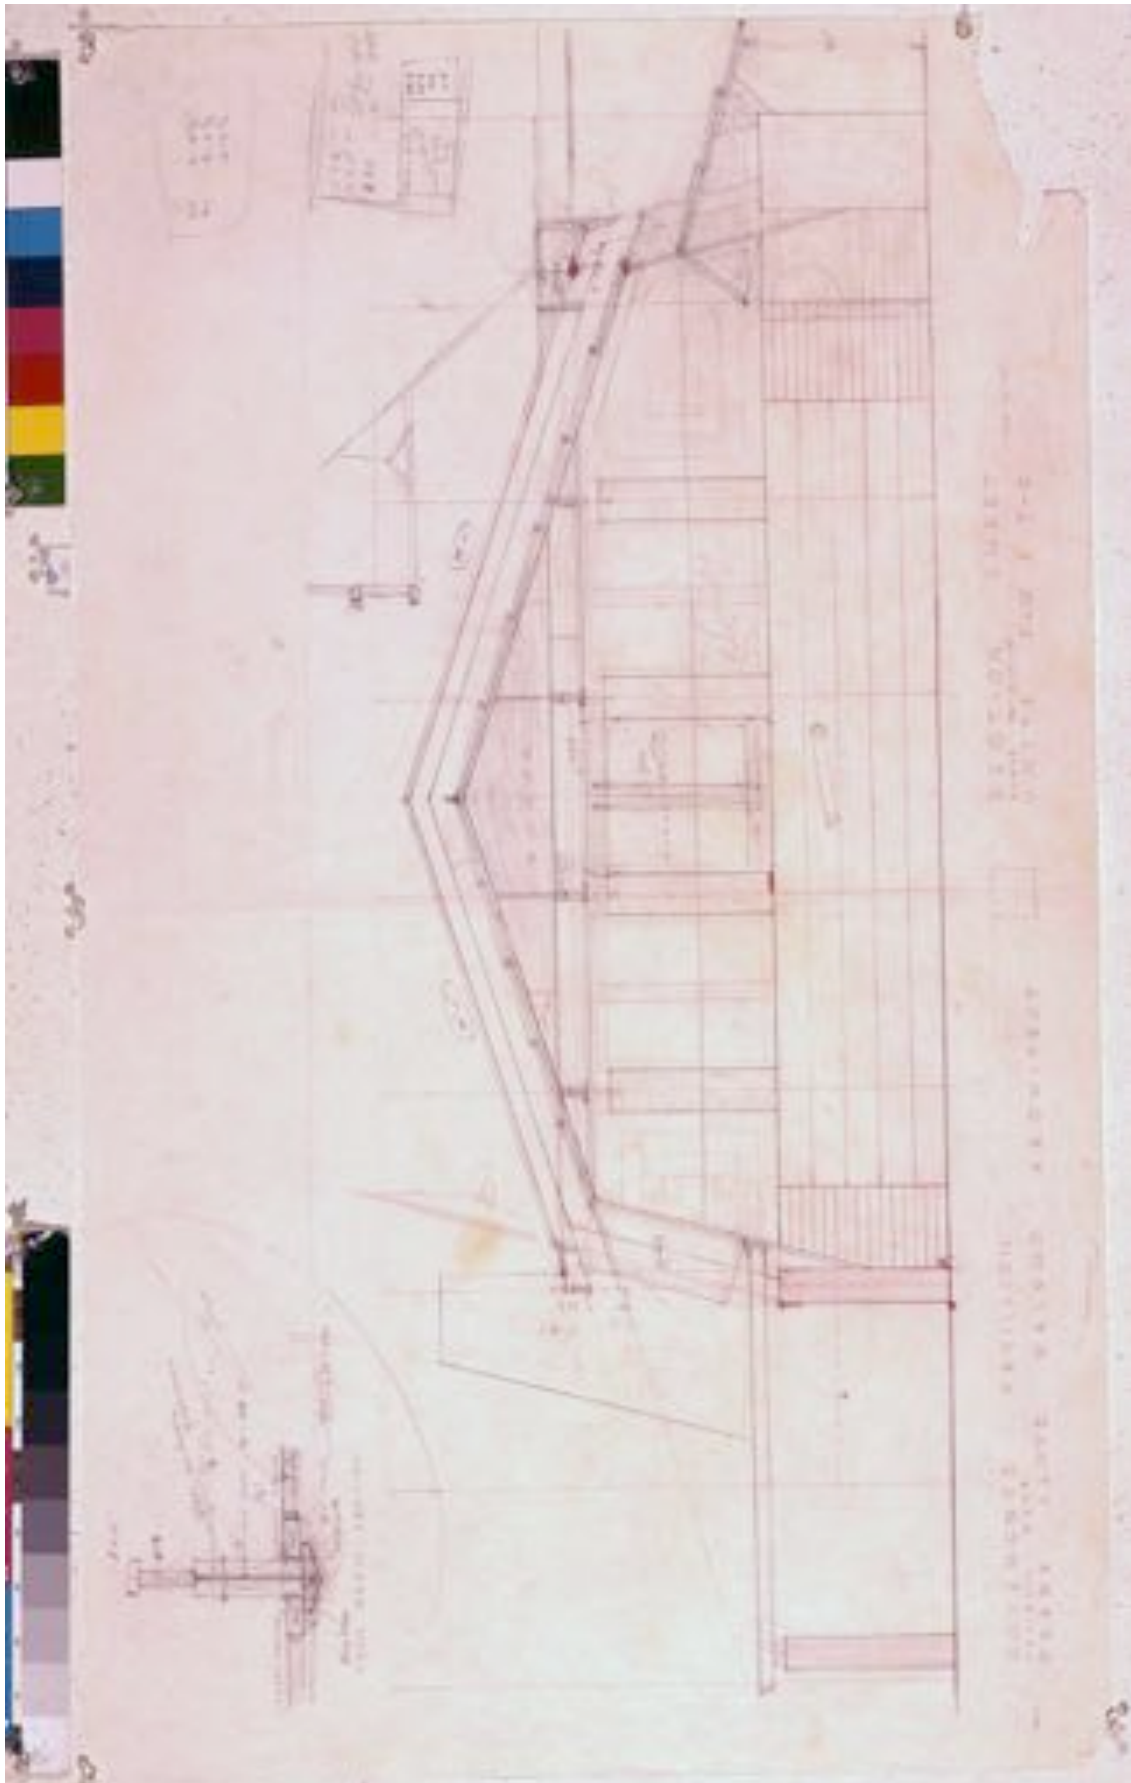
Figure B-103 - Pavilion Cross Section (The Frank Lloyd Wright Foundation Archives, The Museum of Modern Art | Avery Architectural & Fine Arts Library, Columbia University, New York).

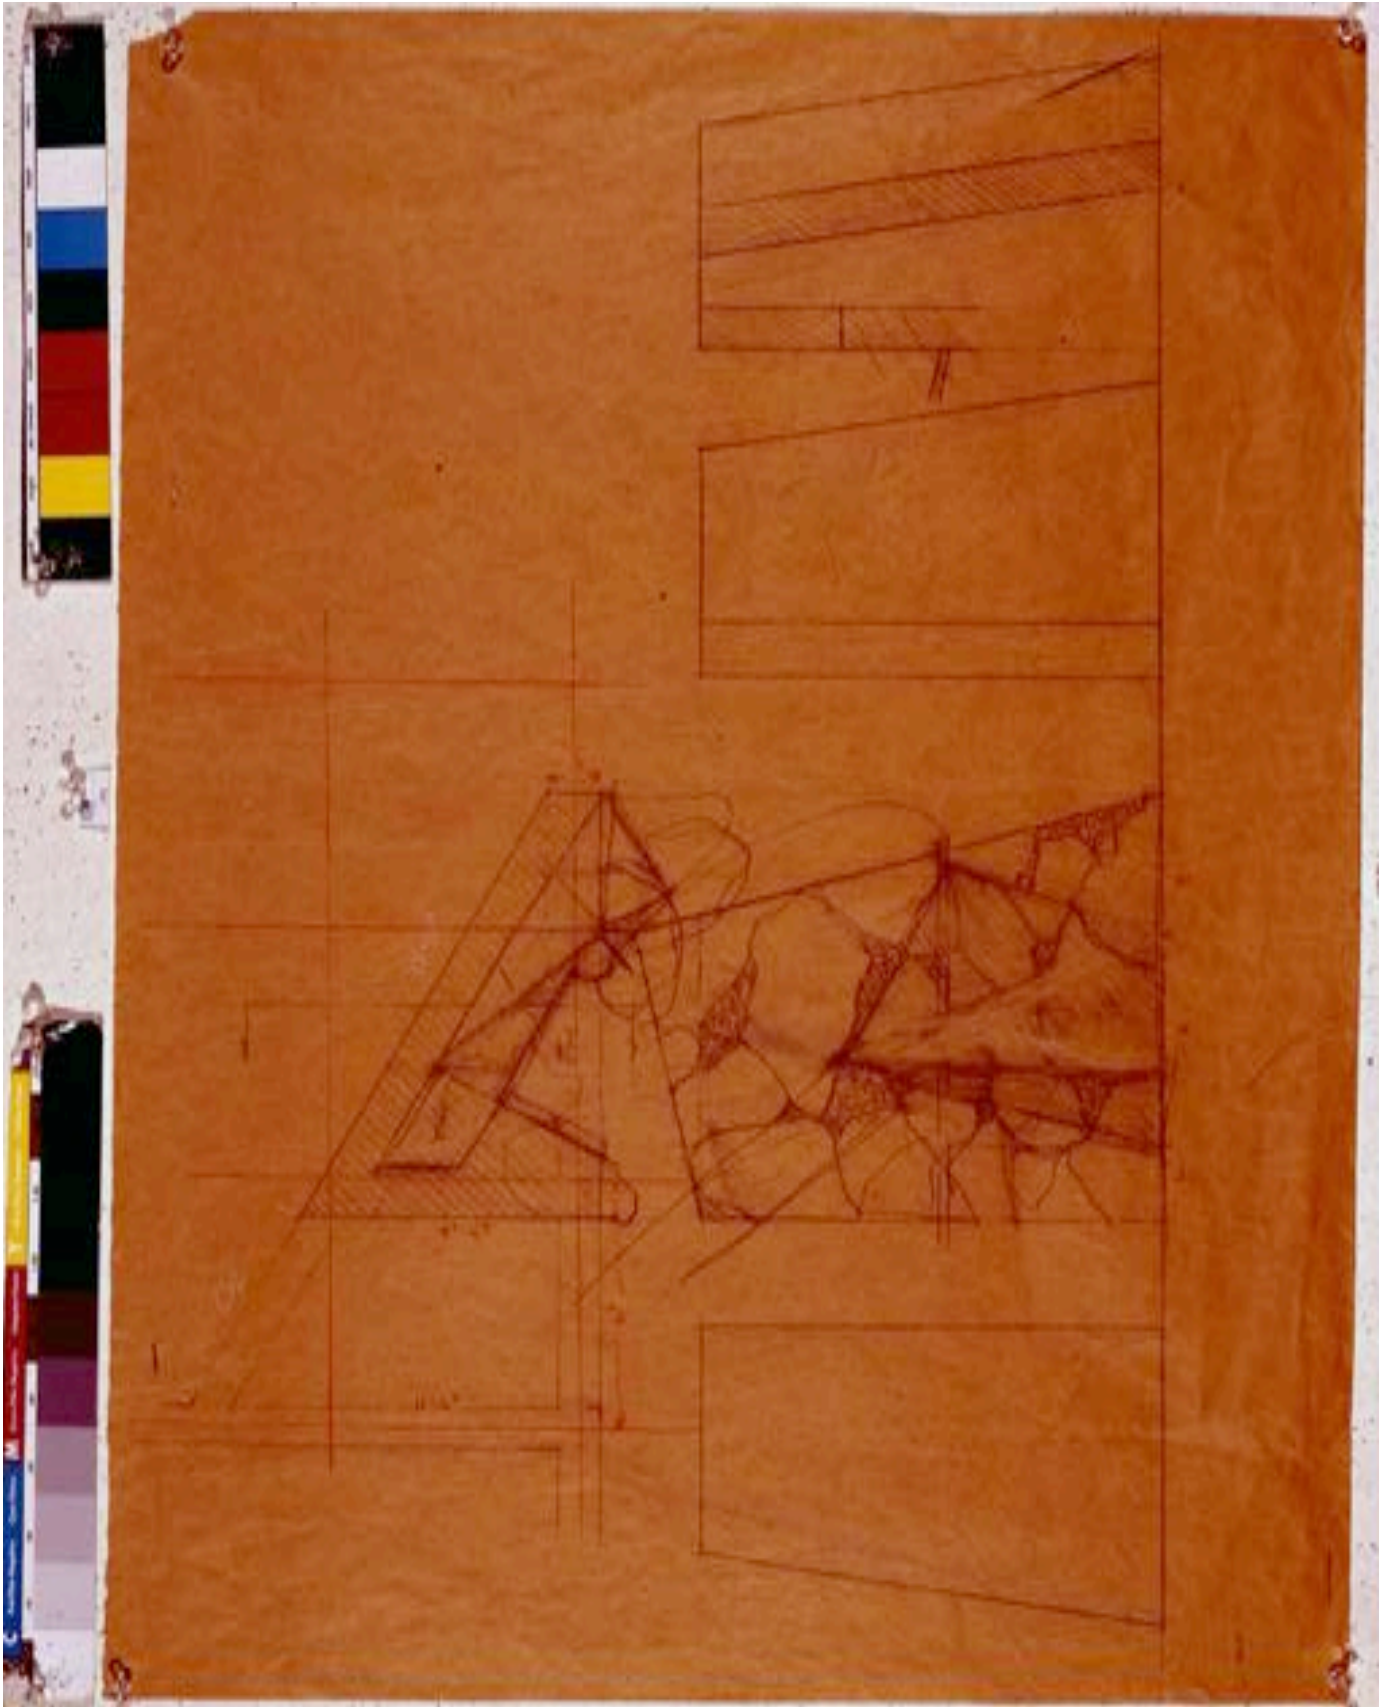
Figure B-104 - Pavilion Fireplace (The Frank Lloyd Wright Foundation Archives, The Museum of Modern Art | Avery Architectural & Fine Arts Library, Columbia University, New York).

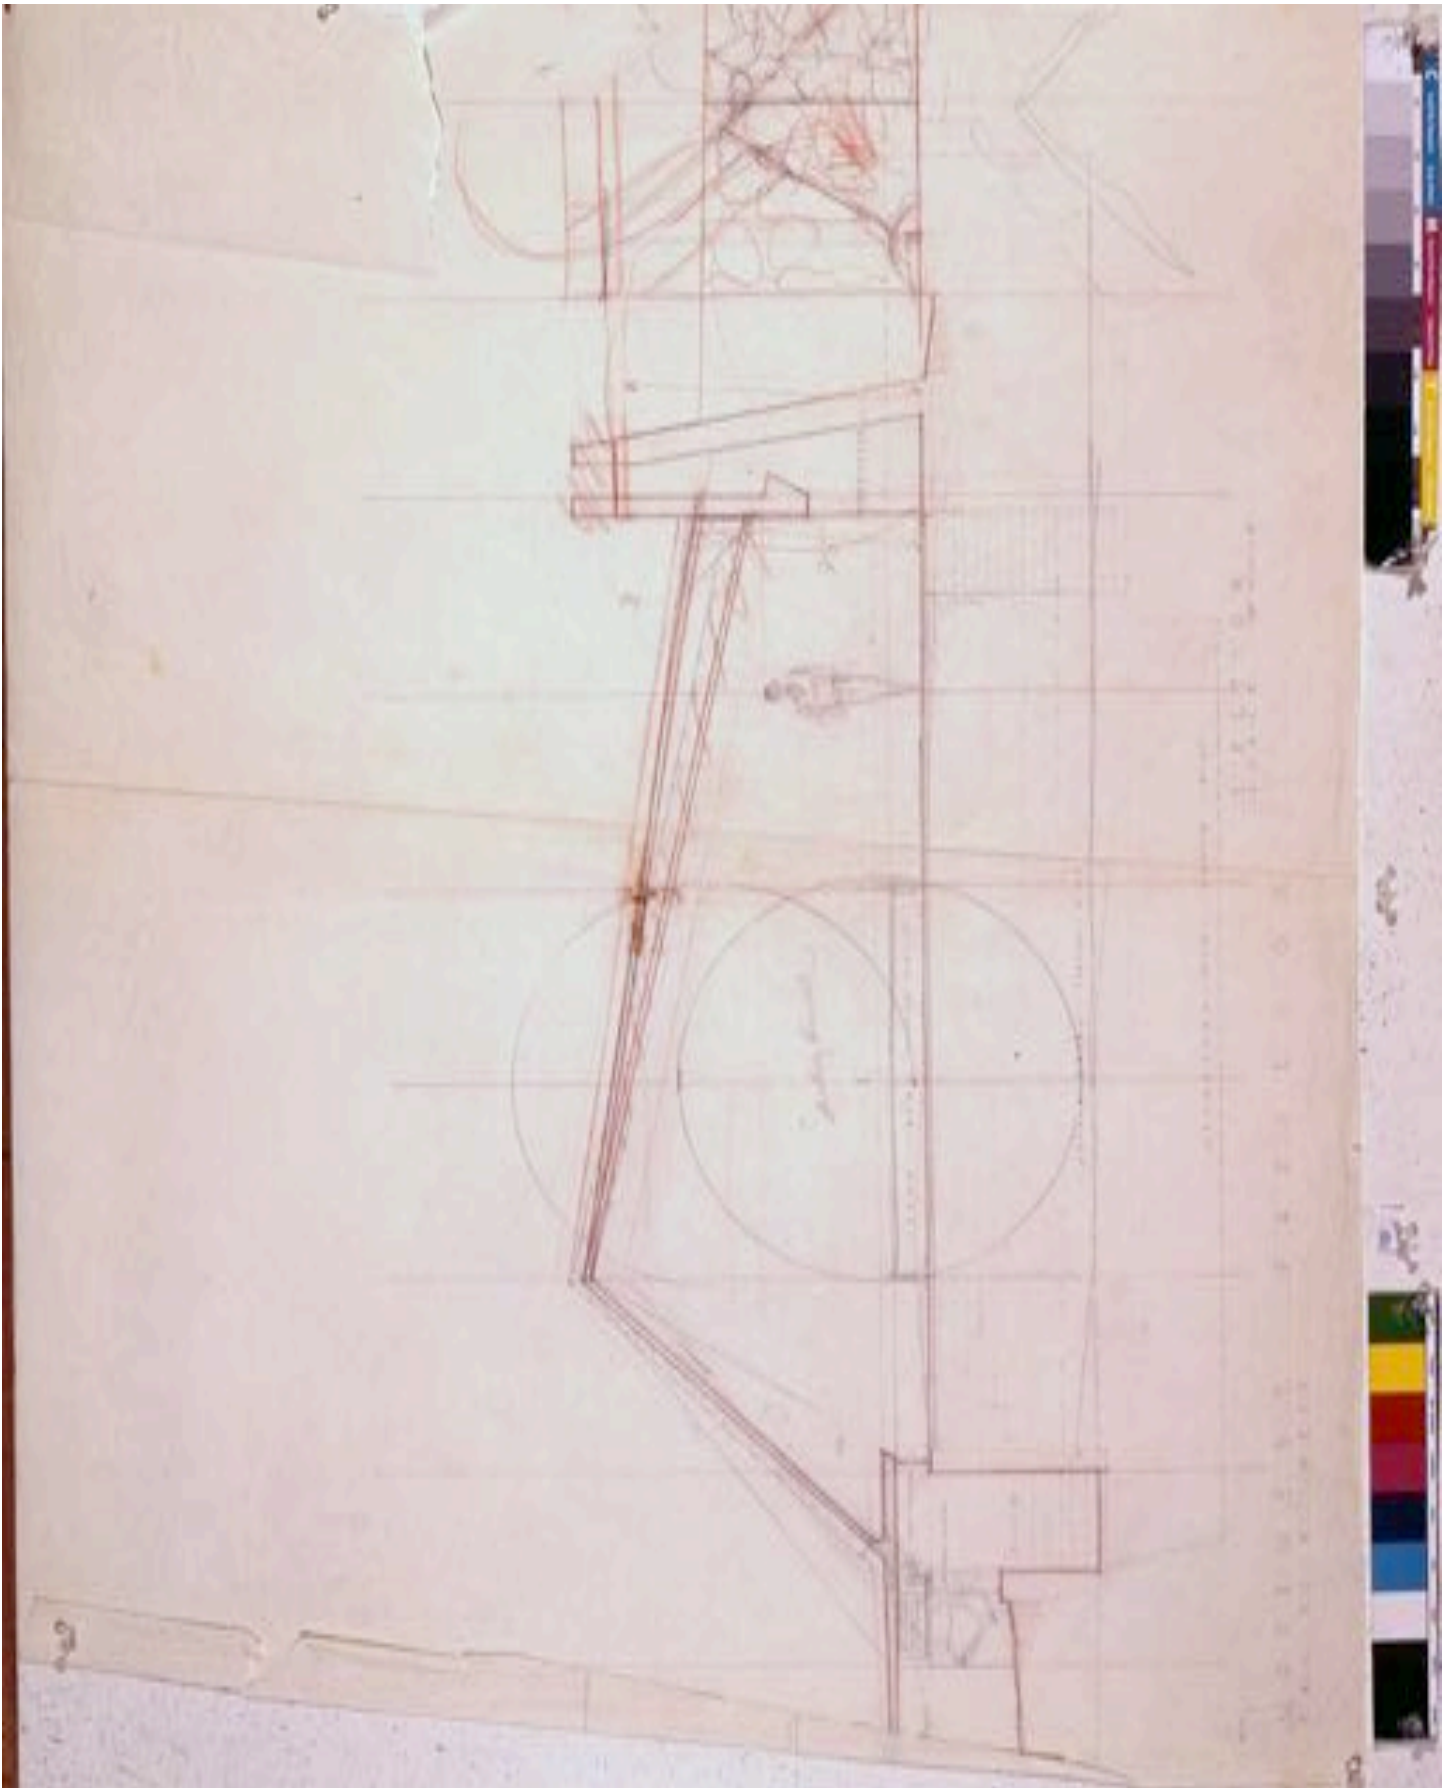
Figure B-105 - Pavilion Cross Section (The Frank Lloyd Wright Foundation Archives, The Museum of Modern Art | Avery Architectural & Fine Arts Library, Columbia University, New York).
