TALIESIN WEST PRESERVATION MASTER PLAN

Harboe Architects, PC

MAY 21, 2015

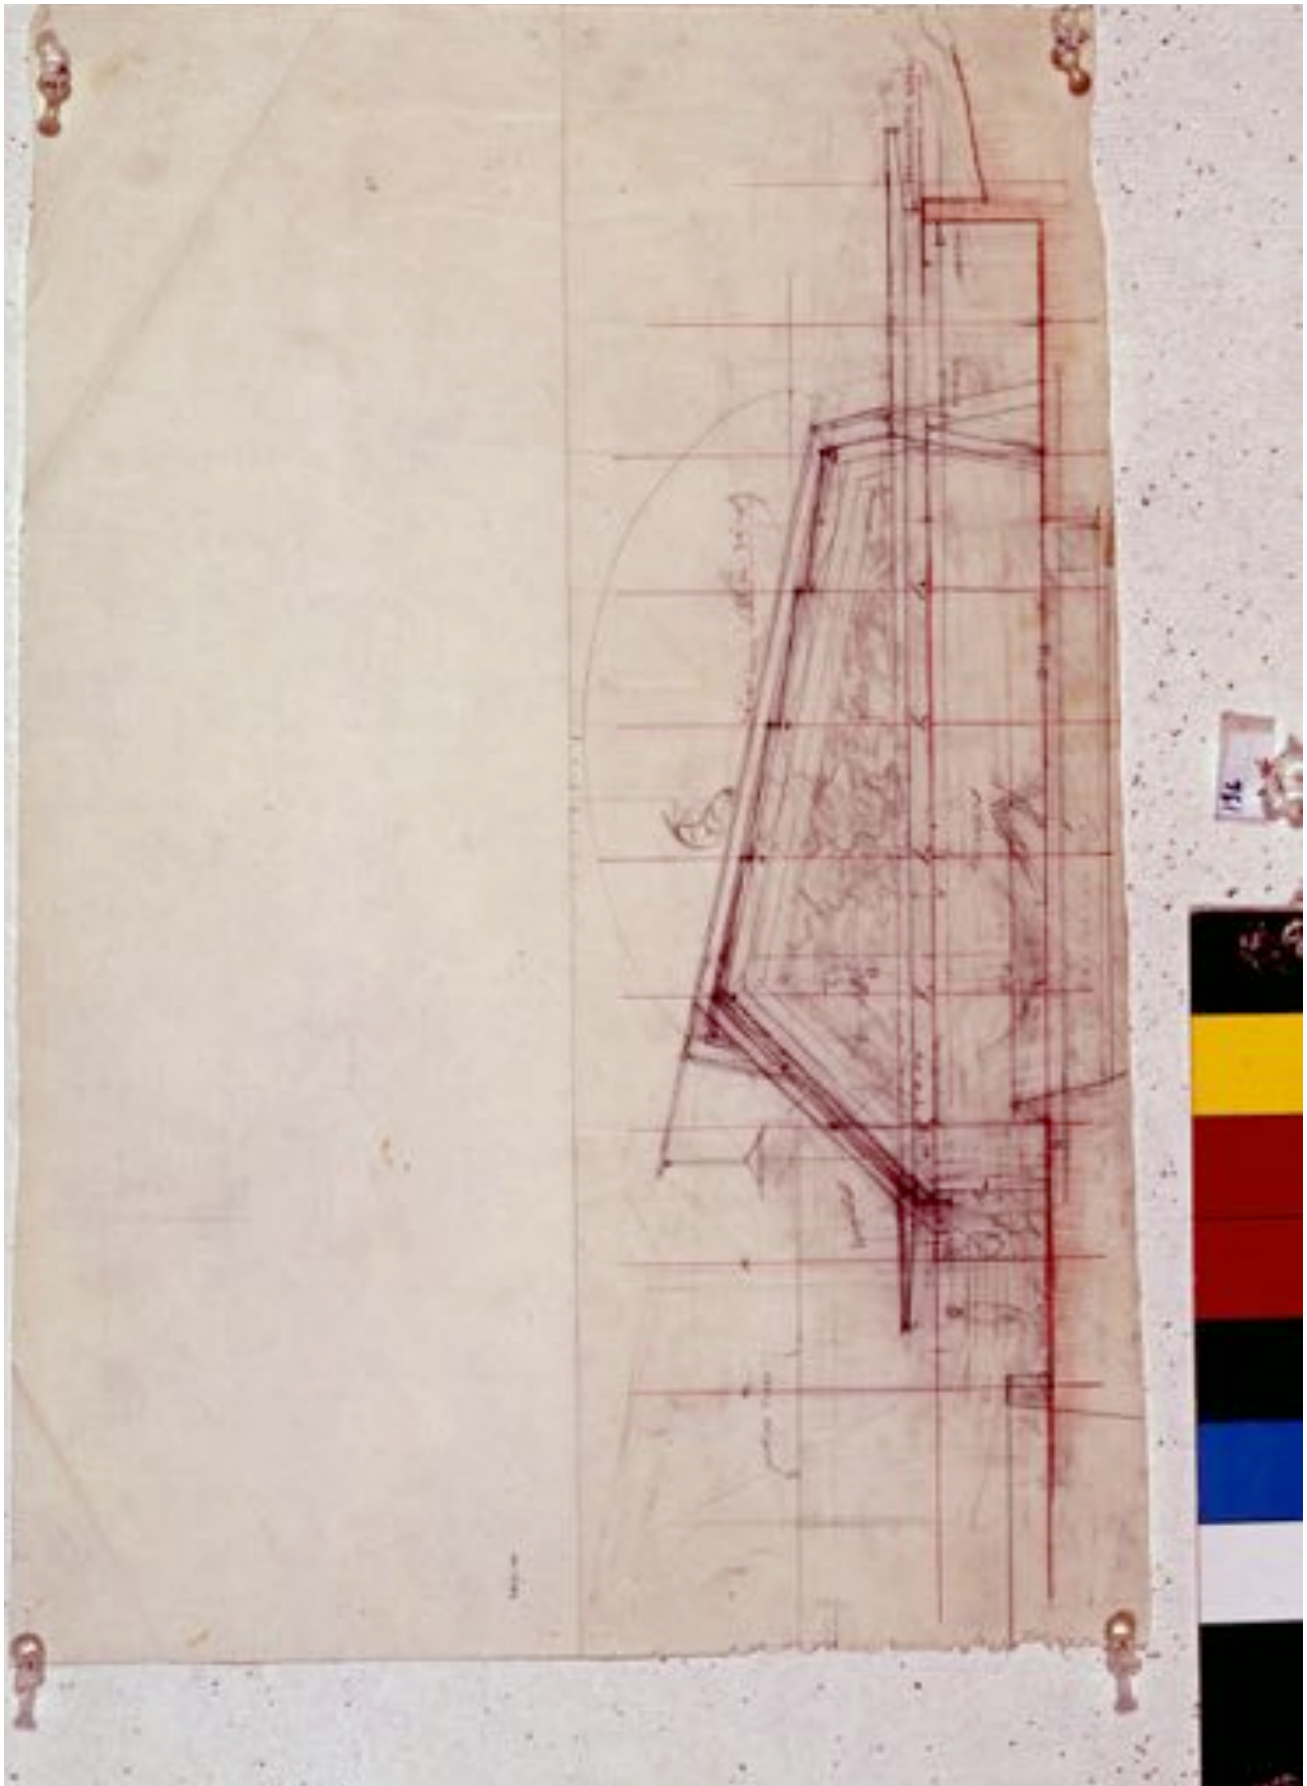
Figure B-106 - Pavilion Cross Section (The Frank Lloyd Wright Foundation Archives, The Museum of Modern Art | Avery Architectural & Fine Arts Library, Columbia University, New York).

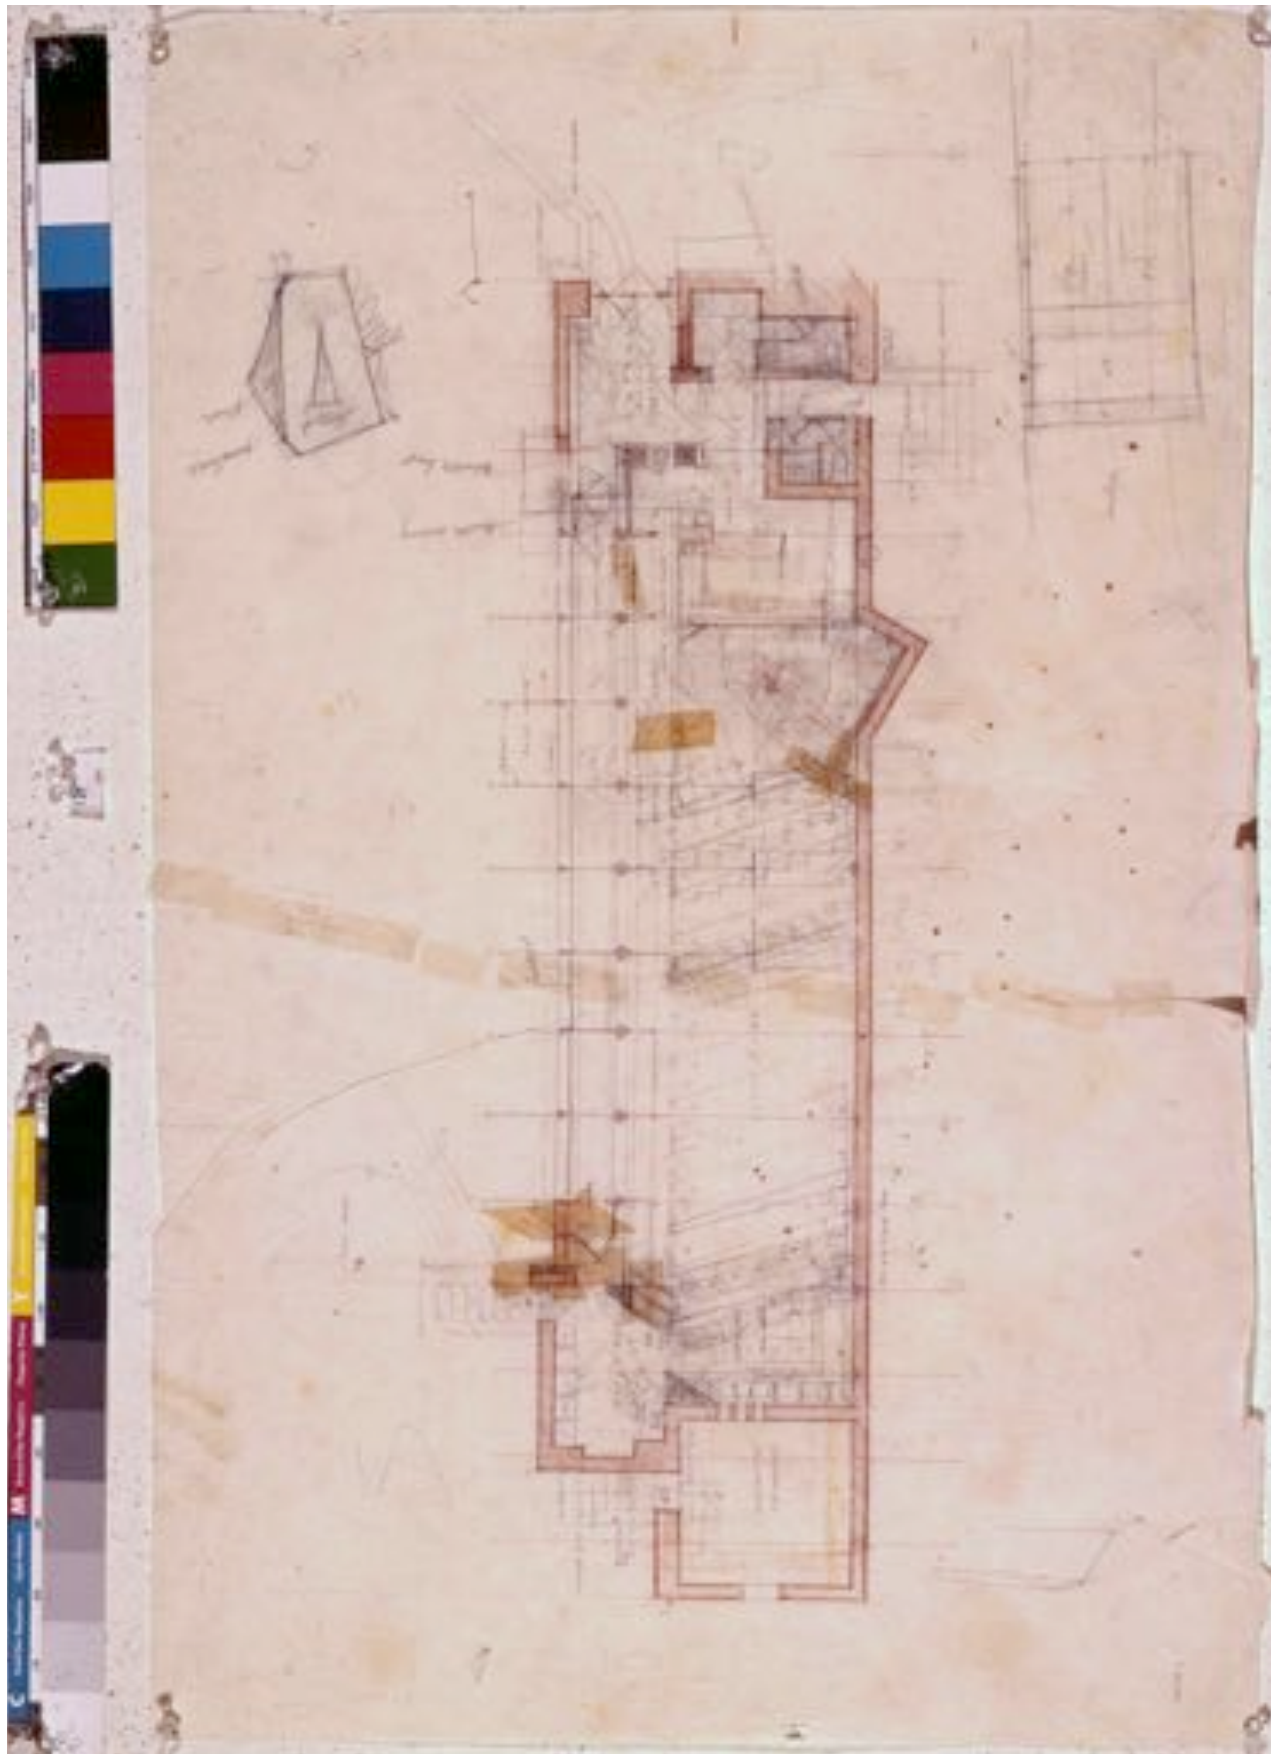
Figure B-107 - Cabaret Plan (The Frank Lloyd Wright Foundation Archives, The Museum of Modern Art | Avery Architectural & Fine Arts Library, Columbia University, New York).

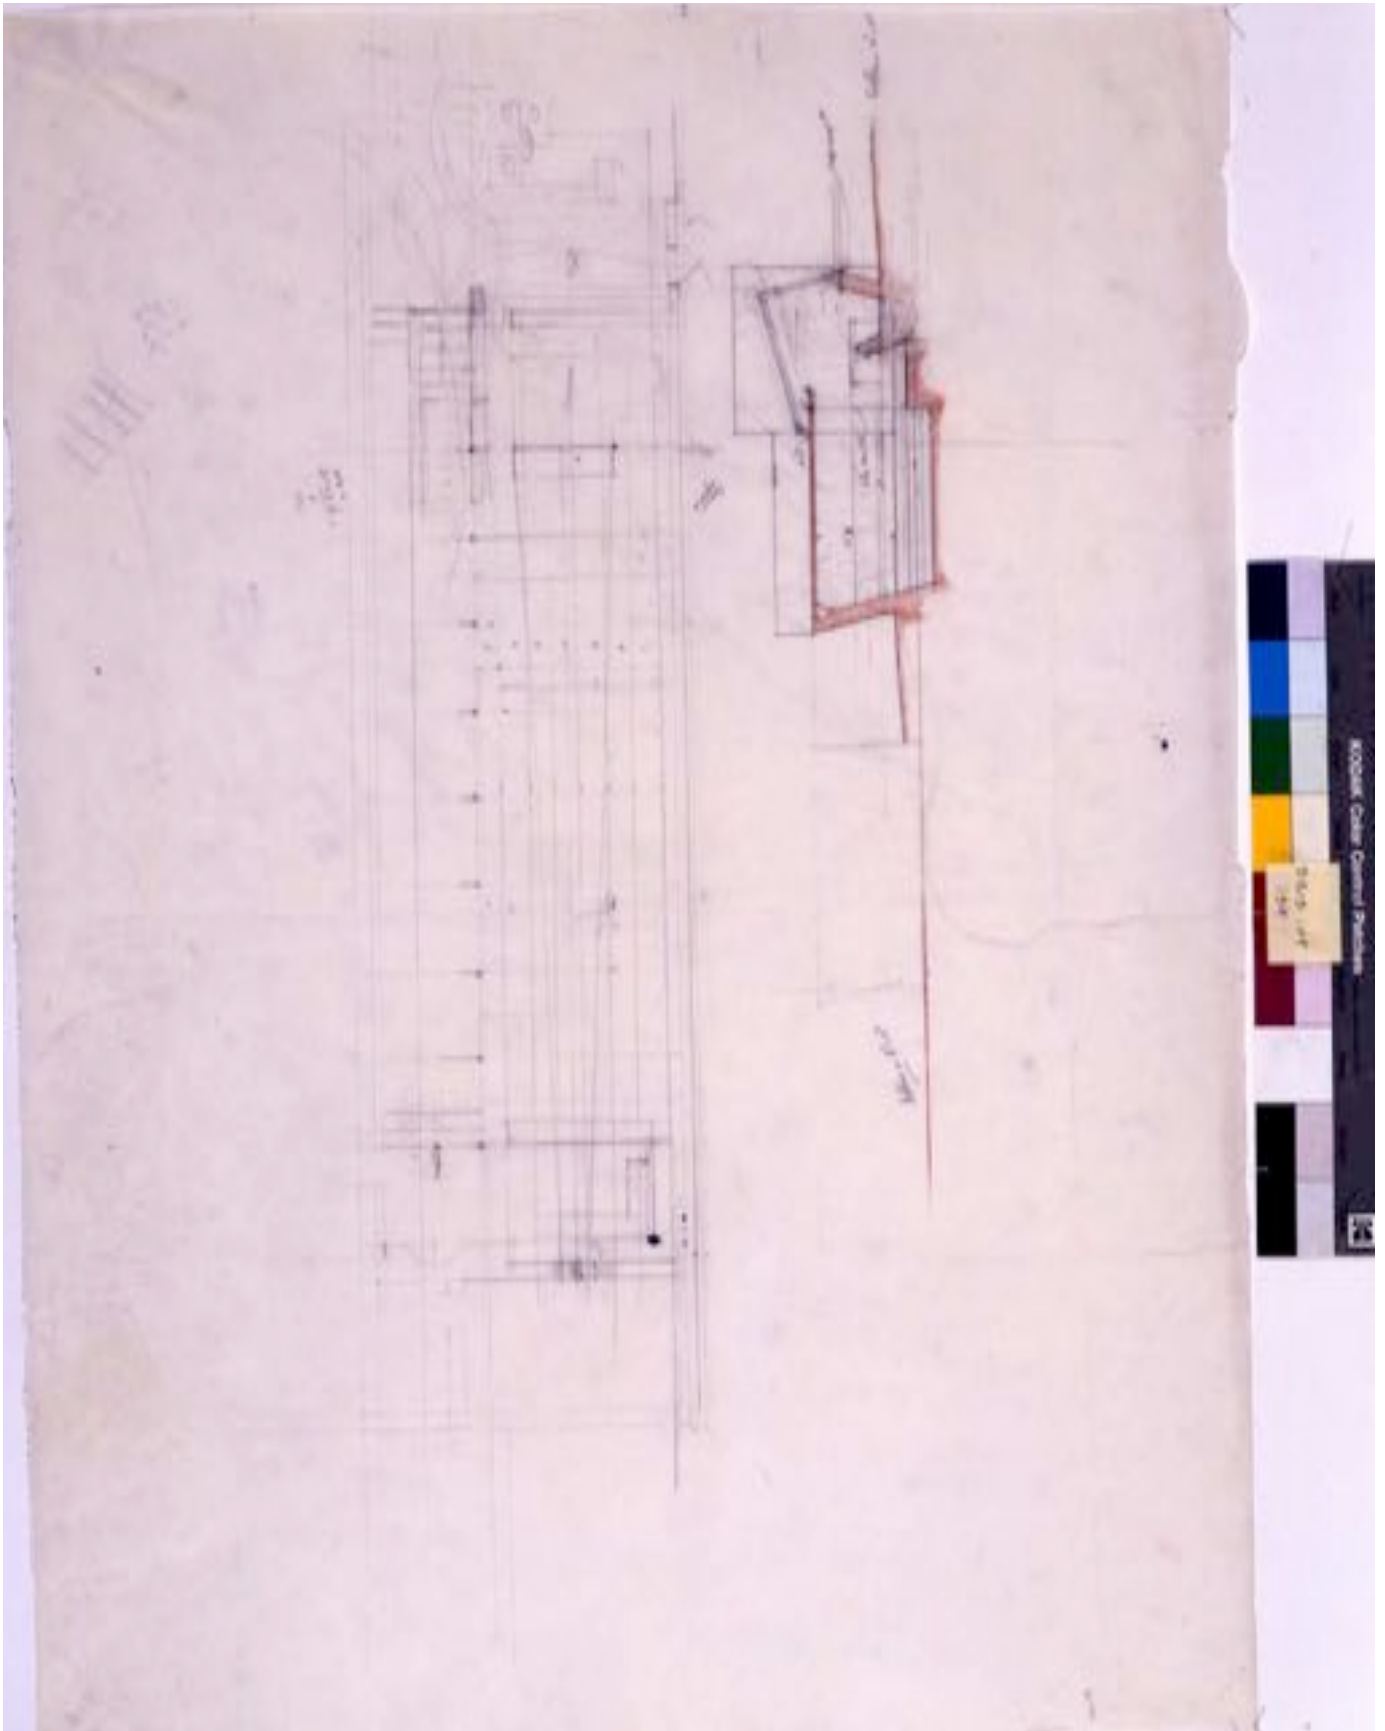
Figure B-109 - Cabaret Plan/Section (The Frank Lloyd Wright Foundation Archives, The Museum of Modern Art | Avery Architectural & Fine Arts Library, Columbia University, New York).

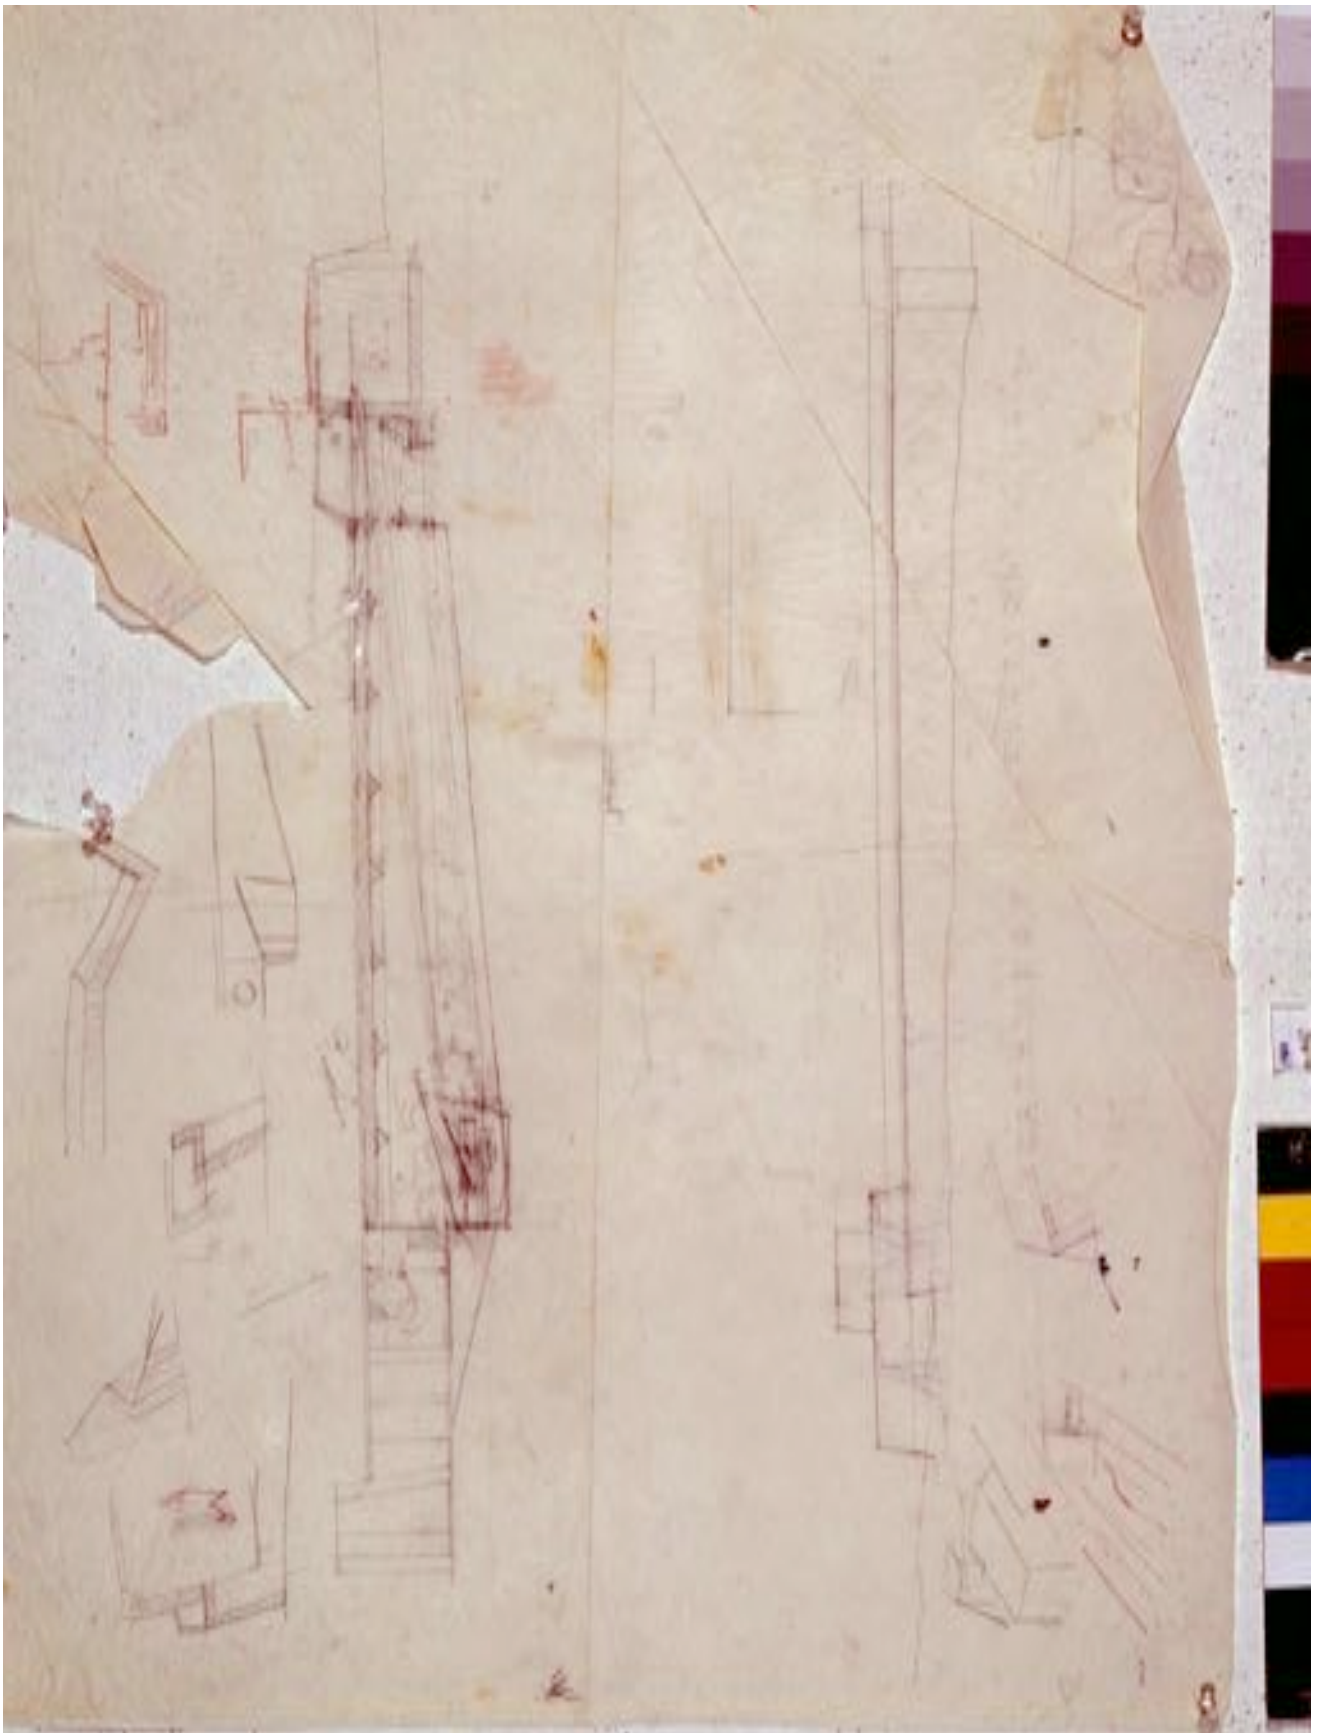
Figure B-110 - Cabaret Elevation (The Frank Lloyd Wright Foundation Archives, The Museum of Modern Art | Avery Architectural & Fine Arts Library, Columbia University, New York).

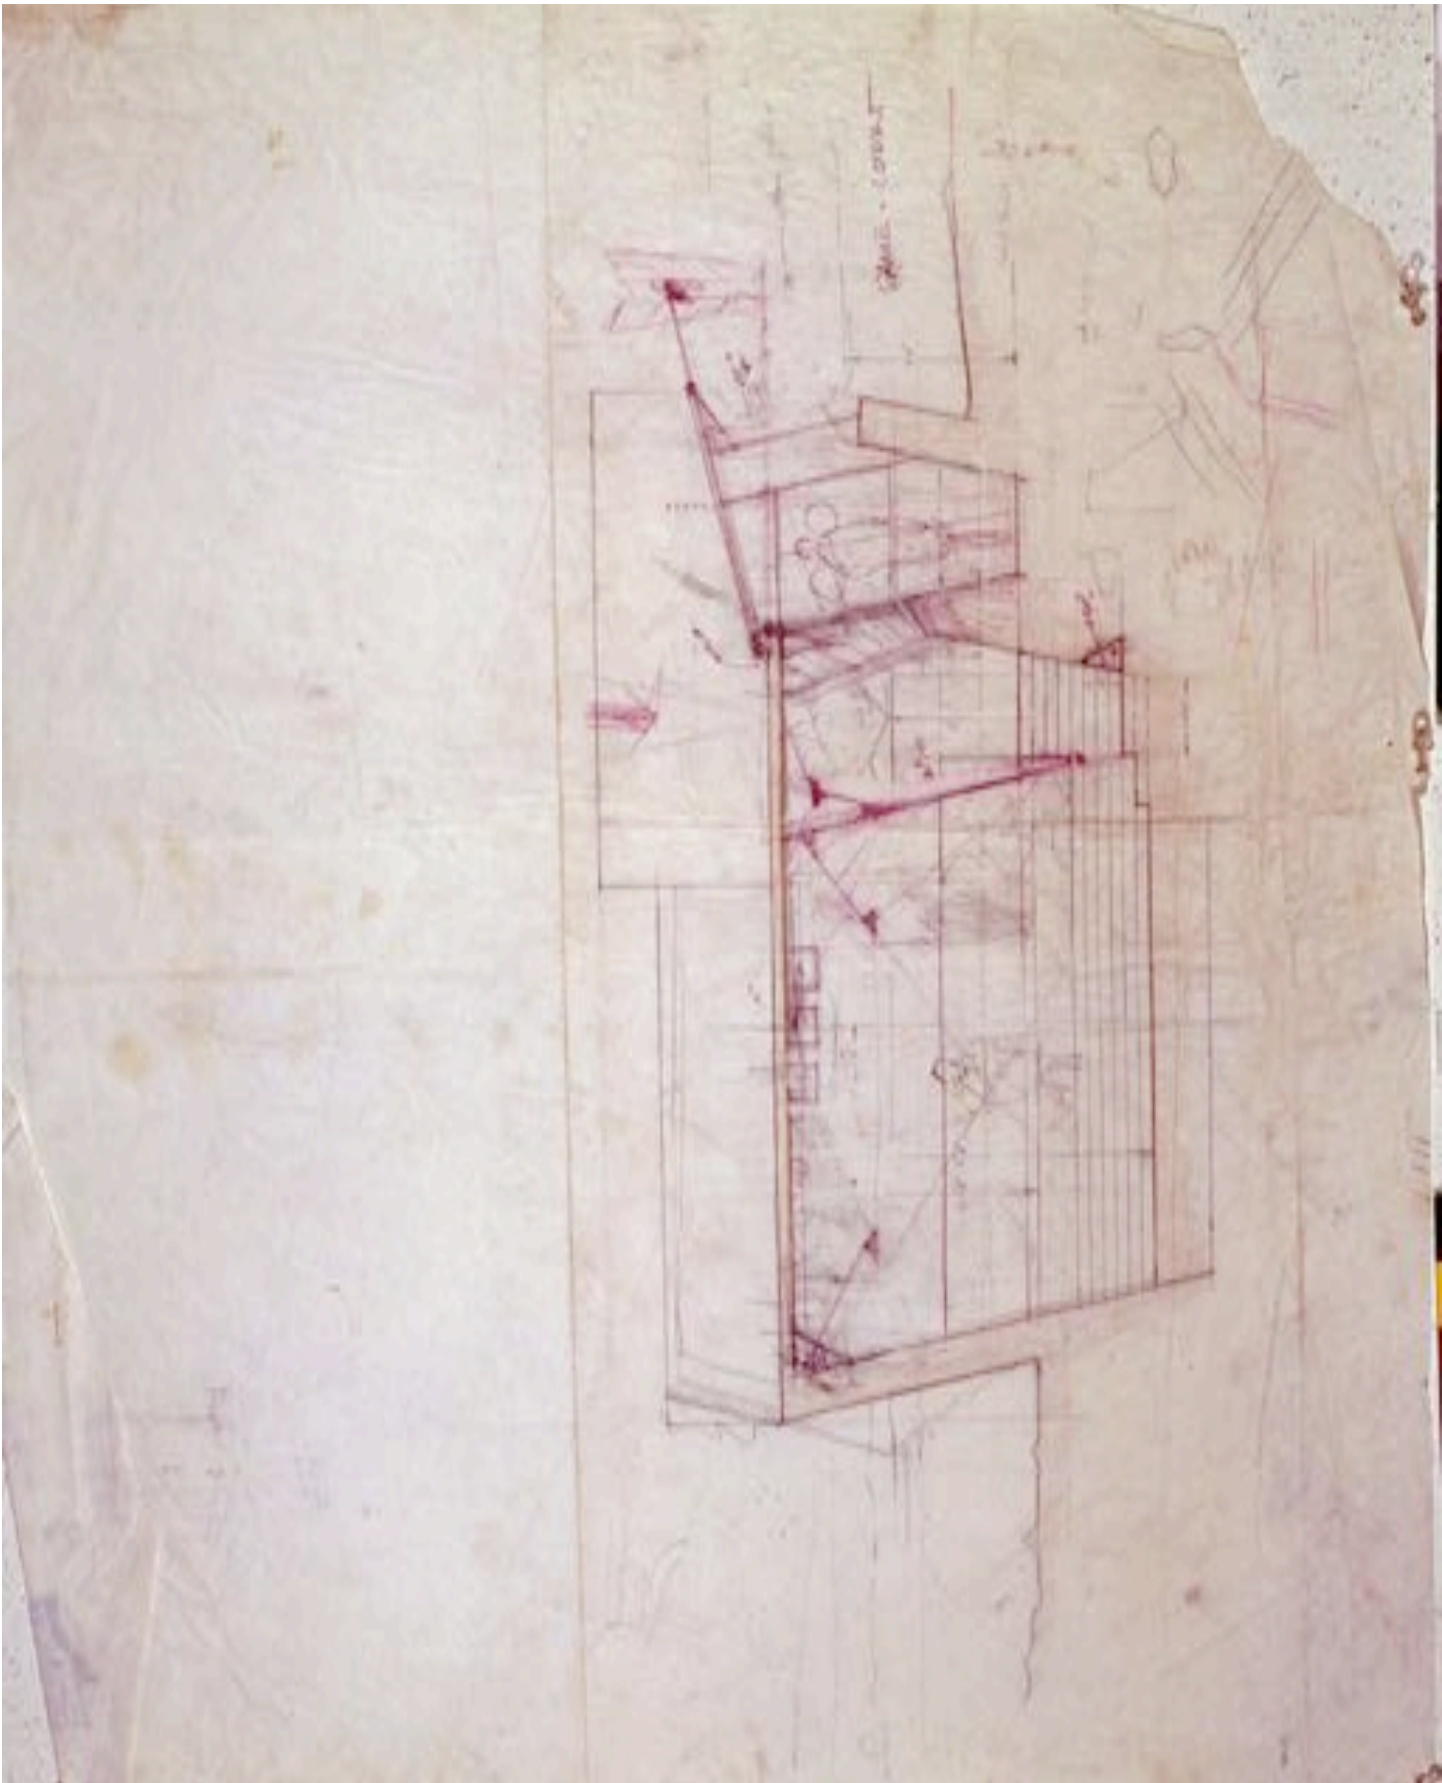
Figure B-111 - Cabaret Cross Section (The Frank Lloyd Wright Foundation Archives, The Museum of Modern Art | Avery Architectural & Fine Arts Library, Columbia University, New York).

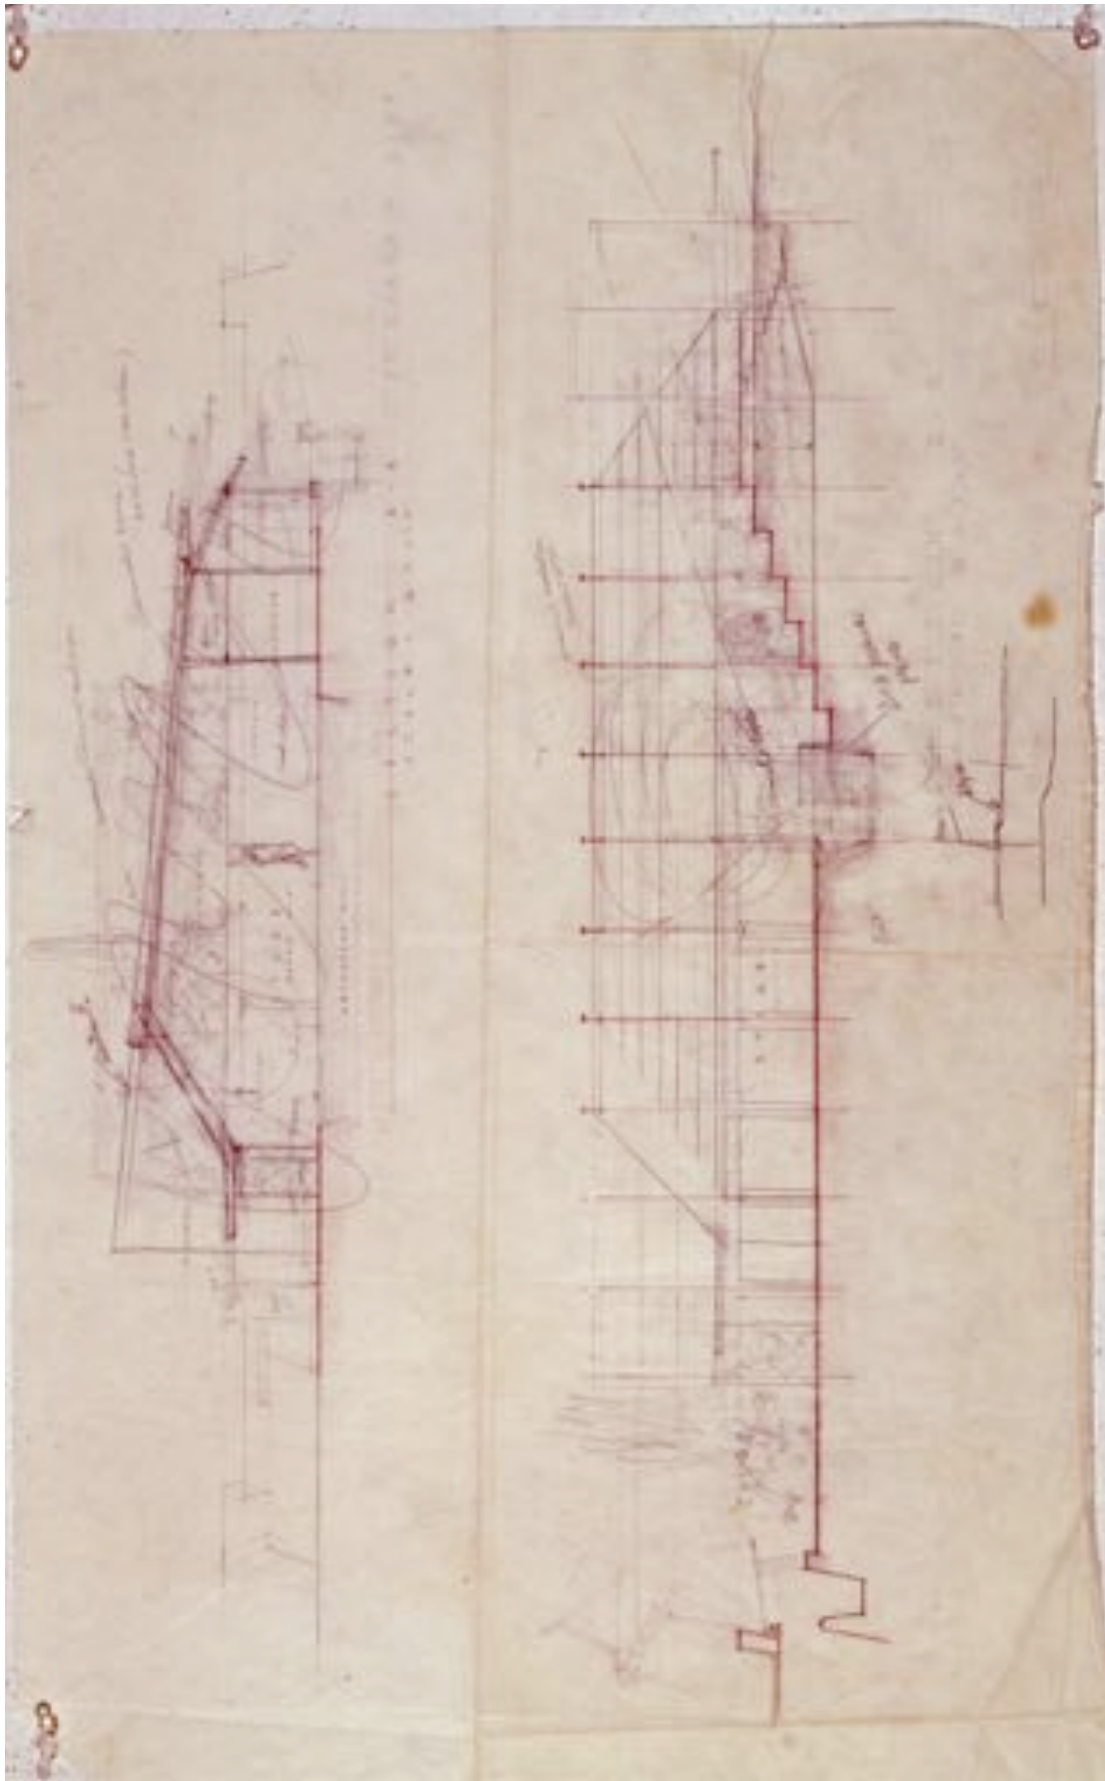
Figure B-112 - Pavilion Section (The Frank Lloyd Wright Foundation Archives, The Museum of Modern Art | Avery Architectural & Fine Arts Library, Columbia University, New York).

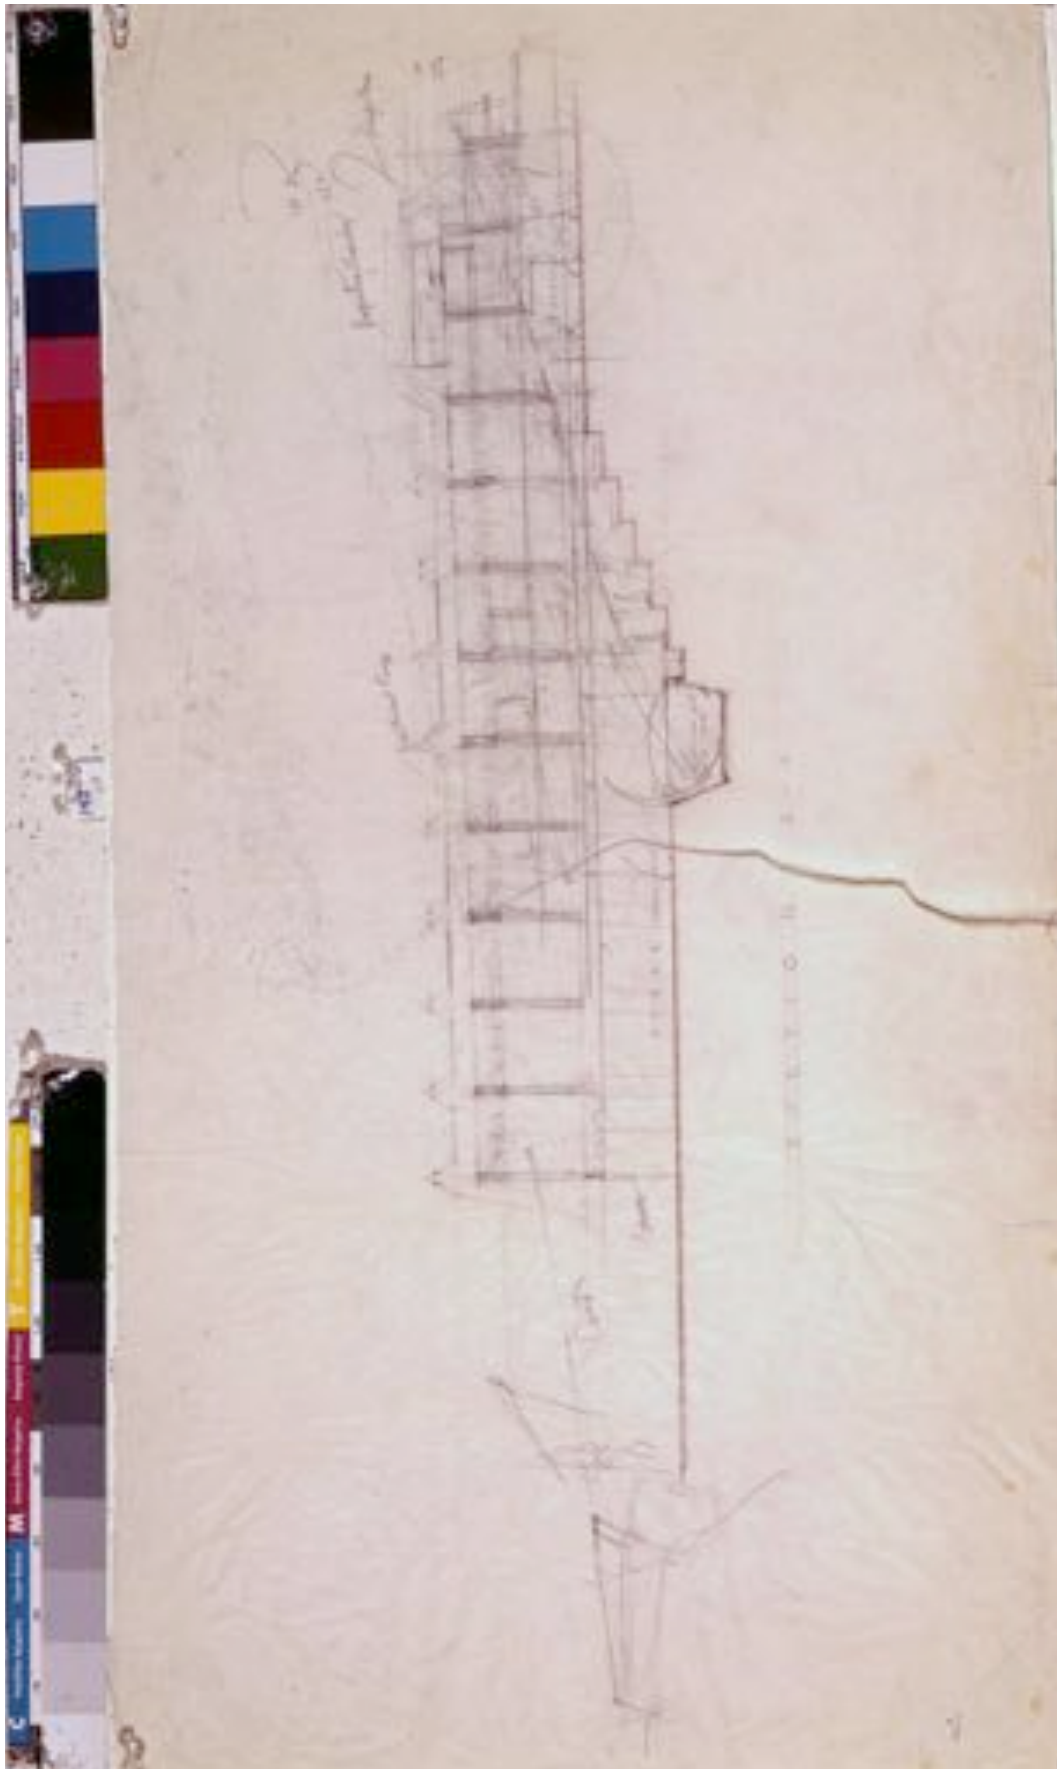
Figure B-113 - Pavilion Longitudinal Section (The Frank Lloyd Wright Foundation Archives, The Museum of Modern Art | Avery Architectural & Fine Arts Library, Columbia University, New York).

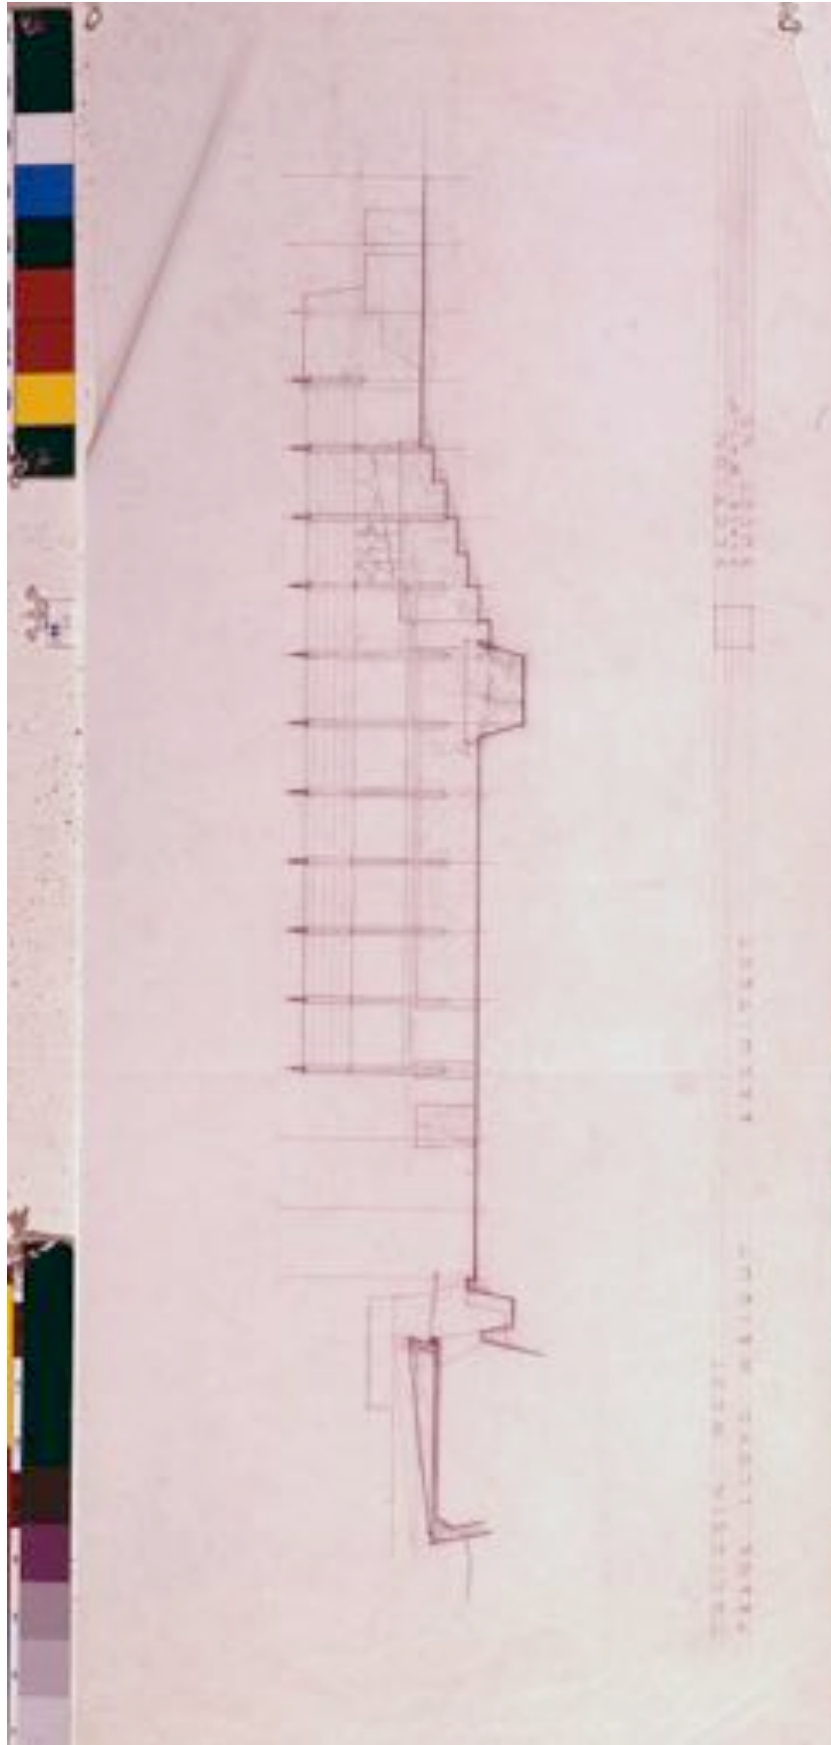
Figure B-114 - Pavilion Longitudinal Section (The Frank Lloyd Wright Foundation Archives, The Museum of Modern Art | Avery Architectural & Fine Arts Library, Columbia University, New York).

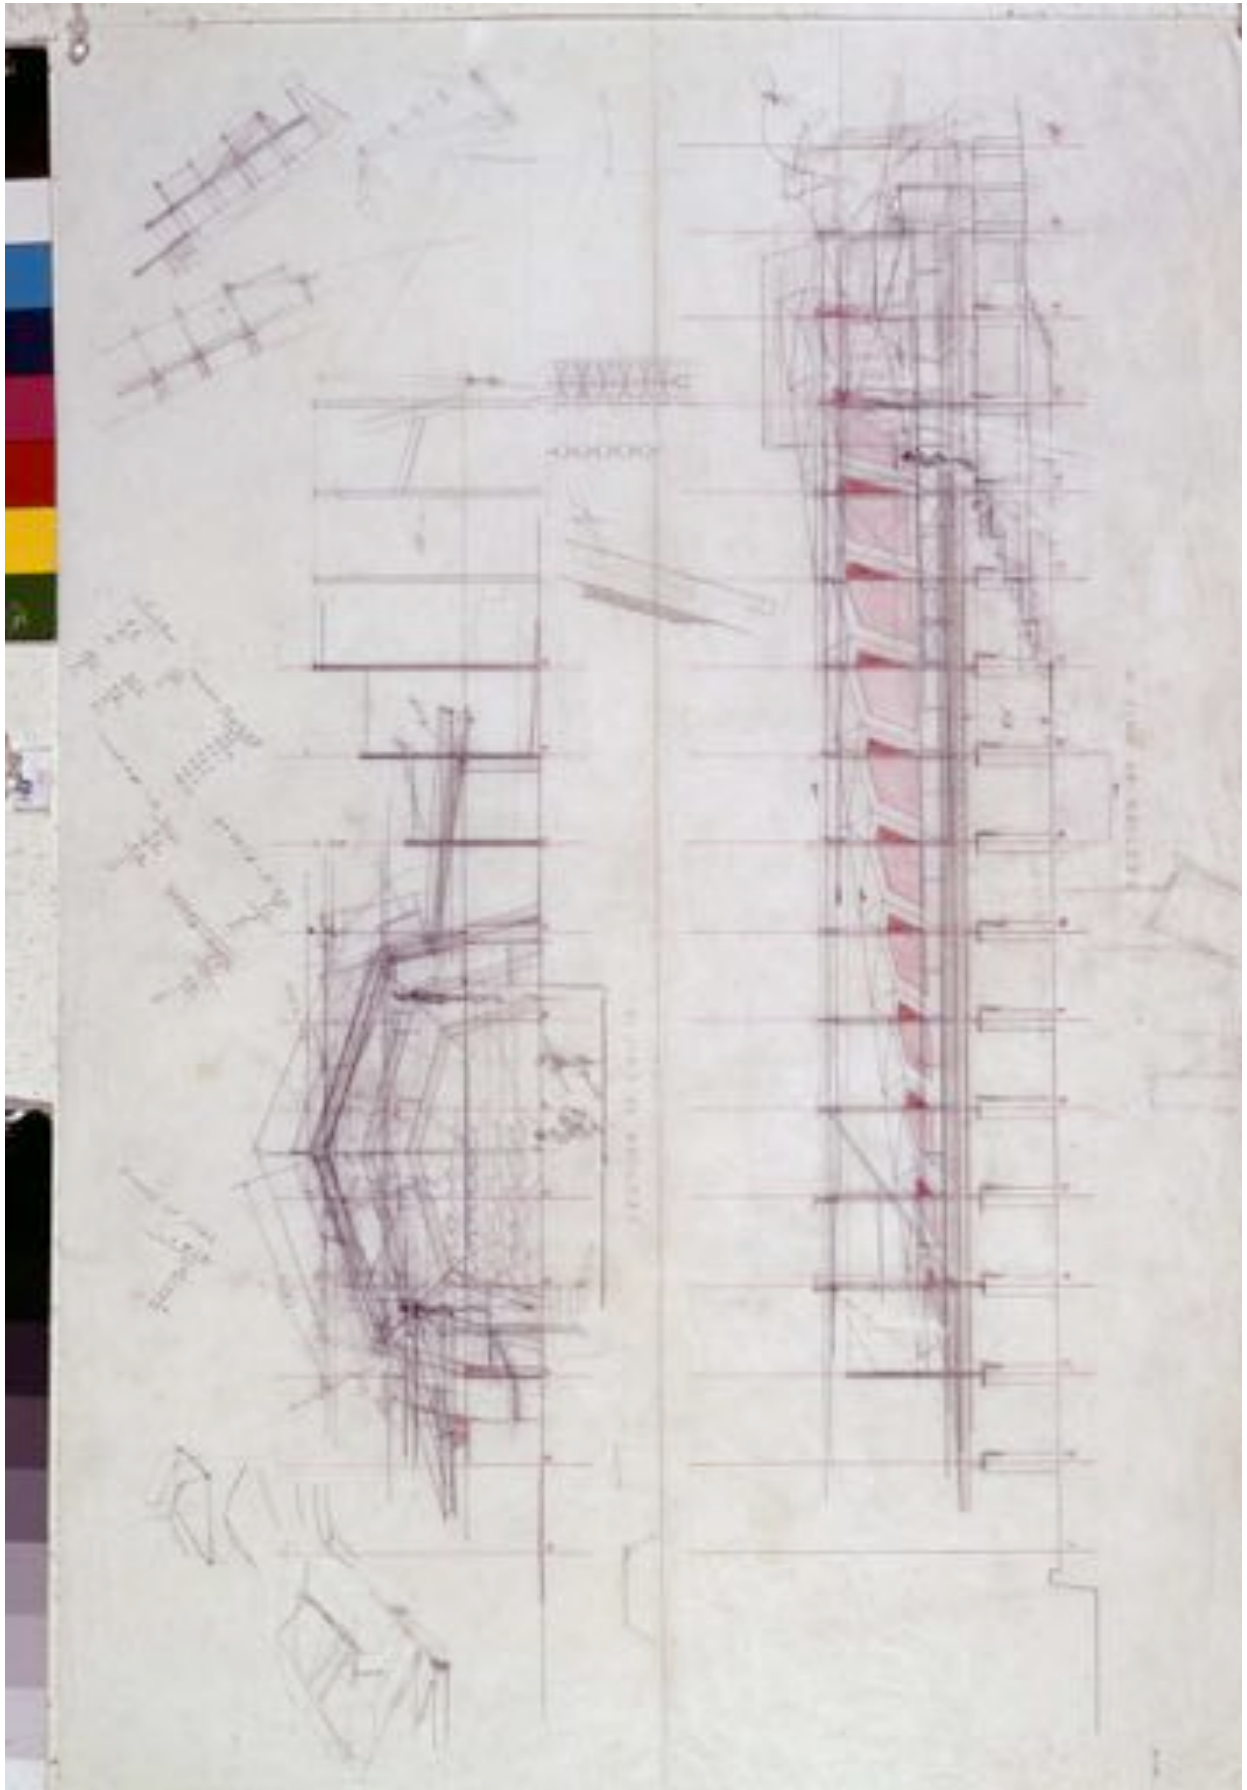
Figure B-115 - Pavilion Roof Section (The Frank Lloyd Wright Foundation Archives, The Museum of Modern Art | Avery Architectural & Fine Arts Library, Columbia University, New York).

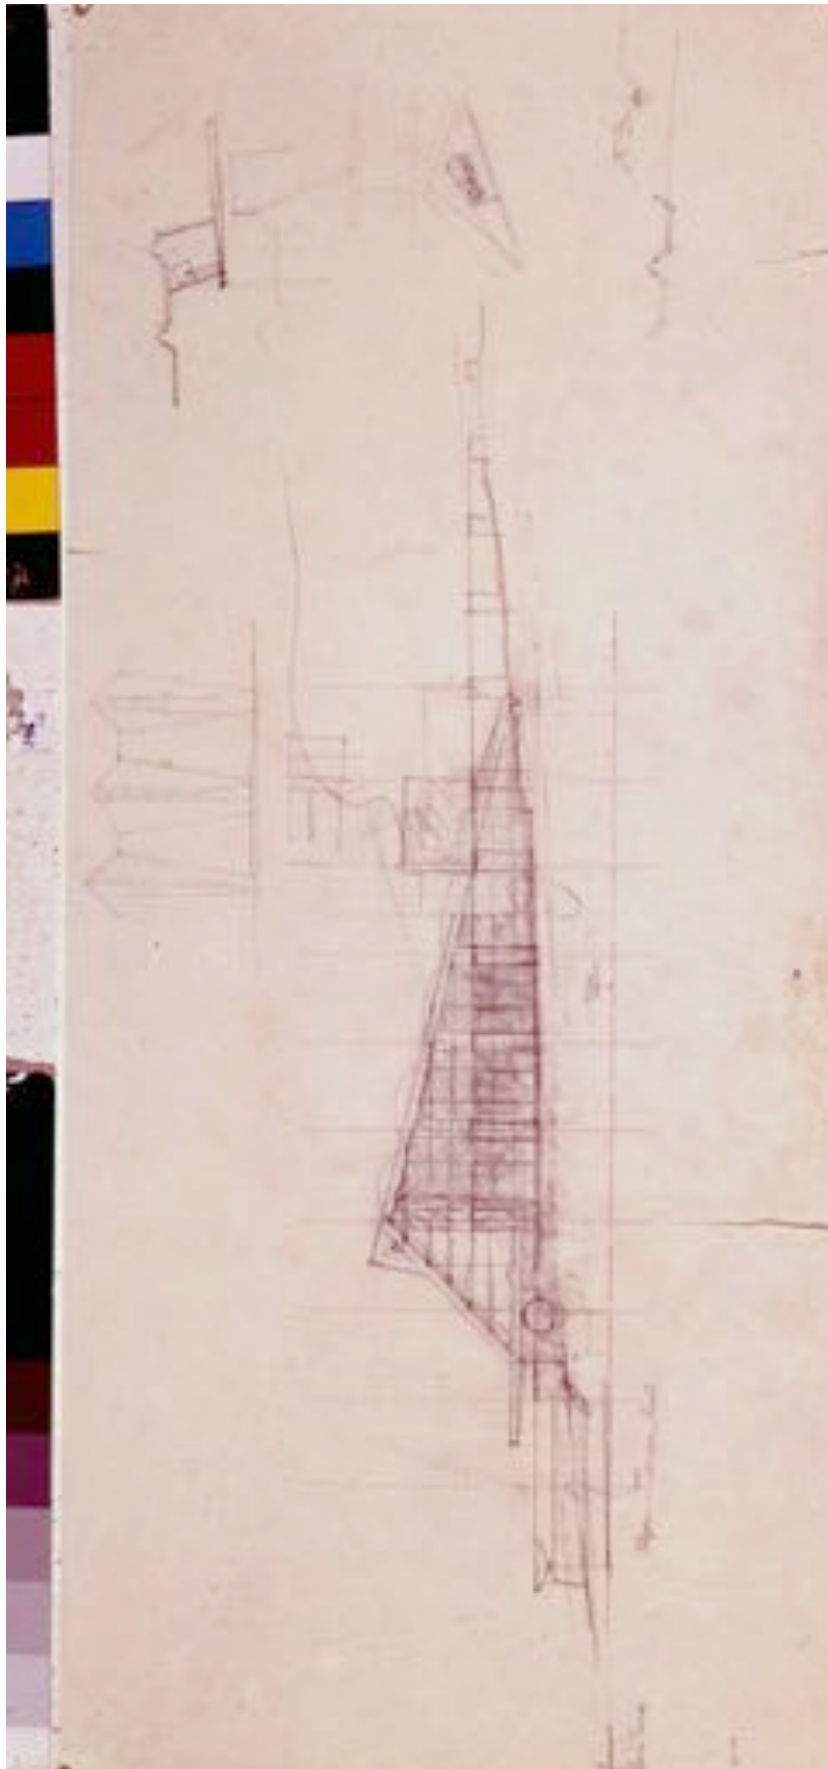
Figure B-116 - Pavilion Elevation (The Frank Lloyd Wright Foundation Archives, The Museum of Modern Art | Avery Architectural & Fine Arts Library, Columbia University, New York).
