TALIESIN WEST PRESERVATION MASTER PLAN

Harboe Architects, PC

MAY 21, 2015

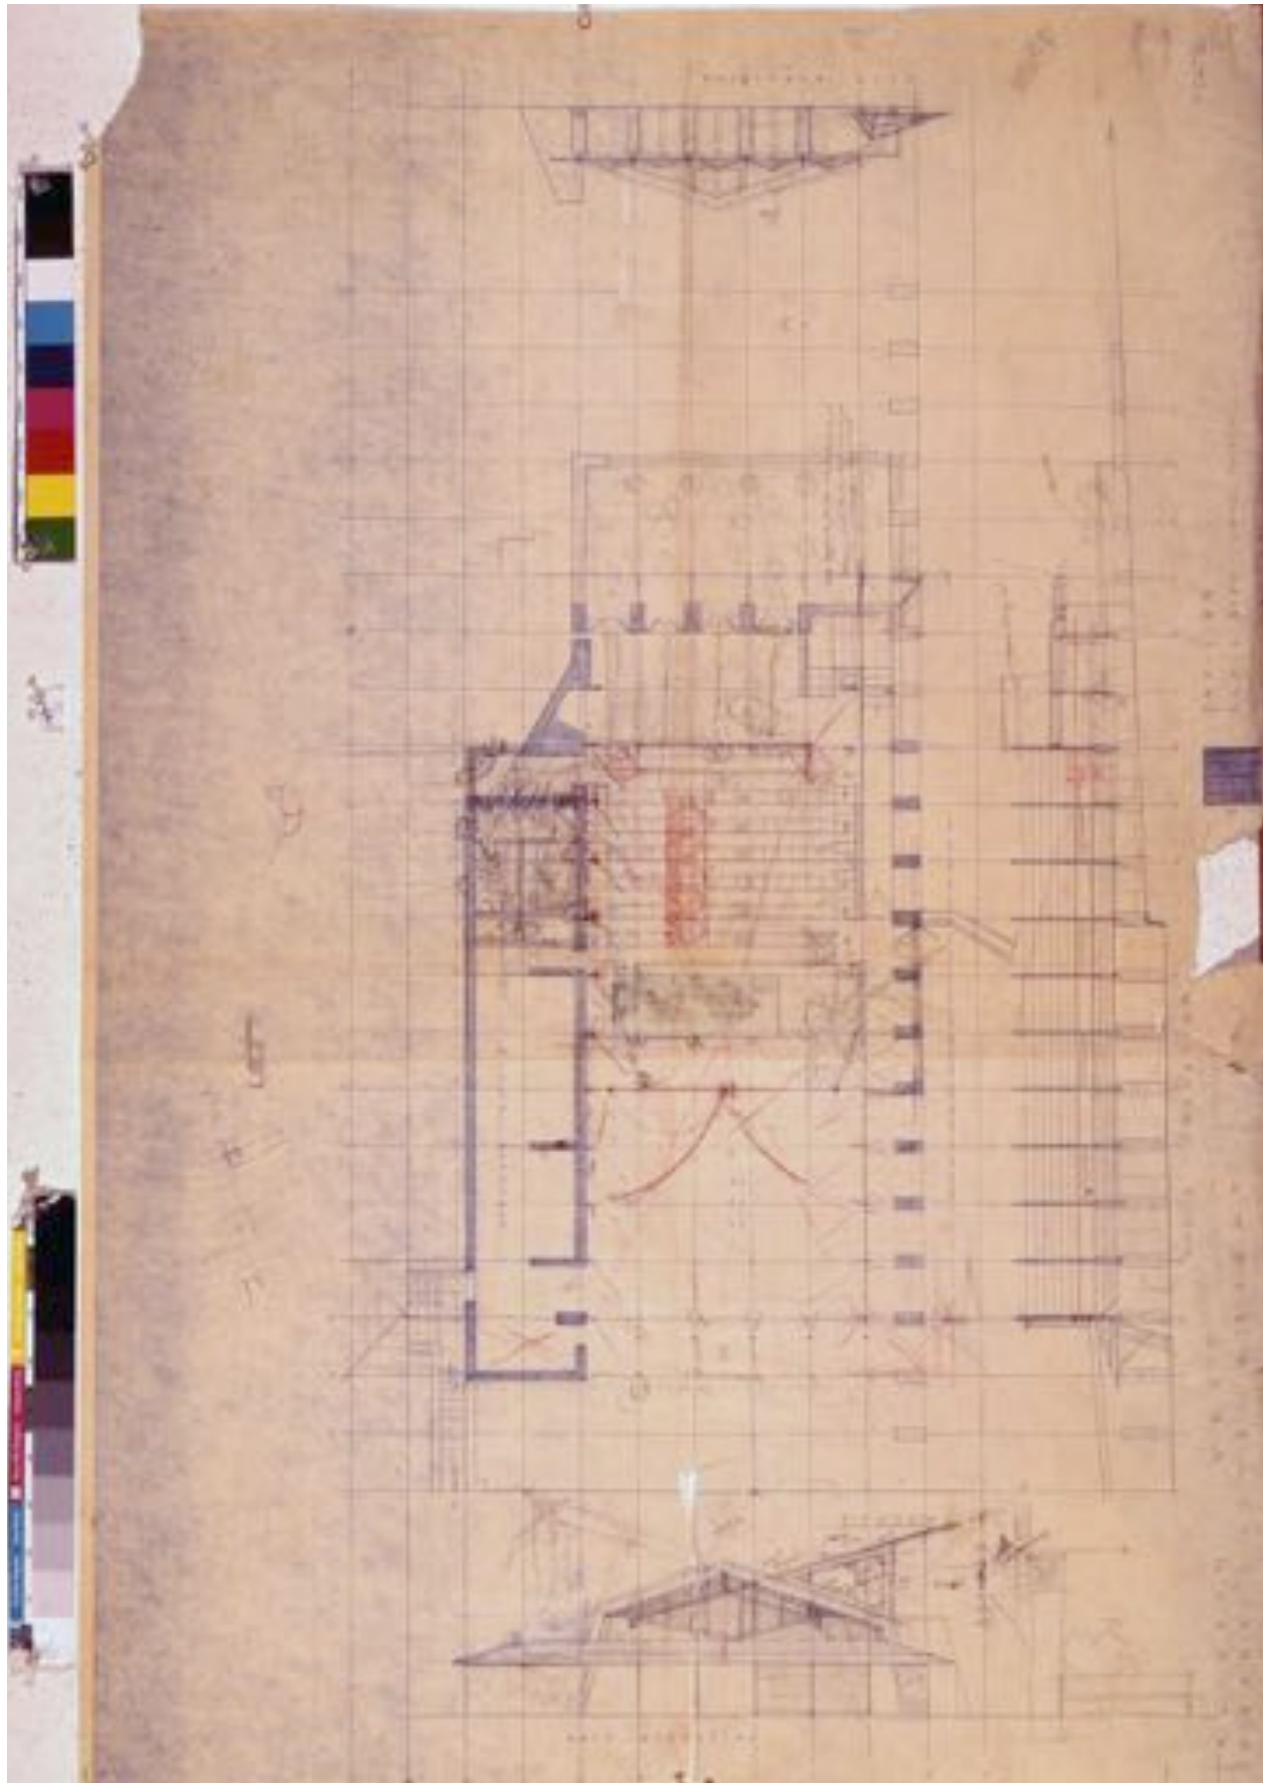
Figure B-117 - Pavilion Plan & 3 Elevations (The Frank Lloyd Wright Foundation Archives, The Museum of Modern Art | Avery Architectural & Fine Arts Library, Columbia University, New York).

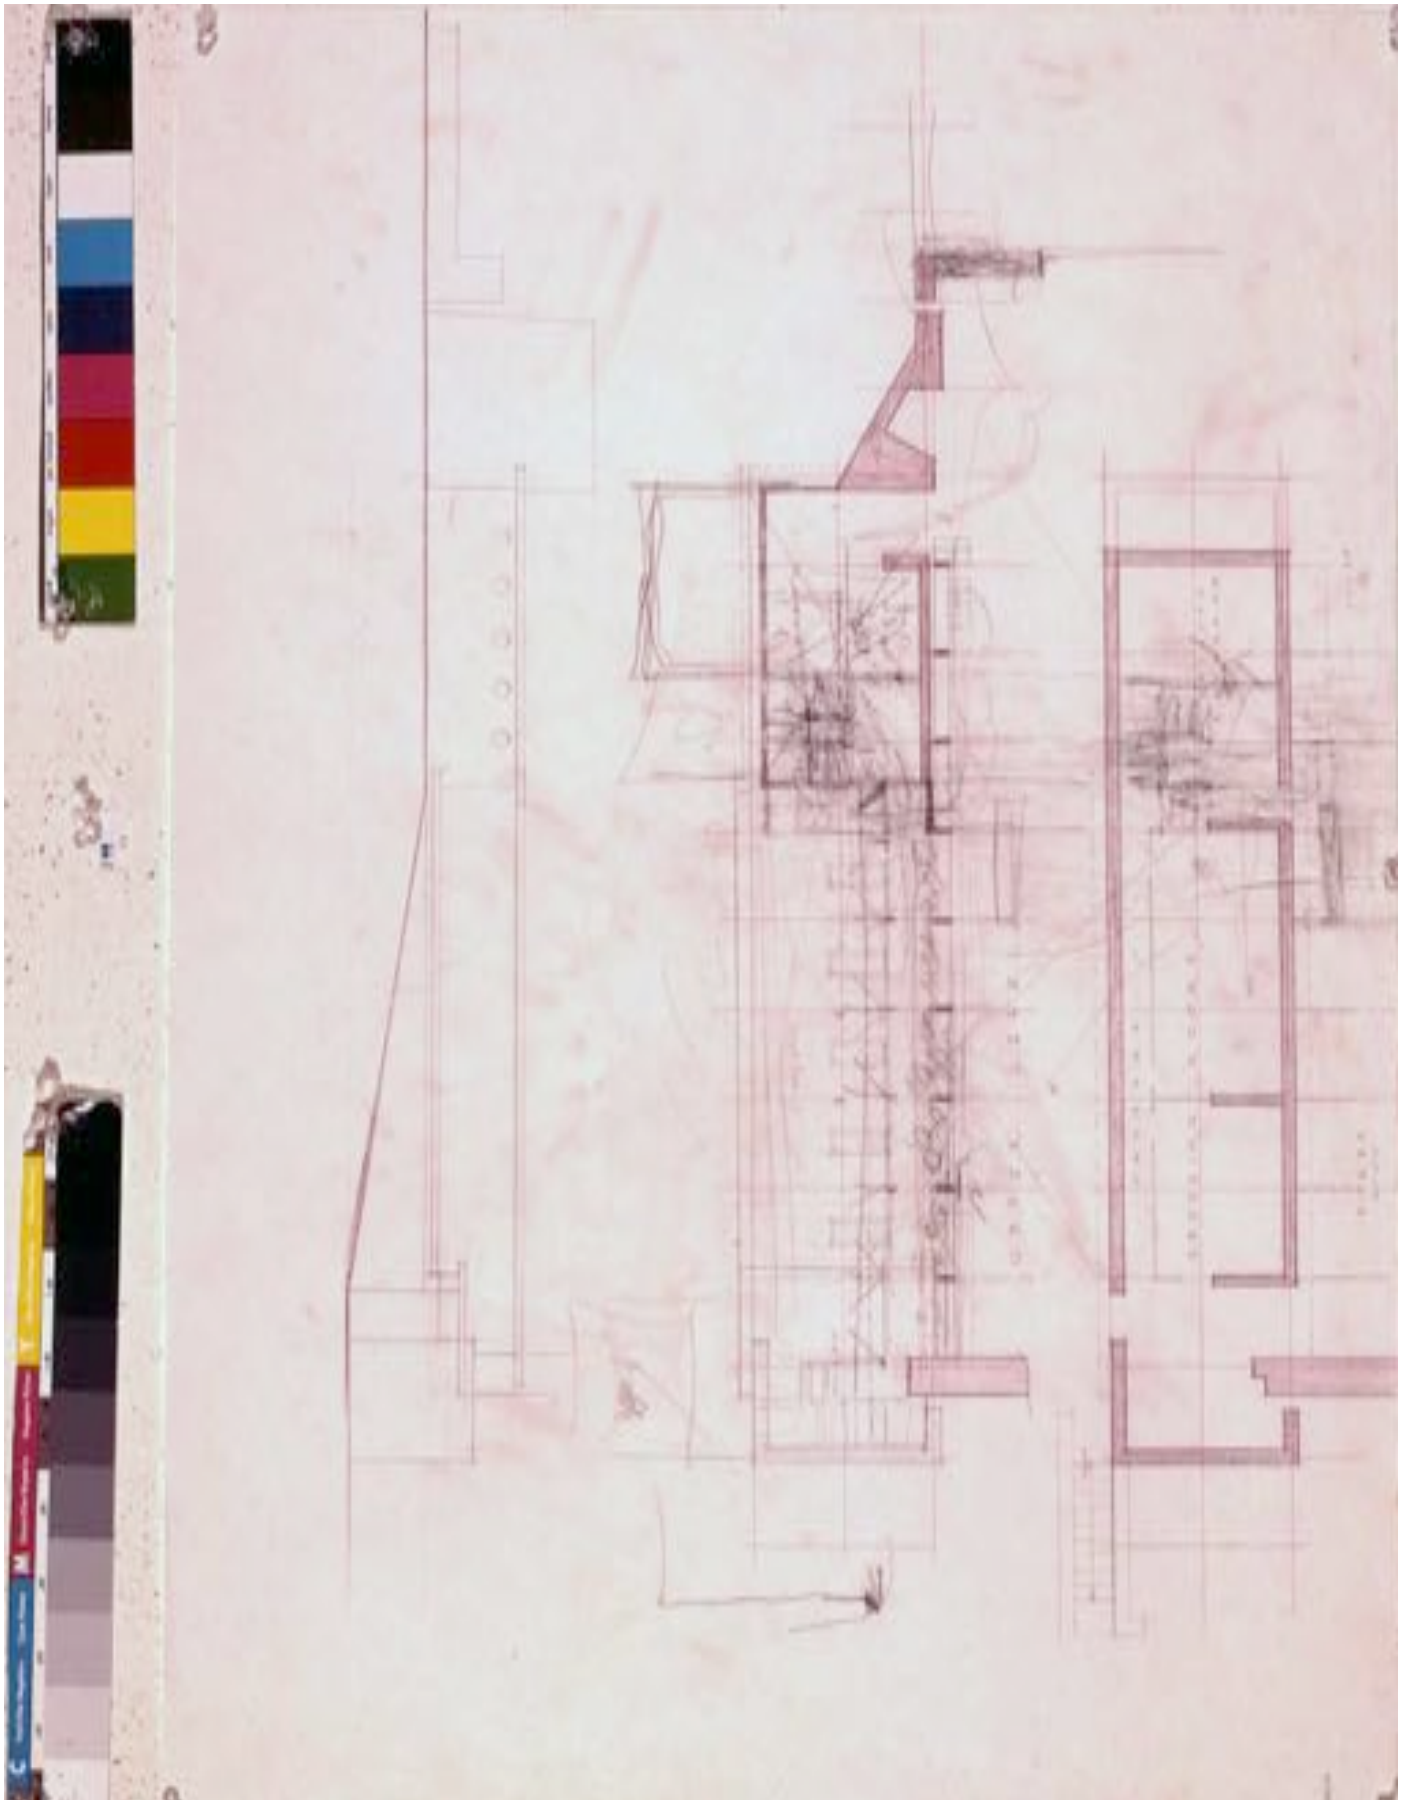
Figure B-119 - Pavilion Plan/Elevation (The Frank Lloyd Wright Foundation Archives, The Museum of Modern Art | Avery Architectural & Fine Arts Library, Columbia University, New York).

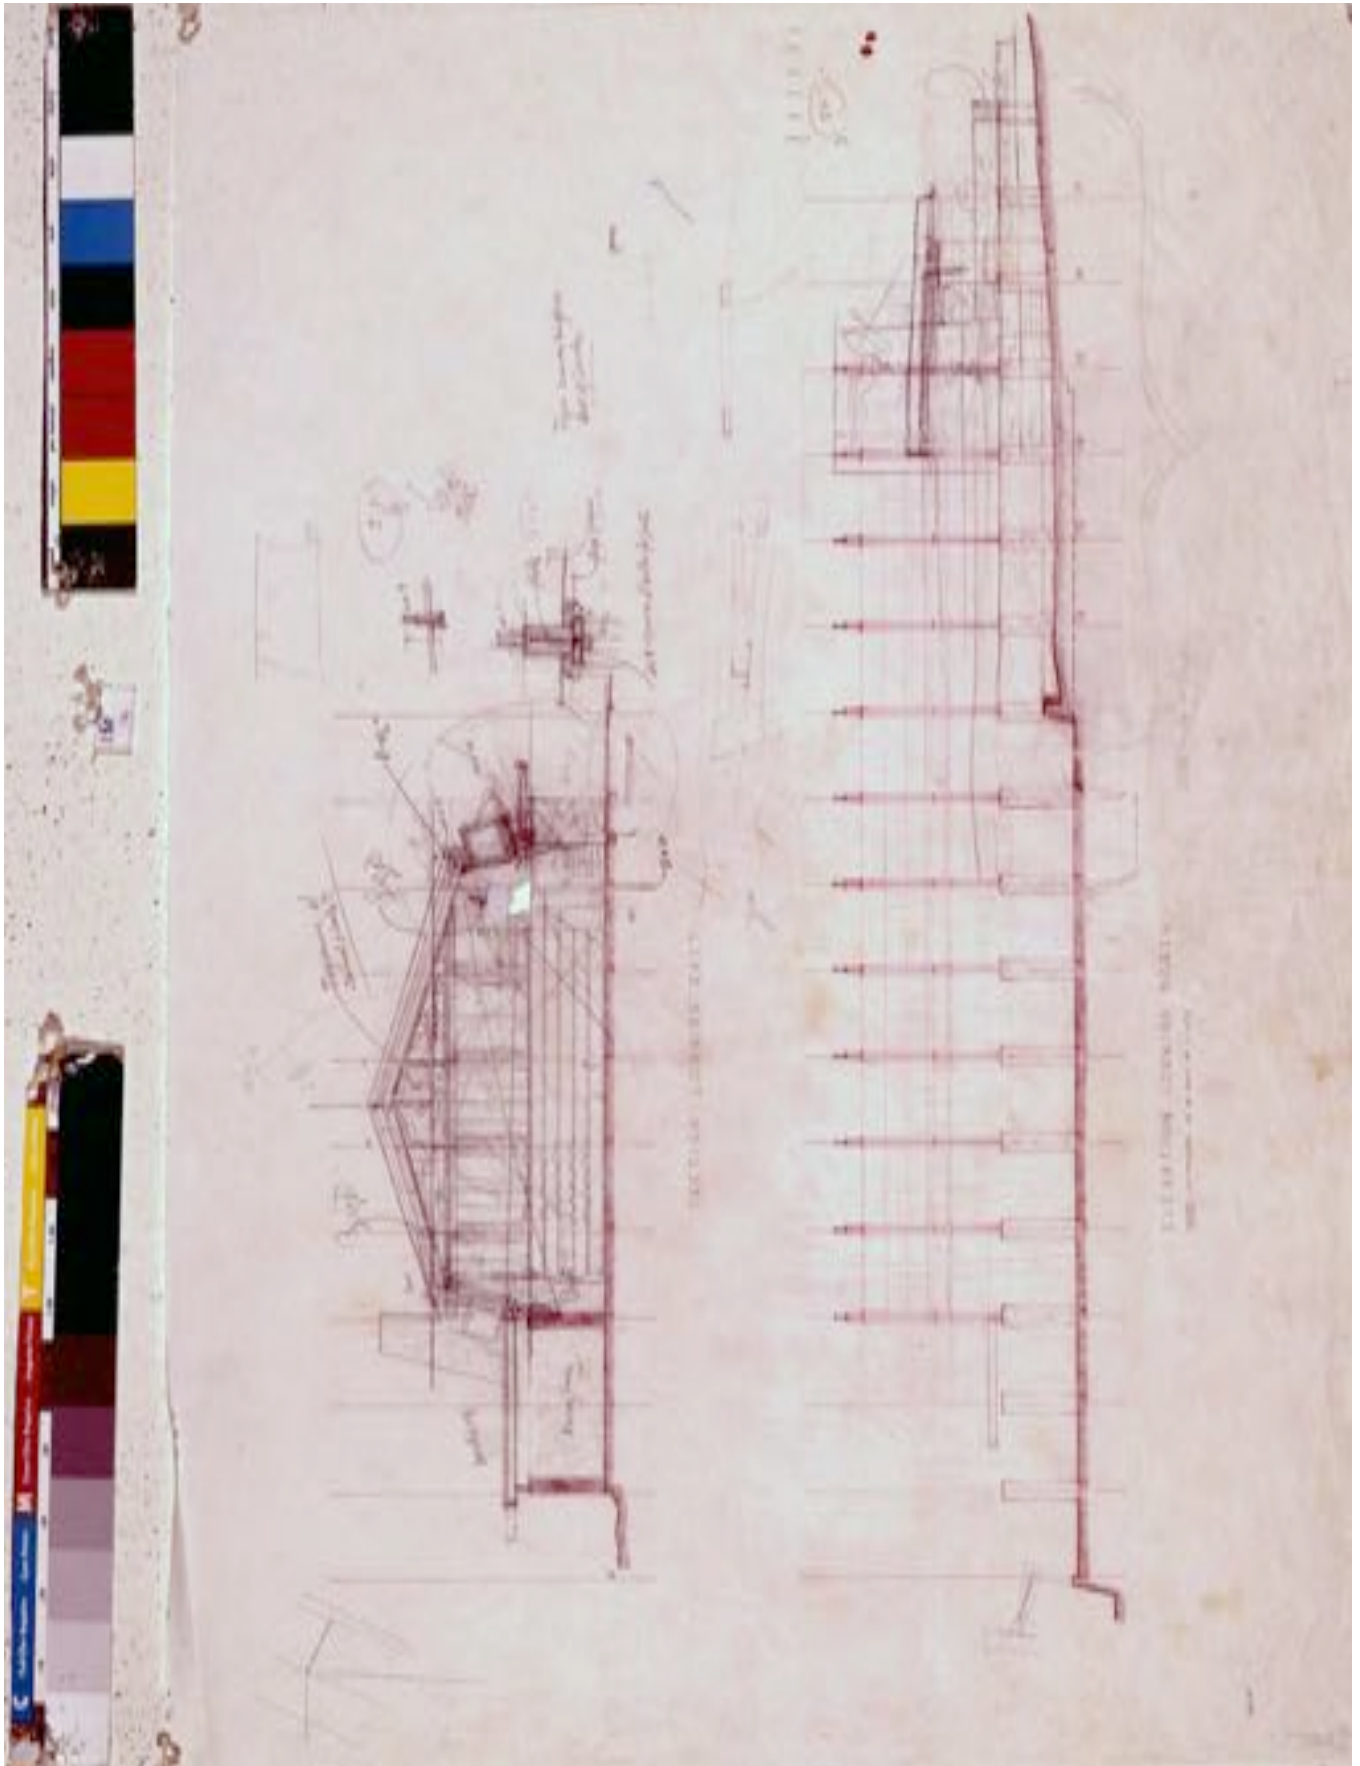
Figure B-120 - Pavilion Elevation & Section (The Frank Lloyd Wright Foundation Archives, The Museum of Modern Art | Avery Architectural & Fine Arts Library, Columbia University, New York).

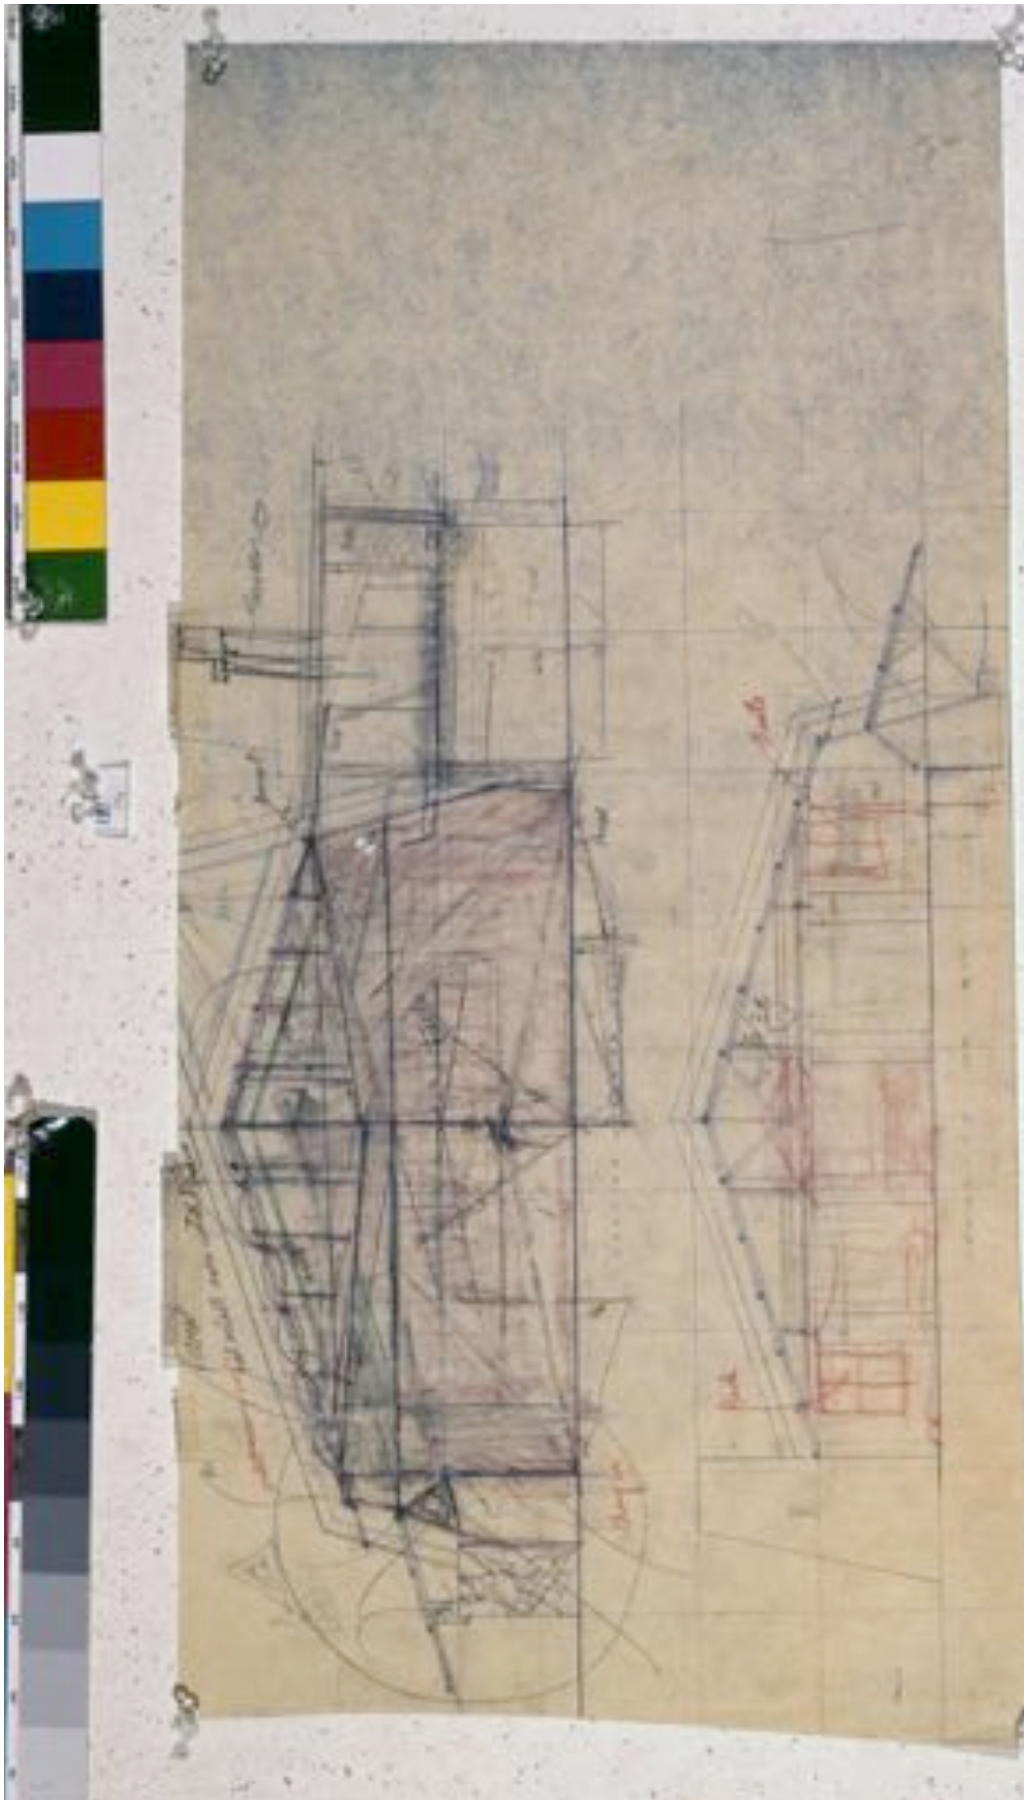
Figure B-121 - Pavilion Elevation/Section (The Frank Lloyd Wright Foundation Archives, The Museum of Modern Art | Avery Architectural & Fine Arts Library, Columbia University, New York).

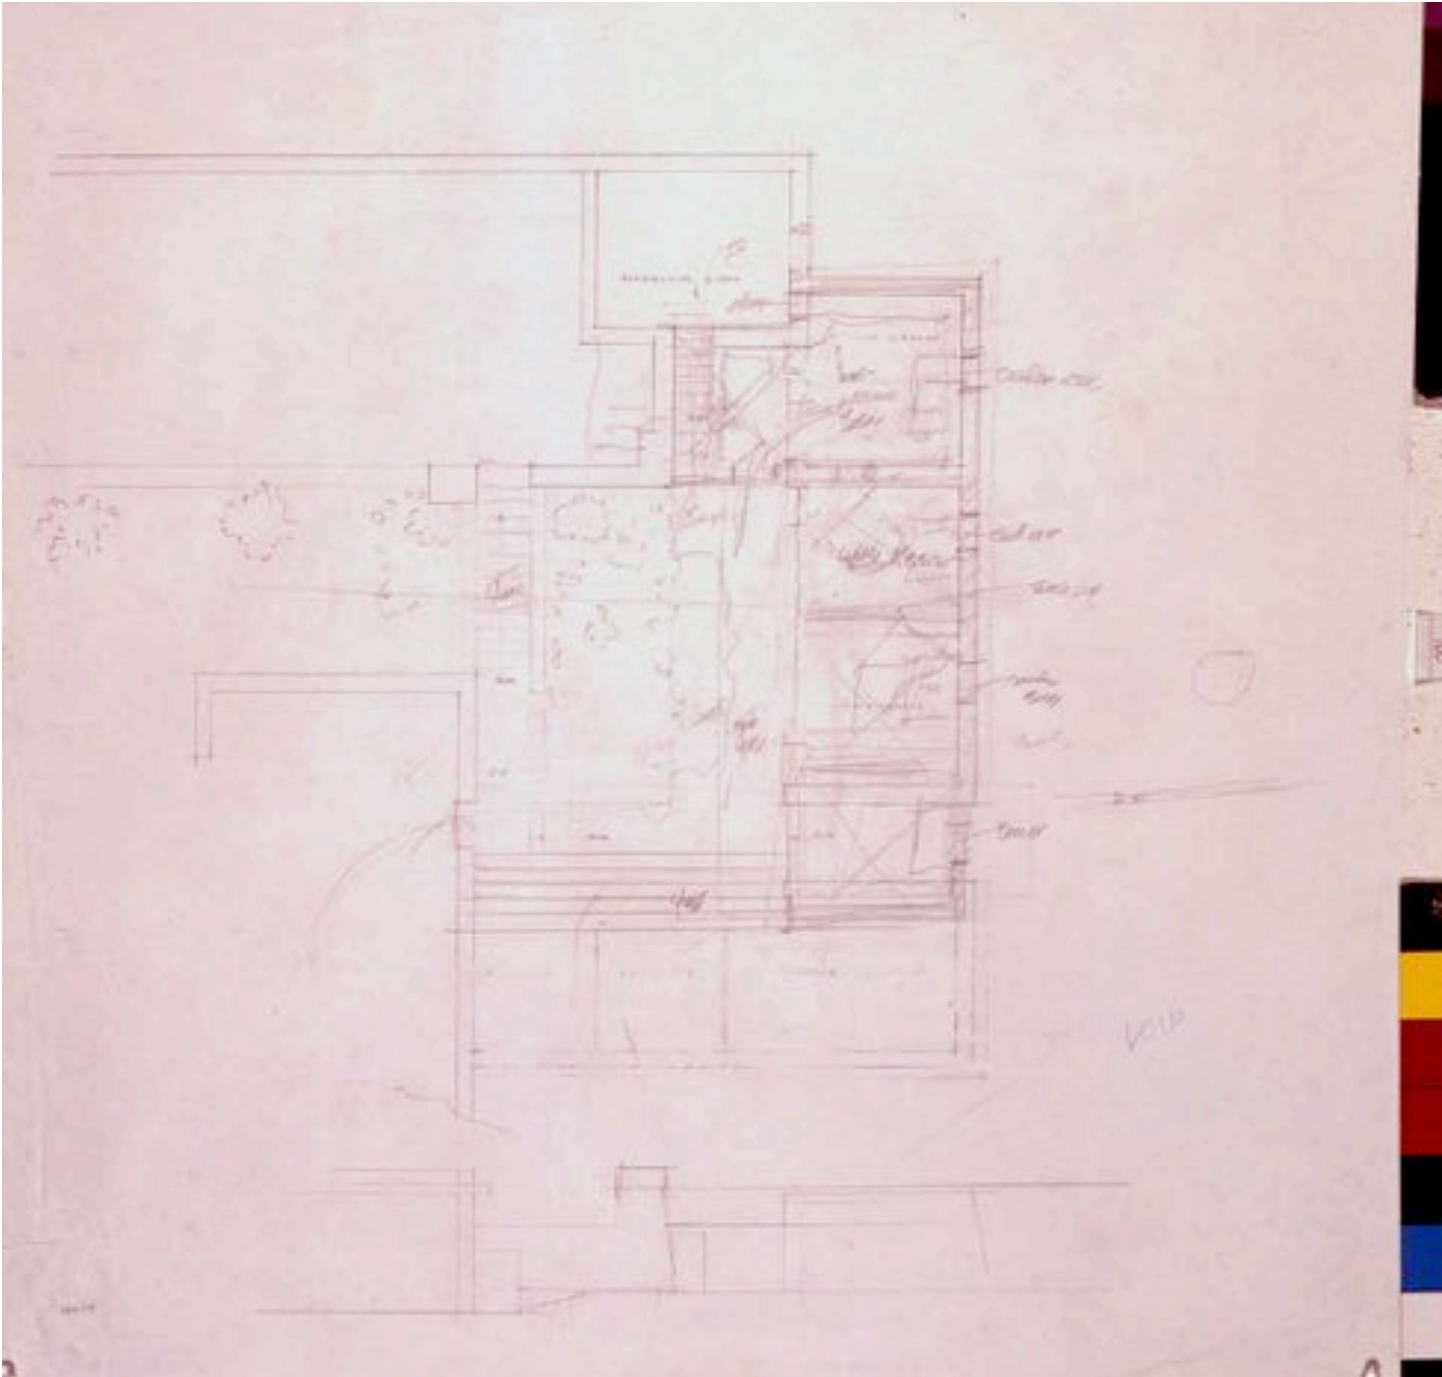
Figure B-122 - Pavilion Music Storage (The Frank Lloyd Wright Foundation Archives, The Museum of Modern Art | Avery Architectural & Fine Arts Library, Columbia University, New York).

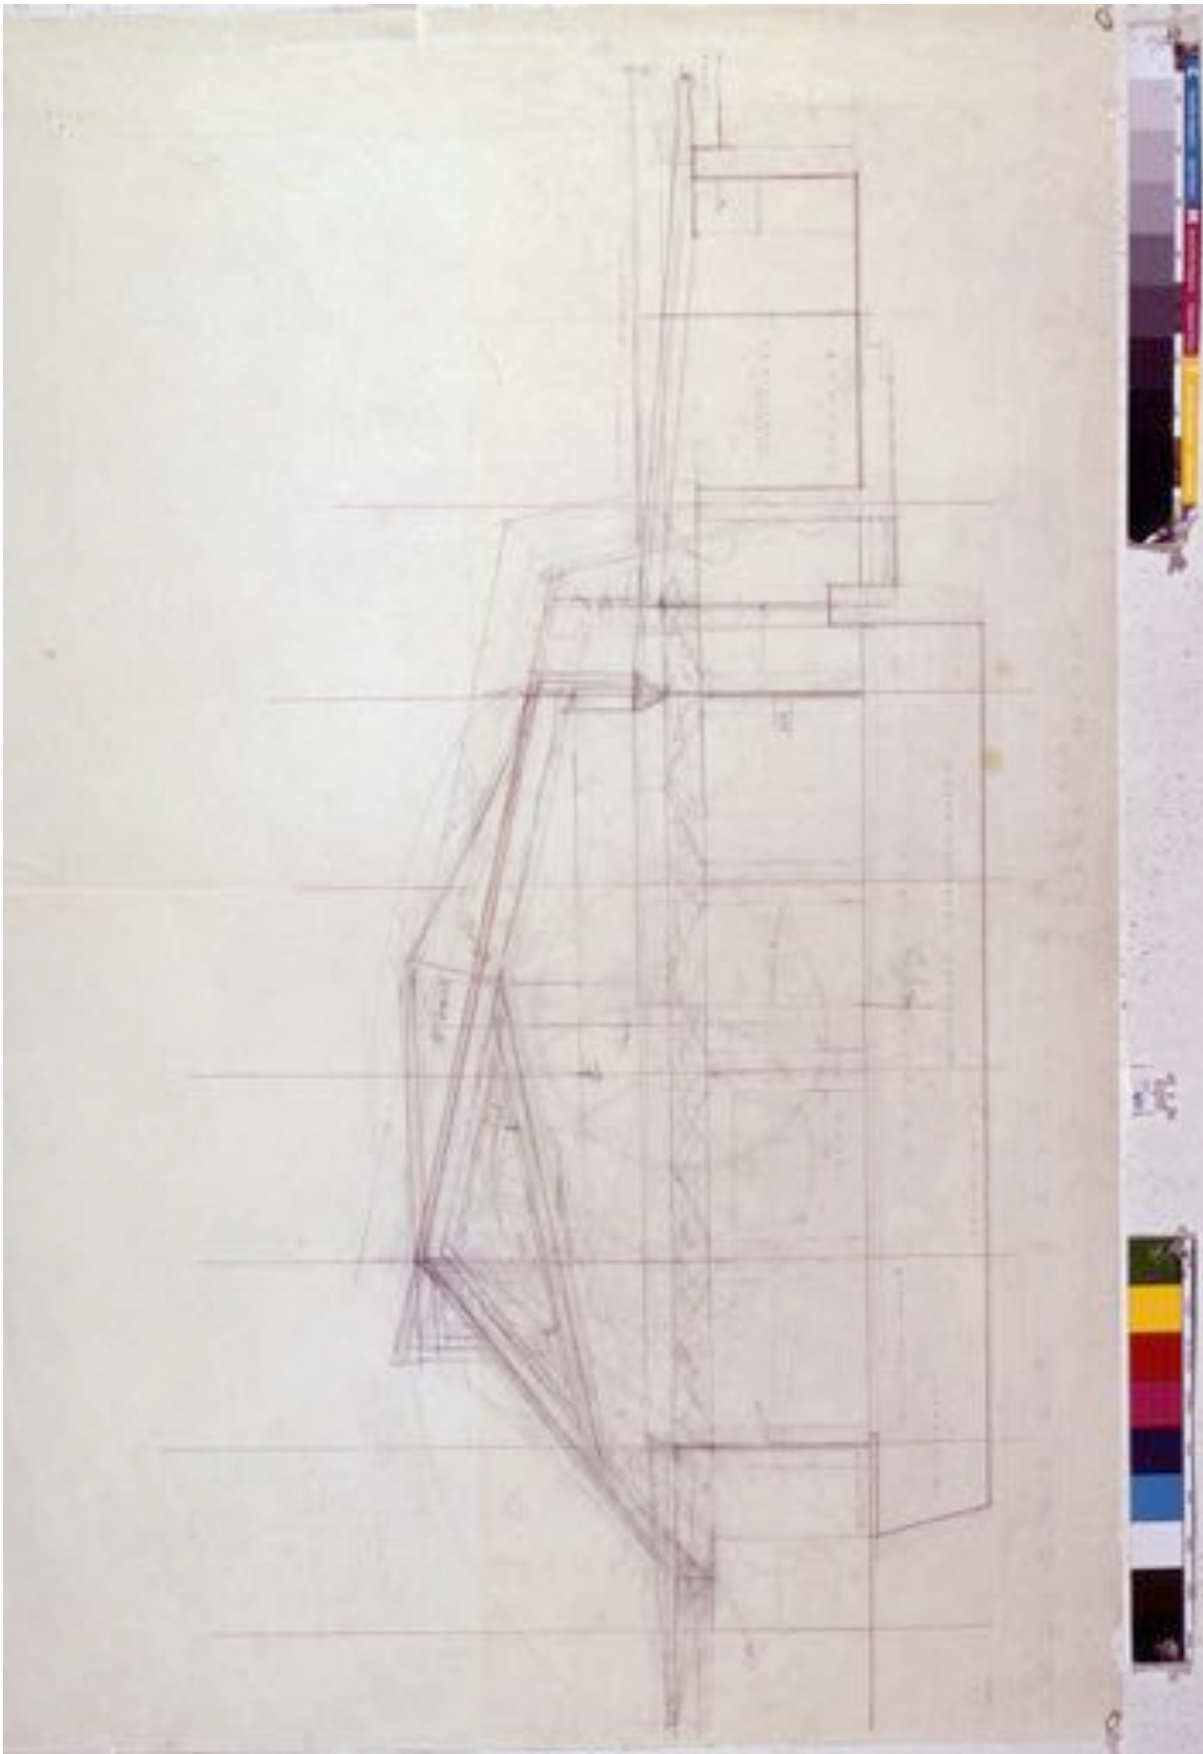
Figure B-123 - Pavilion Stage Section (The Frank Lloyd Wright Foundation Archives, The Museum of Modern Art | Avery Architectural & Fine Arts Library, Columbia University, New York).

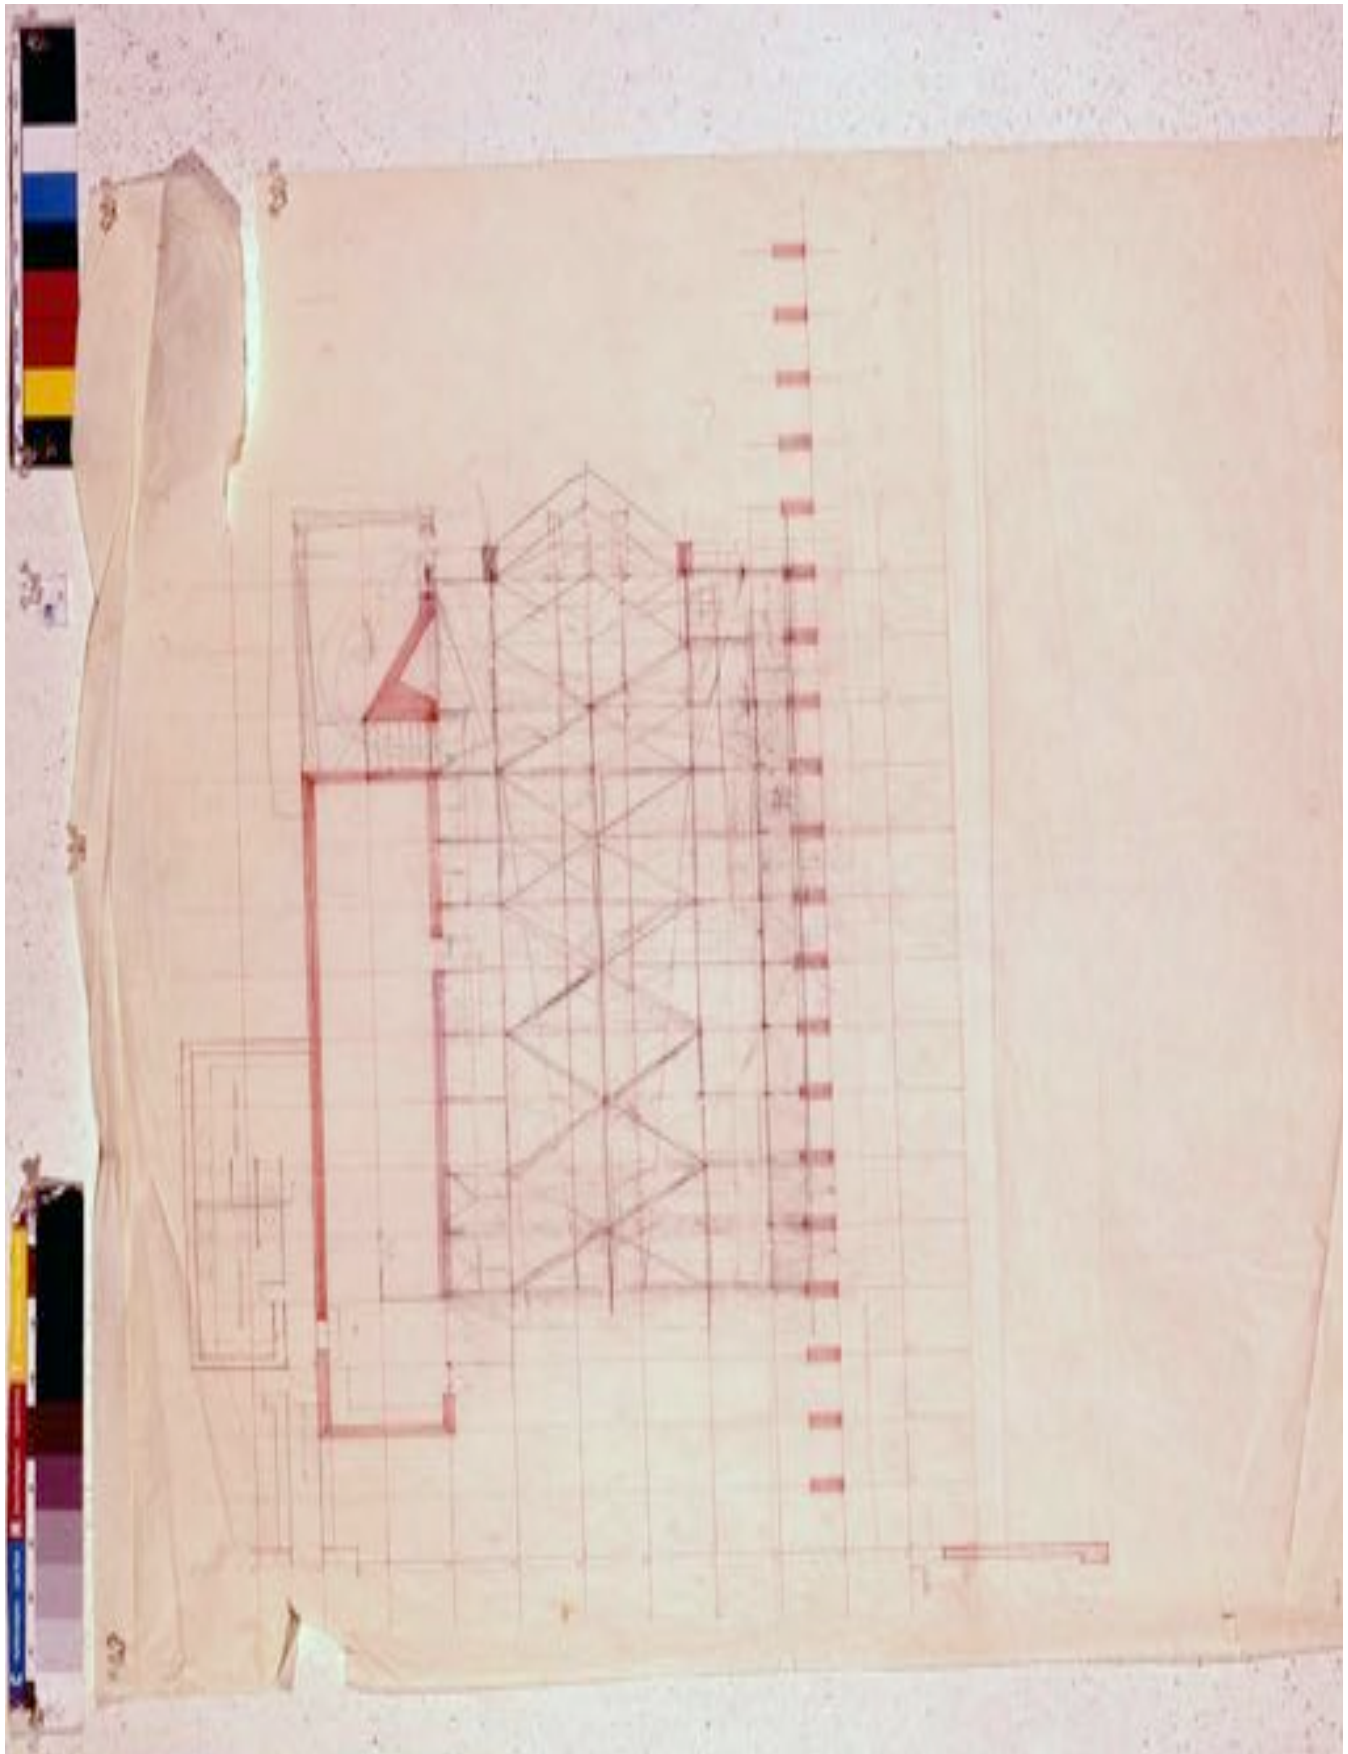
Figure B-124 - Pavilion Roof Plan (The Frank Lloyd Wright Foundation Archives, The Museum of Modern Art | Avery Architectural & Fine Arts Library, Columbia University, New York).

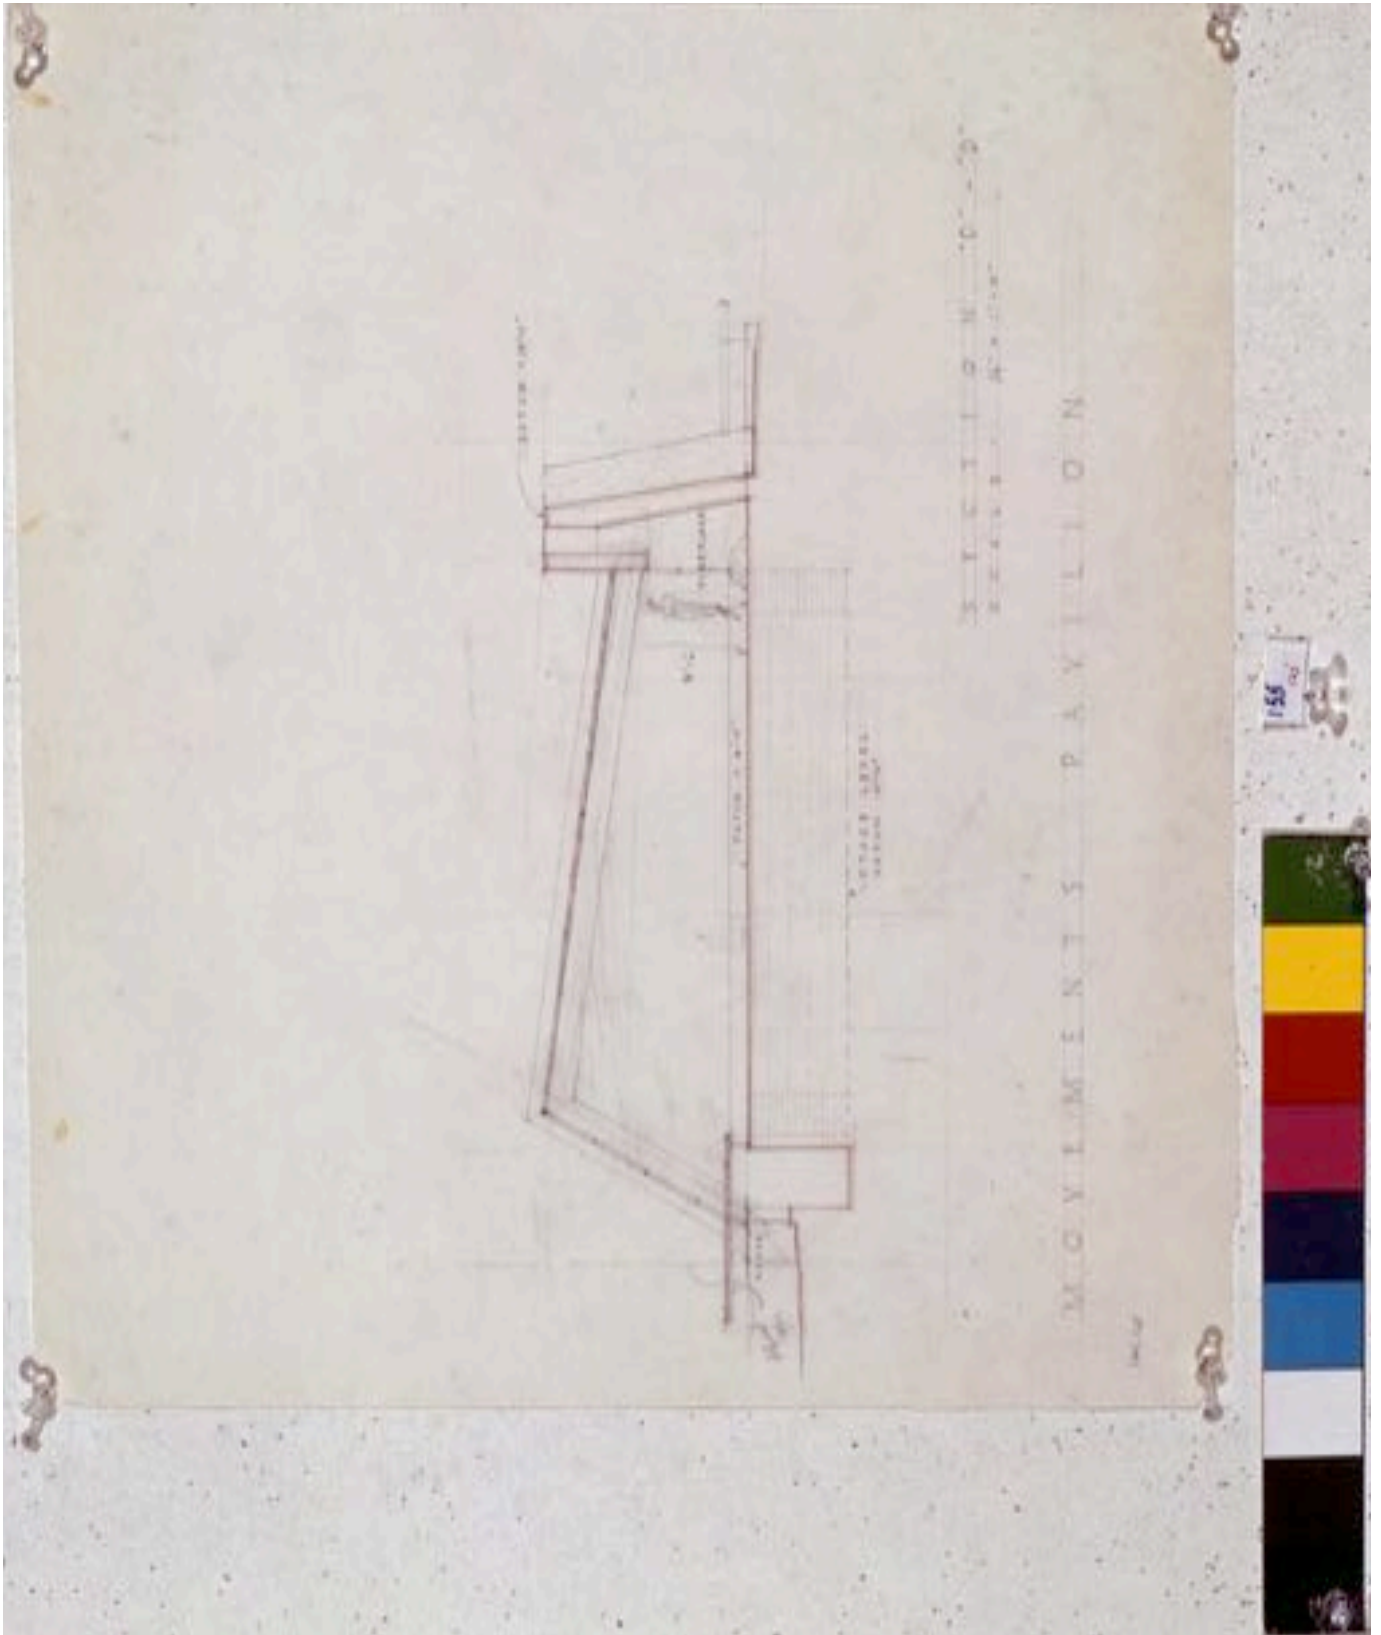
Figure B-125 - Pavilion Section (The Frank Lloyd Wright Foundation Archives, The Museum of Modern Art | Avery Architectural & Fine Arts Library, Columbia University, New York).

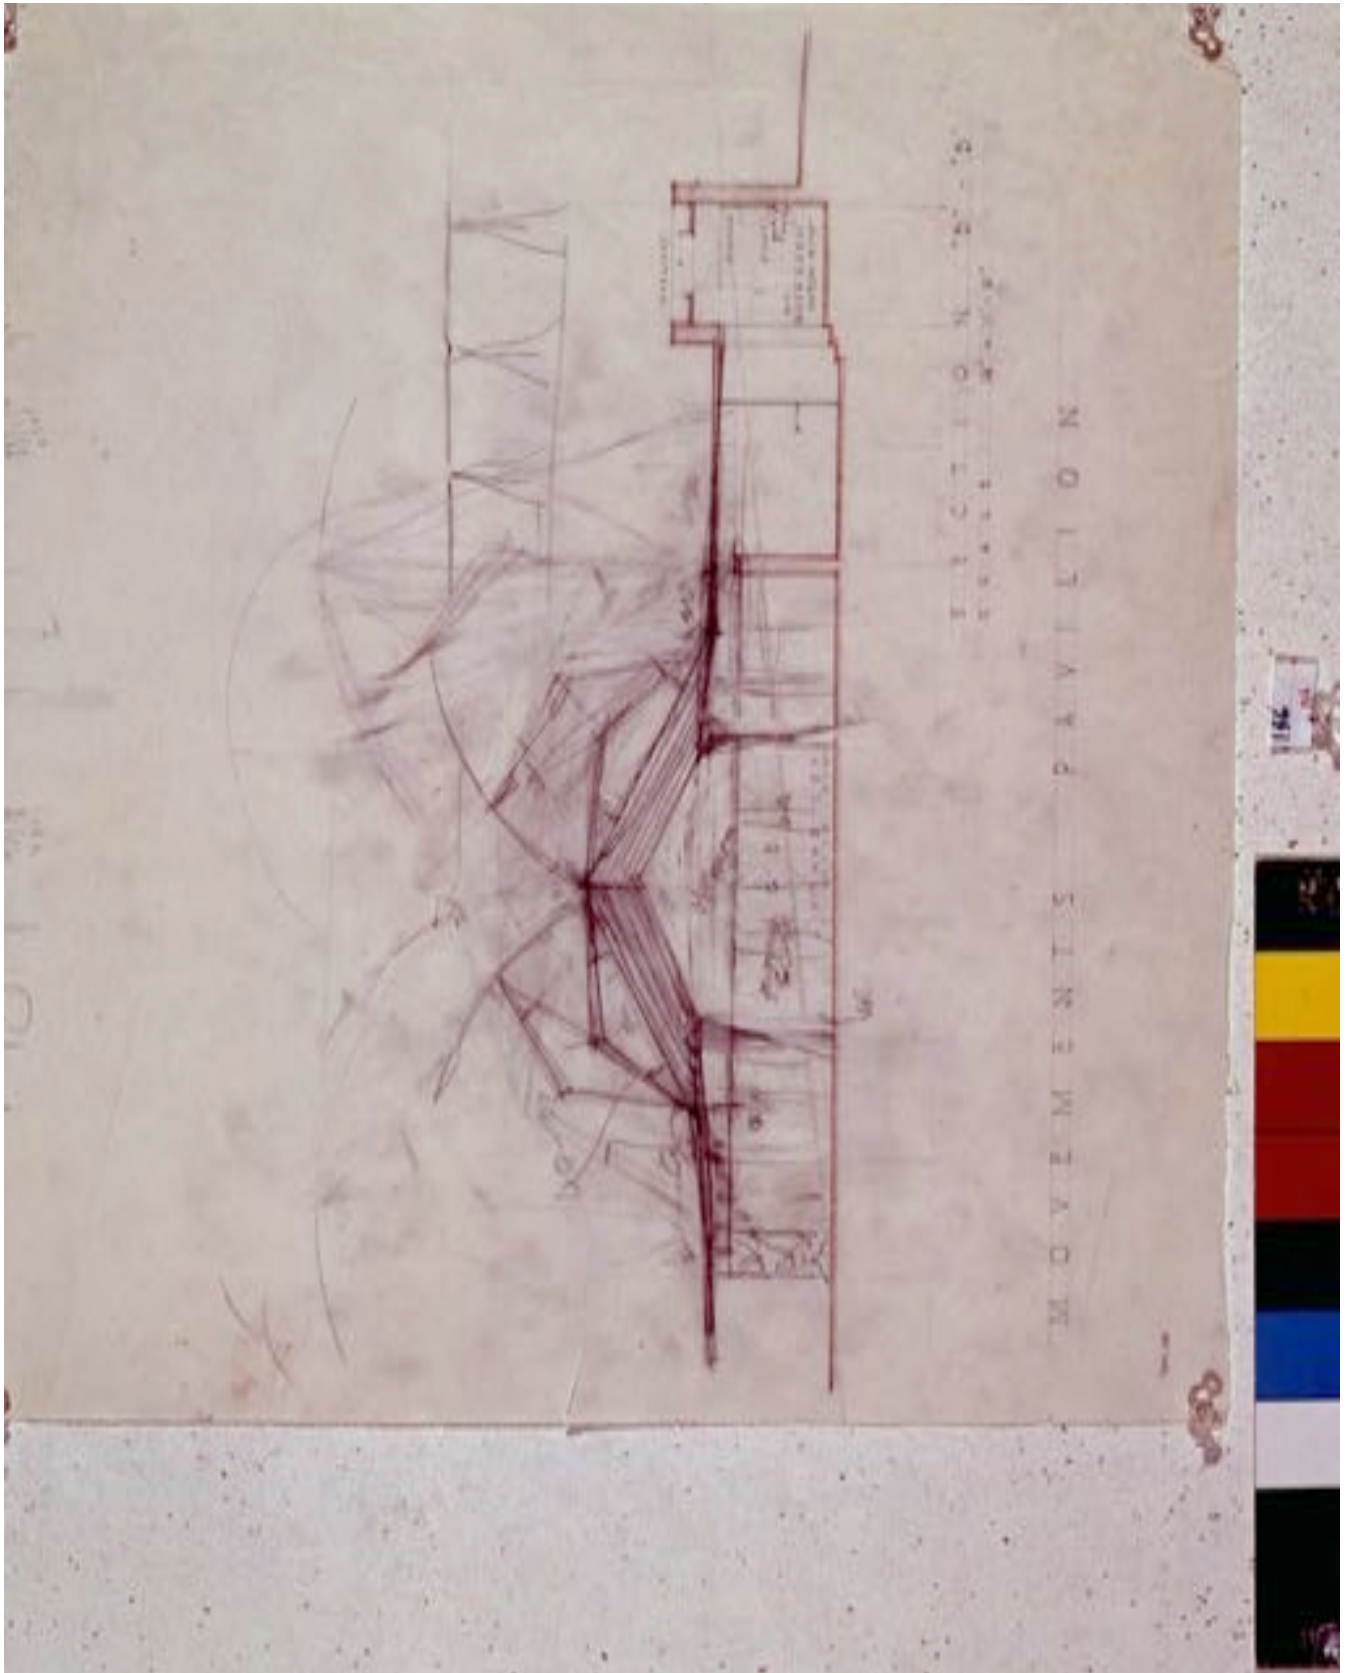
Figure B-126 - Pavilion Stage Roof (The Frank Lloyd Wright Foundation Archives, The Museum of Modern Art | Avery Architectural & Fine Arts Library, Columbia University, New York).

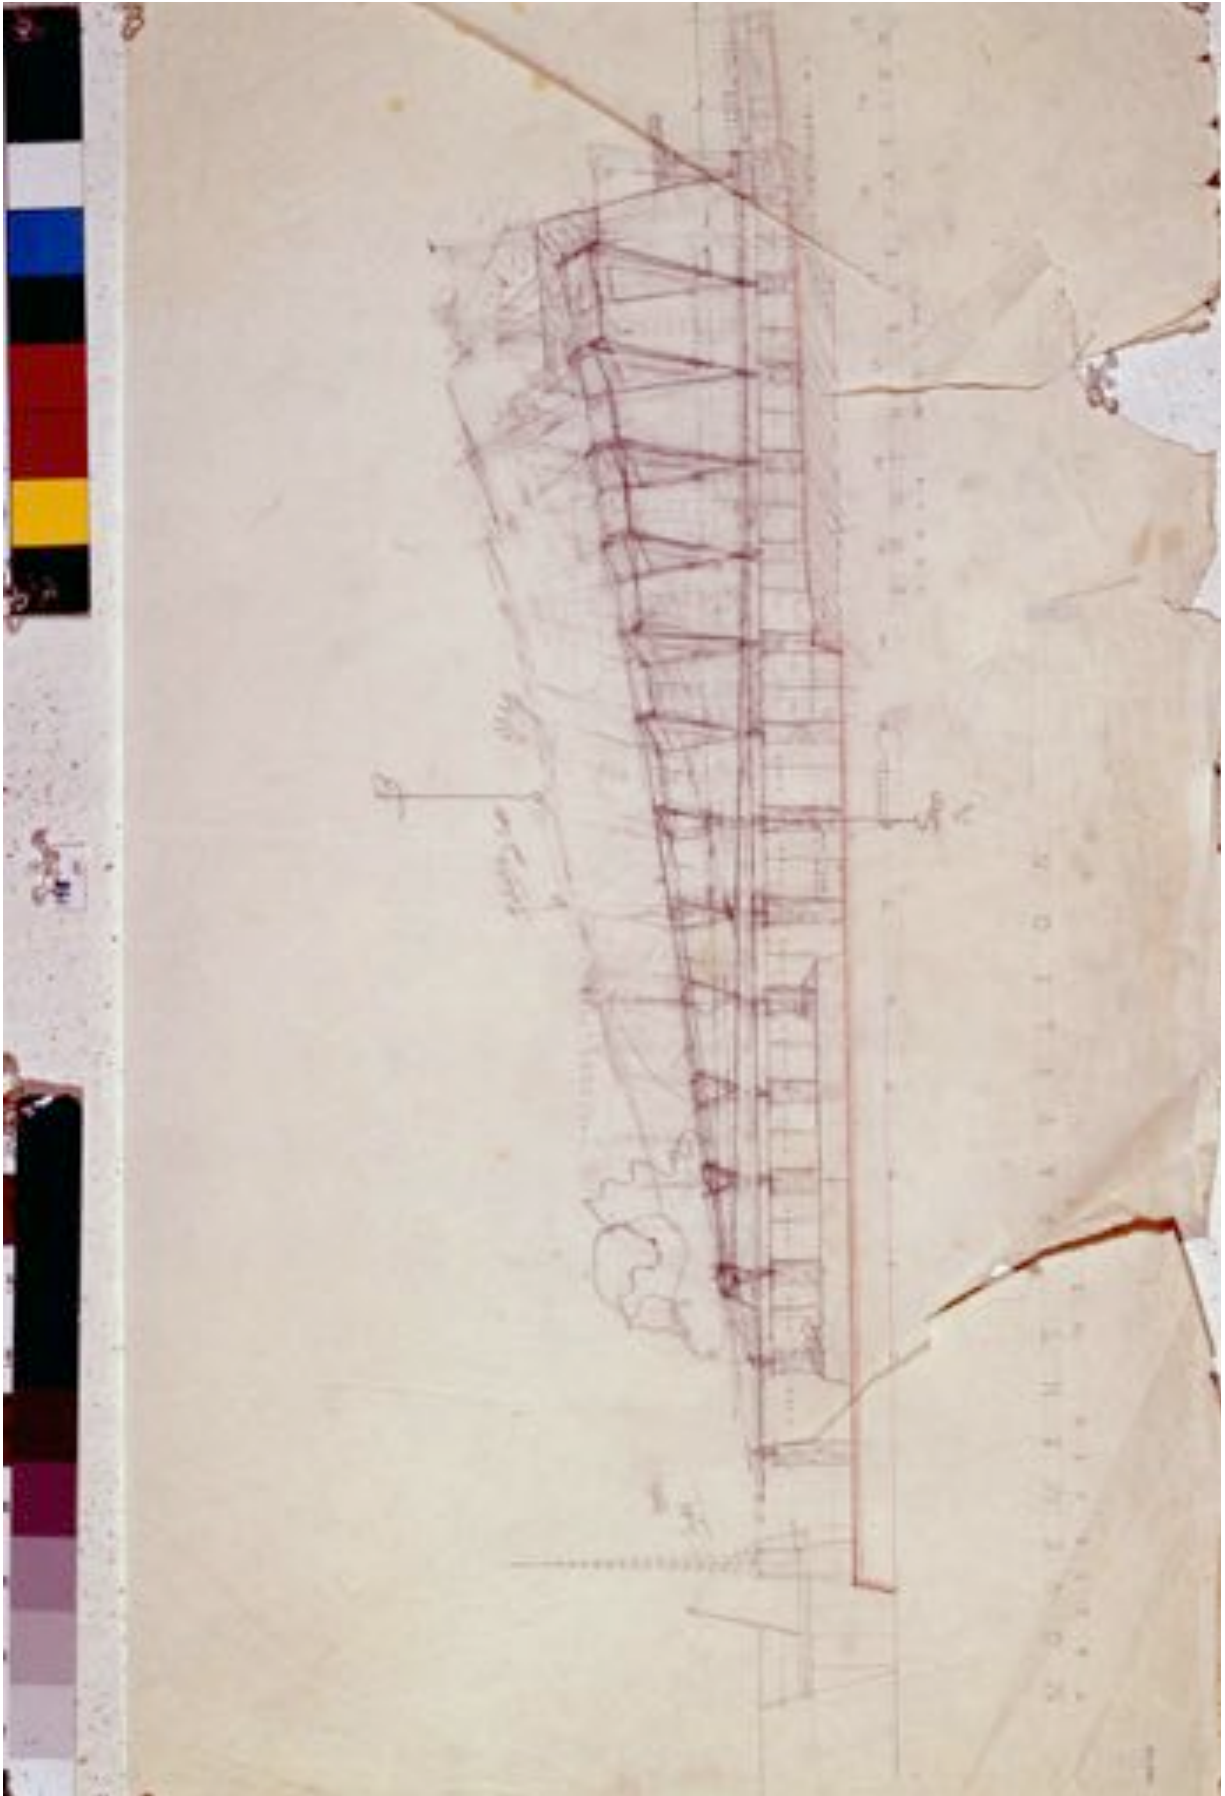
Figure B-128 - Pavilion Concrete Roof (The Frank Lloyd Wright Foundation Archives, The Museum of Modern Art | Avery Architectural & Fine Arts Library, Columbia University, New York).
