TALIESIN WEST PRESERVATION MASTER PLAN

Harboe Architects, PC

MAY 21, 2015

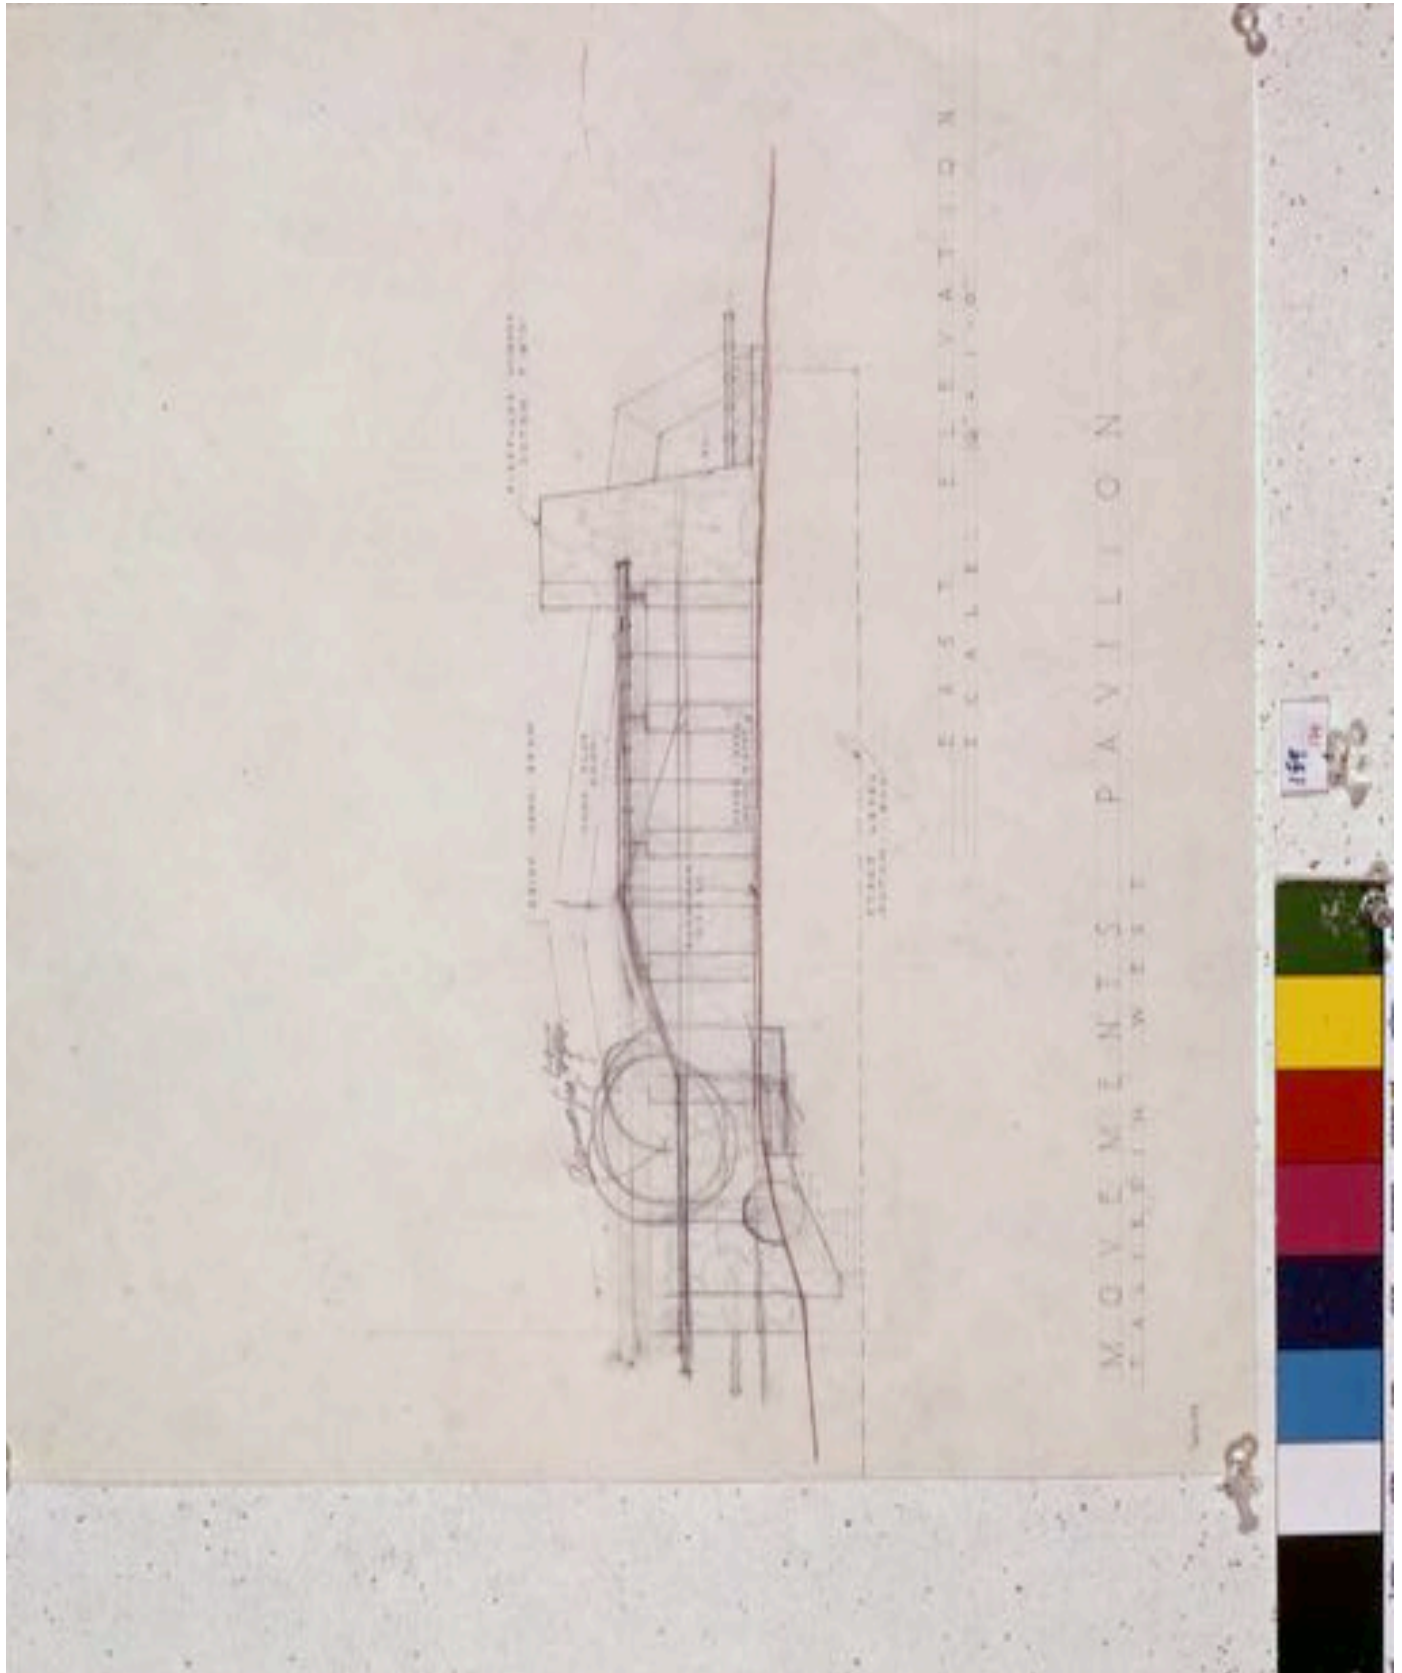
Figure B-129 - Pavilion Cross Section (The Frank Lloyd Wright Foundation Archives, The Museum of Modern Art | Avery Architectural & Fine Arts Library, Columbia University, New York).

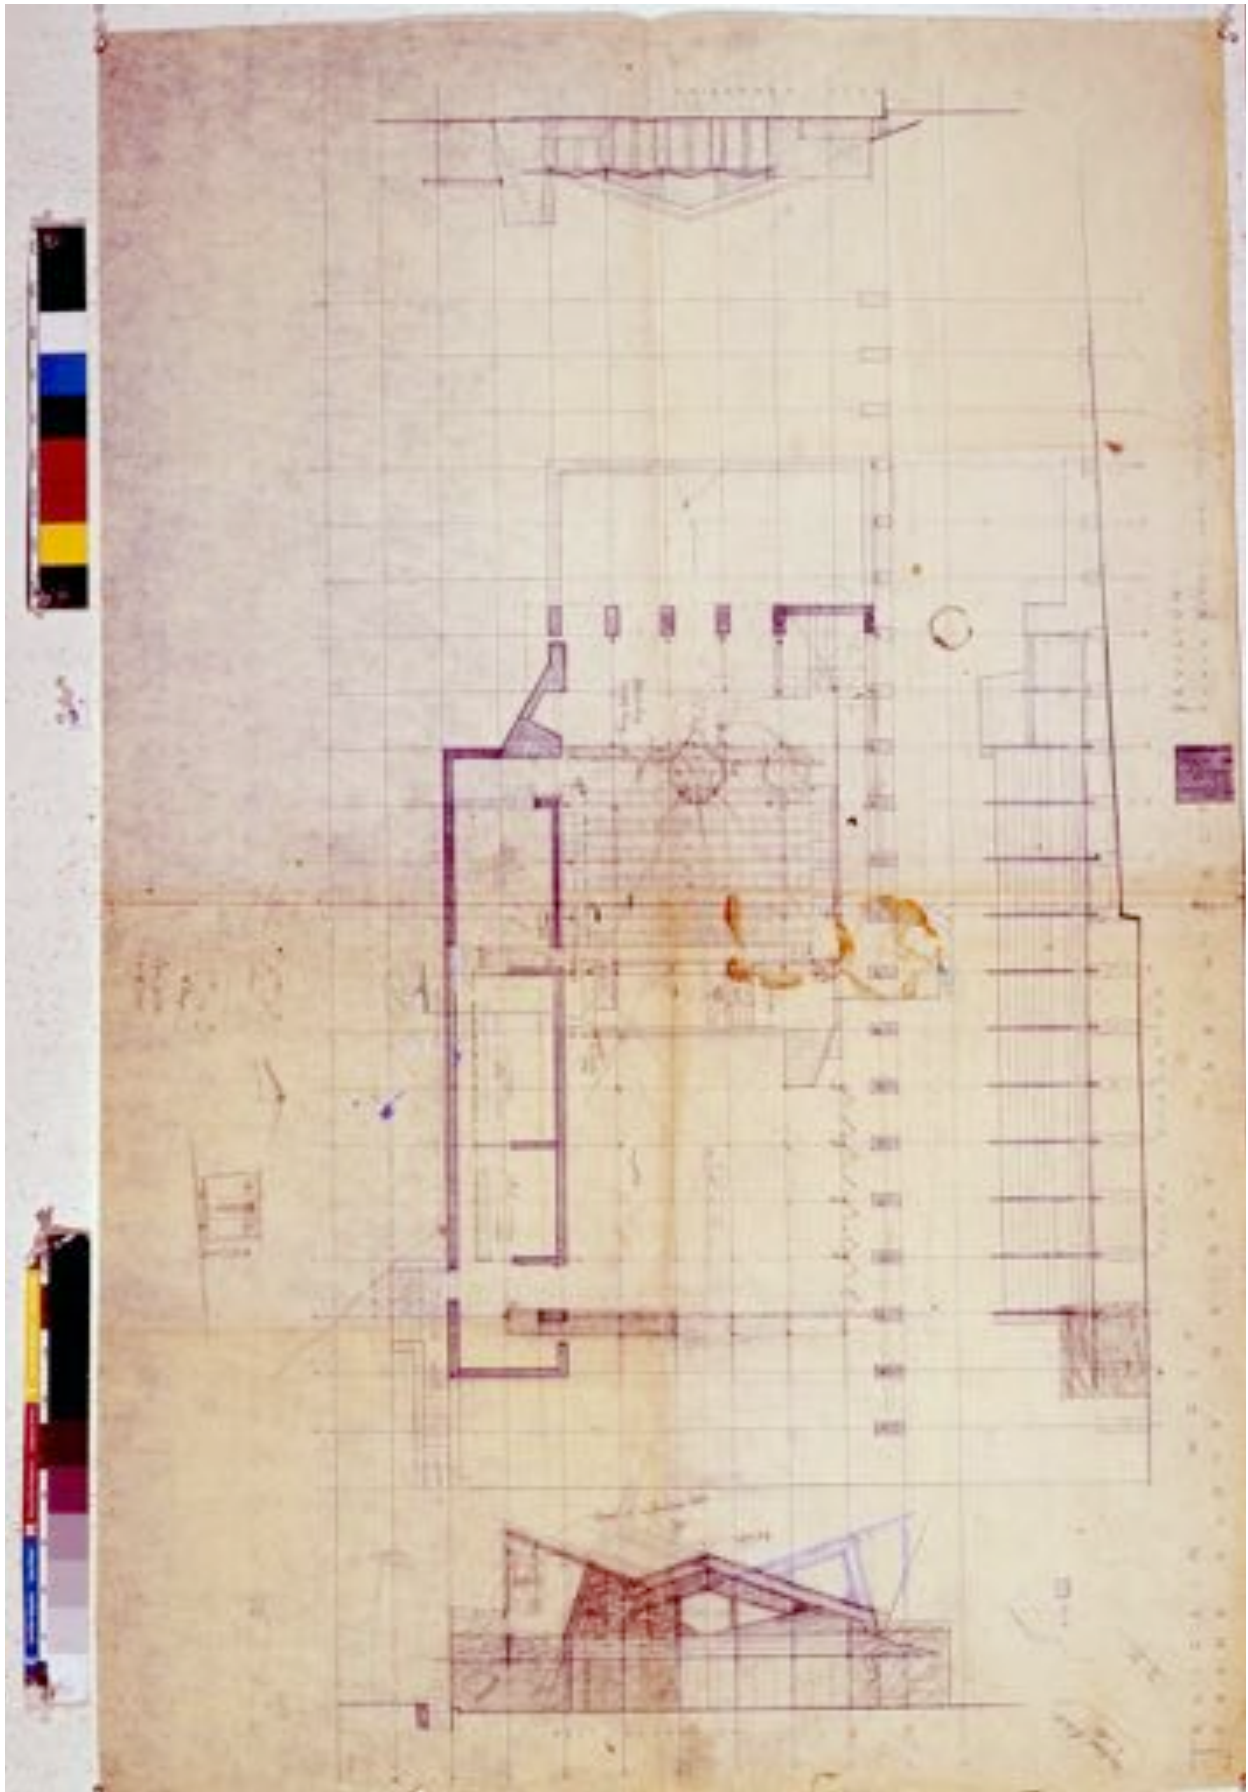
Figure B-130 - Pavilion Plan & Elevations (The Frank Lloyd Wright Foundation Archives, The Museum of Modern Art | Avery Architectural & Fine Arts Library, Columbia University, New York).

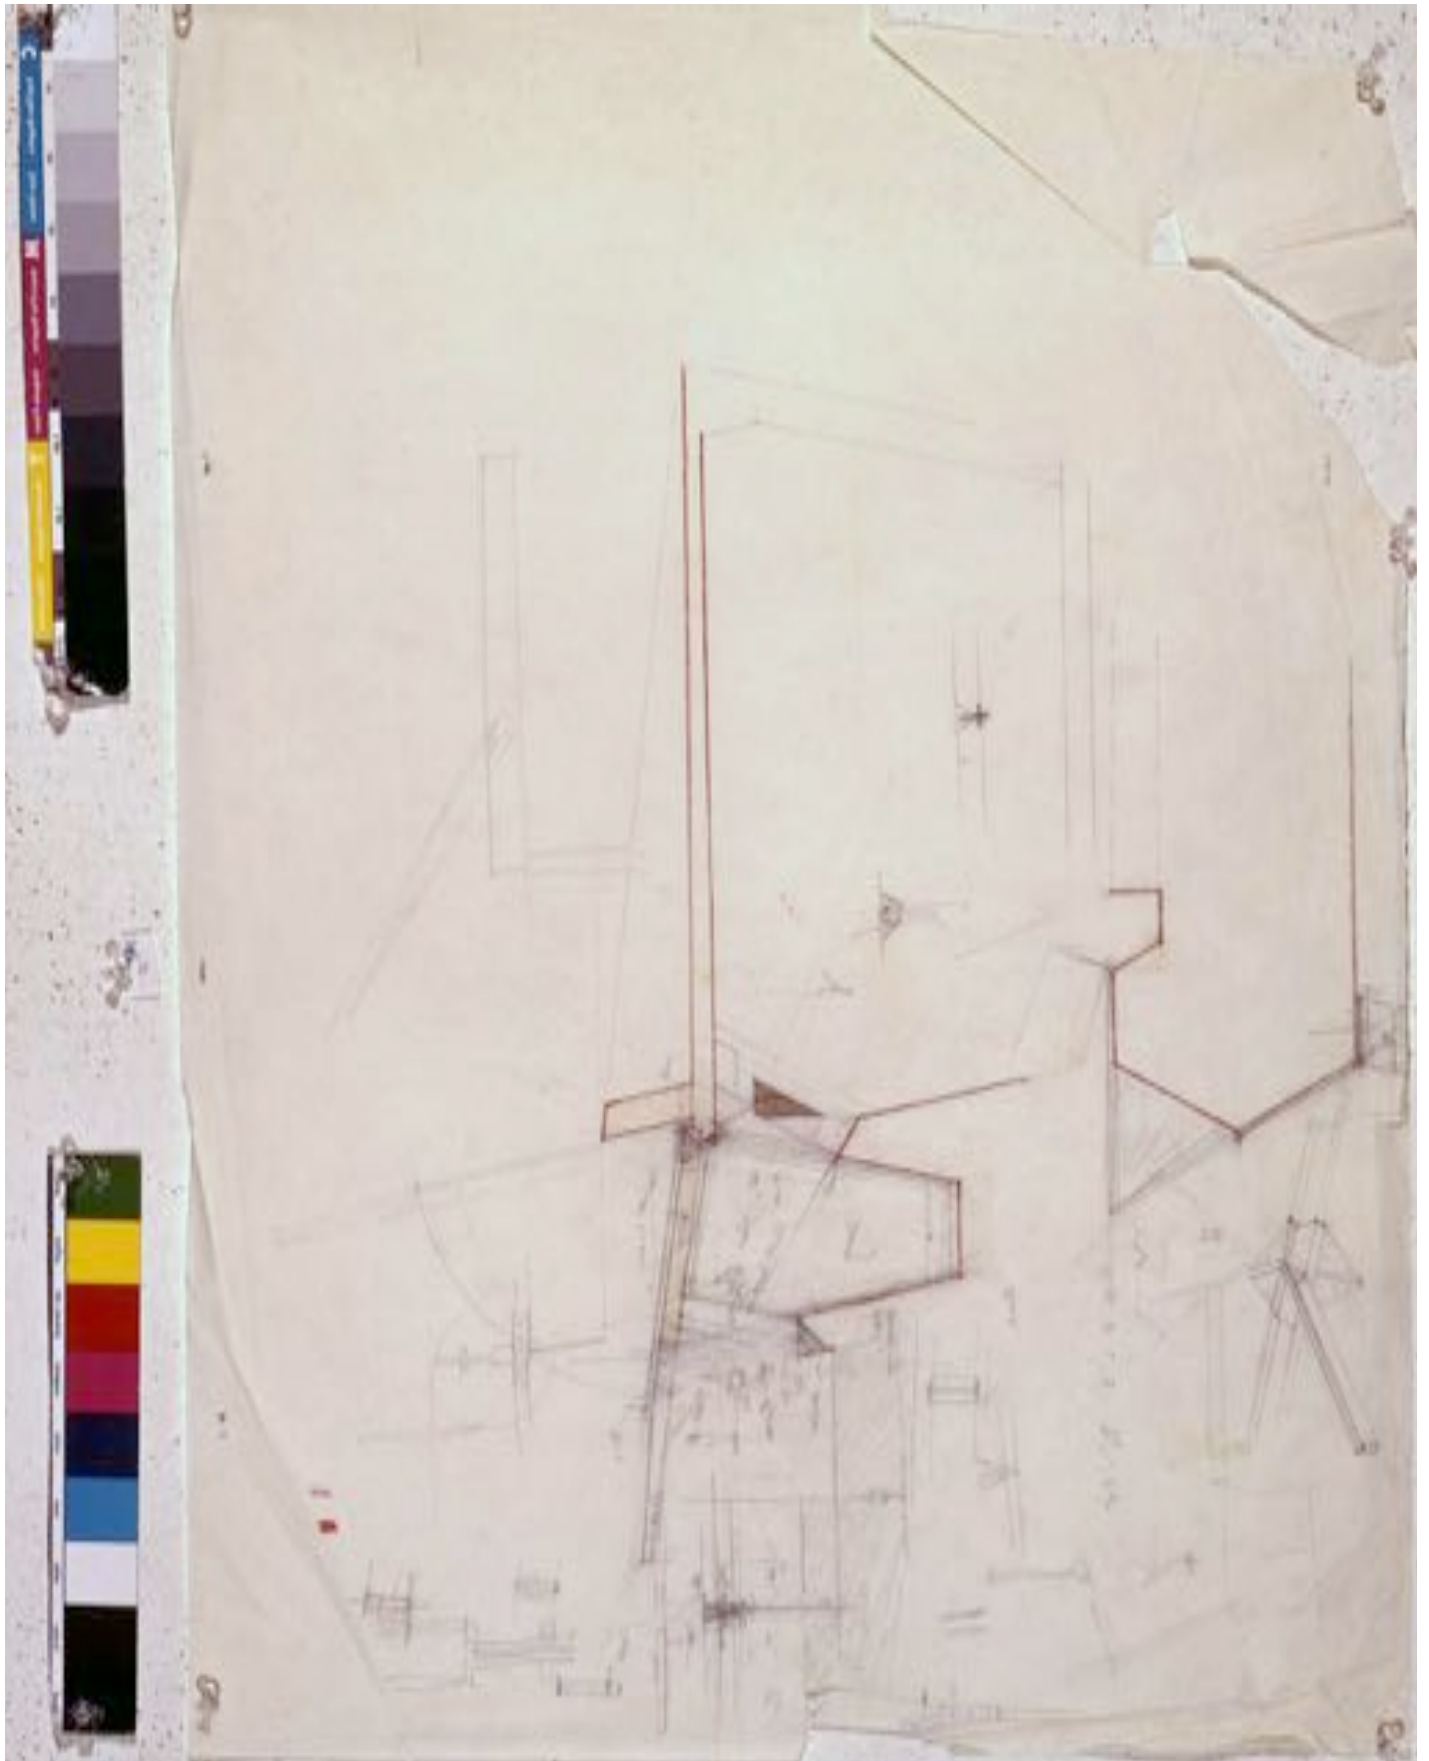
Figure B-131 - Cabaret Section Detail (The Frank Lloyd Wright Foundation Archives, The Museum of Modern Art | Avery Architectural & Fine Arts Library, Columbia University, New York).

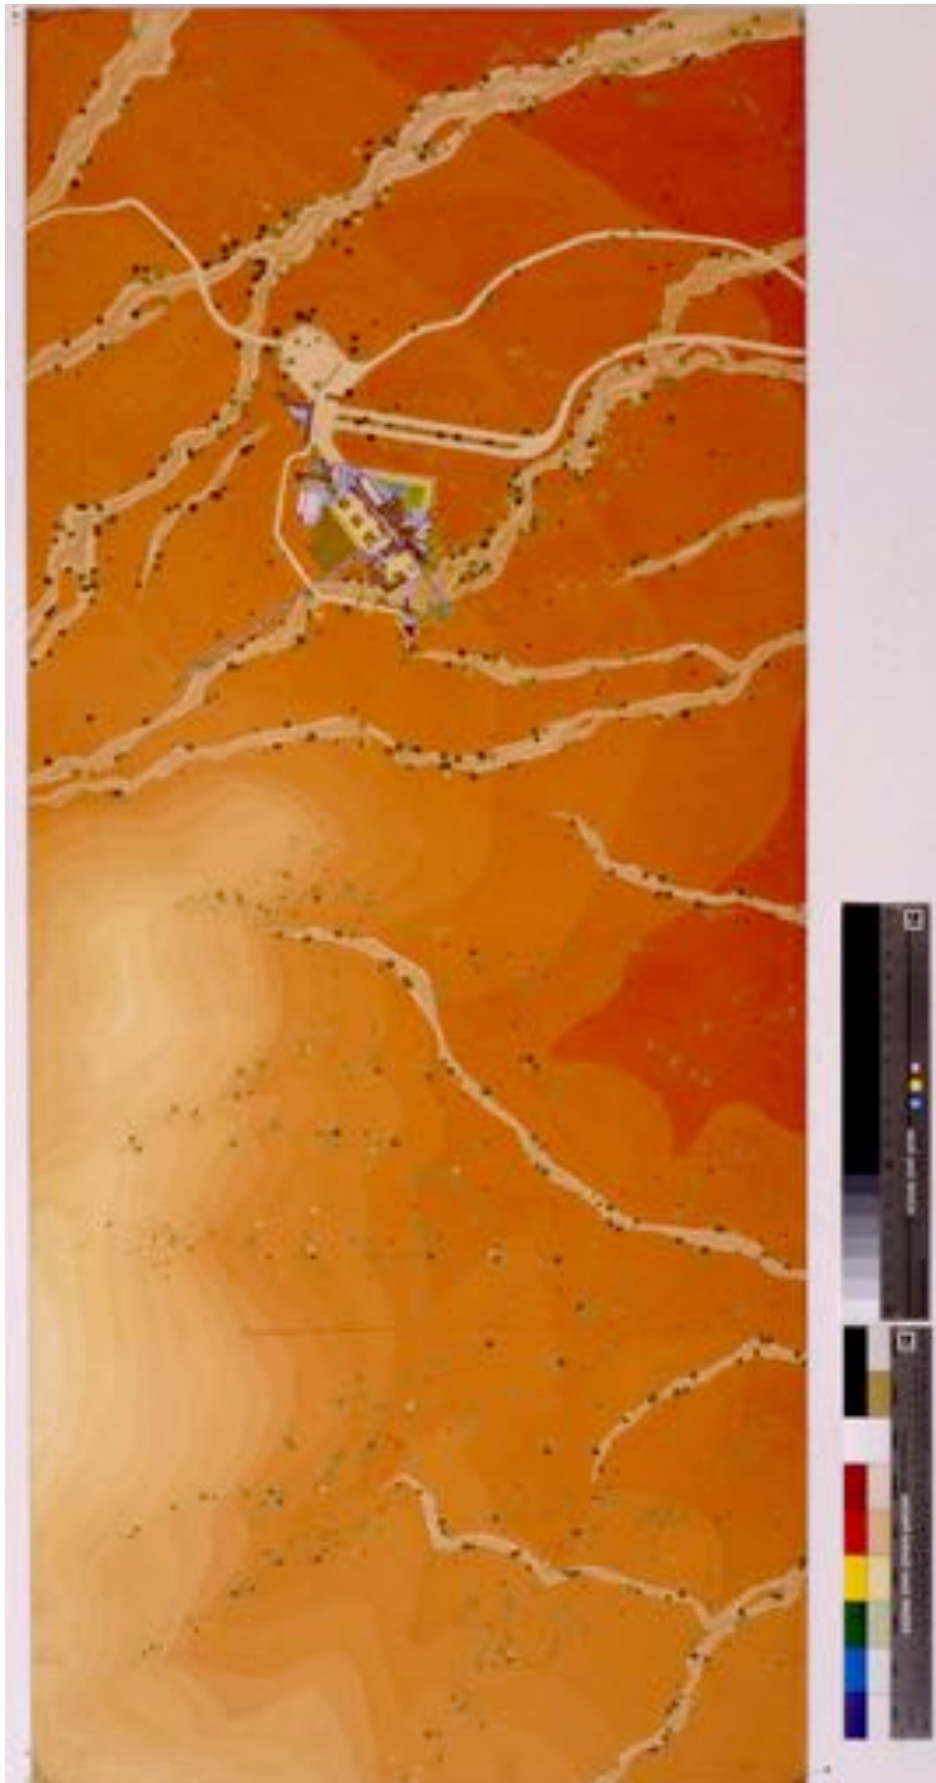
Figure B-132 - Taliesin West Master Plan (The Frank Lloyd Wright Foundation Archives, The Museum of Modern Art | Avery Architectural & Fine Arts Library, Columbia University, New York).

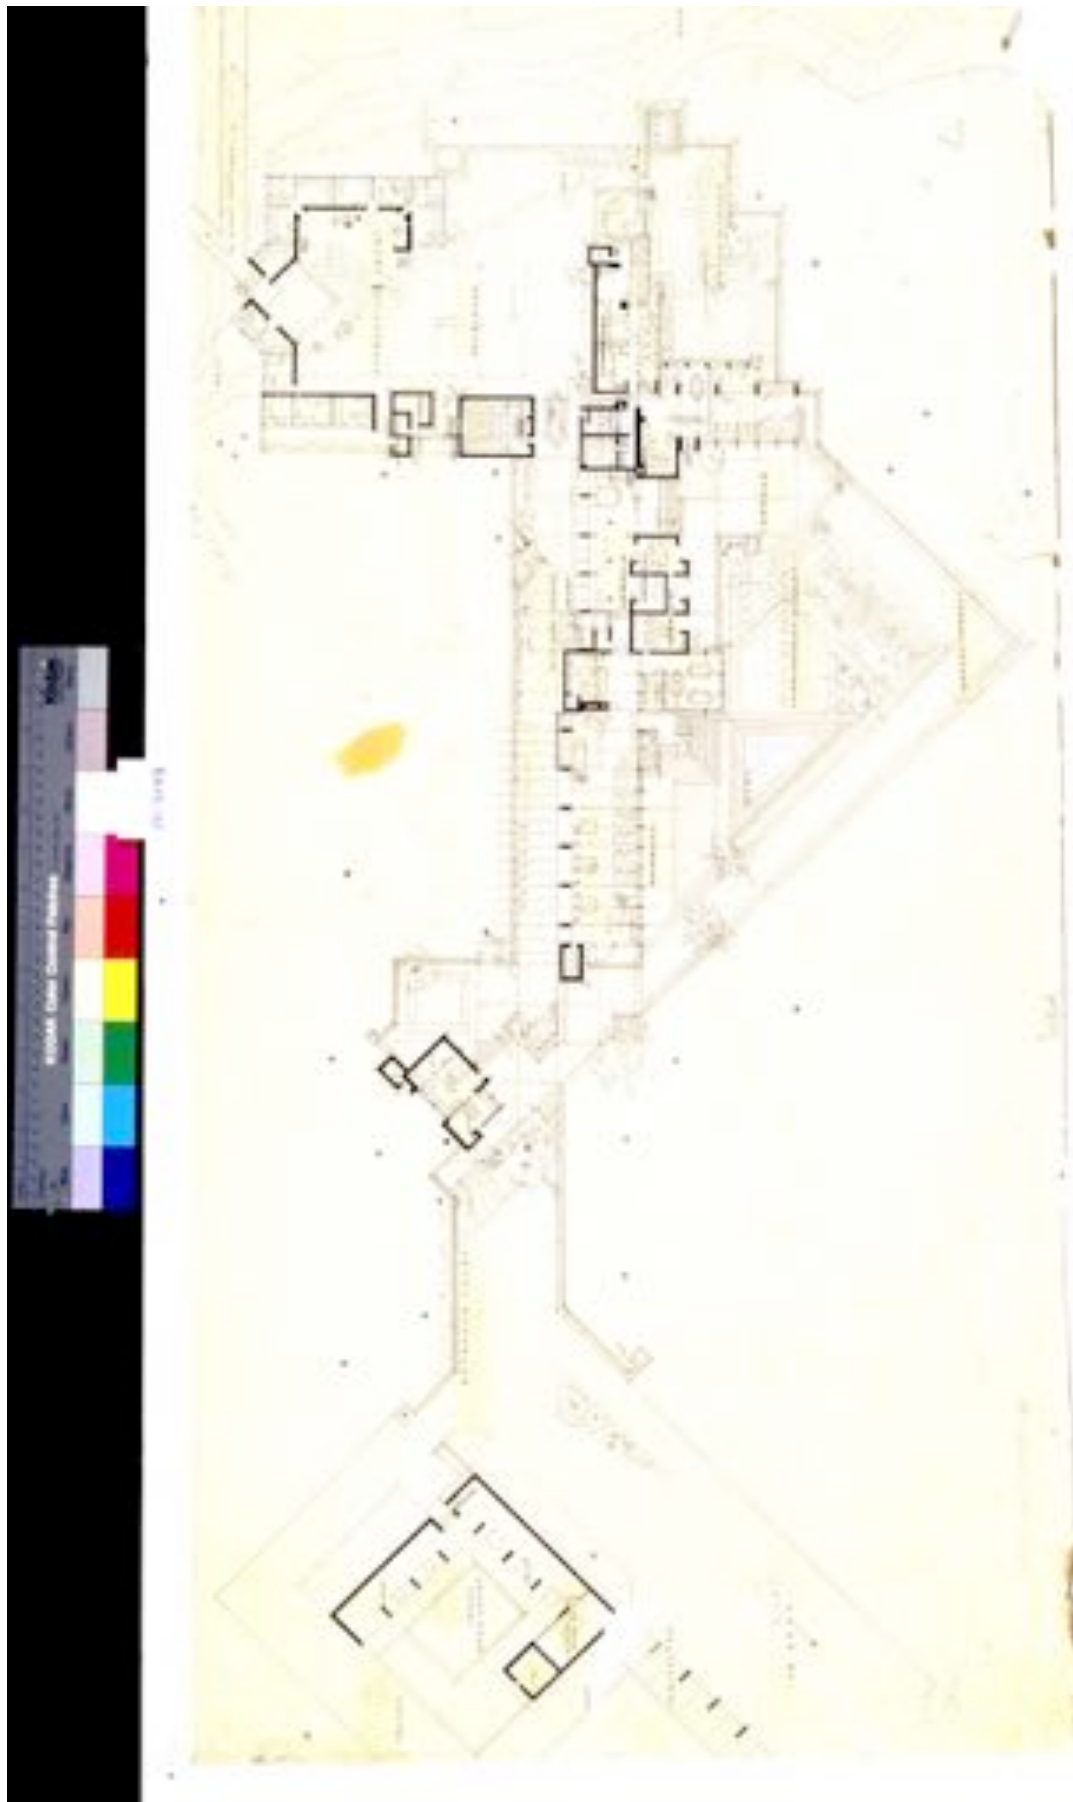
Figure B-135 - Master Plan (The Frank Lloyd Wright Foundation Archives, The Museum of Modern Art | Avery Architectural & Fine Arts Library, Columbia University, New York).

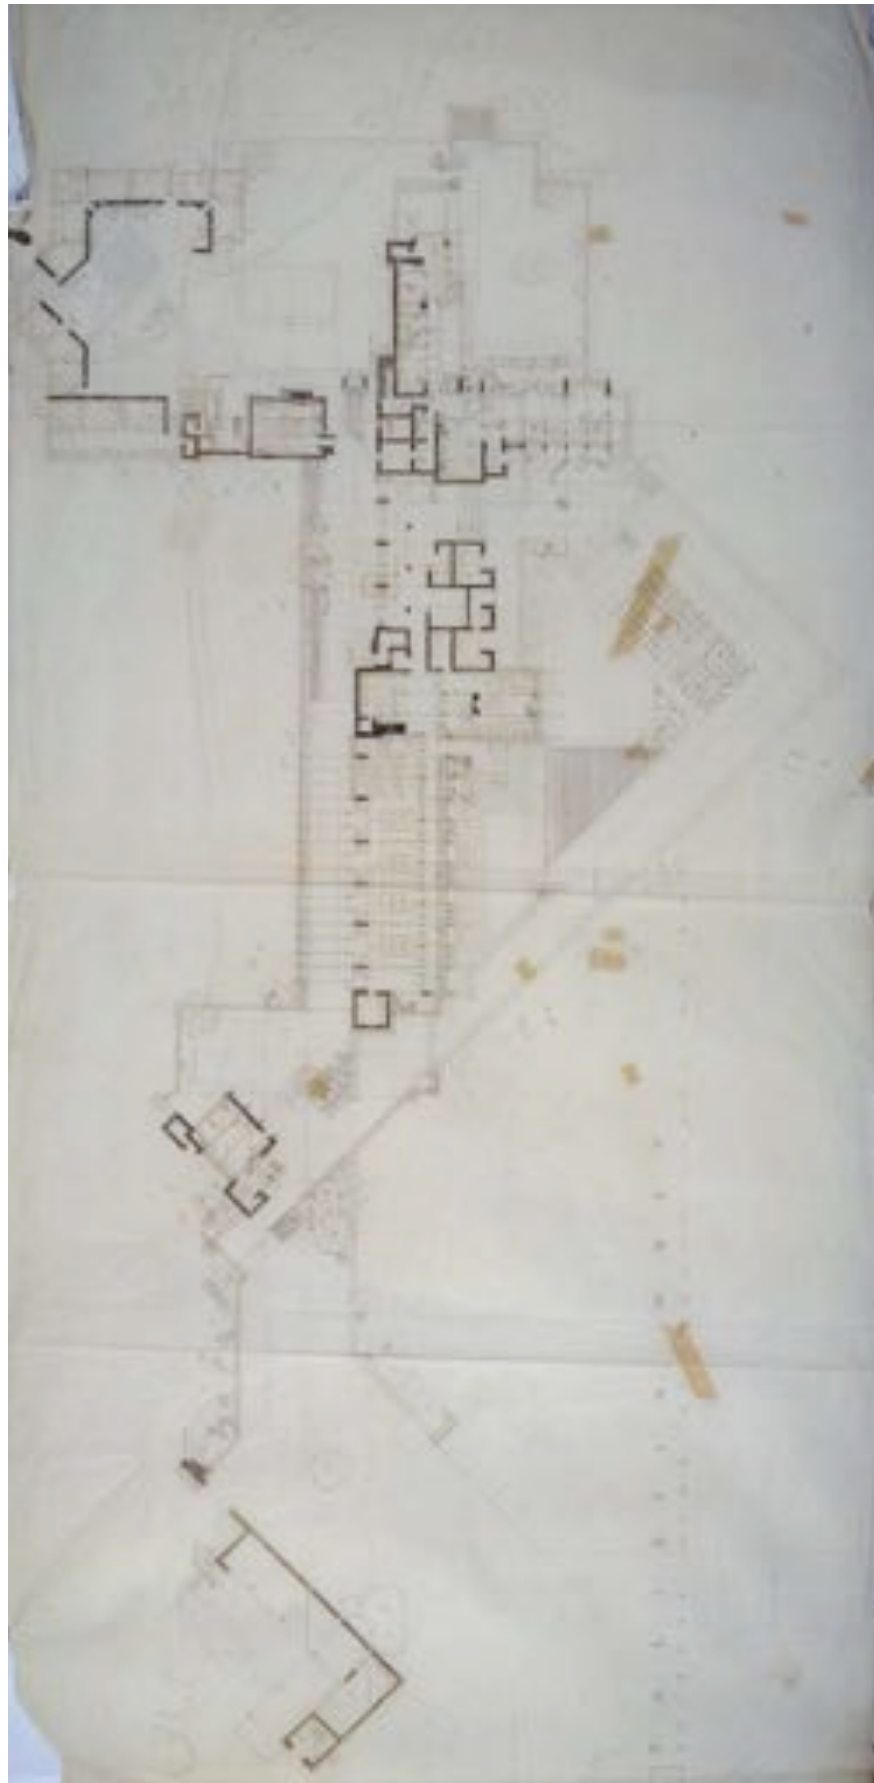
Figure B-137 - Master Plan (The Frank Lloyd Wright Foundation Archives, The Museum of Modern Art | Avery Architectural & Fine Arts Library, Columbia University, New York).

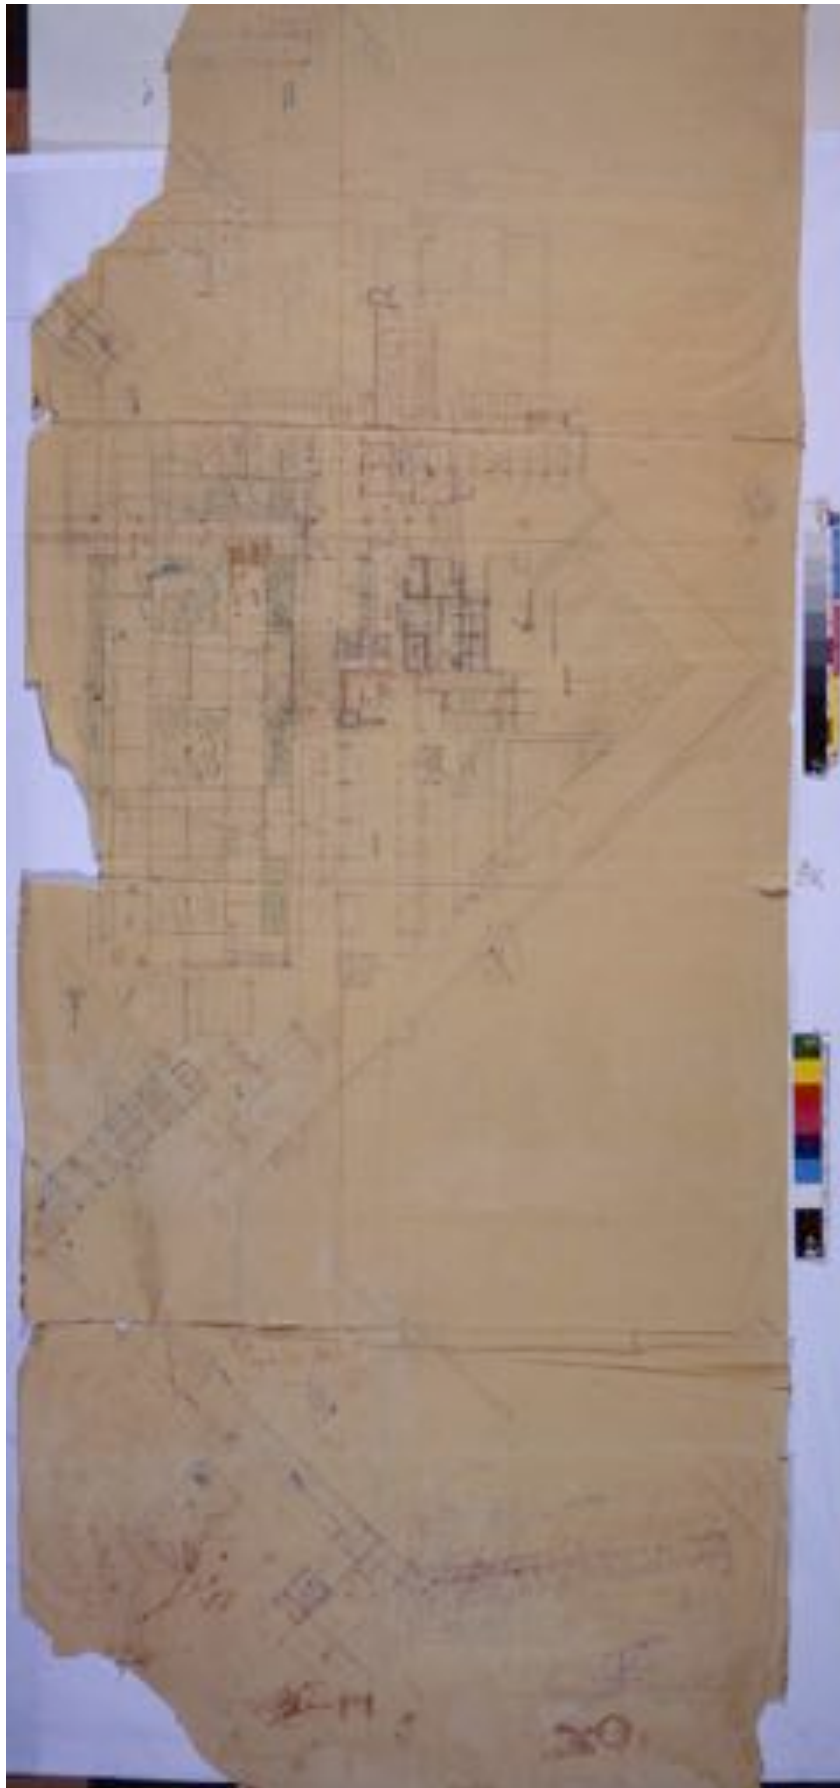
Figure B-138 - Master Plan Print (The Frank Lloyd Wright Foundation Archives, The Museum of Modern Art | Avery Architectural & Fine Arts Library, Columbia University, New York).

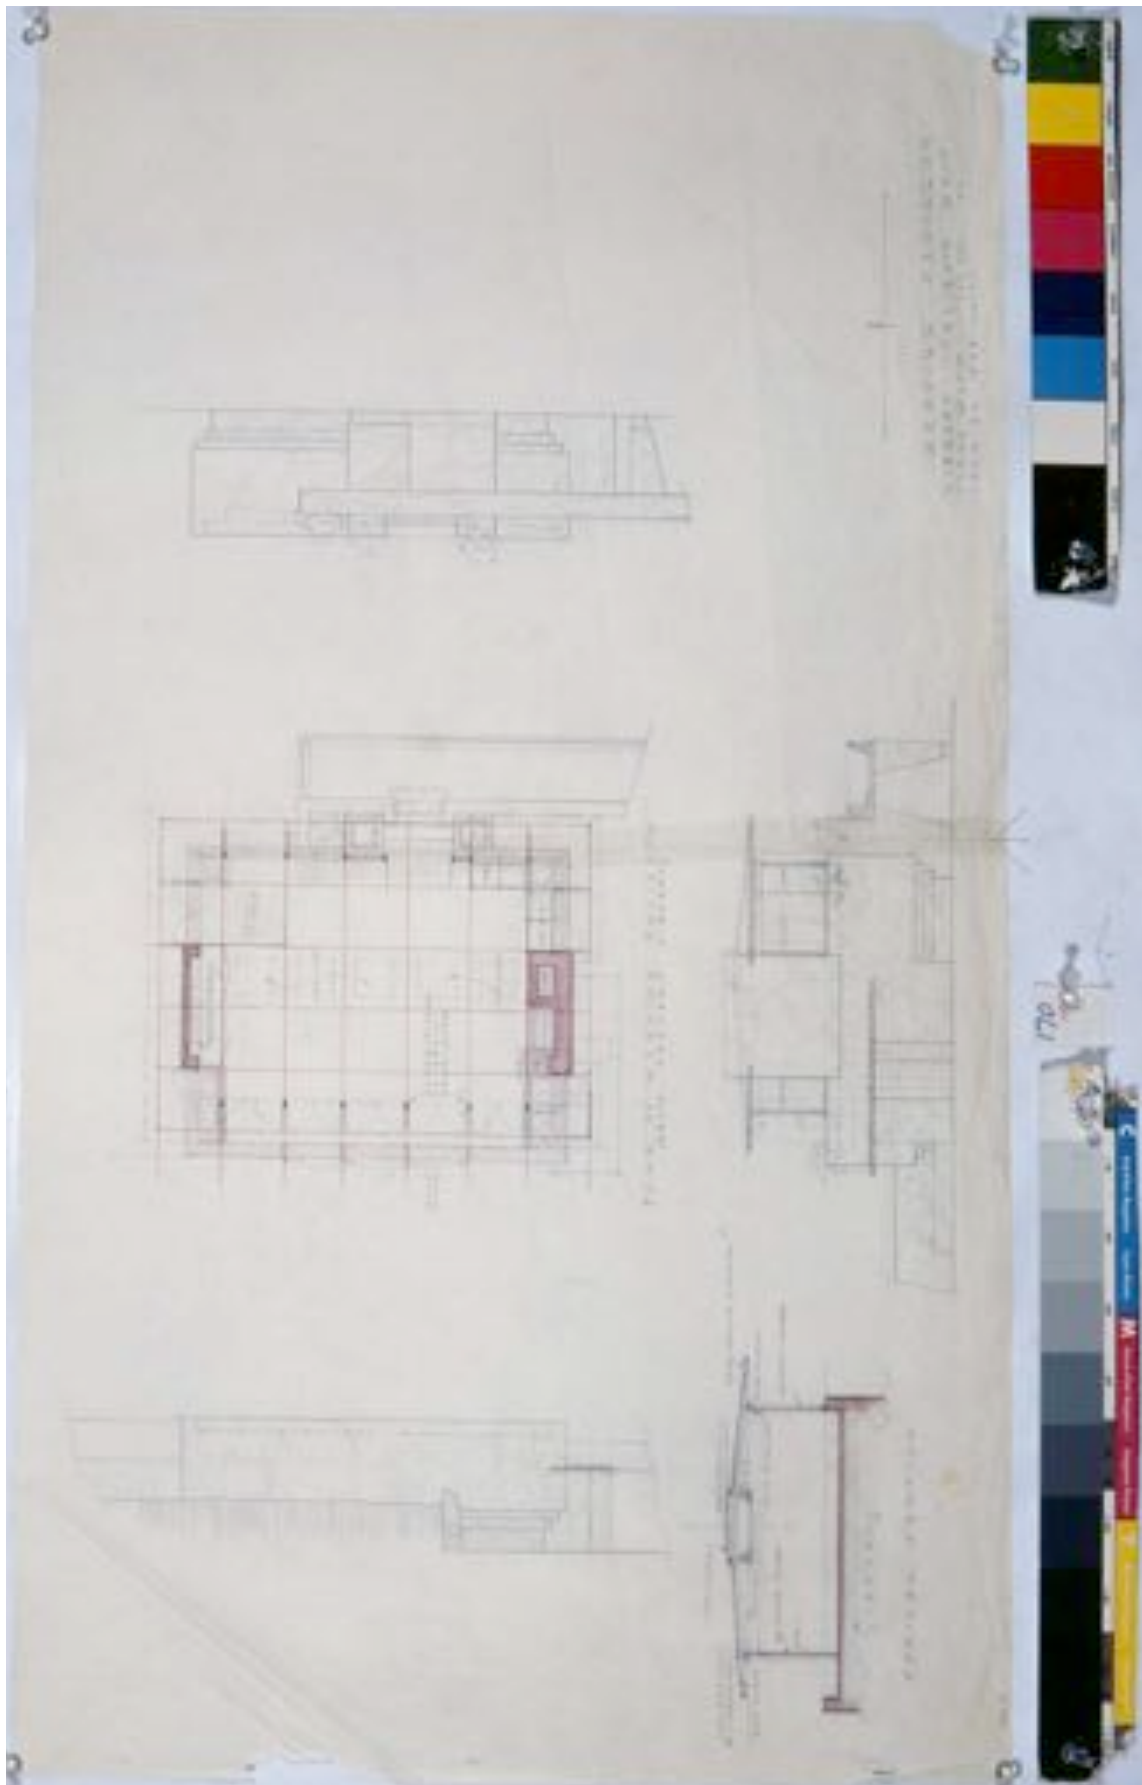
Figure B-140 - Library/Weaving Room (The Frank Lloyd Wright Foundation Archives, The Museum of Modern Art | Avery Architectural & Fine Arts Library, Columbia University, New York).

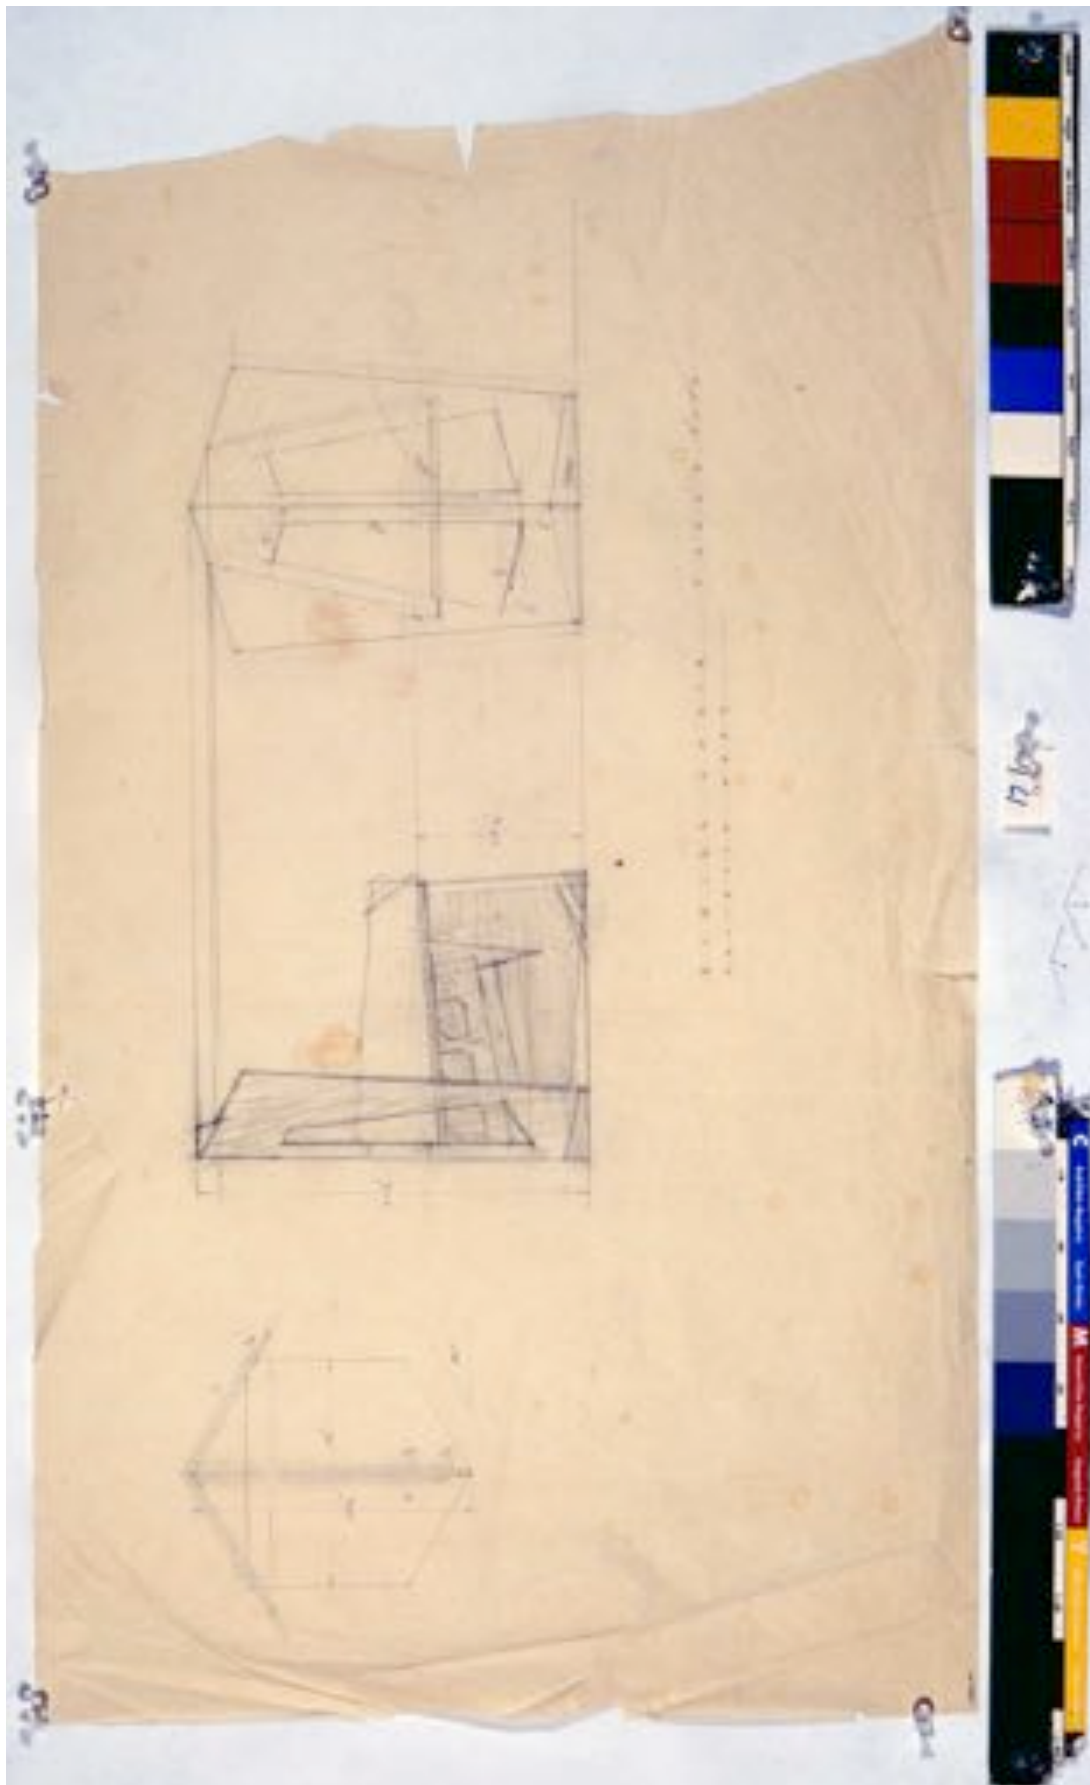
Figure B-141 - Chair (Friedman Type) (The Frank Lloyd Wright Foundation Archives, The Museum of Modern Art | Avery Architectural & Fine Arts Library, Columbia University, New York).

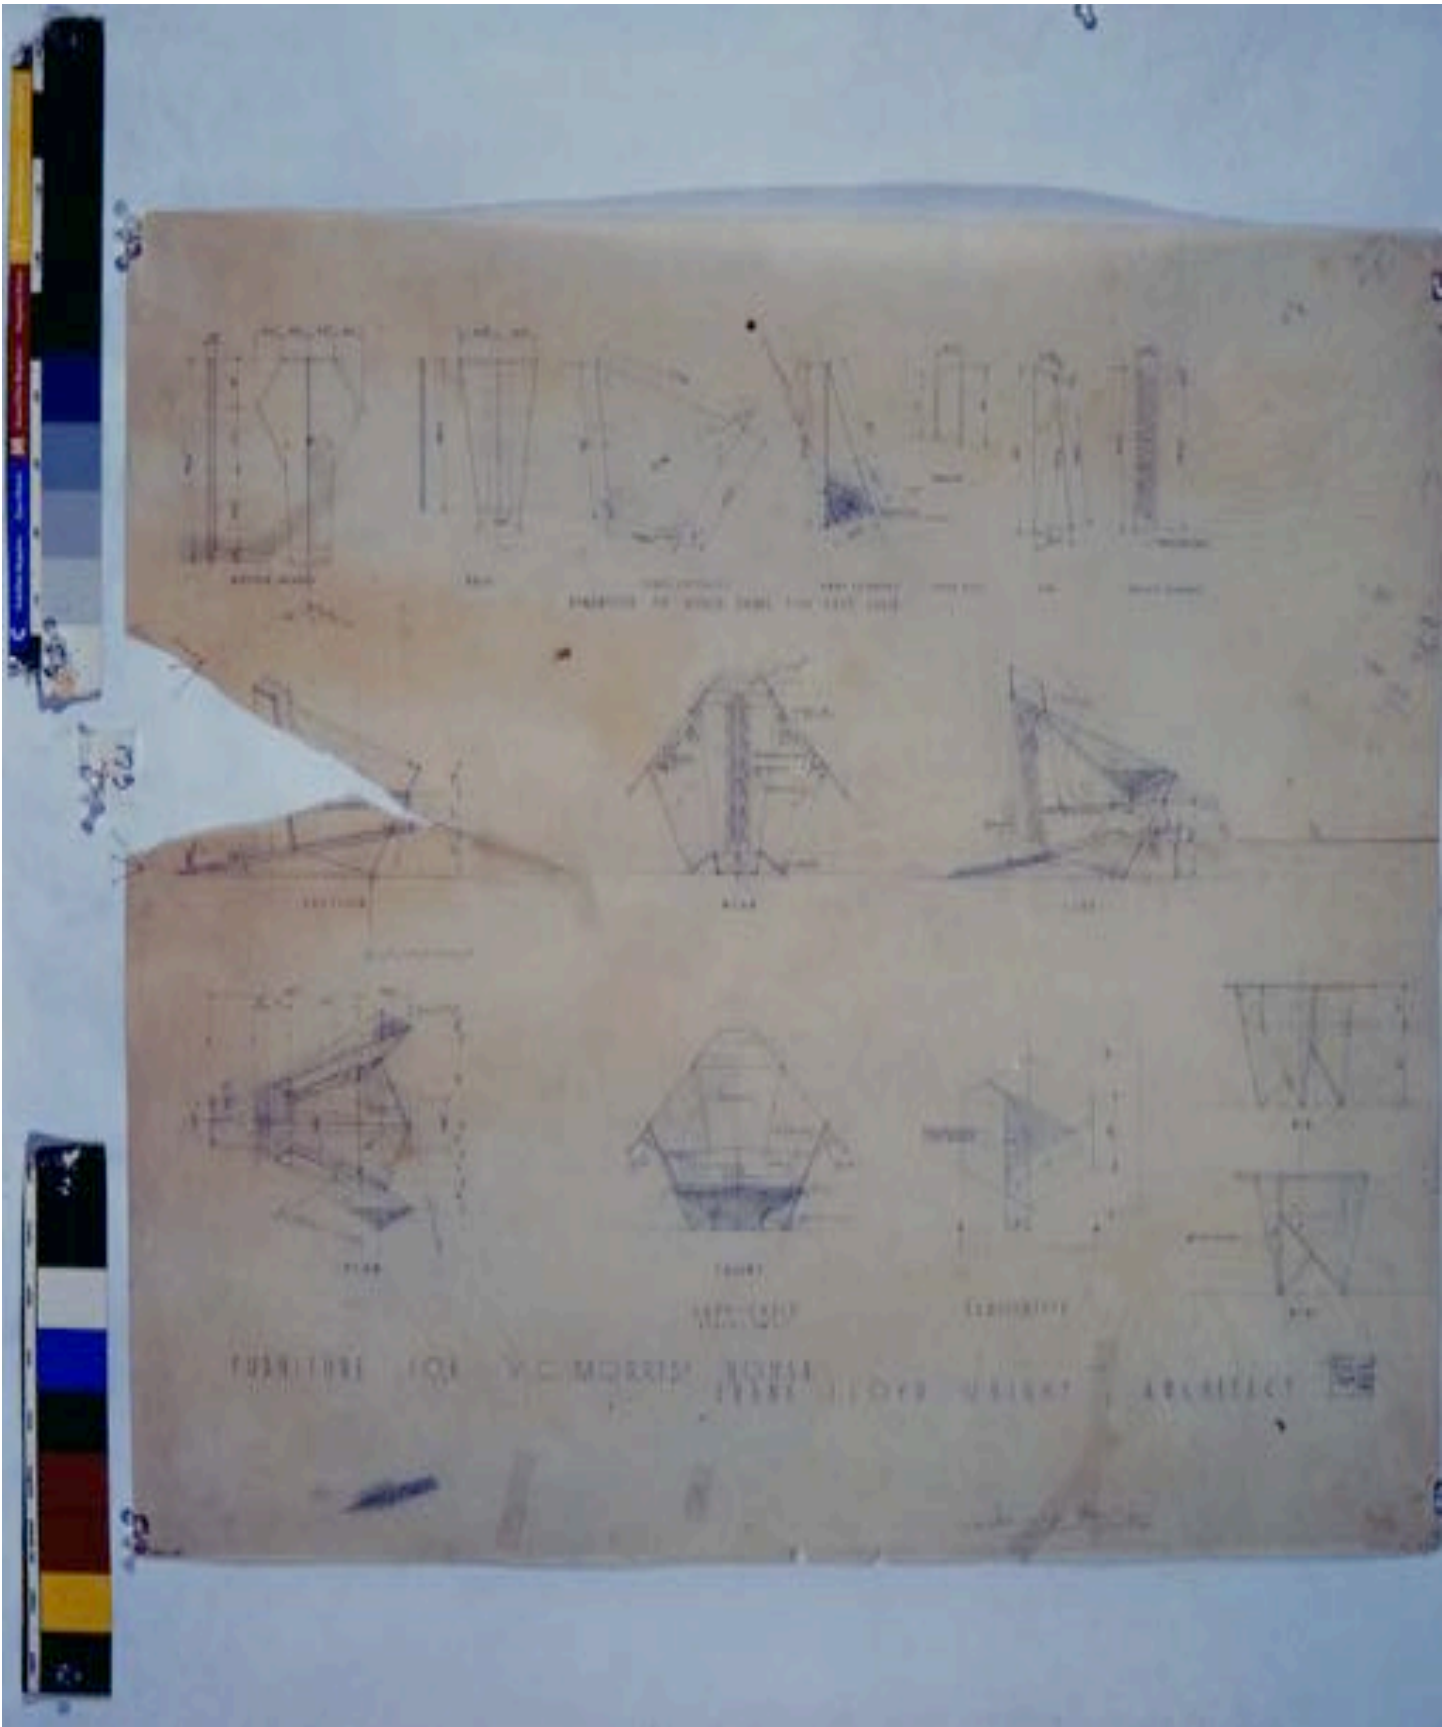
Figure B-143 - Taliesin West Chair (The Frank Lloyd Wright Foundation Archives, The Museum of Modern Art | Avery Architectural & Fine Arts Library, Columbia University, New York).

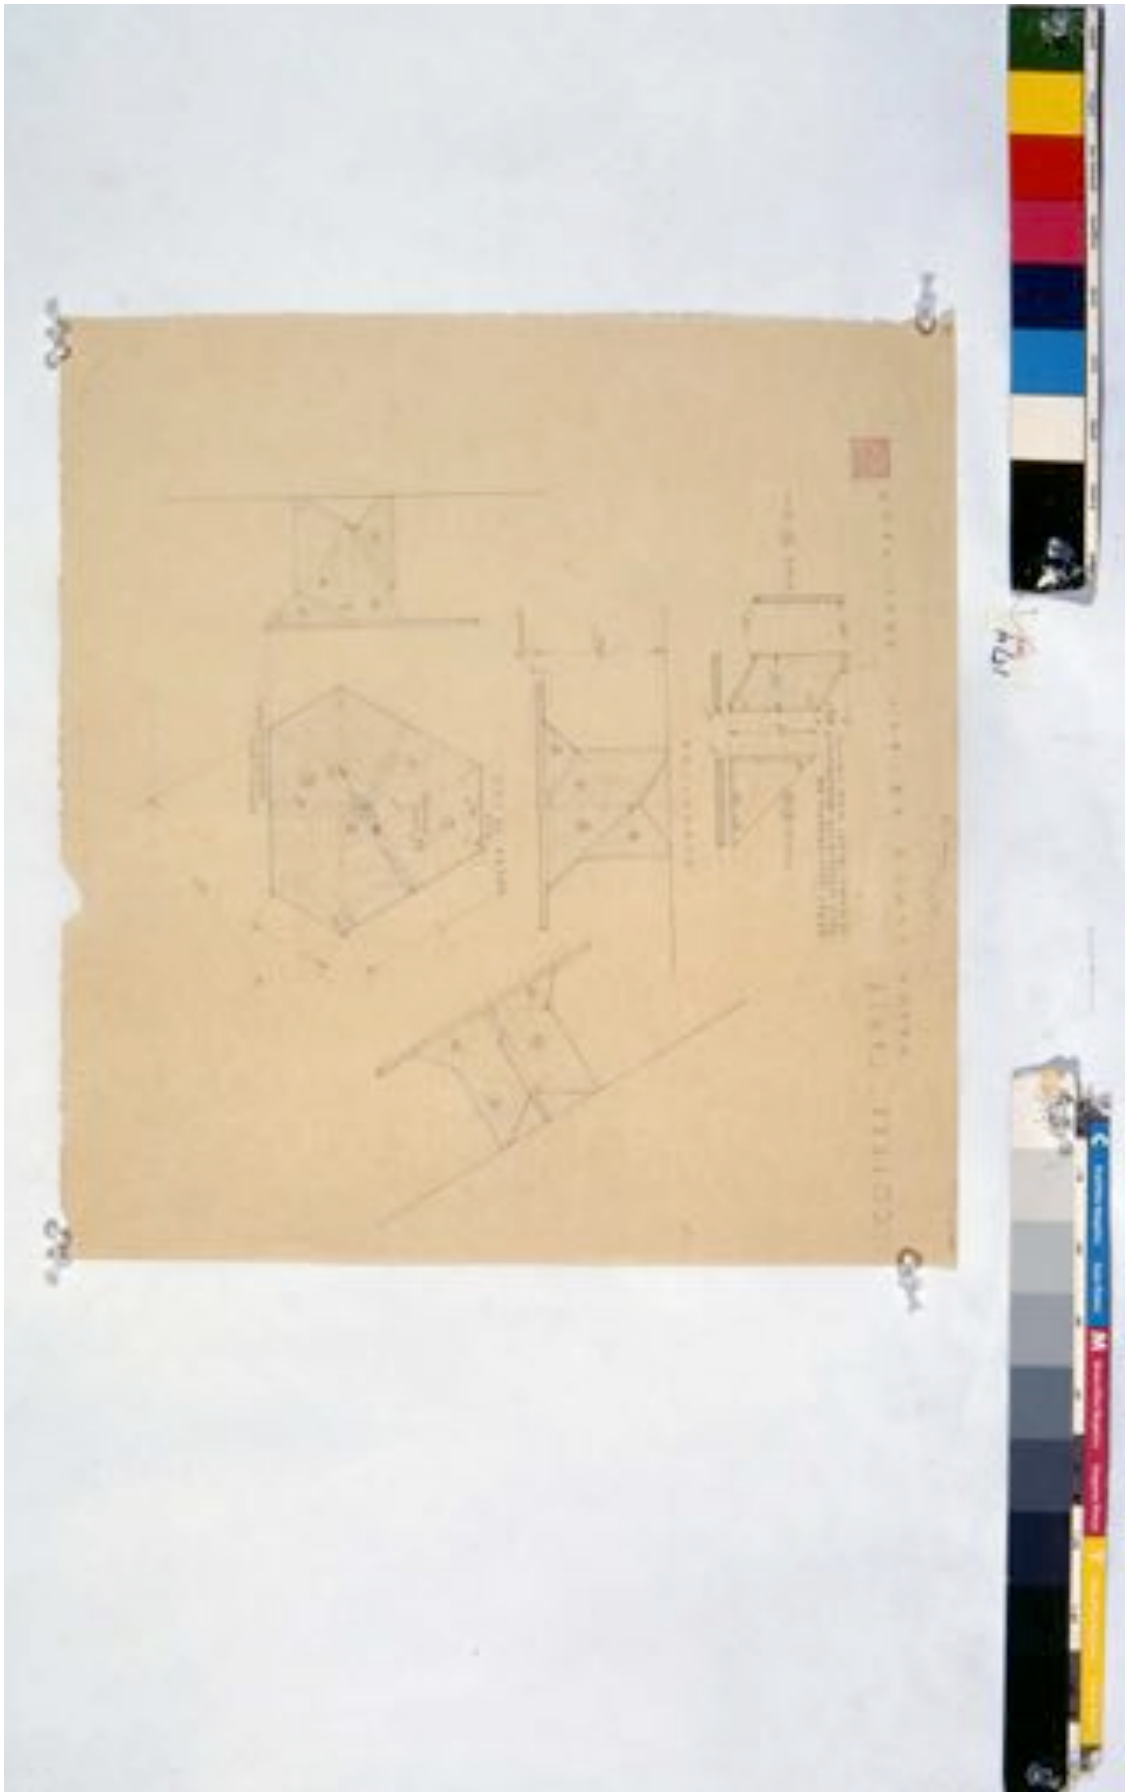
Figure B-144 - Triangular Coffee Table (The Frank Lloyd Wright Foundation Archives, The Museum of Modern Art | Avery Architectural & Fine Arts Library, Columbia University, New York).
