TALIESIN WEST PRESERVATION MASTER PLAN

Harboe Architects, PC

MAY 21, 2015

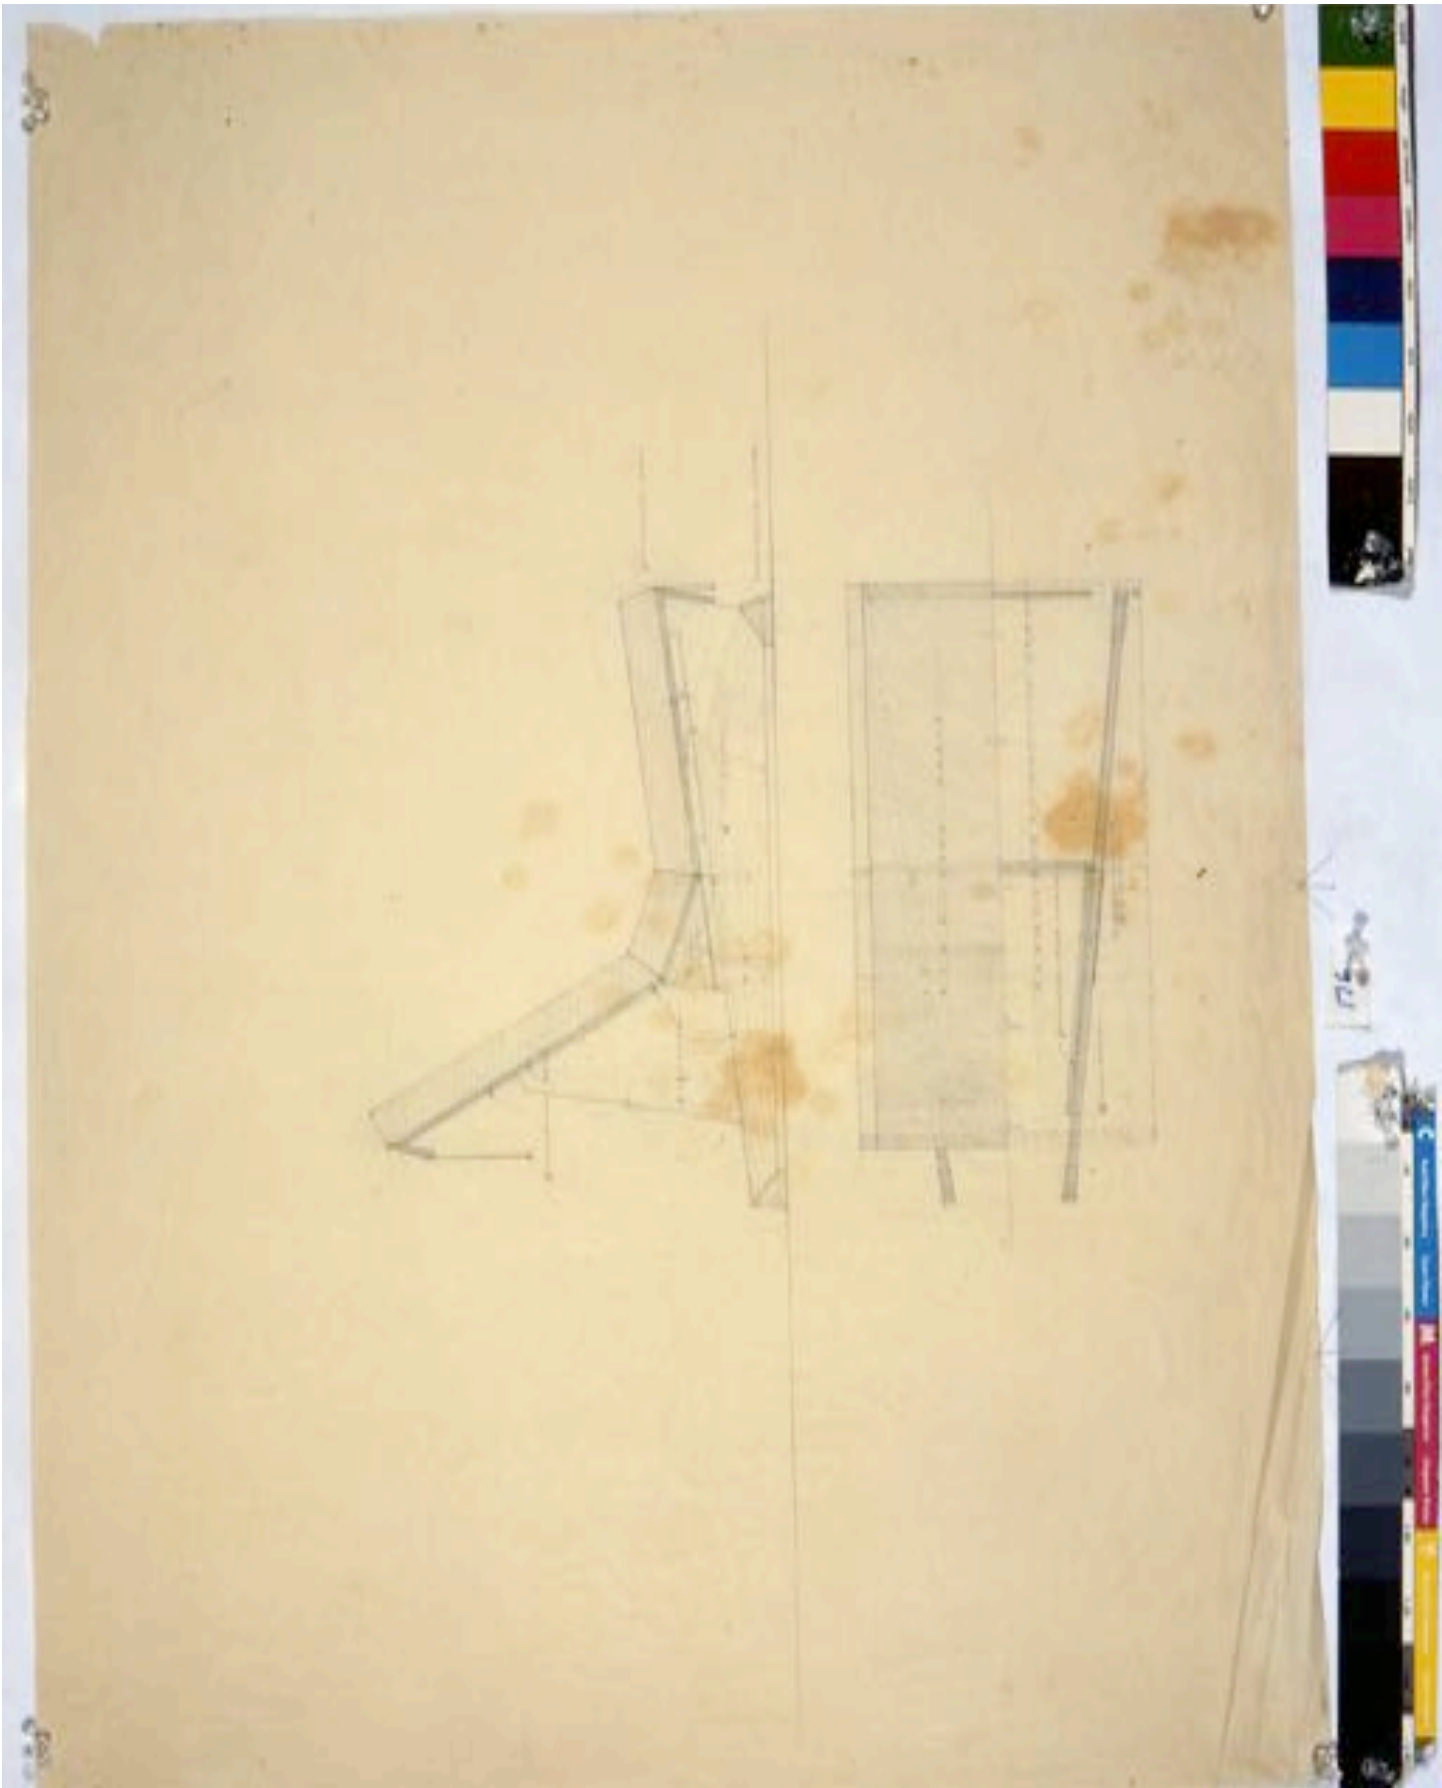
Figure B-146 - Lounge Chaise (The Frank Lloyd Wright Foundation Archives, The Museum of Modern Art | Avery Architectural & Fine Arts Library, Columbia University, New York).

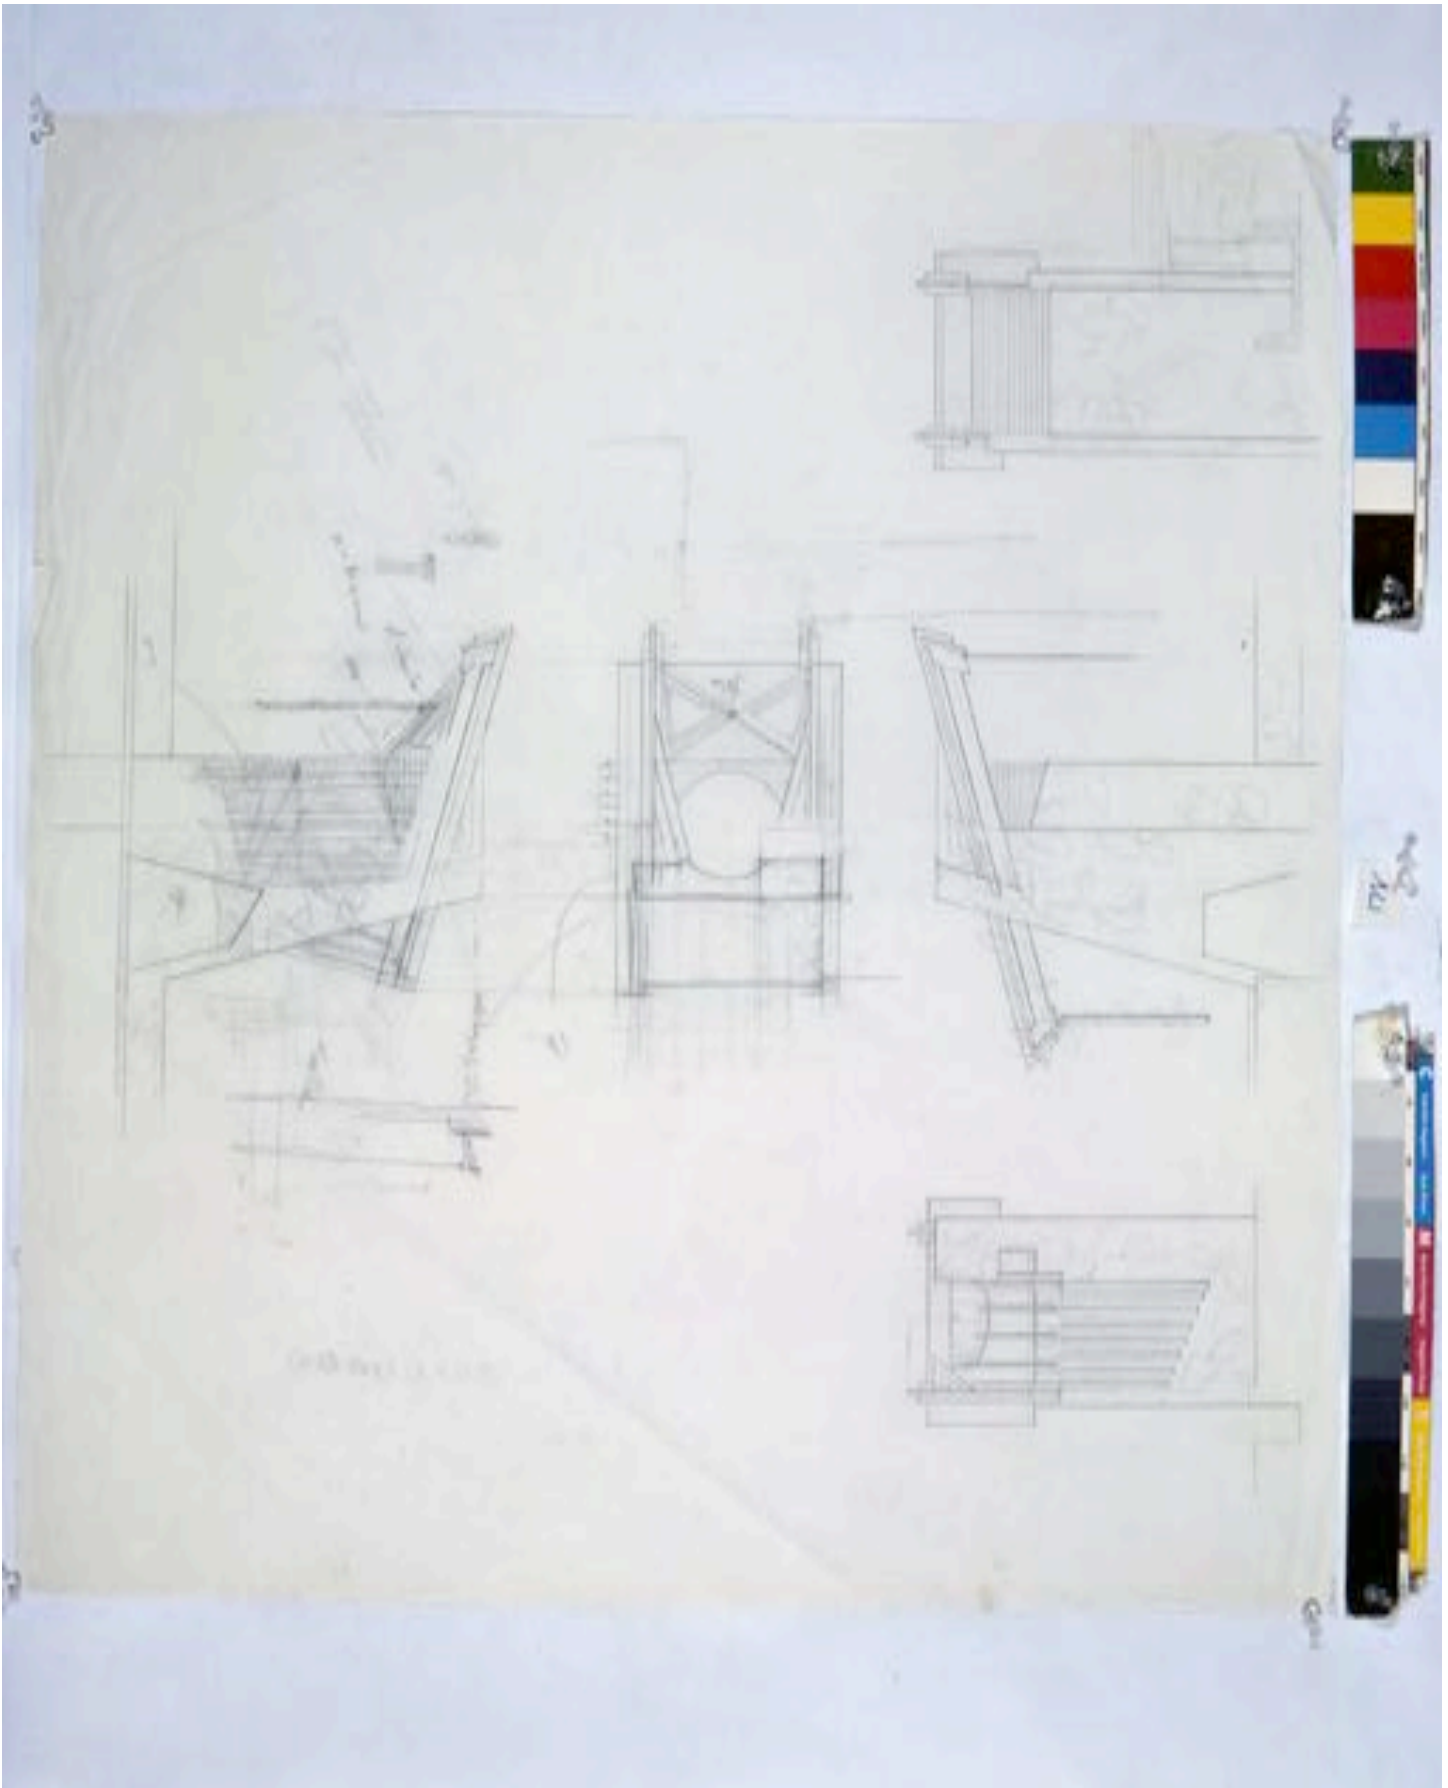
Figure B-148 - Water Tower Chimes (The Frank Lloyd Wright Foundation Archives, The Museum of Modern Art | Avery Architectural & Fine Arts Library, Columbia University, New York).

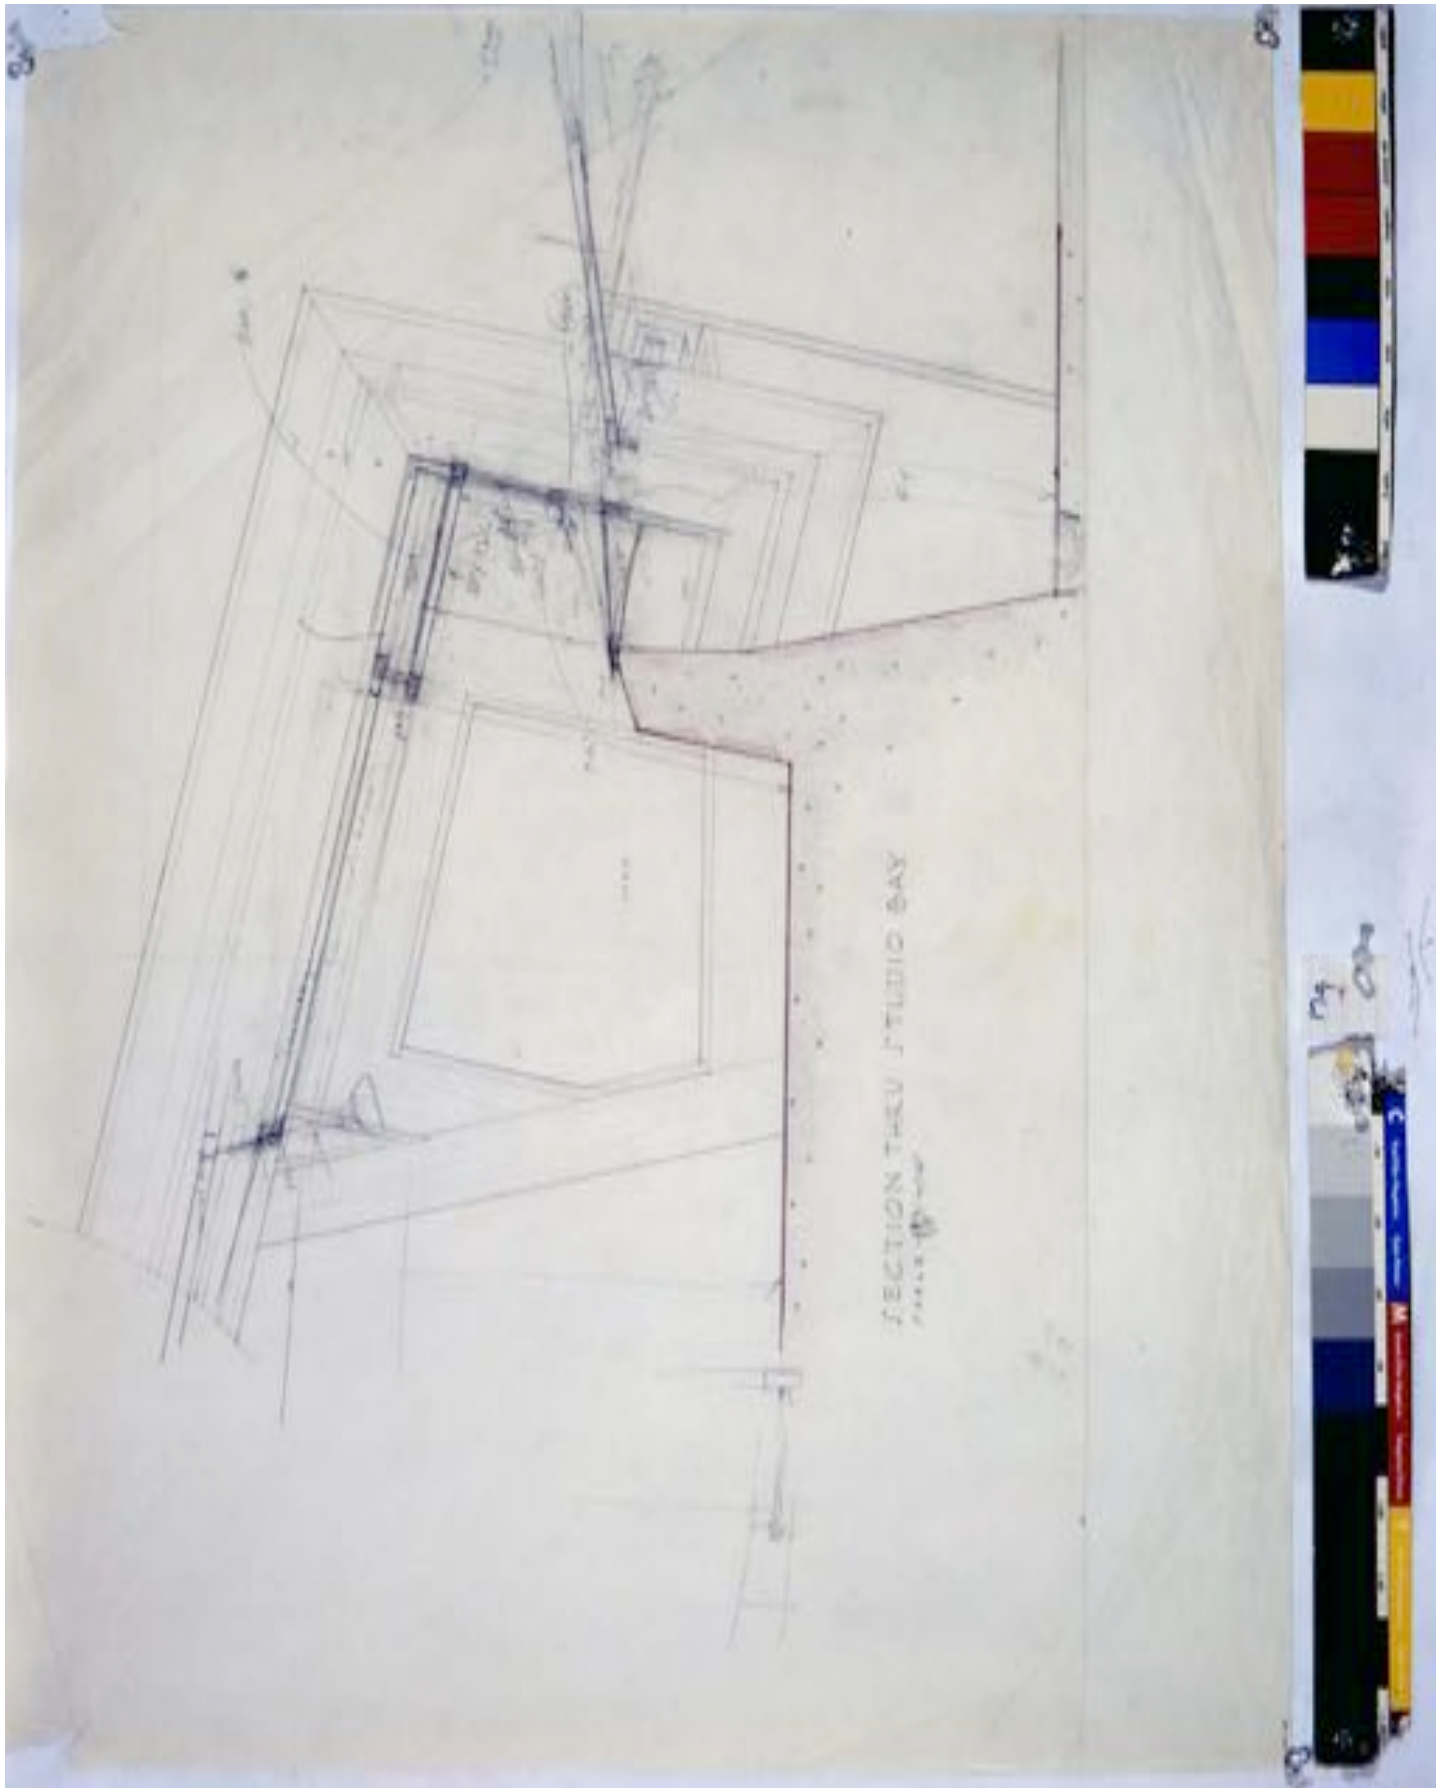
Figure B-149 - Drafting Room Bay Section (The Frank Lloyd Wright Foundation Archives, The Museum of Modern Art | Avery Architectural & Fine Arts Library, Columbia University, New York).

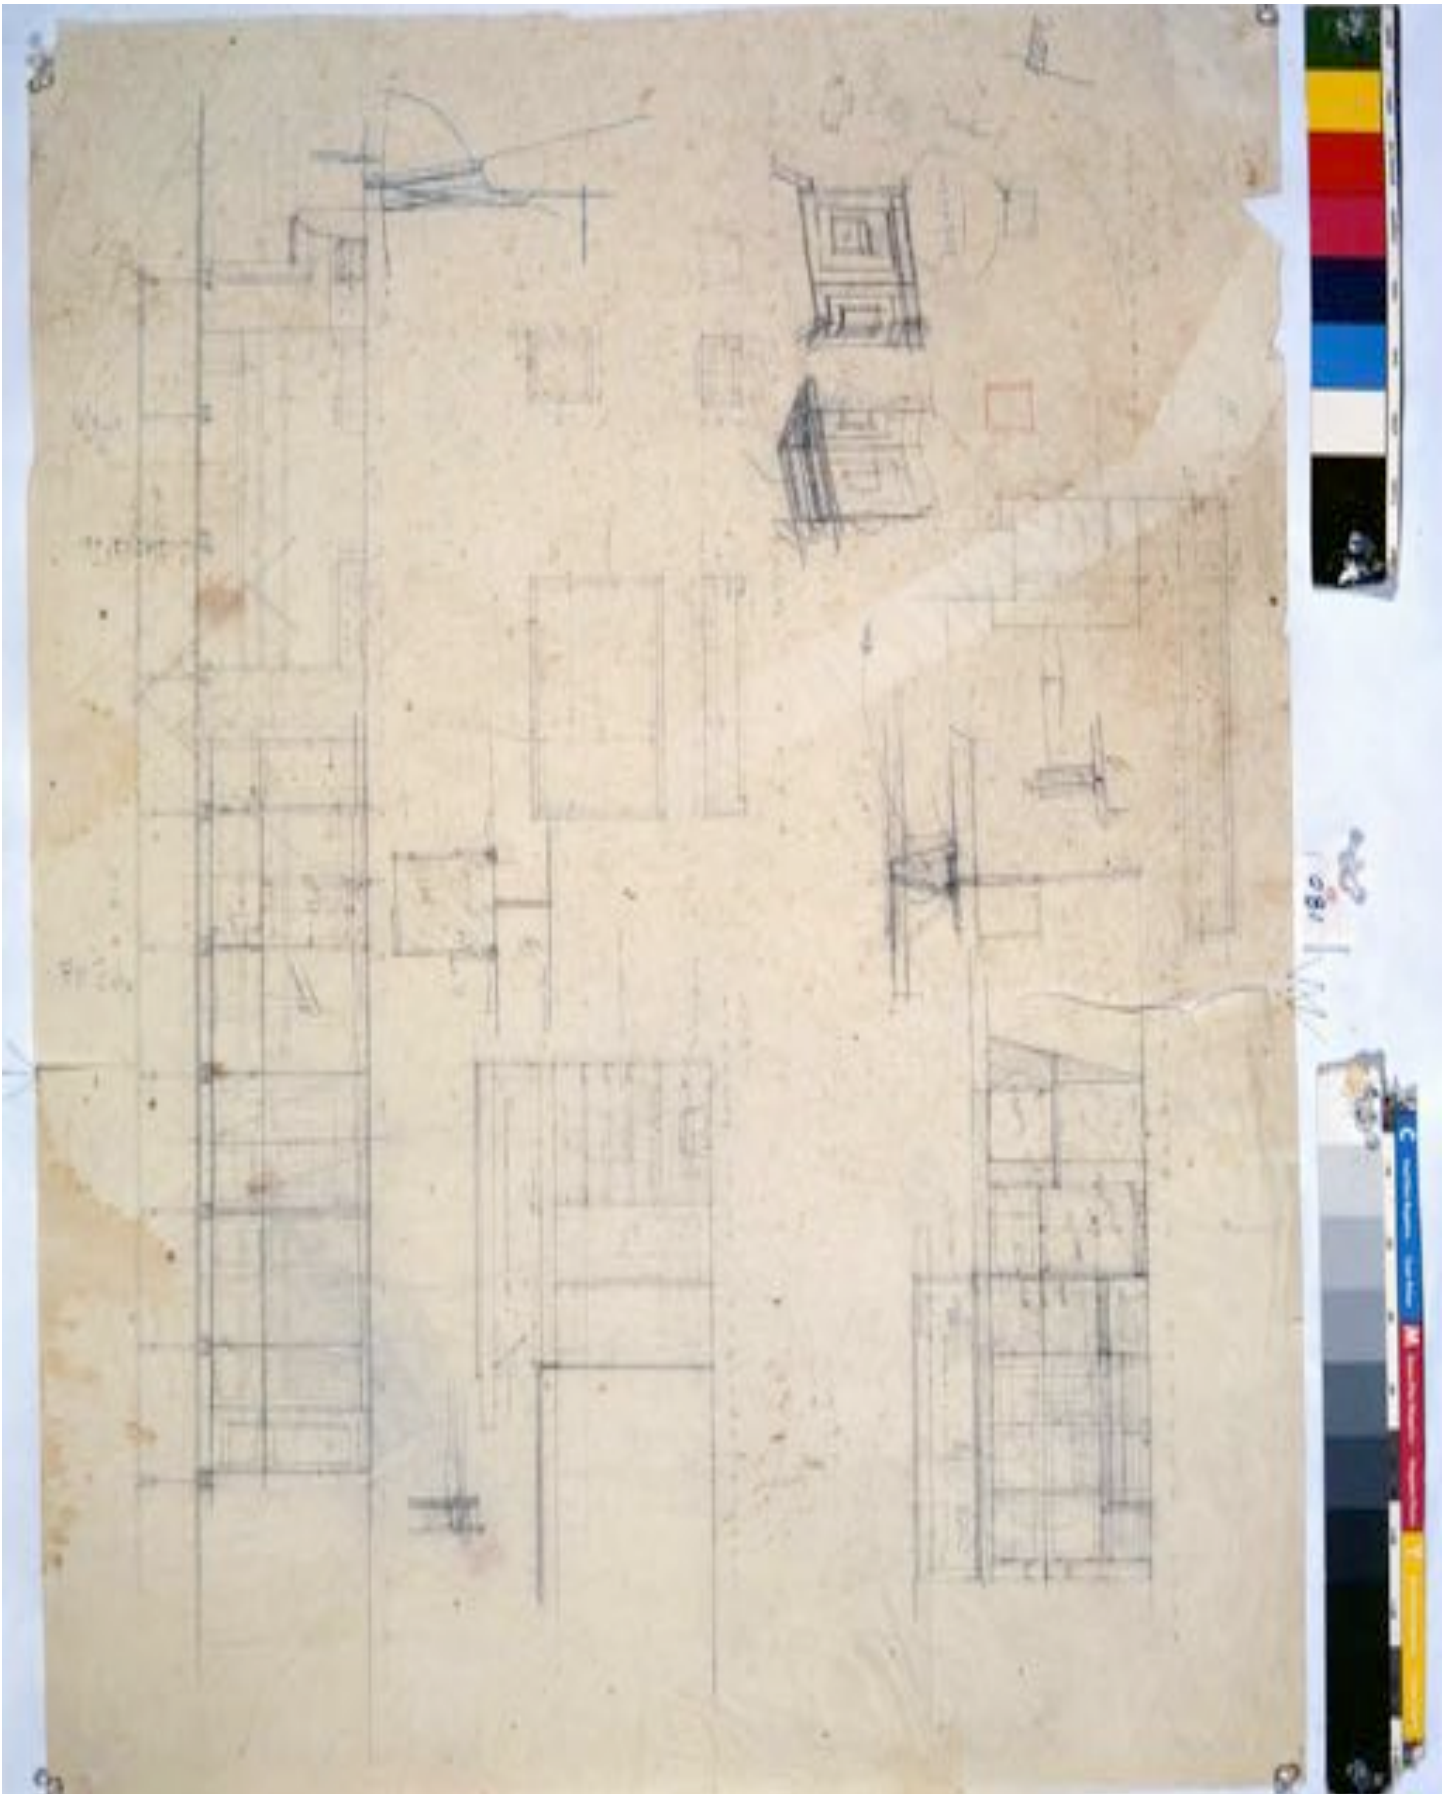
Figure B-150 - Mr. Wright's Room Interior Section (The Frank Lloyd Wright Foundation Archives, The Museum of Modern Art | Avery Architectural & Fine Arts Library, Columbia University, New York).

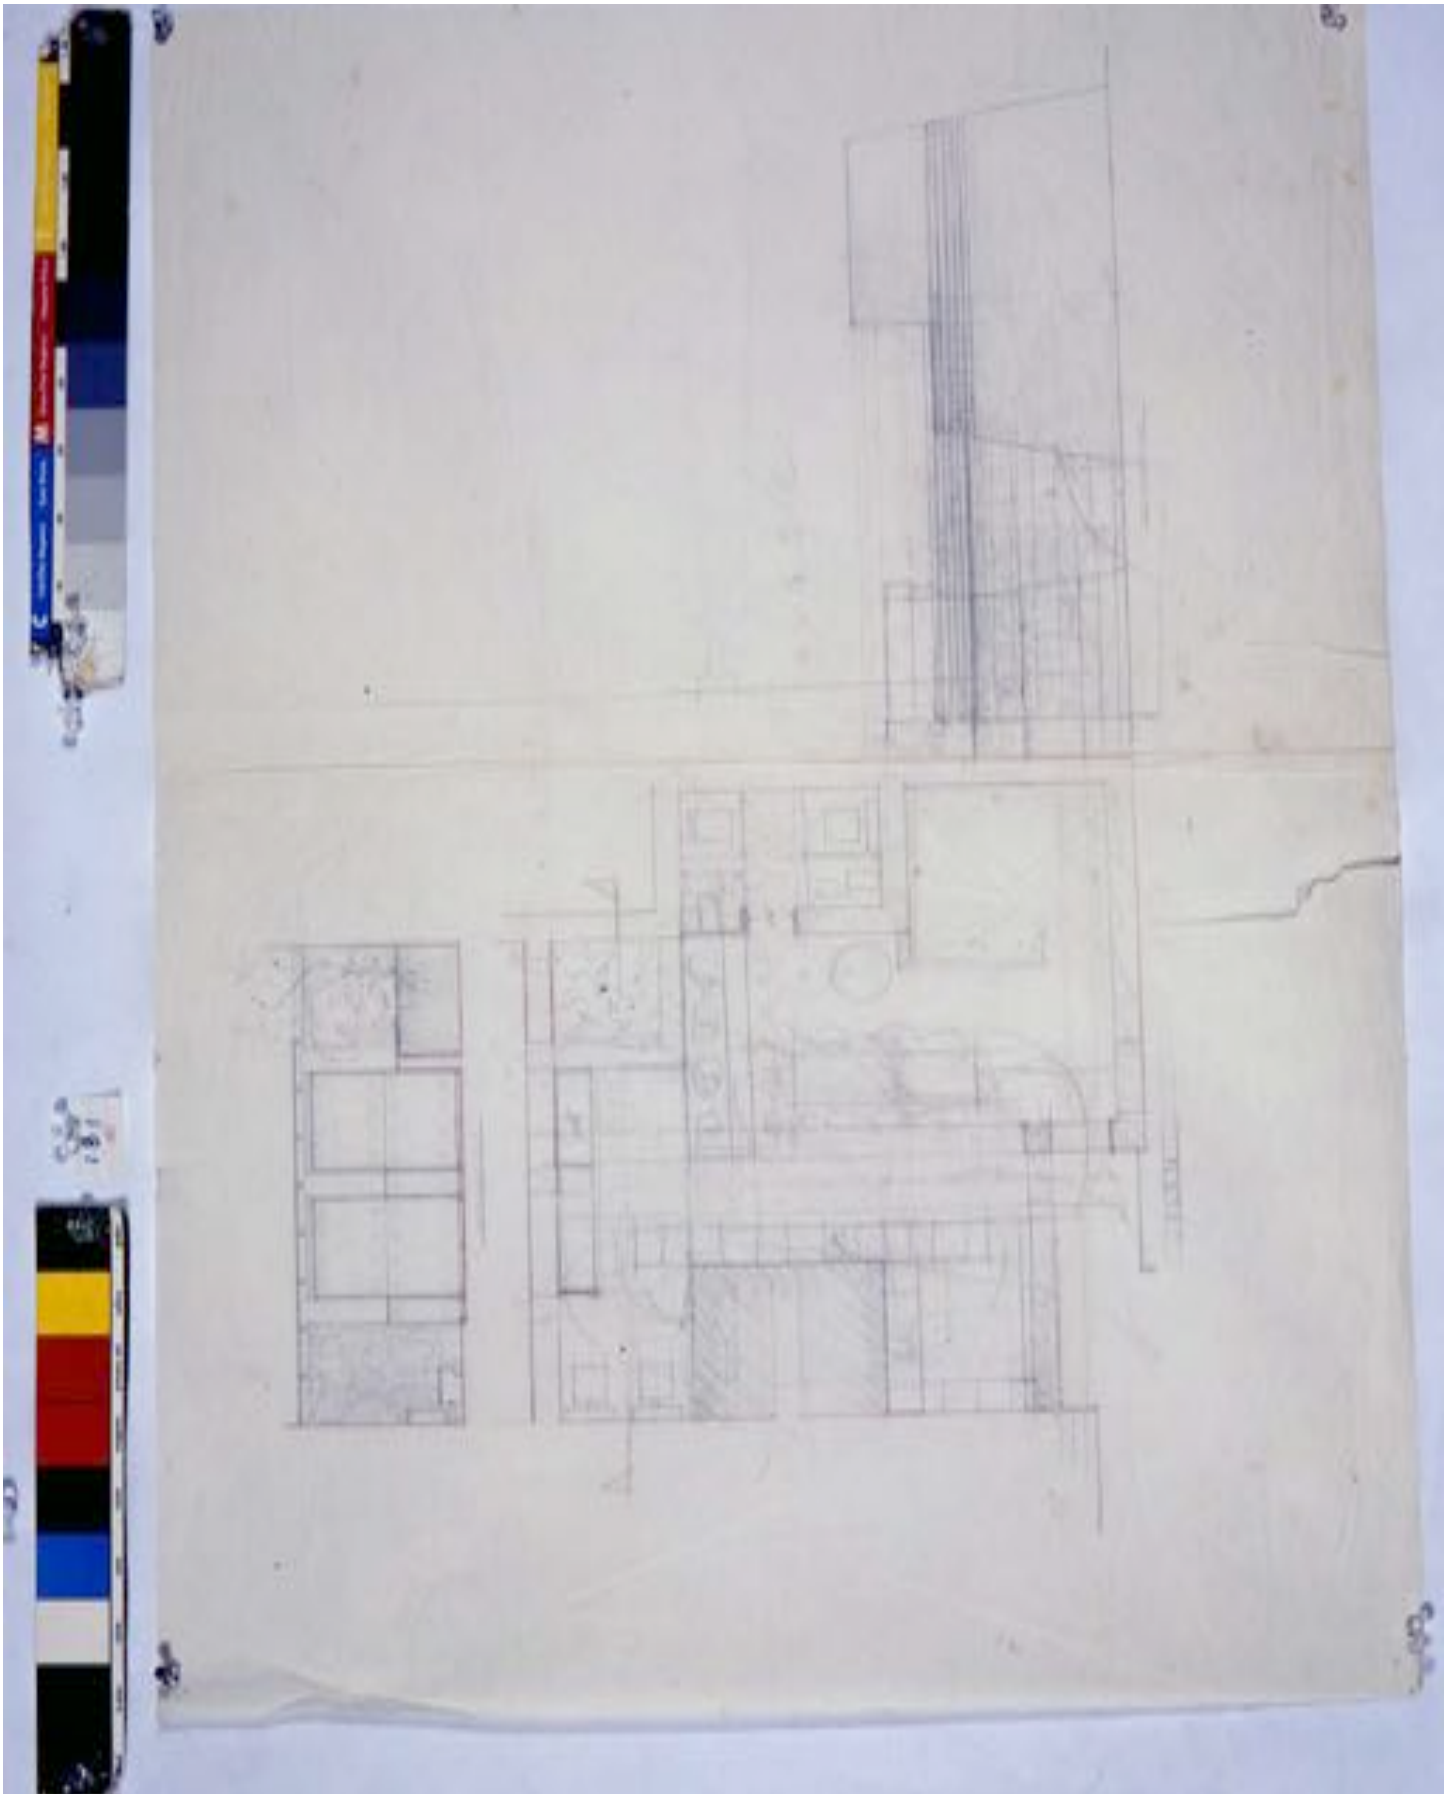
Figure B-151 - Apprentice Court Bath/Locker Room (The Frank Lloyd Wright Foundation Archives, The Museum of Modern Art | Avery Architectural & Fine Arts Library, Columbia University, New York).

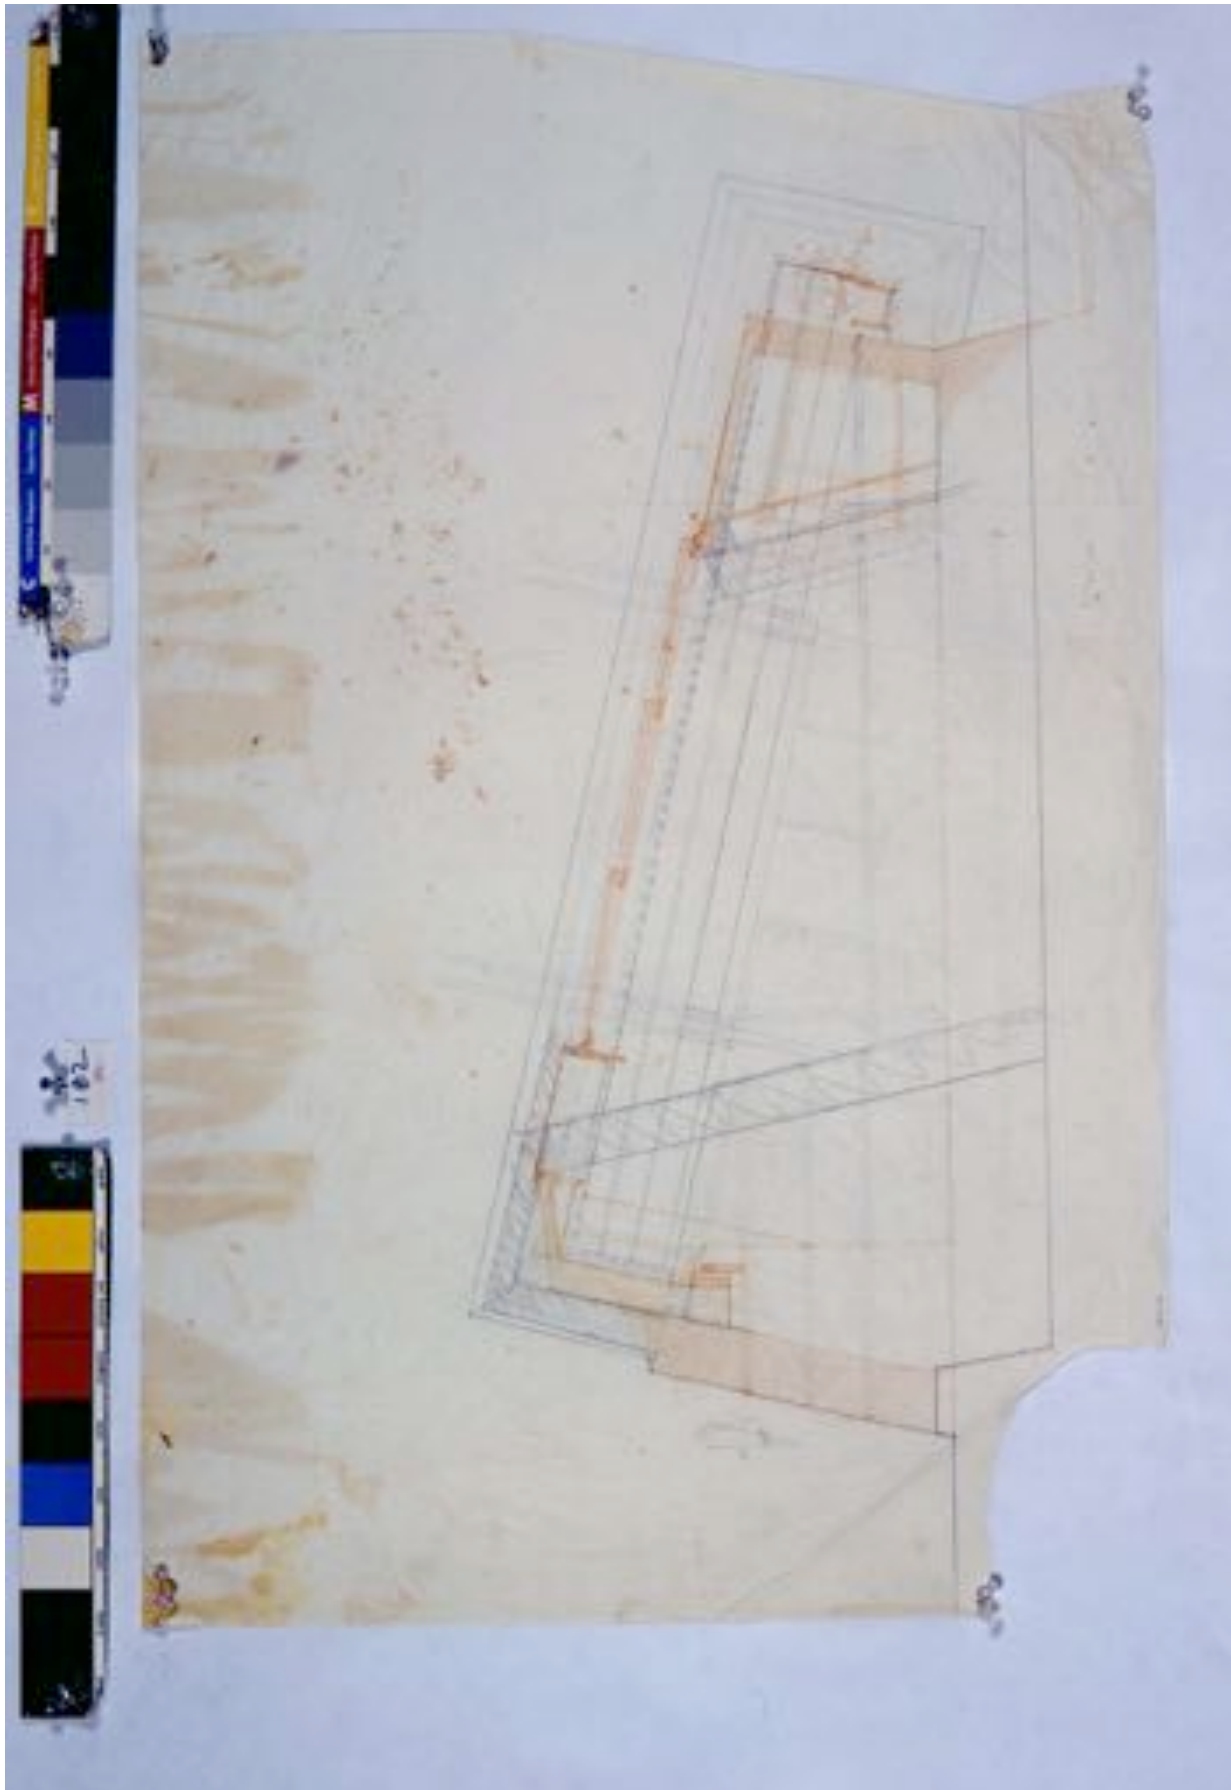
Figure B-152 - Drafting Room Truss Section (The Frank Lloyd Wright Foundation Archives, The Museum of Modern Art | Avery Architectural & Fine Arts Library, Columbia University, New York).

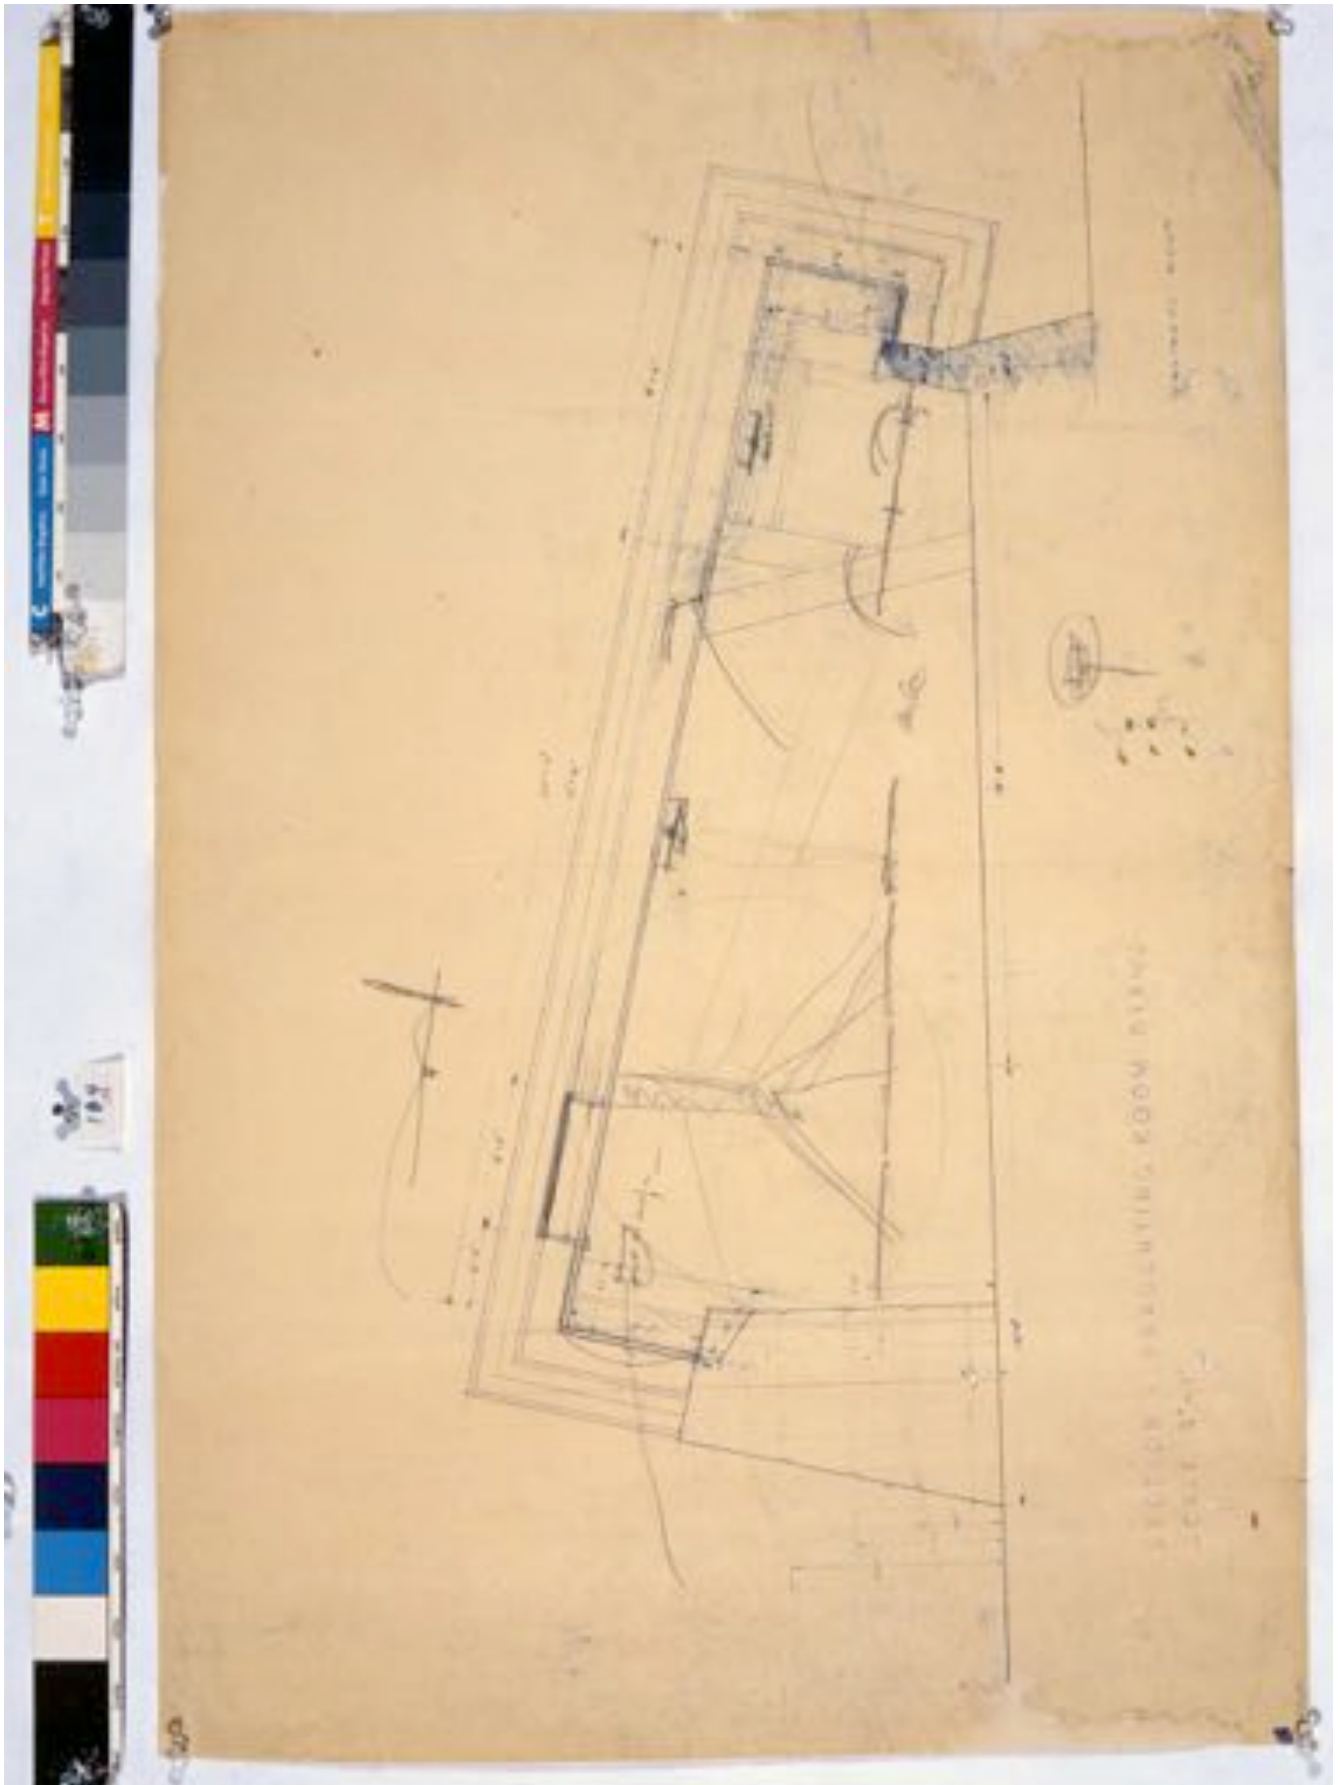
Figure B-154 - Drafting Room Truss Revision (The Frank Lloyd Wright Foundation Archives, The Museum of Modern Art | Avery Architectural & Fine Arts Library, Columbia University, New York).

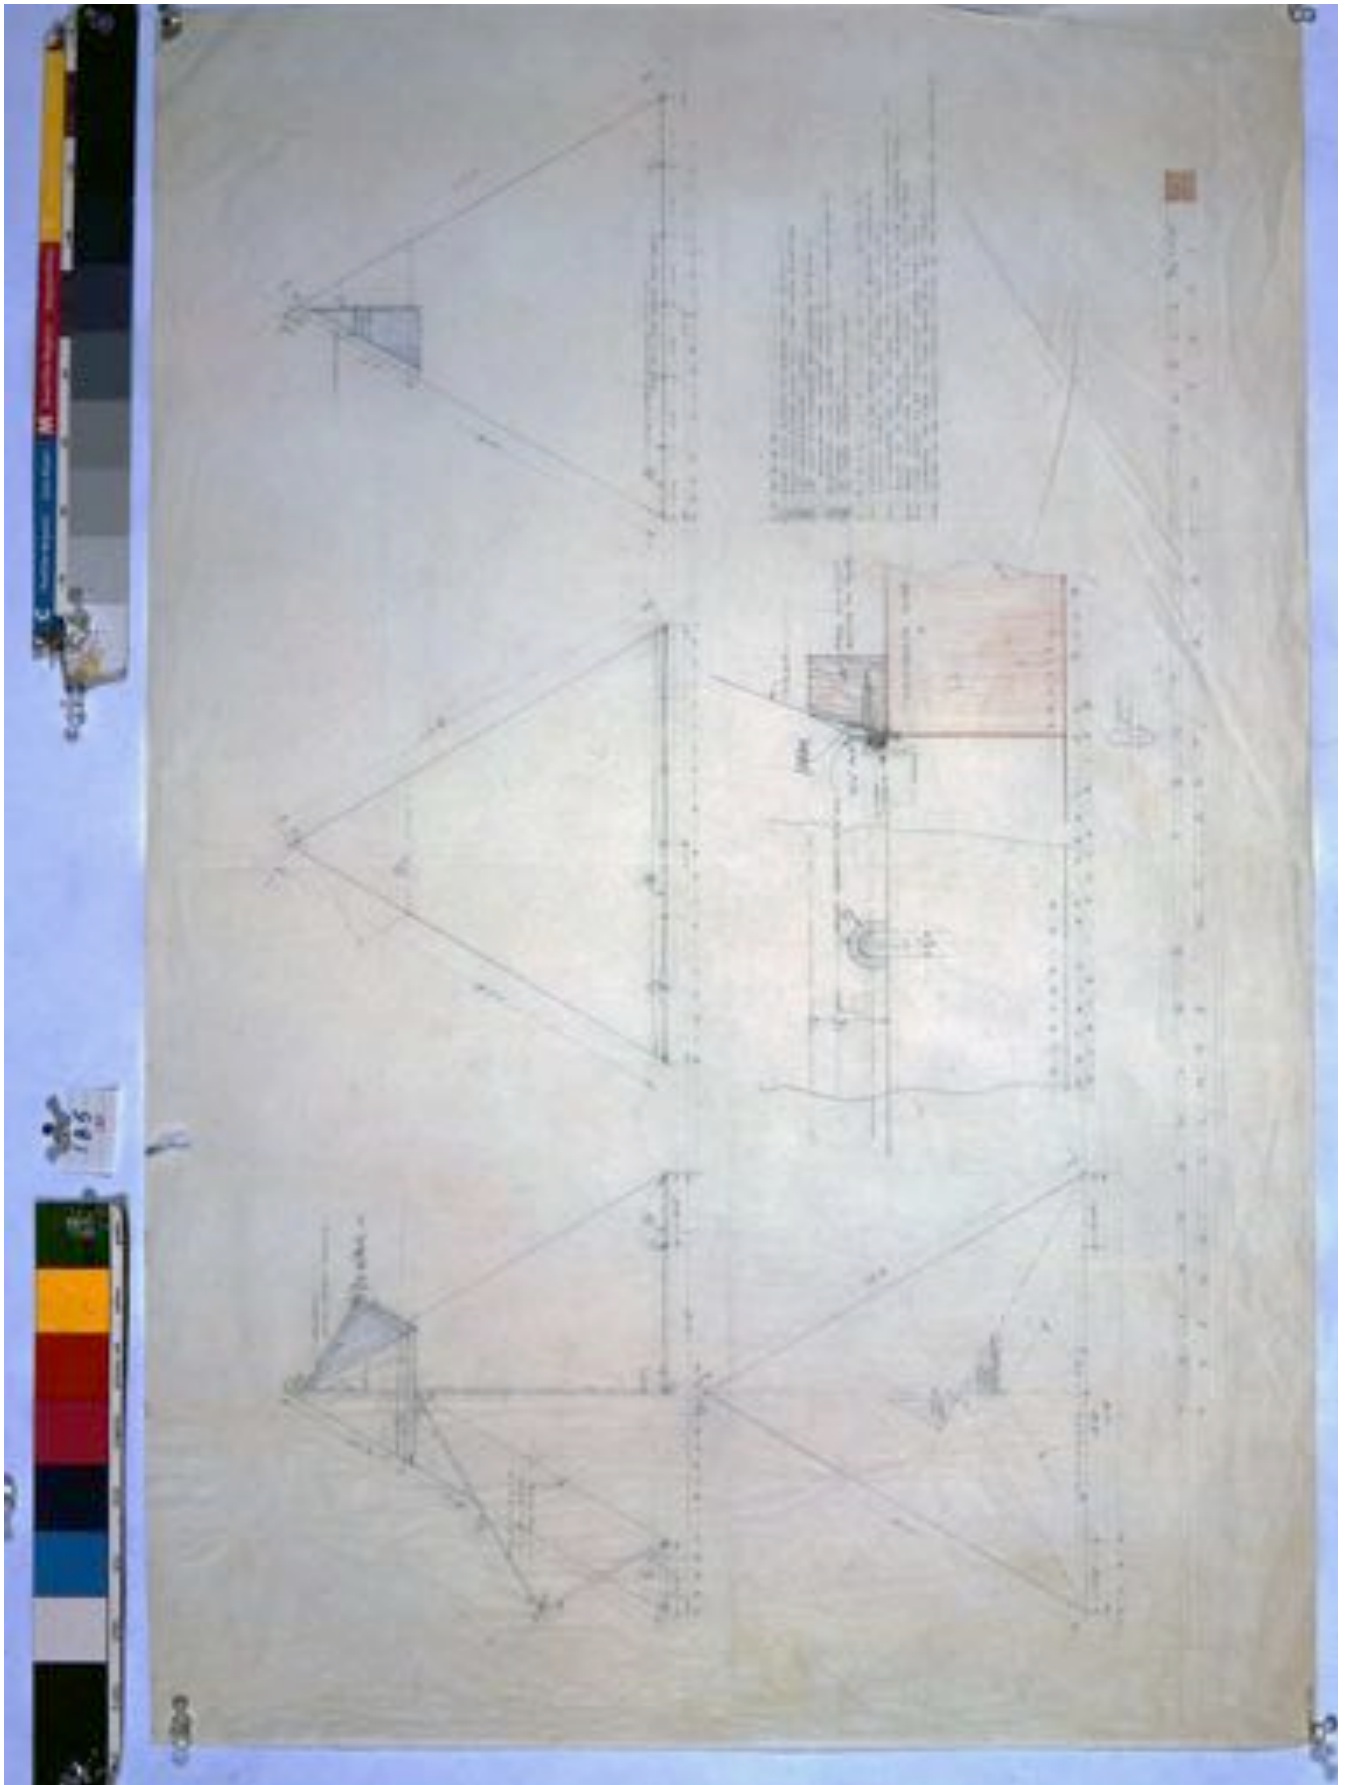
Figure B-155 - Triangular Tent (The Frank Lloyd Wright Foundation Archives, The Museum of Modern Art | Avery Architectural & Fine Arts Library, Columbia University, New York).

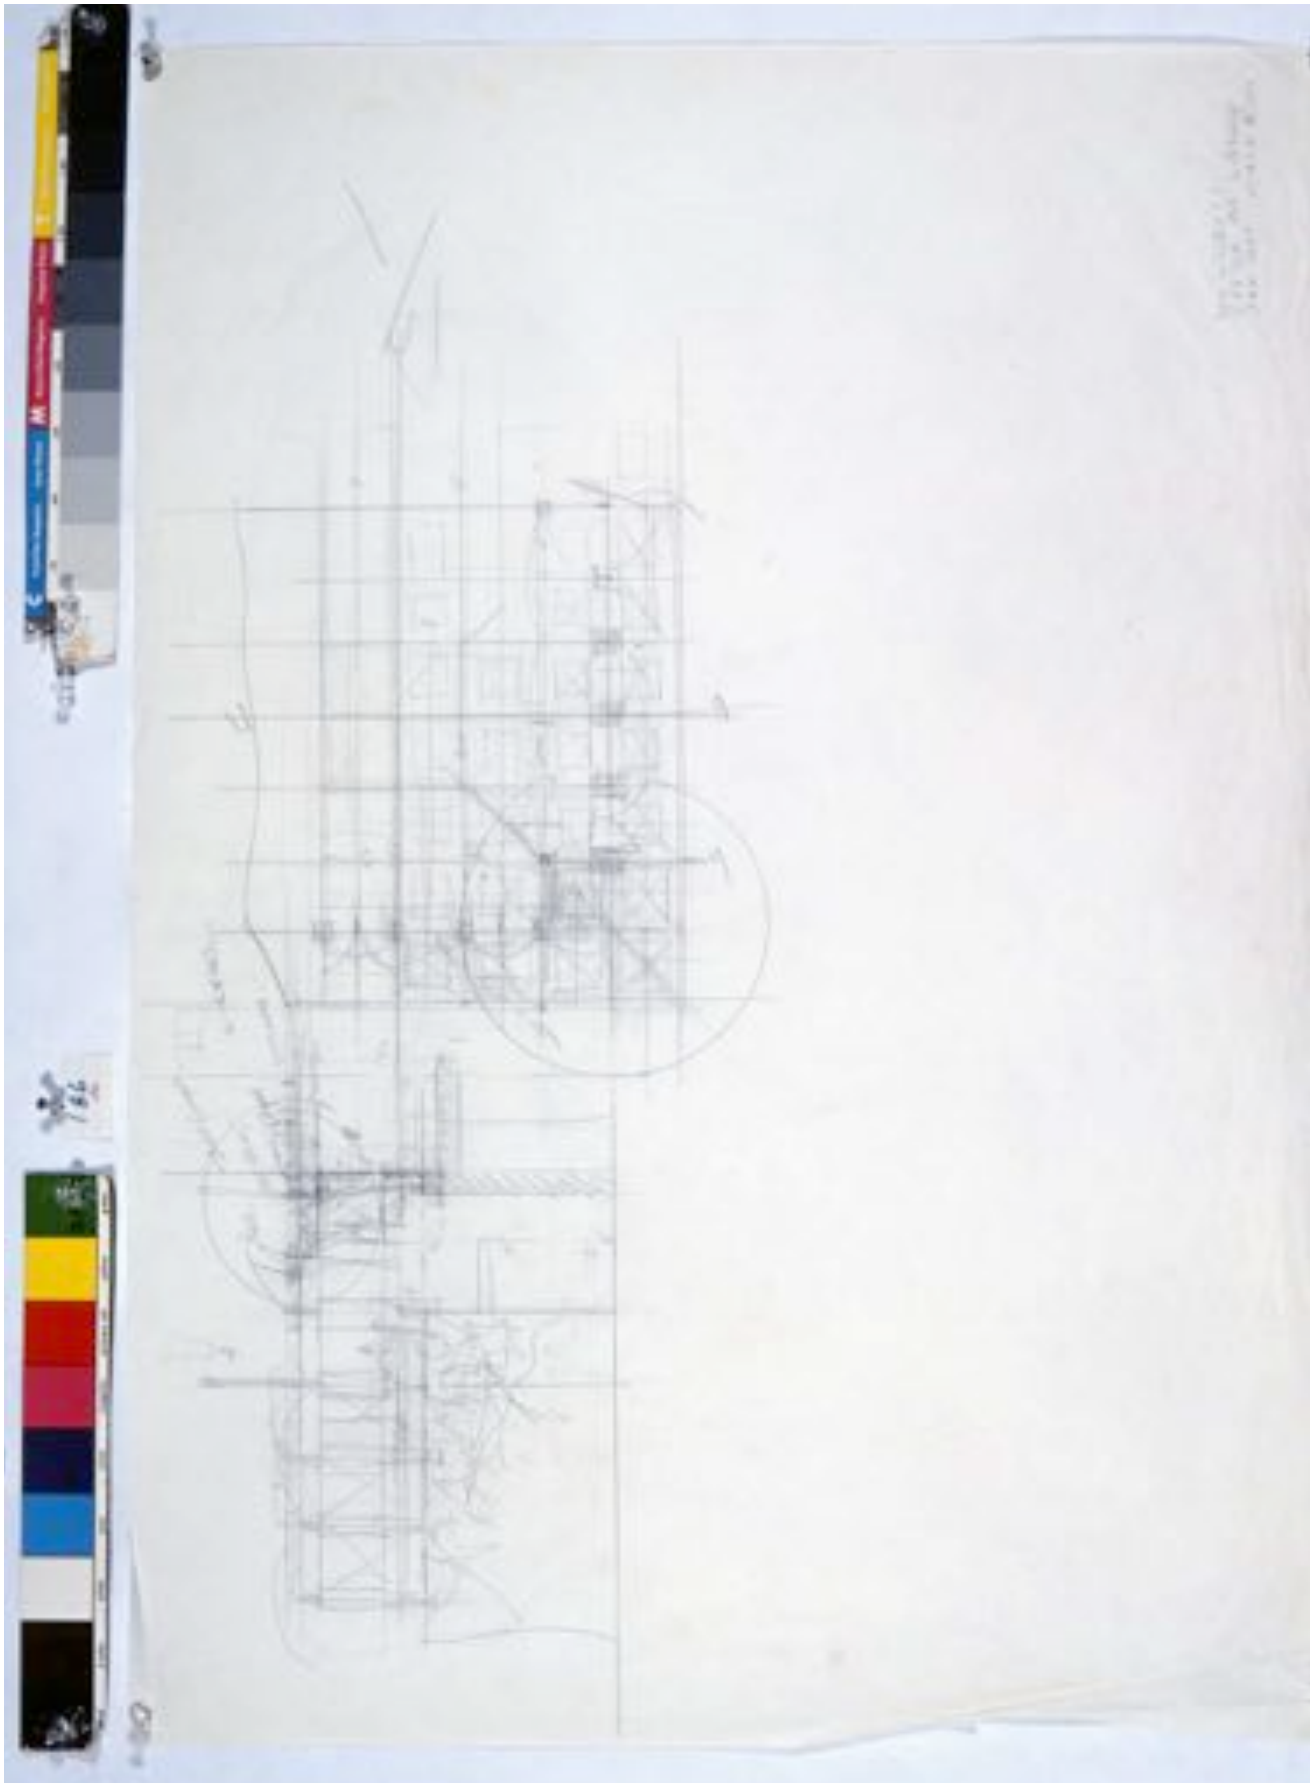
Figure B-156 -Library Sketch(The Frank Lloyd Wright Foundation Archives, The Museum of Modern Art | Avery Architectural & Fine Arts Library, Columbia University, New York).
