TALIESIN WEST PRESERVATION MASTER PLAN

Harboe Architects, PC

MAY 21, 2015

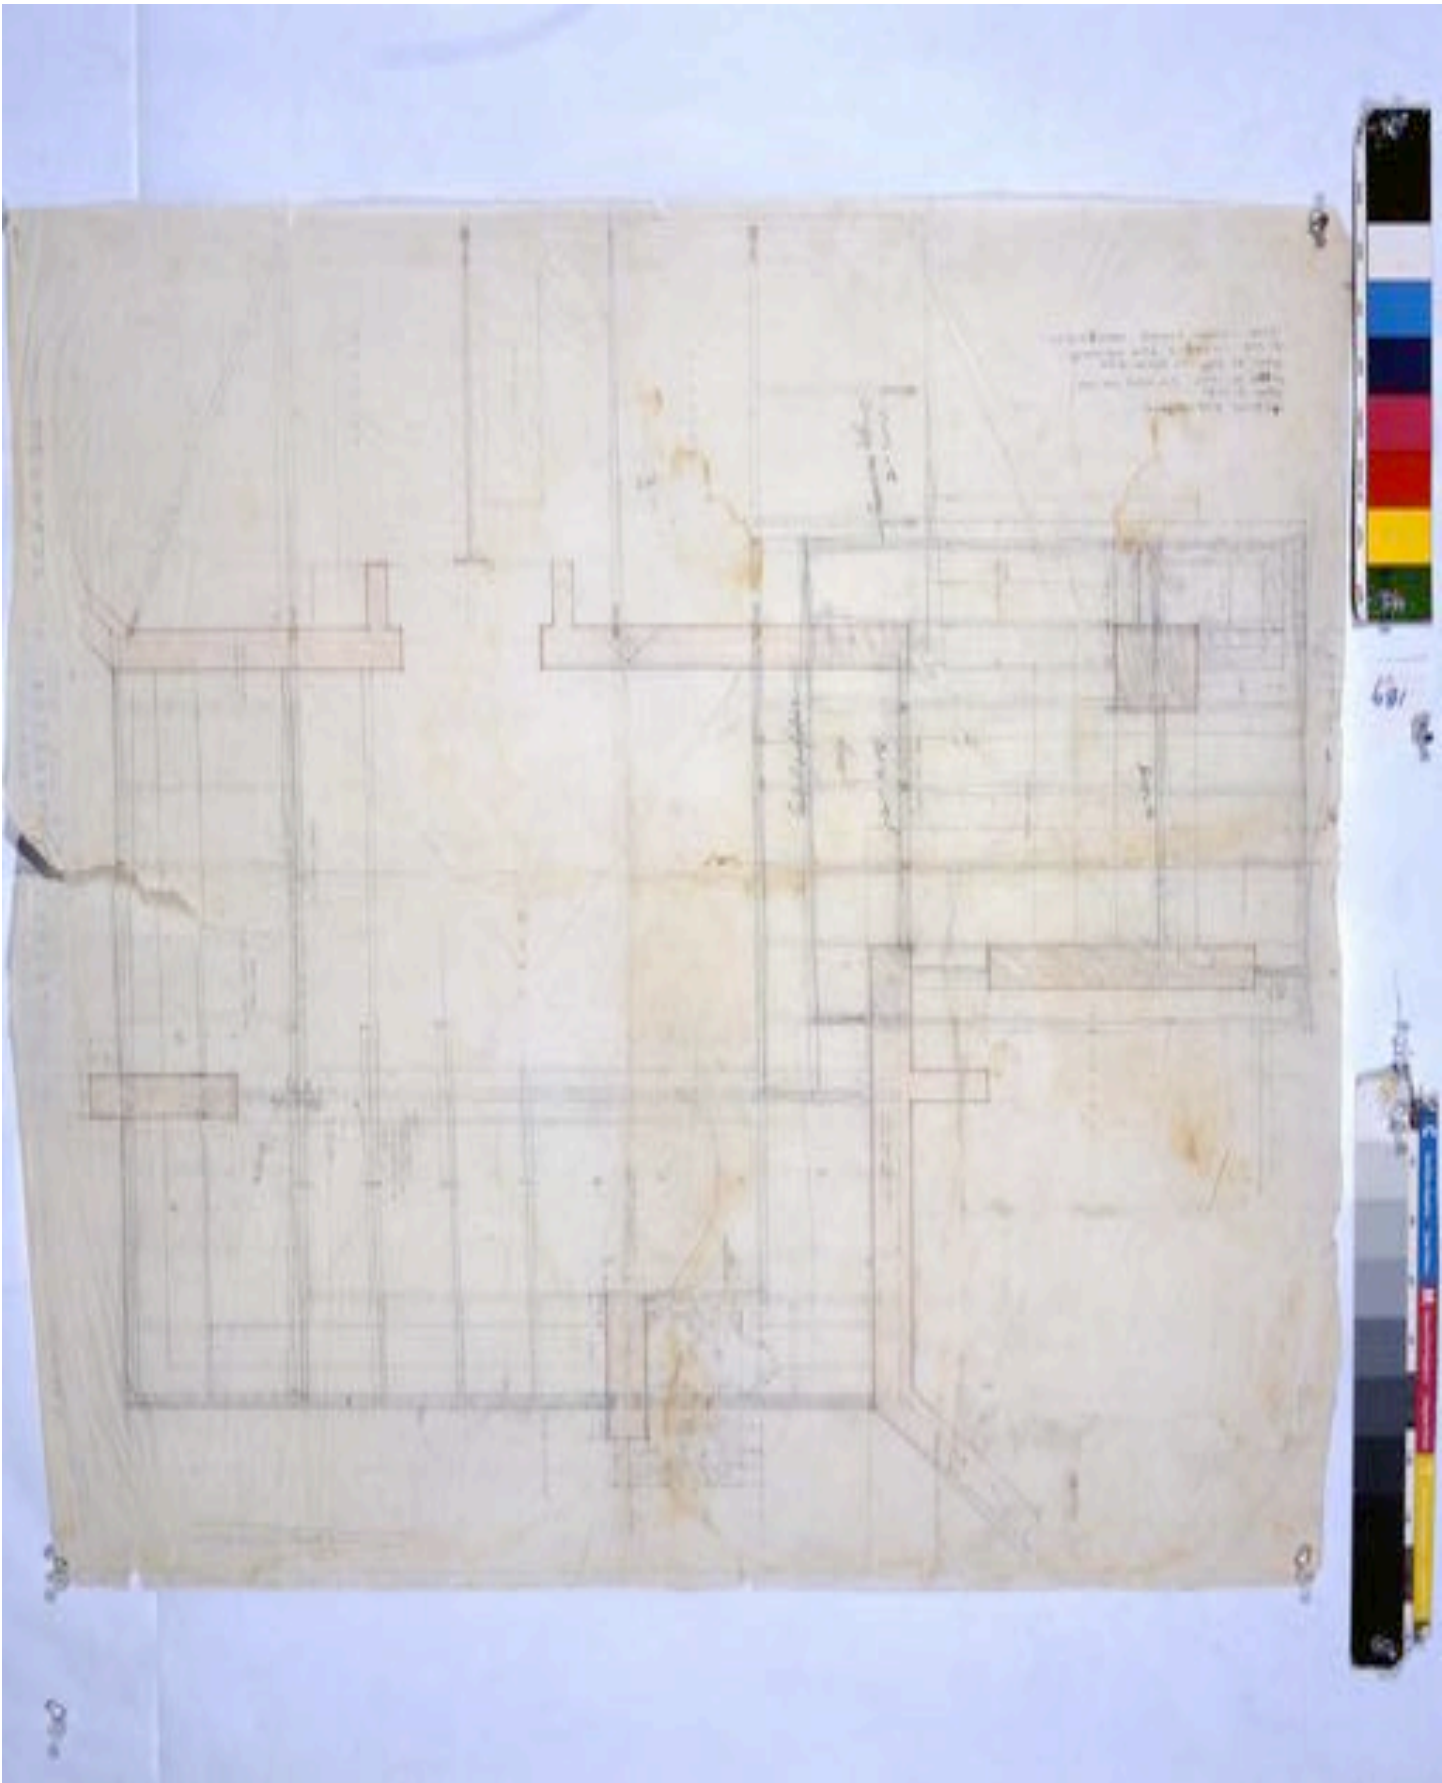
Figure B-159 - Apprentice Court Terrace Roof (The Frank Lloyd Wright Foundation Archives, The Museum of Modern Art | Avery Architectural & Fine Arts Library, Columbia University, New York).

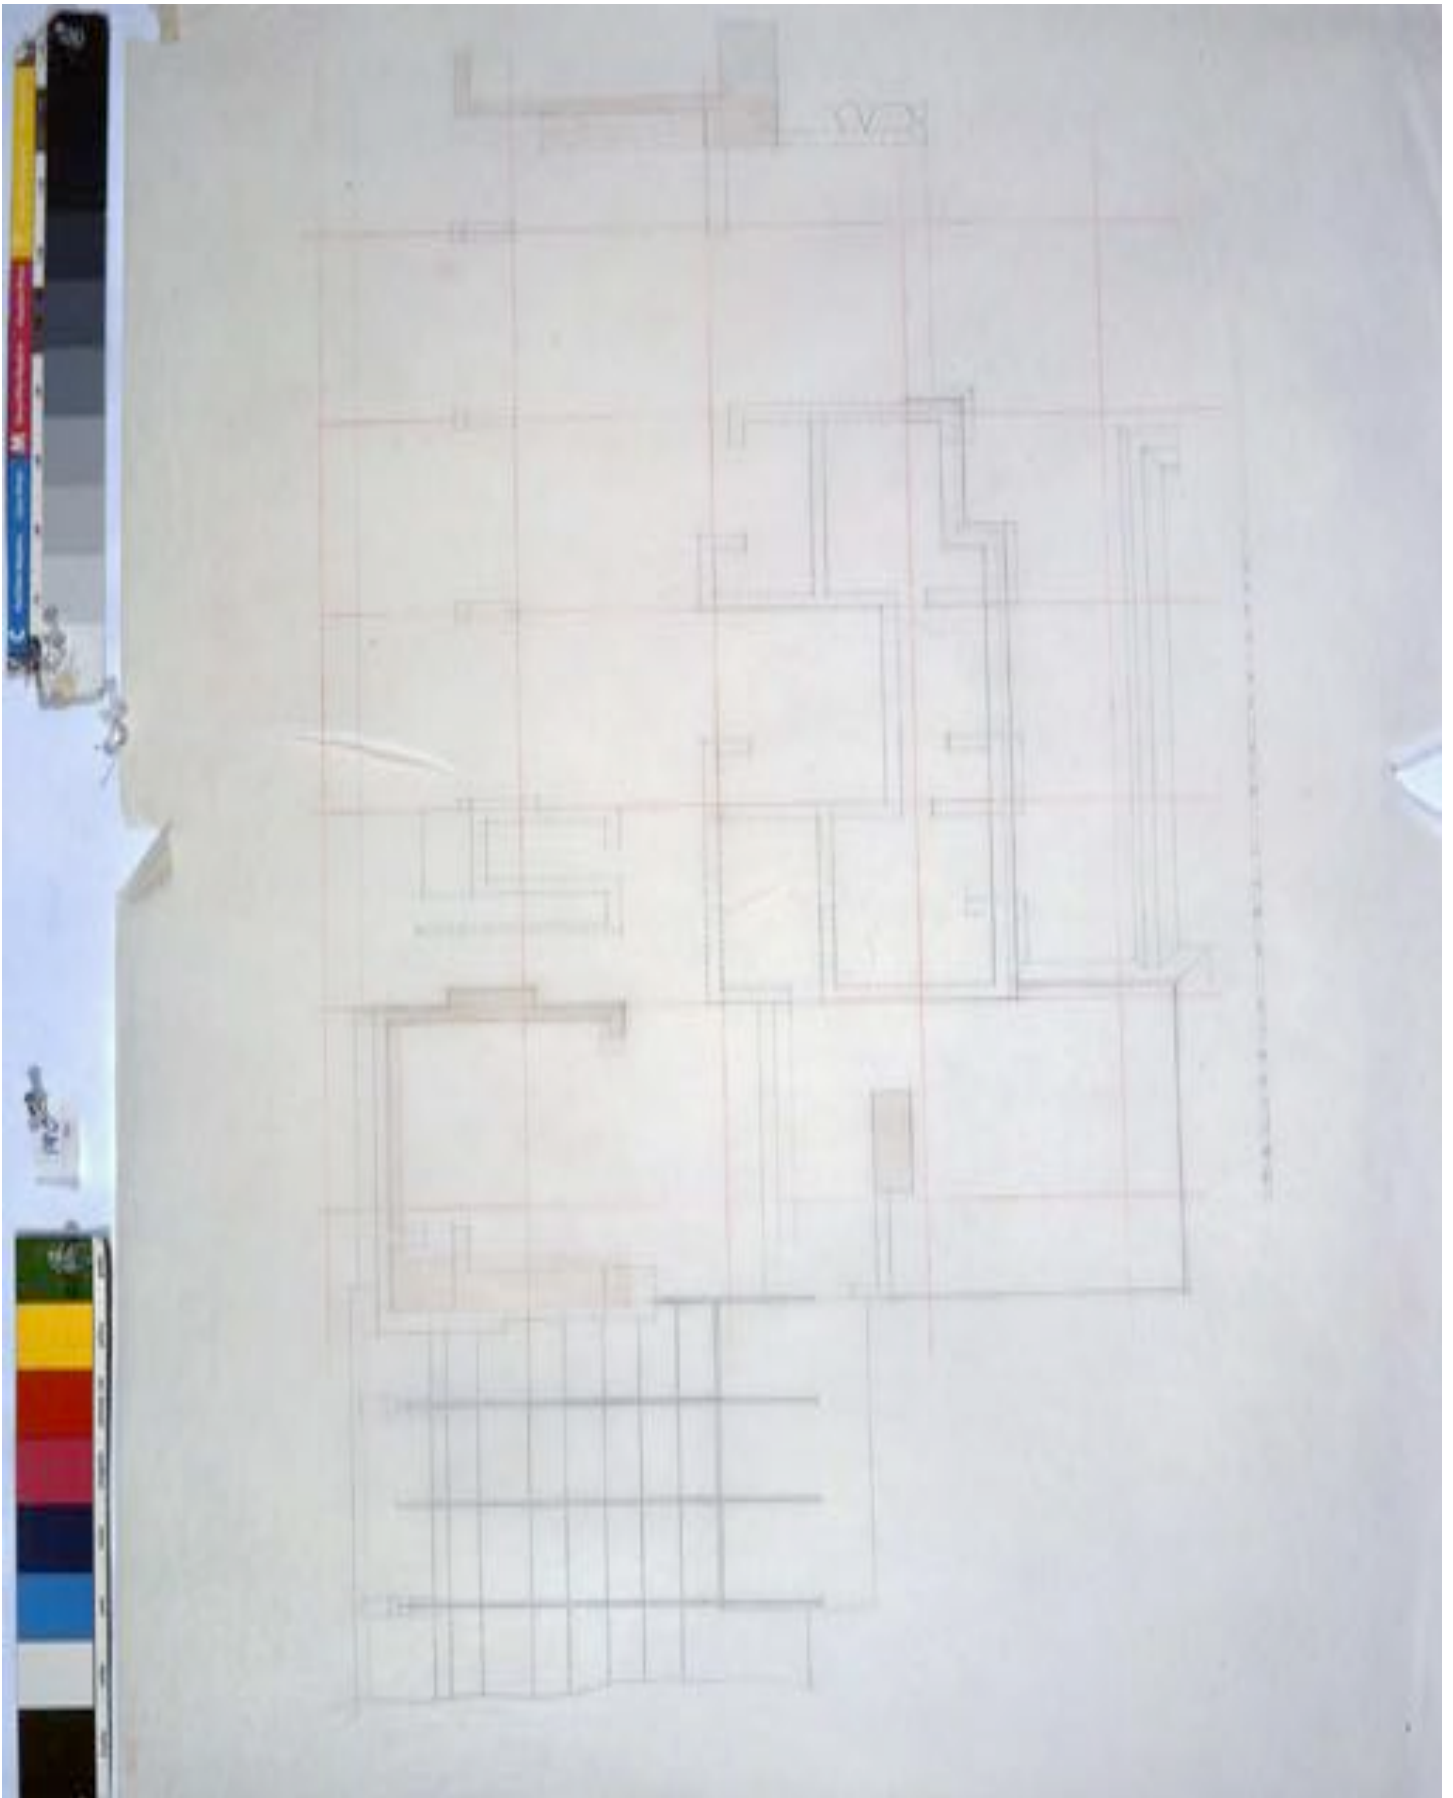
Figure B-160 - Dining Room Revisions (The Frank Lloyd Wright Foundation Archives, The Museum of Modern Art | Avery Architectural & Fine Arts Library, Columbia University, New York).

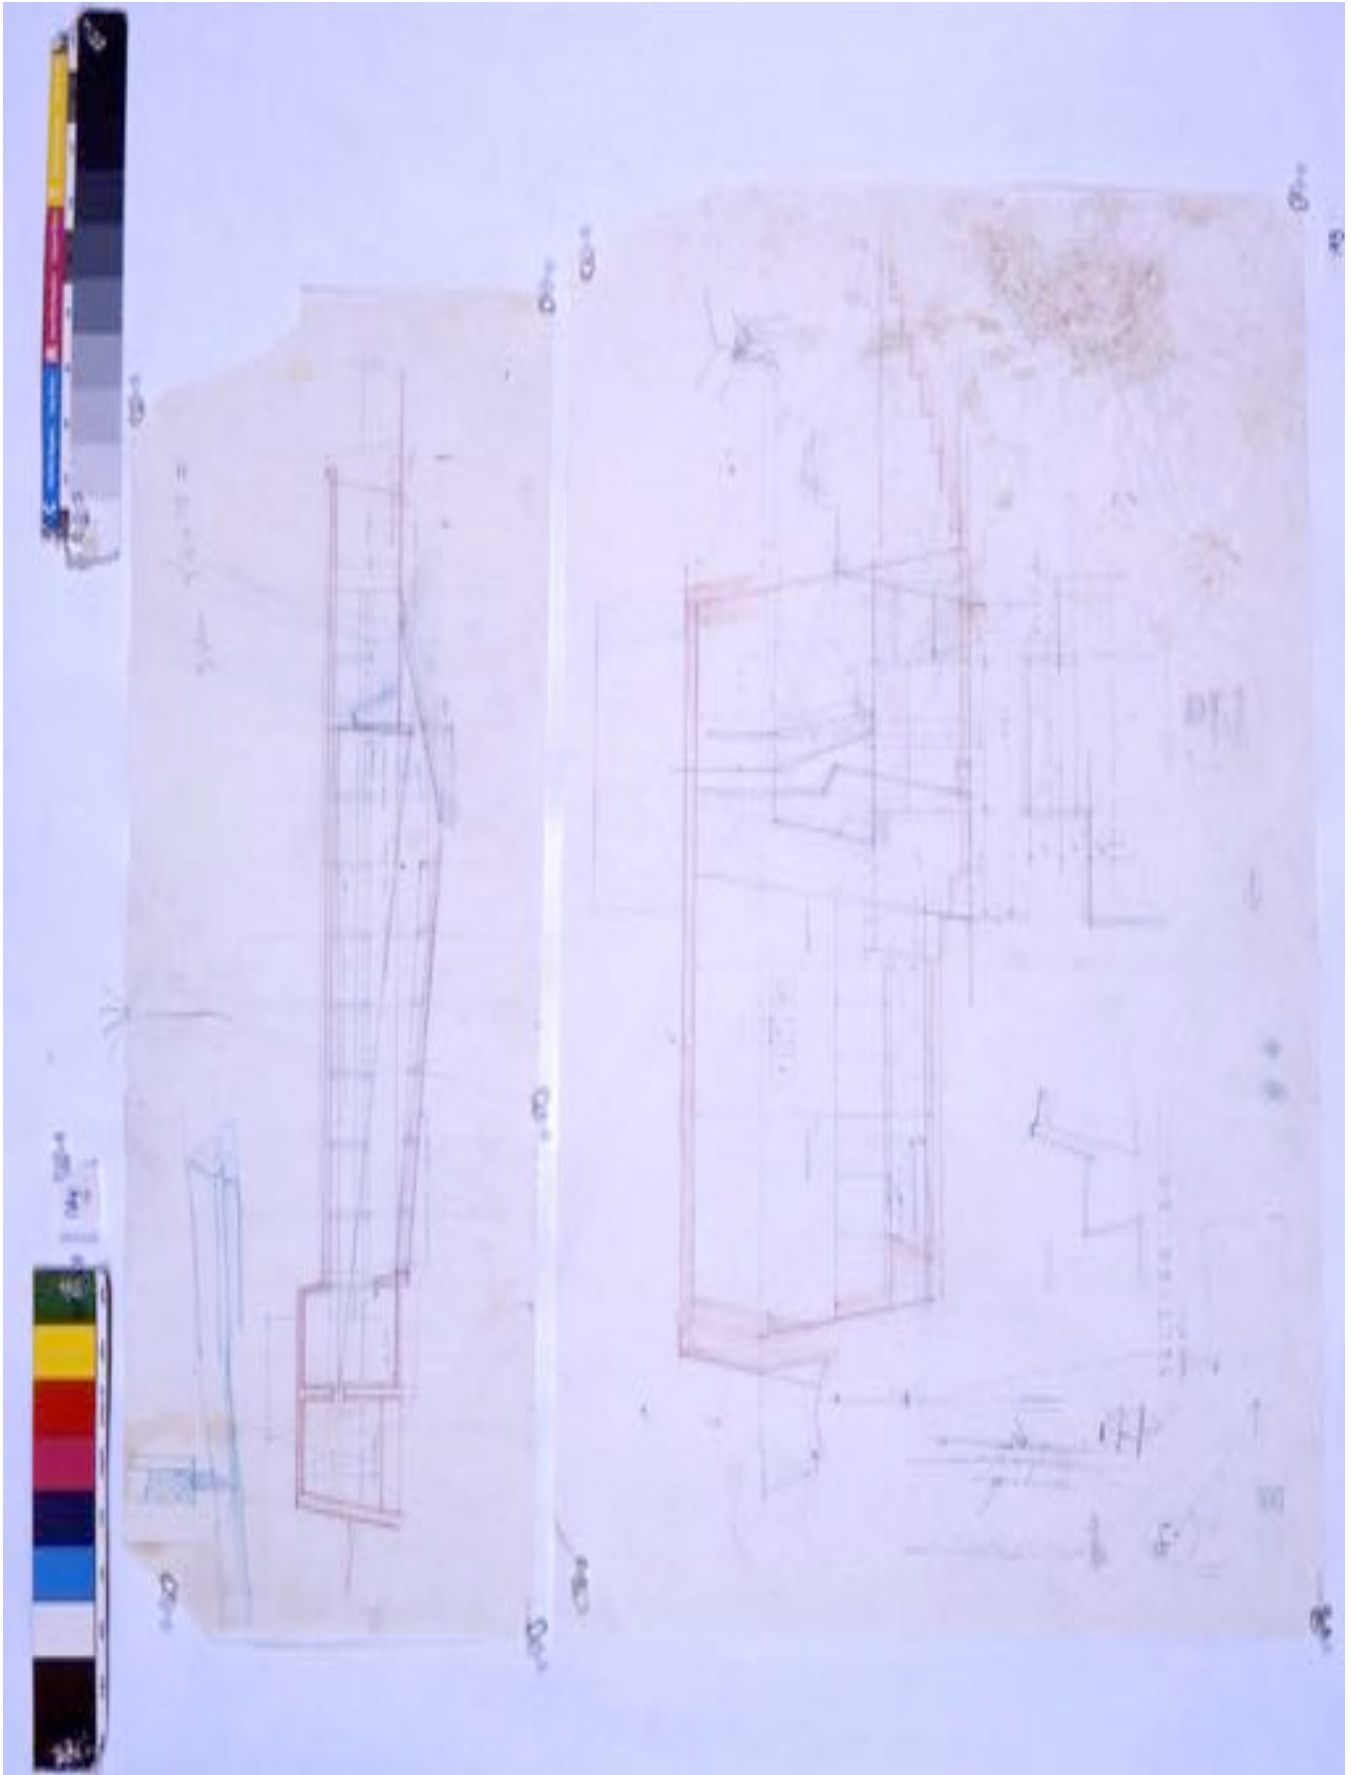
Figure B-163 - Cabaret Longitudinal Section (The Frank Lloyd Wright Foundation Archives, The Museum of Modern Art | Avery Architectural & Fine Arts Library, Columbia University, New York).

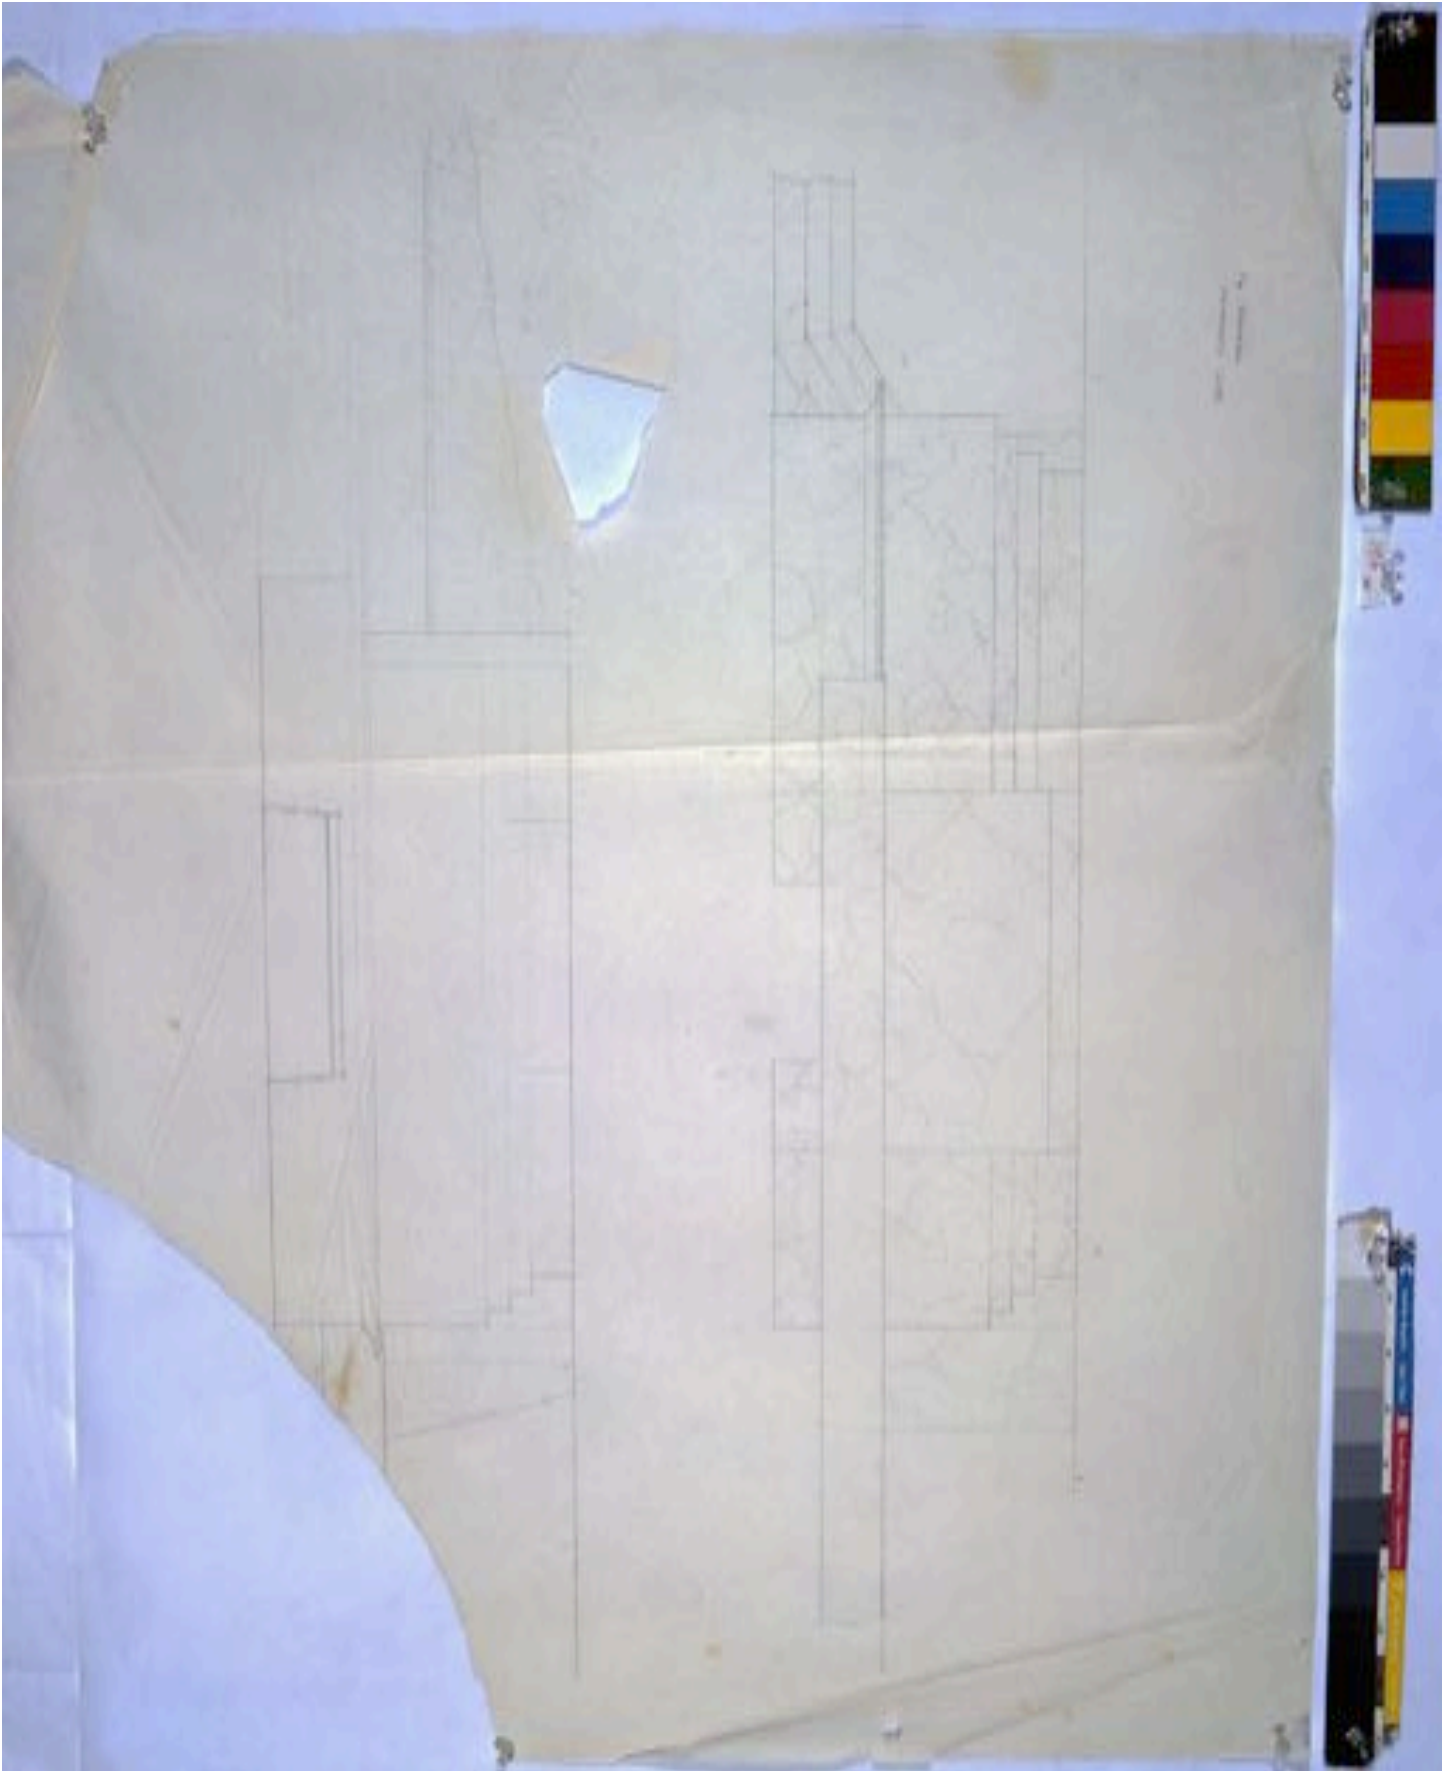
Figure B-163 - Library Revisions (The Frank Lloyd Wright Foundation Archives, The Museum of Modern Art | Avery Architectural & Fine Arts Library, Columbia University, New York).

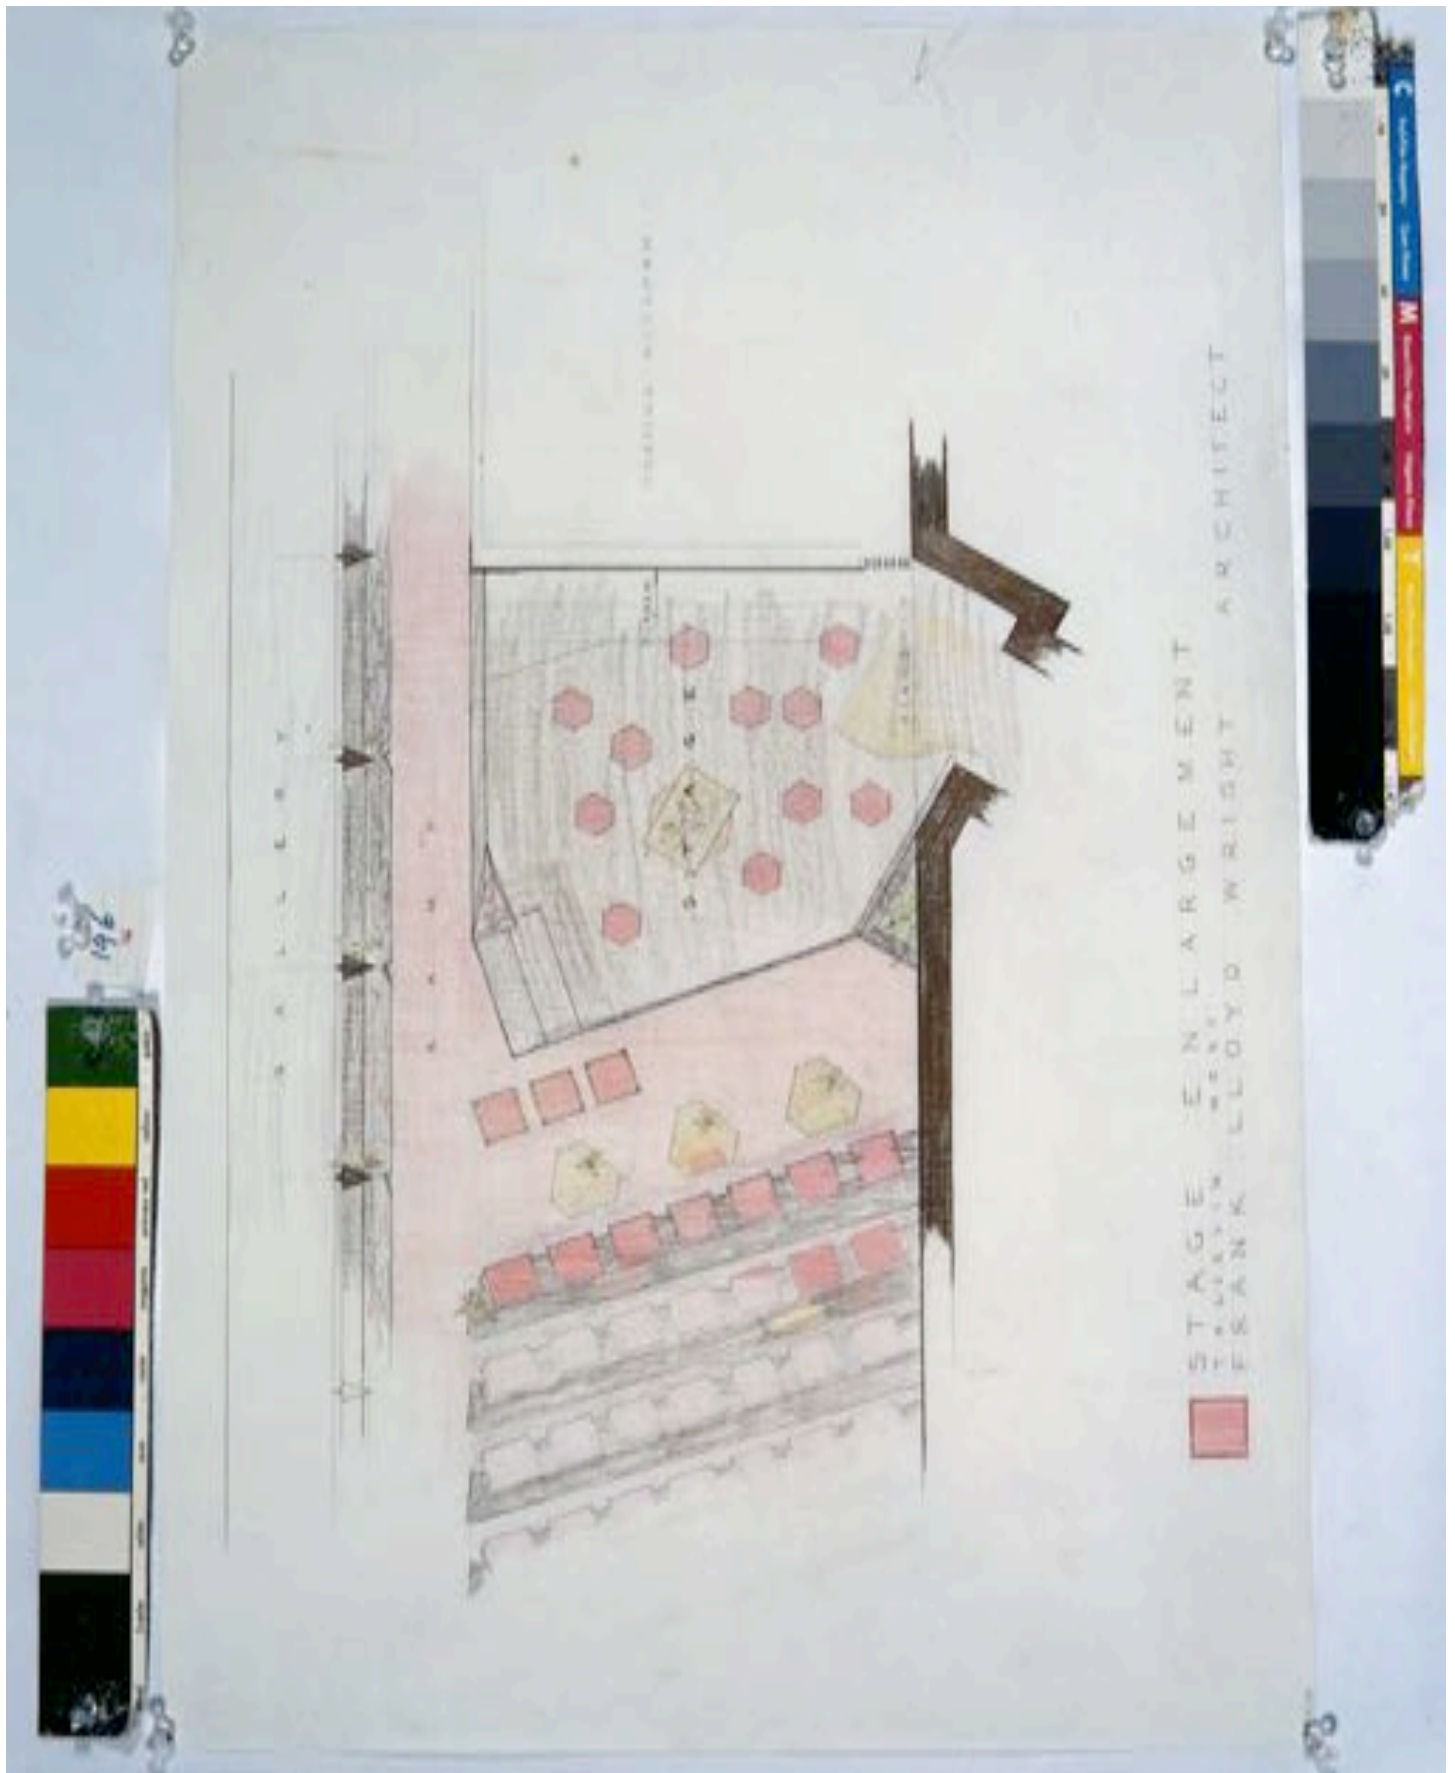
Figure B-166 - Cabaret Stage Plan (The Frank Lloyd Wright Foundation Archives, The Museum of Modern Art | Avery Architectural & Fine Arts Library, Columbia University, New York).

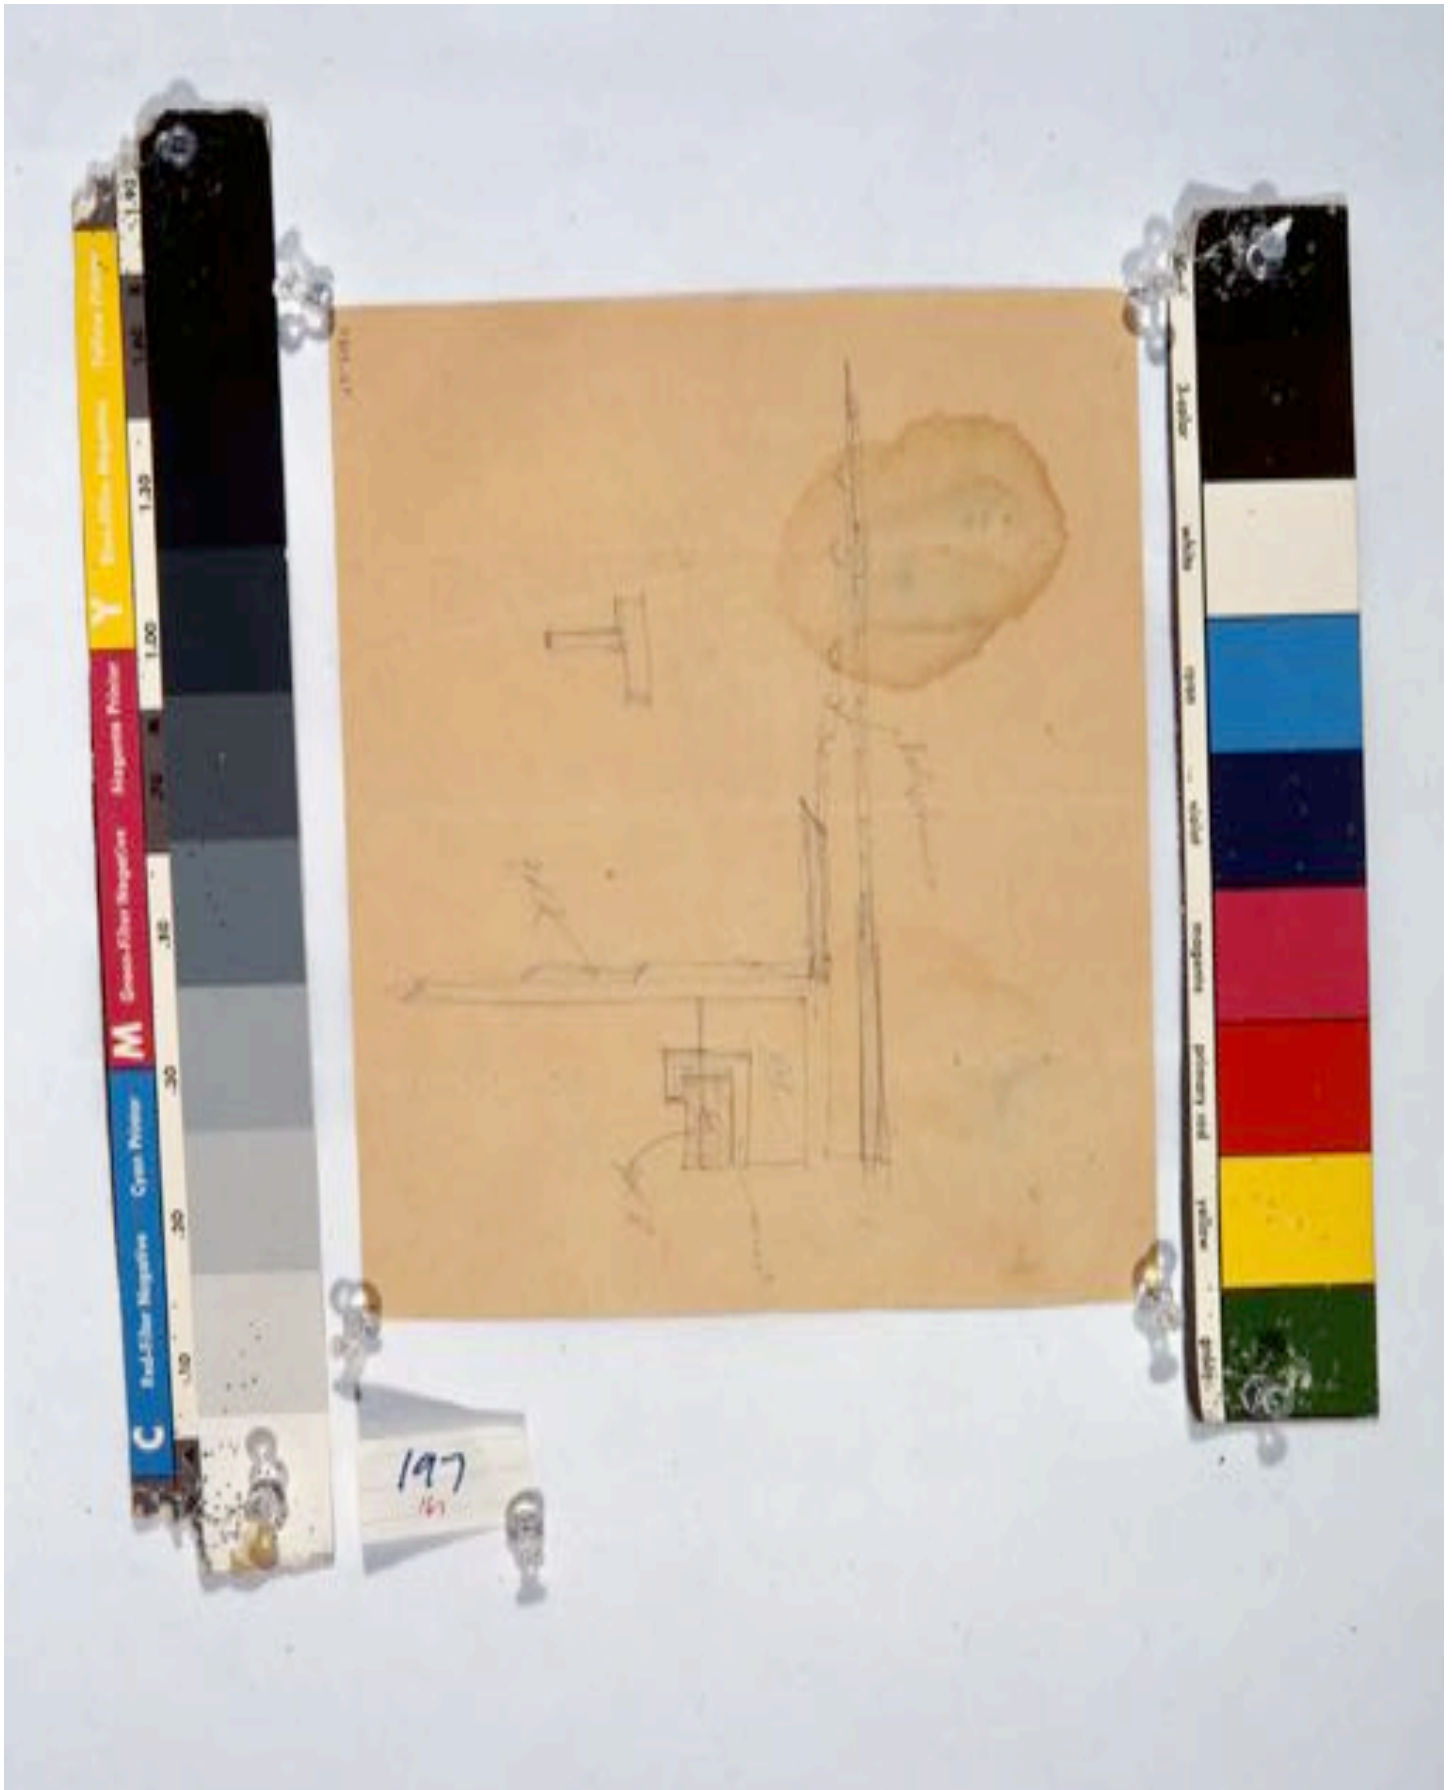
Figure B-167 - Wood Abstract Finial (The Frank Lloyd Wright Foundation Archives, The Museum of Modern Art | Avery Architectural & Fine Arts Library, Columbia University, New York).

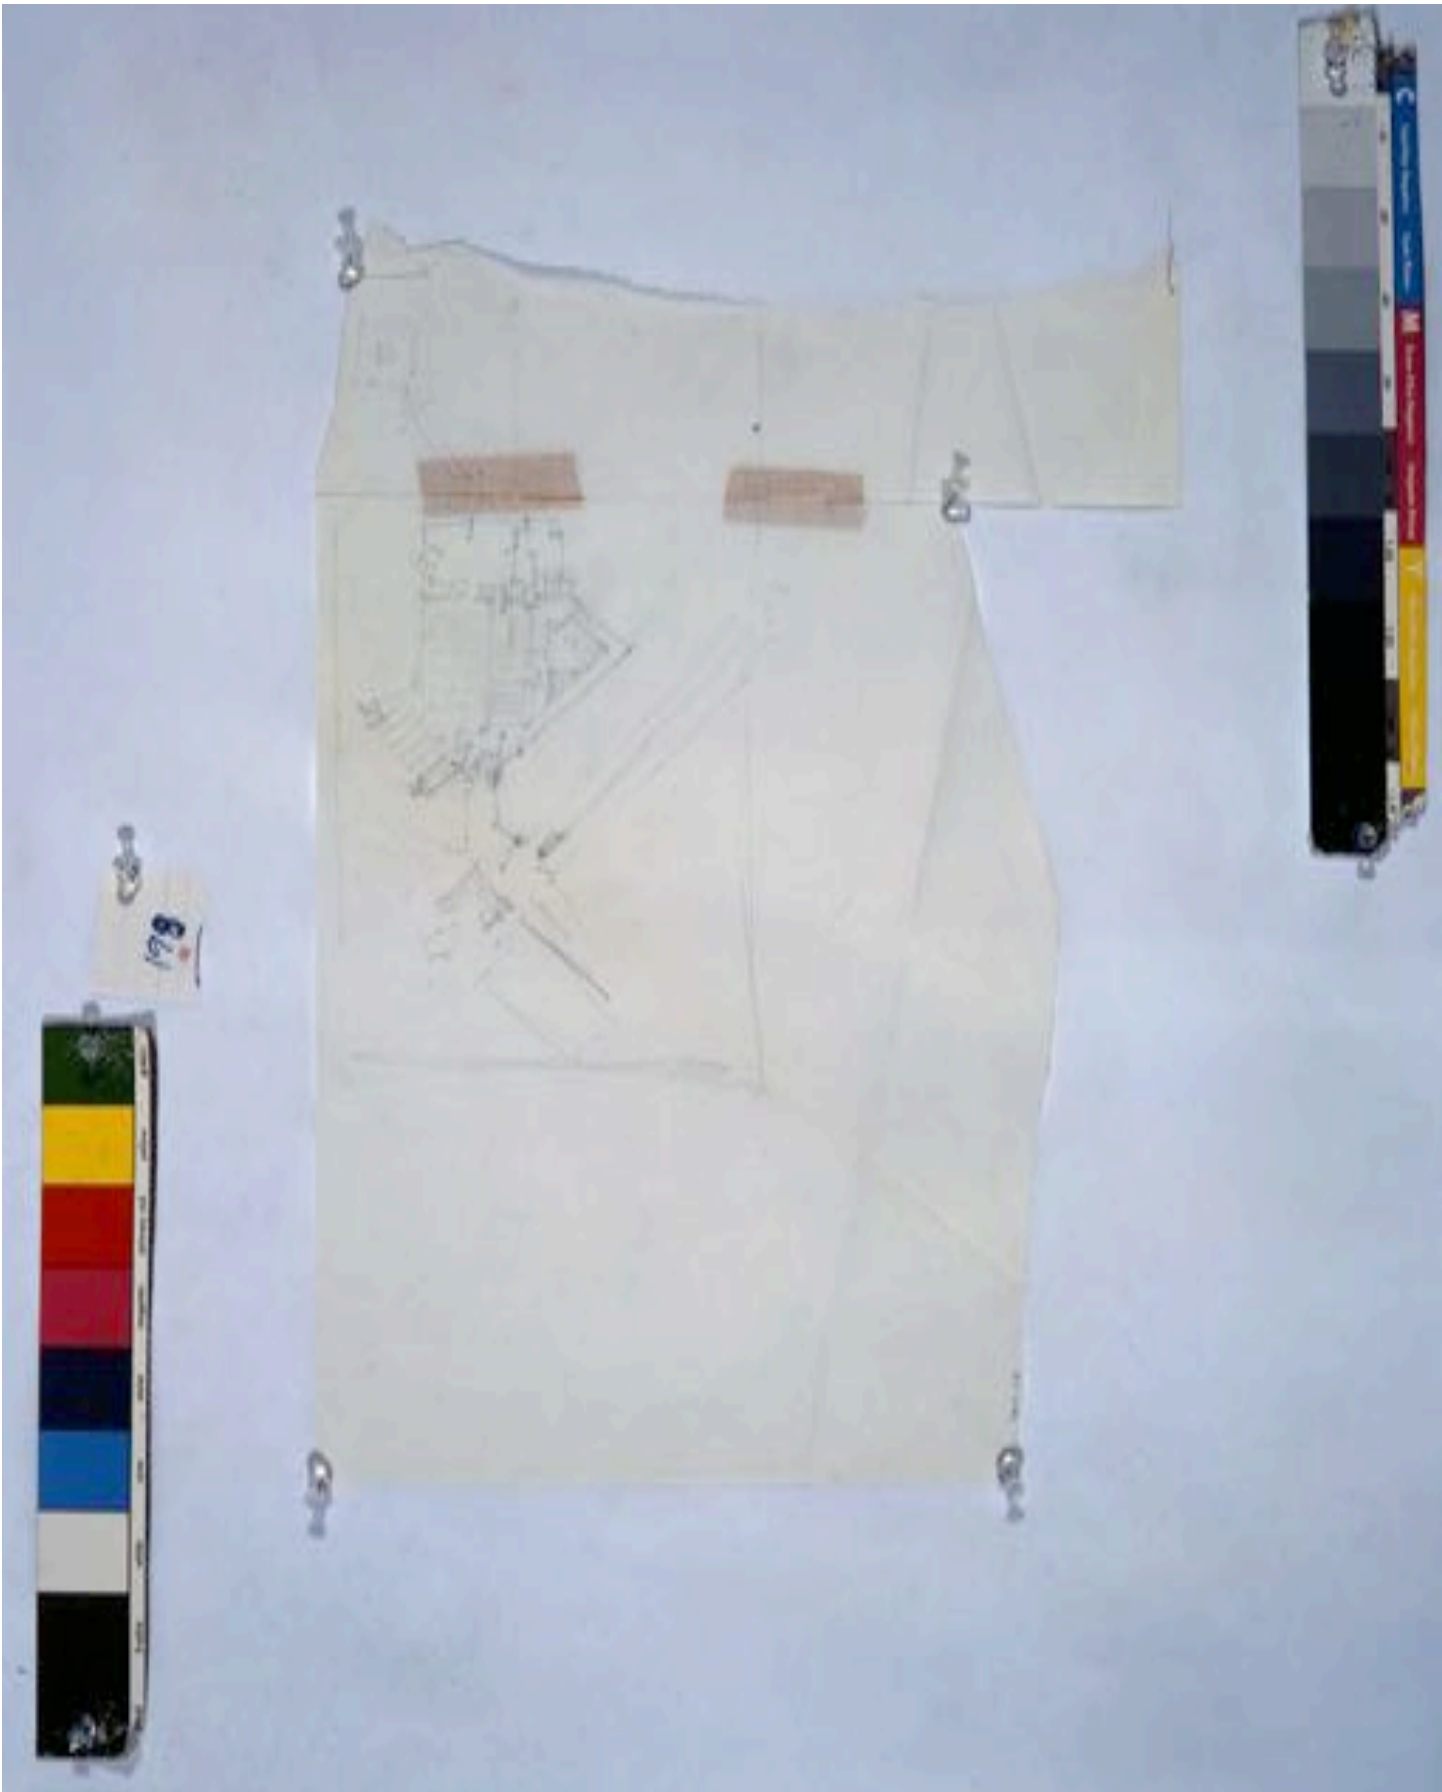
Figure B-168 - Entry Road Revision (The Frank Lloyd Wright Foundation Archives, The Museum of Modern Art | Avery Architectural & Fine Arts Library, Columbia University, New York).

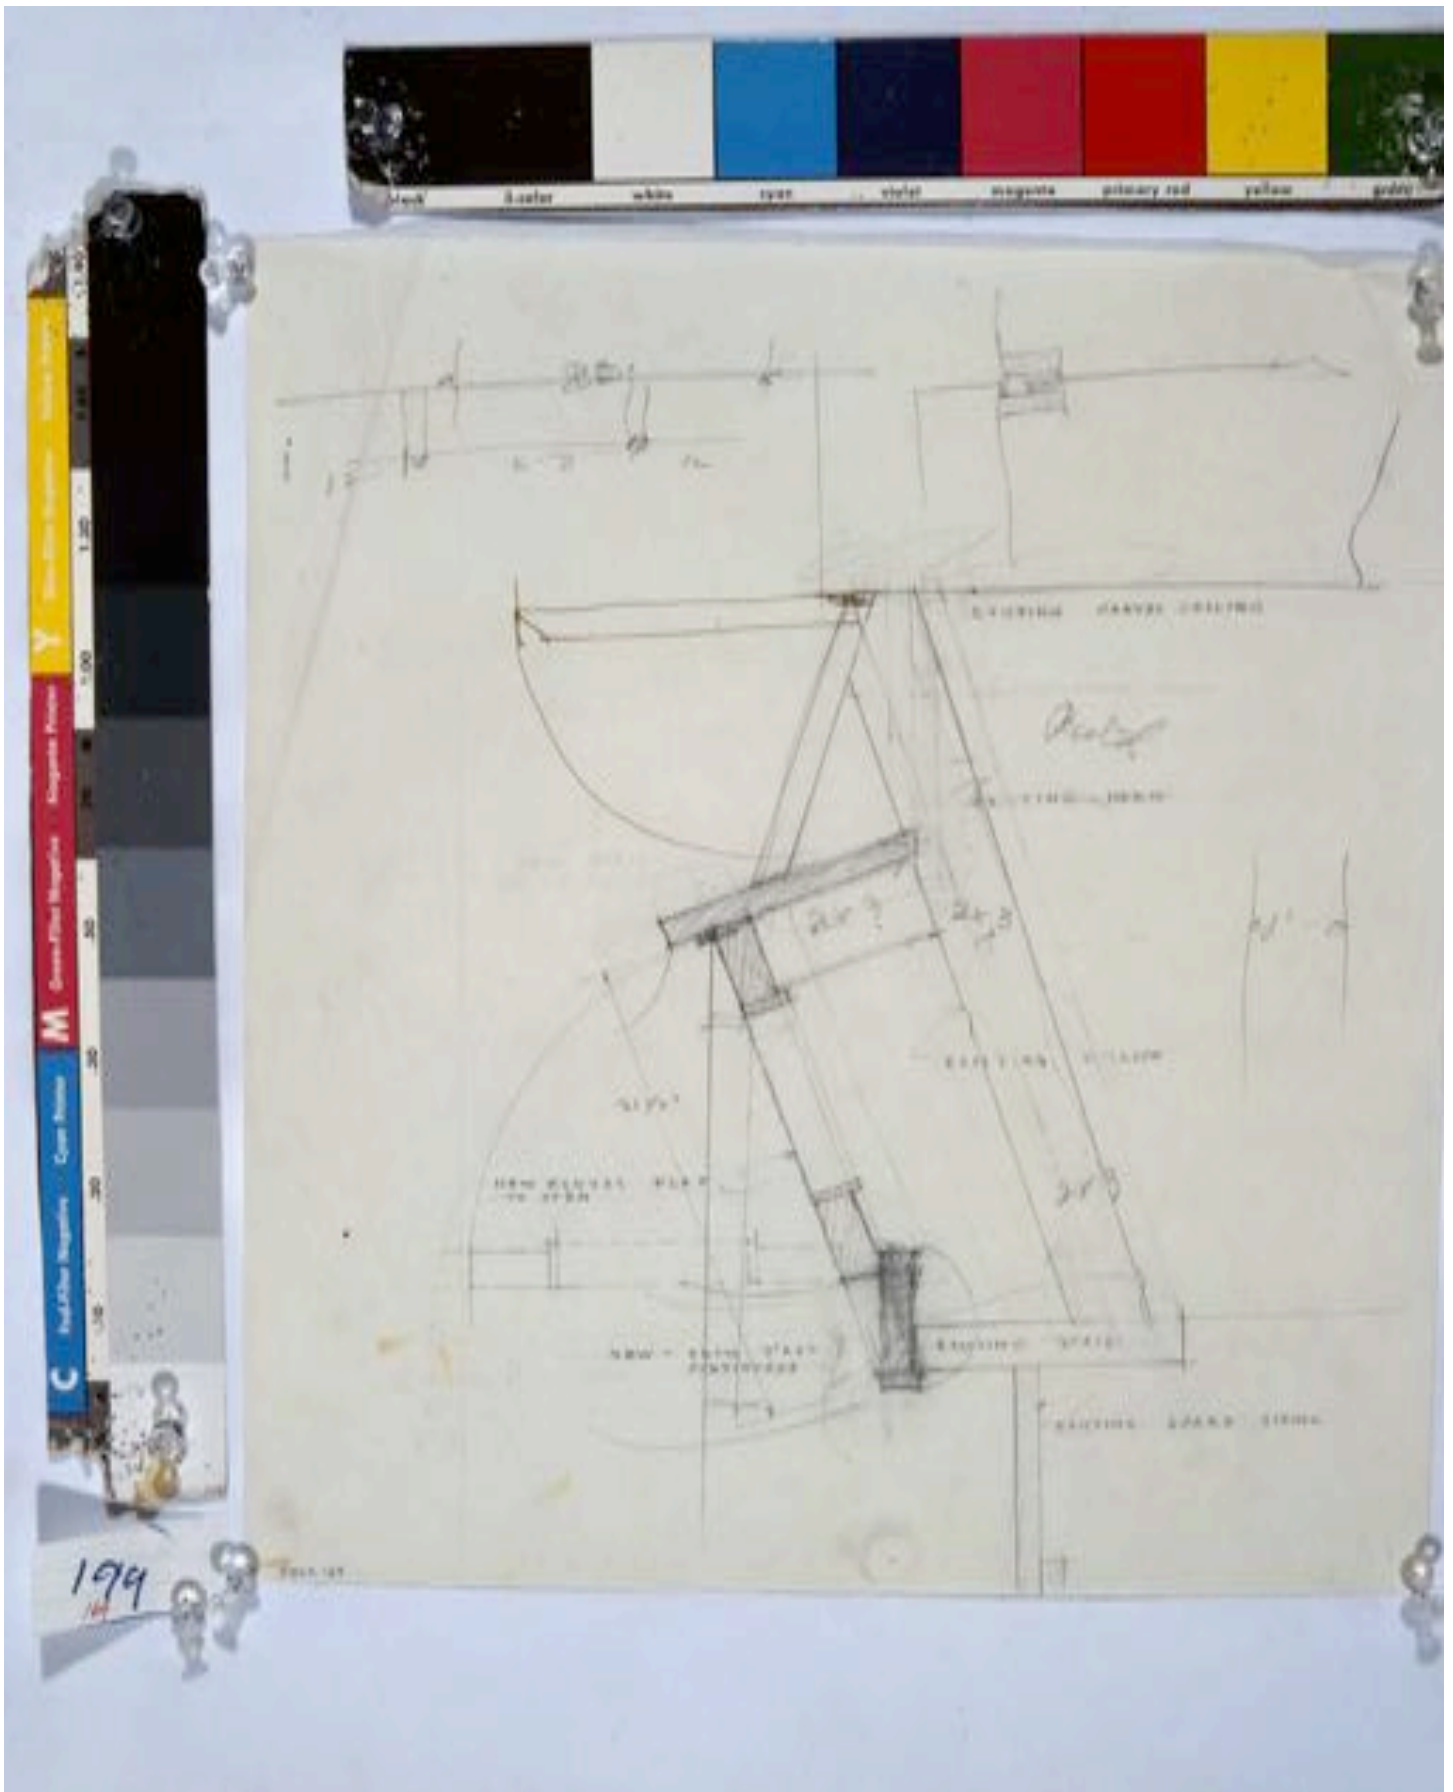
Figure B-169 - Guest Deck Flap Detail (The Frank Lloyd Wright Foundation Archives, The Museum of Modern Art | Avery Architectural & Fine Arts Library, Columbia University, New York).
