TALIESIN WEST PRESERVATION MASTER PLAN

Harboe Architects, PC

MAY 21, 2015

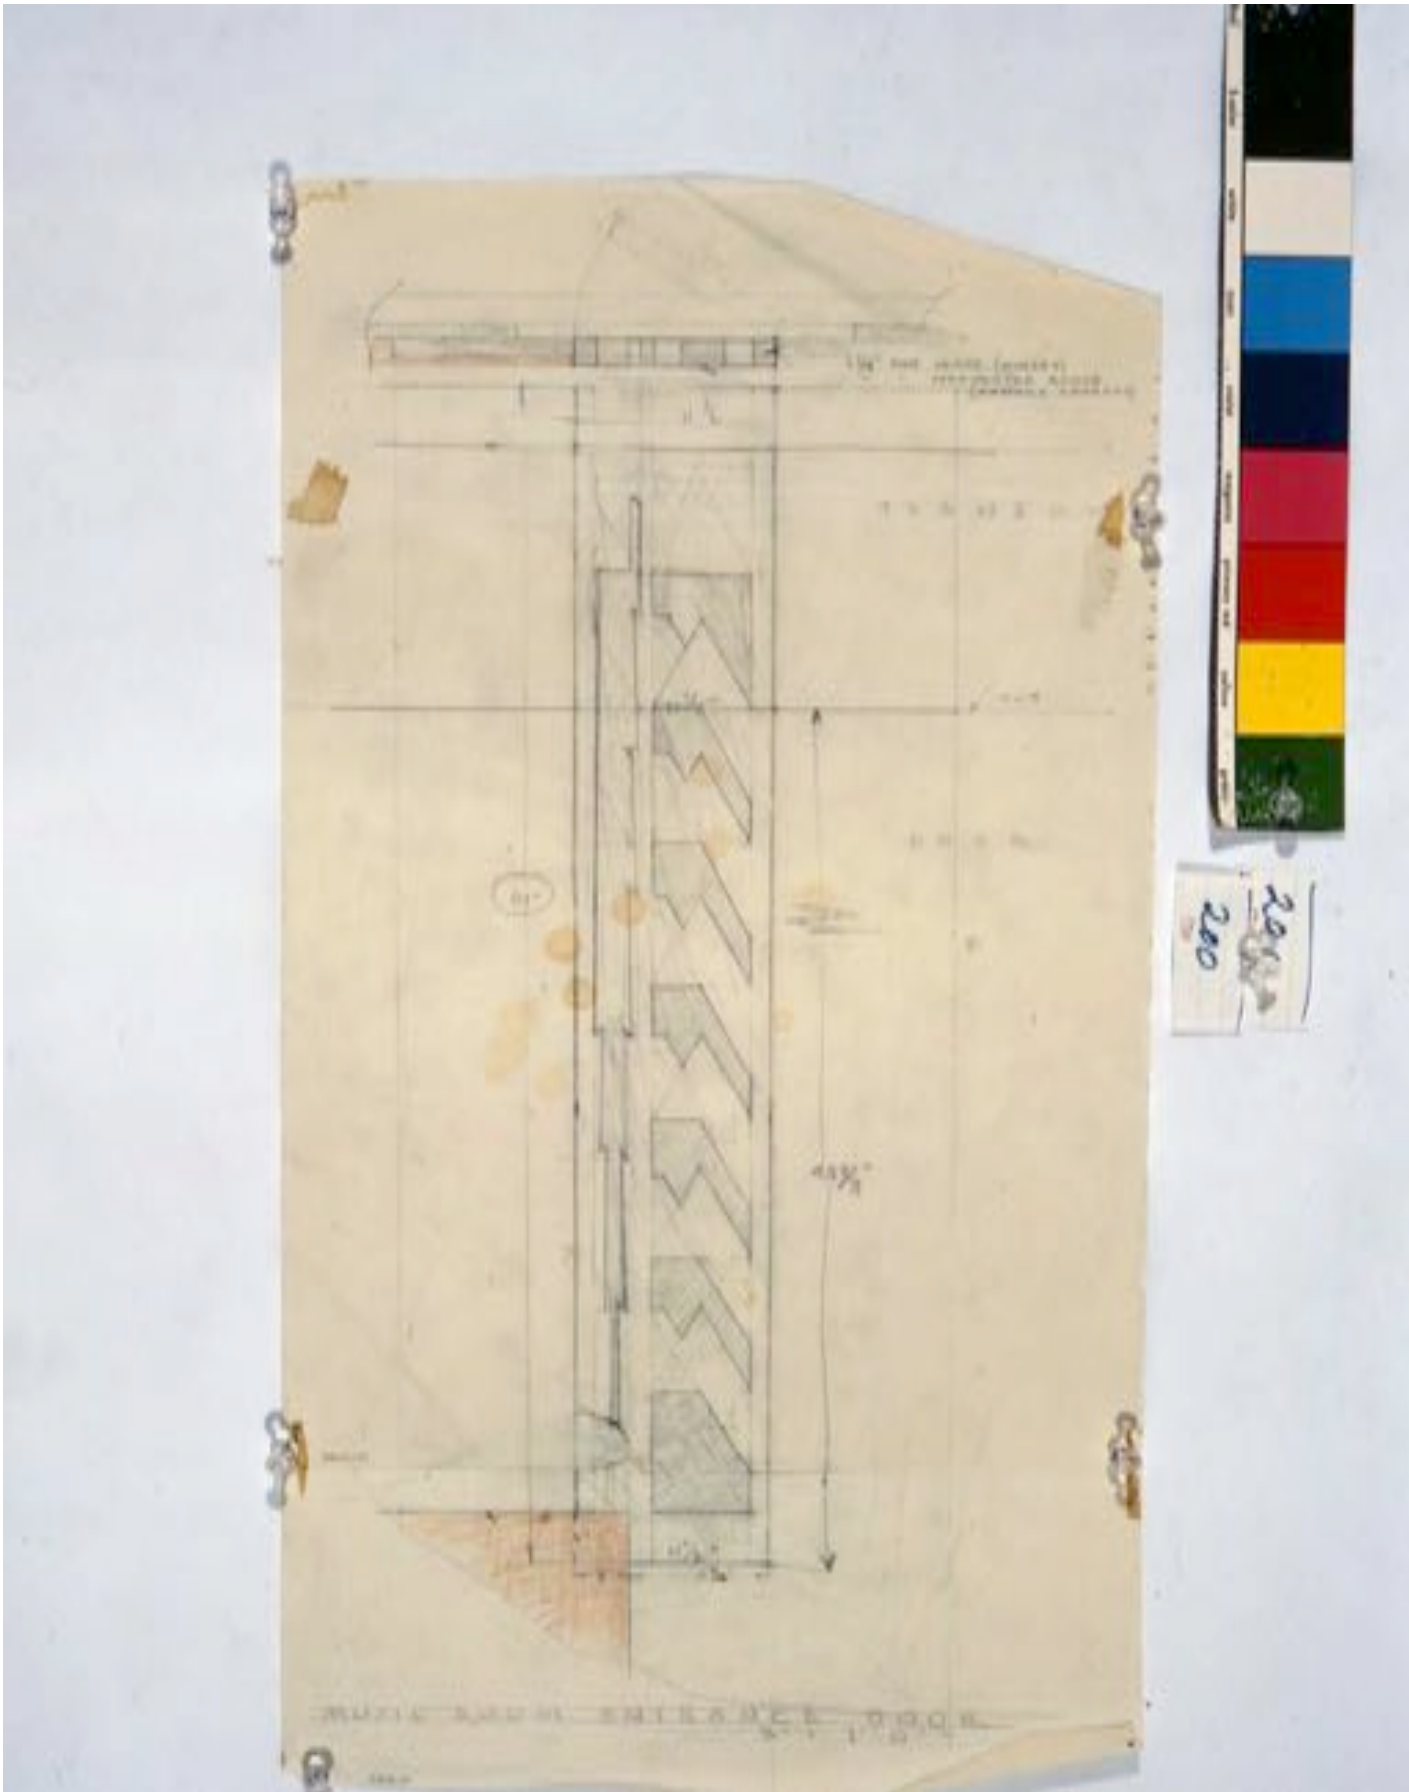
Figure B-170 - Perforated Transom (The Frank Lloyd Wright Foundation Archives, The Museum of Modern Art | Avery Architectural & Fine Arts Library, Columbia University, New York).

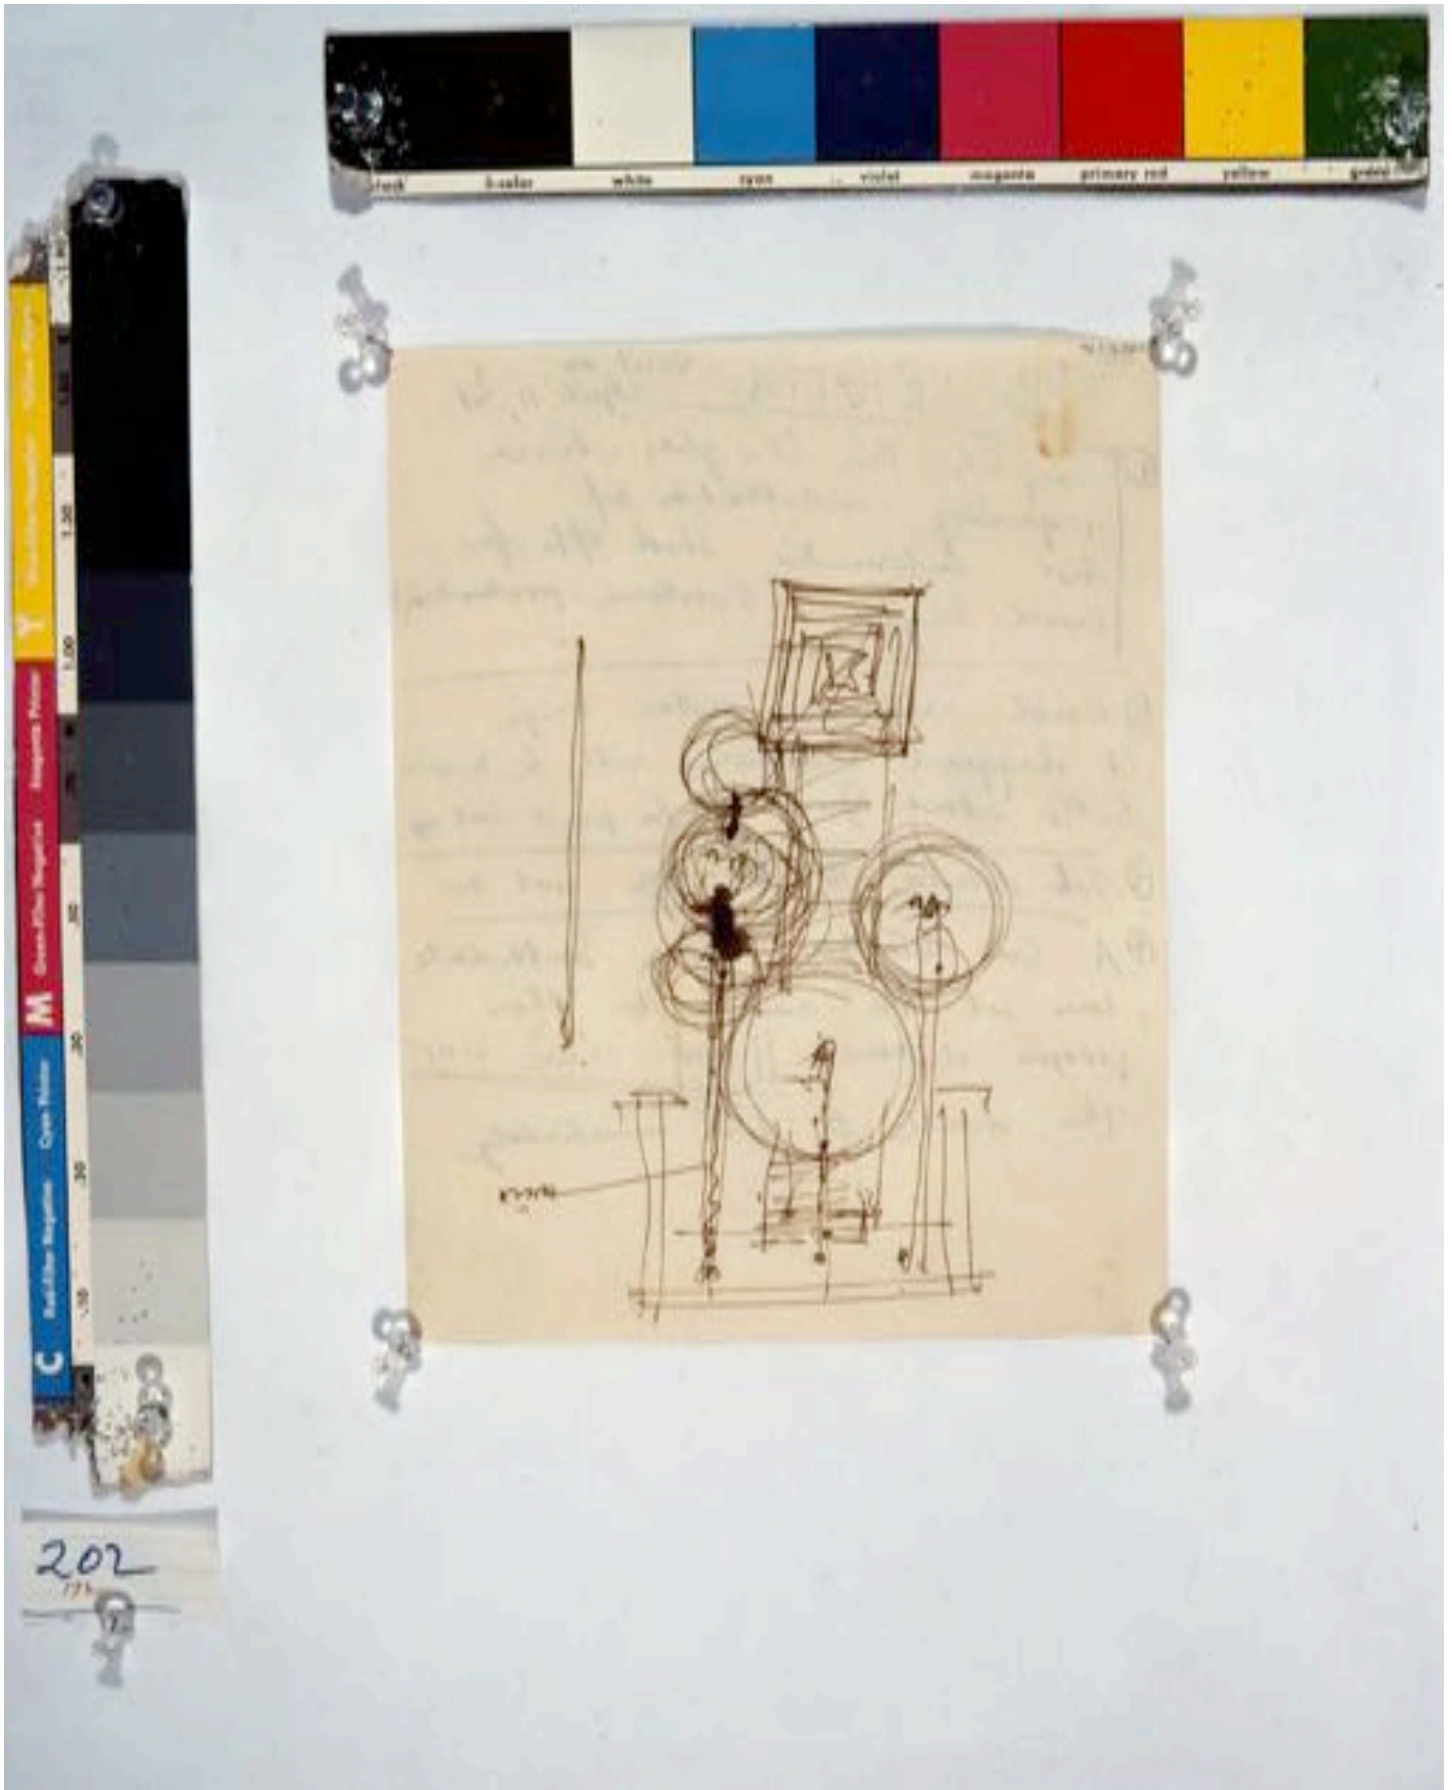
Figure B-172 - Bell Tower Sketch (The Frank Lloyd Wright Foundation Archives, The Museum of Modern Art | Avery Architectural & Fine Arts Library, Columbia University, New York).

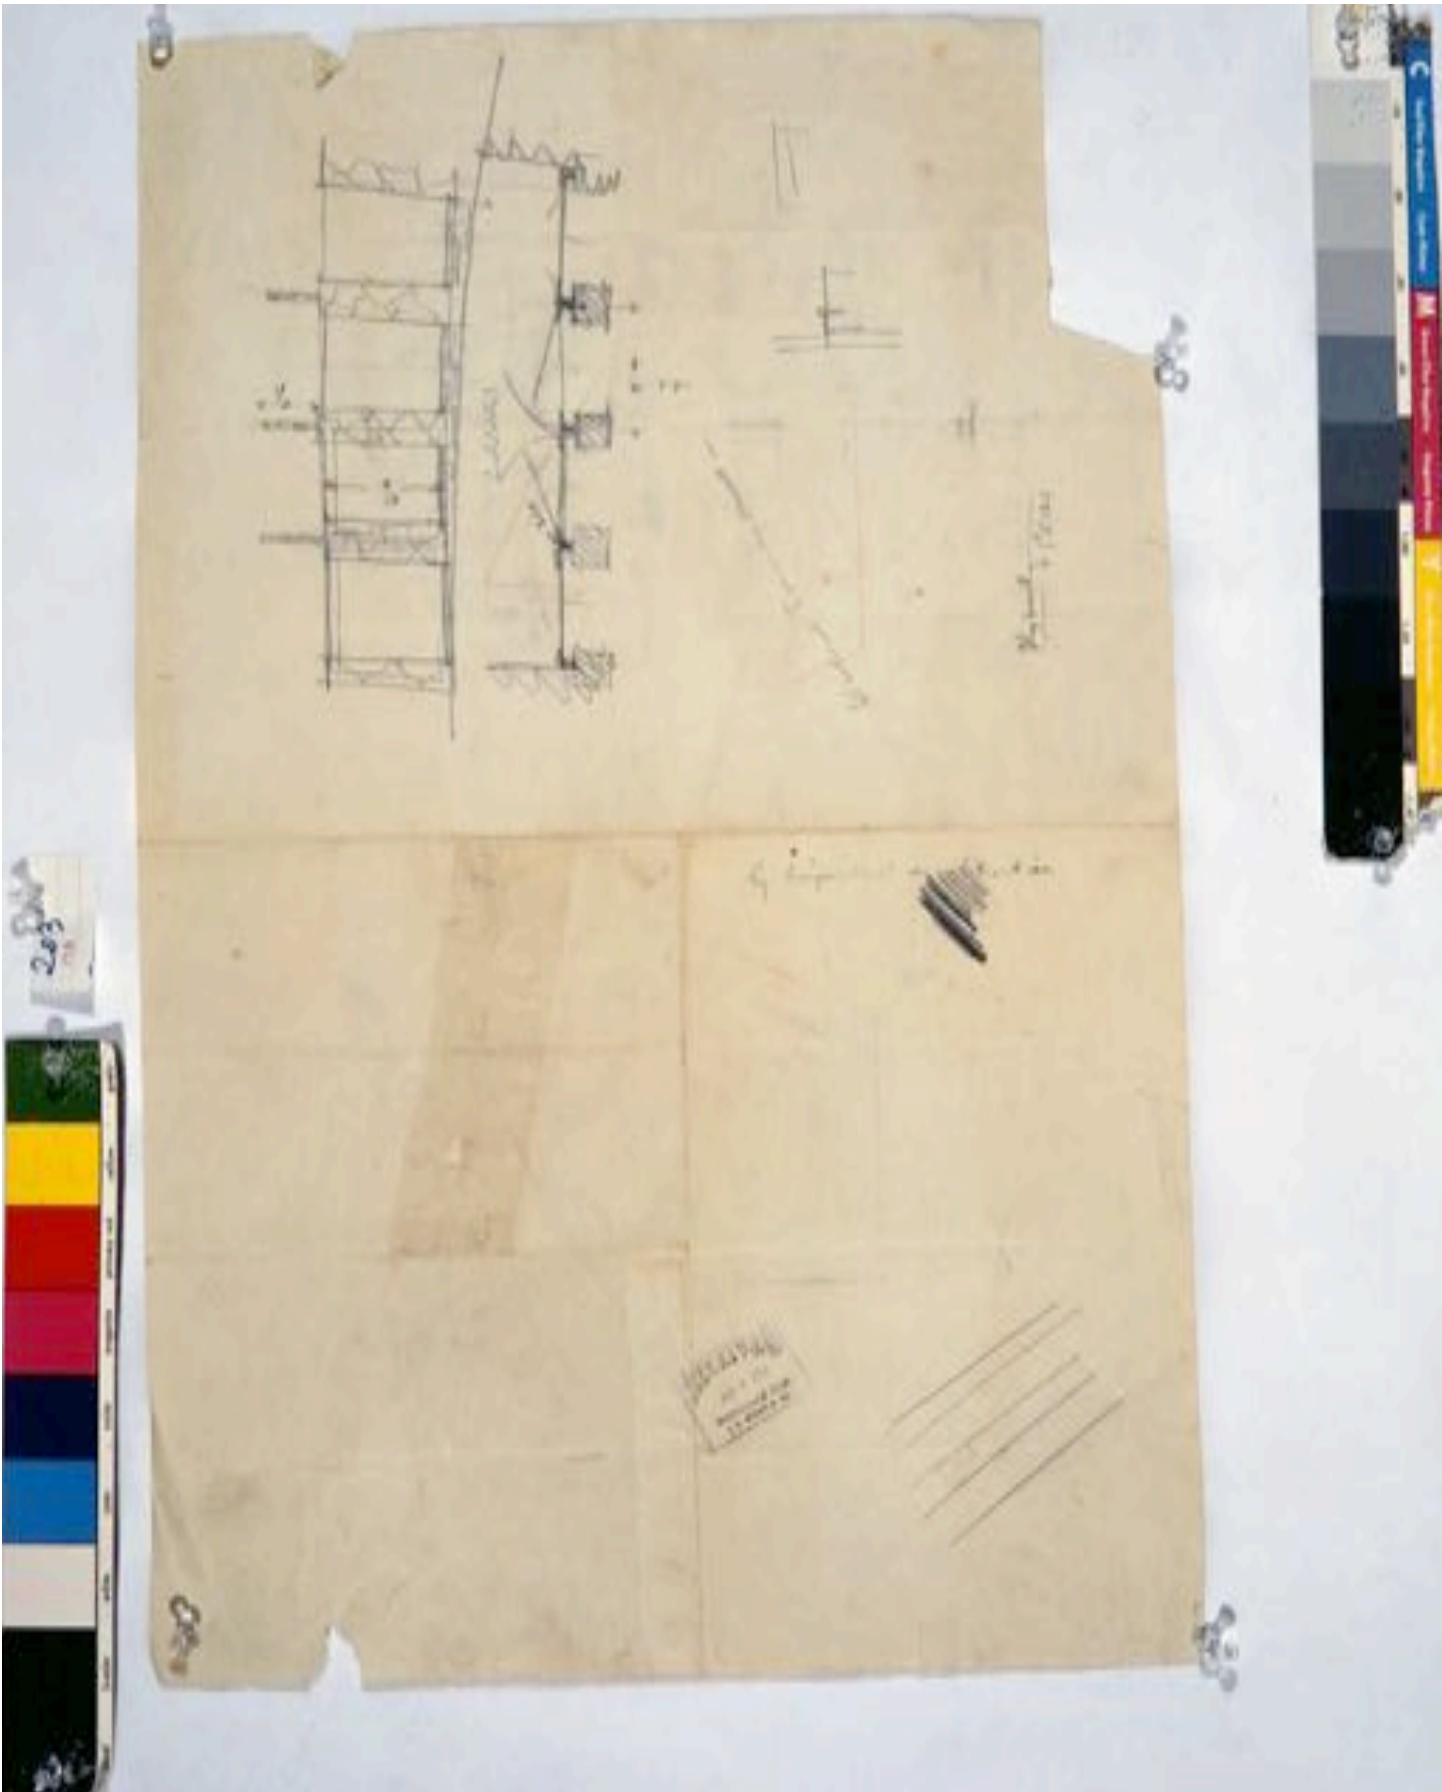
Figure B-173 - Lanai by Lower Room (The Frank Lloyd Wright Foundation Archives, The Museum of Modern Art | Avery Architectural & Fine Arts Library, Columbia University, New York).

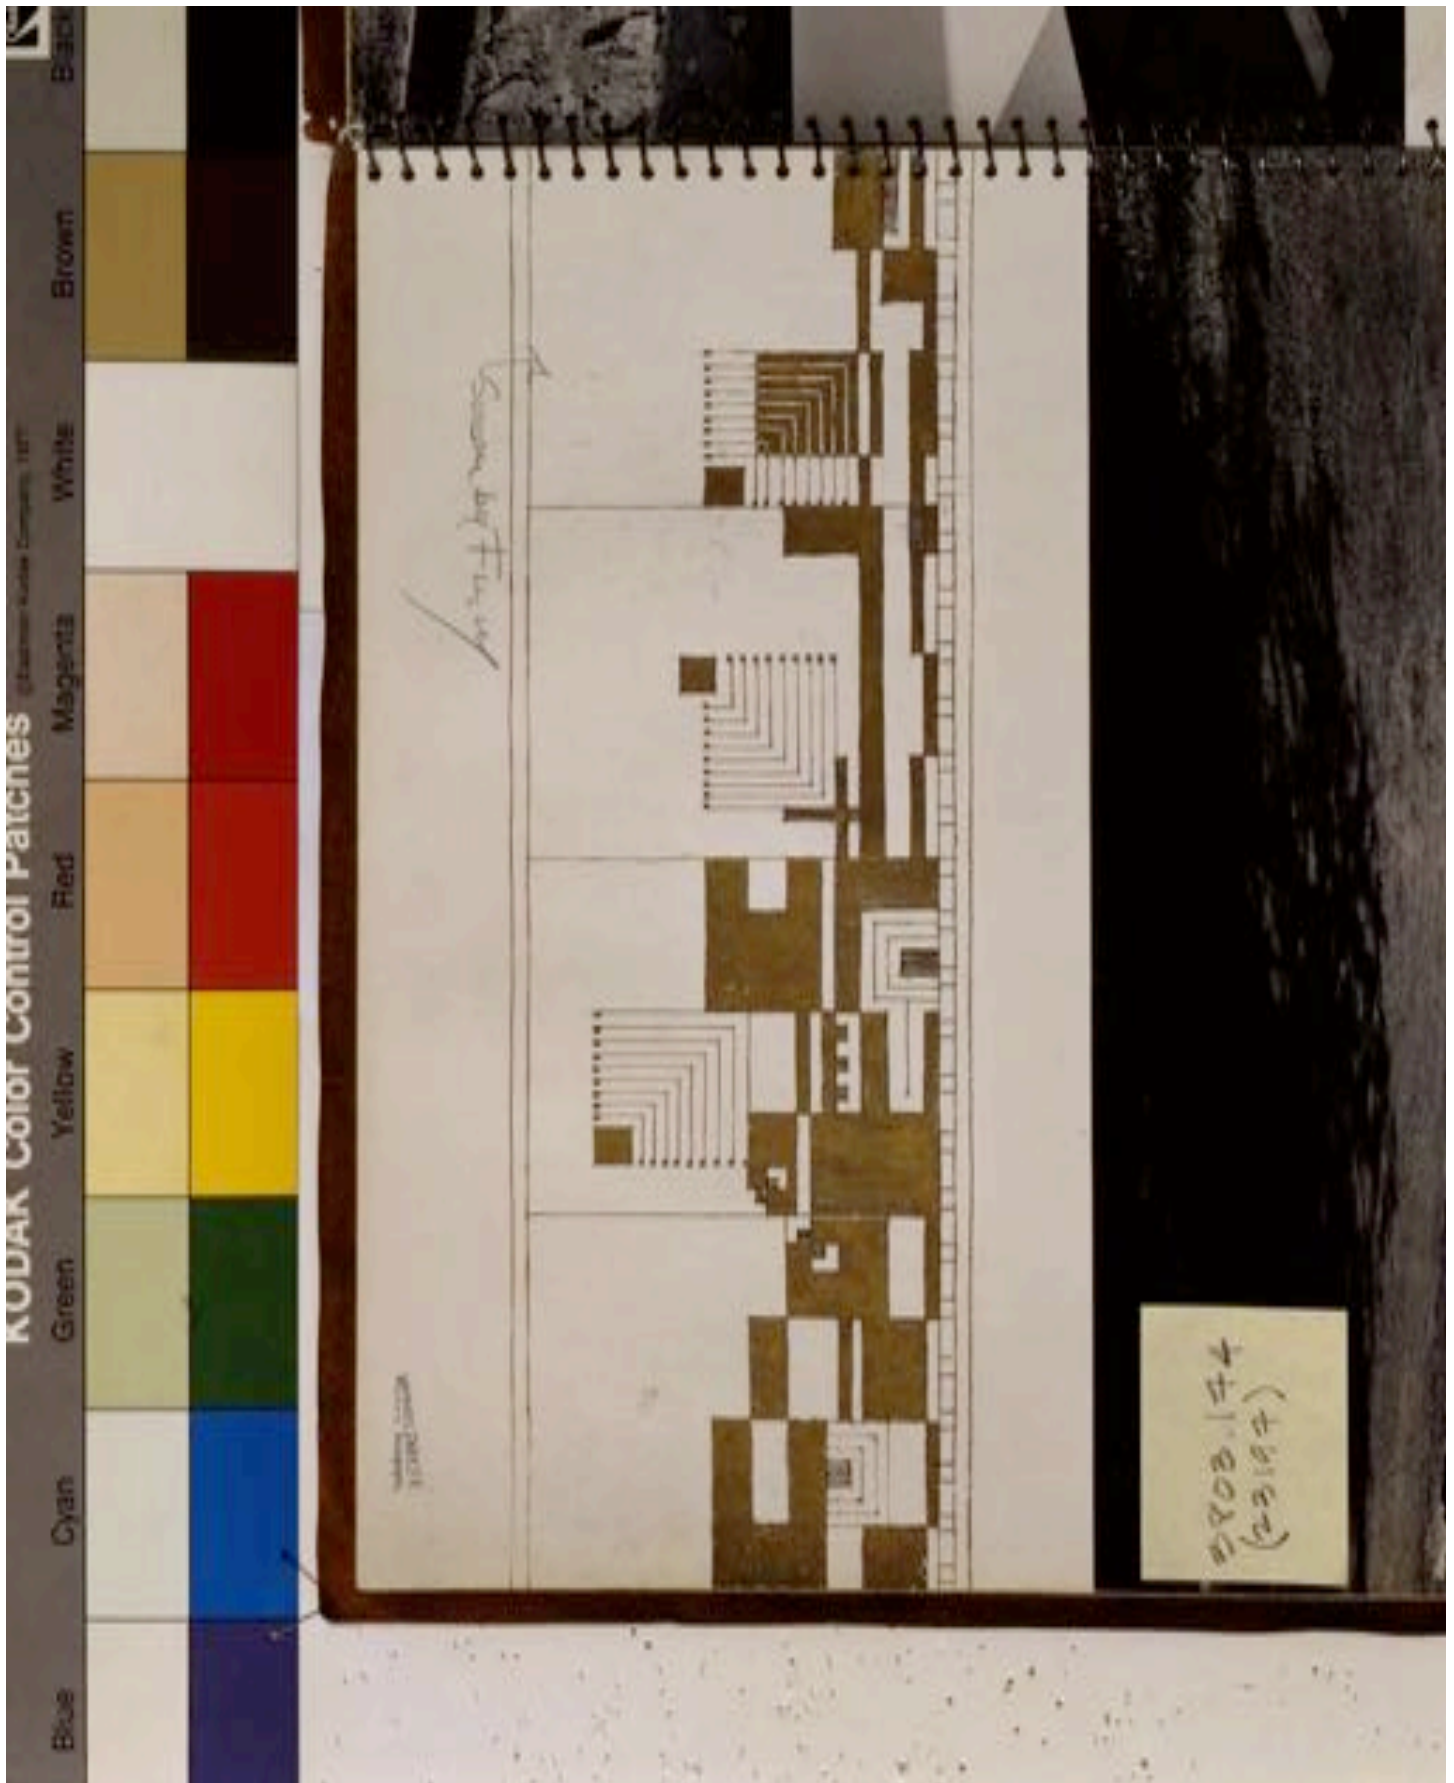
Figure B-174 - Lanai Abstraction (The Frank Lloyd Wright Foundation Archives, The Museum of Modern Art | Avery Architectural & Fine Arts Library, Columbia University, New York).

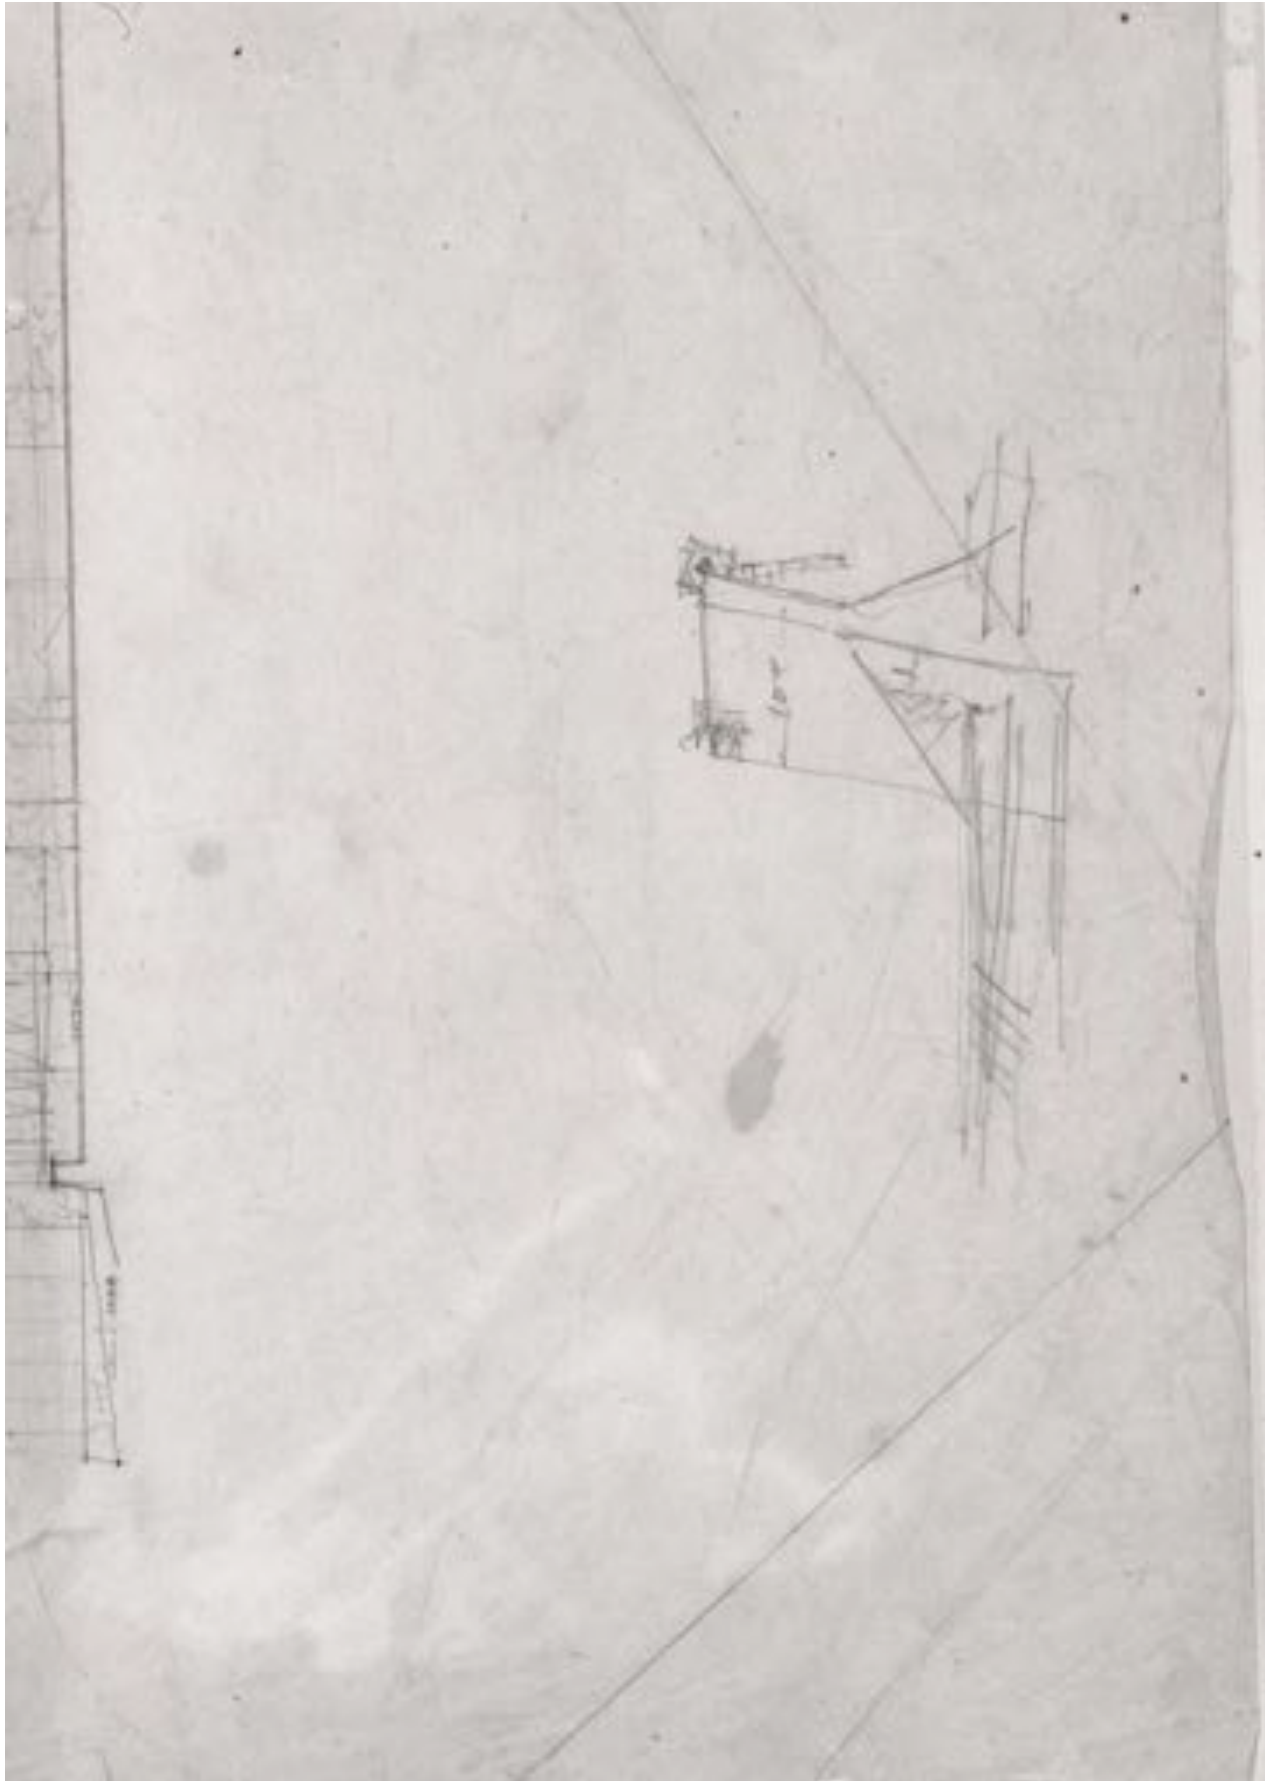
Figure B-175 - Light Tower CS Sketch (The Frank Lloyd Wright Foundation Archives, The Museum of Modern Art | Avery Architectural & Fine Arts Library, Columbia University, New York).

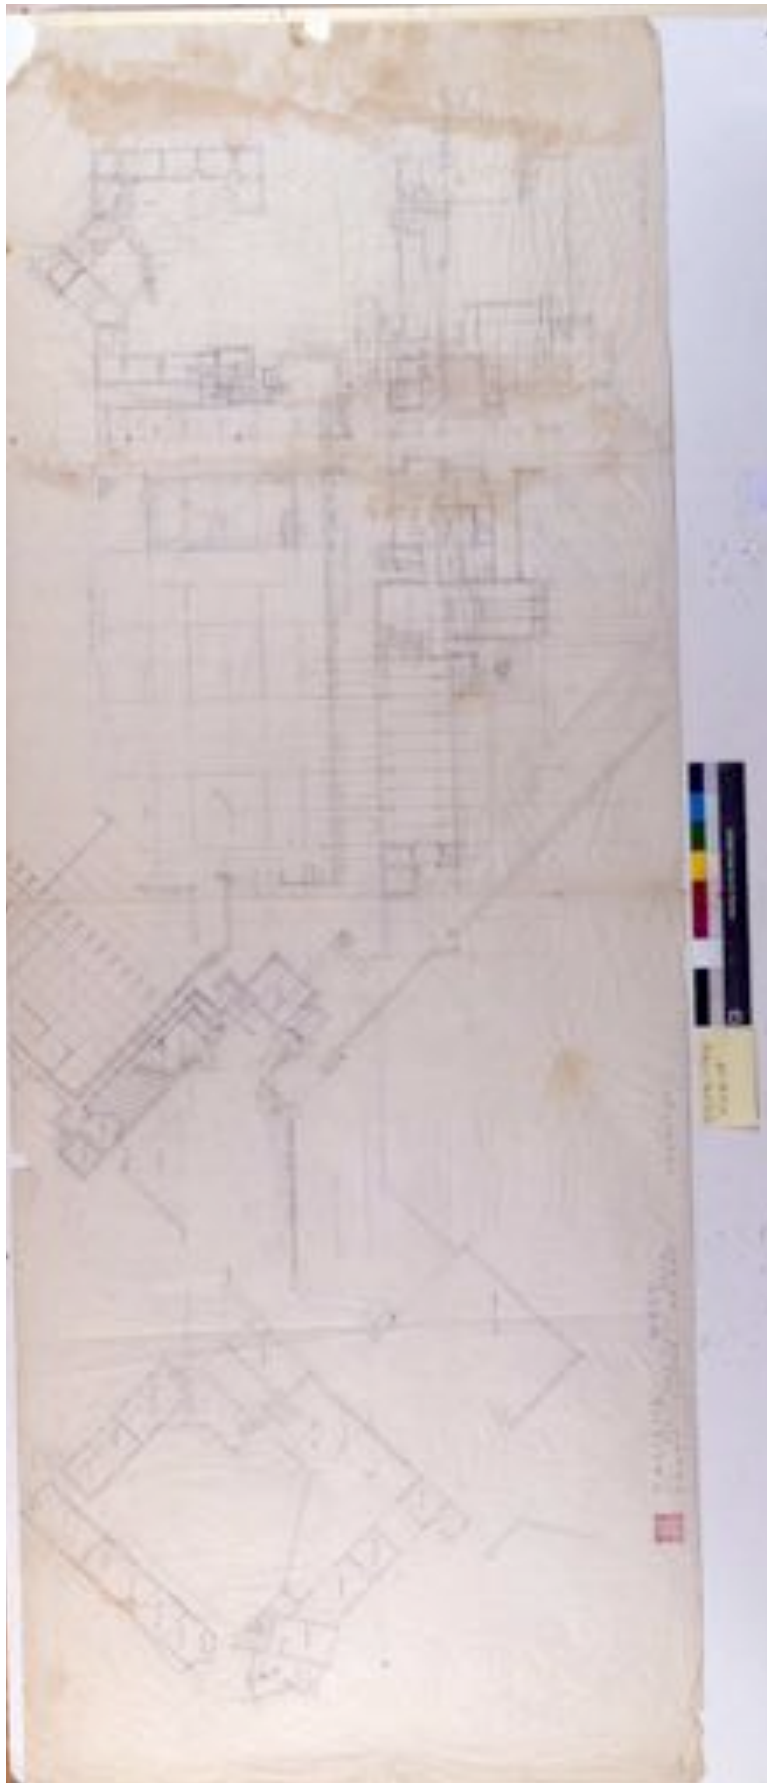
Figure B-176 - Master Plan (The Frank Lloyd Wright Foundation Archives, The Museum of Modern Art | Avery Architectural & Fine Arts Library, Columbia University, New York).

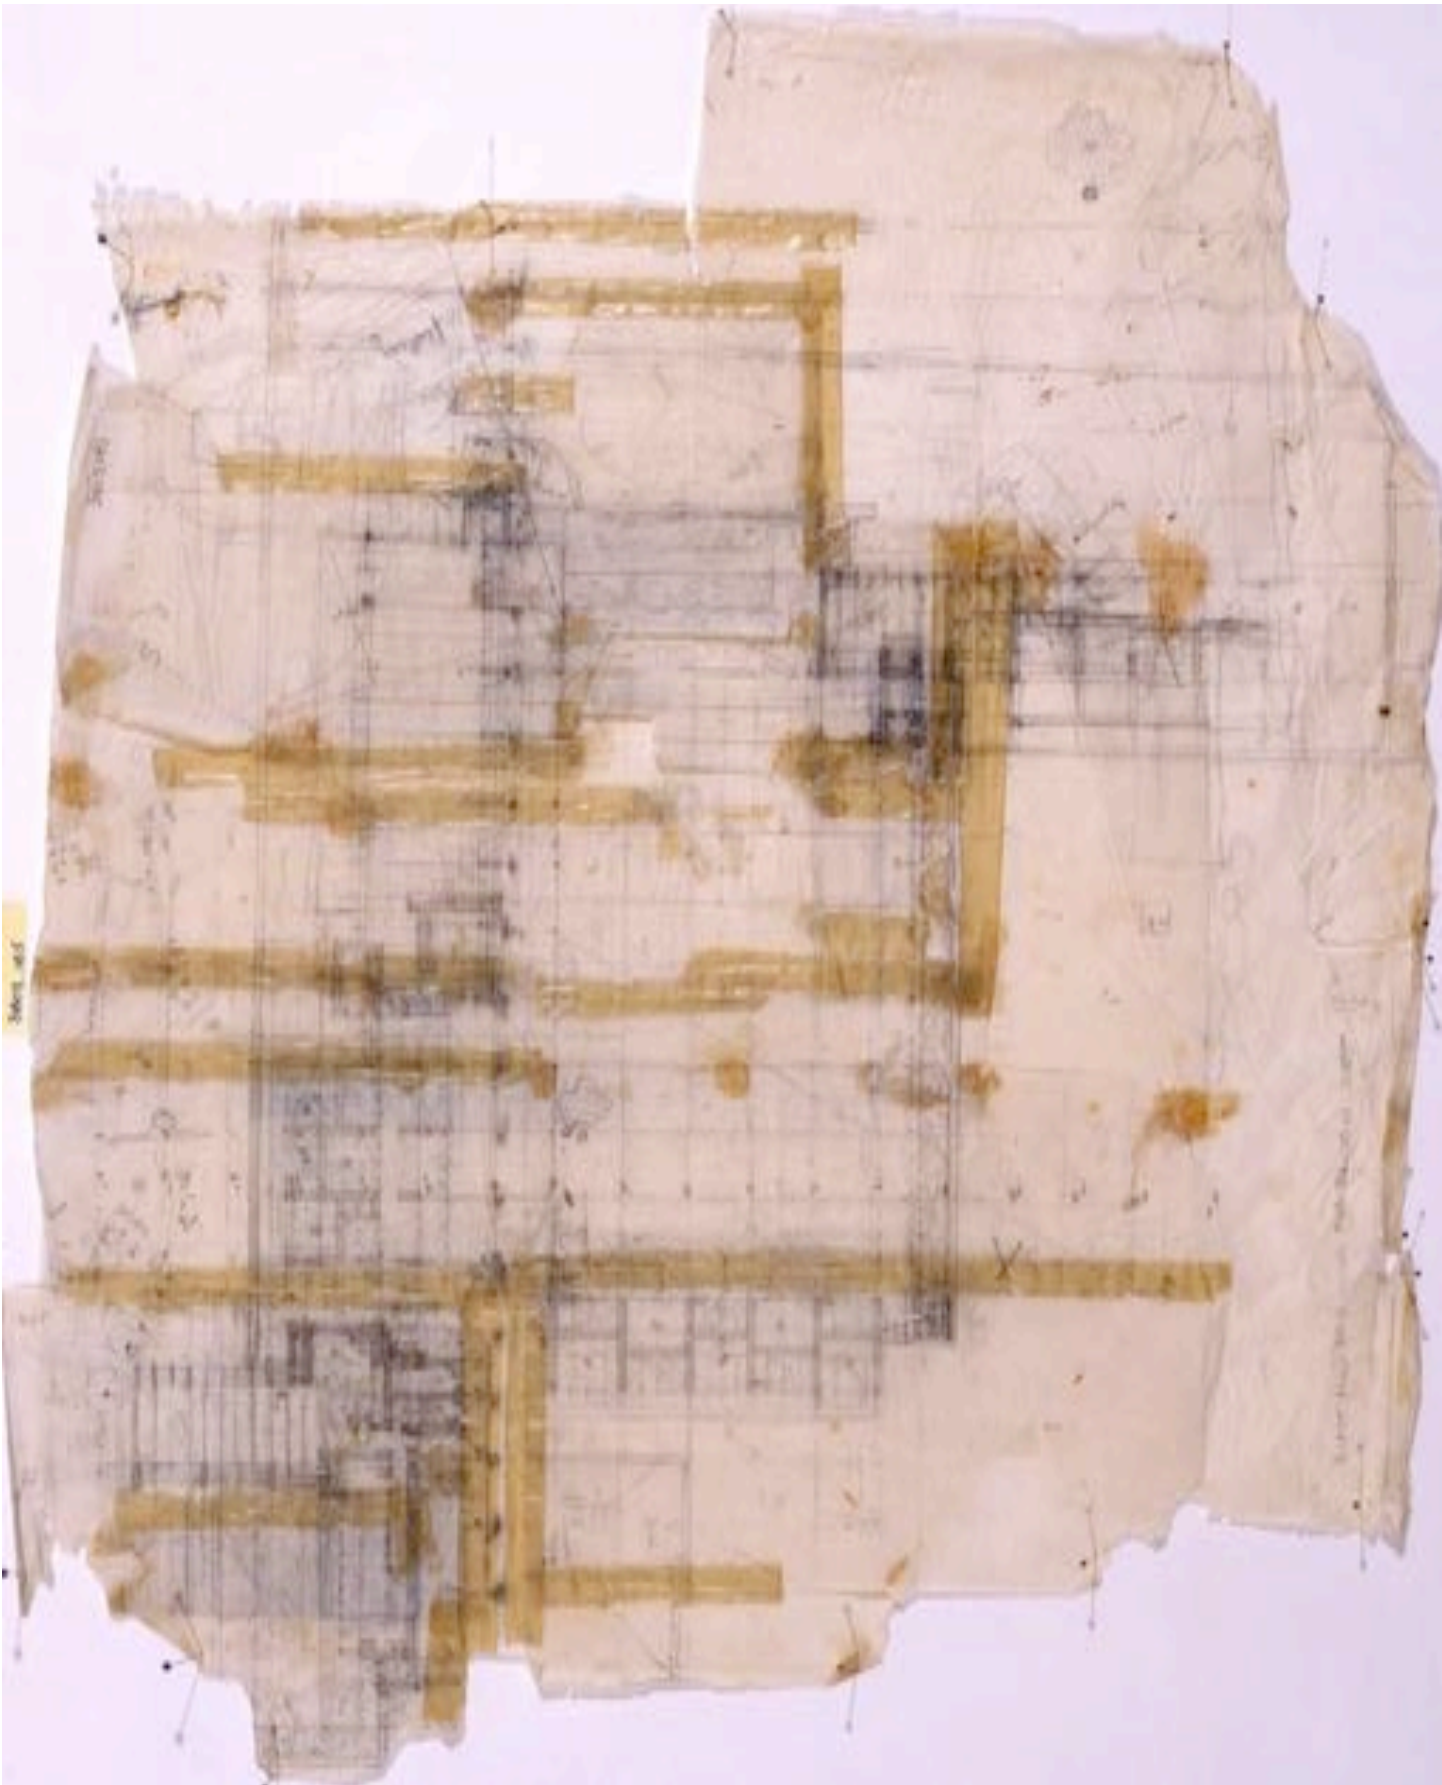
Figure B-185 - Plan, First Scheme (The Frank Lloyd Wright Foundation Archives, The Museum of Modern Art | Avery Architectural & Fine Arts Library, Columbia University, New York).

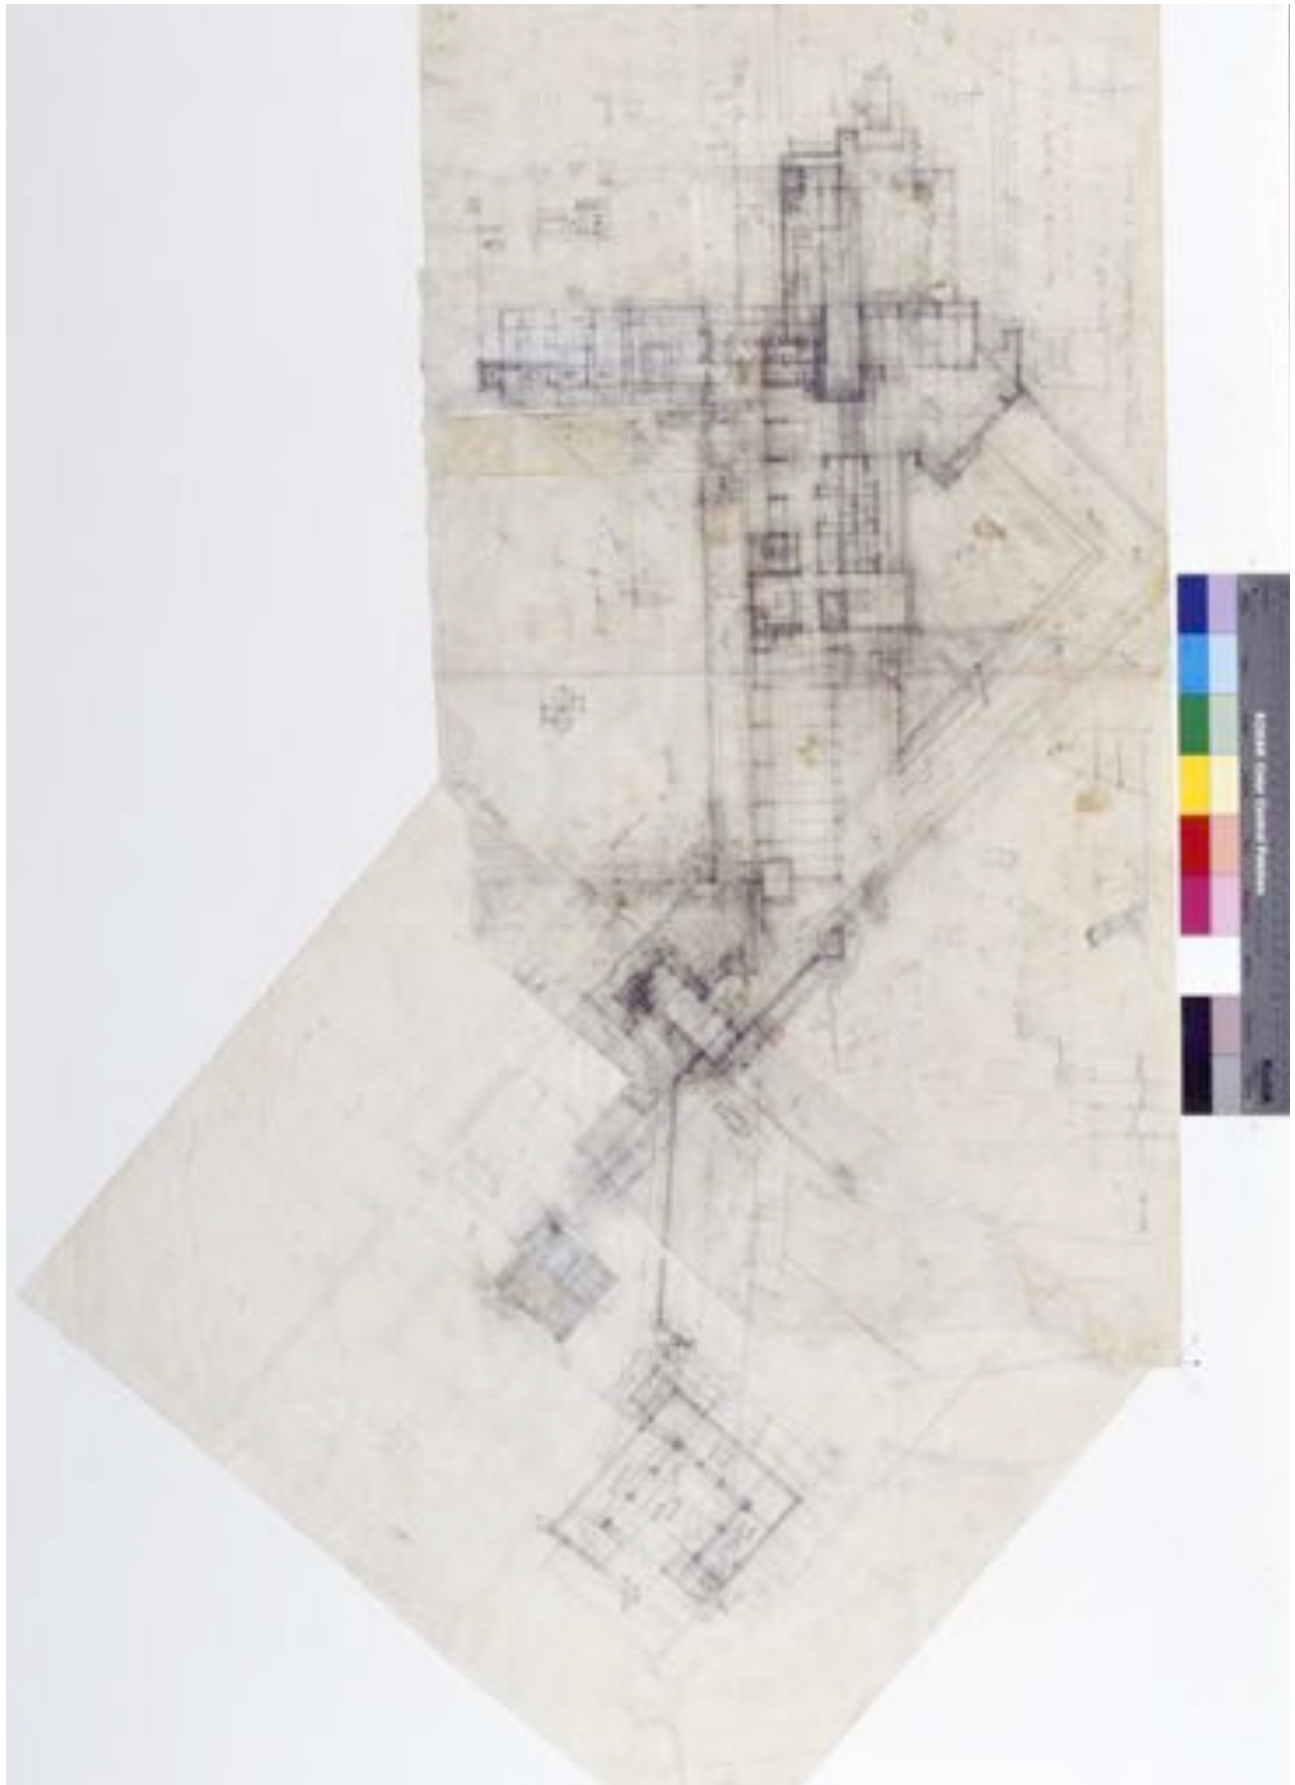
Figure B-186 - Plan, Final Scheme (The Frank Lloyd Wright Foundation Archives, The Museum of Modern Art | Avery Architectural & Fine Arts Library, Columbia University, New York).

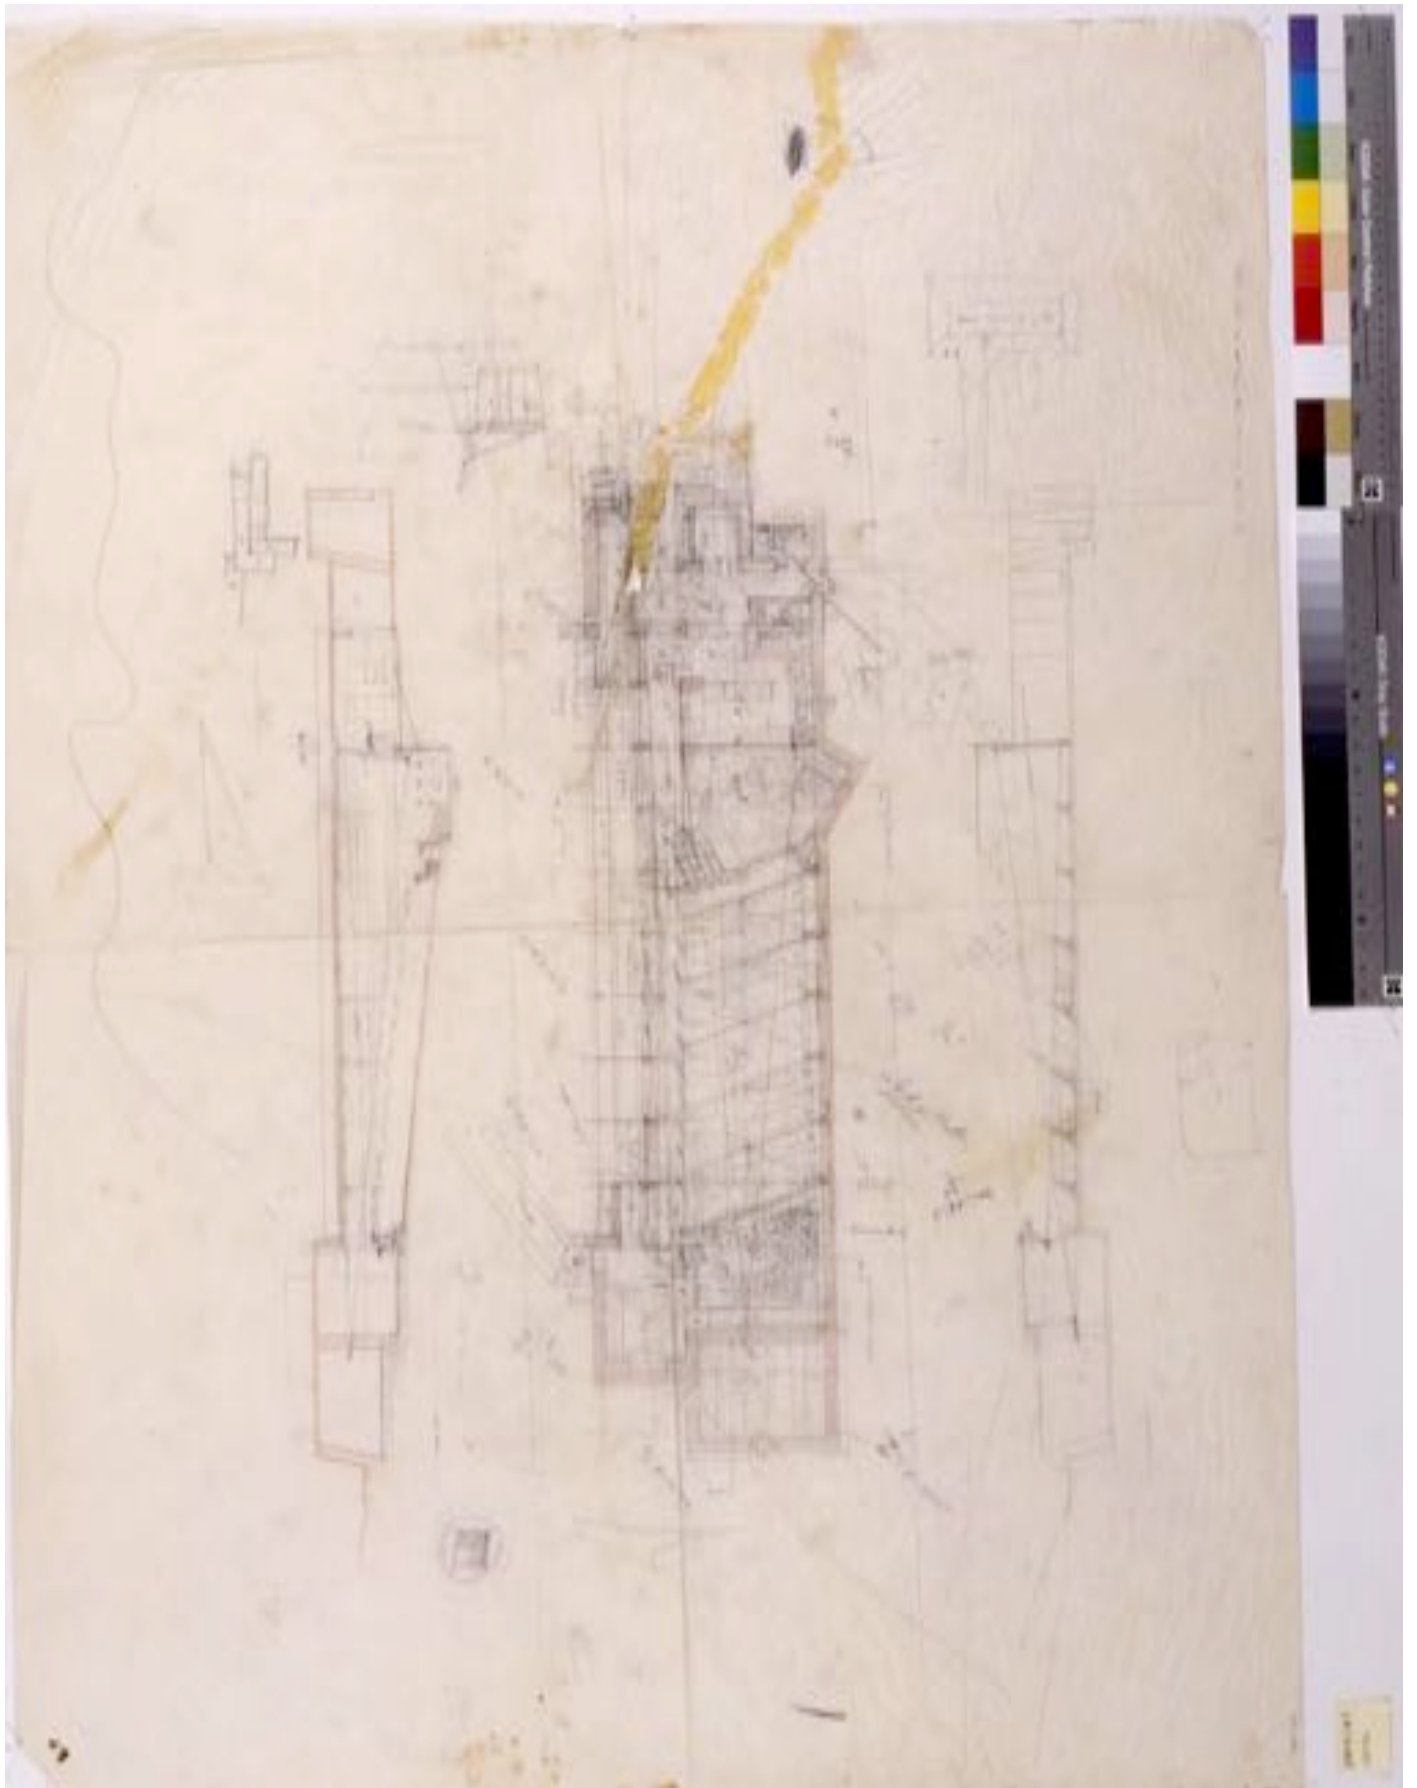
Figure B-187 - Cabaret Plan/Section (The Frank Lloyd Wright Foundation Archives, The Museum of Modern Art | Avery Architectural & Fine Arts Library, Columbia University, New York).
