TALIESIN WEST PRESERVATION MASTER PLAN

Harboe Architects, PC

MAY 21, 2015

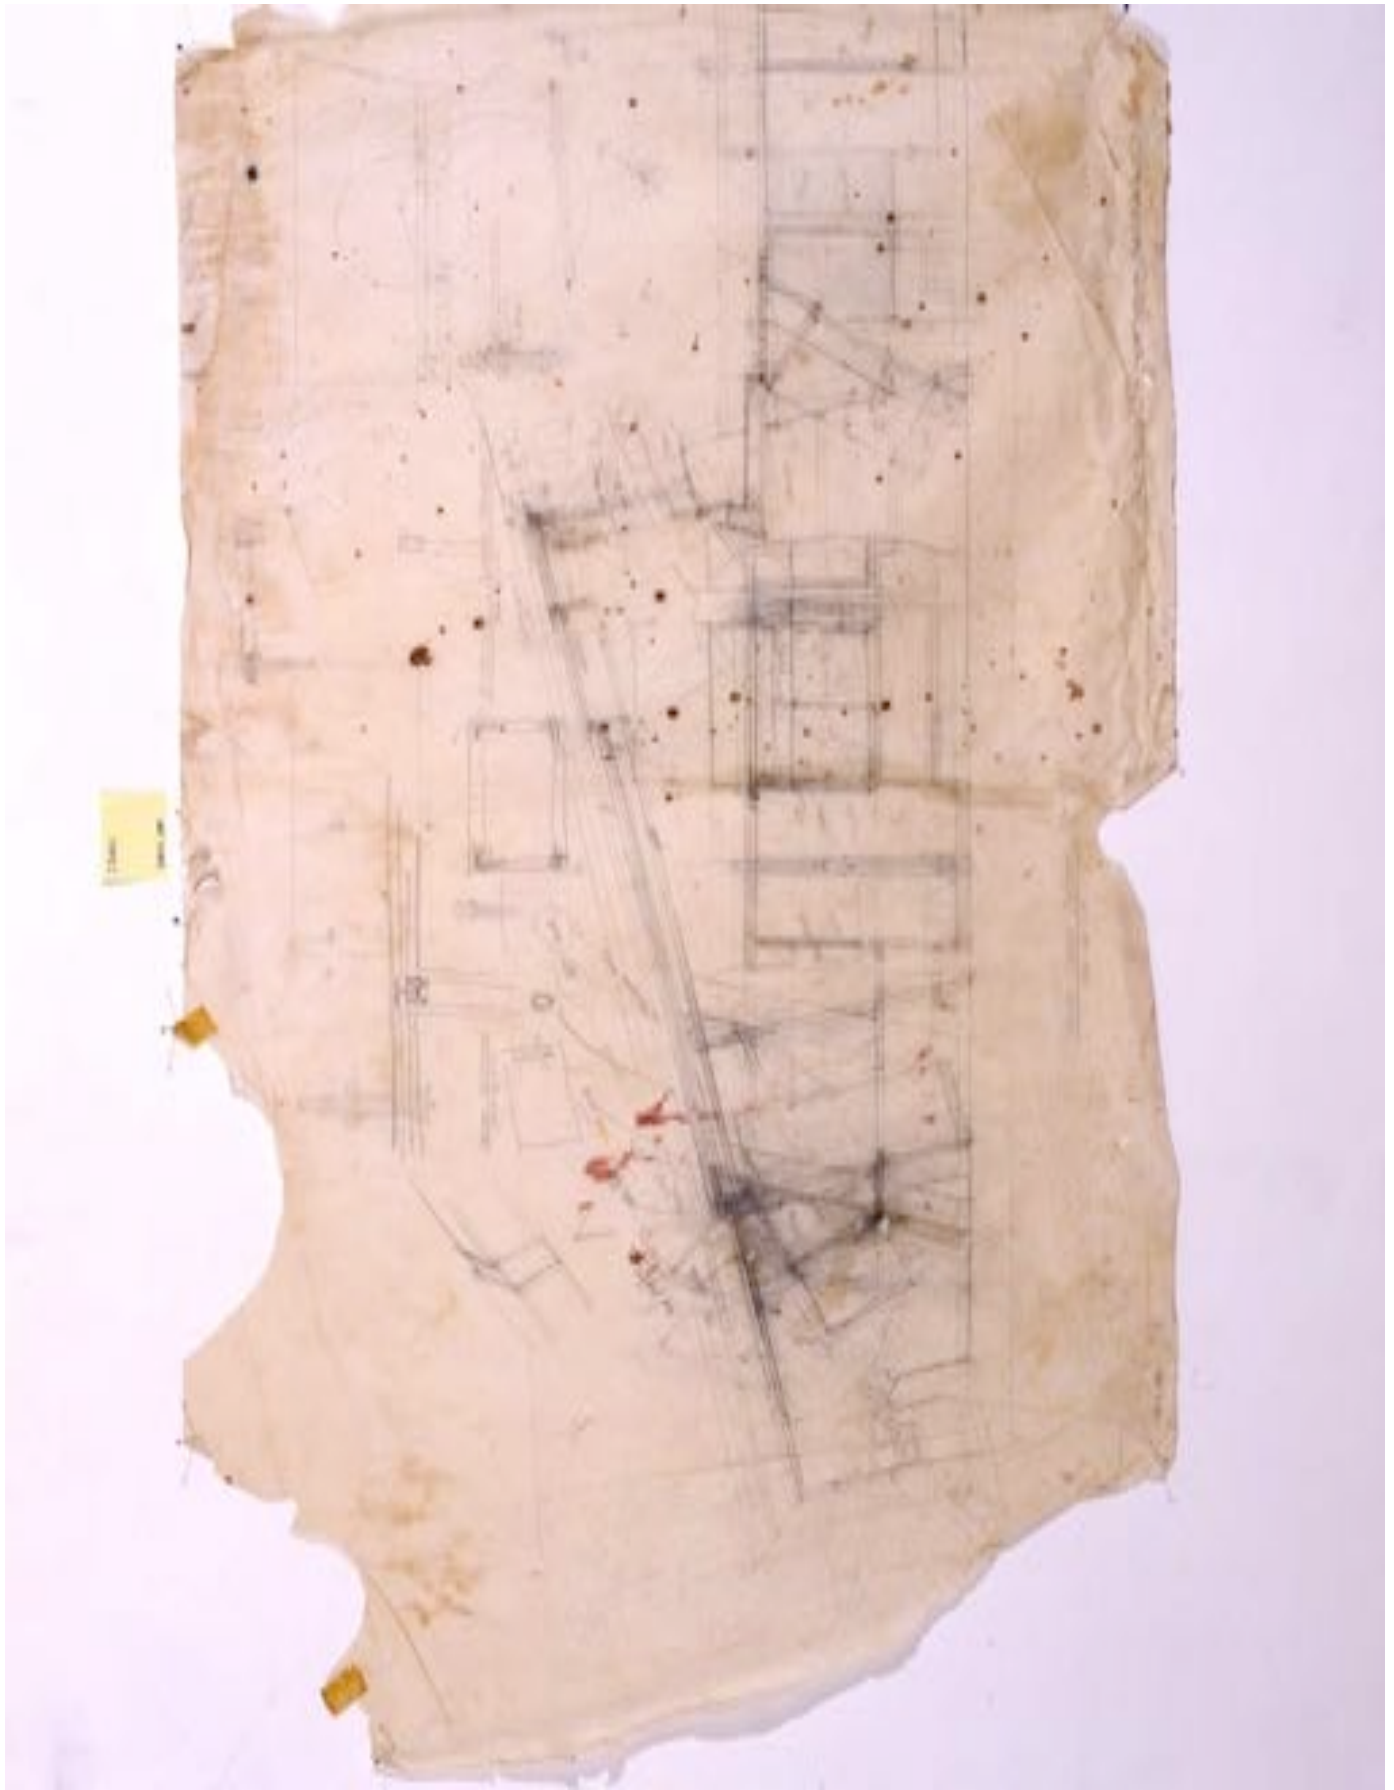
Figure B-188 - Drafting Room Trusses (The Frank Lloyd Wright Foundation Archives, The Museum of Modern Art | Avery Architectural & Fine Arts Library, Columbia University, New York).

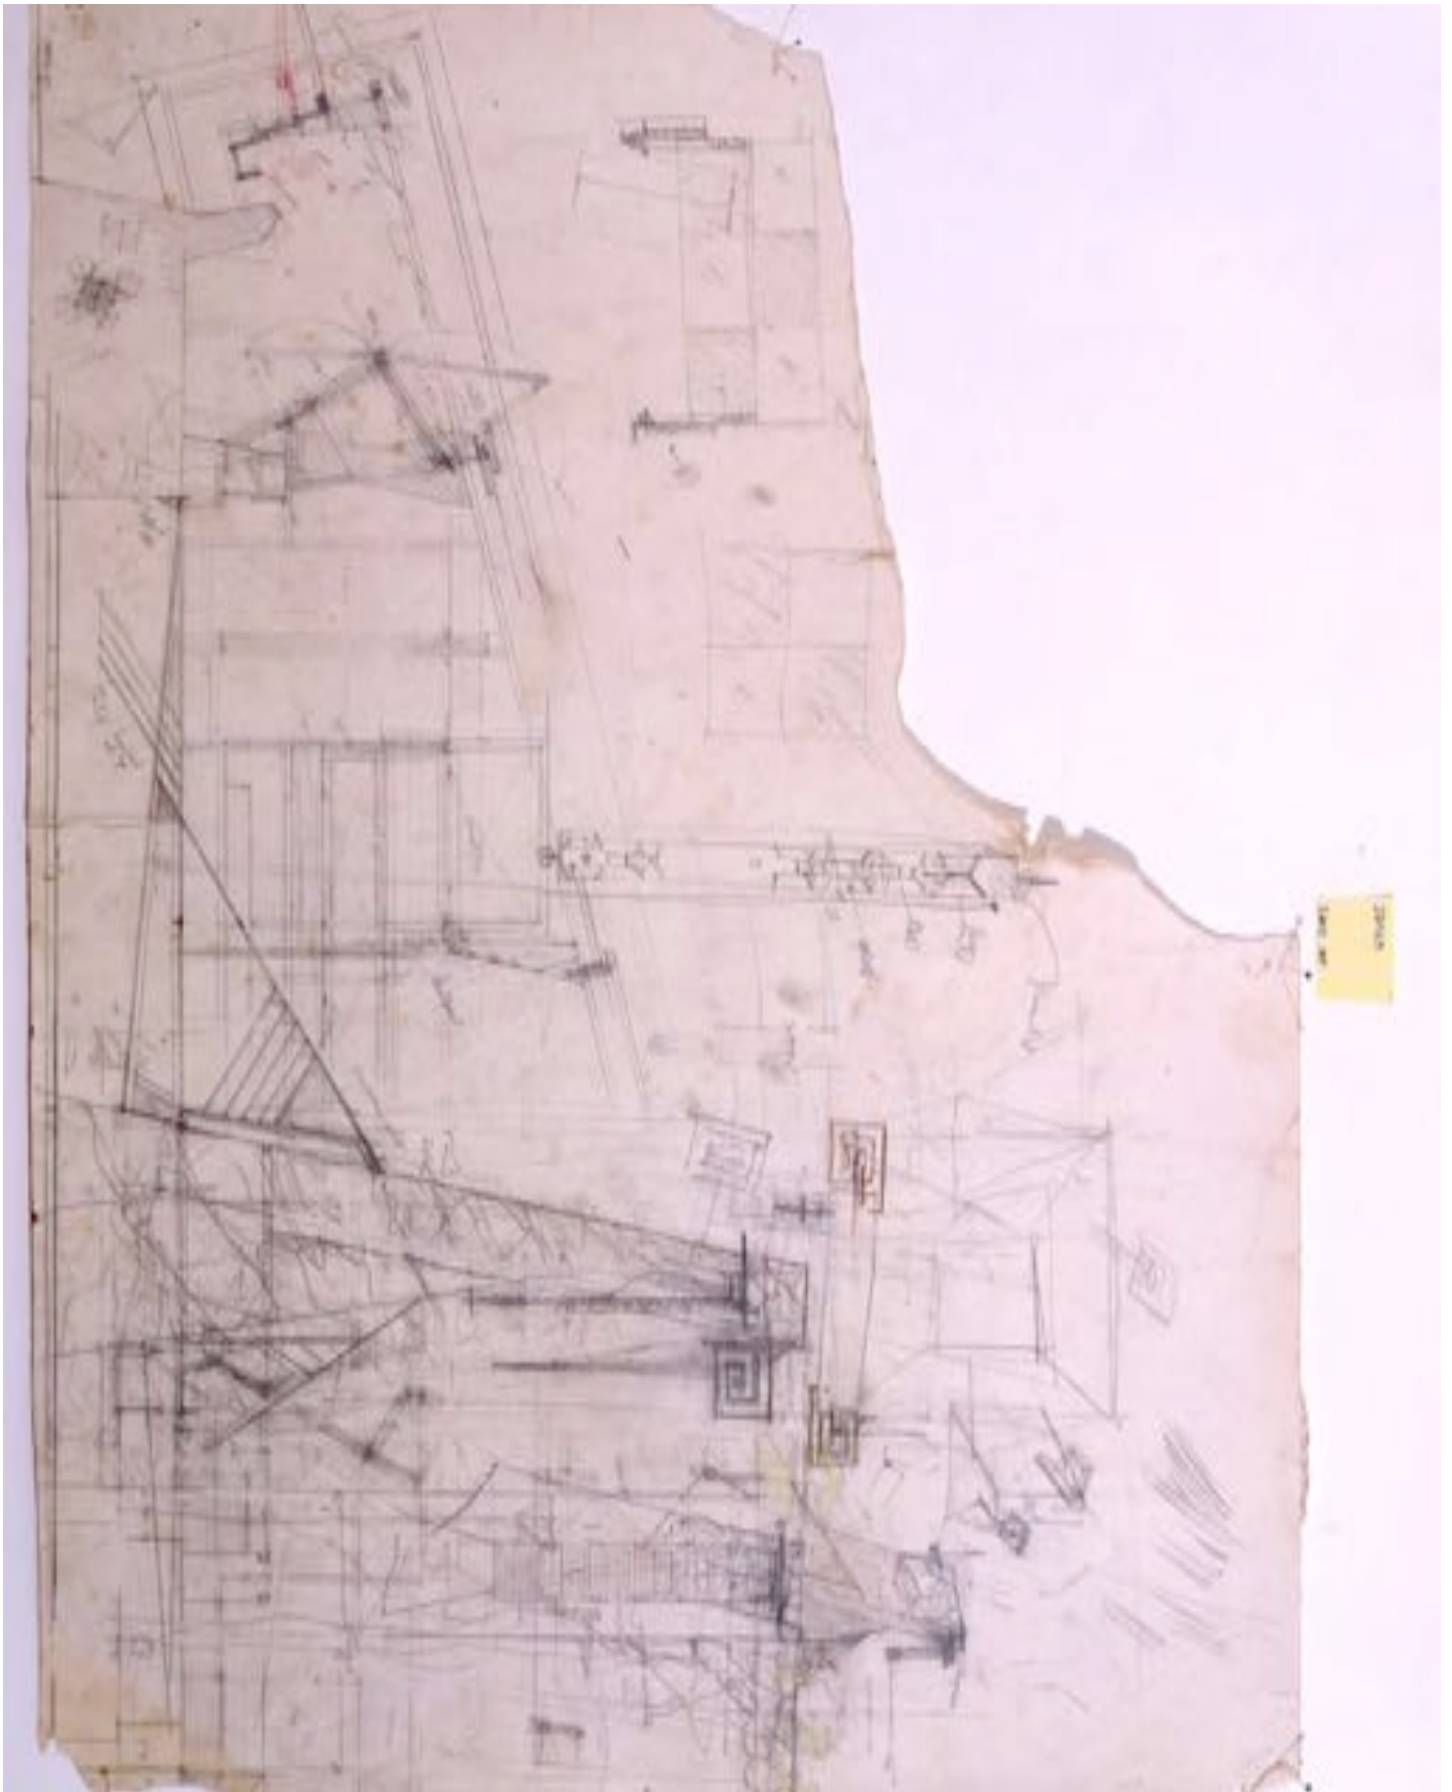
Figure B-189 - Drafting Room Truss/Light Tower (The Frank Lloyd Wright Foundation Archives, The Museum of Modern Art | Avery Architectural & Fine Arts Library, Columbia University, New York).

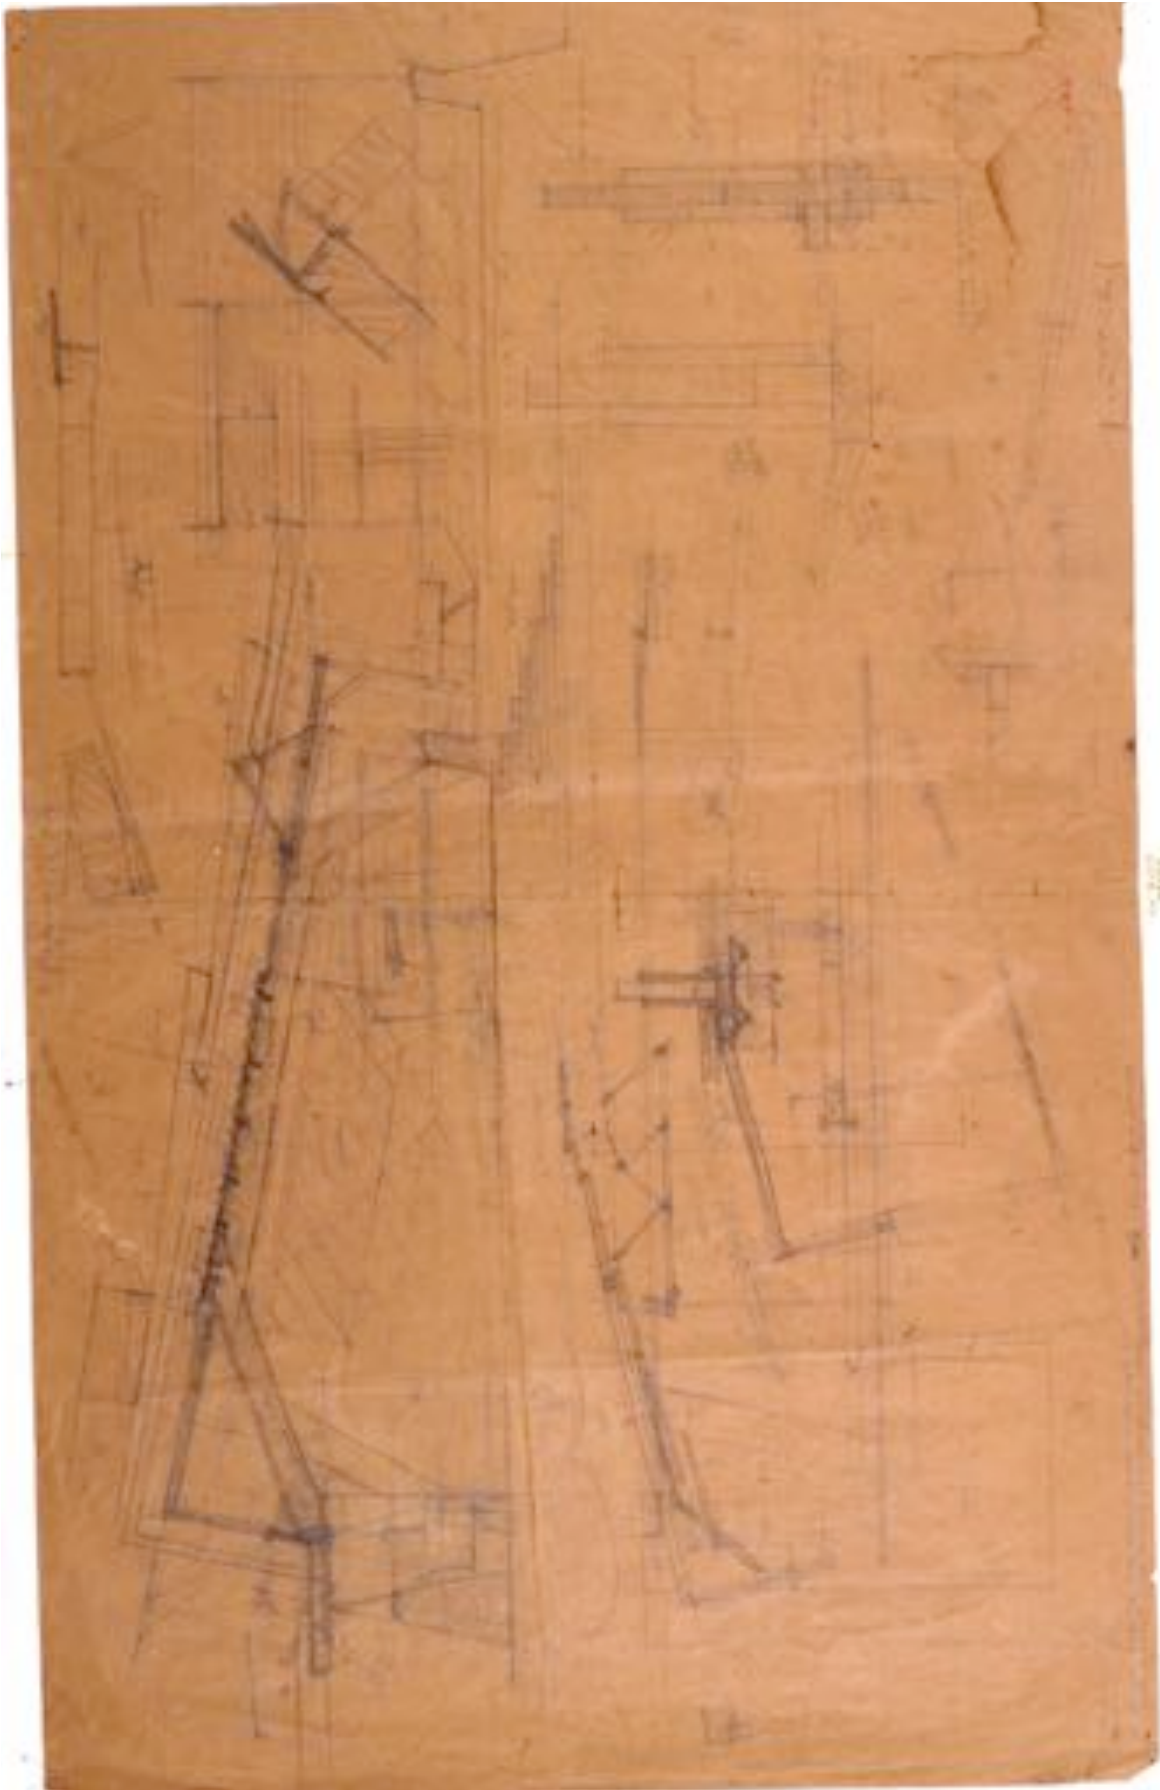
Figure B-190 - Drafting Room Section, Details (The Frank Lloyd Wright Foundation Archives, The Museum of Modern Art | Avery Architectural & Fine Arts Library, Columbia University, New York).

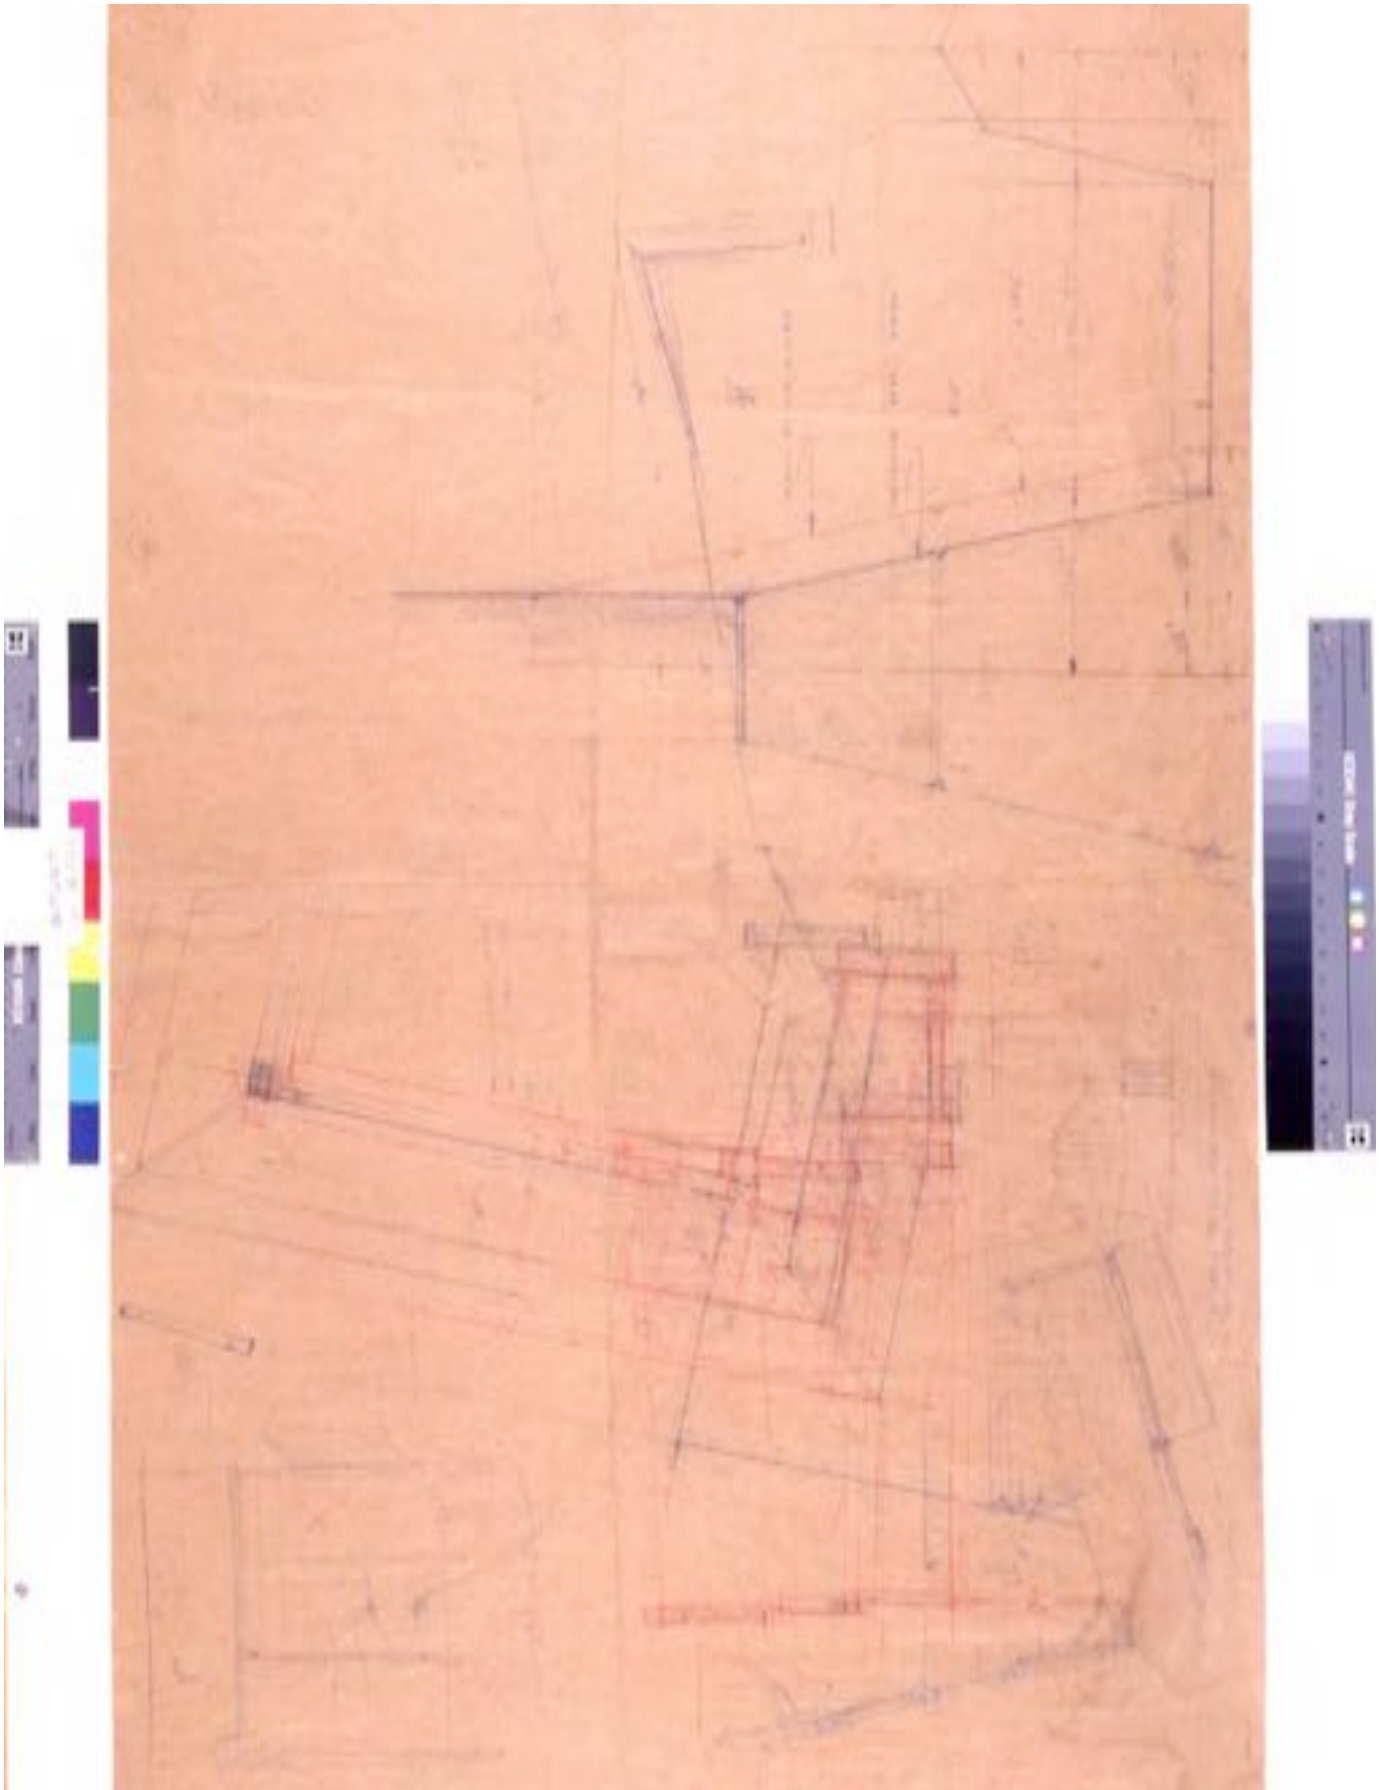
Figure B-191 - Dining Room Deck North Side (The Frank Lloyd Wright Foundation Archives, The Museum of Modern Art | Avery Architectural & Fine Arts Library, Columbia University, New York).

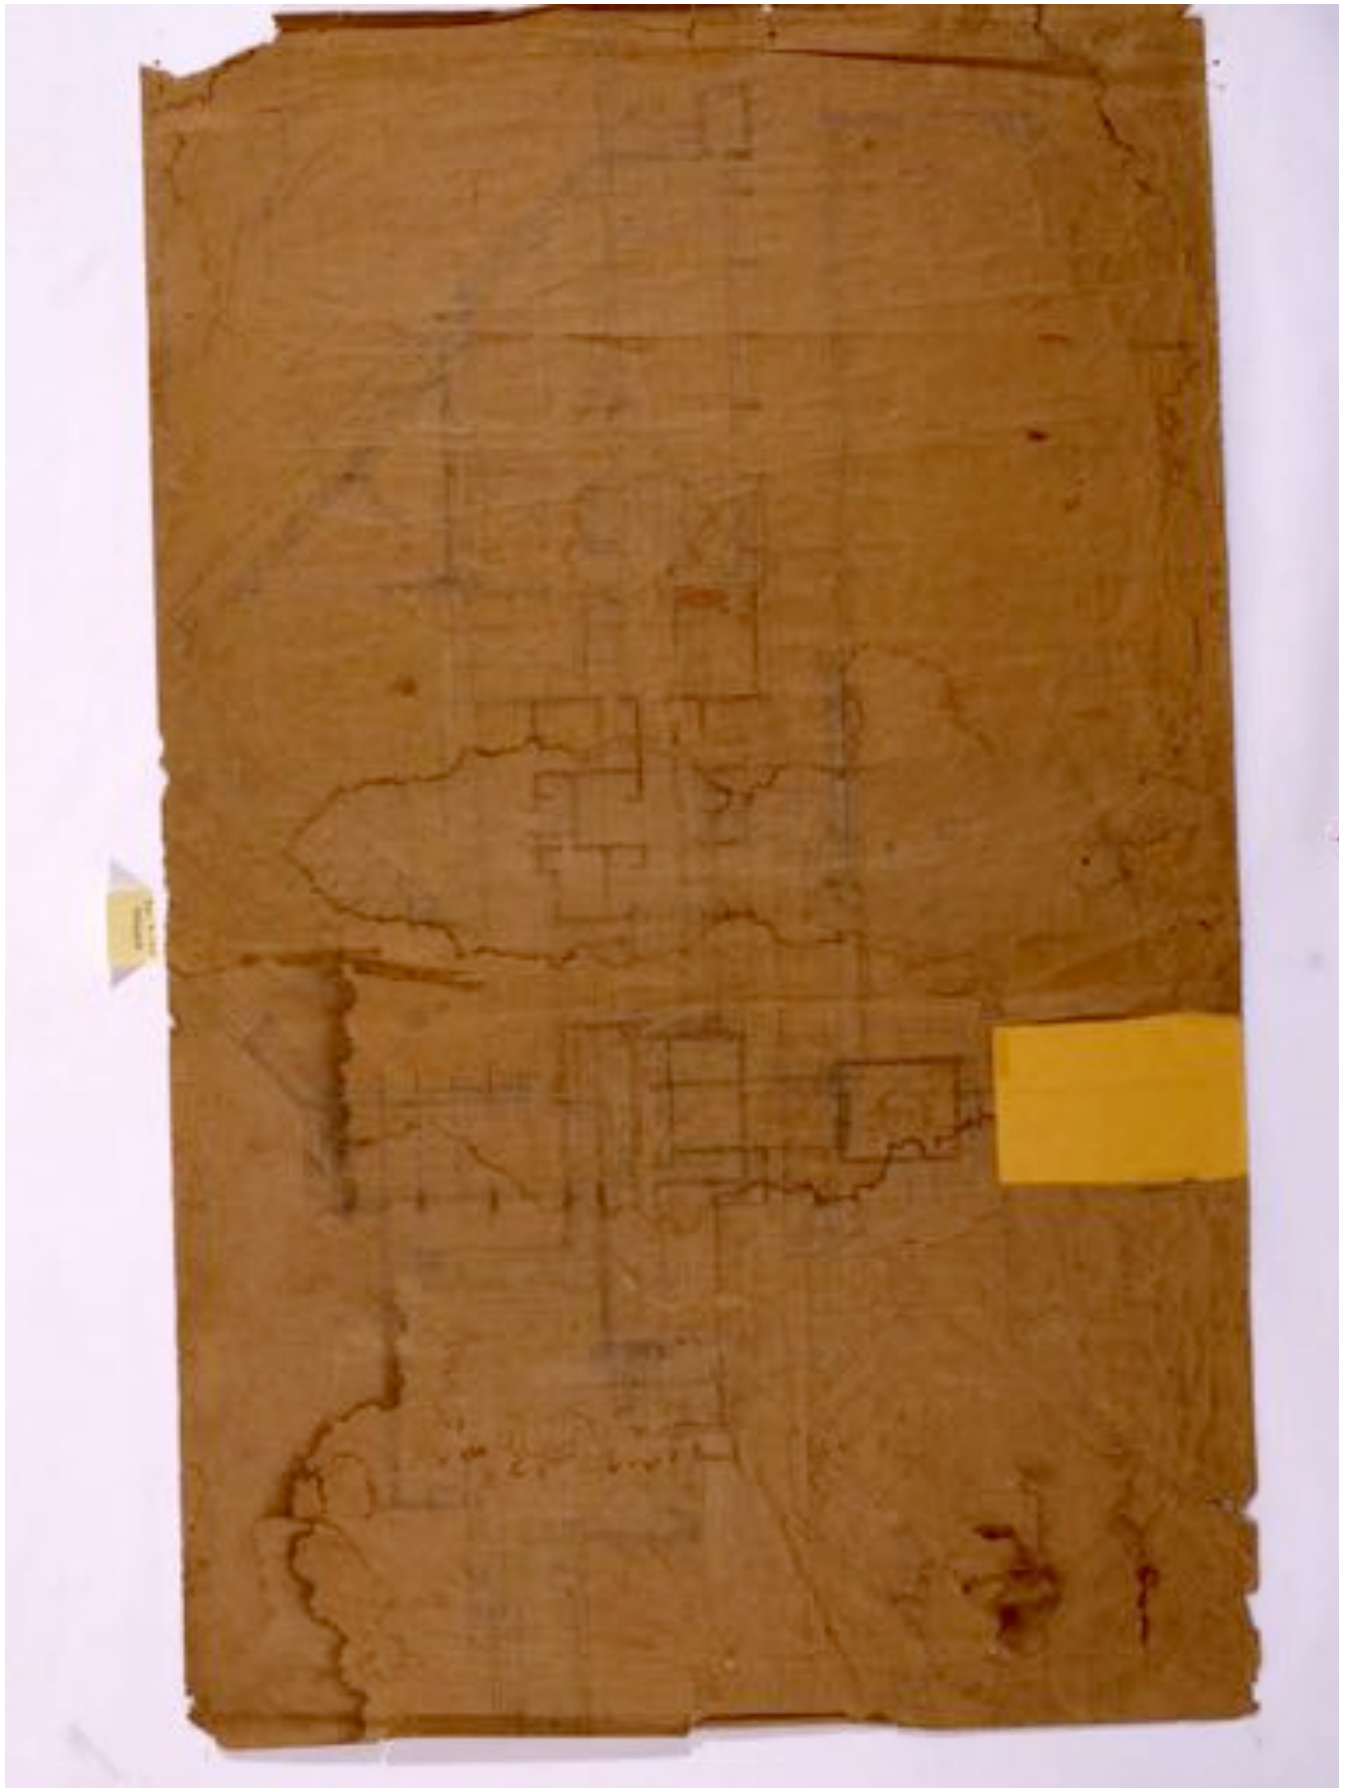
Figure B-192 - General Plan (The Frank Lloyd Wright Foundation Archives, The Museum of Modern Art | Avery Architectural & Fine Arts Library, Columbia University, New York).

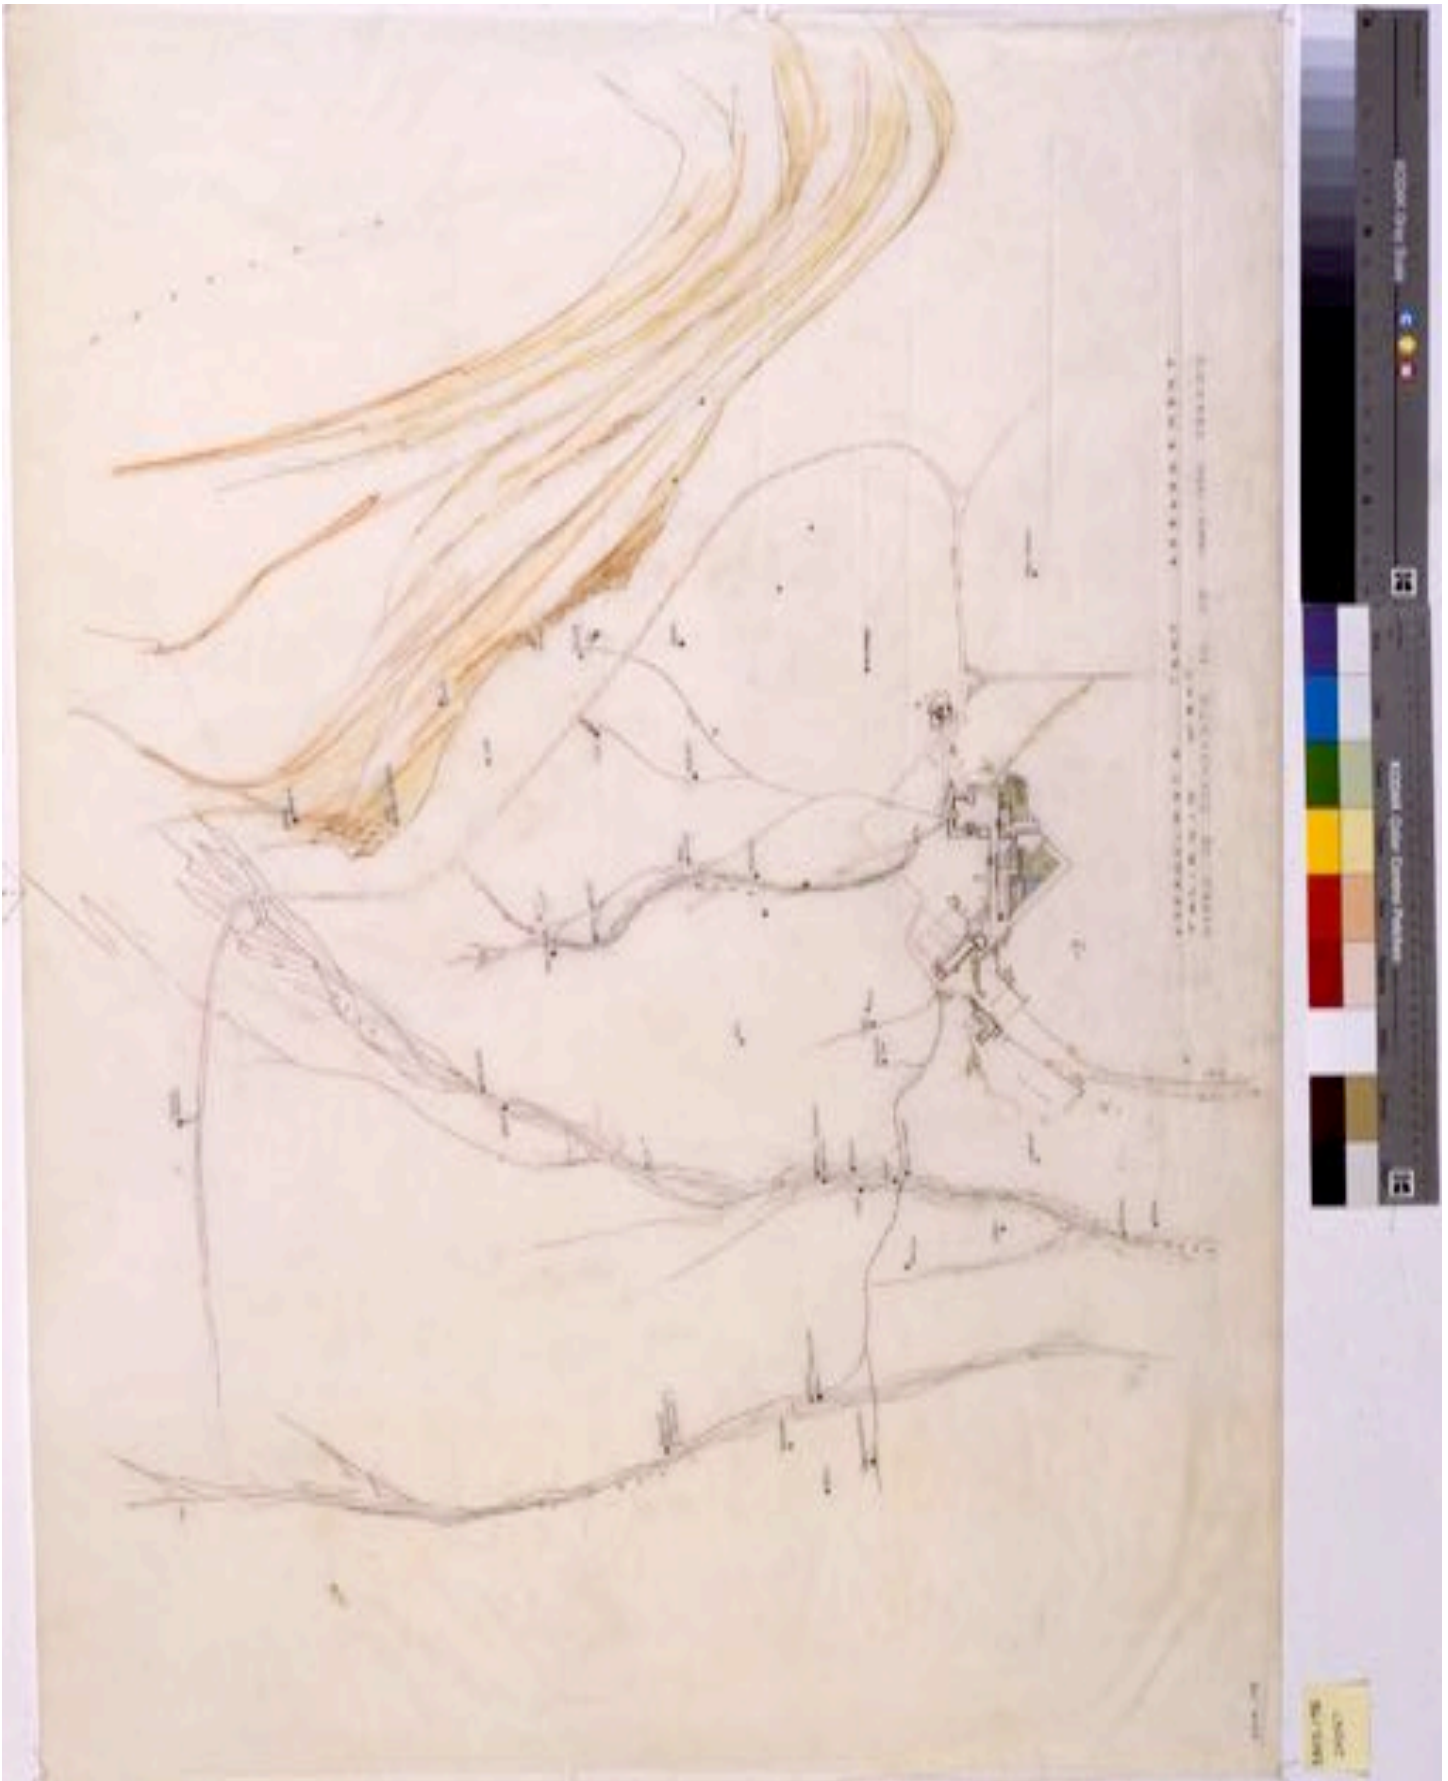
Figure B-195 - Tent Sites (The Frank Lloyd Wright Foundation Archives, The Museum of Modern Art | Avery Architectural & Fine Arts Library, Columbia University, New York).

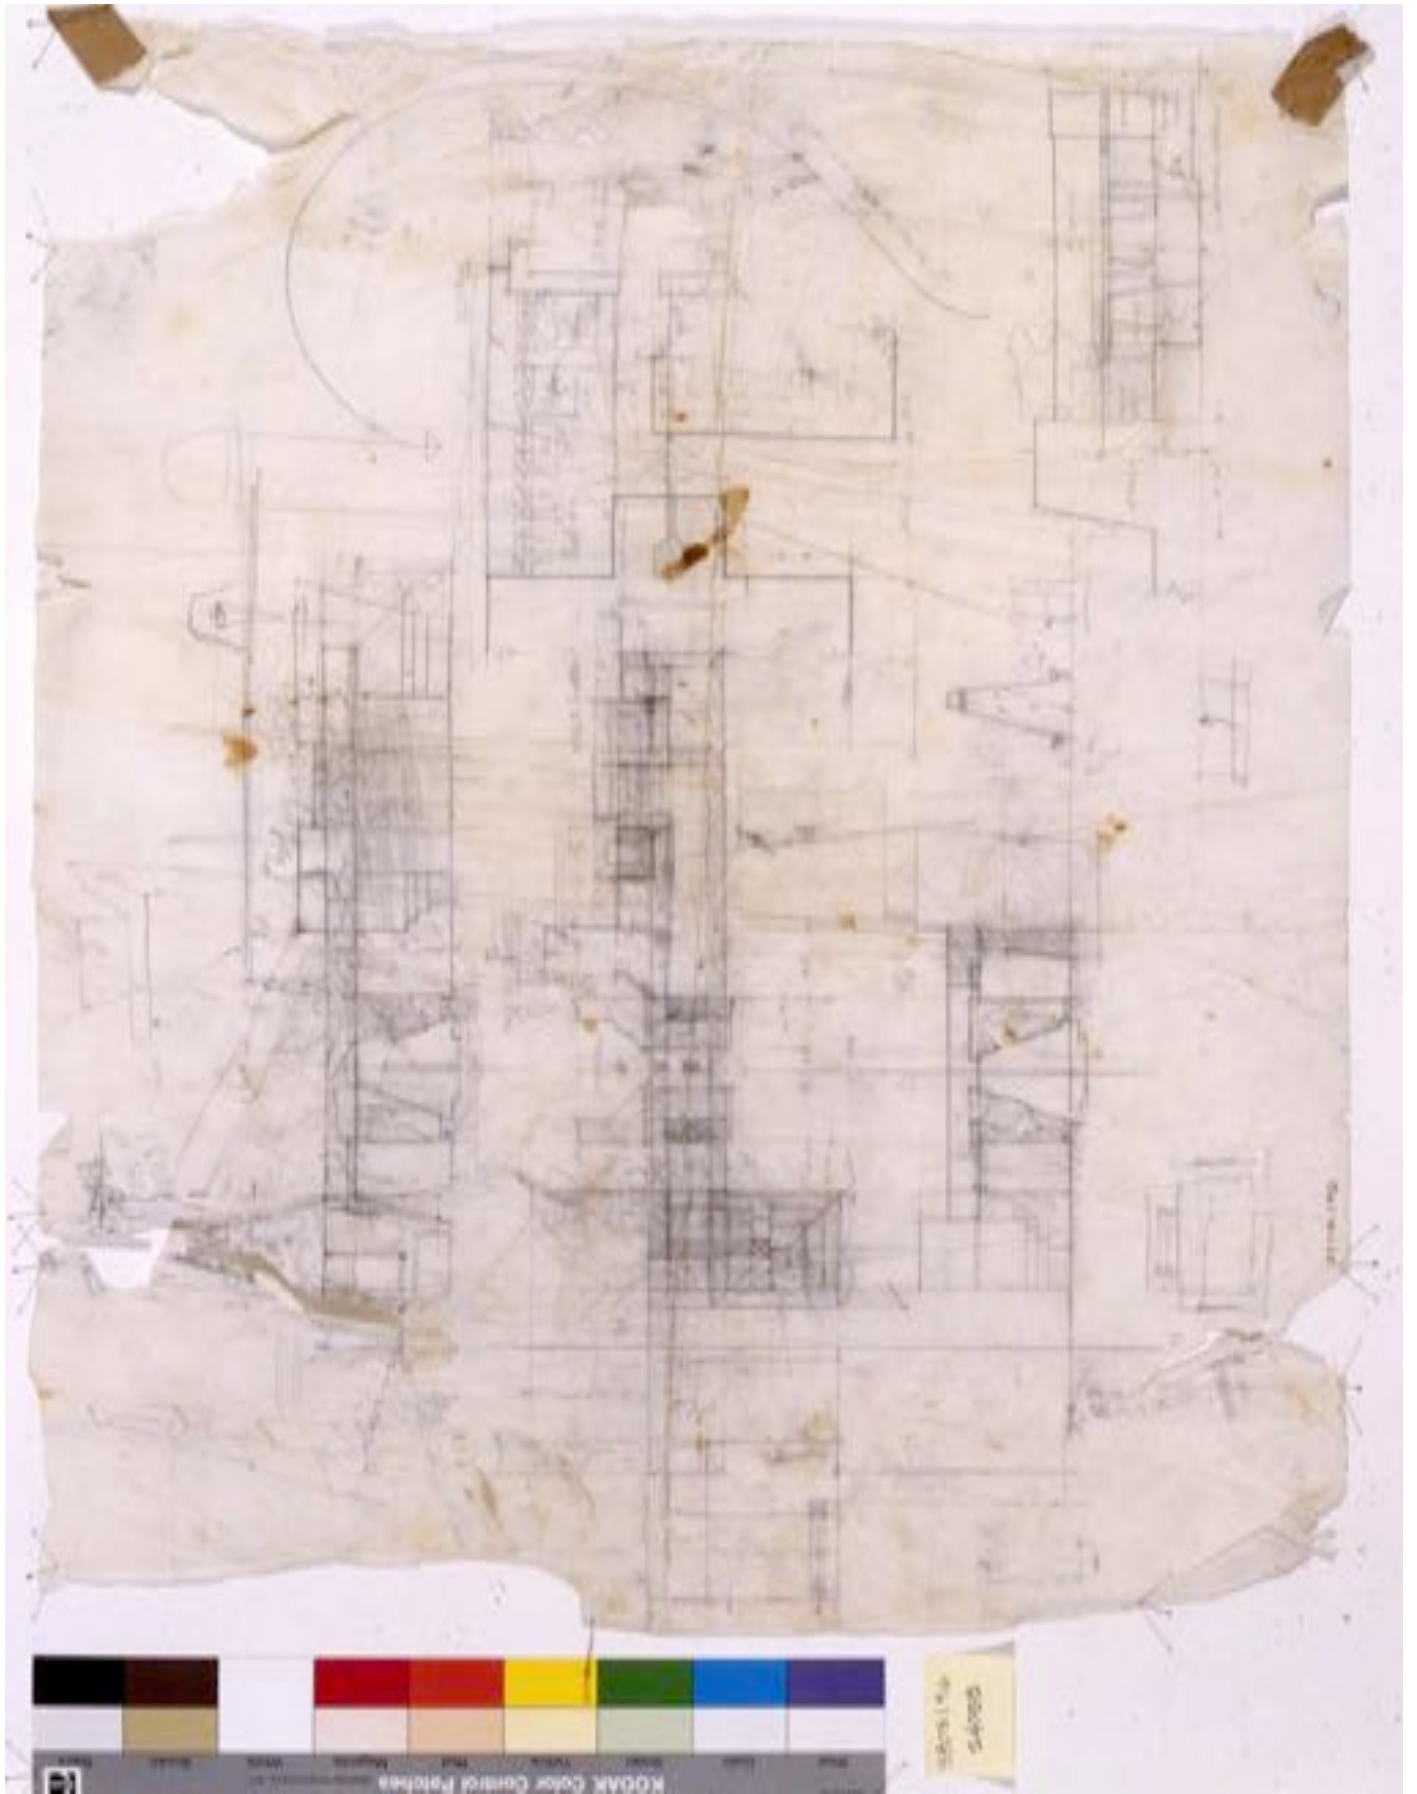
Figure B-196 - Bridge at House/Kiva (The Frank Lloyd Wright Foundation Archives, The Museum of Modern Art | Avery Architectural & Fine Arts Library, Columbia University, New York).

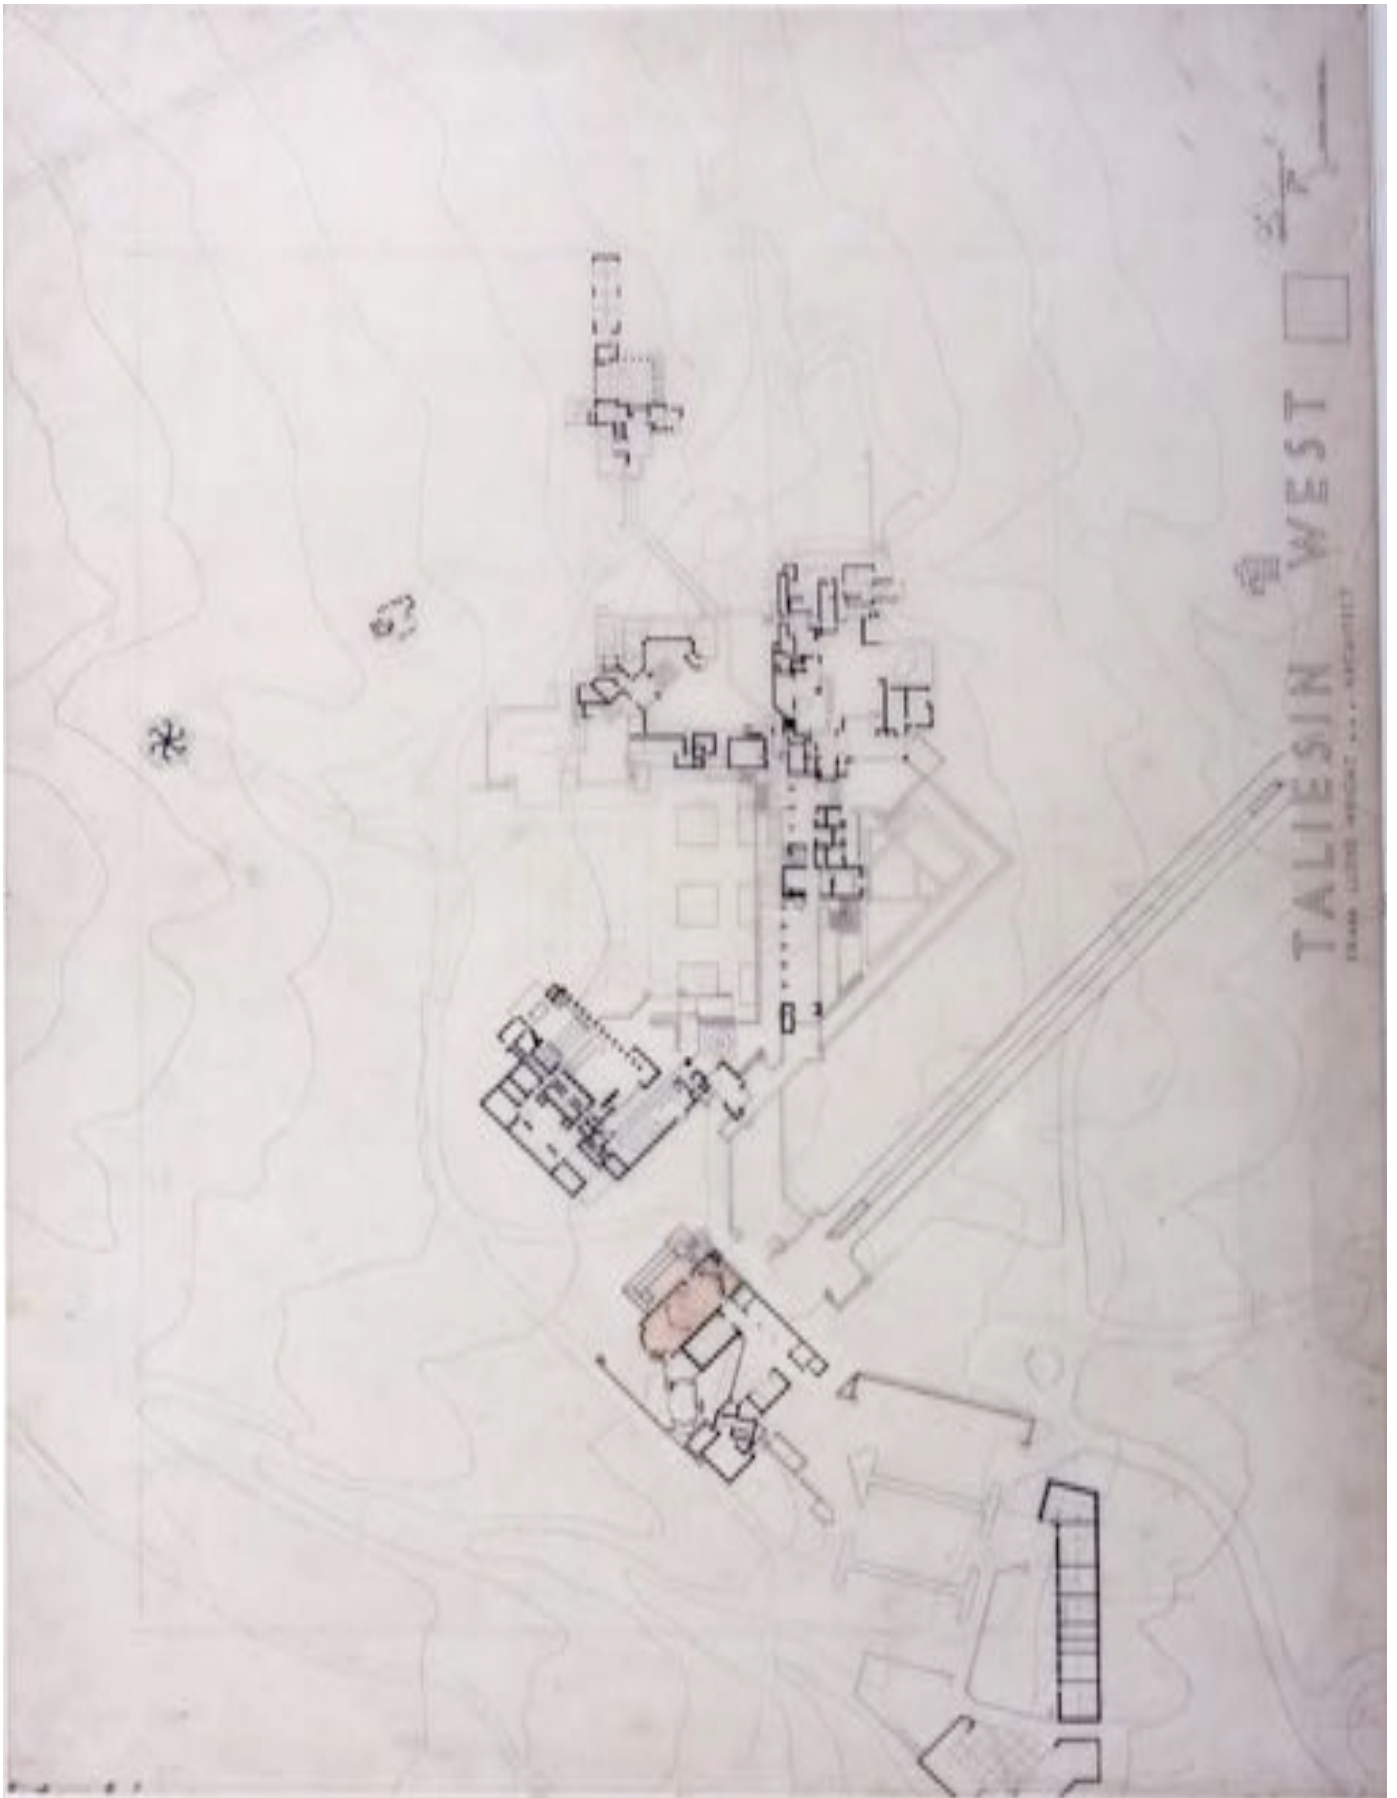
Figure B-204 - Publication Plan (The Frank Lloyd Wright Foundation Archives, The Museum of Modern Art | Avery Architectural & Fine Arts Library, Columbia University, New York).

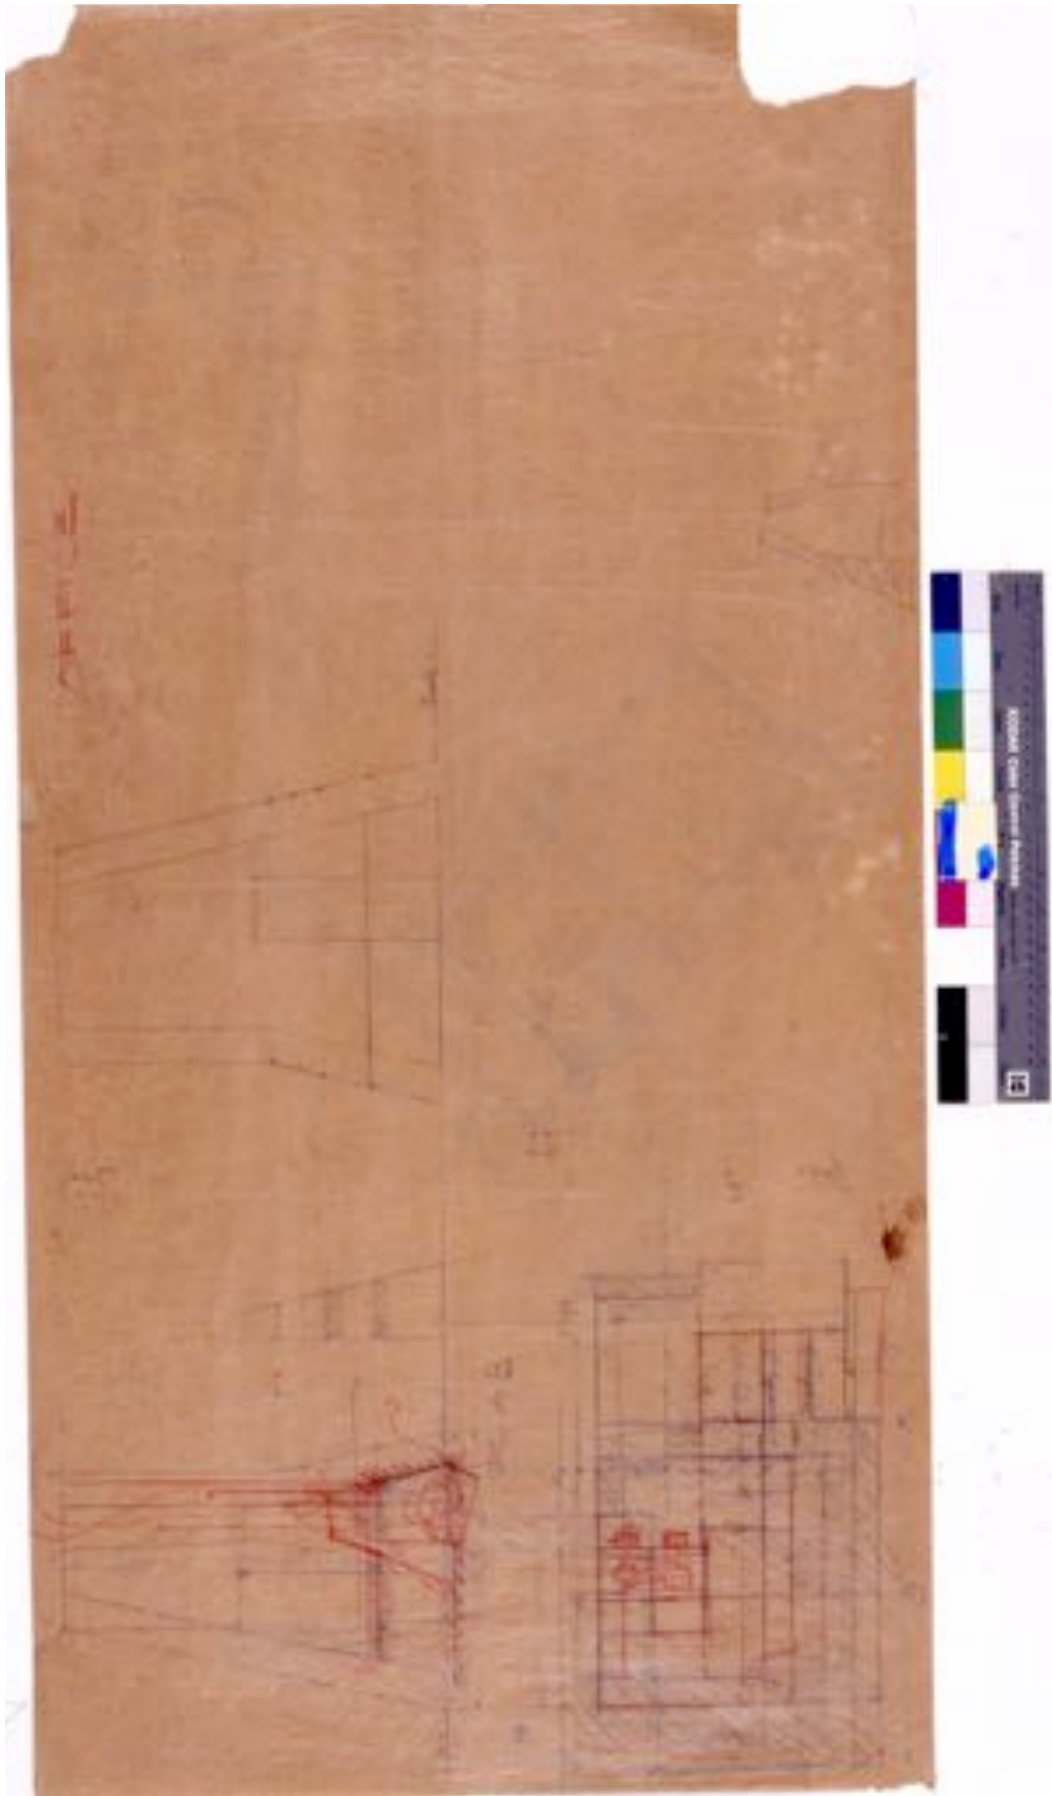
Figure B-206 - Office/Terrace/Plan (The Frank Lloyd Wright Foundation Archives, The Museum of Modern Art | Avery Architectural & Fine Arts Library, Columbia University, New York).
