TALIESIN WEST PRESERVATION MASTER PLAN

Harboe Architects, PC

MAY 21, 2015

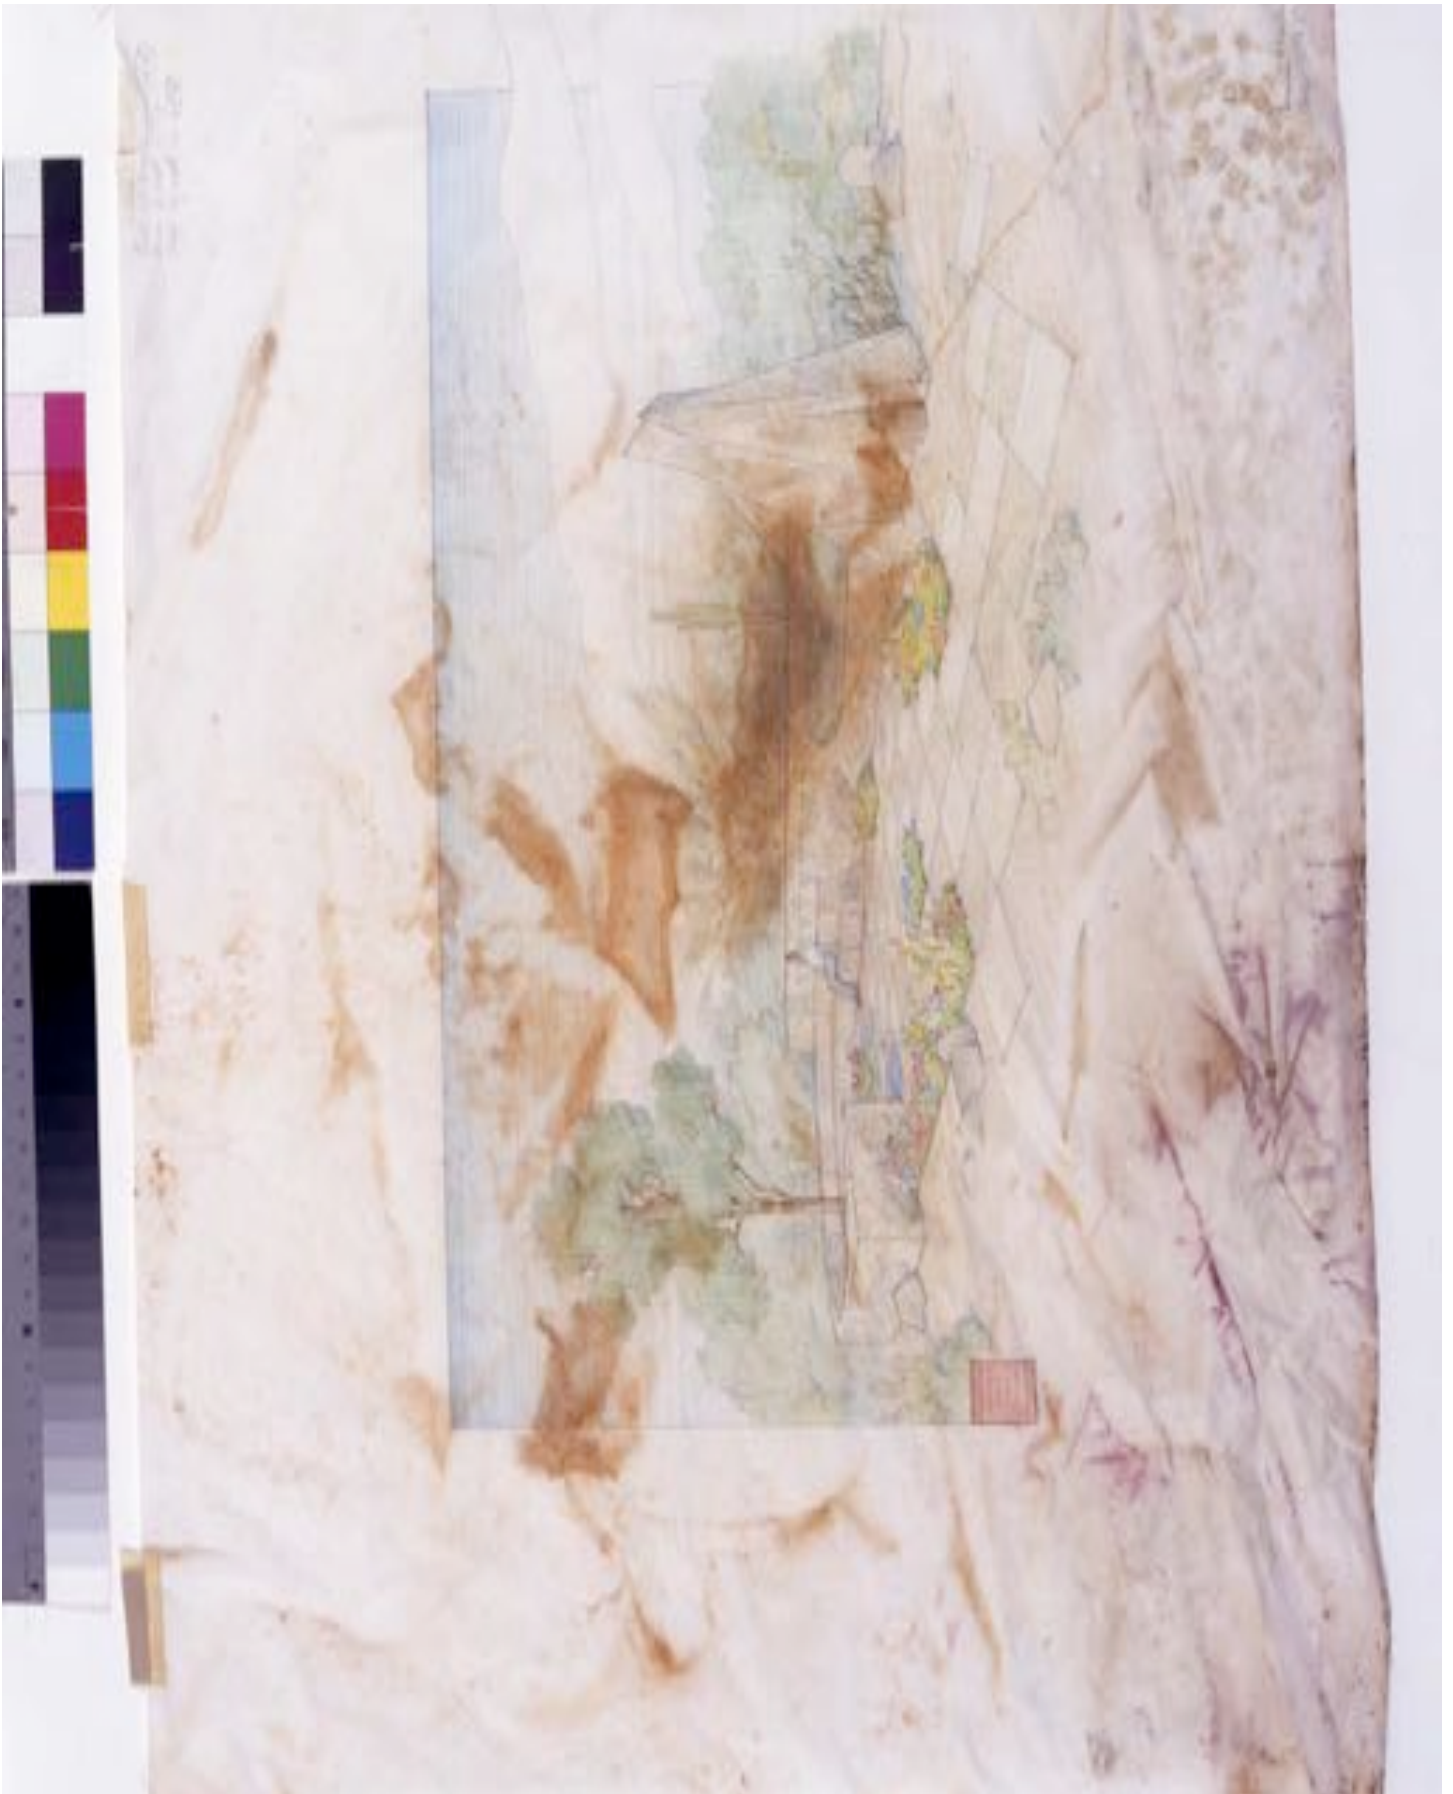
Figure B-207 - FLLW/OLLW Memorial (The Frank Lloyd Wright Foundation Archives, The Museum of Modern Art | Avery Architectural & Fine Arts Library, Columbia University, New York).

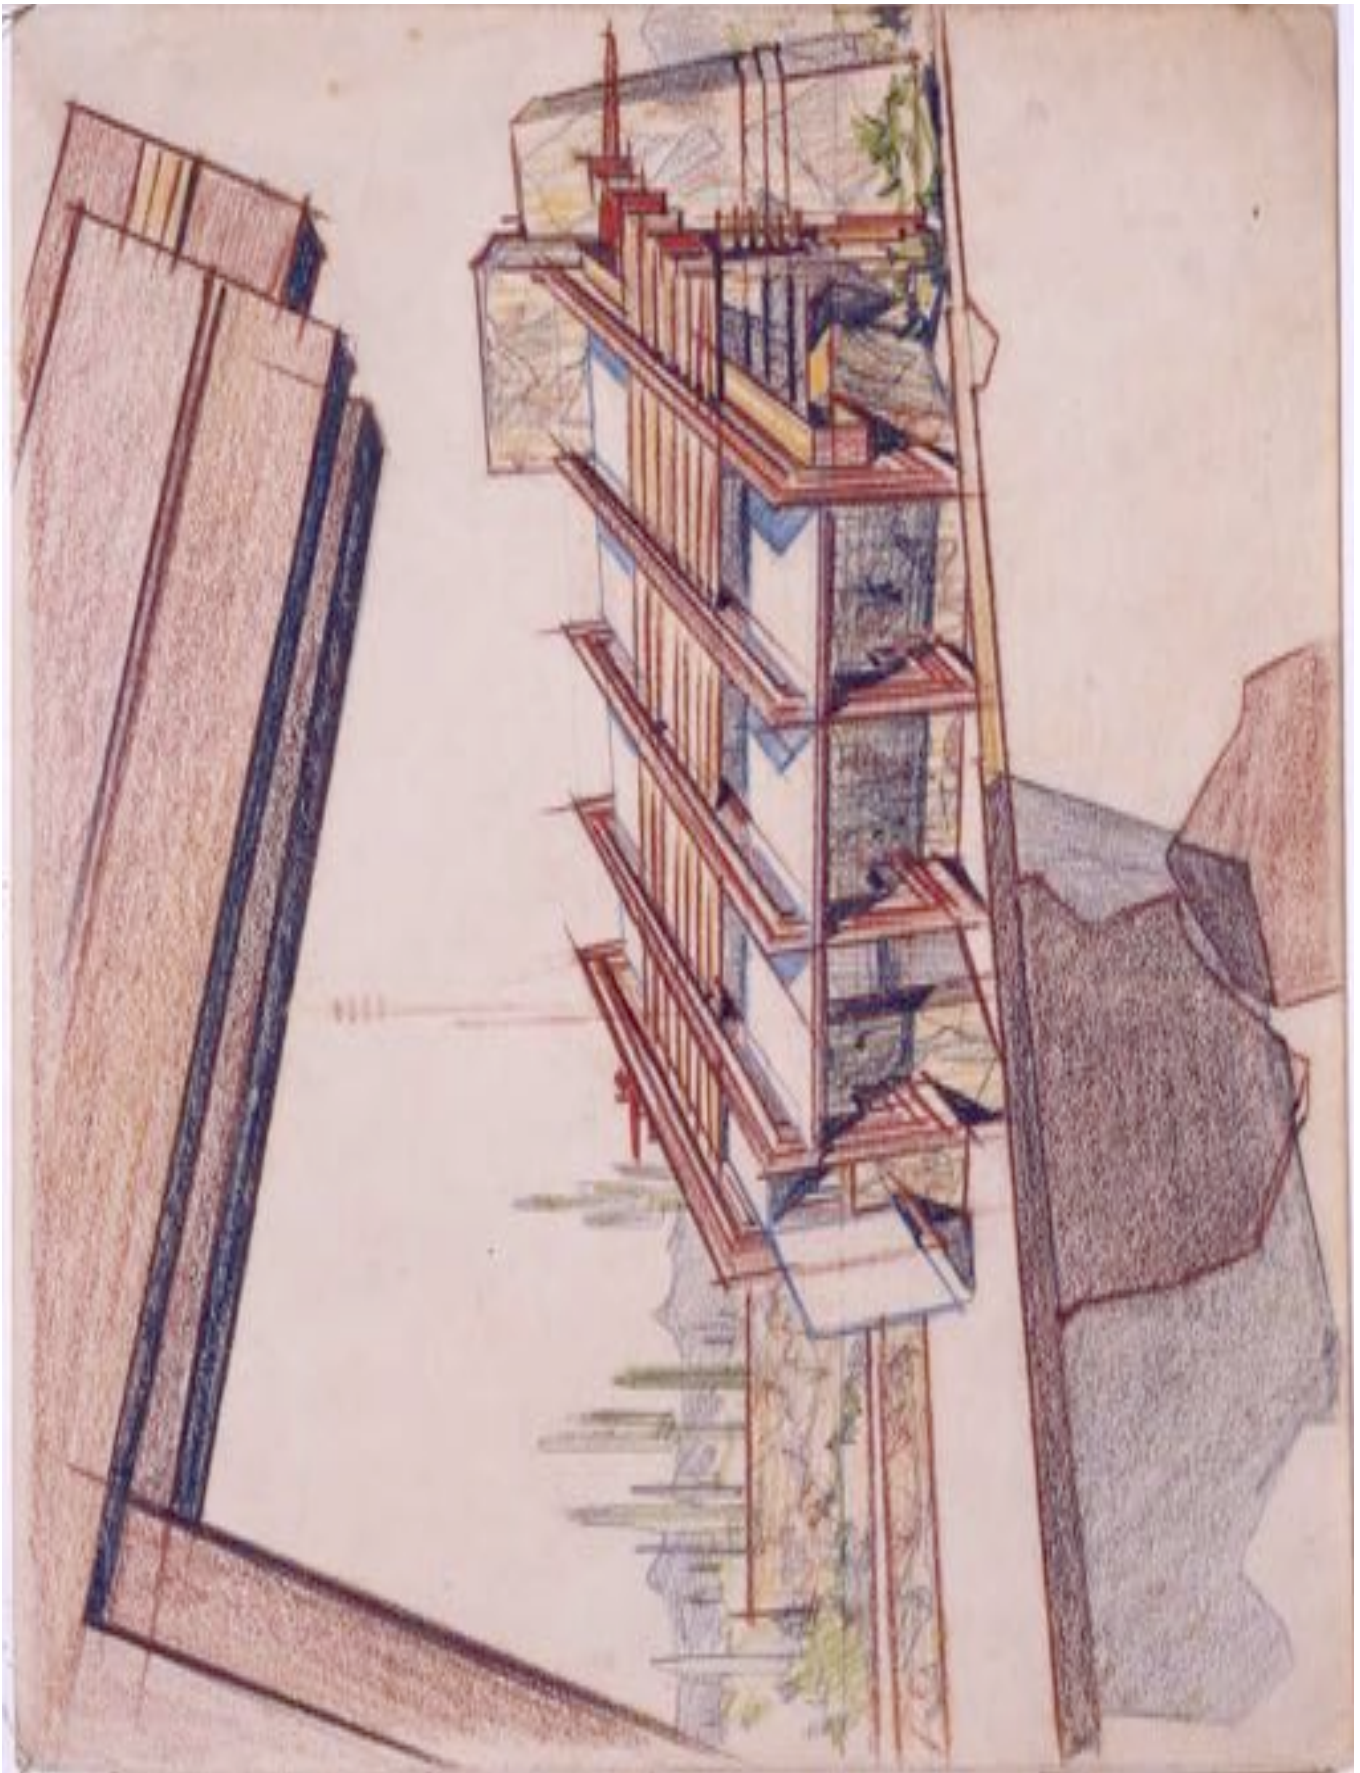
Figure B-208 - Rendering of Office by Jim Thompson (The Frank Lloyd Wright Foundation Archives, The Museum of Modern Art | Avery Architectural & Fine Arts Library, Columbia University, New York).

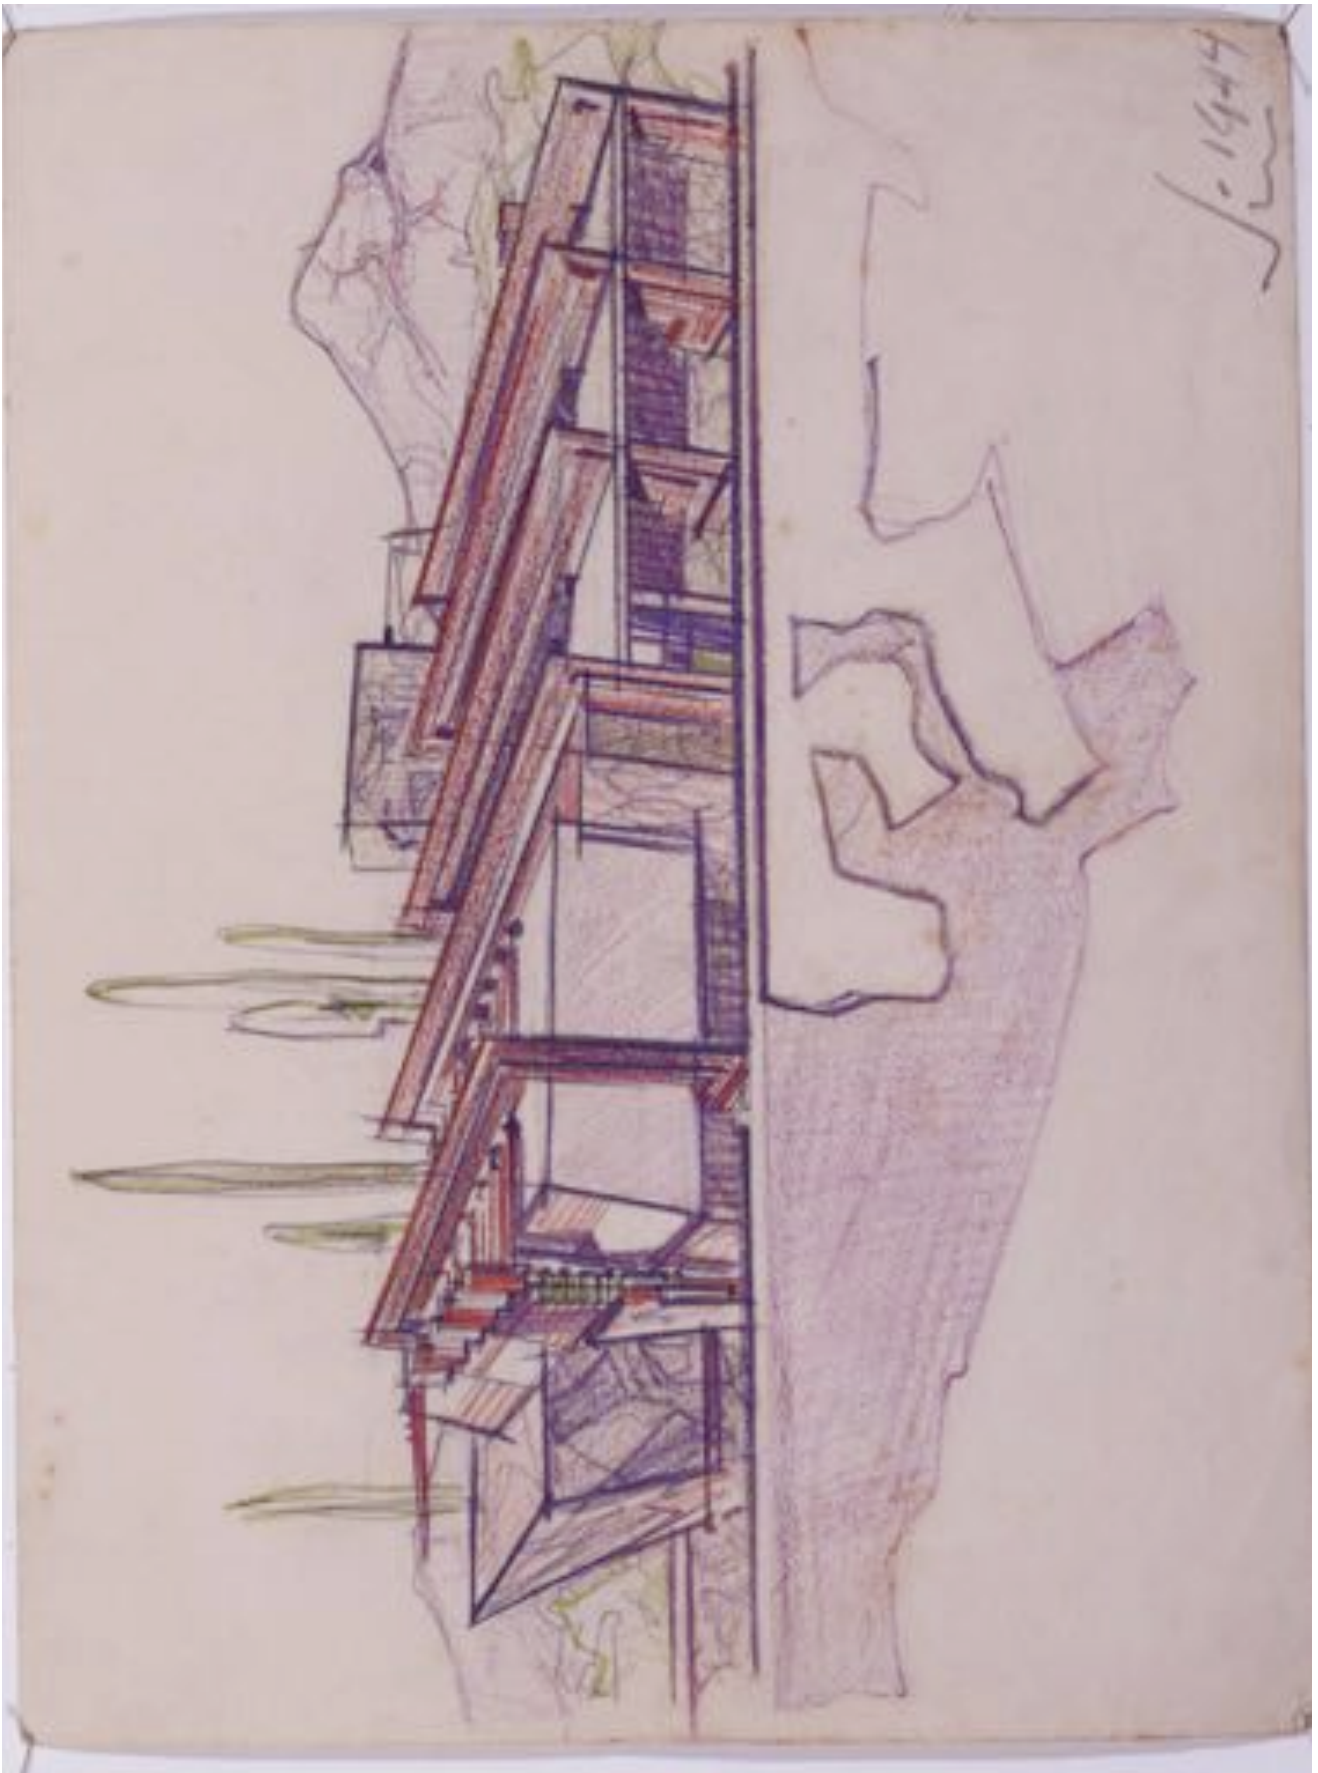
Figure B-209 - Rendering of Office by Jim Thompson (The Frank Lloyd Wright Foundation Archives, The Museum of Modern Art | Avery Architectural & Fine Arts Library, Columbia University, New York).

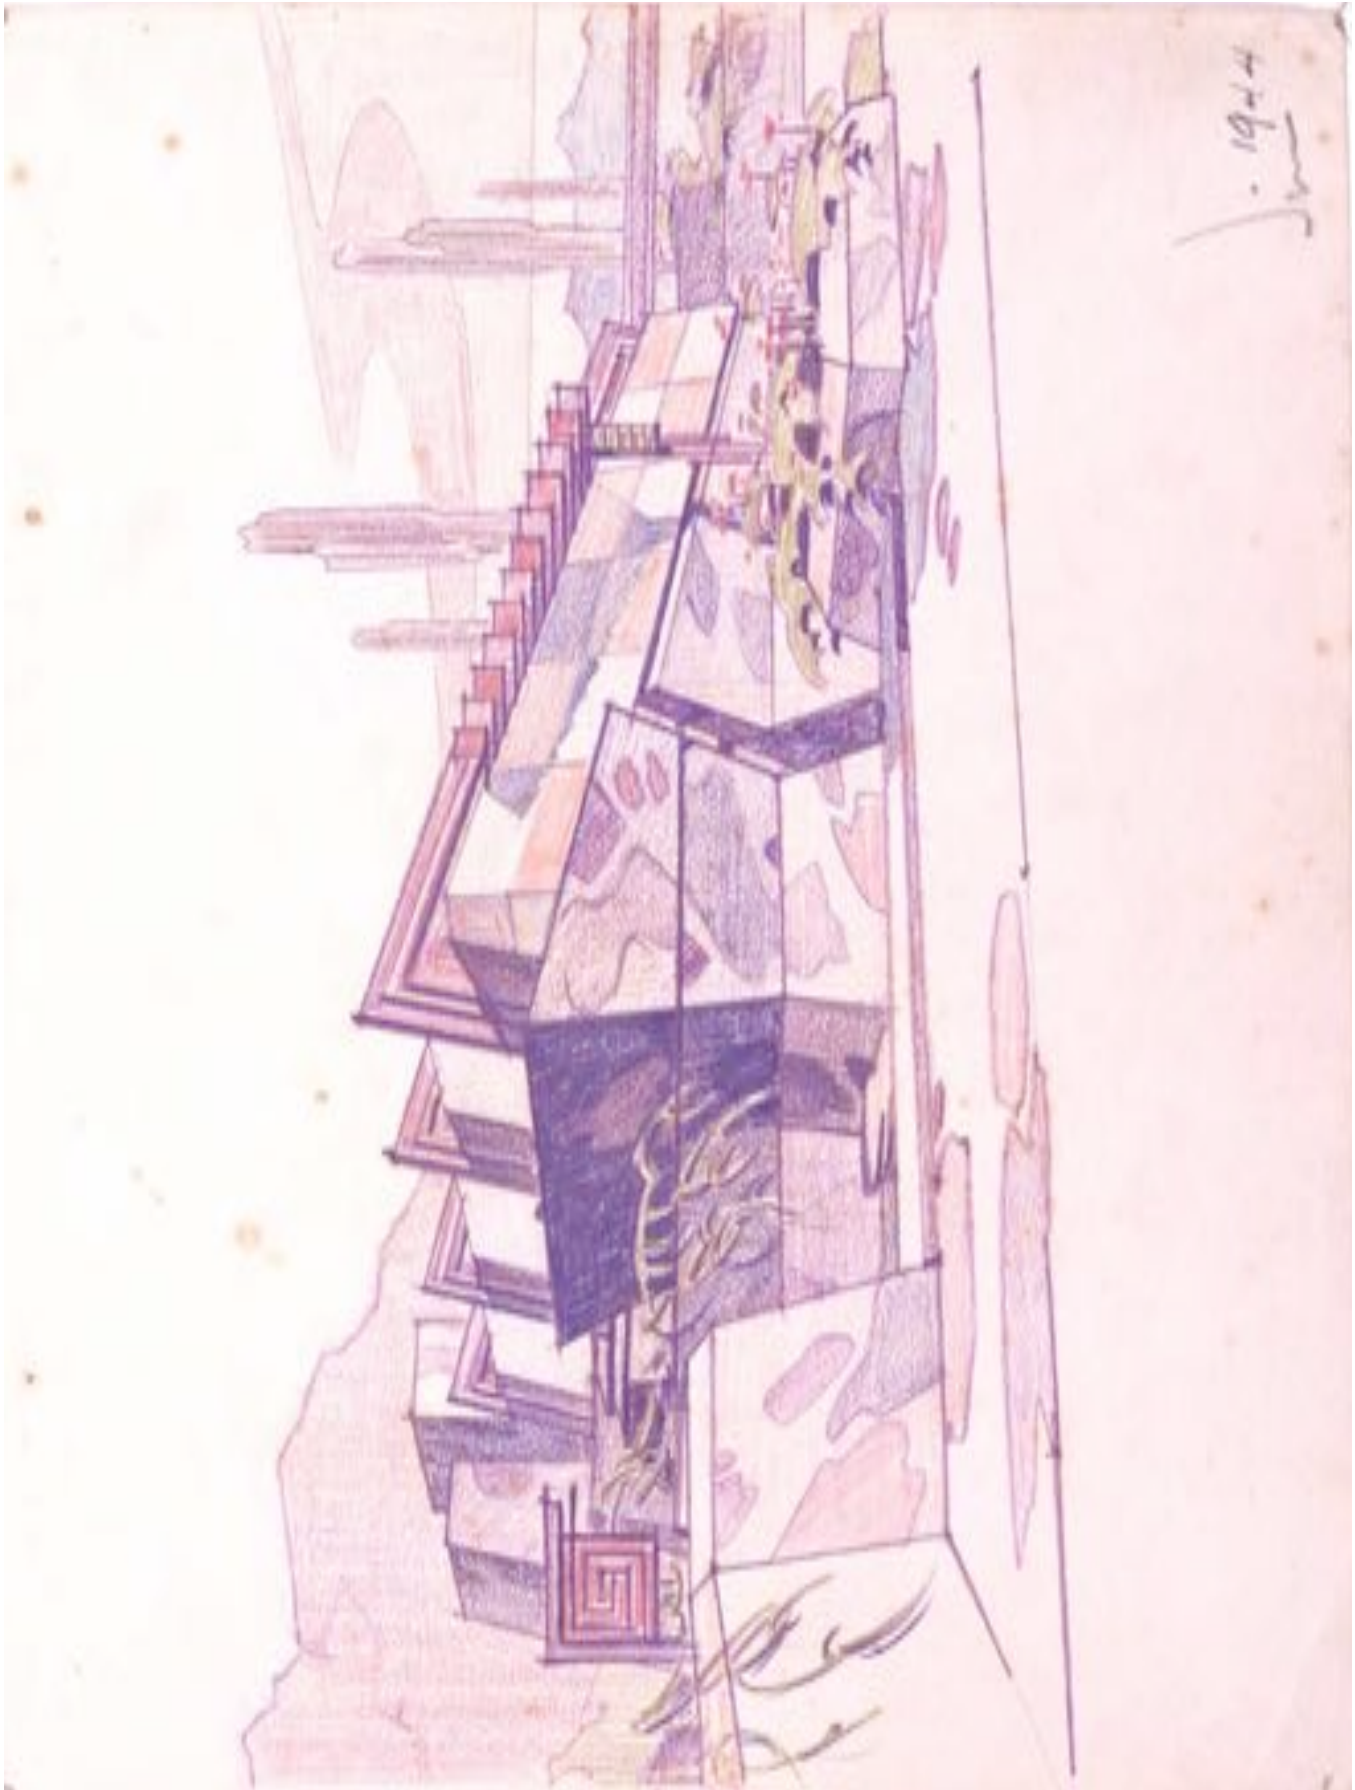
Figure B-210 - Rendering of Office by Jim Thompson (The Frank Lloyd Wright Foundation Archives, The Museum of Modern Art | Avery Architectural & Fine Arts Library, Columbia University, New York).

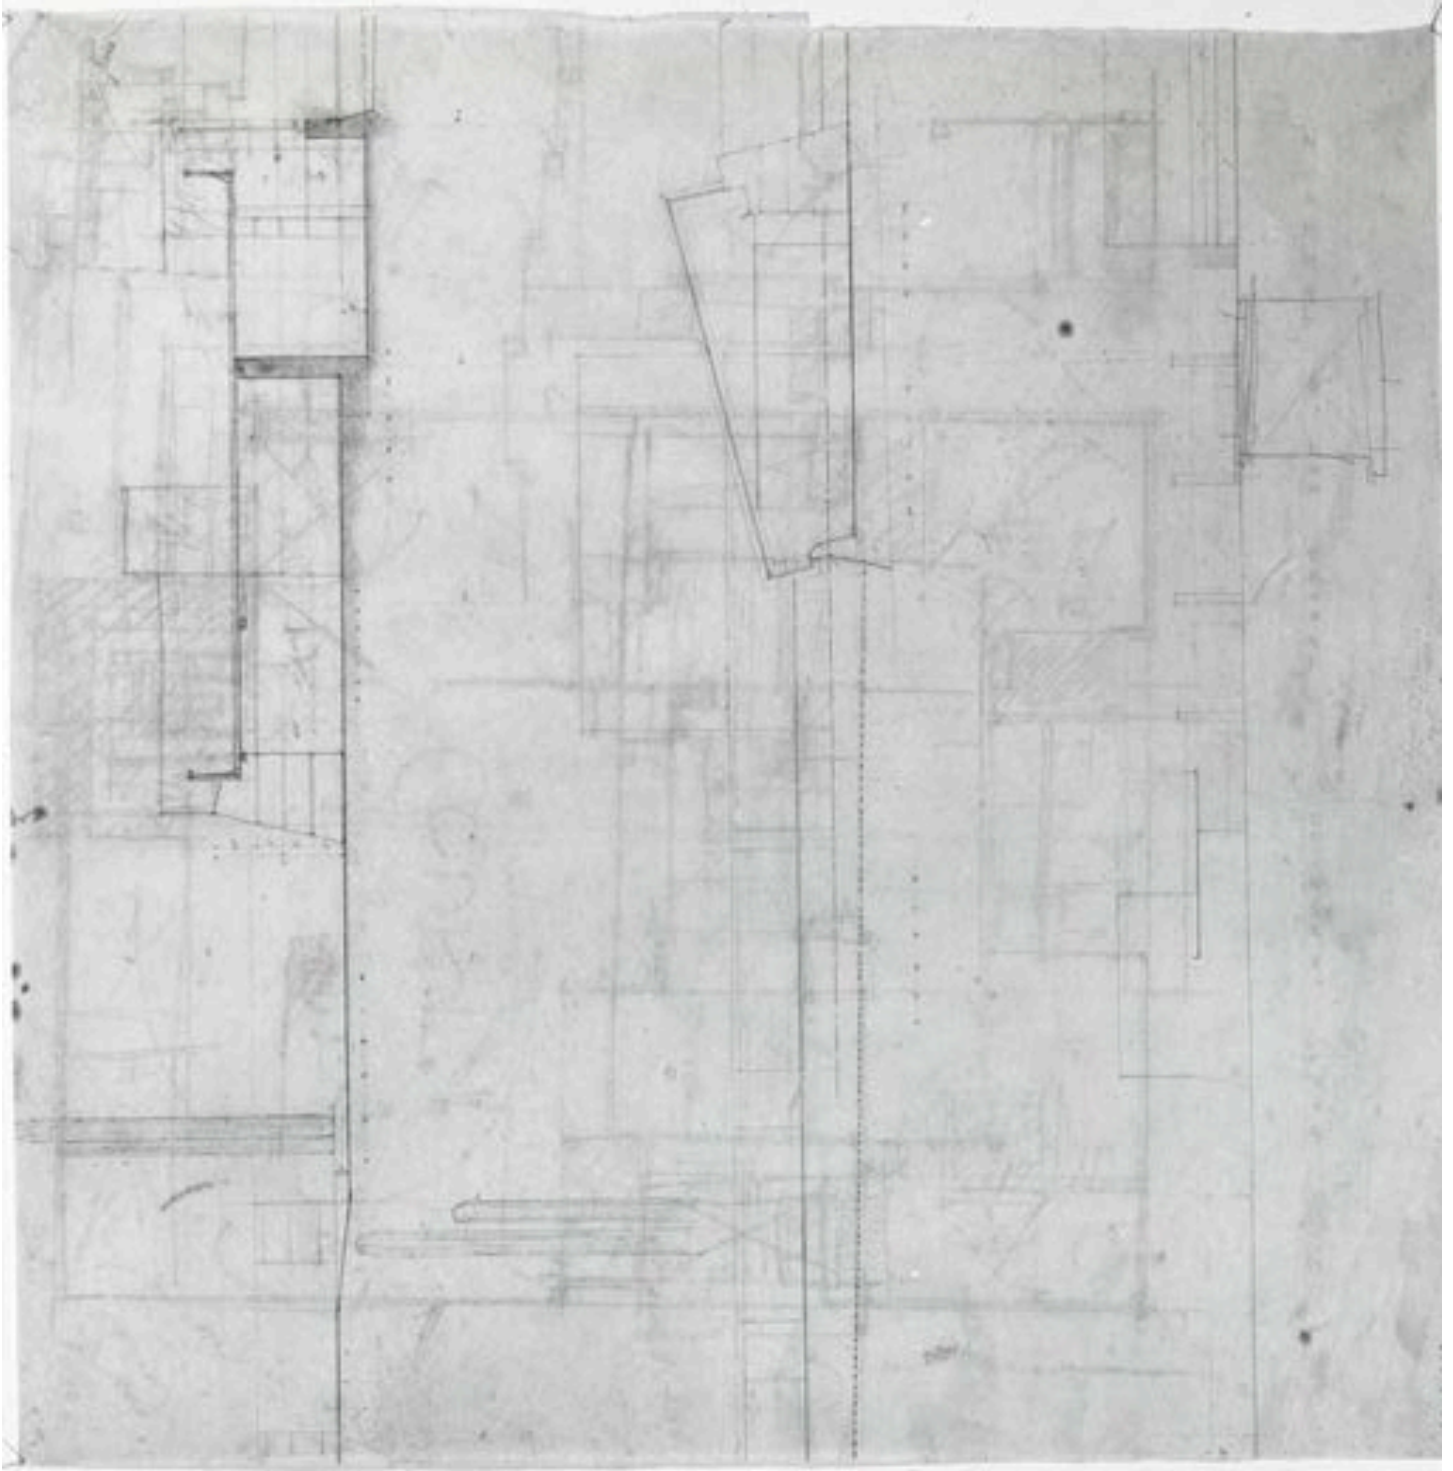
Figure B-219 - Section & Elevations (The Frank Lloyd Wright Foundation Archives, The Museum of Modern Art | Avery Architectural & Fine Arts Library, Columbia University, New York).
