TALIESIN WEST PRESERVATION MASTER PLAN

ABRIDGED VERSION

Harboe Architects, PC

OCTOBER 9, 2015

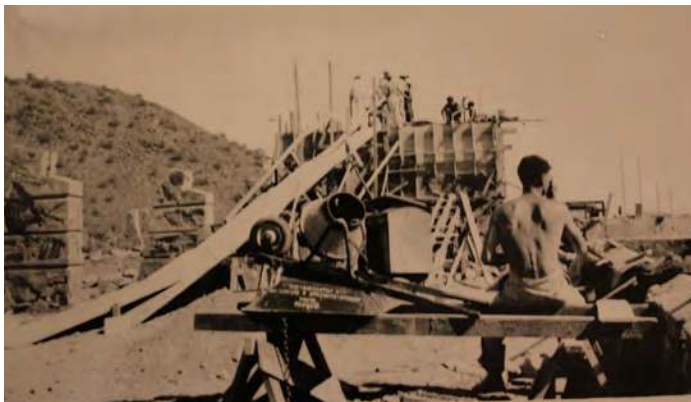
Figure 6-5 - Construction of Kitchen and Drafting Studio, ca 1938 (The Frank Lloyd Wright Foundation Archives, The Museum of Modern Art | Avery Architectural & Fine Arts Library, Columbia University, New York).

Construction began in 1938 and continued into 1941 for these core buildings. The first structure to be built was the vault at the northwest end of the studio. The completion of the vault was crucial, as it was to hold the drawings being completed for all of Wright's architectural projects at the time. The walls of the vault were constructed of what Wright initially termed "desert rubble stone" but eventually came to be known as simply "desert masonry". Wright devised a way to use the abundant native stone around the site mixed with a dry cement mix to construct thick, solid walls to enclose the buildings he designed. What began in the vault quickly became the architectural vocabulary for the structures throughout the rest of the camp.⁵ The buildings were literally made of the desert.

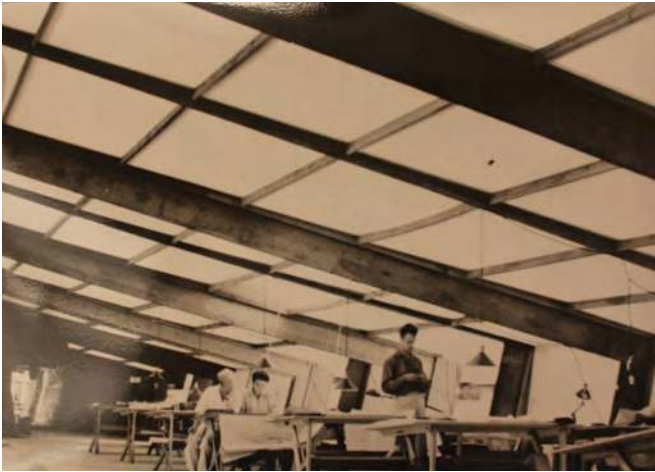
Figure 6-7 - Canvas roof overhead in Drafting Studio, ca. 1939 (The Frank Lloyd Wright Foundation Archives, The Museum of Modern Art | Avery Architectural & Fine Arts Library, Columbia University, New York).

The operable canvas panels were supported on built-up redwood framing members that rested on desert masonry piers and walls. They were opened and closed with a system of ropes and pulleys to let the natural breezes of the desert flow through. Wright continuously modified the canvas roofs, trying to find the best method for construction. The design was changed almost yearly not only because of Wright's desire for perfection in the system, but also because the wood and canvas did not last long in the harsh desert climate in the summertime. This is why the panels were removed and stored for the summer in the first few years at Taliesin West. Wright would continue to experiment with new techniques and materials up until his death in 1959. After that the Fellowship continued to experiment with the roof system first changing the material from canvas fabric to fiberglass – and eventually acrylic – in an effort to improve performance while still maintaining a level translucency.¹⁰

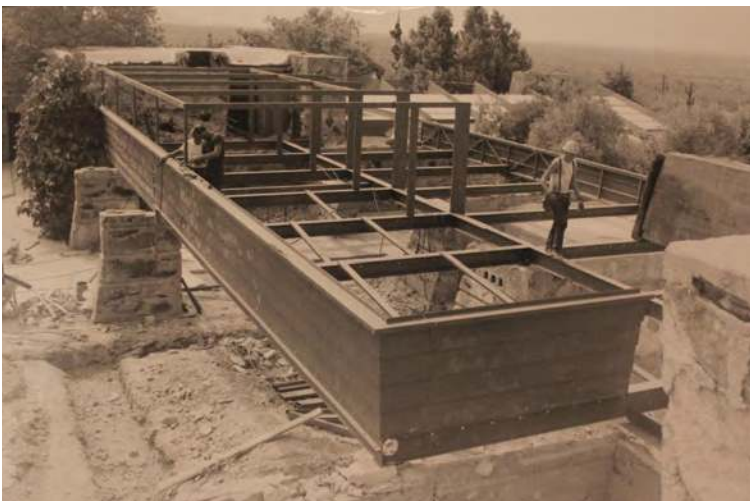
Figure 6-17 - Reconstruction of the Guest Deck in 1970 (The Frank Lloyd Wright Foundation Archives, The Museum of Modern Art | Avery Architectural & Fine Arts Library, Columbia University, New York).

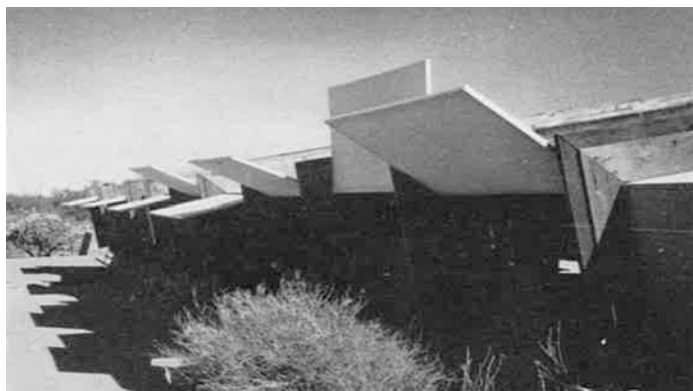
Figure 8-3 - Operable canvas panels on the Drafting Studio, ca. 1939 (The Frank Lloyd Wright Foundation Archives, The Museum of Modern Art | Avery Architectural & Fine Arts Library, Columbia University, New York).
